HIGHLAND & ISLANDS FIRE BOARD

Stornoway Fire Station

STORNOWAY FIRE STATION INSPECTION REPORT

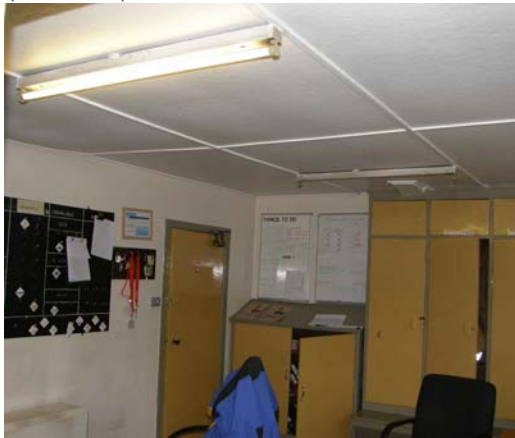
01 - Watch Room lighting

item no.	item	details & recommendations	applicable legislation
01	Watch Room lighting	<p><i>The two florescent lights had missing tubes and no diffusers. This would be an important place of work during incidents and requires lighting to be suitable and sufficient.</i></p> <p><u>Action:</u> Supply and fit two new florescent twin-tube lights c/w diffusers</p>	The Workplace (Health, Safety and Welfare) Regulations 1992, Reg.8
02	Inspection pit in appliance bay	<p><i>This pit is never used and is understood to be permanently waterlogged. It poses an ever-present trip hazard and prevents effective cleaning of the appliance bay floor, especially since the adjacent tiles are cracked and flaking..</i></p> <p><u>Action:</u> Fill the pit to within 200mm of floor level with approx 6.5m³ blinded compacted hardcore and cover with 1200 gauge polythene d.p.m.. Lay 150mm concrete (approx. 0.56m³) with A142 mesh reinforcement. Finish with 225 x 225 x 15mm or nearest equivalent plain natural quarry tiles. (available at 200 x 200 x 20mm from Natural Tiles Ltd, 11 Bryn Siriol, Flint, Flintshire</p>	The Workplace (Health, Safety and Welfare) Regulations 1992, Reg.12(2)(a) and 12(3)

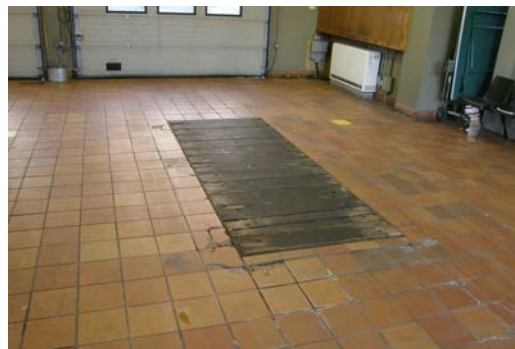
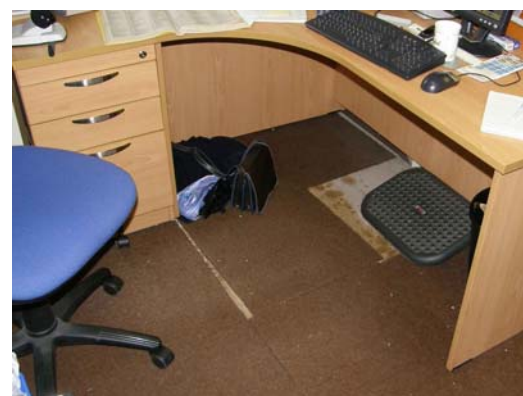
03 – District Office flooring

CH6 5JB, or 194 x 194 x 25mm from Dennis Ruabon Tiles Ltd, Hafod Tileries, Ruabon, Wrexham, LL14 6ET)	
03	District Office flooring	<p><i>Trip hazard – carpet tiles breaking loose with one missing.</i></p> <p><u>Action:</u> Either replace with new tiles/carpeting since this is likely to be a recurring issue, or at the very least glue down loose tiles and take one from under a filing cabinet to replace the missing tile.</p>	The Workplace (Health, Safety and Welfare) Regulations 1992, Reg.12(2)(a)
04	District Office entrance lighting	<p><i>The outside light can only be operated after entering the building. The entrance area is in shadow despite street lights.</i></p> <p><u>Action:</u> Fit a new, more efficient wall-mounted external light with photo-sensitive PIR switch.</p>	The Workplace (Health, Safety and Welfare) Regulations 1992, Reg. 8(1)
05	Equipment and PPE storage	<p><i>Poor ventilation and inadequate heating in the drying room and offshore store are likely to result in early deterioration of equipment. Wet fire-fighting gear is understood to be damp even after a week in the drying room.</i></p> <p><u>Action:</u> Install a storage heater in the offshore equipment store. Change the storage heater in the drying room for a combined convector/storage heater with increased output. Fit a dehumidifier in the drying room.</p>	<p>The Provision and Use of Work Equipment Regulations (PUWER) 1998, Reg.5</p> <p>The Personal Protective Equipment at Work Regulations 1992, Reg.8</p>

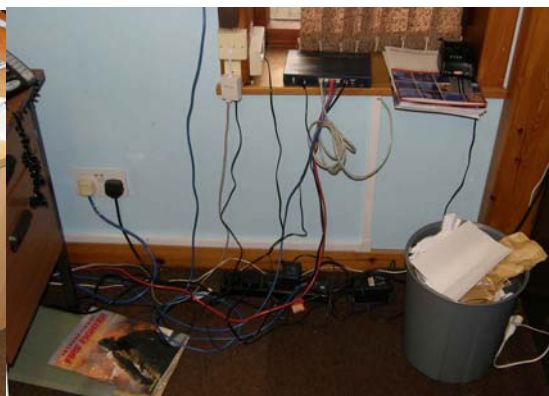
06 – Cables in District Office

06	Electrical safety – District Office	<p><i>Reliance on twin 13 amp low-level sockets has resulted in a plethora of cables and adaptors with the increase in the number of workstations.</i></p> <p>Install electrical cable trunking at dado rail level and provide power, telecom and p.c. sockets at the three workstations.</p>	The Electricity at Work Regulations 1989
07	Emergency lighting throughout	<p><i>In the event of a power failure there are two significant issues. Firstly, retained crews arriving</i></p>	<p>The Fire (Scotland) Act 1995</p> <p>The Fire Safety (Scotland)</p>
