**ANNUAL ROCK SLOPE INSPECTION -
JUNE 2009**

The Highland Council
A890 Stromeferry Bypass

454.1-090519-R1.2-Annual09
August 2009

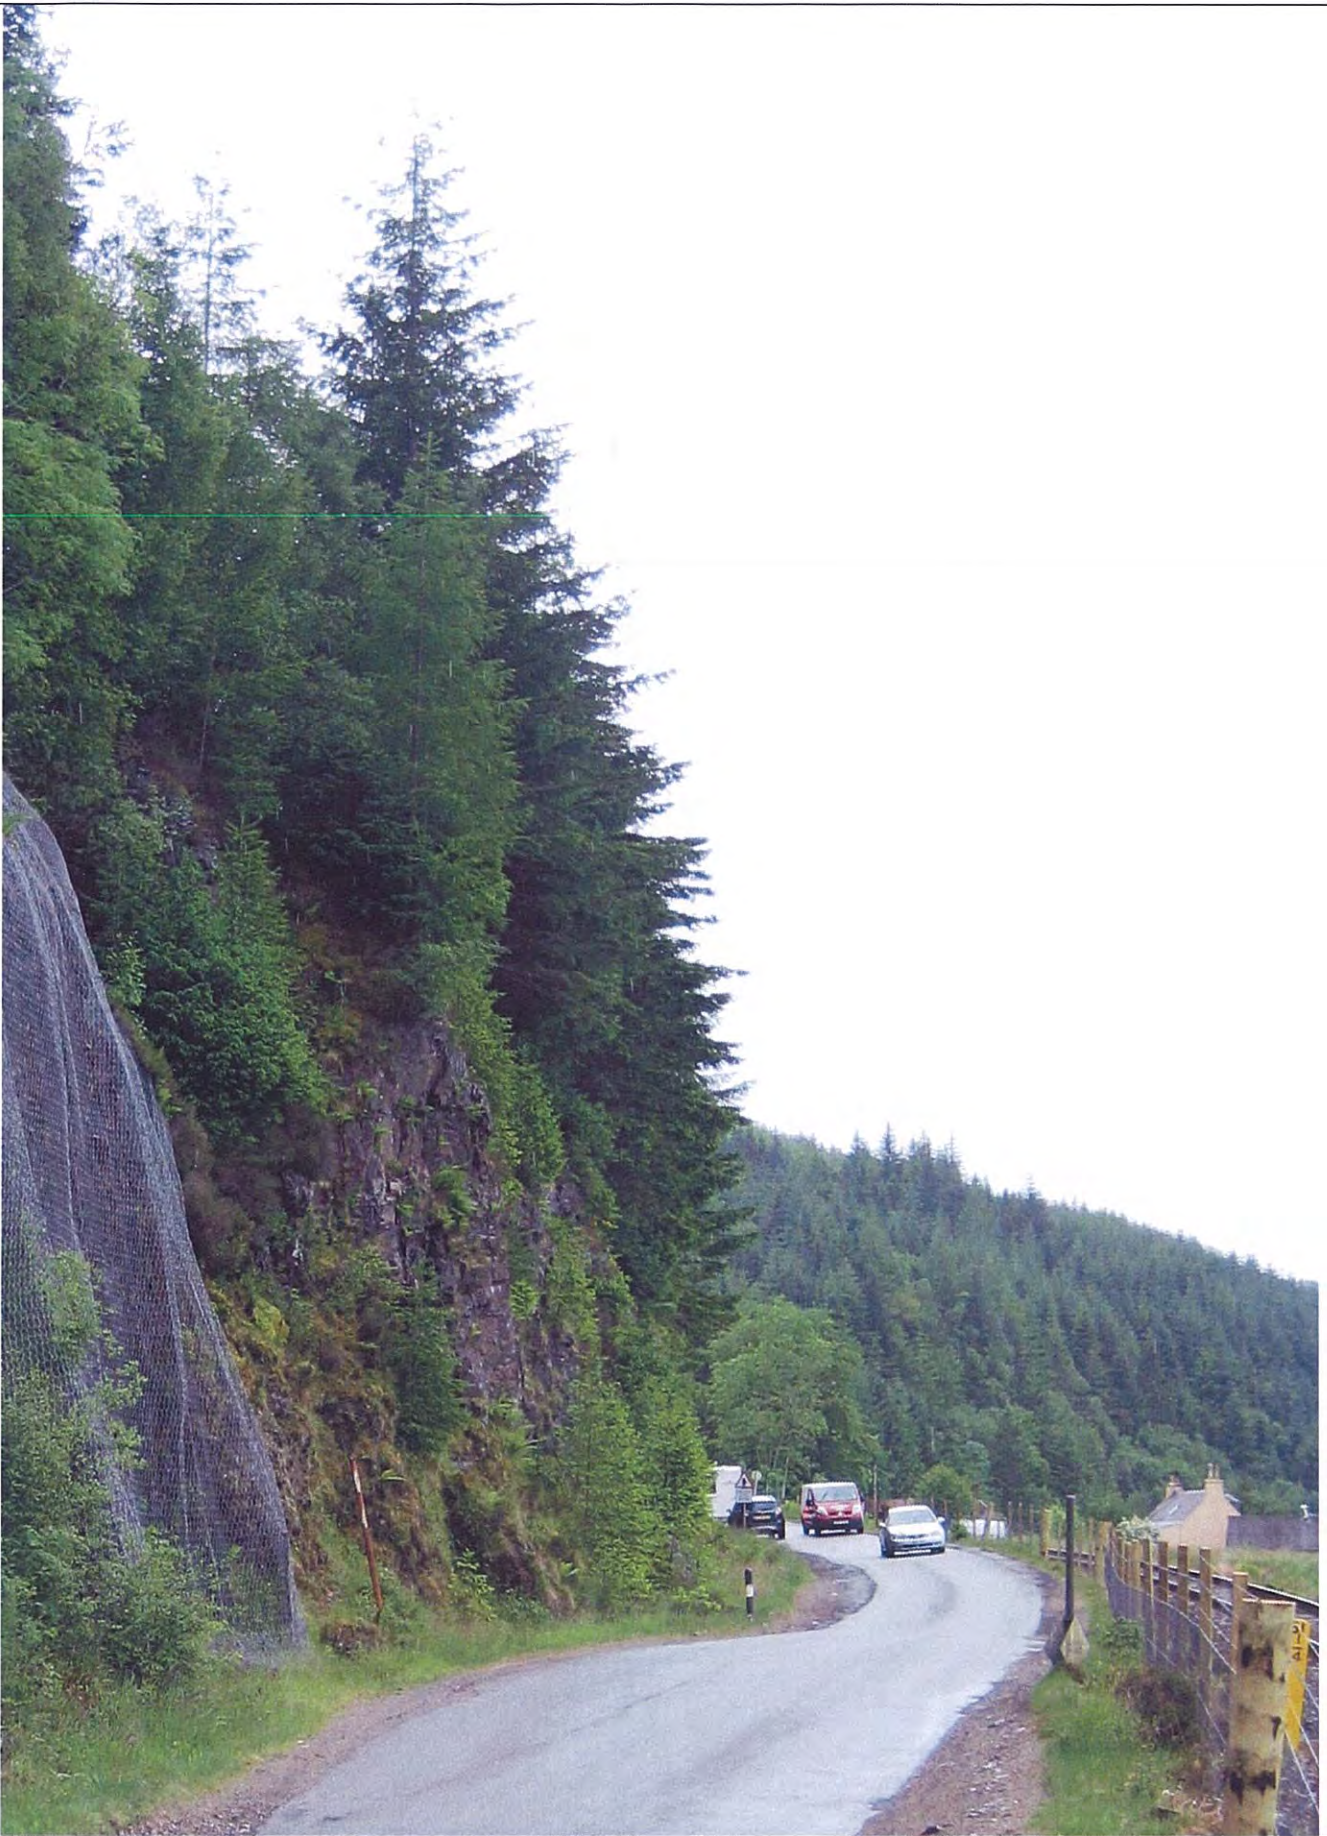
client:	The Highland Council		
approved	N/A		project:	A890 Stromeferry Bypass Annual Inspection June 2009		
date	10th June 2009		title:	Slope AA1		
scale	NTS		project no:	454.1	photograph no:	1
original size	A4

AA1	Chainage: 0023 - 0178	Length: 155m	Height: 10 - 20m
	Grid Ref	Start: NG 89054 35683	Finish: NG 89161 35810
Description of Slope: Natural and excavated rock slope. Forest and forestry track above slope. Ditch (0.5m wide x 0.25m deep).			
Failure Characteristics: General ravelling.			
Existing Remedial Works: 2004: Ditch and culvert cleared.			
Inspection Findings: Ravelling continues, no significant potential failures observed. # 018 Tree at crest of slope with yellow spray paint on trunk on edge of crest. # 024 Tree at crest of slope with yellow spray paint on trunk on edge of crest. # 038 Area of ravelling on face, 4m up, not significant. # 042 2 No. trees on the edge of the crest with small pod of material 1m below. # 063 Small block 200mm x 200mm x 100mm, 8m up – fallen and contained by ditch. # 068 Tree at crest of slope with yellow spray paint on trunk on edge of crest. # 082 Heavy water flow – minor root mass (grass) stripped off face. Possibly due to movements (vehicle) on forestry track above. # 093 Tree at crest of slope with yellow spray paint on trunk on edge of crest. # 127 Tree on edge of crest above rock slope. # 130 Undercut at crest of slope, no signs of deterioration - not significant. # 165 Wedge of weathering schist – deteriorating, but would be contained by ditch. # 168 Culvert clear. Build up of debris in ditch along length of slope.

Current Hazard Index Value: 4			
Remedial / Maintenance Works Required: Remove trees on edge of crest above the rock slope (# 018, 024, 042, 068, 093 and 124). Clear ditch (Annual Maintenance).

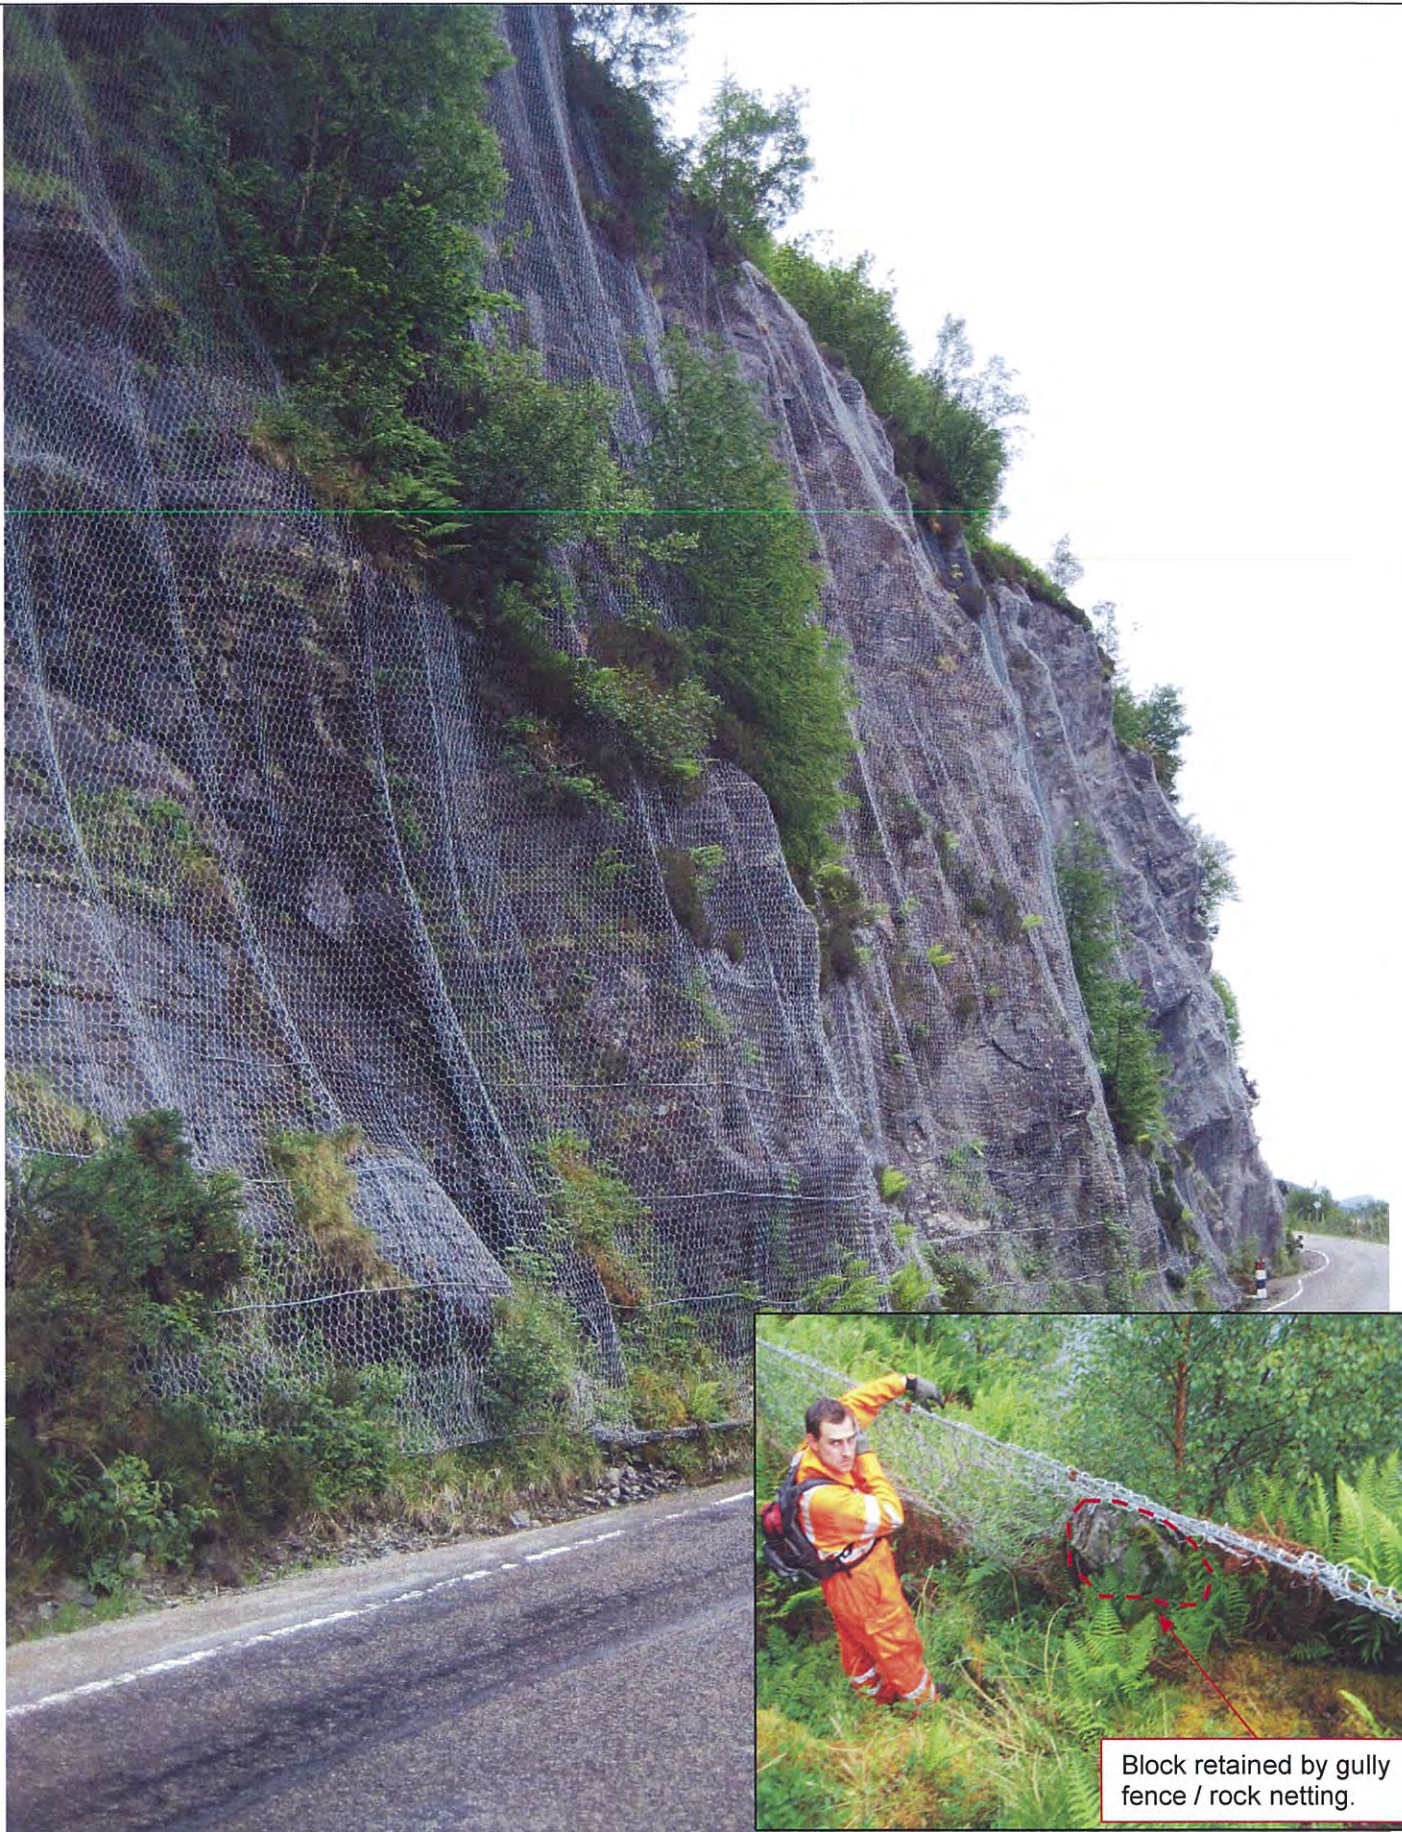
<p>coffey geotechnics SPECIALISTS MANAGING THE EARTH</p>	client:	The Highland Council		
approved	N/A		project:	A890 Strome ferry Bypass Annual Inspection June 2009		
date	10th & 11 th June 2009		title:	Slope AA18		
scale	NTS		project no:	454.1	photograph no:	21
original size	A4

A rockfall occurred on the afternoon of 24th August 2008 from an area above slope AA17 (Ref. 22). The rockfall is believed to have originated from a natural crag located on the upper slopes. The material from the rockfall landed on the road and was cleared from the road by THC. The potential source of the block was identified in October 2008 during the Phase V works. The path taken by the block on the upper slopes was observed during the annual inspection.

Block retained by gully fence / rock netting.

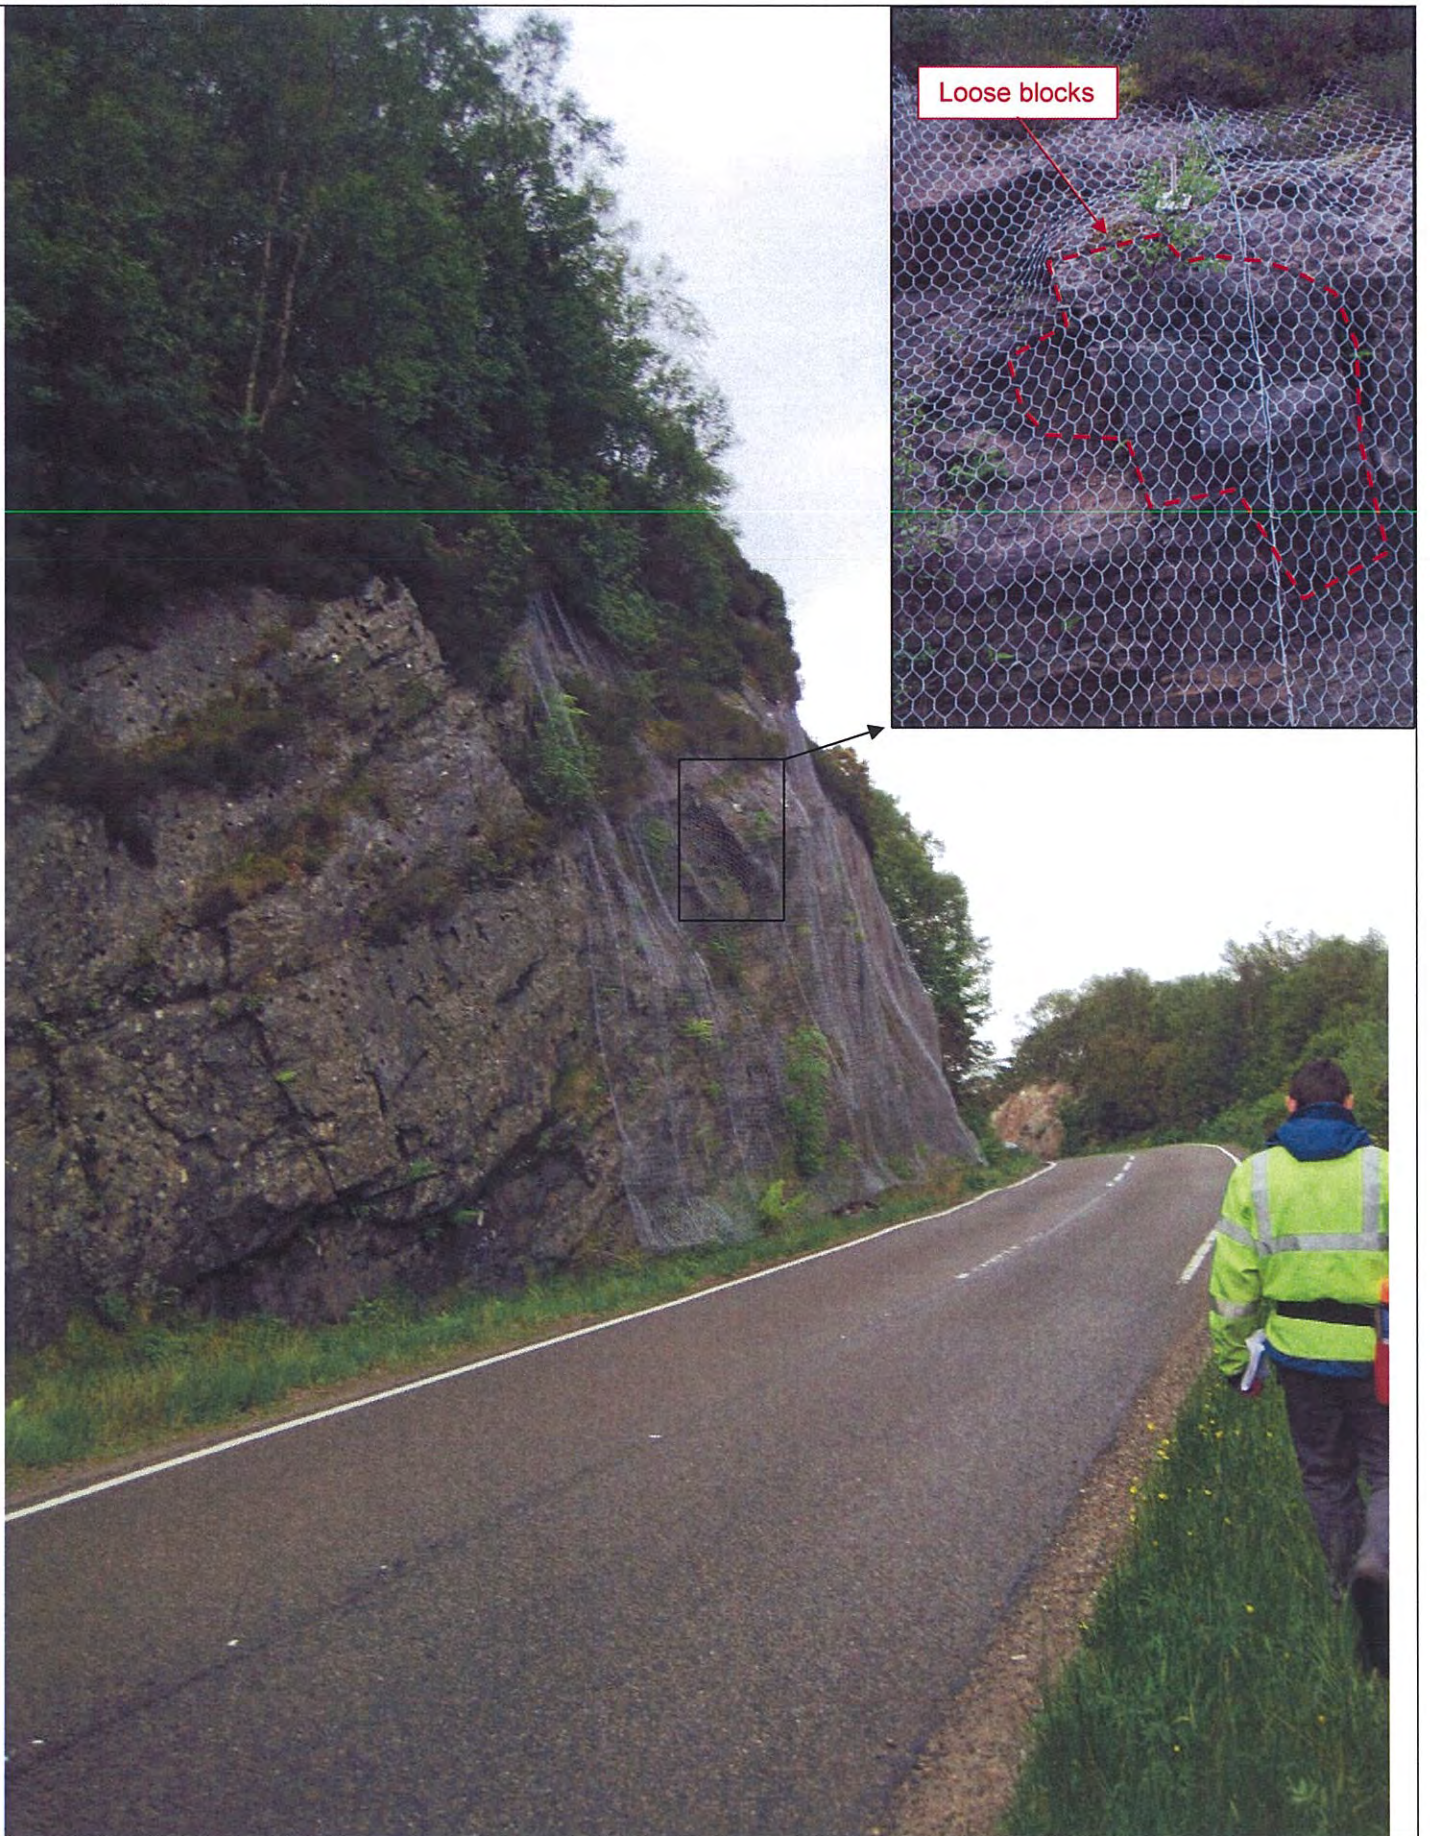
client:	The Highland Council	
project:	A890 Stromeferry Bypass Annual Inspection June 2009	
title:	Slope AA24	
project no: 454.1	photograph no: 29

AA24	3627	<i>Rock debris on corner 2m from end of net. From deterioration of rock nose with bolts. Rock around 2nd last rock bolt looks quite fractured. Easily contained by net. (16th December 2008).</i>	Requires rope access inspection. 0.25m ³ of debris at the toe of the slope. If the fractured material failed it should be contained by the netting.

Slope	Recommendations	Action	Timescale
AA22b	# 3356, 3372 and 3382 – potential failures keep under particular observation during periodic and annual inspections.	THC & Coffey	All inspections
AA24	# 3672 rope access inspection of area of rock fall.	Coffey	Next Phase (VI) of works
AA25, AA26N and AA26S	Slopes not considered a significant hazard. Hence, removed from slope inspection list. Recommend a visual inspection during the Annual Inspections, with reporting only if significant features observed.	Coffey	Annual Inspections (ongoing)

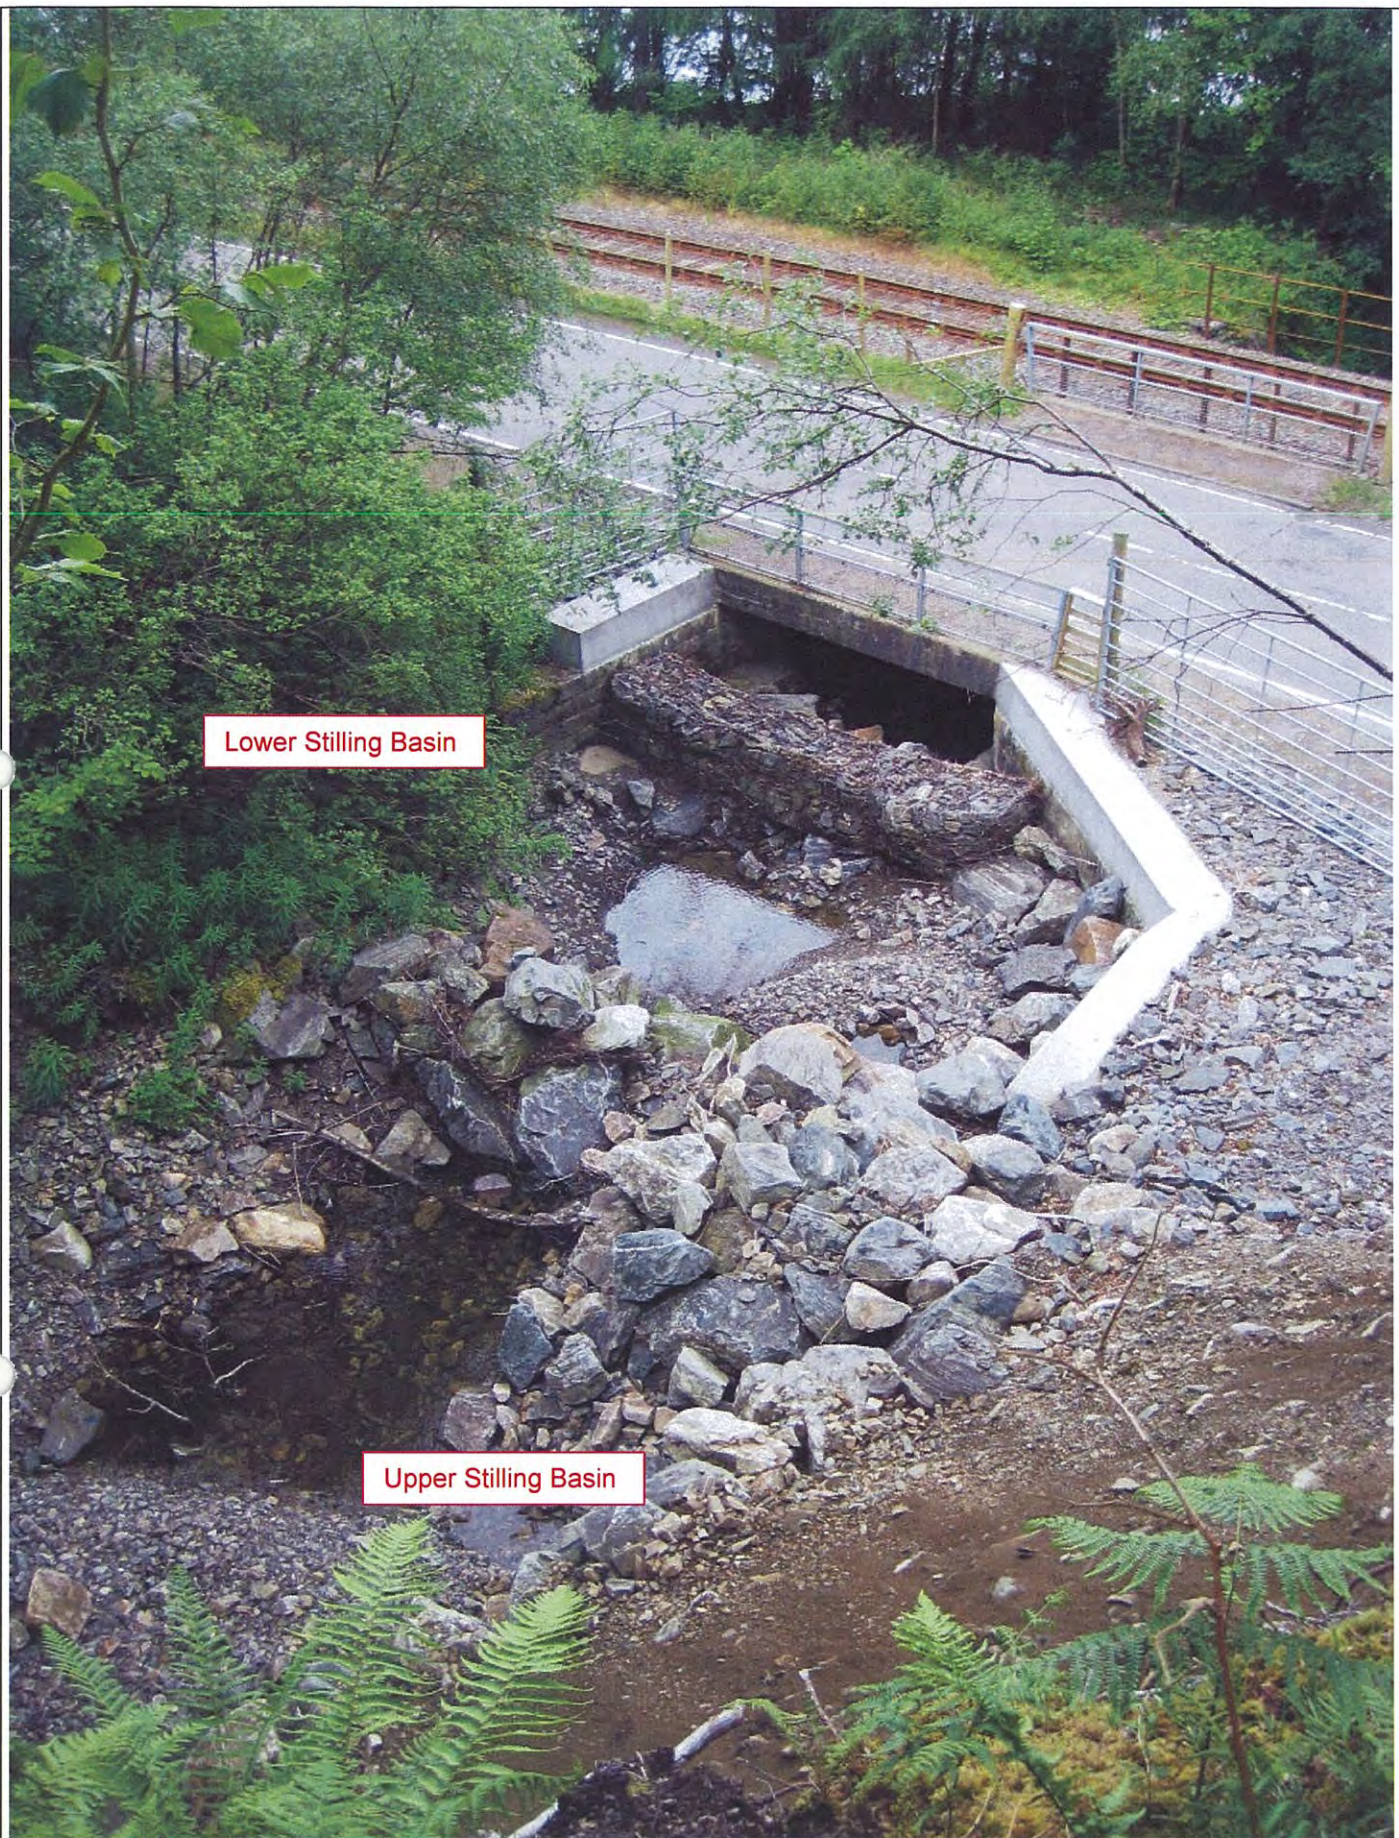
client:	The Highland Council	
project:	A890 Stromeferry Bypass Annual Inspection June 2009	
title:	Frenchman's Burn	
project no: 454.1	photograph no: 30

Based on previous debris flows in Frenchman's Burn the enlarged stilling basins (Ref. 23) should be able to contain "normal" routine debris flows (50 to 200m³), but are likely to have their capacity exceeded by larger less frequent events with a return period of 5 to 15 years. The addition of a new source of approximately 100m³ is likely to lead to a larger than "normal" scale debris flow during. Hence, it is vital that the stilling basins are kept clear of debris accumulations.

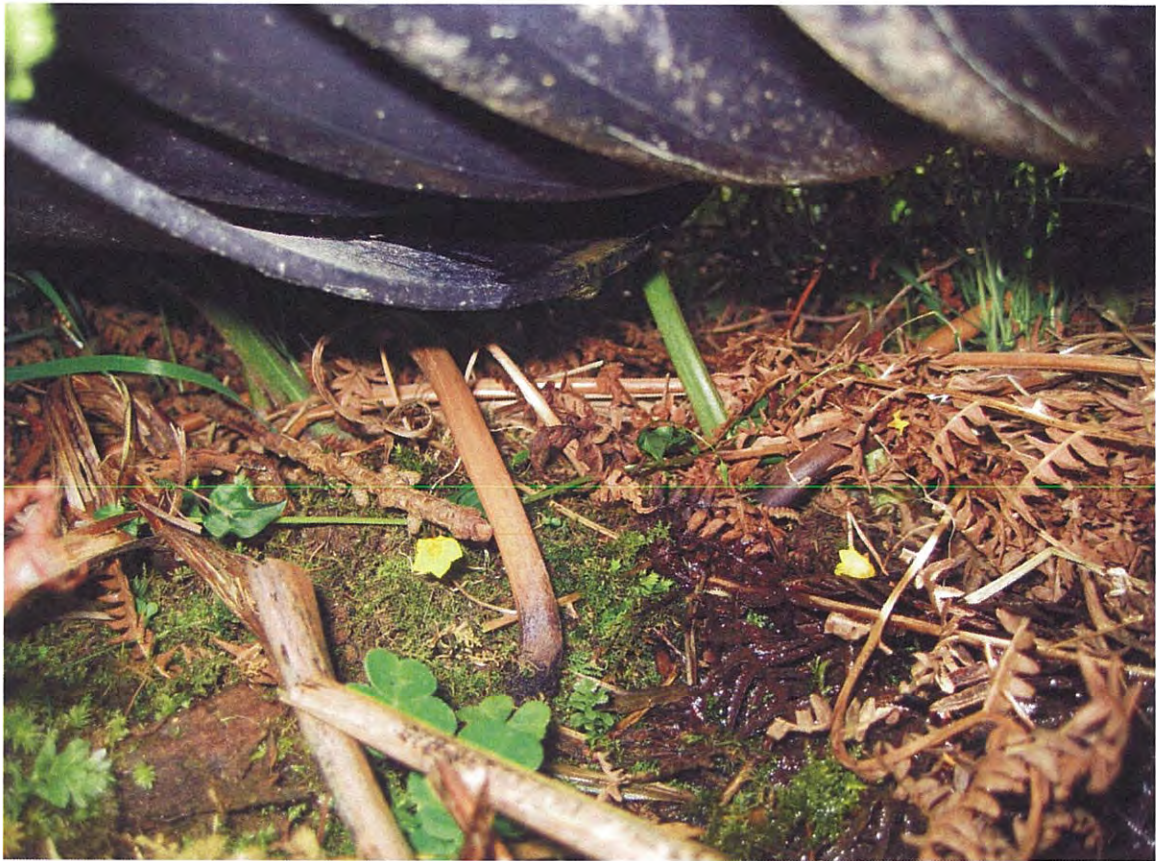
The pipe extending from the drainage ditch down the slope has developed a leak in the upper most joint in the pipe (photograph 35). The restraining collar immediately below this joint is missing a galvanised eye for attaching to the ground anchorage. The cable has been temporarily looped around the collar until the eye can be replaced (photograph 36).
