**ANNUAL ROCK SLOPE INSPECTION -
JUNE ~~2009~~ 2010**

The Highland Council
A890 Stroneferry Bypass

454.1_R_001A_RMD-Annual10
July 2010

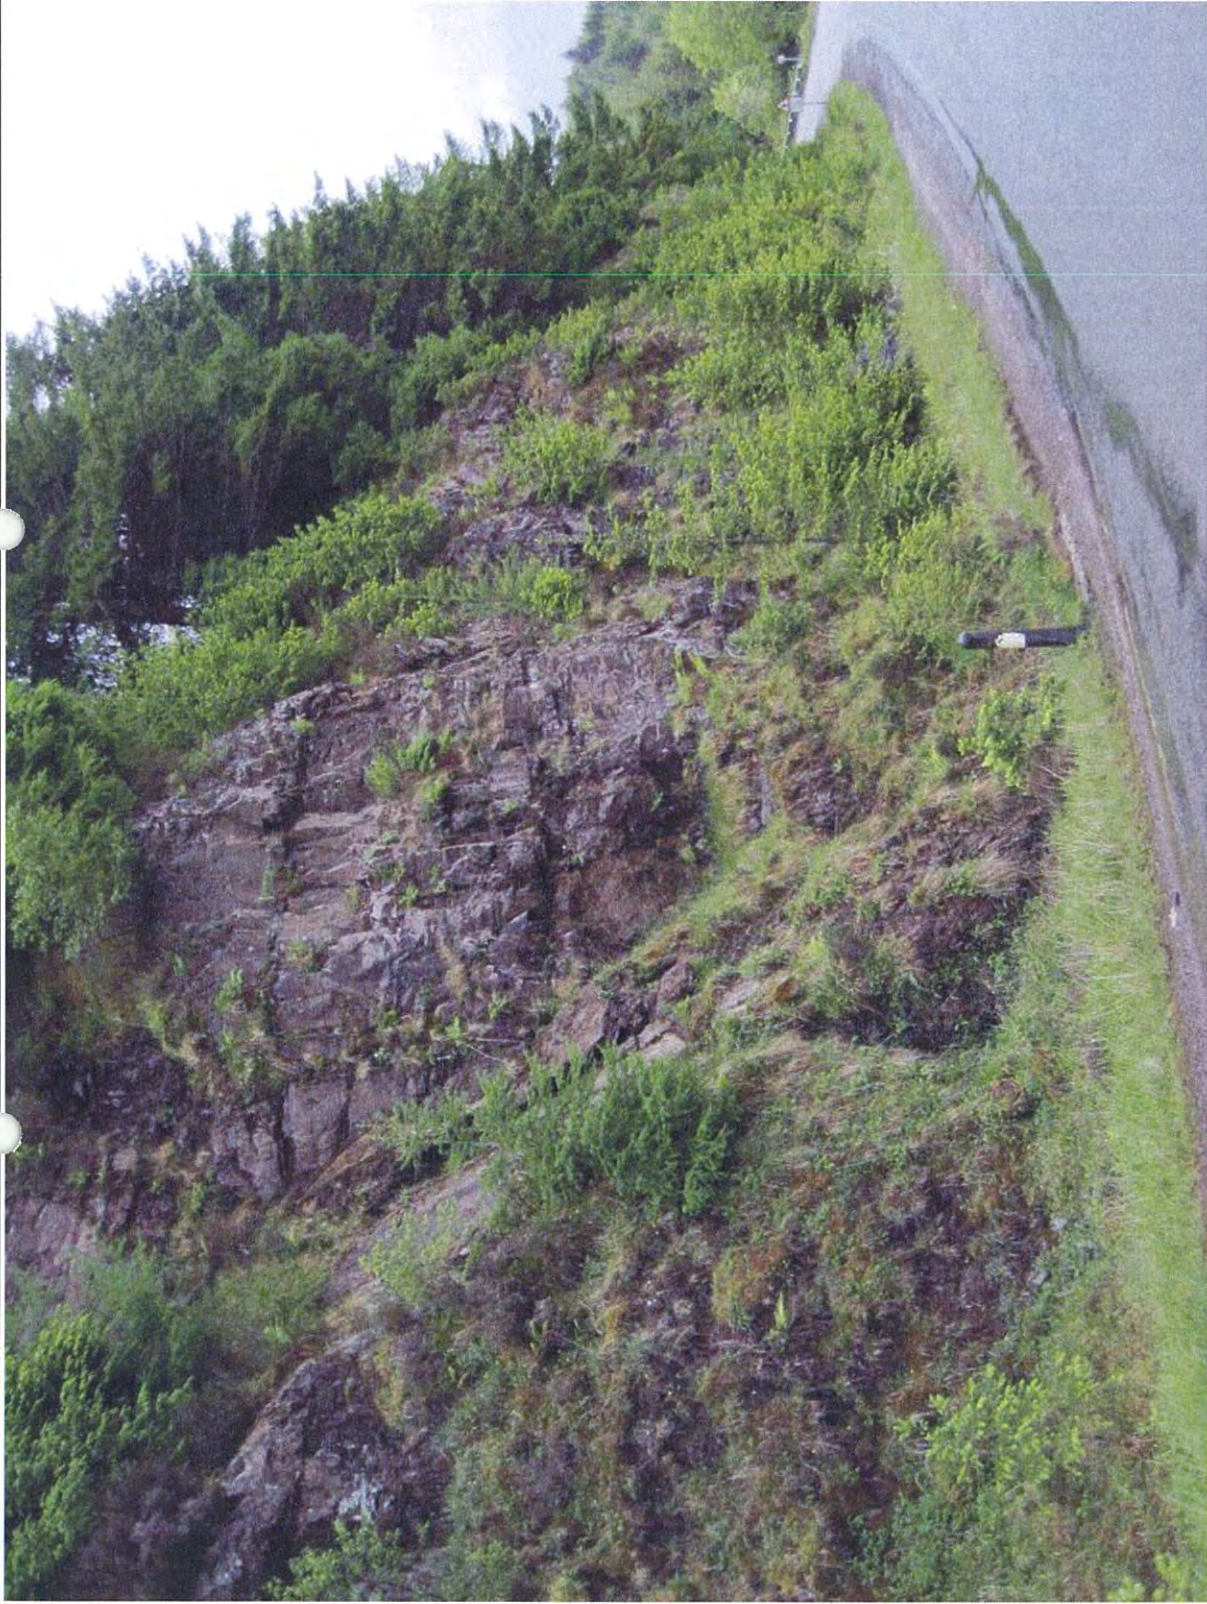
coffey geotechnics <small>SPECIALISTS MANAGING THE EARTH</small>	client:	The Highland Council	
date	09/06/2010		project:	A890 Stromeferry Bypass	
scale	NTS		title:	Annual Rock Slope Inspection - June 2010	
original size	A4		project no:	454.1	figure no: FIGURE 1

AA1	Chainage: 0023 - 0178	Length: 155m	Height: 10 - 20m
	Grid Ref	Start: NG 89054 35683	Finish: NG 89161 35810
Description of Slope: # 0000 starts opposite entrance to Ardnarff House. Natural and excavated rock slope. Forest and forestry track above slope. Ditch (0.5m wide x 0.25m deep).			
Failure Characteristics: General ravelling.			
Existing Remedial Works: 2004: Ditch and culvert cleared. June 2010: Trees removed at # 0018 and 0024 by CAN.			
Inspection Findings: Ravelling continues, no significant potential failures observed. # 0038 Area of ravelling on face, 4m up, not significant. # 0042 2 No. trees on the edge of the crest with small pod of material 1m below. # 0063 Small block 200mm x 200mm x 100mm, 8m up – fallen and contained by ditch. # 0068 Tree at crest of slope with yellow spray paint on trunk on edge of crest. # 0082 Heavy water flow – minor root mass (grass) stripped off face. Possibly due to movements (vehicle) on forestry track above. # 0093 Tree at crest of slope with yellow spray paint on trunk on edge of crest. # 0127 Tree on edge of crest above rock slope. # 0130 Undercut at crest of slope, no signs of deterioration - not significant. # 0139 Pod of material (1m ³) below crest of slope with sapling growing out of the middle. # 0143 Small failure reported previously by The Highland Council. # 0165 Wedge of weathering schist – deteriorating, but would be contained by ditch. # 0168 Culvert clear. Build up of debris in ditch along length of slope.

Current Hazard Index Value: 4			
Remedial / Maintenance Works Required: Remove trees on edge of crest above the rock slope (# 0042, 0068, 0093 and 0124). Remove vegetation and light scale rock face. Clear ditch (Annual Maintenance).

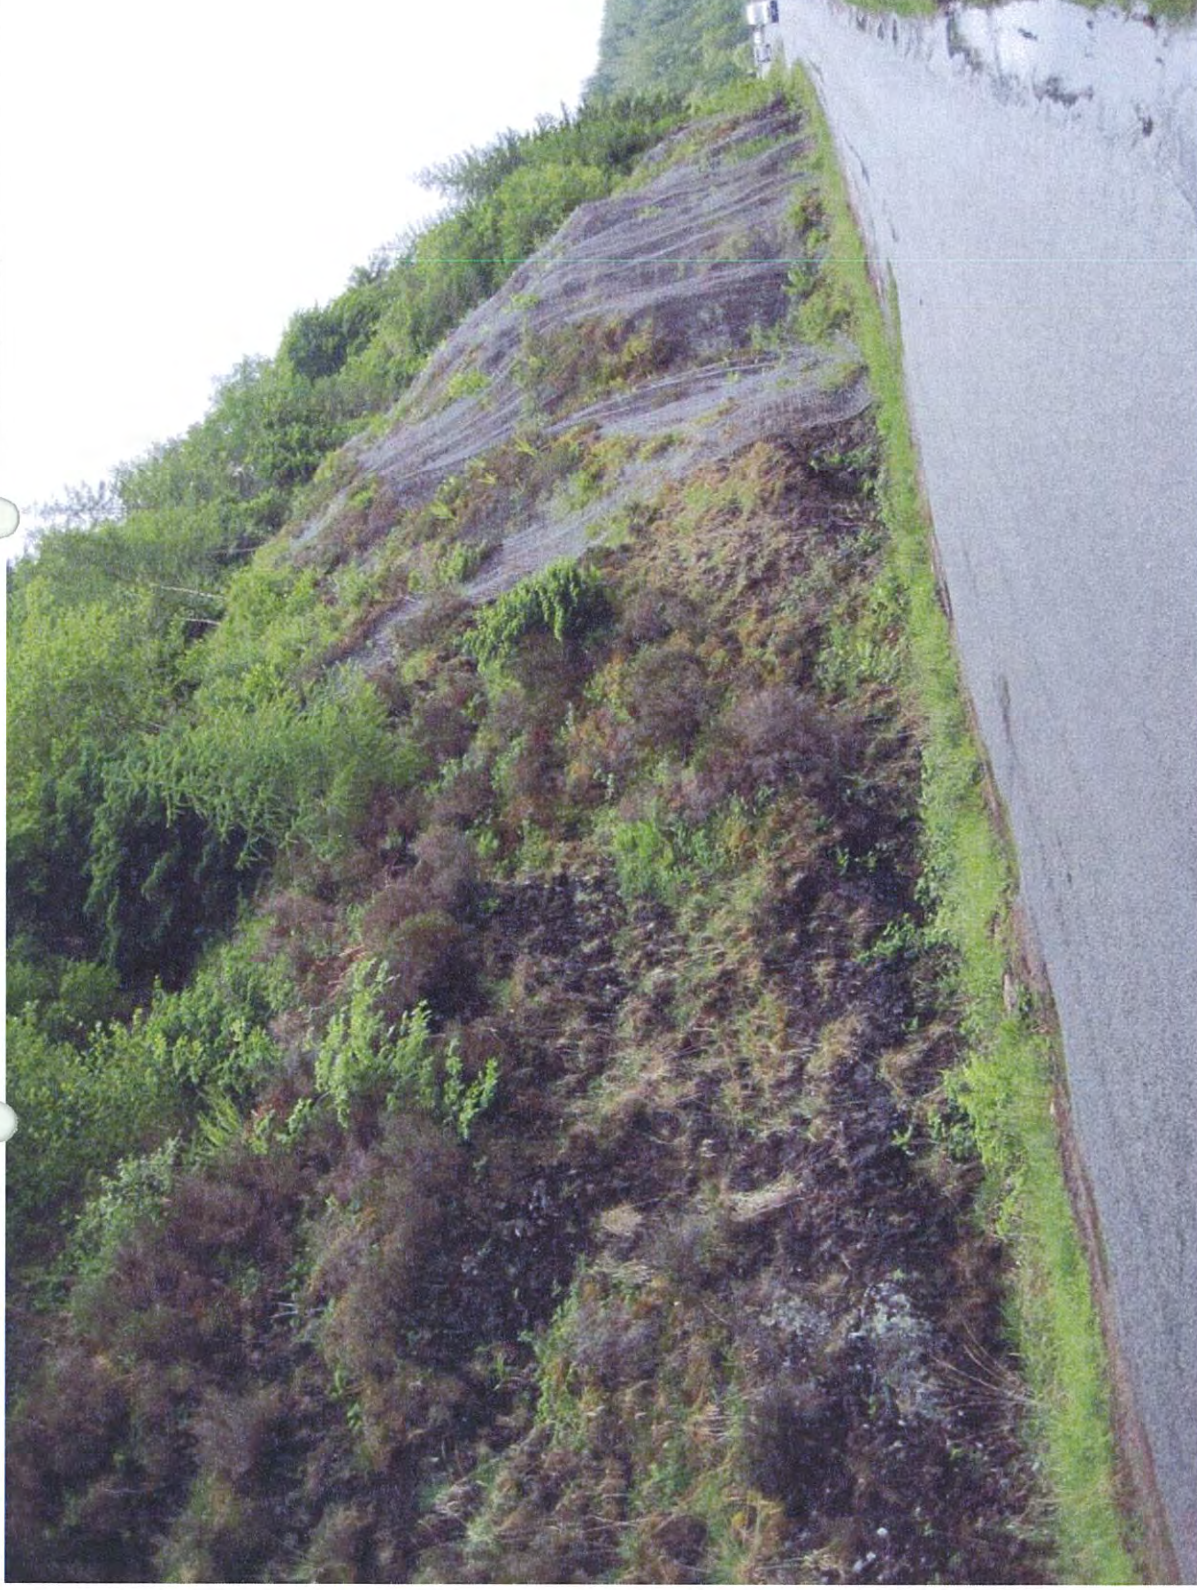
SPECIALISTS MANAGING THE EARTH		client: The Highland Council	
date		09/06/2010				project: A890 Stromeferry Bypass Annual Rock Slope Inspection - June 2010	
scale		NTS				title: Slope AA2	
original size		A4				project no: 454.1	figure no: FIGURE 2

AA2	Chainage: 0178 - 0297	Length: 119m	Height: 20 - 40m
	Grid Ref	Start: NG 89163 35809	Finish: NG 89277 35890
Description of Slope: Natural and excavated rock slope. Forest and forestry track above slope. Ditch (0.5m wide x 0.3m deep).			
Failure Characteristics: General ravelling. Potential plane failures.			
Existing Remedial Works: Localised (# 0178 to 0199 and # 0230 to 0277) draped chain link netting in poor condition, with some double twist rockfall netting patches. 2002: # 0184 Potential failing column scaled (removed) by CAN. 2004: Ditch cleared. January 2006: # 0199 to 0228 Un-netted area, light scaled by TRAC. # 0255 Potential failing column (2m high x 1.5m wide x 0.25m thick) - heavy scaled by TRAC. # 0257 Potential blockfall (1.5m high x 1m wide x 0.25m thick) - heavy scaled by TRAC. # 0178 to 0199 and 0228 to 0277 slope re-netted by TRAC.			
Inspection Findings: Trees at crest appear to be generally in a satisfactory condition. # 0197 Culvert is clear. # 0220 Pod of material (0.25m ³) scaled during inspection. # 0247 Galvanised shackle on netting at toe of slope. # 0259 Culvert clear. # 0276 Build up of debris behind netting from ongoing ravelling and galvanised shackle on netting bottom cable. # 0297 Culvert is one quarter silted – generally clear. Bottom cable on netting installed in 2006 is showing signs of corrosion. Ditch partially blocked in places.

Current Hazard Index Value: 4			
Remedial / Maintenance Works Required: All shackles require threads smearing with adhesive resin (Annual Maintenance). Clear ditch (Annual Maintenance).

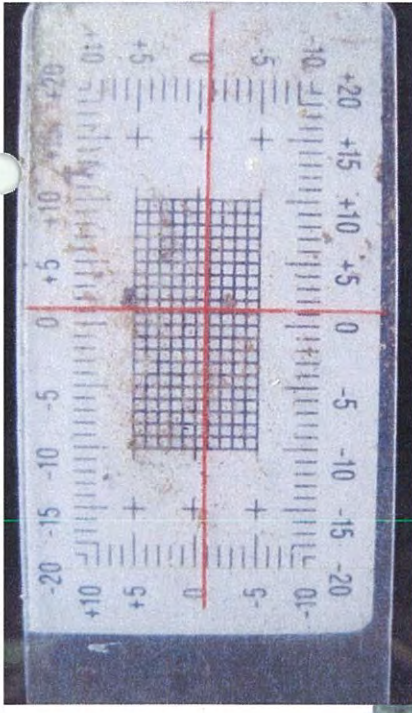
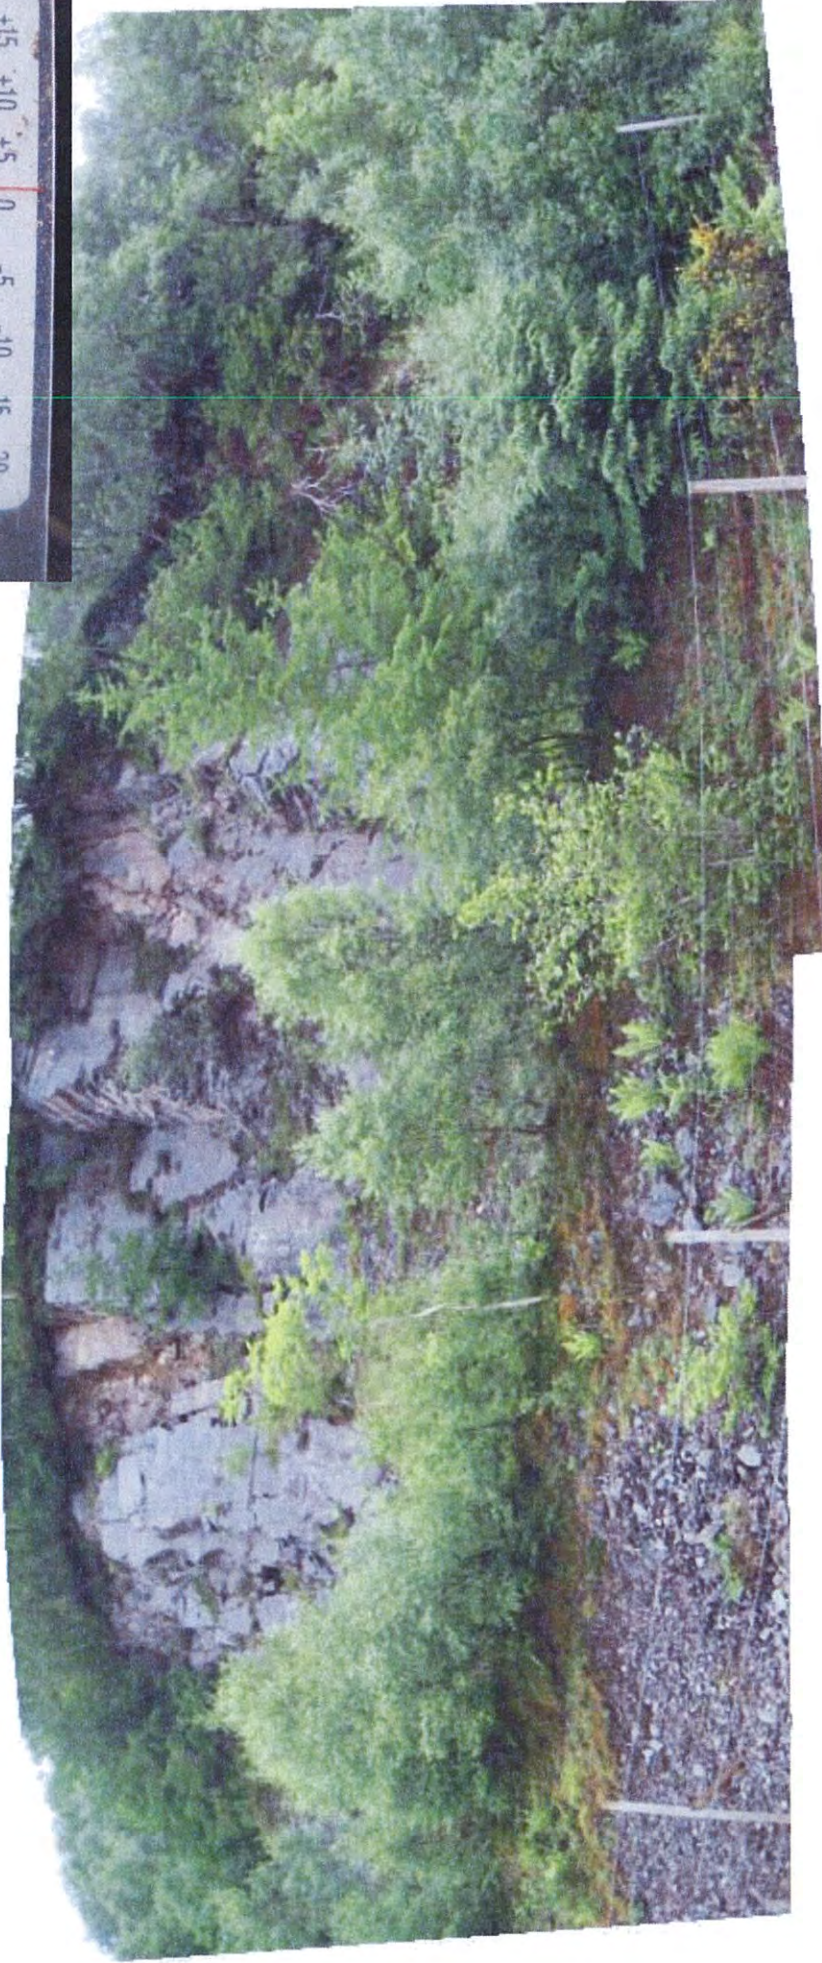
drawn	RMD	  coffey geotechnics SPECIALISTS MANAGING THE EARTH	client:	The Highland Council
date	09/06/2010		project:	A890 Stromeferry Bypass Annual Rock Slope Inspection - June 2010
scale	NTS		title:	Slope AA3
original size	A4		project no:	454.1
			figure no:	FIGURE 3

AA3	Chainage: 0516 - 0630	Length: 114m	Height: 20 - 40m
	Grid Ref	Start: NG 89054 35683	Finish: NG 89161 35810
Description of Slope: # 0516 is at northeast end of Armco barrier. Excavated slope set back from road. Shrubs and mixed forest above slope. From the toe of the rock slope a 40 to 45 talus slope leads down (3m to 5m) to a rock trap (see Existing Remedial Works). From this a talus slope with deer fencing, leads down (3m to 5m) to the ditch at the edge of the road. Ditch 0.5m wide x 0.3m deep at roadside.			
Failure Characteristics: General ravelling. Potential large plane and toppling failures.			
Existing Remedial Works: Rock trap created 3m wide with a 1.25m to 1.5m high 1m wide bund. January 2006: # 0560 Potential toppling failures upper driving blocks removed by TRAC. No blocks escaped during removal. # 0573 Undercut of blocks removed by TRAC. During removal no blocks escaped when the ditch was clear. 1 block escaped when ditch was full.

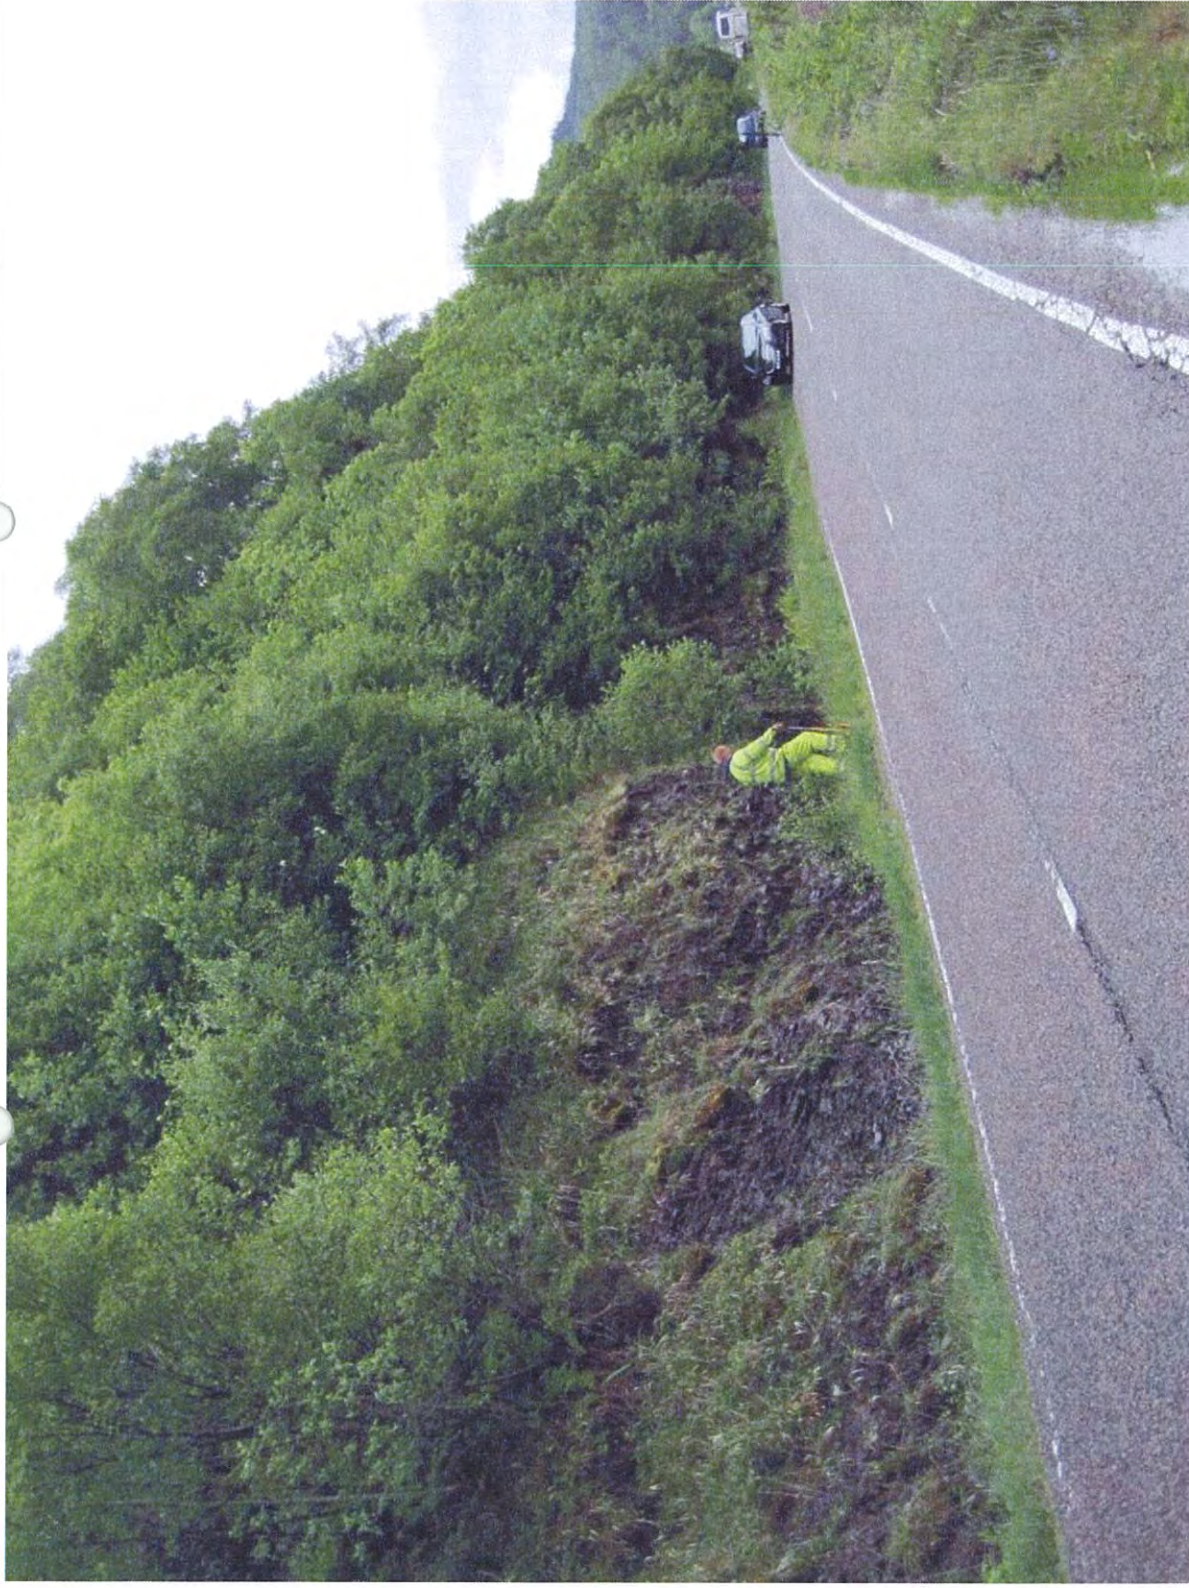
SPECIALISTS MANAGING THE EARTH	client:	The Highland Council
date	09/06/2010		project:	A890 Stromeferry Bypass Annual Rock Slope Inspection - June 2010
scale	NTS		title:	Slope AA4
original size	A4		project no:	454.1
				figure no: FIGURE 4

AA4	Chainage: 0705 -0800	Length: 95m	Height: 10 - 20m
	Grid Ref	Start: NG 89511 36265	Finish: NG 89567 36340
Description of Slope: Natural and excavated rock slope. Shrubs and mixed forest above slope. Ditch (0.5m to 1m wide x 0.5m to 1m deep).			
Failure Characteristics: General ravelling. Potential plane, wedge and toppling failures.			
Existing Remedial Works: 2002: # 0728 Heavy scaling of a plane failure block, some material in ditch, small overhang of remaining material solid, keep under observation. January 2008: # 0725 Vegetation removed and light scaling of small overhanging block by Skye Rope Access.			
Inspection Findings: # 0705 to 0751 Vegetation almost entirely obscuring the slope. # 0712 undercut column. Base of column is fractured and deteriorating. # 0728 2No. overhangs have deteriorated (rockfall reported). # 0740 Overhanging superficial (2m long by 0.5m high by 0.5m deep) 5m above the road level (Appendix B - photograph 6). # 0774 Culvert is clear. # 0795 Superficials washed away during debris flow on 4/10/2004. Ditch is partially blocked in places.

Current Hazard Index Value: 2			
Remedial / Maintenance Works Required: # 0712 Install dentition to base of undercut column. # 0705 to 0751 Remove vegetation and light scale. # 0728 Heavy scale overhangs. # 0740 Remove overhanging superficials. Clear ditch (Annual Maintenance).

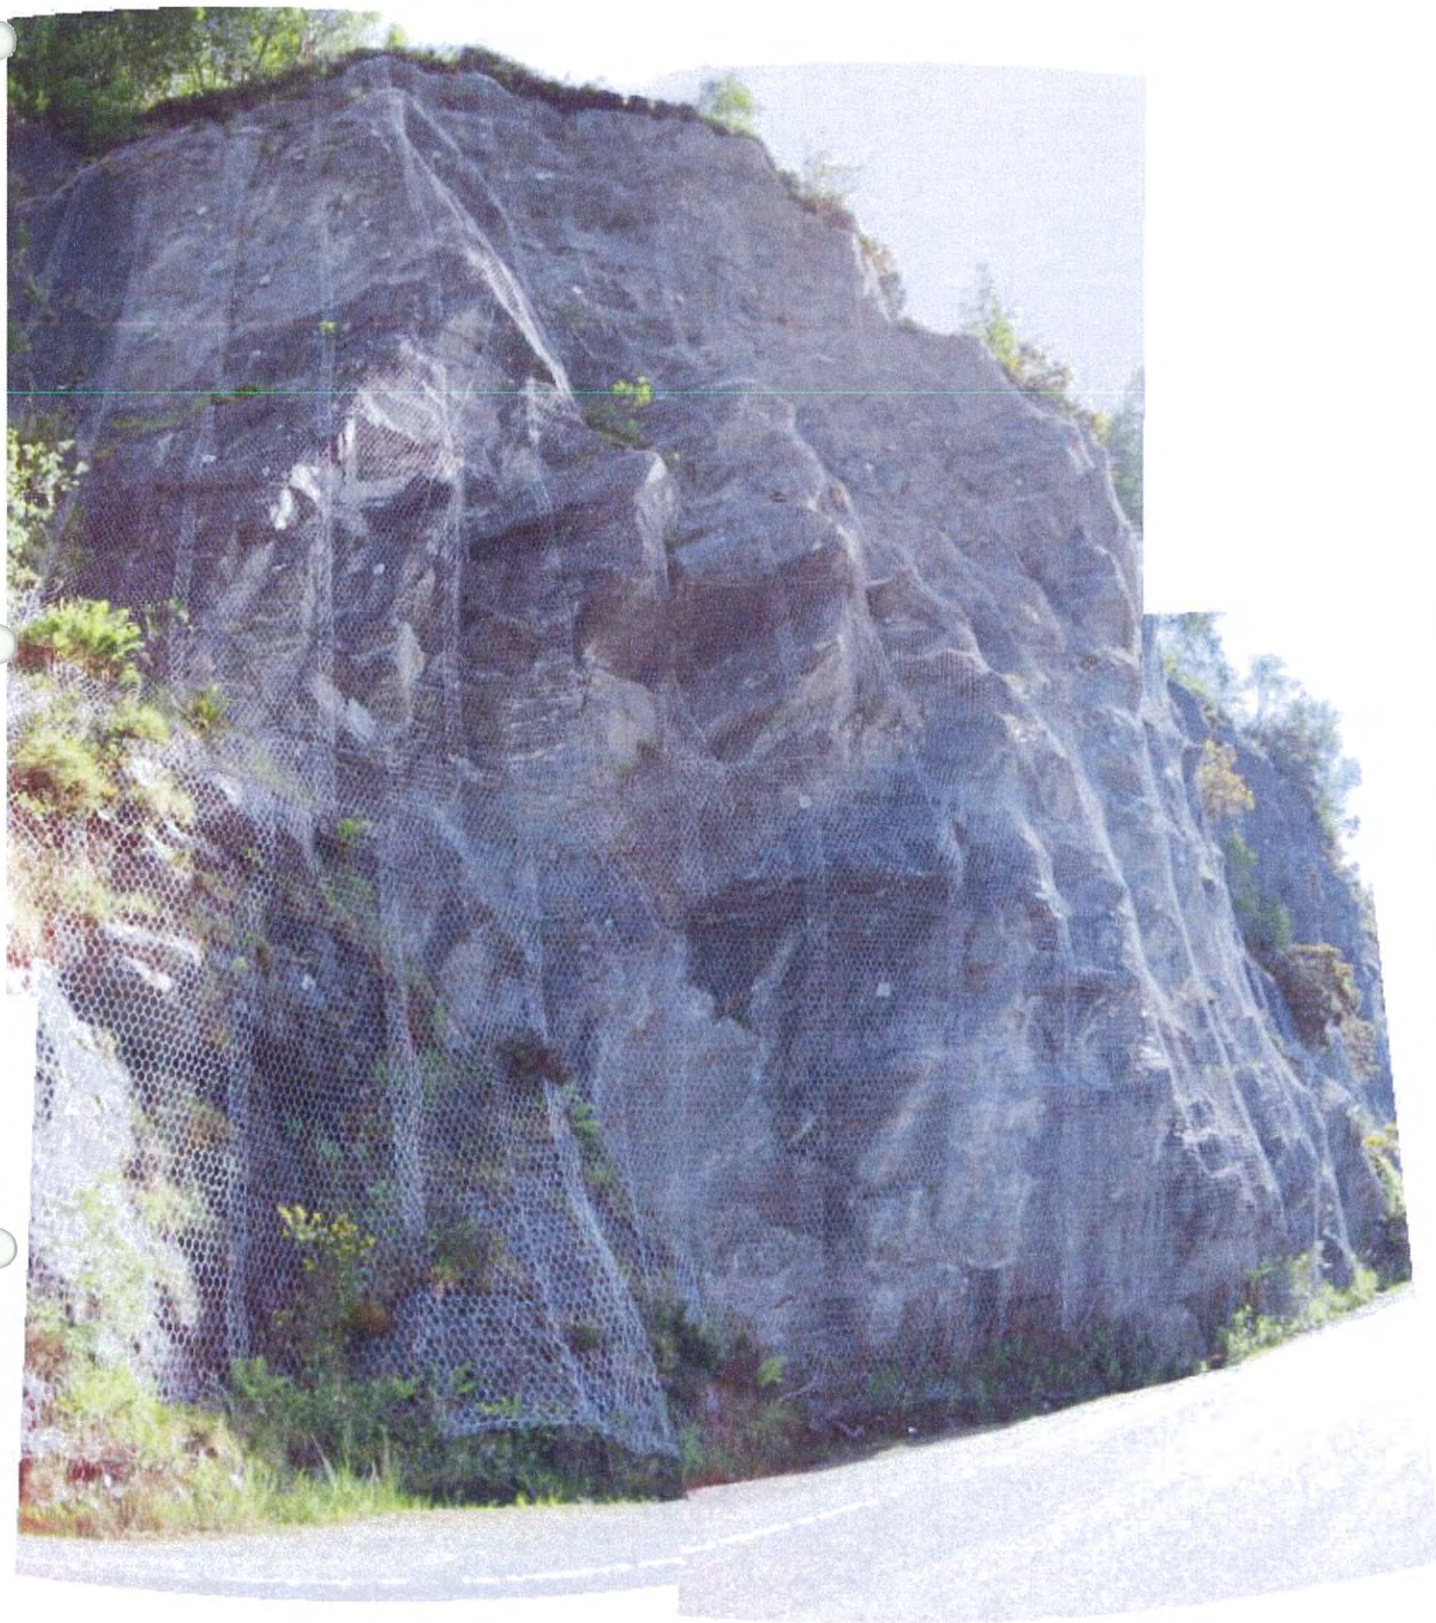
coffey geotechnics <small>SPECIALISTS MANAGING THE EARTH</small>	client:	The Highland Council	
date	09/06/2010		project:	A890 Stromeferry Bypass Annual Rock Slope Inspection - June 2010	
scale	NTS		title:	Slope AA17	
original size	A4		project no: 454.1	figure no: FIGURE 18

2. On the afternoon of the 24th of August 2008 two blocks were found on the road beneath slope AA17. Upon inspection of the upper slopes, the blocks were found to have come from a natural crag, travelled down the upper vegetated slope and over the crest of the netted slope. The initial cause of the rockfall has not been identified, but may have been caused by the root action of the trees.

Slope	Recommendations	Action	Timescale
AA17	# 2860, column of fractured rock under existing netting by "Hughie MacKenzy" graffiti – keep under specific observation during periodic and annual inspections.	THC & Coffey	All inspections
AA18	Clear out ditch.	THC	Annual Maintenance
AA20	# 3080 "I" beam post - the measurements do not enable monitoring of the whole wall. Hence, additional tell tales and inclinometer should be installed.	THC & Coffey	Next Phase (VI) of works
	The "I" beams require maintenance to treat existing corrosion and to protect the steel work from further corrosion.	THC	Outstanding Next Phase (VI) of works
	Clear Culverts	THC	Annual maintenance
AA21	#3271 Removal block next to buttress	THC	Next Phase (VI) of works
AA22b	# 3356, 3372 and 3382 – Potential failures keep under particular observation during periodic inspections.	THC & Coffey	All inspections

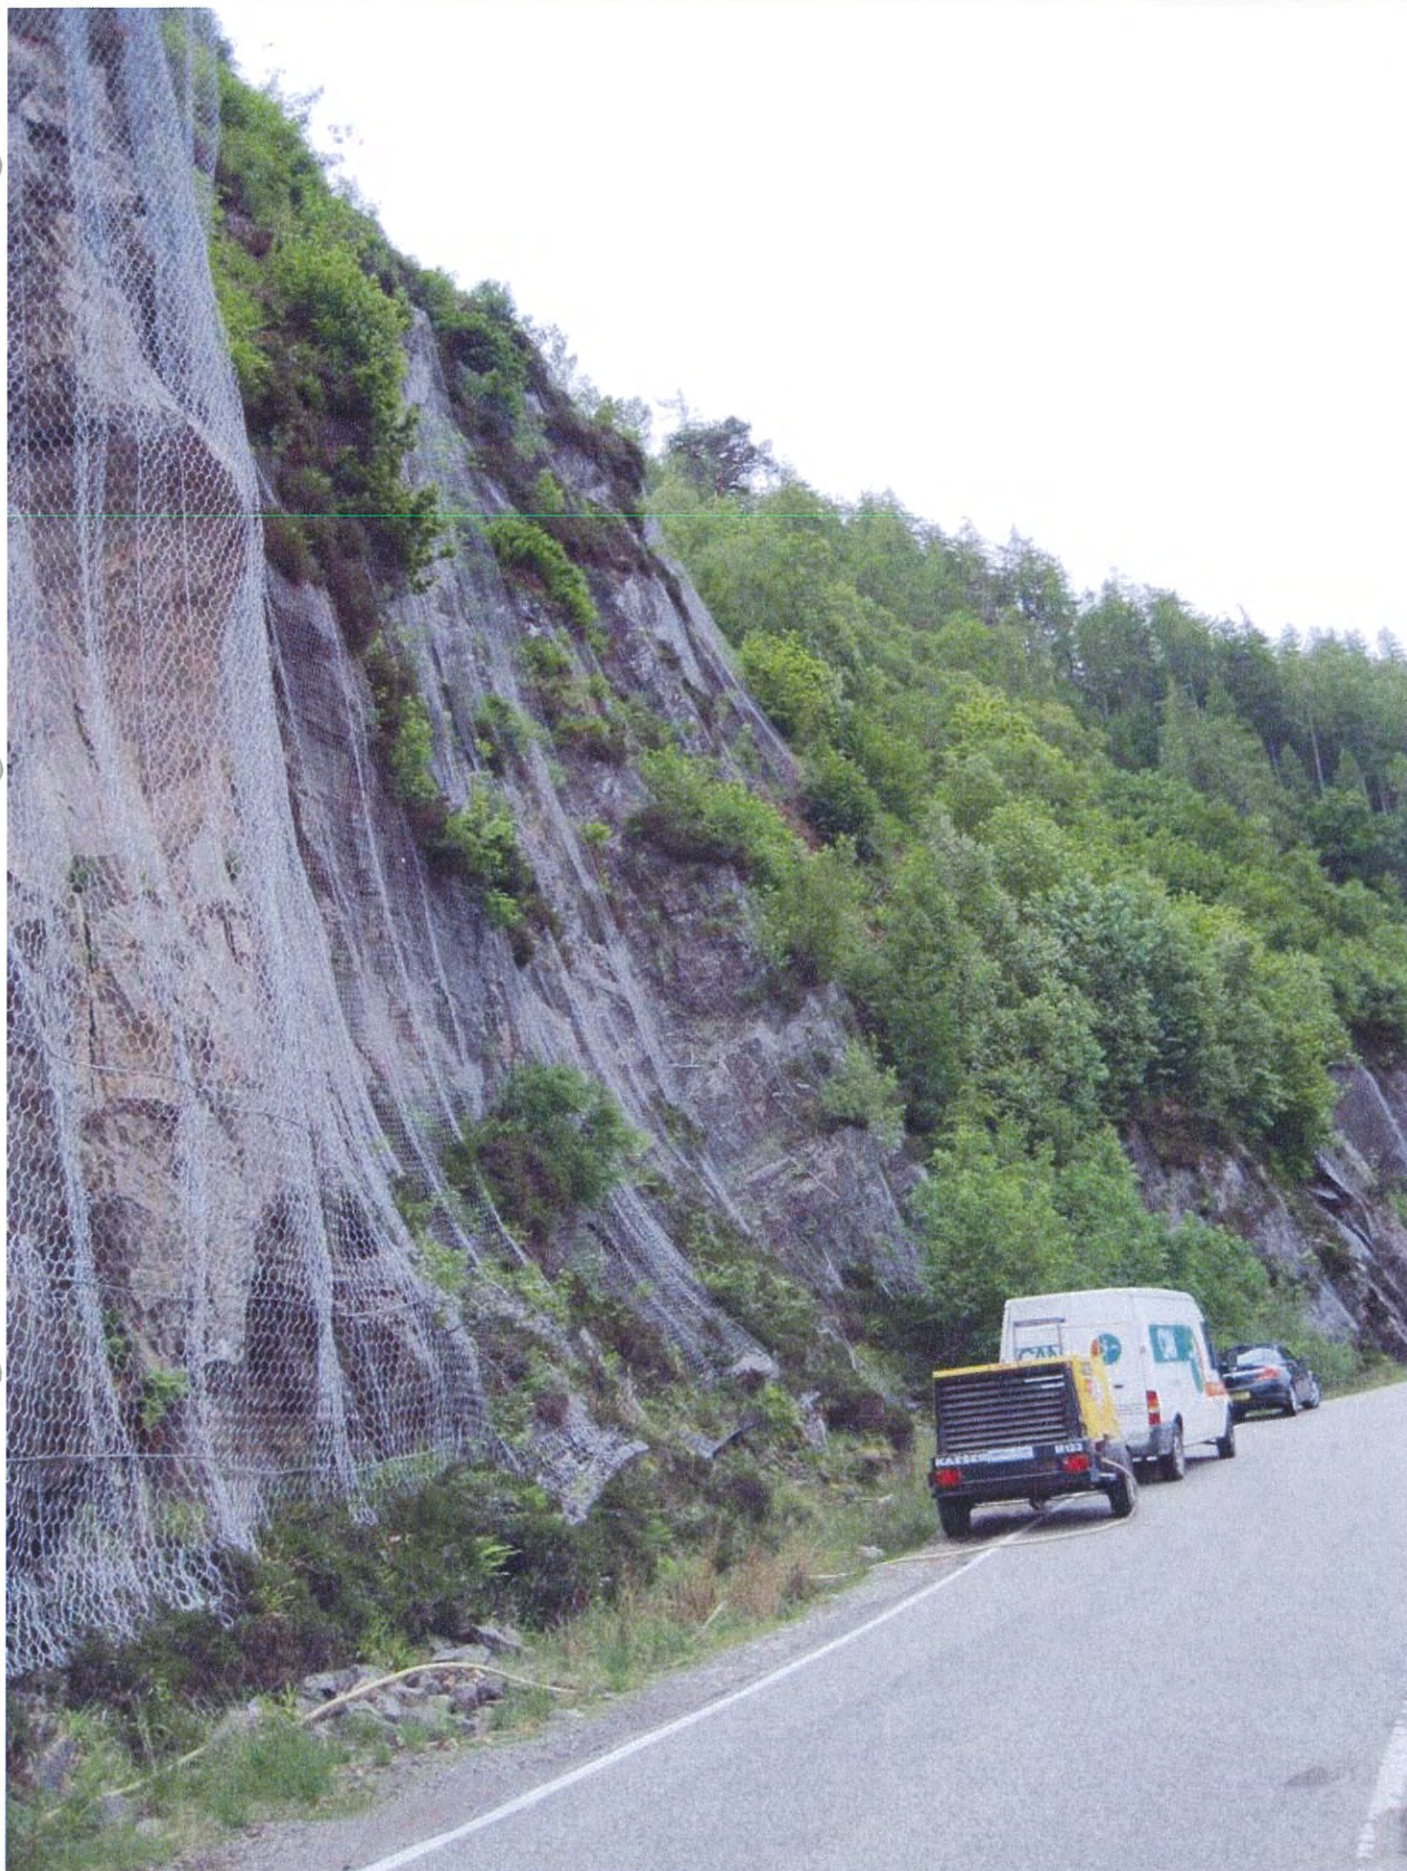
coffey geotechnics <small>SPECIALISTS MANAGING THE EARTH</small>	client:	The Highland Council	
date	10/06/2010		project:	A890 Stromeferry Bypass Annual Rock Slope Inspection - June 2010	
scale	NTS		title:	Slope AA22a	
original size	A4		project no: 454.1	figure no: FIGURE 23

- Several (#3356, #3372 and #3382) of the noses of rock on slope AA22b appear to have deteriorated since the previous annual inspection in 2009. These noses where possible should be reduced in volume or removed by heavy scaling during the next phase (VI) of rock slope remedial works.

#3356, 3372 and 3382 Noses should be heavy scaled / removed under supervision of Geotechnical Engineer / Engineering Geologist.	THC & Coffey	Next Phase (VI) of works
AA24	# 3672 rope access inspection of area of rock fall.	Coffey	Next Phase (VI) of works
AA25, AA26N and AA26S	Slopes not considered a significant hazard. Hence, removed from slope inspection list. Recommend a visual inspection during the Annual Inspections, with reporting only if significant features observed.	Coffey	Annual Inspections (ongoing)

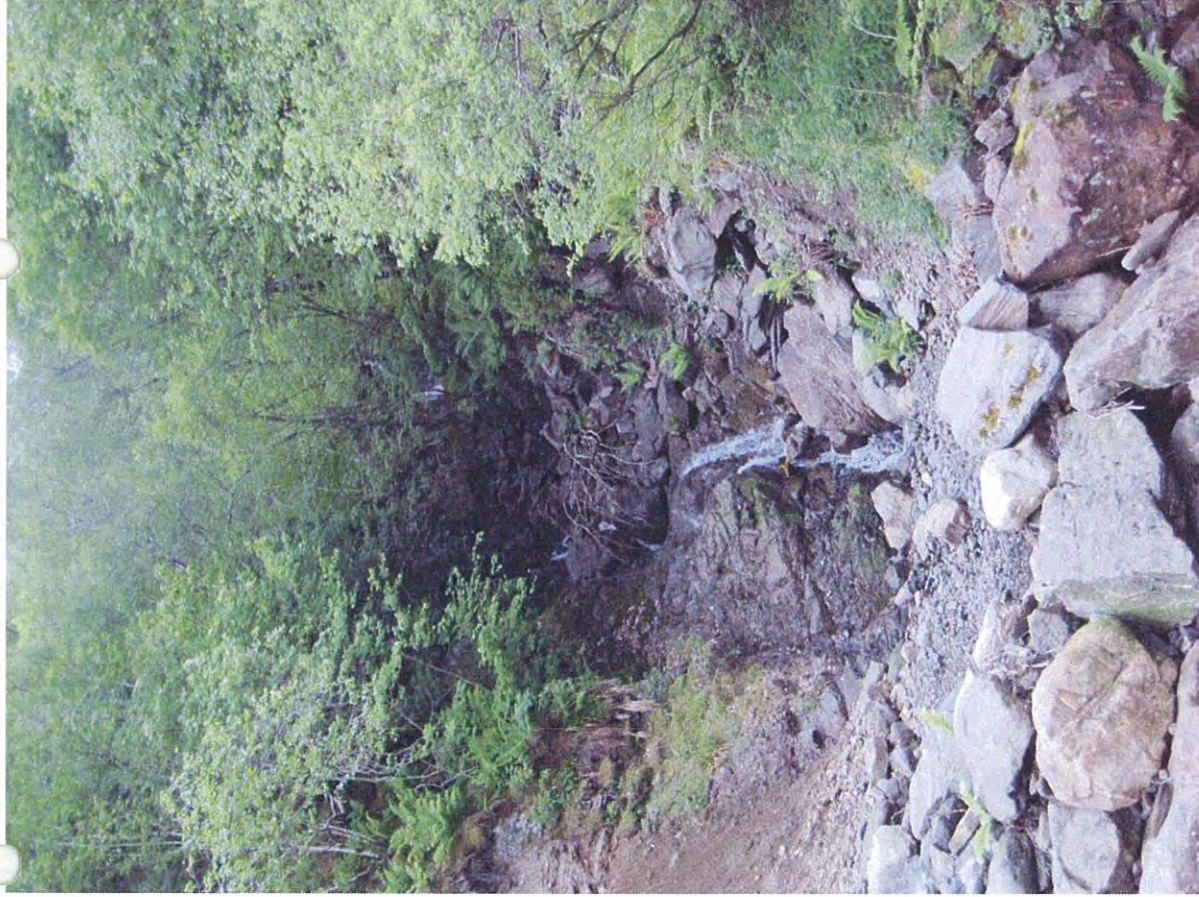
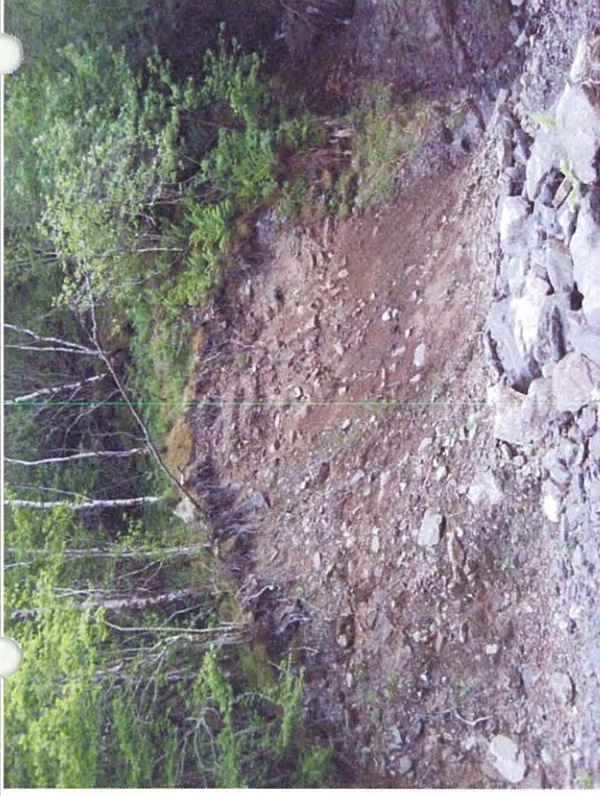
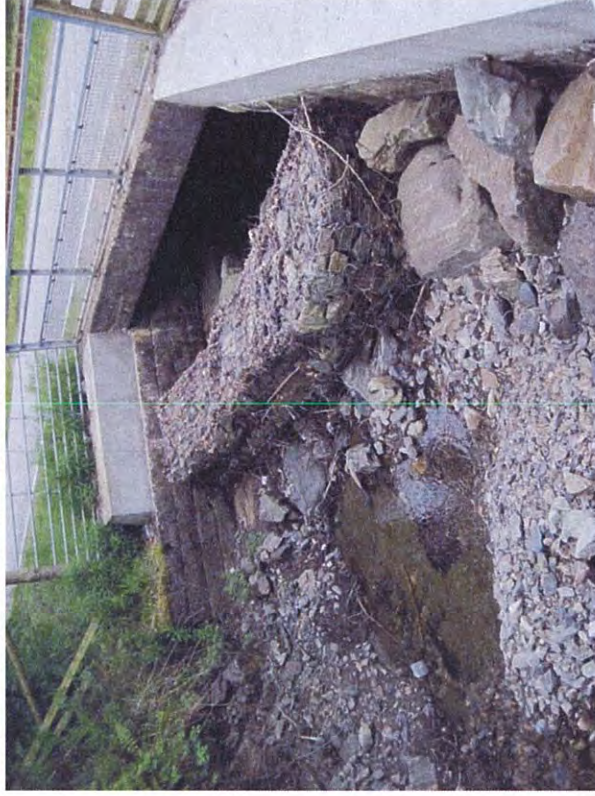
client:	The Highland Council
project:	A890 Stromeferry Bypass Annual Rock Slope Inspection - June 2010
title:	Frenchmans Burn
project no:	454.1
figure no:	FIGURE 28

Frenchman's Burn	2200	Small amount of small stones in top basin with lower fairly clear (7 th July 2009).	Clear out stilling basin during annual maintenance.
		Top basin about 1/3 rd full but lower basin still fairly clear (2 nd February 2010).	
AA15	2592	Approx 0.6 x 0.4 x 0.1 thick block of material from uplink side of nose, 3m up, 5m from start of slope. More loose to follow but all has been and will be contained by netting (May 2010)	Inspected by rope access during annual inspection. Scale area during next contract.
AA16	2770	Large block in rock trap (16 th March 2010).	Not a significant concern, due to trap and netting performing as intended.

Based on previous debris flows in Frenchman's Burn the enlarged stilling basins (Ref. 23) should be able to contain "normal" routine debris flows (50 to 200m³), but are likely to have their capacity exceeded by larger less frequent events with a return period of 5 to 15 years. The addition of a new source of approximately 100m³ is likely to lead to a larger than "normal" scale debris flow during. Hence, it is vital that the stilling basins are kept clear of debris accumulations.

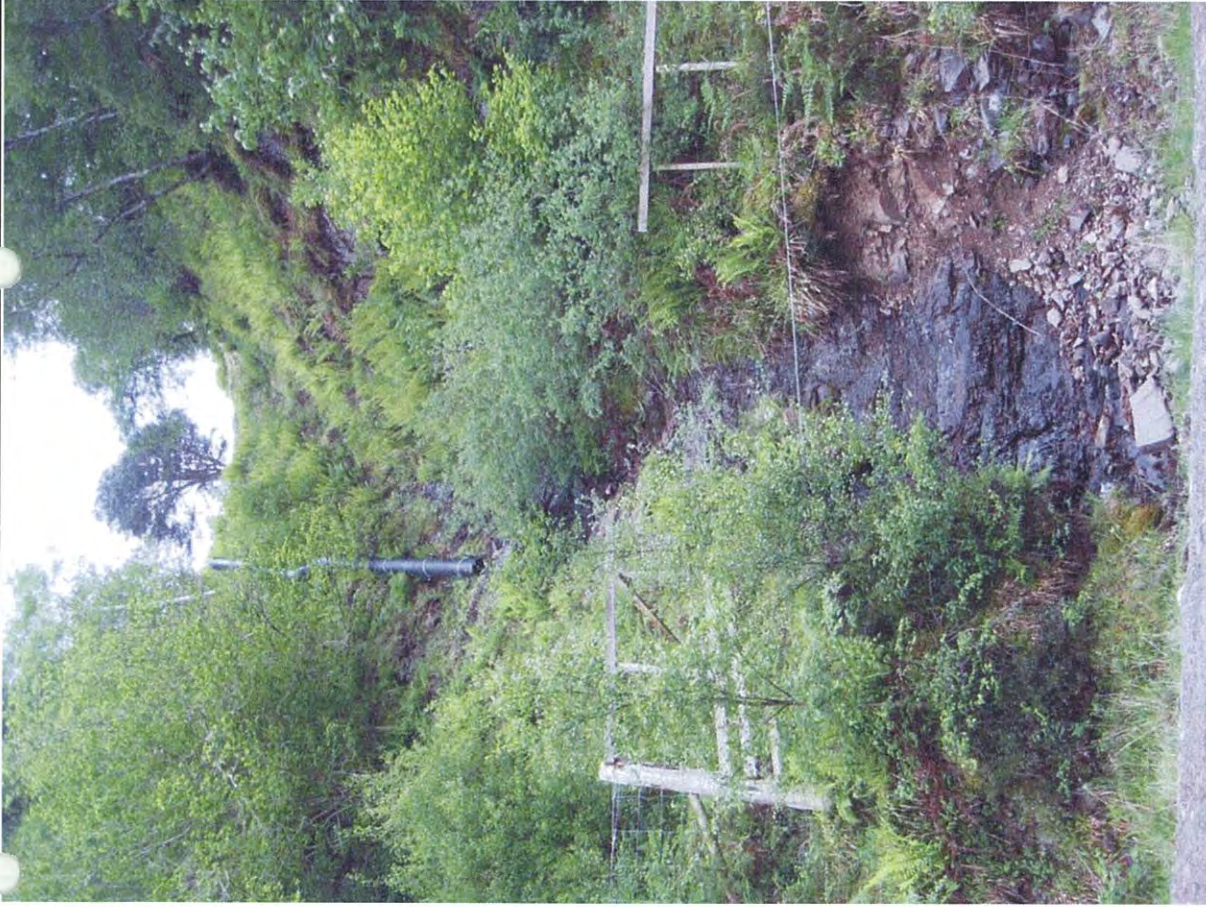
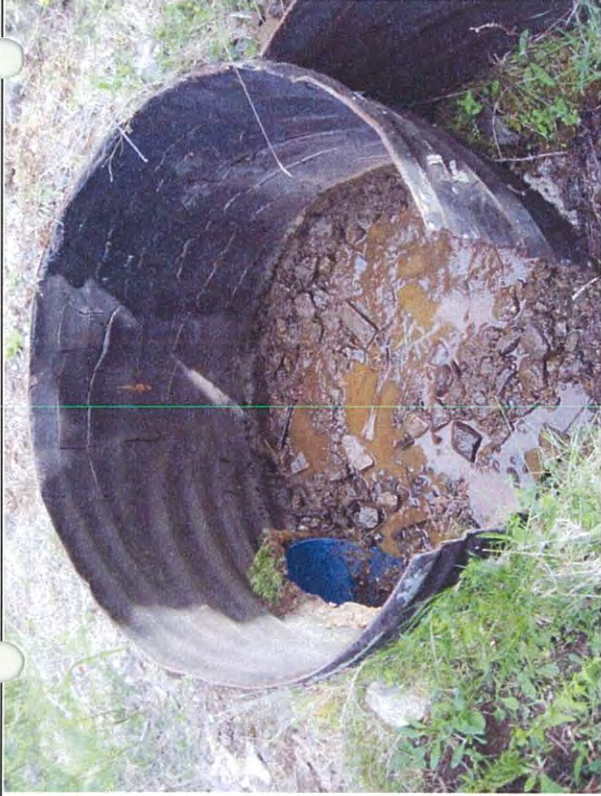
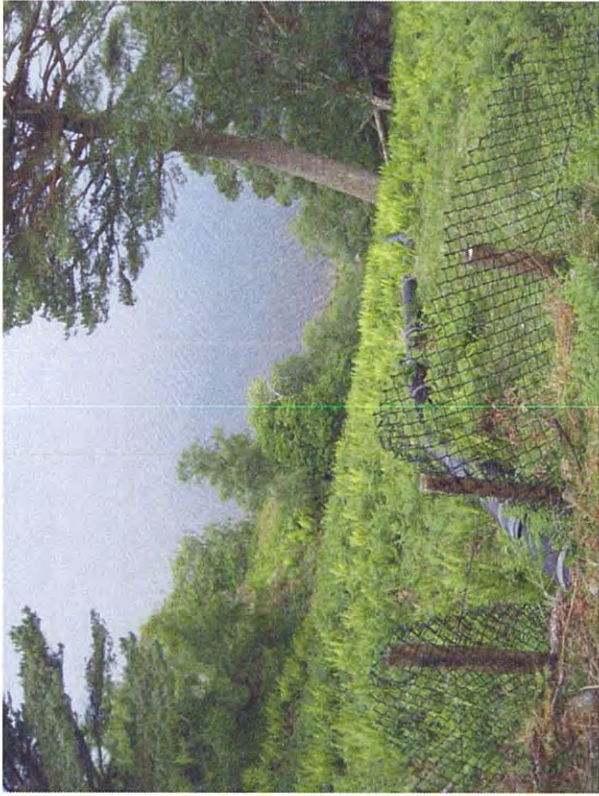
client: The Highland Council
project: A890 Stromeferry Bypass
Annual Rock Slope Inspection - June 2010
title: AA5 / AA6 Drainage Pipe
project no: 454.1
figure no: **FIGURE 29**

The pipe extending from the drainage ditch down the slope has developed a leak in the upper most joint in the pipe. The restraining collar immediately below this joint is missing a galvanised eye for attaching to the ground anchorage. The cable has been temporarily looped around the collar until the eye can be replaced.

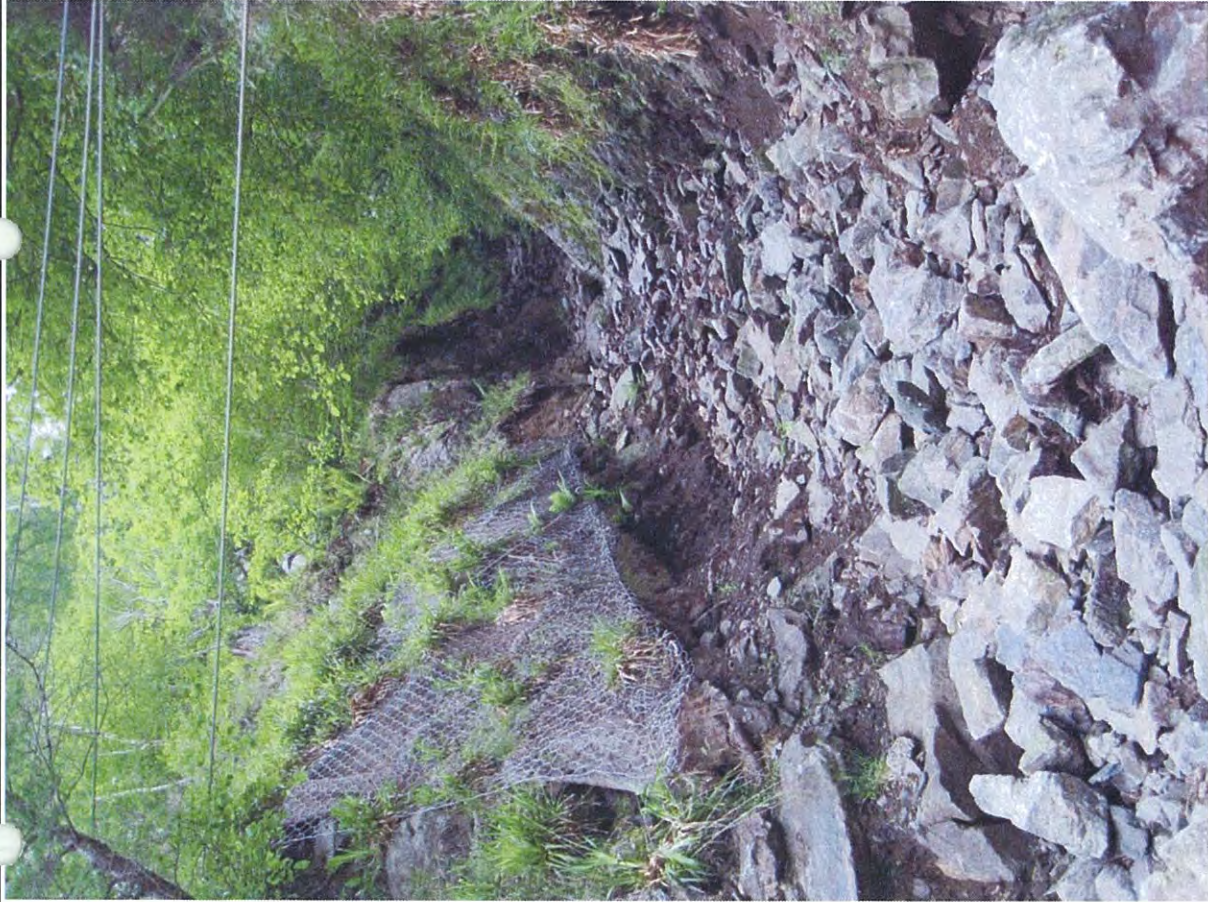
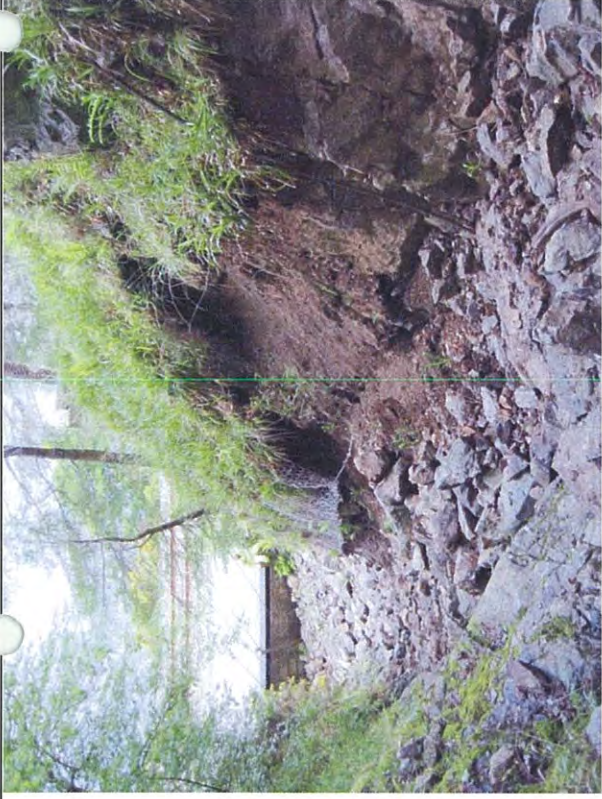
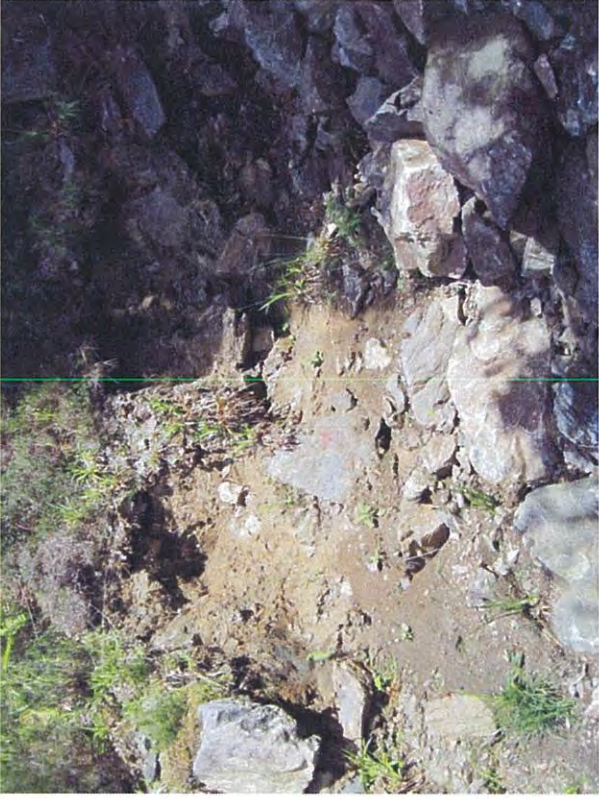
client:	The Highland Council
project:	A890 Stromeferry Bypass Annual Rock Slope Inspection - June 2010
title:	AA19/AA20 Gully
project no:	454.1
figure no:	FIGURE 30

Further erosion of the east gully wall between slopes AA19 and AA20 has occurred up and down stream of the erosion protection measures. Erosion has also occurred immediately below these measures. If this is allowed to continue, it could eventually lead to the undermining of the concrete beam and associated works above. We would recommend that additional erosion protection measures / training of stream within gully are undertaken during the next Phase (VI) of rock slope remedial works.
