Stromeferry Bypass, The Scottish Highlands

A890 Slope Inspection
Report

September 2012

Prepared for:
The Highland Council

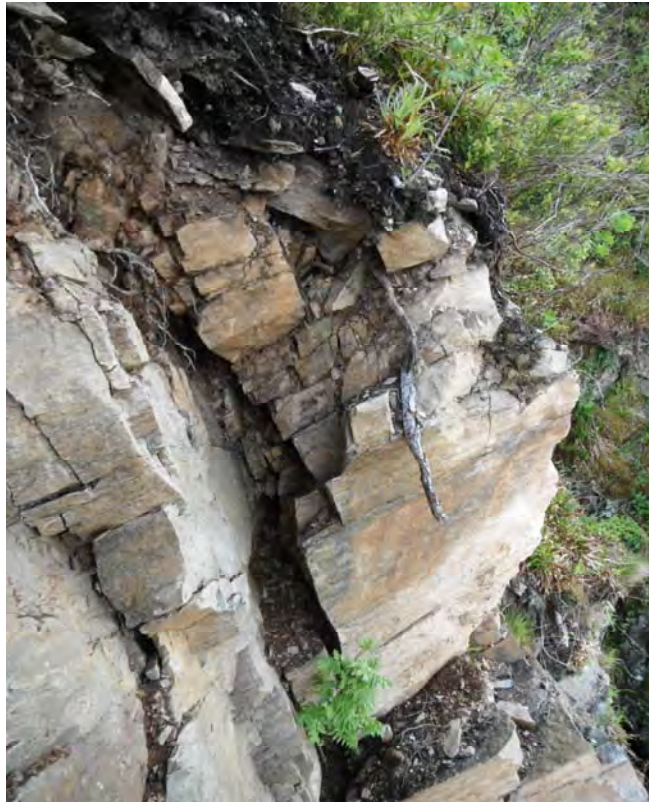
Photo 1: AA7 - 5m³ detached block with a 150mm dilated release joint.

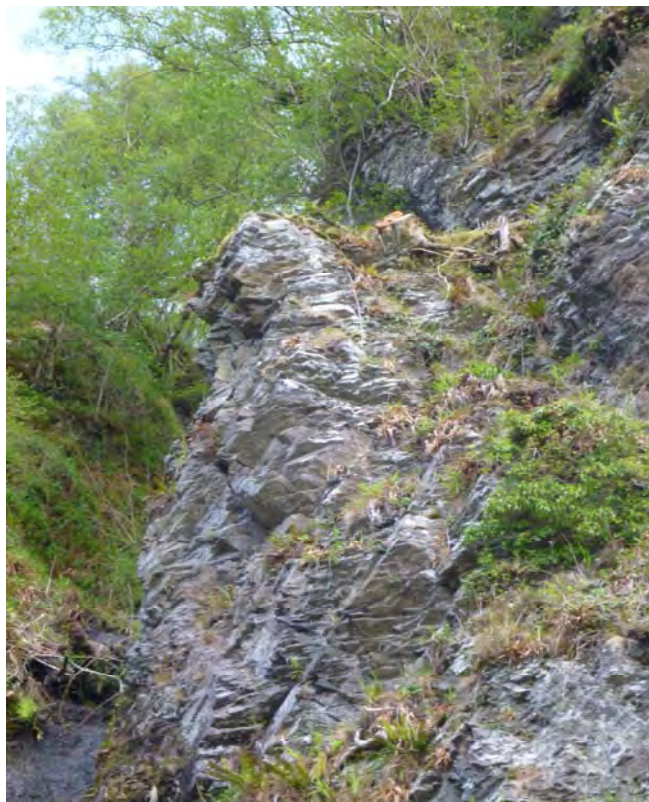
Photo 2: AA8 - 30m³ pinnacle previously subjected to root jacking.

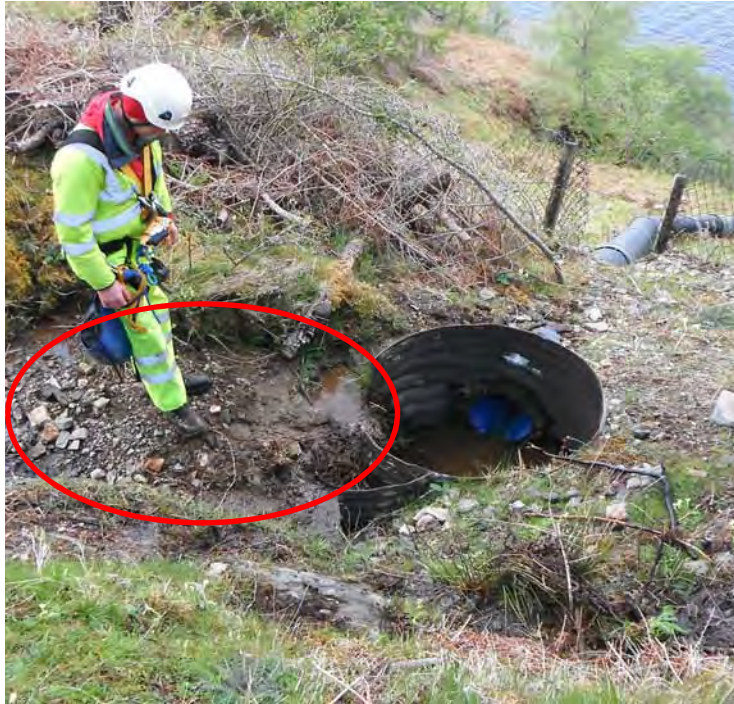
Photo 3: Gully between AA5 and AA6 - End of ditch at catch pit requiring removal of sediment build up to prevent overflowing of water onto slope surface.

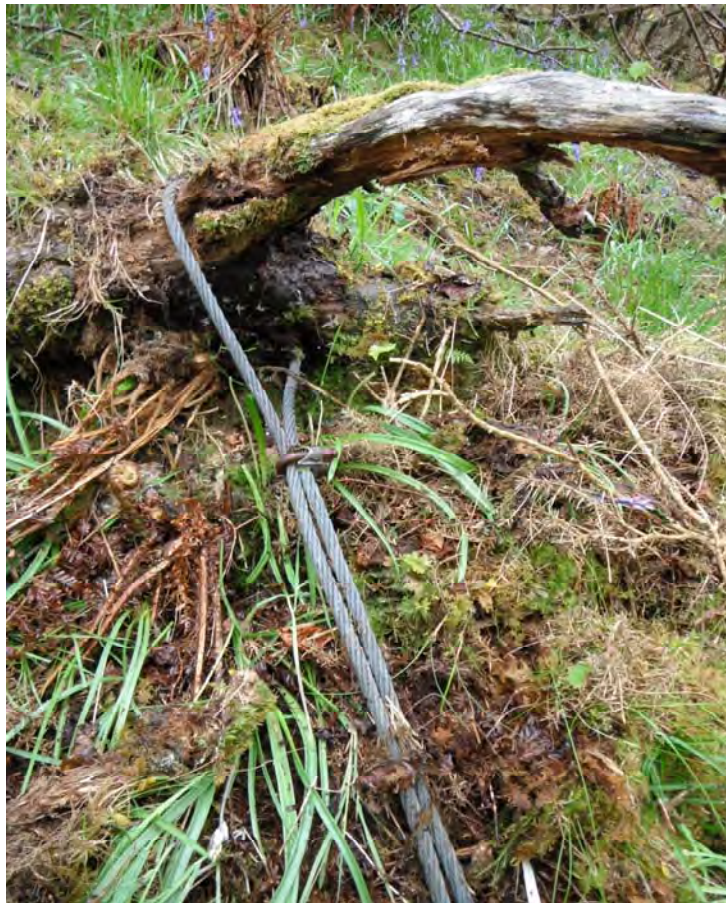
Photo 4: AA14W - Top cable anchor consisting of a rotting tree stump.

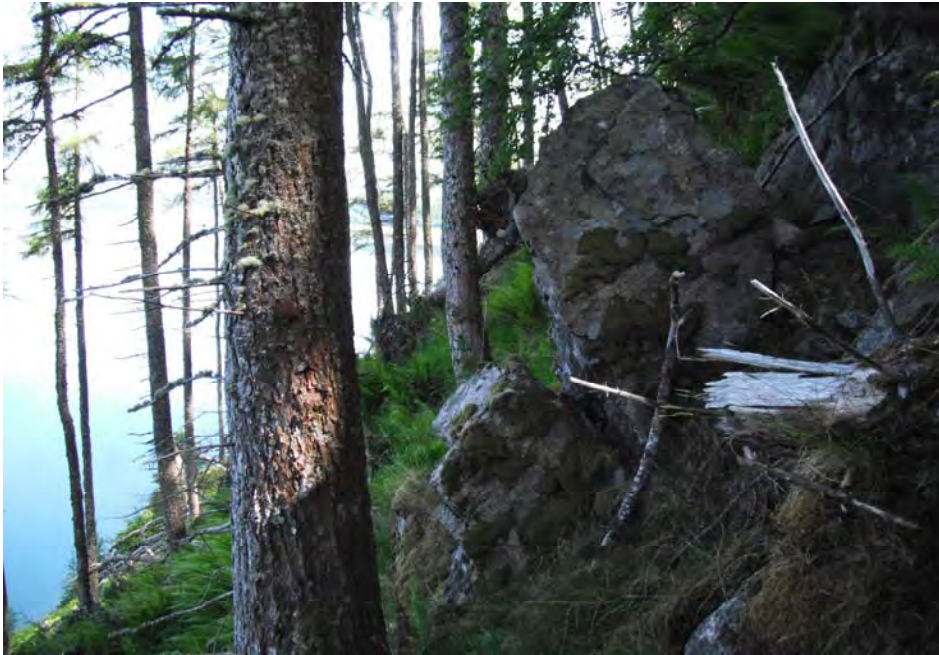
Photo 5: AA13-14 Upper - Detached blocks resting on slope

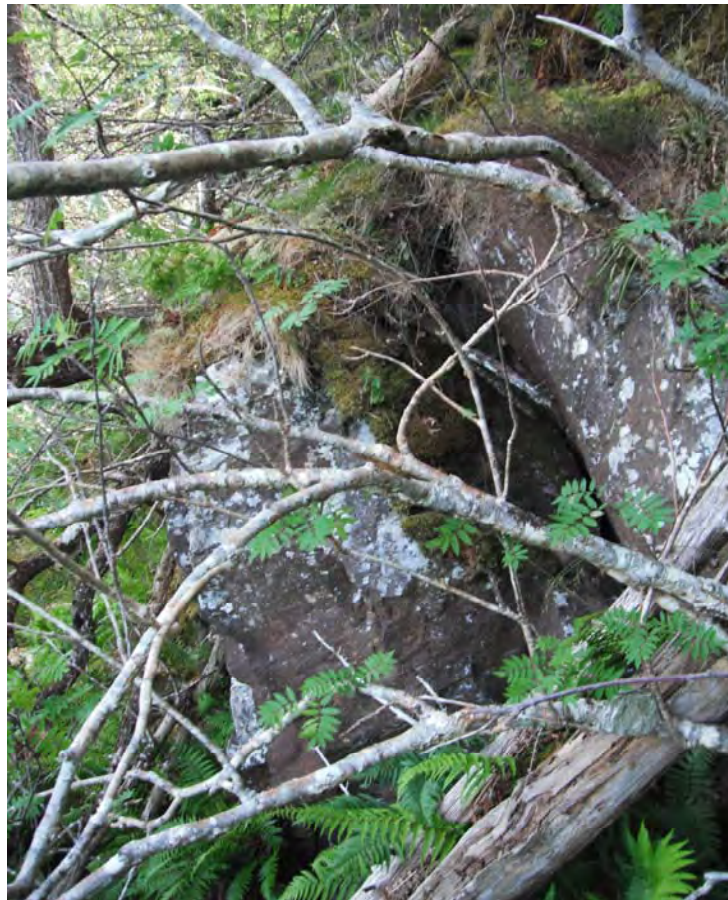
Photo 6: AA15 Upper - 4m³ block wedged behind flake showing signs of dilation.

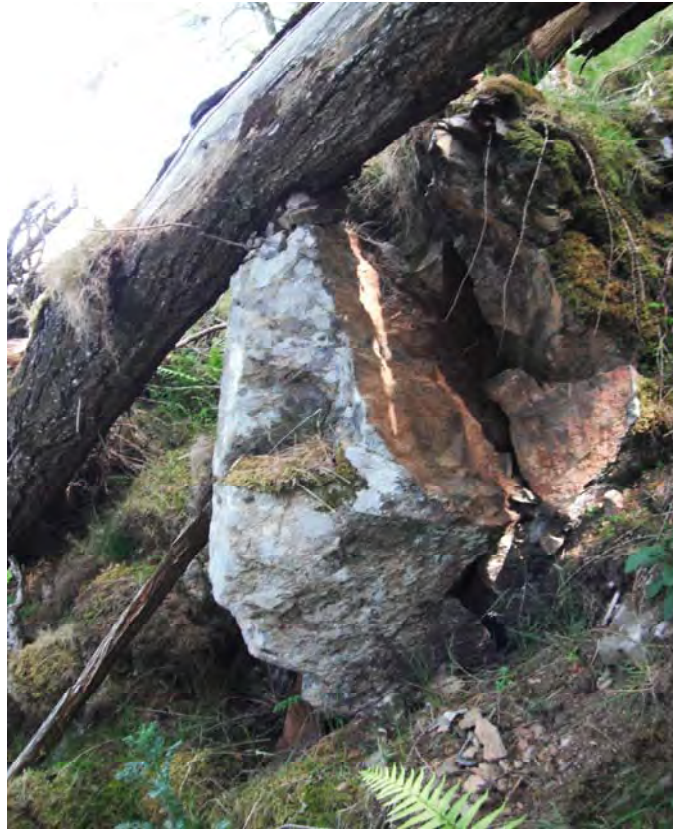
Photo 7: AA16-17 Upper - Unstable detached blocks retained only by fallen trees.

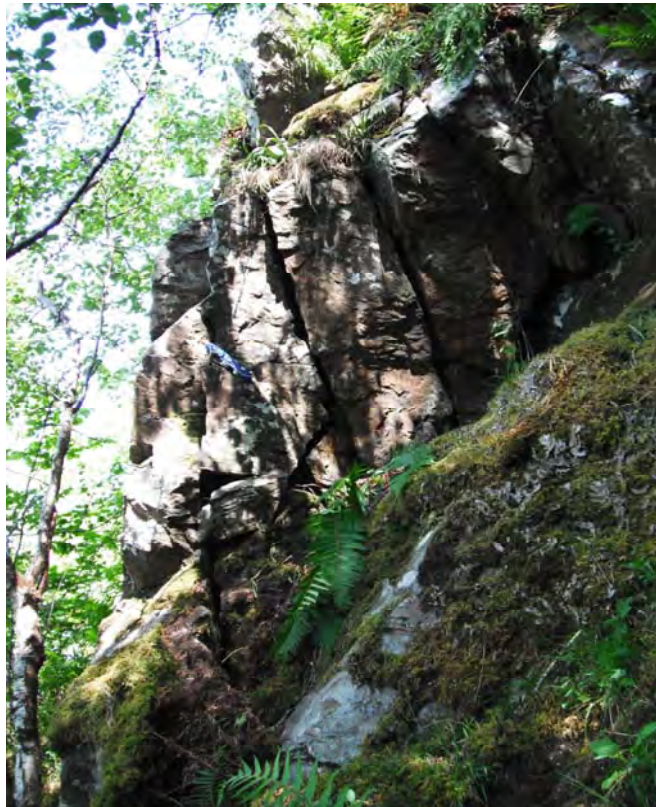
Photo 8: AA16-17 Upper 5 No. block (0.6m^3 each) prone to toppling.

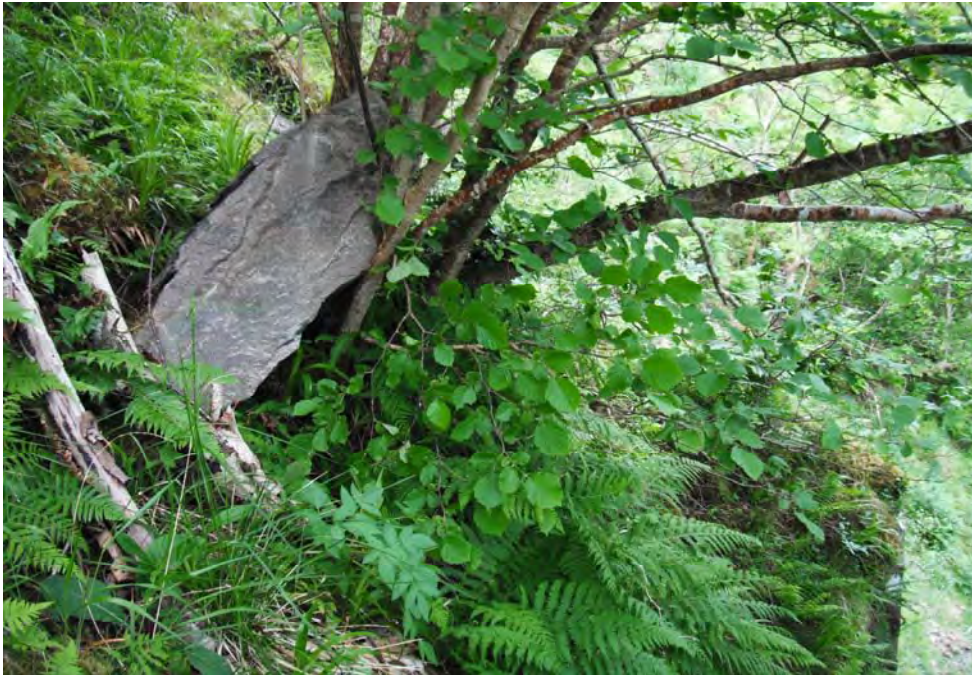
Photo 9: AA19 Upper - Unstable fallen block restrained by vegetation only.

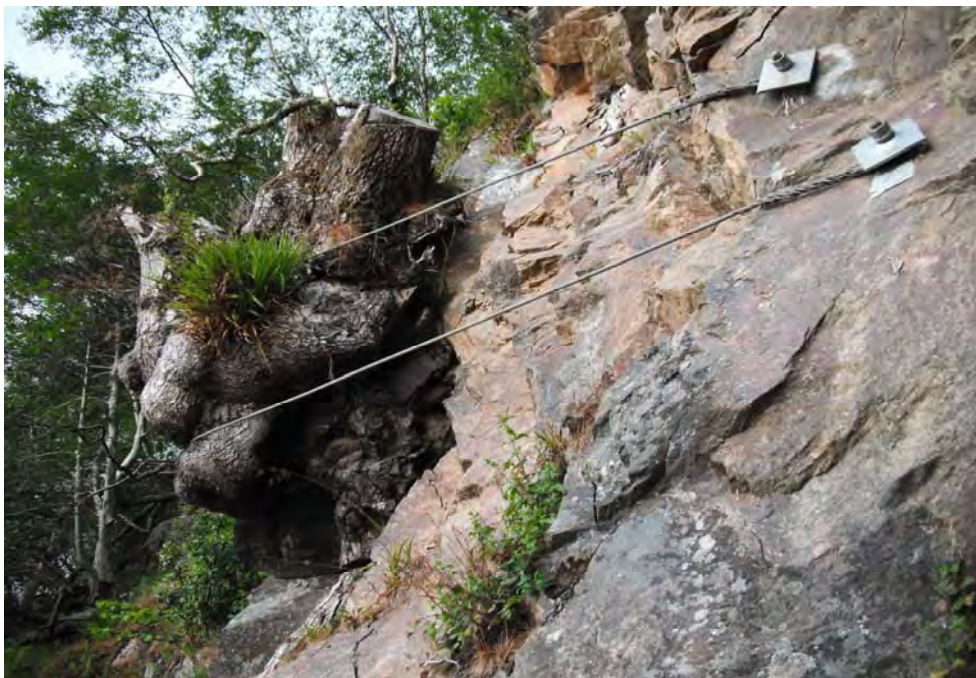
Photo 10: AA19 Upper - 2m³ dead tree stump and rock blocks with cable straps.

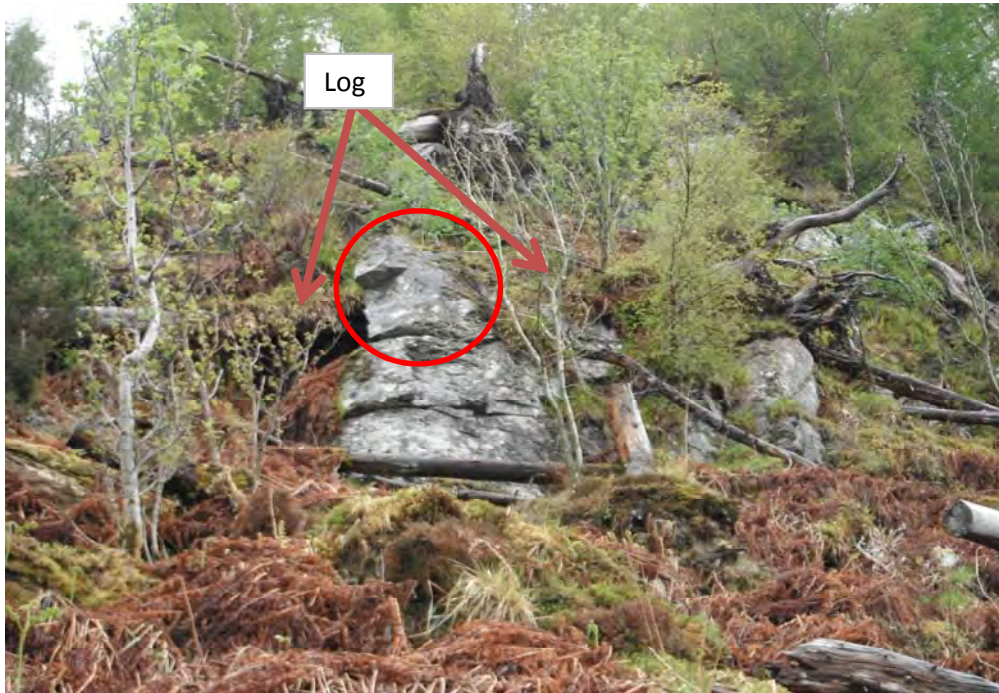
Photo 11: AA16-17 Upper - 1.9m³ block detached block with a fallen tree jammed behind it.

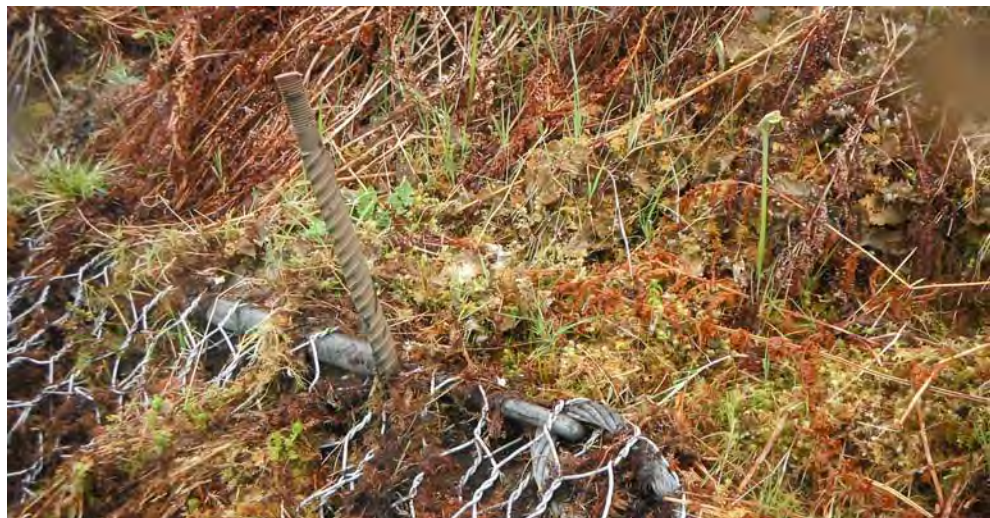
Photo 12: AA17 - Top anchors driven into ground, no evidence of grout.

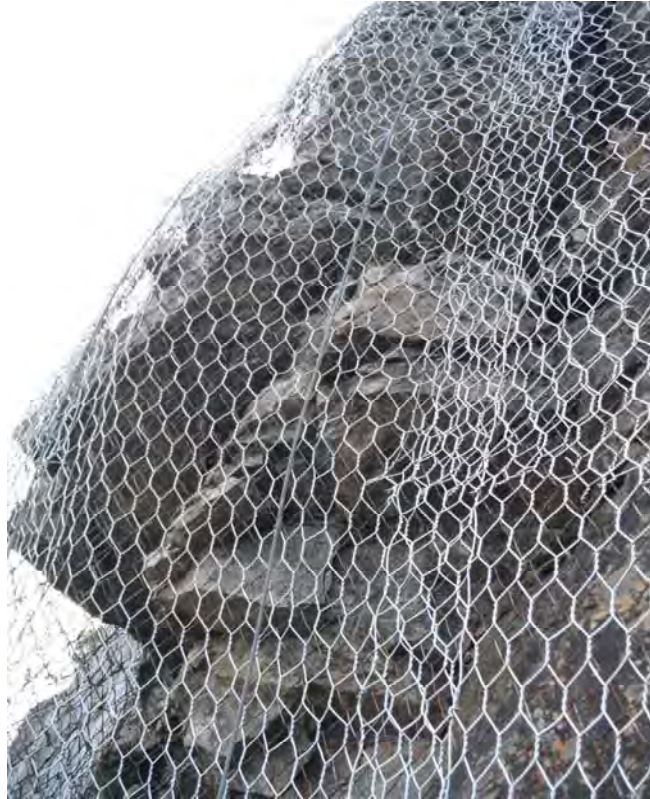
Photo 13: AA22B - 12m³ 'nose' resting on ravelling blocks centred on a poor join in the netting (wire twist joins at 0.5 - 0.7m centres)
