Project No	P530-S1-20-01
Project Name	Burnfield Toilet Block Structural Inspection
Client	Grantown Initiative (Community Group)
Property Address	Existing Burnfield Toilet Block, Burnfield Avenue, Grantown-on-Spey, PH26 3HH
Reason for Inspection	Transfer of Property from Highland Council to Grantown Initiative
Inspection Date	17 th February 2020
Inspection By	Colin JI MacPhee, Bsc (Hons) I.Eng, MICE, FGS

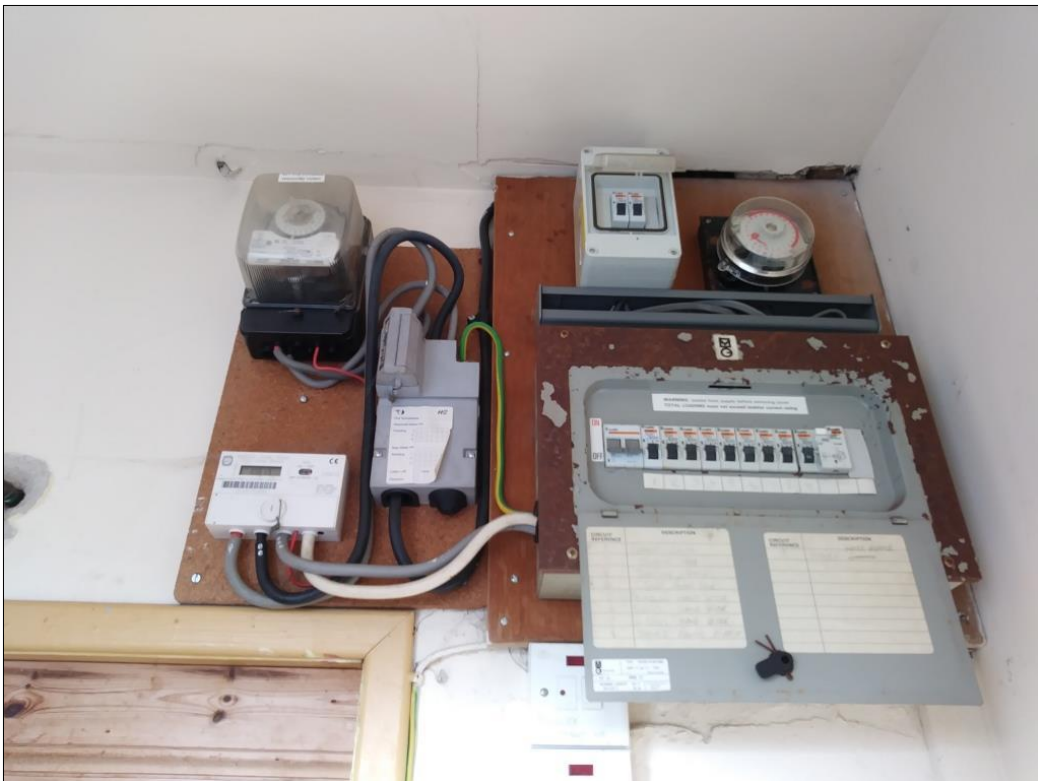
Photograph 8 – Electricity Distribution Board & Meter (Utility Room)

- *Wall tiles missing below urinal in male toilets.*
- *Isolated wood worm noted to plywood backing to electrical distribution board.*
- *Cracking to plaster and paintwork to utility room roof and walls.*
