# A890 Stromeferry Bypass

Annual Slope Inspection Report 2022

The Highland Council

07 September 2022

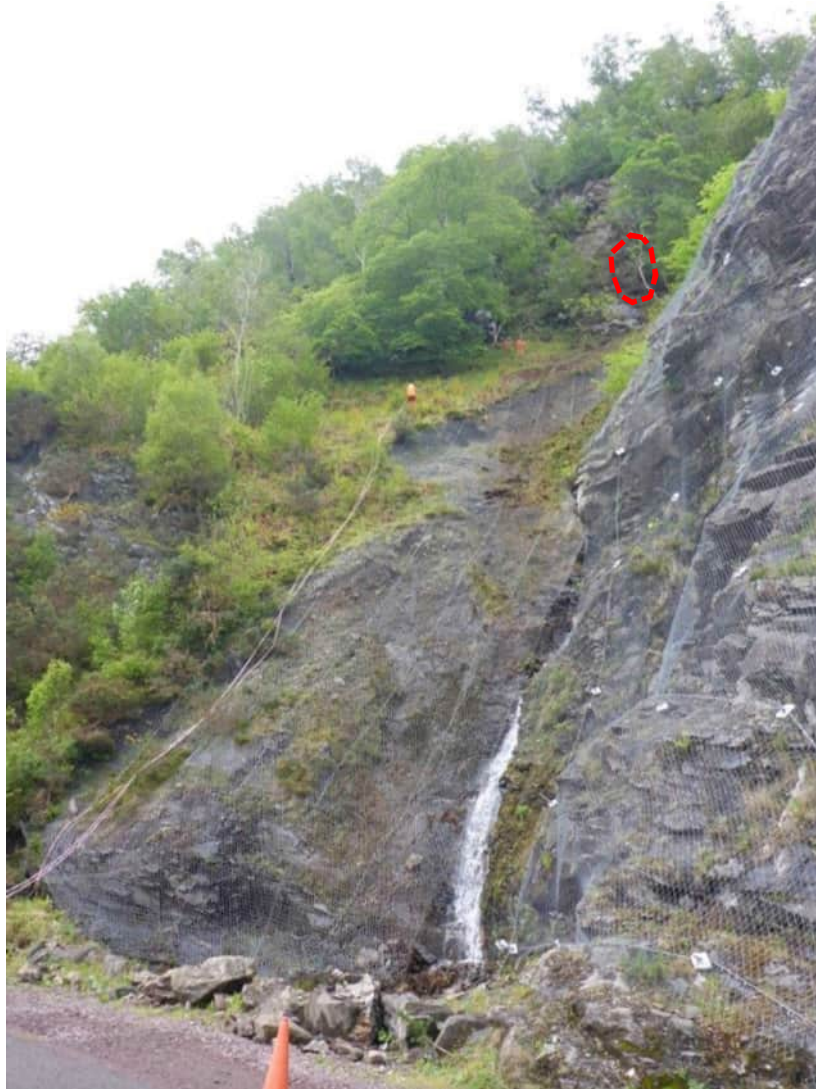
**Photo 1: Slope at AA18-AA19 with failure source area circled.**

The failure resulted in ca. 2m<sup>3</sup> of predominantly rock debris (but with some soil and vegetation) reaching the toe of the slope with the vast majority observed to be retained in the catch pit. Observed block sizes at the toe of the slope ranged from 0.1 x 0.1 x 0.1m to 1.0 x 0.5 x 0.5m, but more typically 0.2 x 0.2 x 0.2m. Debris was present over a ca. 15m verge length at road level, with the furthest travelled block observed in the northern cess of the railway ca. 15m to 20m from the toe of the slope.

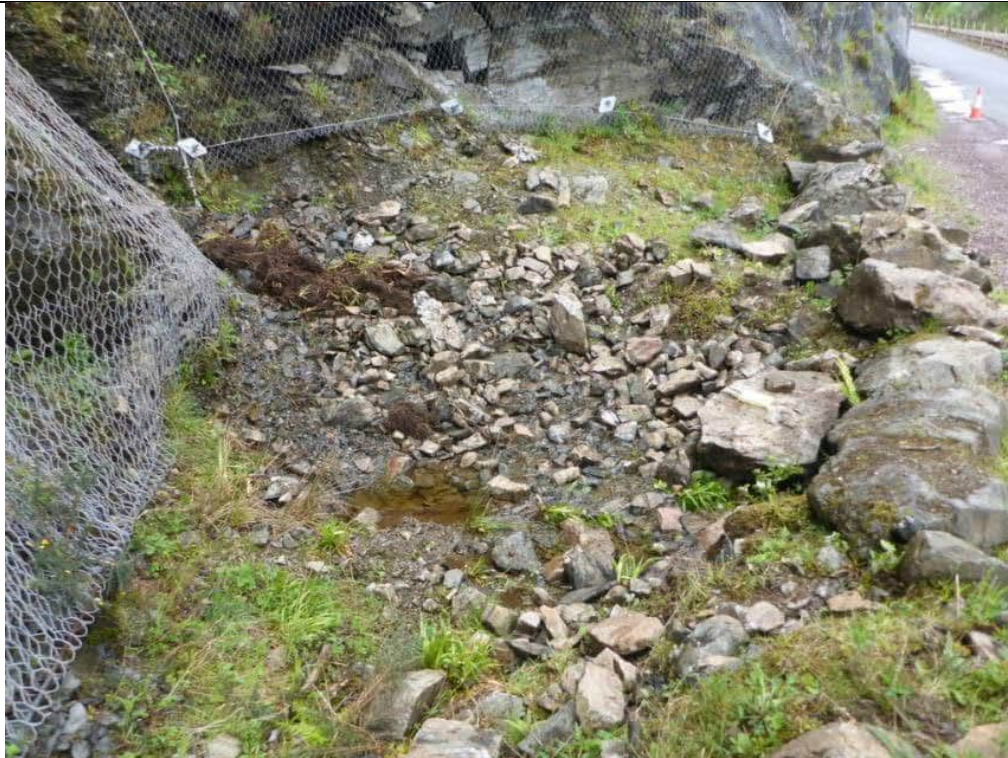
Between the toe of the slope and edge of the road there is a lower area associated with the watercourse which acts as a rock-trap feature (photos 2 and 3). This lower area measures approximately 2 to 5m wide, 10m long and 0.5 to 1.0m deep. This catch pit was partially constructed using scaled boulders generated from adjacent rock slope remedial works in 2012.

**Photo 2: Debris catch pit between toe of slope and road with recent debris accumulation.**

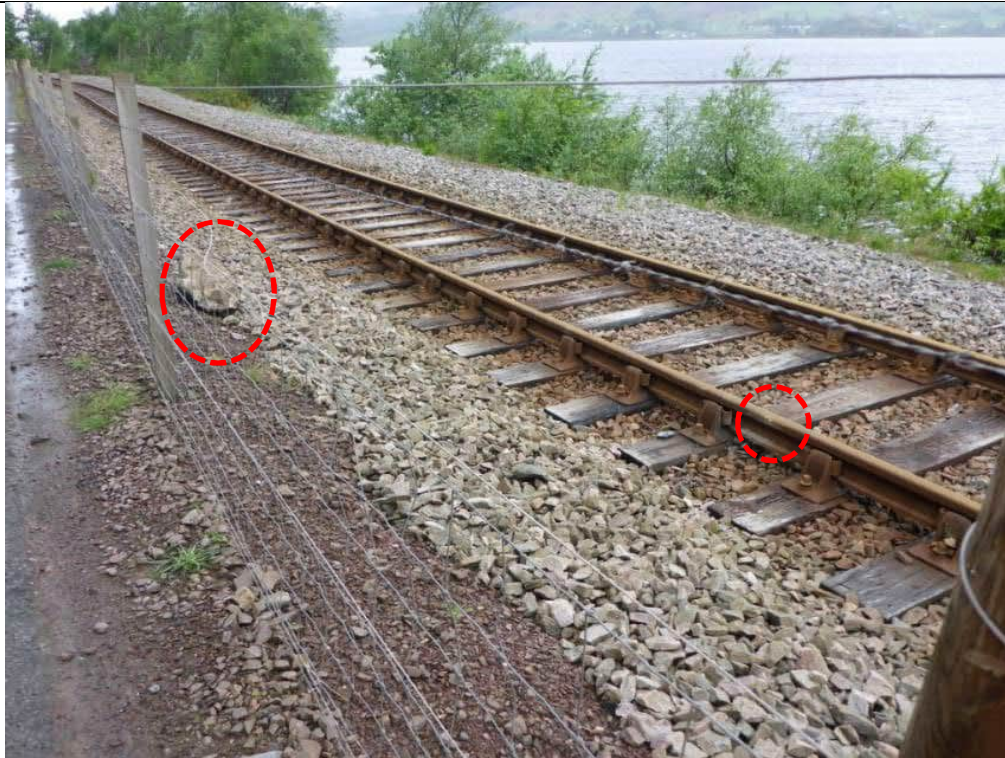
**Photo 4: Block located in railway cess is highlighted above. Broken fence wire indicates it struck fence at ca. 0.7m height. Location of small impact mark on rail line also shown.**

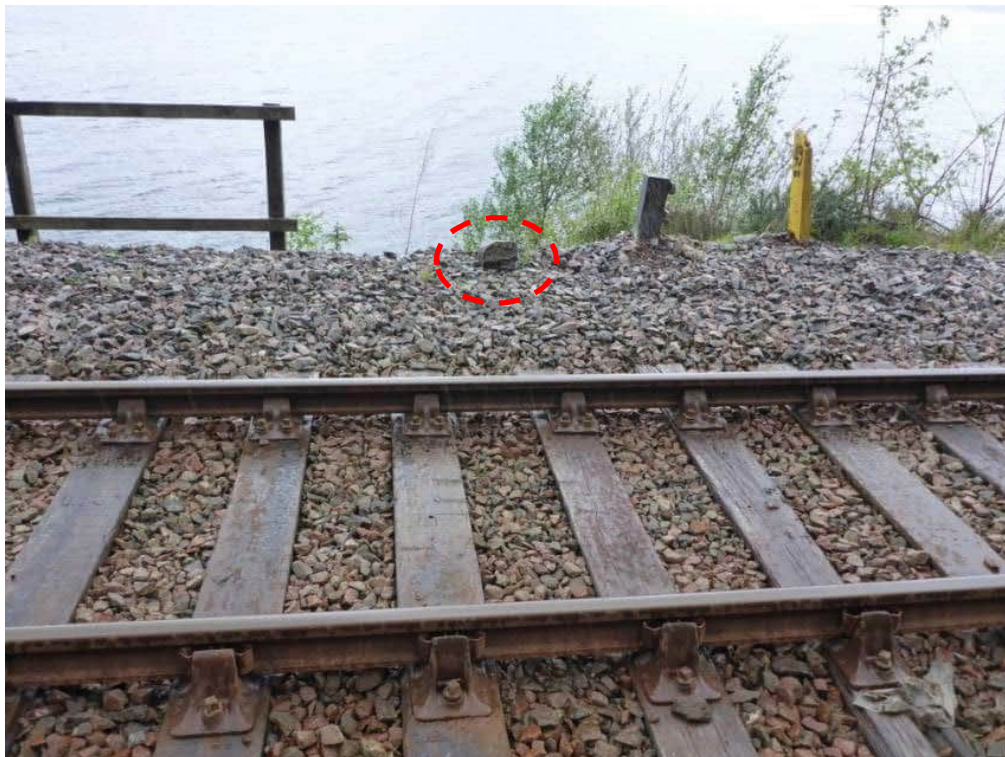
**Photo 5: Block located in railway cess on far side of railway. This block is thought to have originated from the recent failure.**

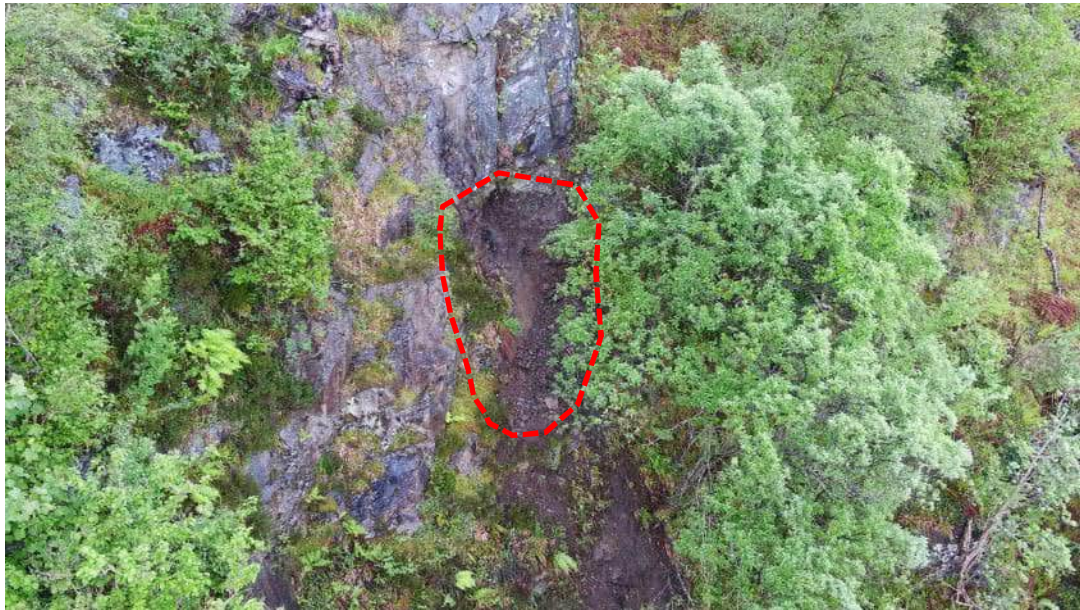
**Photo 6: Failure source area circled.**

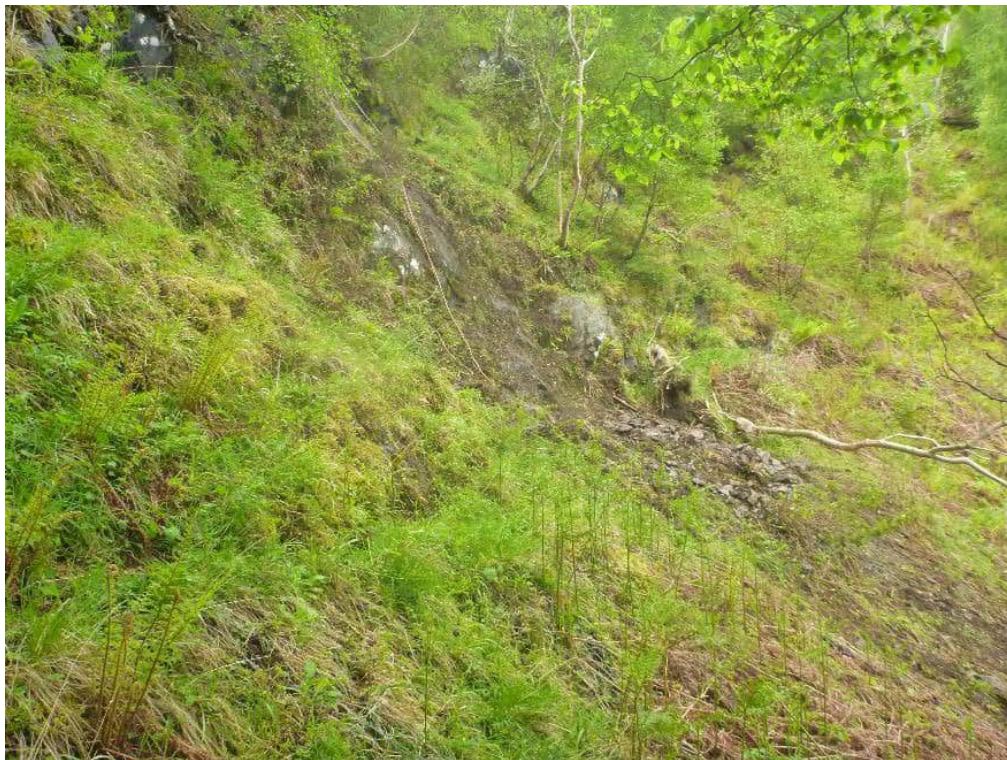
**Photo 7: Scree accumulation on break of slope below upper crags.**

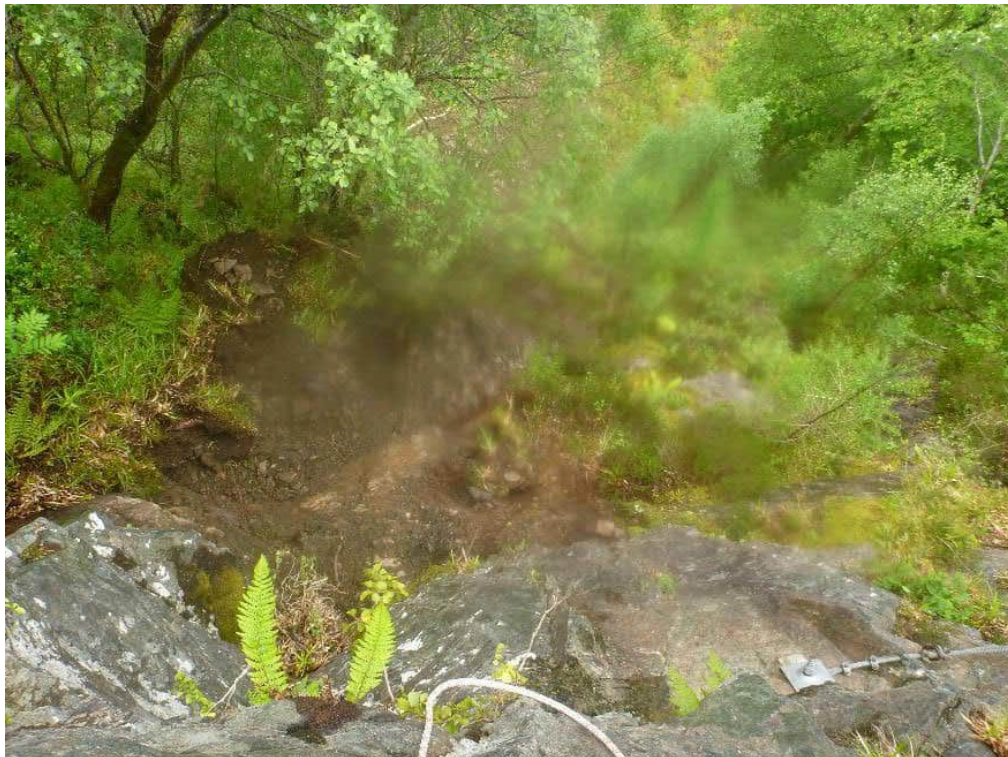
**Photo 9: View downslope of failure source area from upper crags.**

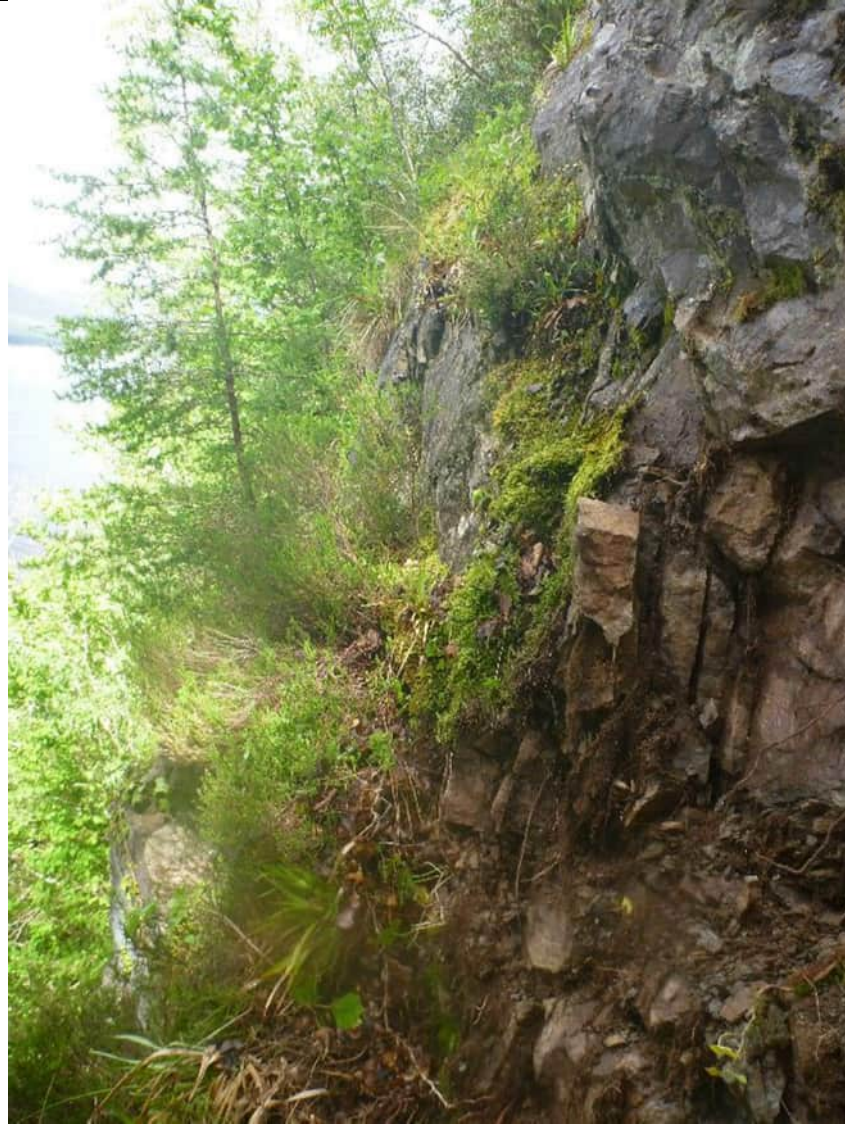
**Photo 10: Weathered rock mass at failure source at mid to lower portion of upper crags.**

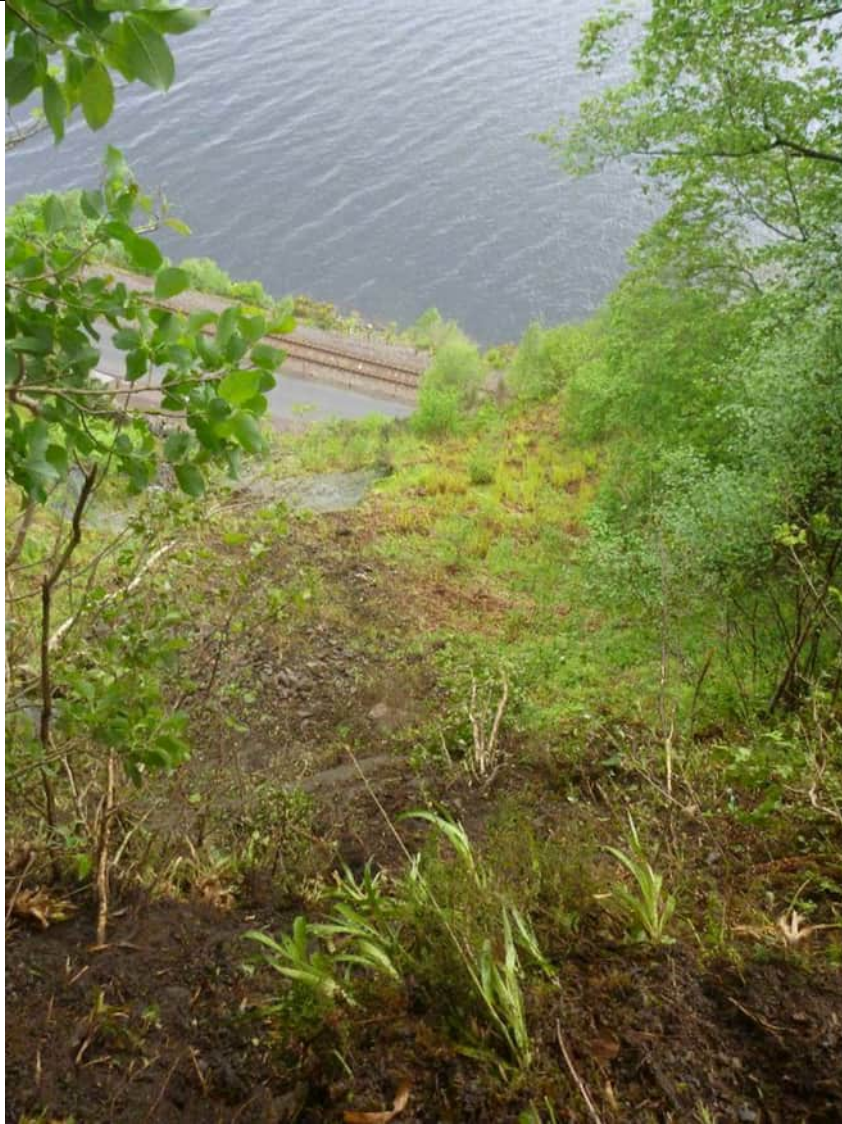
**Photo 11: view downslope from immediately below failure source. Failure/debris flow scar visible downslope to top of mesh.**

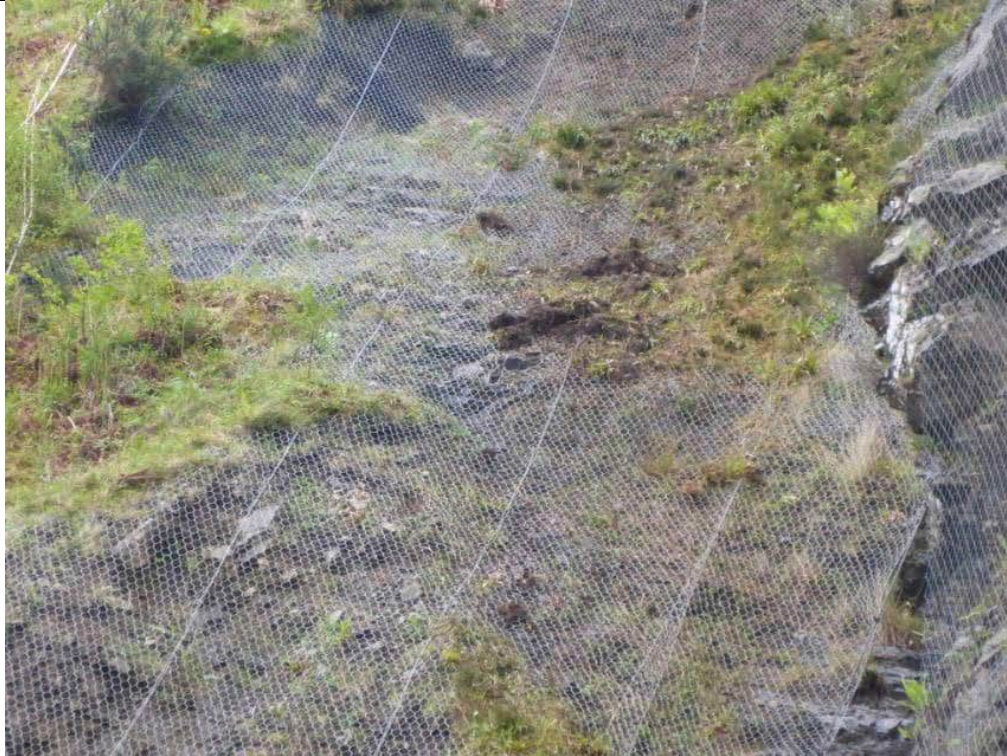
As the debris passed over the drape netting system it caused minor damage, with several tears up to 0.2m observed. Given the nature of the netted slope, the presence of these tears is not considered to pose a significantly increased risk to its function.

**Photo 12: Small tears visible in drape netting system caused by recent failure.**

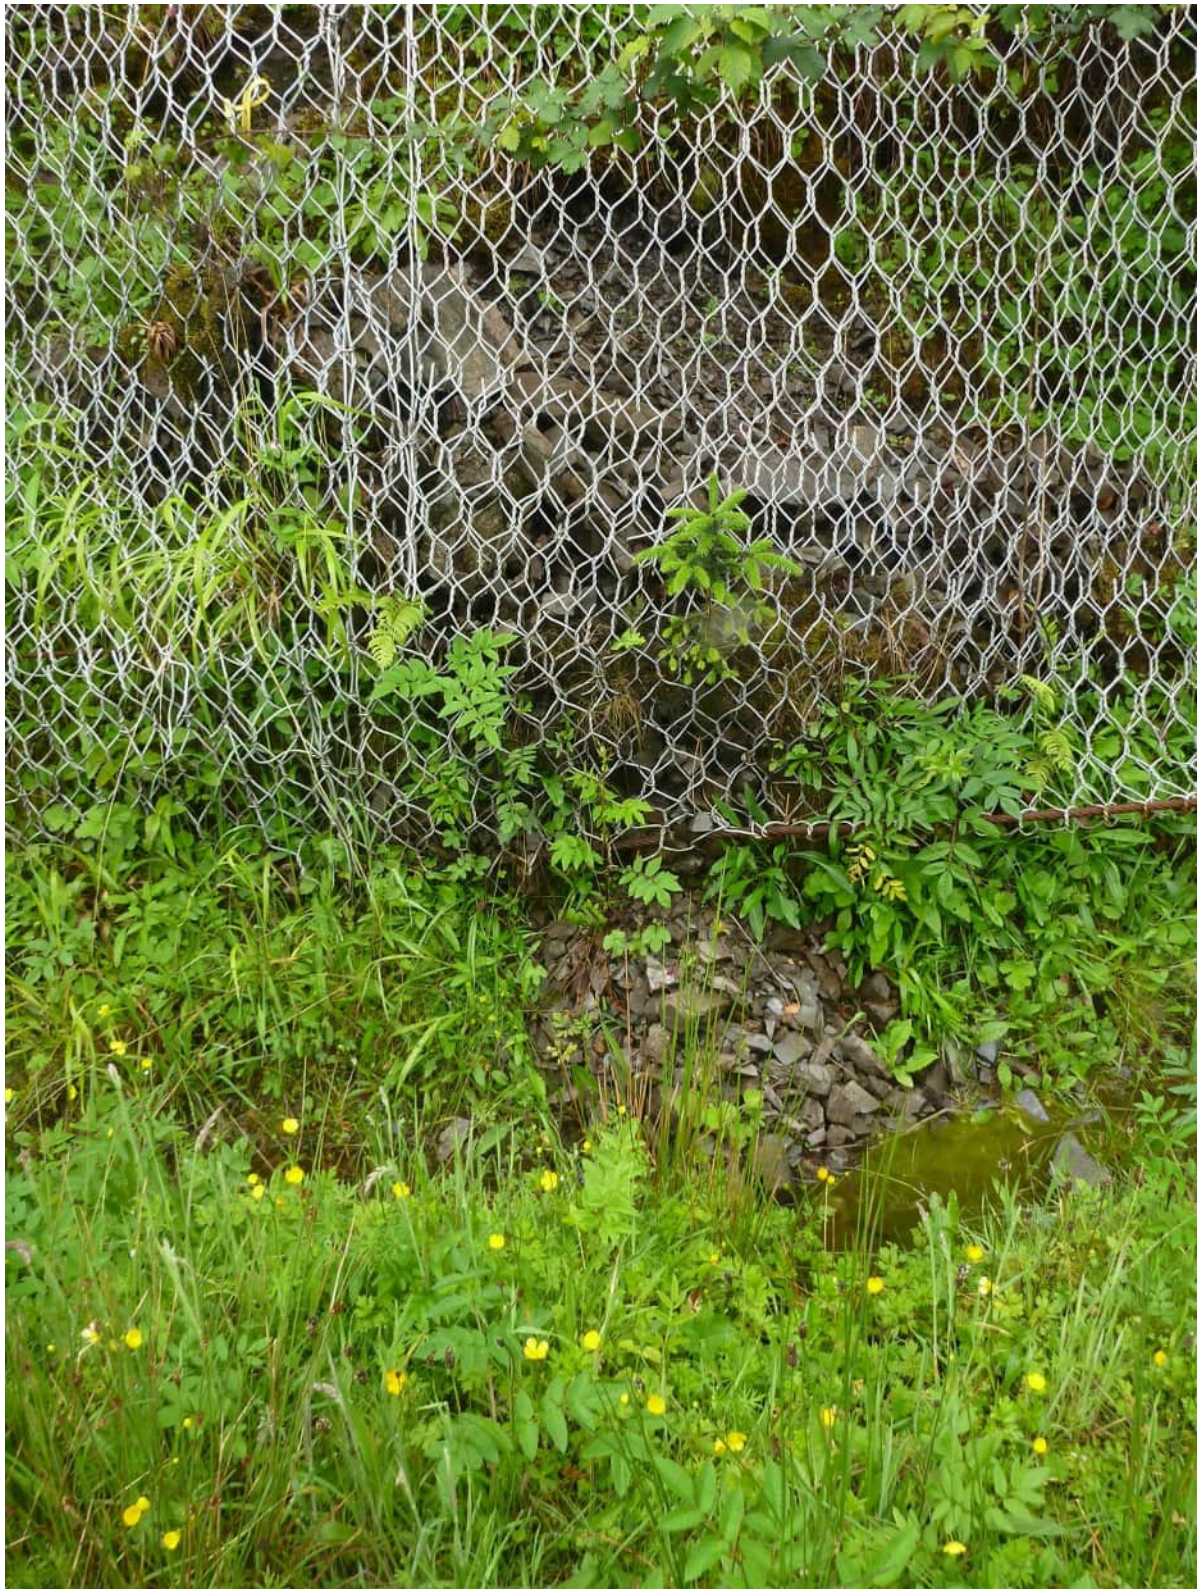
Photograph AA2-1

Debris at base of netting that is recommended to be cleared out at Ch. 273.

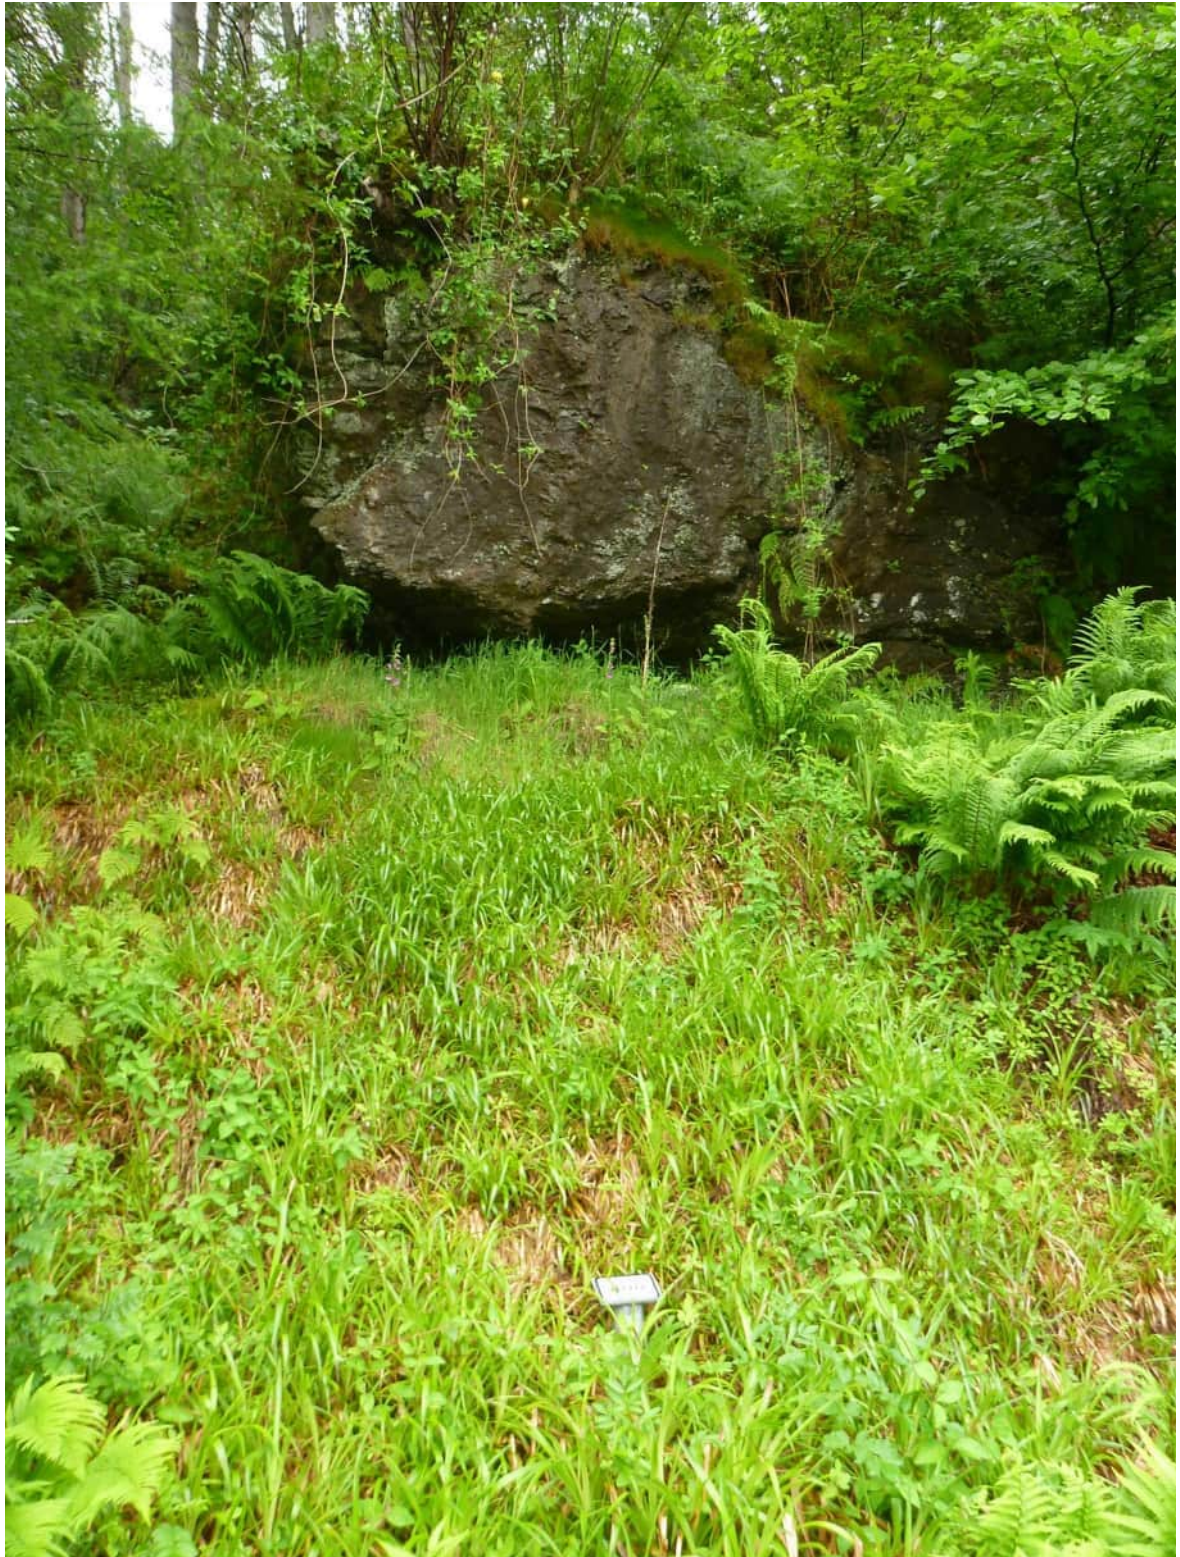
Photograph AA2-2

Controlled removal / heavy scaling of large overhanging boulder positioned 5m above road level at Ch. 400 is recommended.

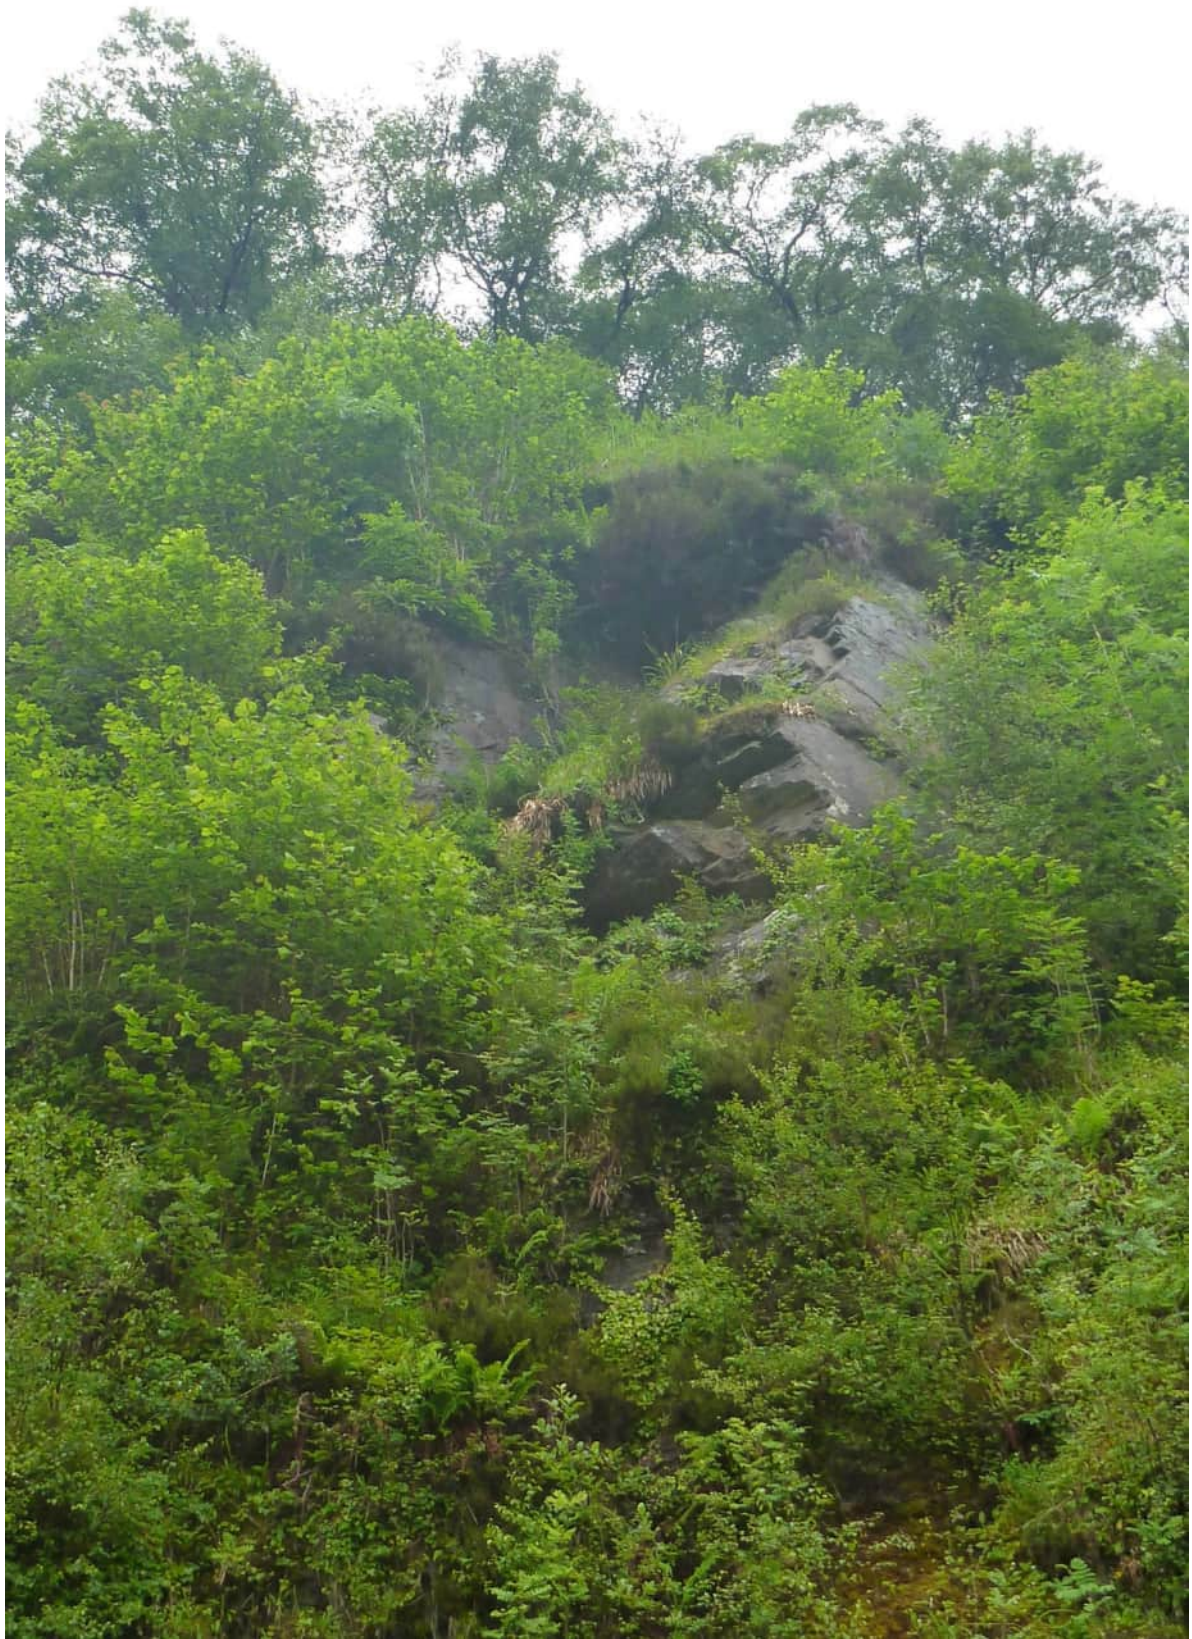
Photograph AA4-1

Column of fractured rock removed by light scaling 6-8m above road at Ch.0764 during Ph.12 works in 2021.

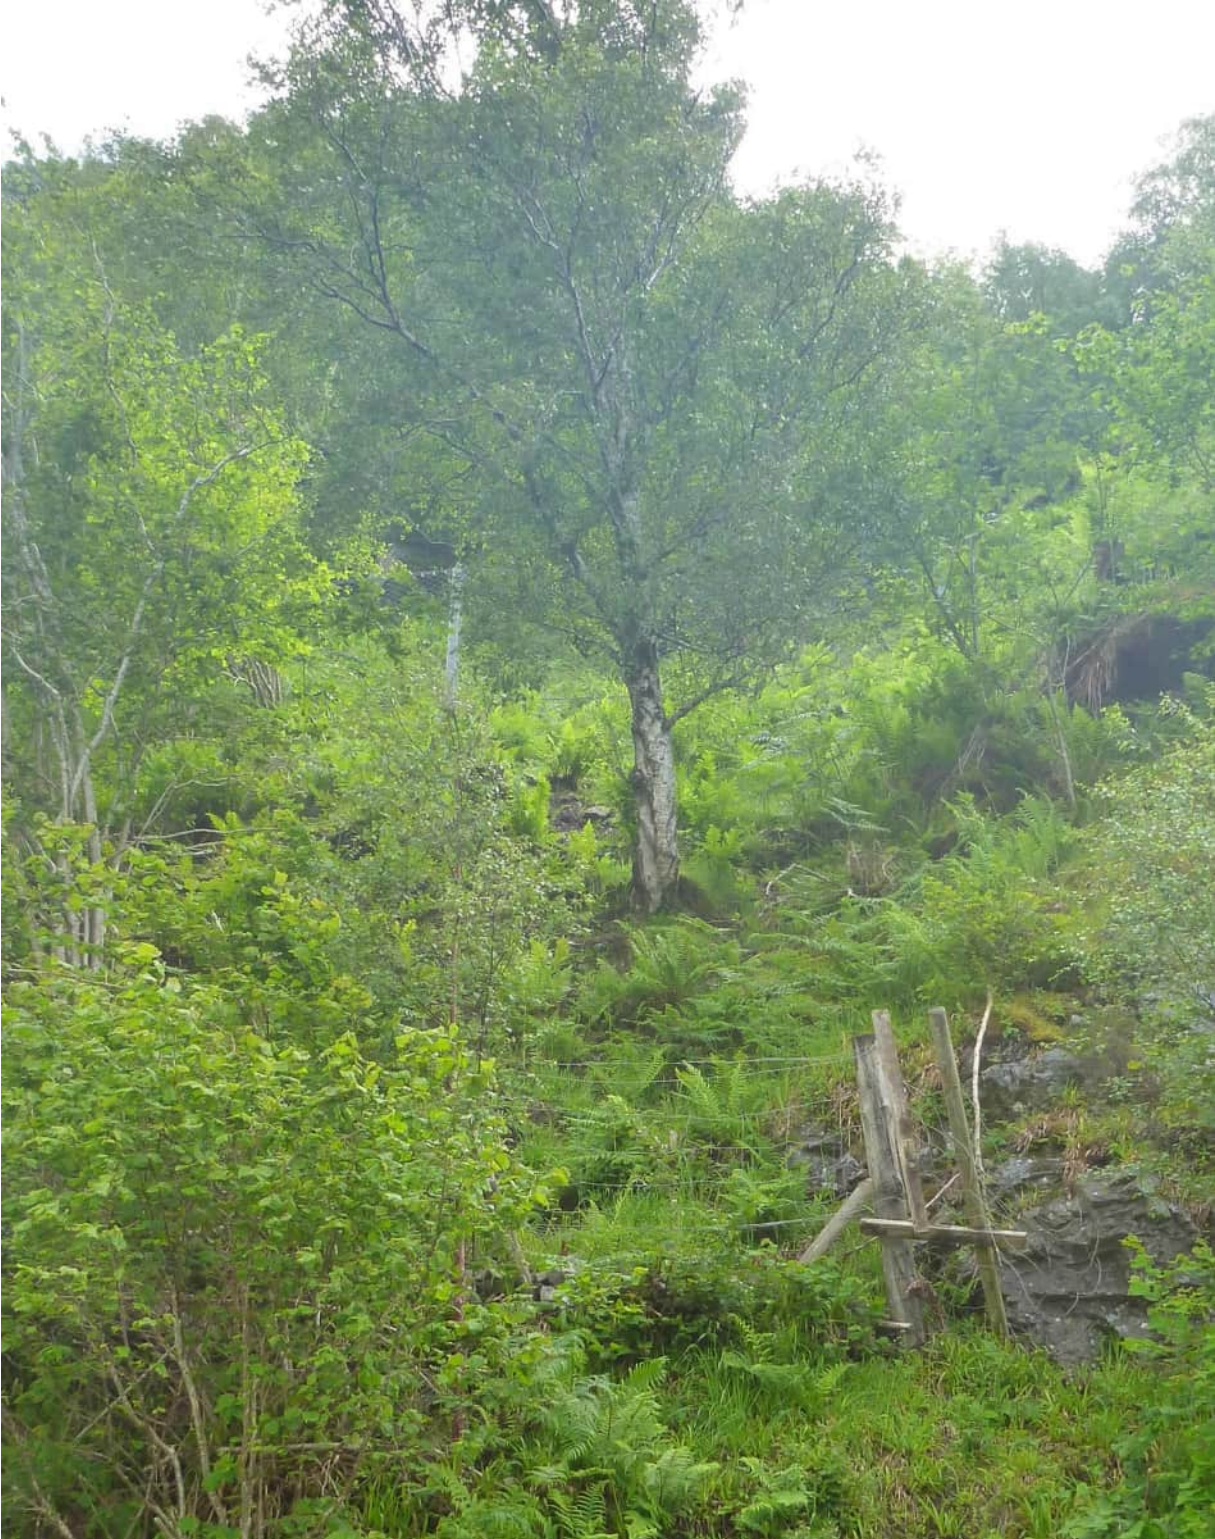
Photograph AA6A-1	Location of new catch fence installed during the 2021 works. (Not clear in photo due to the dense vegetation)
-------------------	---

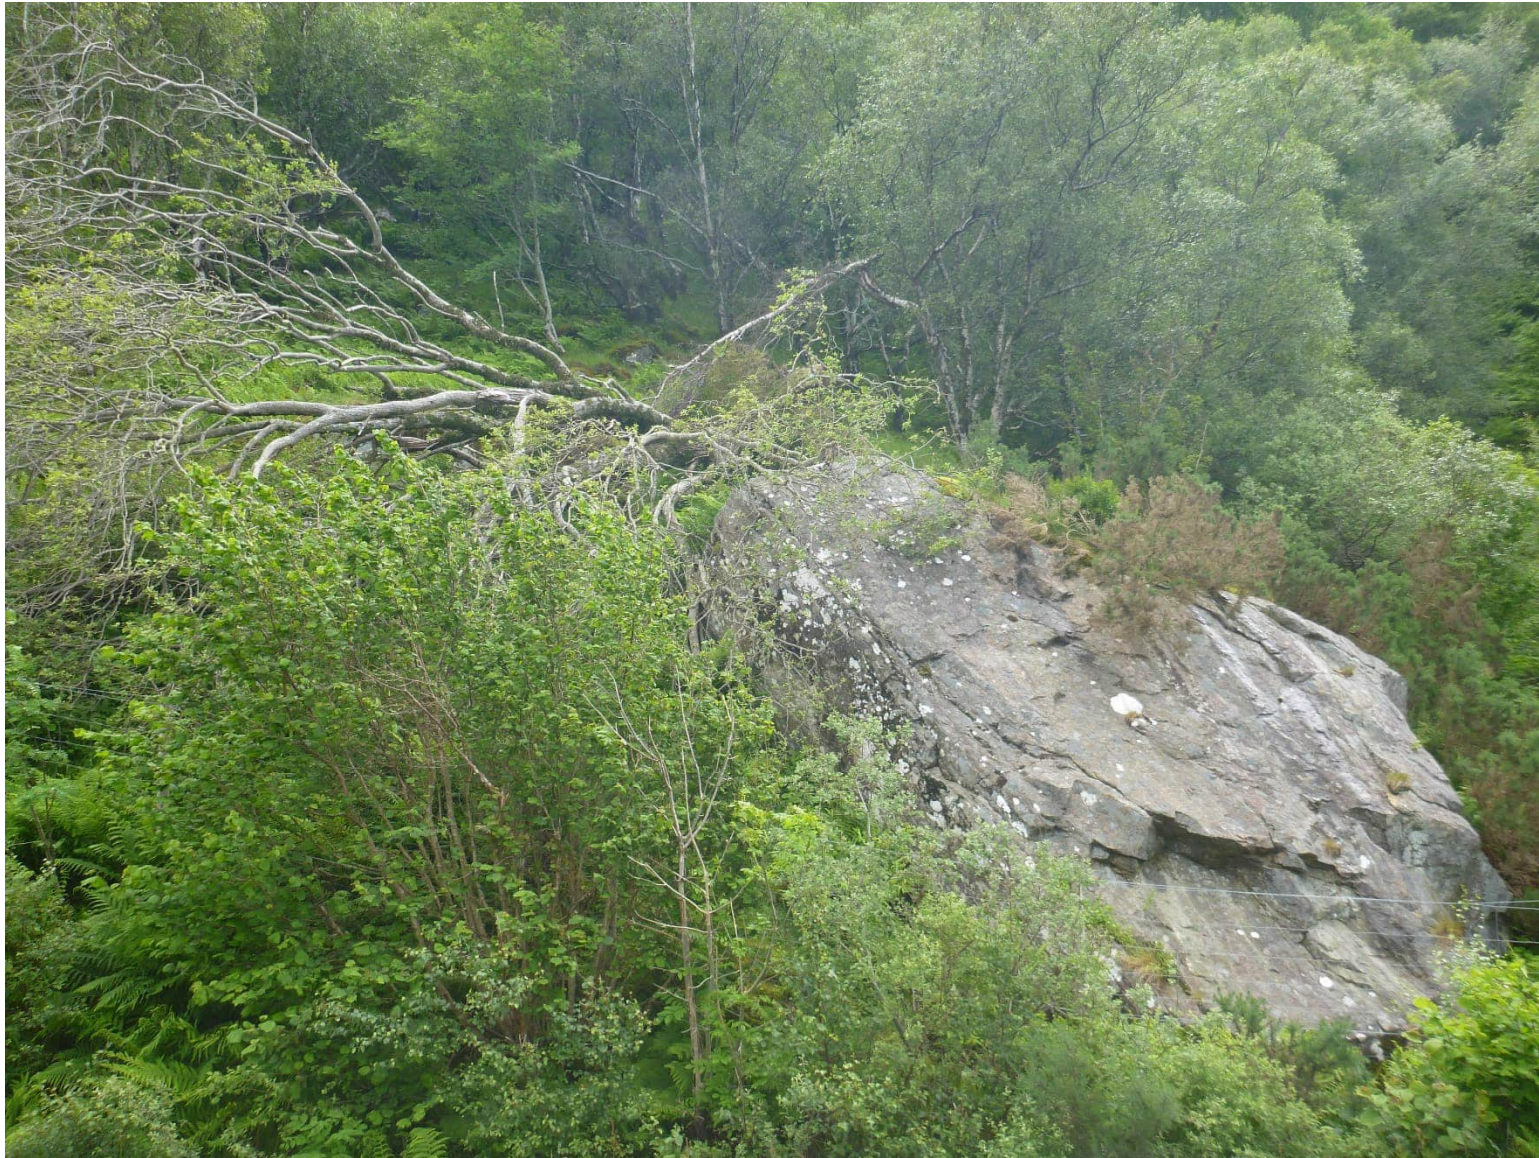
Photograph AA6B-1

Fallen tree at Ch. 1654 posing no risk to the road.

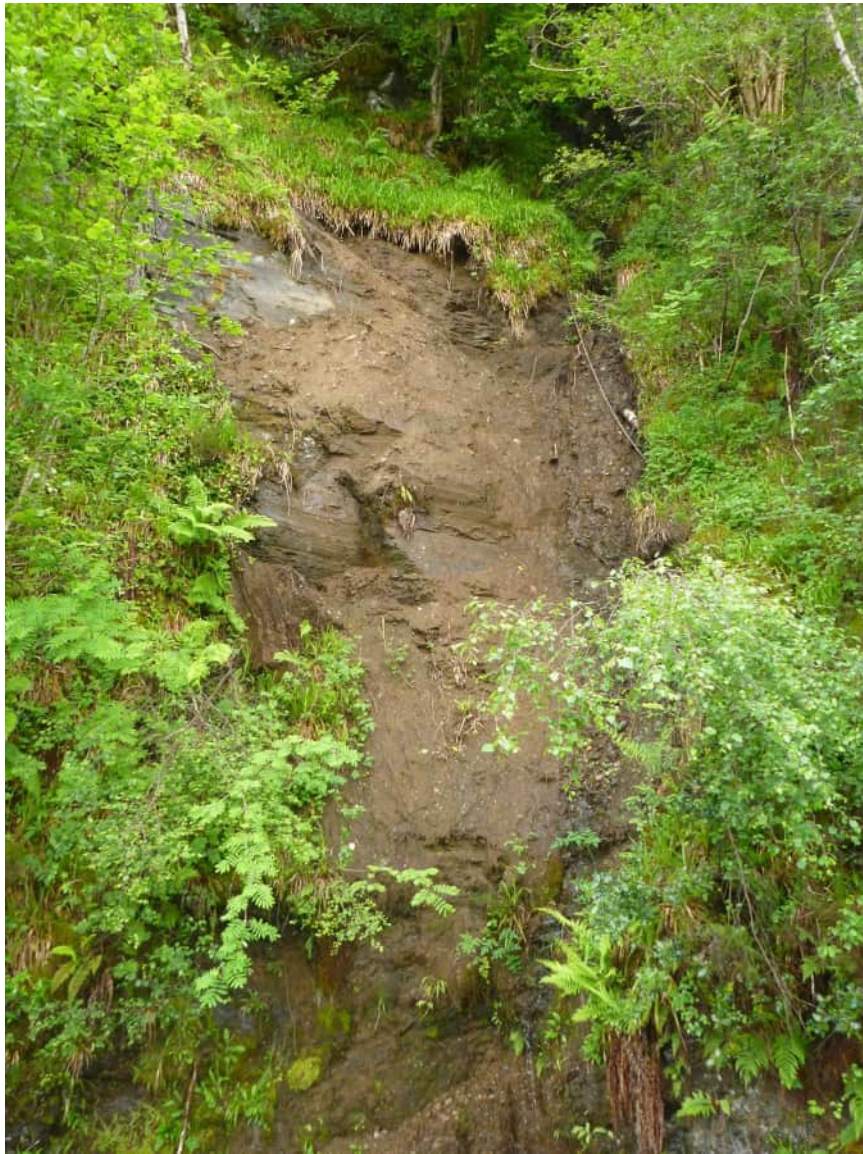
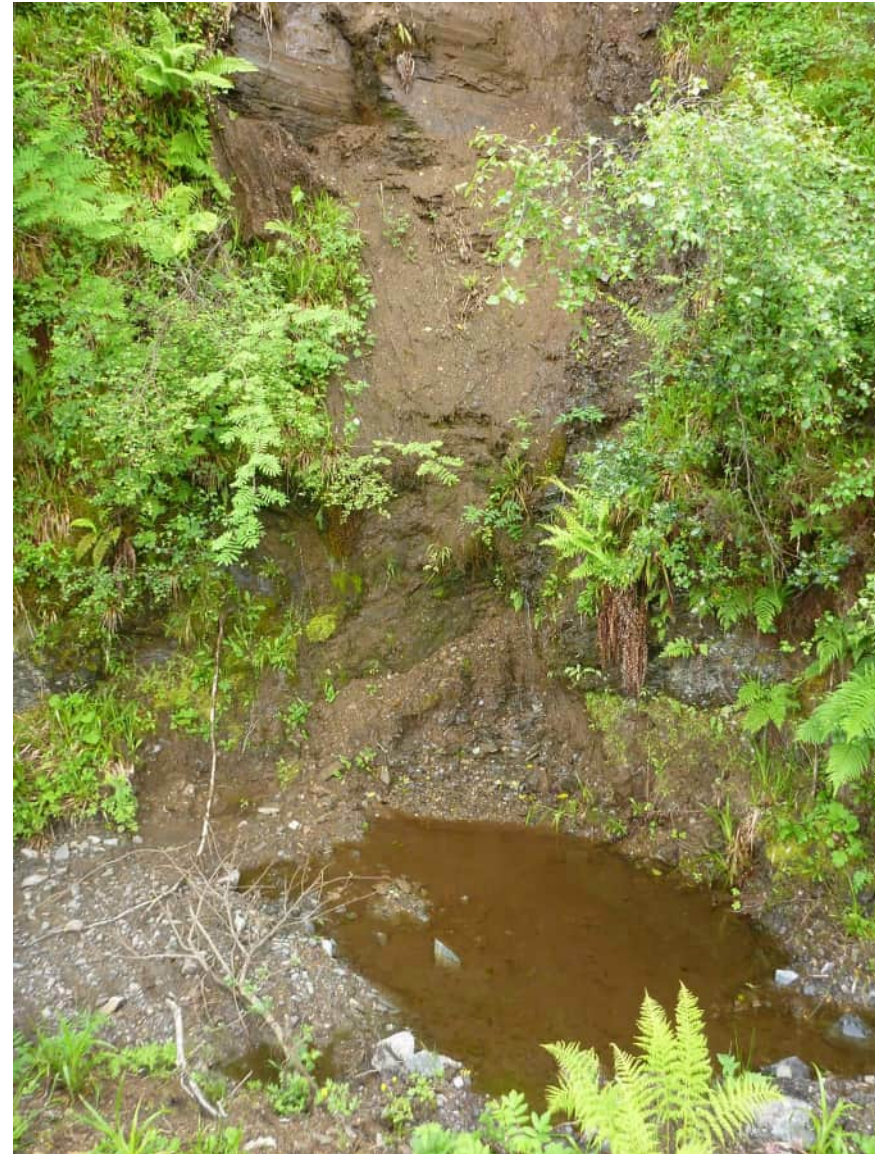
Photographs AA8-1a and 1b

Soil slip/wash out originating c.8m above ground level at Ch. 1892 to 1896. Large ditch with plenty of capacity. Recommend keeping ditch under observation and cleared where required to maintain its capacity.

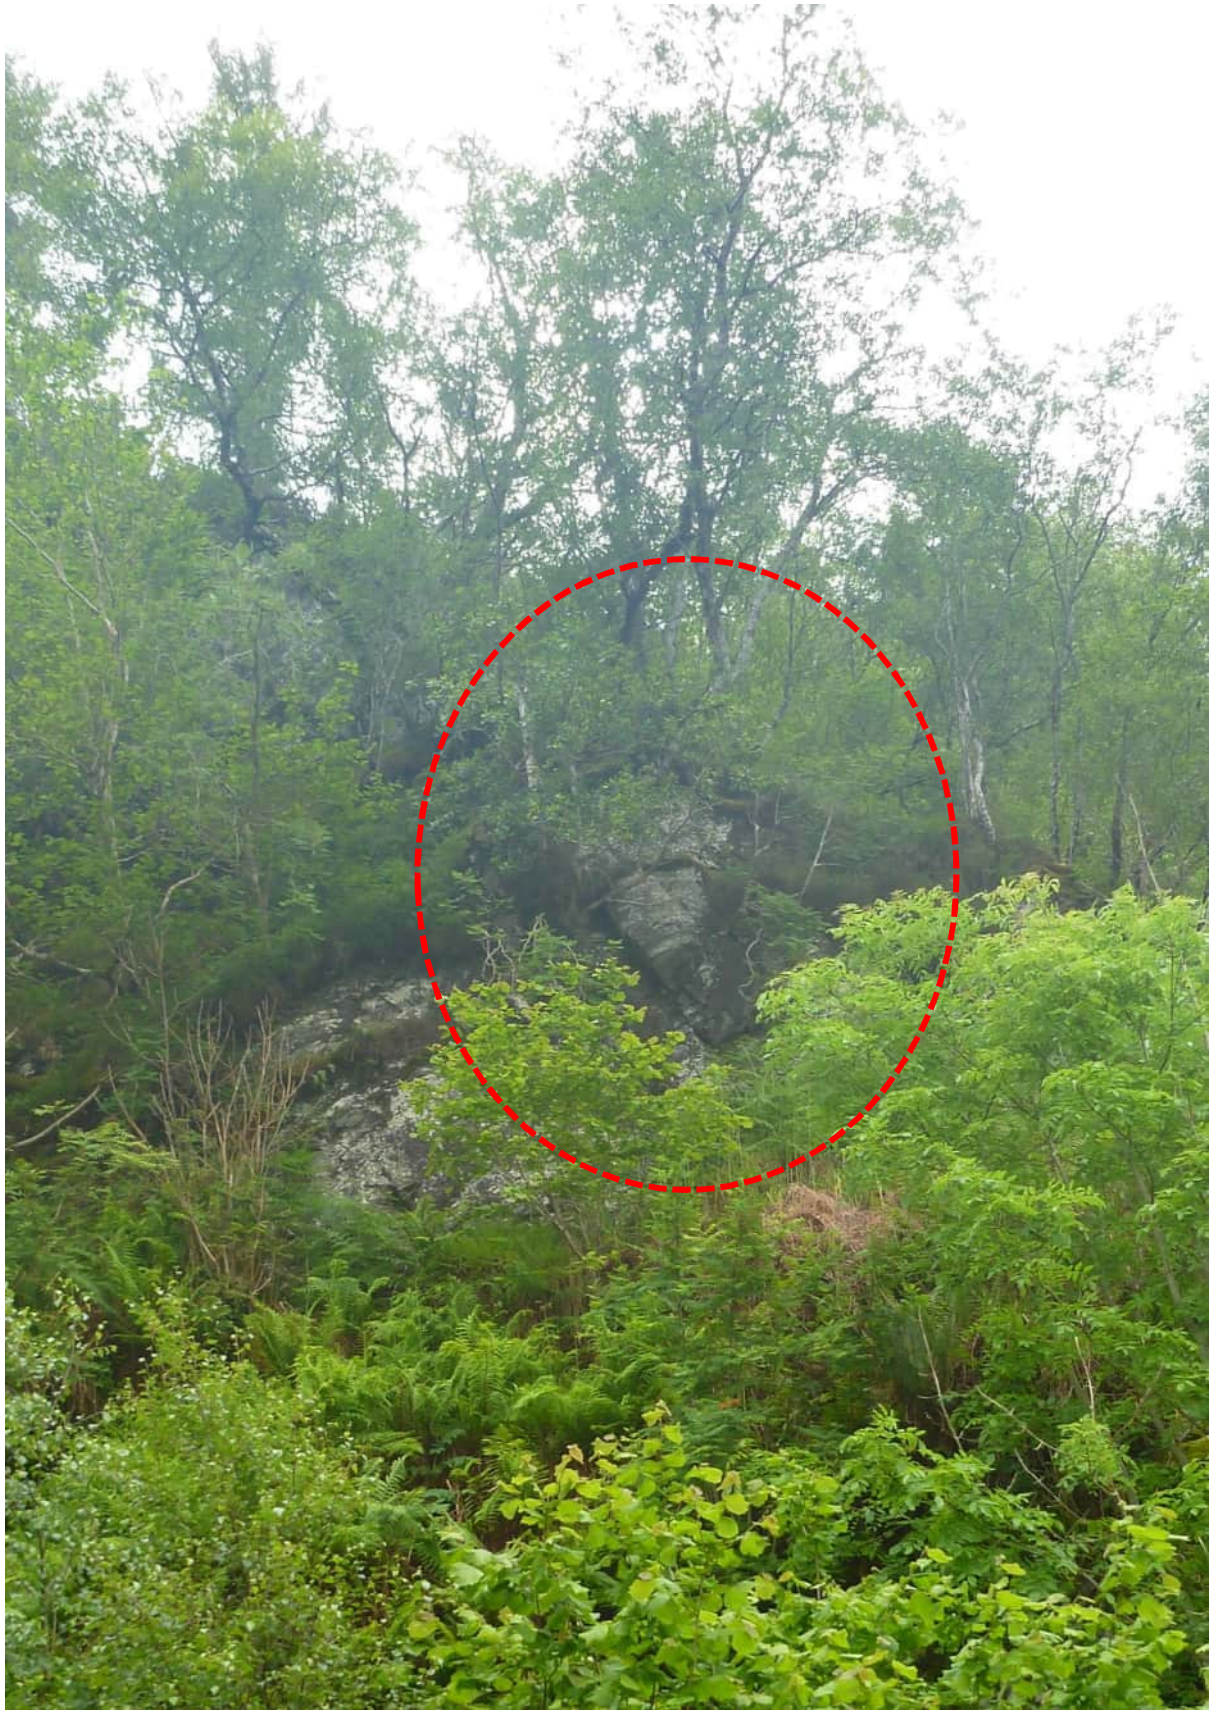
Photograph AA10-1

Wedge of rock with dilated joints 15m above road level at Ch. 2130. Potential for failure due to root-jacking. Potential failure volume is large enough to burst through the deer fence and may either come to rest in the ditch or at the edge of the road.
