# A890 Stromeferry Bypass

Annual Slope Inspection Report 2022

The Highland Council

07 September 2022

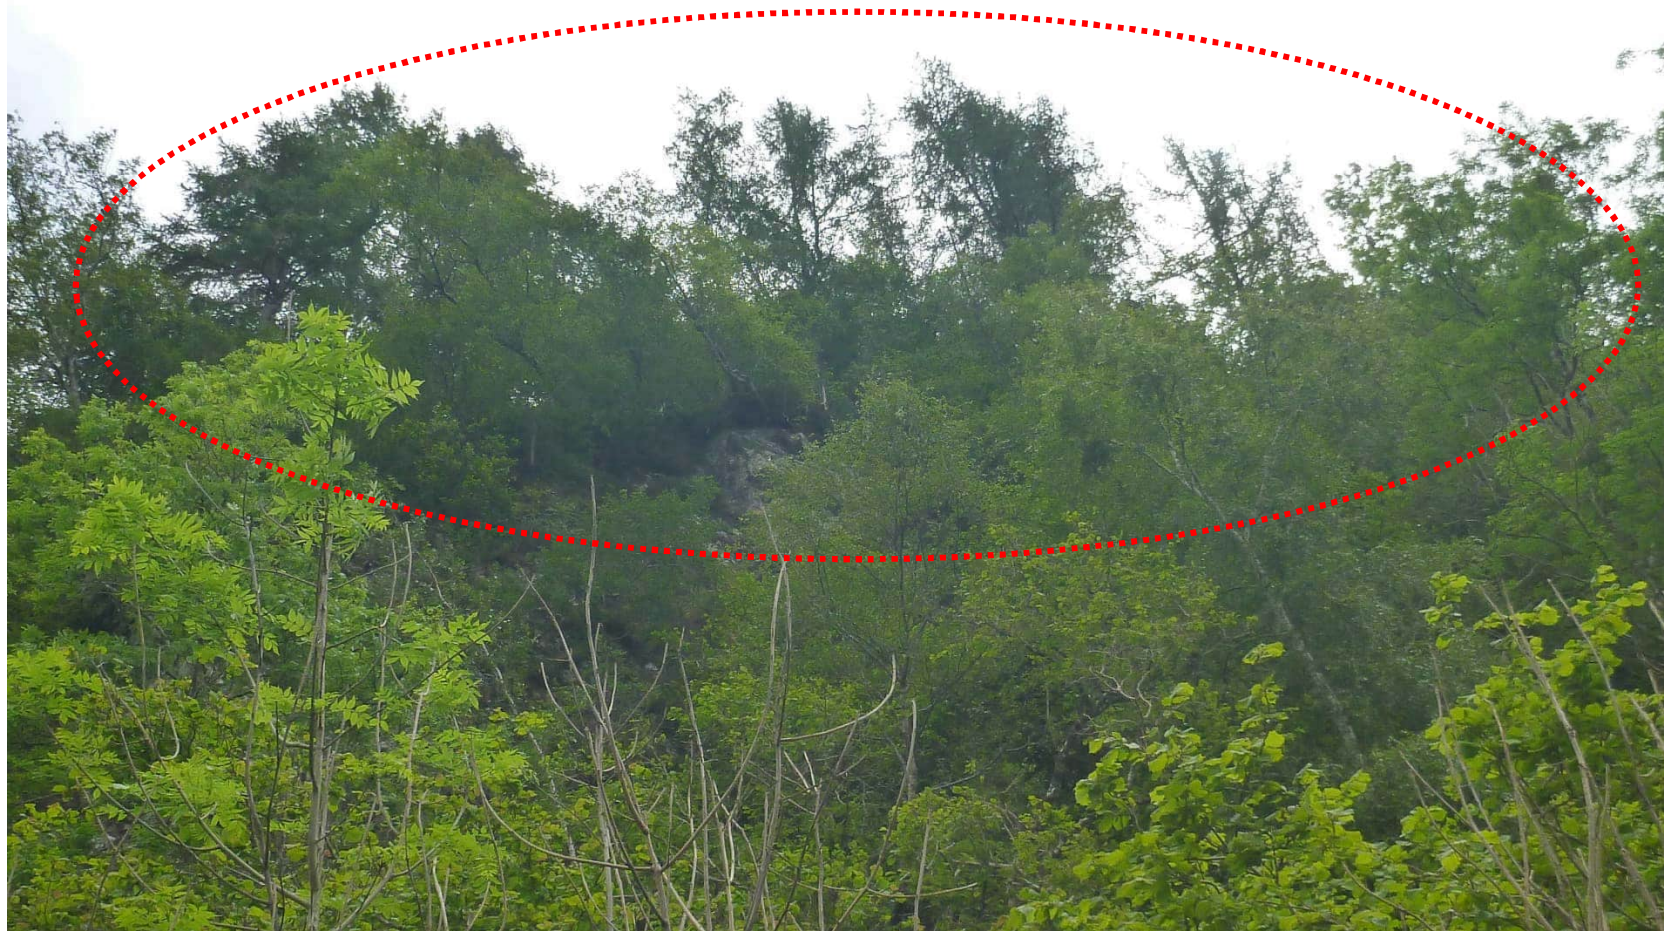
Photograph AA10-2

At approx. Ch. 2240, at the crest of the slope there are a number of trees leaning towards the road. If these were to fall they could dislodge loose rock, but unlikely to impact road due to set back distance of the slope.

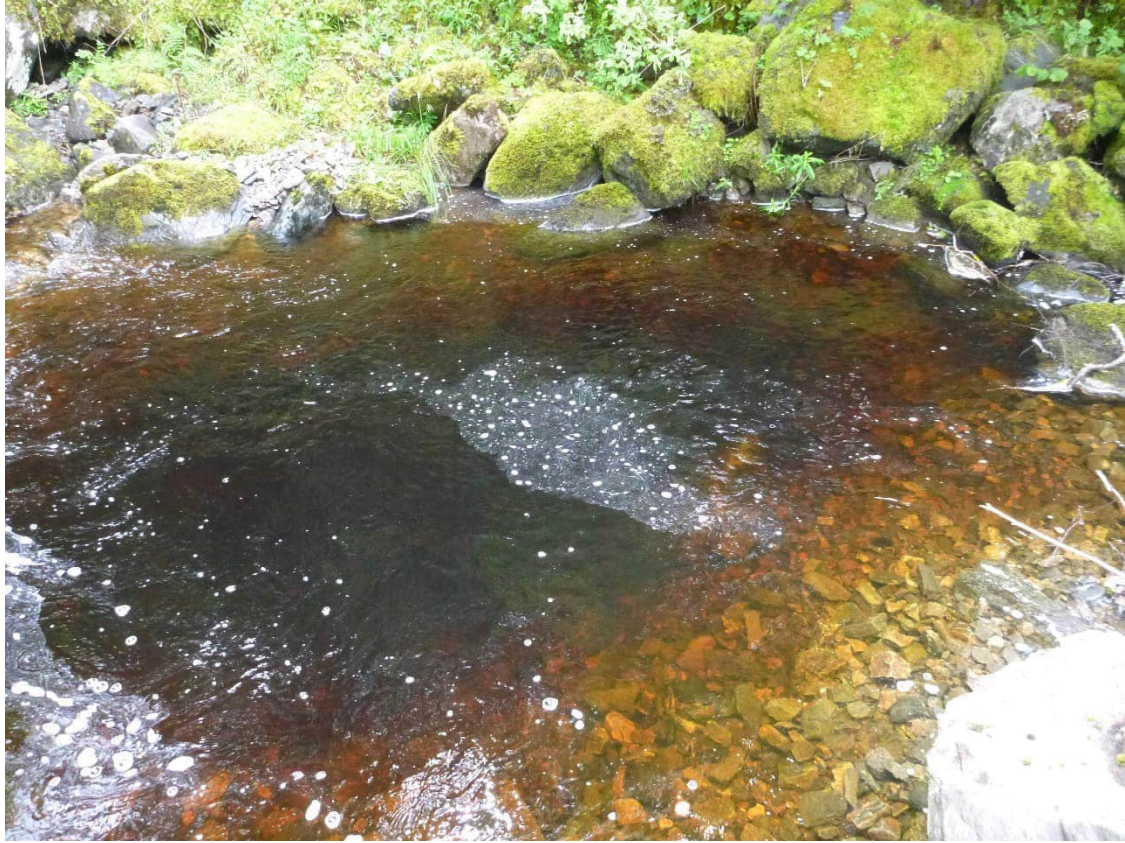
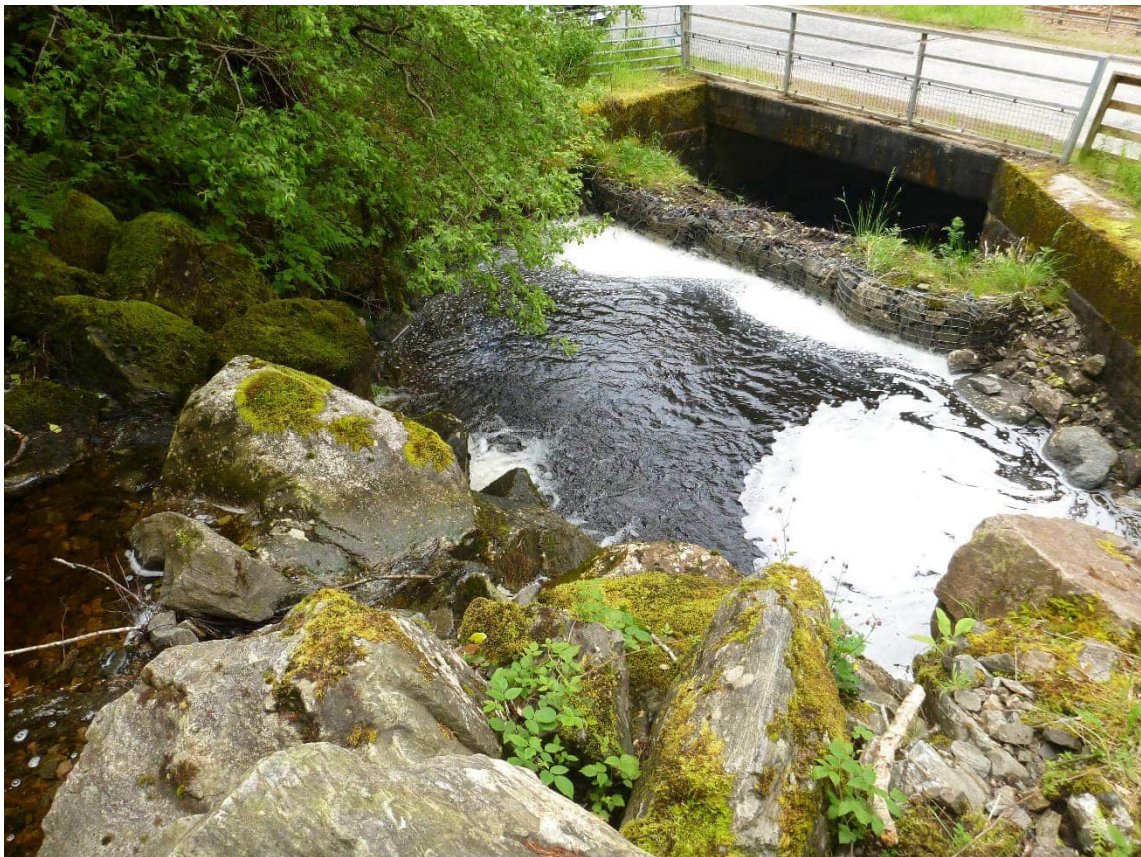
Photographs FB-1 and FB-2

Top: Upper catch pit; Bottom: Lower catch pit  
Both the upper and lower catch pits have good capacity.

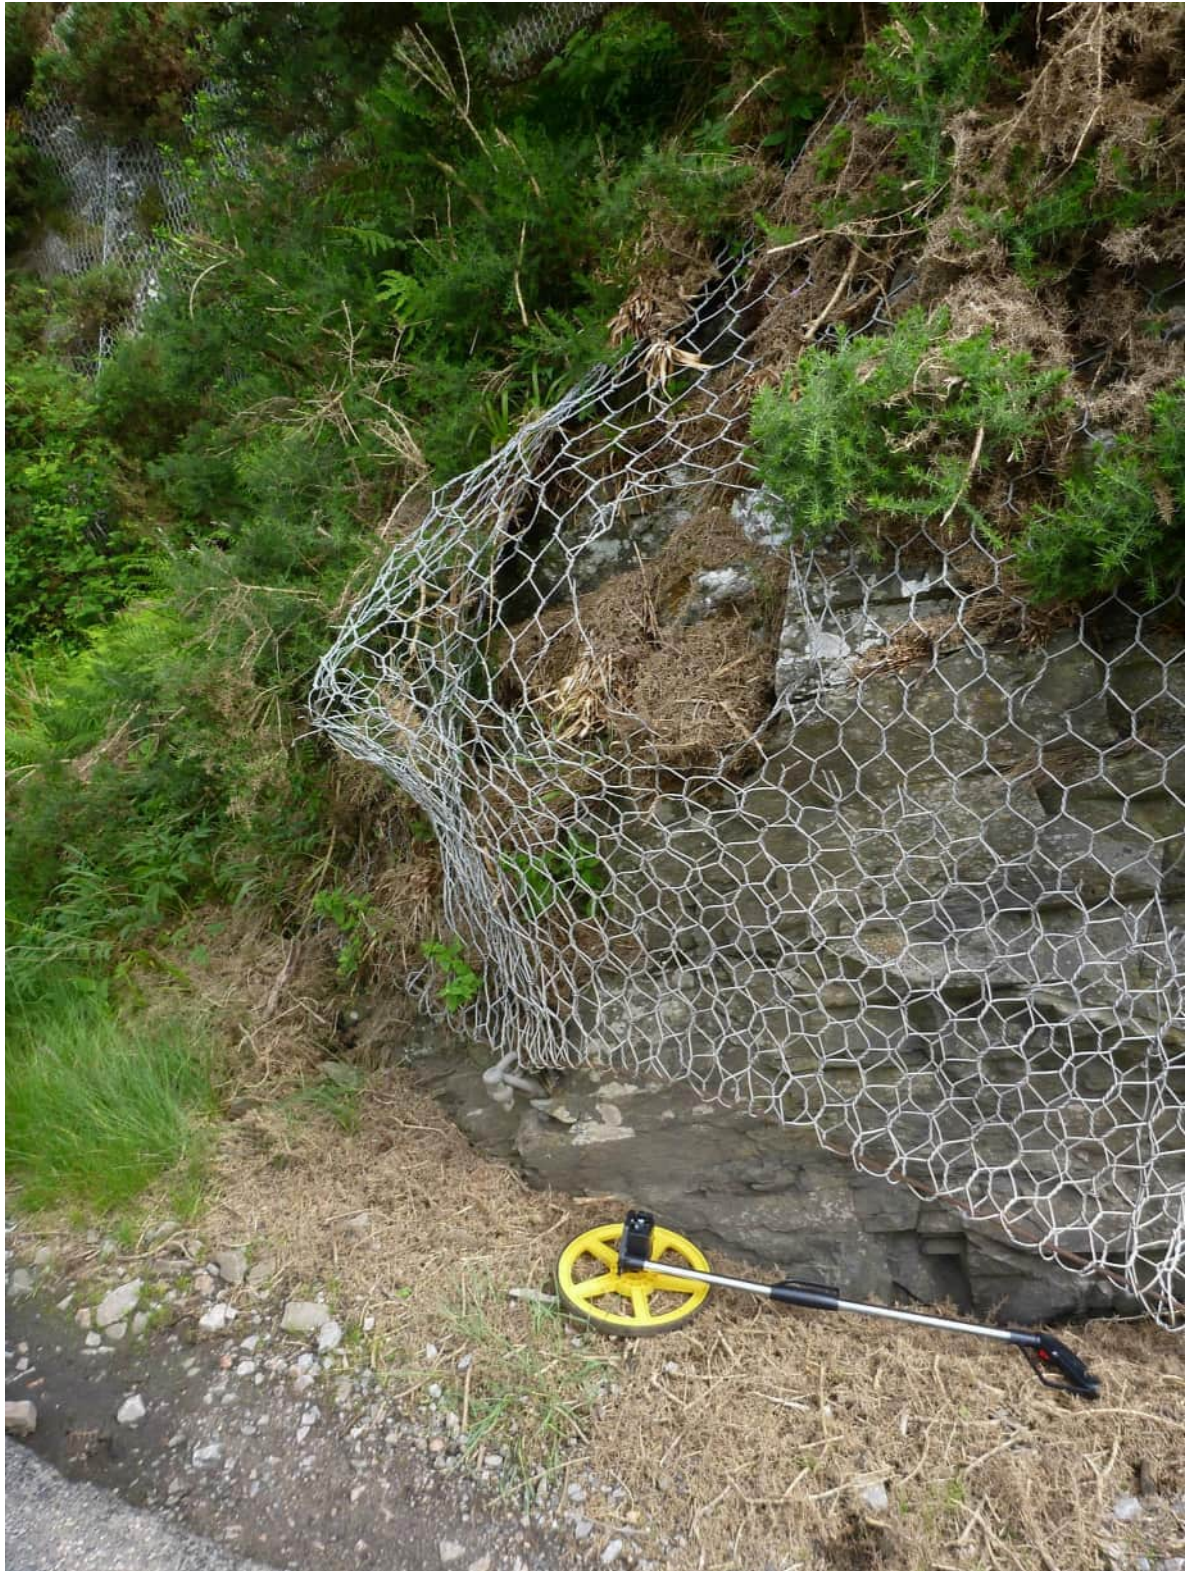
Photograph AA13-1

Netting has been torn at Ch. 2518. This was potentially caused by a grass cutter.

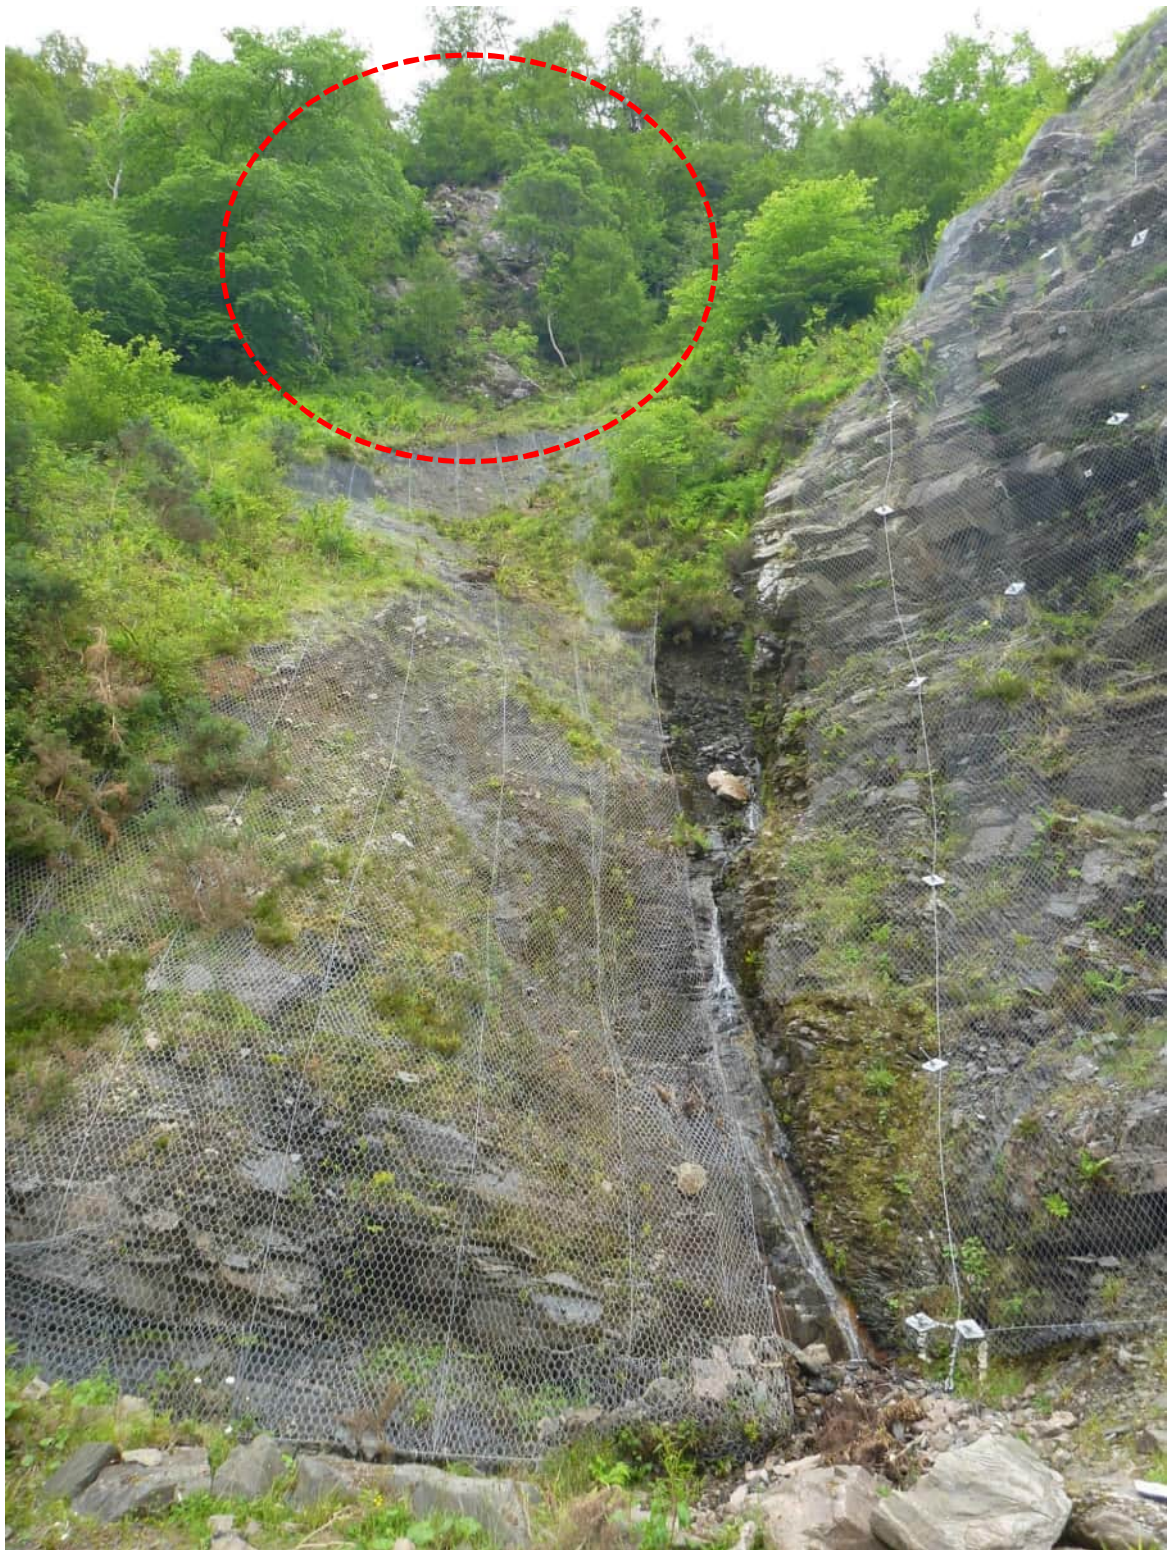
Photograph  
AA18\_19\_19U-1

Location of recent rockfall which impacted the road and railway. Block originated c.70m upslope. Debris caused minor damage to netting system as it passed over it.

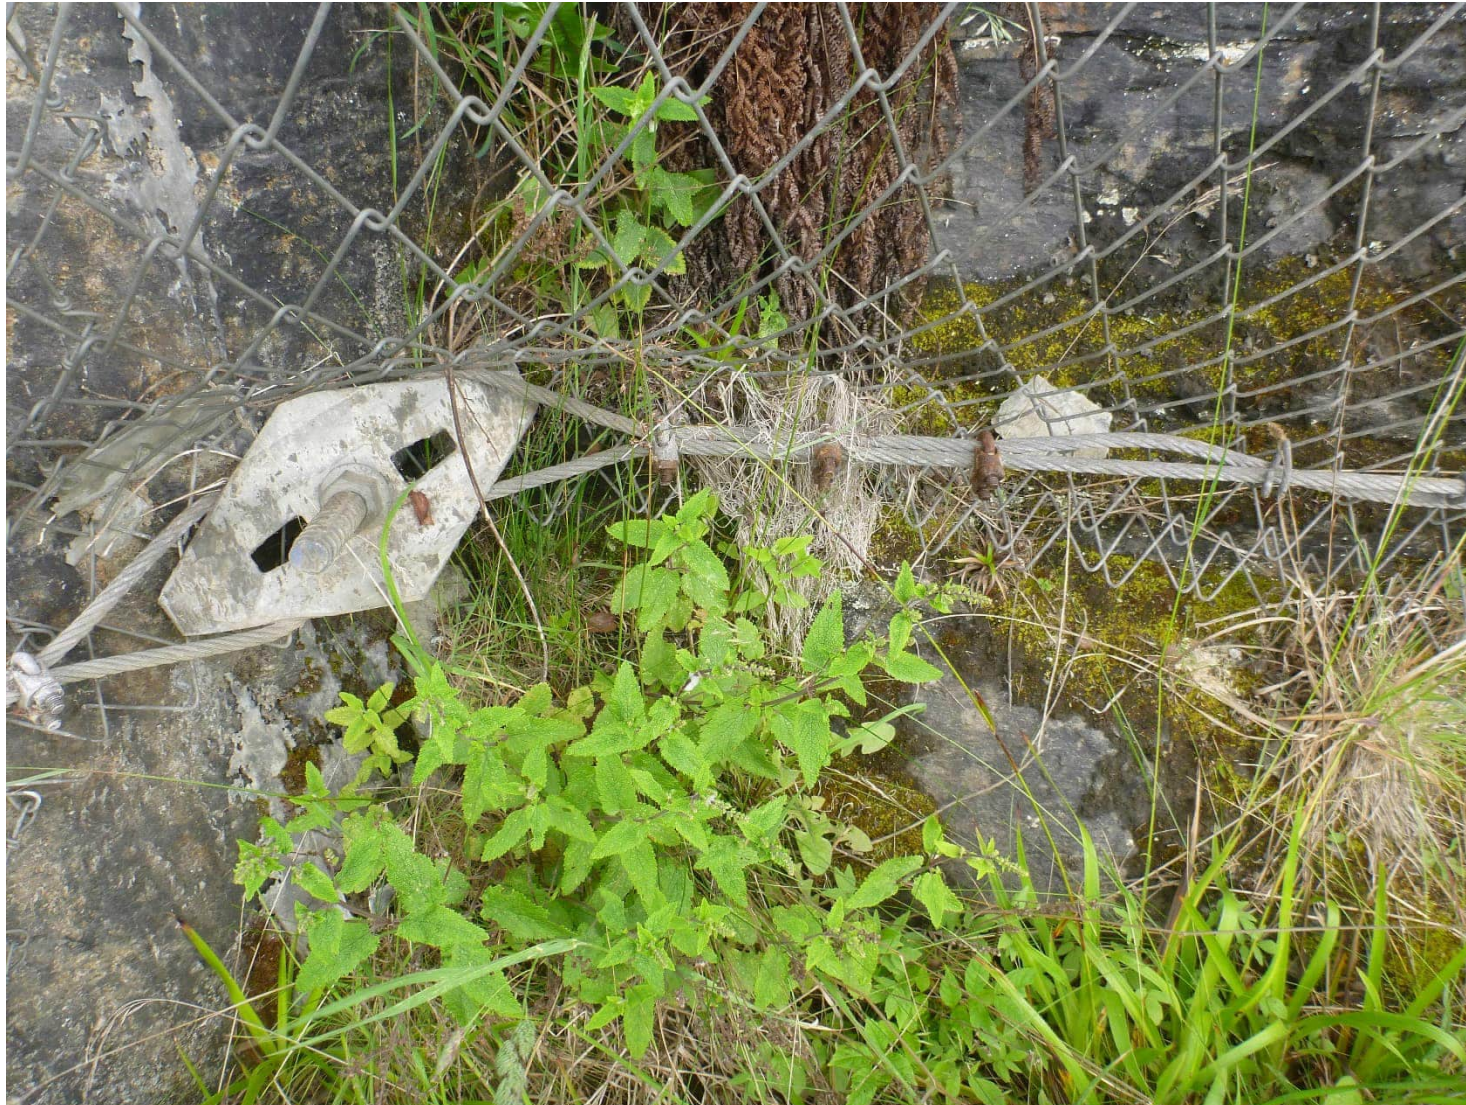
Photograph AA19-1

Example of some of the cable clamps on the bottom cable are starting to corrode at Ch. 3100.

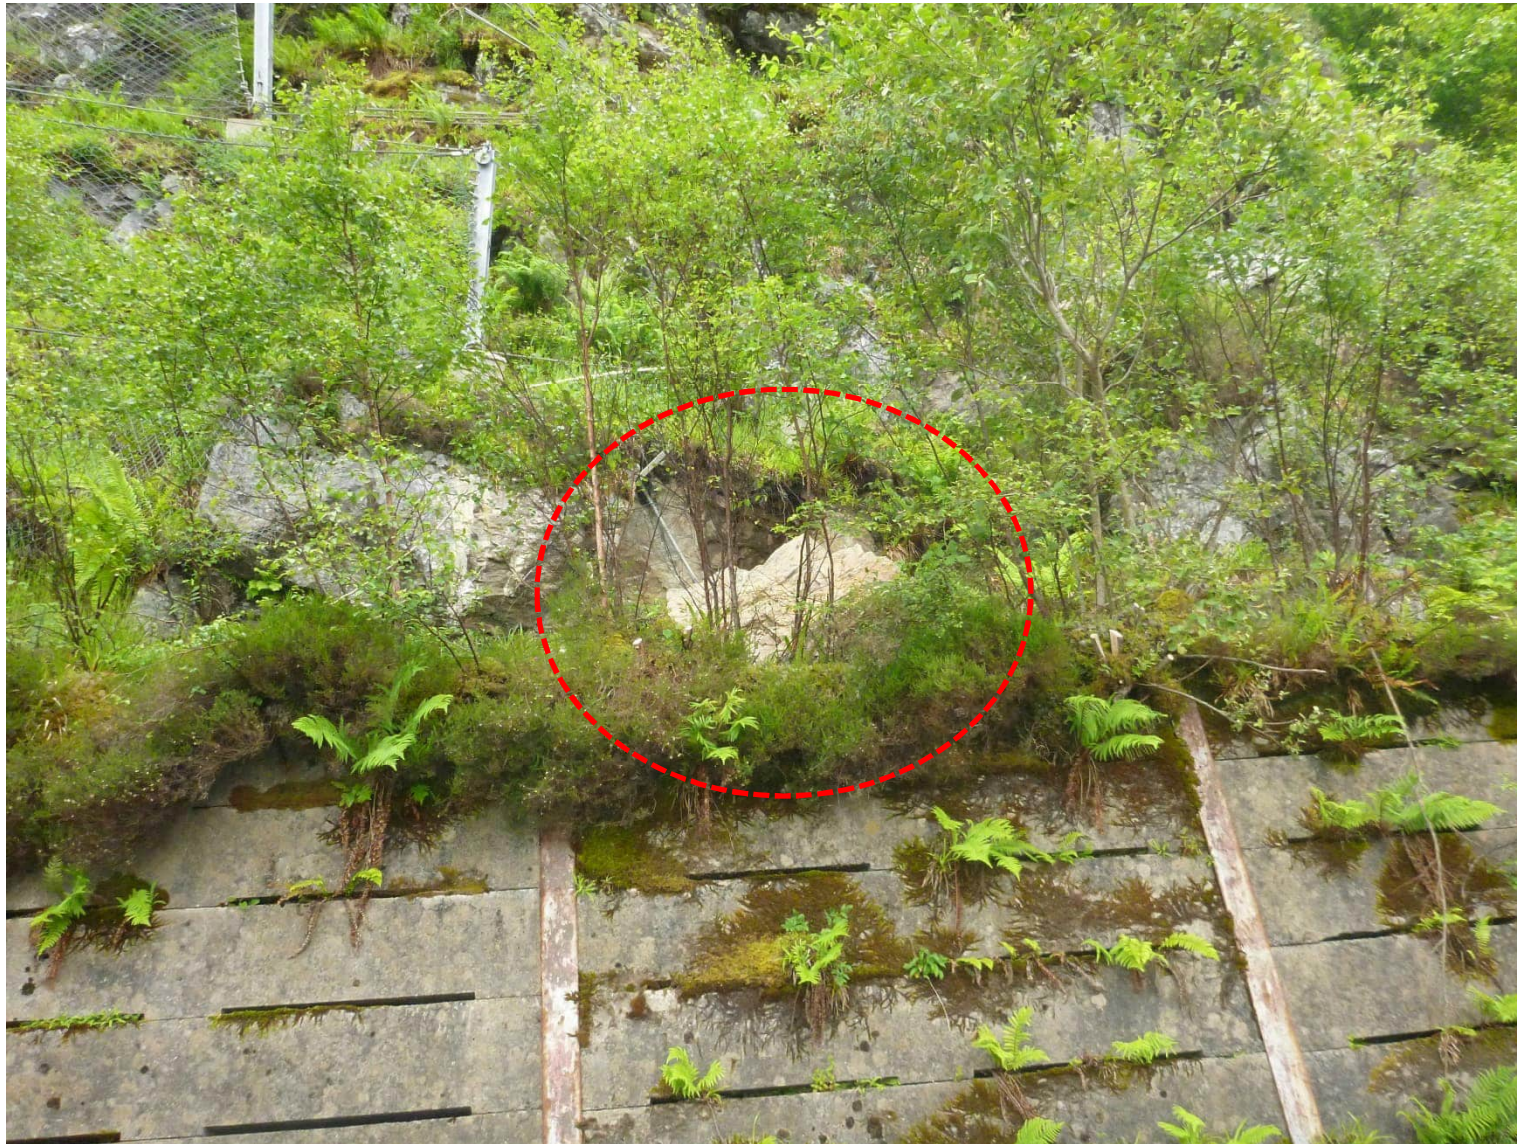
Photograph AA20-1

Block that rotated out during the drilling of a temporary catch fence anchor and landed on flat area above retaining wall at Ch. 3185. Not at risk of further downslope movement.

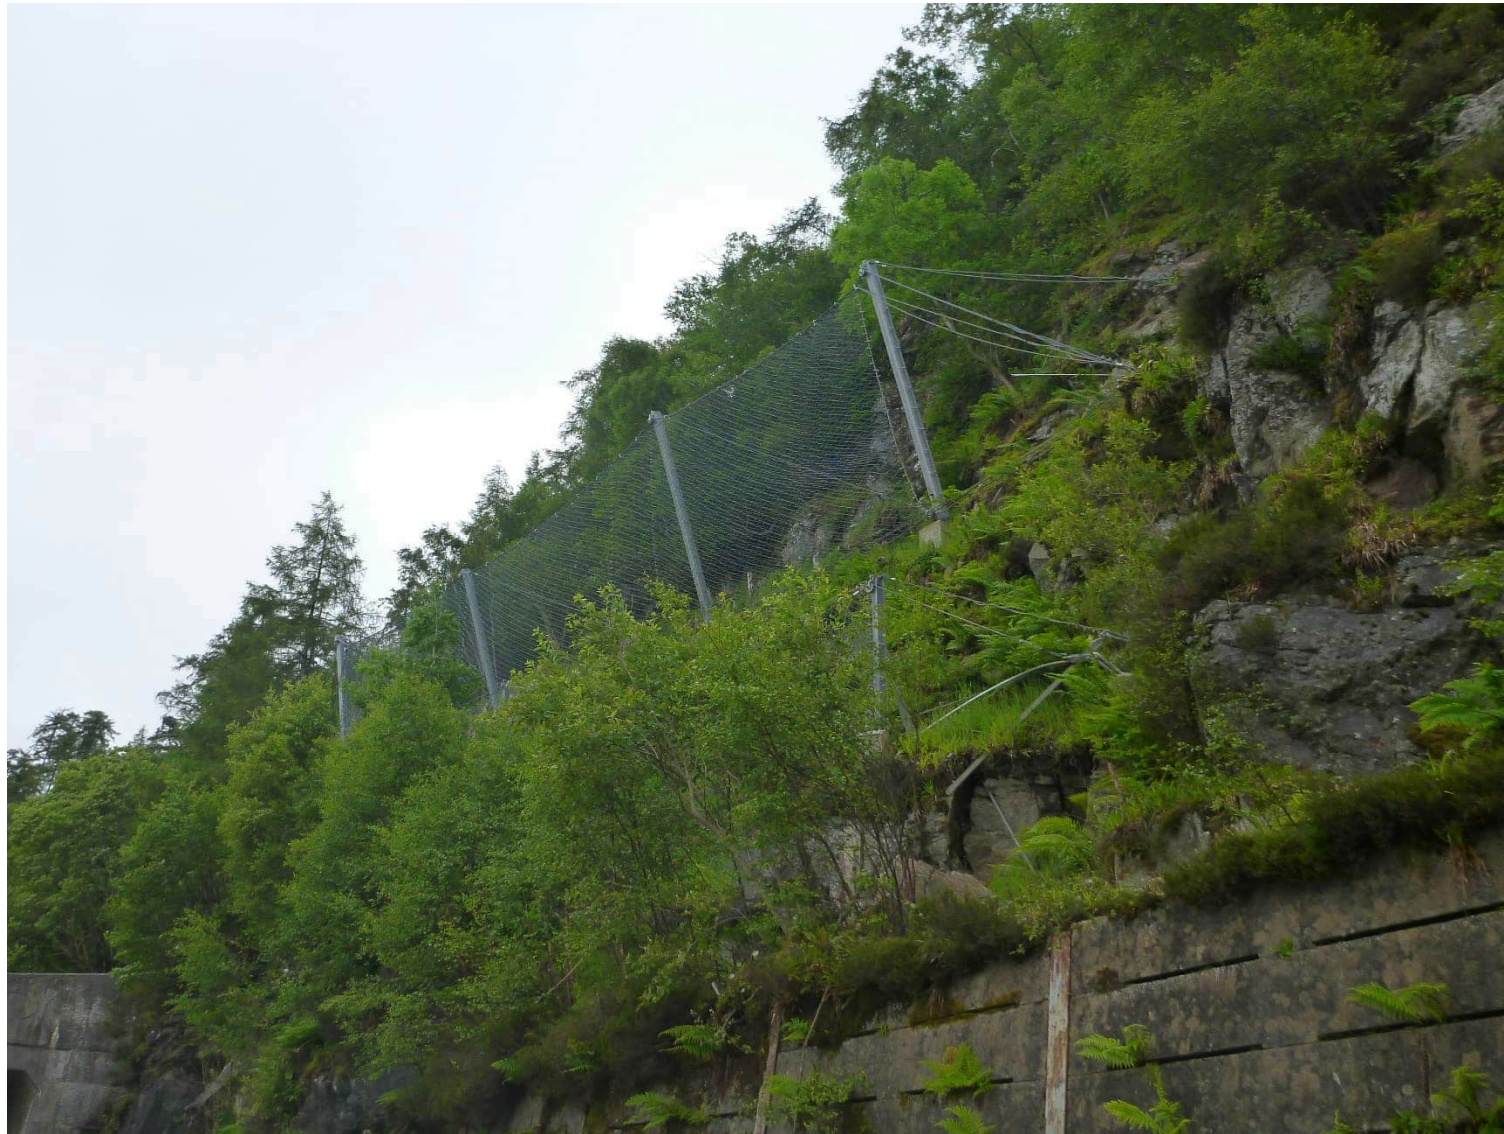
Photograph AA20U-1

Catch fence installed during the Phase 12 2021 works

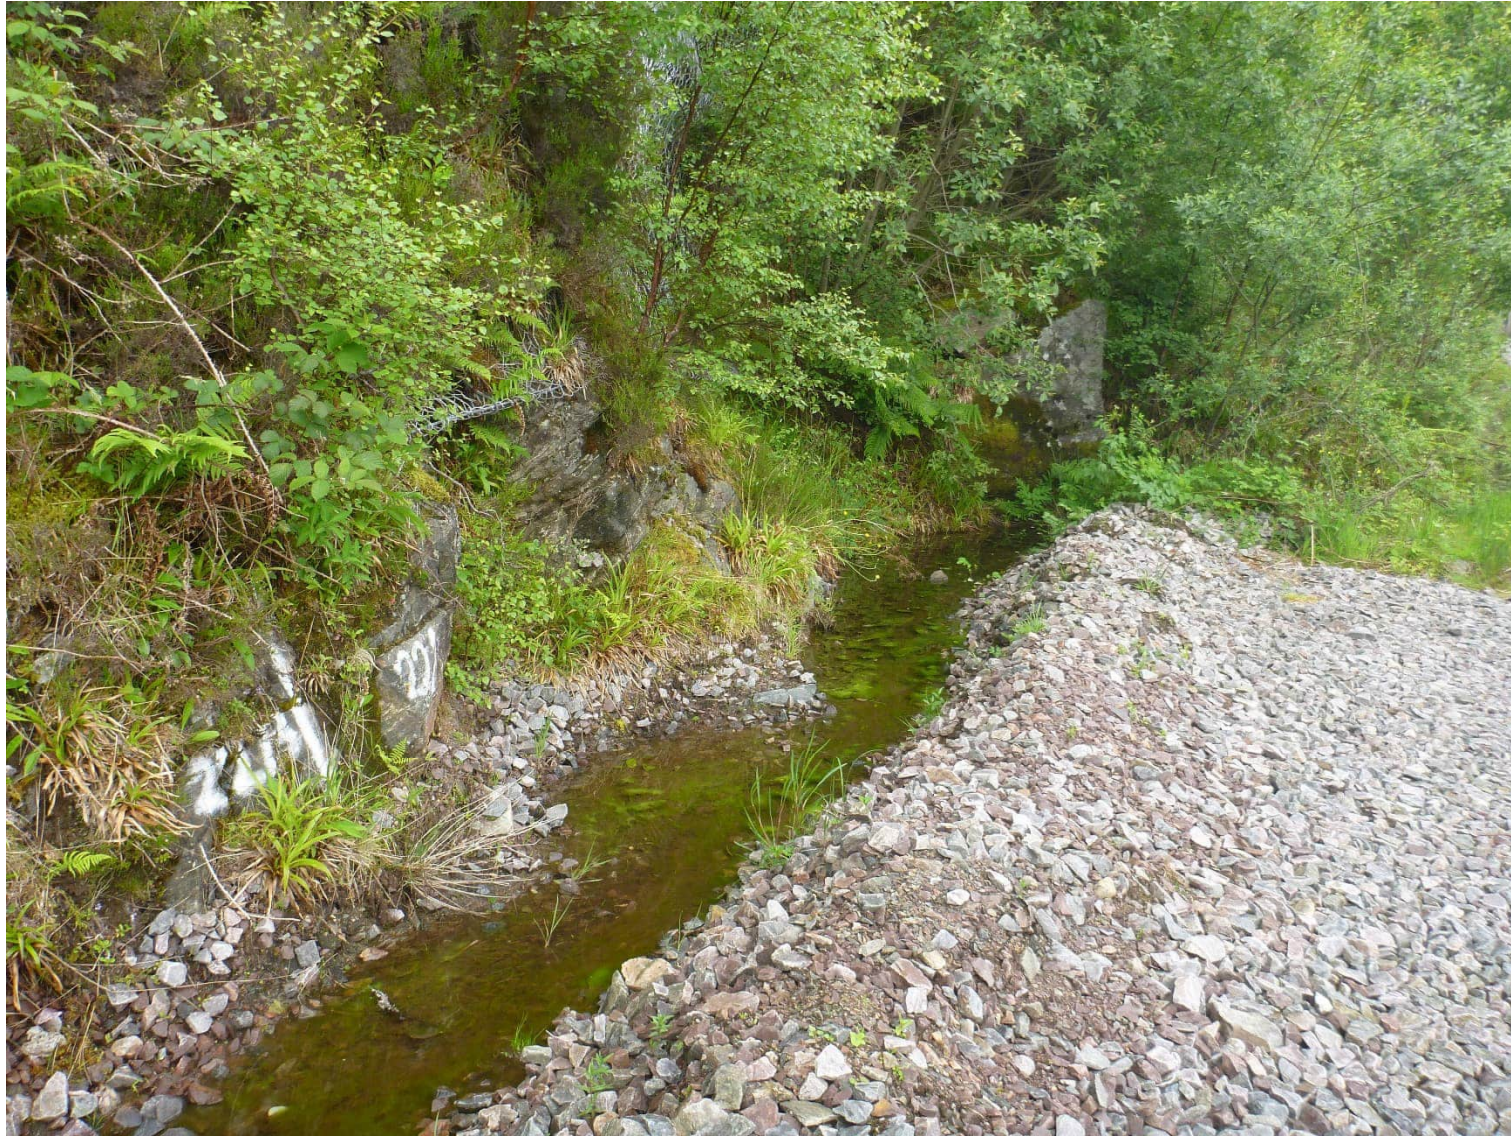
Photograph AA22A-1

Ditch has been re-instated between Ch. 3412 to 3425.

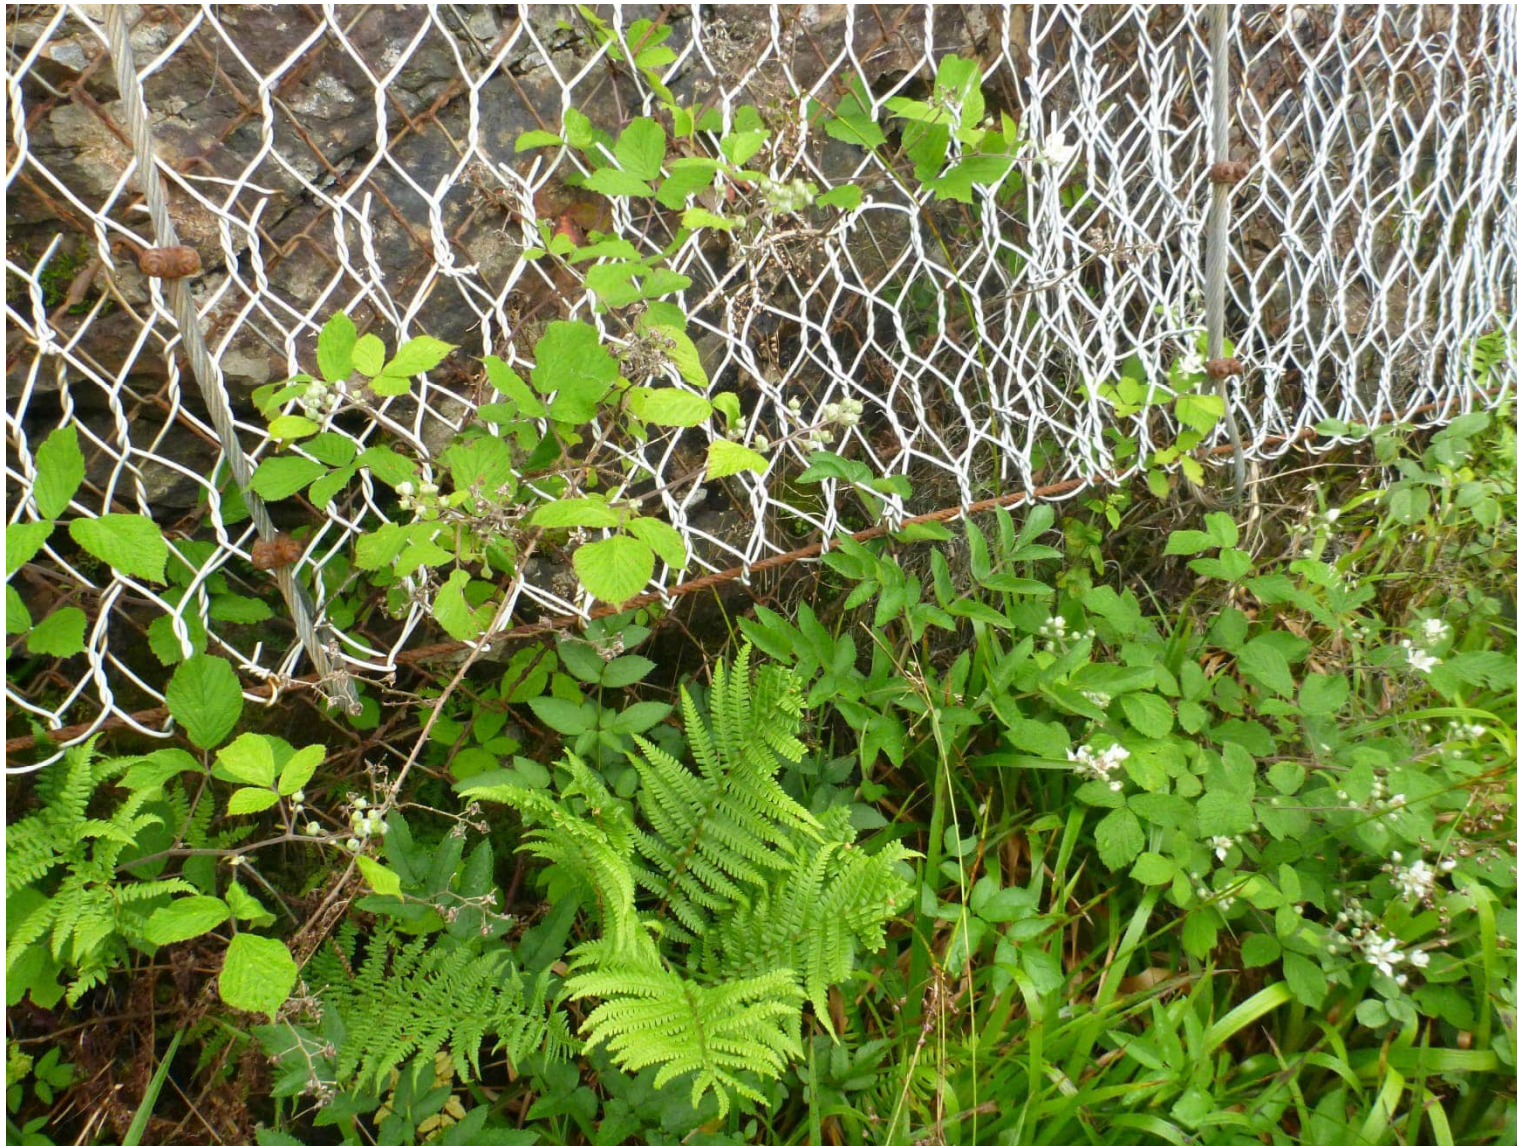
Photograph AA22B-1

Bottom cable and cable clamps on lateral and vertical reinforcing cables are corroded between Ch. 3462 and 3519.

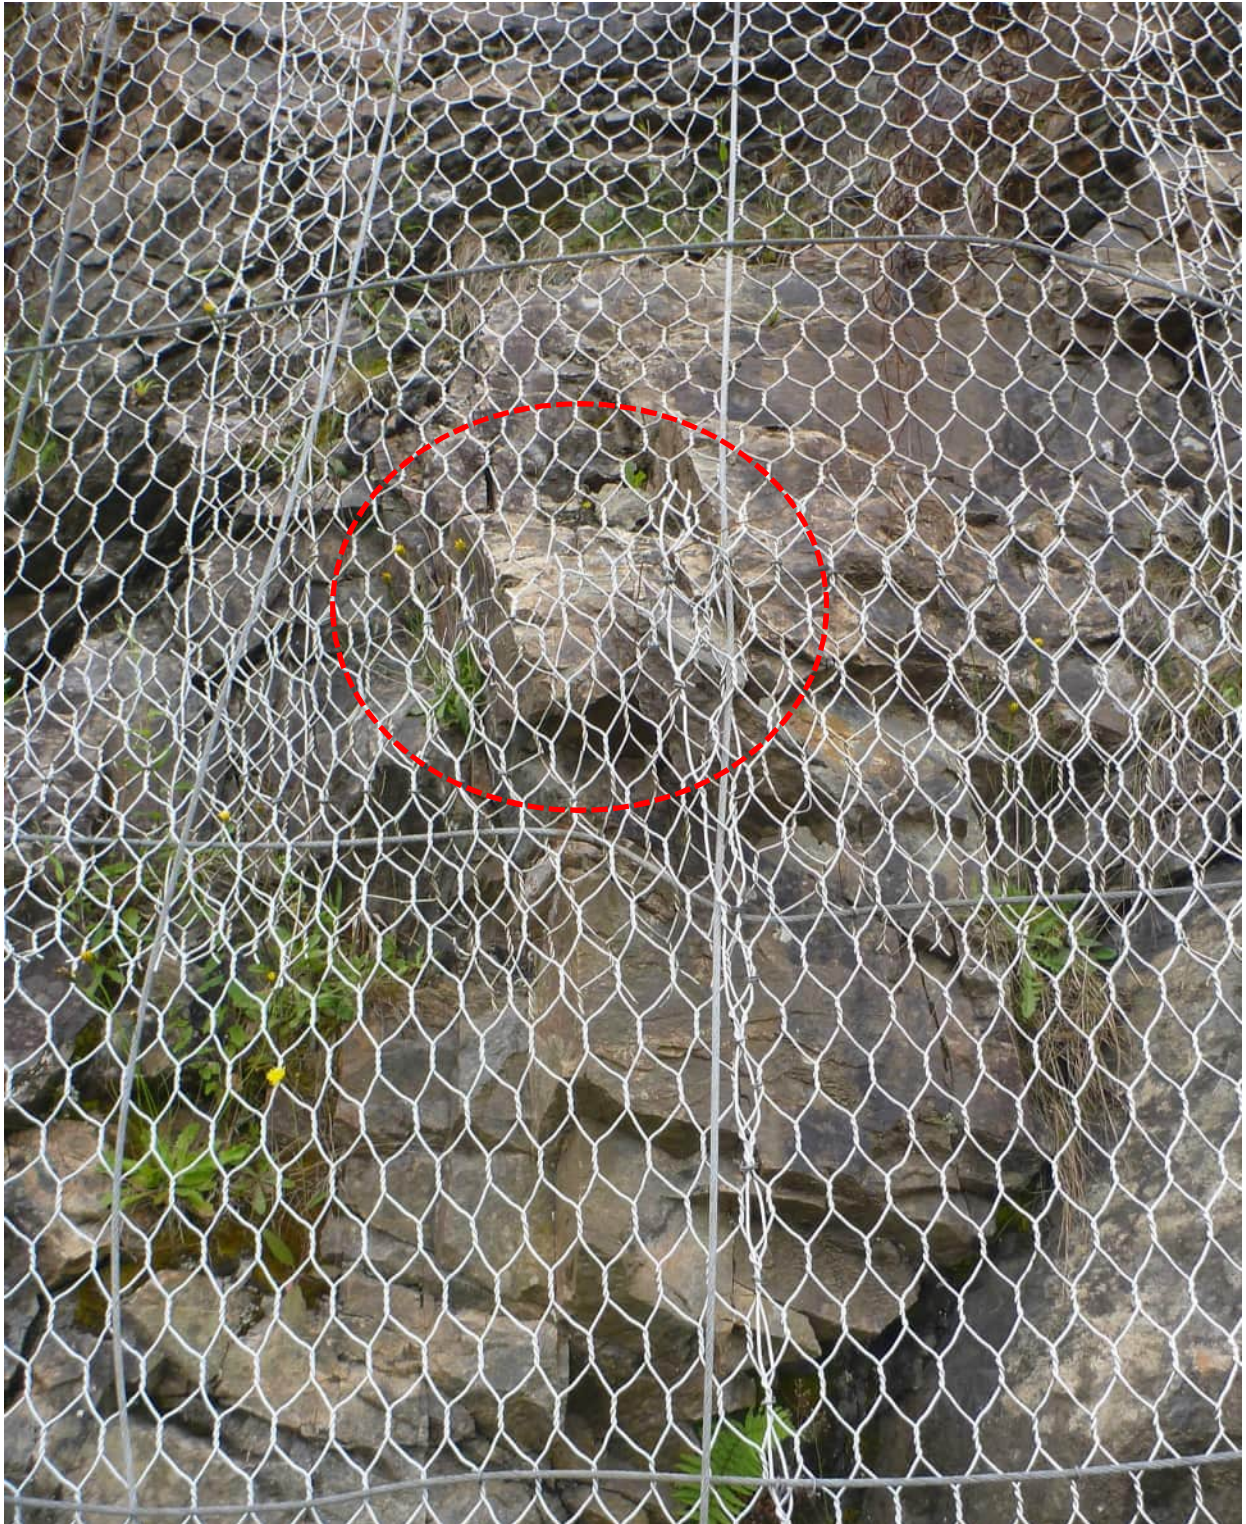
Photograph AA22B-2

Block fall originating c.5m above toe of slope at Ch.3454. Block is c.0.3m x 0.2m x 0.2m and is being held by netting at c.2m above ground level.

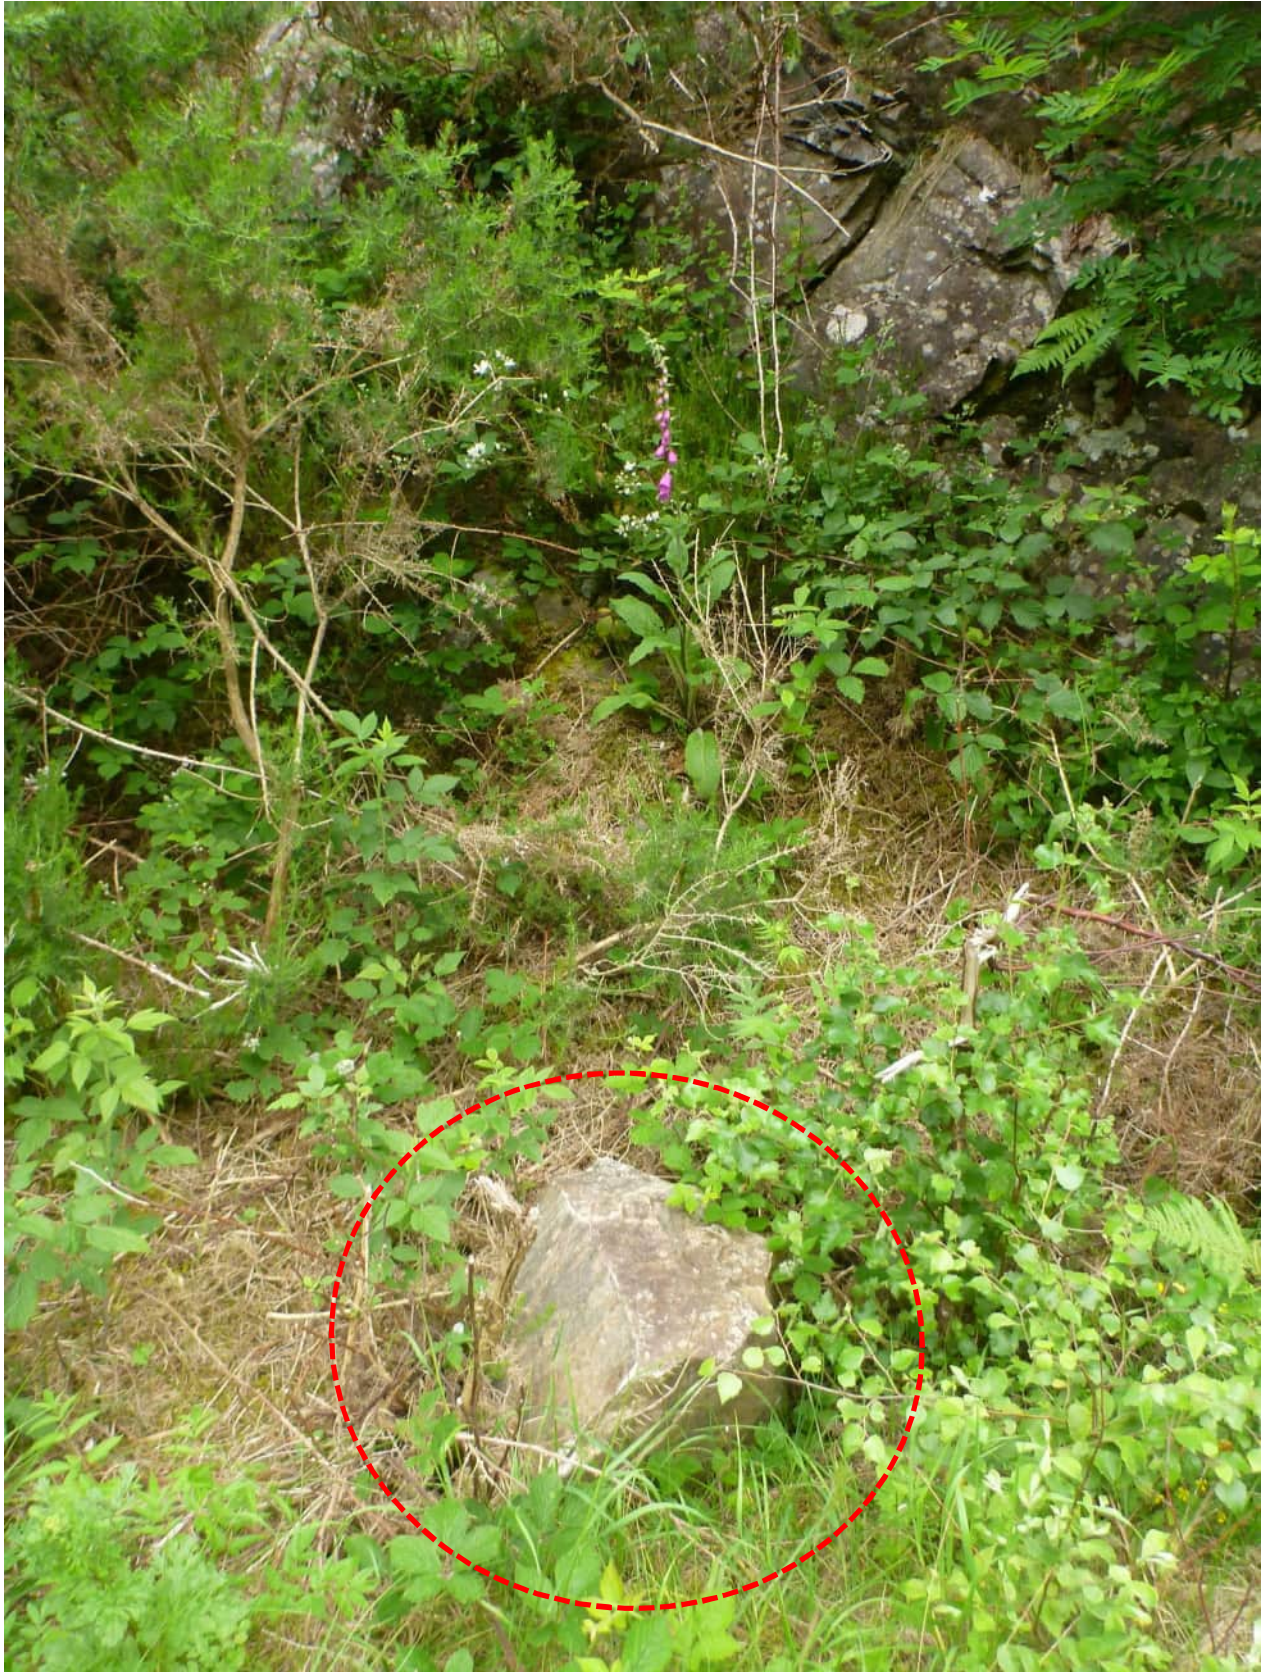
Photograph AA23N-1

Block fall (c.0.4m x 0.4m x 0.3m) has landed in ditch. Block looks to have originated c.2m above the toe of slope.

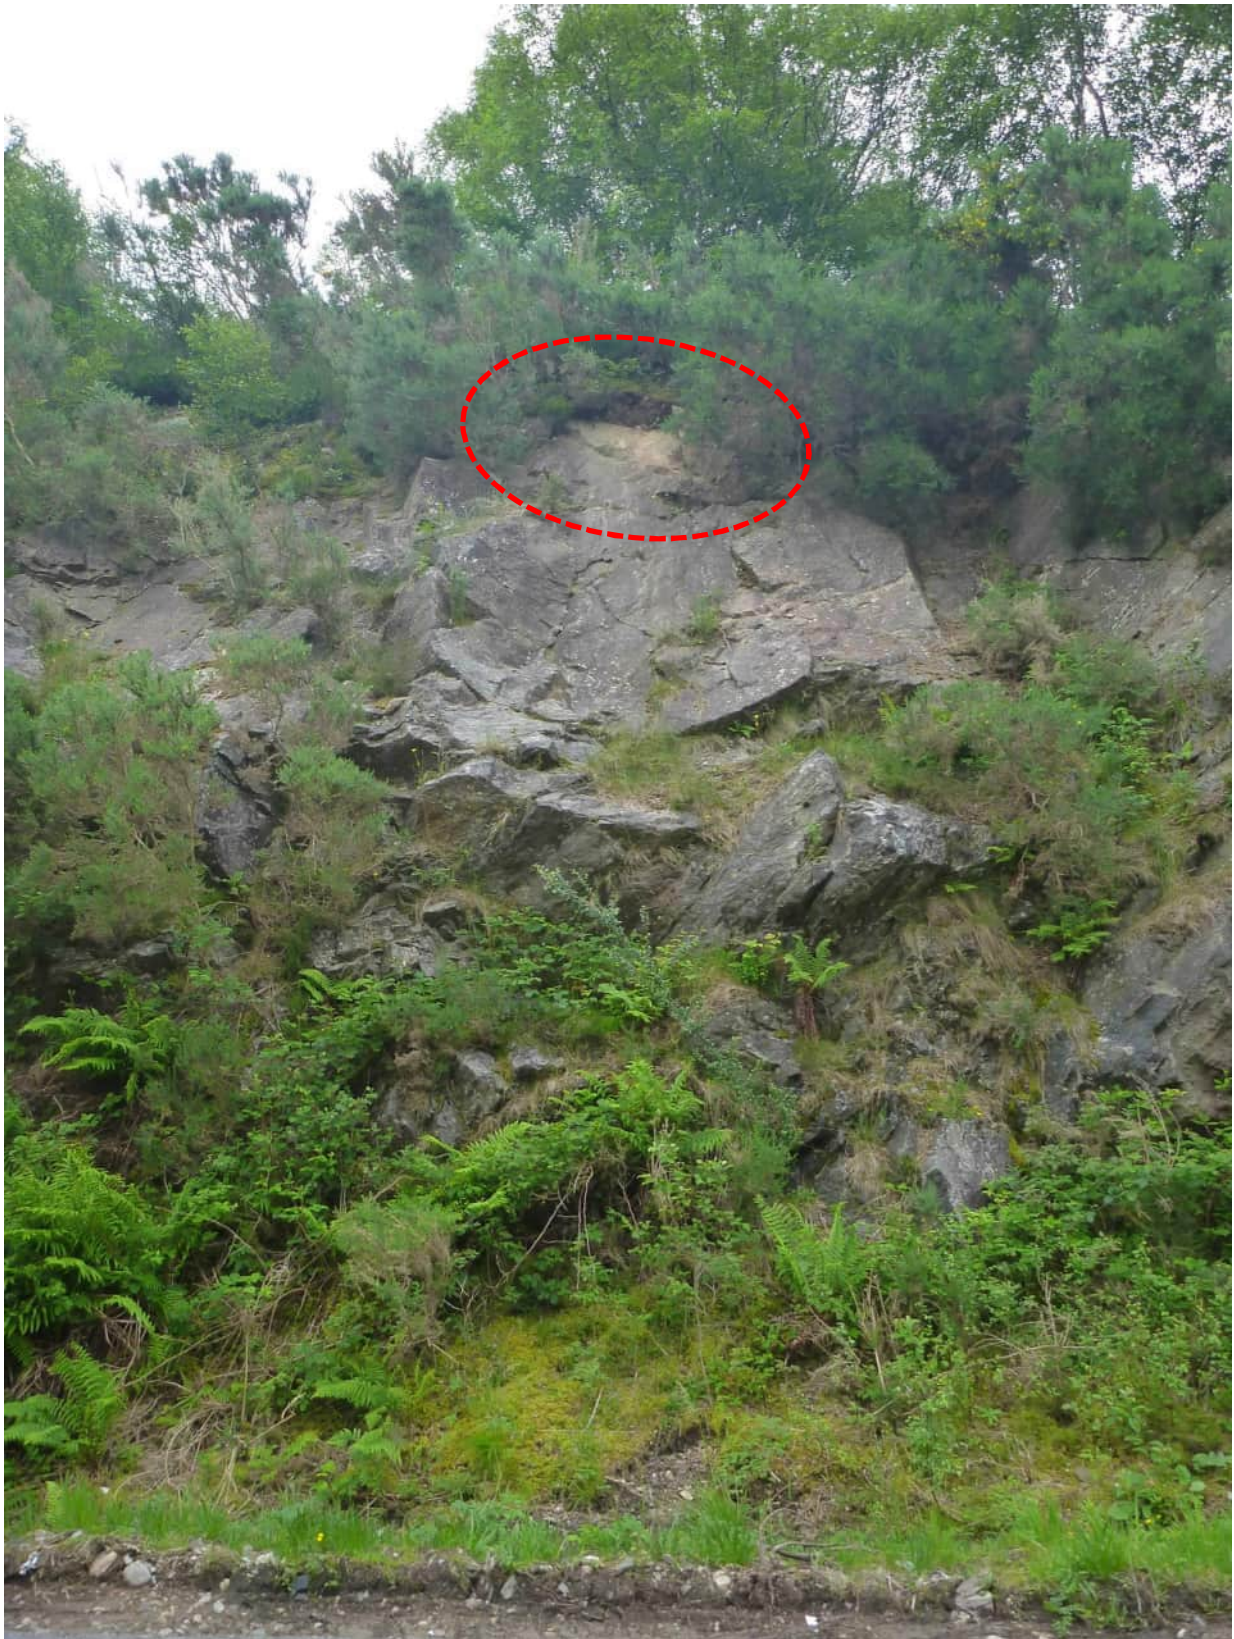
Photograph AA23S-1

Block fall (c.0.25m<sup>3</sup>) landed in ditch during Phase 12 works and has since been cleared. Block originated c.7m above the toe of slope.
