A890 Maman Hill

Annual Slope Inspection Report 2022

The Highland Council

Project Number: 60658712
AECOM Report Ref: GLRP0002

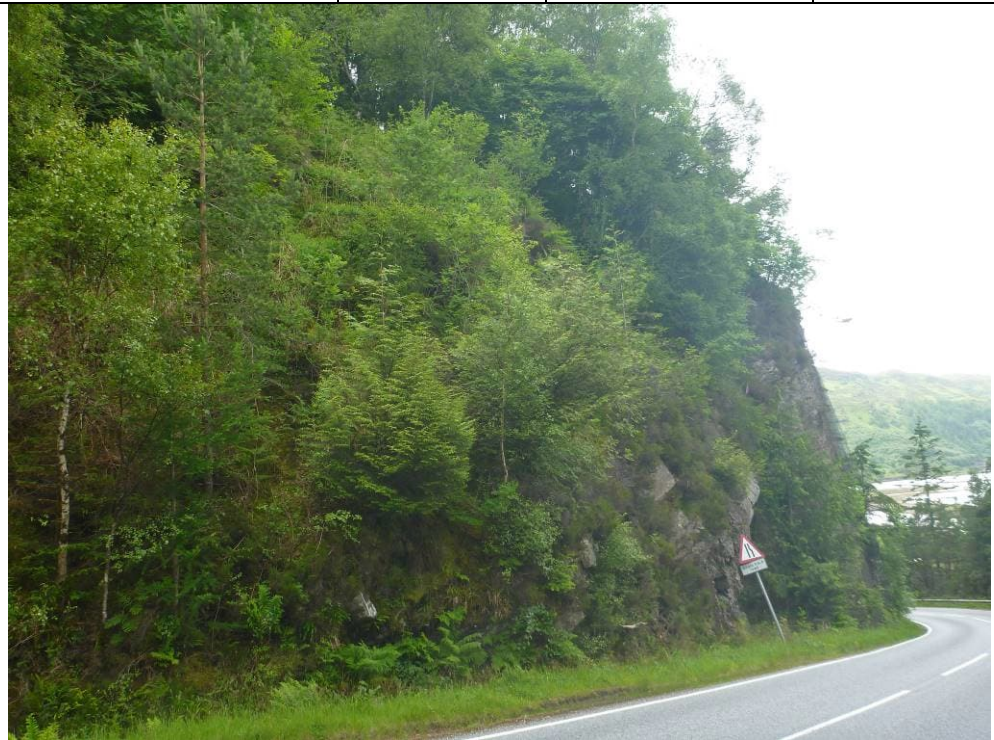
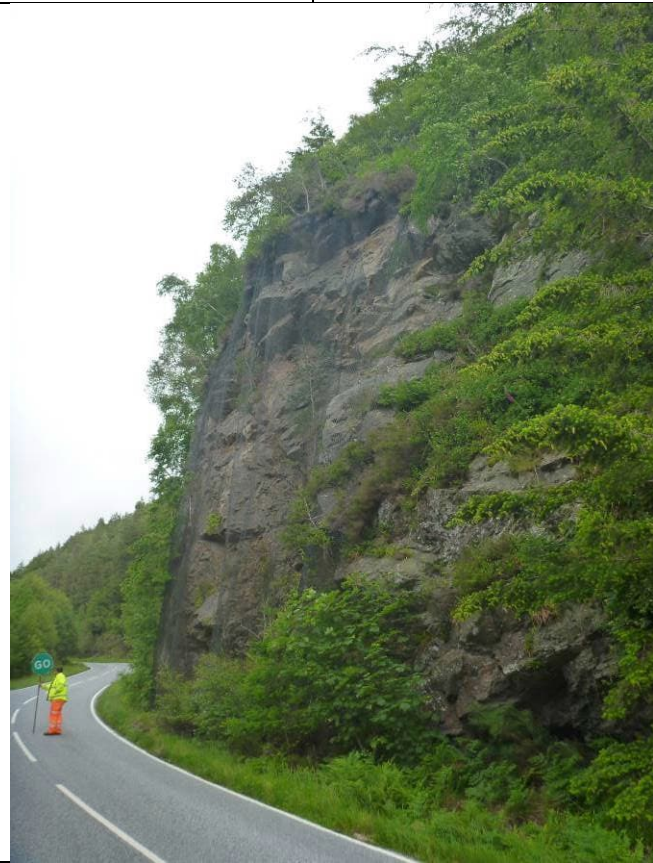
Existing Netting Details or other remedial work details:							
Chainlink drape netting between Ch. 360 and Ch. 375. Netting is corroded and damaged and should be considered ineffective for the retention of anything but the smallest blocks. Anchor points not inspected. Plastic 'geo-grid' style netting present over rock slope between Ch. 375 and Ch. 385. Individual panels unjoined and anchor points have not been inspected. This type of netting is not suitable for the retention of rock falls and should be considered ineffective.							
Other Comments:							
No surface or groundwater flows. Rock mass in poor condition with frequent dilated fractures associated with blast damage, weathering and root jacking. Potential for planar failures as well as raveling, root jacking and block falls from above overhangs. Some small scale raveling type failures were noted to be imminent with blocks readily dislodge by hand. Ditch and verge likely to retain debris from some small scale failures but locally absent / narrow. Occasional blocks observed at toe – typical dimensions 0.1 x 0.1 x 0.1m.

Hazards Observed:							
Location		Comments					
Throughout M4		Numerous small scale (<0.02m ³) raveling type failures observed, some of which were deemed to be imminent (i.e. readily dislodged by hand).					
Ch. 370 to 380		A large overhang was observed ca. 3-5m below the crest of the rock face, however, joints were observed to be tight and no significant risk of failure identified.					
Ch. 370		A dilated sliding plane at 50° and with a 1.5m high x 2.5m wide x 1.5m deep block above was observed ca. 10m above road level. Loose rock noted along sliding plane. Risk of ca. 5m ³ plane failure. No ditch and narrow verge so failure debris likely to reach road.					
Ch. 370 to 380		Several areas of blast damage noted with dilated joints and loose rock observed. No ditch and only a narrow verge present beneath highest section of the rock slope. Debris noted along toe of slope in this area and potential for additional failures to occur.

Ch. 374		Overhang at crest (1.0-1.3m) with dilated fracture along left hand side. "Supporting block" on 58° sliding plane. Root jacking potential.					
Ch. 378		Dilated plane observed 8m above road level. Slightly keyed in at left hand side but fractured rock mass ca. 3.5m wide x 0.5m deep x 1m high. Potential for failure exists and narrow verge below means this poses a risk to the road.					
SUMMARY				Comments			
Hazard Rating =		3		Potential failure volumes up to 5m ³ identified.			
Pathway Rating =		5		Existing remedial measures considered ineffective and there is no ditch and only a narrow verge beneath the largest potential failures. Due to potential rock fall trajectories, all rock fall debris is considered likely to reach road.			
Receptor Rating =		1.2		Minimum sightline 60m.			
Risk Value =		18.0					
Risk Level =		Very High					
Recommended Remedial Works / Actions							
Re-inspection by end of June 2023; High risk slope so remedial works recommended to reduce risk. Remedial works likely to comprise full de-vegetation and light scaling exercise with targeted active netting system over the highest portion of the rock slope where several significant potential failures have been identified.

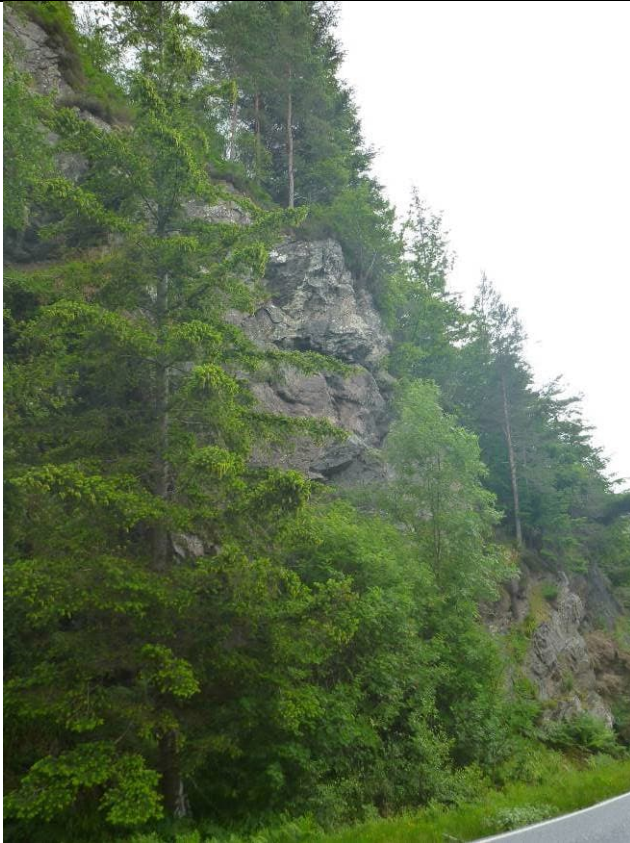
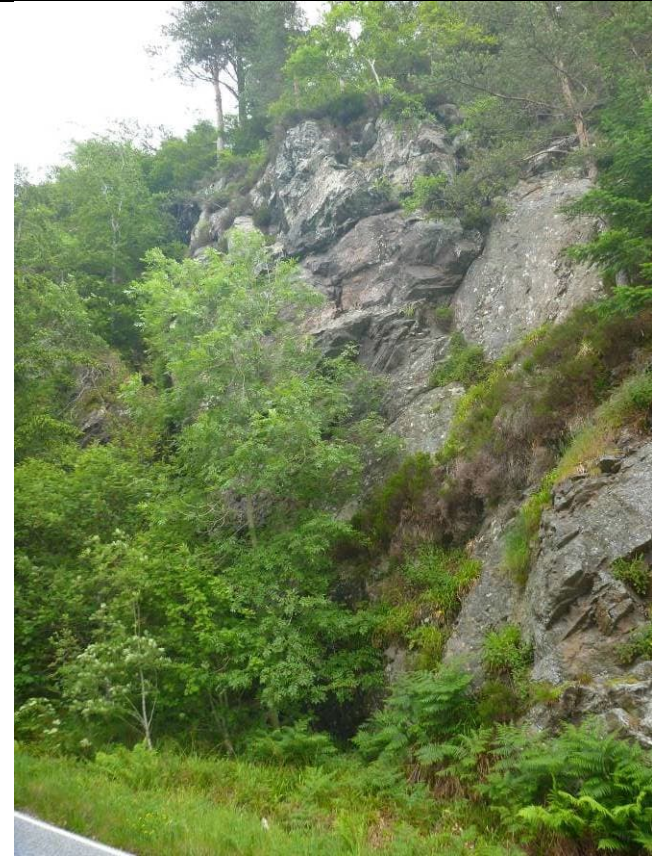
Existing Netting Details or other remedial work details:						
None						
Other Comments:						
<p>No surface or groundwater flows.</p> <p>Rock slope set slightly back from road and appears to comprise natural crags rather than a man-made (blasted) rock slope. The slope is locally overhanging and a cave feature is present at the northern end of the slope, possibly a former sea cave.</p> <p>Rock mass generally in good condition with tight fractures but occasionally noted to be very dilated suggesting historical movement. Ongoing ravelling of small blocks is evident, with several precarious blocks observed along the crest of the slope. Localised potential for larger scale rock falls up to around 3m³ observed.</p> <p>Wide verge (5m) likely to retain debris from all but the largest of rock falls.</p>						
Hazards Observed:						
Location		Comments				
Throughout M5		Ongoing ravelling. Precarious blocks noted along crest.

Ch. 398		Detached block ca. 2m x 2m x 0.7m. Open on left hand side and with a dilated back release joint. Keyed in on right hand side but difficult to see how well. Upper part of right hand side has 70mm dilated joint. Trajectory of blockfall hard to predict so doweling may be required to protect road.				
Ch. 400		Overhanging block at crest with 10-50cm wide dilated release joint.				
Ch. 405		Column of rock ca. 4-8m above road level. 1.5m wide, 0.5m deep. Potential for rock fall as unsupported but wide verge below likely to prevent debris reaching road.				
Ch. 407		Dilated crack to rear of lichen covered block 8-10m above road level. Keyed in below.				
SUMMARY			Comments			
Hazard Rating =		3	Potential rock fall volumes up to 3m ³ identified.			
Pathway Rating =		3	Majority of rock fall debris likely to land on roadside verge. Potential for some debris from larger scale rock falls to reach road. Trajectories of rock falls hard to predict due to slope profile so conservative value chosen for pathway rating.

Receptor Rating =		1.2	Minimum sightline 60m.			
Risk Value =		10.8				
Risk Level =		High				
Recommended Remedial Works / Actions						
<p>Re-inspection by end of June 2023;</p> <p>High risk so remedial measures recommended. Consideration should be given to installation of targeted dowels to secure individual blocks / areas of rock mass at risk of rock fall and reduce risk further. Allowance for 20 No. 4m long dowels to be installed as required.</p>						
Assessed in field by:	JG/PLM	Date:	22/06/2022	Reviewed by:	PLM	Date: 26/08/2022

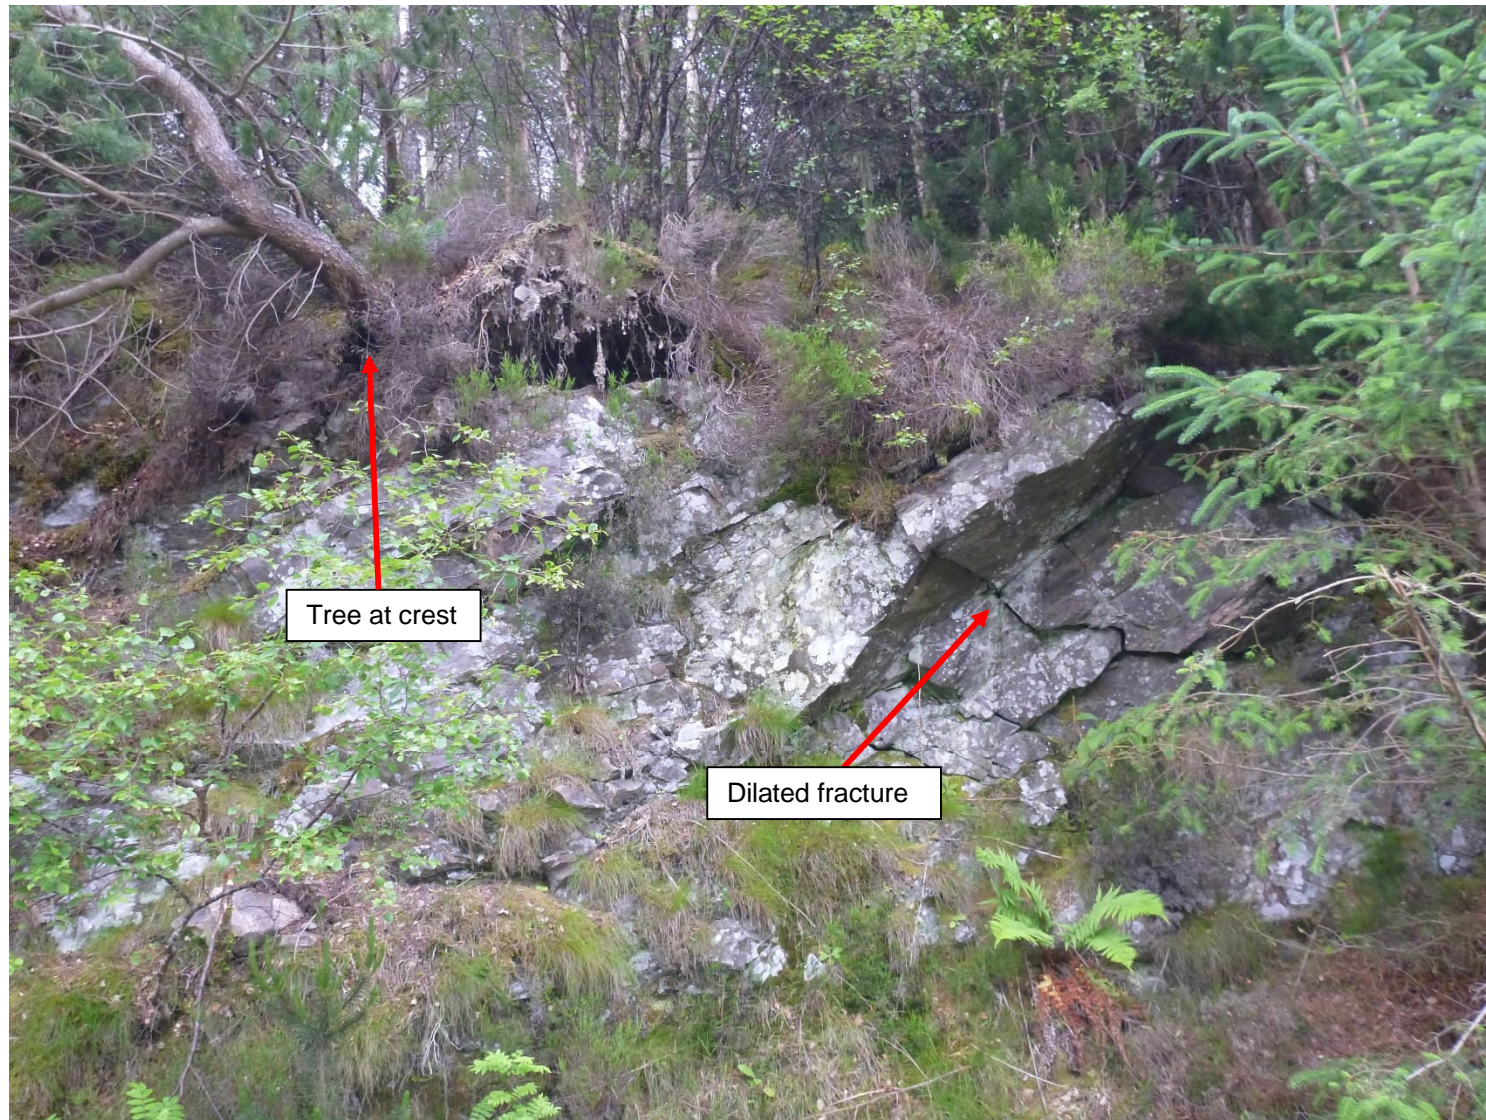
Photograph M1-1

Other Comments:							
No surface or groundwater flows. Rock mass generally in good condition, although dilated fractures noted locally. Potential for kinematic failure is low. Ch. 018 to 030: there is vegetation in the ditch that could be cleared.							
Hazards Observed:							
Location		Comments					
Throughout M1		Small scale (<0.01m ³) raveling type rock falls likely as rock mass continues to weather.					
Throughout M1		Trees at crest have potential to cause root jacking (e.g. Ch. 018)					
Ch. 018		Approx. 6 blocks in verge c.2m x 0.1m x 0.1m					
Ch. 020		Block (c.2m x 1m x 1.5m) with dilated back fracture (low risk due to presence of ditch)					
SUMMARY			Comments				
Hazard Rating =		2		Generally limited to small scale raveling although locally potential for larger block fall(s) associated with root jacking. Block size not expected to exceed 1m ³ .			
Pathway Rating =		2		Most rock fall debris likely to land in verge.

Tree at crest with potential for root-jacking at Ch.018.
Block with dilated back fracture at Ch.020.

Receptor Rating =		1.2		Minimum sightline 45m.			
Risk Value =		4.8					
Risk Level =		Low					
Recommended Remedial Works / Actions							
Re-inspection by end of June 2023. Low risk so remedial works not deemed necessary, however, felling of trees along crest would reduce risk further. Recommend monitoring ditch and clearing when required to maintain its capacity.							
Assessed in field by:	JG/PLM	Date:	22/06/2022	Reviewed by:	PLM	Date:	26/08/2022

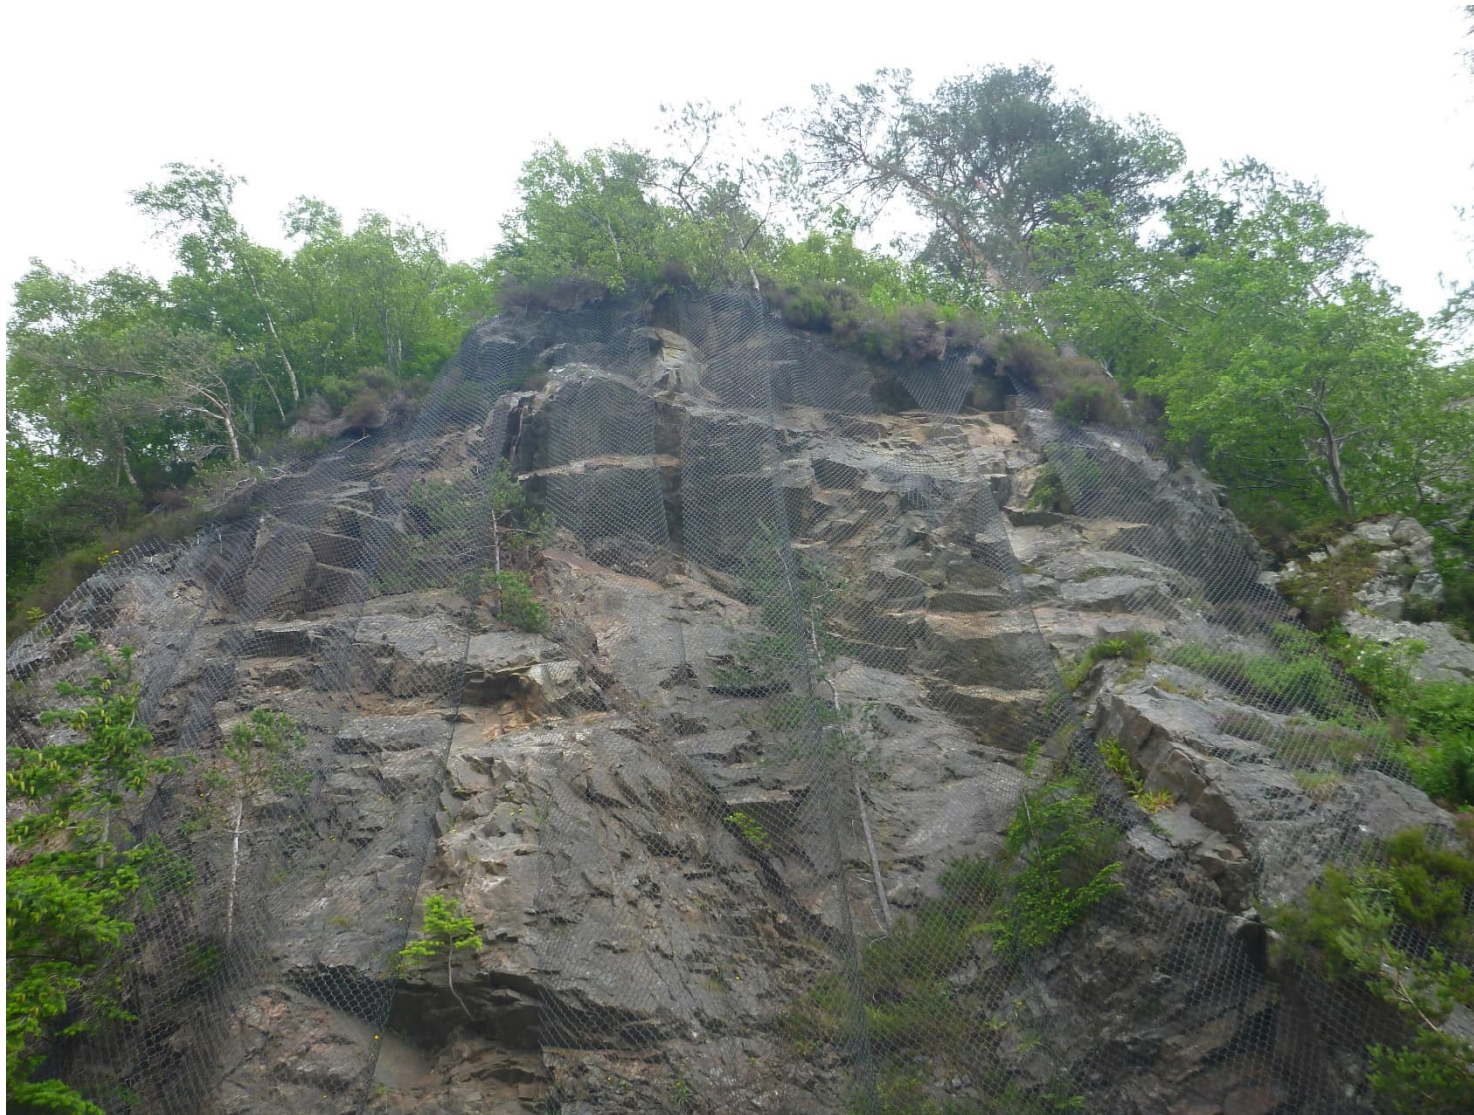
Photograph M4-1

General photo of hazardous area at rock slope including the large overhang c.3 to 5m below crest of slope.

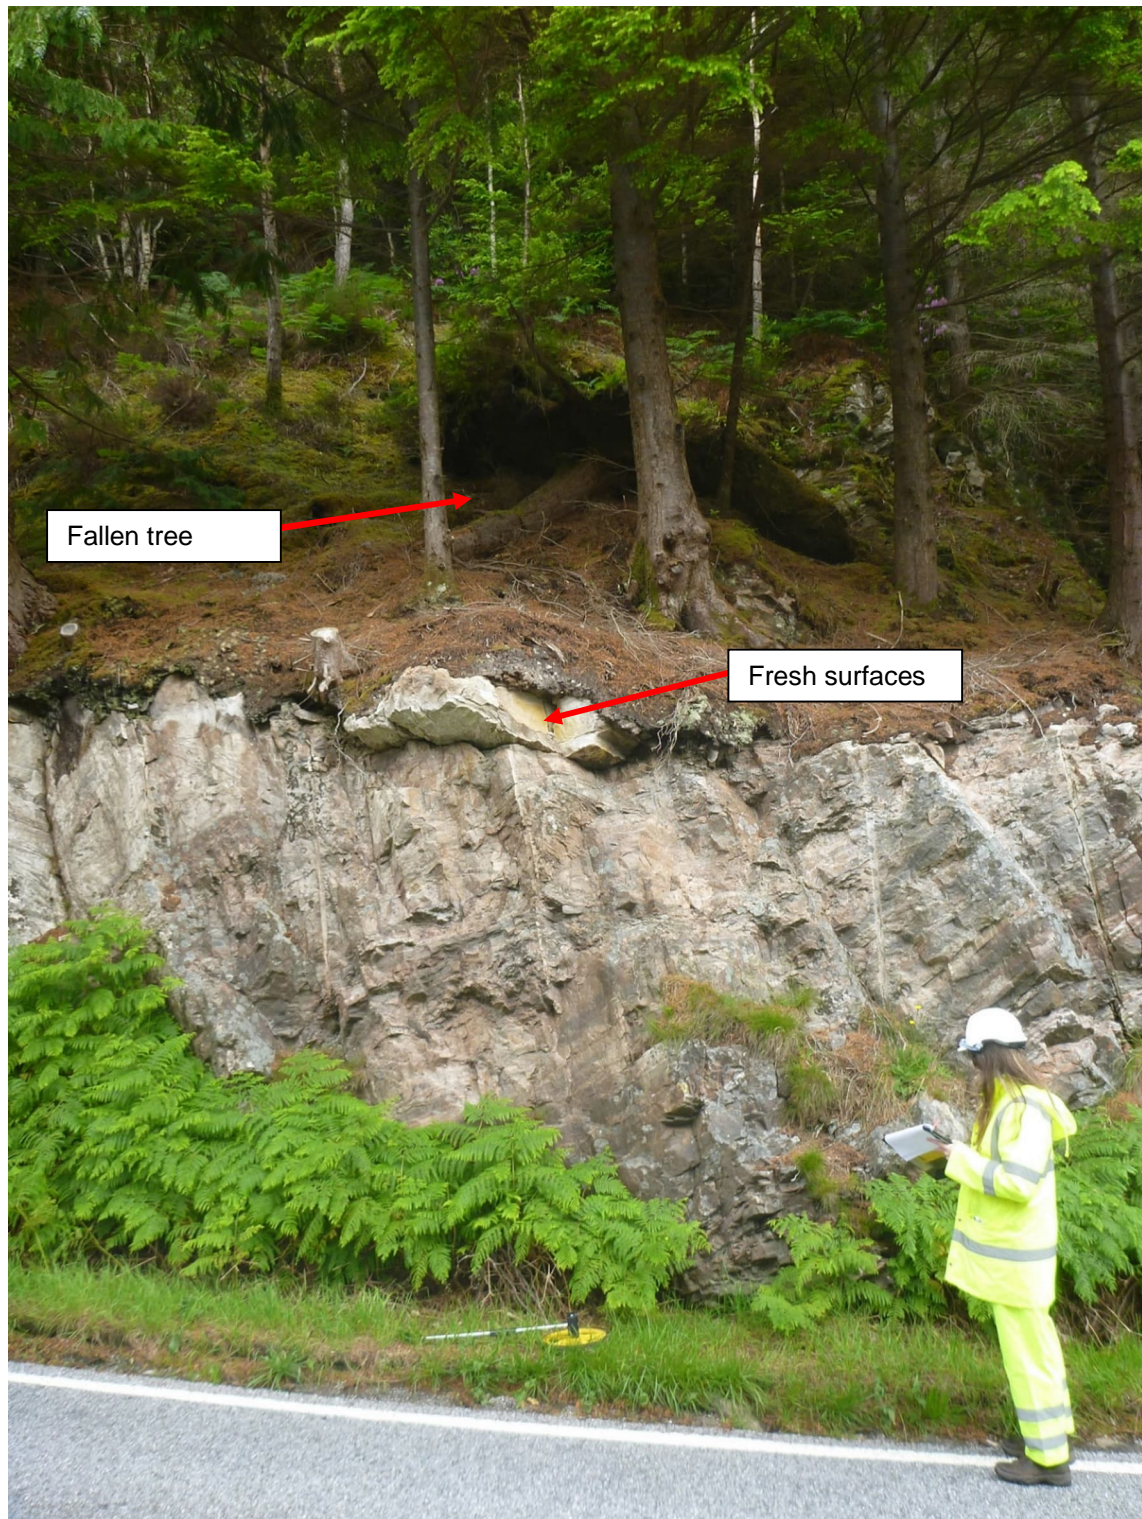
Photograph M6-1

Ch. 455		Fresh surfaces at crest of slope indicating recent rockfall (first observed by AECOM in 2019). Block not currently in ditch/verge so has been moved. Block anticipated to have been 0.3m x 0.2m based upon fresh surface.					
SUMMARY				Comments			
Hazard Rating =		2		Potential rock fall volumes up to 1m ³ identified.			
Pathway Rating =		2		Majority of rock falls likely to be small blocks which will land on roadside verge. Debris from larger potential toppling failure at Ch. 420 may reach road.			
Receptor Rating =		1.2		Minimum sightline 60m.			
Risk Value =		4.8					
Risk Level =		Low					
Recommended Remedial Works / Actions							
Re-inspection by end of June 2023. Low risk slope so remedial works not required, however, risk could be further reduced through scaling and felling of trees along crest.							
Assessed in field by:	JG/PLM	Date:	22/06/2022	Reviewed by:	PLM	Date:	26/082022

Fallen tree 3m back from slope posing no risk to the road.
Fresh surfaces indicating a relatively recent rock fall (at least before the 2019 inspection).
