**Job Title**  
Highland School RAAC Survey –  
Charleston Academy

**Prepared for**  
Highland Council and Watts Property  
Service

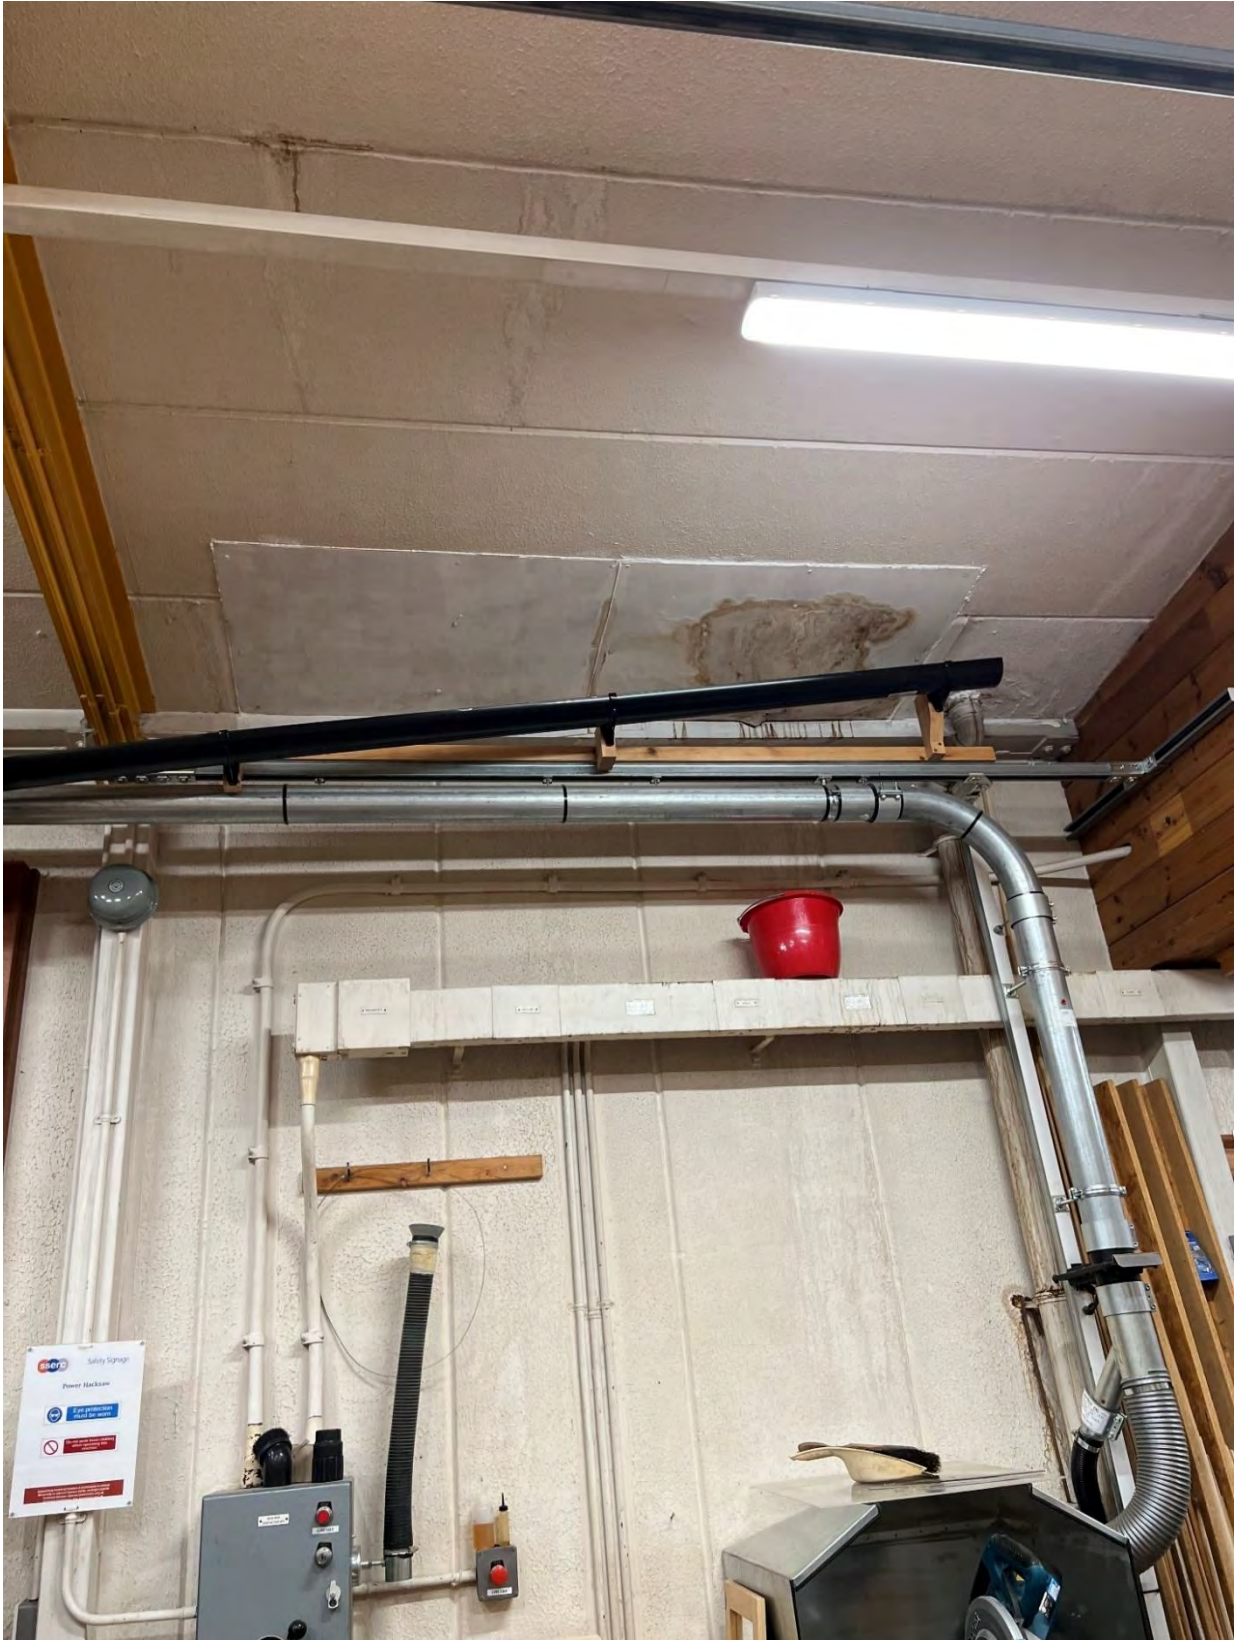
*Photo N.3 – Water damage to Siporex panels (Tech Dept)*

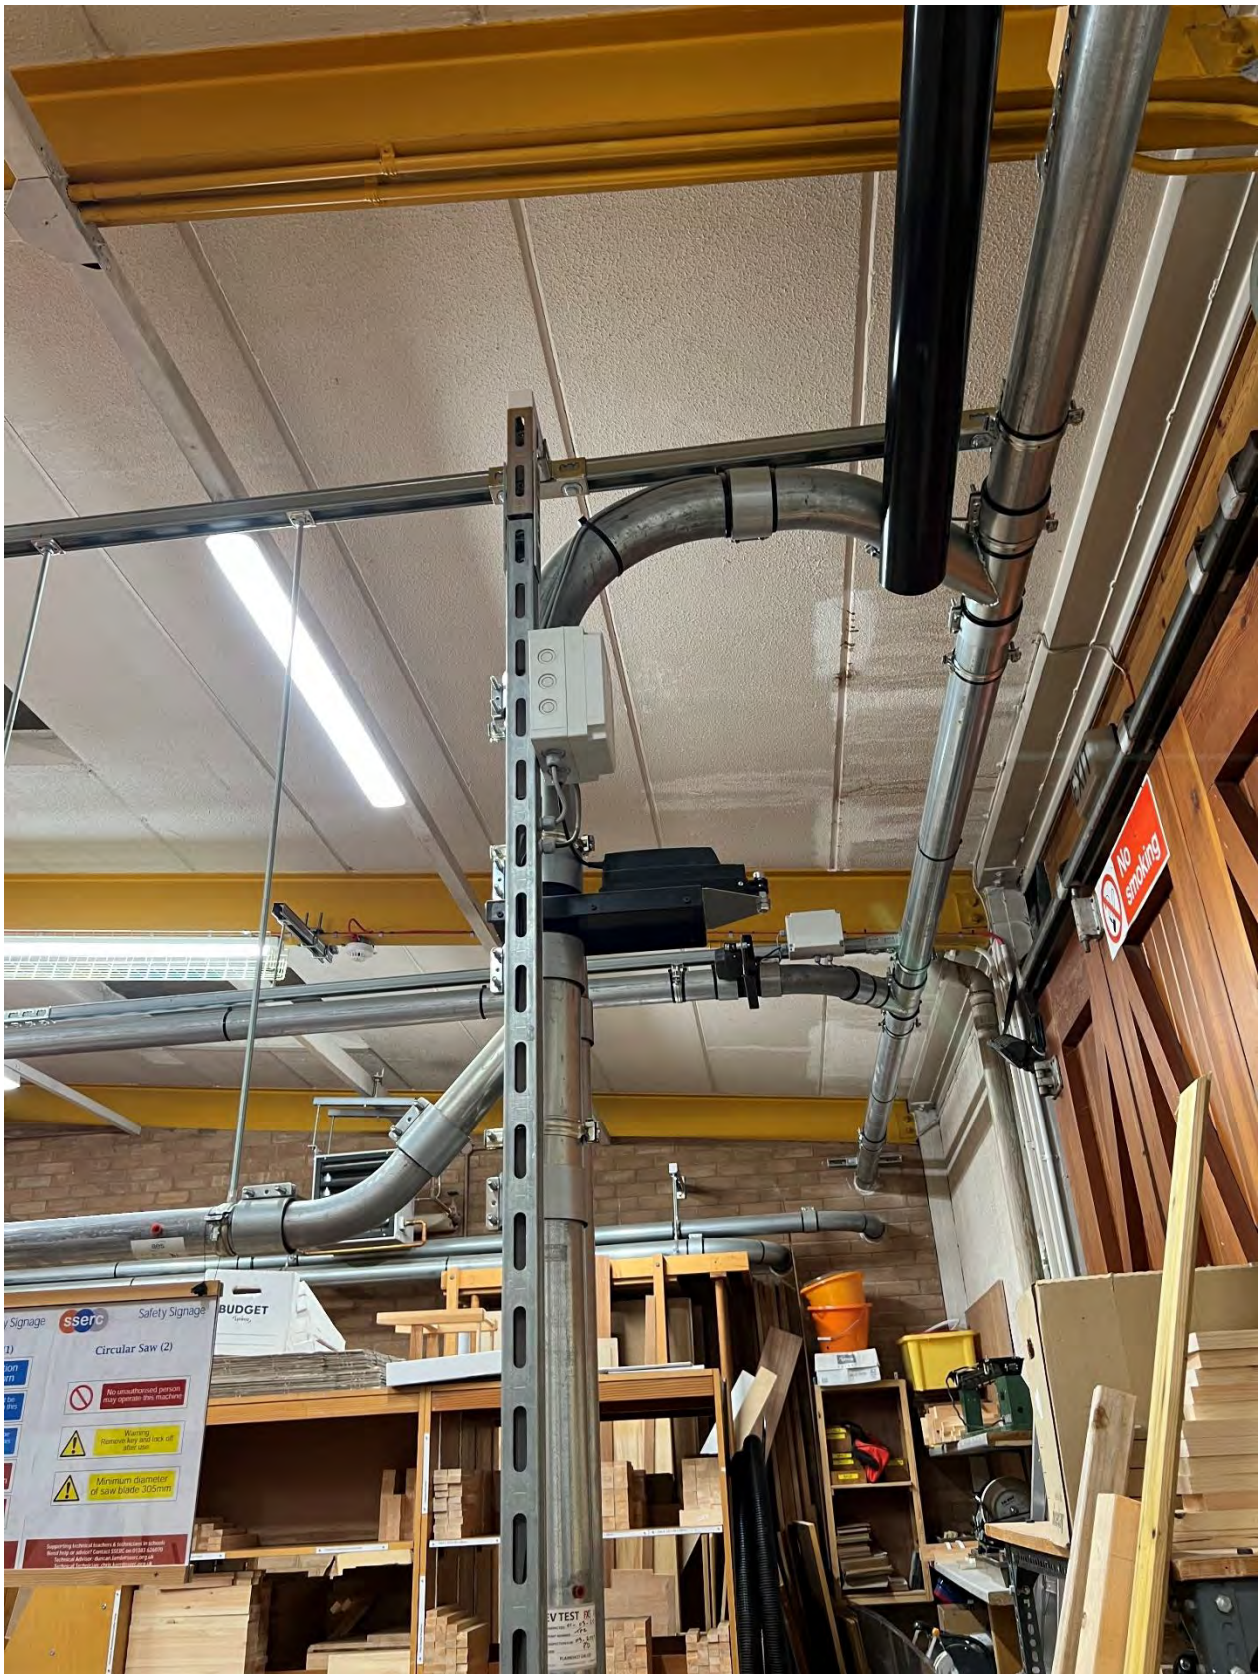
*Photo N.4 - Water damage to Siporex panels (Tech Dept)*

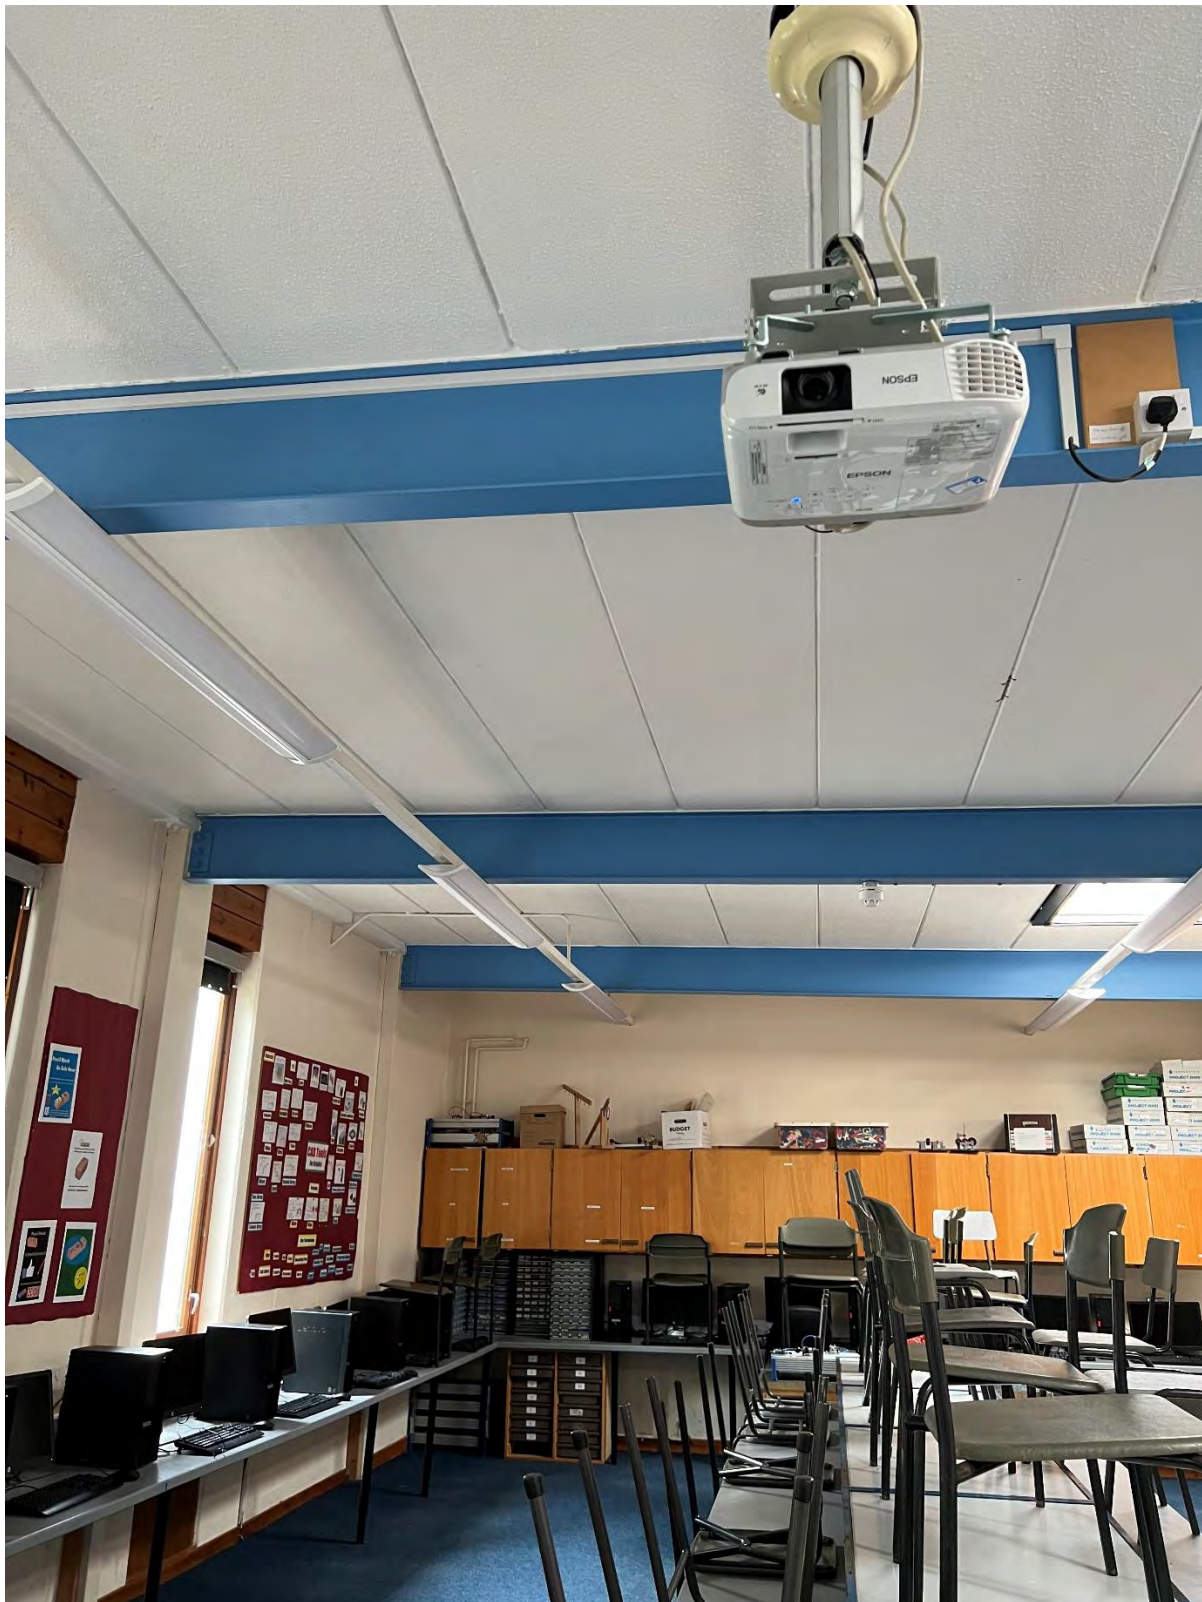
*Photo N.5 - Bearing length appears to be less than 75mm throughout (Science Dept)*

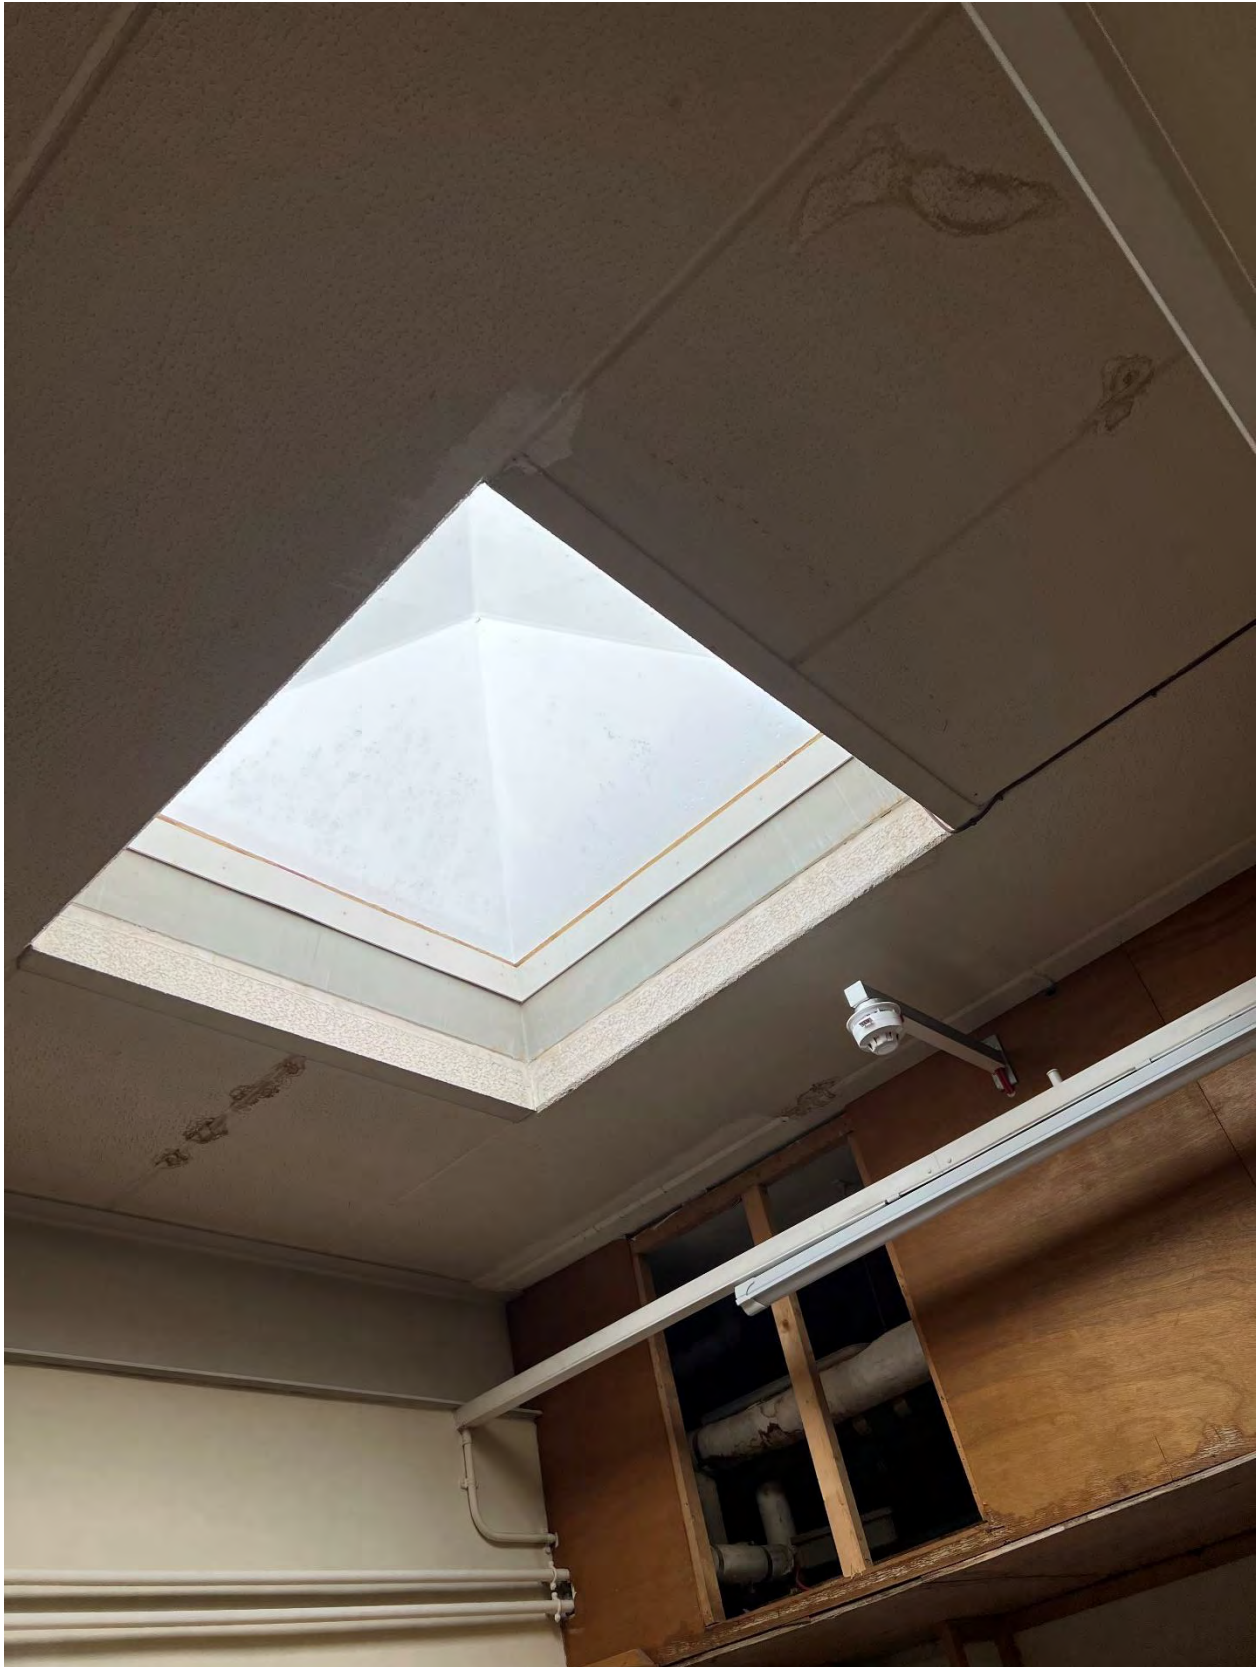
*Photo N.7 - Water damage to Siporex panels (Science Dept)*

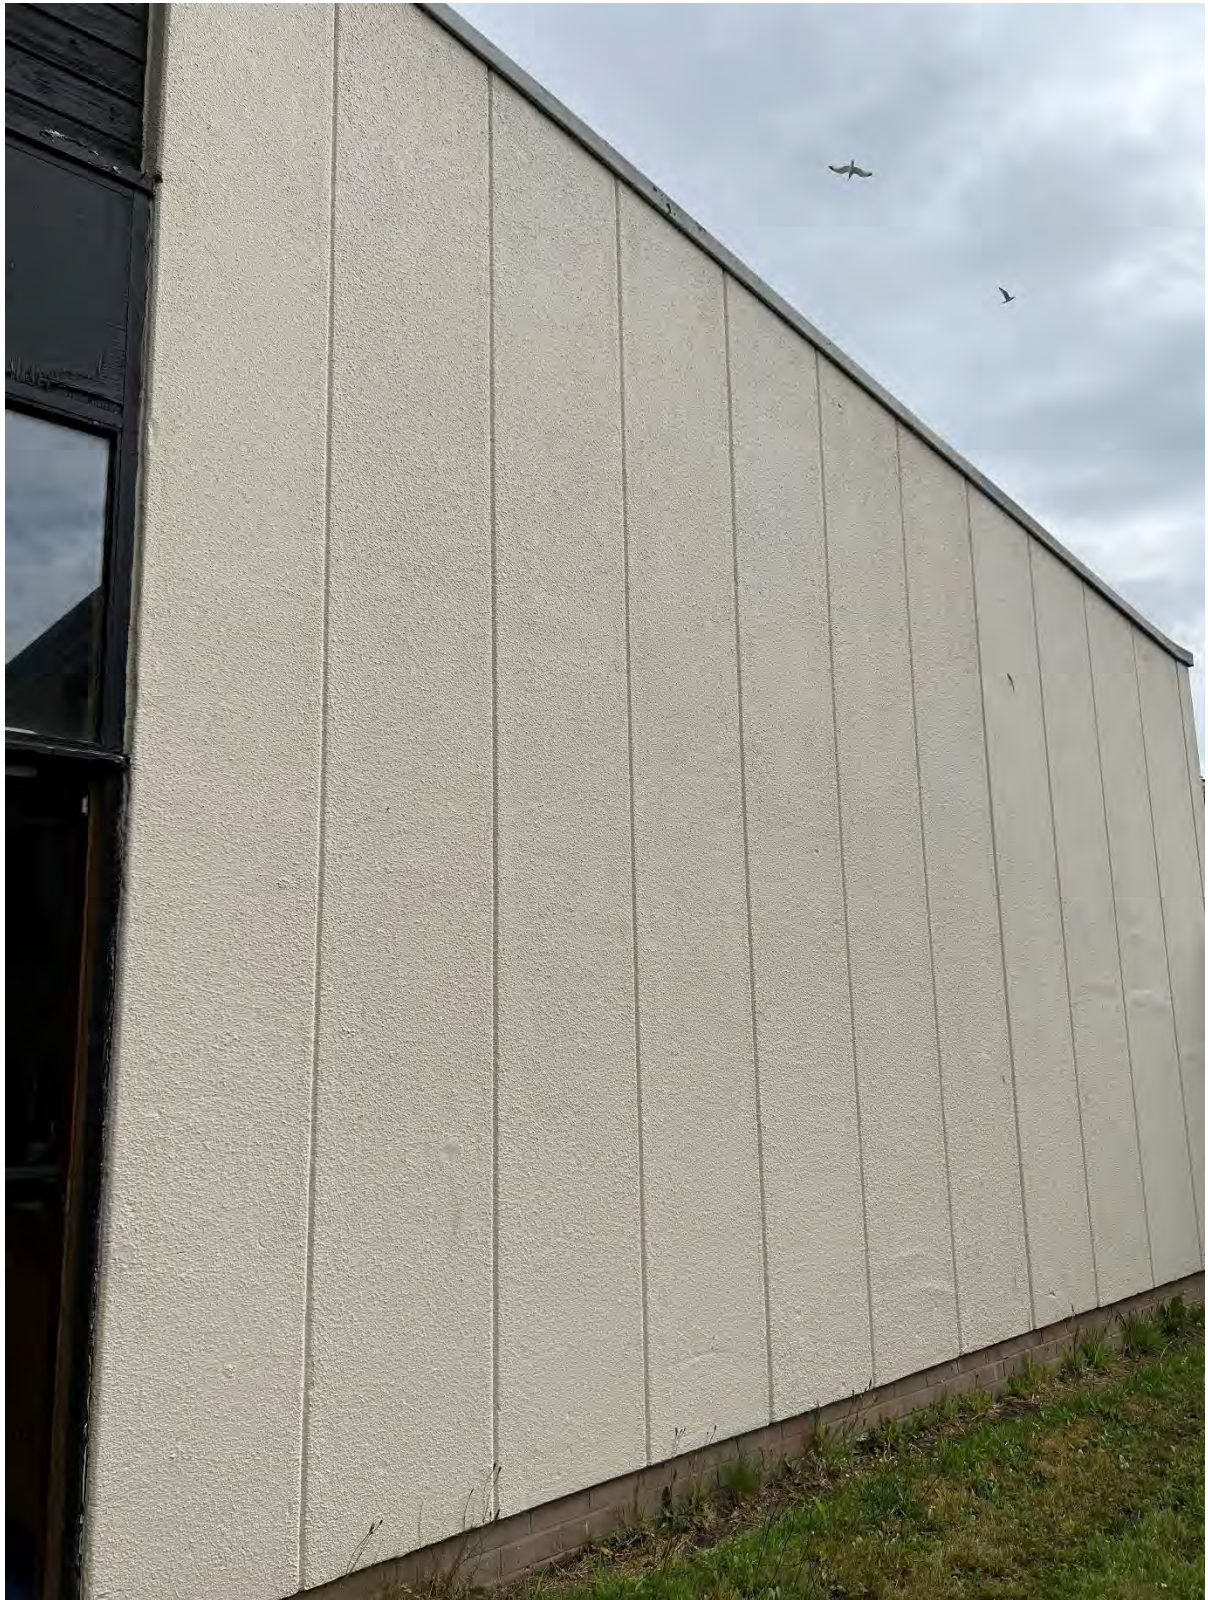
*Photo N.8 – External view of Siporex Wall panels (Art Dept)*

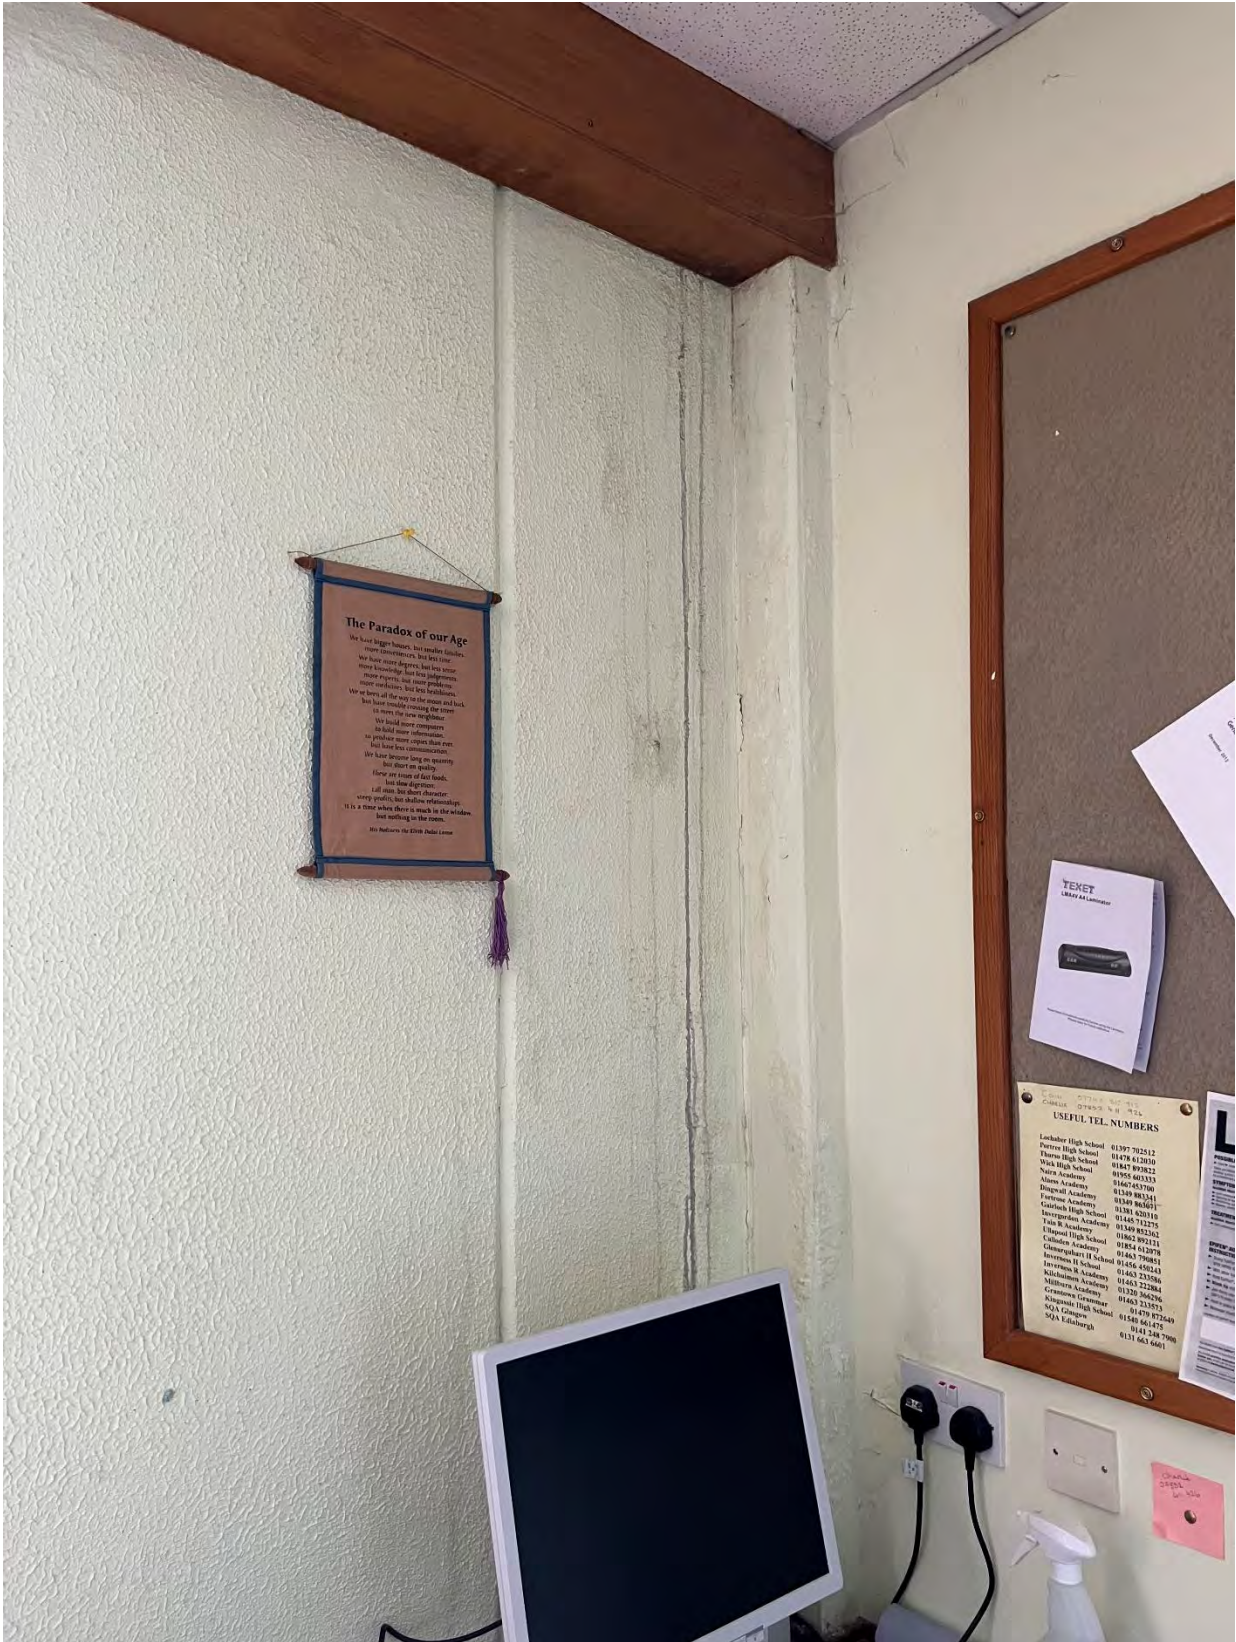
*Photo N.10 - Internal view of Siporex Wall panels with water damage (Science Dept)*

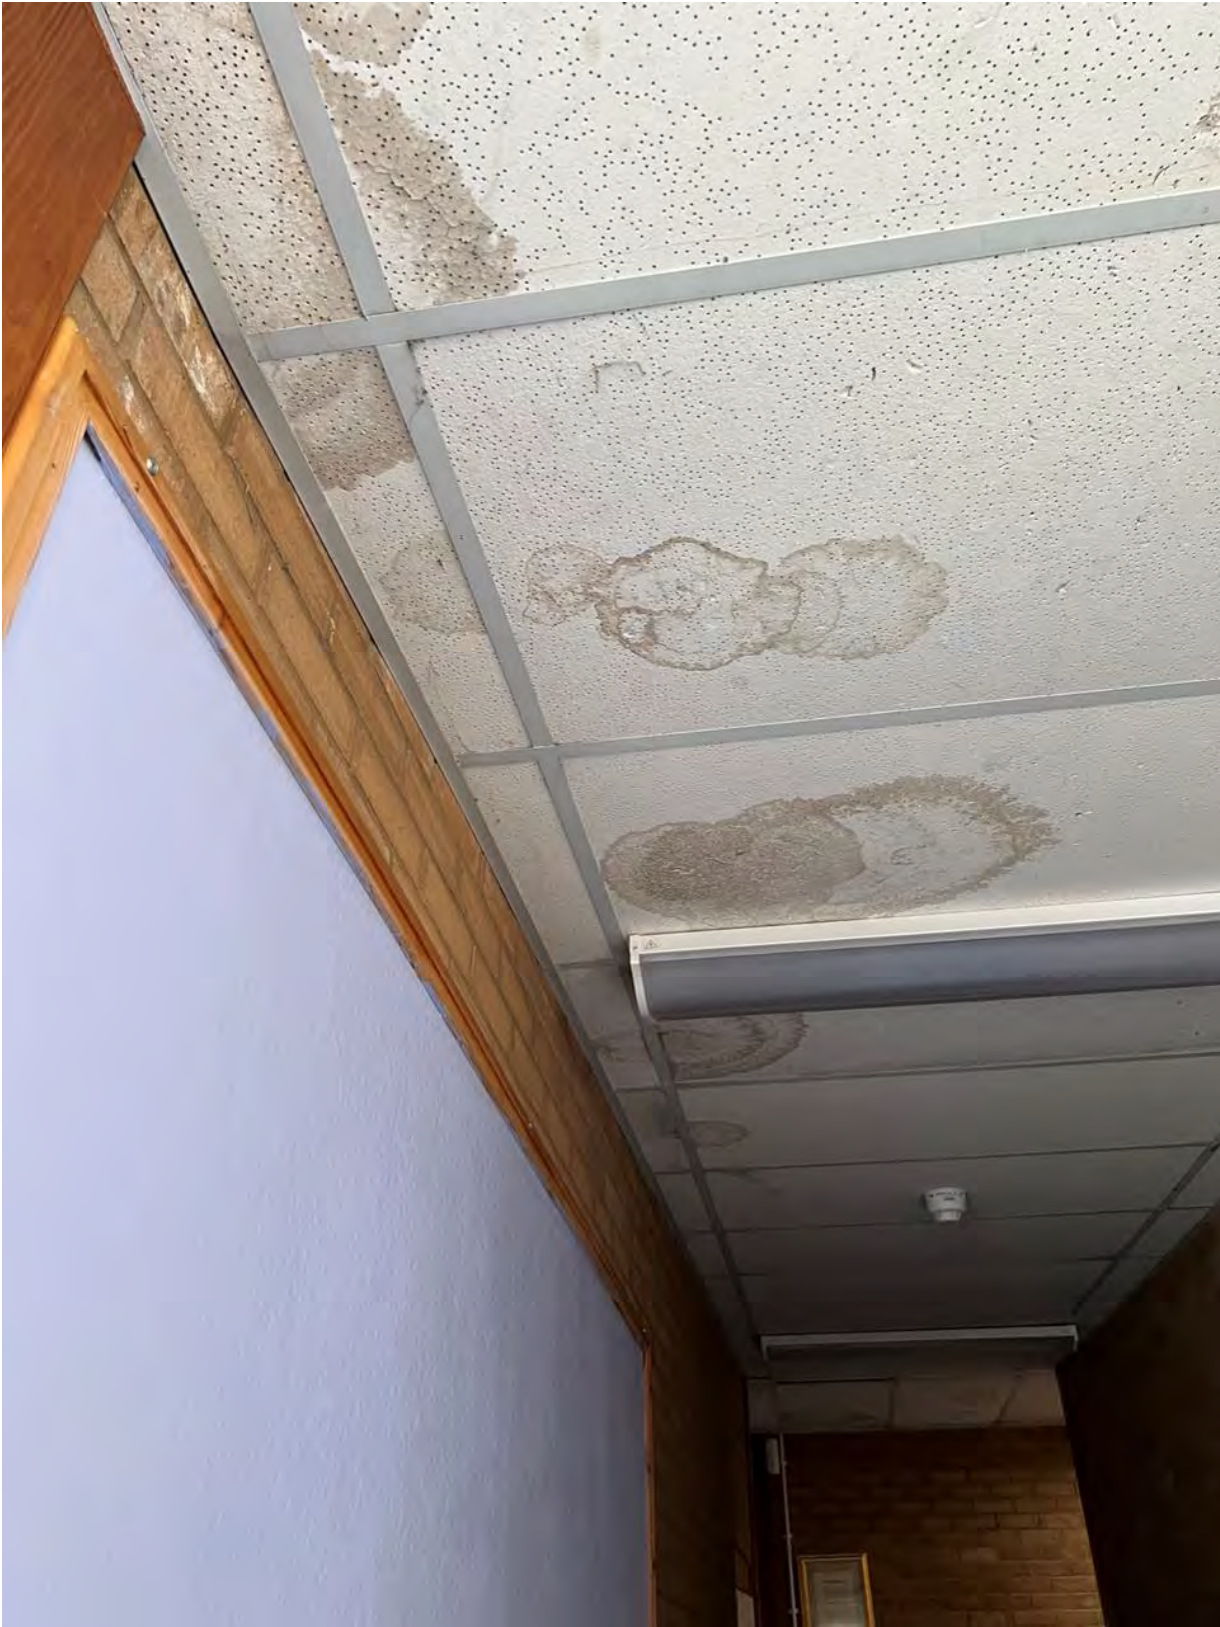
*Photo N.11 – Water staining on ceiling tiles indicates potential water ingress (corridor to Home Economic Dept)*

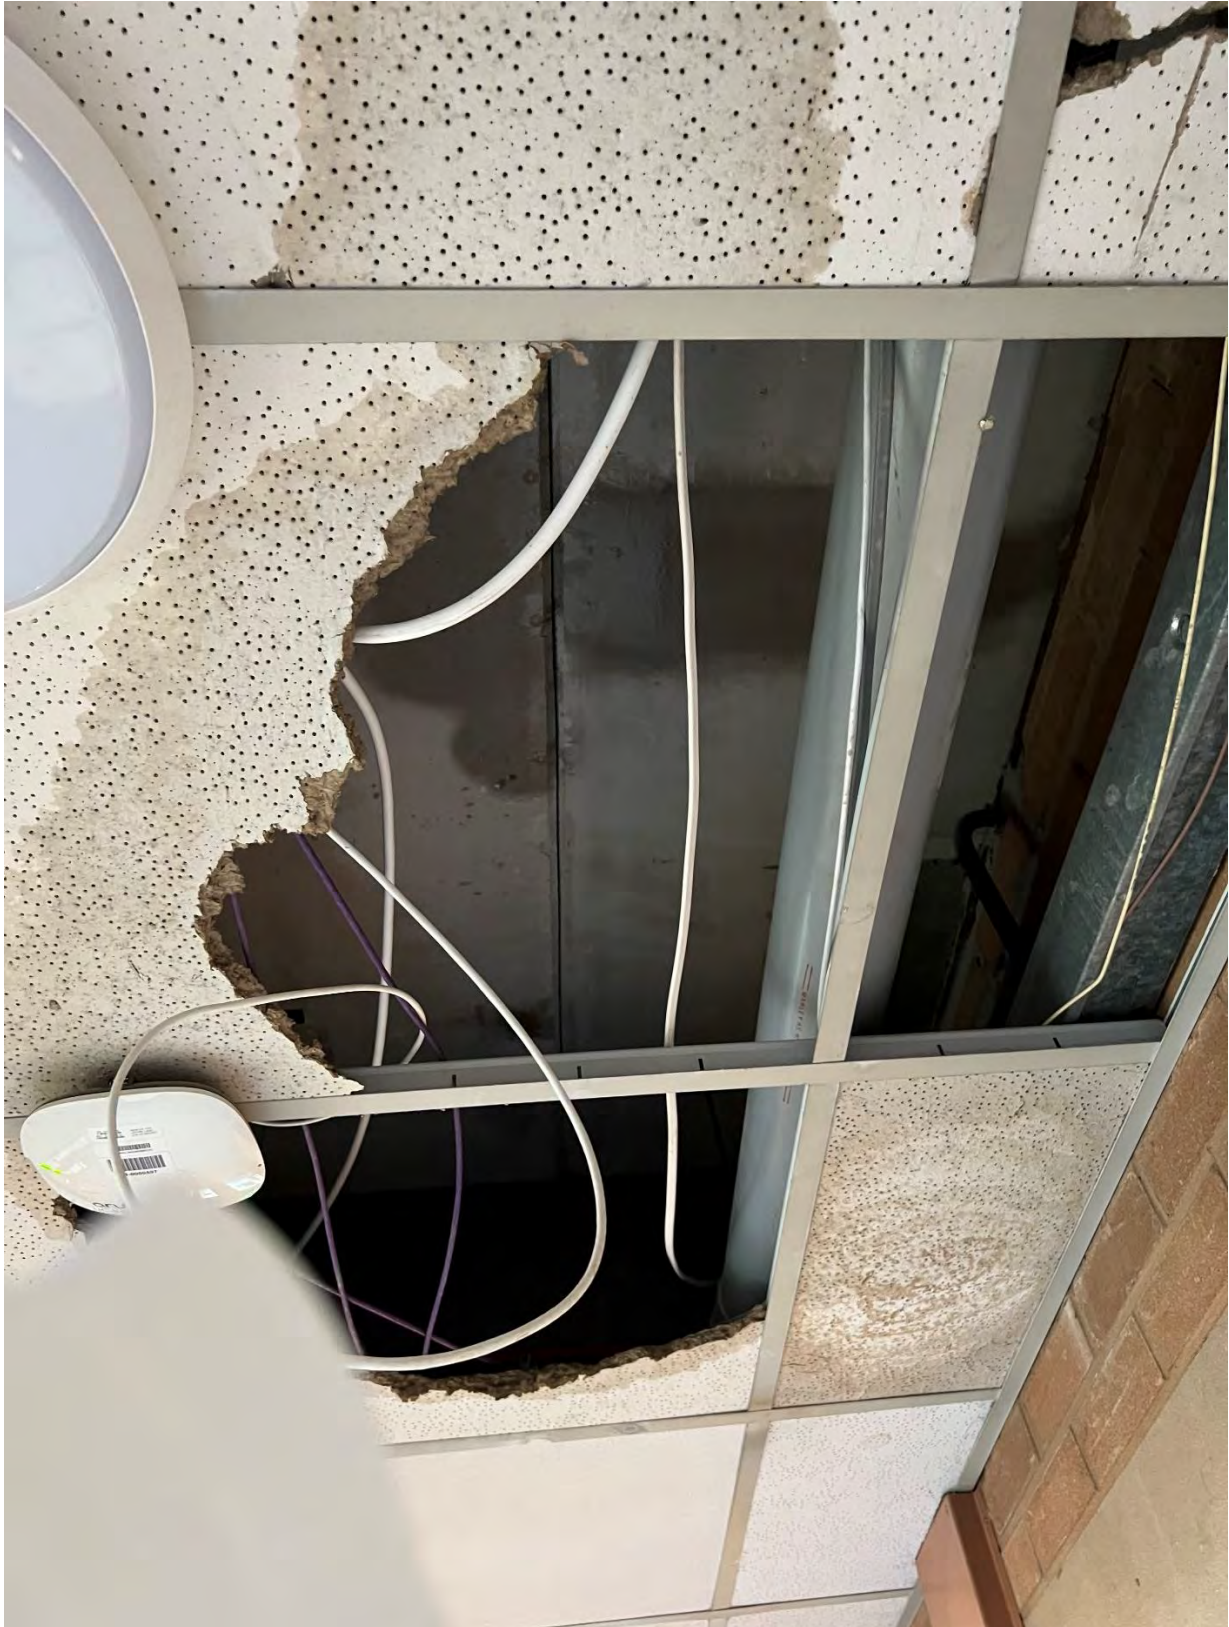
*Photo N.12 – Visible water staining on Siporex panels (Science Dept)*

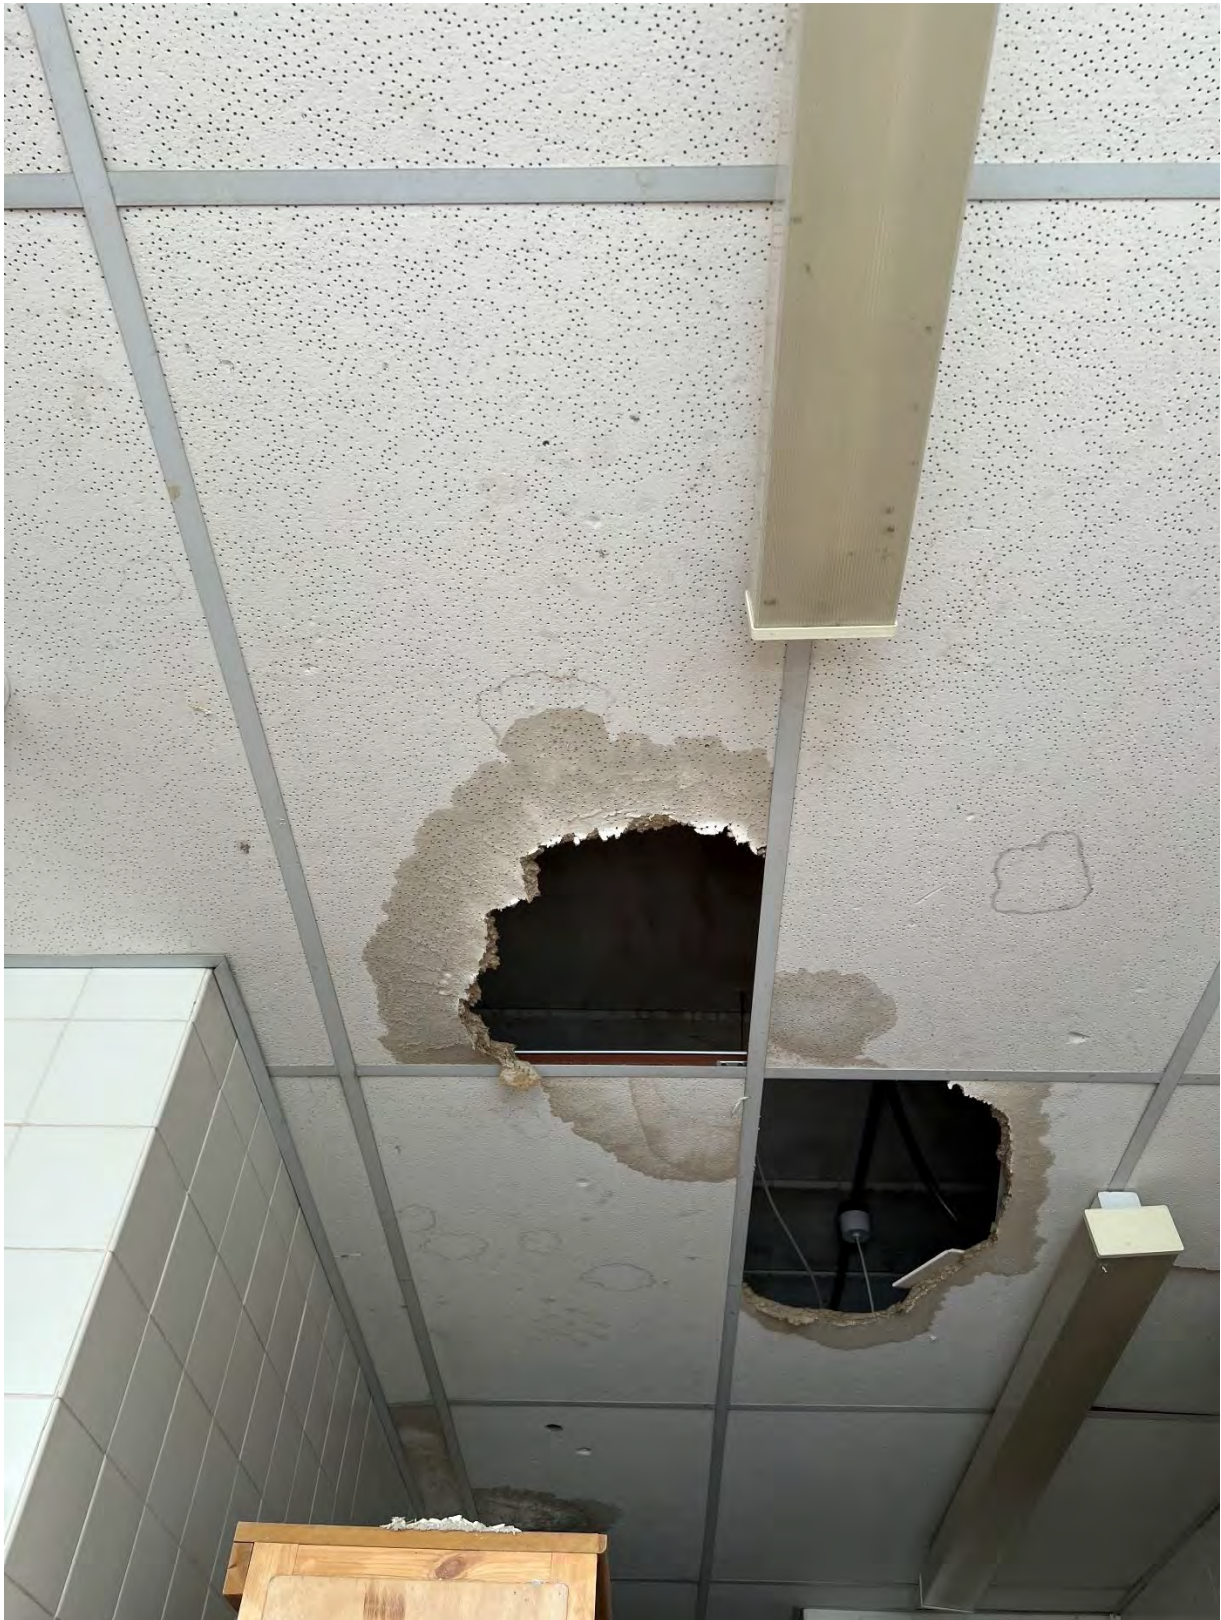
*Photo N.13 - Visible water staining on Siporex panels (Science Dept toilets)*

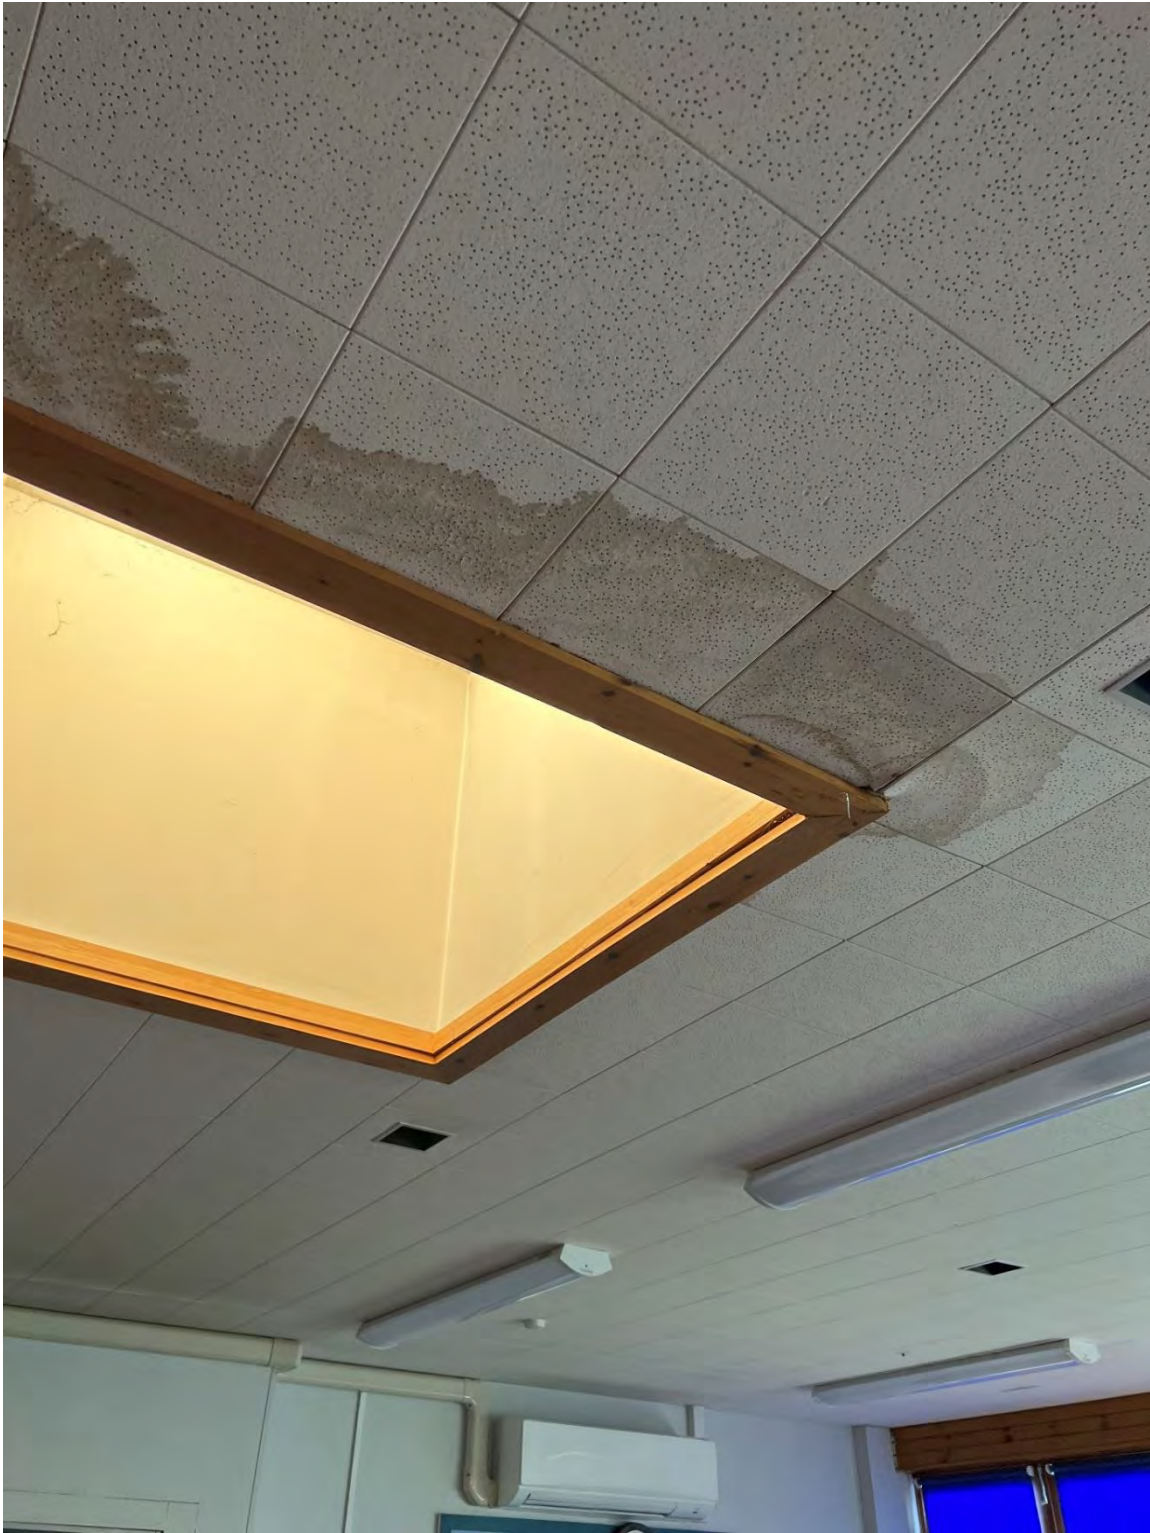
*Photo N.14 - Water staining on ceiling tiles indicates potential water ingress (Staff Room)*

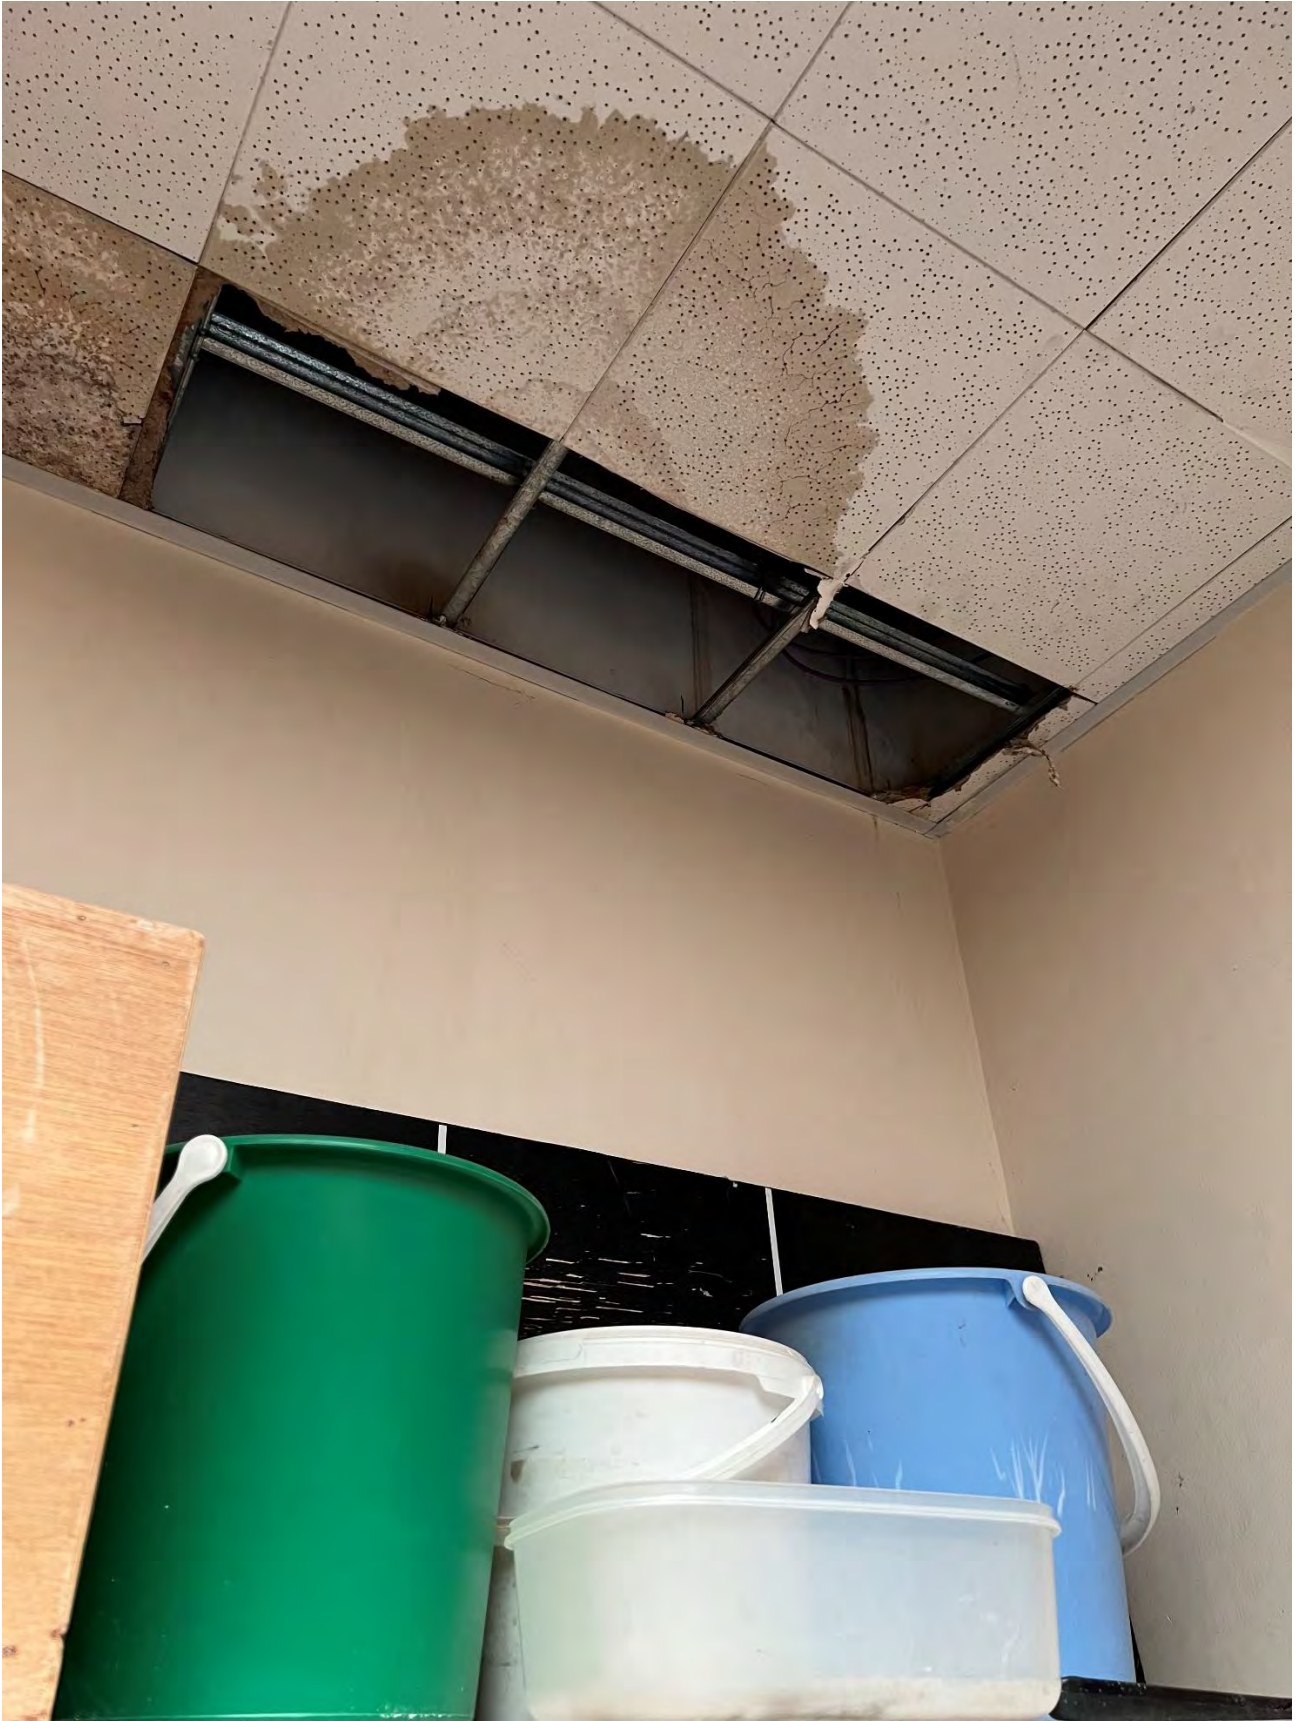
*Photo N.15 - Water staining on ceiling tiles indicates potential water ingress (Admin Area)*
