**Job Title**  
Highland School RAAC Survey –  
Charleston Academy

**Prepared for**  
Highland Council and Watts Property  
Service

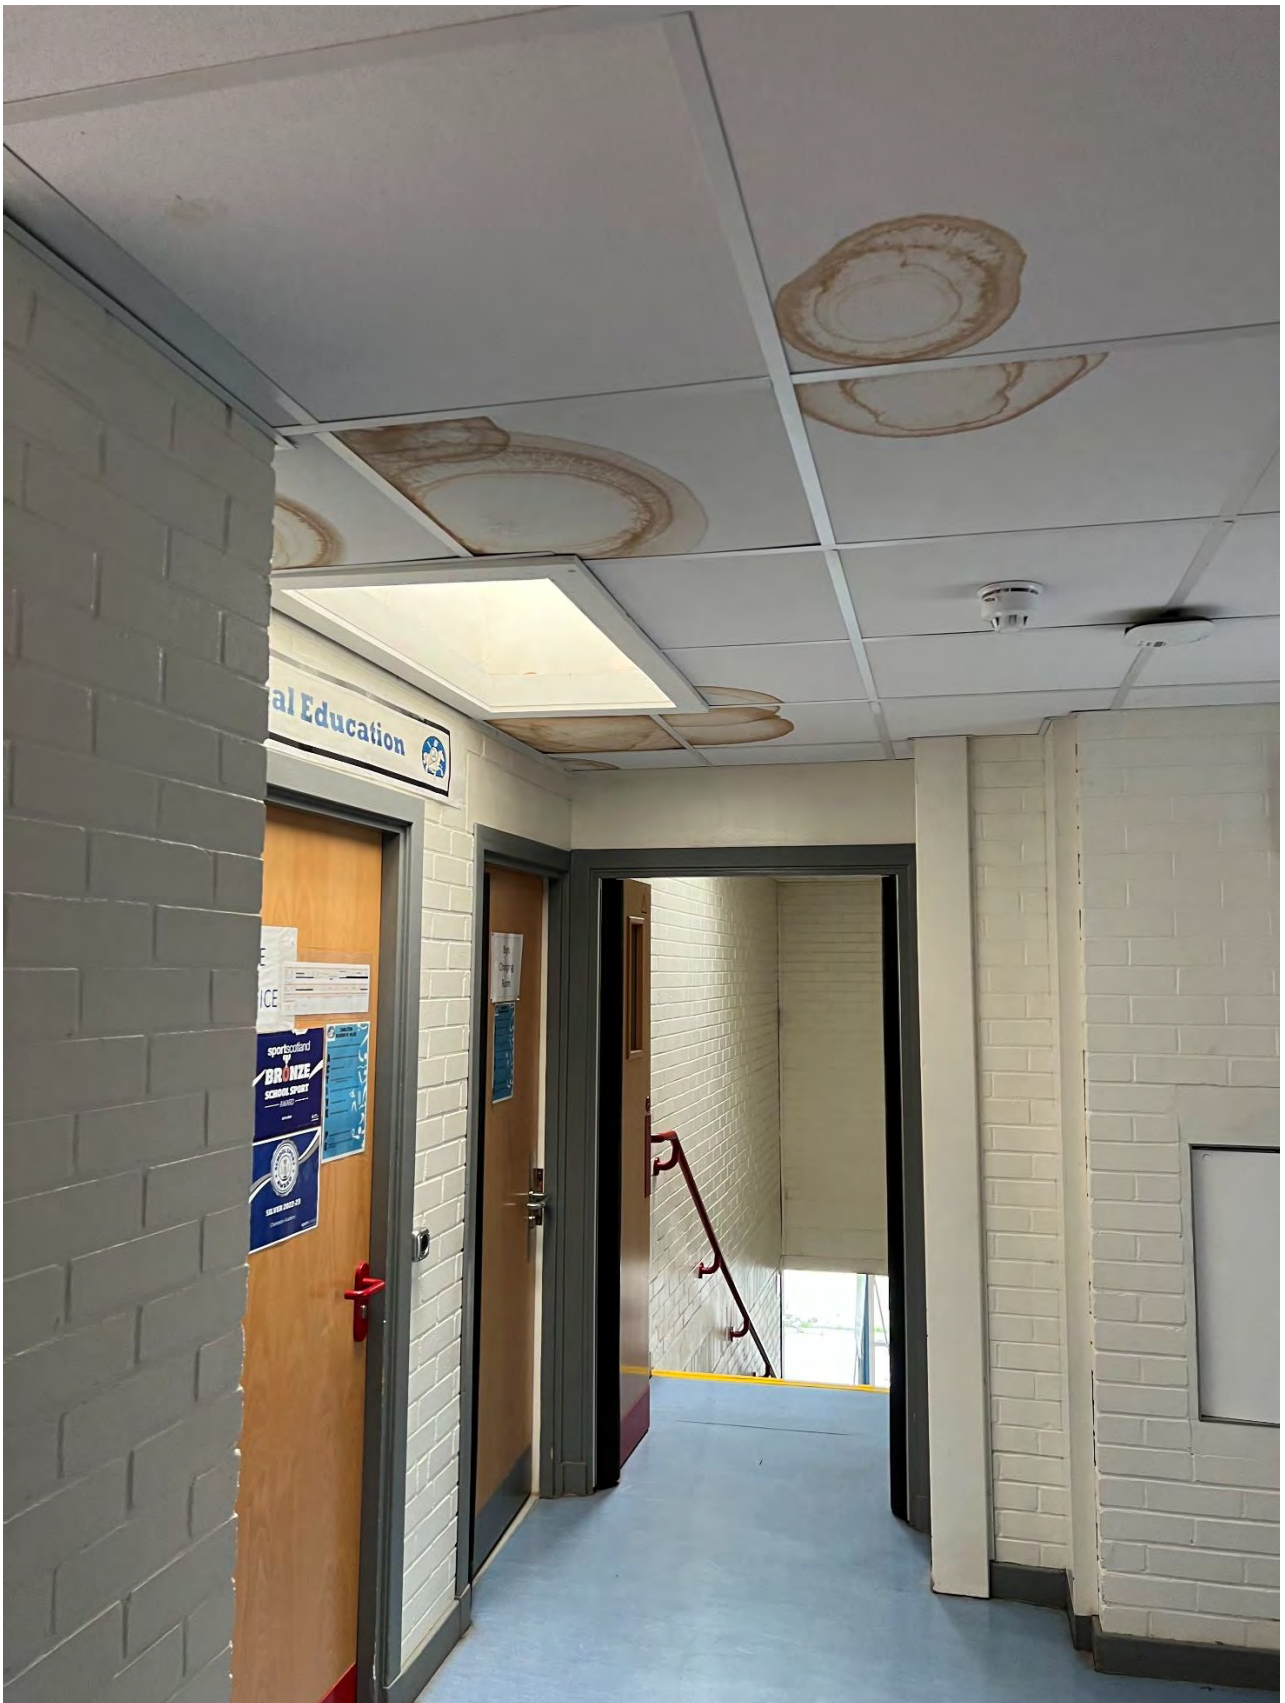
*Photo N.16 – Extensive water staining to ceiling tiles (Admin area)*

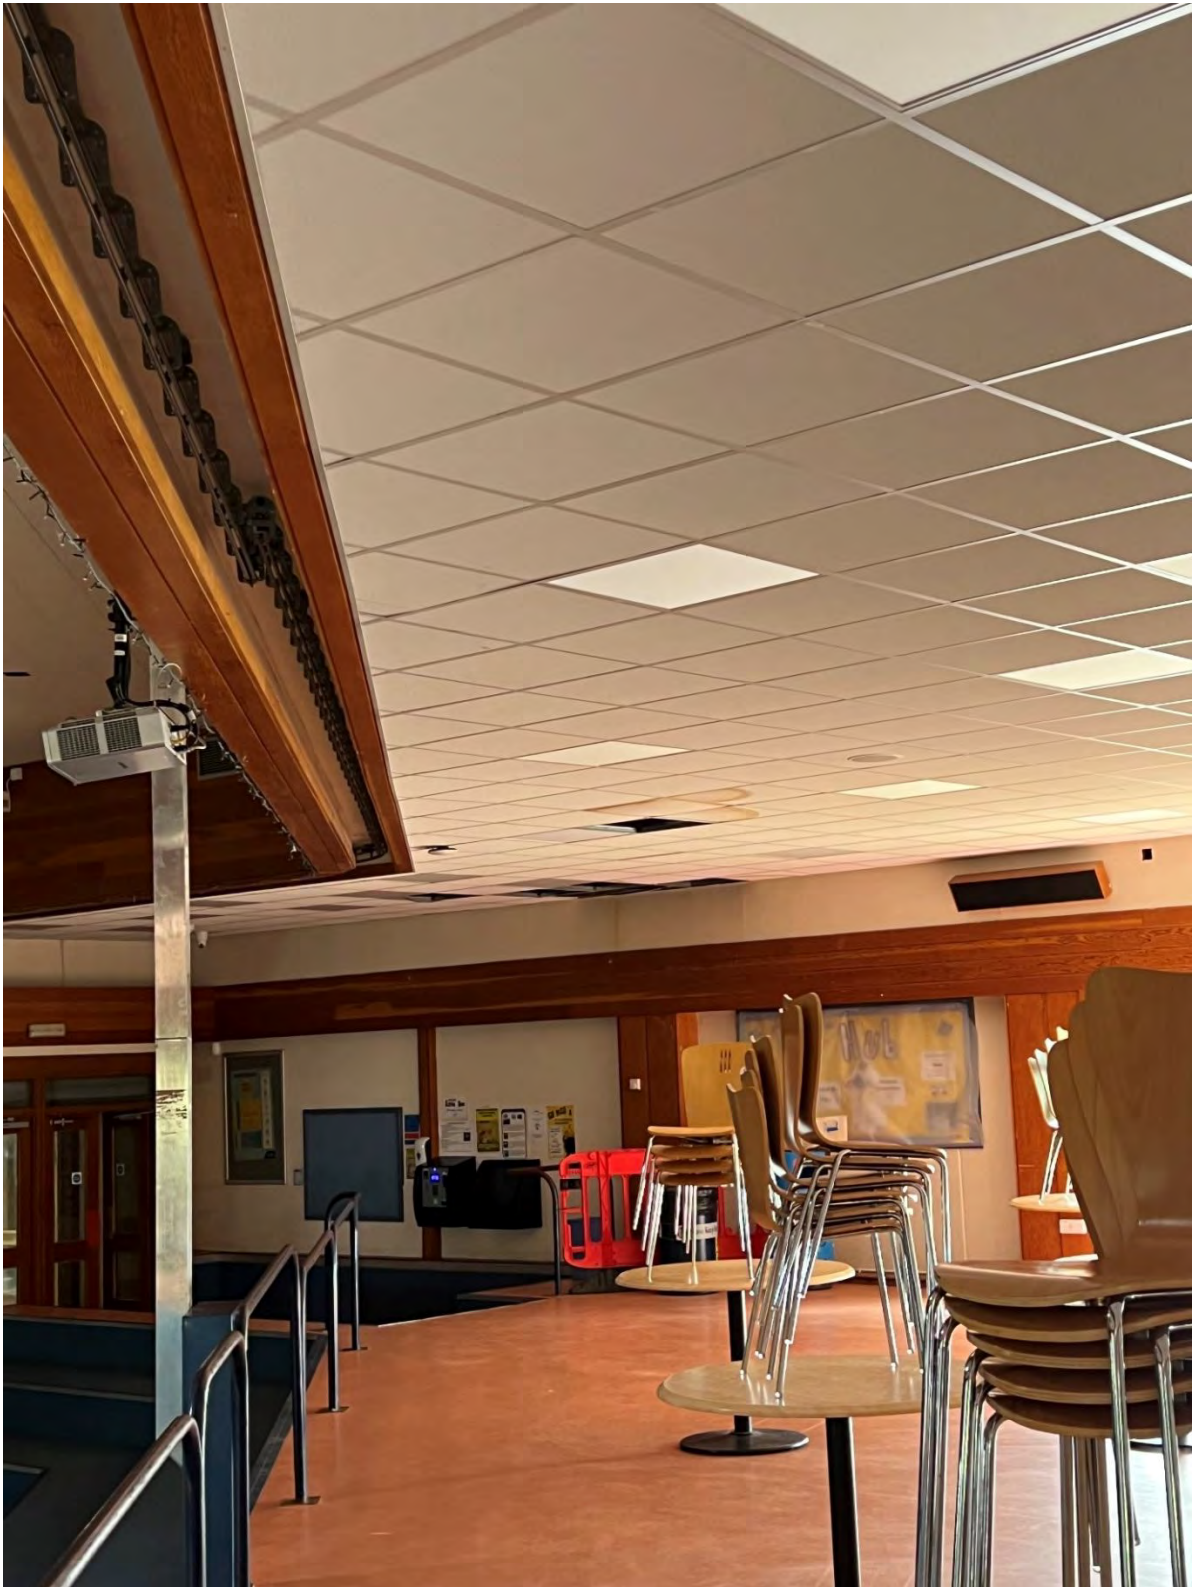
*Photo N.17 – Water staining to ceiling however roof construction appears to be profiled metal deck in main hall (Assembly Hall)*

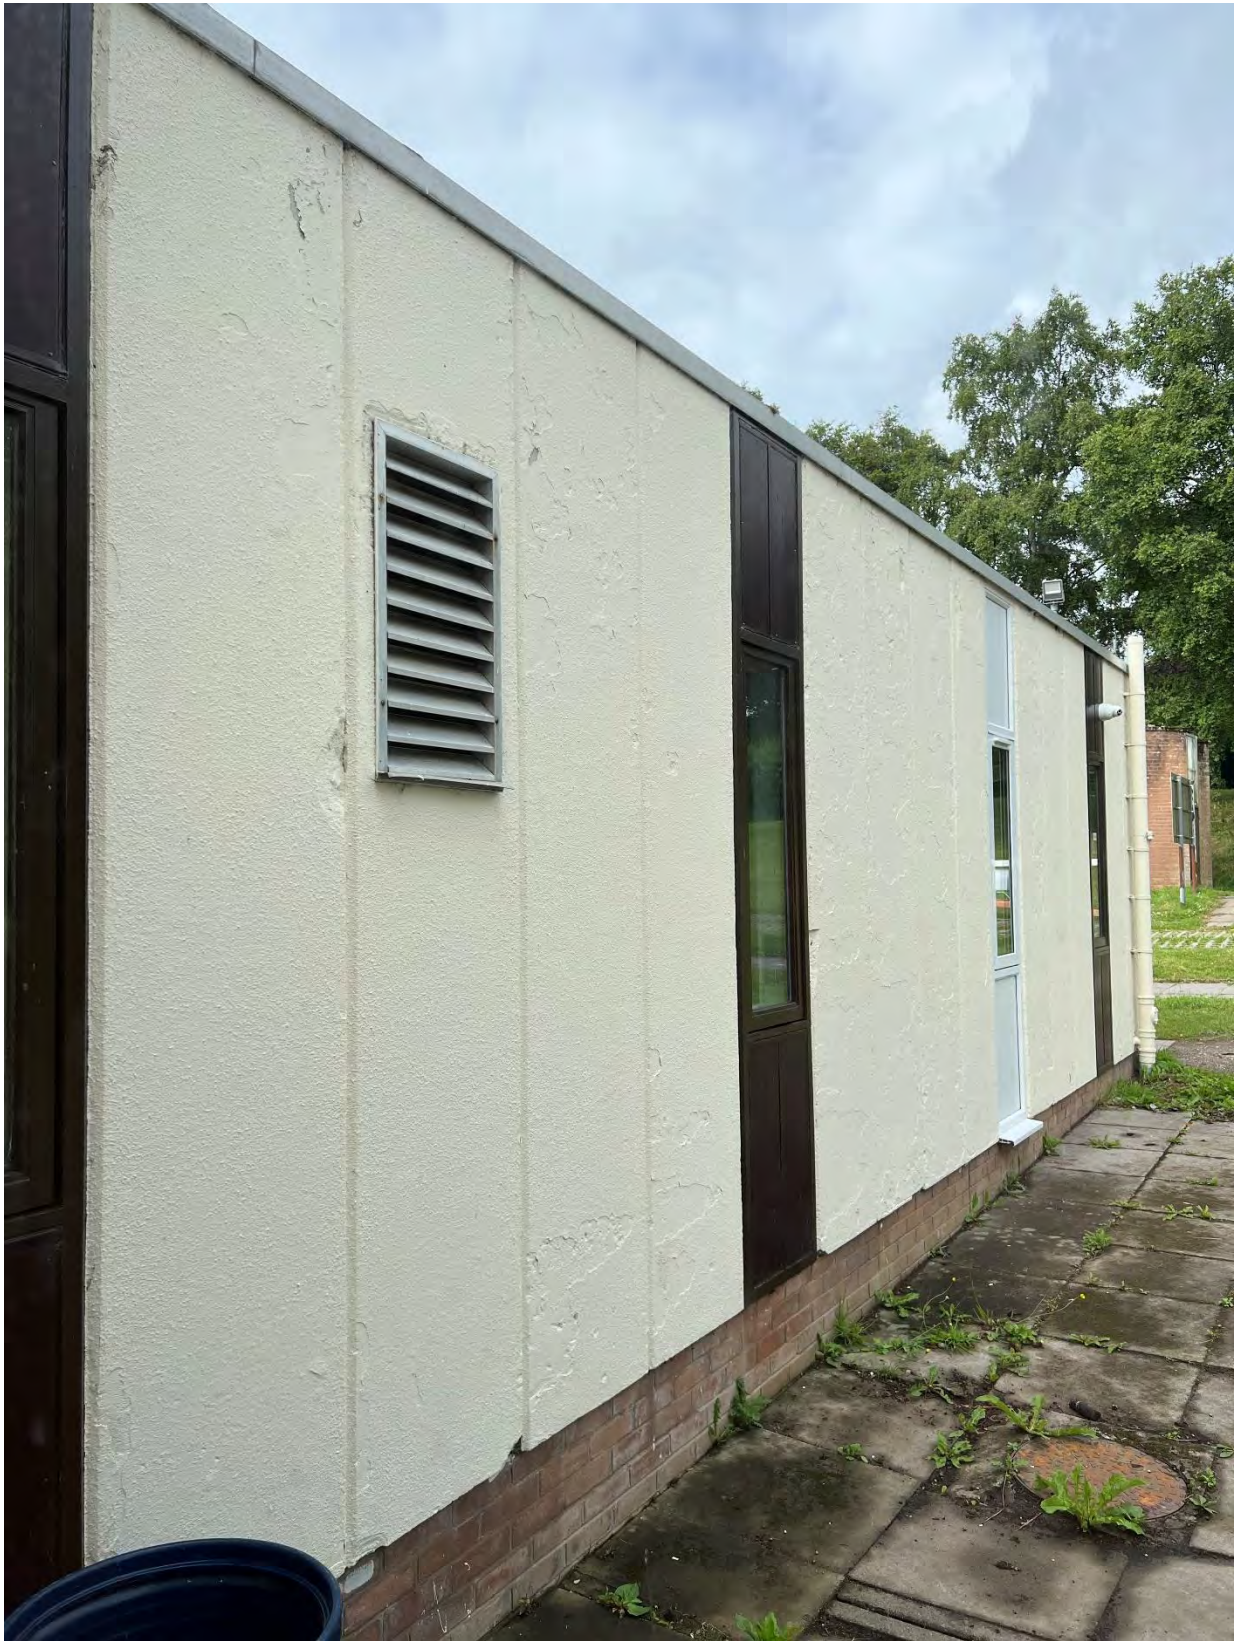
*Photo N.18 – External siporex wall panels (kitchen block)*

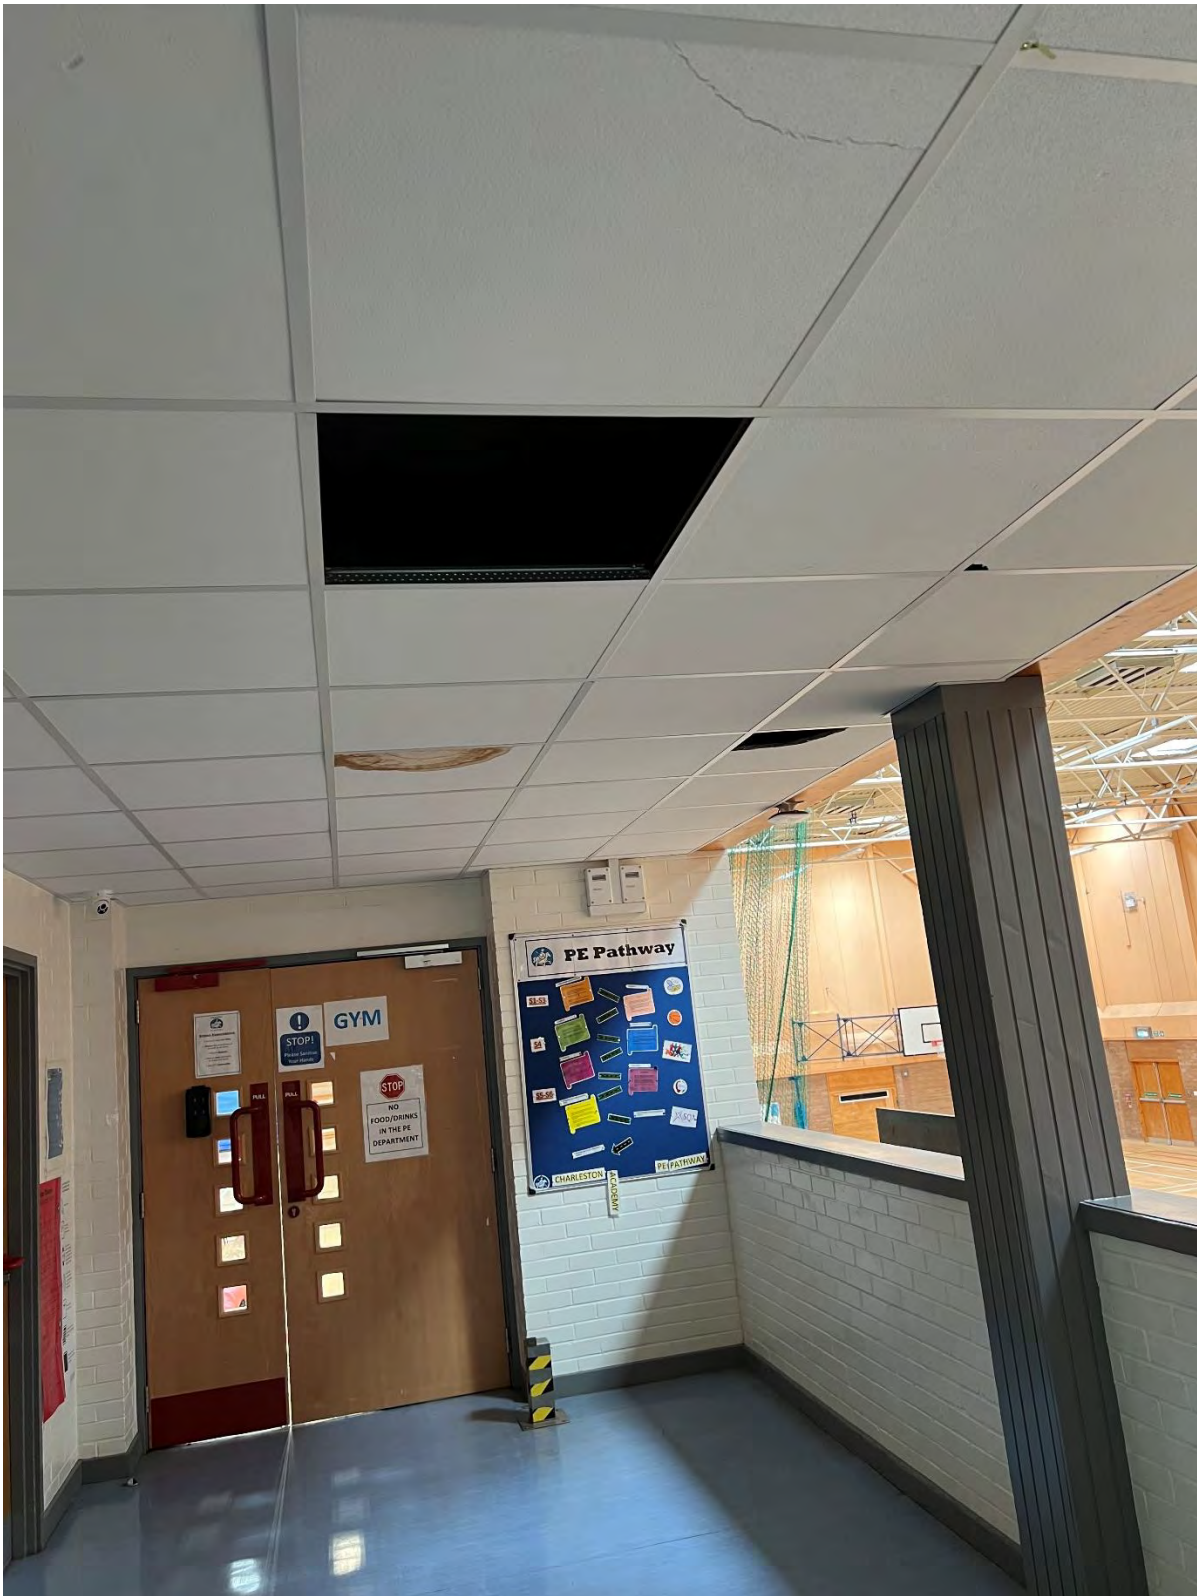
*Photo N.19 - Extensive water staining to ceiling tiles (Community/gym block)*

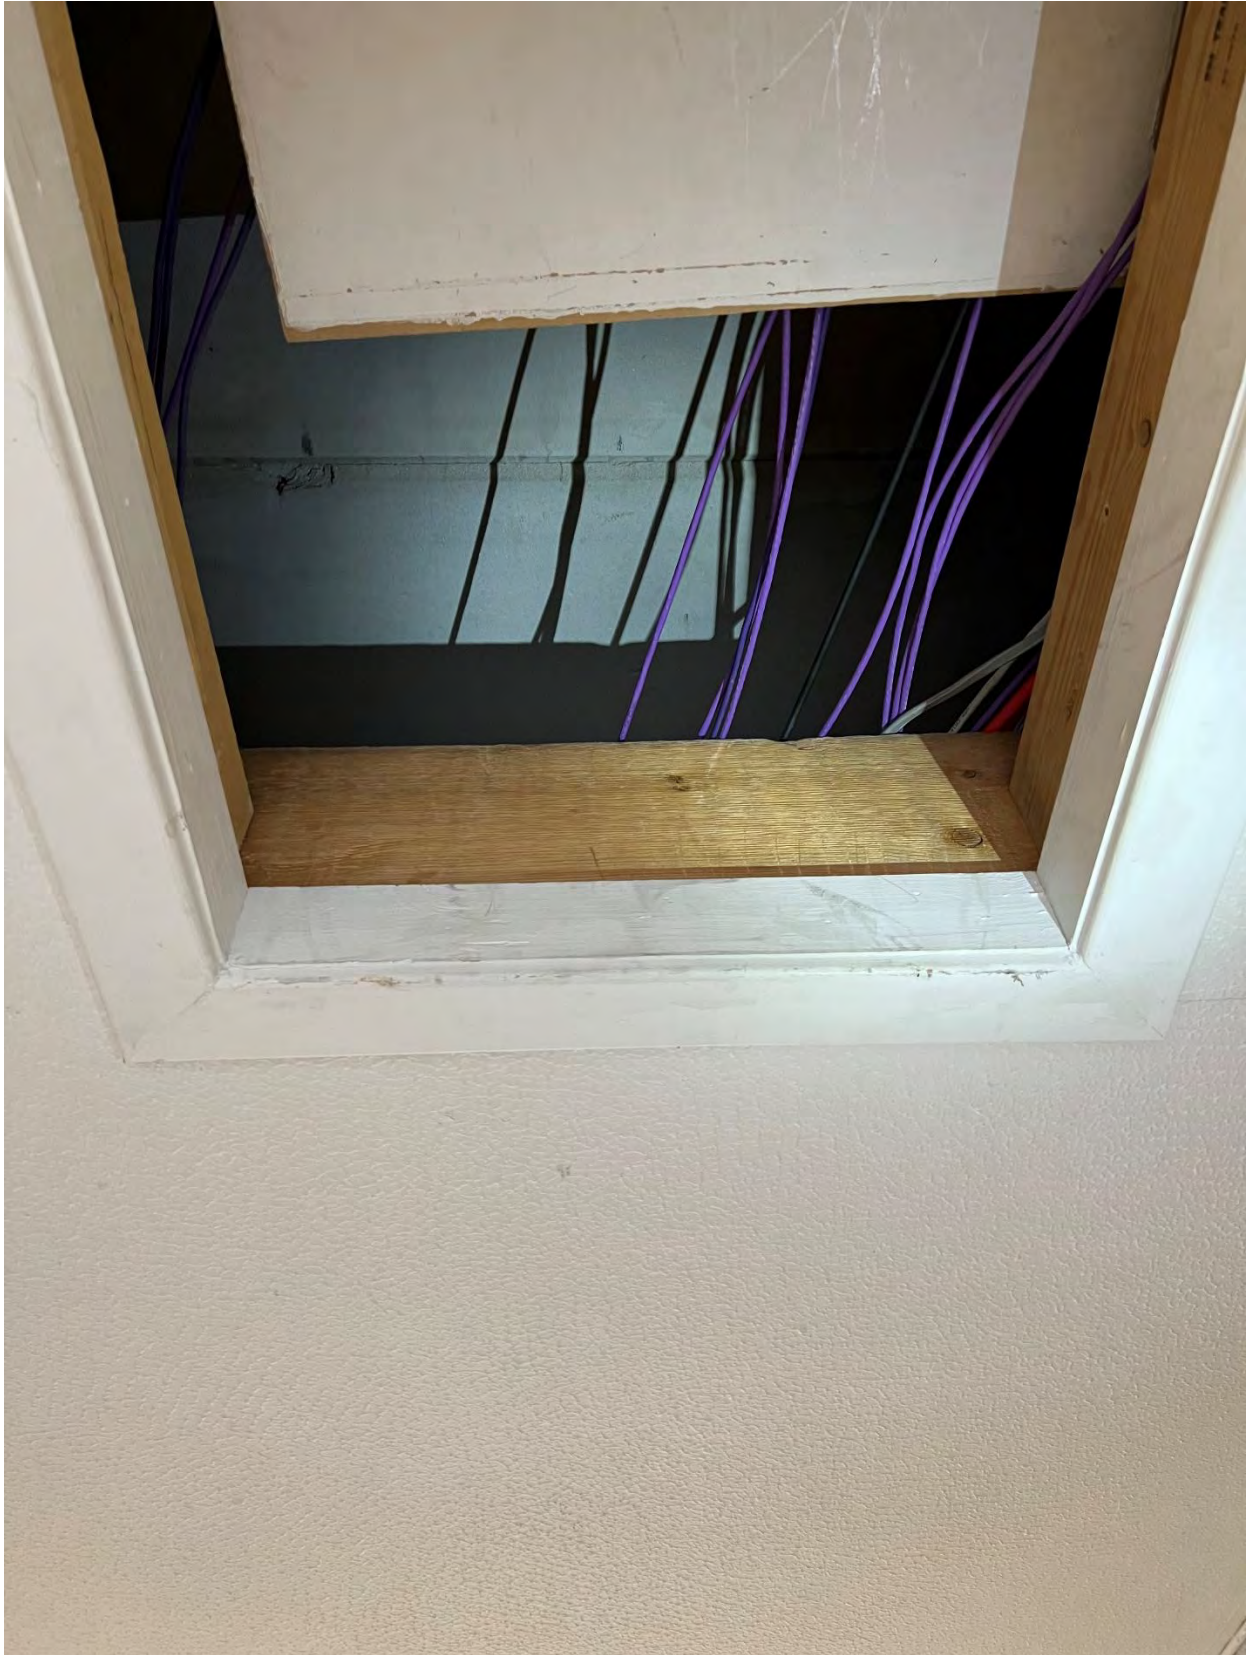
*Photo N.20 – Siporex roof panels identified in ceiling void (Community/gym block)*

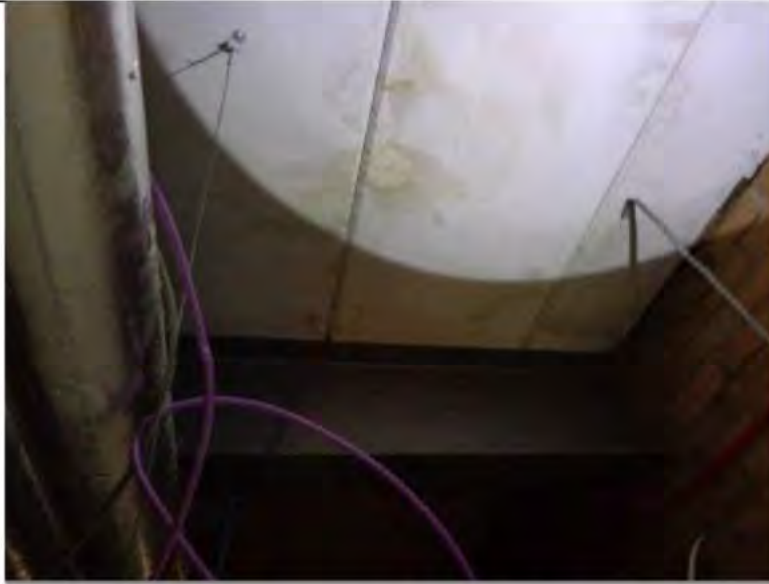
**Photo No 3 – Water staining on the underside of panels above a suspended ceiling**

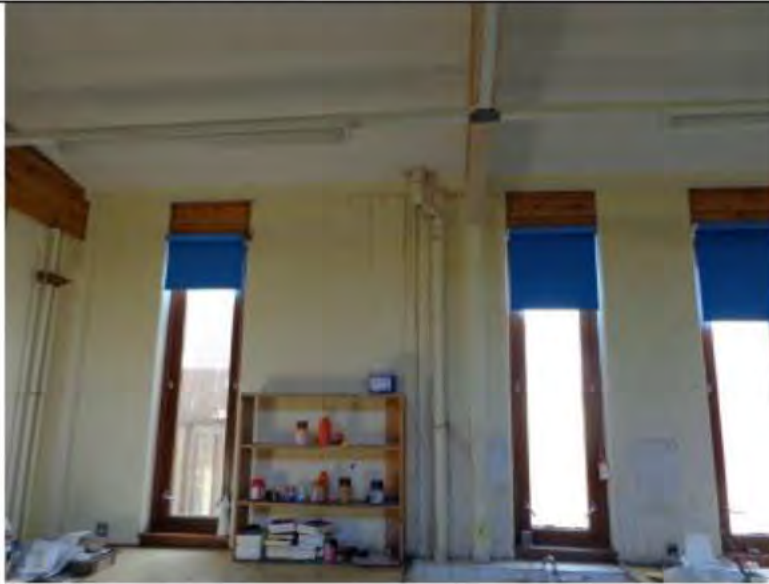
**Photo No 4 – Evidence of leaking at rainwater downpipes**

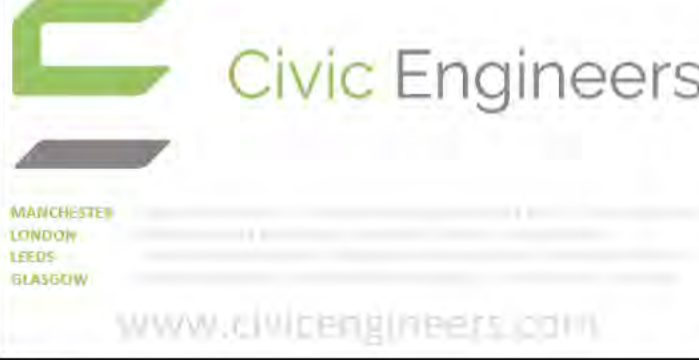
Project  
**HIGHLAND COUNCIL  
CHARLESTON ACADEMY**

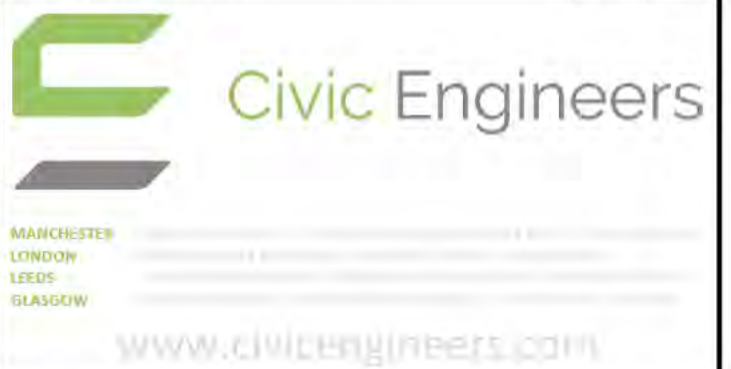
**Project**  
HIGHLAND COUNCIL  
CHARLESTON ACADEMY

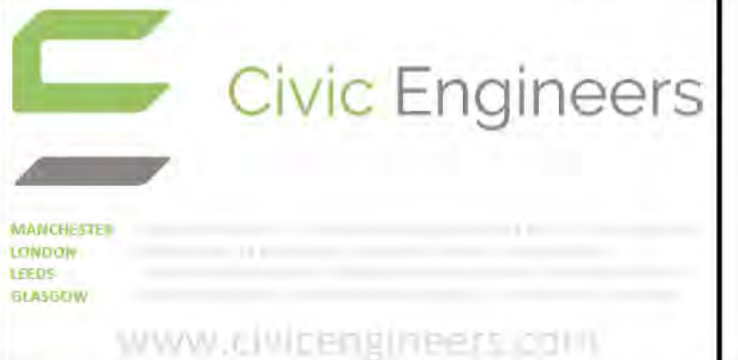
Project  
**HIGHLAND COUNCIL  
CHARLESTON ACADEMY**
