A890 Stromeferry Bypass

Annual Slope Inspection Report 2023

The Highland Council

11 July 2023

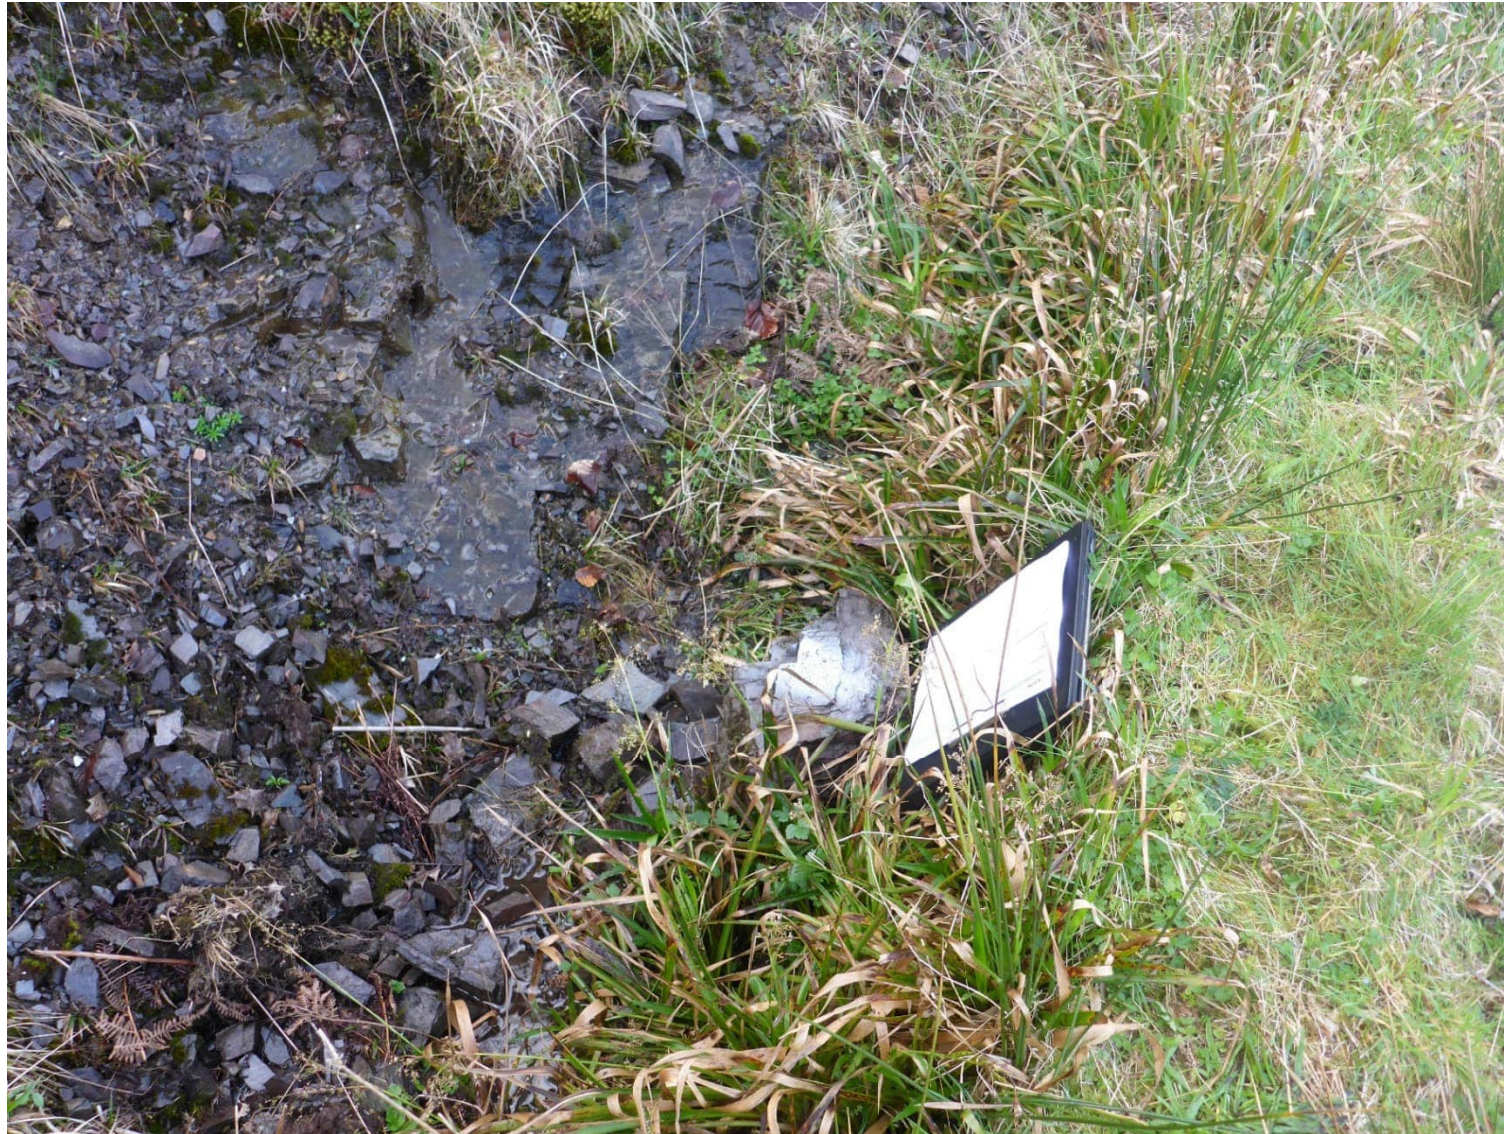
Photograph AA1-1

Year observation first noted: 2023

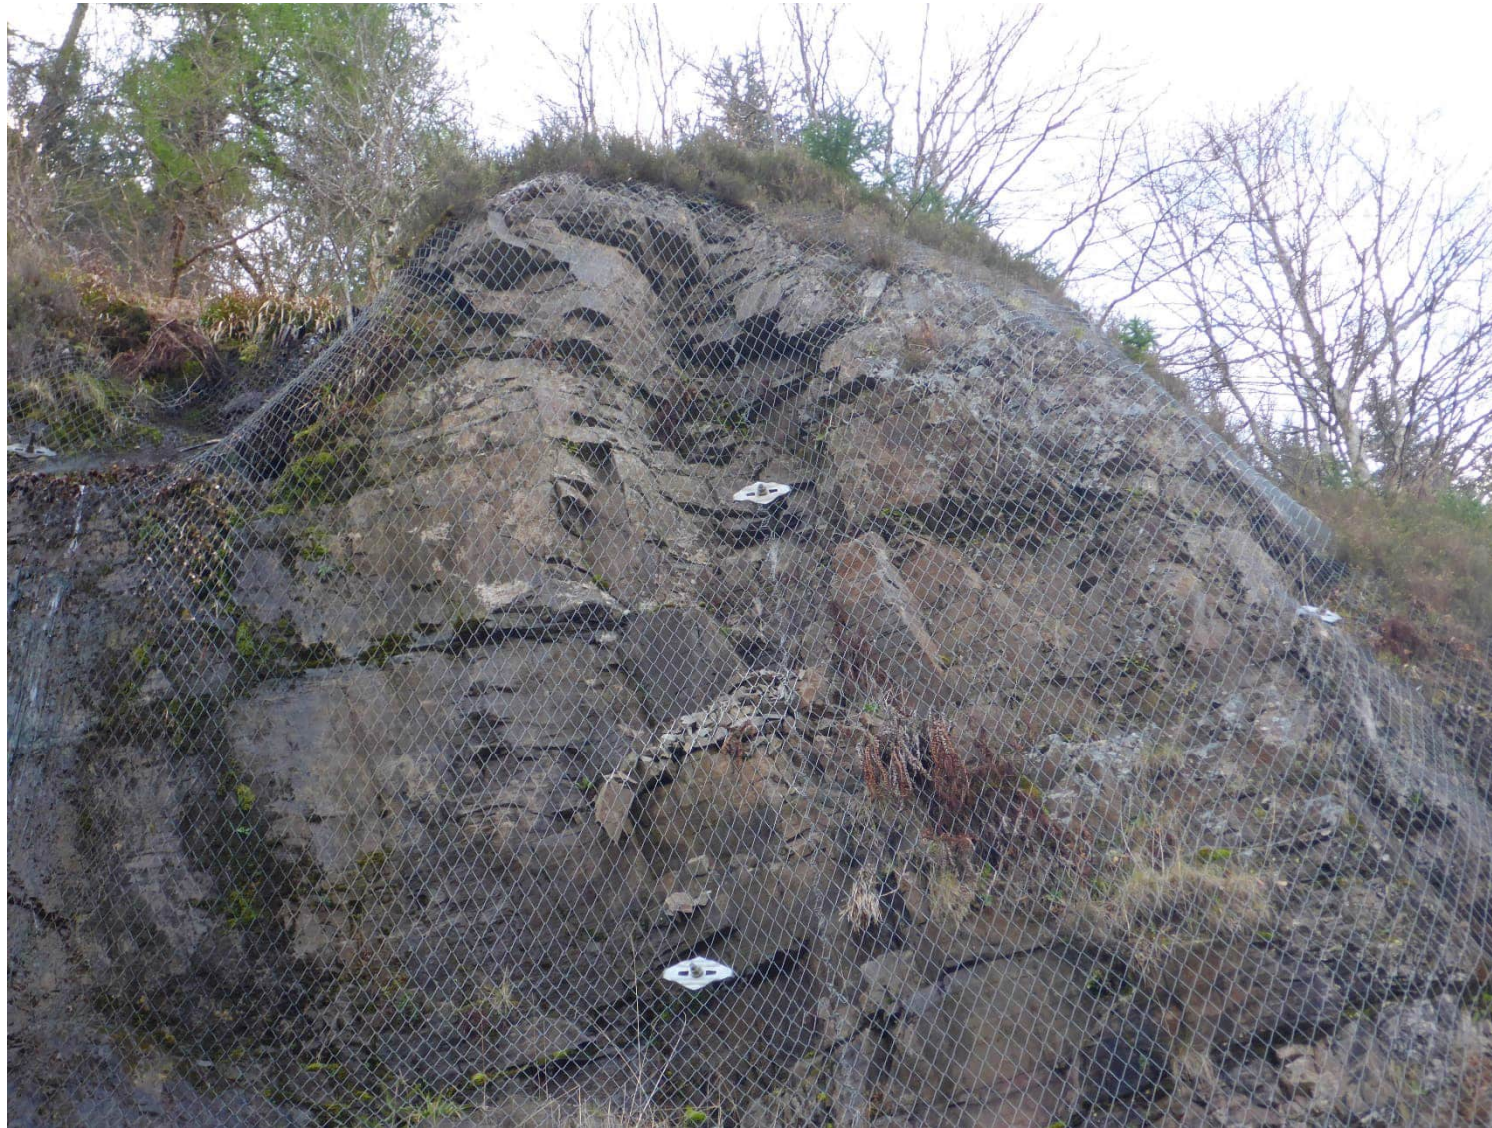
Photograph AA1-2

Year observation first noted: 2021

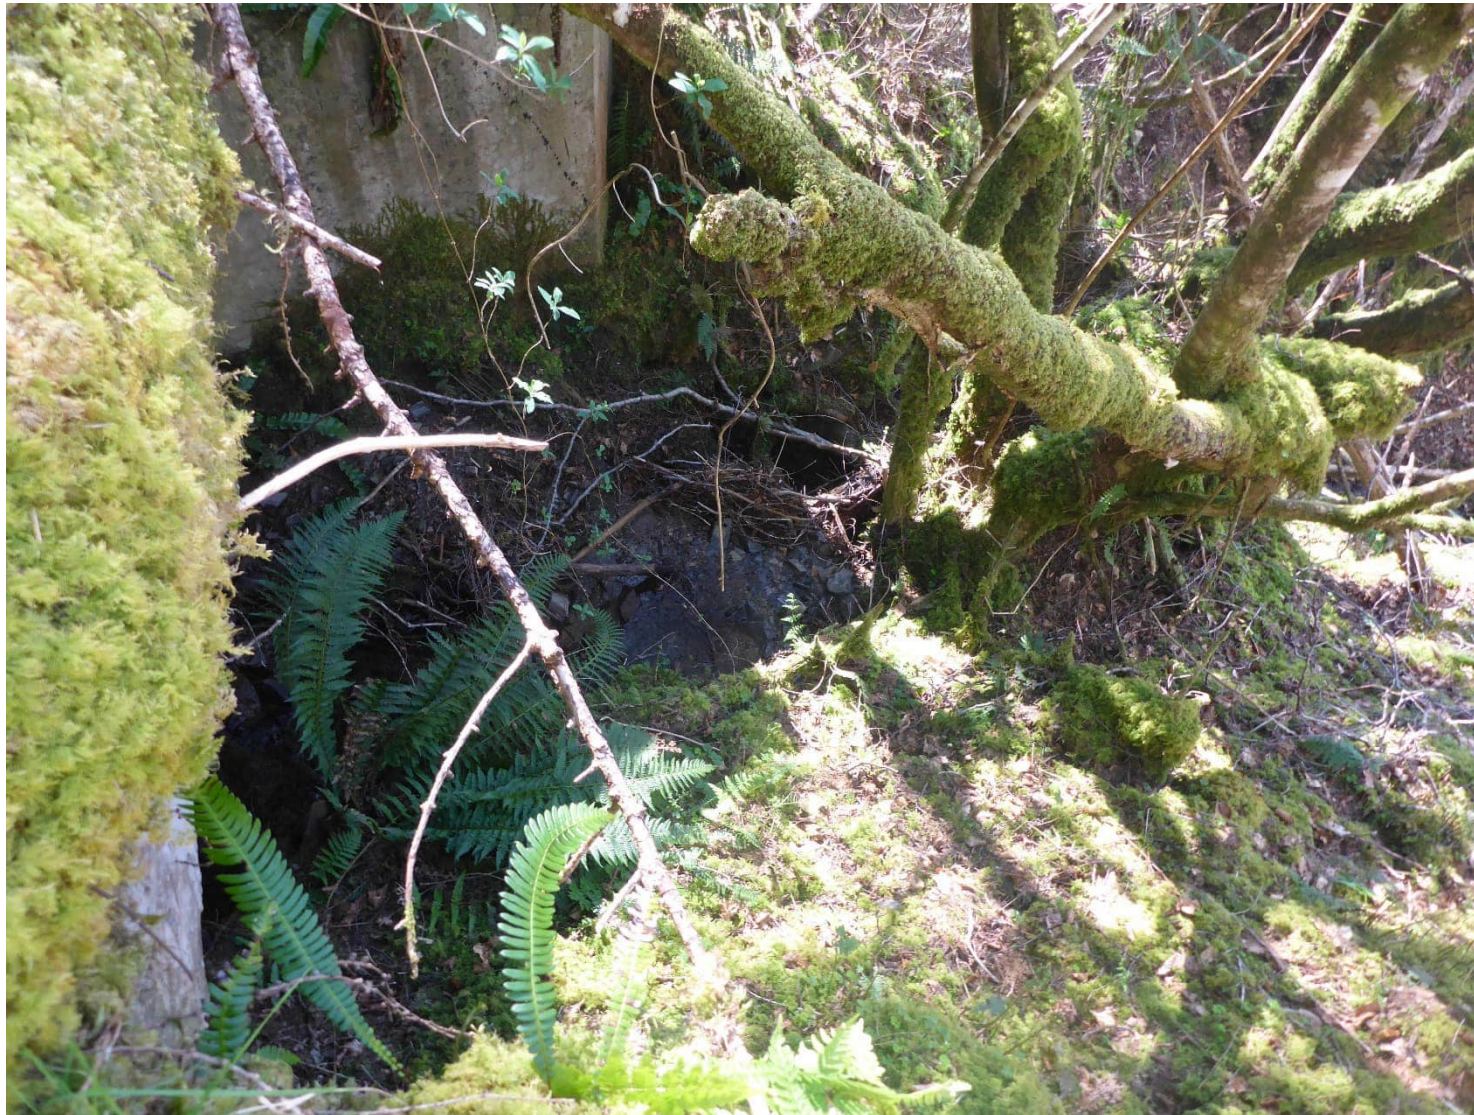
Photograph AA1-3

Year observation first noted: 2023

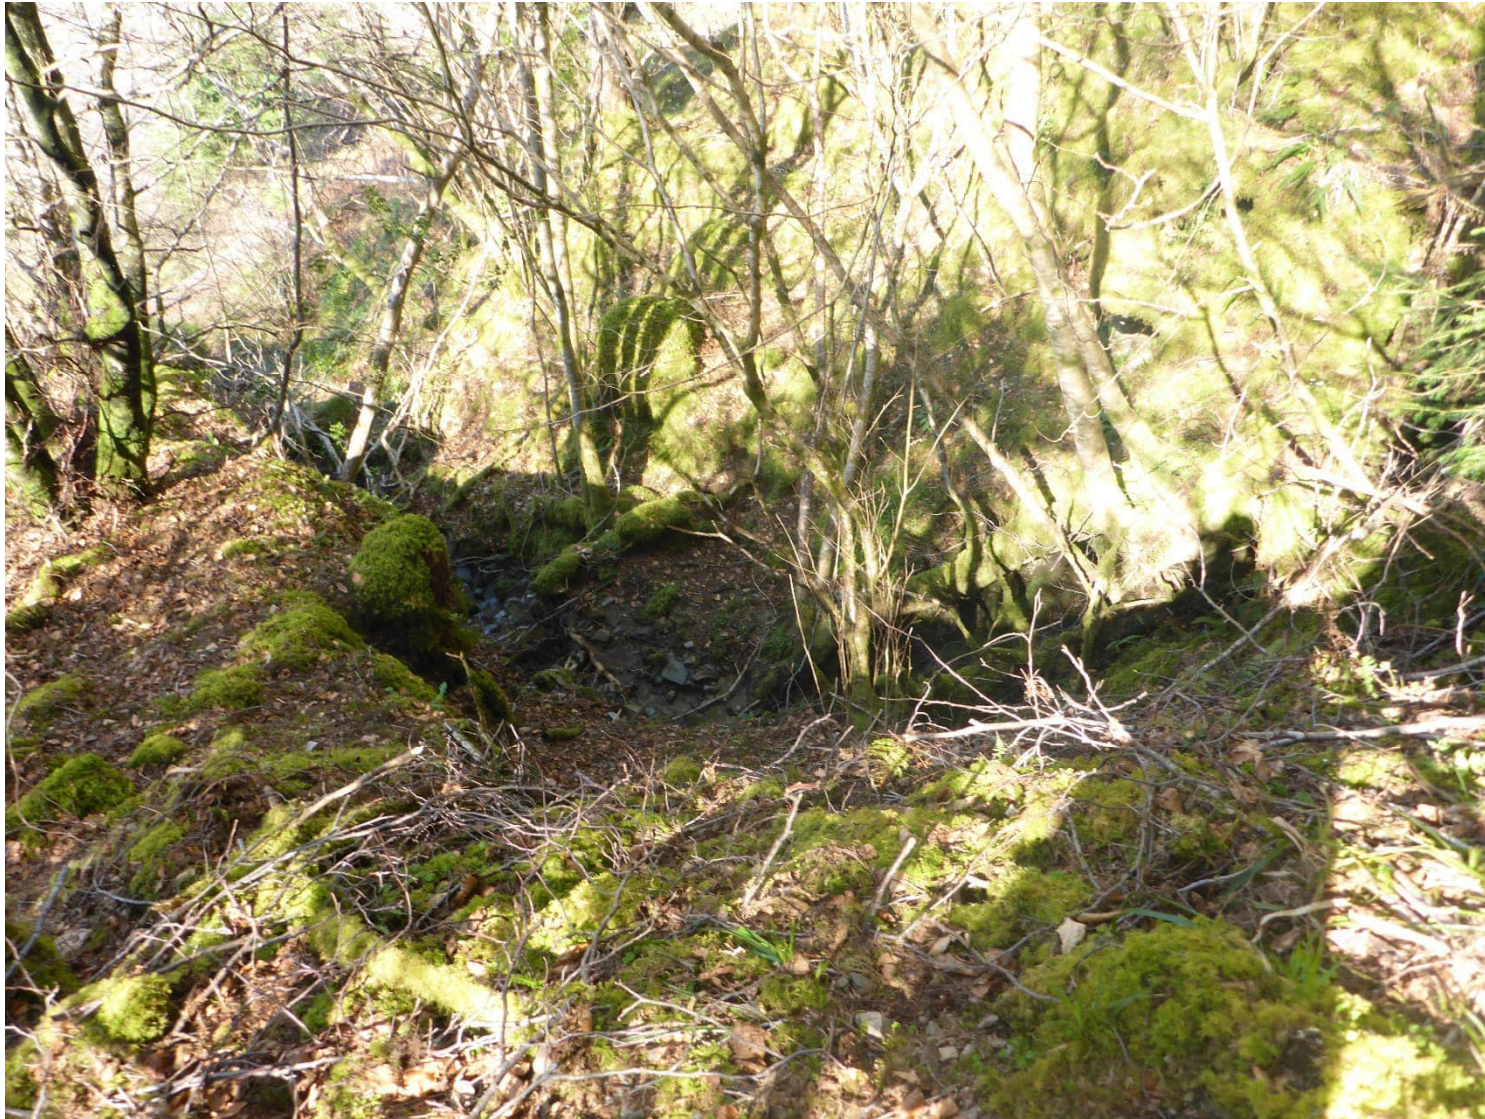
Photograph AA1-4

Year observation first noted: 2023

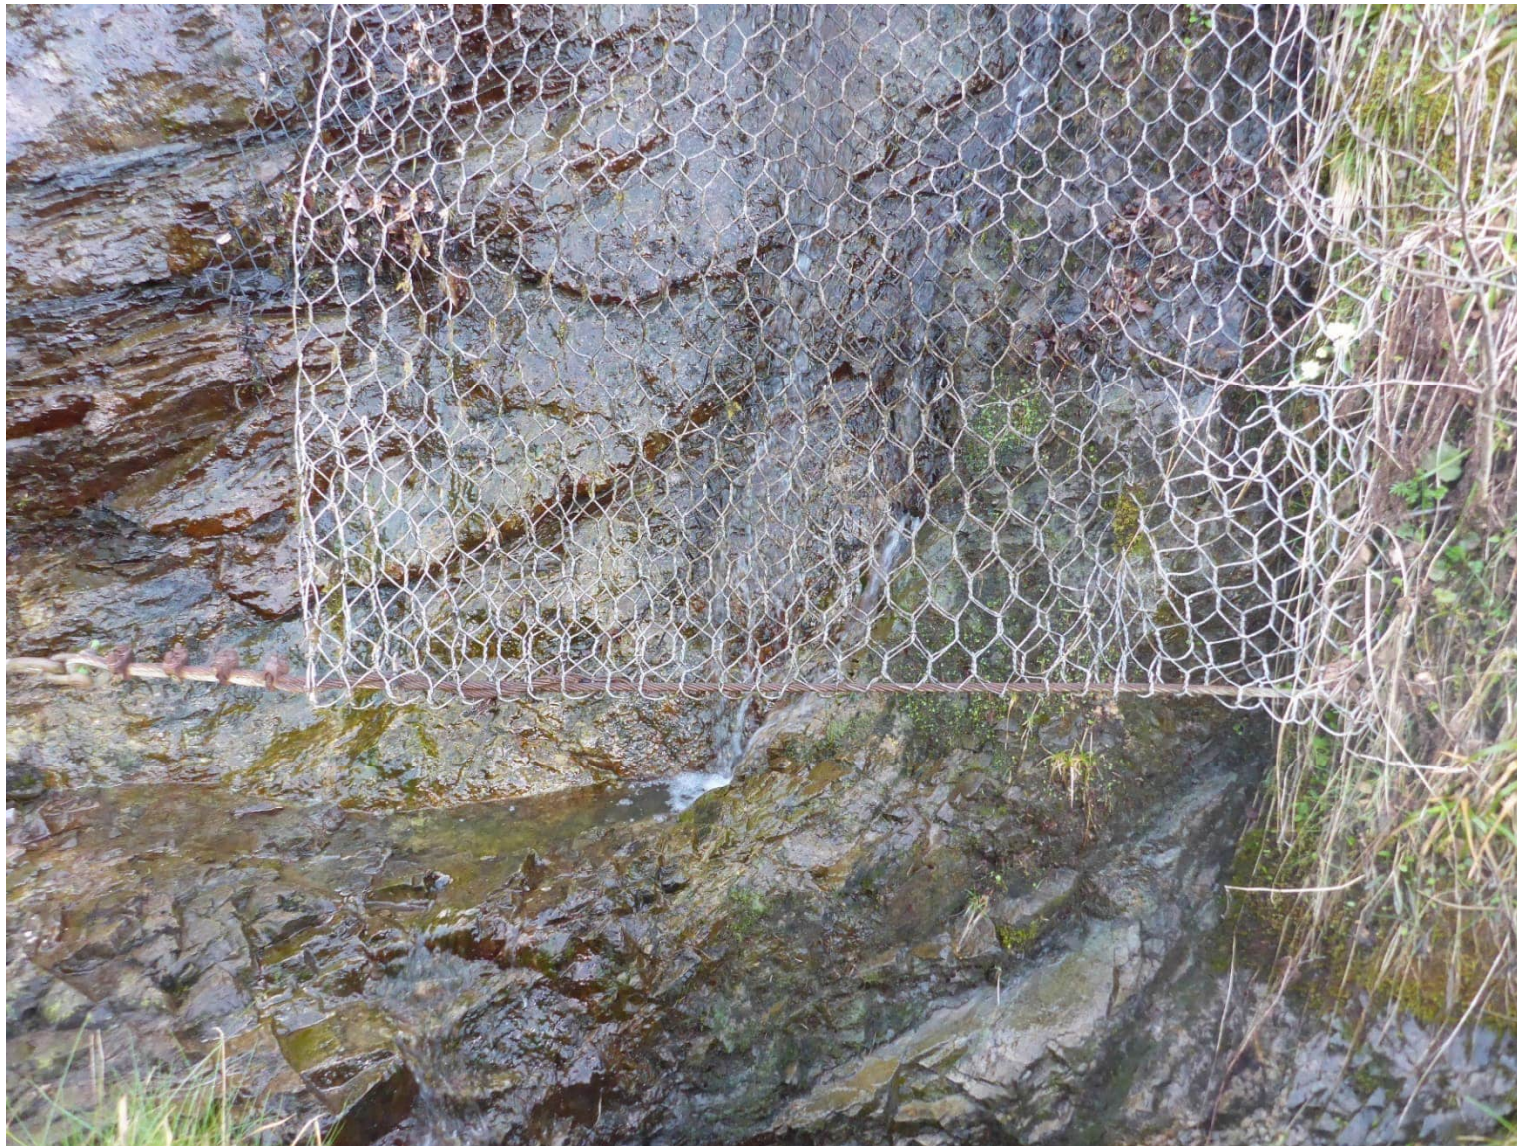
Photograph AA2-1

Year observation first noted: 2021

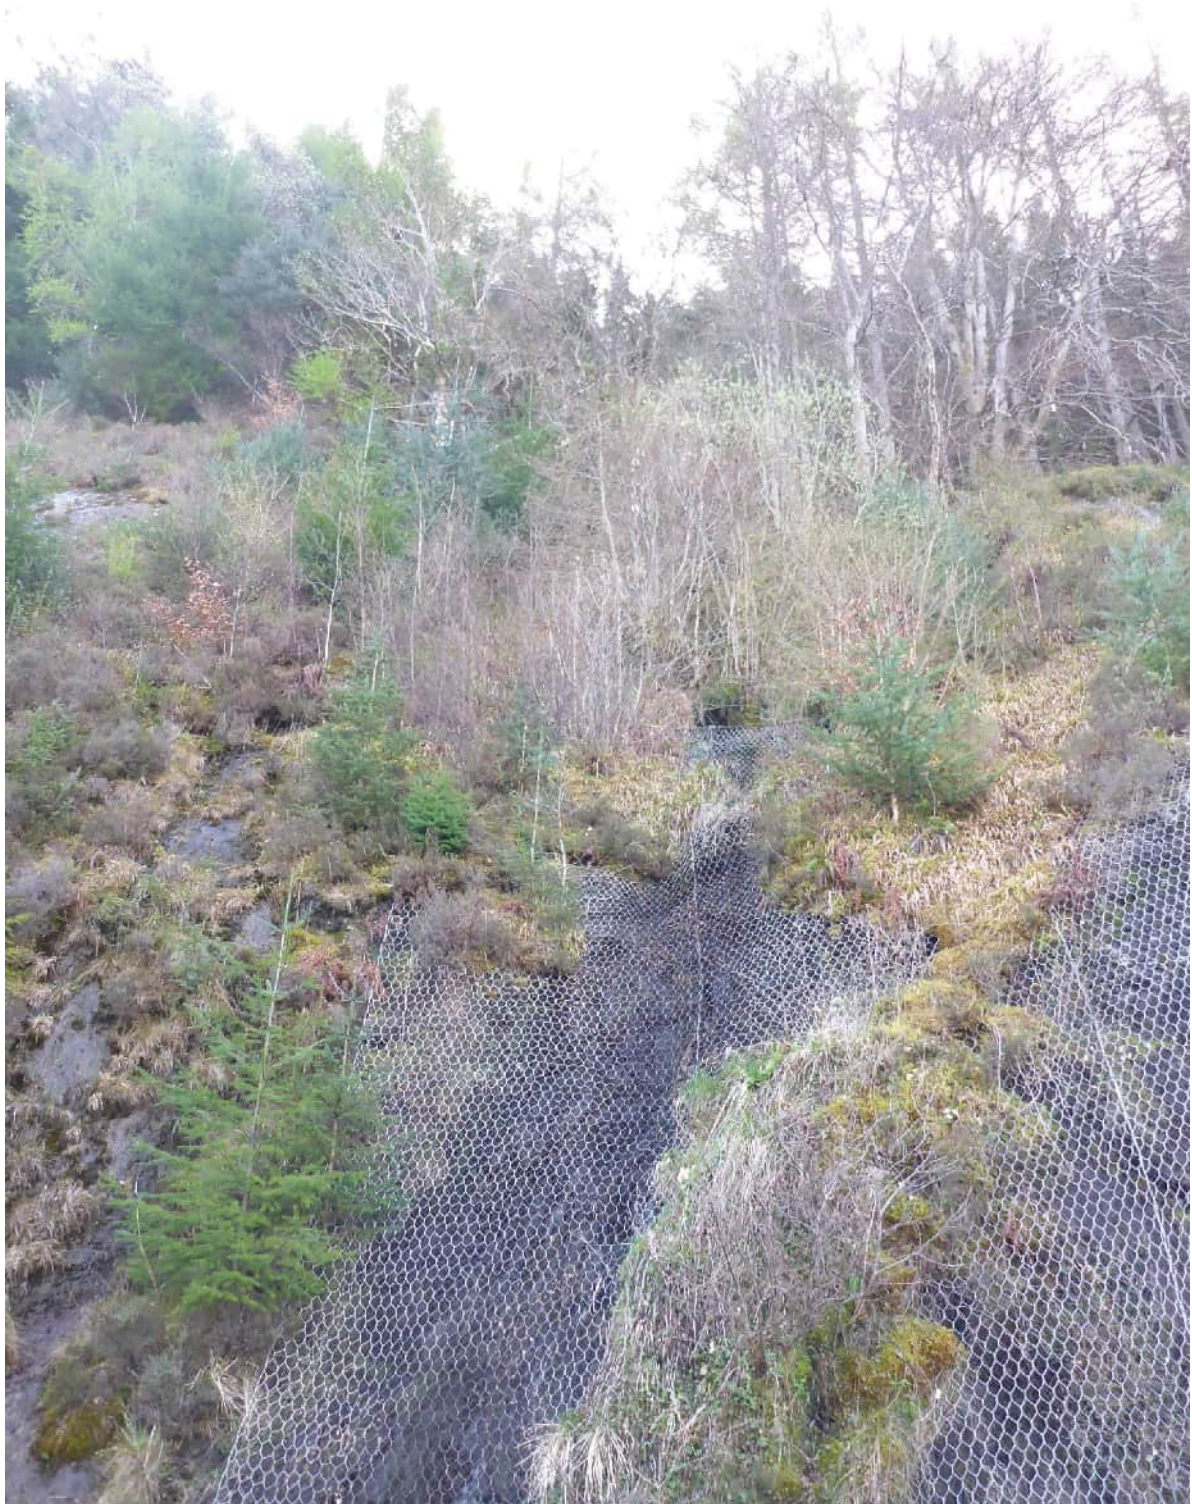
Photograph AA2-2	Trees at eastern edge of gully at crest of rock face are overhanging and at risk of falling and dislodging blocks.	Year observation first noted: 2016
------------------	--	------------------------------------

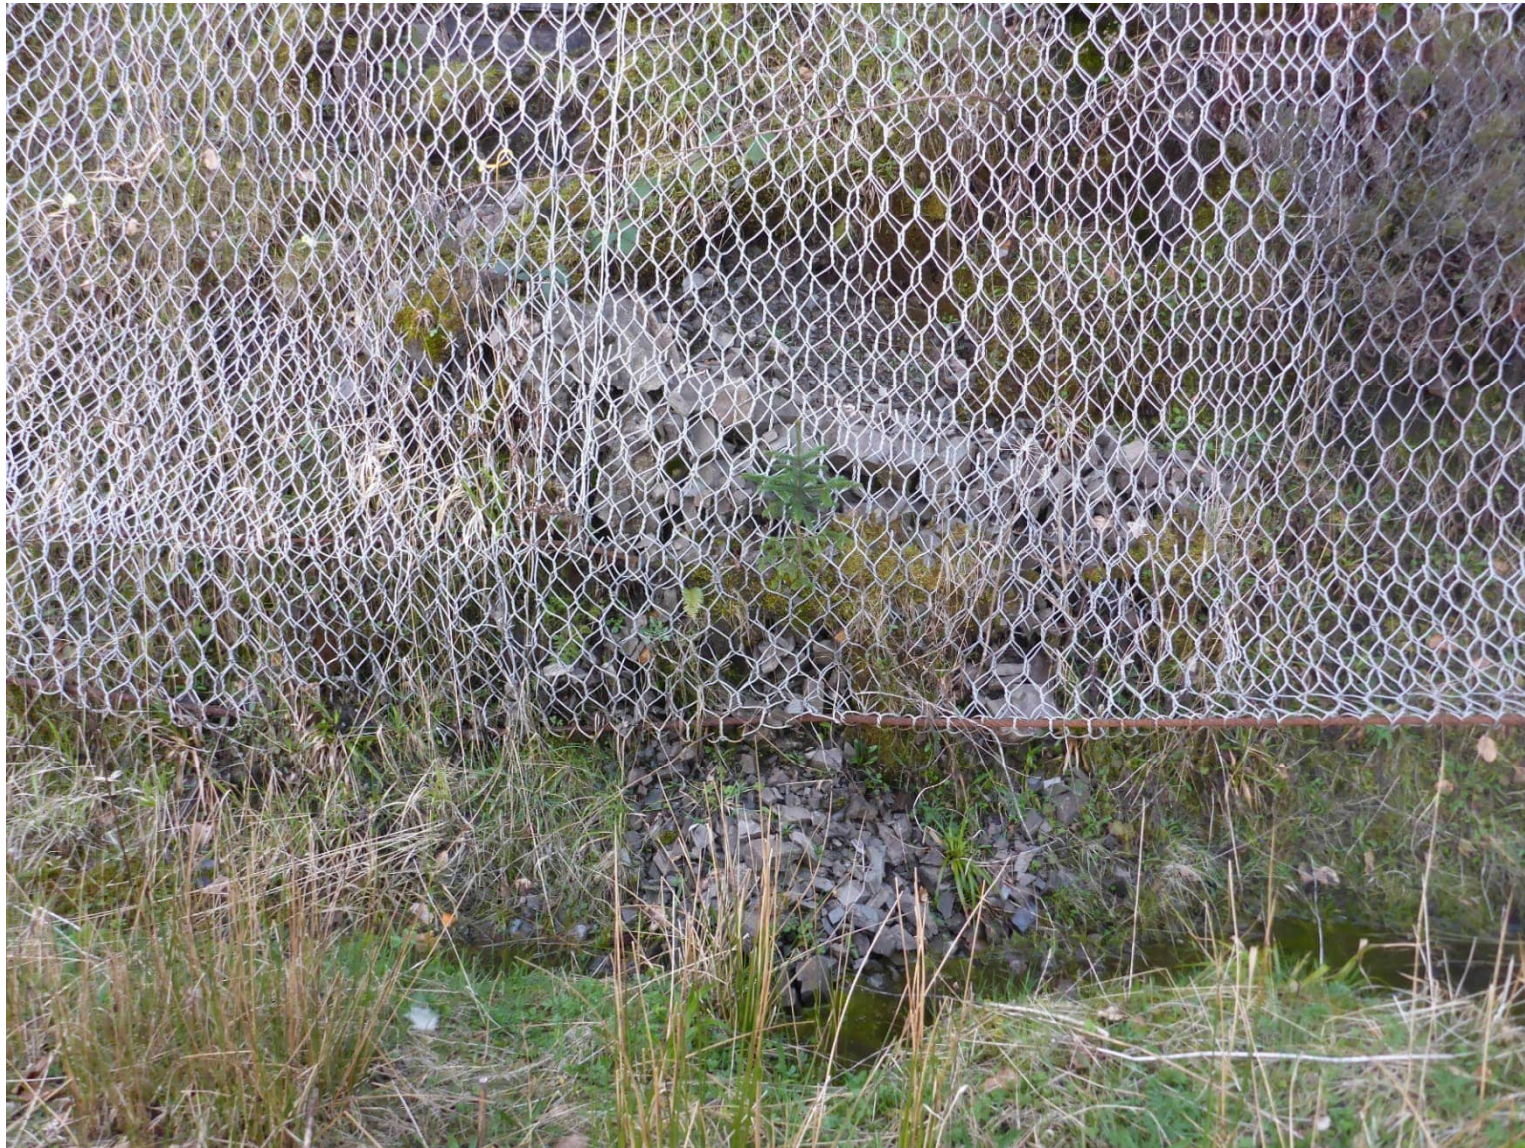
Photograph AA2-3

Year observation first noted: 2021

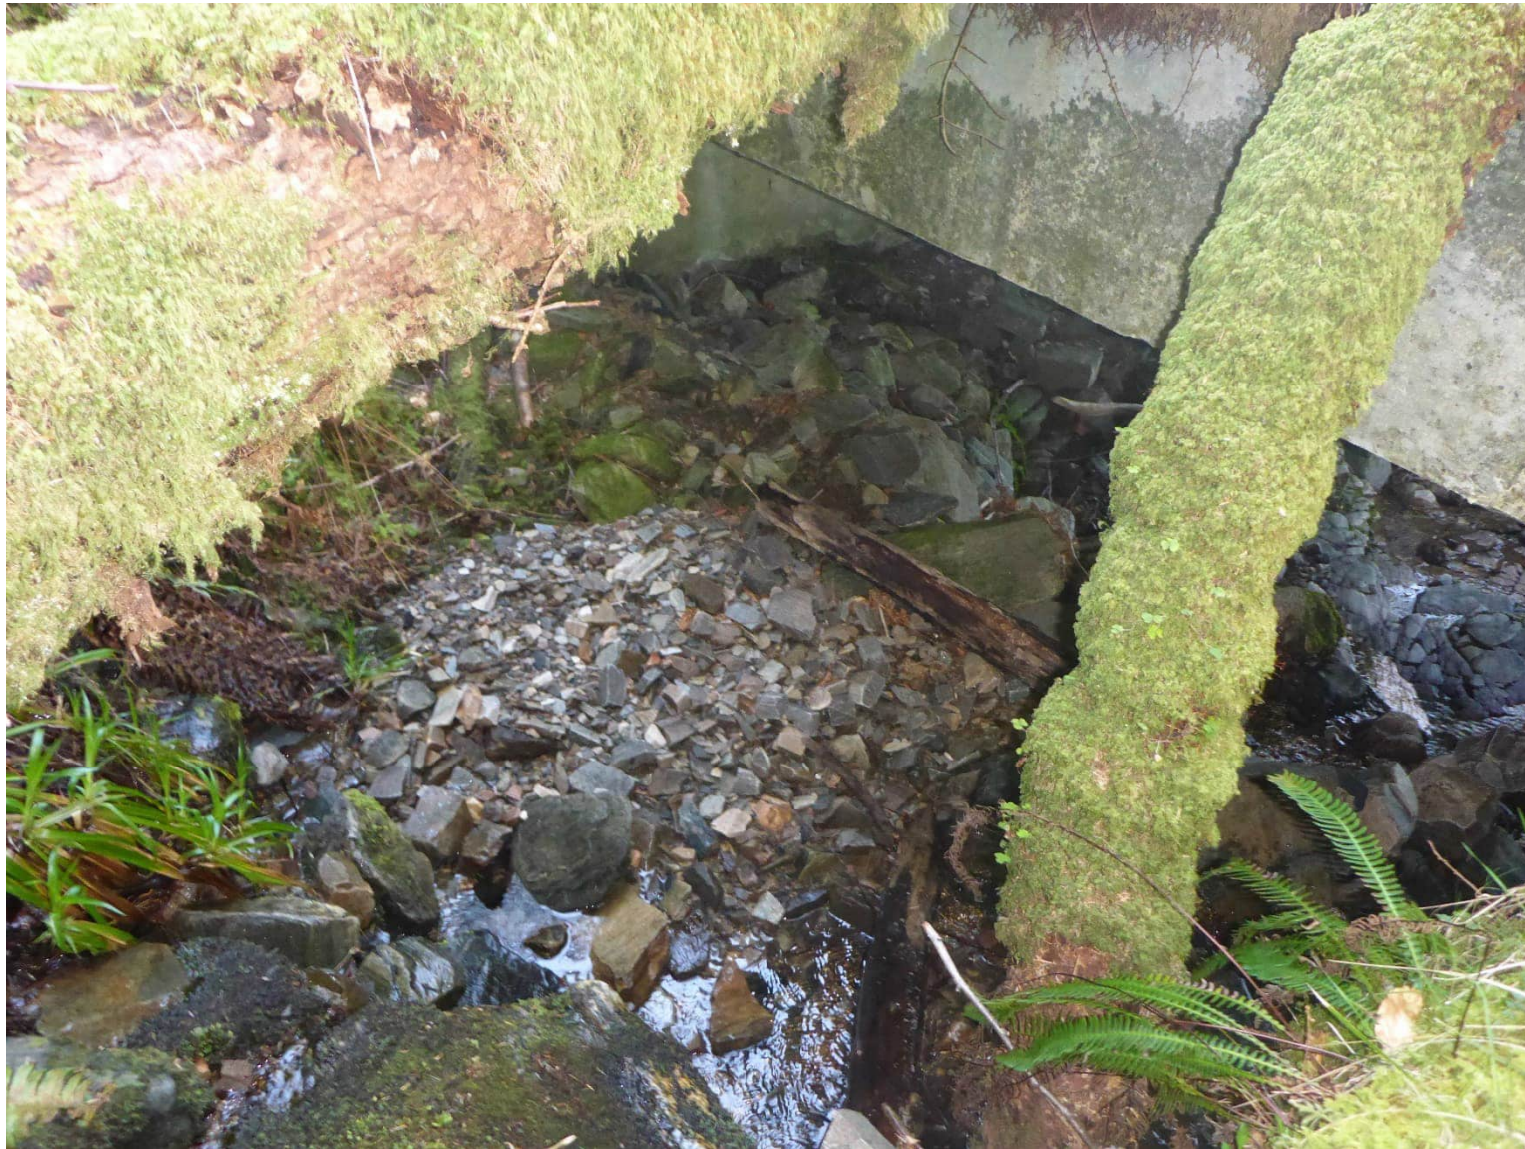
Photograph AA2-4

Year observation first noted: 2023

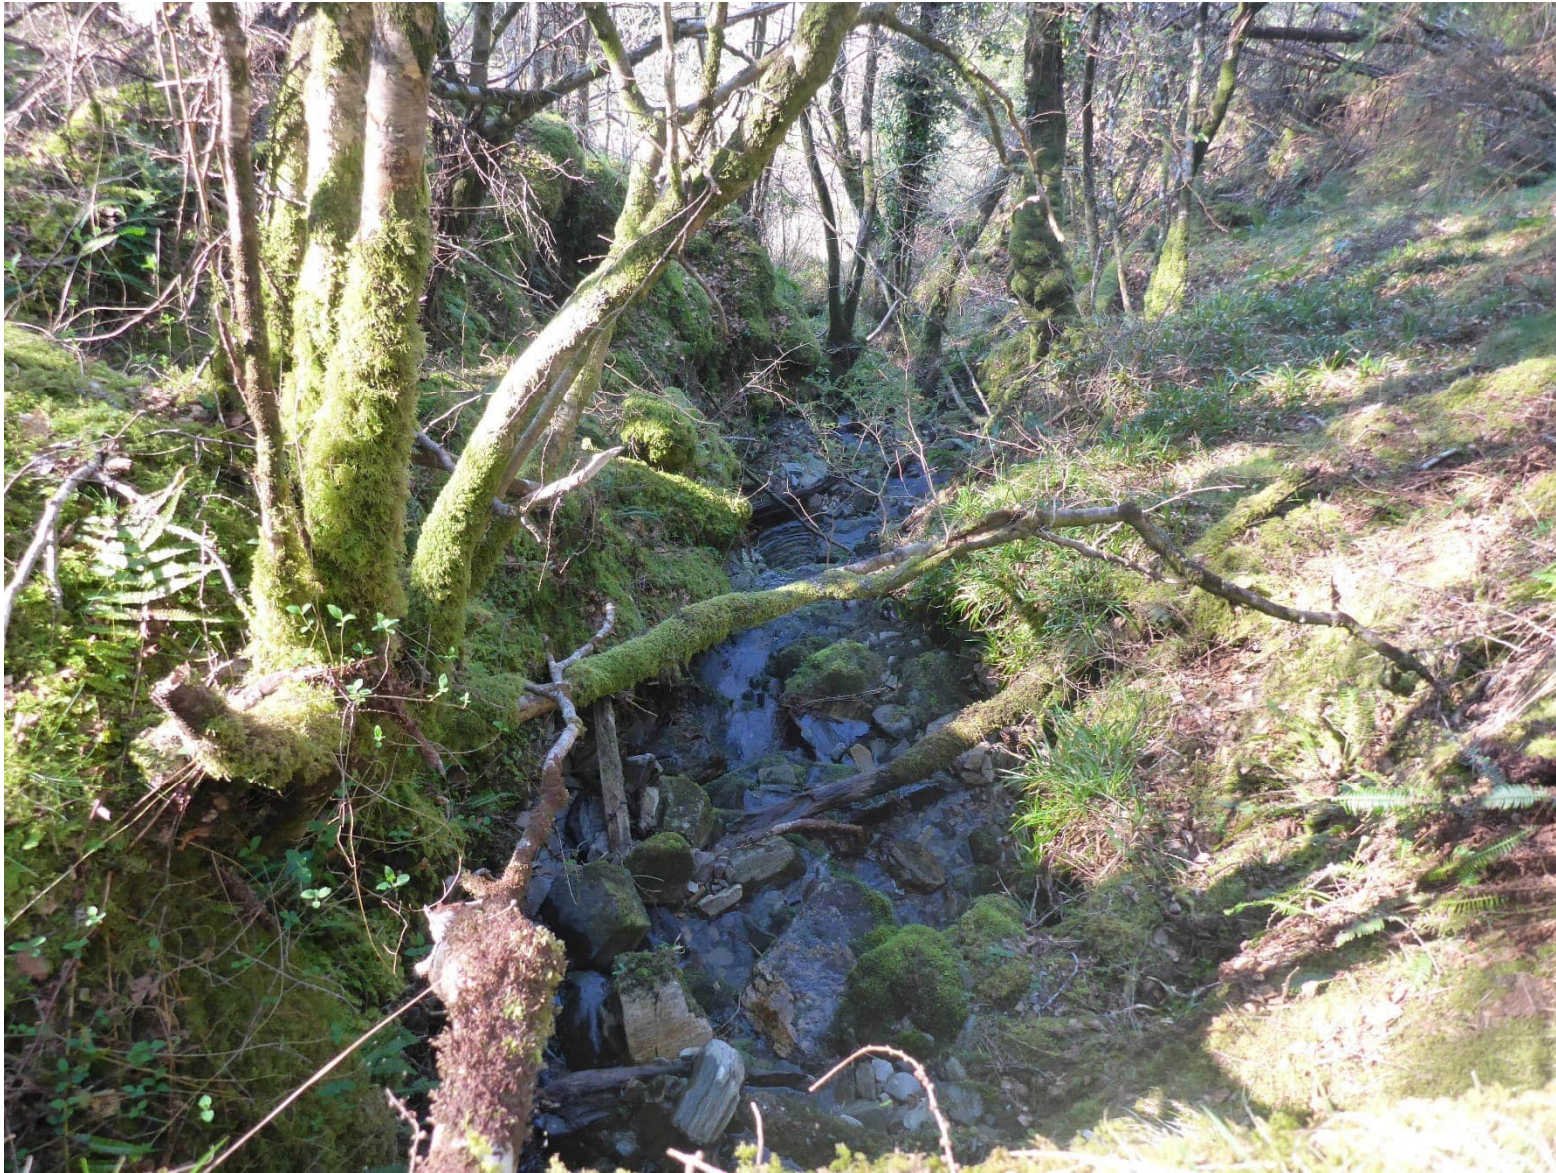
Photograph AA2-5

Year observation first noted: 2023

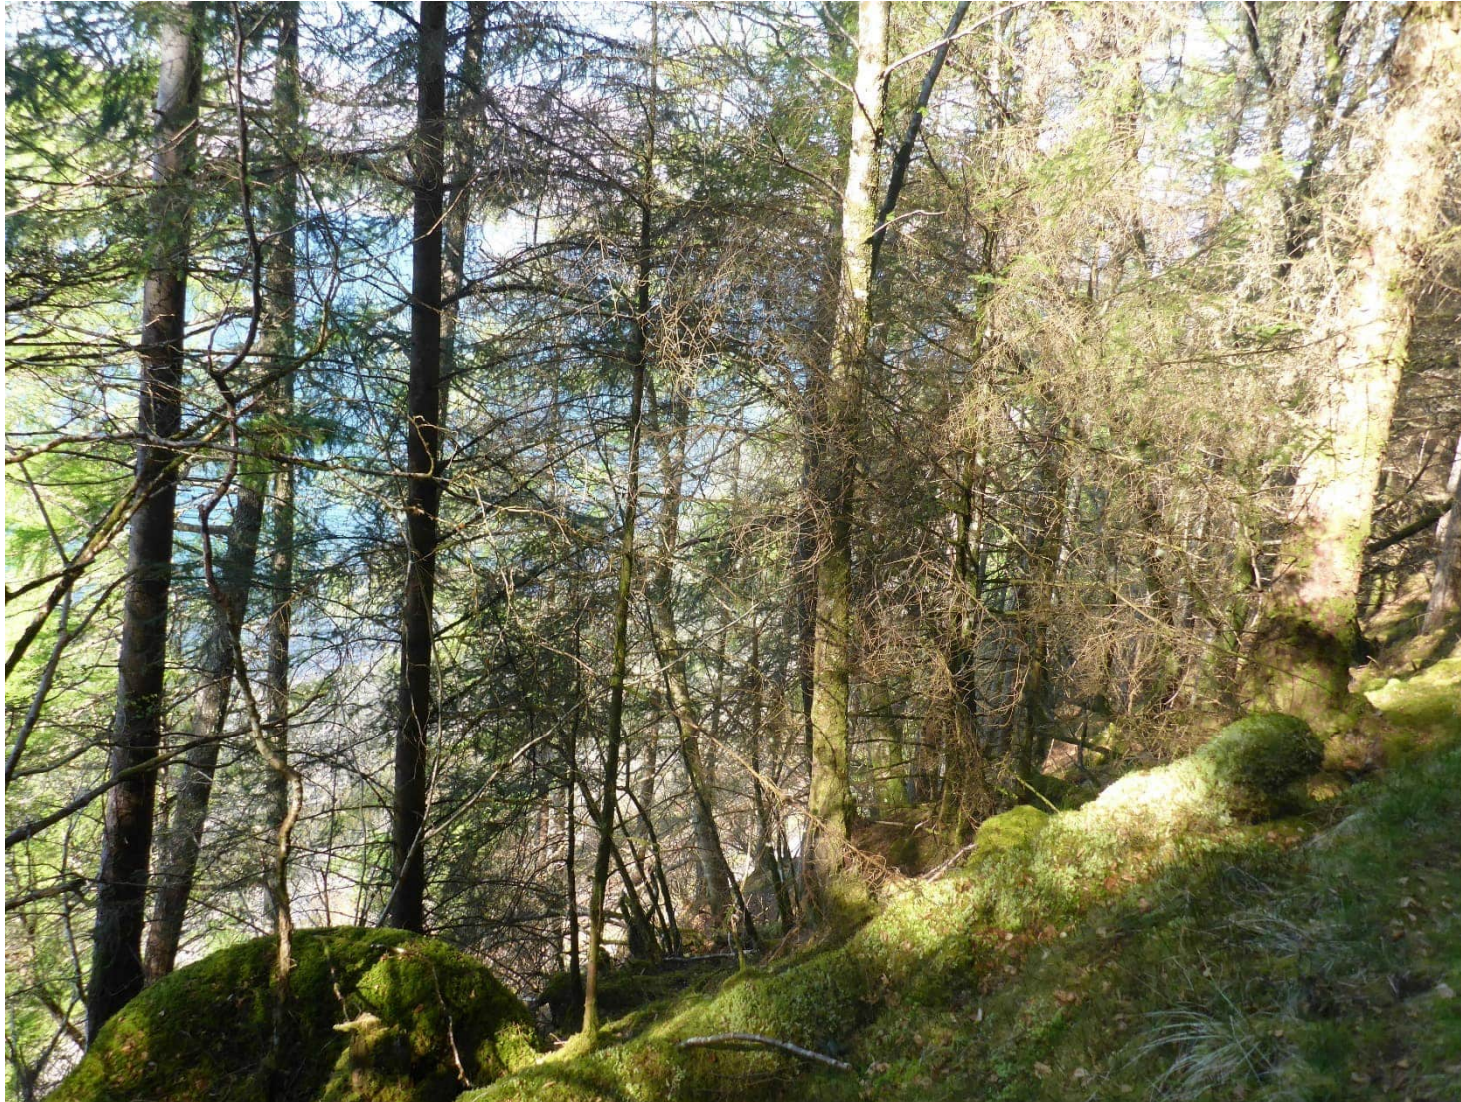
Photograph AA2-6

Year observation first noted: 2023

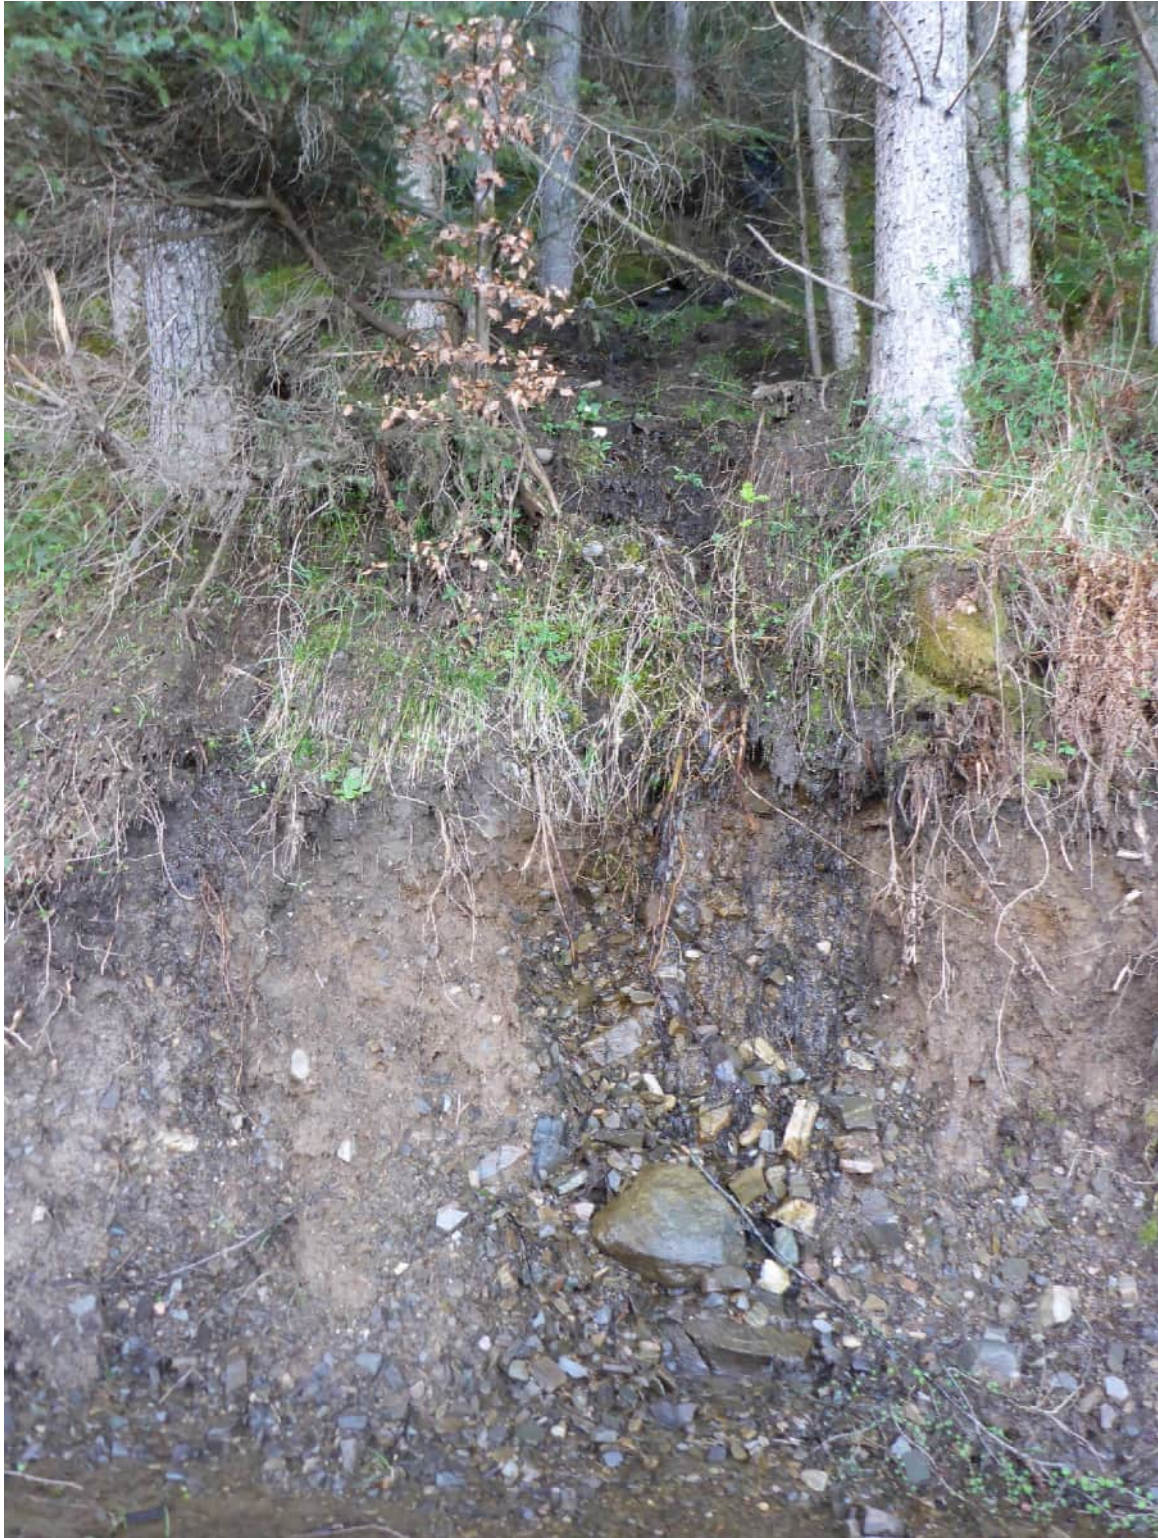
Photograph AA2A-1	At Ch. 425 – Location of soil wash-out which occurred in February 2023.	Year observation first noted: 2023
-------------------	---	------------------------------------

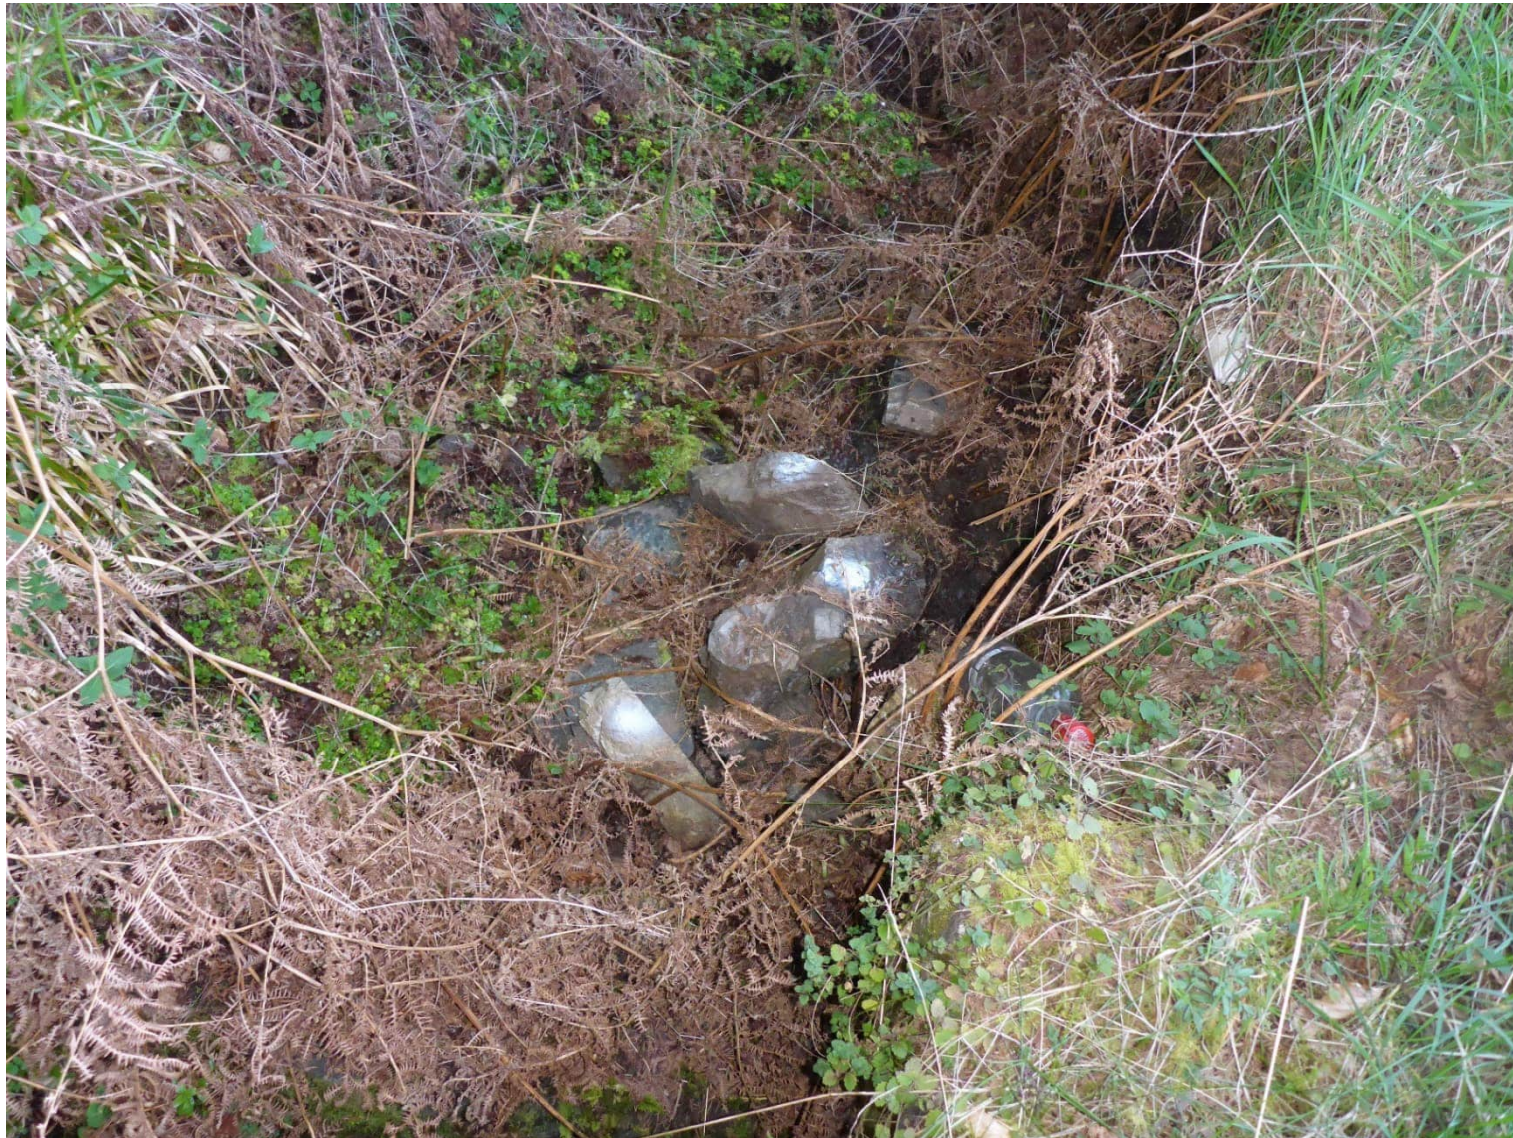
Photograph AA2A-2

Year observation first noted: 2023

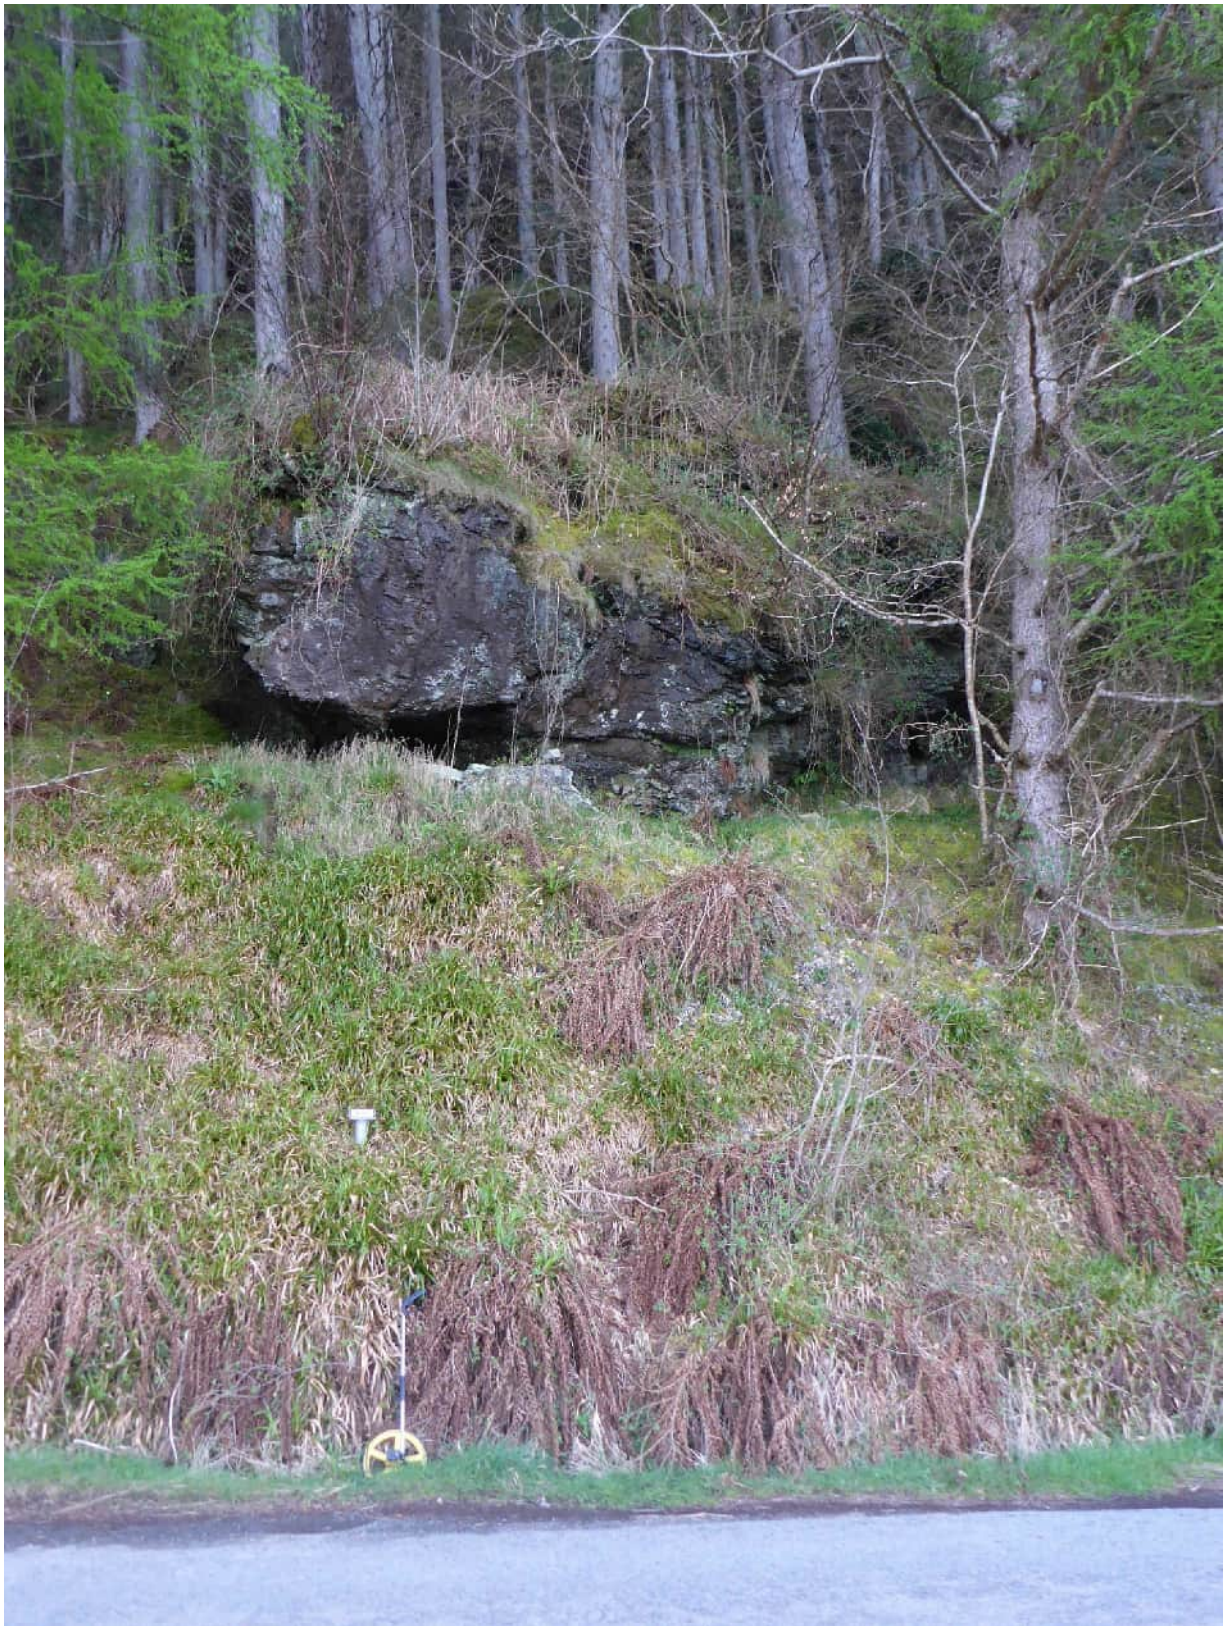
Photograph AA2A-3	At Ch. 400 - Large overhanging boulder 5m above road level	Year observation first noted: 2016
-------------------	--	------------------------------------
