A890 Stromeferry Bypass

Annual Slope Inspection Report 2023

The Highland Council

11 July 2023

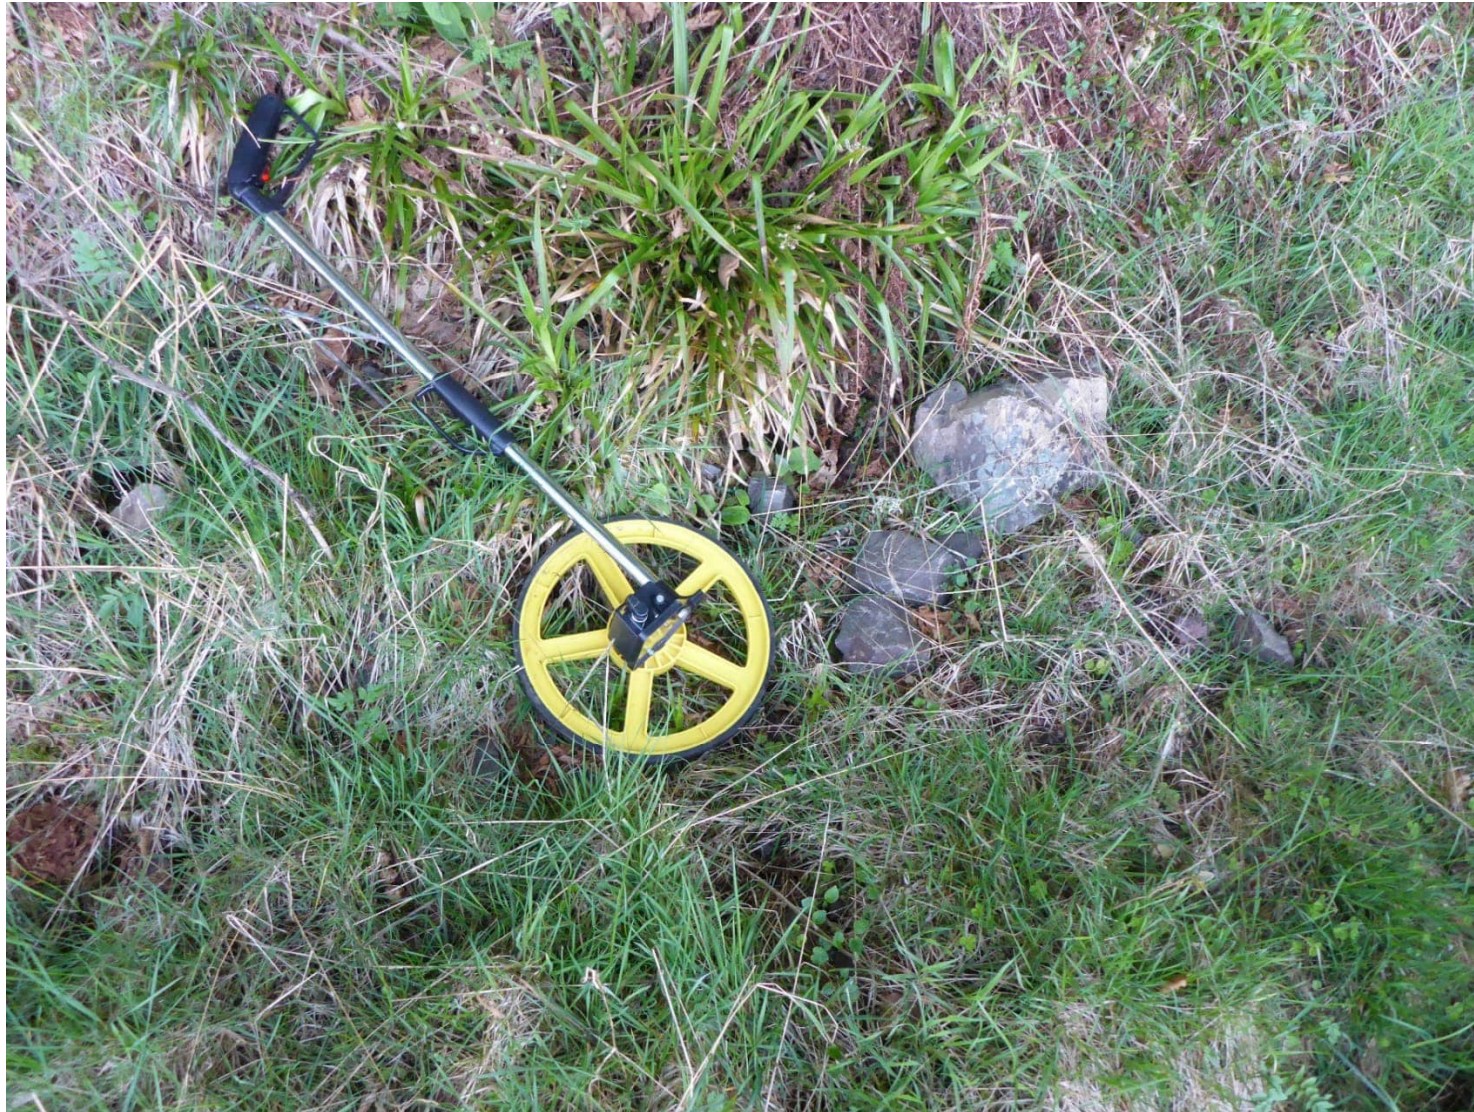
Photograph AA2A-4

Year observation first noted: 2021

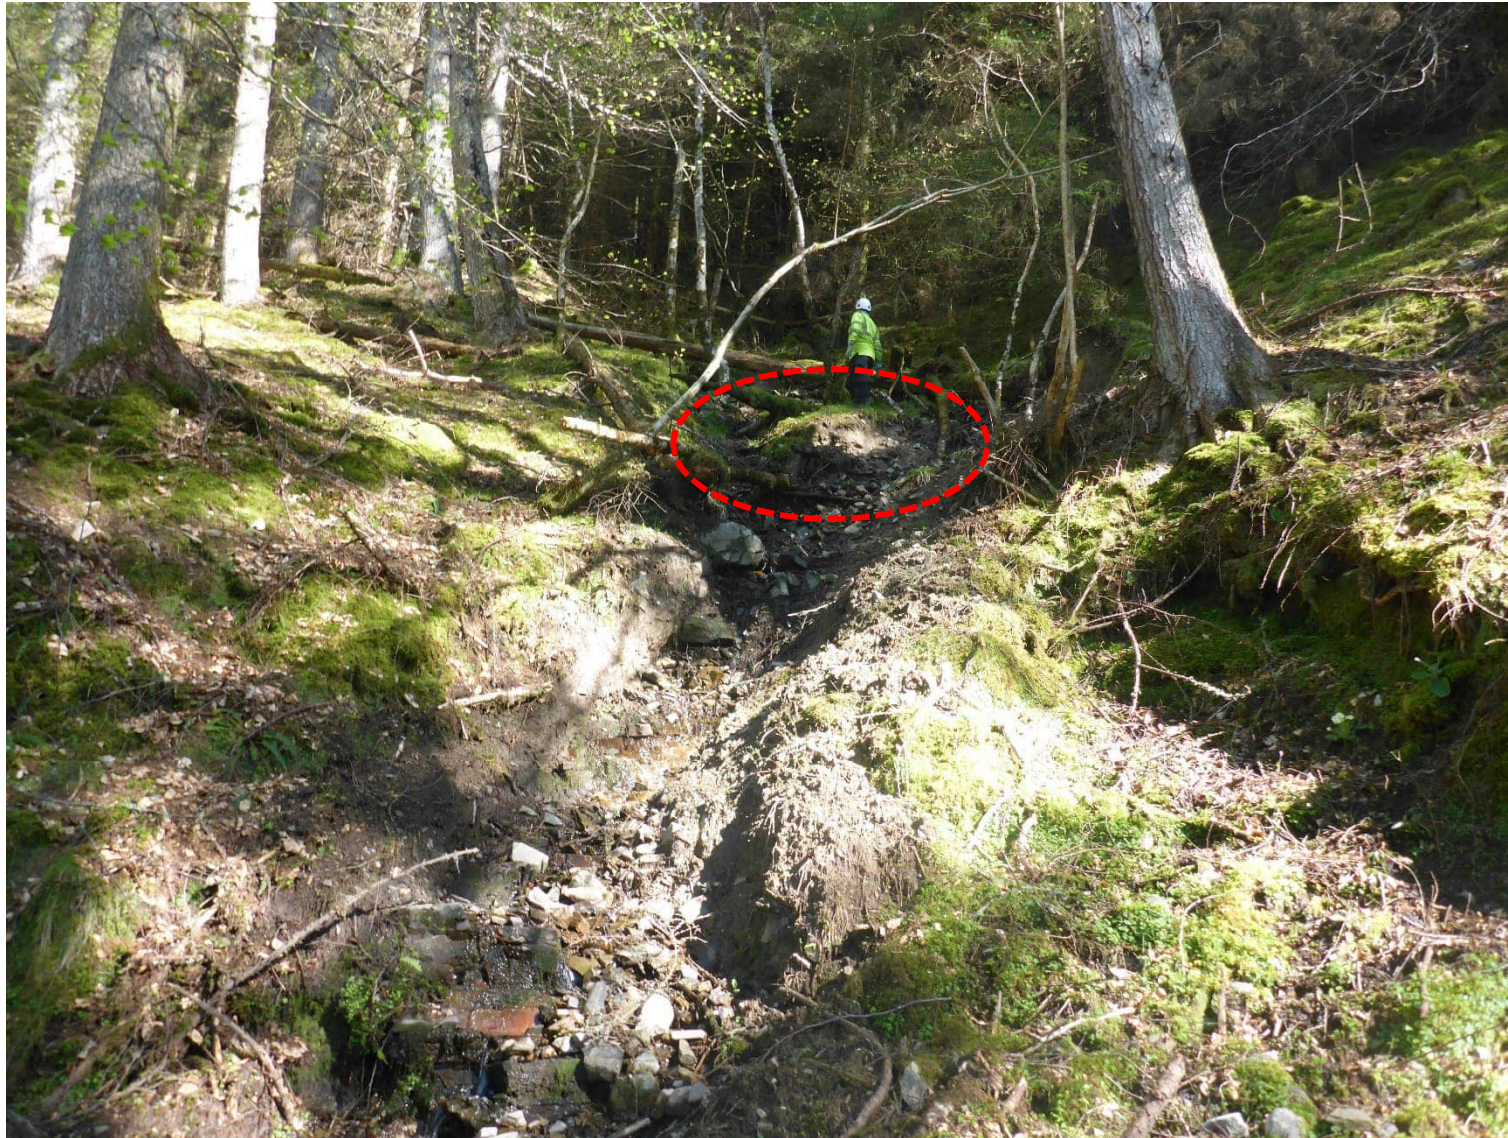
Photograph AA2A-5

Year observation first noted: 2023

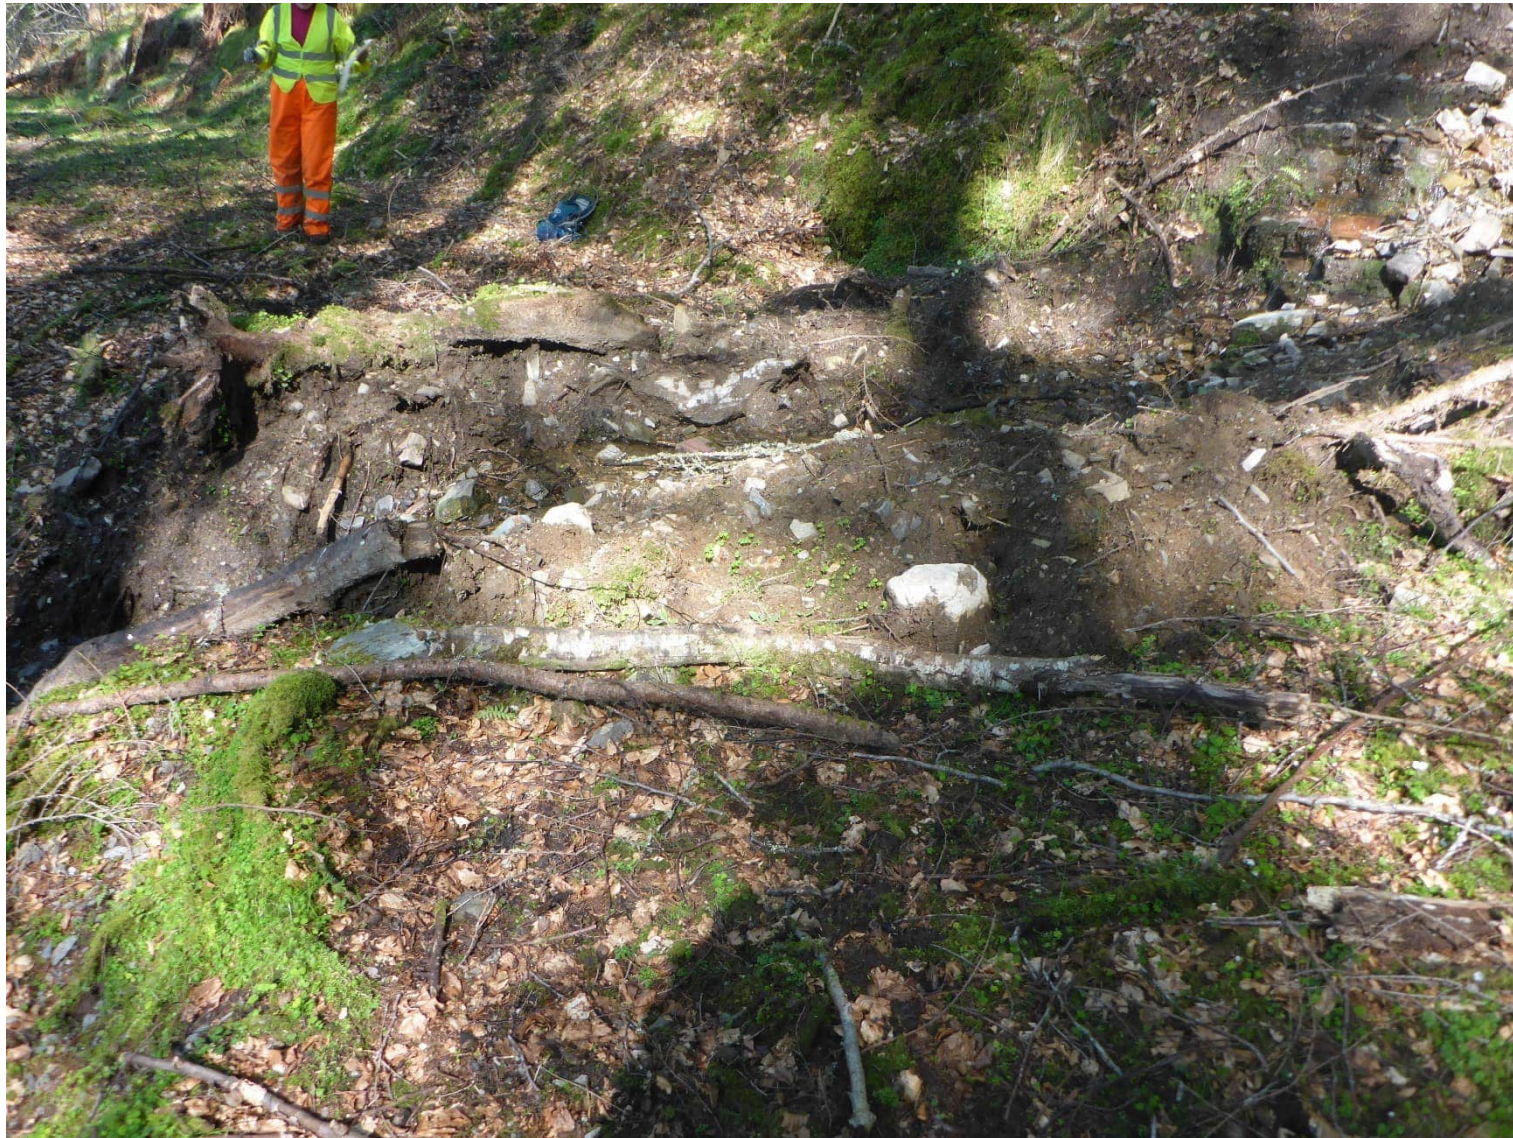
Photograph AA2A-6

Year observation first noted: 2023

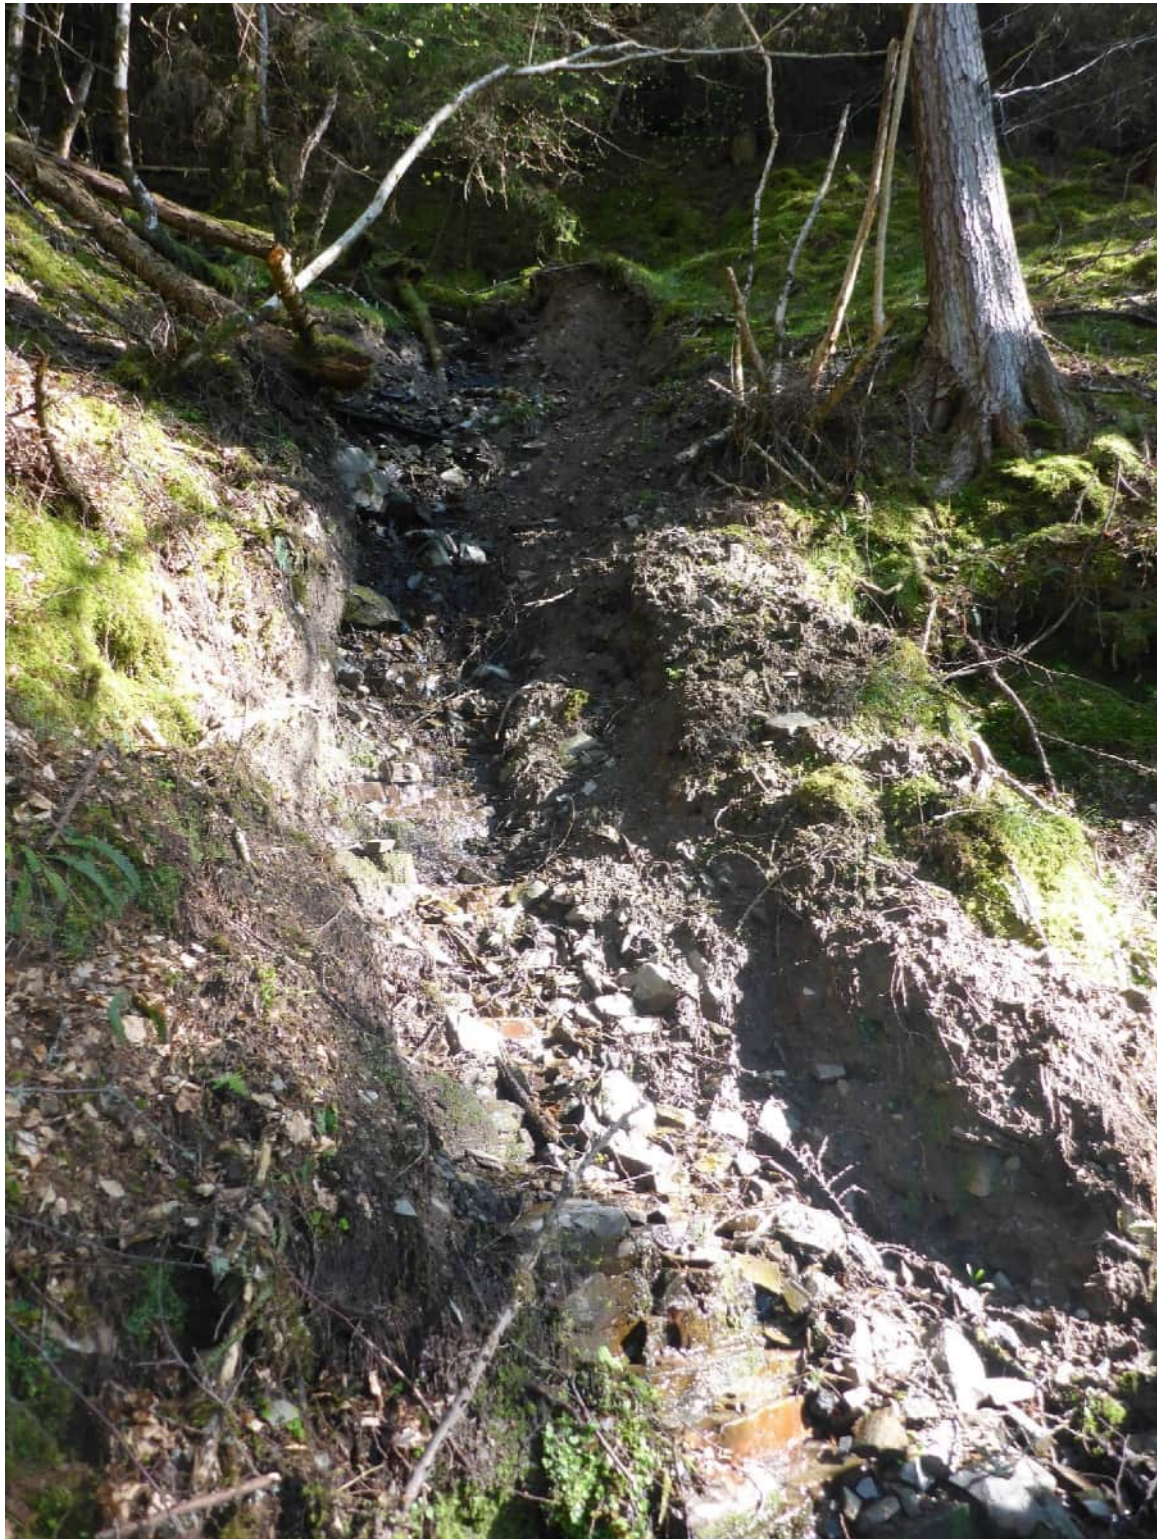
Photograph AA2A-7	Above AA2A – Downslope of source area, the channel has been stripped down to bedrock.	Year observation first noted: 2023
-------------------	---	------------------------------------

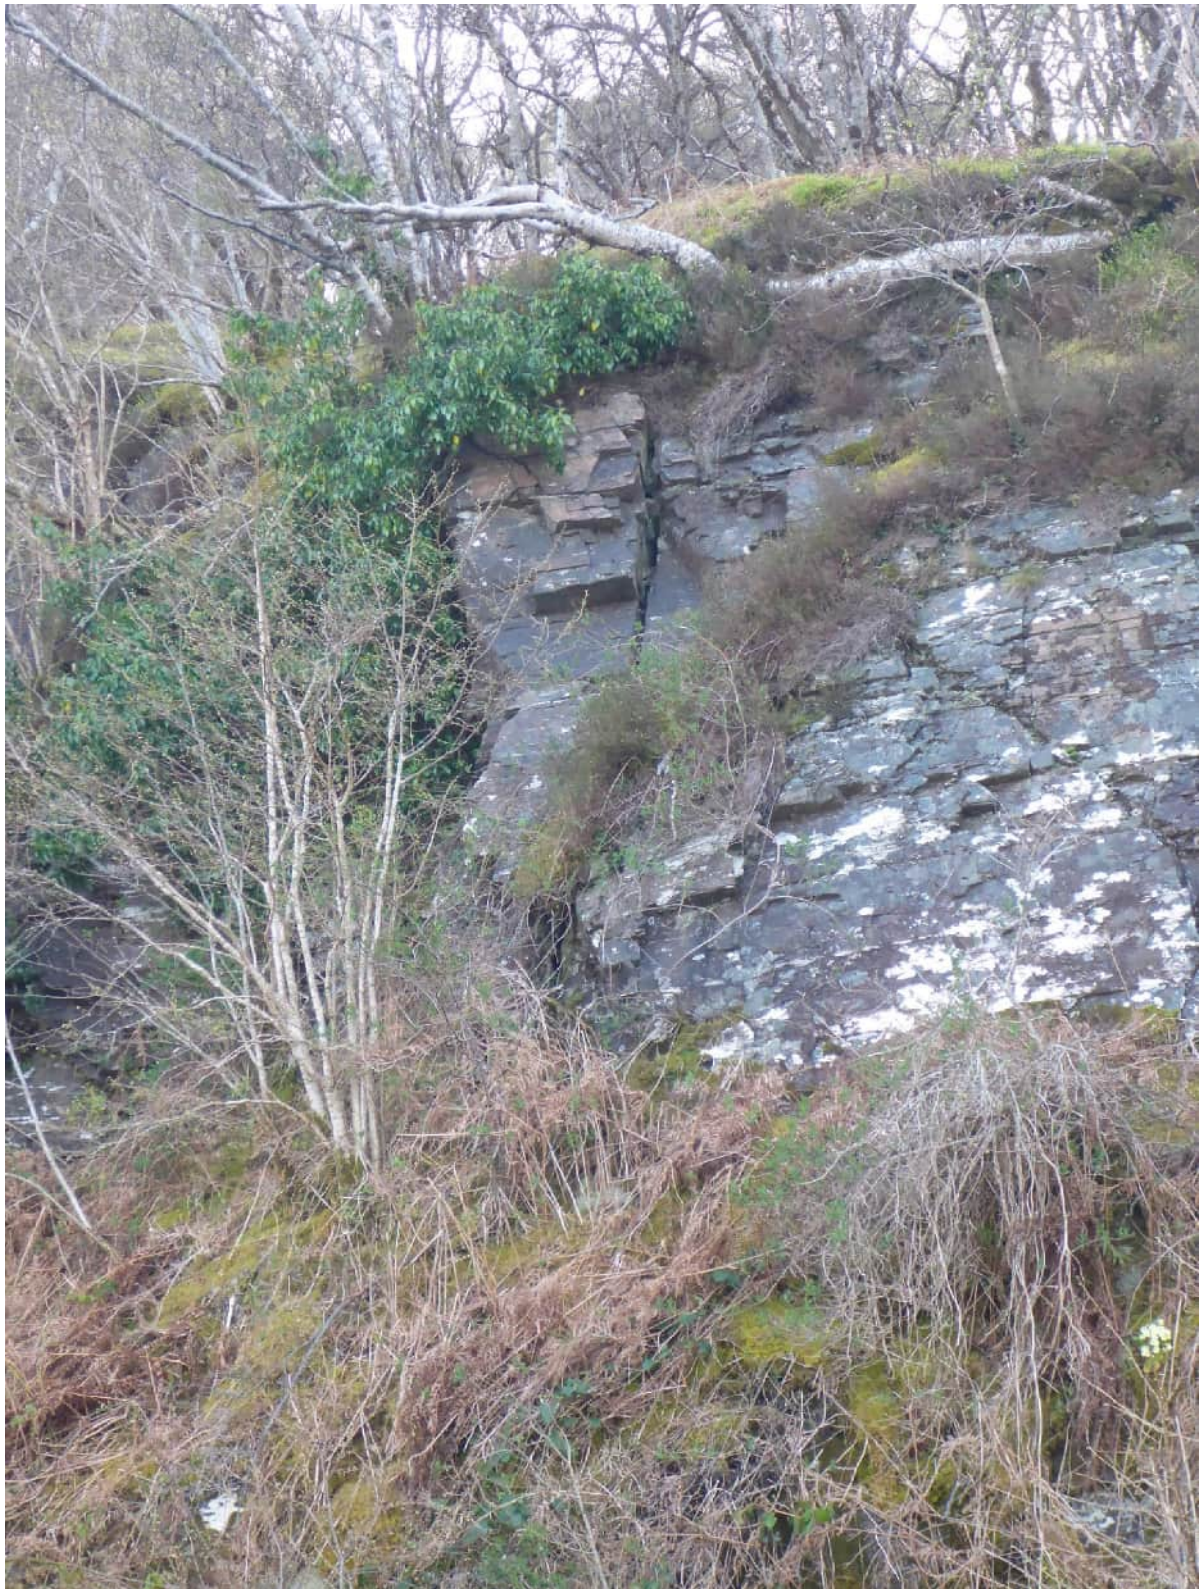
Photograph AA3-1	At Ch. 575 - Potential for toppling/block fall up to 2m ³ originating from 5-8m above road level	Year observation first noted: 2016
------------------	---	------------------------------------

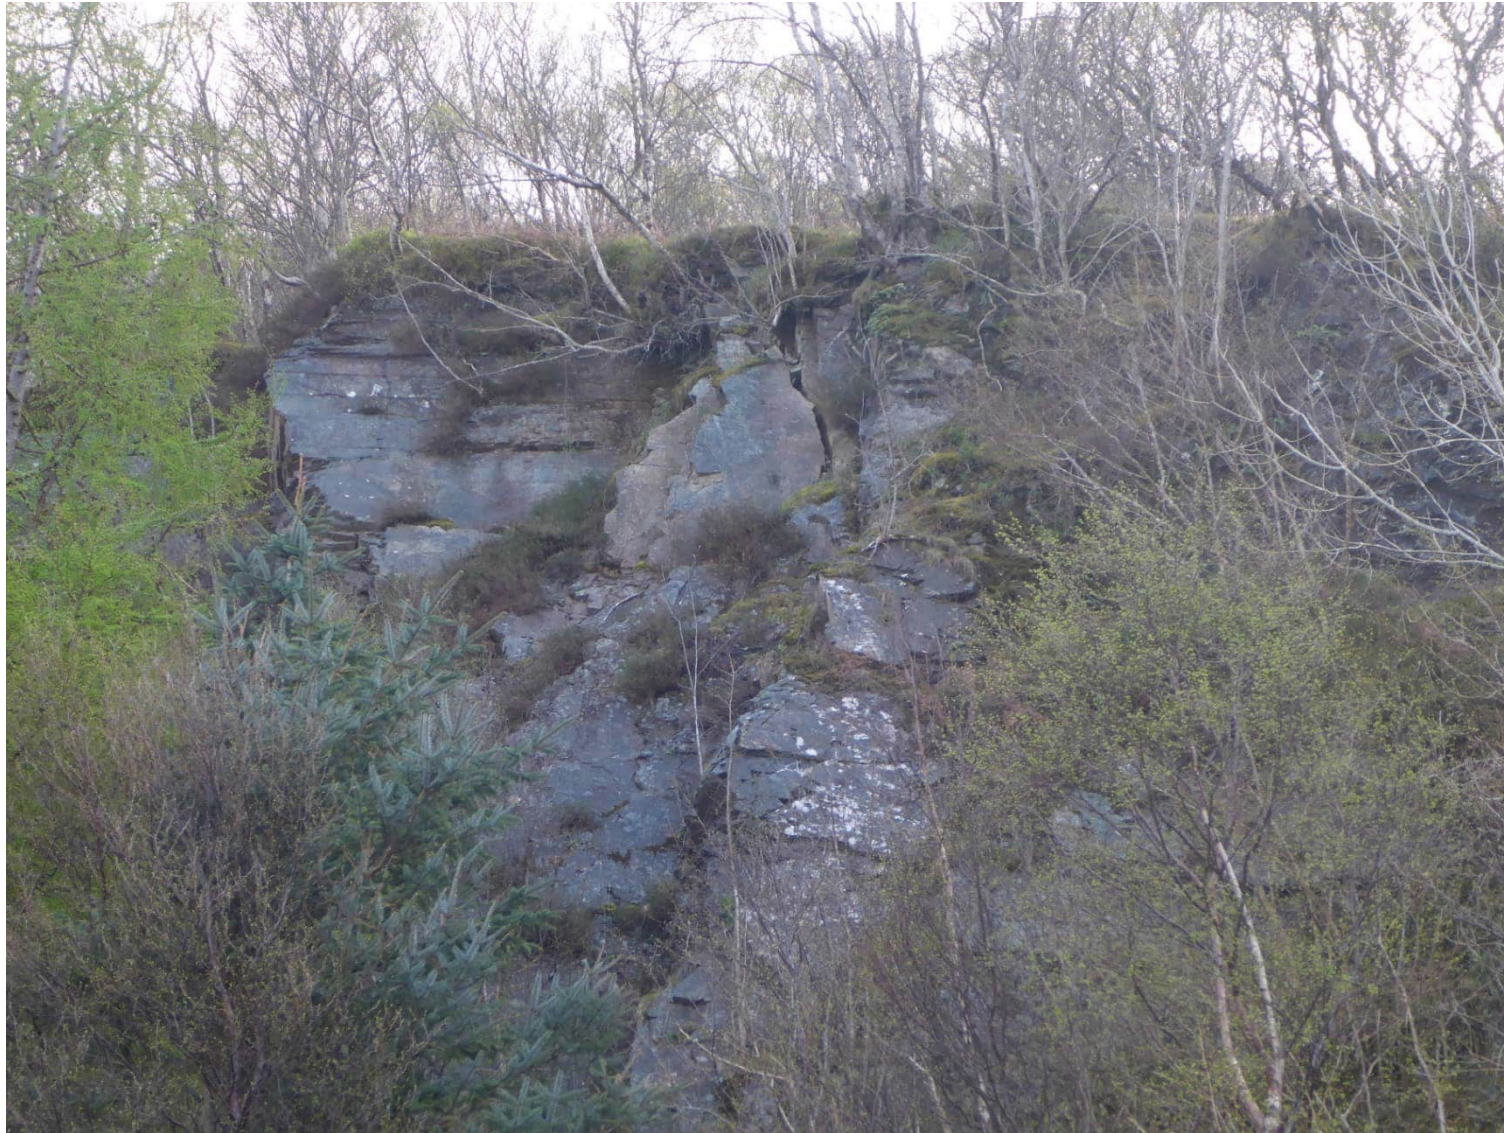
Photograph AA3-2

Year observation first noted: 2021

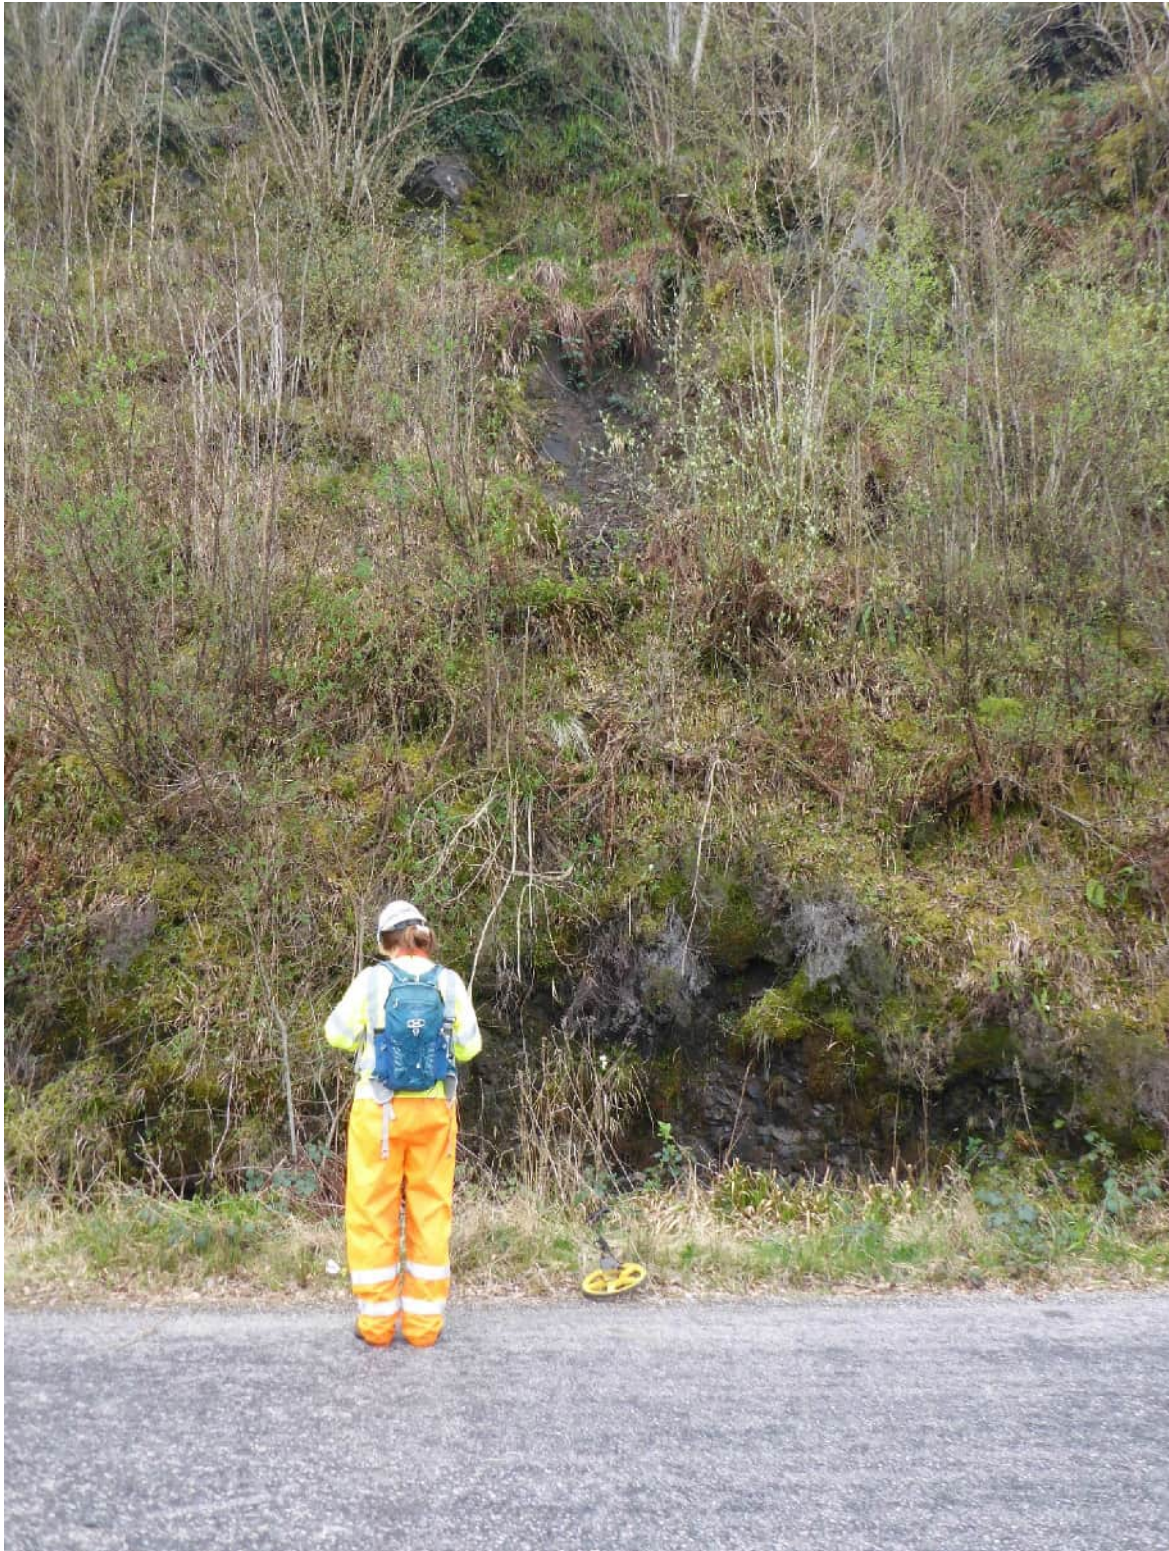
Photograph AA4-1	At Ch. 810 – Minor soil slip occurred and was contained by verge/drain. Originated from c.8m upslope. Slight overhang of vegetation at crest of failure slope remains.	Year observation first noted: 2021
------------------	--	------------------------------------

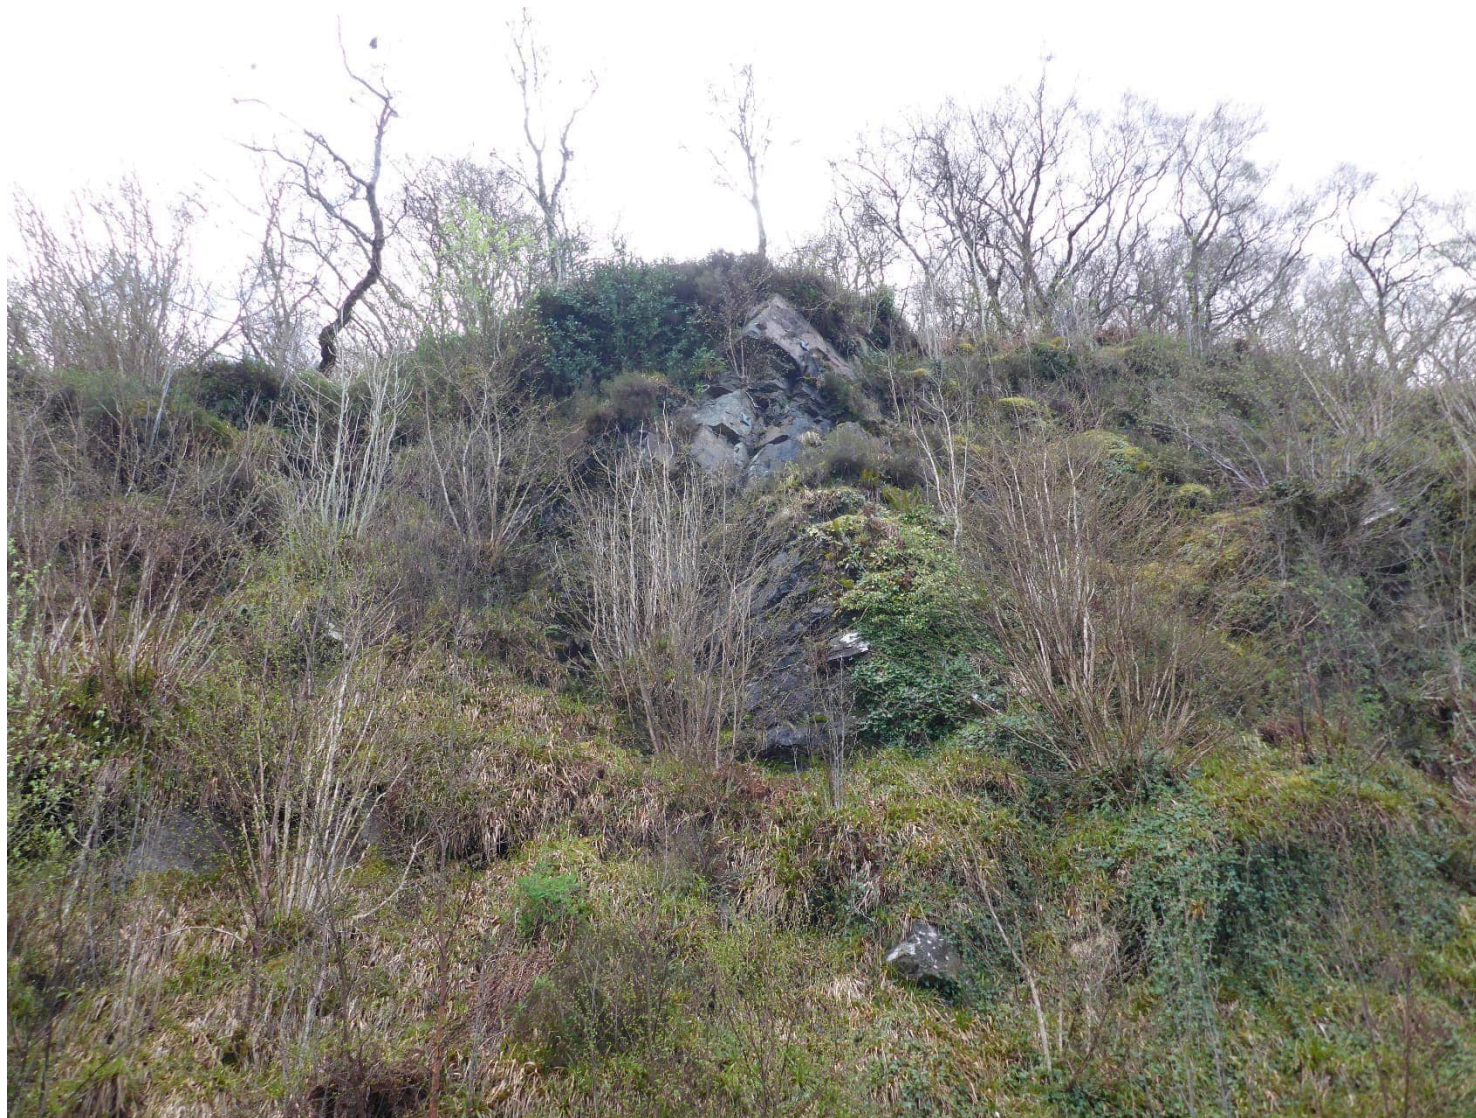
Photograph AA4-2

Year observation first noted:
2016

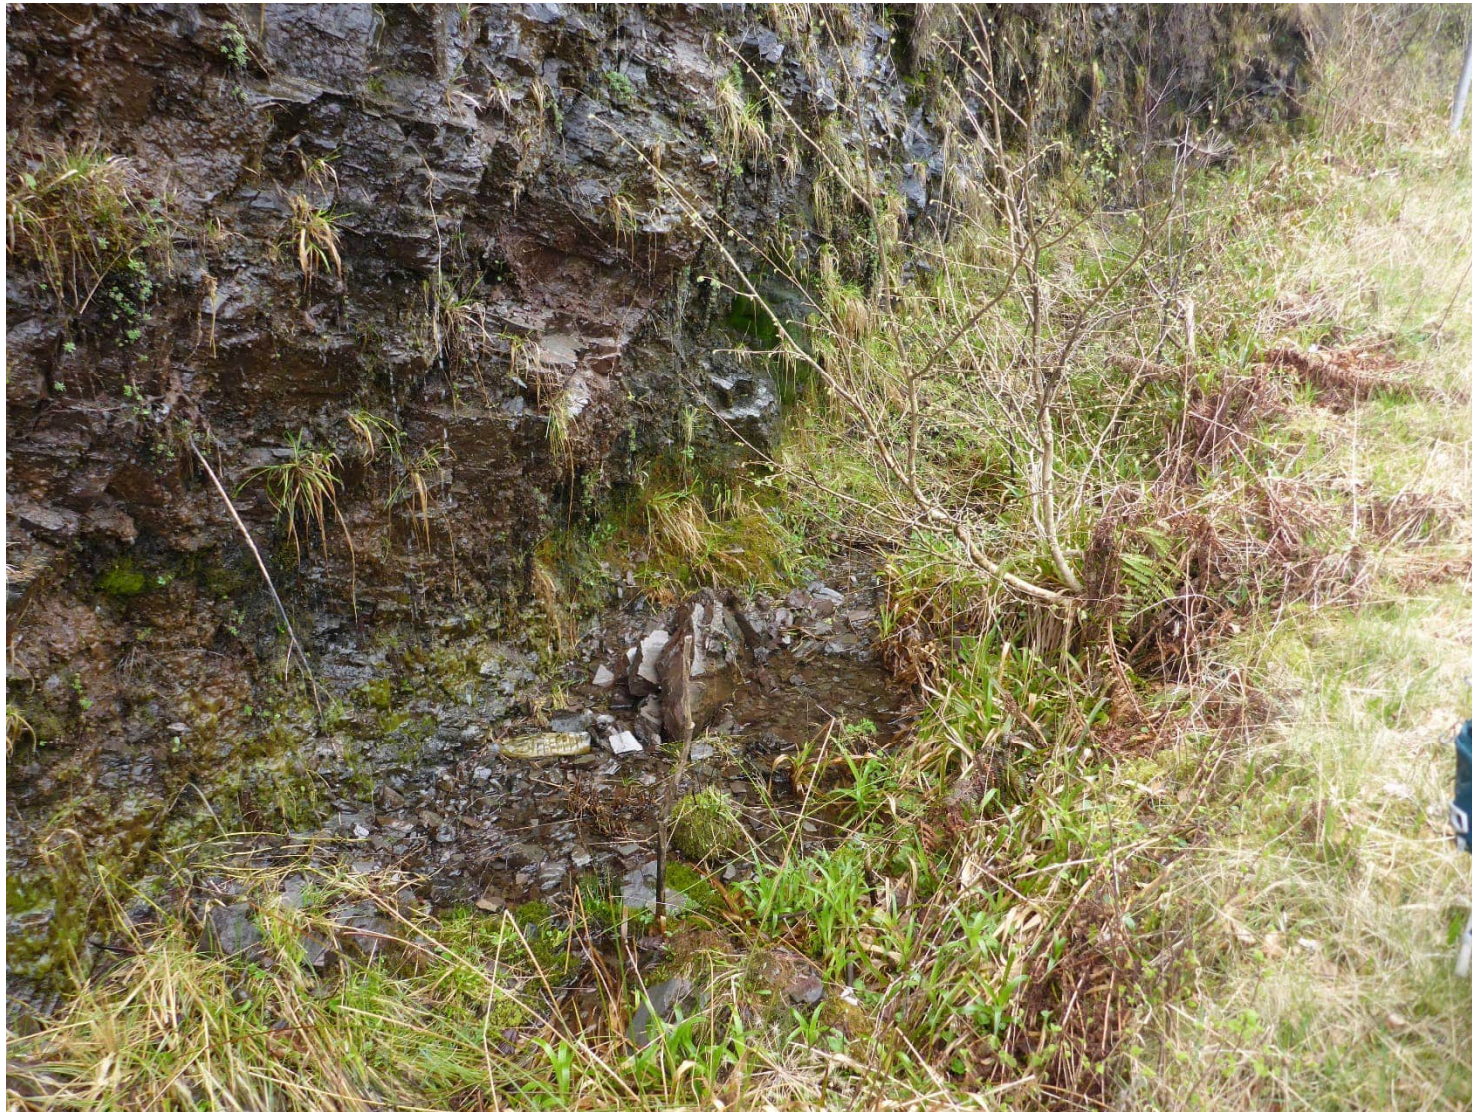
Photograph AA4-3

Year observation first noted:
2023
