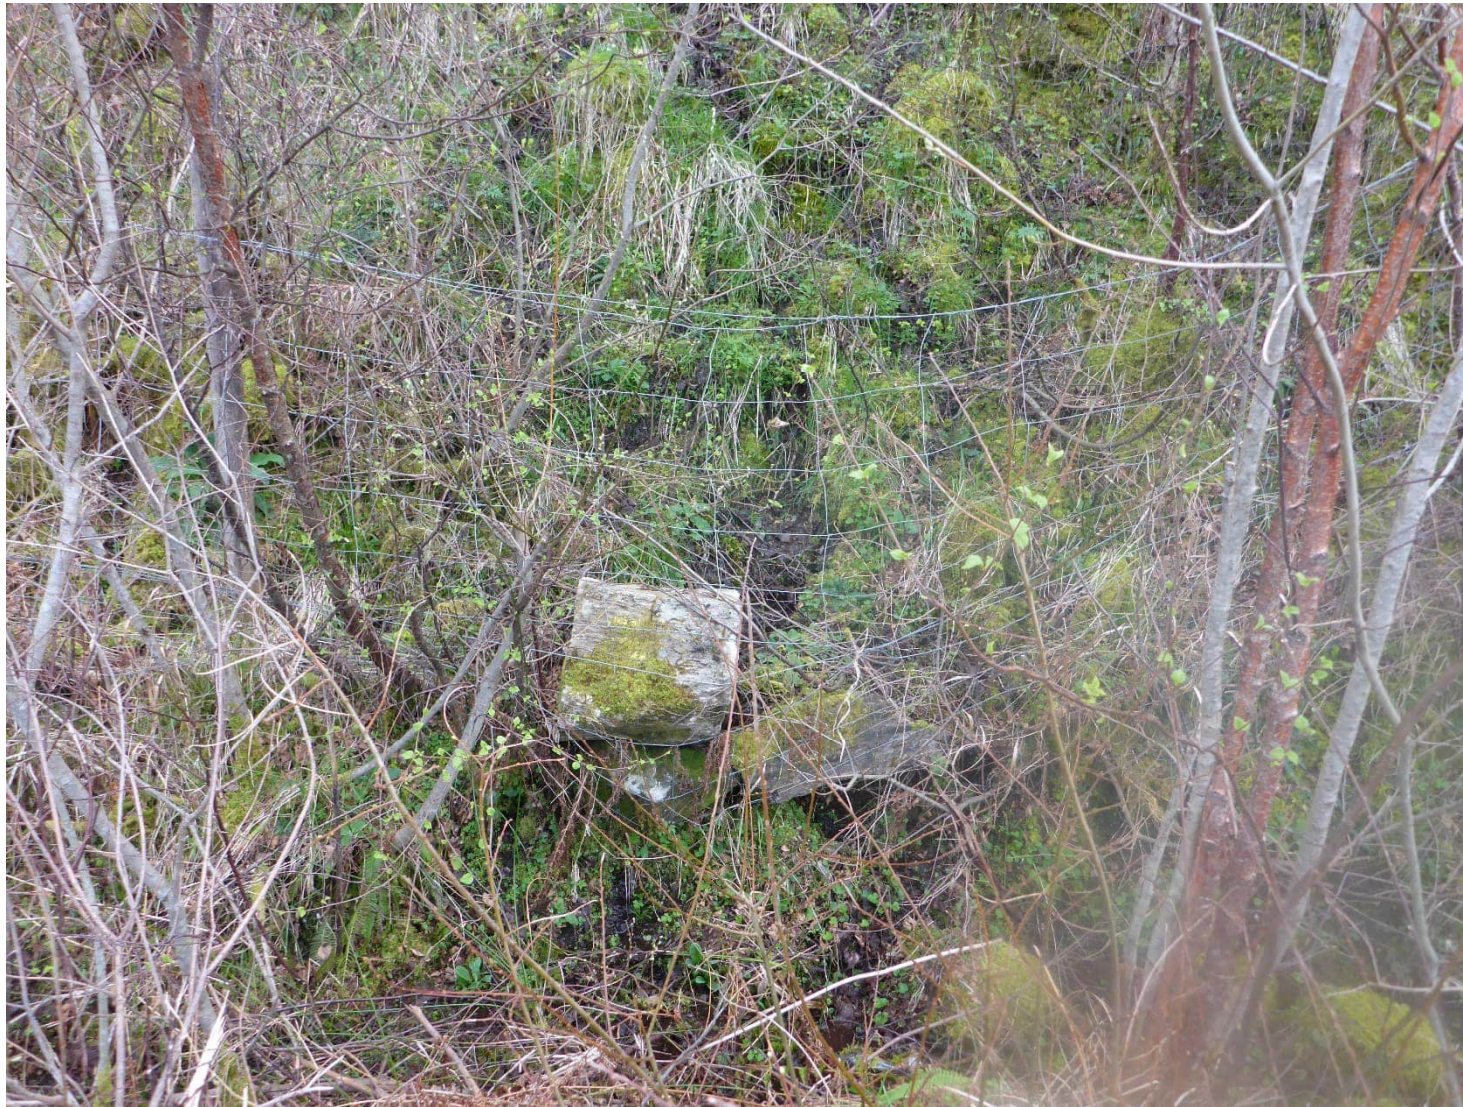
Photograph AA4U-1

At Ch. 858 - Three blocks have come to rest at deer fence. Appear to have originated from waterlogged slope ca. 8m above road.

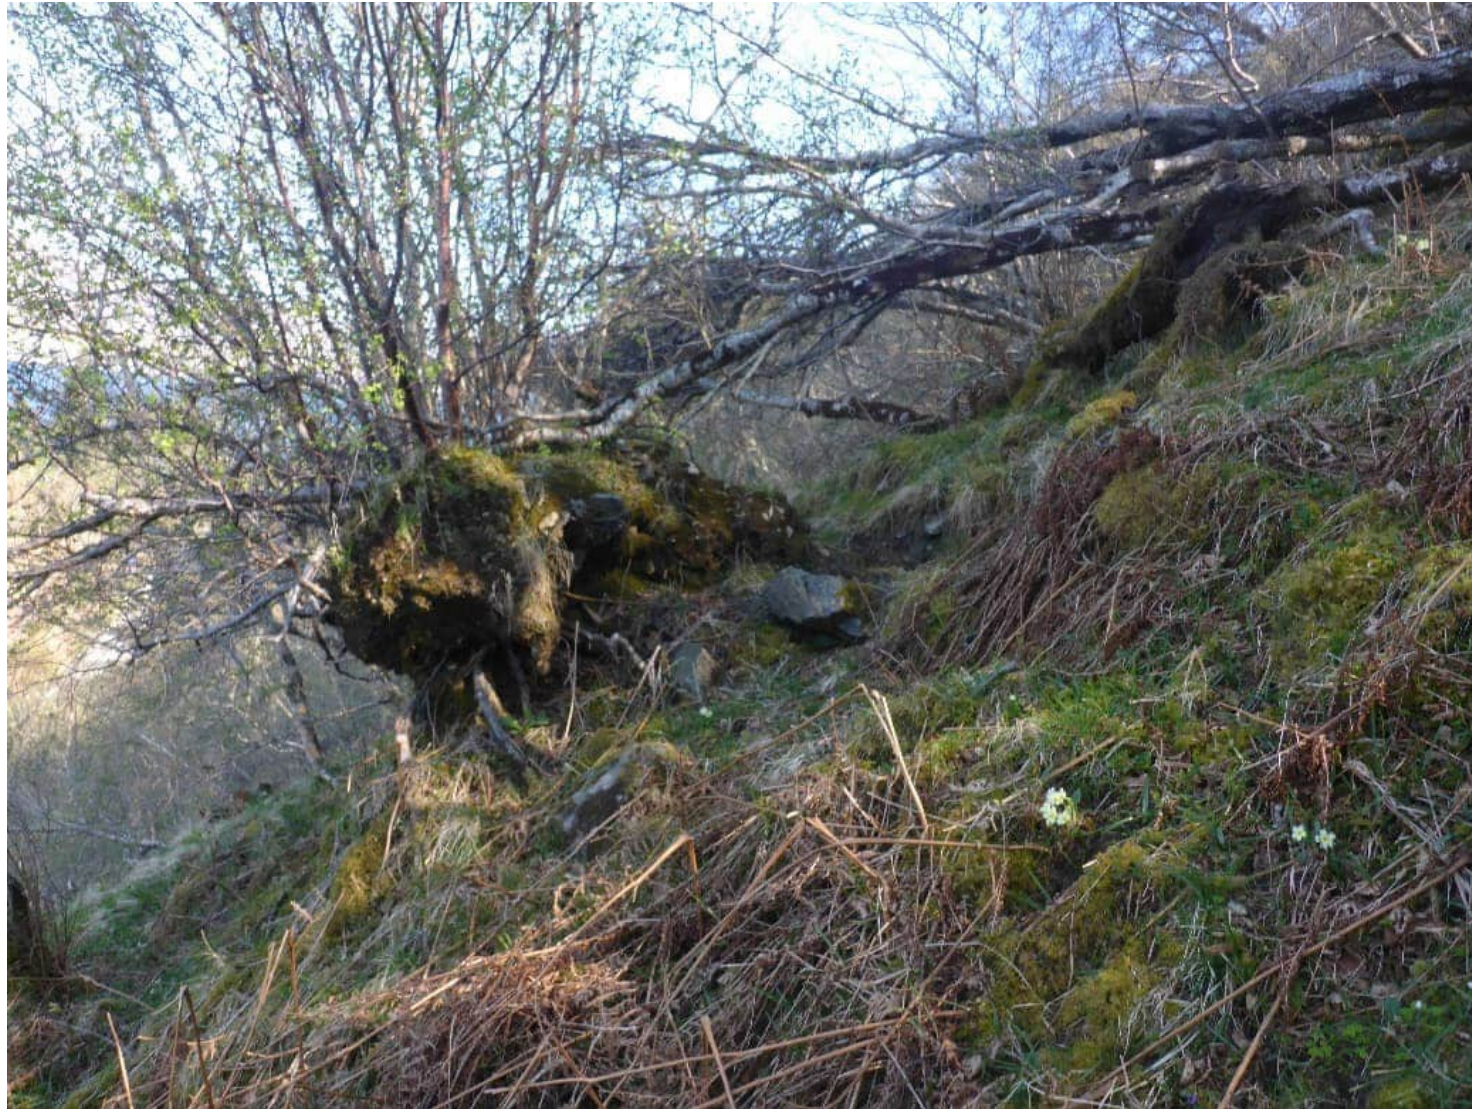
Photograph AA4U-2

At Ch. 858 - c.25 to 30m upslope there are several uprooted trees with boulders in root balls – considered to be most likely source of blocks at fence.

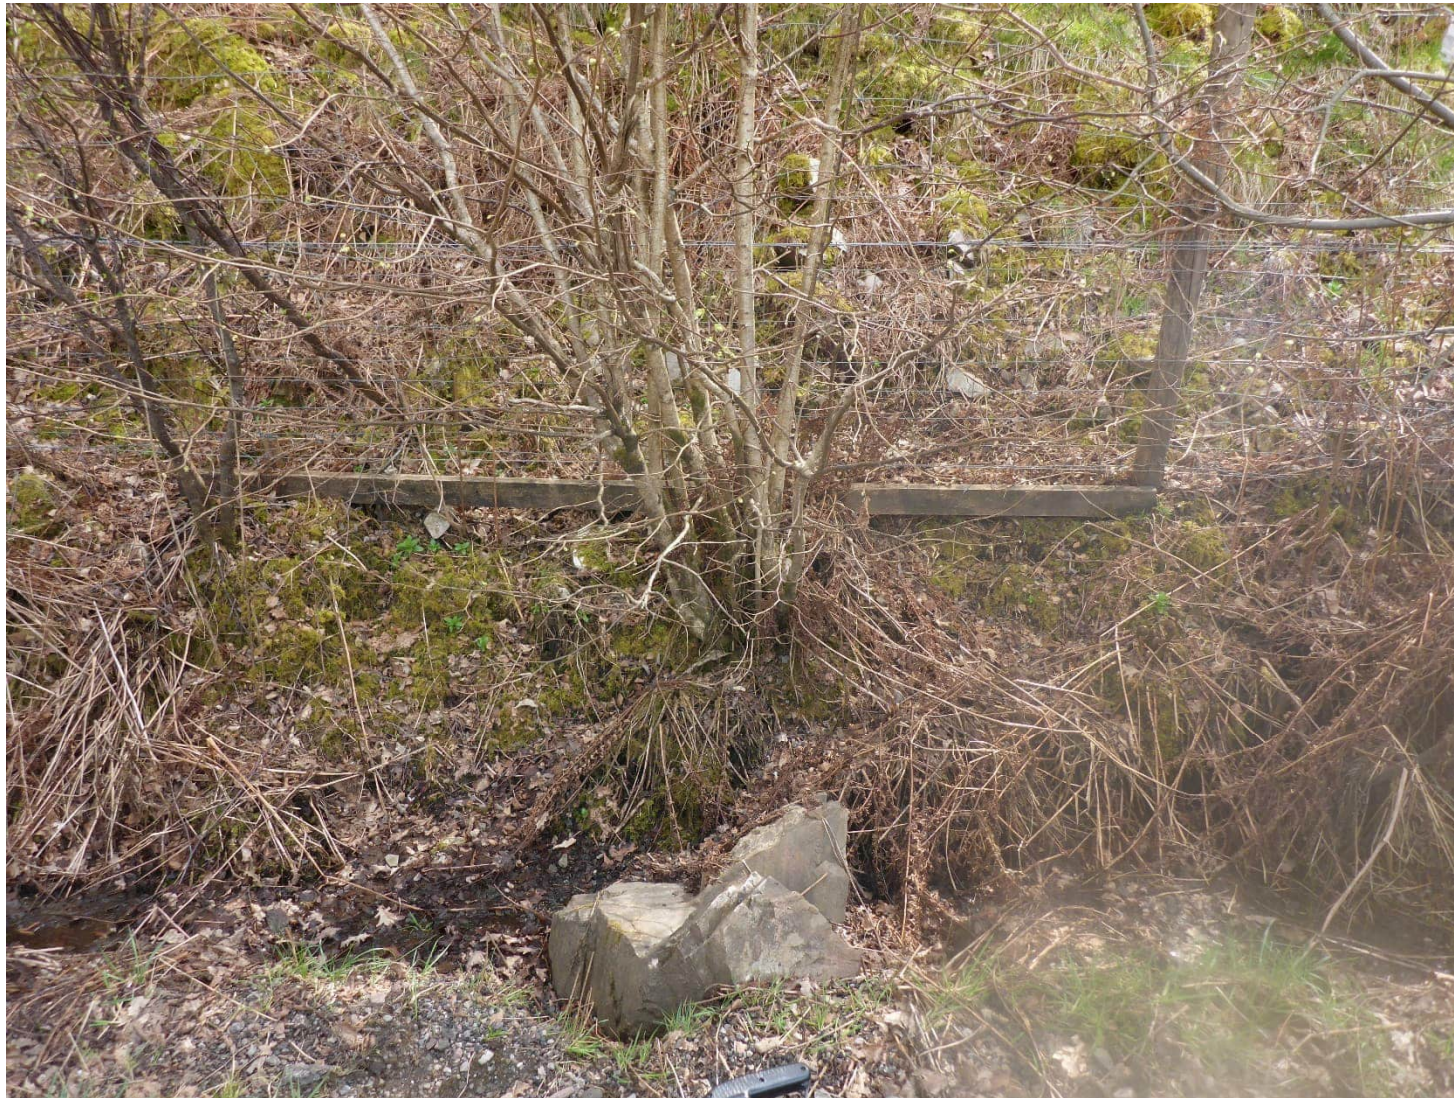
Photograph AA5-1

At Ch. 1285 - Large (0.75m x 0.5m x 0.4m) and smaller block in ditch where it has burst through fence (identified in 2020)

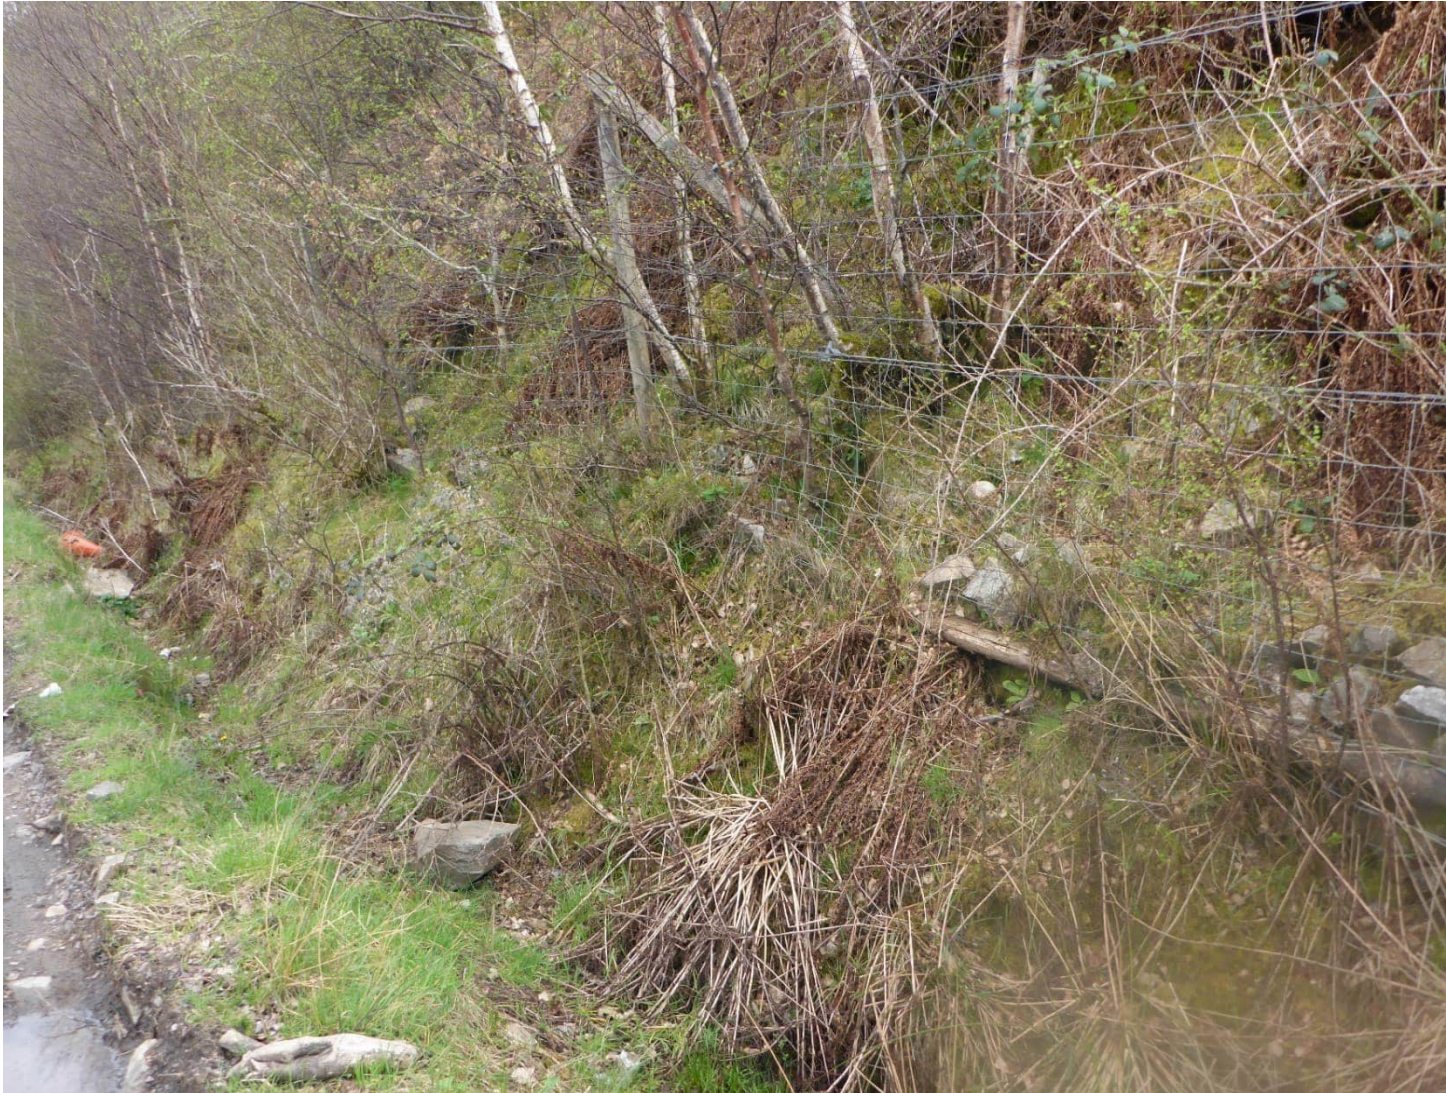
Photograph AA5-2

At Ch. 1328 - Several large blocks in roadside ditch (largest 0.4m x 0.3m x 0.25m). One block has burst through deer fence and landed in ditch, but other blocks may have landed on road before being moved. Total failure volume is 0.25 - 0.5m³.

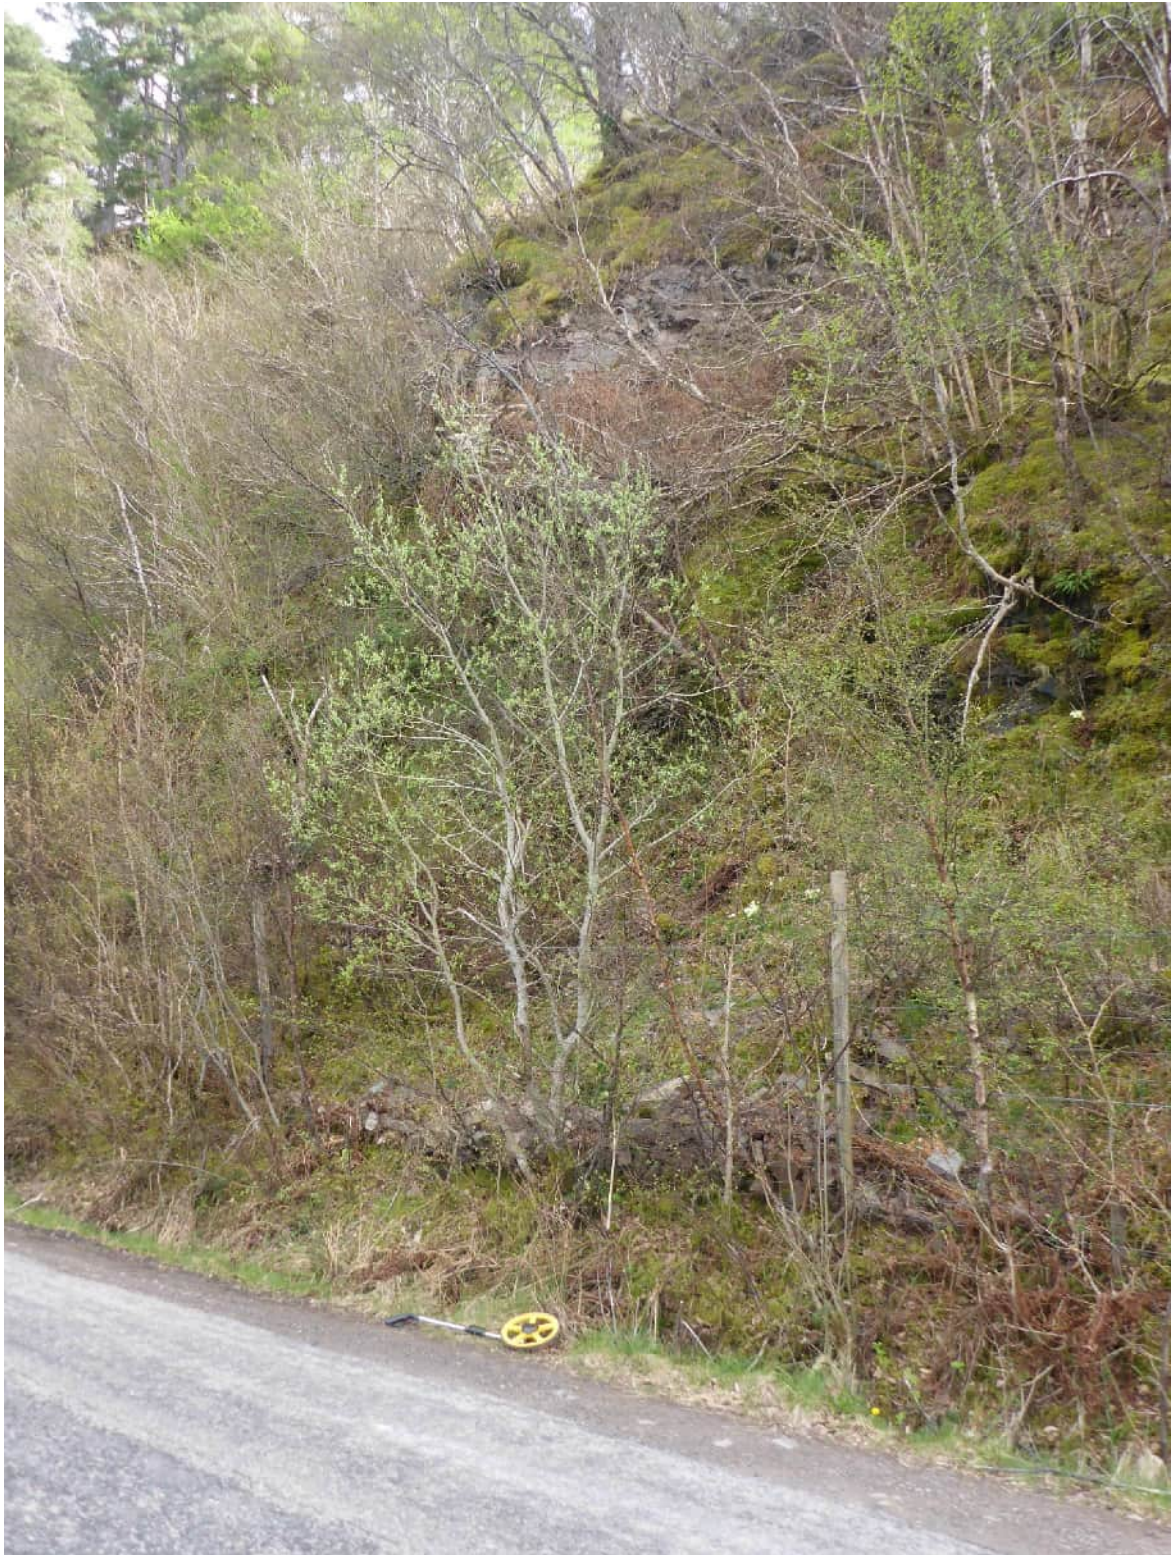
Photograph AA5-3	At Ch. 1360 – A greater accumulation of blocks behind deer fence originating from 2021 scaling.	Year observation first noted: 2023
------------------	-------------------------------------------------------------------------------------------------	------------------------------------

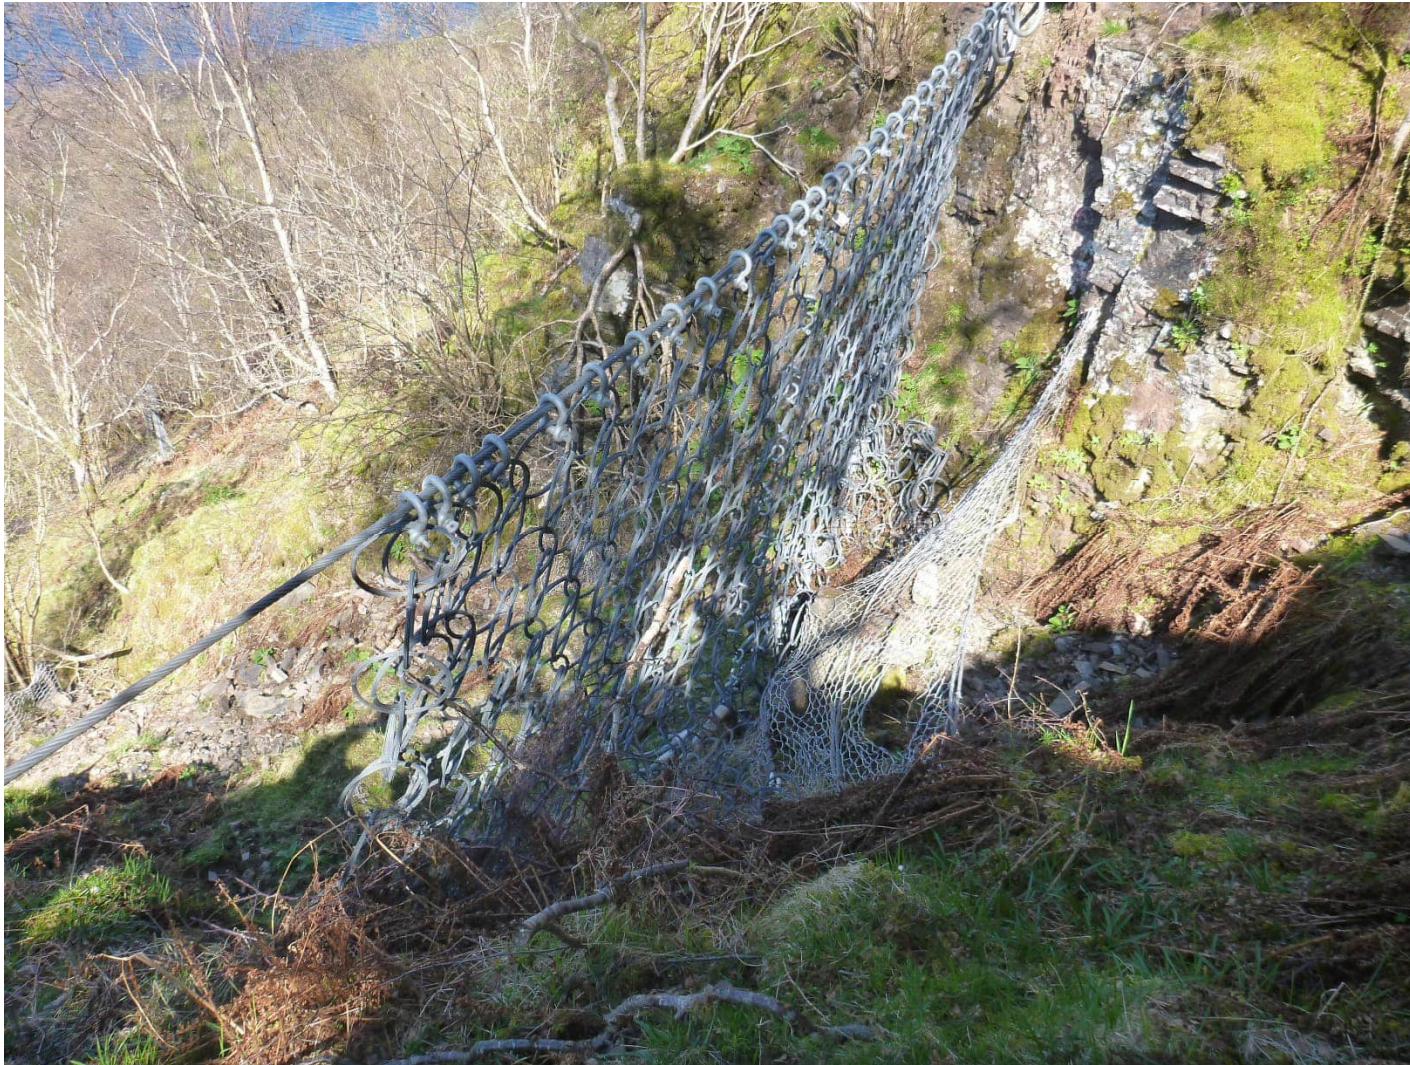
Photograph AA6A-1

At Ch. 1511 – Catch fence (installed during Phase 12 works) in good condition. Three boulders retained by older catch fence however, it is now damaged.

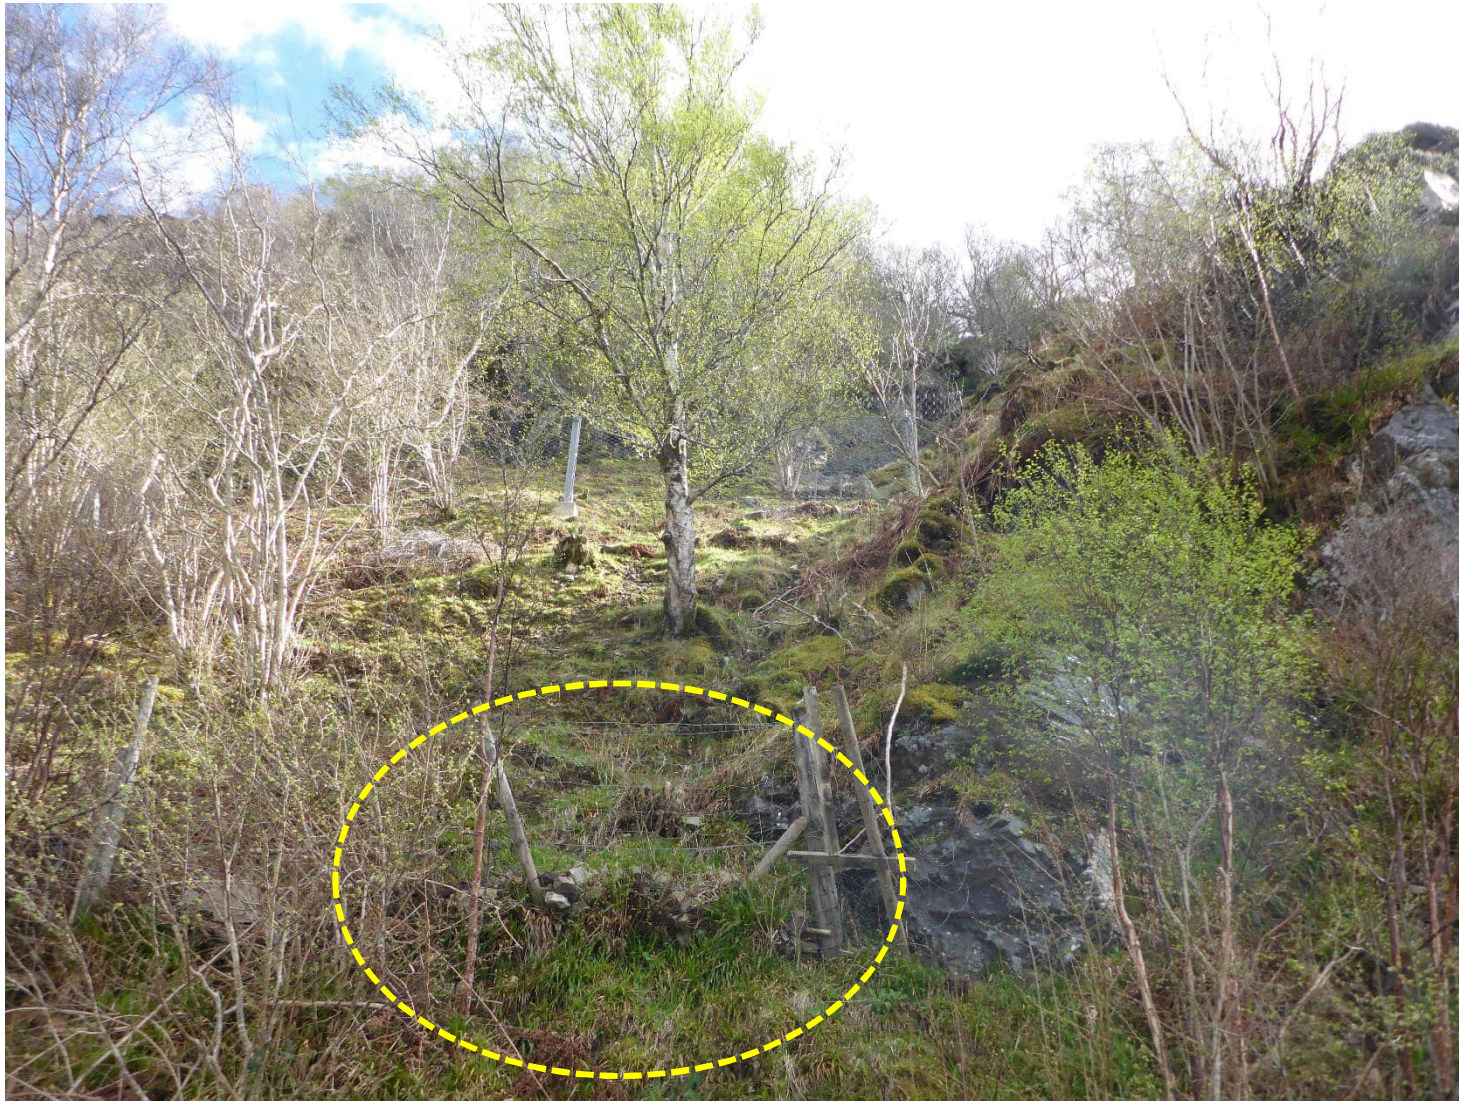
Photograph AA6A-2

At Ch. 1505 - Accumulation of blocks at deer fence ca.3m above road level, along 5m length of slope.

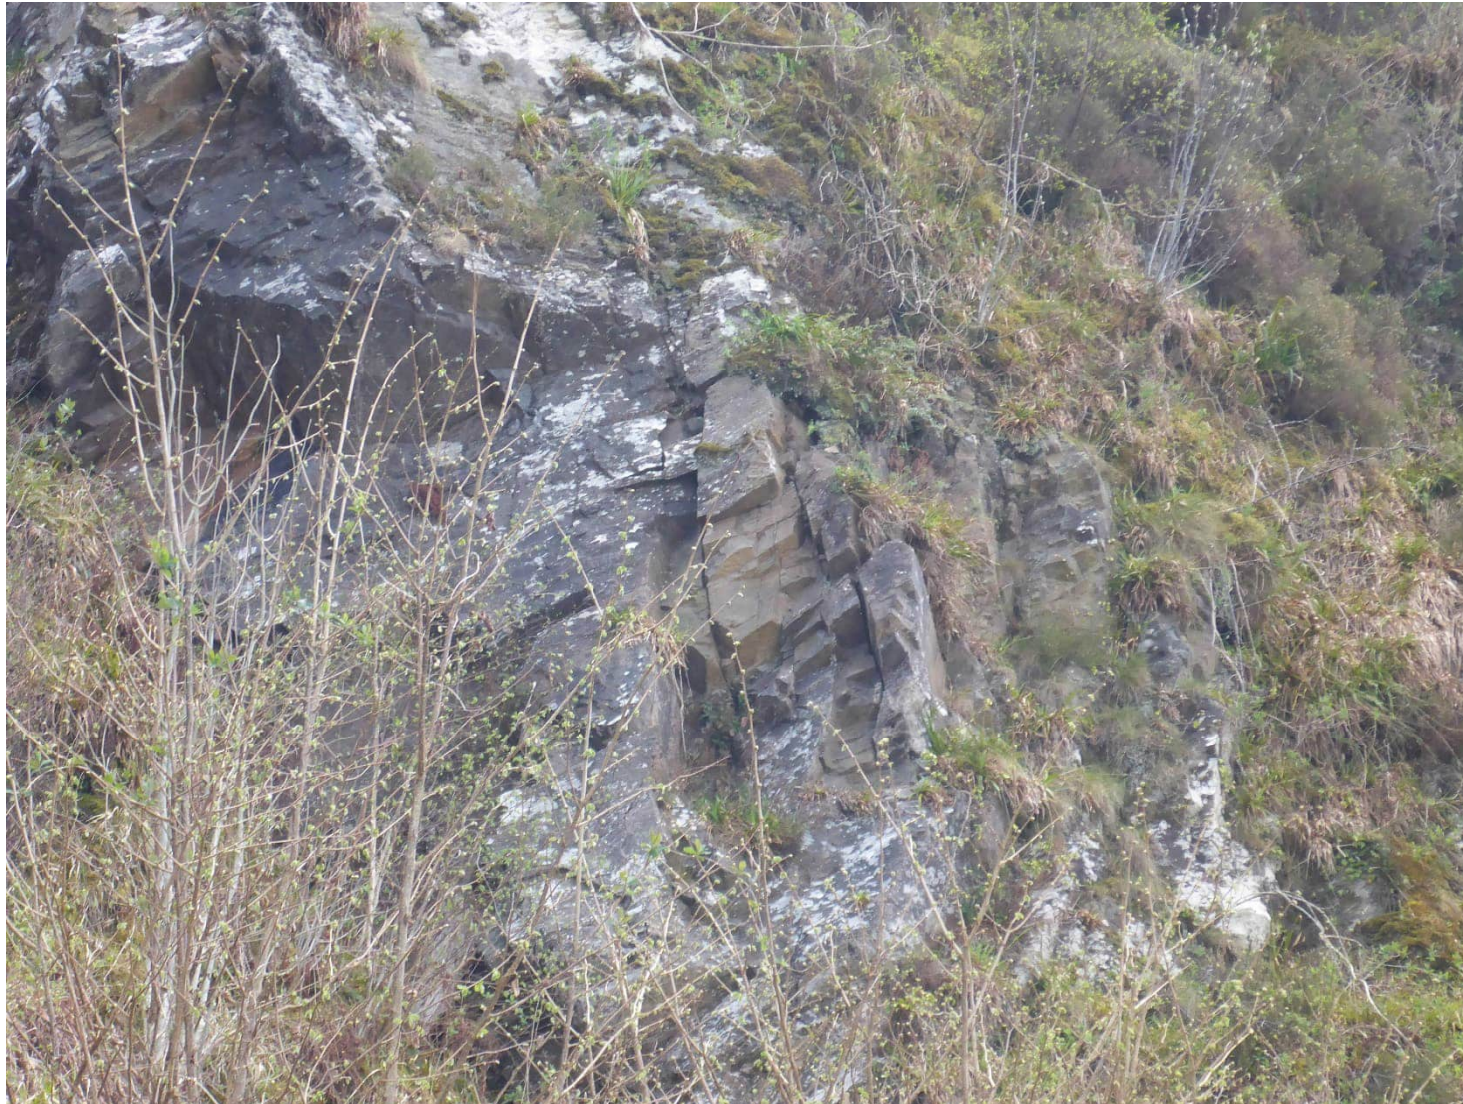
Photograph AA7-1

At Ch. 1803 - Dilated fractures observed c. 15m above road level.

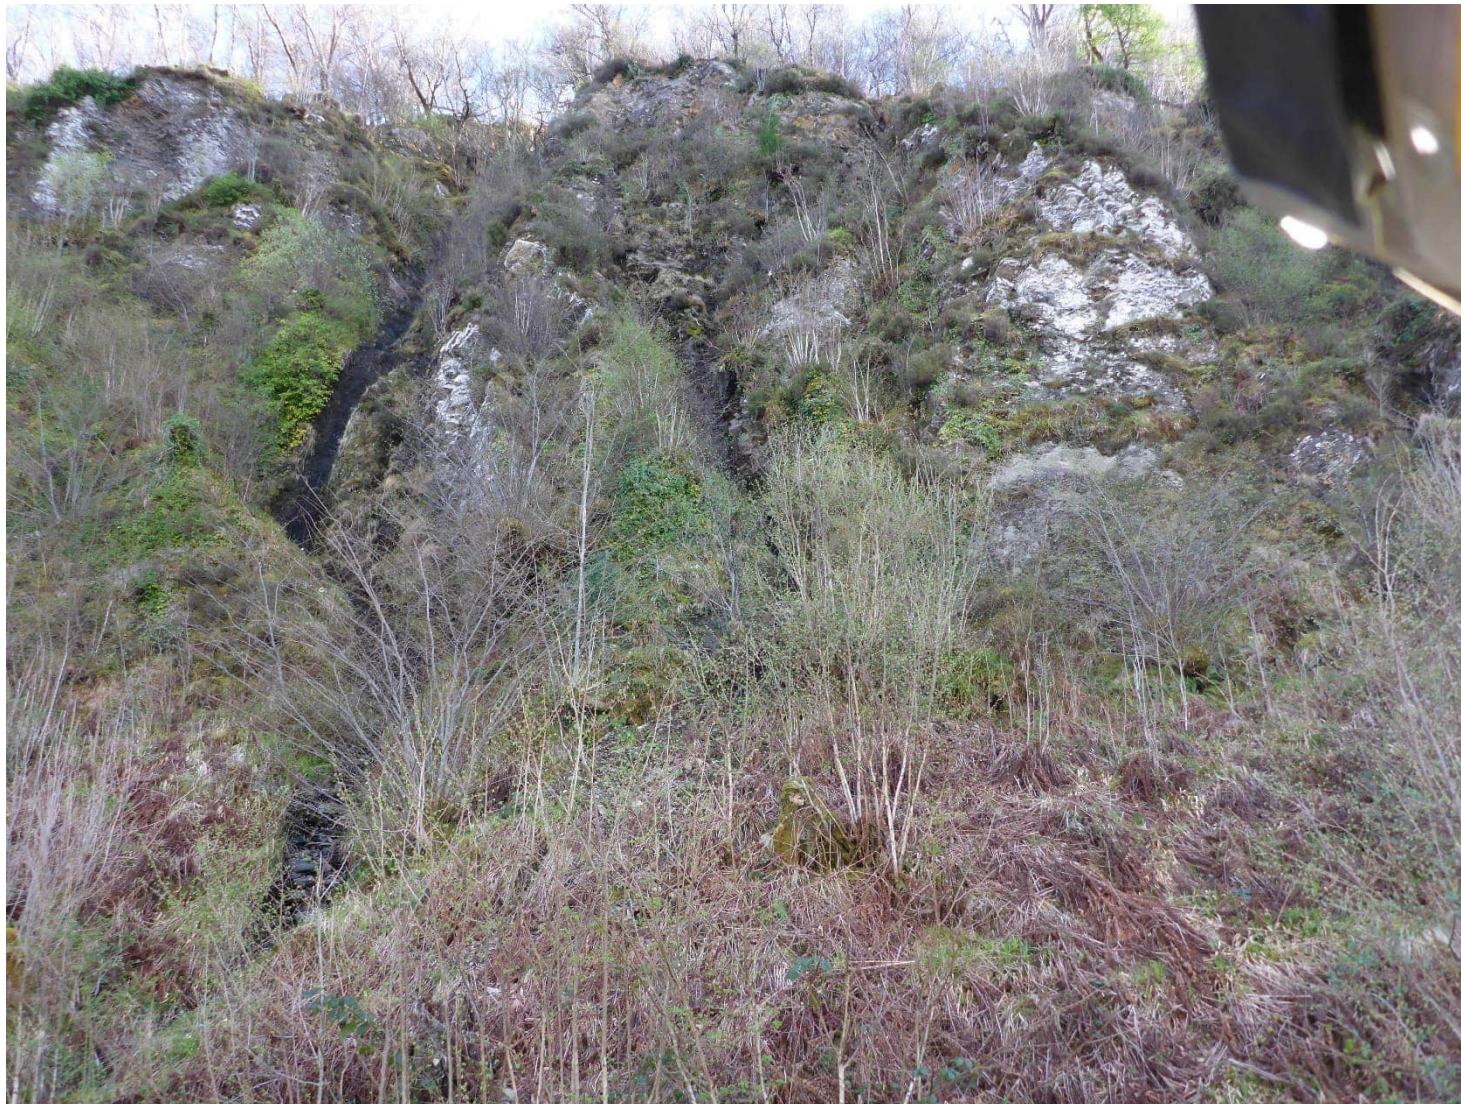
Photograph AA7-2

At Ch. 1820 - Fractured rock on right hand side of previous washout

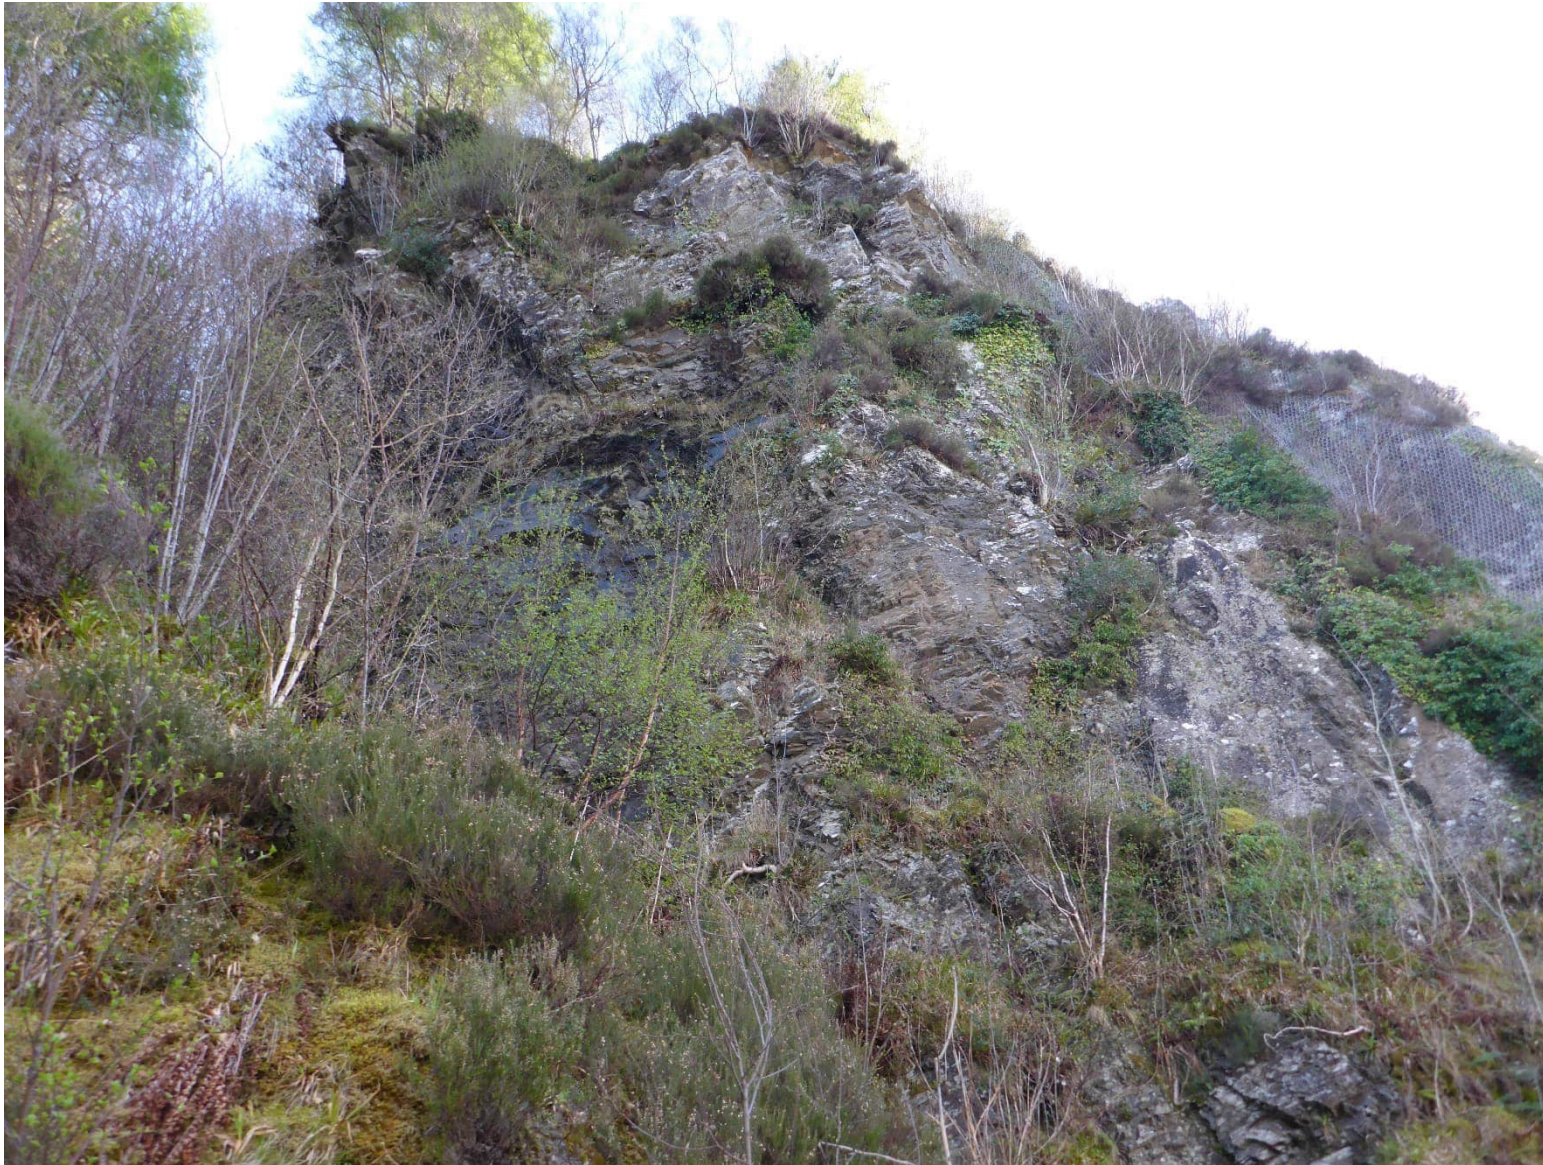
Photograph AA8-1

At Ch. 1940 – A number of overhangs towards crest of slope.

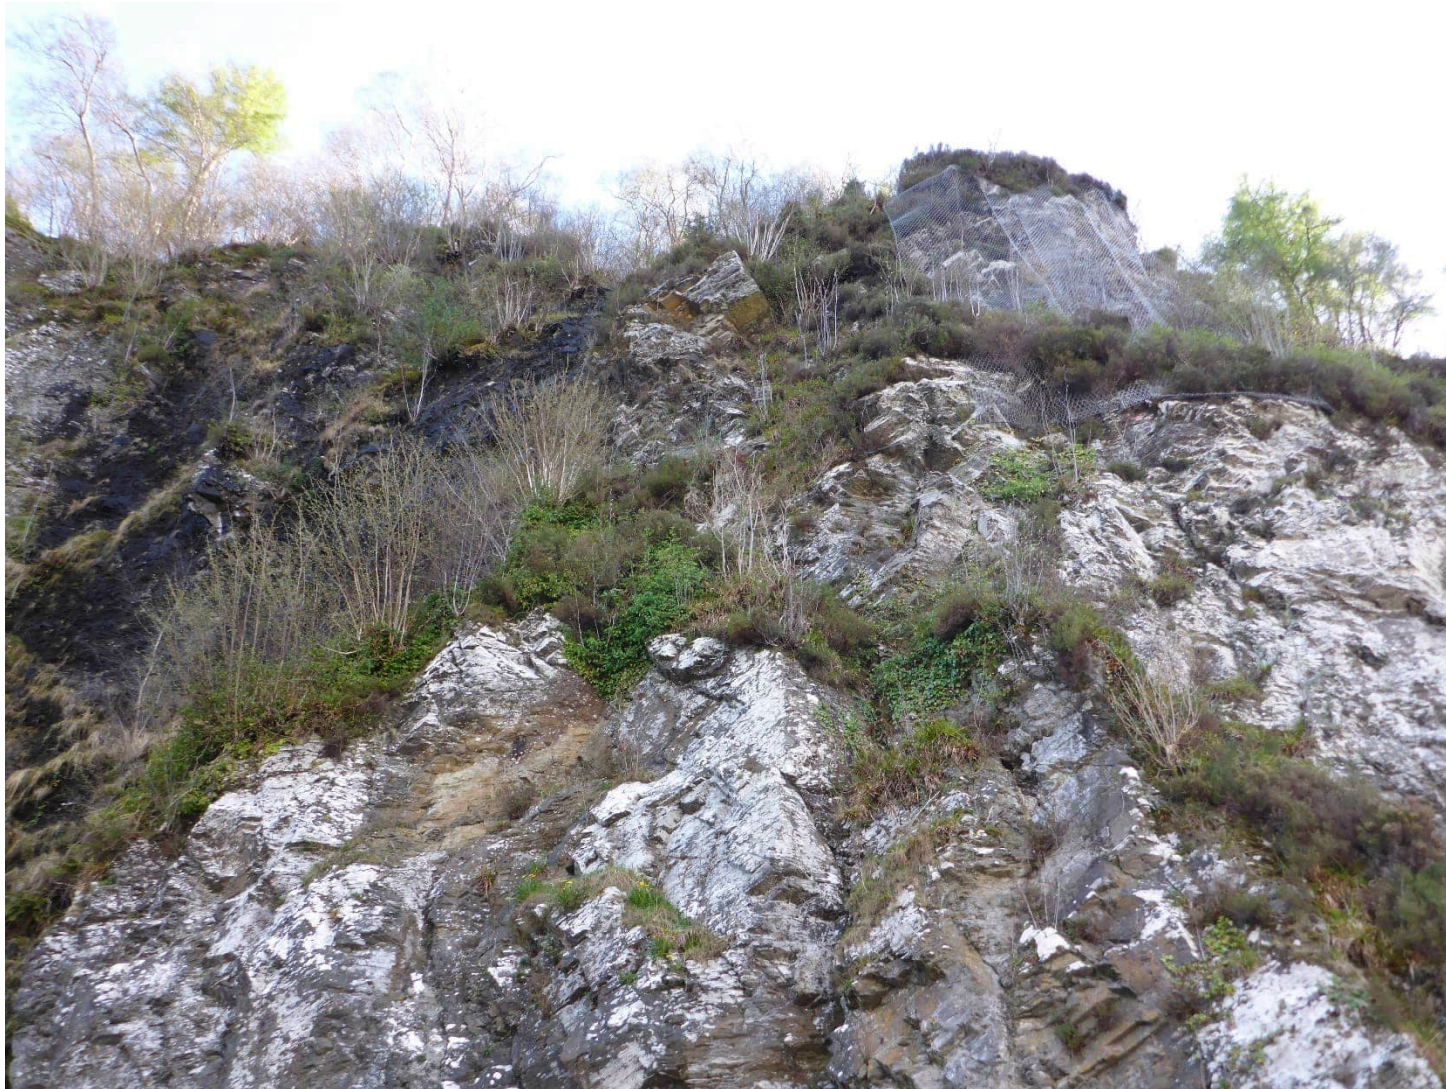
Photograph AA9-1

At Ch. 1978 – Overhanging square blocks near crest with dilated joint at rear

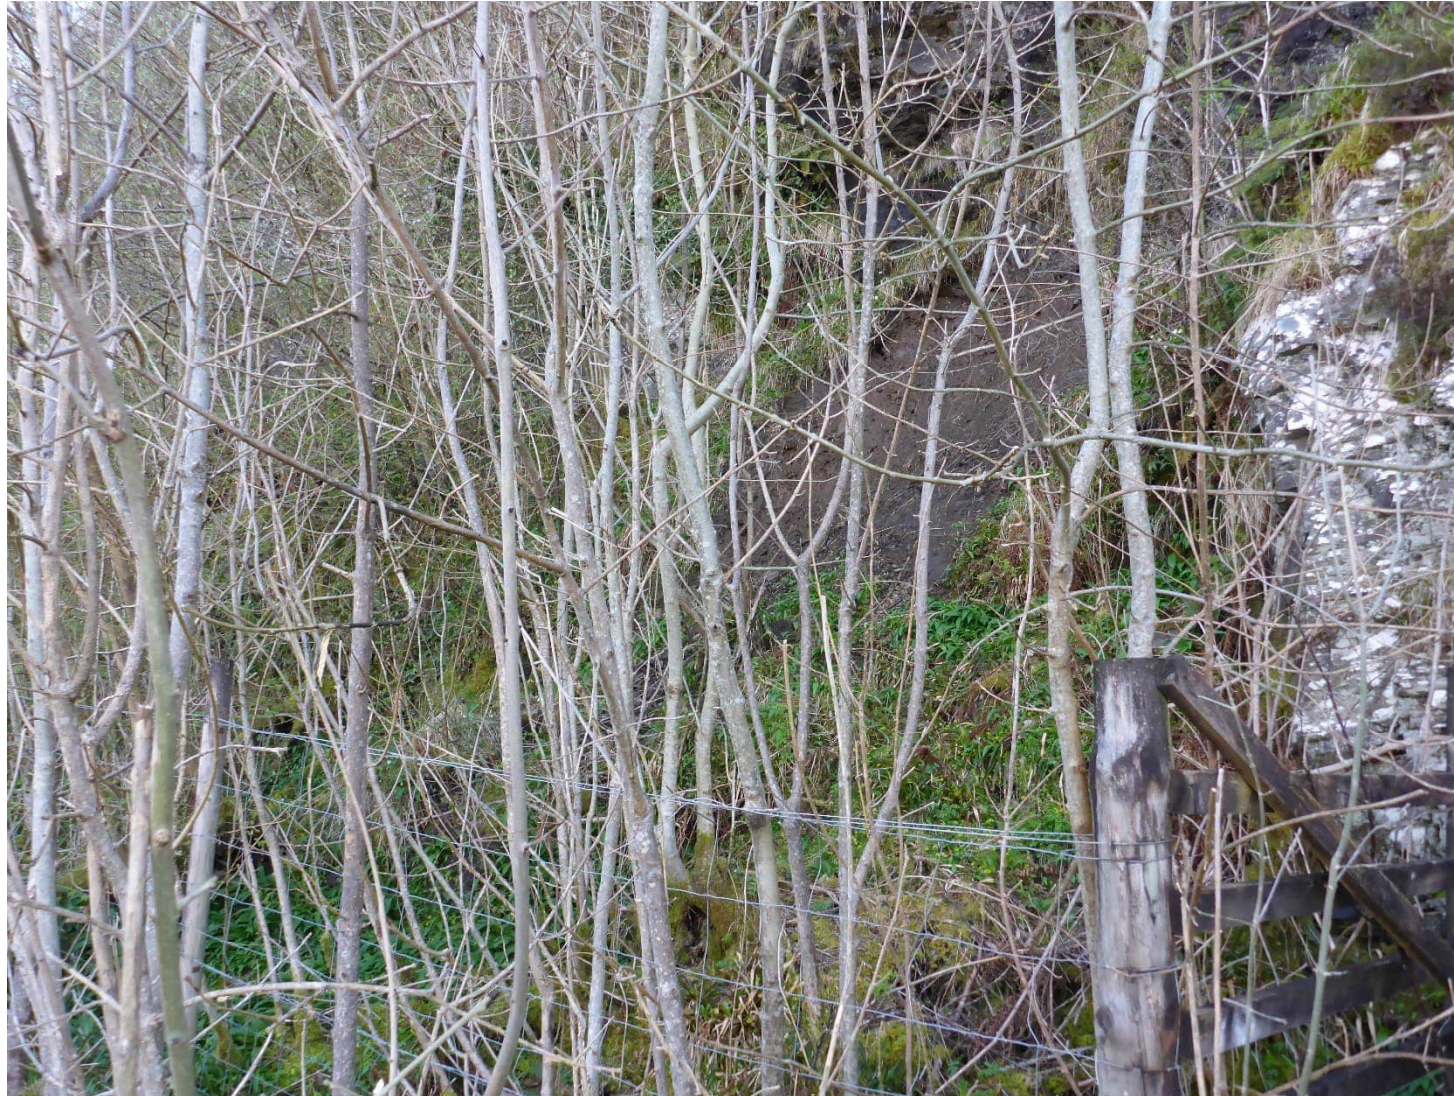
Photograph AA10-1

At Ch. 1995 – Small soil slip has come to rest on slope before deer fence.

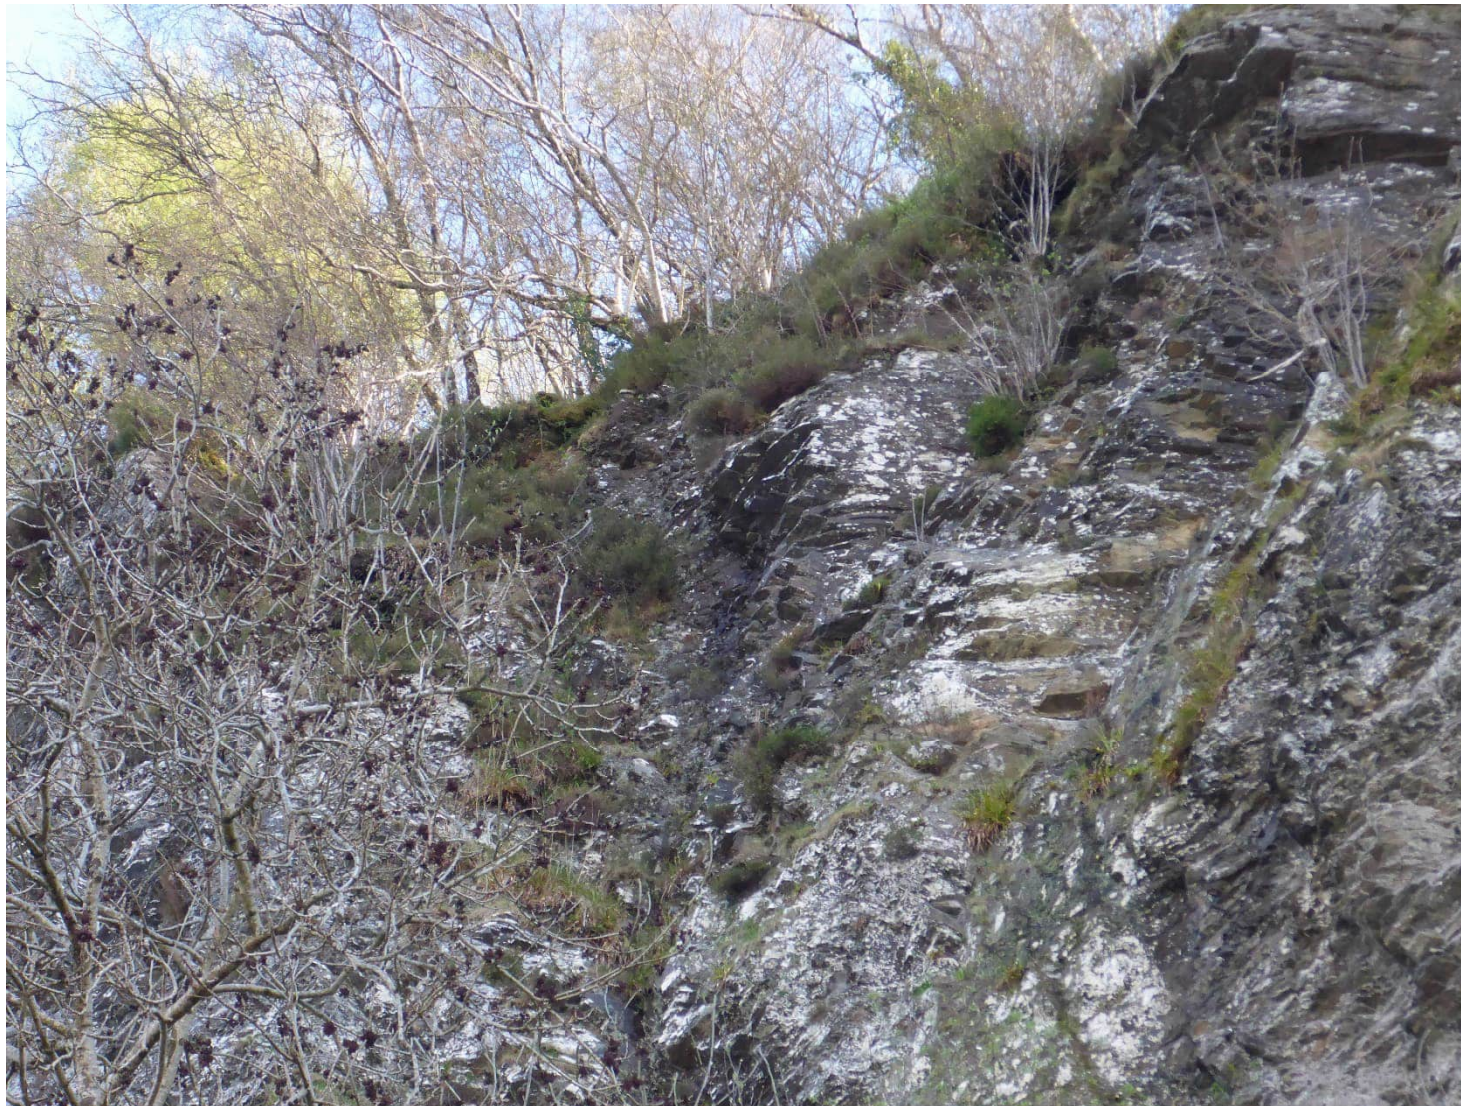
Photograph AA10-2

At Ch. 2000 - Large scale potential wedge failure. Is c.10m wide x 10m high feature at the crest of the rock slope

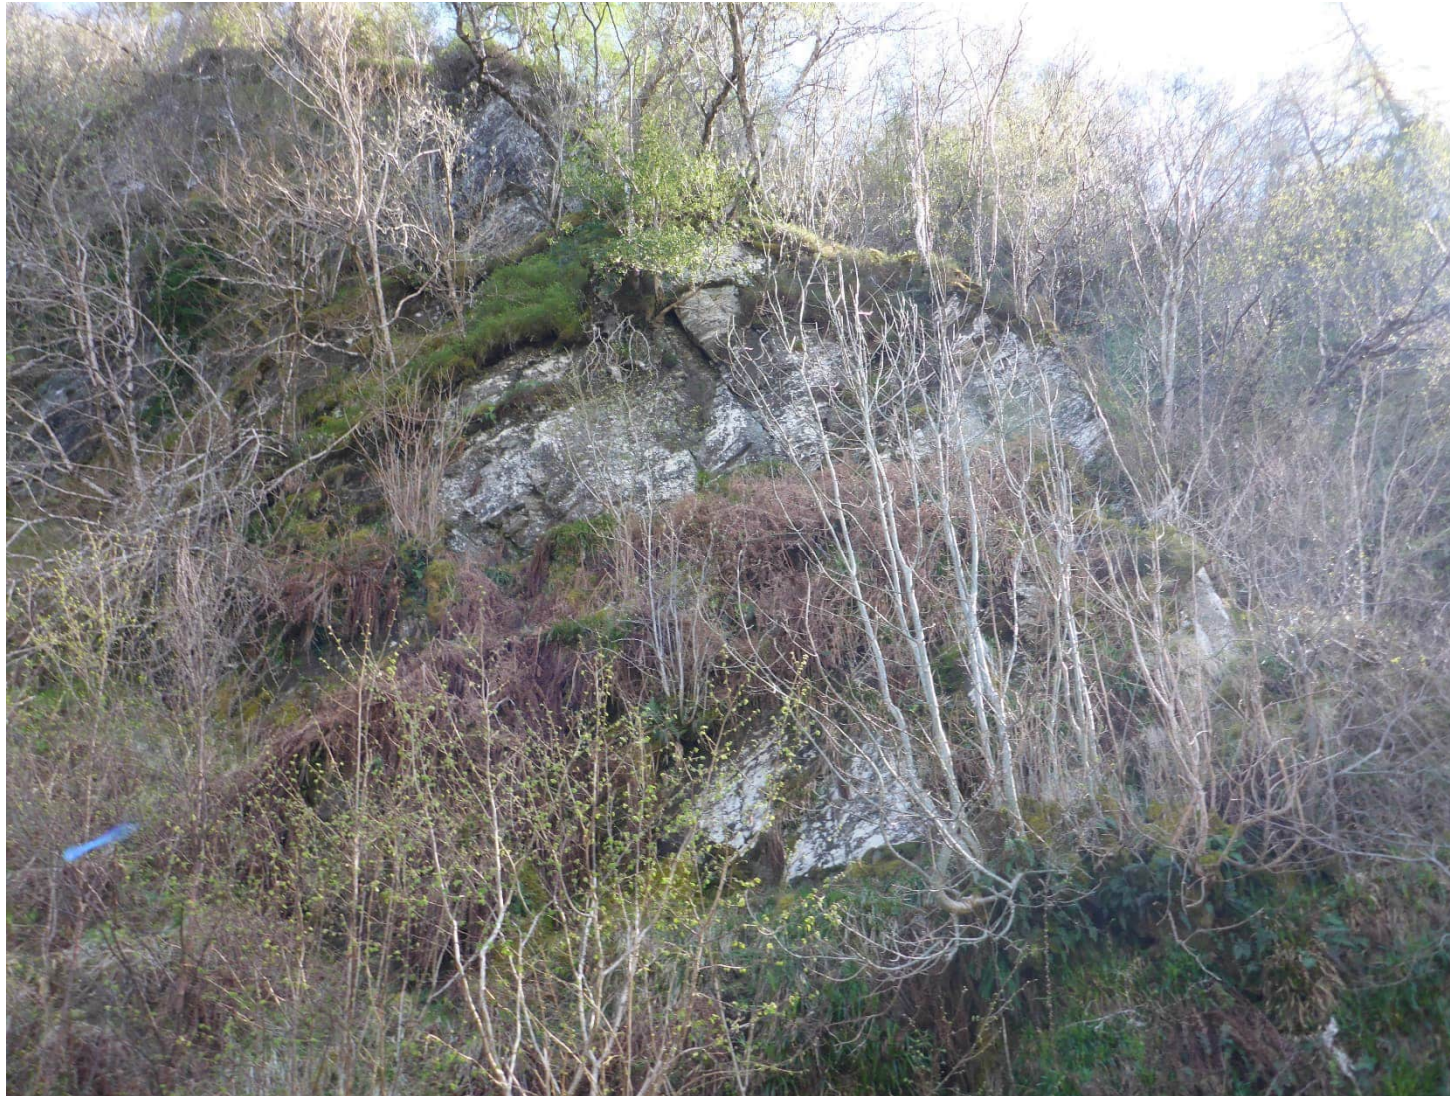
Photograph AA10-3

At Ch. 2130 – Potential wedge failure observed ~15m above road level. Potential for root jacking and release joints observed.
