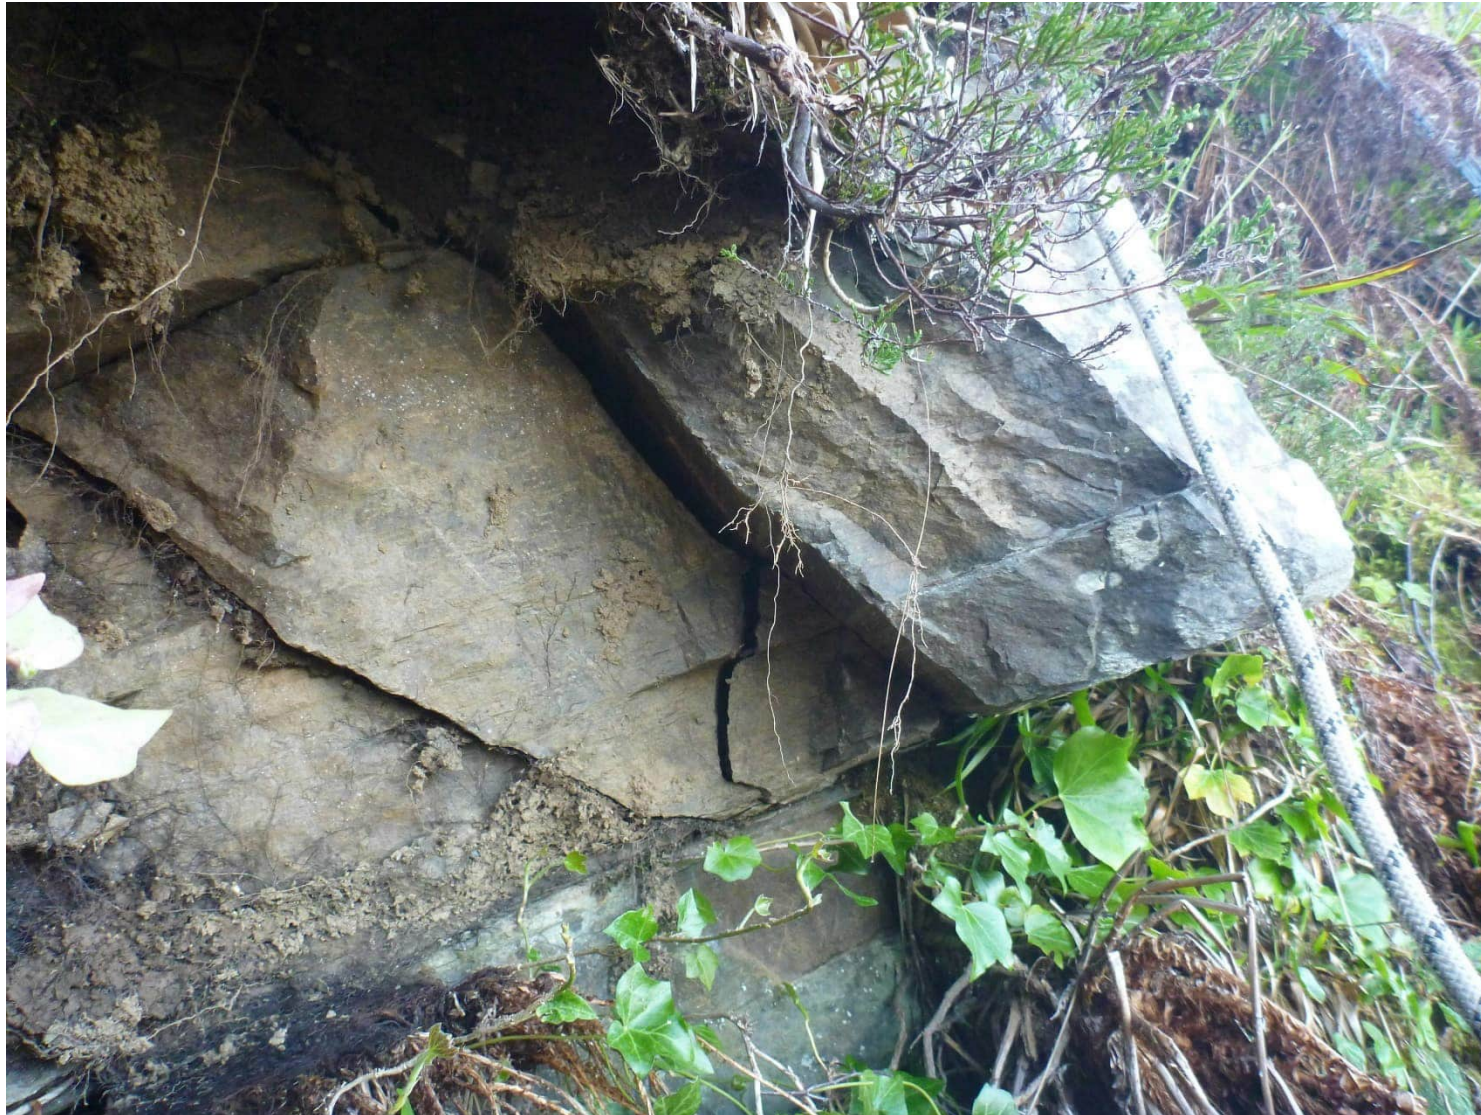
Photograph AA12-1

At Ch. 2428 (Rope Access) – Block keyed in at tight hand side and dilated fracture at back.

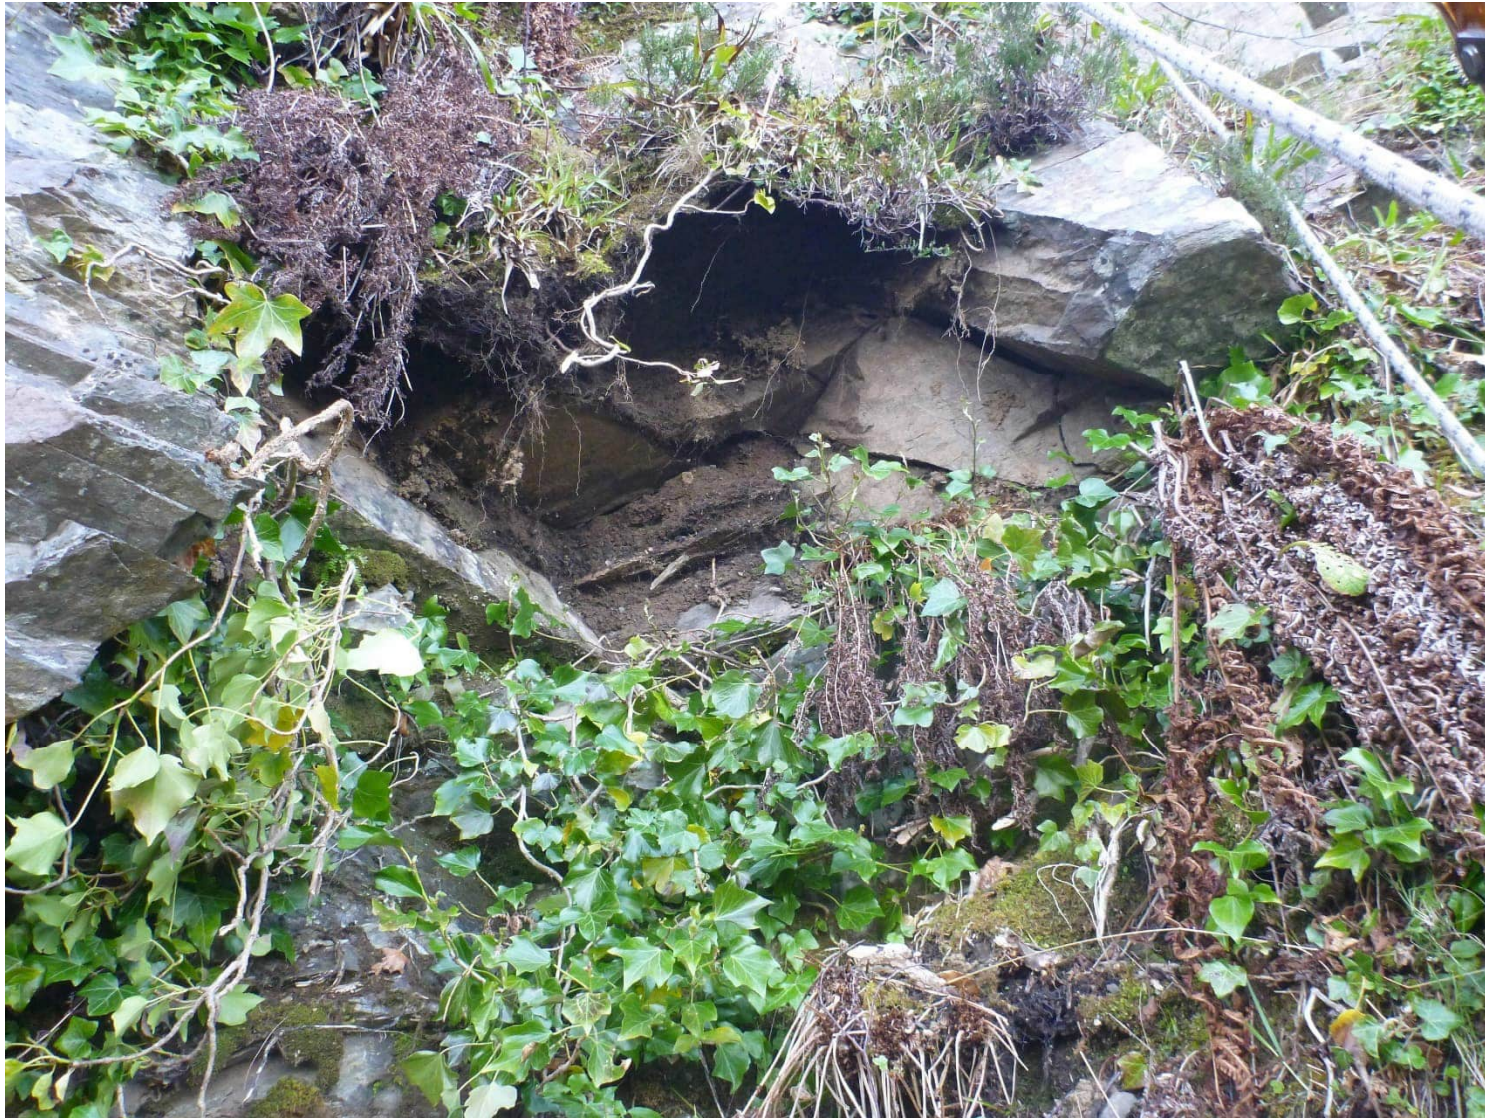
Photograph AA12-2

At Ch. 2428 (Rope Access) – Block keyed in at tight hand side and dilated fracture at back.

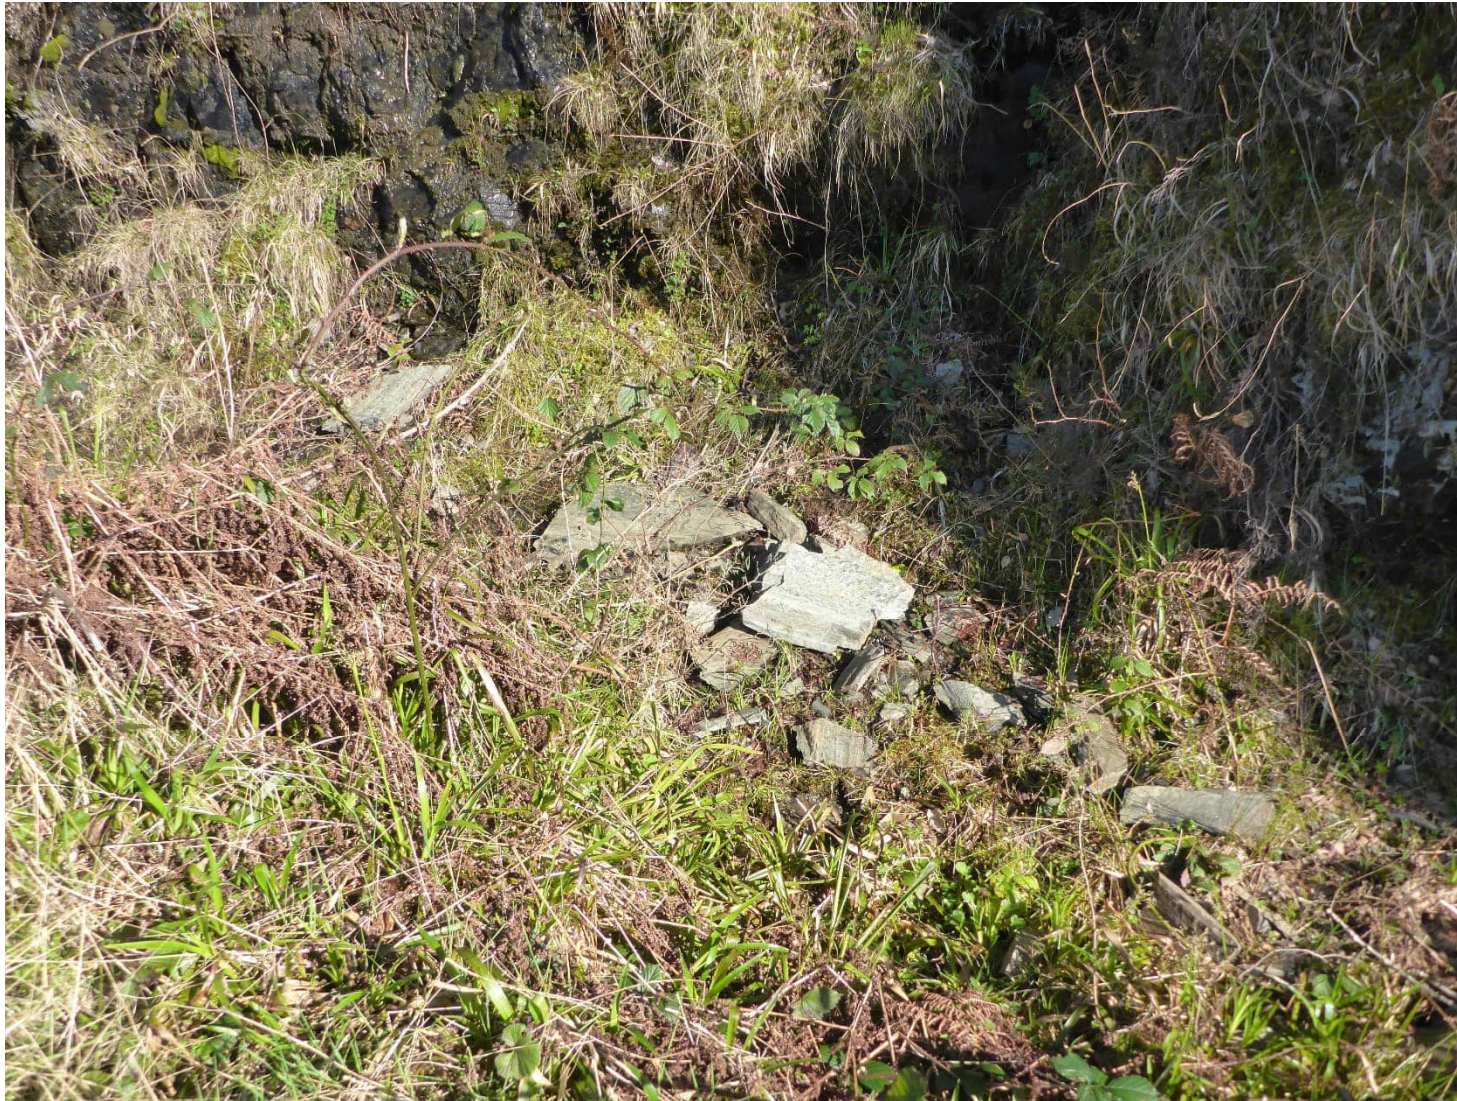
Photograph AA12-3

At Ch. 2428 – Several blocks in verge (up to 0.3m x 0.2m x 0.15m). Cumulatively around x10 blocks.

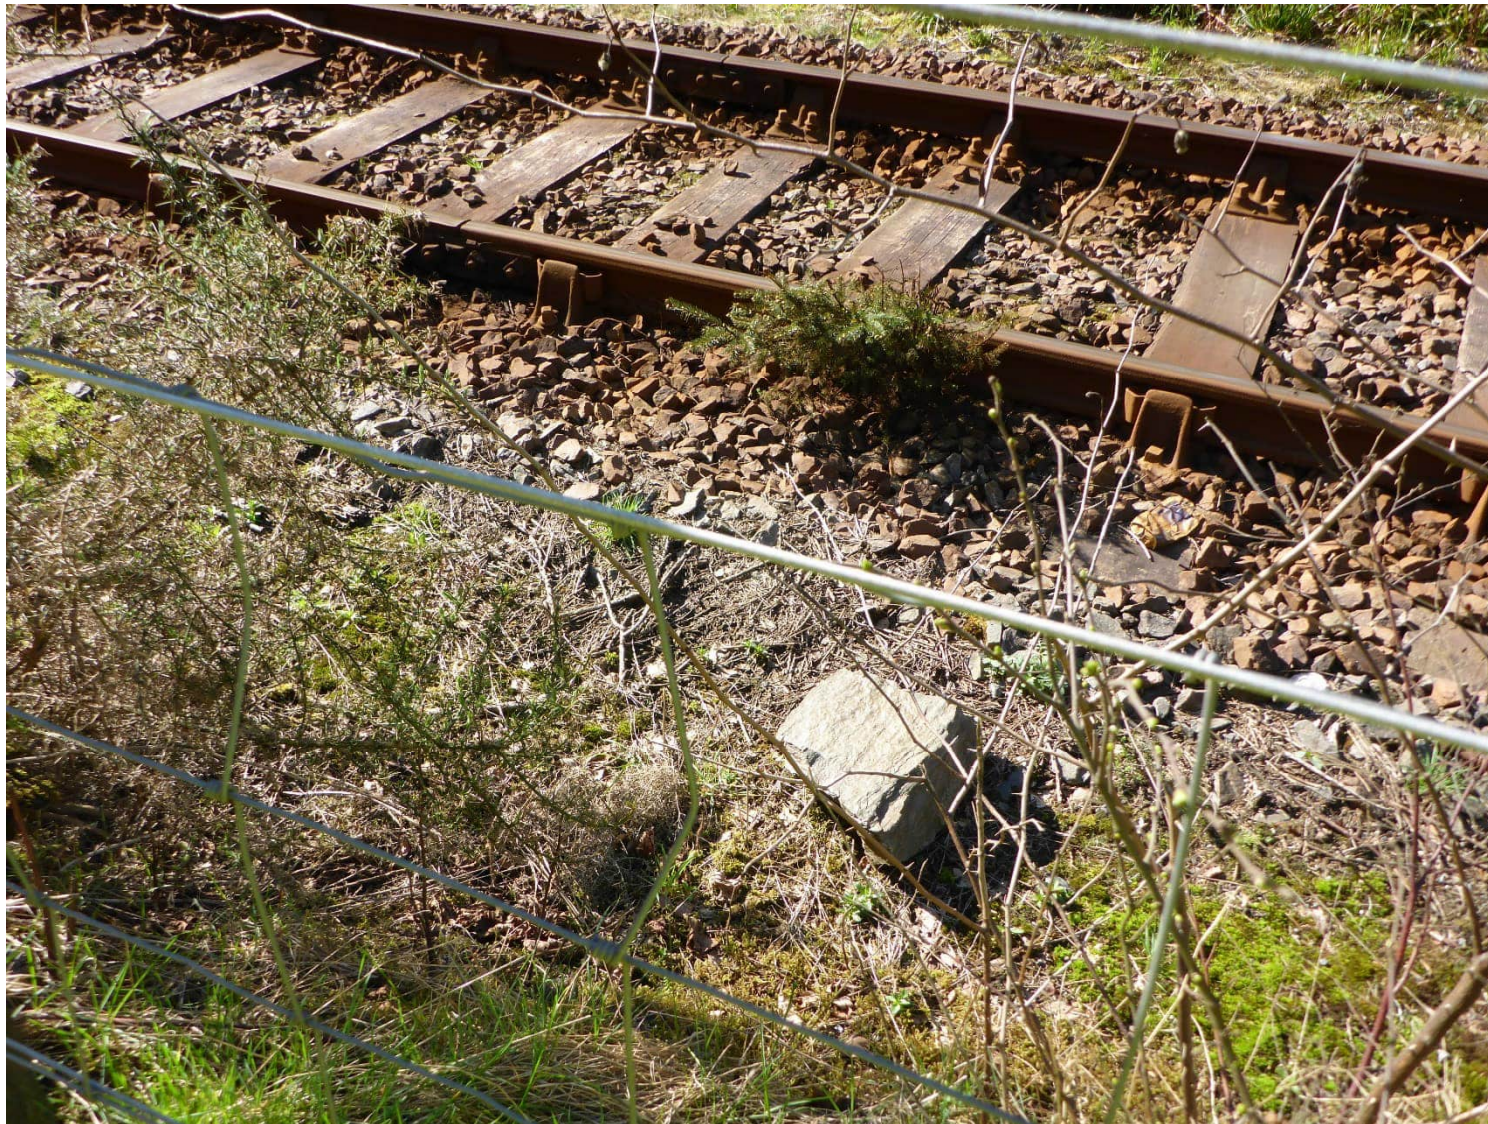
Photograph AA12-4

At Ch. 2428 – Small block in rail boundary c. 0.25m x 0.1m x 0.2m. Most likely that block impacted road/roadside and someone has placed it within the railway boundary to clear it away from the road.

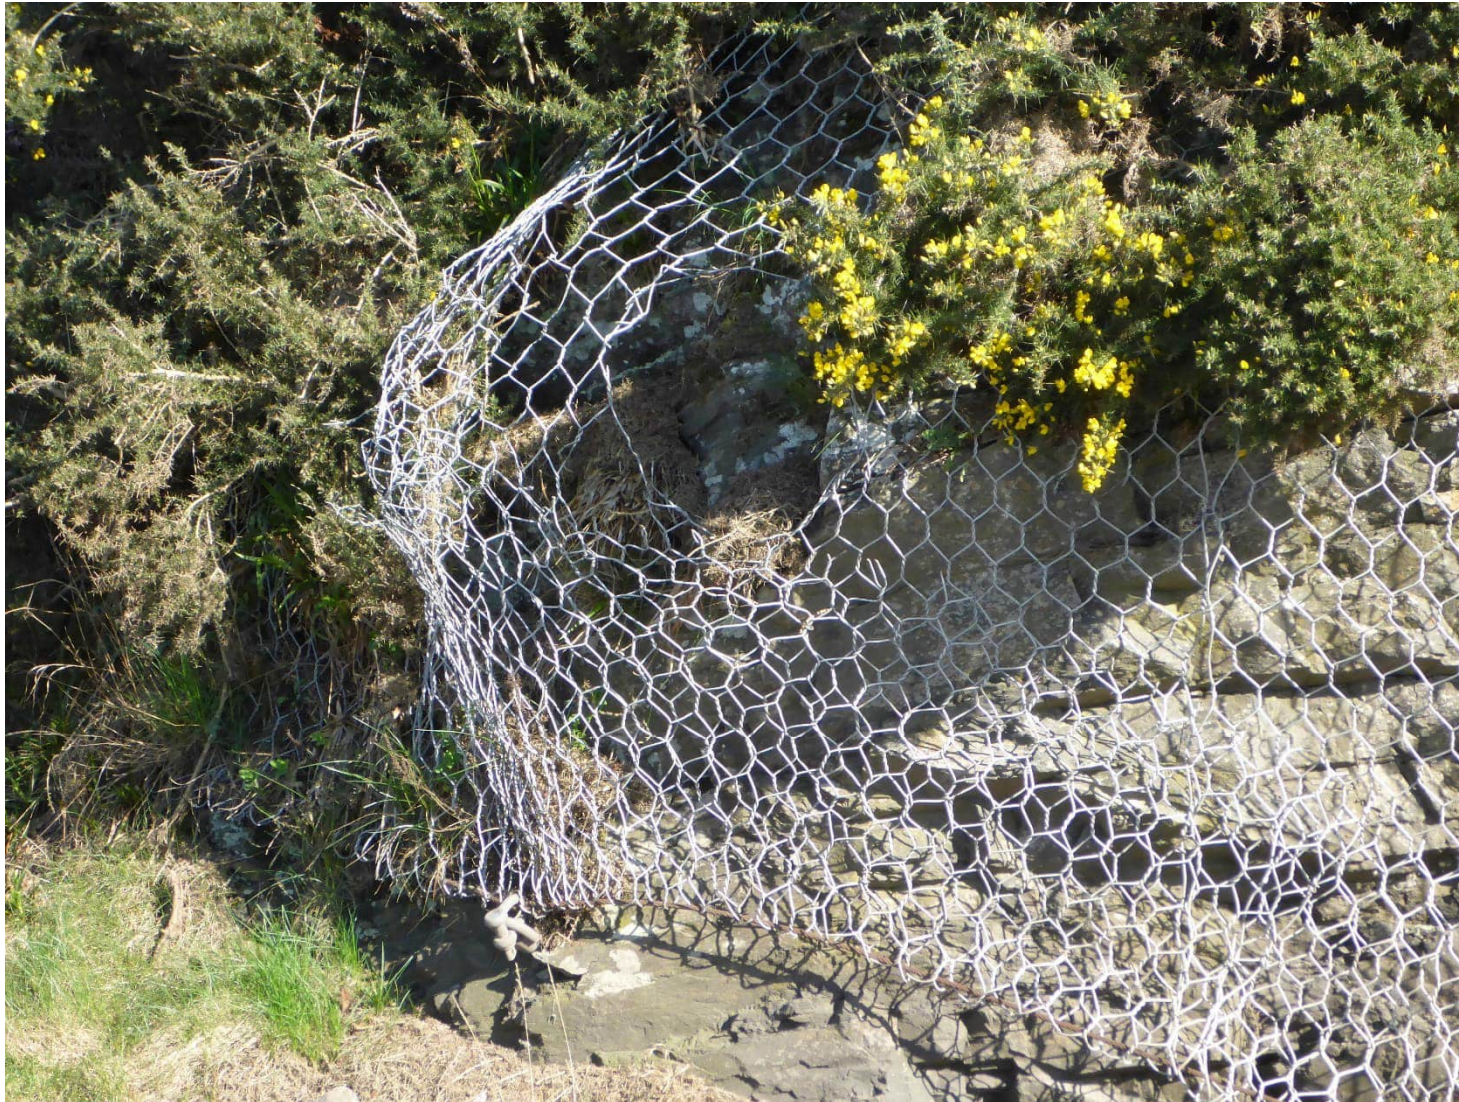
Photograph AA13-1

At Ch. 2518 - Netting has been torn, potentially by grass cutter.

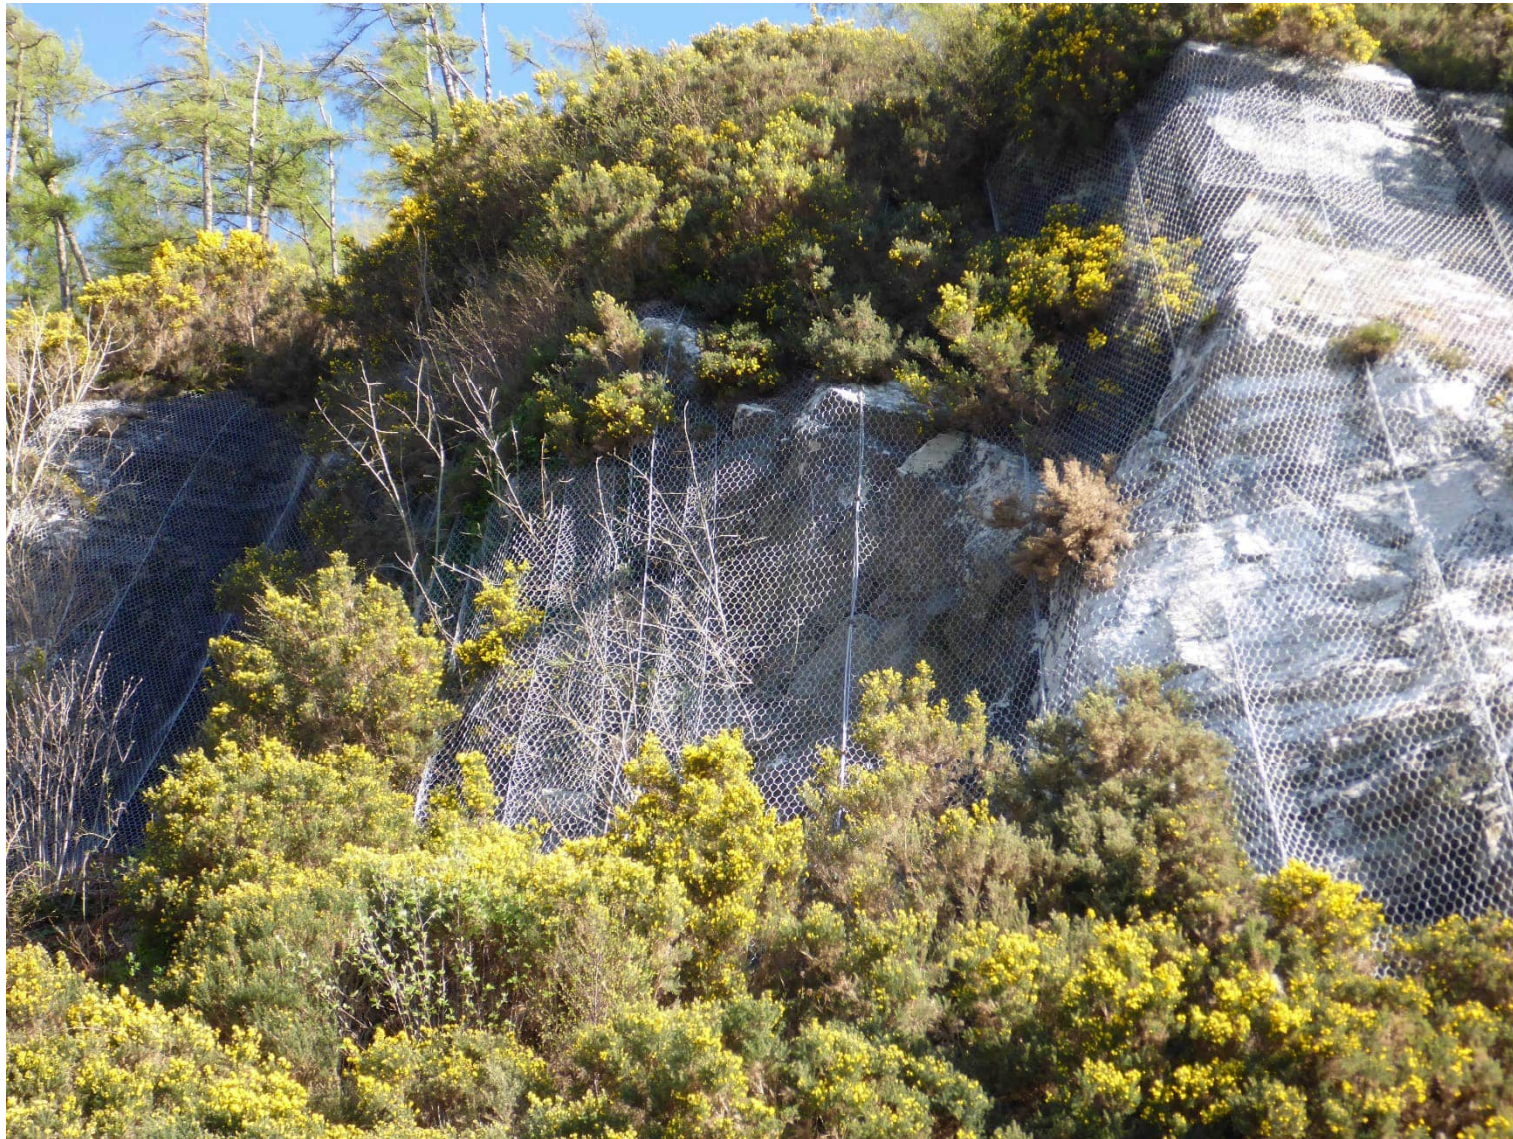
Photograph AA13-2

At Ch. 2535 - Overhanging area c.12 to 15m above toe with gapping mesh below

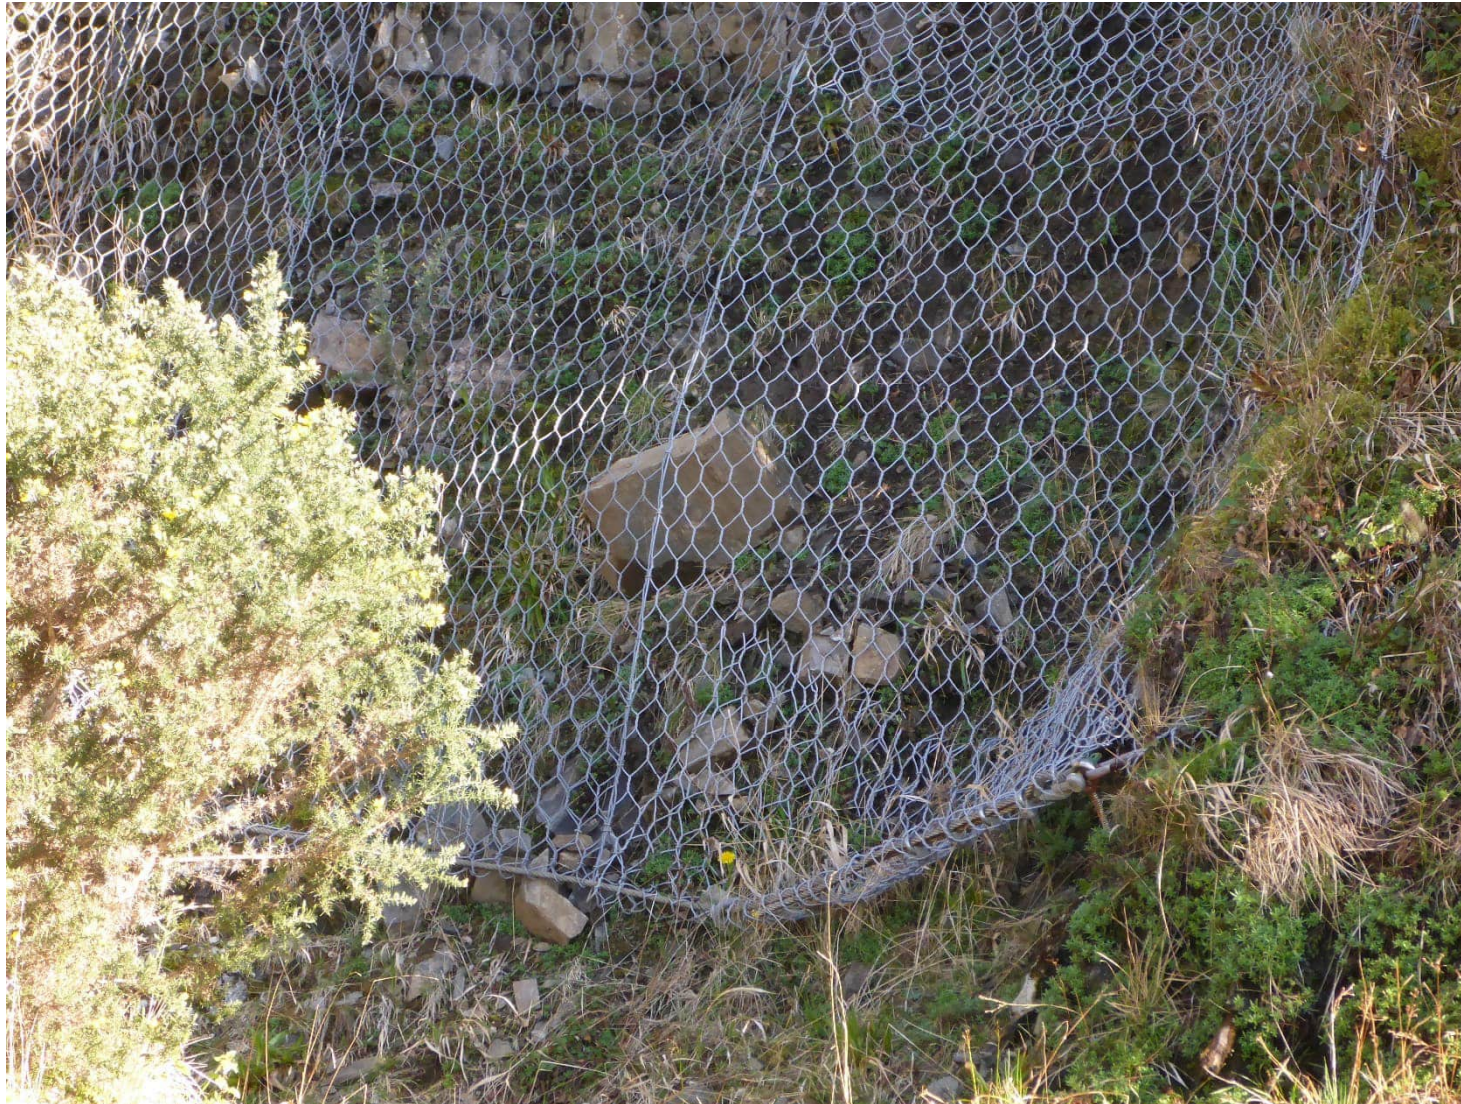
Photograph AA13-3

At Ch. 2545 - Blocks behind netting c.1.5m above toe, source c.5m above toe (0.5m x 0.3m x 0.1m). Not extensively straining/deforming netting. No action required.

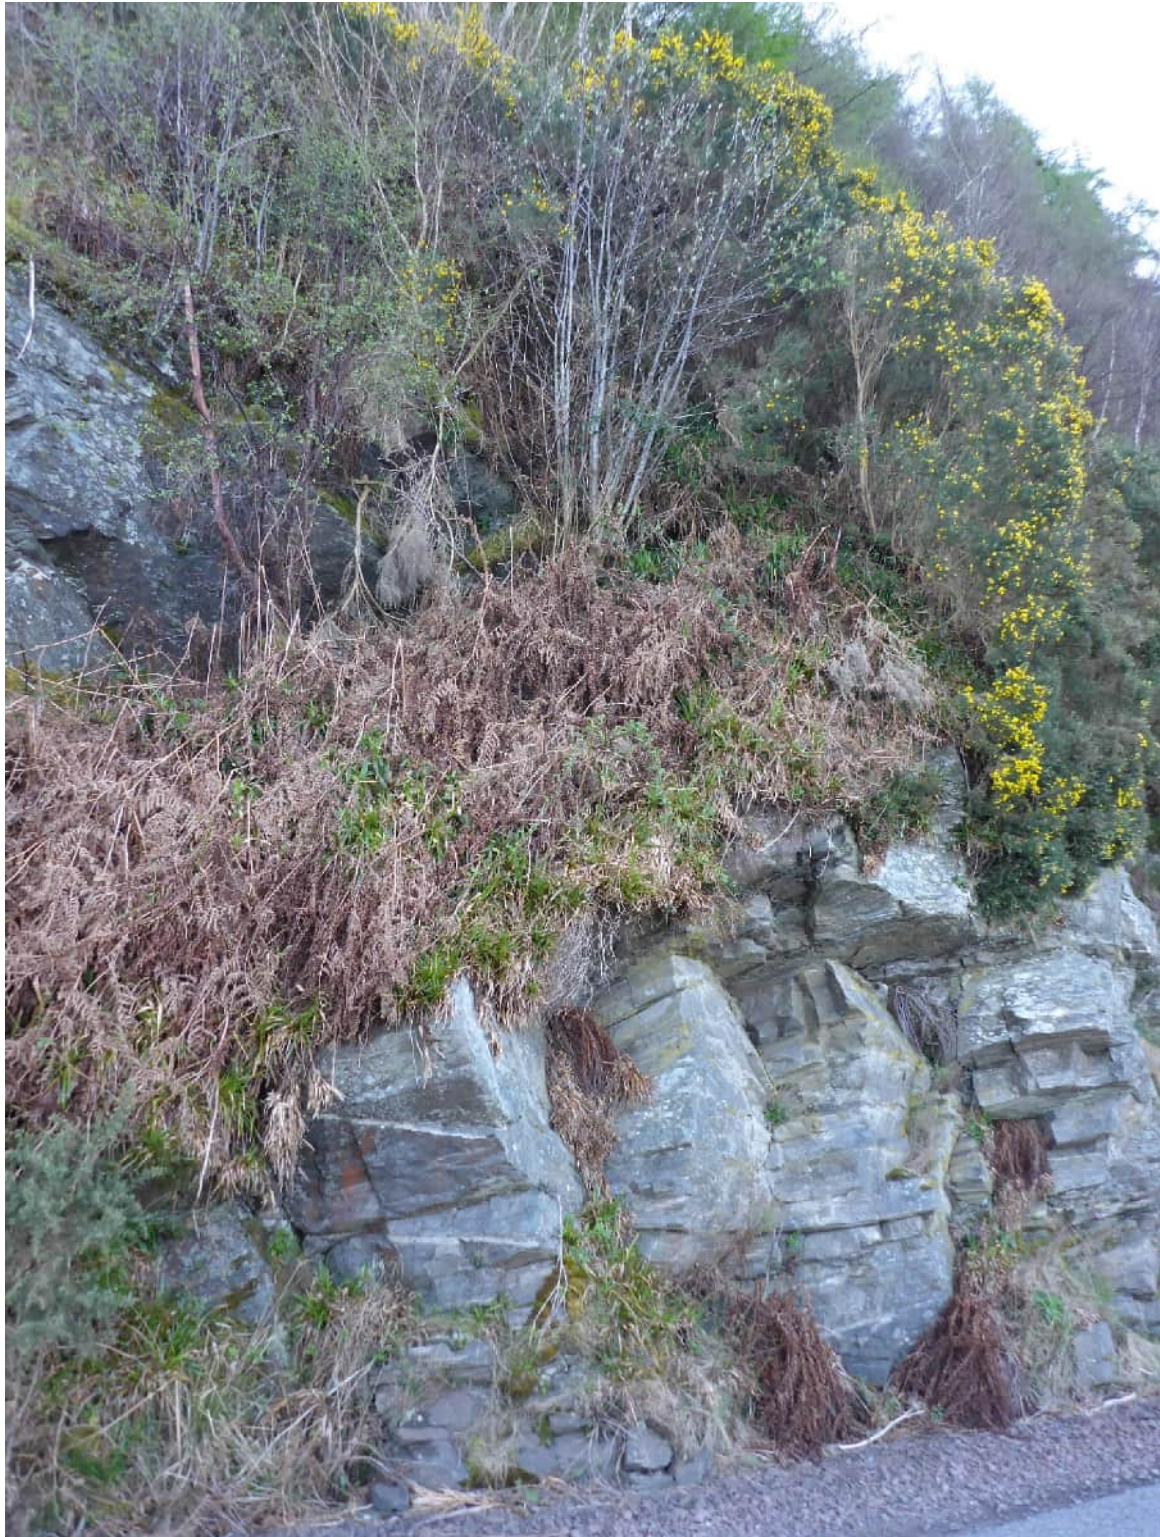
Photograph AA16-1	Between Ch. 2851 to 2872 – Vegetation very well established increasing root-jacking potential.	Year observation first noted: 2023
-------------------	------------------------------------------------------------------------------------------------	------------------------------------

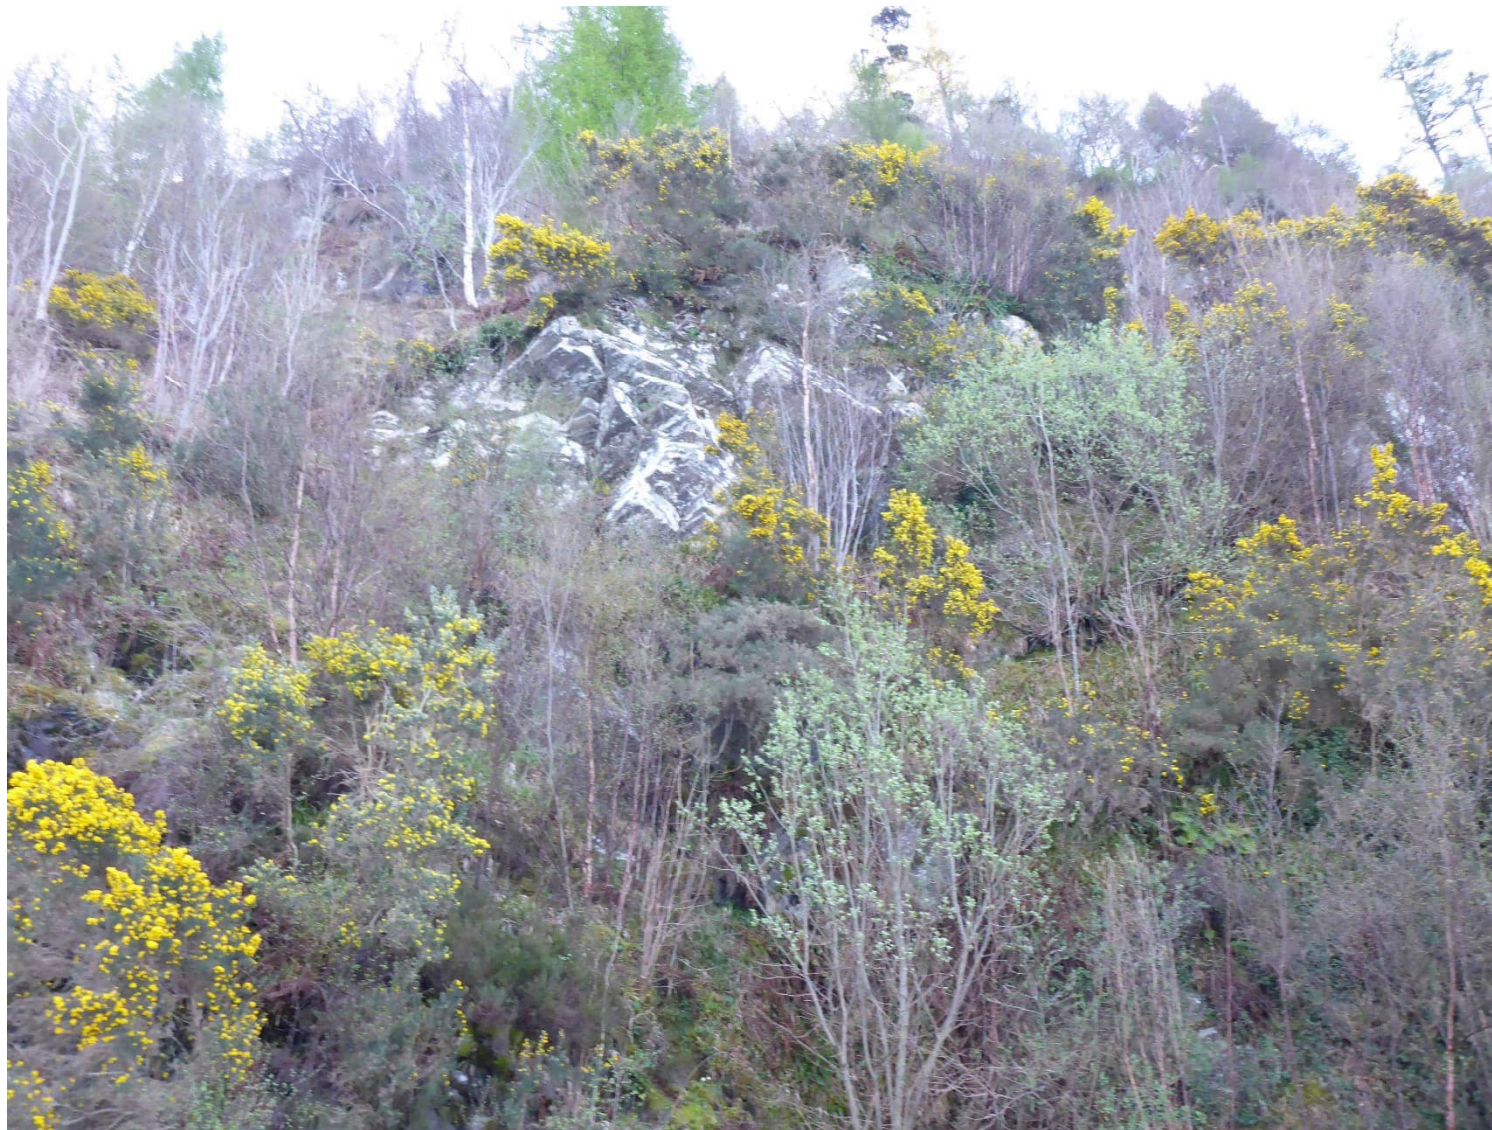
Photograph AA16-2

At Ch. 2910 – Overhang at crest of slope.

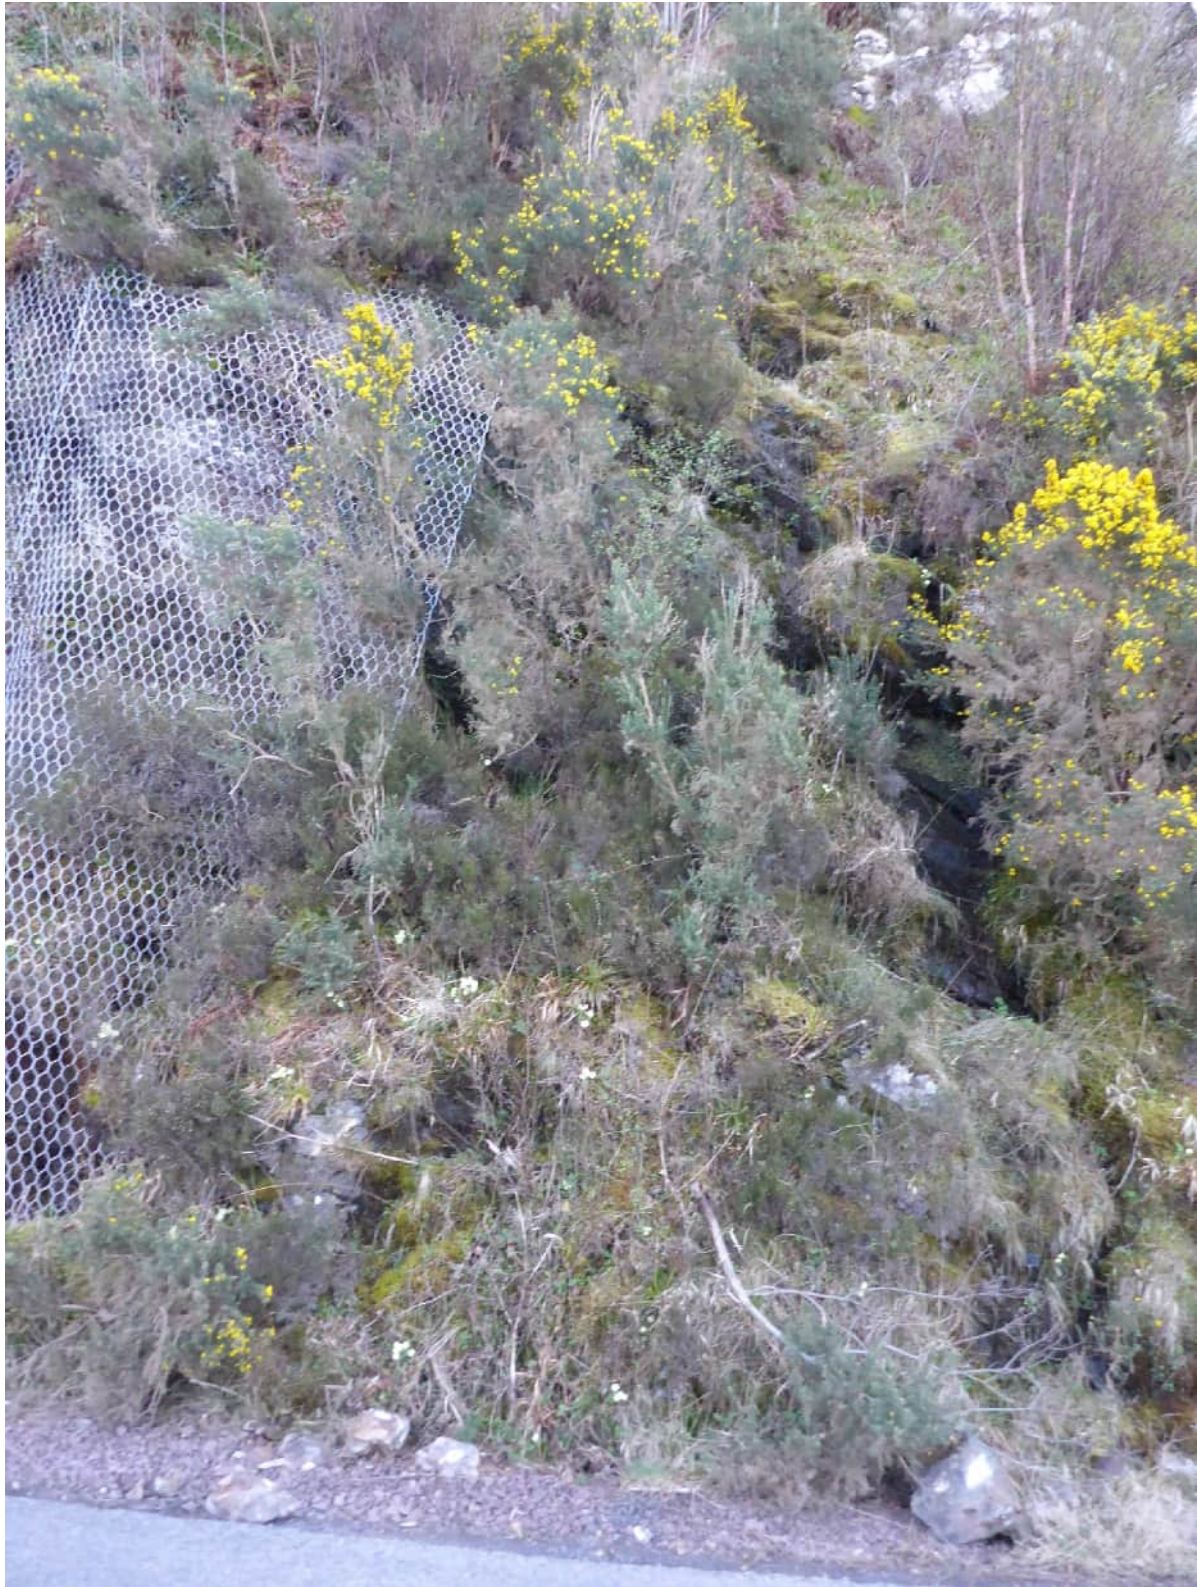
Photograph AA16-3	At Ch. 2922 - 3x small blocks in verge (0.25m x 0.15m x 0.15m). Not known if landed here or moved here. Source unknown.	Year observation first noted: 2023
-------------------	----------------------------------------------------------------------------------------------------------------------------	------------------------------------

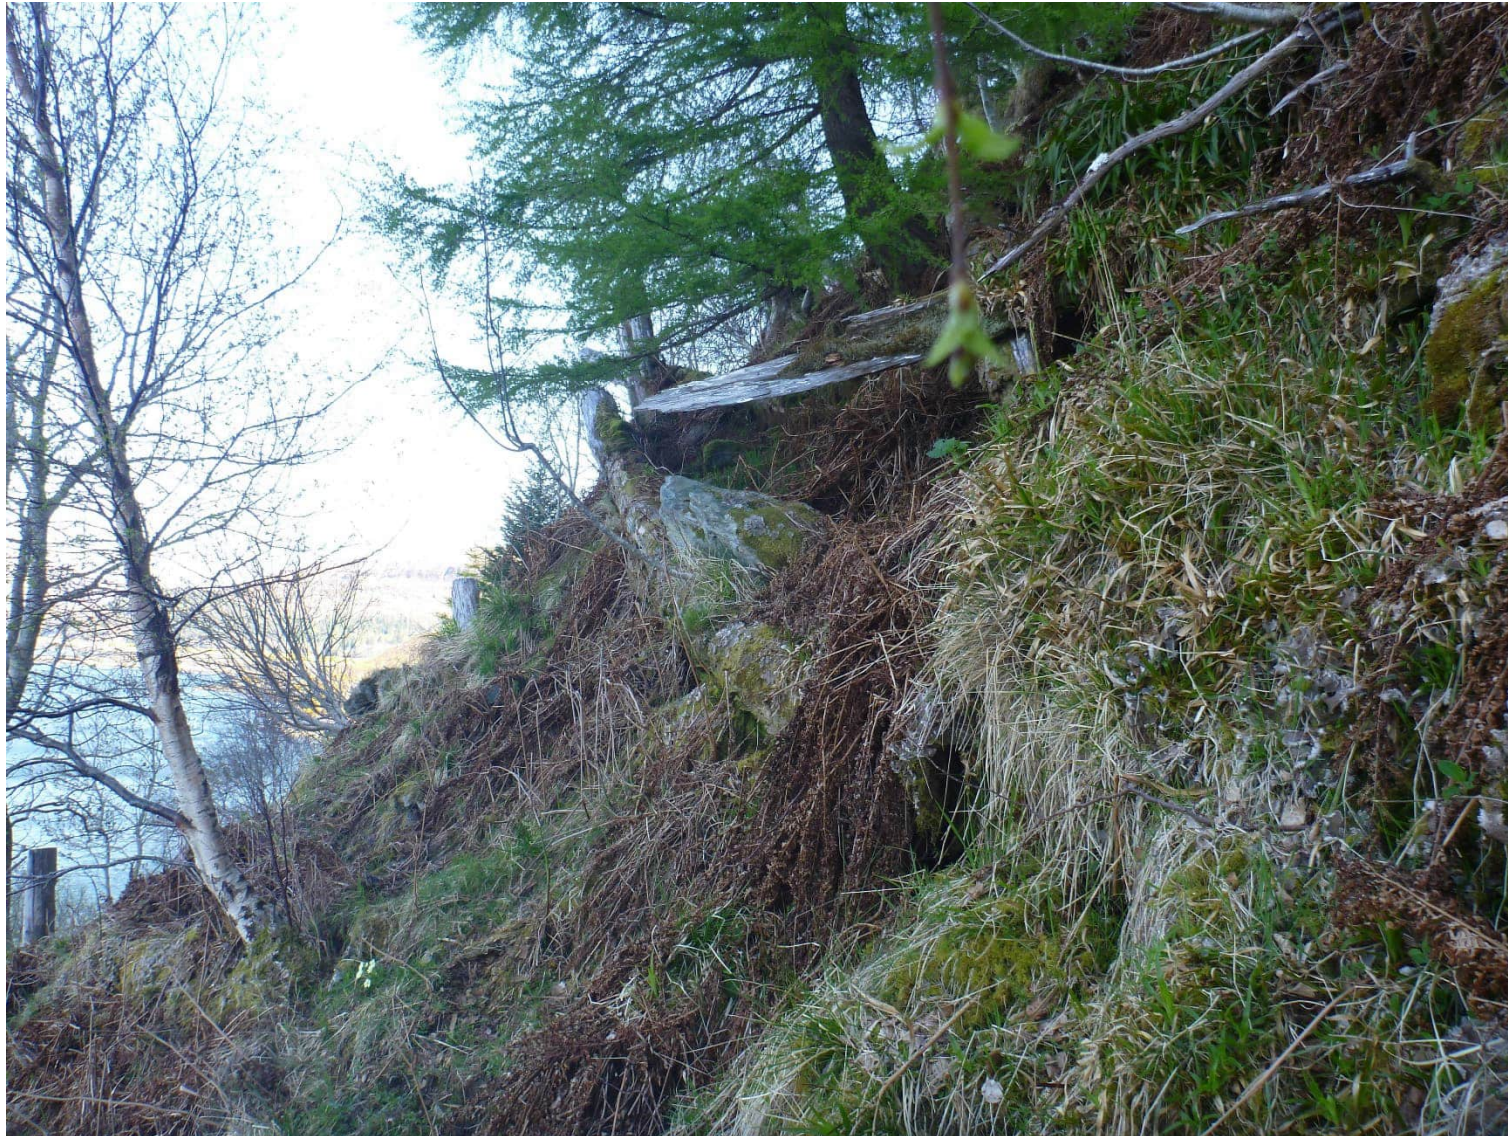
Photograph AA16/17U-1

Example of block resting against fallen tree trunk. This one is at NGR NG 91103 37585 ± 5 m, alt. 50 ± 5 m. Block 1.0x0.5x0.5m.

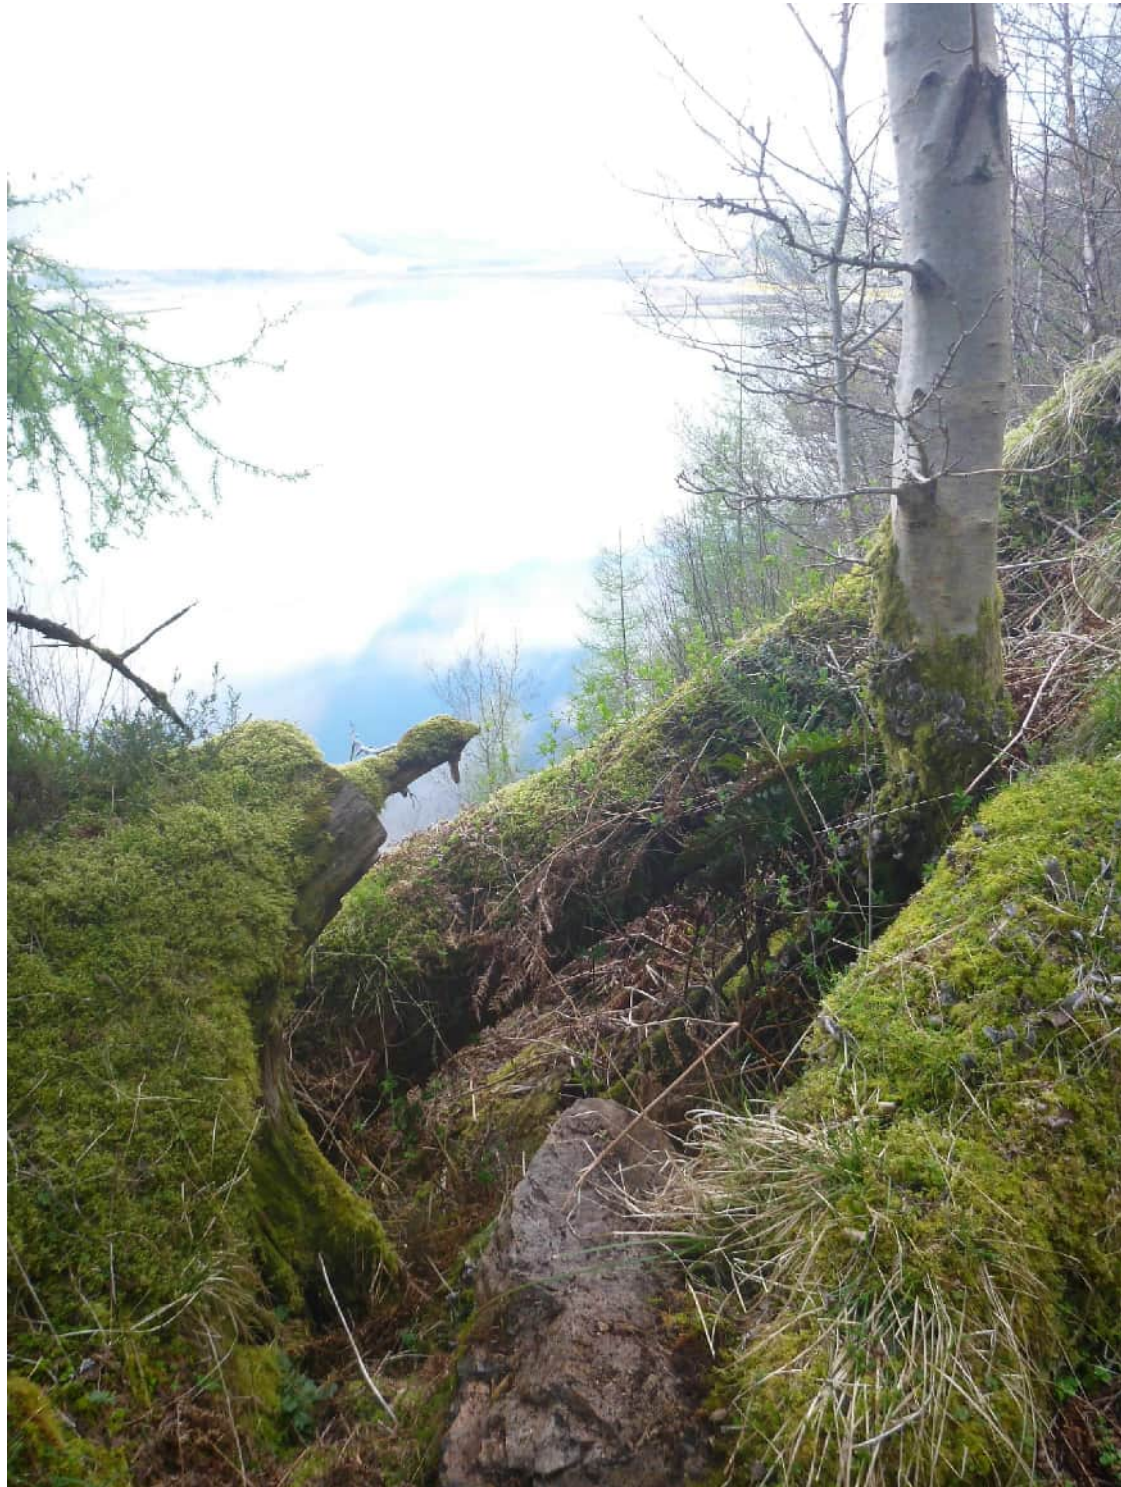
Photograph AA18U-1	High above AA18 - loose block lying on ground amongst fallen long tree trunks. Block elongate and 1.2m max dimension.	Year observation first noted: 2023
--------------------	-----------------------------------------------------------------------------------------------------------------------	------------------------------------

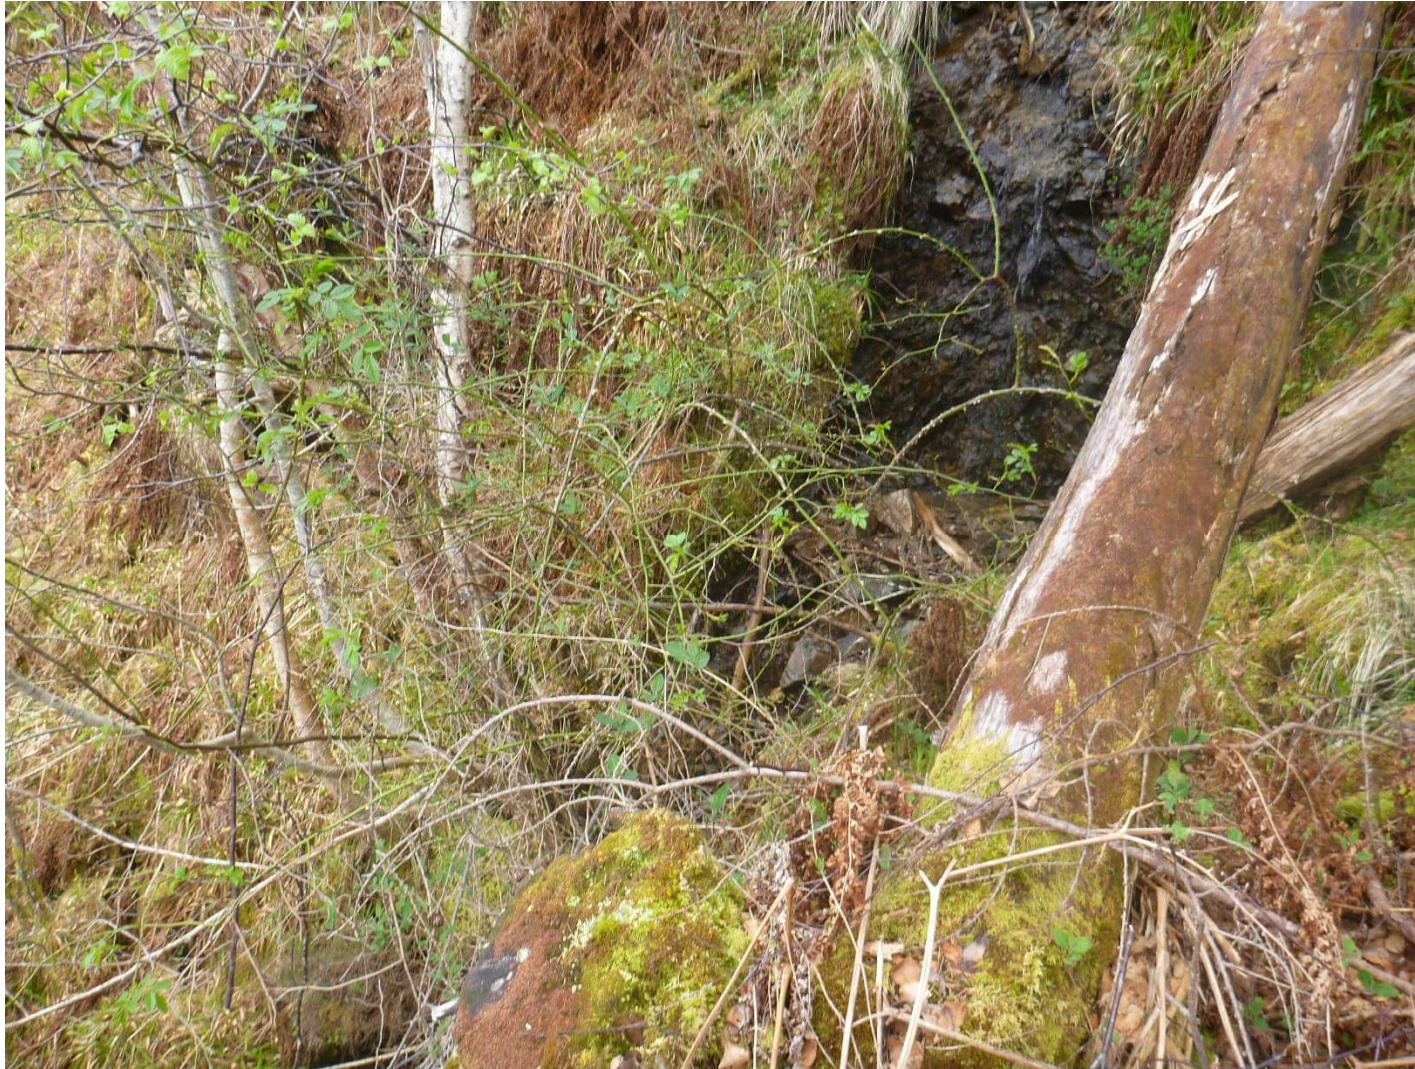
Photograph AA18U-2	Year observation first noted 2023	High above AA18 - Debris 'dams' of blocks and branches in water course. Likely source of some block falls
-----------------------	--------------------------------------	-----------------------------------------------------------------------------------------------------------
