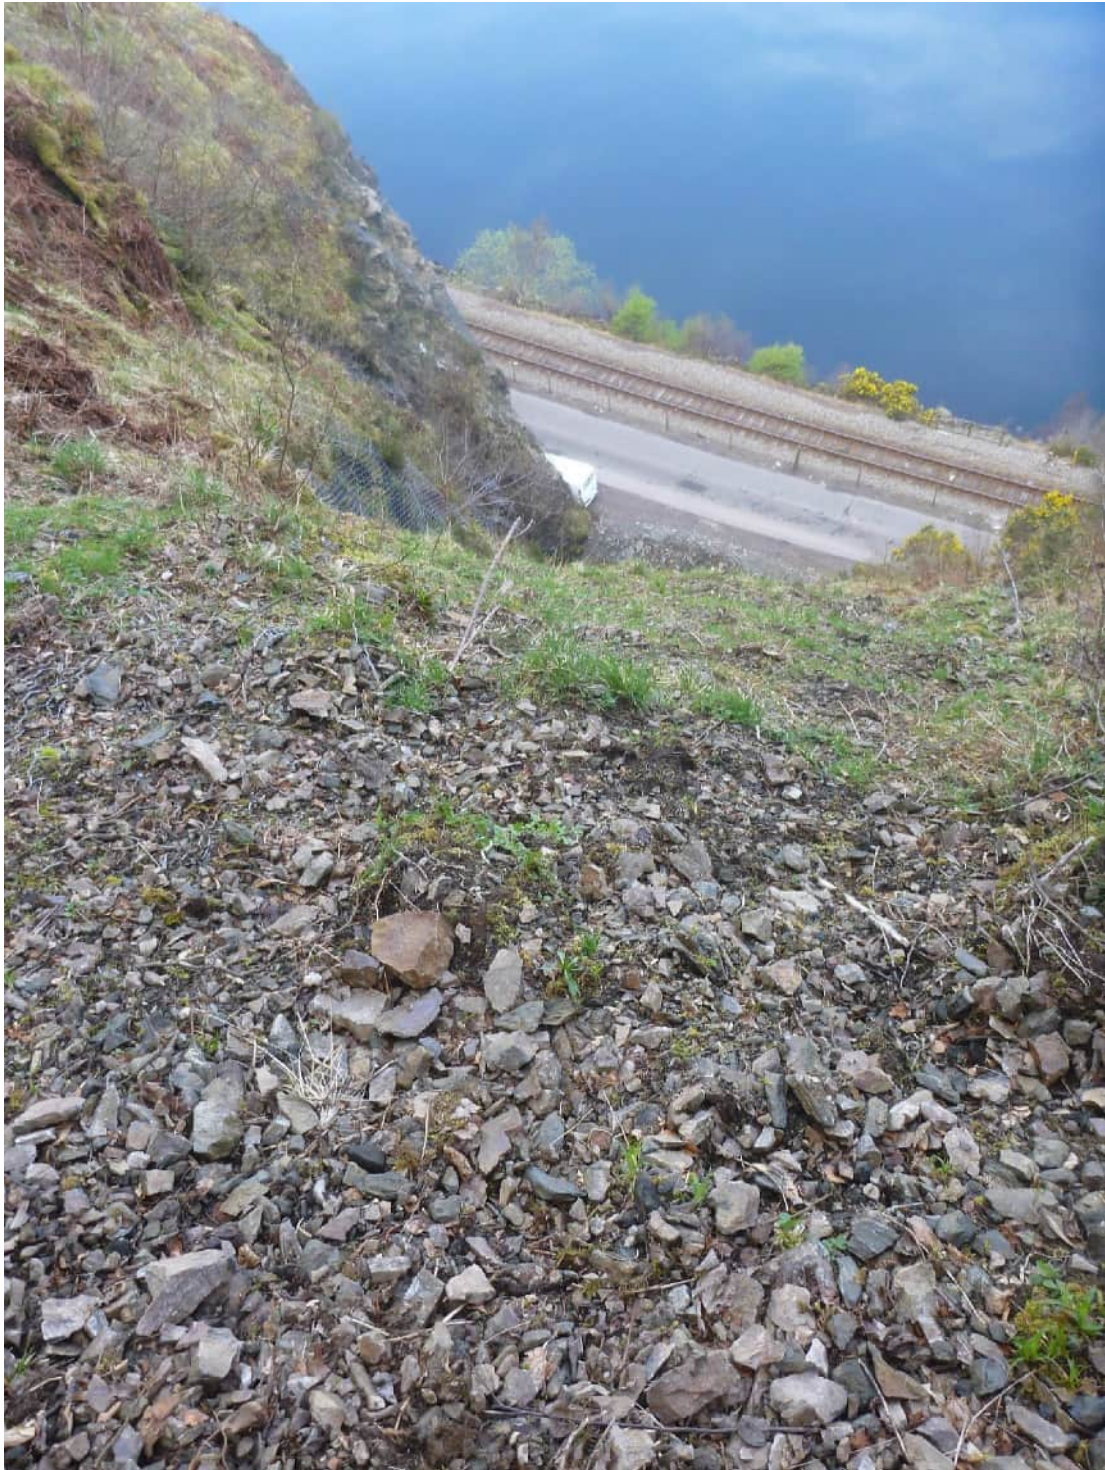
Photograph AA18U-3	High above AA18 - Scree area cleared in September 2022 emergency works – scree is re-accumulating and needs to be cleared again.	Year observation first noted: 2023
--------------------	----------------------------------------------------------------------------------------------------------------------------------	------------------------------------

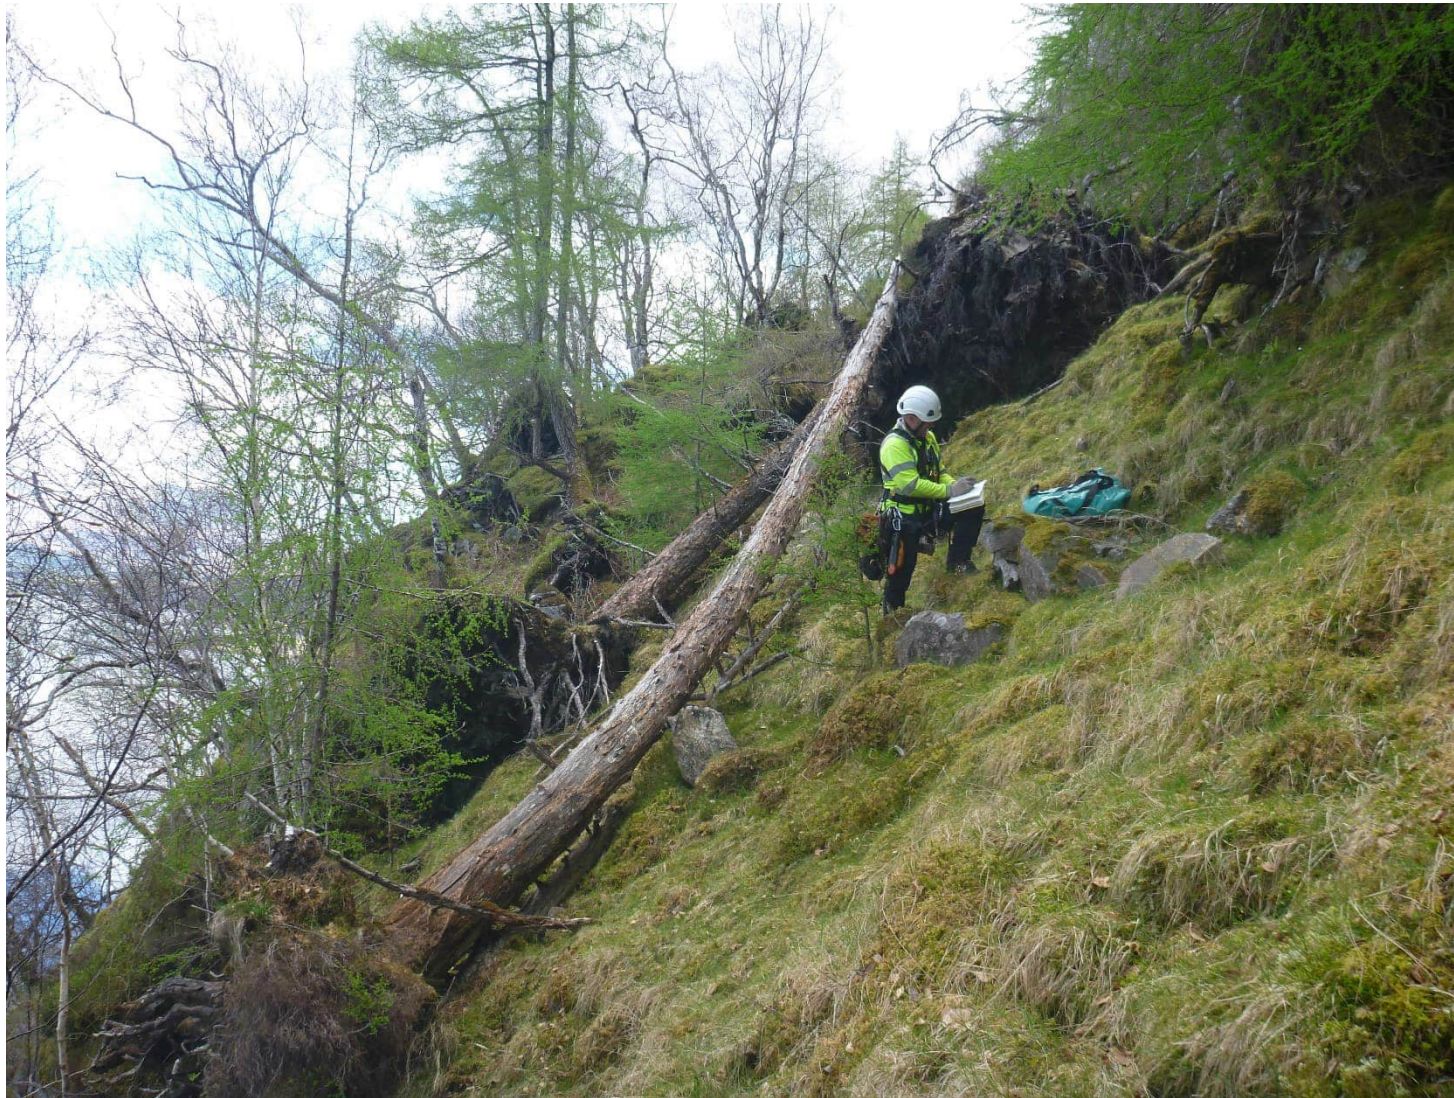
Photograph AA18U-4

High above AA18 - several fallen trees with elevated root balls containing blocks/hanging blocks

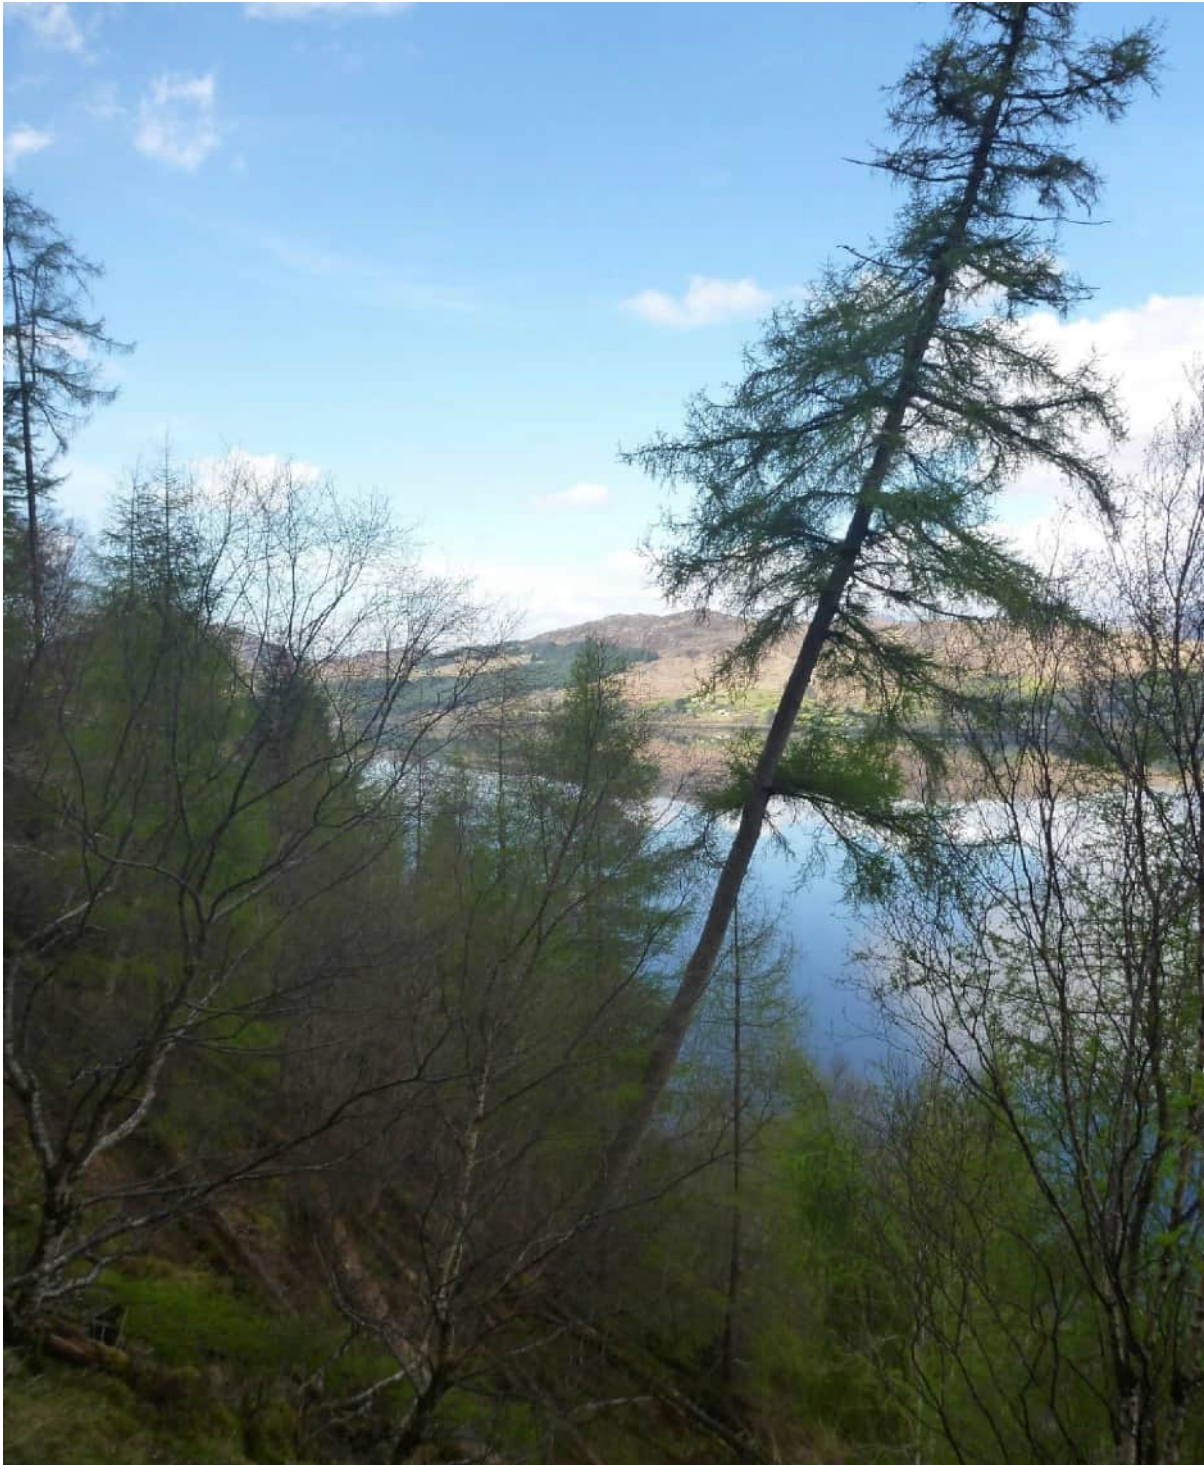
Photograph AA18U-5	High above AA18 - A very tall tree leaning at 20° (bearing 290° from NGR location, ca. 30 – 35m away)	Year observation first noted: 2023
--------------------	-------------------------------------------------------------------------------------------------------	------------------------------------

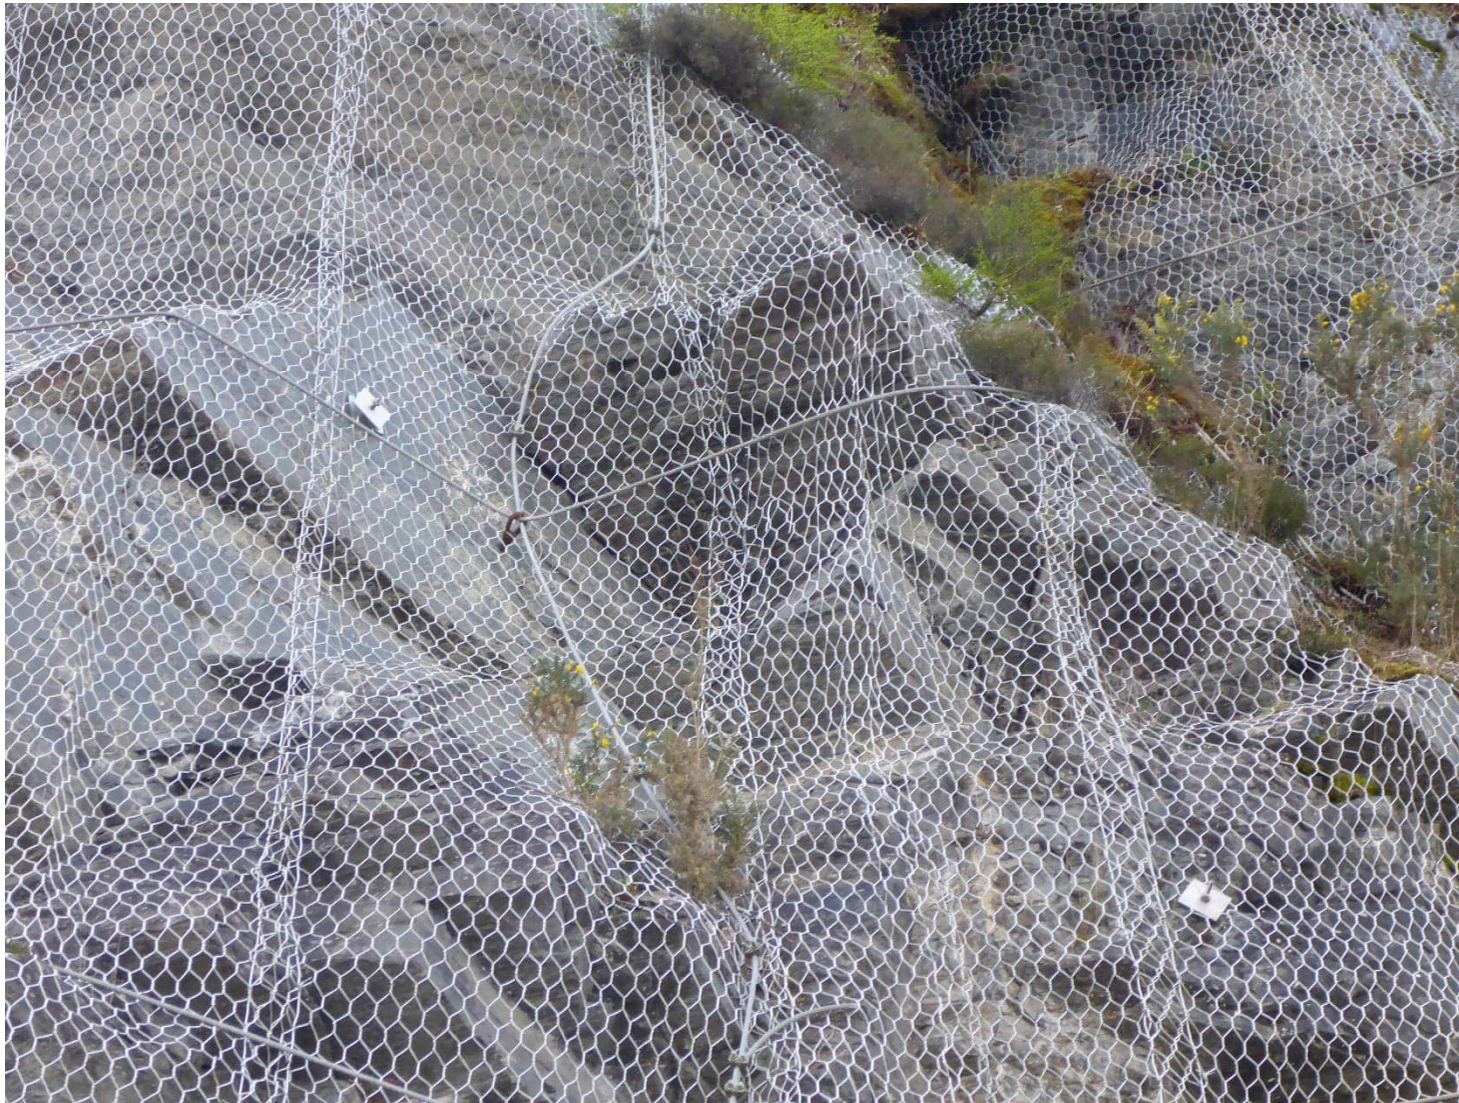
Photograph AA17-1

At Ch. 2965 - Large wedge approximately 10m above road level, with smaller wedge above.

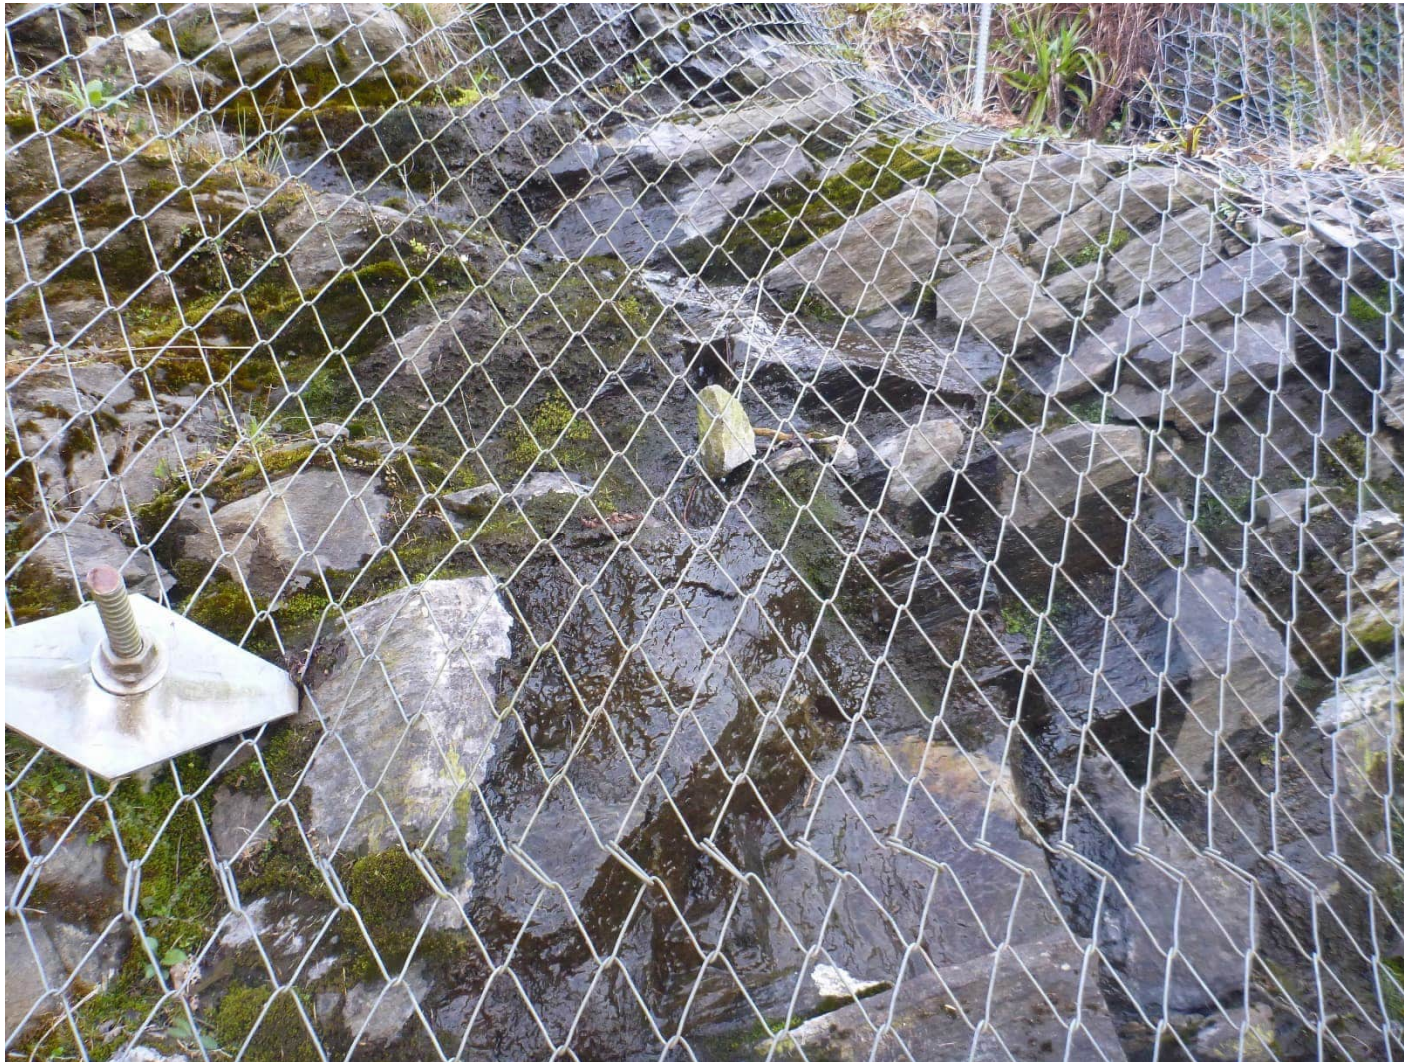
Photograph AA18-1

At Ch. 2990 (rope access) – TECCO netting in good condition

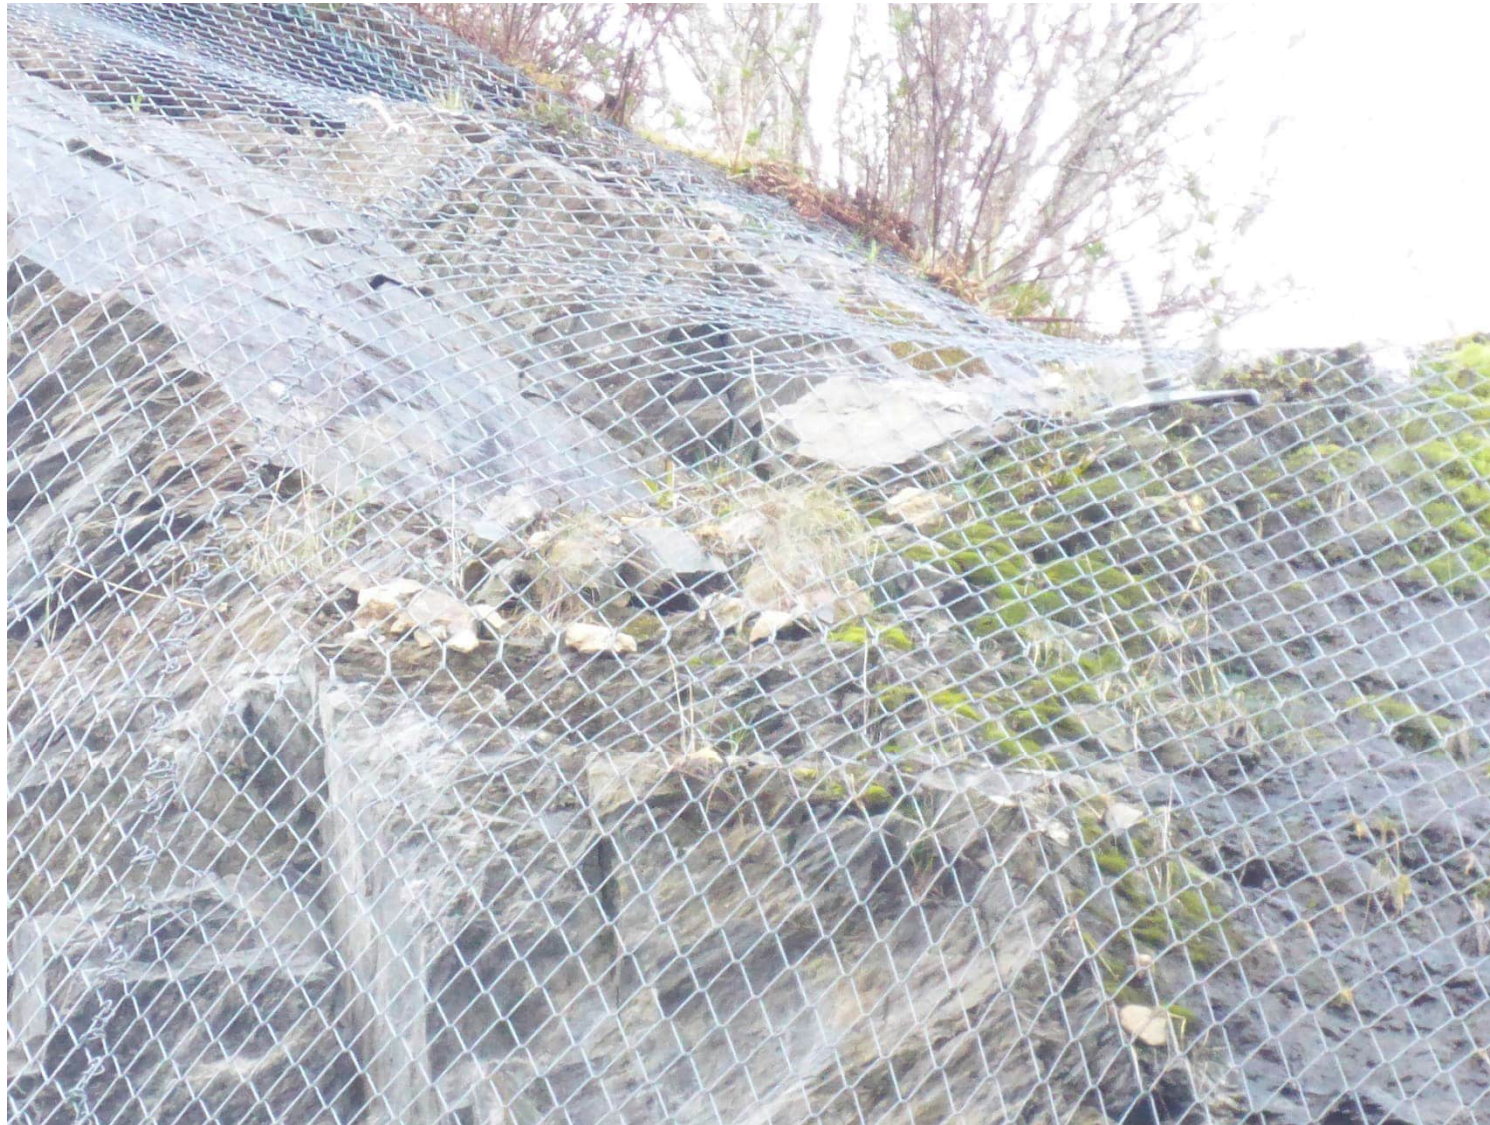
Photograph AA18-2

At Ch. 2995 - Some loose blocks behind netting near crest. One block c.0.15m x 0.15m x 0.15m caught behind netting and pulling netting out slightly from slope.

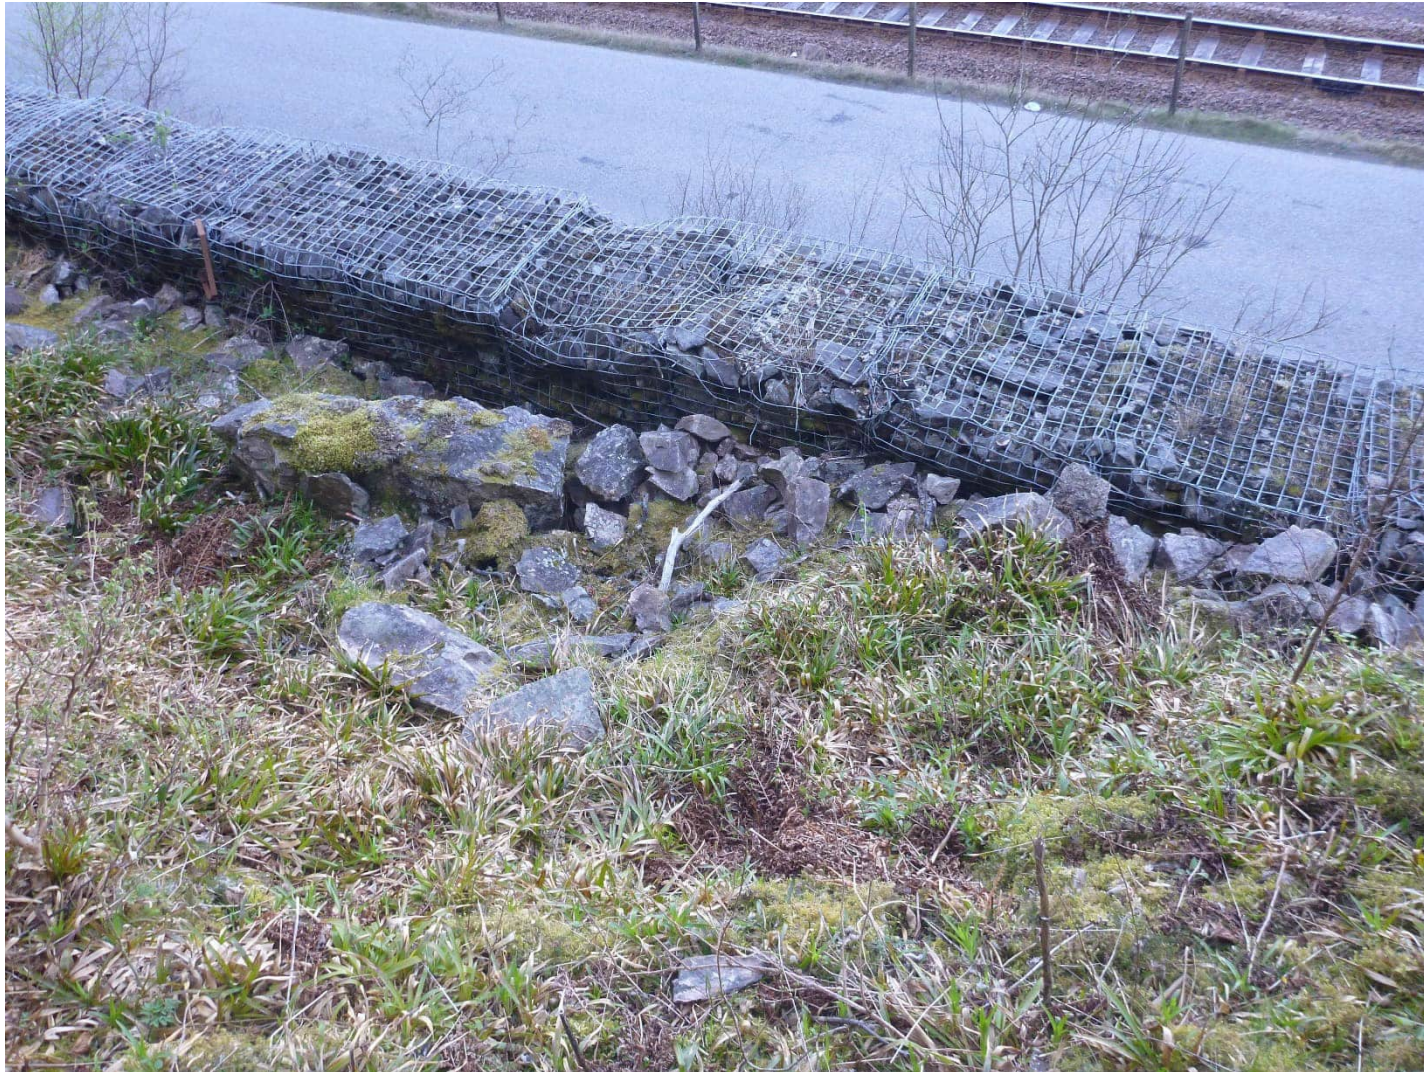
Photograph AA19-1

At Ch. 3145 - Parts of mesh around gabions are damaged. Would be beneficial to clear out debris behind the gabions.

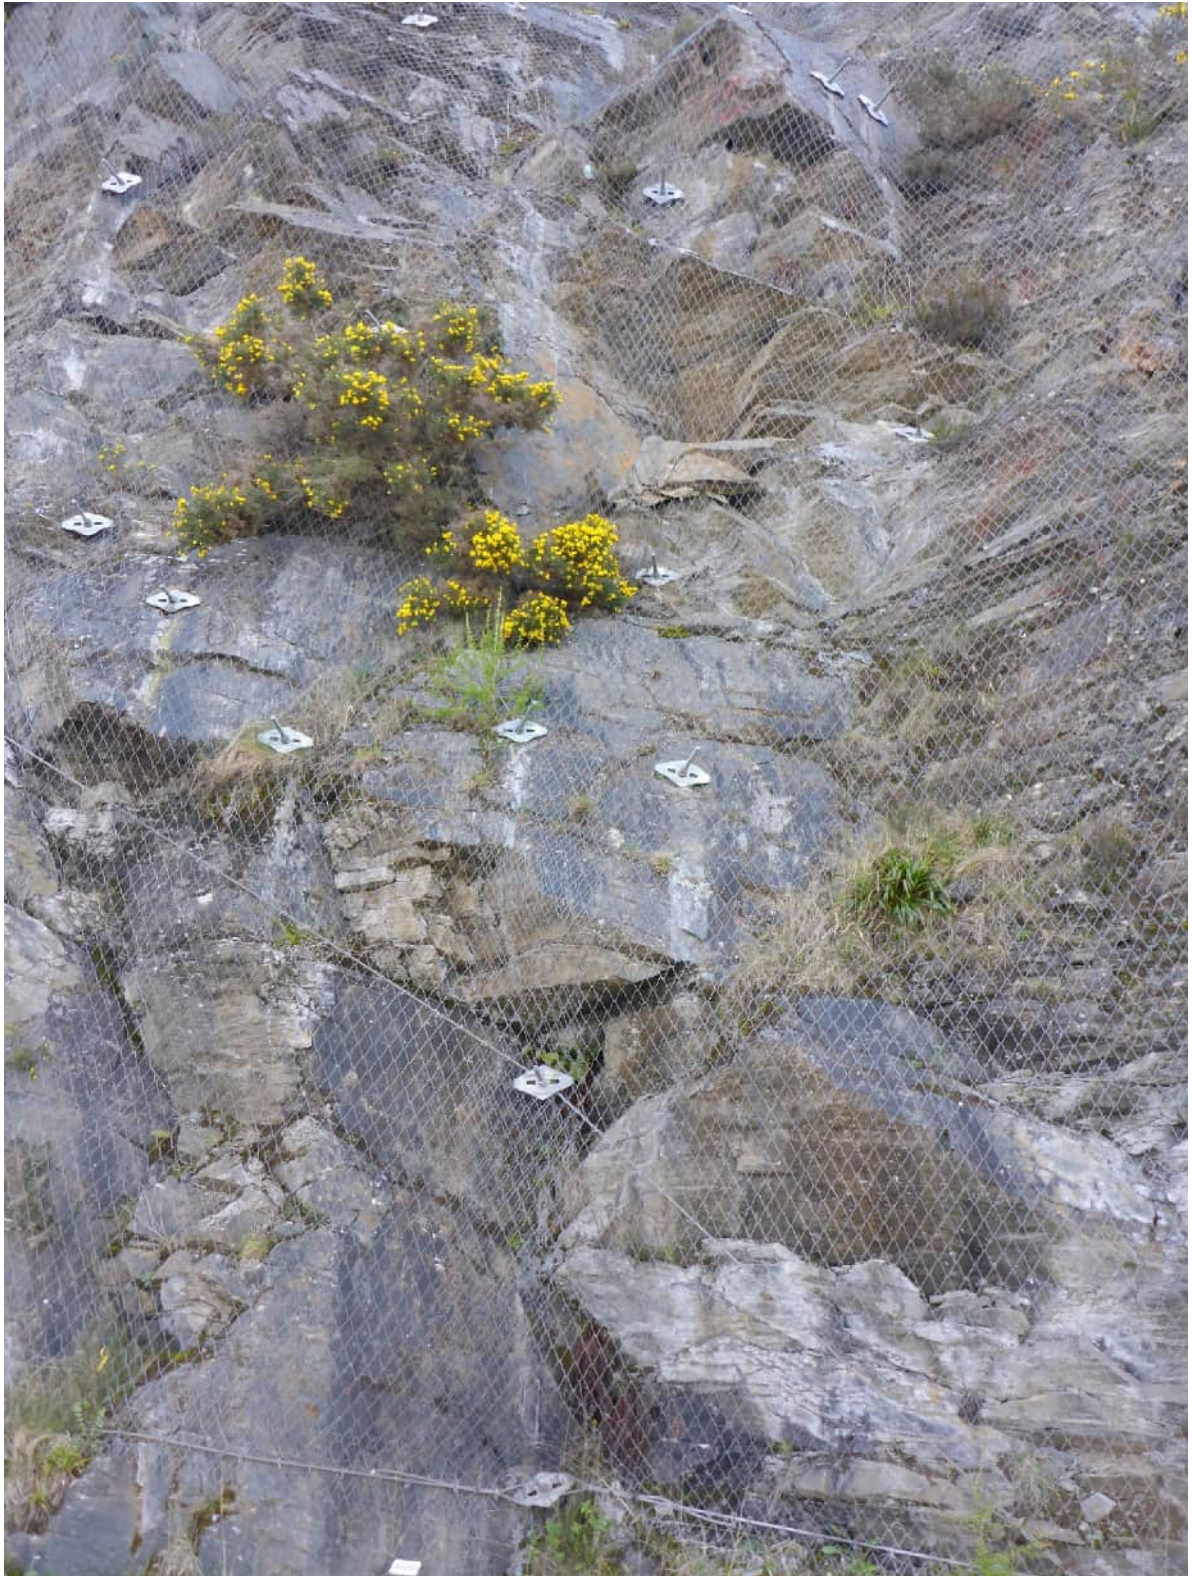
Photograph AA19-2	At Ch. 3100 - 0.25m ³ failure retained by netting system c.6-8m above road.	Year observation first noted: 2018
-------------------	----------------------------------------------------------------------------------------	------------------------------------

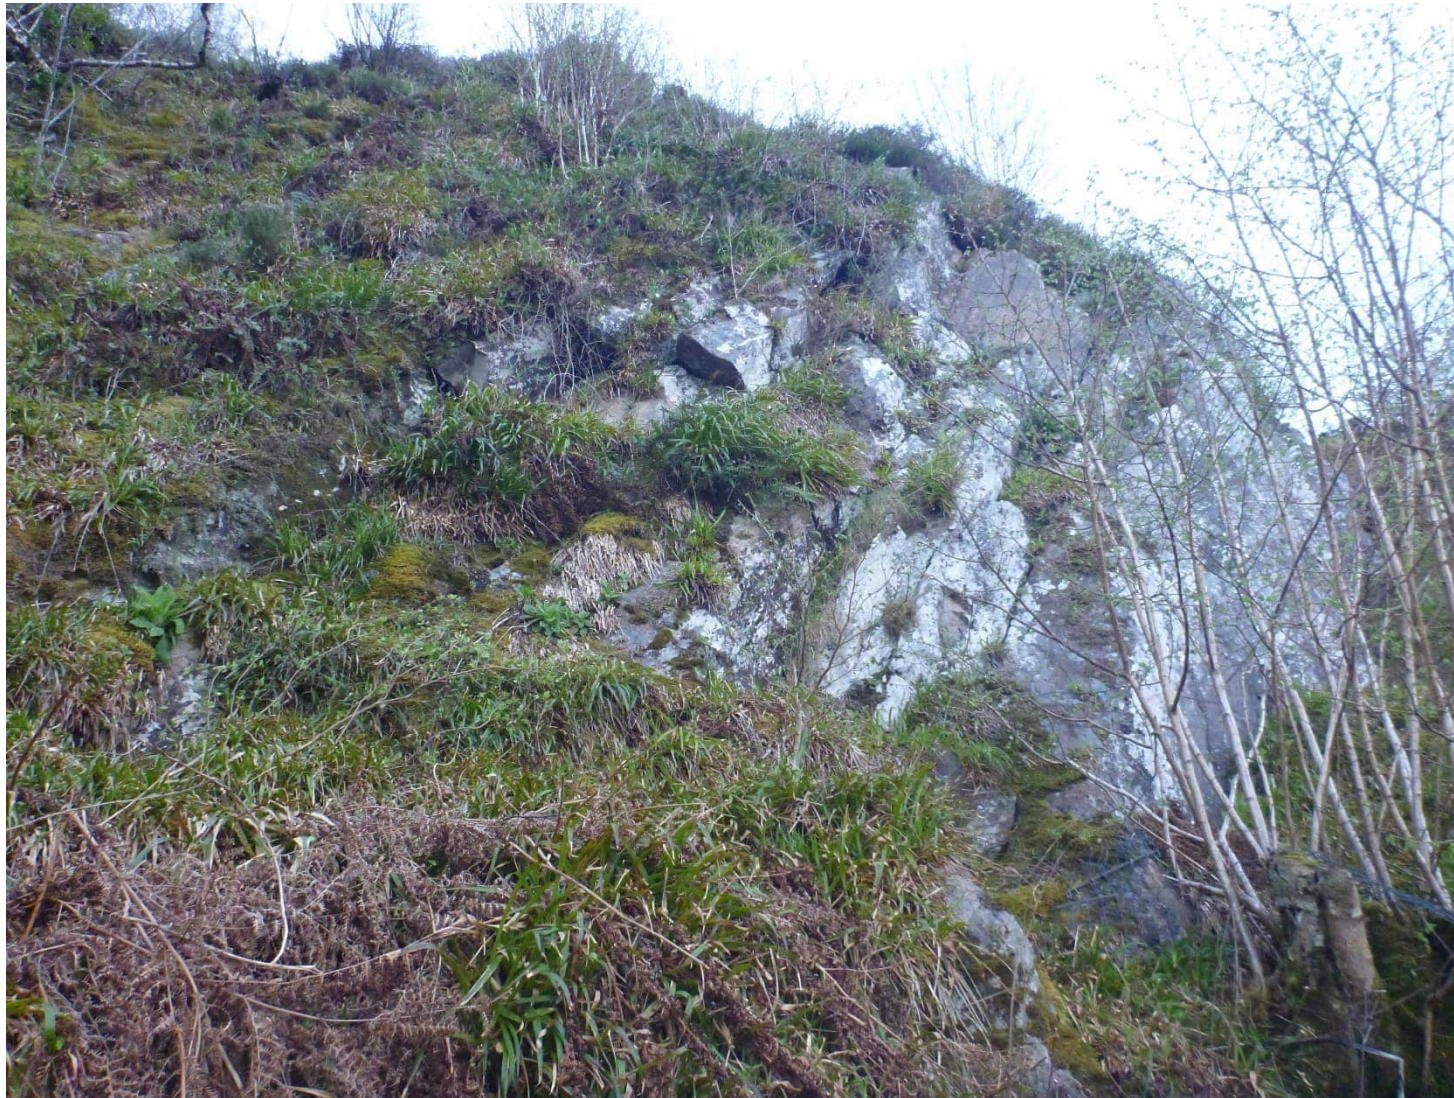
Photograph AA19U-1

At Ch. 3145 (Rope Access) – Sporadic areas of rock exposure with occasional dilated joints and root jacking potential.

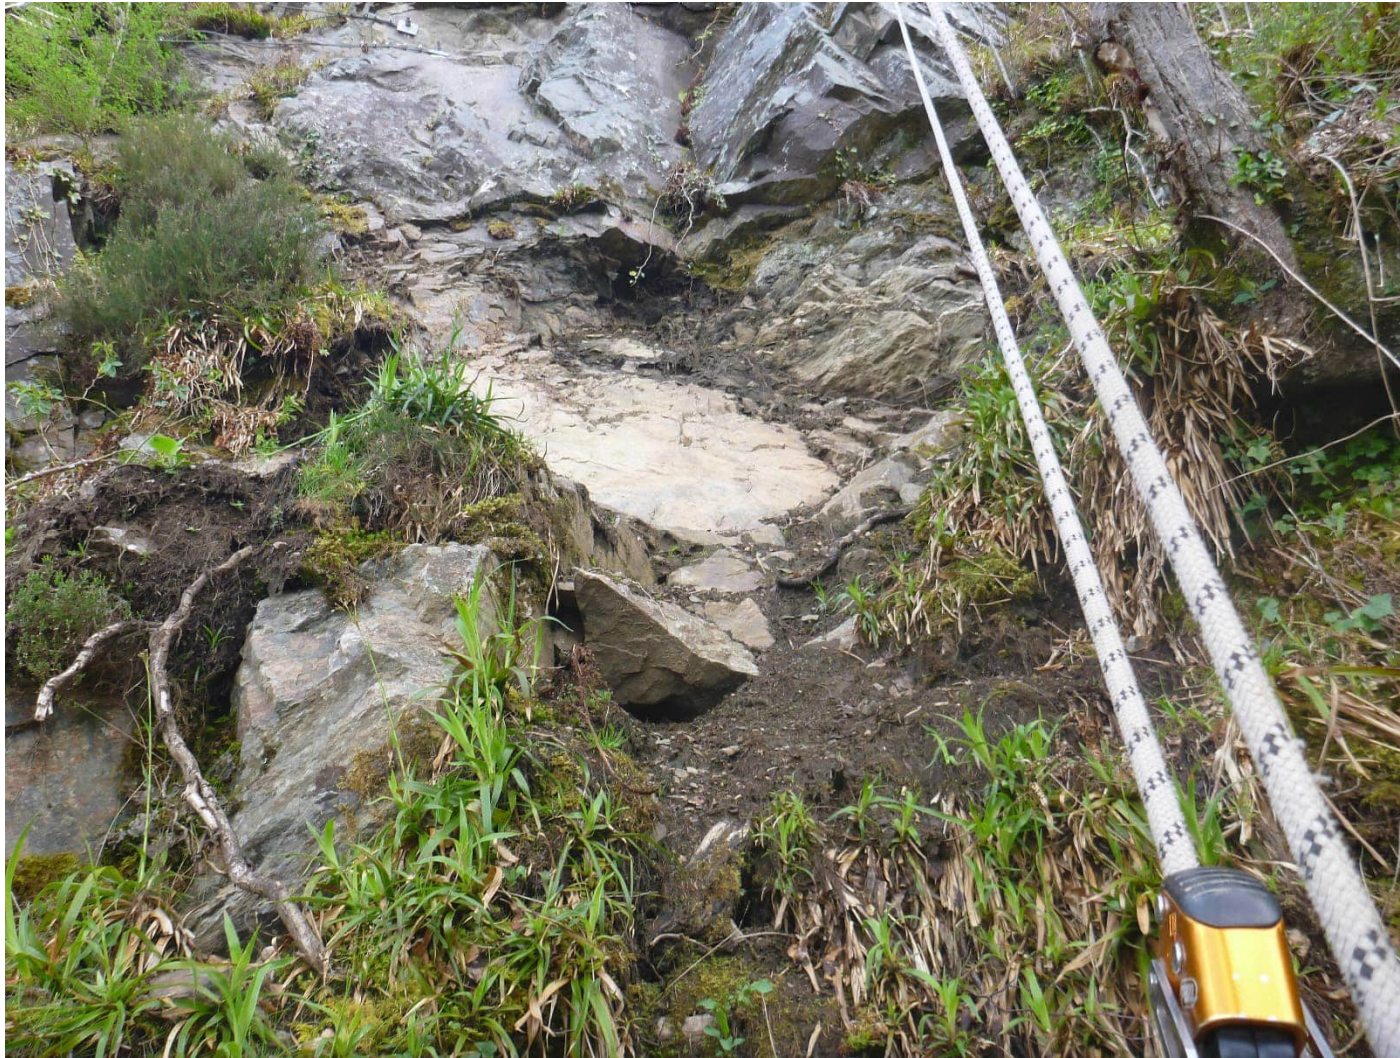
Photograph AA19U-2

Rope access inspection to assess upper crags at AA19U. Potential source area of the 2nd March 2023 Rock Fall.

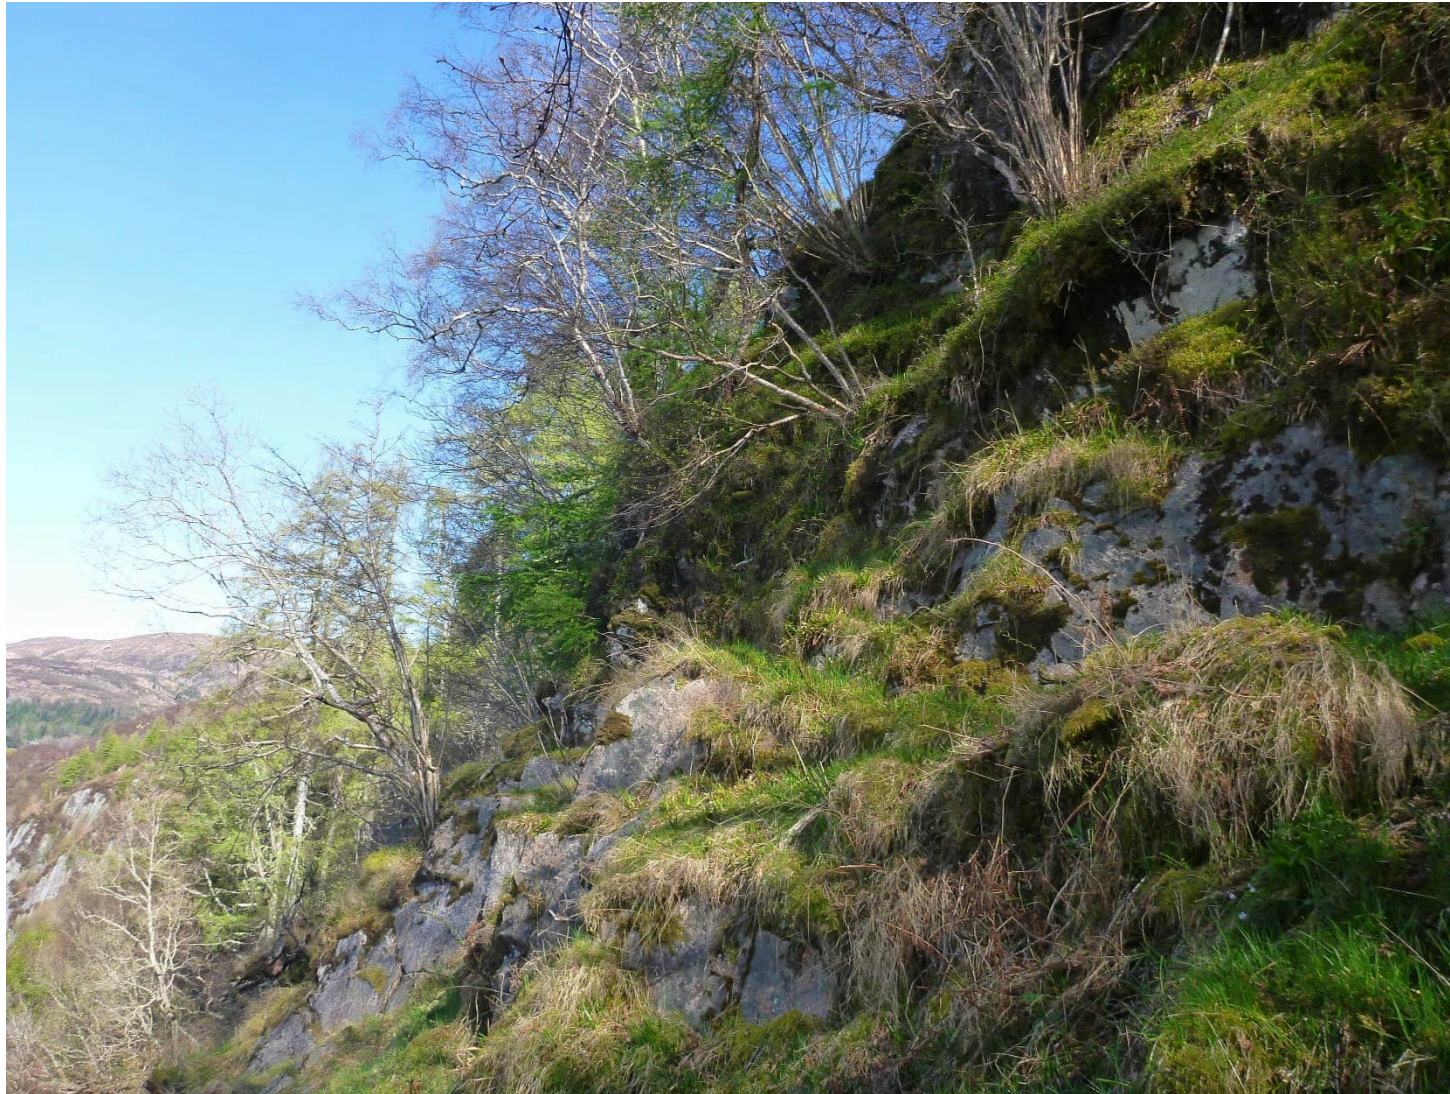
Photograph AA19U-3

Rope access inspection to assess upper crags at AA19U. Crags generally massive but there are areas where exposed faces have dilated joints and blocks could release. Risk of root-jacking observed also.

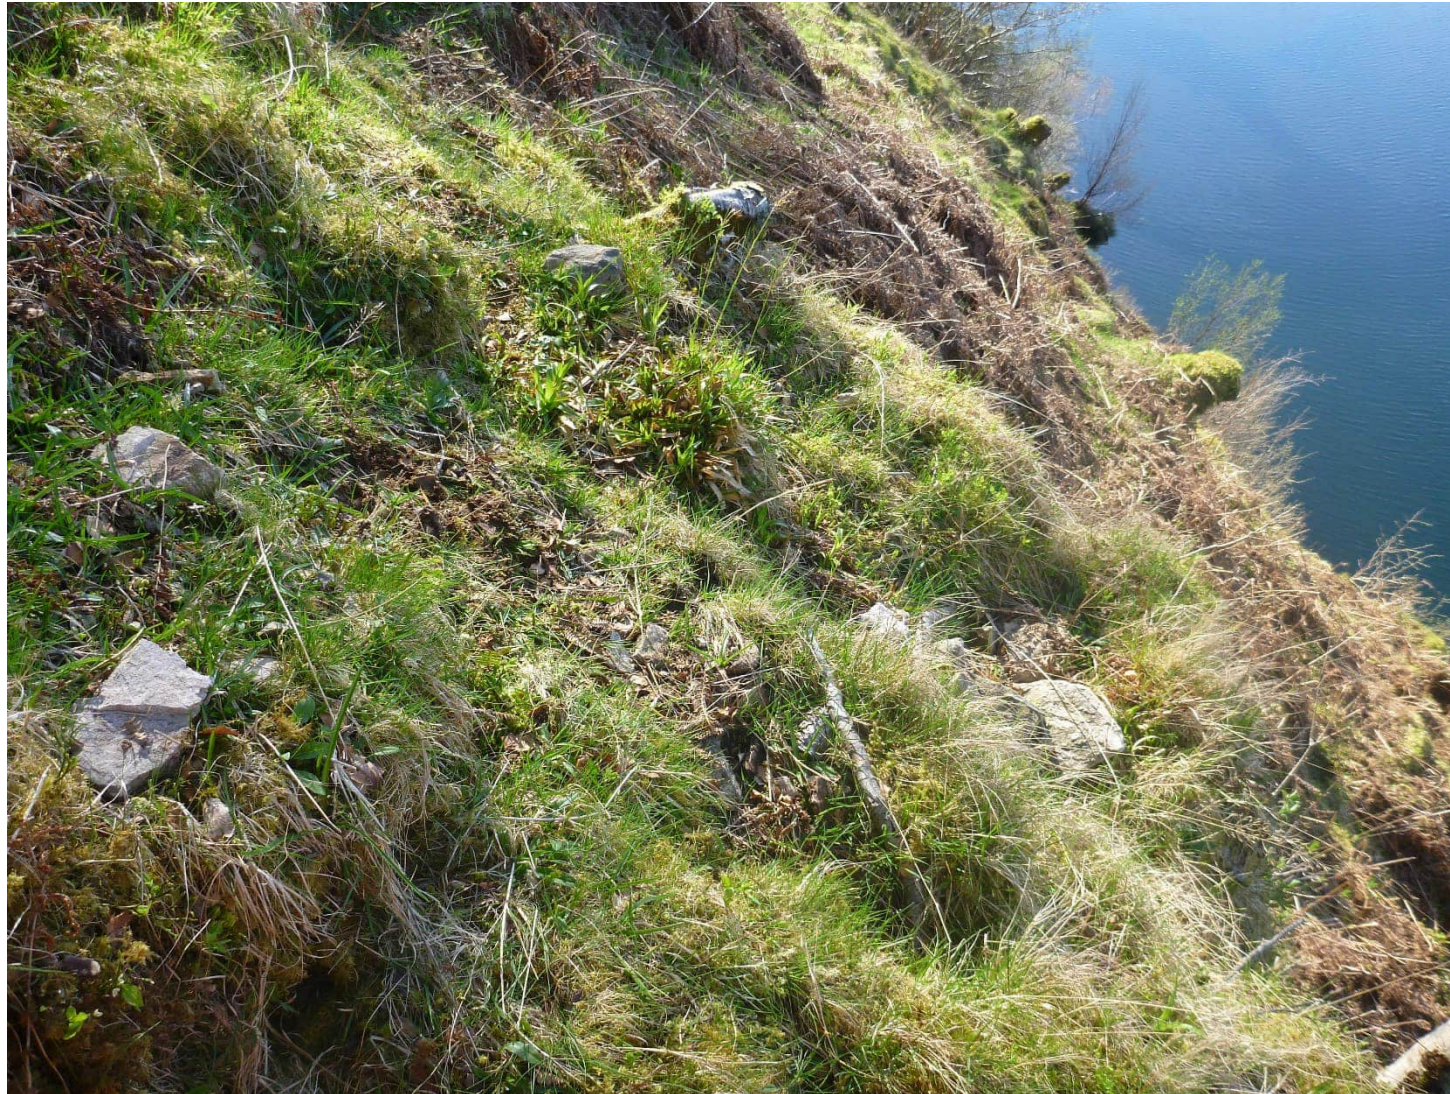
Photograph AA19U-4

Rope access inspection to assess upper crags at AA19U. Boulders lying on slope.

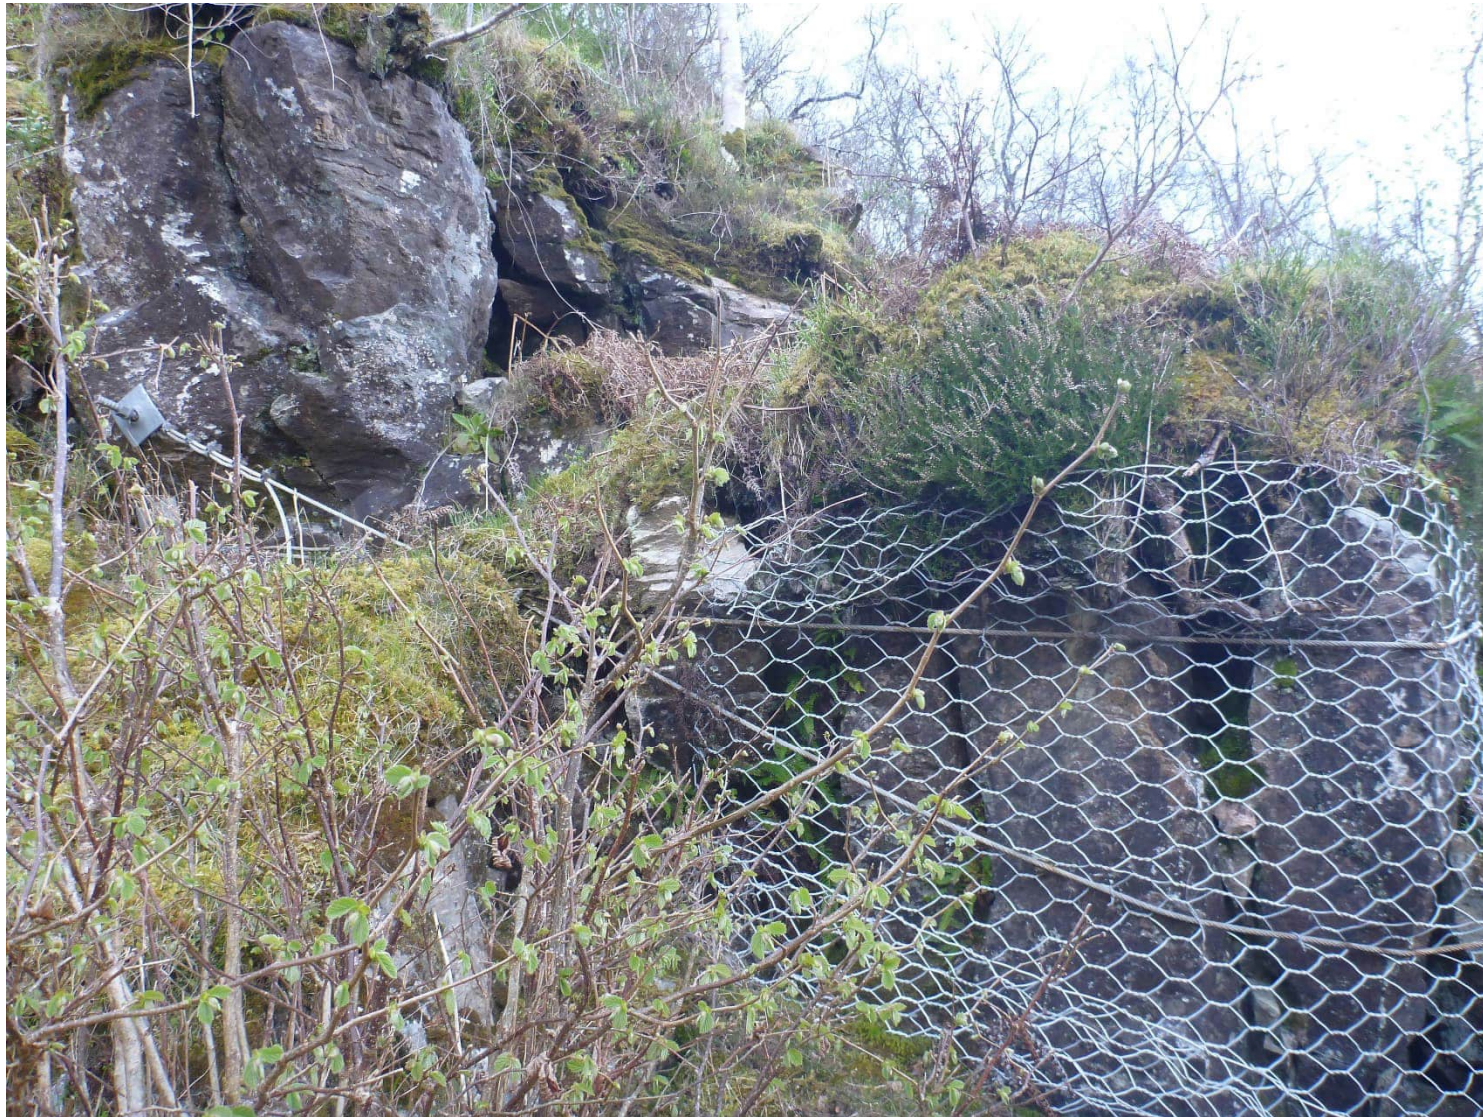
Photograph AA19U-5

Rope access inspection to assess upper crags at AA19U. Area of Maccaferri mesh strapped around bluff 2m high and 4m wide secured by two cables.

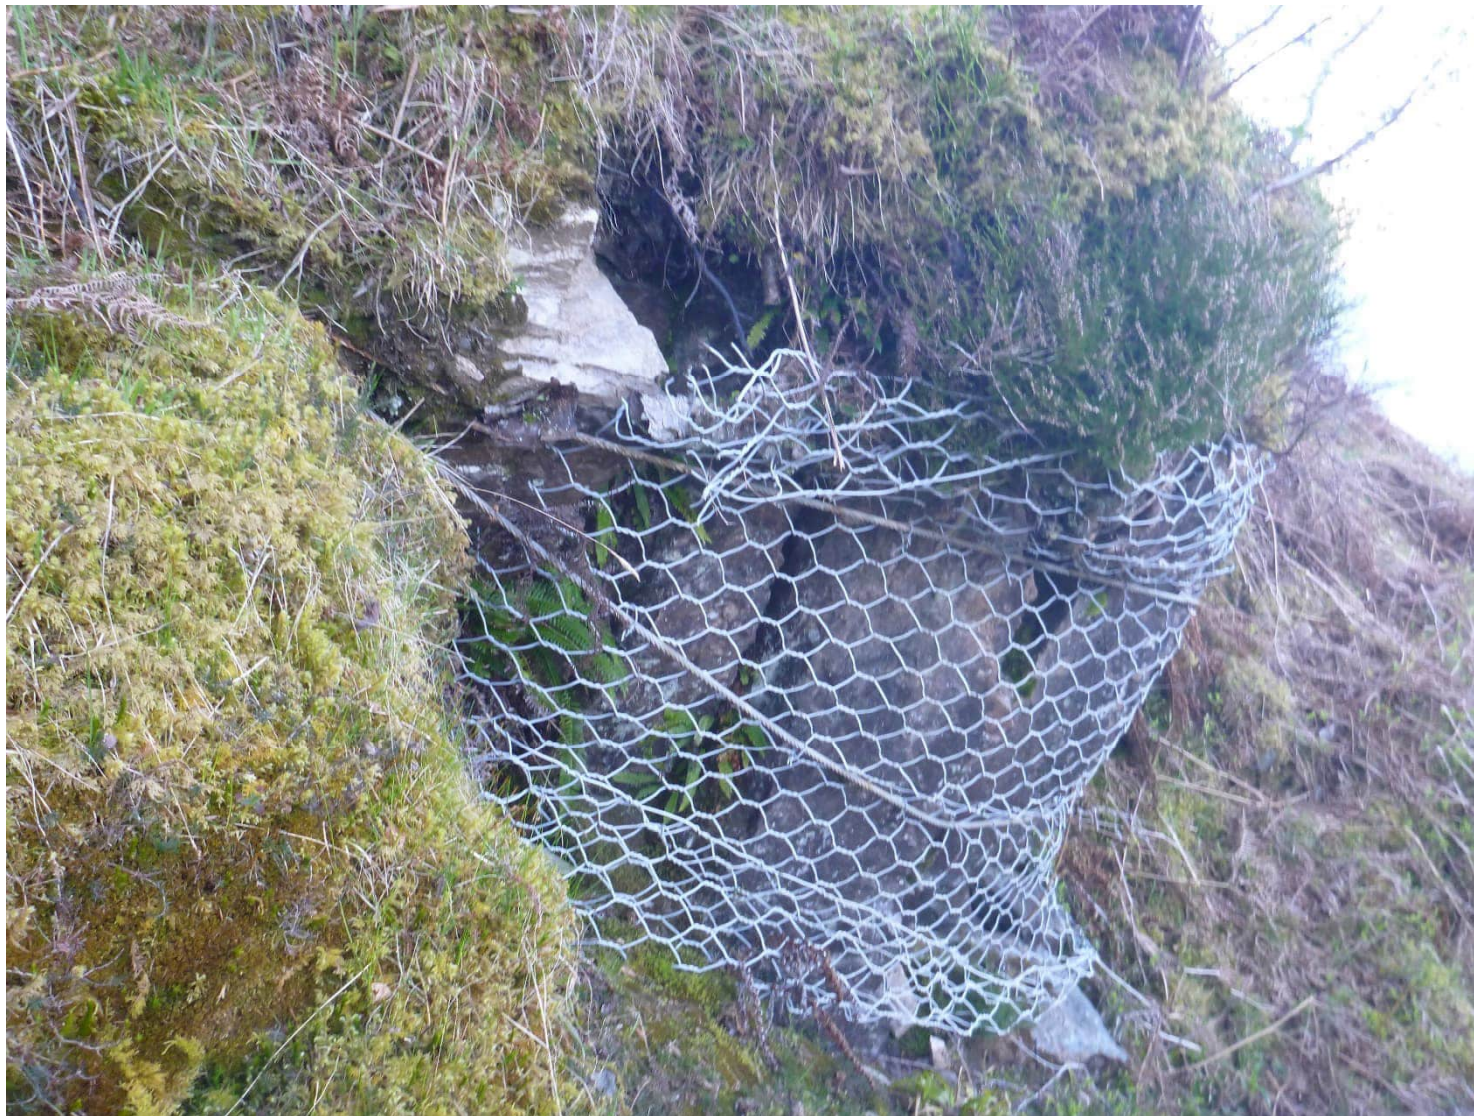
Photograph AA19U-6

Rope access inspection to assess upper crags at AA19U. Location of missing block and fresh surface at top of mesh.
