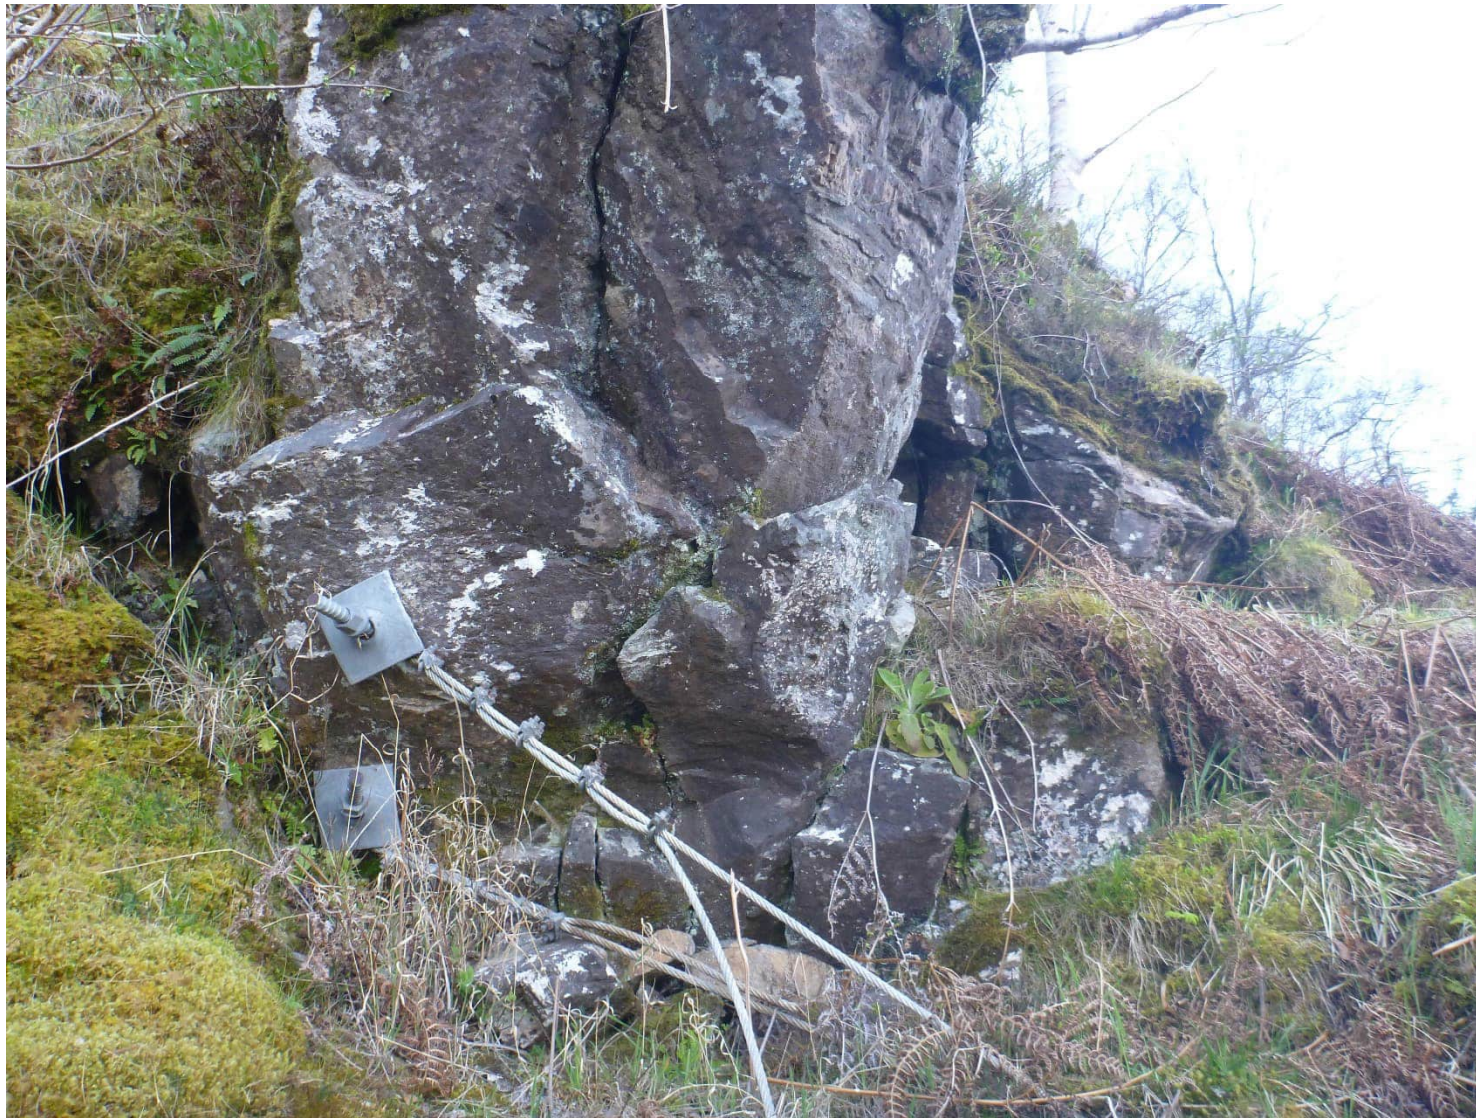
Photograph AA19U-7

Rope access inspection to assess upper crags at AA19U. Loose blocks held by cables at risk of falling.

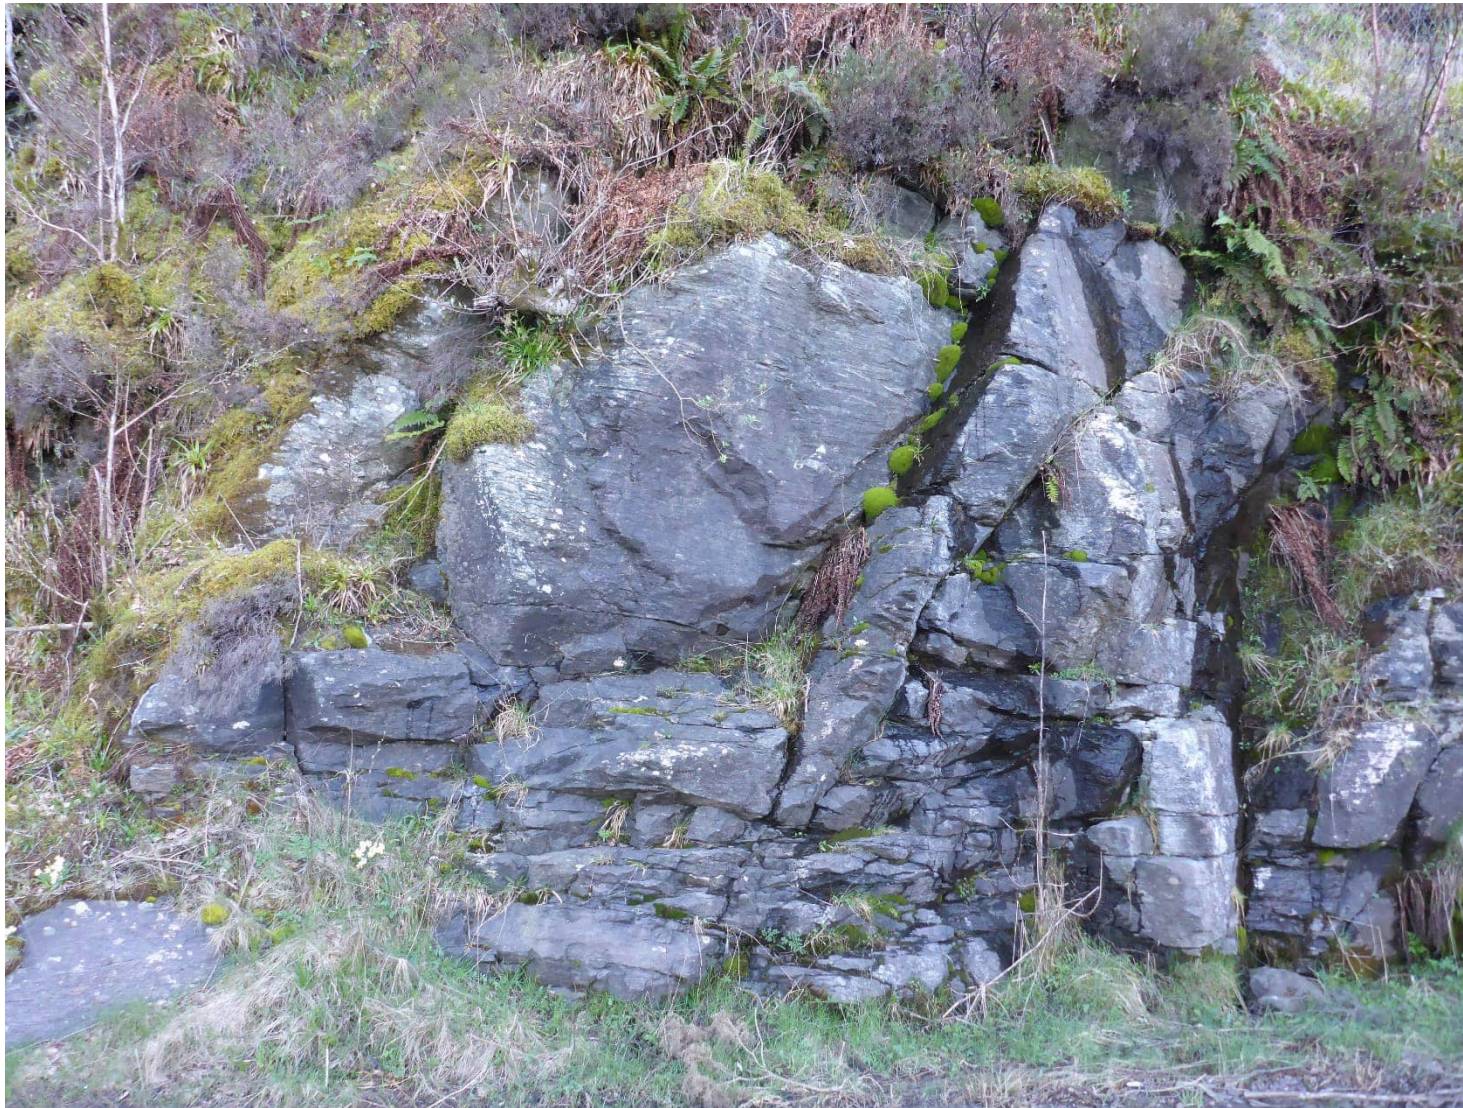
Photograph AA20-1

At Ch. 3182 - Root-jacking observed; occasional small blocks can be expected to fail and may land on the road.

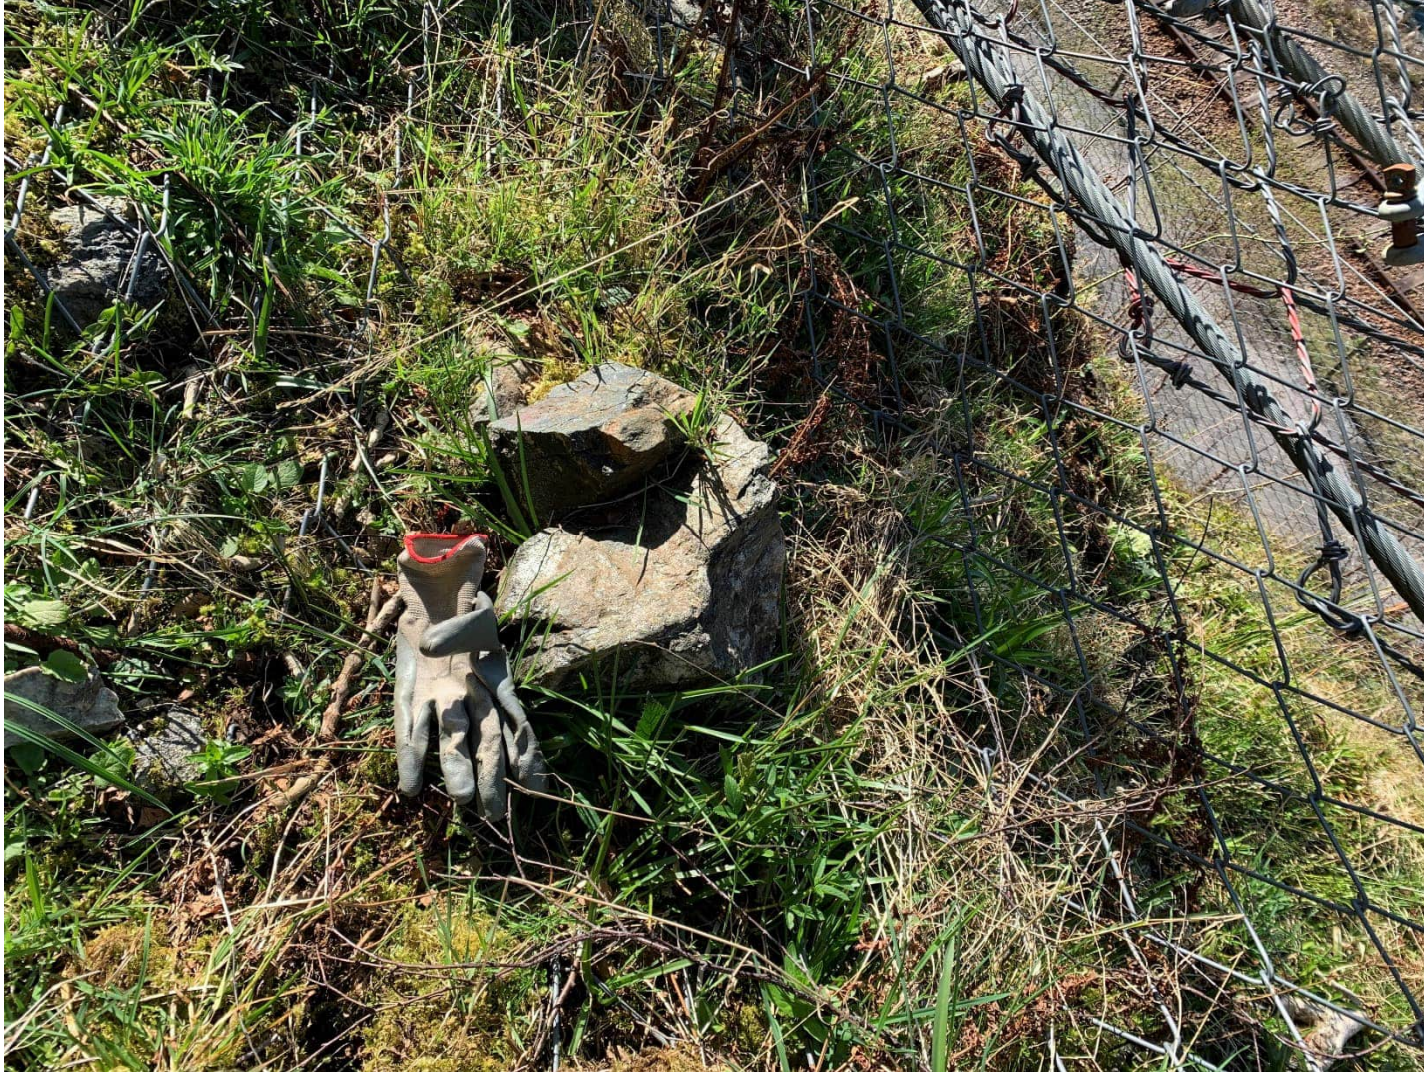
Photograph AA20U-1

At Catch Fence – an example of some of the small blocks noted which have been retained the fence.

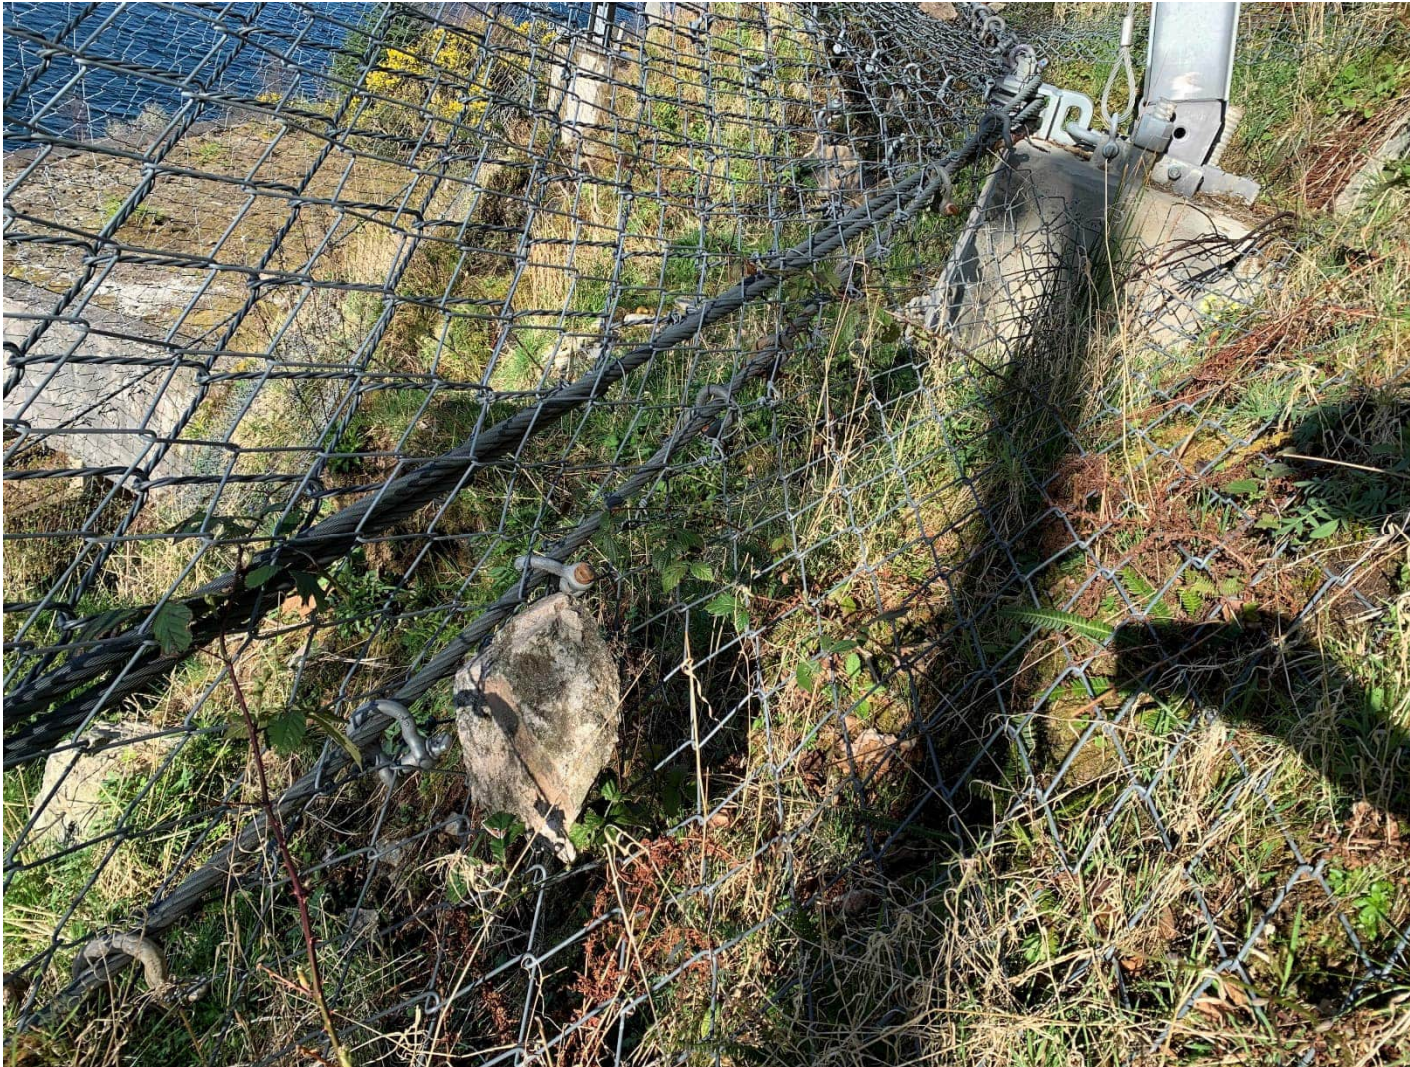
Photograph AA20U-2

At Catch Fence – an example of some of the small blocks noted which have been retained the fence.

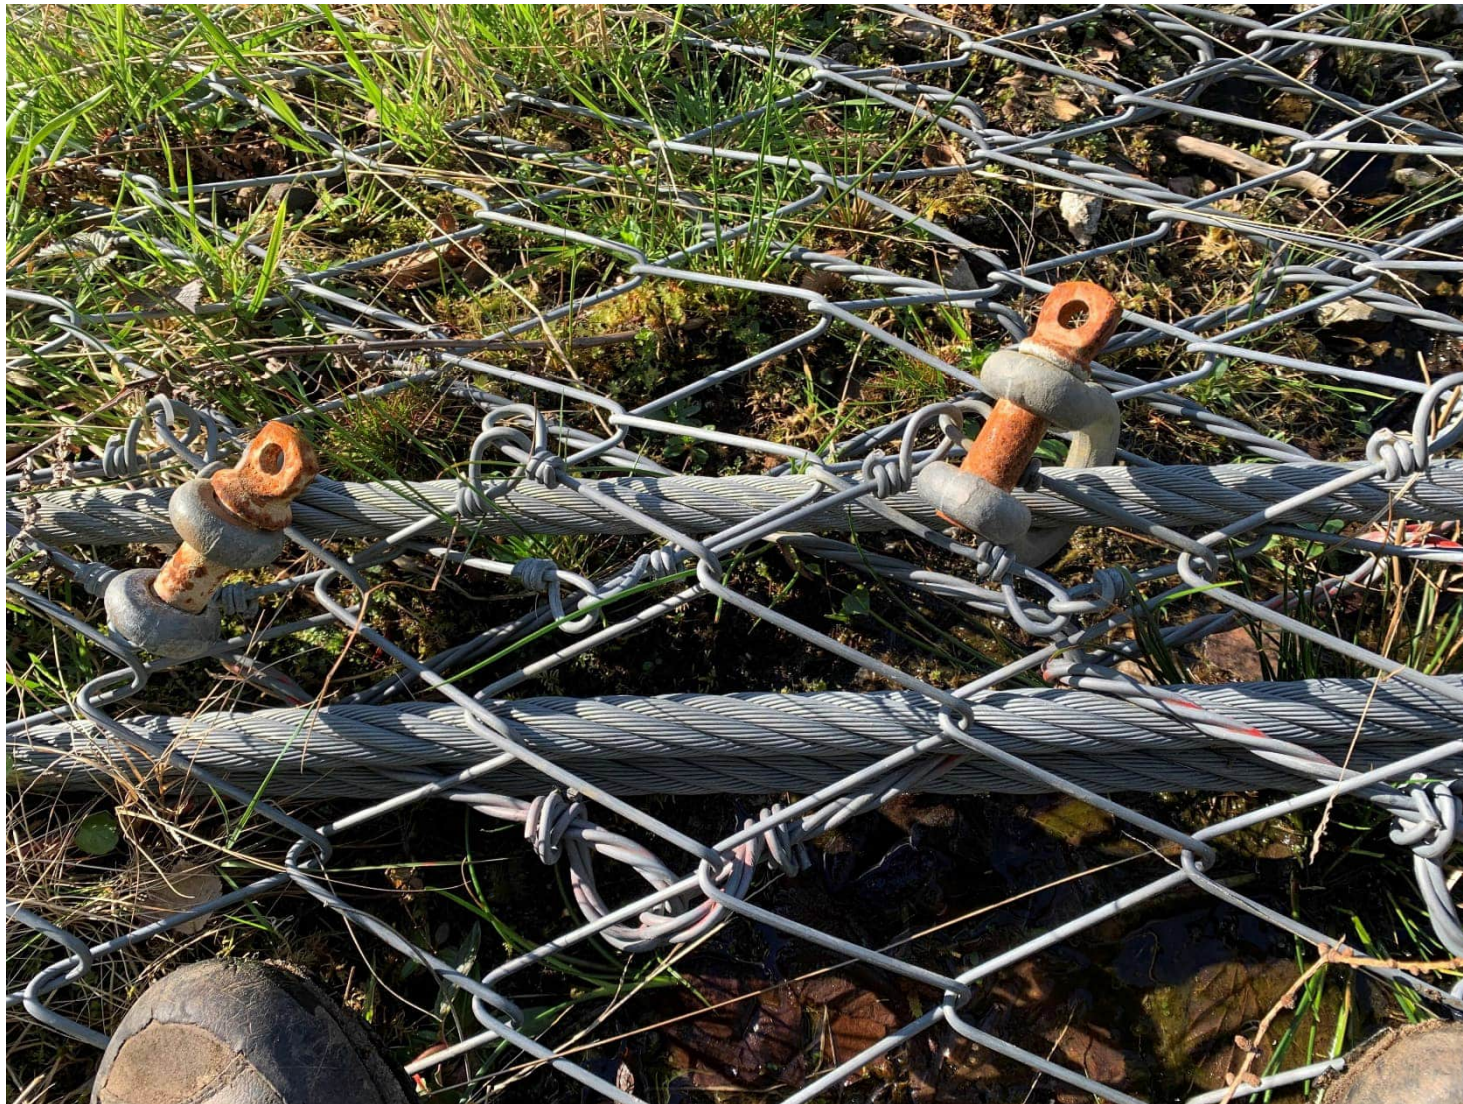
Photograph AA20U-3

Some surface corrosion evident on shackle bolts.

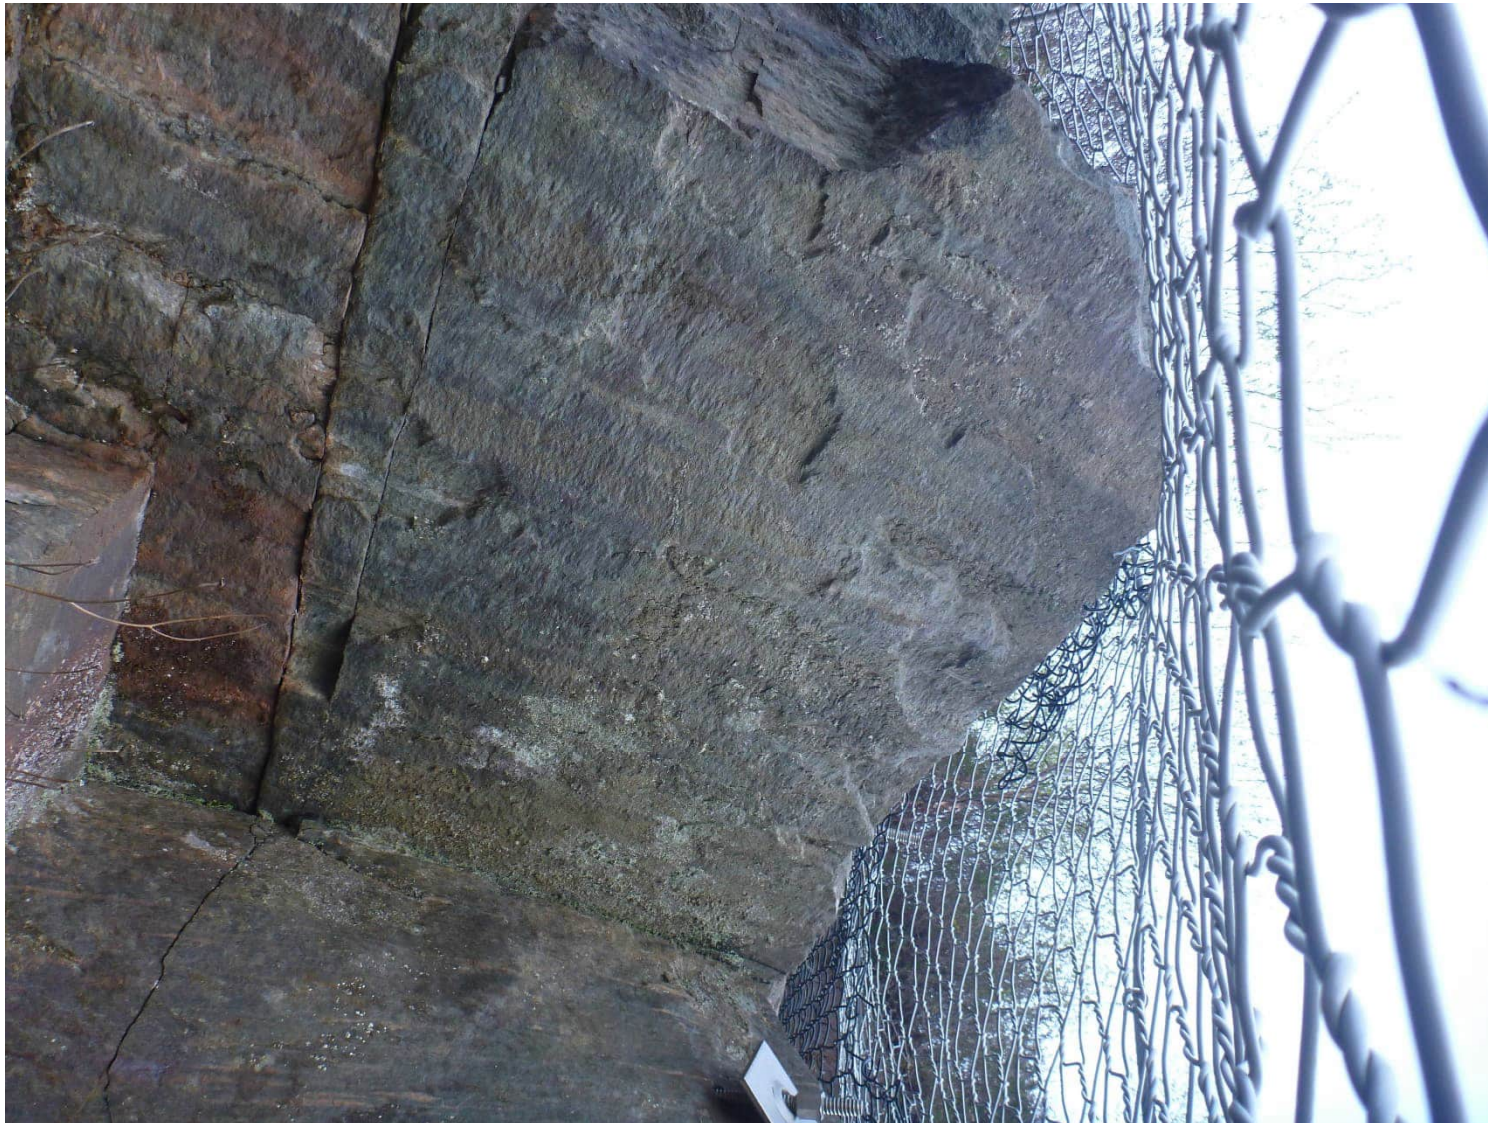
Photograph AA21-2

At Ch. 3350 (Rope access) – Overhanging rock mass ca. 1.5m and gape below is 2m

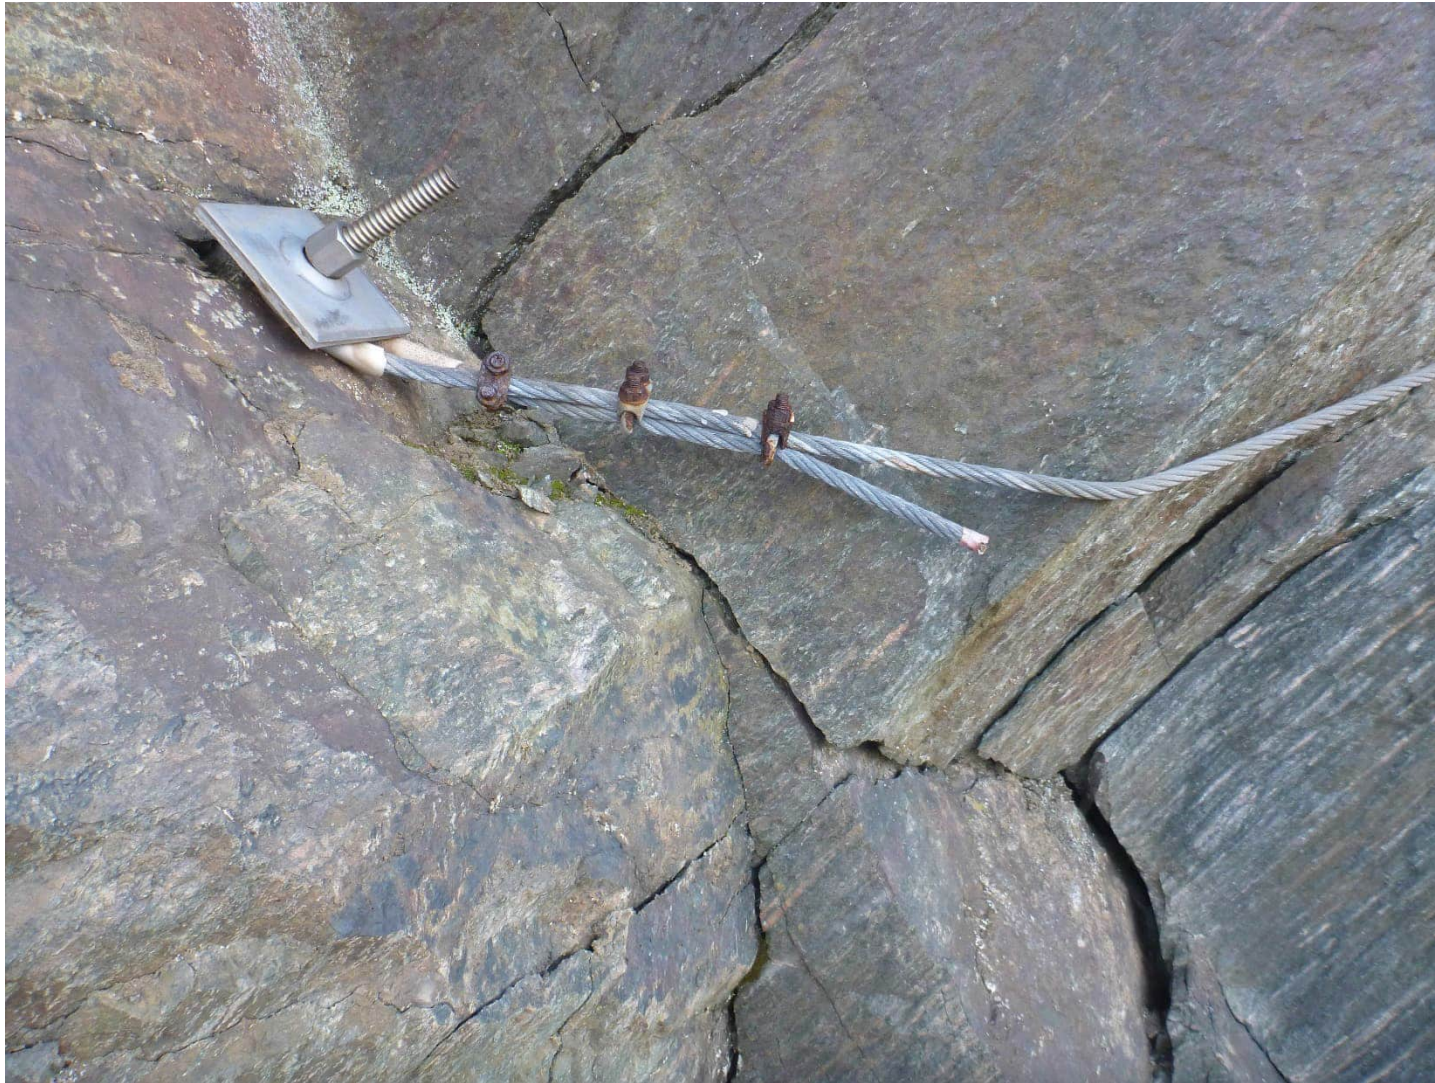
Photograph AA21-3

At Ch. 3350 (Rope access) – Cable clamps on cable restraint are corroded

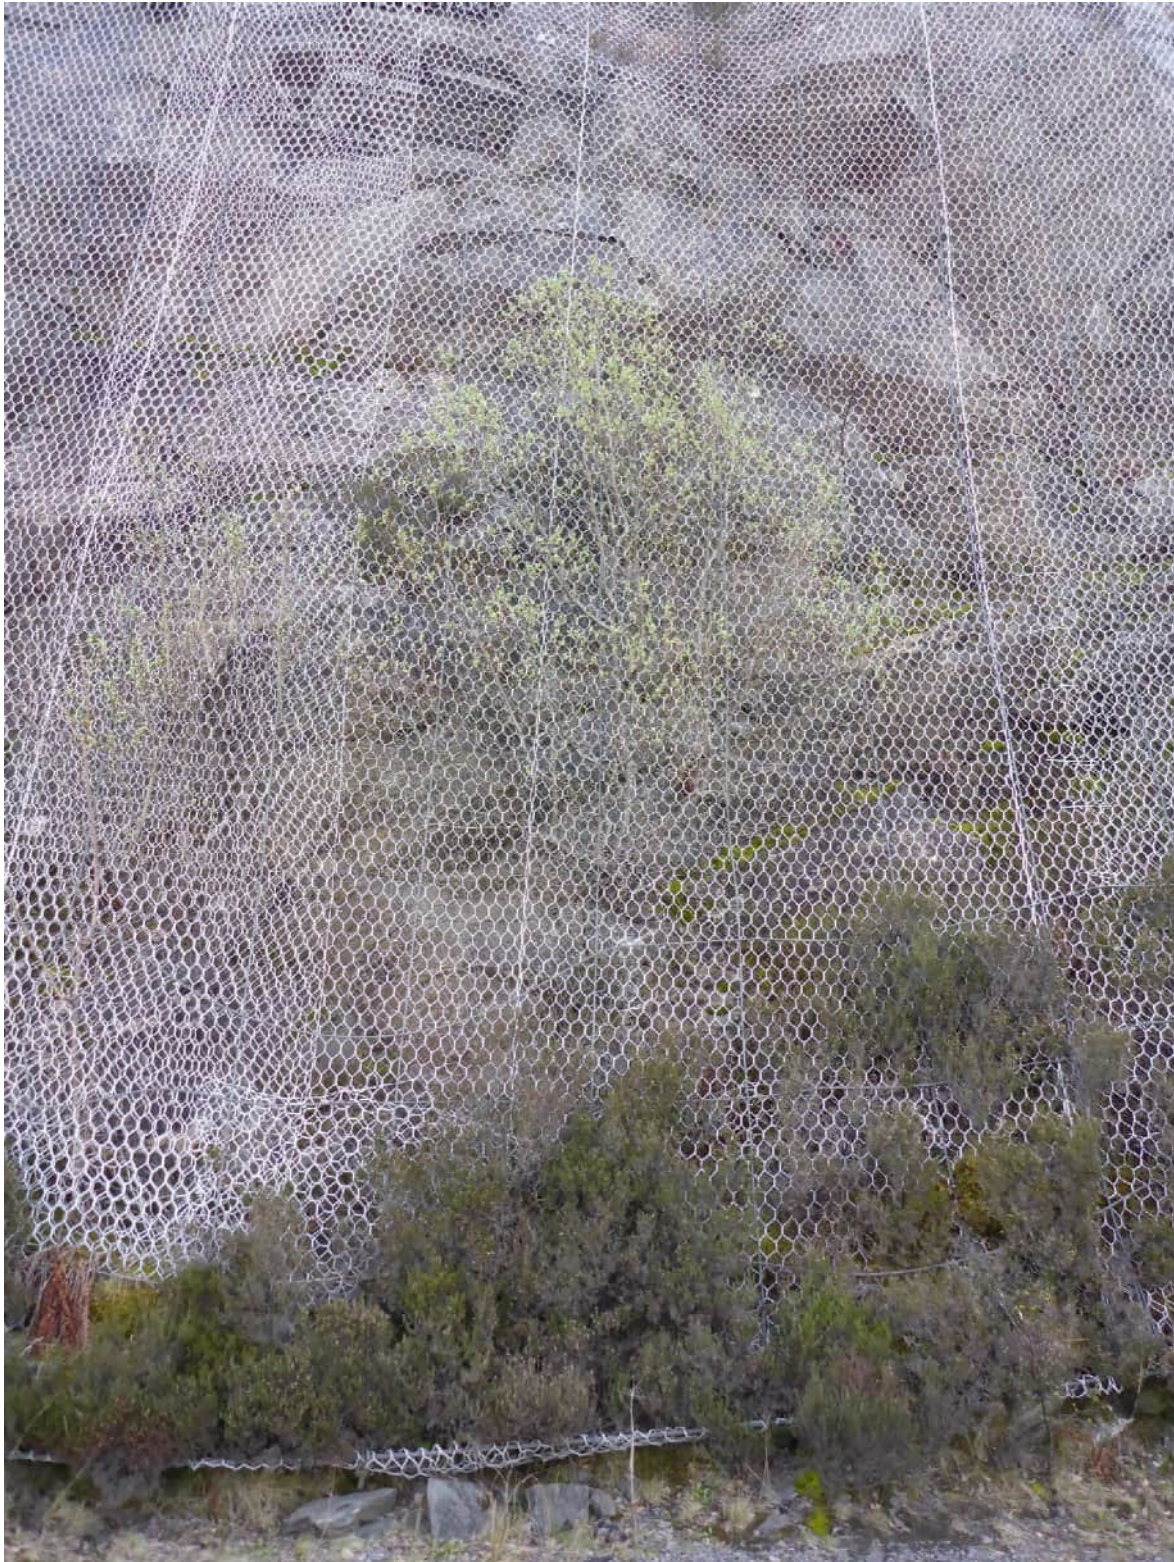
Photograph AA21-4	At Ch. 3310 - Root jacking potential approximately 3m above road level.	Year observation first noted: 2016
-------------------	-------------------------------------------------------------------------	------------------------------------

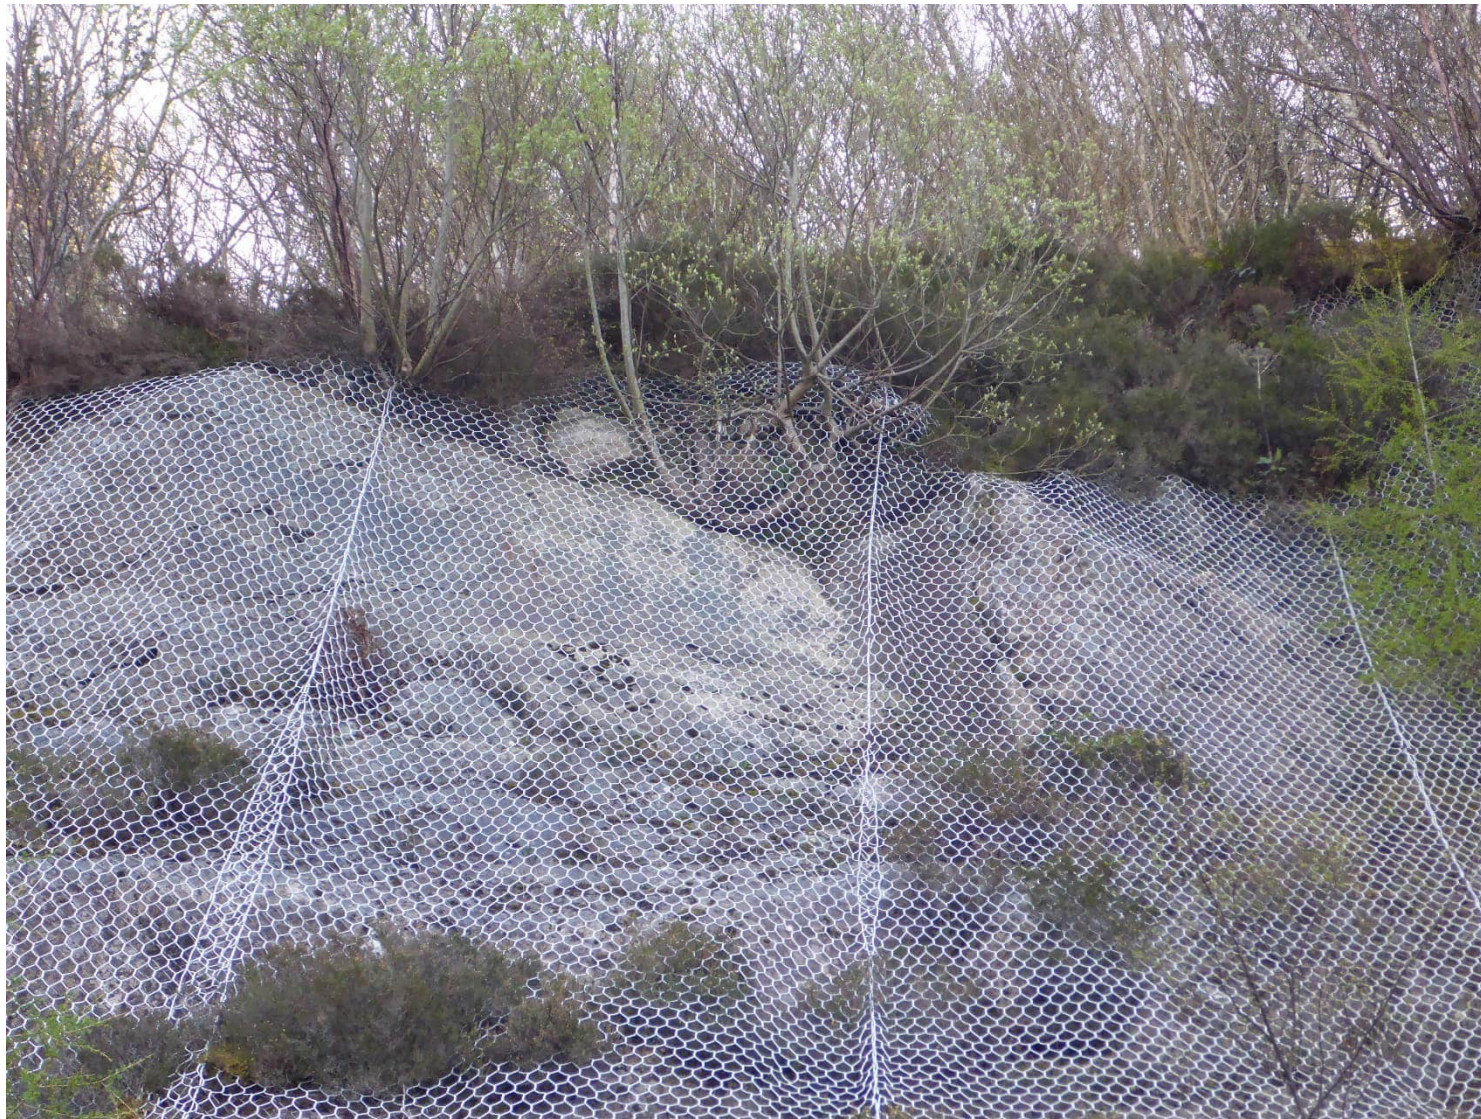
Photograph AA21-5

At Ch. 3363 – Broken rock mass at crest with root jacking also an issue. Several blocks with potential to fall.

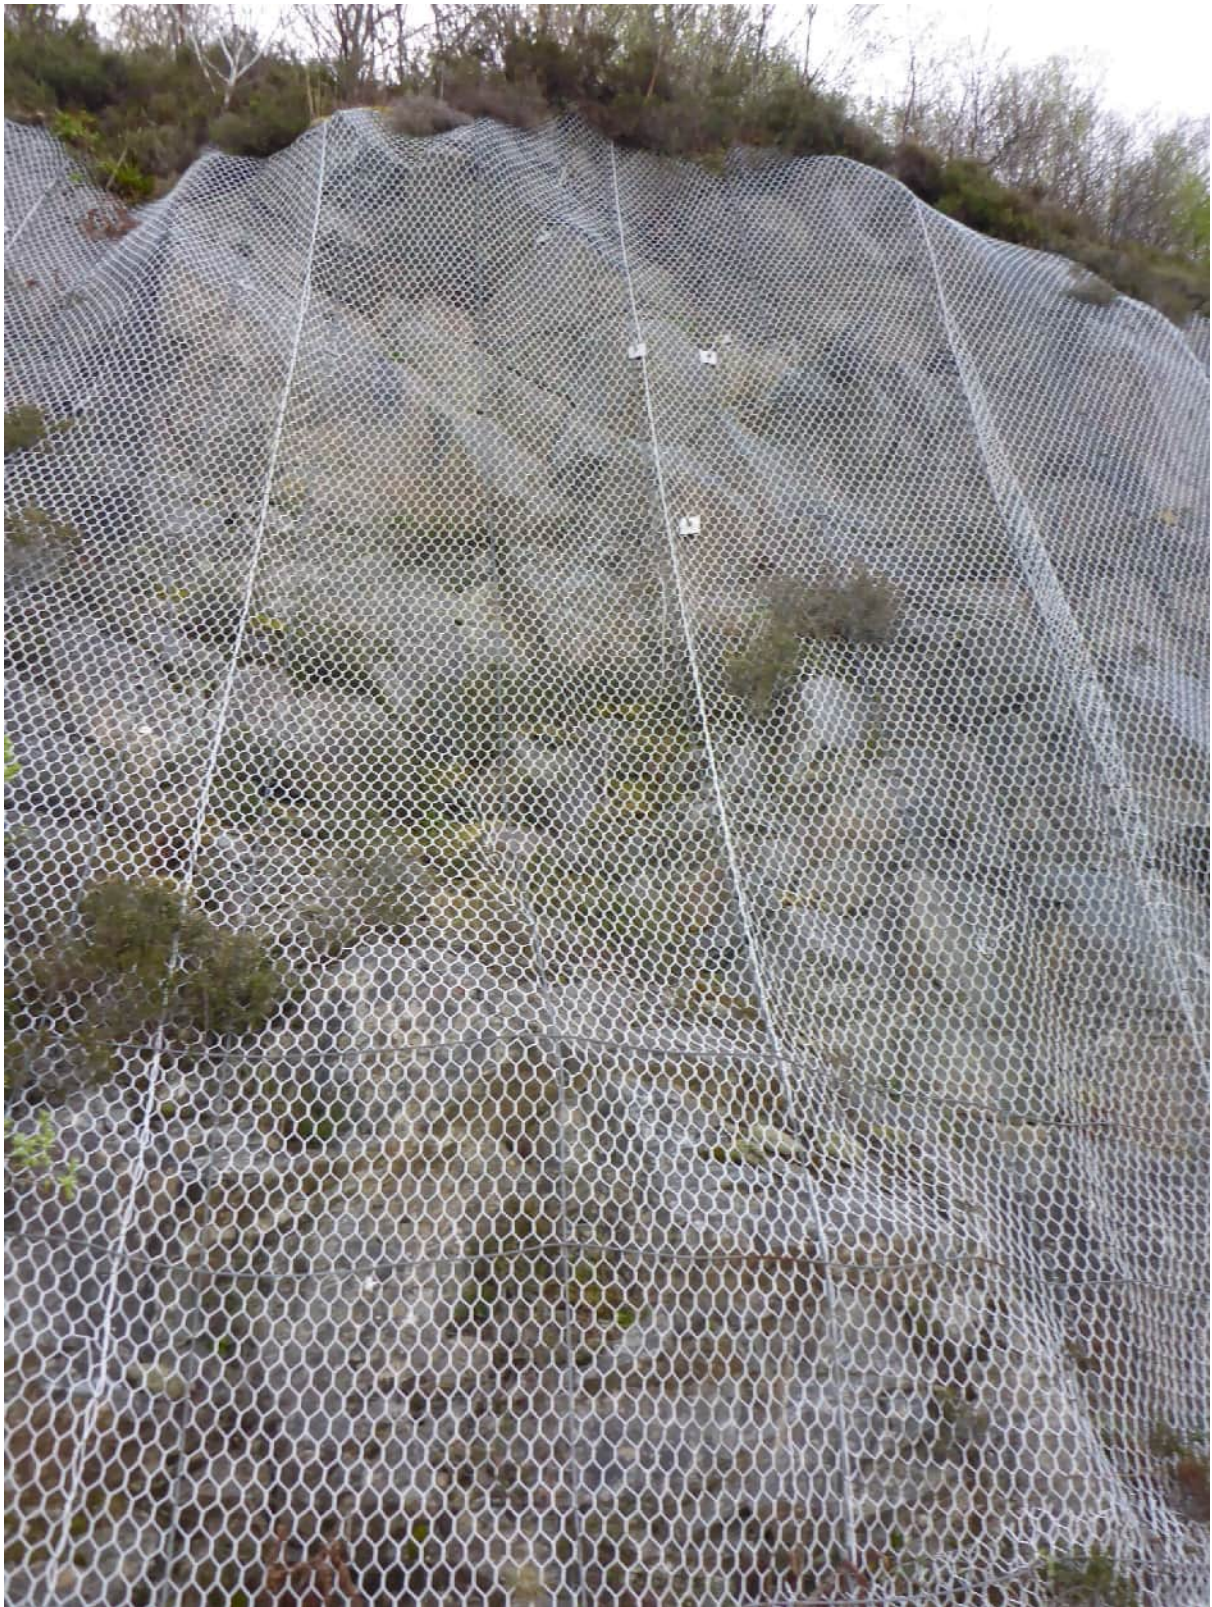
Photograph AA21-6	At Ch. 3350 - Rock mass at crest with dilated release plane.	Year observation first noted: 2019
-------------------	--------------------------------------------------------------	------------------------------------

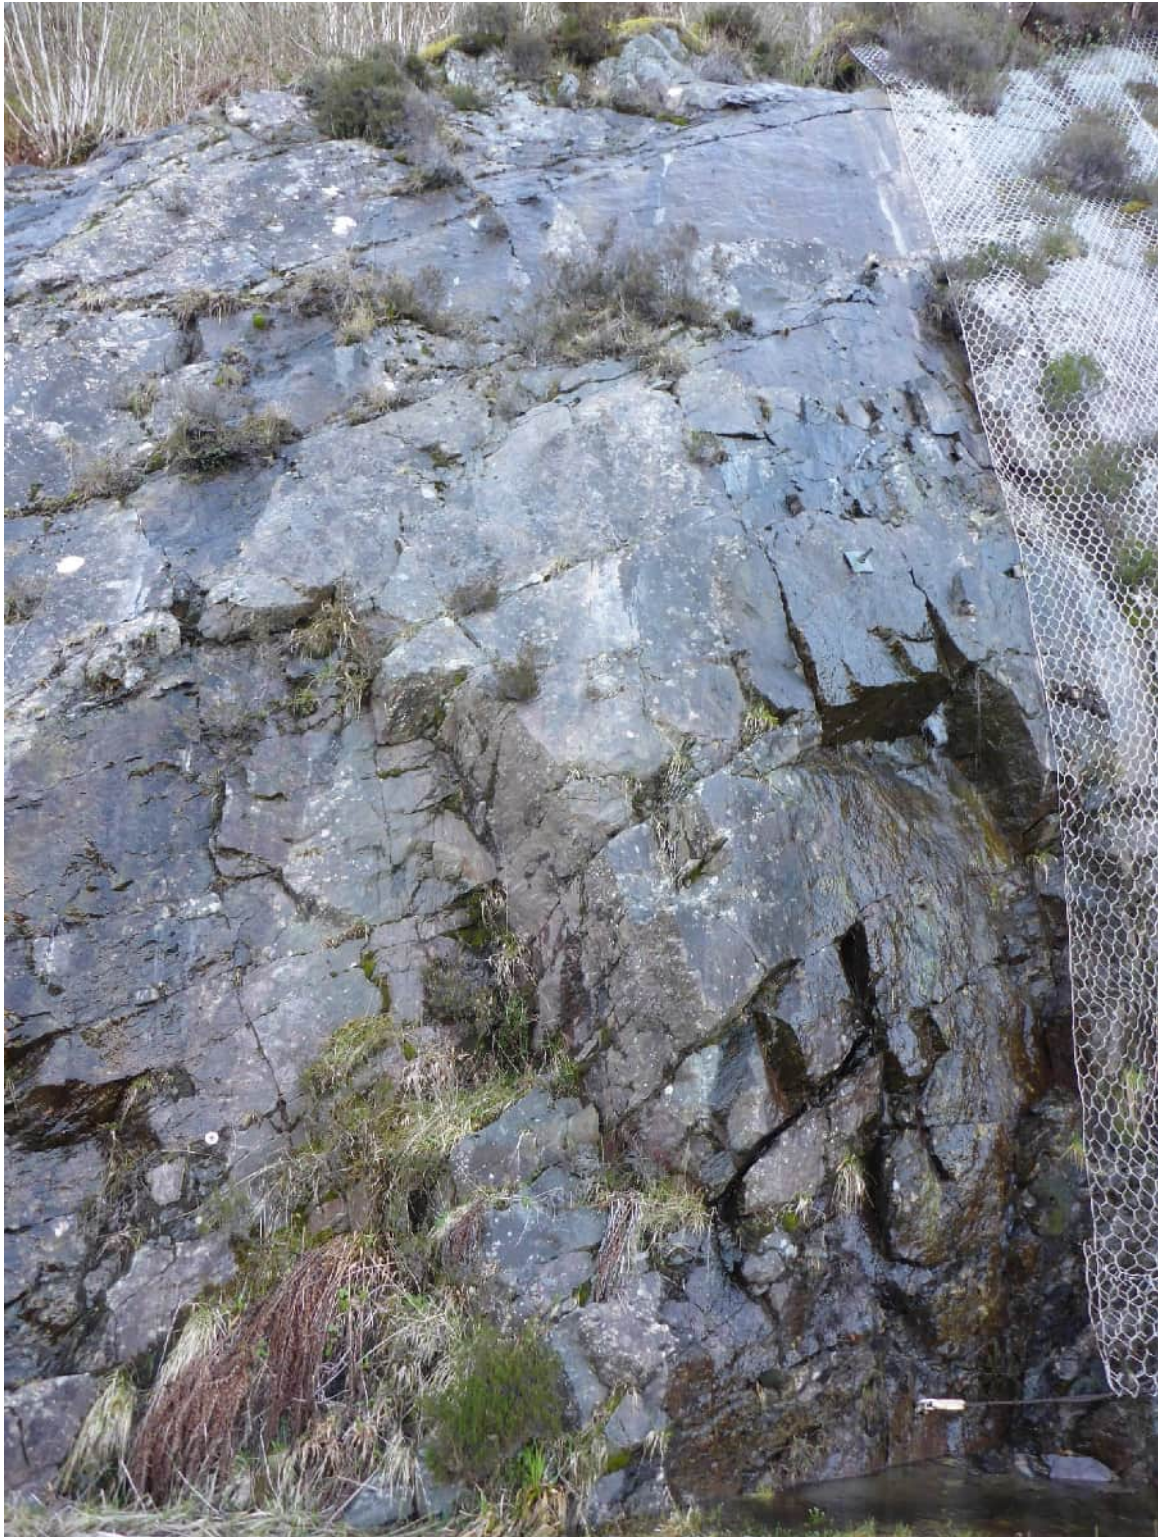
Photograph AA21-7	At Ch 3371 - dilated fractures on face of rock slope in area of water flow.	Year observation first noted: 2021
-------------------	-----------------------------------------------------------------------------	------------------------------------

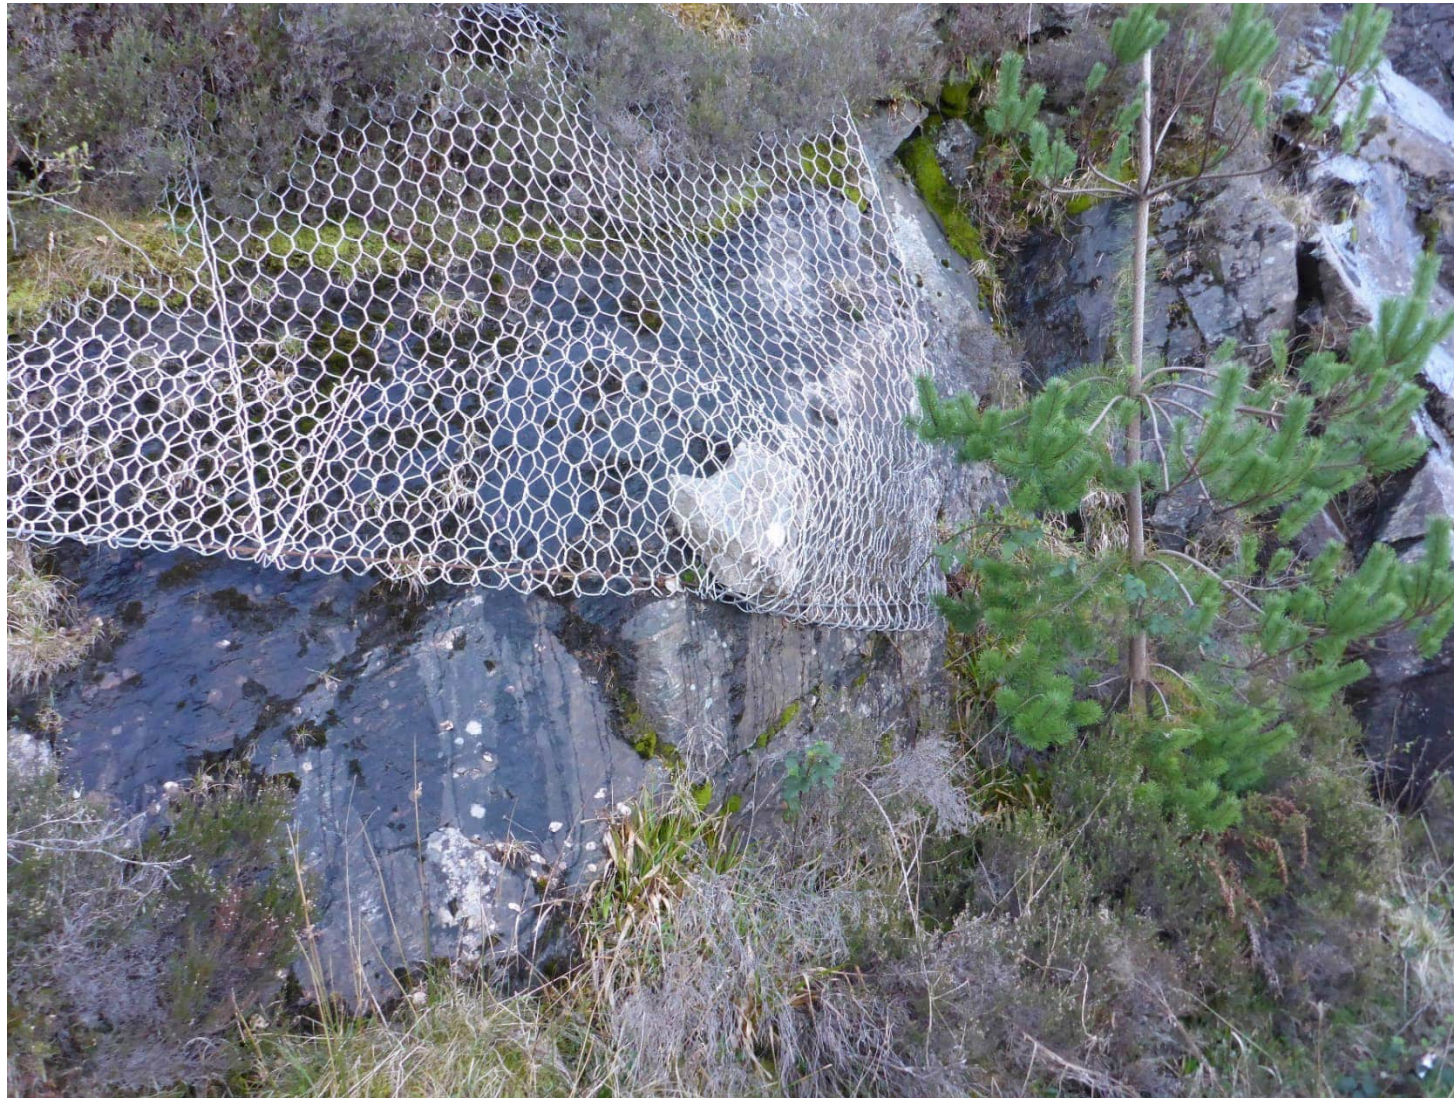
Photograph AA22A-1

At Ch. 3388 – A 0.3m x 0.3m x 0.1m block retained at base of netting 1.5m above road level.

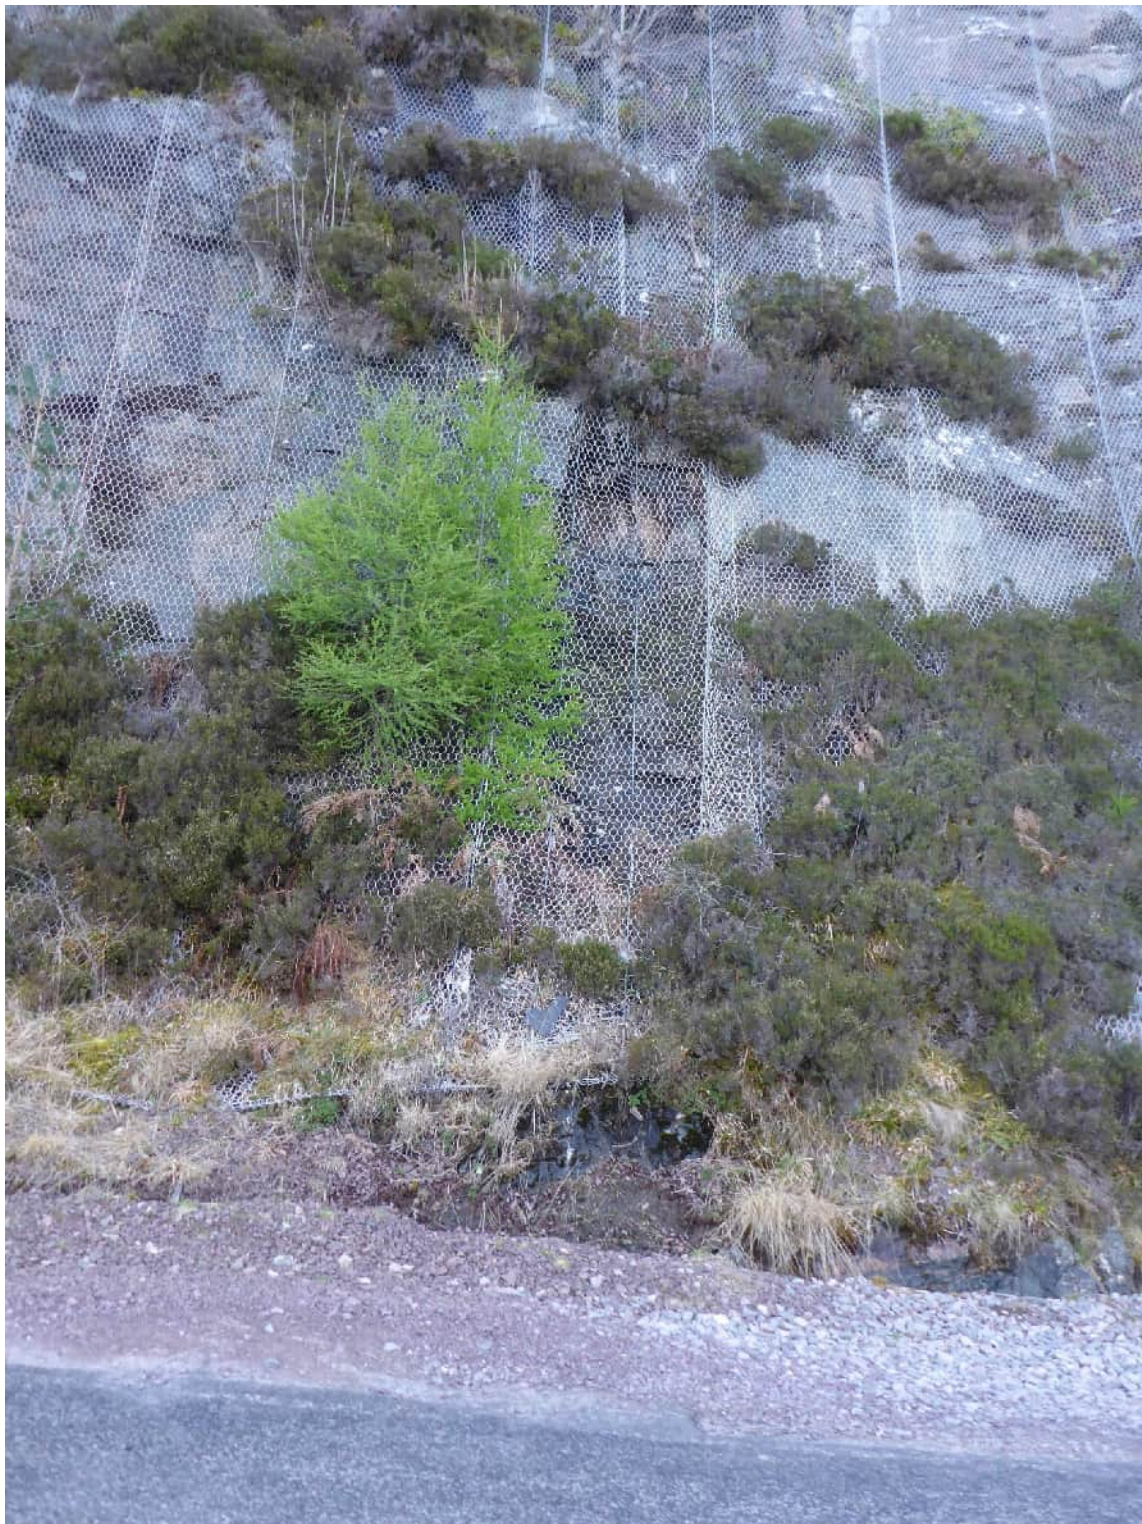
Photograph AA22B-2	At Ch. 3425 – Rock Fall originating c.6m above road level; blocks (c.0.25m ³) have slid along a steep release plane and come to rest at toe of slope behind netting.	Year observation first noted: 2021
--------------------	----------------------------------------------------------------------------------------------------------------------------------------------------------------------------------	------------------------------------
