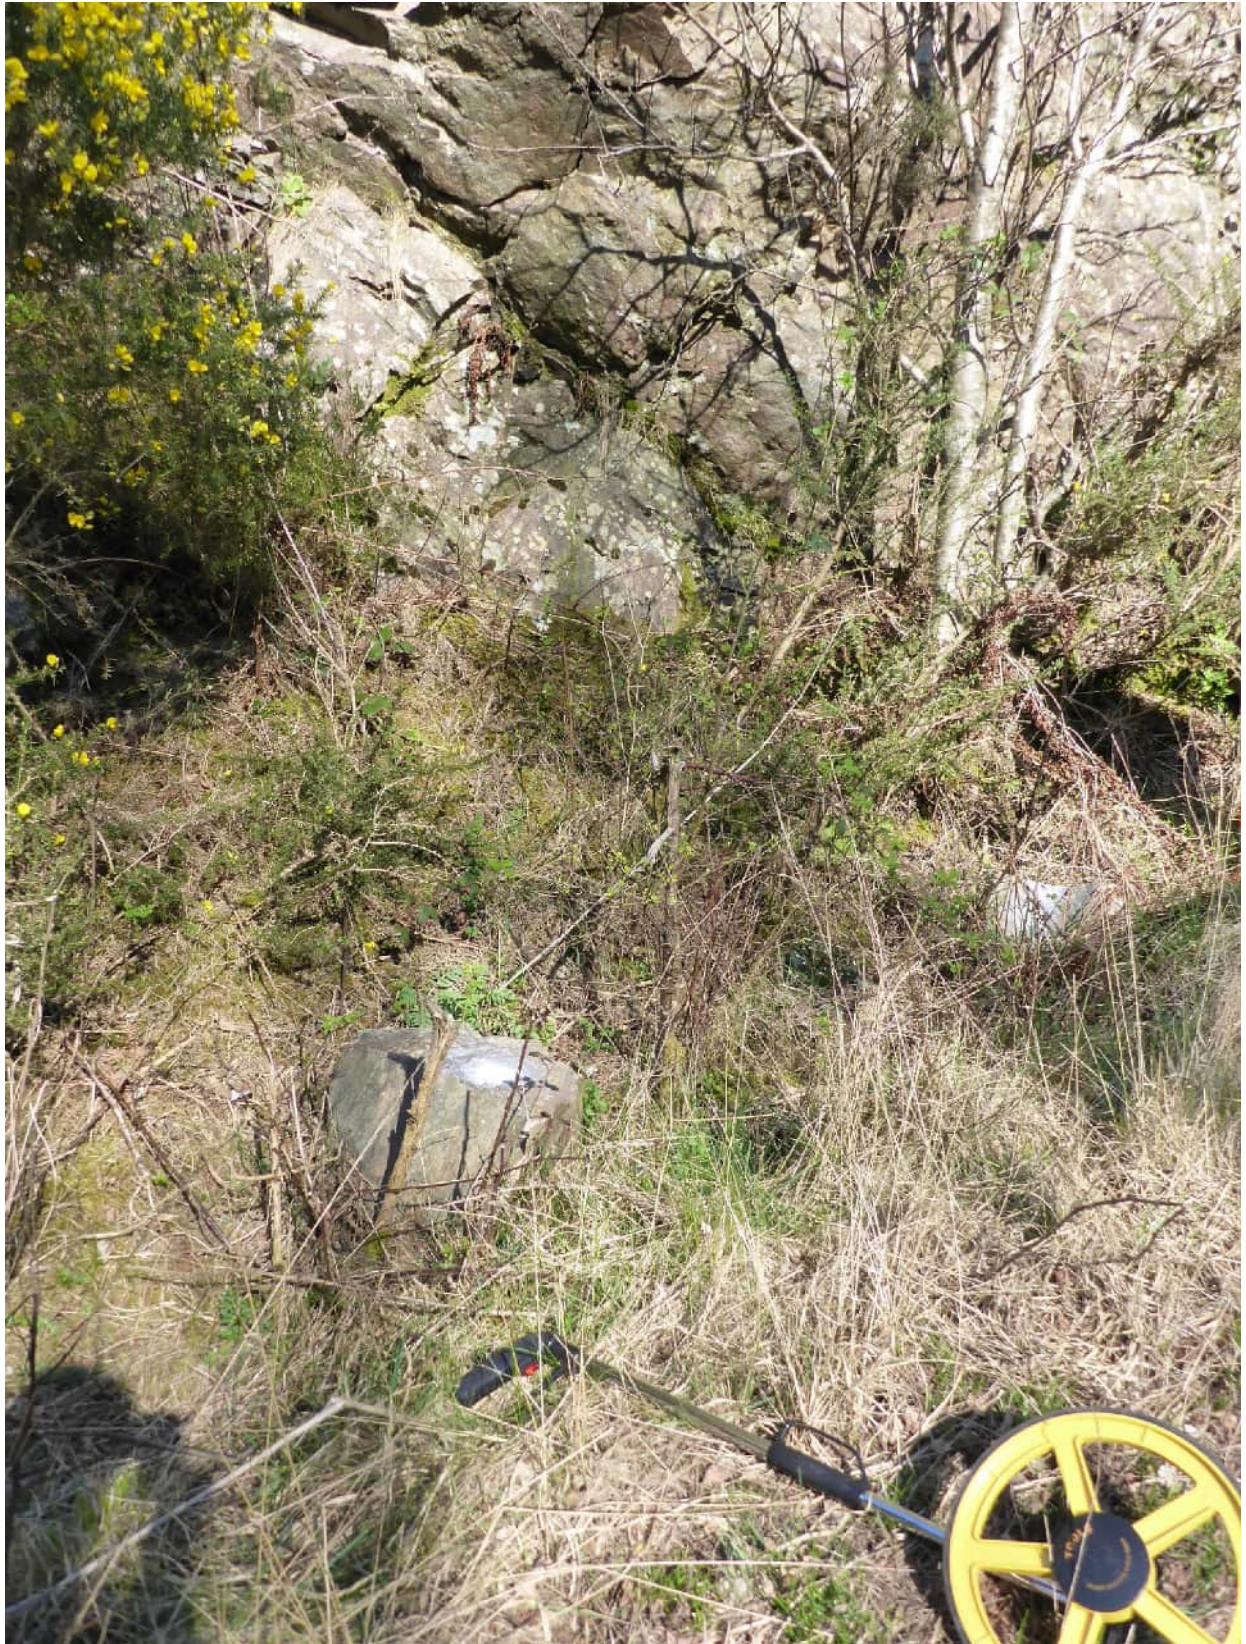
Photograph AA23N-1	At Ch. 3669 – Block fall in 2022 c.0.4m x 0.4m x 0.3m has landed in the ditch. Block originated c.2m up rock slope.	Year observation first noted: 2022
--------------------	---------------------------------------------------------------------------------------------------------------------	------------------------------------

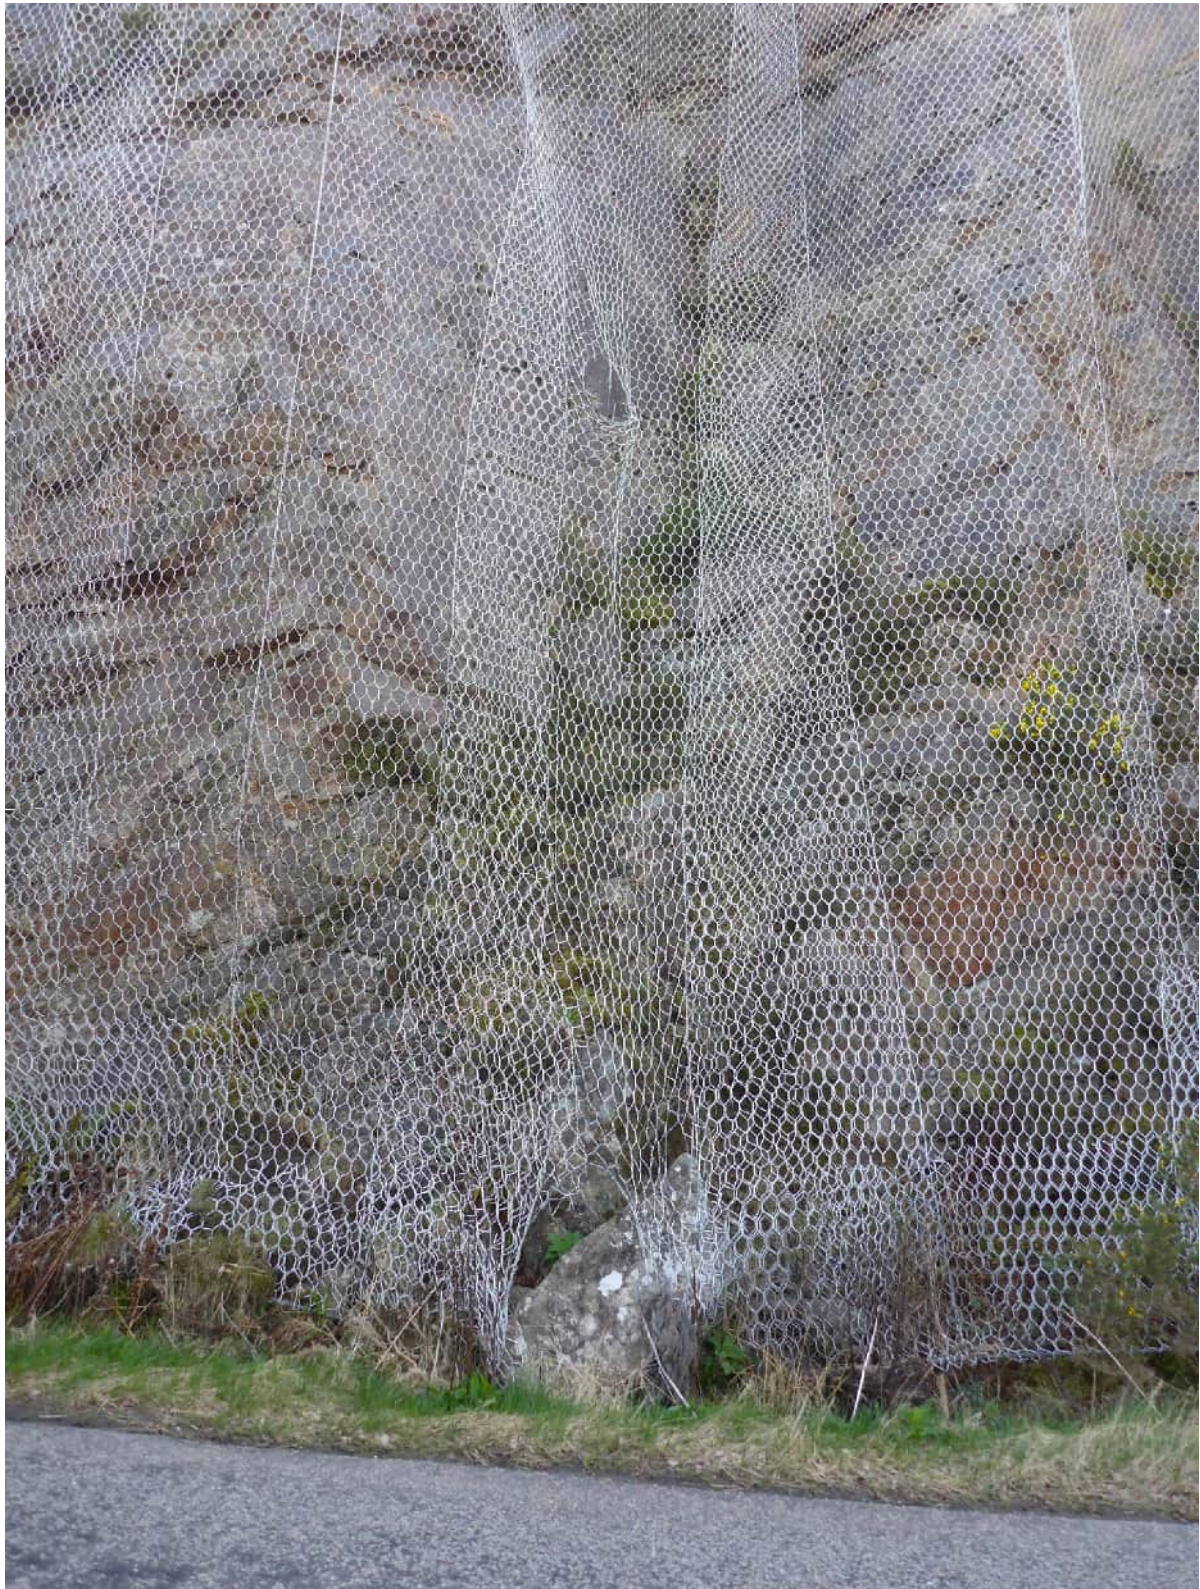
Photograph AA24-1	At Ch. 3740 – Rock Fall in October 2020. Block originated c.10m above road level and has left a small puncture in netting c.5m above road level and tear at toe.	Year observation first noted: 2020
-------------------	------------------------------------------------------------------------------------------------------------------------------------------------------------------	------------------------------------

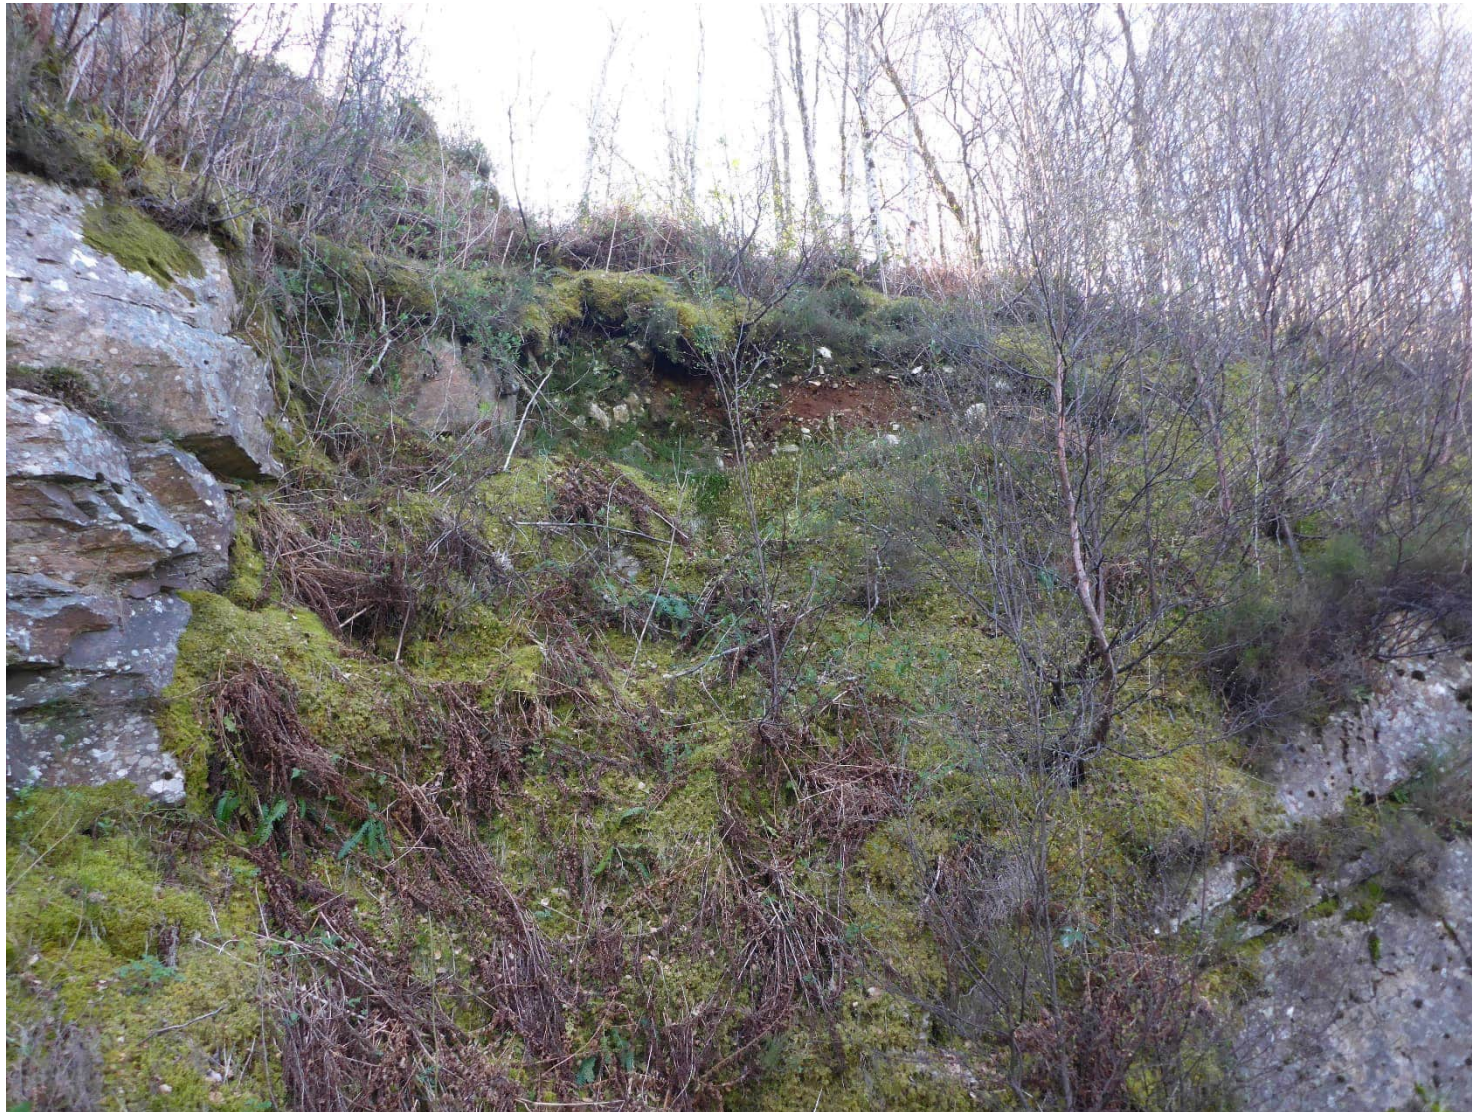
Photograph AA24-2

At Ch. 3783 - Exposed soil slope 4m above road level with boulders in back scar of previous failure which could weather out and reach road. Slumping is also noted upslope from back scar.

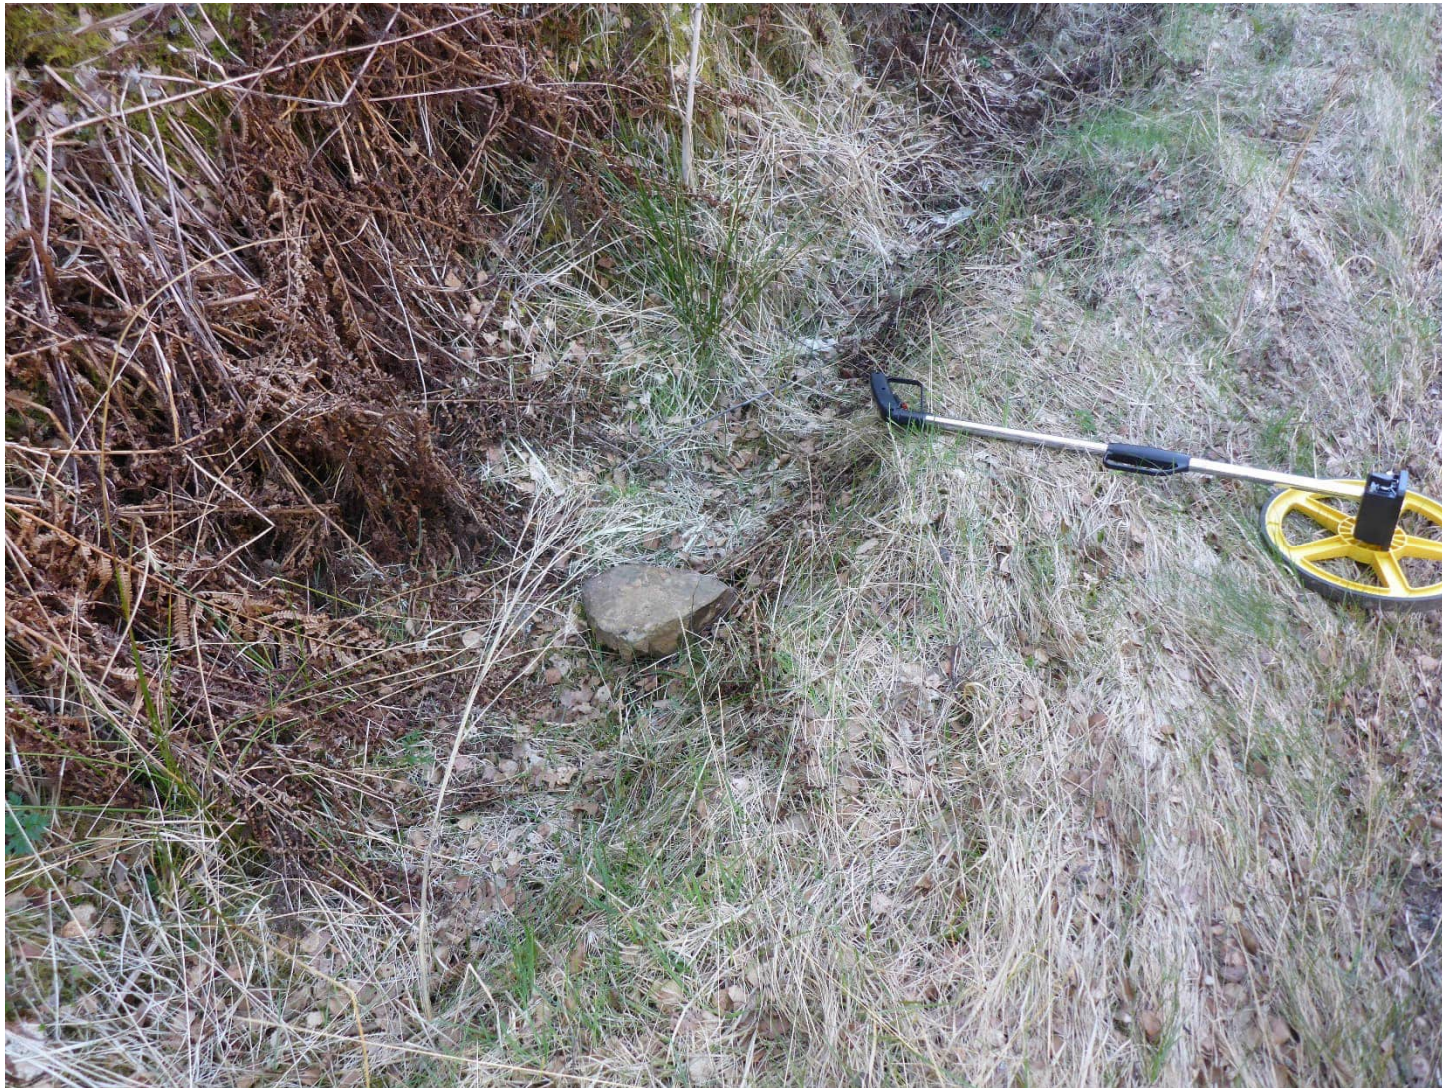
Photograph AA24-3

At Ch. 3870 – recent block fall in 2023 (planar failure). Block c.0.1m x 0.1m x 0.1m in ditch.
