# A890 Maman Hill

Annual Slope Inspection Report 2023

The Highland Council

Project number: 60658712  
AECOM Report Ref: GLRP0004

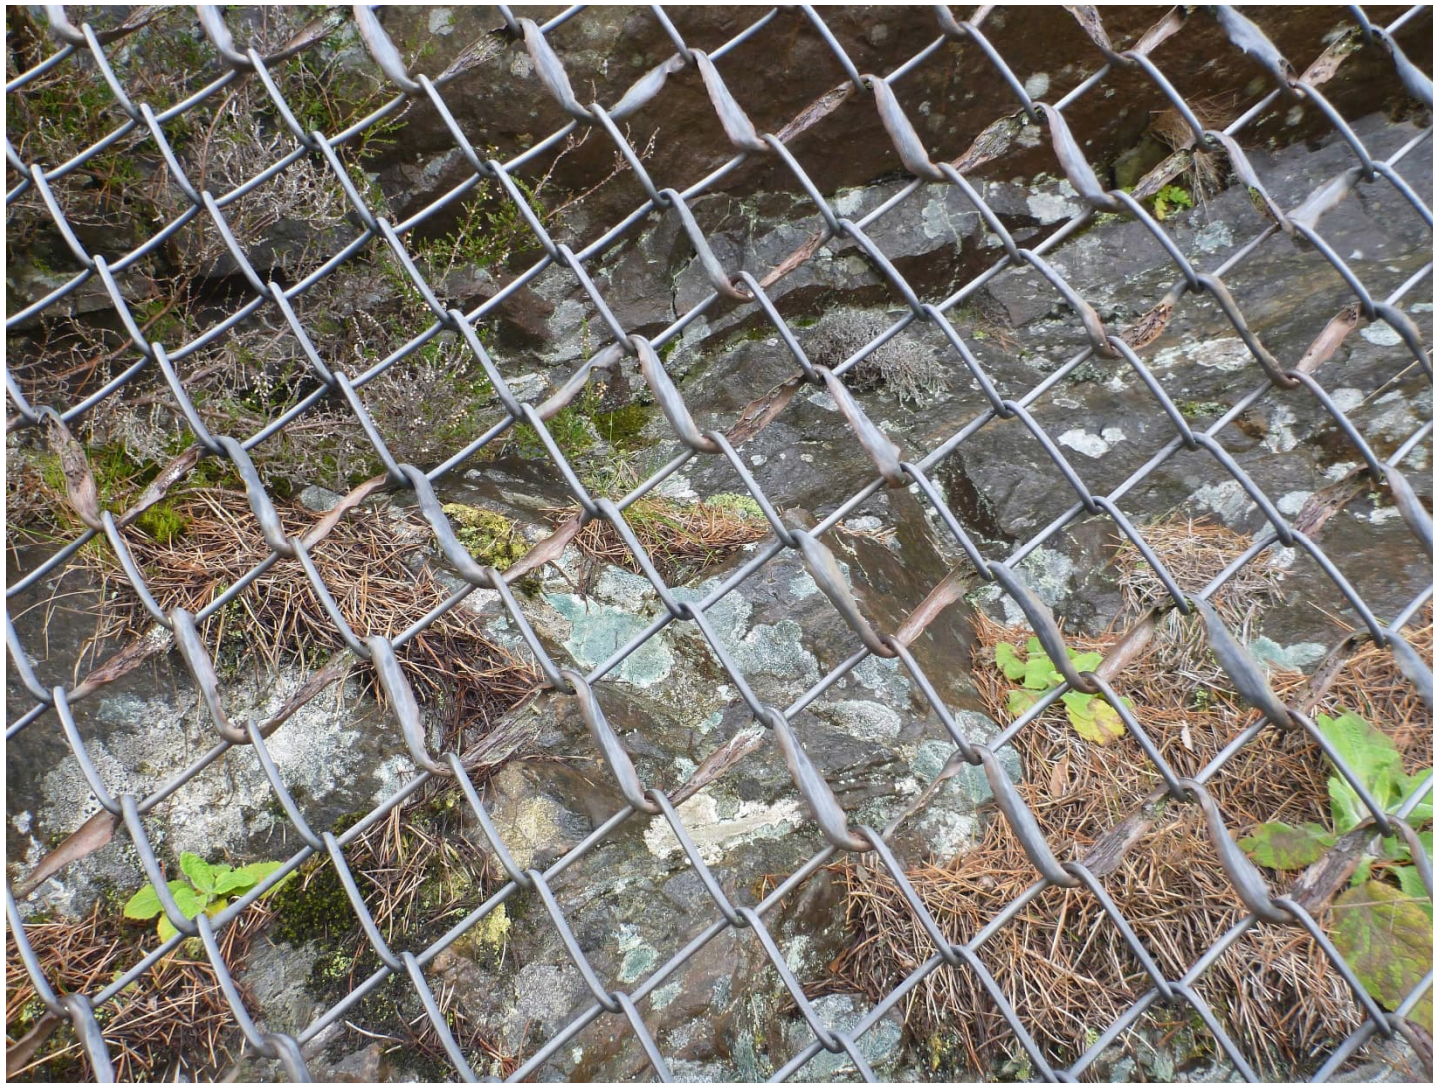
Photograph M1-1

Existing netting or other remedial work details:				
Year of Works	Description of Works	Comments	2023 Inspection Observations	Photo Reference
Unknown. Pre-dates AECOM's first involvement in the A890 Stromeferry Bypass in 2012.	Localised chain-link drape netting between Ch 030 to 070.	Netting covers c.65% of slope (anchorages have not been inspected). The netting is highly corroded and locally damaged and should be considered ineffective.	No change noted during the 2023 Inspection	M1-1

Between Ch. 030 to 070 – Chain-link netting is highly corroded.

Year observation first noted: 2019

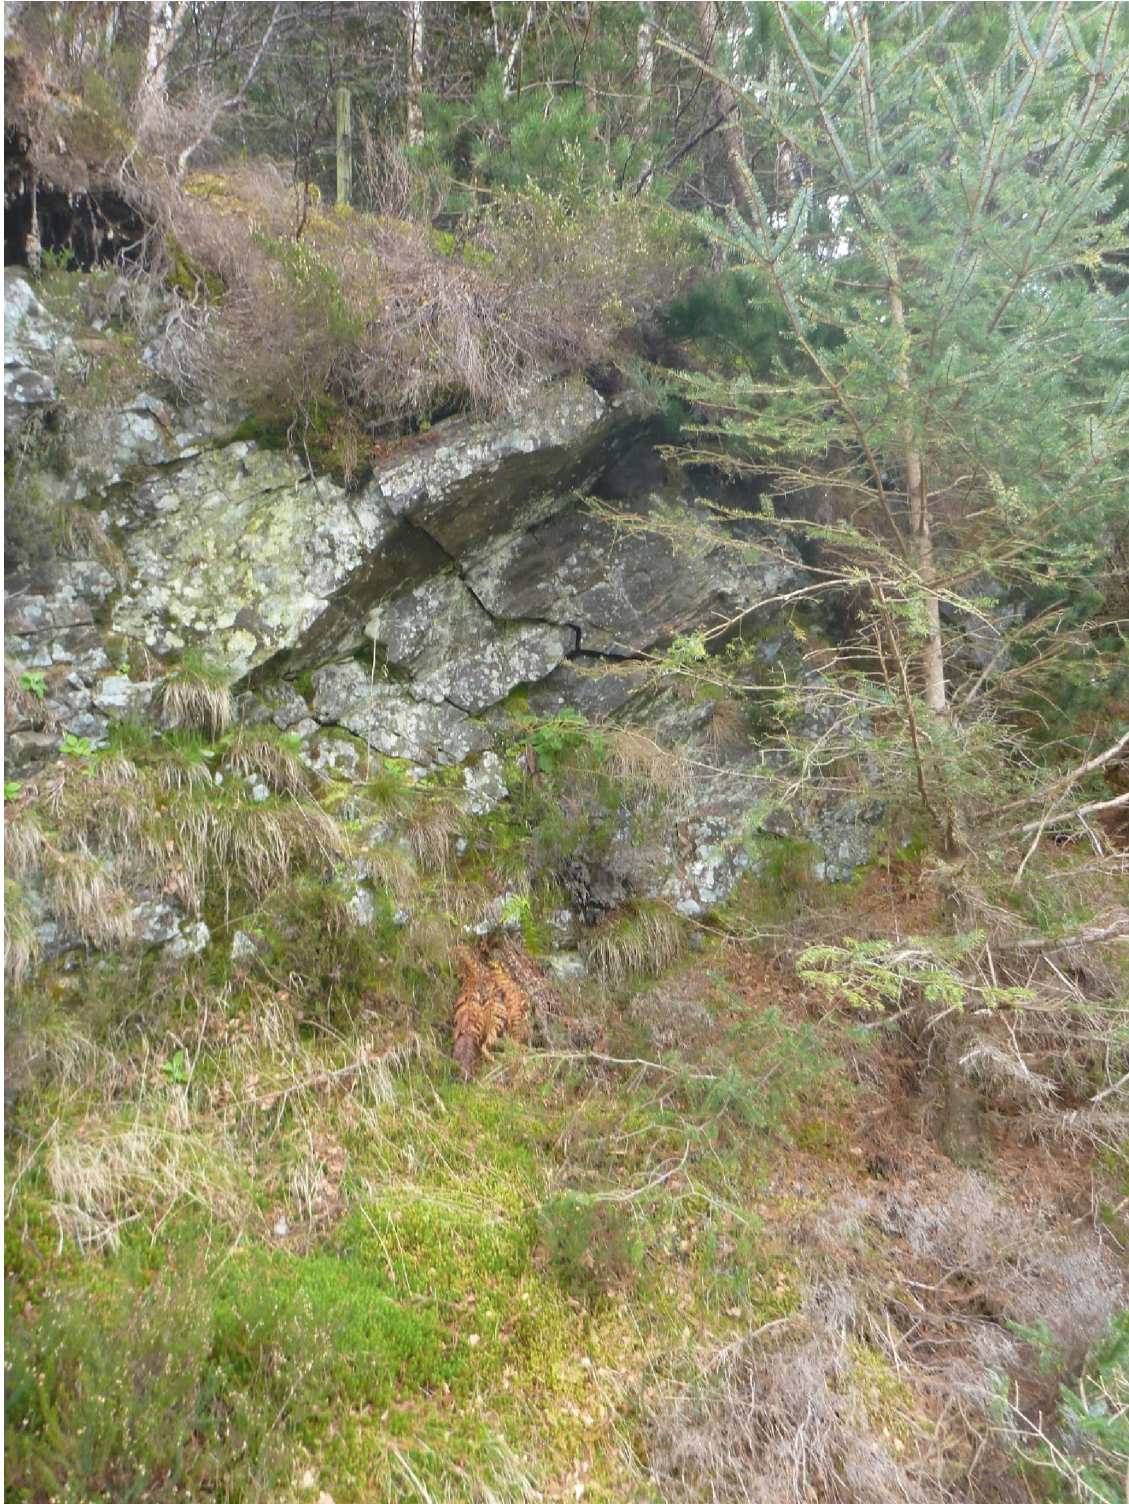
Ch. 020	<b>2022 Inspection:</b> Block (c.2m x 1m x 1.5m) with dilated back fracture (low risk due to presence of verge)	No change noted during the 2023 Inspection	M1-2
---------	---	--	------

Photograph M1-2	At Ch. 020 – Block (c.2m x 1m x 1.5m) with dilated back fracture (low risk due to presence of ditch)	Year observation first noted: 2019
-----------------	--	------------------------------------

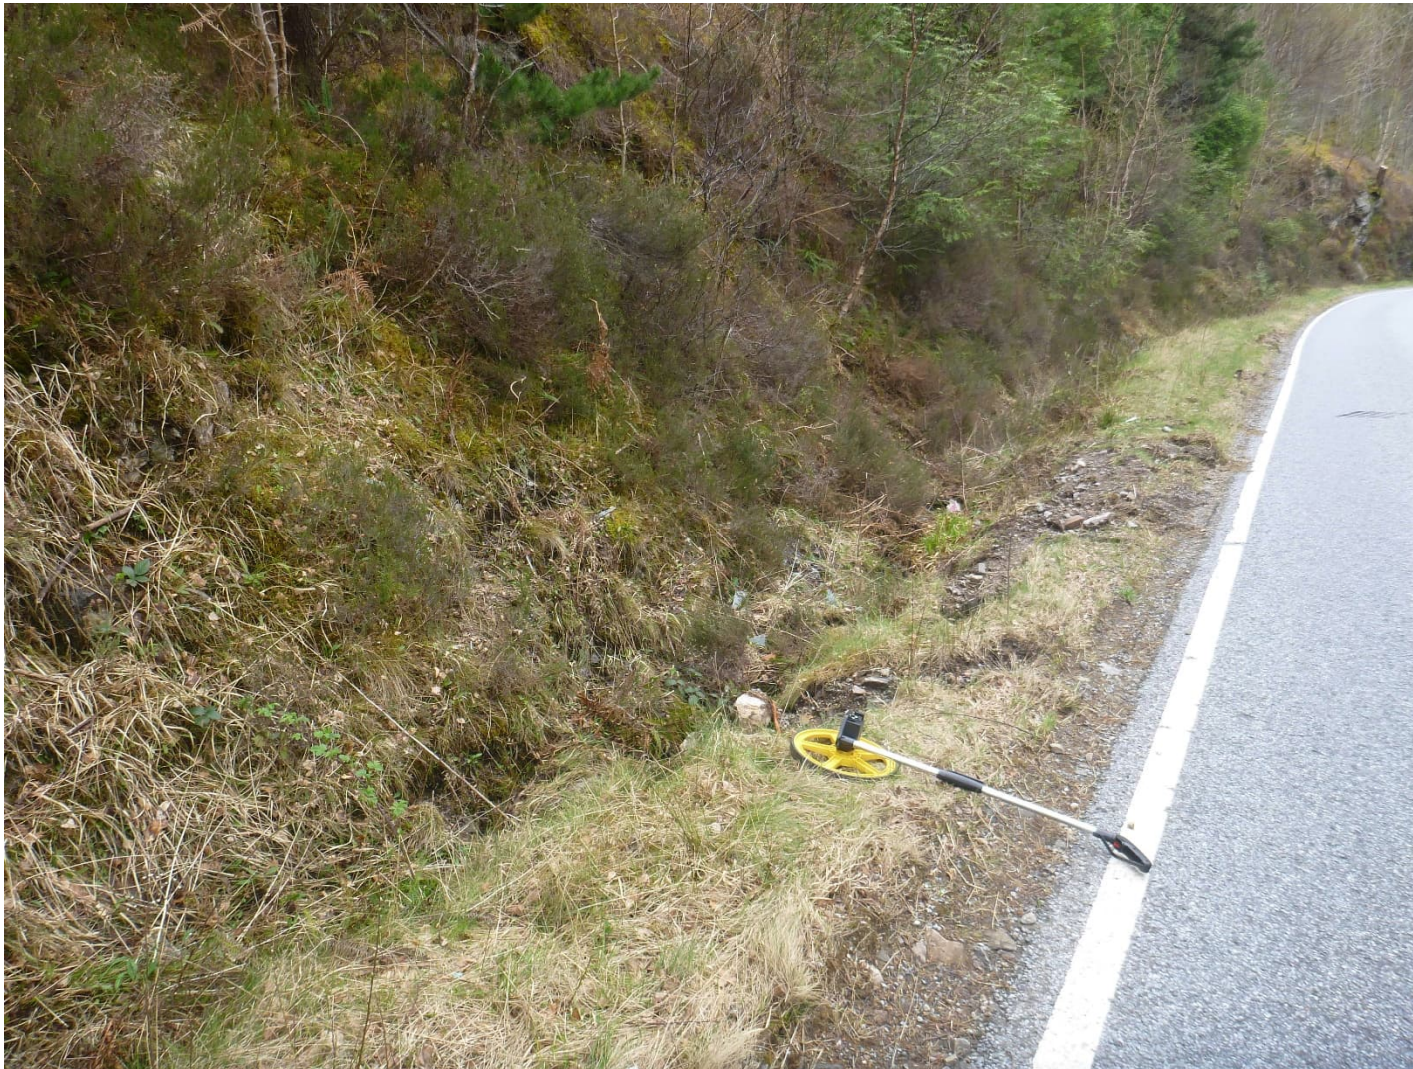
Photograph M2-1

Location	Description of Hazard (s) from Previous Inspections	2023 Inspection Observations	Photo Reference
Throughout M2	<b>2019 Inspection:</b> Small scale (<0.02m <sup>3</sup> ) ravelling / root jacking rock falls likely as rock mass continues to weather. However, ditch and verge at toe are considered effective and the associated likelihood of debris reaching the road is therefore low.	No change noted during the 2023 Inspection	
Ch. 226 to 235	N/A	Ditch has been locally damaged by vehicle going off road. Maintenance works not required as ditch is not below an area of significant rock fall hazard.	M2-1

Between Ch. 226 to 235 – Ditch has been locally damaged by vehicle off road.

Year observation first noted: 2023

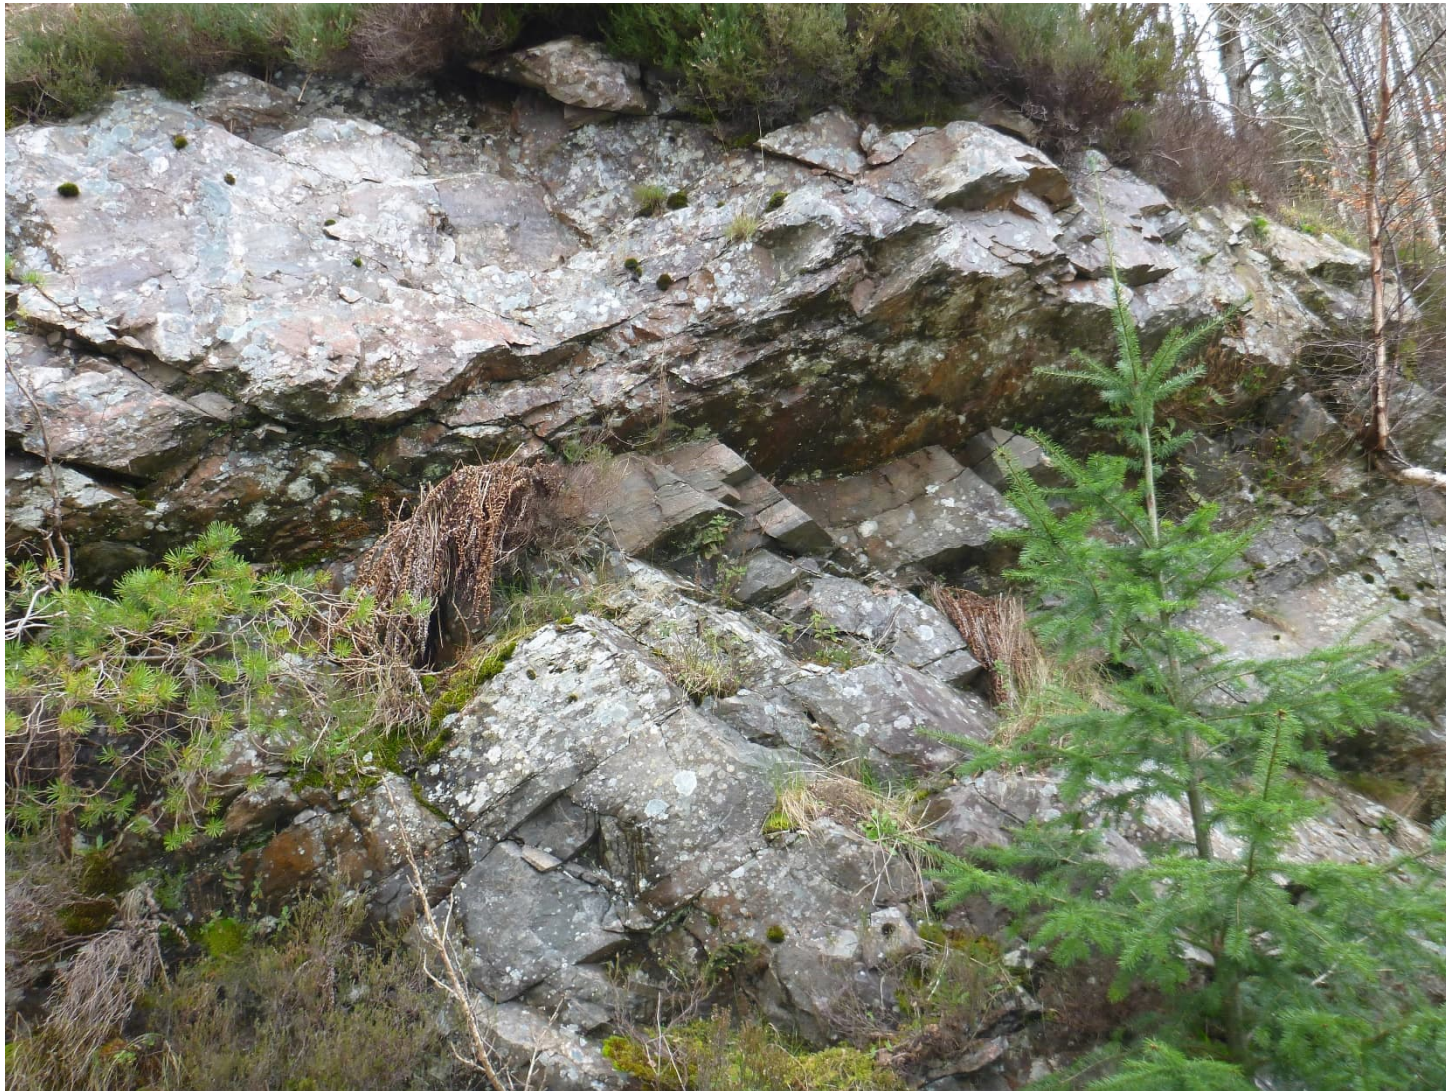
Photograph M3-1

At Ch. 311 – Localised overhangs with potential for rock fall of unsupported blocks.

Year observation first noted: 2019

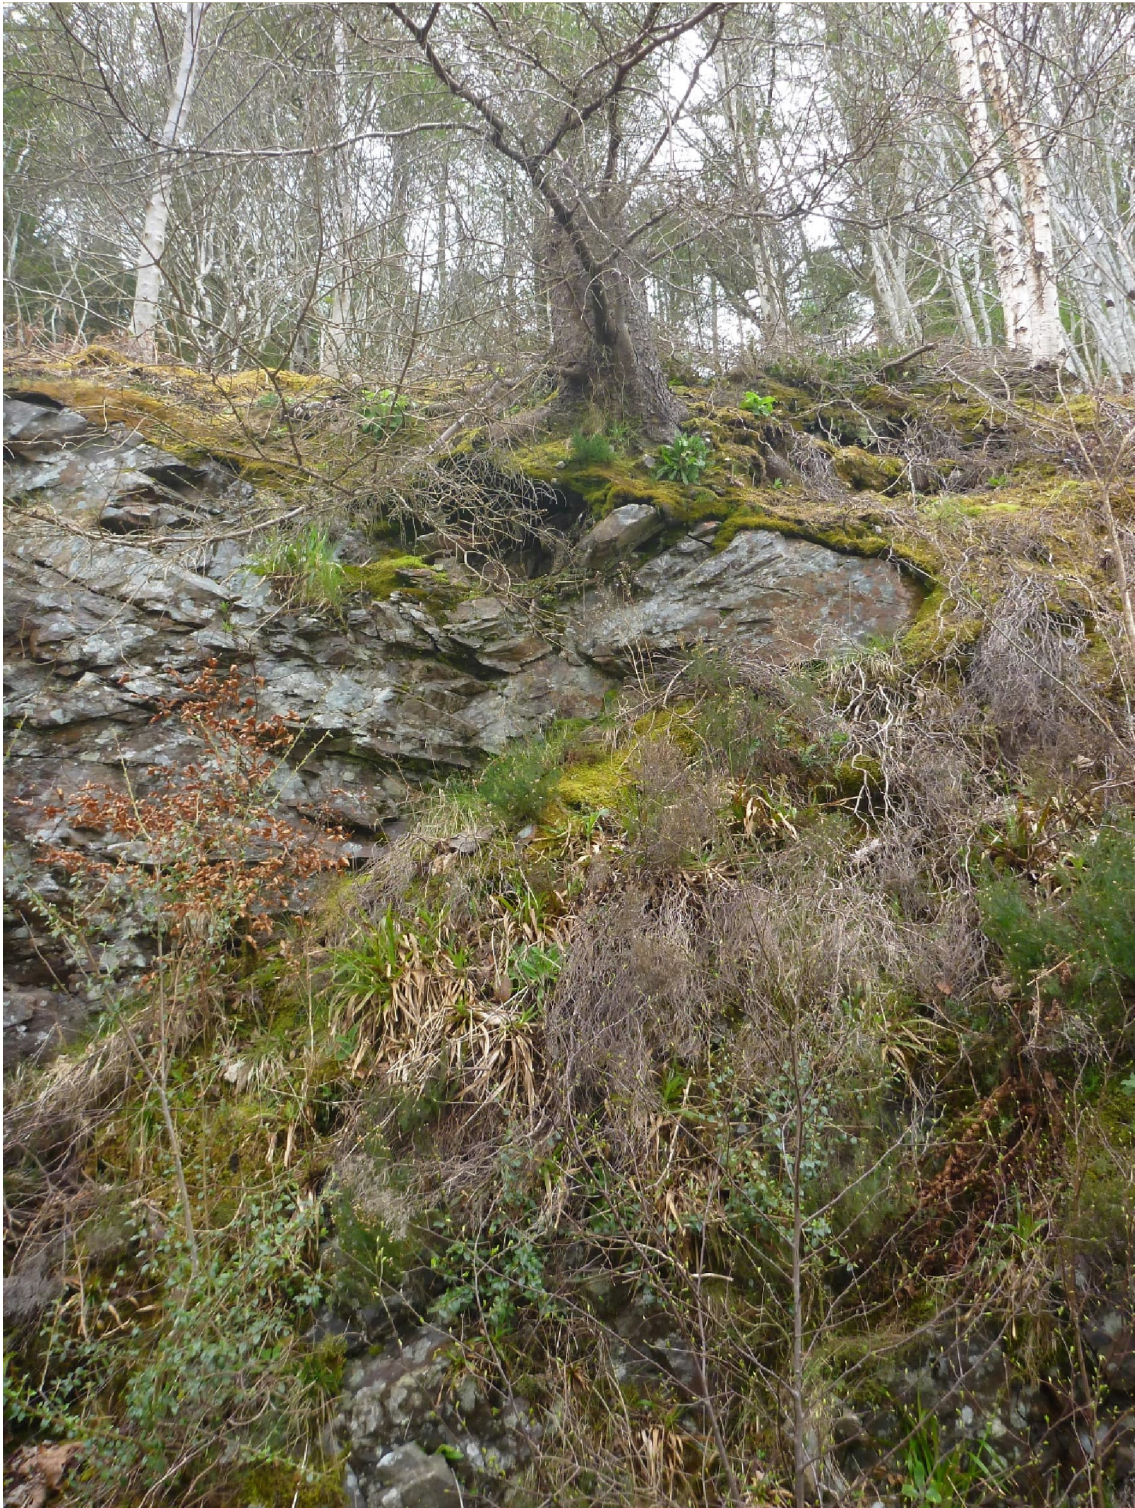
Photograph M3-2	At Ch. 304 – Material beneath tree creating root-jacking potential	Year observation first noted: 2023
-----------------	--	------------------------------------

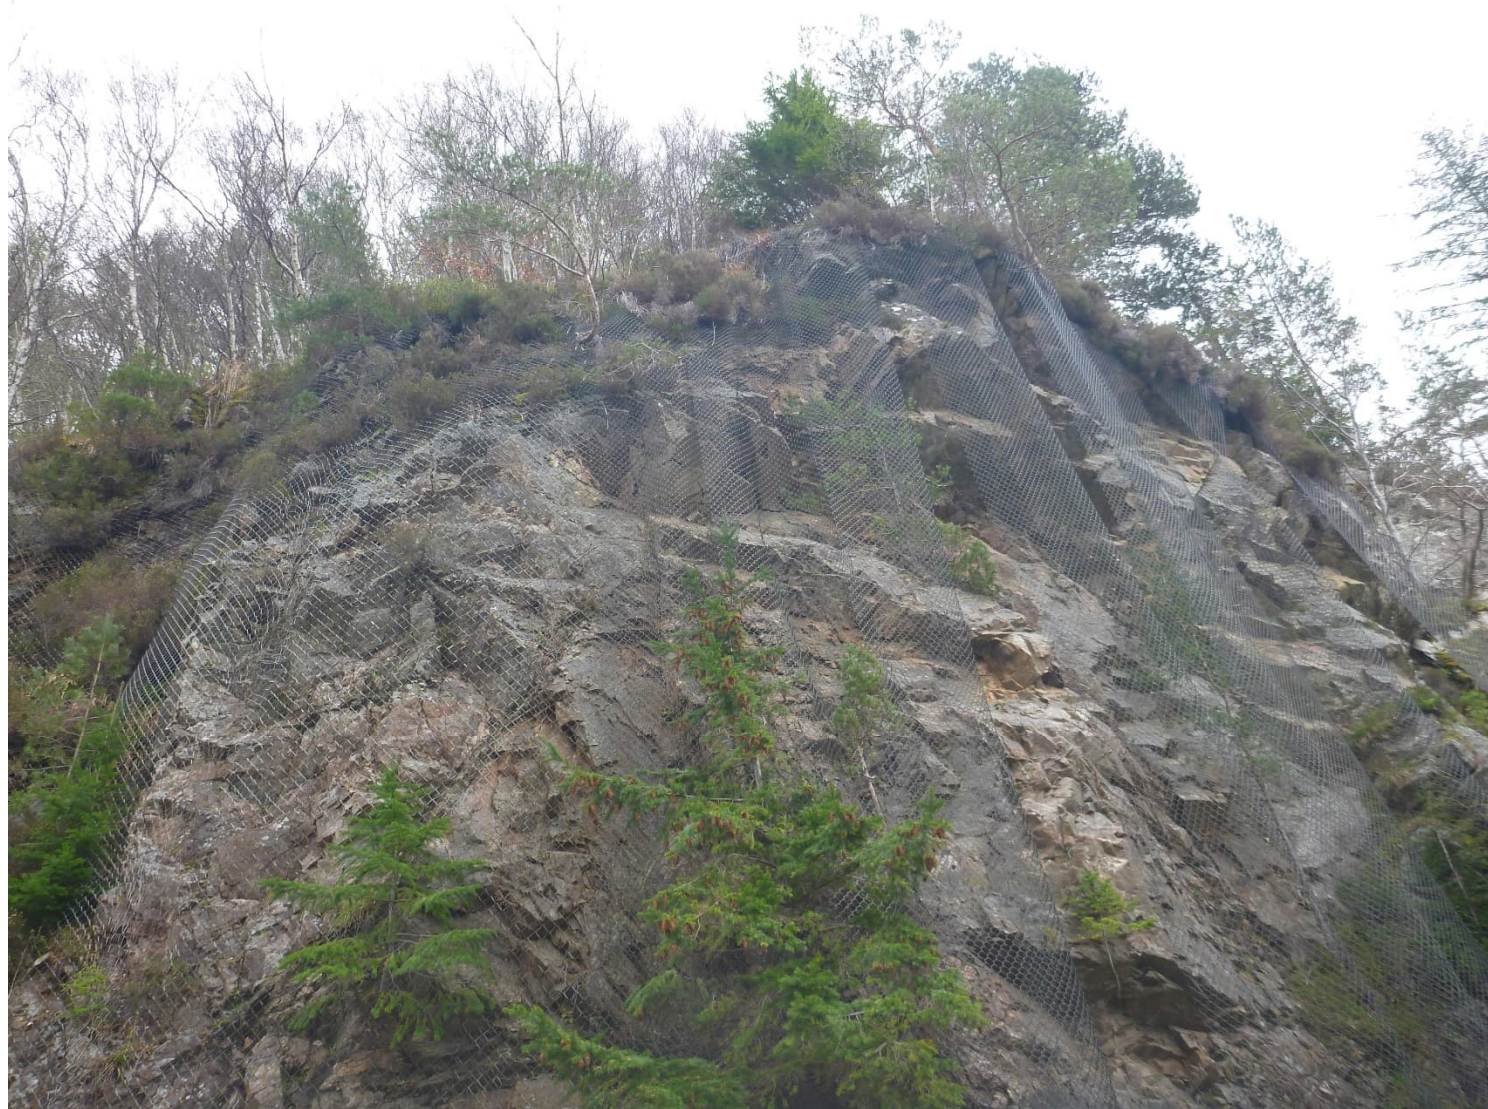
Photograph M4-1

Hazards Observed:			
Location	Description of Hazard (s) from Previous Inspections	2023 Inspection Observations	Photo Reference
Throughout M4	<b>2019 Inspection:</b> Numerous small scale (<0.02m <sup>3</sup> ) raveling type failures observed, some of which were deemed to be imminent (i.e. readily dislodged by hand).	No change noted during the 2023 Inspection	N/A
Ch. 370	<b>2019 Inspection:</b> A dilated sliding plane at 50° and with a 1.5m high x 2.5m wide x 1.5m deep block above was observed ca. 10m above road level. Loose rock noted along sliding plane. Risk of ca. 5m <sup>3</sup> plane failure. No ditch and narrow verge so rock fall debris likely to reach road. (Repeat rope access inspection completed in 2021 – no change)	No change noted during the 2023 Inspection	N/A
Ch. 370 to 380	<b>2019 Inspection:</b> A large overhang was observed ca. 3-5m below the crest of the rock face, however, joints were observed to be tight and no significant risk of rock fall identified.	No change noted during the 2023 Inspection	M4-1

General photo of hazardous area at rock slope including the large overhang c.3 to 5m below crest of slope.

Year observation first noted: 2019

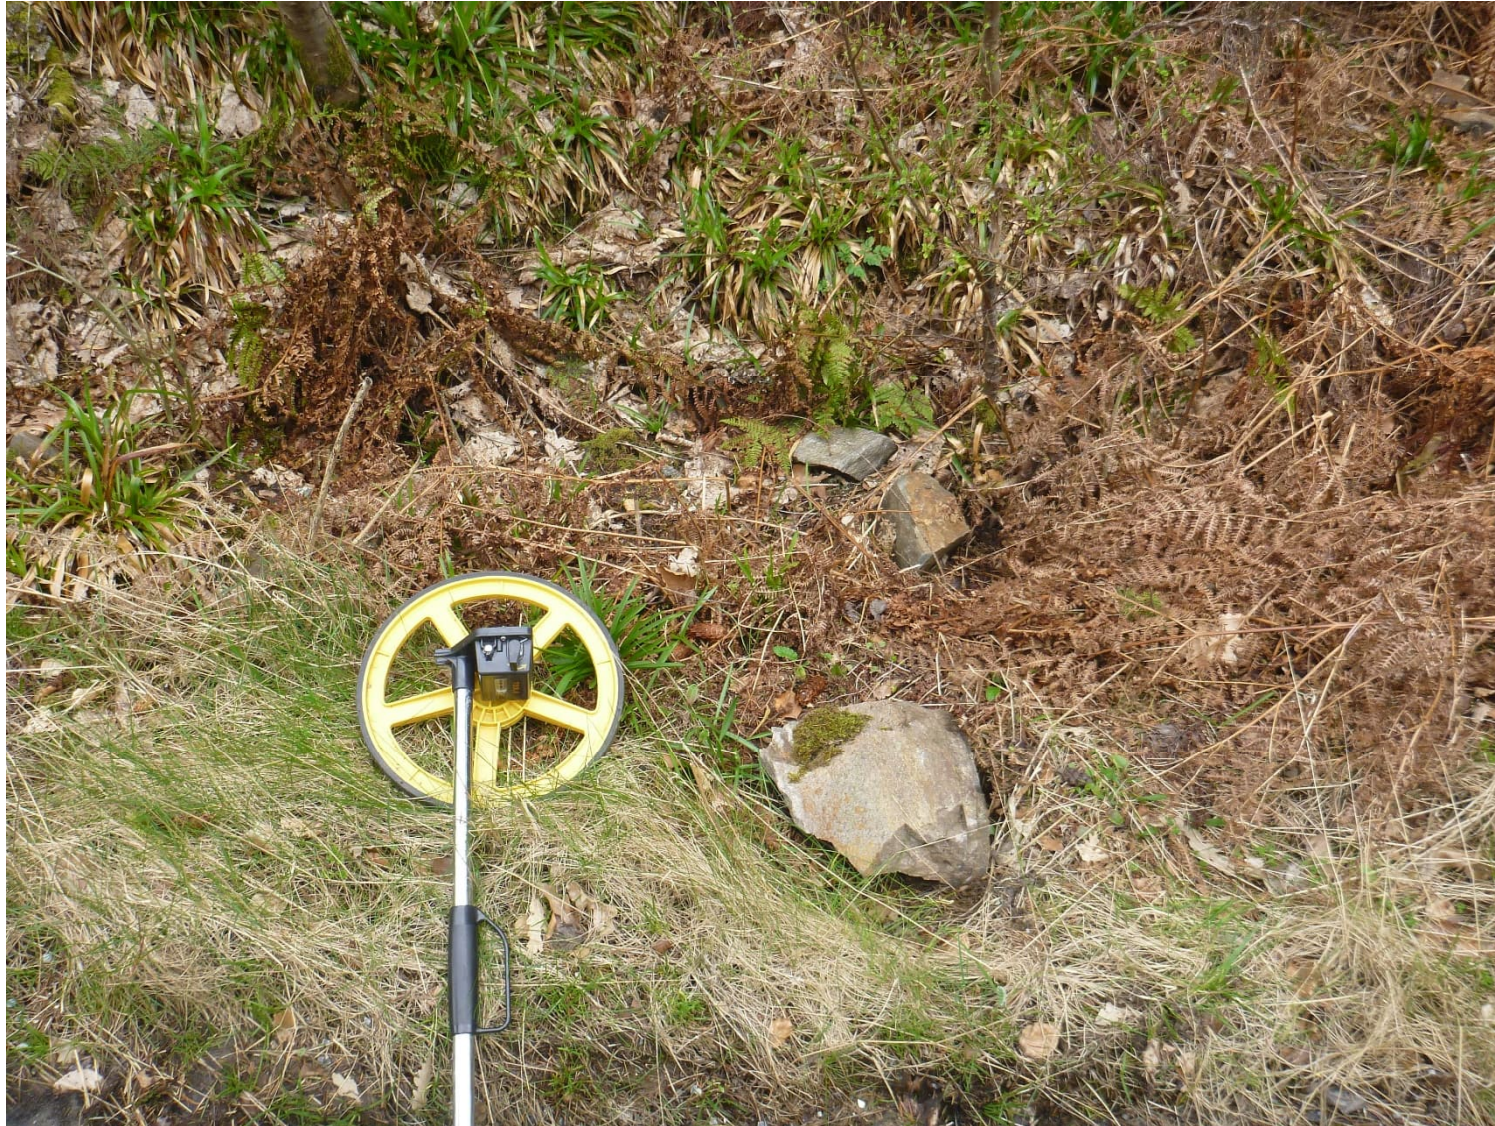
Photograph M4-1

Ch. 378	<b>2019 Inspection:</b> Dilated plane observed 8m above road level. Slightly keyed in at left hand side but fractured rock mass ca. 3.5m wide x 0.5m deep x 1m high. Potential for rock fall exists and narrow verge below means this poses a risk to the road.	No change noted during the 2023 Inspection	N/A
Ch. 388	-	3 new blocks in ditch up to 0.3m side length.	M4-2

At Ch. 388 - 3 new blocks in ditch up to 0.3m.

Year observation first noted: 2023

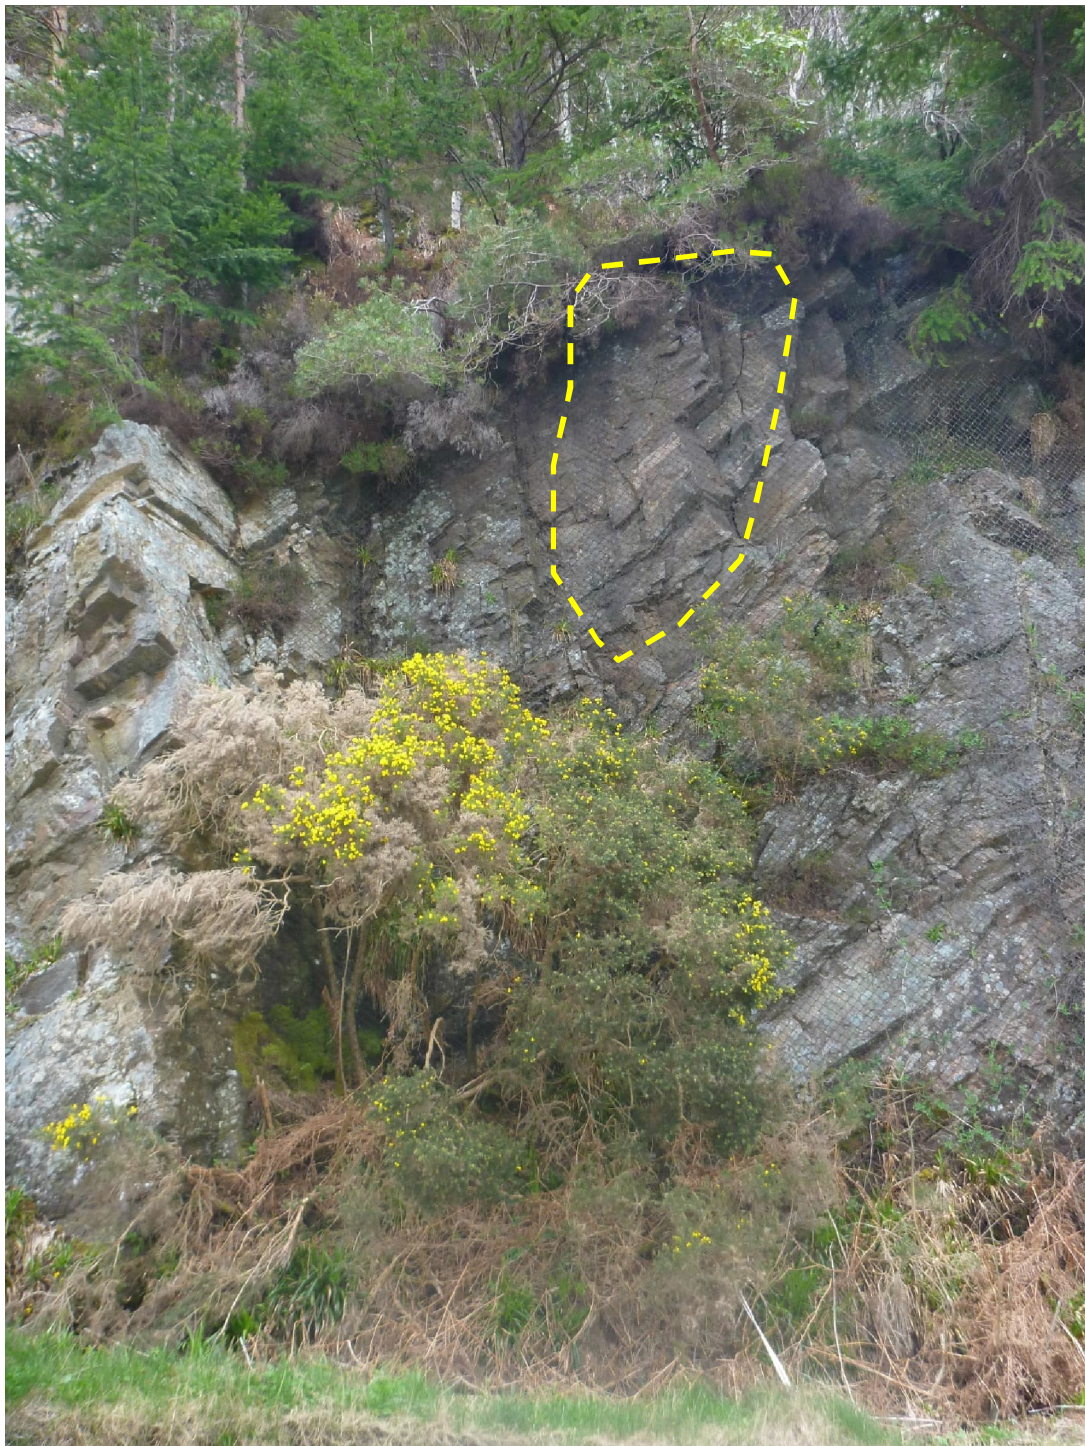
Hazards Observed:			
Location	Description of Hazard (s) from Previous Inspections	2023 Inspection Observations	Photo Reference
Throughout M6	<b>2019 Inspection:</b> Ongoing ravelling and root jacking, particularly along crest.	No change noted during the 2023 Inspection	N/A
Ch. 420	<b>2019 Inspection:</b> Potential toppling failure identified ca. 6m above road level. Dilated fractures. 0.5-1.0m <sup>3</sup> .	No change noted during the 2023 Inspection	M6-1

Photograph M6-1	At Ch. 420 – Potential toppling failure identified ca. 6m above road level. Dilated fractures. 0.5-1.0m <sup>3</sup> .	Year observation first noted: 2019
-----------------	--	------------------------------------

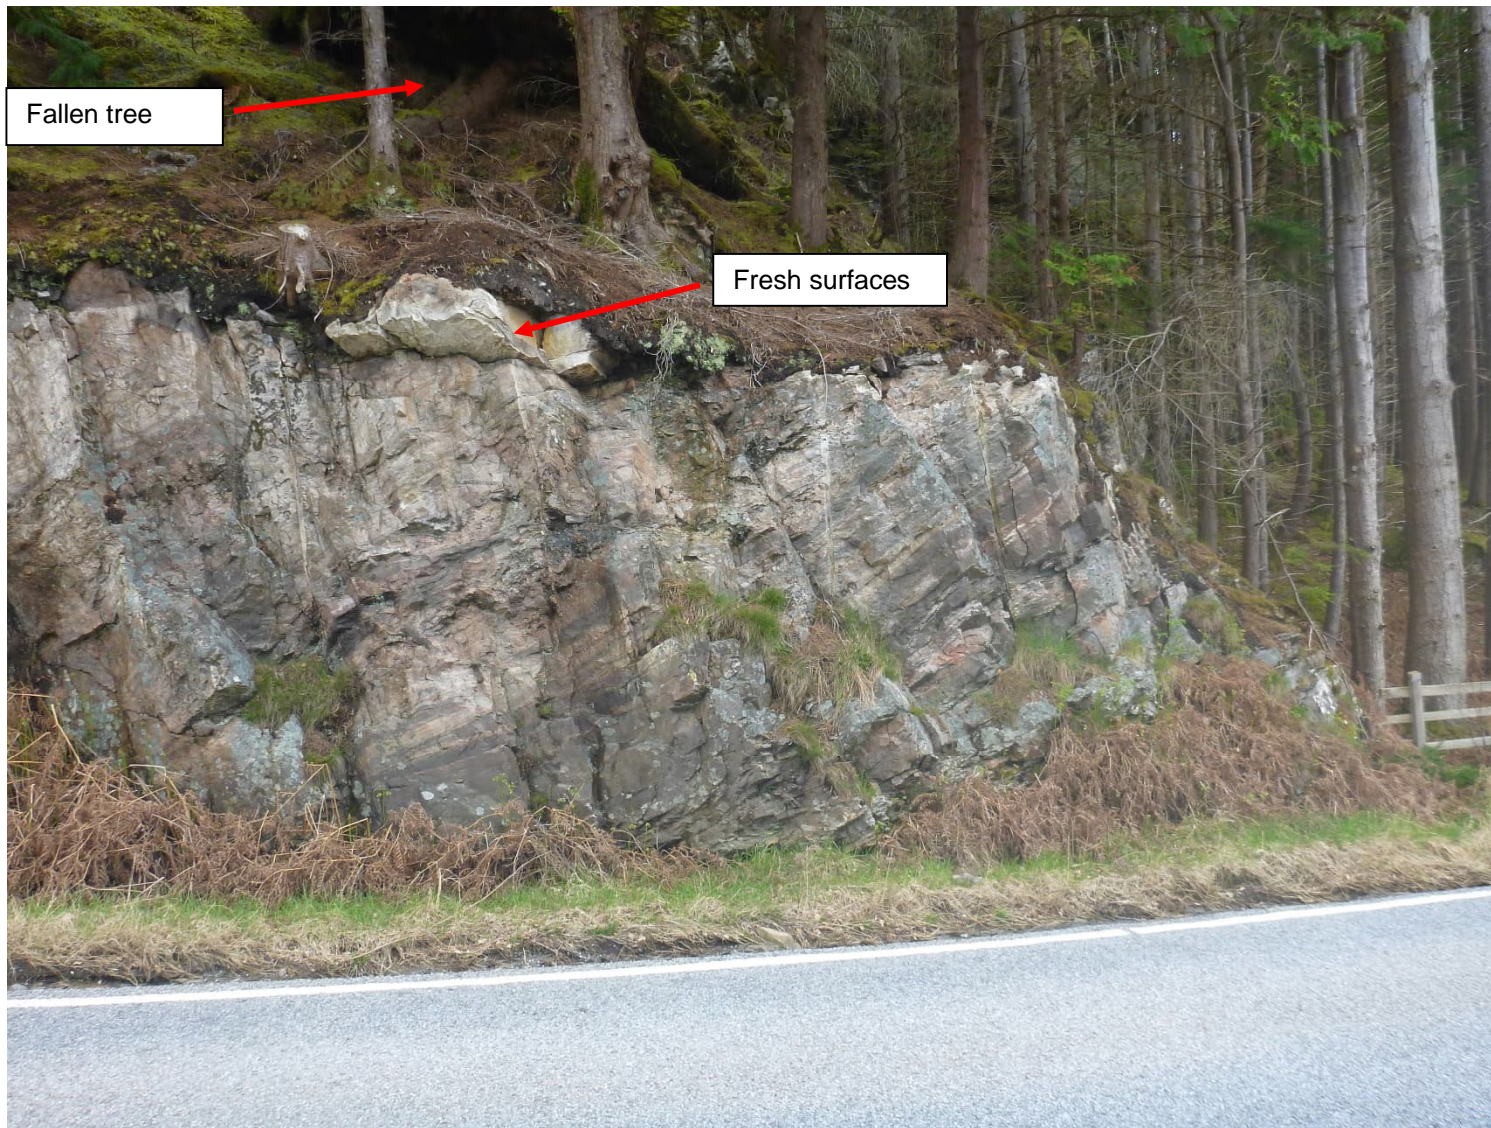
Photograph M6-2

Ch. 455	<b>2022 Inspection:</b> Fallen tree c.3m back from crest of slope. Tree has been cut (unsure when this was completed). Not posing risk to road.	No change noted during the 2023 Inspection	N/A
Ch. 455	<b>2022 Inspection:</b> Fresh surfaces at crest of slope indicating recent rockfall. Block not currently in ditch/verge so has been moved. Block anticipated to have been 0.3m x 0.2m based upon fresh surface.	No change noted during the 2023 Inspection	M6-2

At Ch. 455 - Fallen tree 3m back from slope posing no risk to the road.  
Fresh surfaces indicating a relatively recent rock fall.

Year observation first noted: 2022
