A890 Maman Hill

Annual Slope Inspection 2024

The Highland Council

Project number: 60685712
AECOM Report Ref: GLRP0009

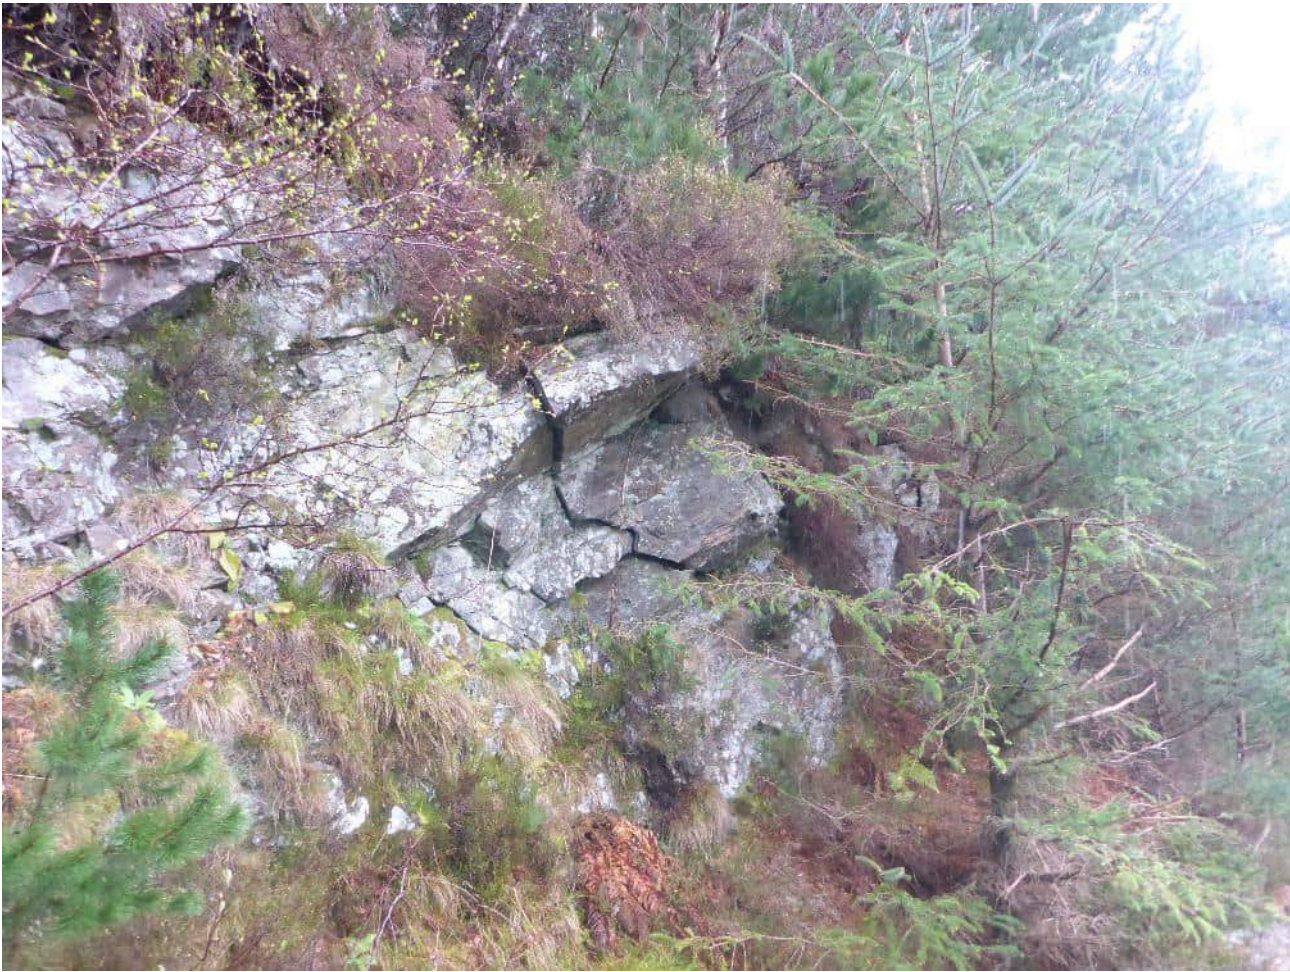
Photograph M1-1	Ch. 020 – block (c.2m x 1m x 1.5m) with dilated back fracture (poses low risk to road due to presence of verge).	Year observation first noted: 2022
-----------------	--	------------------------------------

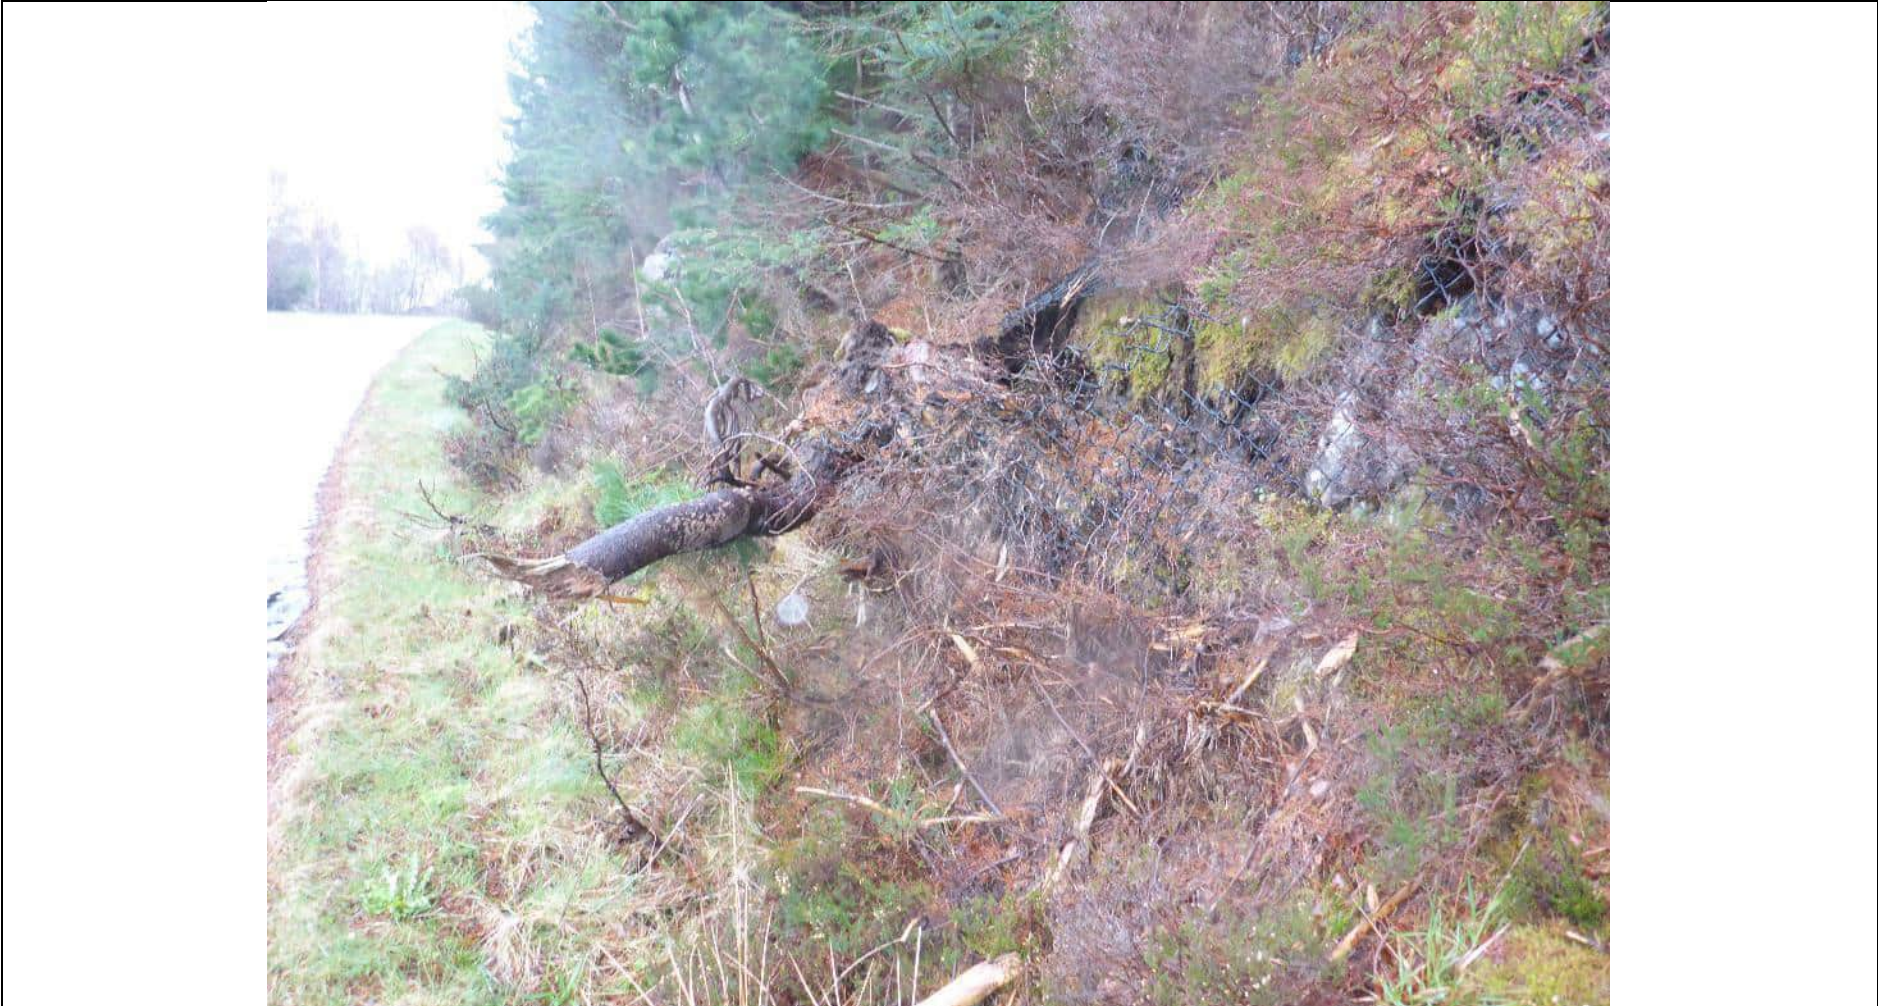
Photograph M1-2	Ch. 032– Rotated tree root protruding from rock slope.	Year observation first noted: 2024
-----------------	--	------------------------------------

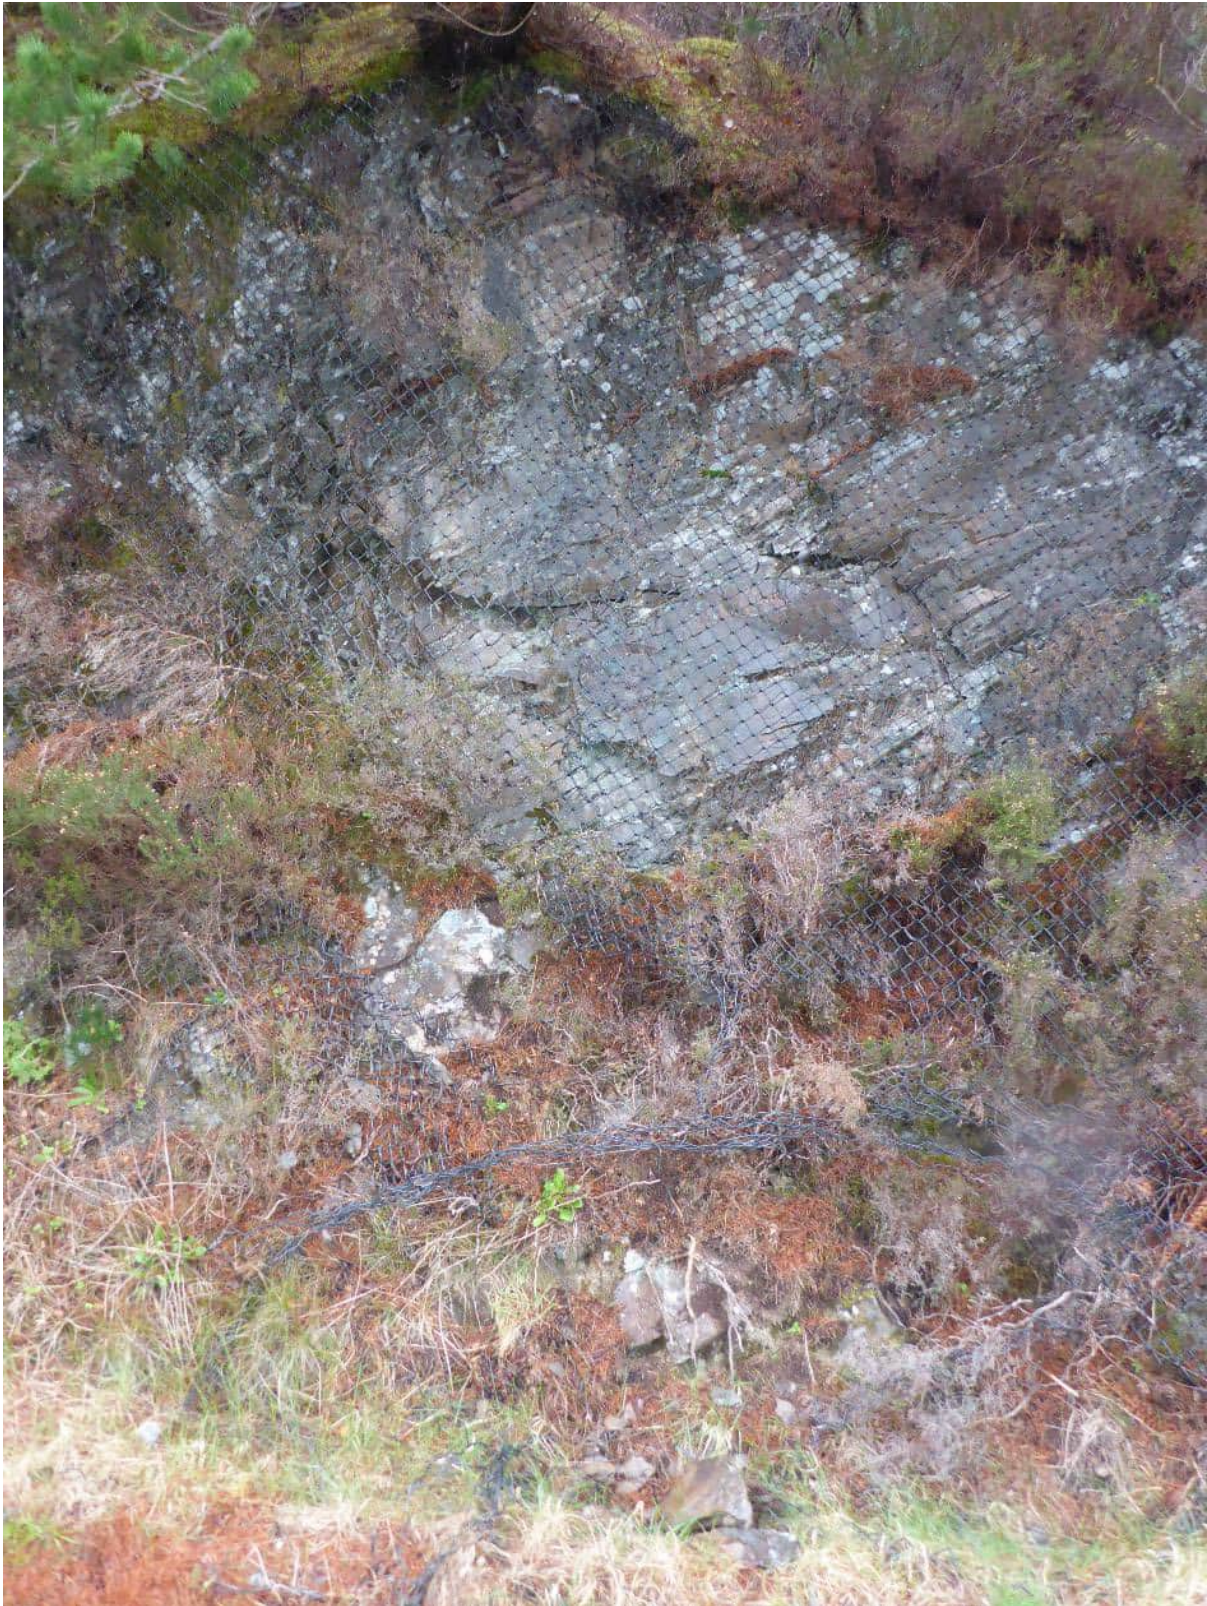
Hazards Observed:			
Location	Description of Hazard (s) from Previous Inspections	2024 Inspection Observations	Photo Reference
Ch. 018	2022 Inspection: Trees at crest of slope presenting risk of root-jacking. Approx. 6 blocks c.2m x 0.1m x 0.1m are in the verge.	No change noted during the 2024 inspection.	N/A
Ch. 020	2022 Inspection: Block (c.2m x 1m x 1.5m) with dilated back fracture (low risk due to presence of verge)	No change noted during the 2024 inspection.	M1-1
Ch. 032	N/A	Tree root has rotated out from slope. Rock slope behind is clean and does not present a hazard.	M1-2
Ch. 053	N/A	Several small blocks present in the verge which have a source location 5m high, at the crest of the slope. There is potential for more blocks to fall and land on the verge or edge of the road.	M1-3

Photograph M1-3	Ch. 053 – Several small blocks at toe of slope.	Year observation first noted: 2024
-----------------	---	------------------------------------

Recommended Remedial Works / Actions							
N/A		N/A		<ul style="list-style-type: none">- Re-inspection by end of April 2025- Felling of trees along crest- Scaling of loose rock behind netting (between Ch. 030 to 070)			
Assessed in field by:	MT/SB/PLM	Date:	15/04/2024	Reviewed by:	PLM	Date:	28/05/2024

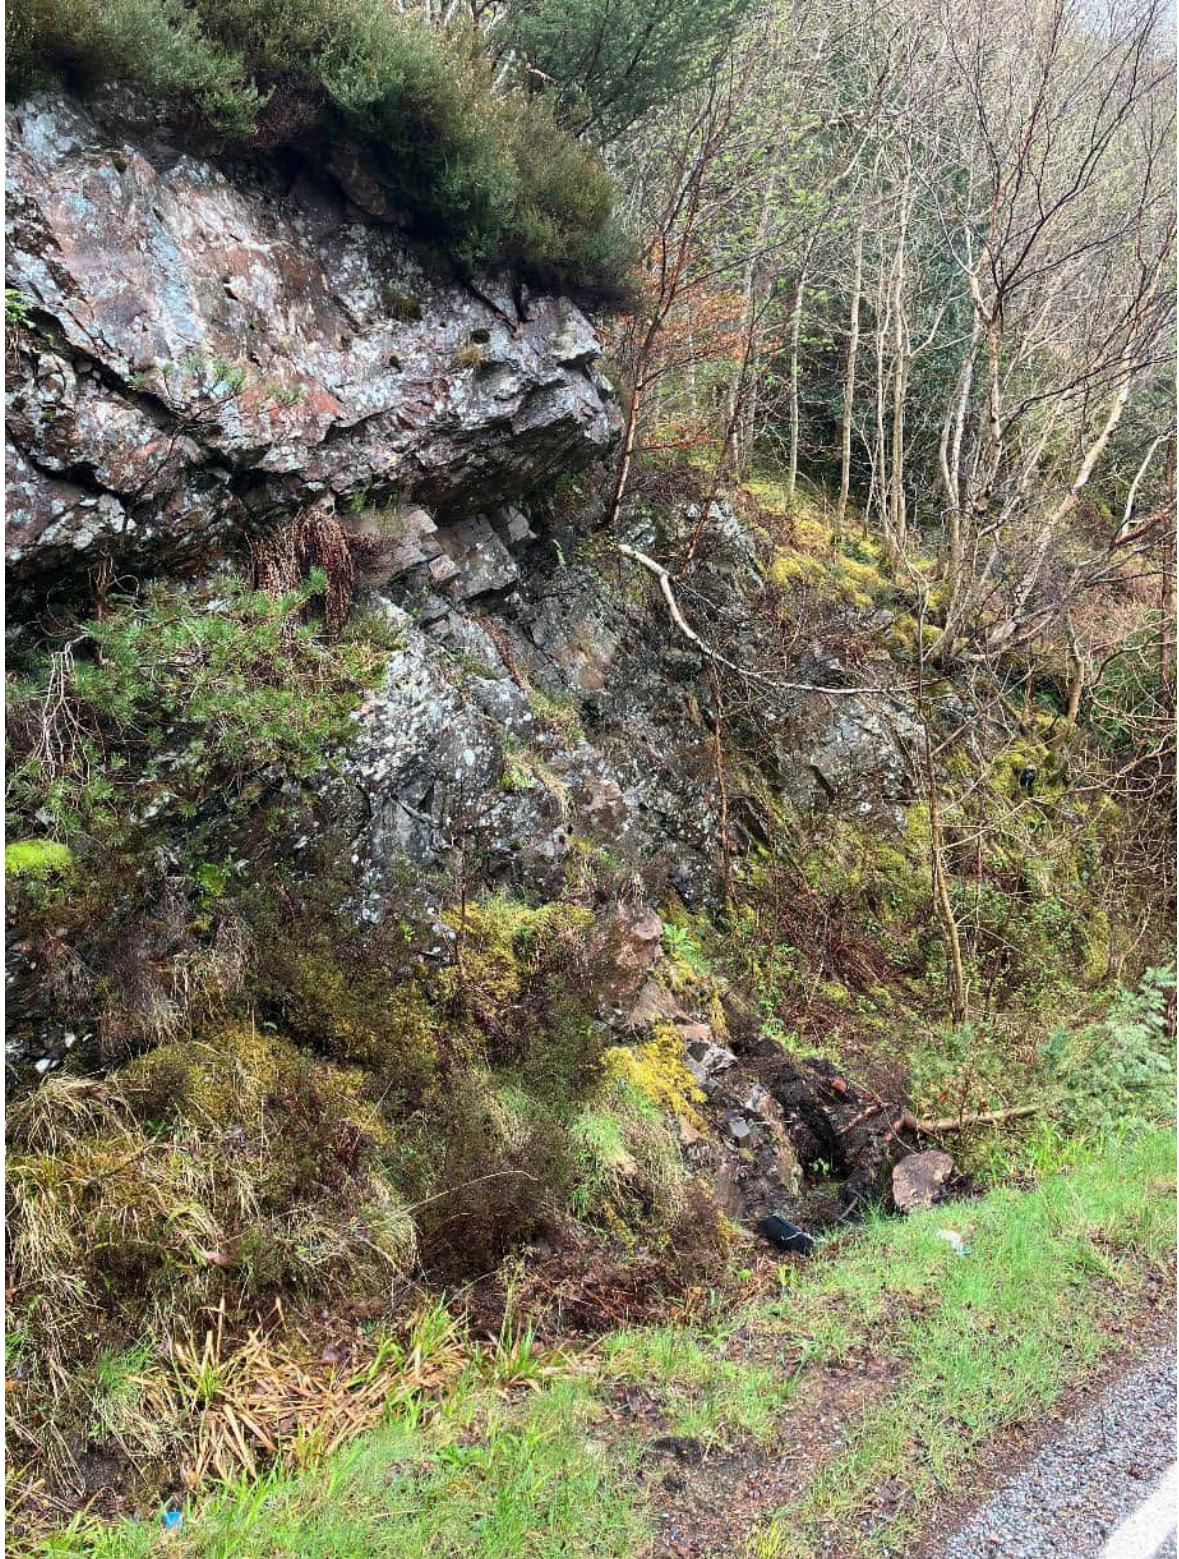
Photograph M3-1

Location	Description of Hazard (s) from Previous Inspections	2024 Inspection Observations	Photo Reference
Throughout M3	2019 Inspection: Numerous small scale (<0.02m ³) ravelling type rock falls observed, some of which were deemed to be imminent (i.e. readily dislodged by hand).	No change noted during the 2024 inspection.	N/A
Throughout M3	2019 Inspection: Localised overhangs with potential for rock fall of unsupported blocks. Individual block size typically <0.1m ³ (e.g. at Ch. 311)	No change noted during the 2024 inspection.	N/A
Ch. 304	2023 Inspection: Rock mass beneath tree exhibiting root-jacking potential	No change noted during the 2024 inspection.	N/A
Ch. 311	N/A	A tree has fallen away from the slope. Possibly due to a vehicle leaving the road and entering	M3-1

Hazards Observed:			
Location	Description of Hazard (s) from Previous Inspections	2024 Inspection Observations	Photo Reference
		the ditch (evidence of disturbed verge and vehicle debris). No significant hazard.

Ch. 311 – Fallen tree.

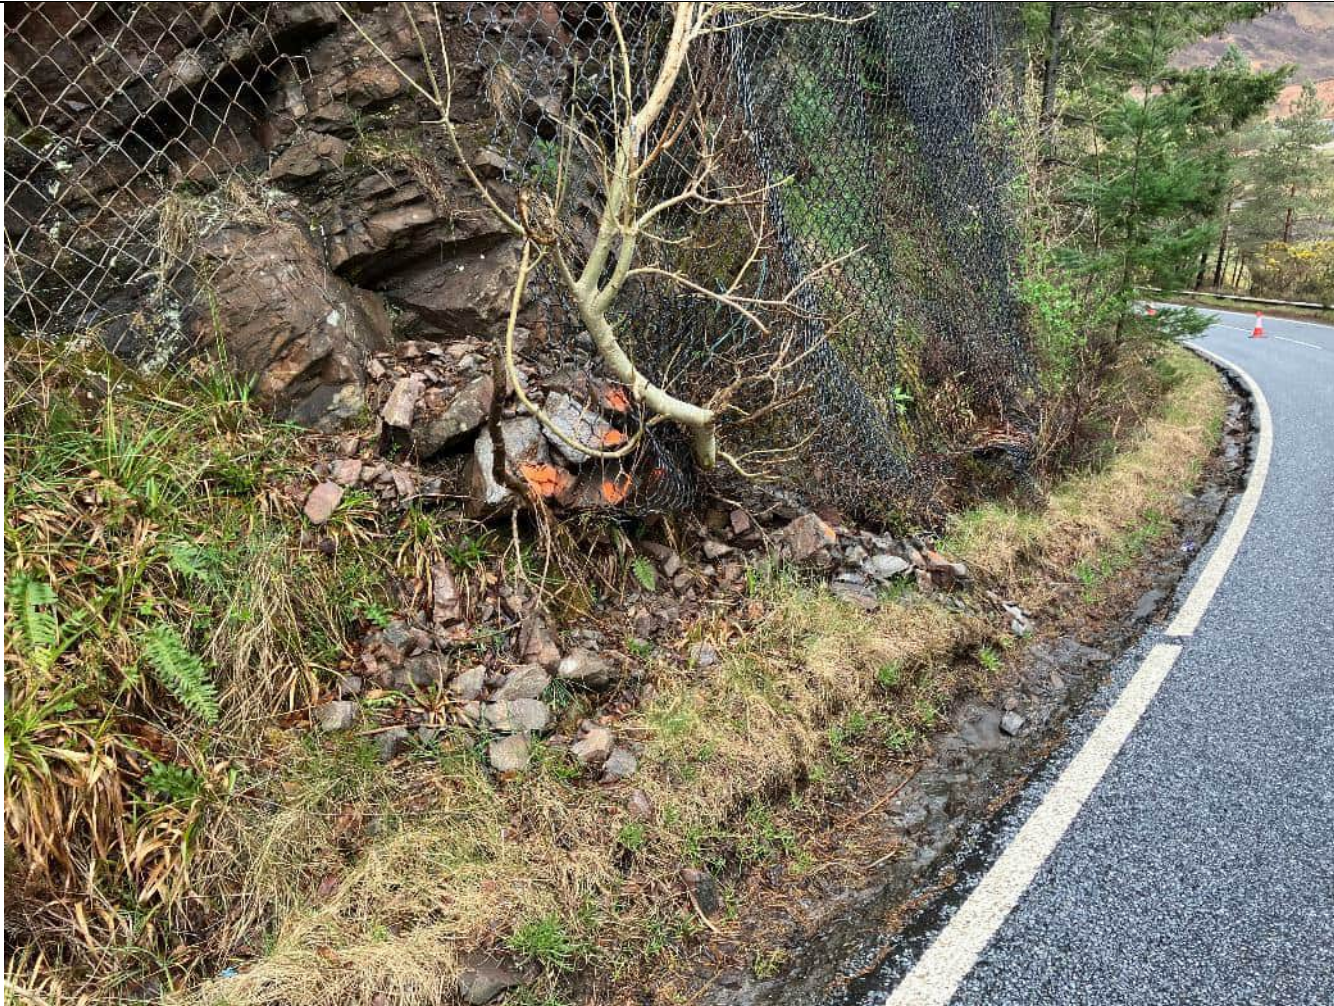
Photograph M4-1

Ch. 370 to 380	2019 Inspection: Several areas of blast damage noted with dilated joints and loose rock observed. No ditch and only a narrow verge present beneath highest section of the rock slope. Debris noted along toe of slope in this area and potential for additional rock falls to occur.	An accumulation of small blocks at toe of netting and in verge. Individual blocks up to 0.2m in diameter and total volume of fallen blocks is approximately up to 0.75m ³ . The source of the fallen blocks appears to be from possibly two locations. One location is 1-2m above the toe of the slope and the other is 3-4m	M4-1 M4-2 M4-3

Between Ch. 370 - 380 – accumulation of rock fall debris at toe of slope and verge. Rocks are resting against small tree and beginning to spill out onto narrow verge.

Recommended Remedial Works / Actions						
Large Scale Rock Fall Protection Works (Category 3)			Localised Targeted Rock Fall Protection Works (Category 2)	Ongoing Maintenance (Category 1)		
<ul style="list-style-type: none"> - AECOM completed the design of the following rock fall remedial works for M4 in November 2023. It is understood that THC intends to progress works later in 2024. <ul style="list-style-type: none"> ▪ Ch. 347 to 362: drapery netting system. ▪ Ch. 362-415: active netting system. 			N/A	<ul style="list-style-type: none"> - Full de-vegetation (including felling of trees along crest) and light scaling (required as enabling / preparatory works for Category 3 works). - Re-inspection by end of April 2025 		
Assessed in field by:	MT/SB/PLM	Date:	18/04/2024	Reviewed by:	PLM	Date: 28/05/2024

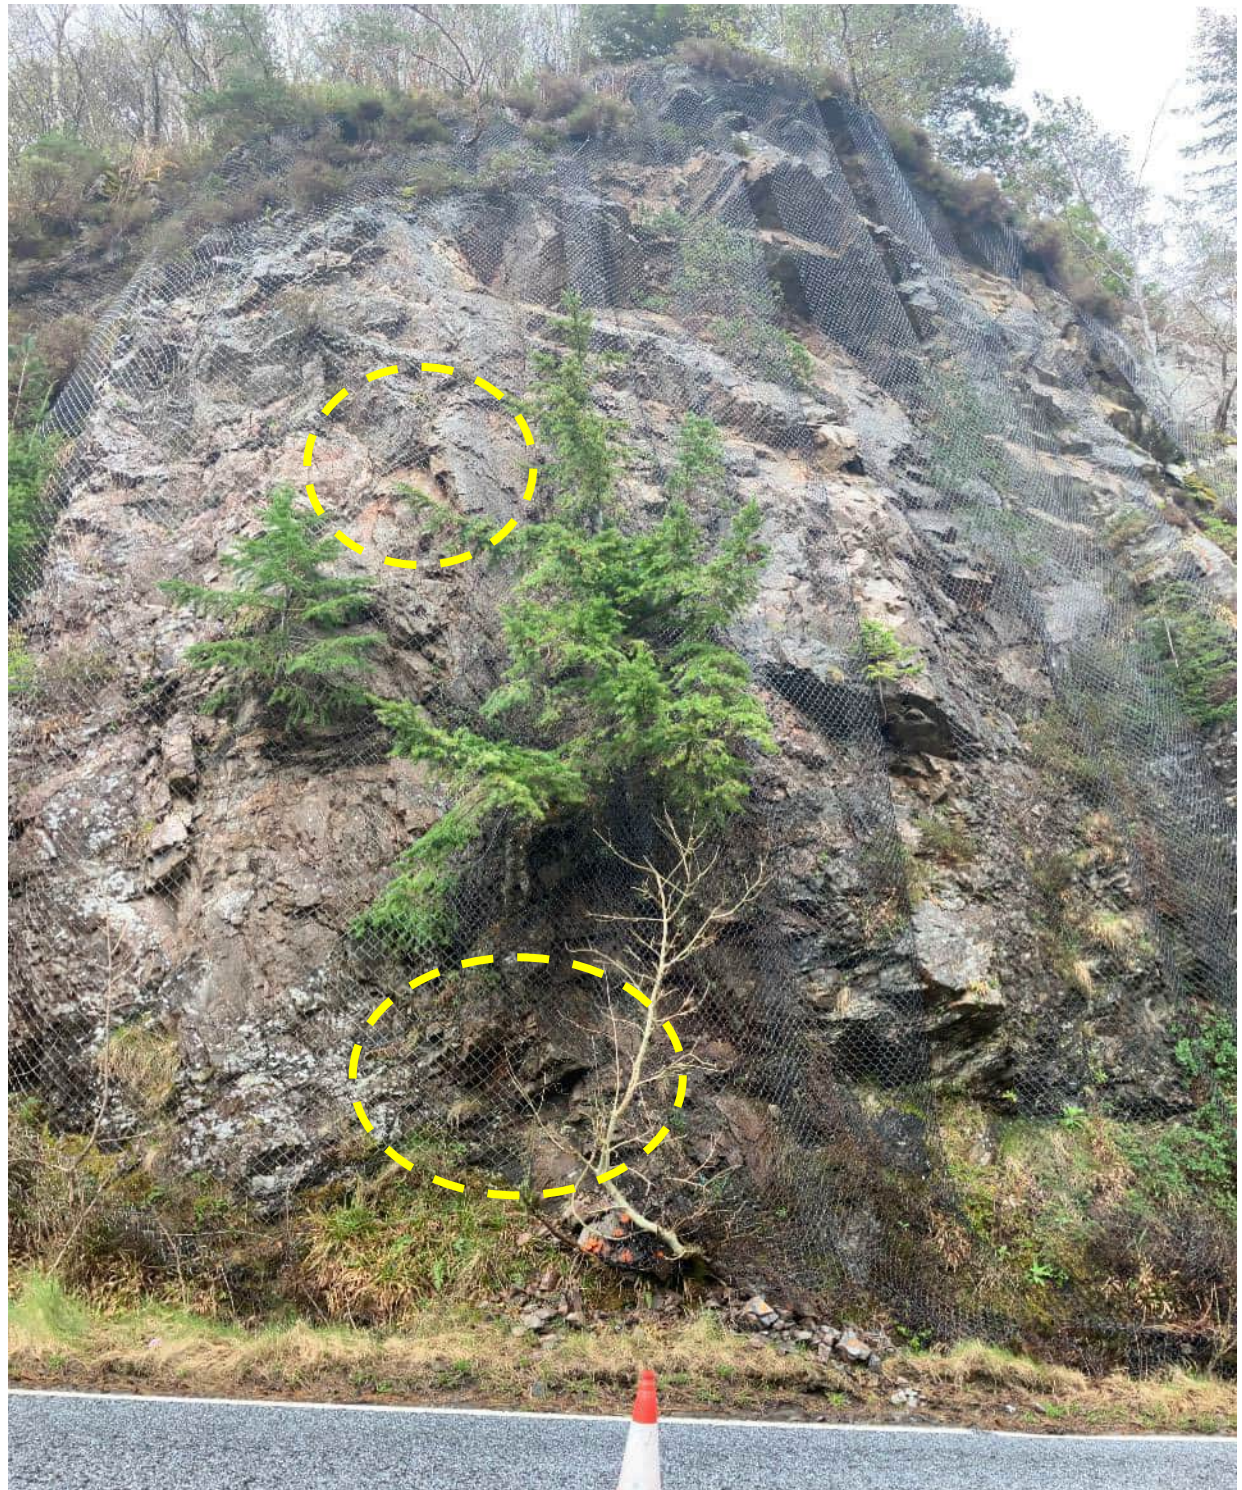
Photograph M4-2

Between Ch. 370 - 380 – accumulation of rock fall debris at toe of slope and on narrow verge. Source areas circled.

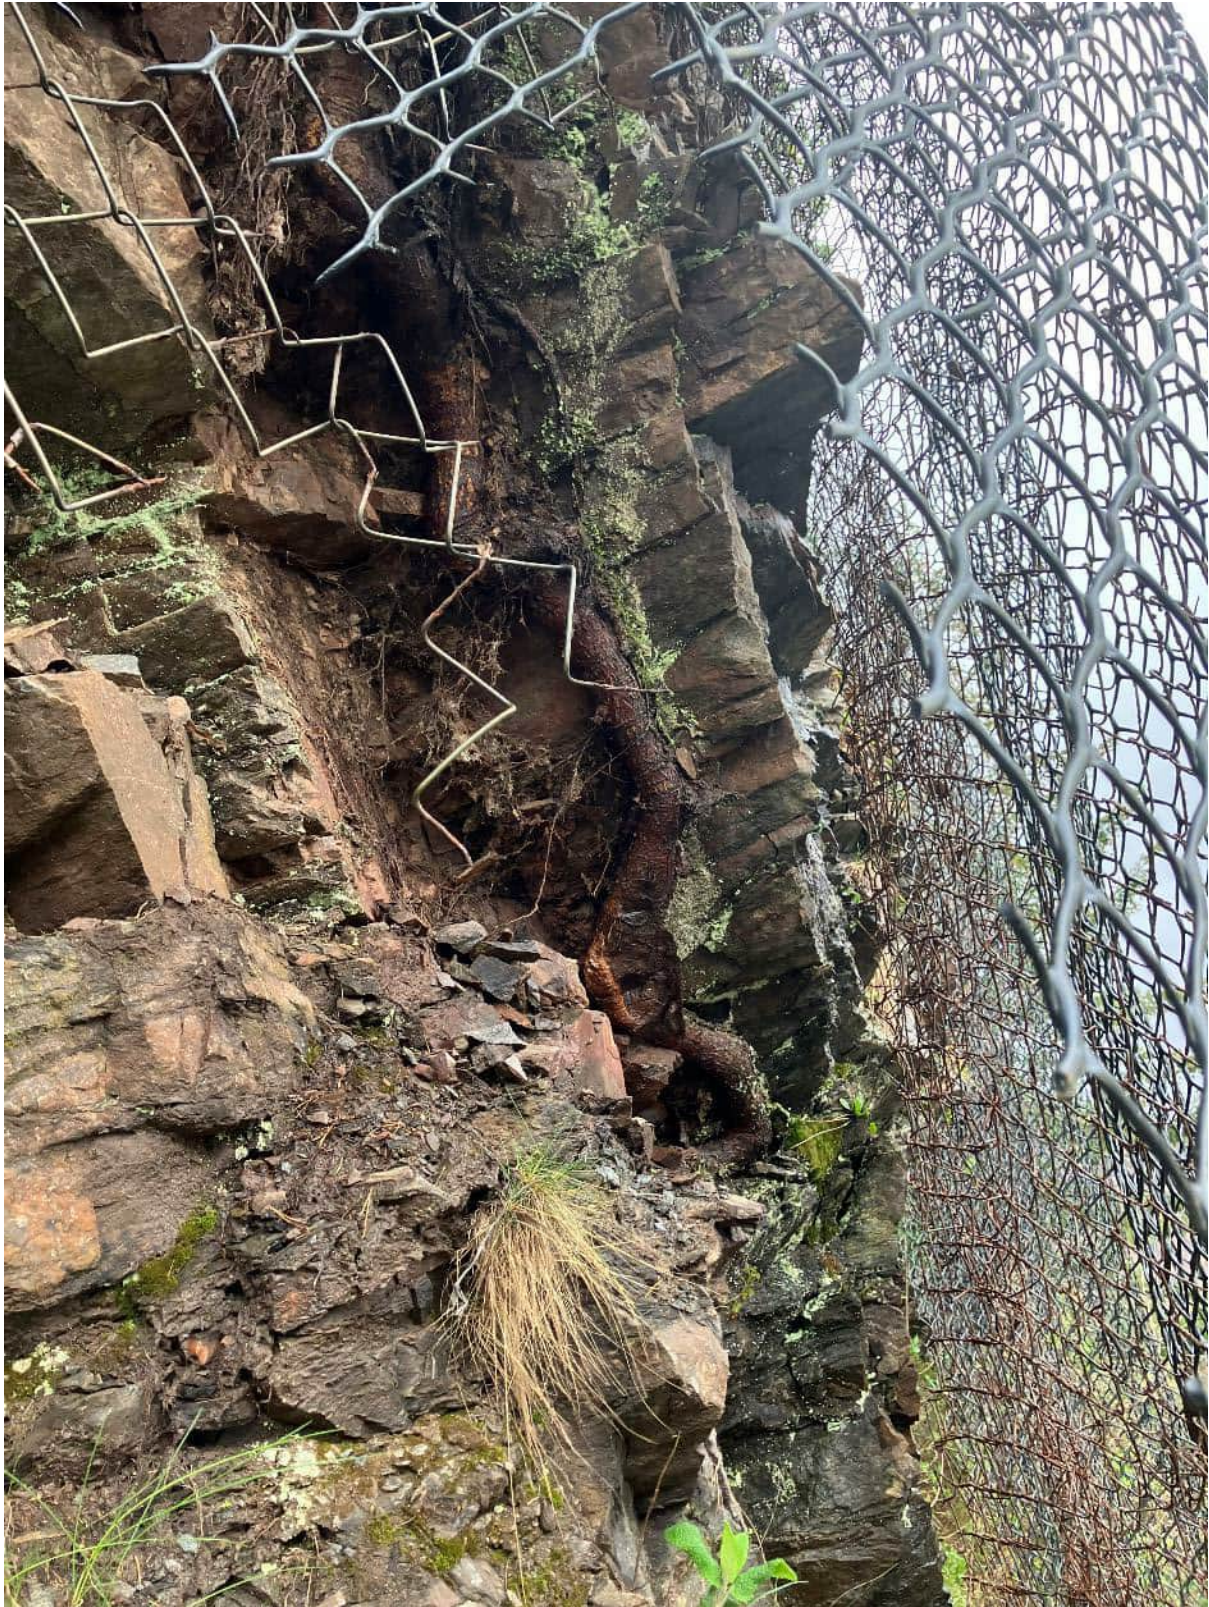
Hazards Observed:			
Location	Description of Hazard (s) from Previous Inspections	2024 Inspection Observations	Photo Reference
		above the toe of the slope. Both show areas of fresh surfaces and root jacking potential is present. Further root jacking potential is possible and another 0.5-0.75m ³ of blocks could fall. Given absence of verge at this location there is potential for blocks to reach the road.	
Ch. 374	2019 Inspection: Overhang at crest (1.0-1.3m) with dilated fracture along left hand side. "Supporting block" on 58° sliding plane. Root jacking potential. (Rope access completed in 2021).	No change noted during the 2024 inspection.	M4-4
Ch. 378	2019 Inspection: Dilated plane observed 8m above road level. Slightly keyed in at left hand side but fractured rock mass ca. 3.5m wide x 0.5m deep x 1m high. Potential for rock fall exists and narrow verge below means this poses a risk to the road.	No change noted during the 2024 inspection.	N/A

Photograph M4-3	Between Ch. 370 - 380 – One of the two rock fall source areas with clear signs of root jacking.	Year observation first noted: 2024
-----------------	---	------------------------------------

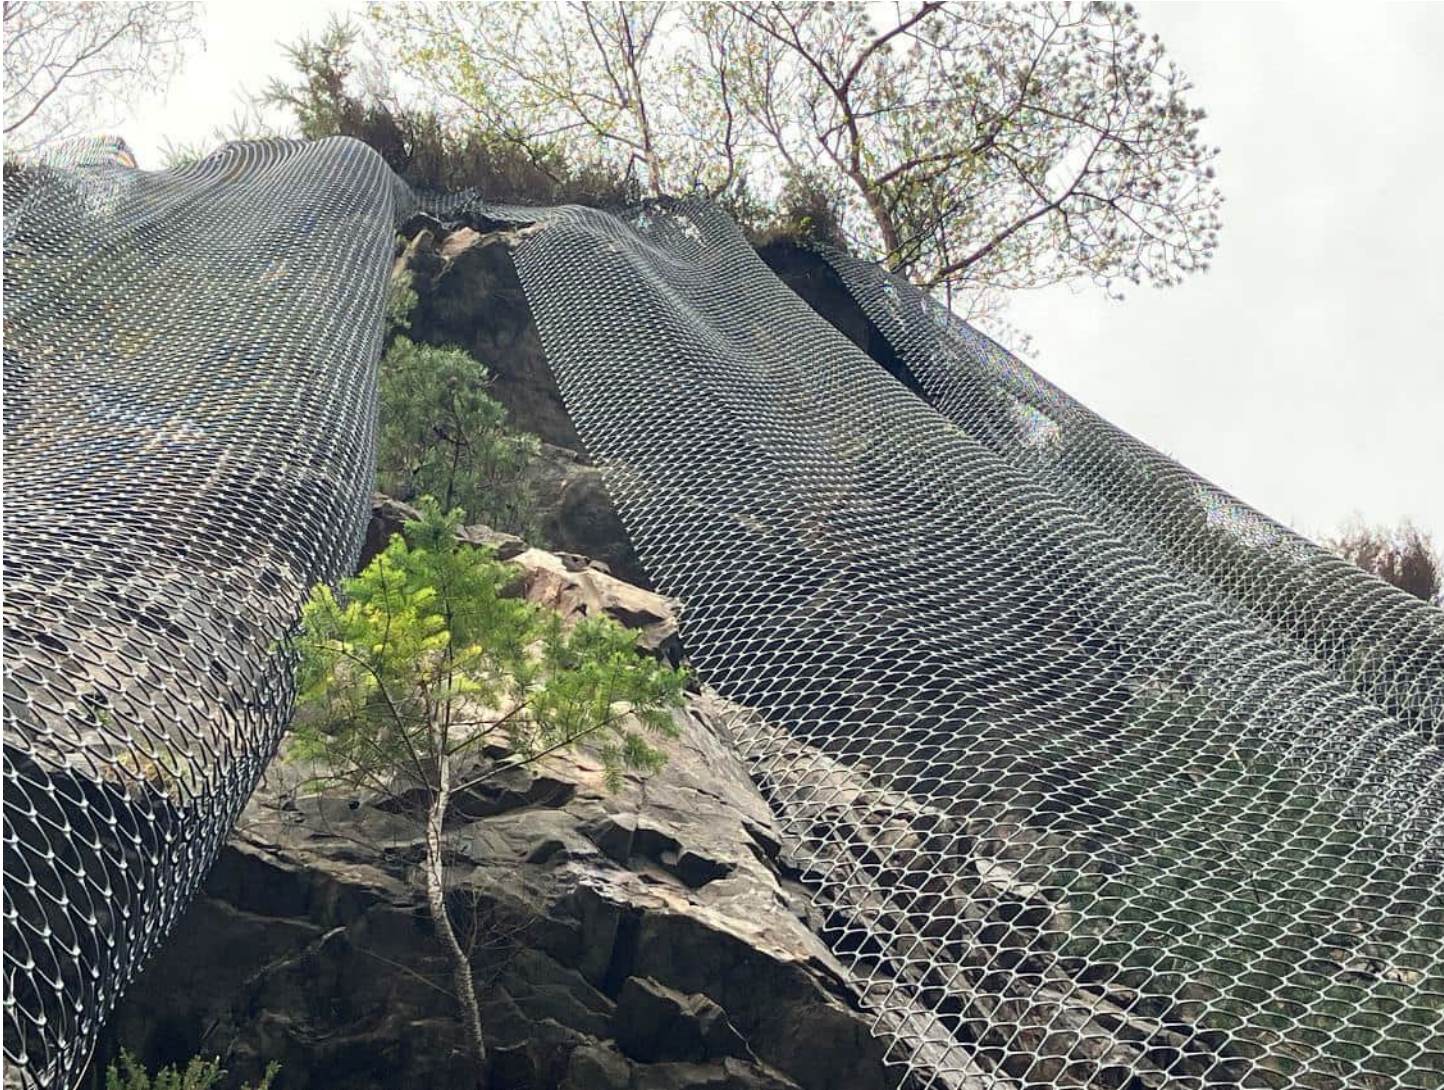
Photograph M4-4

Ch. 374 – overhang at crest of slope with dilated fractures along the left hand side.

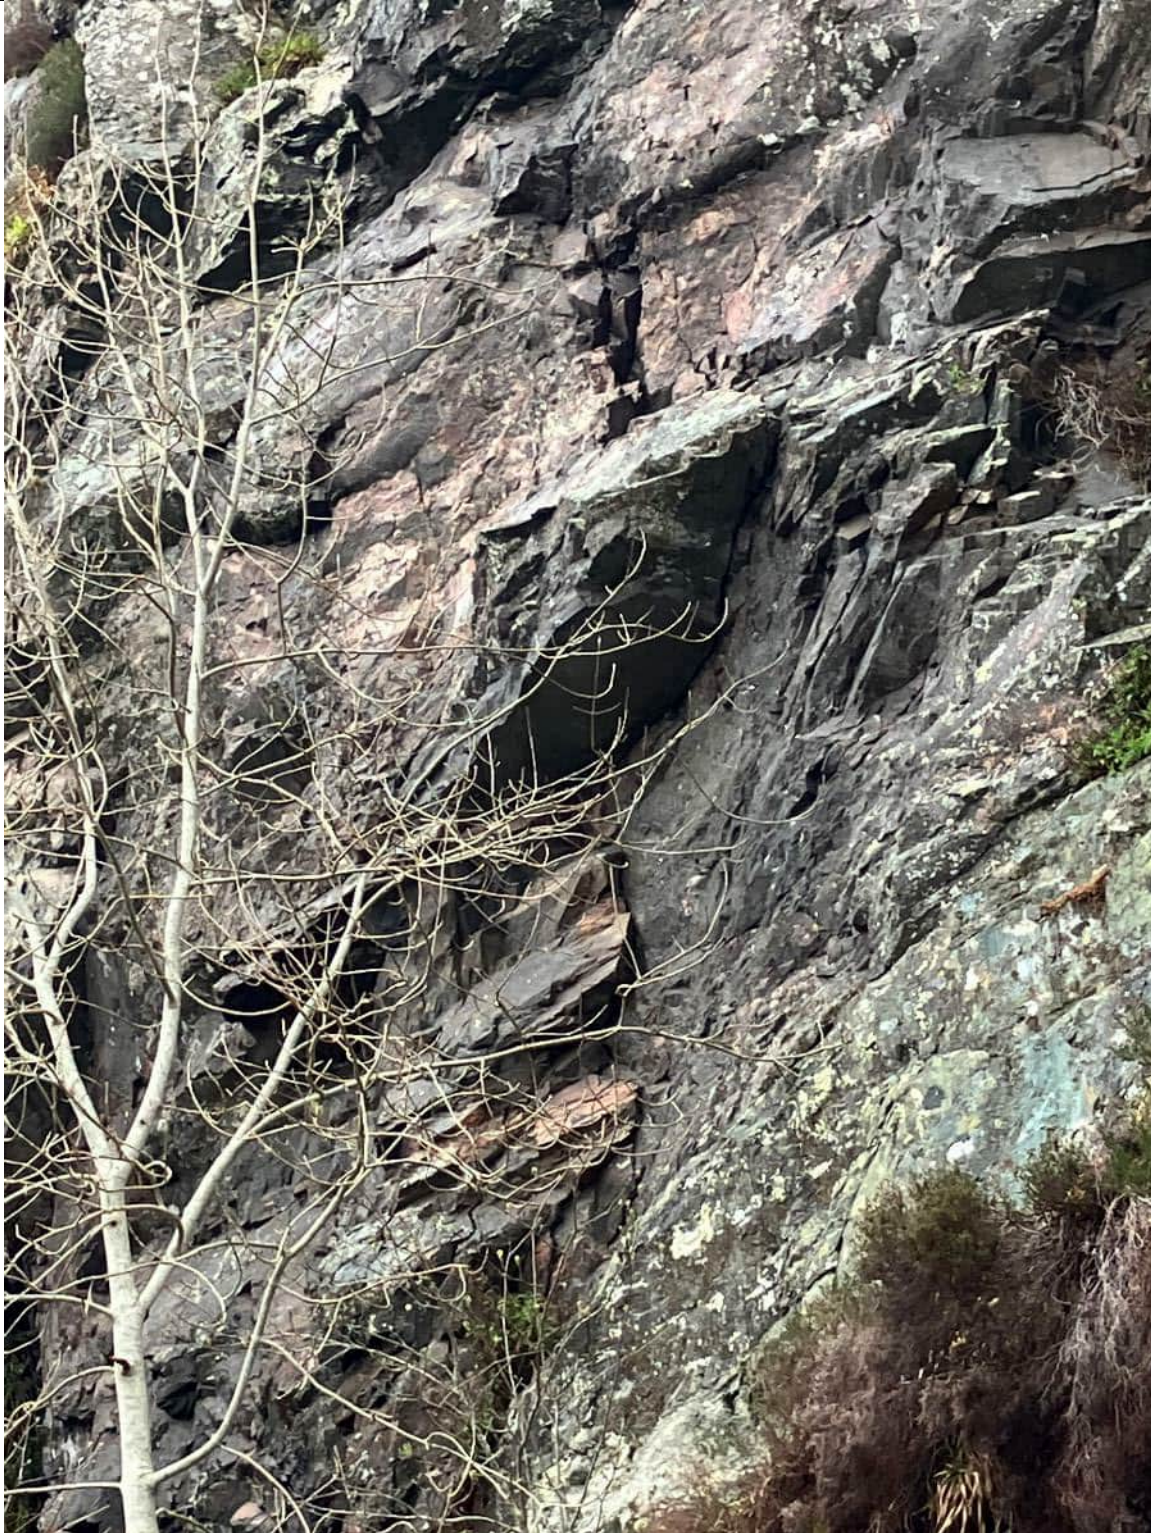
Photograph M5-1

Ch. 407	2019 Inspection: Dilated crack to rear of lichen covered block 8-10m above road level. Keyed in below.	No change noted during the 2024 inspection.	M5-1
Ch. 393	N/A	<p>A rock fall has occurred and there are numerous large and small blocks which have landed in the verge and roadside ditch. Source location approximately 15m above road level at Ch. 396. The largest fallen block was 3.6m from the edge of the tarmac and measured 1.3 x 1.1 x 0.7m. Blocks behind this were 0.9 x 0.7 x 0.4m; 0.6 x 0.45 x 0.35m; 0.4 x 0.4 x 0.25m; 0.75 x 0.45 x 0.3m, plus ca. 20 blocks up to 0.3m in size.</p> <p>Blocks also landed in the ditch 1.2m from edge of tarmac. Largest block in ditch was 0.8 x 0.65</p>	<p>M5-2 M5-3 M5-4 M5-5 M5-6</p>

Ch. 407 - Dilated crack to rear of lichen covered block 8-10m above road level. Keyed in below.

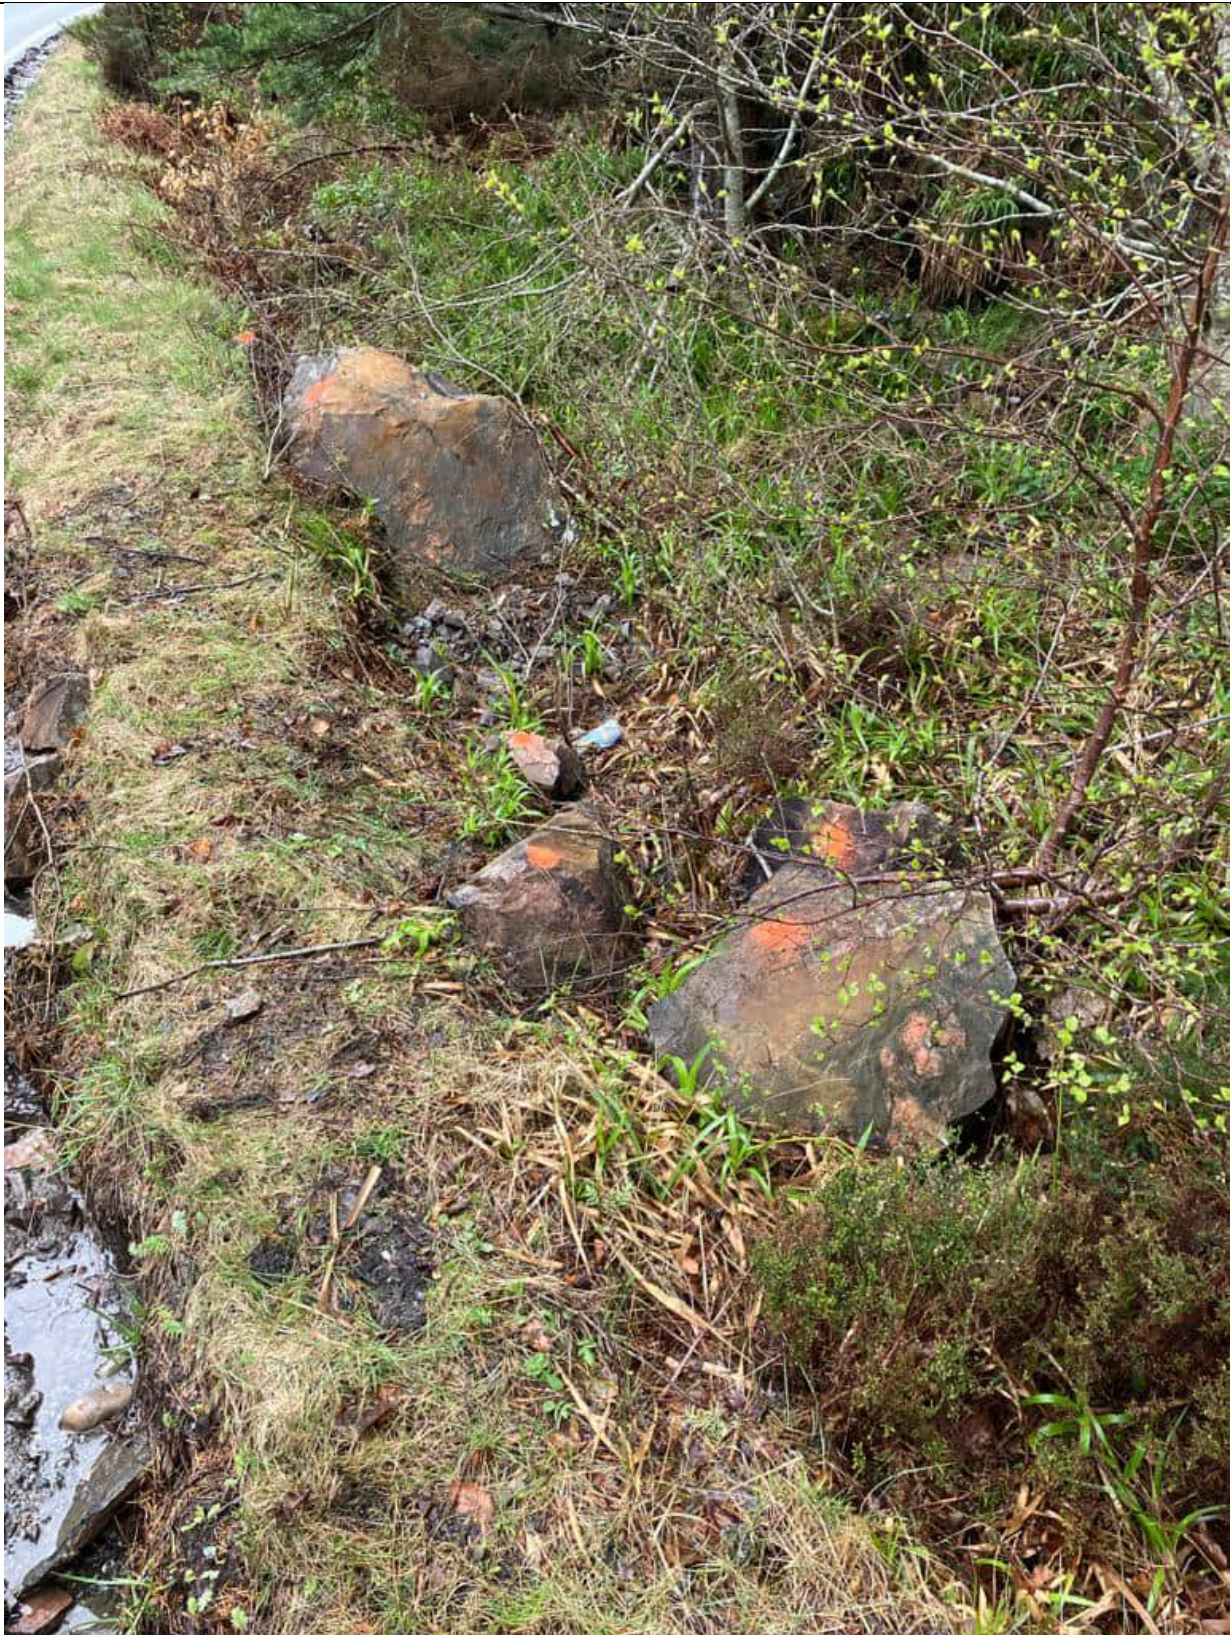
Hazards Observed:			
Location	Description of Hazard (s) from Previous Inspections	2024 Inspection Observations	Photo Reference
		<p>x 0.6m. Plus 5 blocks up to 0.6 x 0.4 x 0.25m in size. Approximately 2-3m³ of blocks had fallen in total.</p> <p>Due to the verge now having numerous blocks contained within it, the risk for further rock falls is increased as other rocks could fall and hit the blocks sitting in the verge and potentially 'bounce' into the road. This could lead to a potential significant hazard.</p>

Photograph M5-2	Between Ch. 393 – 395 – blocks originating from recent rock fall which have landed in the ditch and grass verge.	Year observation first noted: 2024
-----------------	--	------------------------------------

Recommended Remedial Works / Actions						
Large Scale Rock Fall Protection Works (Category 3)		Localised Targeted Rock Fall Protection Works (Category 2)		Ongoing Maintenance (Category 1)		
N/A		<ul style="list-style-type: none"> - AECOM completed the design of the following rock fall remedial works for M5 in November 2023. It is understood that THC intend to progress works later in 2024. • Installation of spot dowels in individual blocks / area of rock mass at risk of rock falls. Provisionally allow for 20 No. 4m long dowels. • Localised scaling should occur to remove potentially loose blocks. 		<p>The works outlined below should be progressed as 'urgent' works, as soon as practicable:</p> <ul style="list-style-type: none"> - Scaling of loose and potentially loose material on face around Ch.396; - Removal of blocks from verge and roadside ditch and create catch bund from material; - Re-inspection during / following 'urgent' works to confirm is existing 'Category 2' works design remains appropriate. - Routine annual inspection by end of April 2025.

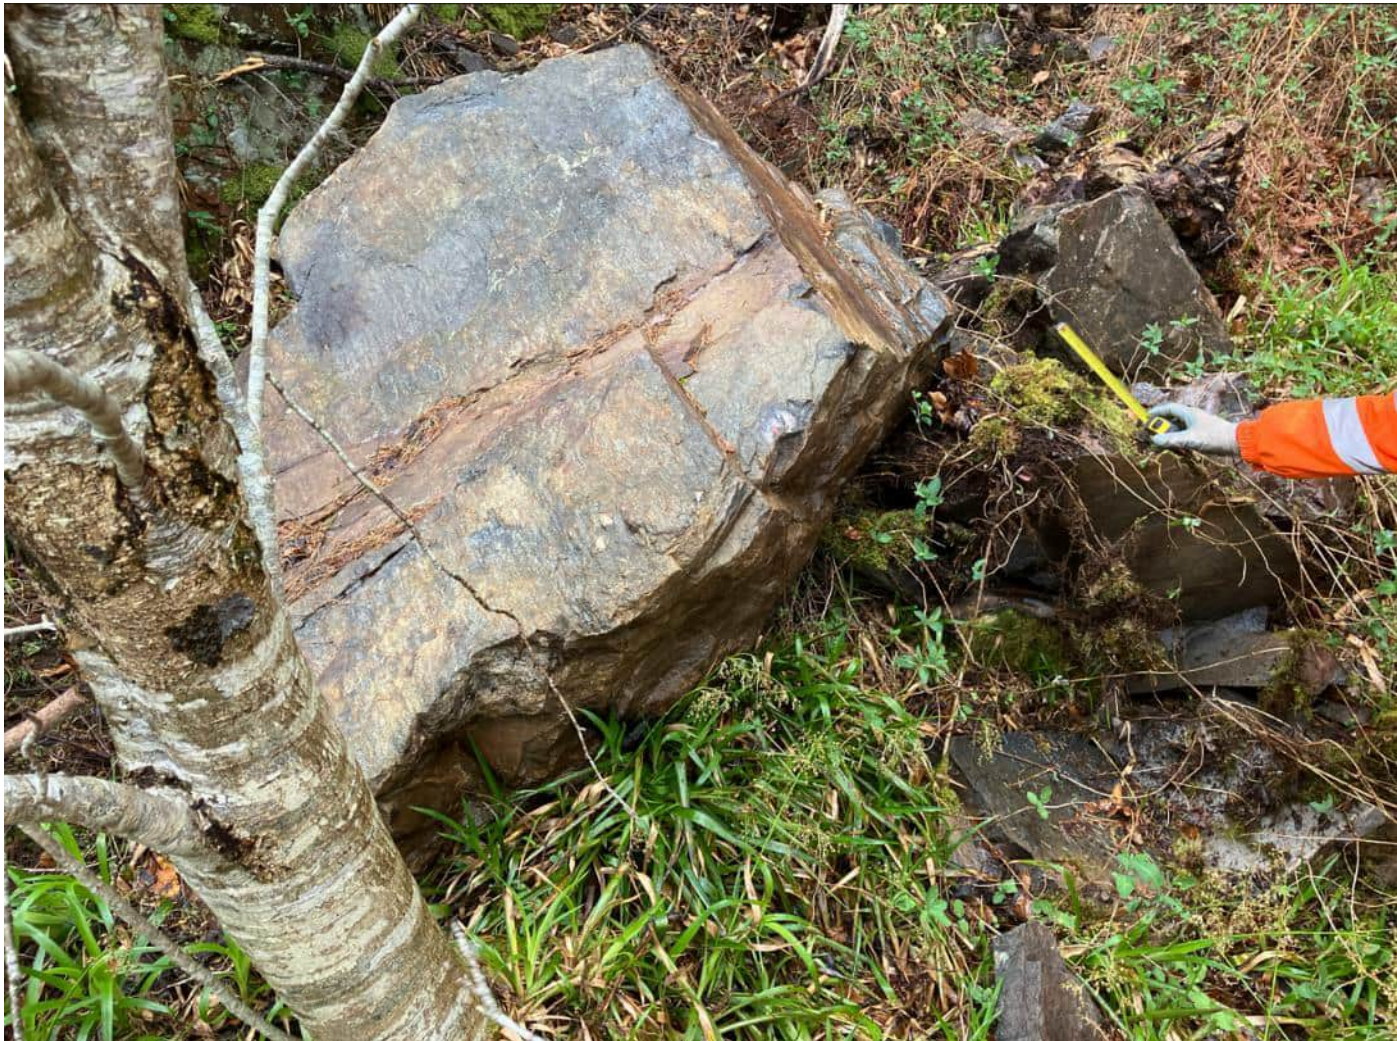
Photograph M5-3

Ch. 393 – a large block which has landed in the verge from recent rock fall.

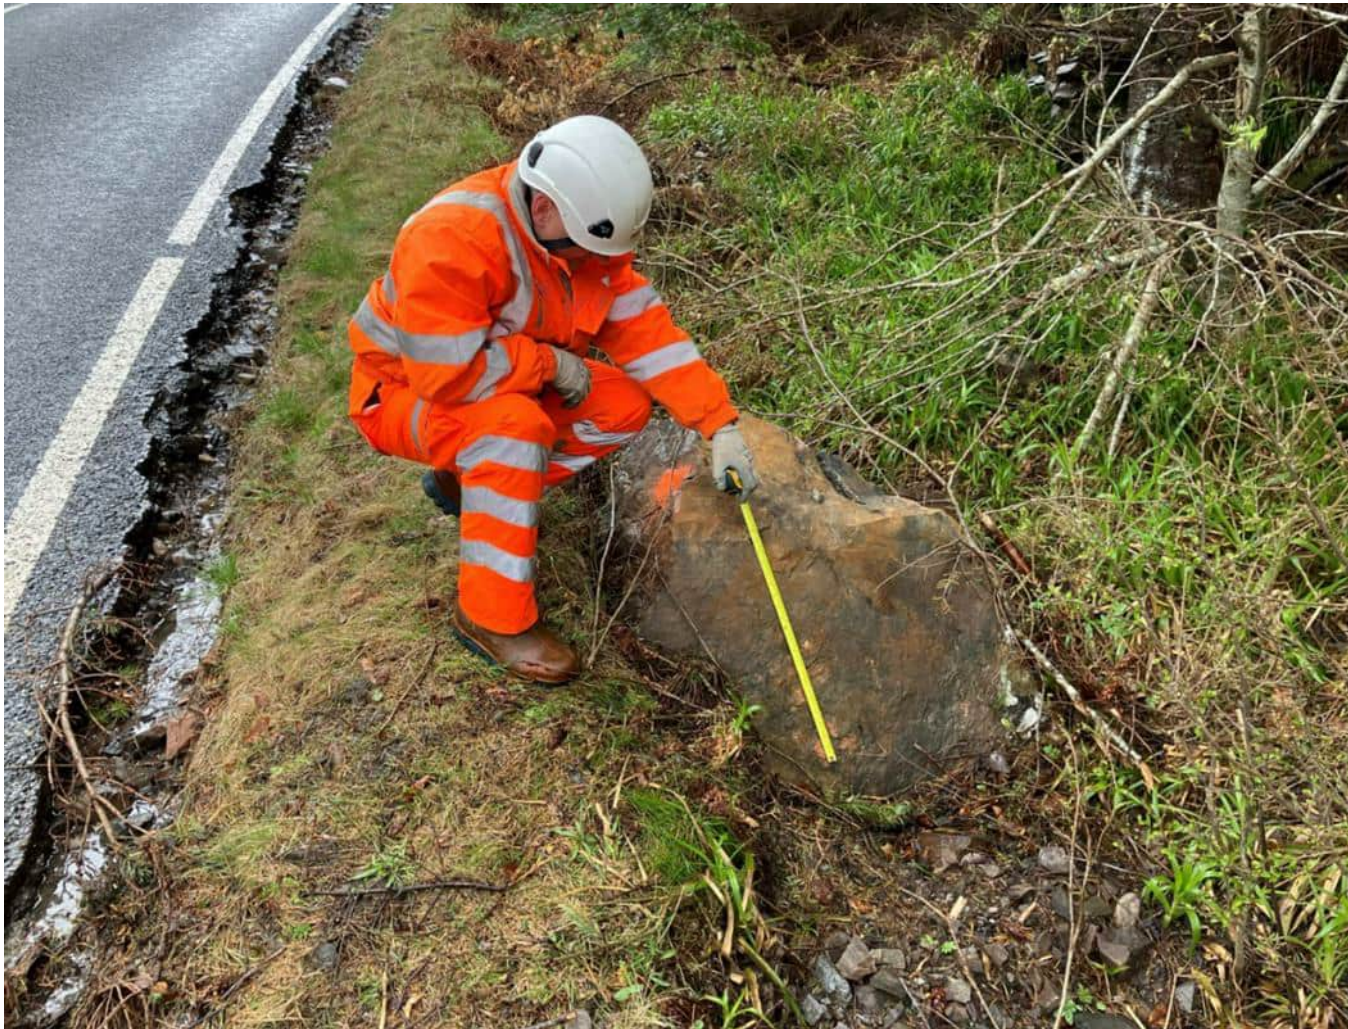
Photograph M5-4

Ch. 393 – a large block which has landed 1.2m away from the road from recent rock fall.
