A890 Maman Hill

Annual Slope Inspection 2024

The Highland Council

Project number: 60685712
AECOM Report Ref: GLRP0009

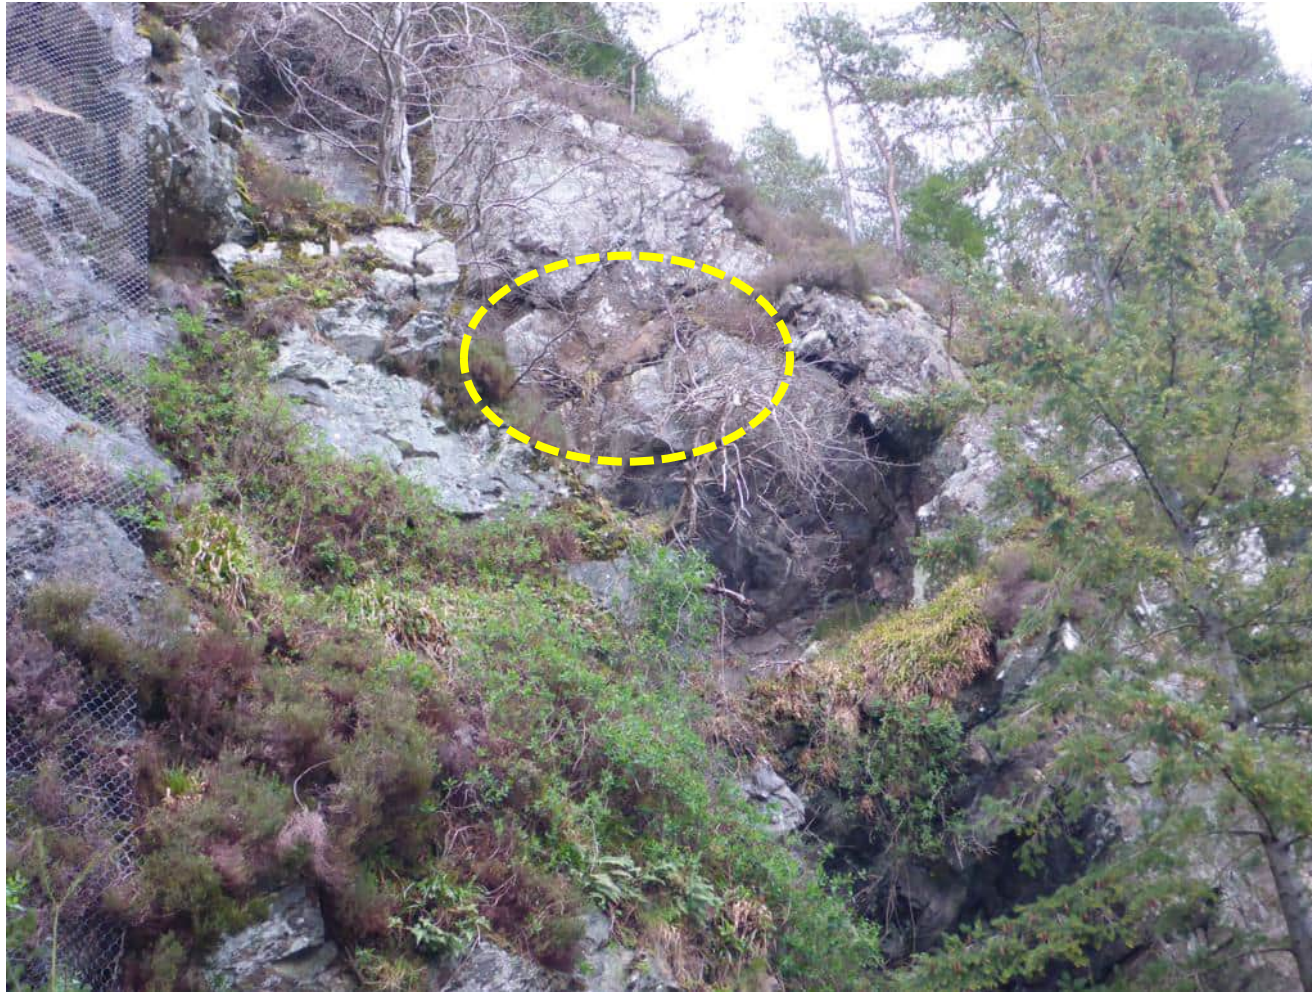
Photograph M5-5

Ch 396 – source location of recent rock fall circled in yellow.

Recommended Remedial Works / Actions						
Large Scale Rock Fall Protection Works (Category 3)		Localised Targeted Rock Fall Protection Works (Category 2)		Ongoing Maintenance (Category 1)		
N/A		<ul style="list-style-type: none"> - AECOM completed the design of the following rock fall remedial works for M5 in November 2023. It is understood that THC intend to progress works later in 2024. • Installation of spot dowels in individual blocks / area of rock mass at risk of rock falls. Provisionally allow for 20 No. 4m long dowels. • Localised scaling should occur to remove potentially loose blocks. 		<p>The works outlined below should be progressed as 'urgent' works, as soon as practicable:</p> <ul style="list-style-type: none"> - Scaling of loose and potentially loose material on face around Ch.396; - Removal of blocks from verge and roadside ditch and create catch bund from material; - Re-inspection during / following 'urgent' works to confirm is existing 'Category 2' works design remains appropriate. - Routine annual inspection by end of April 2025.

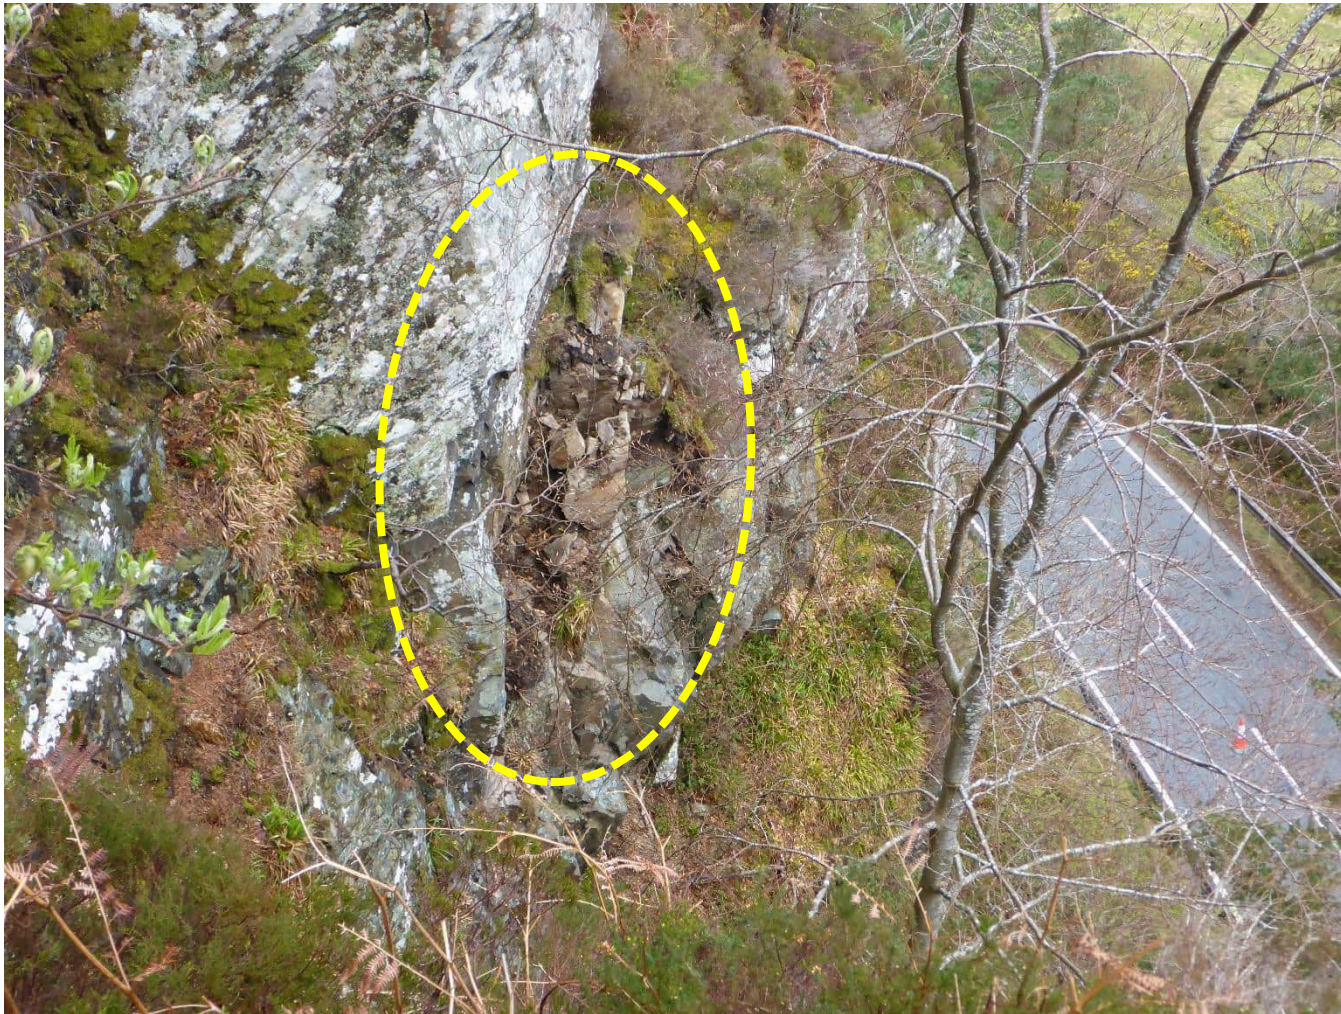
Photograph M5-6

Ch 396 – source location of recent rock fall taken during rope access inspection. Source location circled.

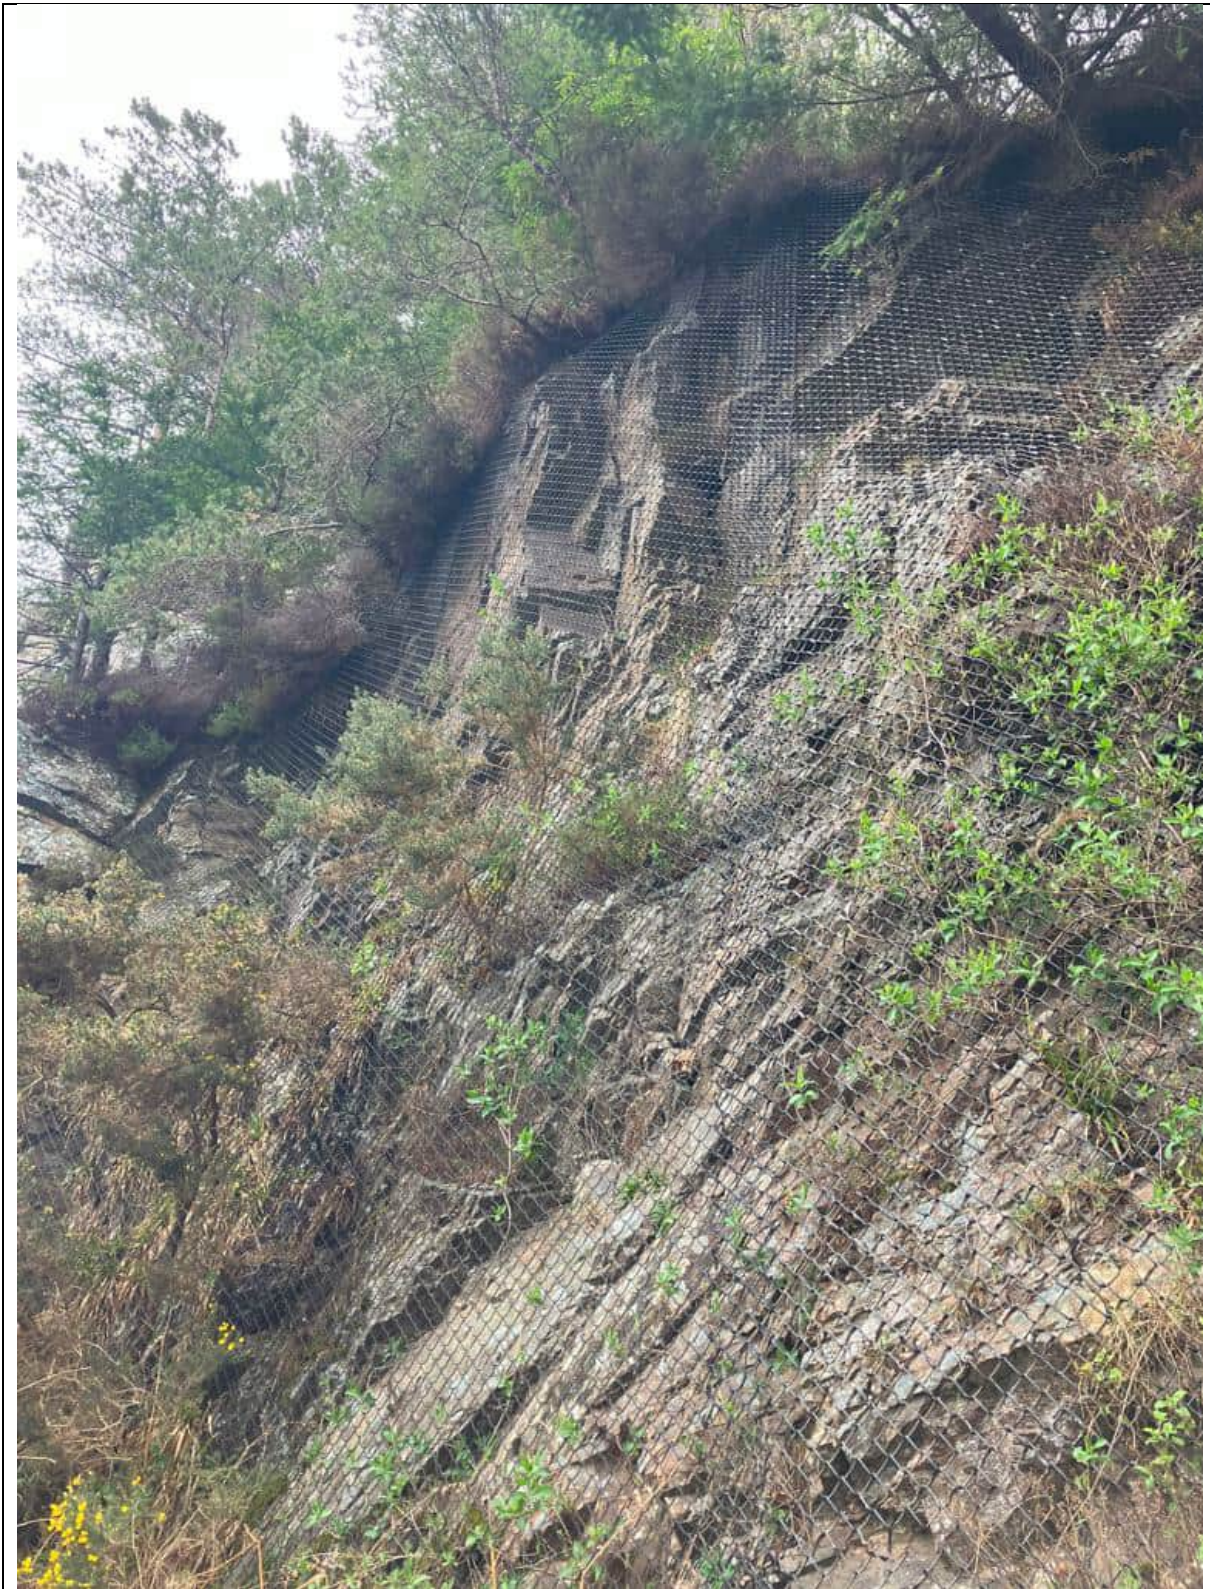
Photograph M6-1

Ch. 420 – Potential toppling failure identified ca. 6m above road level.

Recommended Remedial Works / Actions							
Large Scale Rock Fall Protection Works (Category 3)			Localised Targeted Rock Fall Protection Works (Category 2)		Ongoing Maintenance (Category 1)		
N/A			N/A		<ul style="list-style-type: none"> - Re-inspection by end of April 2025. - Fell trees at crest of rock face and scaling of loose rock 		
Assessed in field by:	MT/SB/PLM	Date:	18/04/2024		Reviewed by:	PLM	Date: 28/05/2024
