MV MAID OF GLENCOUL

LOADING RAMPS ALIGNMENT NOTE

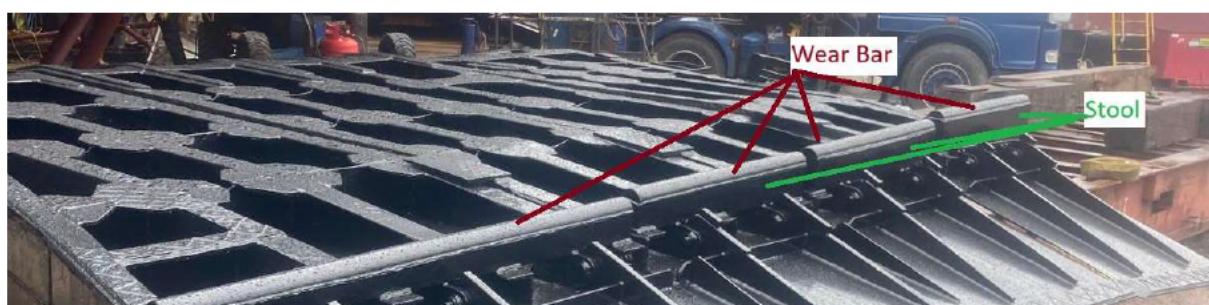
Figure 1 - Underside of Maid of Glencoul Ramp

The following image shows one of the Ramps, upside down following repair works. The sacrificial Wear Bars and Stools are indicated:

During the 2025 Annual Overhaul a rebuild of the Stool, Wear Bars and Finger Flaps was undertaken to address excessive wear damage. A separate Note was written by [REDACTED] explaining the works undertaken and best endeavours undertaken to return the Stools and Wear Bars to their original height. There are no design drawings available to indicate the original geometry of the ramps, so this was the best approach that could be taken.

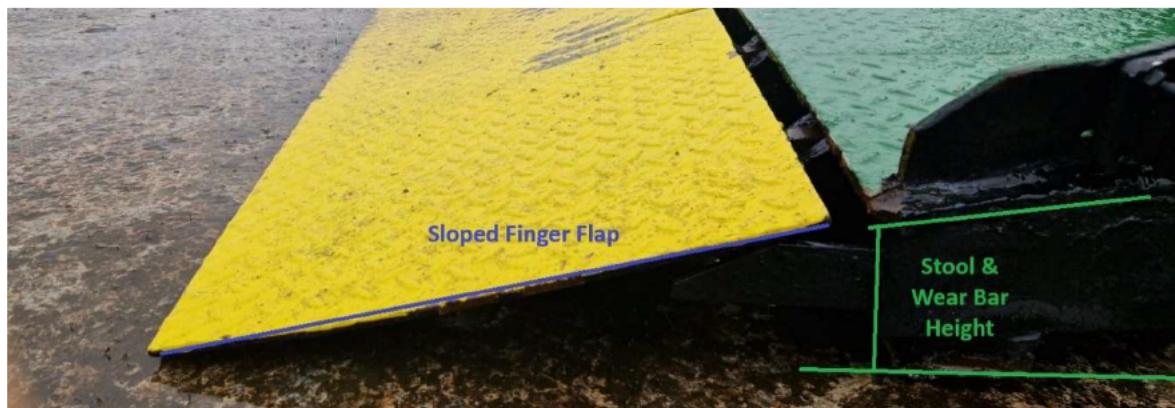
Figure 2 - Finger Slope and Stool Height

Since returning to service, a number of cars have been damaged due to contact with either Ramp or Slipway when moving from Slipway to Ramp, or vice versa.

It is also noted that during the lifetime of the Vessel, car design has evolved substantially, including longer and lower overhangs at the bumpers and underskirt. For this reason, the ramps of modern roll on / roll off ferries tend to have much longer Finger Flap geometry giving a more gradual transition between Slipway and Ramp.

With the relatively short Finger Flap length on MV Maid of Glencoul, even slight variations in the height of the Stool and Wear Bar can significantly affect the slope of the Finger Flap. This is illustrated in Figure 2 below.

After return to service and the incidence of vehicle contacts, the Wear Bars have been further modified and reduced in height slightly.

This is believed to have improved the Slipway / Ramp interface. However, it is acknowledged that the quality of this interface is limited by the 50-year-old design geometry of the Ramps.
