## INSPECTION REPORT

Ref: MofGC 010425\_1

### MV Maid of Glencoul Bow & stern loading ramps

Vessel: Maid of Glencoul

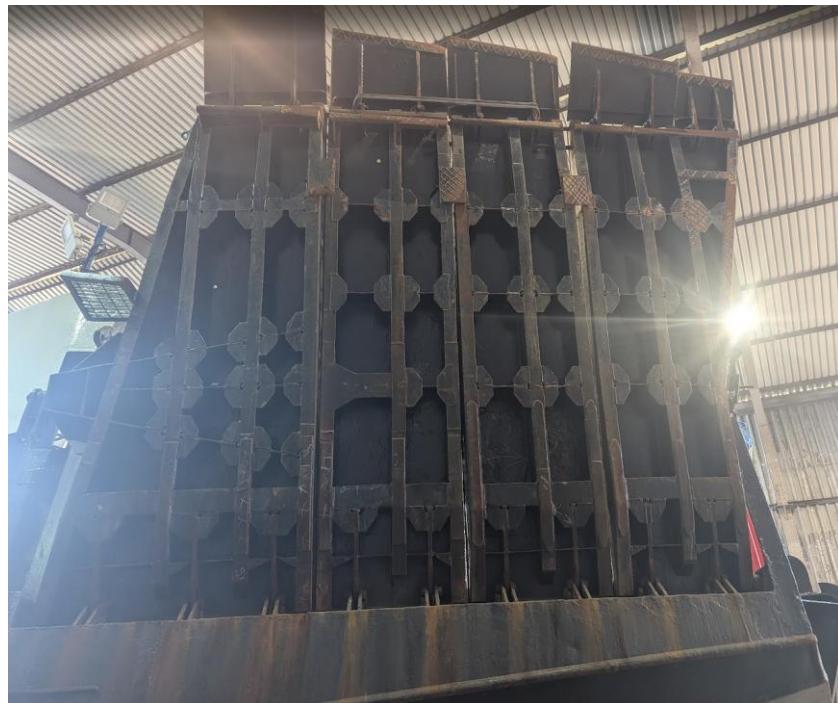
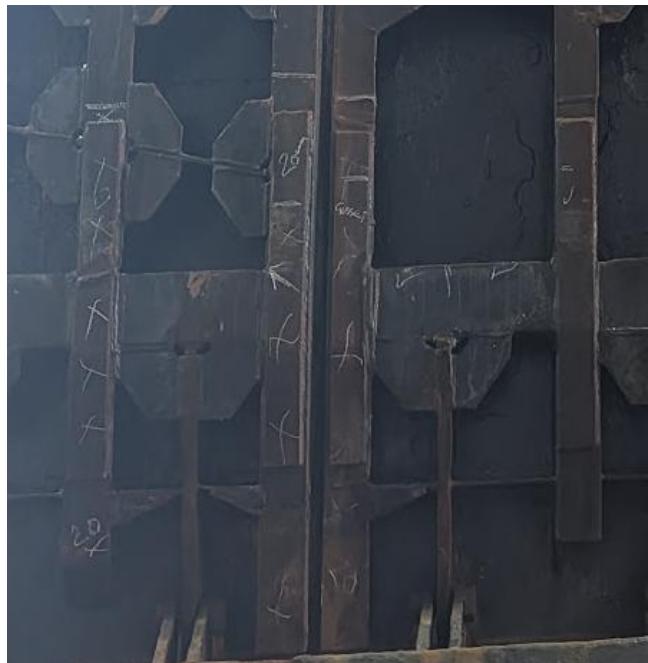
1. Failure and cracking of welds was noted on historic reinforcing and repairs to the flanges of the principle longitudinal structural members in way of the 2nd transverse some 900mm from the hinge line.

It is recommended that the top flanges are cropped over a length of approx. 700mm (as marked) and the material replaced with S235 20mm thk bar. All weld to be continuous and transitions to original lighter flange material to be tapered 1:4.

Care is to be taken to ensure a minimum of 75mm clearance between new flange butt welds and any existing web weld seams.

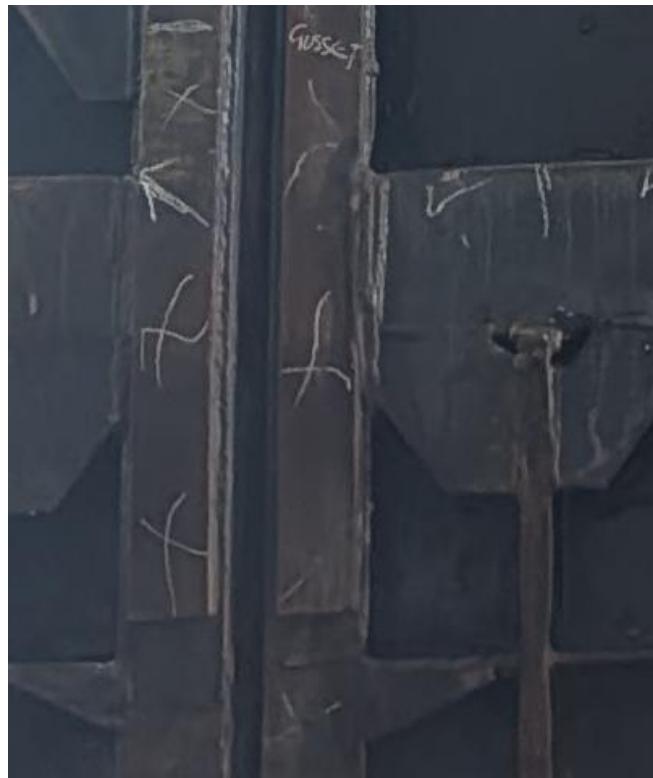
2. Numerous minor cracks where noted (as marked) at the connections of longitudinal and transverse flange and toes of bracket connections on the 1<sup>st</sup> & 2<sup>nd</sup> transverse grillage members

Many of these issues will be resolved as part of general flange repairs detailed in 1. above, but where this is not the case, the cracks are to be ground out, arrested and welds repaired.

Consideration should be given to fitting additional gusset plates outboard side of the connection between longitudinal & 2<sup>nd</sup> transverse member.

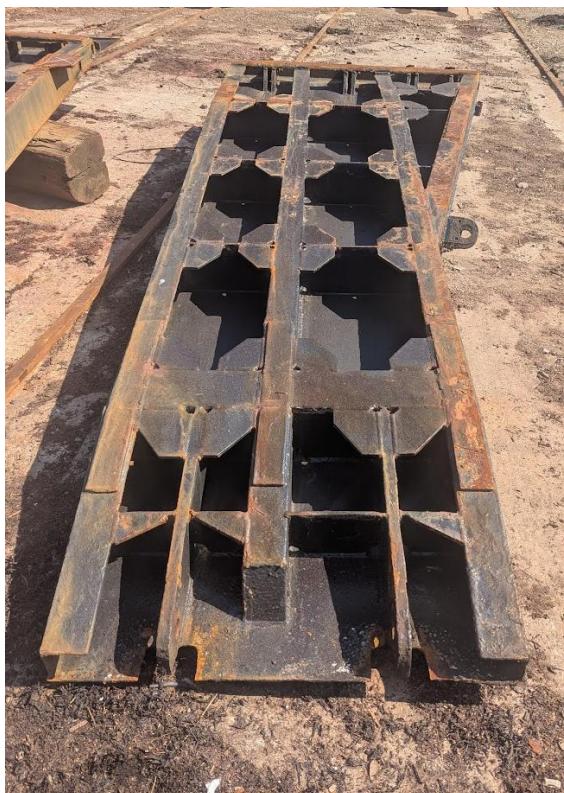
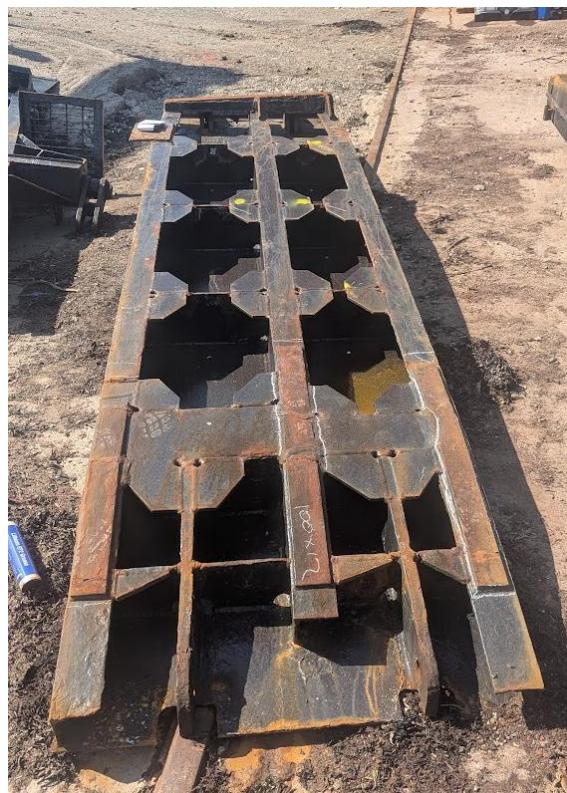
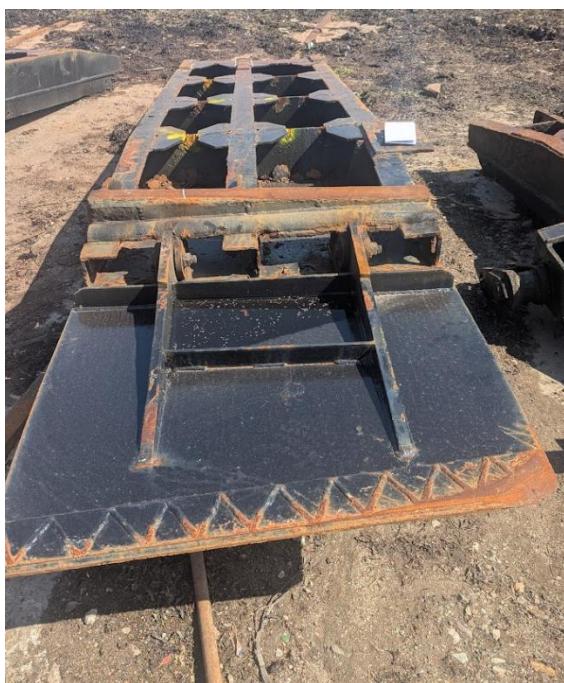
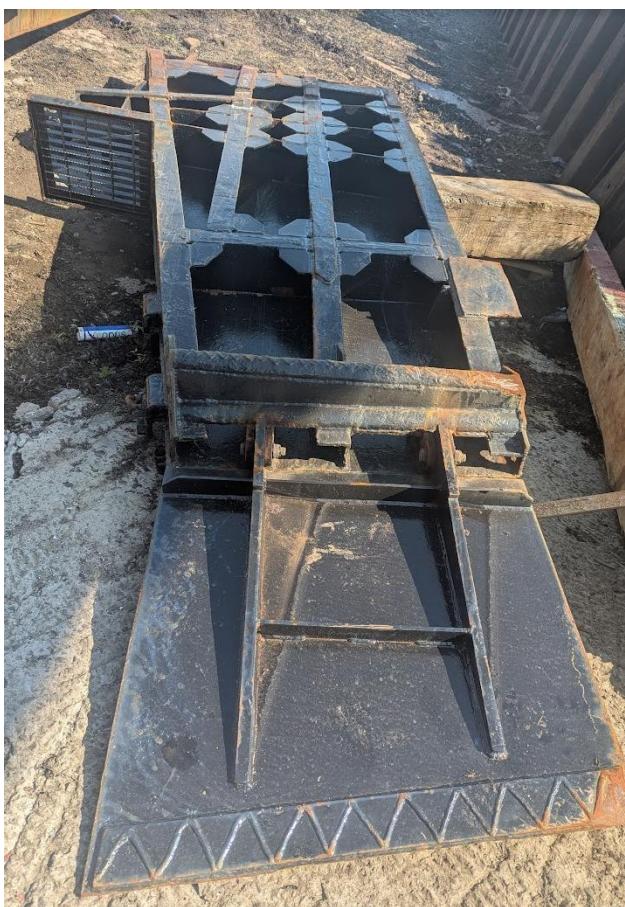
Aft ramp fingers

The after ramp was generally found to have the same issues as the forward ramp, although to a lesser extent and severity.

Repair instructions as recommended for the forward ramp fingers should apply equally to the after ramp, with:

- Principle girder flanges to be cropped and replaced as marked
- Cracked welds at flange connections and gusset toes (as marked) ground out and rewelded.
- Additional gussets added where practical.
- Stools and grounding bars to be made good.
