Appendix A

Incidents

Incidents since 26th May 1997

(as reported upto 15th Nov 1997)

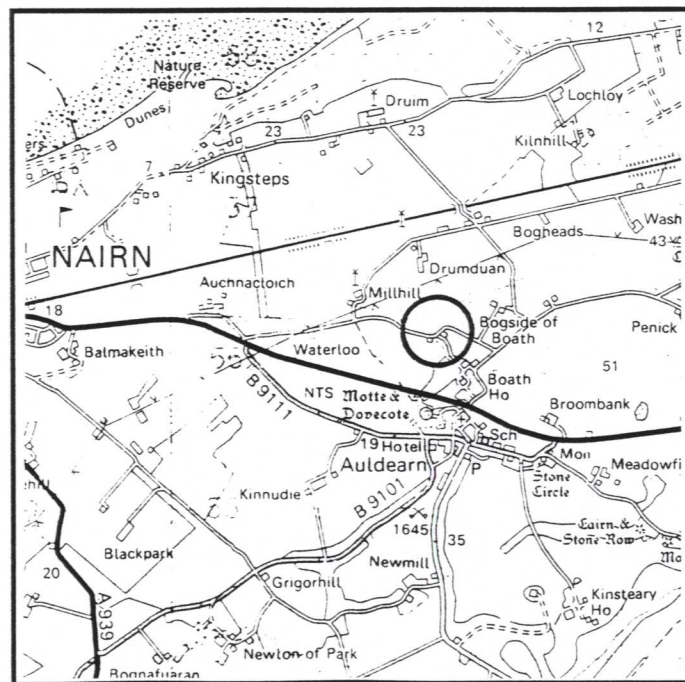
Auldearn - Mill of Boath

Property flooded as a result of burn overflowing.
Cf ARTM report dated 17/7/97

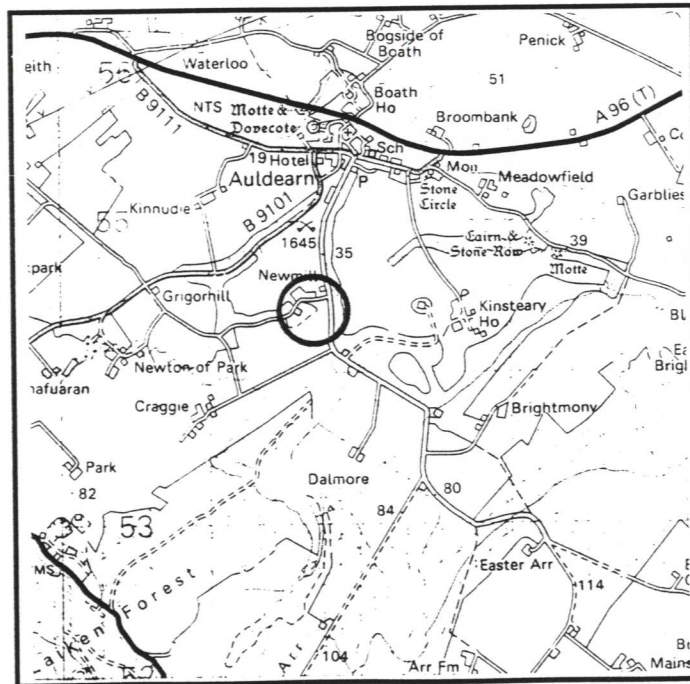
Auldearn - Newmill

Flooding of fields, road, and property when Auldearn Burn overflowed.
Cf ARTM report dated 17/7/97

Overspill culvert which presumably alleviated flooding in the past has been filled in and replaced by smaller pipe. Owner in question to be advised.

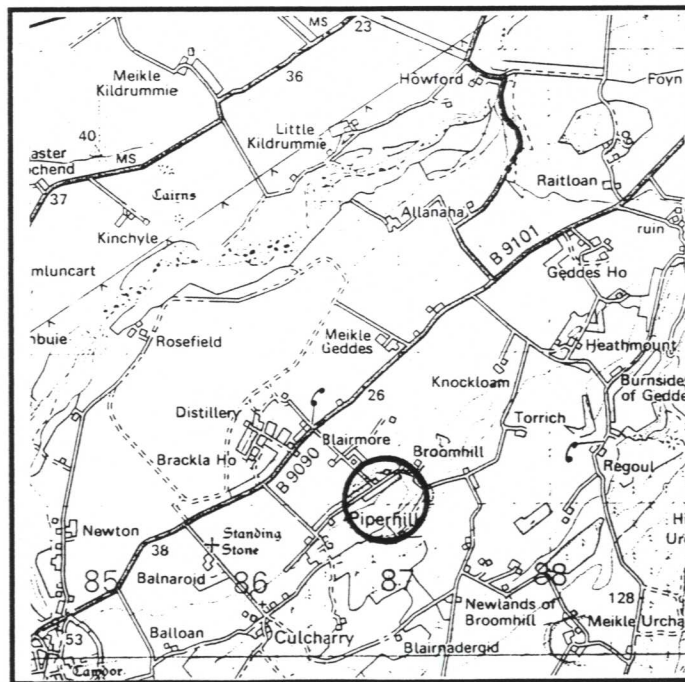
Cawdor - Cottage in Piperhill

Water flowing off fields opposite cottage crossed road and entered cottage.
Cf ARTM report dated 17/7/97

Adjacent gully and soakaway unable to cope with flows; requires improved local drainage.

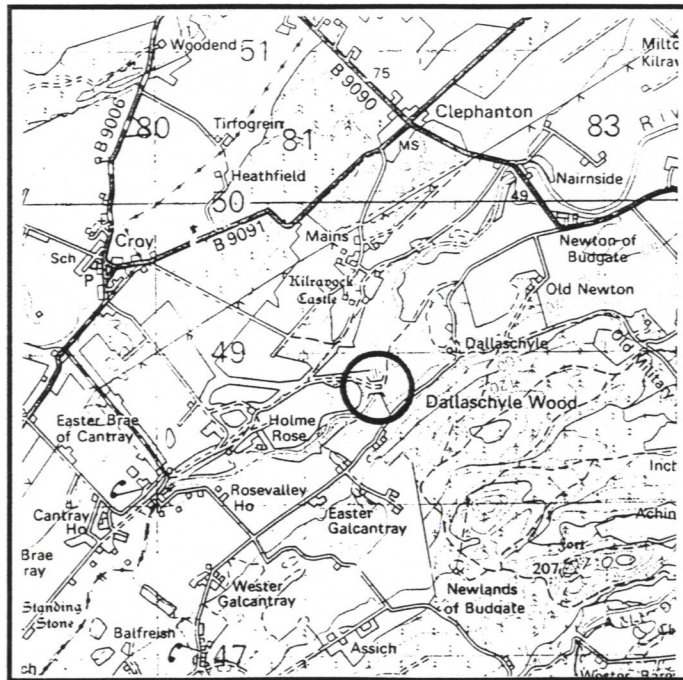
Cawdor - Kilravock Footbridge

Bridge washed away by flood waters.
Cf ARTM report dated 17/7/97

Private structure which has never been adopted.

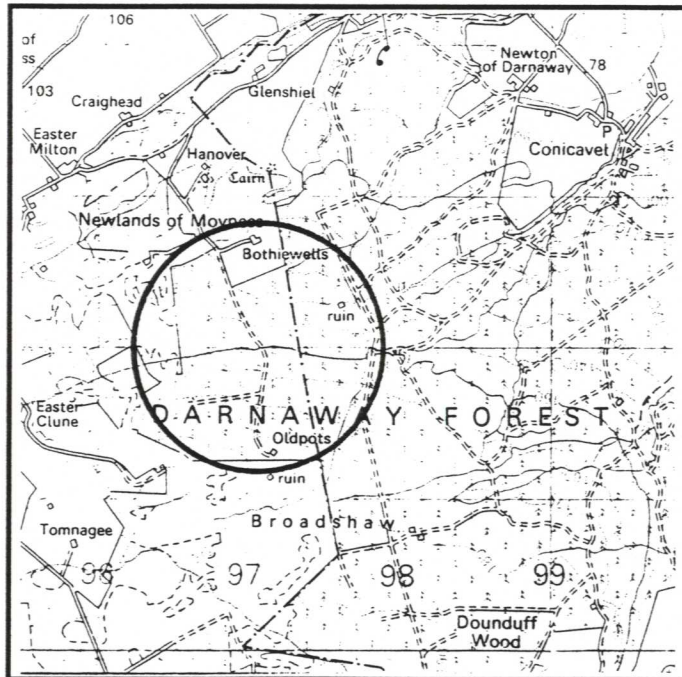
Cawdor - Old Pots road

Road badly eroded by flood waters since surfaced by unbound material.
Cf ARTM report dated 17/7/97

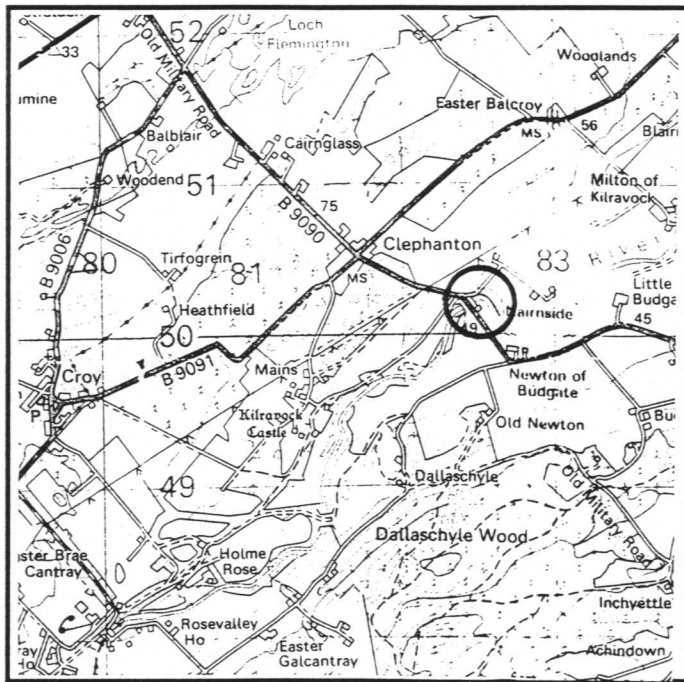
Cawdor - Whitebridge Cottage

Flooding isolated property following overtopping of adjacent river banks.
Cf ARTM report dated 17/7/97

House on river flood plain and bed being built up with gravel thereby reducing waterway.

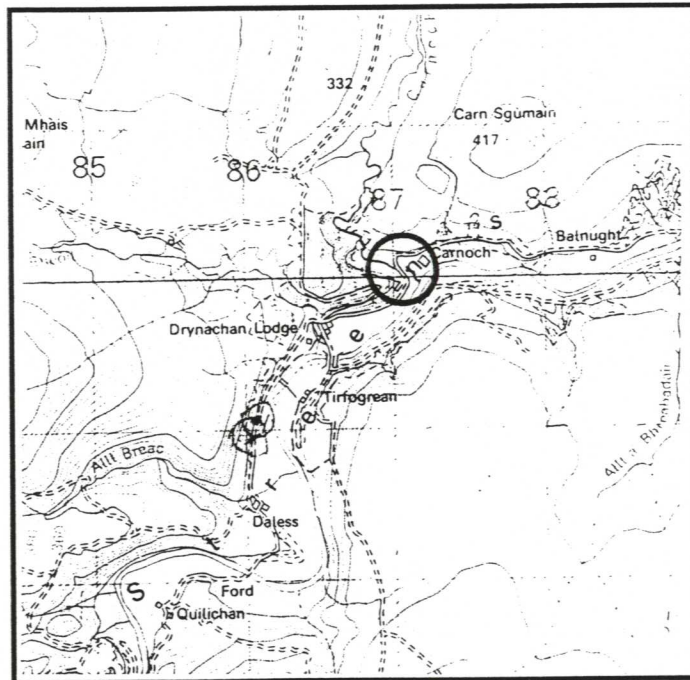
Drynachan - bridge over Carnoch Burn

Invert below bridge pitched with large stones held in place by timber framework and this damaged. Bridge abutments being undermined Cf ARTM report dated 17/7/97

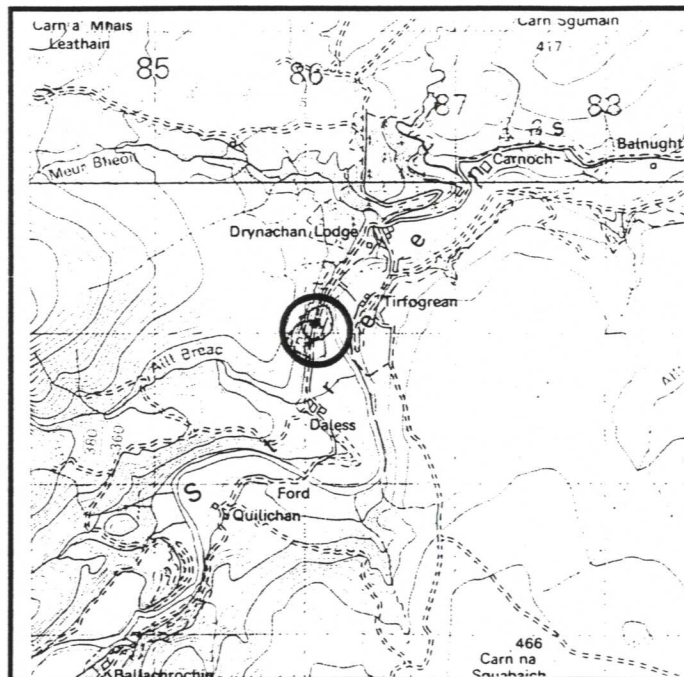
Drynachan - Daless Road

Landslide in two locations due to flash flood conditions.
Cf ARTM report dated 17/7/97

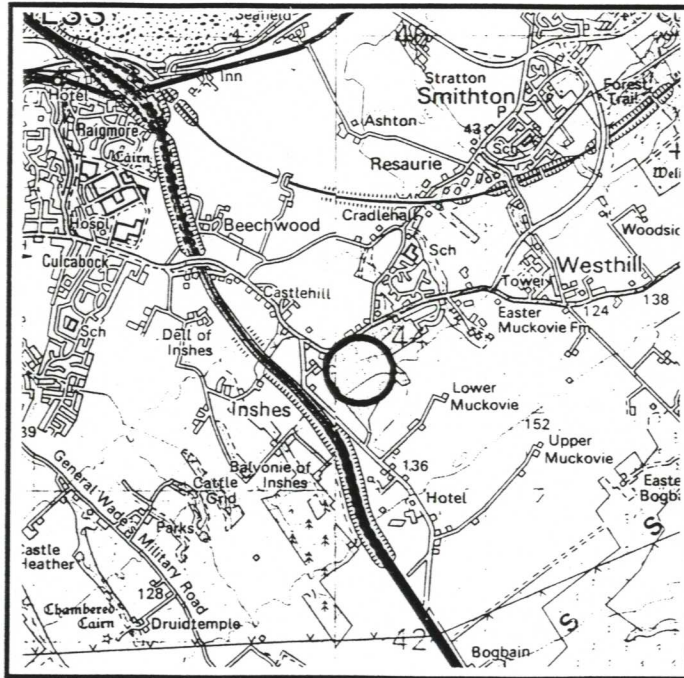
Inverness - Culloden Area

Flooding occurred at Birchwood Road.
For further details see ARTM report 18/7/97.

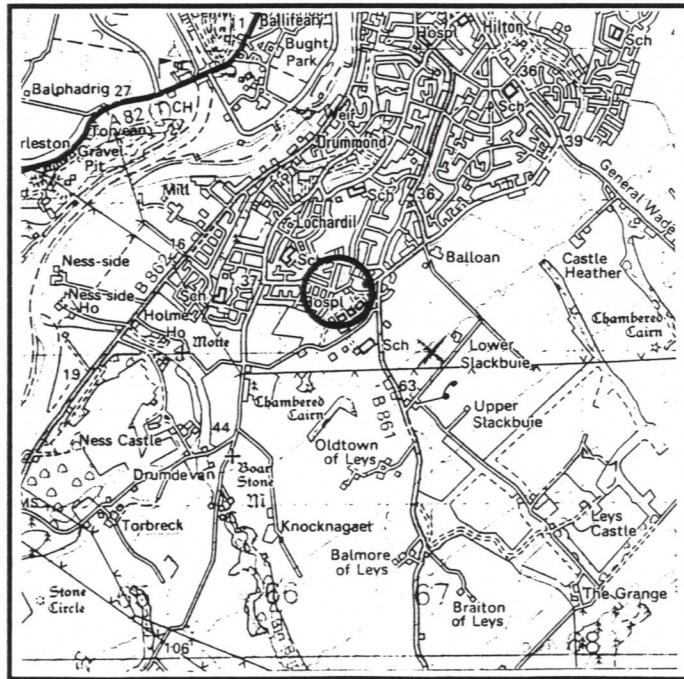
Inverness - Drumdevan Road

Water overflowed from the Ault na Skiach burn and affected Nos 3 - 33. It crossed gardens and then entered the road drainage system. For further details see ARTM report 18/7/97.

Recurring problem.

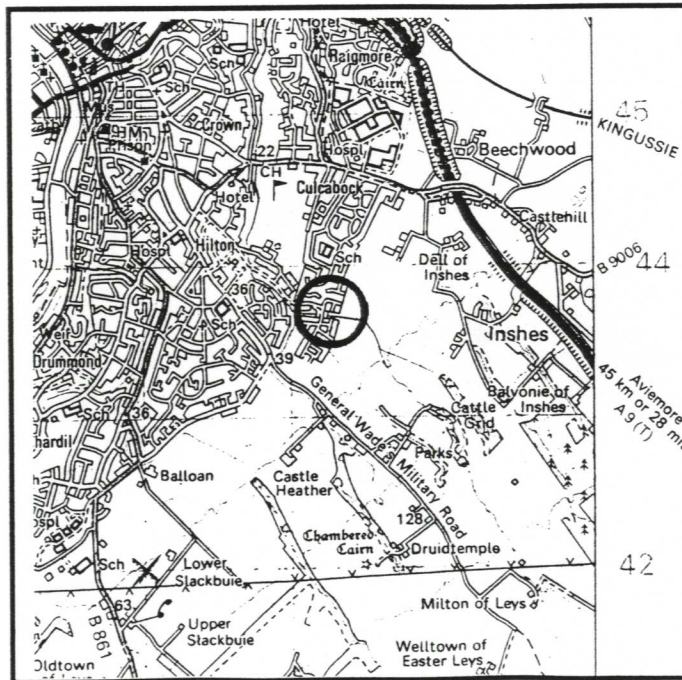
Inverness - Falcon Avenue

Culvert grid blocked waterway and there was flooding of adjacent roads.
Volume of water such that despite being cleared grid became blocked again later.
For further details see ARTM report 18/7/97.

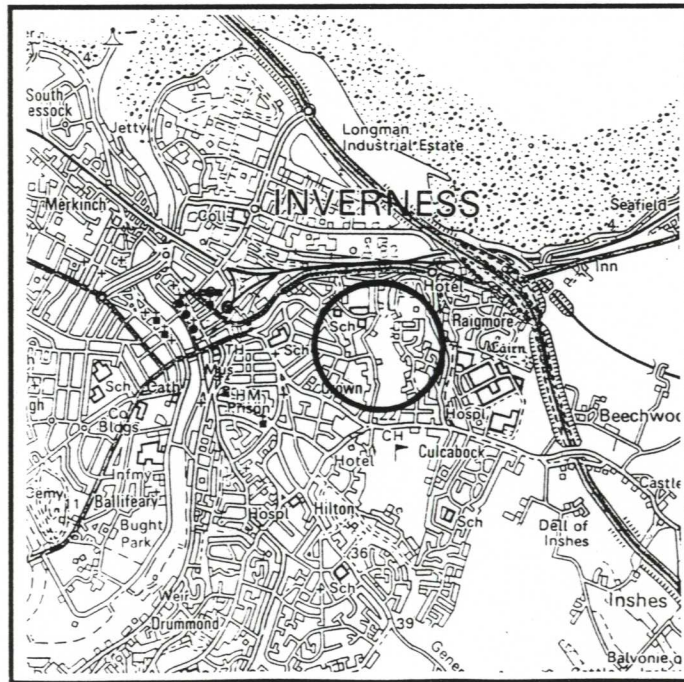
Inverness - Millburn

Flash floods resulted in high flows in the Millburn which caused flooding of the golf course and adjacent roads.

There were also problems at the house between Harris Road and Old Mill Road which was flooded; at the houses below the Kingsmill Hotel; at Diriebught Cottage; at Millburn Academy; at the cottages at the lower end of Diriebught Road; and at the recent new houses on Diriebught Road. All being inundated.

The burns running through Inverness are all recognised as problematic and have been the subject of several studies. Until such time that measures are taken there will be problems.

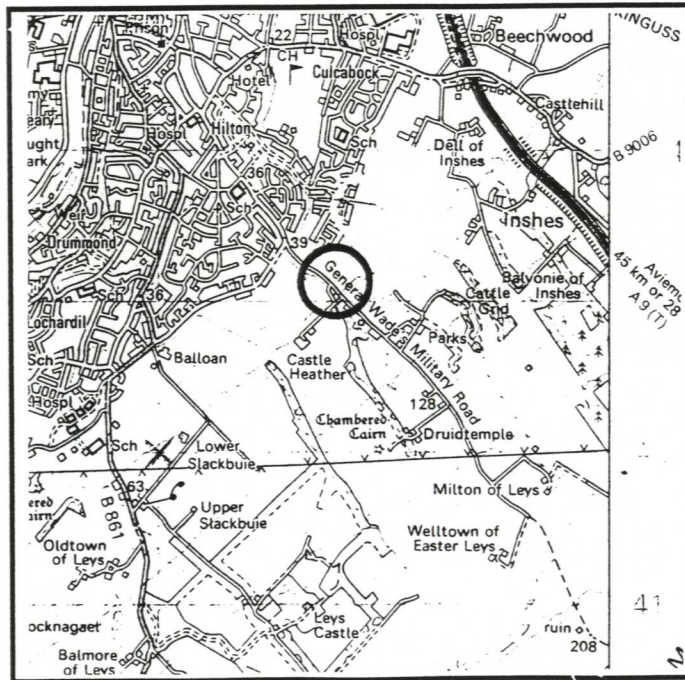
Inverness - Old Edinburgh Road

Ditch became blocked by debris and water flooded Old Edinburgh Road and also caused problems at the roundabout on the Inverness Distributor. In the same area Mason Road and Teal Avenue were also affected by flood water.

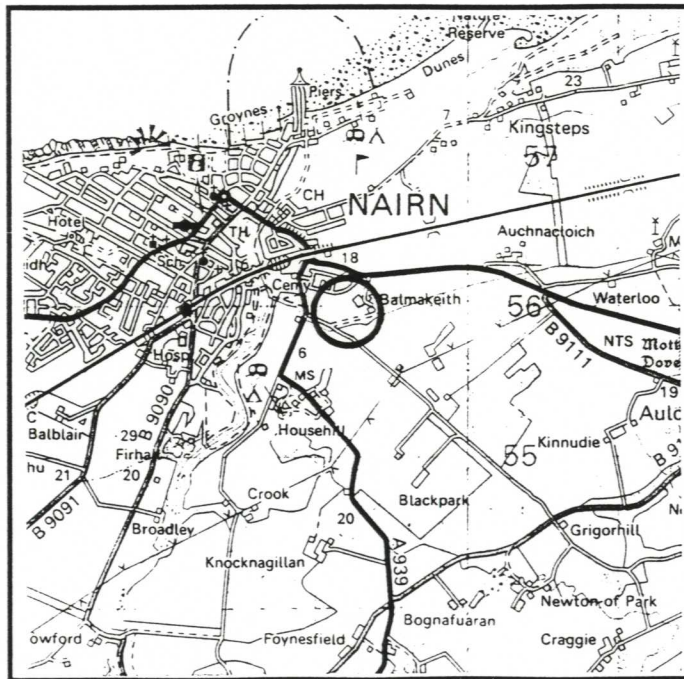
Nairn - Balmakeith Park Housing Estate

High levels in Auldearn Burn resulted in flooding of adjacent road and underfloor area of nearby houses.
Cf ARTM report dated 17/7/97

Houses built on flood plain of Auldearn Burn and liable to be flooded again in future. See assessment.
