#### **APPENDIX E**

#### REPORTED FLOODING OCCURRENCES NOVEMBER 2007 TO NOVEMBER 2009

(Note the following is a summary of the information collated for each flooding incident)

#### Caithness, Sutherland & Easter Ross

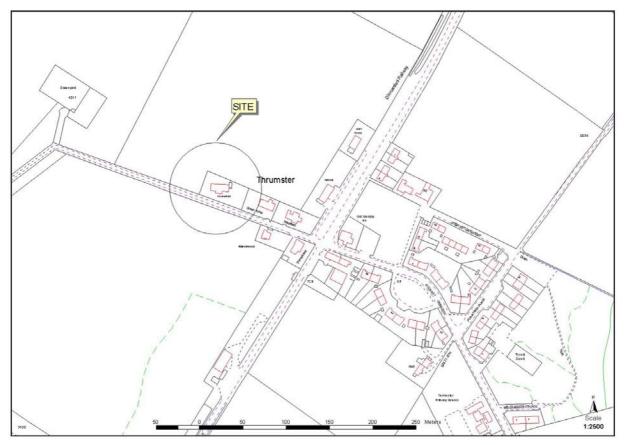
<b>RECORDING FORM: (Mai</b>	RECORDING FORM: (Mark all applicable options)		
Location of Flood:	Fourwinds, Cemetery road, Thrumster		
Water Course Name/Ref:	Surface water drain		
Grid Reference:	333569, 945285		
Description of Flood:	Water was surcharging from a gully in front of the house and running into the garden. The water was a few inches deep in places. Pieces of tree roots had washed down and blocked the pipe at the gully connection. Stopping water from continuing along drain and causing to surcharge out of the gully.		
Date/Time of Start/Duration of Flood:	13 october 2009 11.00am to 15 october 2009 12.00 noon		
Threat to People and Properties? (Please give details)	Garden had a few inches of water in it.		
Source of Notification: Name: Address: Tel No:	Mr Scott Fourwinds Cemetery Road Thrumster		
Works Undertaken: (Please give details)	Rodding and jetting of the a surface water drain.		
Works Required:

Does the site have a history of flooding? (Please give details)	Has had a similar problem in the past. Works were undertaken 2 years ago to remove tree roots growing through joints in the pipes.		
Recording Officer: Date Completed:	J S Gunn 15 October 2009		
Comments:

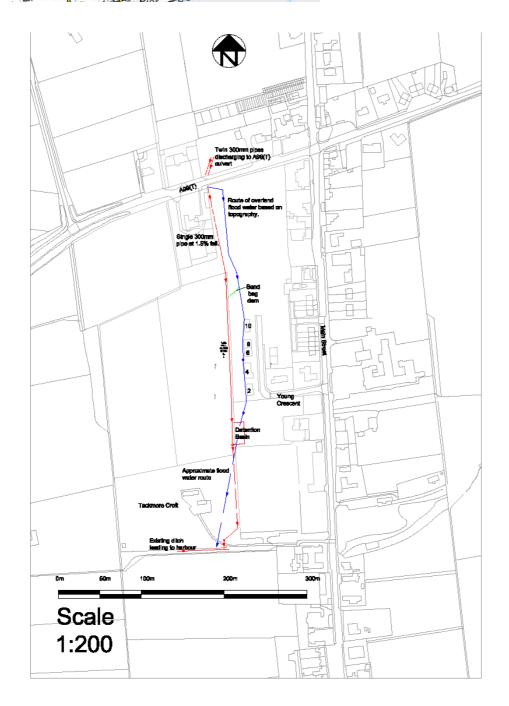
RECORDING FORM: (Mark all applicable options)		
Location of Flood:	Young Crescent, Lybster	
Water Course Name/Ref:	Unknown	
Grid Reference:	Young Crescent OSGR 324694, 935990 Tackmore Croft OSGR 324619, 935813	
Description of Flood:	Approx 300mm ponded water at the back of Nos 2,4, 6 & 8 Young Crescent. House No 2 also flooded with foul water from the sewer to a depth of 50mm.	
Date/Time of Start/Duration of Flood:	24 Jul 2009 Flood started approx 1100 & ended 3 hours later	
Threat to People and Properties? (Please give details)	<ul> <li>House No 2 Flooding to 50mm above floor level. Foundations flooded to approx 300mm, at floor level. Garden flooded with ponded water to approx 300 – 400 mm depth. </li> <li>House Nos 4, 6 &amp; 8 Foundations flooded to approx 300mm, just below floor level. Garden flooded with ponded water to approx 300 – 400 mm depth. House No 10 Flood water flowed over the garden with minimal impact. Tackmore Croft Flooding to fields &amp; access track with erosion to track.</li></ul>

Does the site have a history of flooding?	The site flooded in October 2006 during the widespread flooding. This was later confirmed as a 1 in 50 year event of rainfall over the
(Please give details)	preceding 10 days.
Recording Officer: Date Completed:	Iain Moncrieff 20 Aug 2009
Comments:	During the Planning Application for this development Mr Spencer & Miss Lucas of Tackmore Croft noted the area was subject to flooding. As a result TECS recommended the solum levels of houses 2,4,6,8 & 10 were to be 1m higher than the adjacent burn. Following a survey it was determined that the floor levels of No 2 & 4 were 0.49m & 0.27m below the adjacent burn. It is considered that the risk of flooding to the foundations would have been reduced if this planning condition had been met. At the planning stage it was considered that the main risk of flooding to the housing development would be from the ditch & not from the 300mm pipe upstream. Raising the floor levels to +1m on top of the adjacent ditch would not have prevented the gardens from ponding or from flooding the detention basin & Tackmore Croft. Based on the Institute of Hydology's Report No 124 Flood Estimation for Small Catchments, the annual flow from the catchment area was calculated as 0.3 cu m/s. For a return period of 30 years the flow increases to 0.6 cu m/s and 0.9 cu m/s for a 200 year return period. However the 300mm pipe between the A99(T) and Young Crescent will only carry 0.14 cu m/s. The ditch opposite the houses can carry 2.5 cu m/s but the 225mm pipe downstream of the Young Crescent can only carry 0.06 cu m/s. Consequently the 225mm & 300mm pipe swill surcharge under the annual flood flow. On the 24 Jul 09, the 300mm pipe surcharged at the manhole at the A99(T). The force of the water caused the partial collapse of the manhole aggravating the situation. Once the manhole surcharged the flood water continued to flow over land & surcharged the detention basin built as part of the scheme & then continued to flood Tackmore Croft. House No 2 at Young Crescent was flooded internally with foul water from the ditch & the scheme's detention basin surcharged at the manhole connecting the detention basin surcharged at the manhole connecting the detention basin surcharged the flood water running over land onto Tackmore Croft. House No 2 at Young Cre

Source of Notification: Name: Address: Tel No:	J Hindmarch CWO TECS	
Works Undertaken: (Please give details)	Sand bag dam built by TECS on the field to the north of the houses to divert the flood water back into the ditch. Fire Brigade pumped out foundations & gardens. Scotland Transerv cleared the collapsed manhole. Scottish Water removed solids from surcharged sewer manholes.	
Works Required:	Replace the existing pipe from the A99 – Young Crescent. Replace the existing pipes from downstream of the houses to tie into the ditch running east to west which is located to the south of Tackmore Croft. Clean out the ditch to the south of Tackmore Croft.

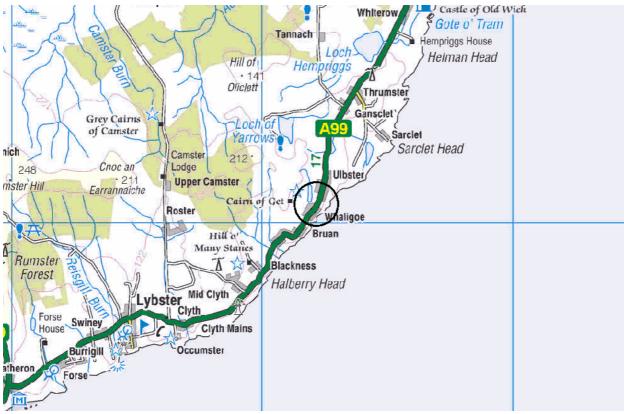
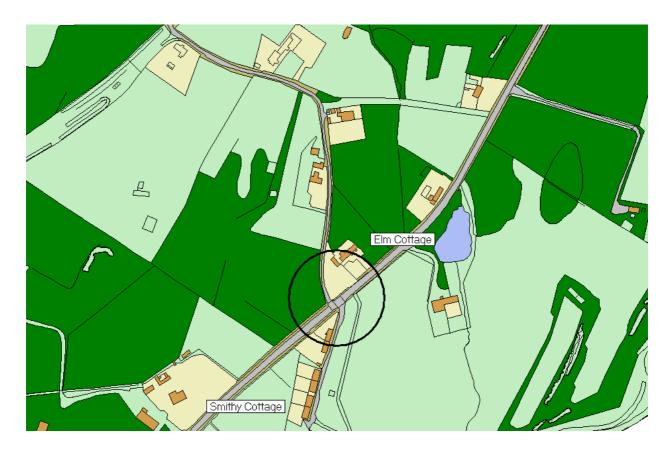
<b>RECORDING FORM: (Ma</b>	rk all applicable options)	
Location of Flood:	A99(T) at Clyth & Ulbster	
Water Course Name/Ref:	Unknown C21	
Grid Reference:	OSGR 332030, 940487	
Description of Flood:	The Lybster to Wick road especially in Clyth and Ulbster is really badly flooded and no signs or anything to the flooding.	
Date/Time of Start/Duration of Flood:	3 September 2009	
Threat to People and Properties? (Please give details)	Road Closed	
Source of Notification: Name: Address:	Mrs Sheena MacBeath 11 Mowat Place, Main Street Lybster, KW3 6AJ	
Tel No:	01593 721509	
Works Undertaken: (Please give details)	Passed to Transerv. Road closed	
Works Required:	May need ditch to sea cleaned out.	
Does the site have a history of flooding? (Please give details)	Flooded in general area – Elm Cottage 02 Oct 01 See Biennial Flood Report No 3 2001. Also Smithy Cottage – date unknown. See Biennial Report No 5 2005 & 20 Oct 06. See Biennial Report No 7.

Recording Officer: Date Completed:	I Moncrieff 16 Sep 09	
Comments:	See CC 11436 This property is at risk of further flooding.

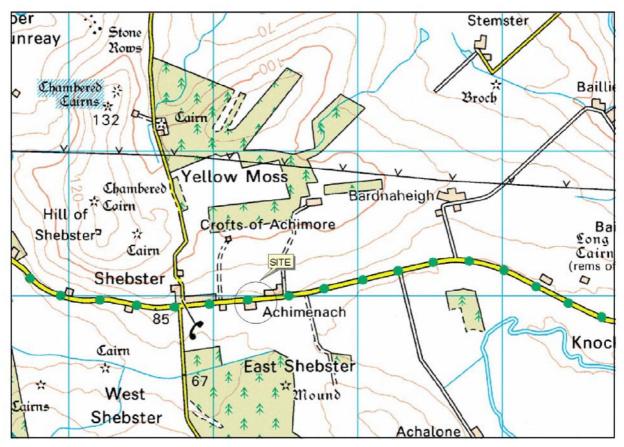
RECORDING FORM: (Mark all applicable options)		
Location of Flood:	Achiebeg Farm, Shebster, Reay	
Water Course Name/Ref:	Roadside drains	
Grid Reference:	302249, 963979	
Description of Flood:	Surface water from the road ran into the farm yard and buildings	
Date/Time of Start/Duration of Flood:	July 2009	
Threat to People and Properties? (Please give details)	Water was running into some of the farm buildings	
Source of Notification: Name: Address: Tel No:	Mrs A Oag Brims Mains Thurso Kw14 7xu	
Works Undertaken: (Please give details)	No works undertaken	
Works Required:	Kerbing and verging along frontage of farm yard and replace filter material on roadside drains	
Does the site have a history of flooding? (Please give details)	None reported	
Recording Officer: Date Completed: Comments:	J Gunn 29 July 2009	
	1

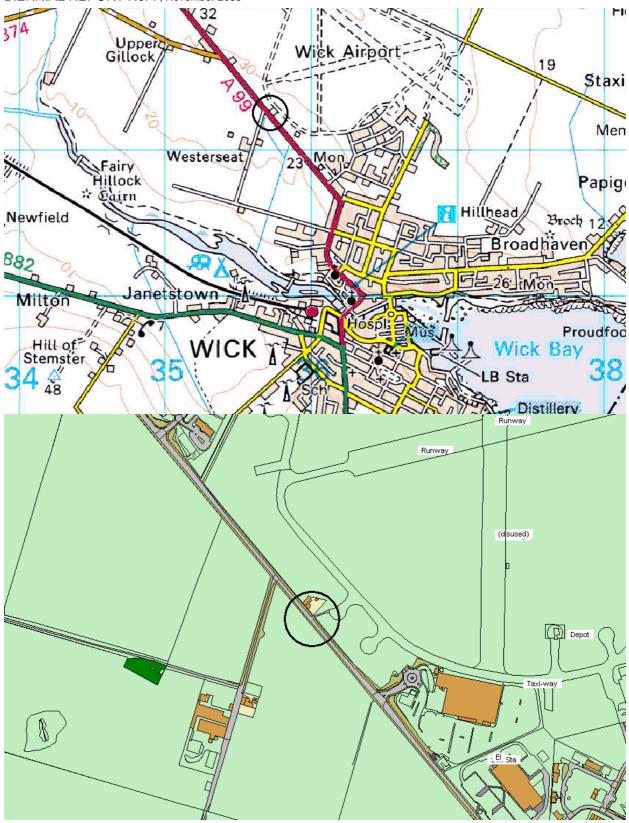
RECORDING FORM: (Mark all applicable options)			
Location of Flood:	Aikerness Cottages on A99 off Westerseat Entrance		
	Allentiese eellagee en Aee en Weelereeal Enlance		
Water Course Name/Ref:			
Grid Reference:	335749/952203		
Description of Flood:	Airport Surface Water Flowing Down Track (SE of Cottages) on to		
	A99 Carriageway		
Date/Time of	4 September 2009 - 10.30am		
Start/Duration of Flood:			
Threat to People and	Affecting Part of the Carriageway		
Properties?	Road Users		
(Please give details)			
Source of Notification:	John Niwa		
Name:	PIO		
Address:			
	01955 607737		
Tel No:			
Works Undertaken:	None		
(Please give details)			
Works Required:			
Deep the site house			
Does the site have a			
history of flooding? (Please give details)			
(Flease give details)			
Recording Officer:			
Date Completed:			
Comments:

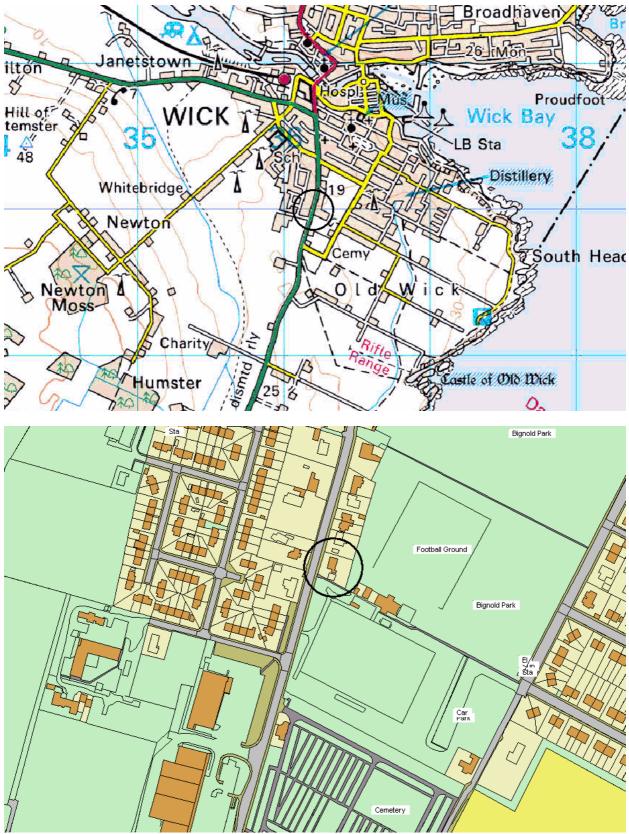
RECORDING FORM: (Mark all applicable options)		
Location of Flood:	B & B Adjacent to Harmsworth Park, Wick	
Water Course Name/Ref:		
Grid Reference:	336213/950009	
Description of Flood:	Surface Water From A99 due to Burn Bursting its Banks	
Date/Time of Start/Duration of Flood:	3 September 2009 – 18.00pm	
Threat to People and Properties? (Please give details)	The House	
Source of Notification: Name: Address:	John Niwa PIO	
Tel No:	01955 607737	
Works Undertaken: (Please give details)	Fire Brigade with Pumps	
Works Required:	Awaiting Major A99 Drainage Works	
Does the site have a history of flooding? (Please give details)	October 2006 and Others	
Recording Officer: Date Completed:		
Comments:

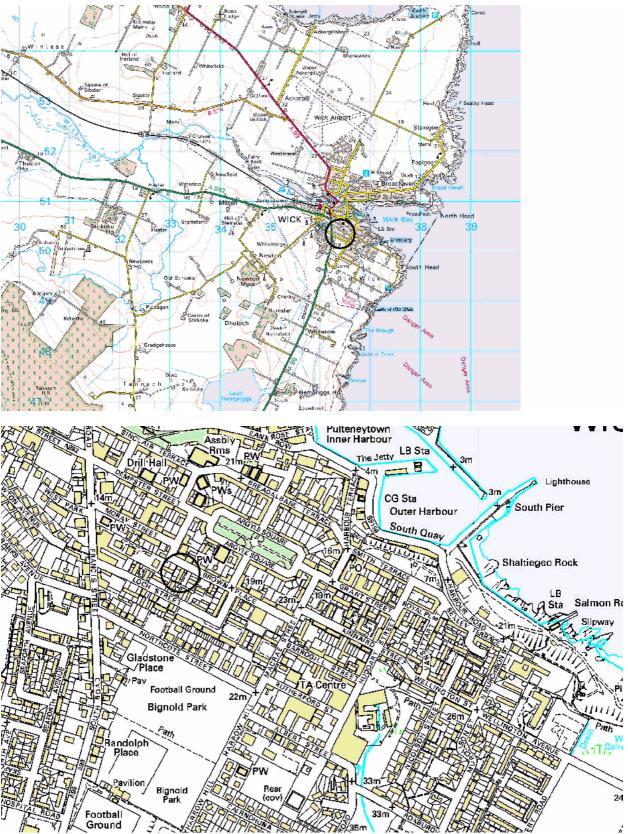
RECORDING FORM: (Mark all applicable options)	
Location of Flood:	37 Brown Pl, Wick
Water Course Name/Ref:	N/A
Grid Reference:	
Description of Flood:	Footway flooded at above propoerty
Date/Time of Start/Duration of Flood:	3 September 2009
Threat to People and Properties? (Please give details)	Threatening to flood house
Source of Notification: Name: Address:	Mrs Taylor 37 Brown Pl Wick
Tel No:	01955 603063
Works Undertaken: (Please give details)	None
Works Required:	Check footway is falling towards kerb.
Does the site have a history of flooding? (Please give details)	No previous records
Recording Officer: Date Completed:	I Moncrieff 16 Sep 09
Comments:	See CC 11435 Surface water gathering on the road and pavements causing great difficulty as the pavement slopes resulting in the water gathering at the doorstep and surrounding area - the water has no channels to go down to drain away basically so it just gathers.

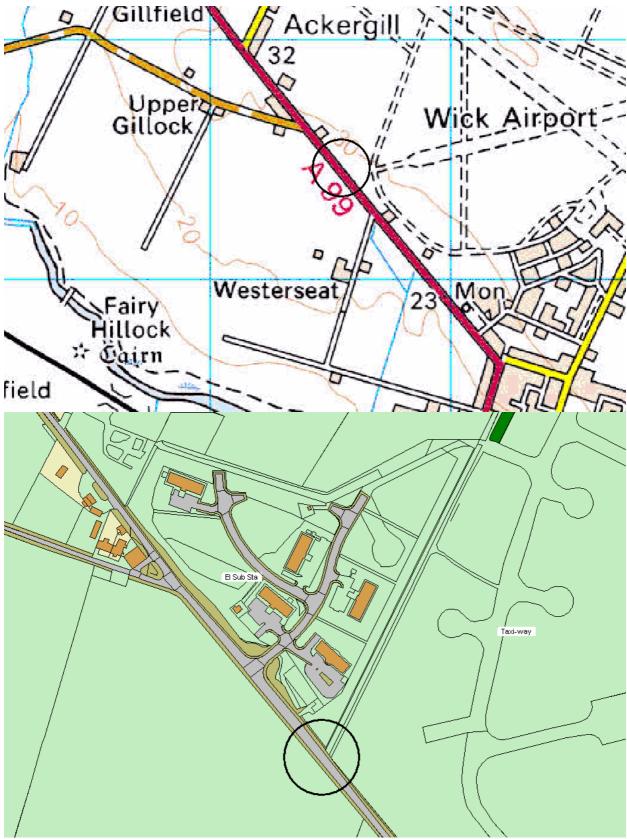
RECORDING FORM: (Mark all applicable options)	
Location of Flood:	SE Boundary of Business Park, Lochshell
Water Course Name/Ref:	
Grid Reference:	335541/952447
Description of Flood:	Ditch overflowing on to A99 partly covering carriageway
Date/Time of Start/Duration of Flood:	4 September 2009
Threat to People and Properties? (Please give details)	Road Users
Source of Notification: Name: Address:	John Niwa PIO
Tel No:	01955 607737
Works Undertaken: (Please give details)	
Works Required:	
Does the site have a history of flooding? (Please give details)	
Recording Officer: Date Completed:	
Comments:

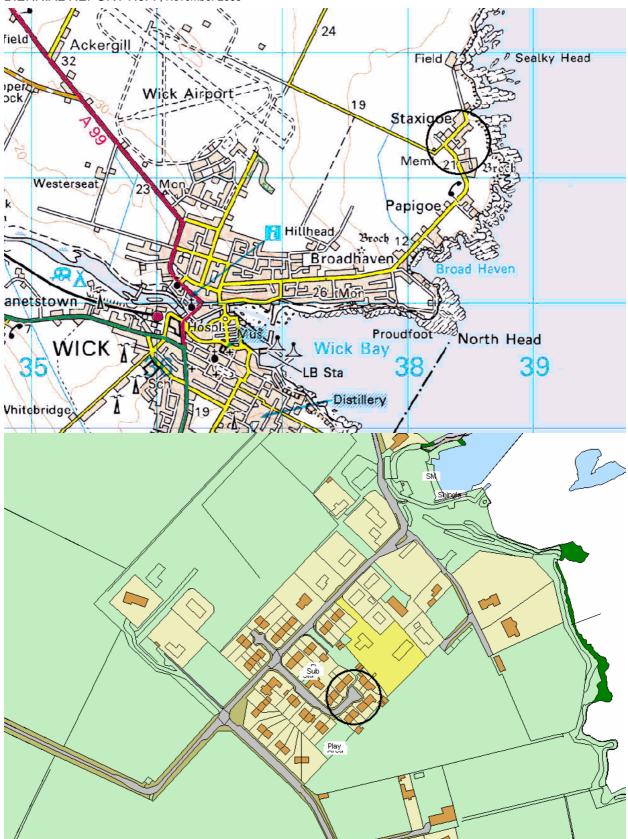
RECORDING FORM: (Mai	RECORDING FORM: (Mark all applicable options)	
Location of Flood:	Elzy Grove, Staxigoe Turning Head	
Water Course Name/Ref:		
Grid Reference:	338413/952286	
Description of Flood:	Kerbed Turning Head in Housing Scheme Water Level Rose, Slow to Drain	
Date/Time of Start/Duration of Flood:	3 September 2009 - 17.00pm	
Threat to People and Properties? (Please give details)	Possible Threat to Properties	
Source of Notification: Name: Address:	John Niwa PIO	
Tel No:	01955 607737	
Works Undertaken: (Please give details)		
Works Required:	Clean Out Gullies	
Does the site have a history of flooding? (Please give details)	?	
Recording Officer: Date Completed:		
Comments:

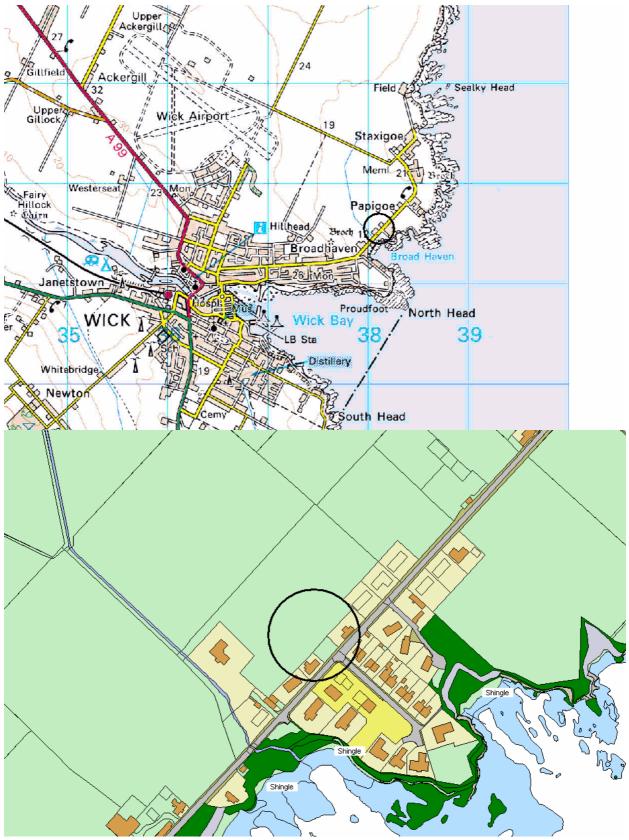
de all ann l'achta an ('ana')
RECORDING FORM: (Mai	
Location of Flood:	Fas Skerry, Papigoe
Water Course Name/Ref:	
Grid Reference:	338114/951565
Description of Flood:	Road Channel Water Ponding at Front Door
Date/Time of Start/Duration of Flood:	3 September 2009 - 16.00pm
Threat to People and Properties? (Please give details)	Could Flood House
Source of Notification: Name: Address:	John Niwa PIO
Tel No:	01955 607737
Works Undertaken: (Please give details)	Sand Bags Deployed
Works Required:	
Does the site have a history of flooding? (Please give details)	Yes - 2006
Recording Officer: Date Completed:	
Comments:

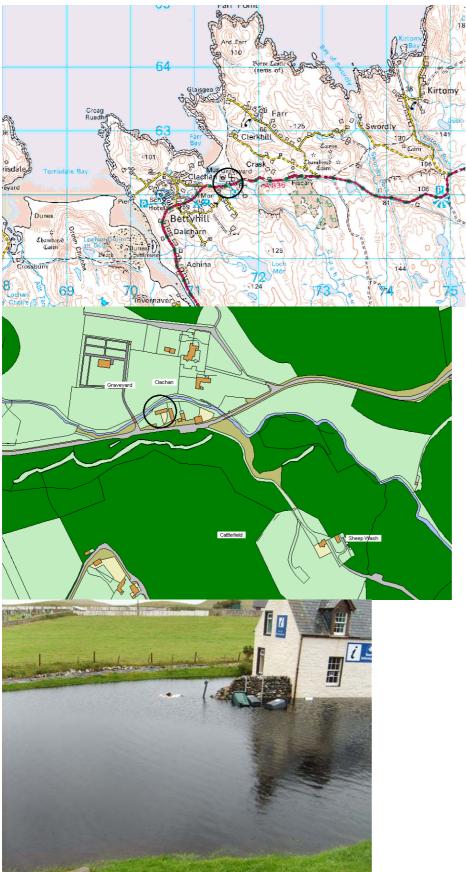
RECORDING FORM: (Ma	
Location of Flood:	Bettyhill Café & Tourist Information Bettyhill
Water Course Name/Ref:	Clachan Burn
Grid Reference:	OSGR 271538, 962181
Description of Flood:	Car park & ground floor of café flooded out to approx 150mm. Cause of flood uncertain. Previous floodings caused by adjacent burn overtopping & flap valve rusted open.
Date/Time of Start/Duration of Flood:	03 Sep 09 Started sometime after 5.30pm & continued through the night.
Threat to People and Properties? (Please give details)	Café car park & ground floor flooded out. Café closed to business.
Source of Notification: Name: Address: Tel No:	Mr Boyle Bettyhill Café Bettyhill
Works Undertaken: (Please give details)	Fire Brigade in attendance on 04 Sep 09 to pump out car park & café.
Works Required:	Inspect & replace flap valve. Possibly raise gabion wall Possibly kerb road.
Does the site have a history of flooding? (Please give details)	Flooded circa 1985 with gabion flood defence wall constructed. Flooded on 28 Jun 2004 possibly due to flap valve. Flooded on 26 Oct 2006. Flood defence wall over topped.

Recording Officer: Date Completed:	Iain Moncrieff
Comments:	The property is at risk of further flooding.

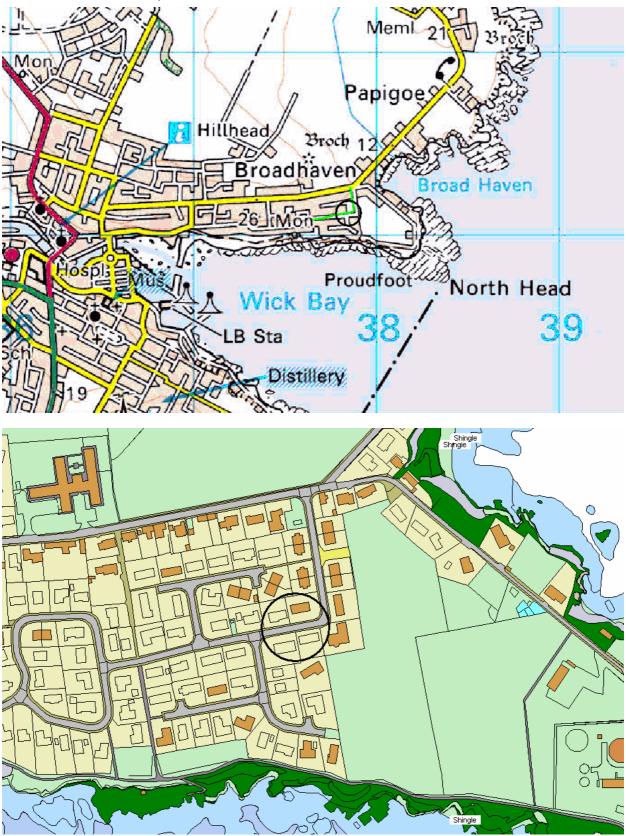
<b>RECORDING FORM: (Mai</b>	rk all applicable options)
Location of Flood:	No 10 & 12 Murray Avenue, Wick
Water Course Name/Ref:	Unknown N/A
Grid Reference:	OSGR 337847, 951122
Description of Flood:	Gully surcharged, with flood water flowing down driveways.
Date/Time of Start/Duration of Flood:	03 Sep 09 circa 2000 hrs, peaked in 3hrs
Threat to People and Properties? (Please give details)	Garages & gardens flooded
Source of Notification: Name: Address:	Mr Doull 10 Murray Ave Wick
Tel No:	01955 605458
Works Undertaken: (Please give details)	Sand bags delivered.
Works Required:	Extra gully required.
Does the site have a history of flooding? (Please give details)	Previous flooded on: 16 Sep 07. See 2007 Biennial Flood Report 01 Aug 06
Recording Officer: Date Completed:	Iain Moncrieff
Comments:	Gullies connect to 150mm Scottish Water surface water sewer. SW consider that 100mm tail from gully to sewer is too small. These properties are at risk of further flooding.

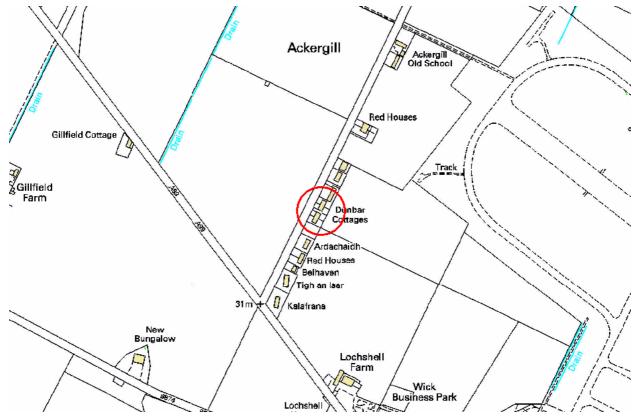
RECORDING FORM: (Mark all applicable options)	
Location of Flood:	Nos 1 & 2 Dunbar Cottages,
	Ackergill
	Wick
Water Course Name/Ref:	N//A
Grid Reference:	OSGR 335248, 953130
Description of Flood:	Park slopes down to rear of houses. Overland flow caused gardens to flood to 2' to back & front of houses.
Date/Time of Start/Duration of Flood:	03 Sep 09 circa 2000 hrs, peaked in 3hrs
Threat to People and	2 no houses nearly flooded to foundations through air vents. 2' deep.
Properties?	No 1 Mr C MacLeod
(Please give details)	No 2 Miss K Reid
Source of Notification:	Mr C MacLeod
Name:	No 1 Dunbar Cottages
Address:	Ackergill
Tel No:	
Works Undertaken:	Fire Brigade in attendance last night. Mr MacLeod pumping water
(Please give details)	away himself.
Works Required:	Unable to extend recent drain to rear of houses due to gradient &
	topography. May be able to install cut off drain in park. Further studies required.
Does the site have a	Flooded in Oct 06. See 2007 Biennial Flood Report

history of flooding?	
(Please give details)	
Recording Officer:	Iain Moncrieff
Date Completed:	
Comments:	The property is at risk of further flooding.
	Park owned by Mr W Mackay, Upper Ackergill. Adjacent park owned
	by GMR Henderson.
	Input from airport?

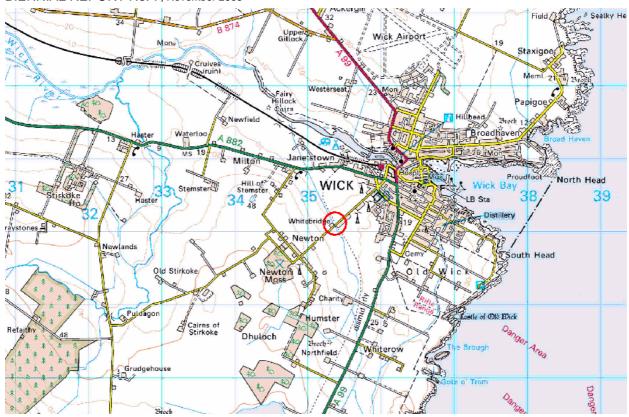
<b>RECORDING FORM: (Mai</b>	rk all applicable options)
Location of Flood:	Burnside, Whitebridge, Newton Hill
Water Course Name/Ref:	
Grid Reference:	OSGR 335405, 950086
Description of Flood:	Burn flooded from approx 0.5 cum /s to 7 cu m/s. Bridge & recently installed bypass culvert still couldn't take the flow & burn overtopped its banks. This caused the house to be flooded again (see Oct 2006).
Date/Time of Start/Duration of Flood:	03 Sep 09 circa 2000 hrs
Threat to People and Properties? (Please give details)	House adjacent to burn.
Source of Notification: Name: Address:	l Moncrieff Principal Engineer TECS
Tel No:	01955 609996
Works Undertaken: (Please give details)	House pumped out.
Works Required:	Previously suggested to Mr Falconer to build a pc block wall sunk into the ground to try to keep the water out.
Does the site have a history of flooding? (Please give details)	Flooded twice in Oct 06. See 2007 Biennial Flood Report

Recording Officer: Date Completed:	Iain Moncrieff
Comments:	The property is at risk of further flooding.

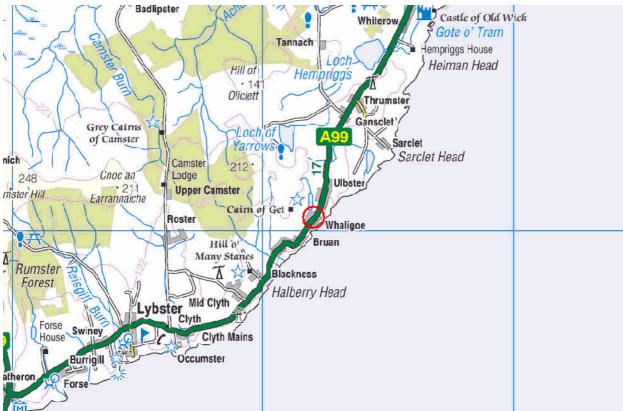
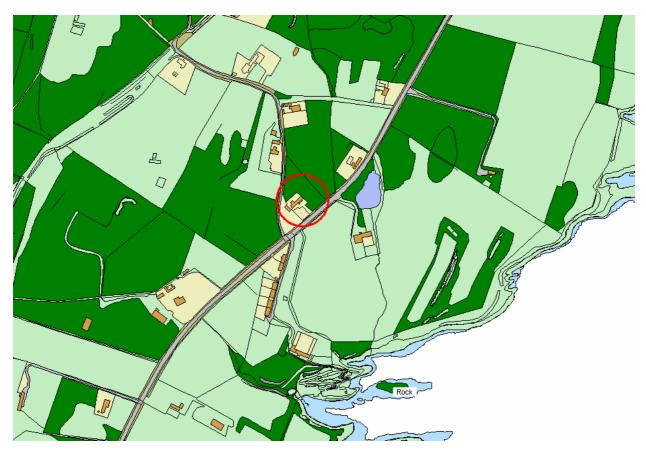
RECORDING FORM: (Mark all applicable options)	
Location of Flood:	Elm Cottage Ulbster
Water Course Name/Ref:	C21 Ulbster
Grid Reference:	OSGR 332042, 940528
Description of Flood:	Garden & surrounding low lying fields flooded with ponded water.
Date/Time of Start/Duration of Flood:	03 Sep 09 circa 2000 hrs, peaked in 3hrs Flooded till 4 <sup>th</sup> Sep 09.
Threat to People and Properties? (Please give details)	1 no houses nearly flooded, garden under water.
Source of Notification: Name: Address:	I Moncrieff Principal Engineer TECS
Tel No:	01955 607796
Works Undertaken: (Please give details)	?
Works Required:	?
Does the site have a history of flooding? (Please give details)	Repeatedly flooded in recent years. Old filled in ditch recently reopened to take excess flow but overtopped. See 2005 Biennial Flood Report 'Smithy Cottage'
Recording Officer: Date Completed:	Iain Moncrieff
Comments:	The property is at risk of further flooding.
