Inverness East Post Flood Report

Final Report

February 2012

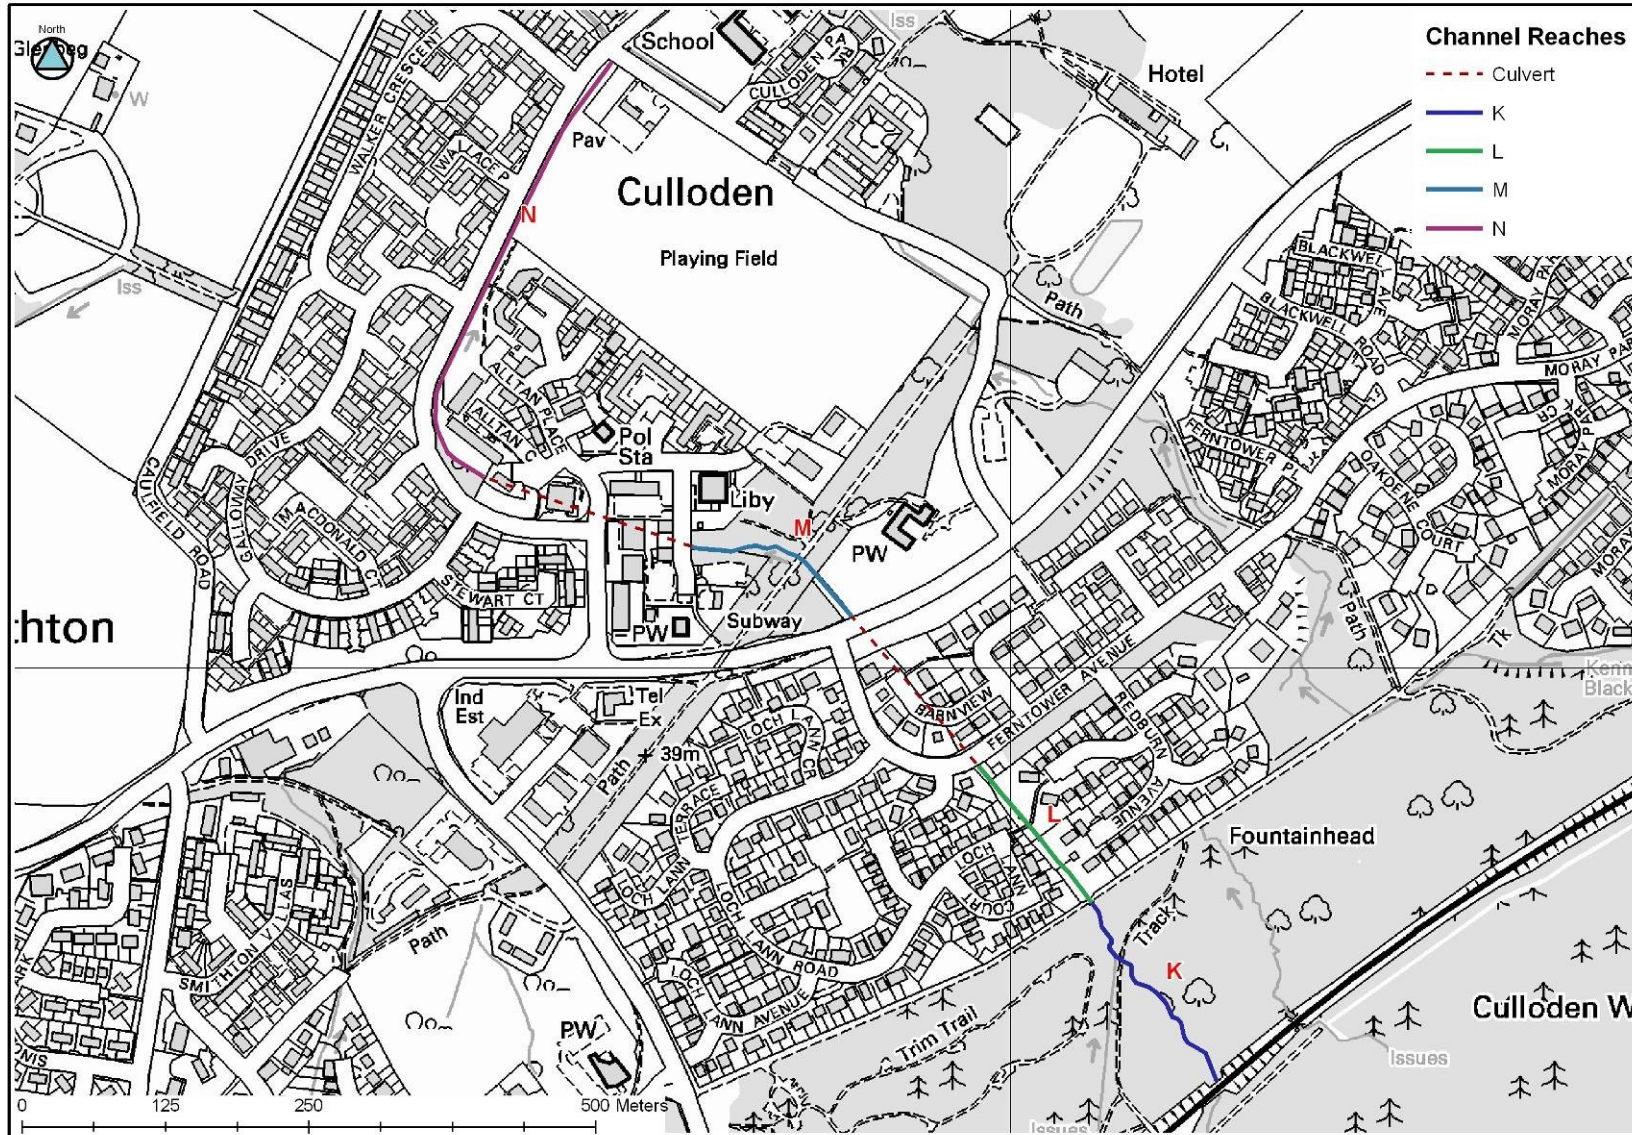
Figure 2-1: Culloden Burn West Channel Reaches

Reach	Summary	Erosion Risk Category
K	Steep, erosive reach within a steep sided densely vegetated valley. The channel has a step-pool form, with some steps formed by natural logjams. Sediment eroded from the reach would be passed downstream although much of this would be caught behind the gabion dam at the downstream extent of this reach.	High
L	Straightened and highly modified reach, with the channel lined with gabions along its length. Sediment has accumulated at various points along this reach, but is particularly observed at the downstream extent of the reach, upstream of the Ferntower Avenue culvert.	Low
M	Small, shallow sided valley with sections of both erosion and sediment accumulation.	Medium
N	Stable reach, with only a couple of localised sections of bank erosion and little evidence of sediment accumulation.	Low

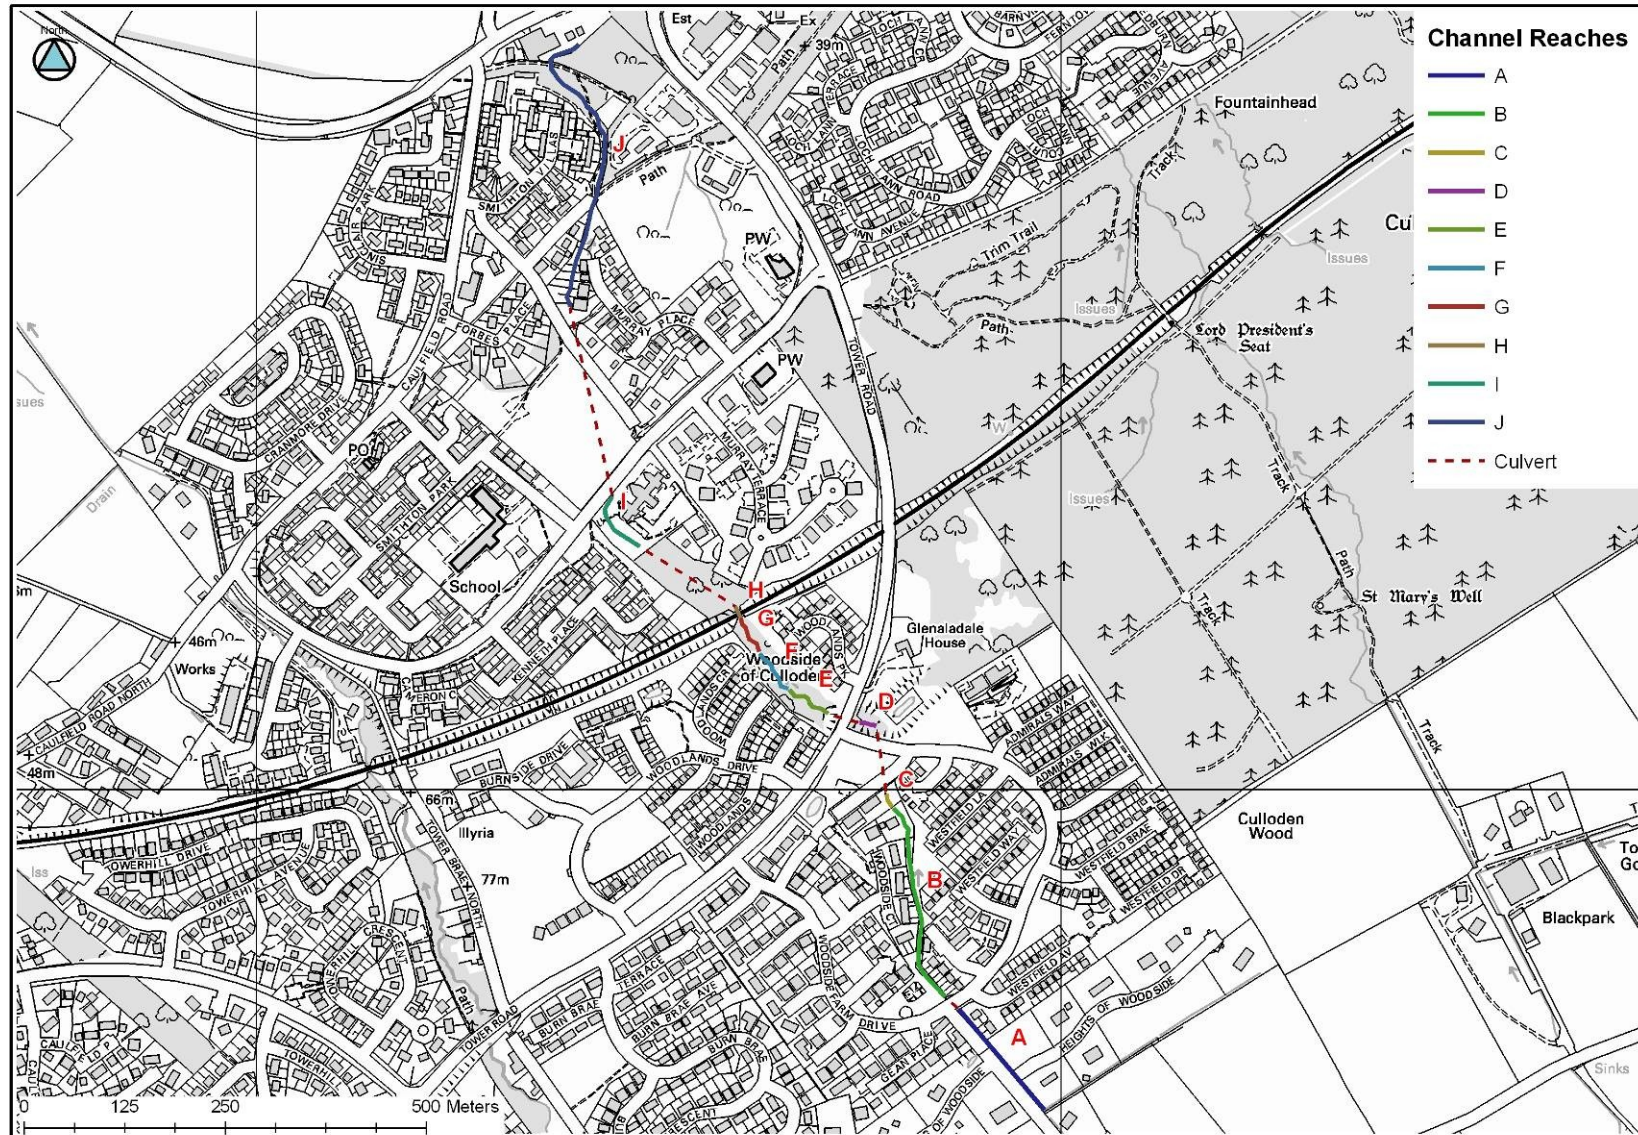
Figure 2-2: Smithton Burn Channel Reaches

Reach	Summary	Erosion Risk category
A	Historic straightening and improvements to land drainage within the upper catchment. Natural sediment load from the upper catchment is low, with this reduced further by the historical lining of the channel.	Low
B	The burn has been significantly modified within this reach, with development present to the top of either bank. The banks have sporadically been reinforced to protect property and allow for structures spanning the burn. The cumulative effect of the changes is that the erosion potential of the burn has increased, with the confinement of the burn focussing the energy within the channel during flood events. The sporadic nature of the modifications results in the erosion transferring to other areas and thus releasing a significant amount of sediment downstream.	Medium
C	Sediment is transferred through this reach and there is no form of sediment management to prevent the material from upstream continuing on into Woodside Farm Drive culvert.	High

D	The reach is effective at conveying sediment from upstream, and is also subject to further erosion. This is exemplified by a SUDS outfall that is sitting 0.5-1m above the bed level. However, there is also some deposition immediately upstream of Tower Road culvert.	Medium
E	A large scour pool is present at the end of Tower Road culvert, with sediment deposition downstream; the accumulation of sediment confirms the ability of the culverts upstream to convey sediment from the upper reaches. Downstream of the pool the burn is relatively natural. It is subject to erosion and is effective at conveying sediment downstream through a step-pool system.	High
F	The reach is steep and has undergone extensive recent erosion. This may have resulted from the historical clearing of sediment in the vicinity of the railway bridge, which created a nick-point that then spread upstream during a subsequent flood. A series of boulder weirs have recently been installed in an attempt to stabilise the channel and control the bed level through the reach.	High

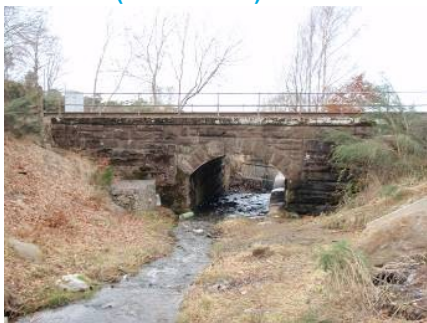
G	<p>The channel gradient decreases and the burn widens upstream of the railway bridge, thus resulting in sediment deposition. Significant alteration of the channel at this location has taken place following the recent flood events. This is demonstrated in the photographs below.</p> <p>Pre flood (March 2010)</p>
