7 Groundwater flood risk

7.1 Scottish Government Groundwater flood hazard study (2011)

7.2 Groundwater flood risk

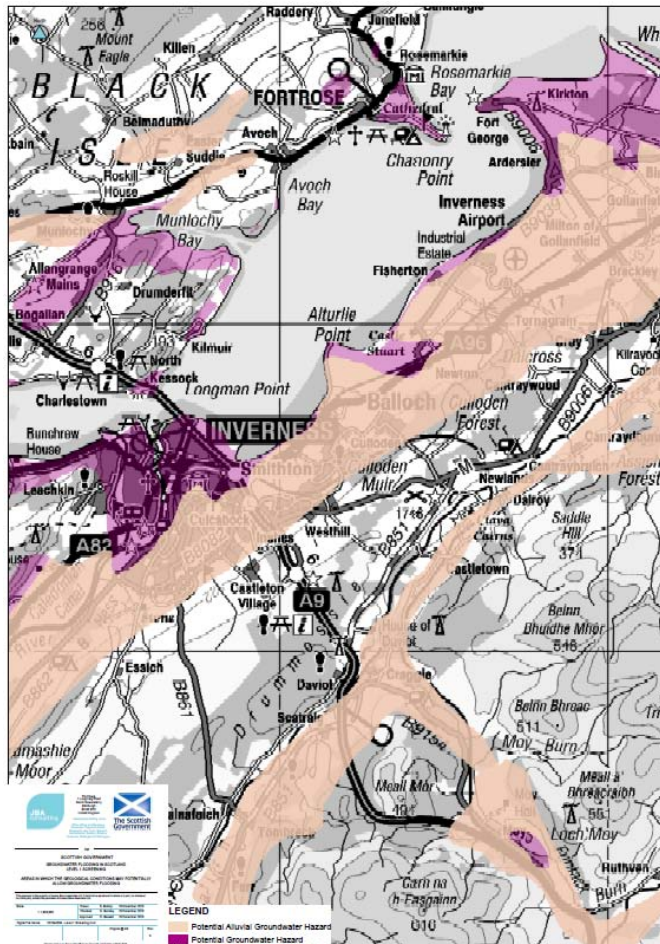
An image of the Level 1 screening map is presented in Figure 7-1 below and highlights zones potentially susceptible to groundwater flooding and potential groundwater hazards that includes permeable superficial deposits (e.g. alluvium and glacial sand and gravel) within existing river valleys. However, it should be noted that this level 1 assessment is broad scale and based solely on pre-existing geological mapping.

Figure 7-1: Level 1 groundwater screening map for Inverness

It is recommended that Highland Council collates and reviews all available borehole information in the area of Culloden and Smithton with a view to providing this to SEPA in order for this to be used as part of the Level 2 assessments. Output from these Level 2 studies should be reviewed prior to any more detailed assessment of groundwater hazards in the area.

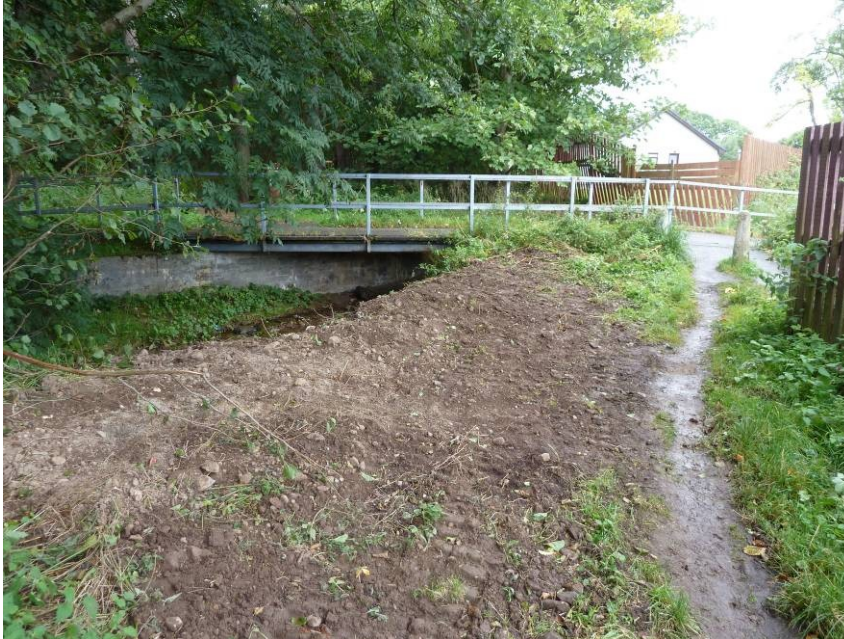
Figure 8-3: Repaired bank at location of bank overtopping into Smithton Villas

Anecdotal evidence suggests that out of bank flows may have occurred on the Smithton Burn at chainage 303 (as shown in Figure 8-3). The top of bank was surveyed after remedial works and suggests that the current bank level is suitable high to avoid out of bank flows. The pre-flood bank level is not known.

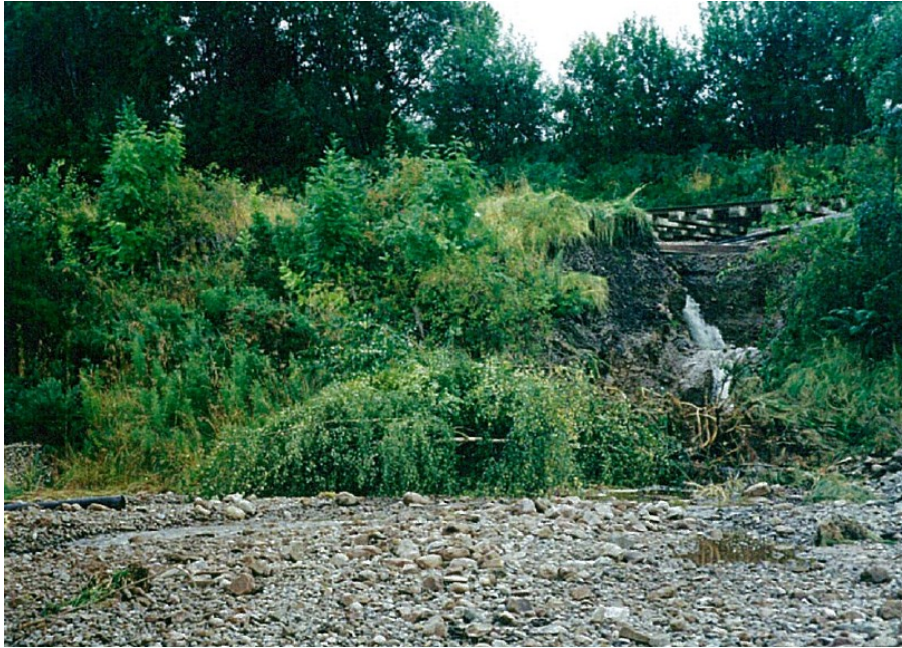
Figure 8-7: Flood from the Railway in September 2002 to Murray Terrace
