Appendices

A Summary of Biennial Report information relating to burns

B.1 Culloden Burn West

D.1 Smithton Burn

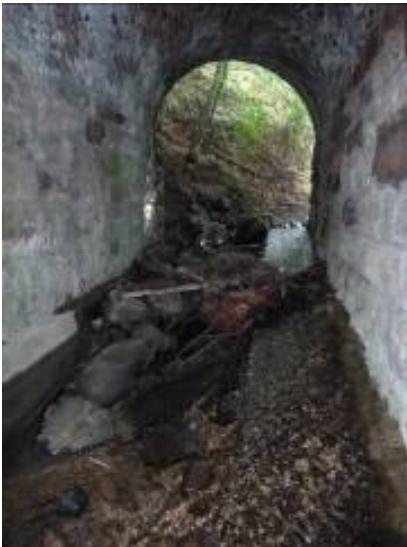
Name: Railway Bridge

Upstream face of bridge

Description: Single span arch bridge

Other: Bed rock upstream, concrete scour protection visible. Large boulders and debris located within U/S and D/S of structure.

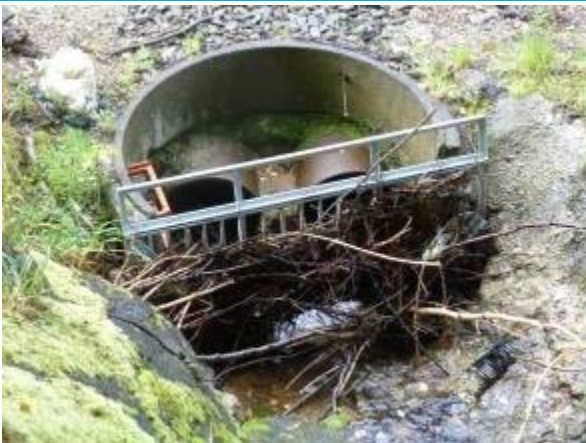
Name: Railway Culvert (tributary of Culloden Burn West)

Upstream face of culvert

Description: Double circular steel culvert beneath railway

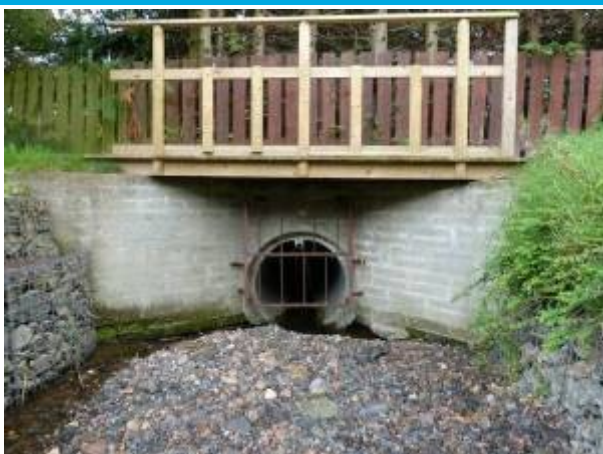
Name: Culvert beneath garden of [redacted] Redburn Avenue

Upstream face of culvert

Description: Circular concrete culvert - 1040mm diameter
OS NGR: NH
Opening area: 0.85 m²
Screen?: Yes
Blockage Risk: High
Access: Access through gardens off Redburn Avenue
Maintenance: Garden access bridge over culvert restricts maintenance. Potentially high risk for maintenance during flood.
Other: Screen replaced after 2009.

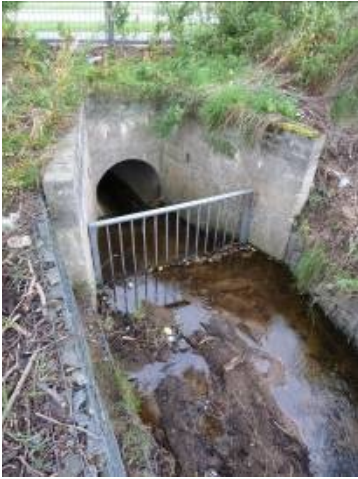
Name: Culvert beneath Ferntower Avenue, Barnview and main road

Upstream face of culvert

Description: Circular concrete culvert - 1050mm diameter
OS NGR: NH
Opening area: 0.87 m²
Screen?: Yes – half height screen
Blockage Risk: Medium
Access: Restricted. No vehicular access. Access over fence. Burn fenced in either side.
Maintenance: Difficult to maintain. Poor access. Nowhere to place material once removed from screen.
Other: Screen completely blocked during July flood and acting as a weir – water below top of headwall. Culvert shape is different at downstream end suggesting culverts abutted to each other. Potential for internal blockage.

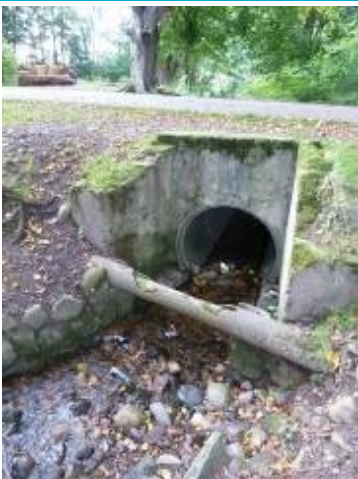
Name: Culloden walkway culvert

Upstream face of culvert

Description: Circular concrete culvert - 1050mm diameter
OS NGR: NH
Opening area: 0.87 m²
Screen?: No
Blockage Risk: Medium – due to pipe crossing upstream.
Access: Unrestricted access via walkway.
Maintenance: Open access but no safety or areas to store material once removed.
Other: Relatively short section of channel upstream. Maintenance of channel and bank upstream could reduce blockage at this culvert.

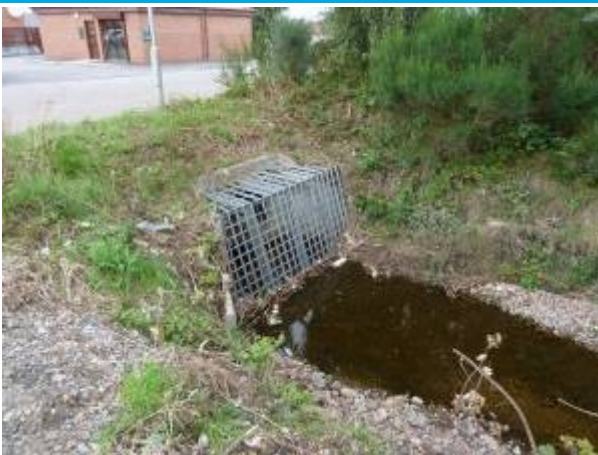
Name: Culloden Centre Culvert

Upstream face of culvert

Description: Circular concrete culvert - 1400mm diameter
OS NGR: NH
Opening area: 1.54 m²
Screen?: Yes – fine square mesh
Blockage Risk: High
Access: Unrestricted access from Culloden Centre.
Maintenance: Easy access, but loose ground surrounding inlet and screen. Safety of operatives for screen clearance during flood conditions could be improved due to lack of appropriate working positions, handrails and harness points.
Other:

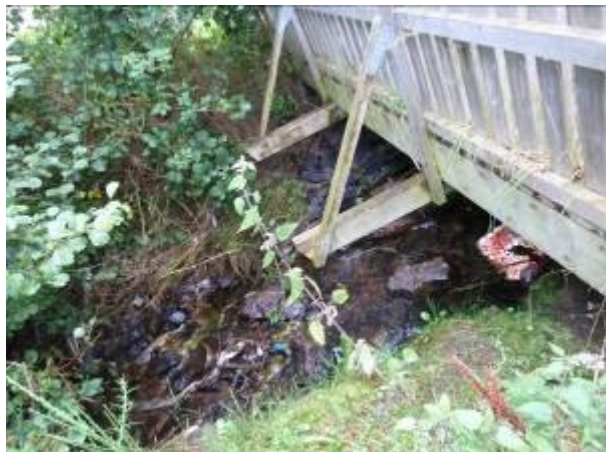
Name: Footbridge upstream of Culloden Recreation Ground

Downstream face of culvert

Description: Wooden foot bridge

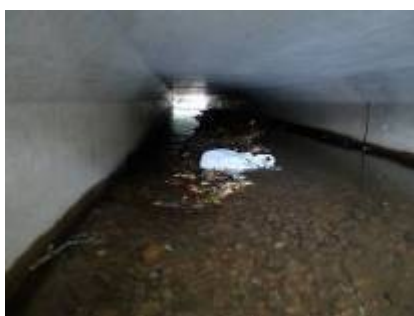
Other: A small weir is located upstream. The culvert has a gravel bed to an approximate depth of 100mm and a gravel bar throughout the culvert.

Gravel bed
through
culvert

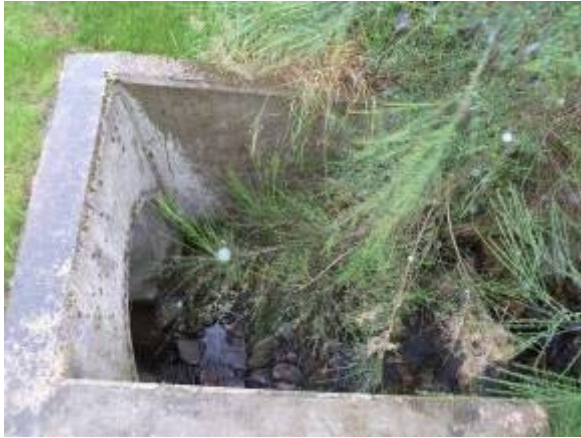
Name: Culvert beneath Heights of Woodside

Upstream *face of culvert*

Description: Circular concrete culvert - 800mm diameter

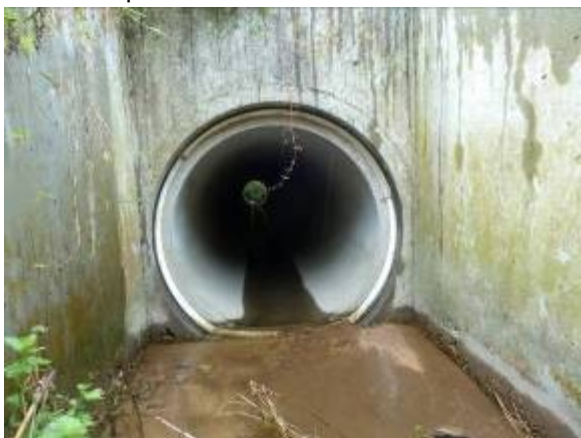
Maintenance: Maintenance access is good. Safety of operatives could be improved.

Other: Channel heavily overgrown upstream.

Upstream face of culvert

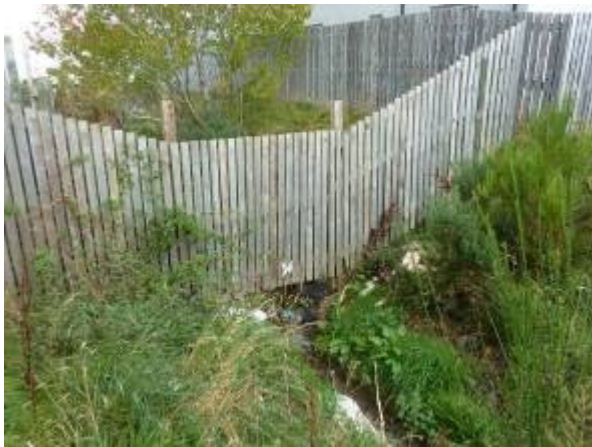
Name: Boundary fence restricting access to burn

Upstream face of fence

Description: Boundary fence
OS NGR: NH
Opening area: 1.18 m²
Screen?: No
Blockage Risk: Medium
Access: Access to upstream side possible adjacent SUDS pond off Woodside Farm Drive
Maintenance: Maintenance during flood conditions is not possible due to unsafe and restricted access.
Other:

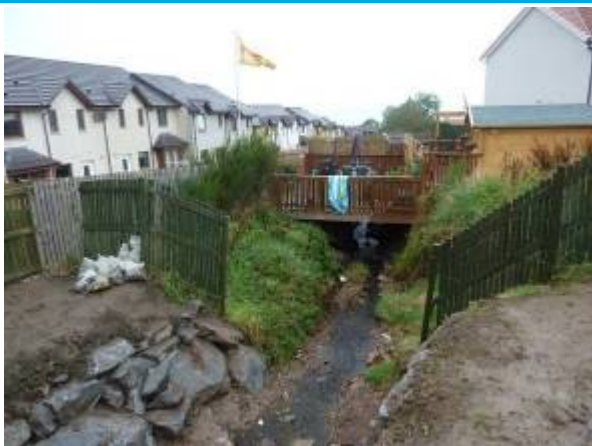
Name: Property decking extending over burn

Upstream face of decking "bridge"

Description: Patio decking over river
OS NGR: NH
Opening area: Not surveyed
Screen?: No
Blockage Risk: Medium
Access: No access other than via channel during low flow conditions (via Westfield Lane).
Maintenance: Access during flood conditions via riparian properties only. Maintenance during flood conditions is not possible due to restricted access.
Other: Banks and gabion baskets beneath decking are in poor condition and eroding due to lack of bank vegetation. Banks upstream have been lined with rock to stabilise channel.
 Not surveyed or modelled

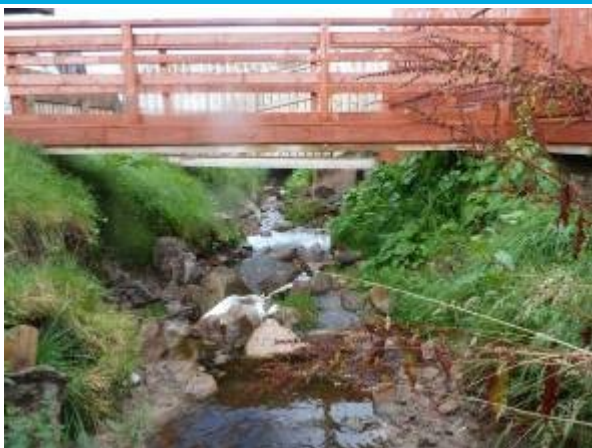
Name: Property decking extending over burn

Upstream face of decking "bridge"

Description: Patio decking over river
OS NGR: NH
Opening area: Not surveyed
Screen?: No
Blockage Risk: Medium
Access: No access other than via channel during low flow conditions (via Westfield Lane). Maintenance during flood conditions is not possible due to restricted access.
Maintenance: Access during flood conditions via riparian properties only.
Other:
 Not surveyed or modelled

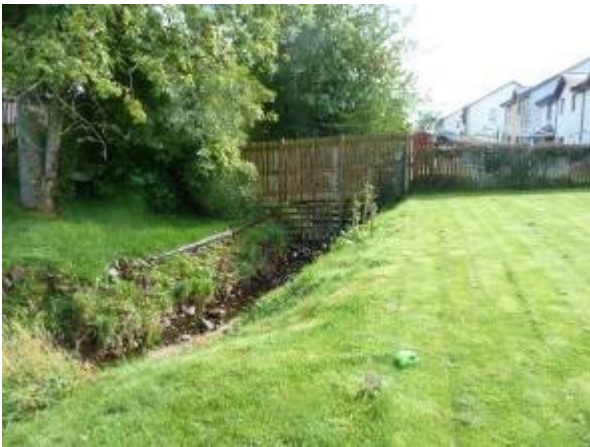
Name: Property boundary fence

Downstream face of fence

Description: Boundary fence with water gate
OS NGR: NH
Opening area: Not surveyed
Screen?: No
Blockage Risk: Medium
Access: Access via garden of No. [redacted] Woodside Court
Maintenance: Access to downstream side available. Access to upstream side is restricted as channel is fenced in behind property boundary fences.
Other: The recent floods did not remove or wash away the water gate suggesting that very little material or debris was washed down the channel to this point.
 Not surveyed or modelled

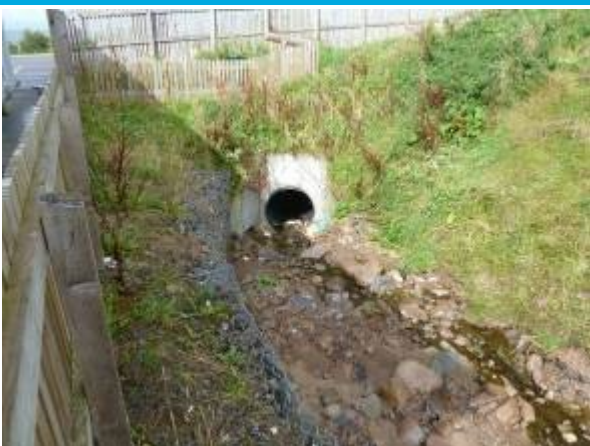
Name: Culvert beneath ?? and Woodside Farm Drive

Upstream face of culvert

Description: Circular concrete culvert - 1050mm diameter
OS NGR: NH
Opening area: 0.87 m²
Screen?: No
Blockage Risk: Medium
Access: Access from Woodside Village
Maintenance: Culvert inlet is fenced off. Difficult to access inlet. Maintenance during flood conditions is difficult due to restricted access and lack of appropriate working positions handrails and harness points.
Other: Channel bed upstream is highly mobile and eroding providing substantial debris and material that could block culvert inlet.

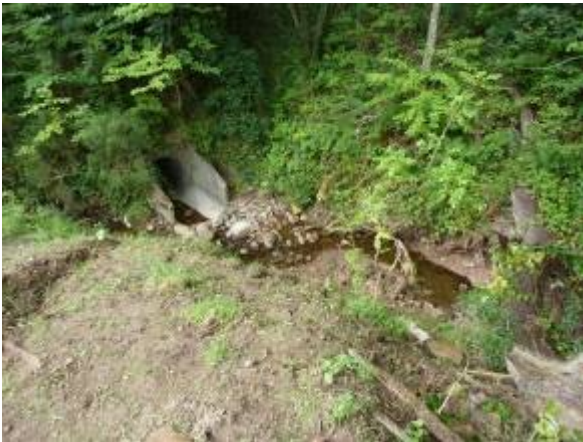
Name: Culvert beneath Tower Road

Upstream face of culvert

Description: Circular concrete culvert - 1500mm diameter
OS NGR: NH
Opening area: 1.77 m²
Screen?: No
Blockage Risk: Medium
Access: Difficult access from Woodside Farm Drive.
Maintenance: Situated in steep channel. Maintenance during flood conditions is difficult due to restricted access and lack of appropriate working positions handrails and harness points.
Other: A temporary access track from Woodside Farm Drive to the right side of the burn has been provided for post flood works/maintenance. This material is at risk of being undermined and causing further channel/culvert blockage. Works to protect the toe of this slope are recommended.

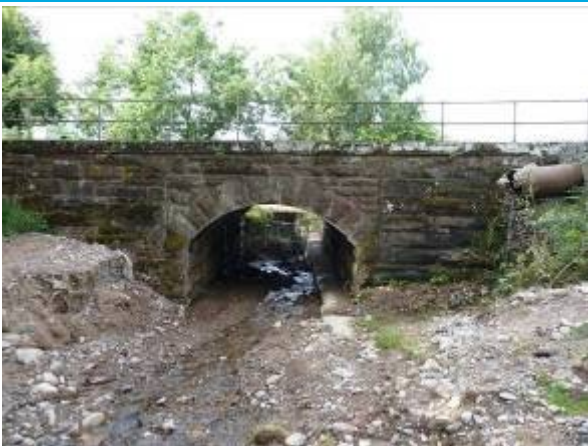
Name: Railway culvert

Upstream face of culvert

Description: Single span stone arch bridge
 Network Rail Line Reference Number: HGL2
 Network Rail Structure Number: 290/334
OS NGR: NH
Opening area: 4.38 m²
Screen?: No
Blockage Risk: Low
Access: Access from Woodlands Park.
Maintenance: Maintenance during flood conditions is restricted by railway and uncontained channel upstream.
Other: Significant sediment accretion and deposition witnessed before and after recent floods. Significant bed load is available in reach upstream. Post flood works have taken place in reach upstream to create boulder dams to limit gravel movement.

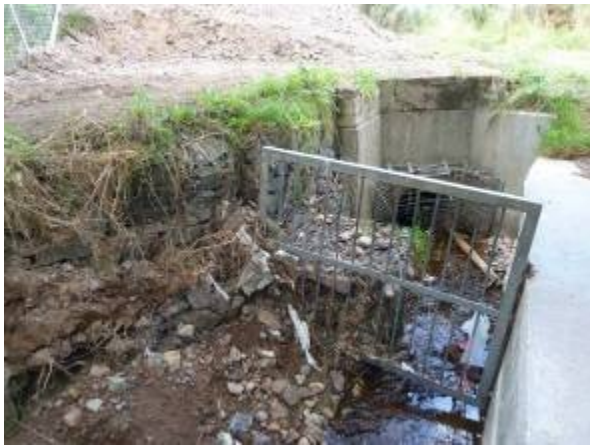
Name: Culvert beneath high ground adjacent to Murray Terrace

Downstream face of culvert

Description: Circular concrete culvert - 900mm diameter
OS NGR: NH
Opening area: 0.64 m²
Screen?: Yes No. 2: fine square mesh located 2m upstream and further screen over inlet.
Blockage Risk: High
Access: Access from Murray Terrace [REDACTED]
Maintenance: Maintenance is unsafe during flood conditions due to lack of appropriate screens, handrails and harness points.
Other: In-channel gabion protection on left bank reduces channel capacity. Initial screen is at the height of the headwall which if completely blocked could lead to bypassing flows.
 Material removed from the channel during the recent floods has been piled up on the left bank and is at risk of mobilisation/re-entering the river.

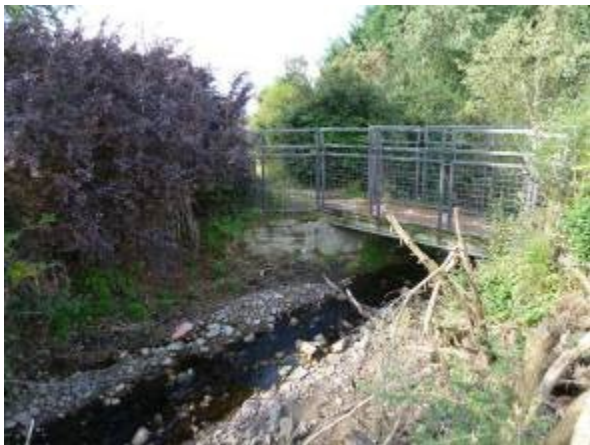
Name: Footbridge in grounds of burnt out retirement home

Upstream face of bridge

Description: Concrete bridge with metal railings
OS NGR: NH
Opening area: 2.22 m²
Screen?: No
Blockage Risk: Low
Access: Access via burnt out old people's home off Murray Road.
Maintenance:
Other: Channel is heavily overgrown upstream and downstream of channel.

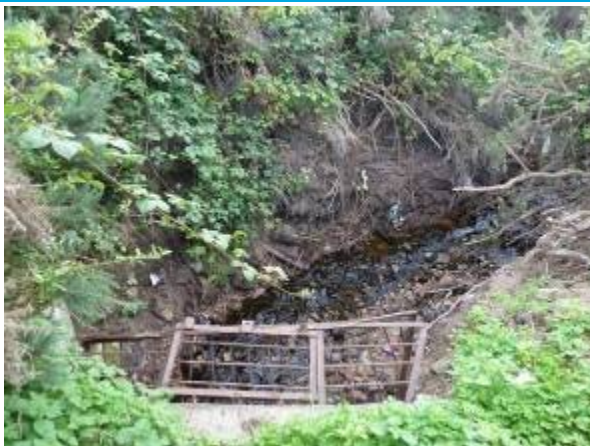
Name: Culvert beneath Murray Road

Upstream culvert inlet and channel

Description: Circular concrete culvert - 900mm diameter
OS NGR: NH
Opening area: 0.64 m²
Screen?: Yes – fine square mesh in poor condition.
Blockage Risk: Culvert is currently blocked by 50% at downstream end. High blockage risk.
Access: Access from Murray Road.
Maintenance: Restricted access over fence. Heavily overgrown channel upstream. Screen slopes towards the culvert inlet at the base making screen clearance during flood conditions difficult and unsafe.
Other: Screen is in poor condition.

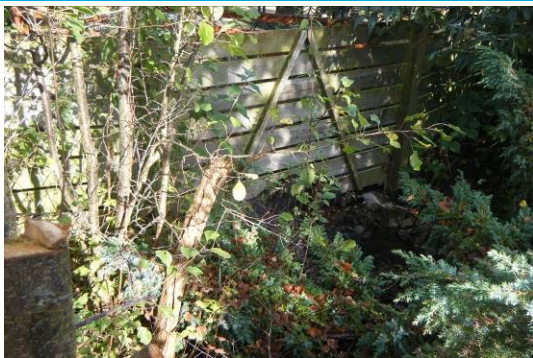
Name: Numerous property boundary fences, bridges and culverts at rear of Murray Place

Description: Various
OS NGR: NH
Opening area: As small as 0.41 m²
Screen?: No
Blockage Risk: High
Access: Access from Murray Place
Maintenance: Maintenance during flood conditions is difficult due to restricted access.
Other: Numerous structures present. Key structures were surveyed and included within the model.

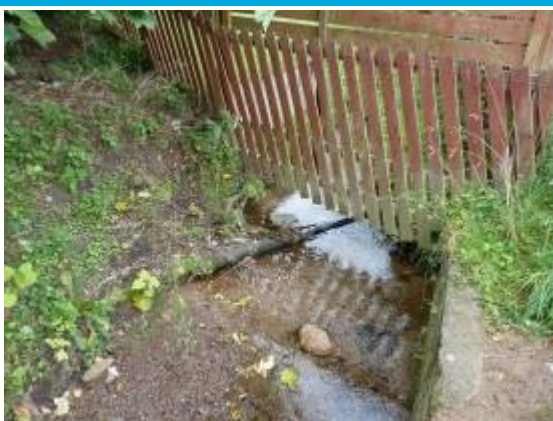
Name: Property fence on boundary of Murray Place

Downstream face of fence

Description: Property boundary fence
OS NGR: NH
Opening area: Not surveyed
Screen?: No
Blockage Risk: High
Access: Access from footpath between Smithton Road and Tower Road or via garden of No. [redacted] Murray Place.
Maintenance:
Other:
 Not surveyed or modelled

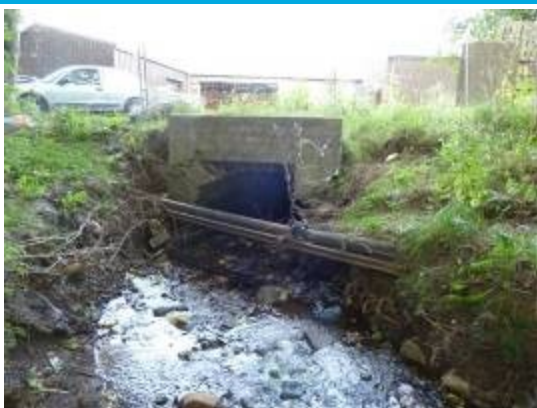
Name: Culvert beneath access road

Upstream face of culvert

Description: Single span stone arch culvert

Other: A concrete block work headwall has been constructed on the upstream side. A pipe crosses the inlet that may accumulate debris during flood conditions.

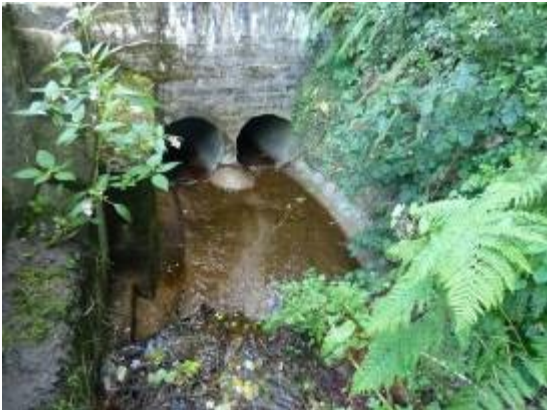
Name: Culvert beneath garage on main road

Upstream face of culvert

Description: Double corrugated metal culvert - 900mm diameter

Other: A small weir is located upstream of the inlet.

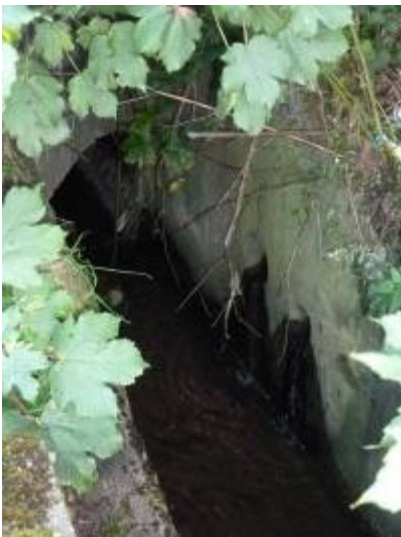
Name: Culvert beneath Barn Church Road leading to Culloden Burn West

Upstream face of culvert

Description: Circular concrete culvert - 1200mm diameter

Maintenance: Access to culvert opening is difficult. Banks are overgrown. Fence that restricts access is in poor condition. Material removed from channel cannot be stored locally.

Other: Outlet joins Culloden Burn West culvert beneath Culloden Centre.

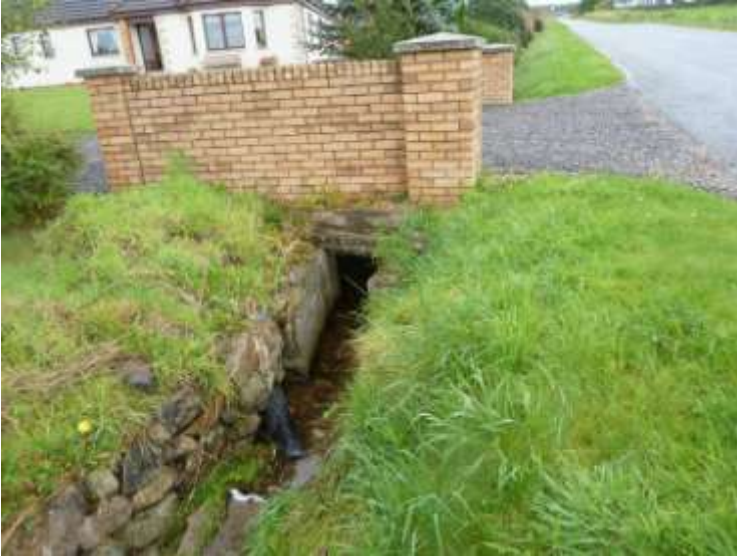
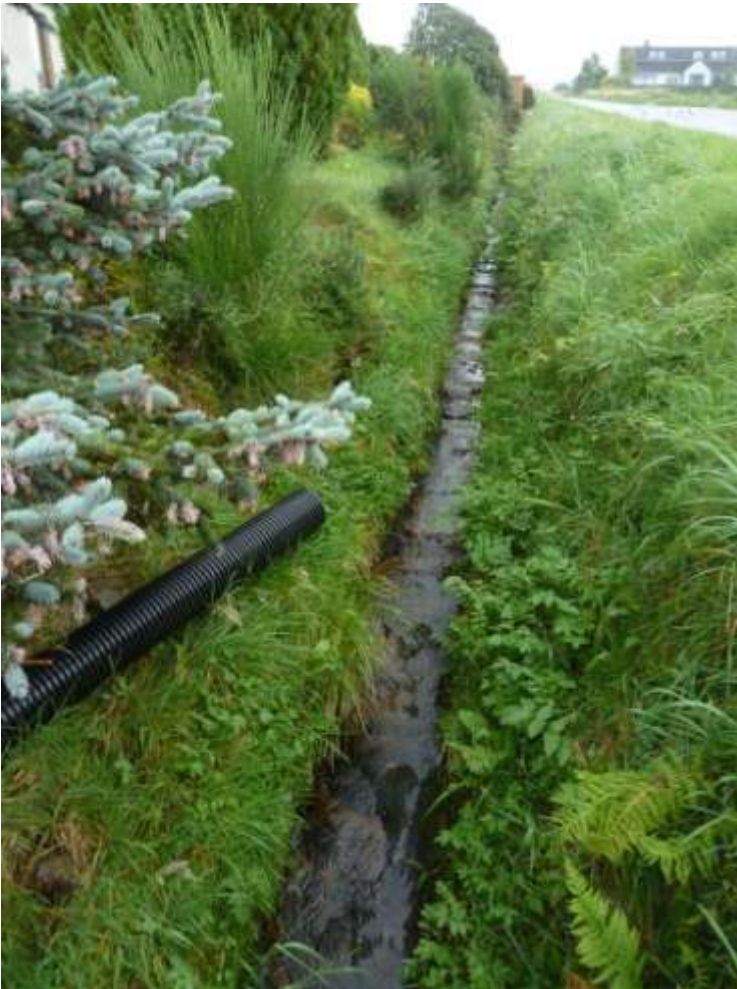
Channel narrow (0.3-0.5m wide), very straight and no natural valley.

Banks lined with stone pitching – this is very old and there are small isolated pockets of bank erosion where the pitching has failed.

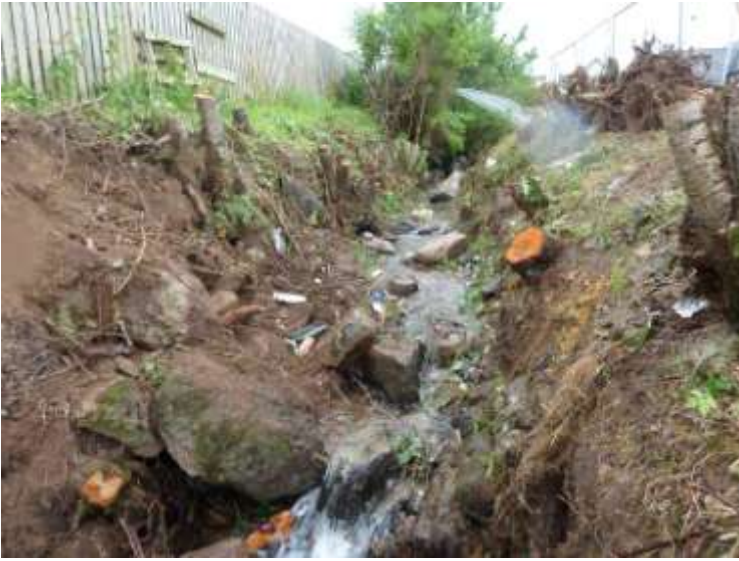
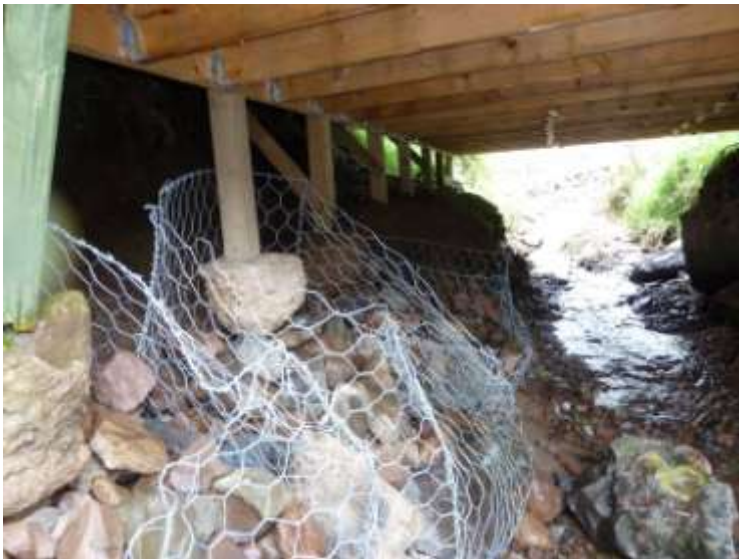
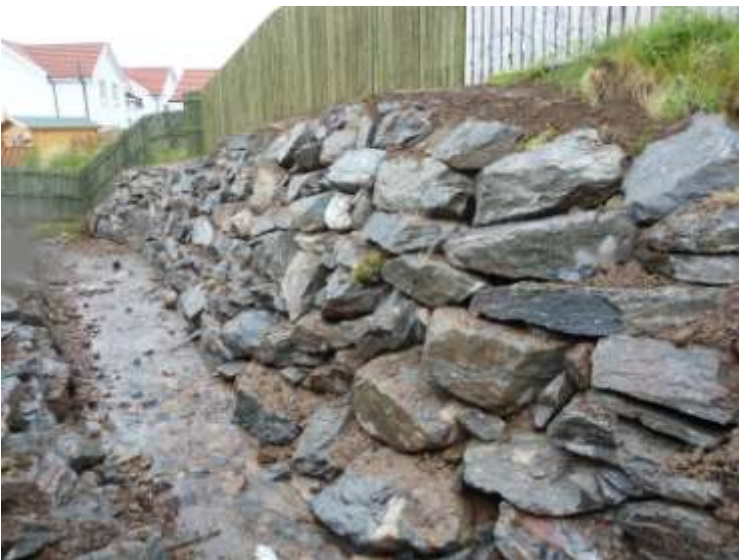
Narrow and deep with steep banks and obvious recent bed incision at the base of either bank – in some places this has resulted in full bank collapse. A step in bed level is formed by a logjam at approximately NH 71809 44920, with a large pool and severe bank erosion downstream of the jam.

Banks are a mixture of natural and reinforced sections. Undermining and subsequent failure of the banks is common. Reinforcement of some sections using rip-rap had recently been undertaken.

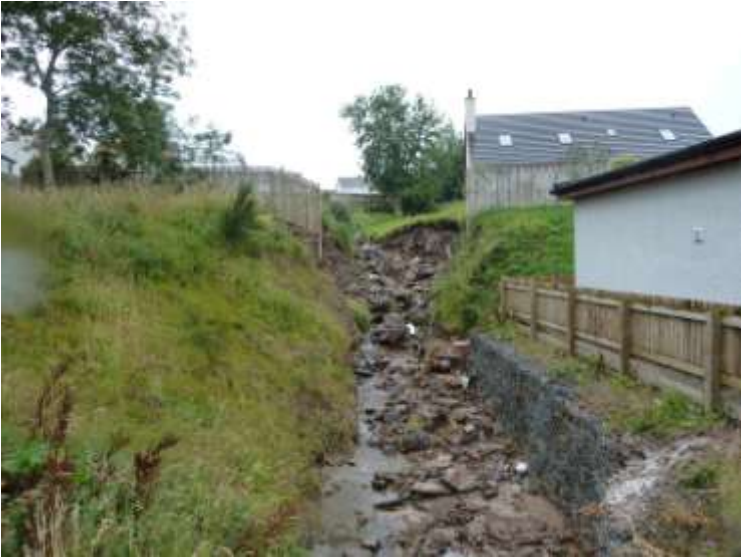
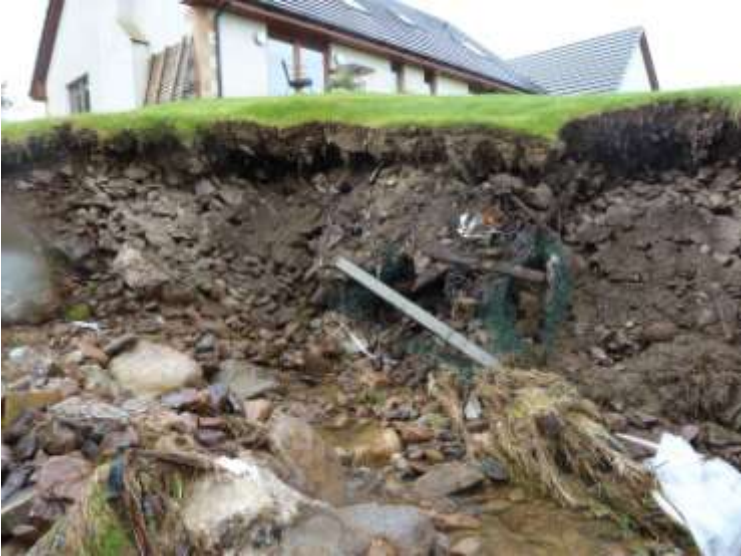
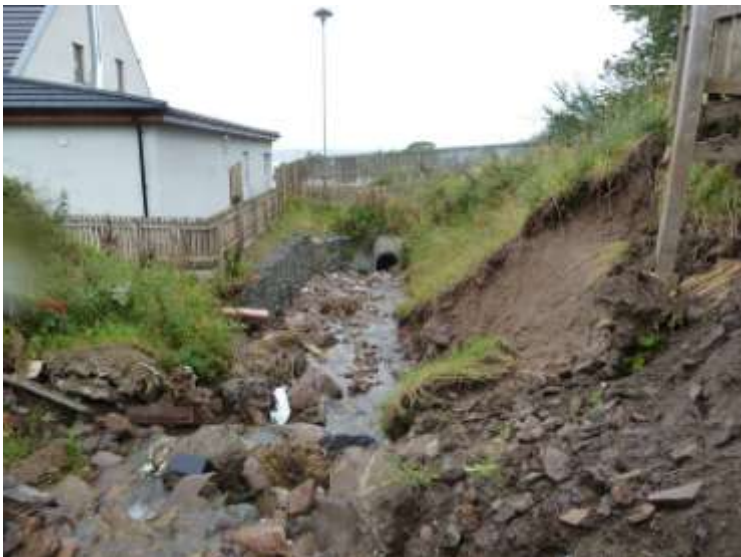
Narrow with evidence of recent sediment deposition immediately upstream of the culvert inlet. Upstream the bed level rises steeply with severe erosion of the left bank and minor erosion in the channel bed at the base of the slope.

The left bank is reinforced with gabion baskets. The right bank is formed by a steep grass slope – this is eroded in places and is comprised of till.

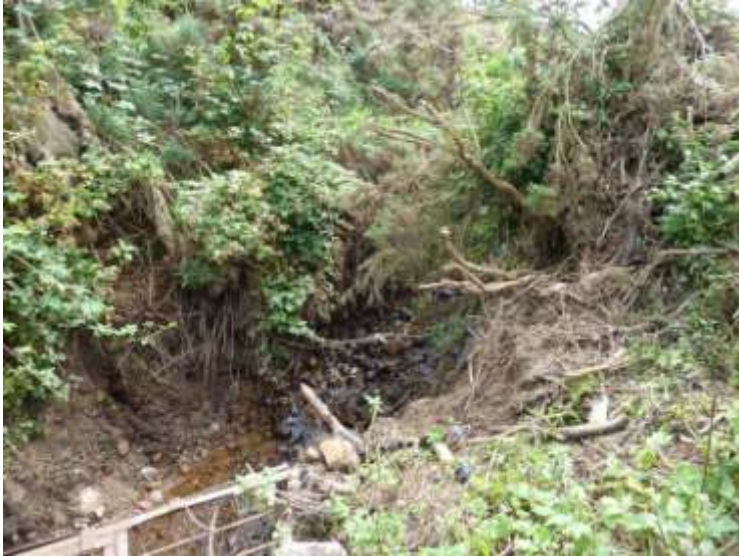
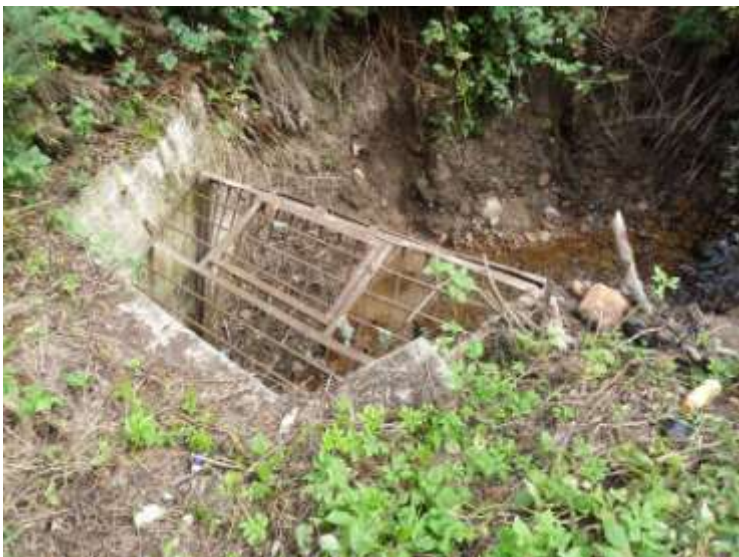
Narrow and fairly deep channel with evidence of small areas of sediment deposition. This confirms that some sediment can pass through the Murray Terrace culvert upstream.

Densely vegetated, steep banks with till evident at the base of the banks.

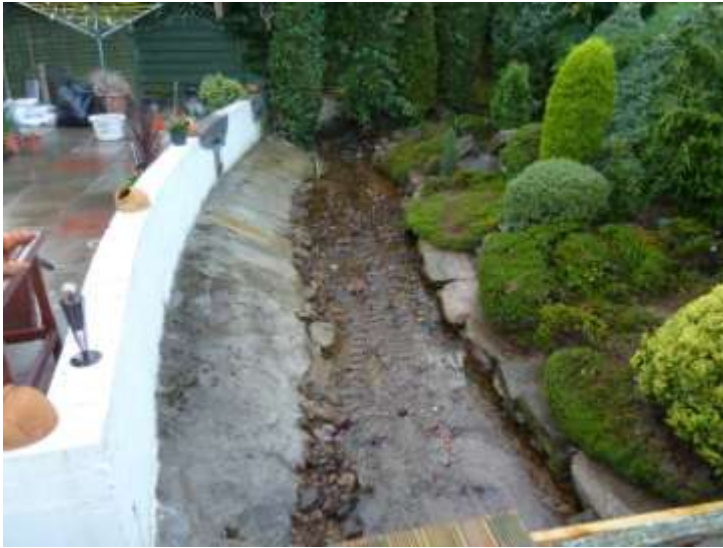
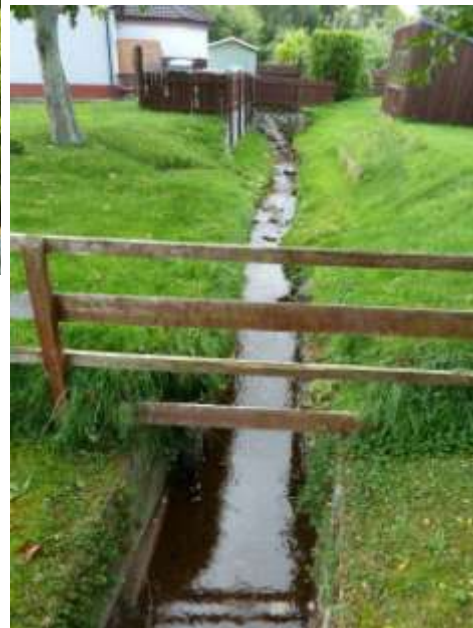
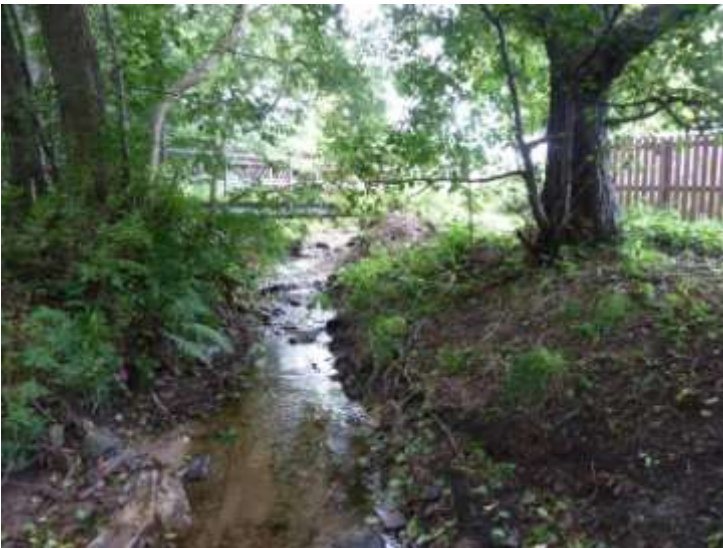
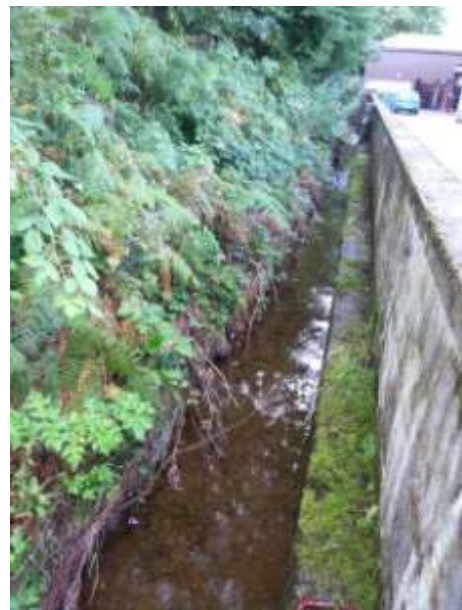
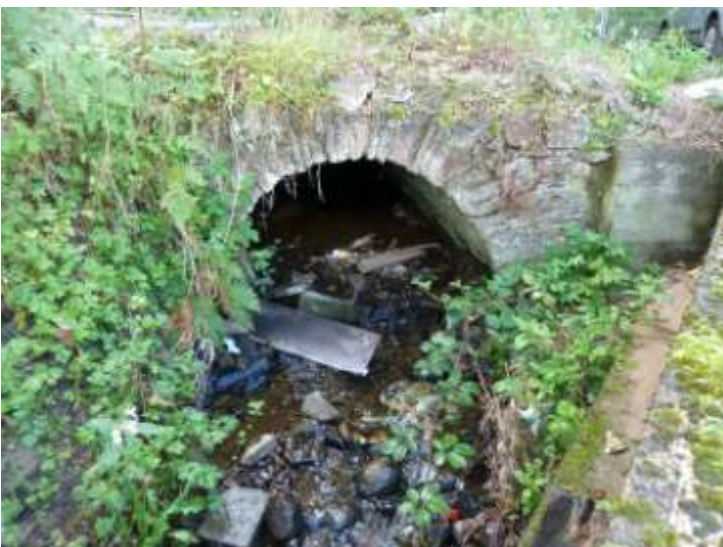
Stable reach with little evidence of erosion or deposition. The channel varies in width between 0.5 and 2m, and is largely confined by development.

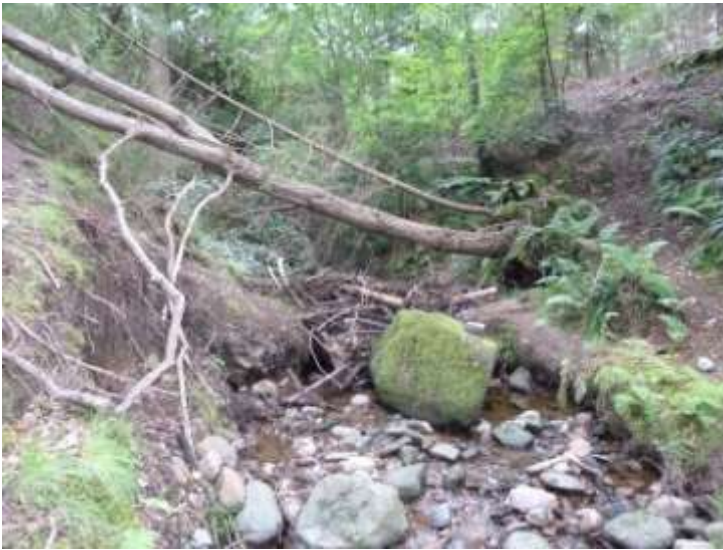
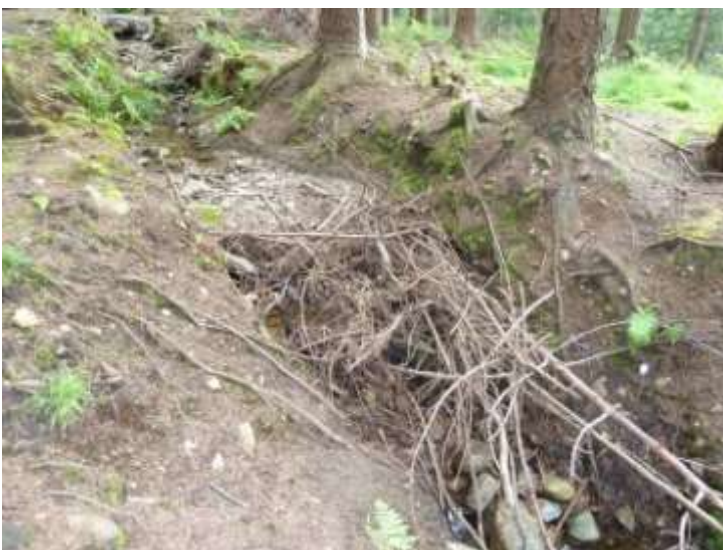
The channel flows through dense woodland and has a steep gradient. The reach takes a step-pool form, with a number of the steps formed by natural logjams across the channel. Sediment is accumulated upstream of these jams, and would therefore be released downstream should the logjams fail. Overall the reach is erosive, with sediment passing downstream.

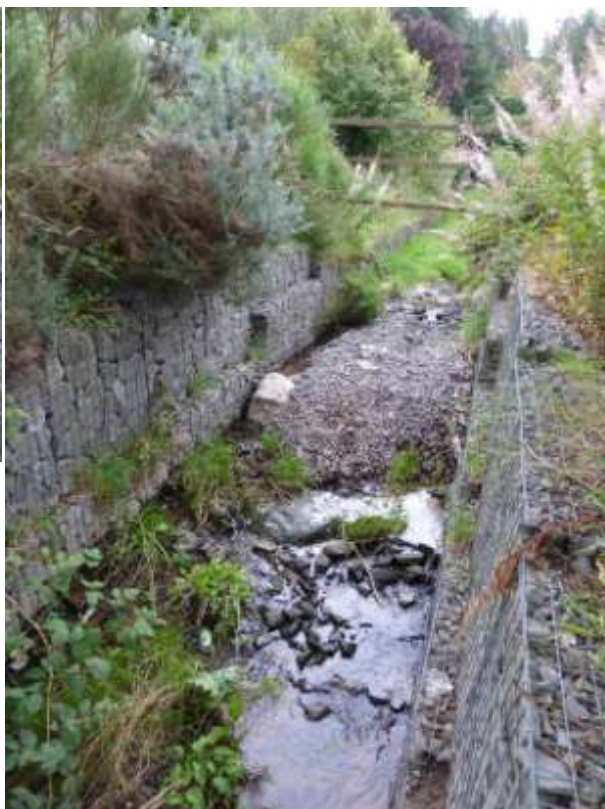
The channel is highly modified throughout the reach, and is straightened and lined with gabion baskets along the reach length. The form of the channel varies between a rectangular form and a trapezoidal channel. There is evidence of sediment accumulation, particularly at the downstream extent of the reach, upstream of Ferntower Avenue culvert. In addition, there is vegetation (grass) growing within the channel.

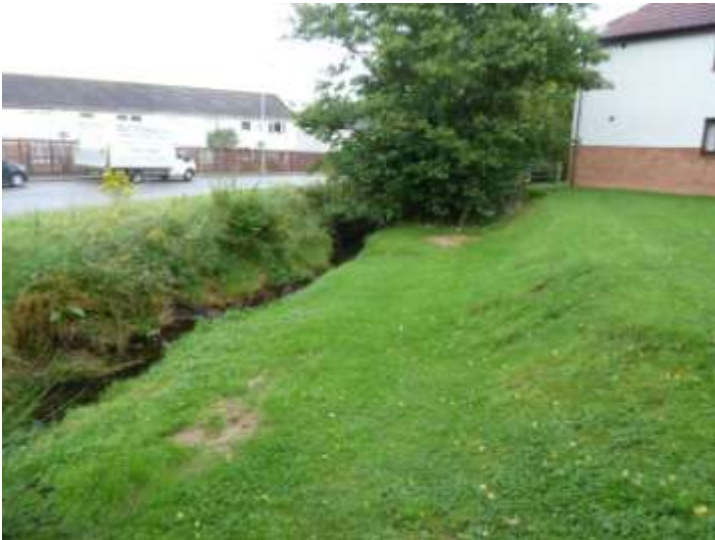
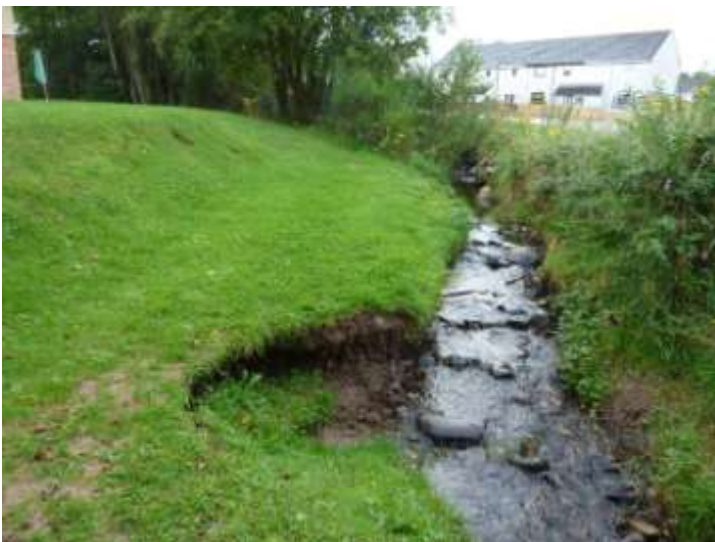
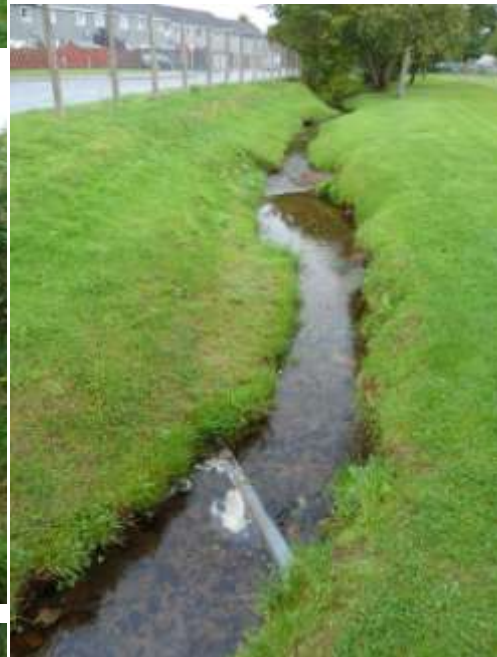
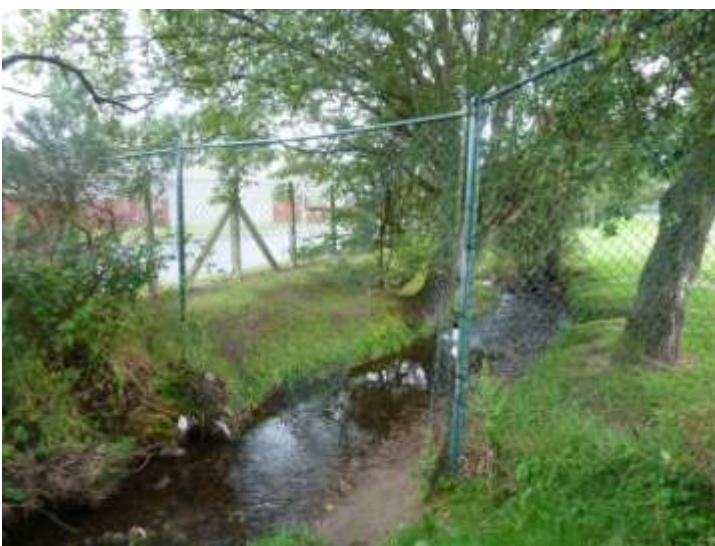
The channel is comprised of a shallow, narrow channel at the base of a small, localised valley. The reach is relatively stable and there is little evidence of sediment accumulation, and only a couple of small areas of bank erosion.
