6 Existing Route Review

6.1.1 A cycle review of the A862 and the minor roads between Inchmore, Kirkhill and Dunballoch was undertaken. The route review has been broken down into sections as shown in Appendix G, from the junction with King Brude Road to Beauly town centre:

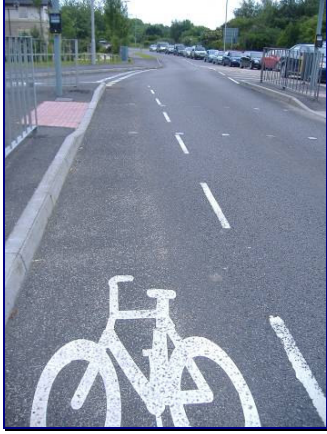
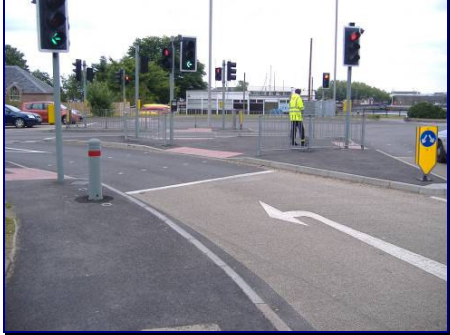
<p>Section A: King Brude Road Junction</p> <p>Key points:</p> <ul style="list-style-type: none"> • Large three arm signalised junction with pedestrian phases and some short, isolated sections of advisory cycle route. • All red phase when Swing Bridge on canal is in operation. • 30mph speed limit • Facilities for pedestrians

Width	Various, between 7.4 and 8.0m. Left and right turn lanes between 3.8 and 3.9m.	
Surface	Good condition, recently resurfaced	
Gradient	Excellent – flat	
Signage	No existing signage for cyclists	
Lighting/ Visibility	Good visibility, junction lit	
Problems/barriers for cyclists	<p>No advanced stop lines</p> <p>Two left turn filter lanes that force cyclists to change lanes in order to go straight on – a manoeuvre which may be difficult and daunting to novice cyclists</p> <p>Wide junctions can also be intimidating to cyclists and inter-green times may not be long enough to allow cyclists to clear</p>

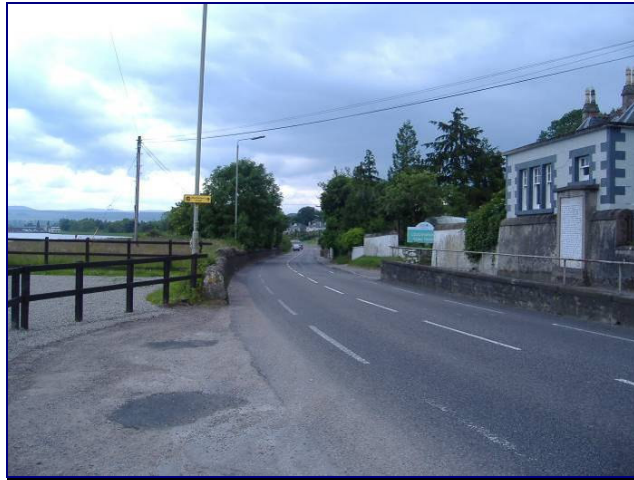
Section A: Clachnaharry

- Narrow road fronted with mostly residential properties, some businesses and local award winning pub famous for real ale.
- Advisory cycle lanes throughout most of village that stop by old school
- 30mph speed limit
- Footway continuous on southern side of road, partial on northern side

Width	Various, between 6.8 and 7.2m. Cycle lanes vary between 1.0 and 1.5m.
Surface	Good
Gradient	Excellent – flat
Signage	Some advisory cycle lanes signs
Lighting/ Visibility	Mostly good visibility, but poor in some sections. Lighting adequate
Problems/barriers for cyclists	<p>There are times when there is a lot of on-road parking outside residential properties and the pub.</p> <p>Narrow road can lead to drivers overtaking cyclists too closely.</p> <p>Section of road travelling towards Inverness hems cyclists in as it has a wall sitting directly on the edge of the carriageway where there is no footway.</p>

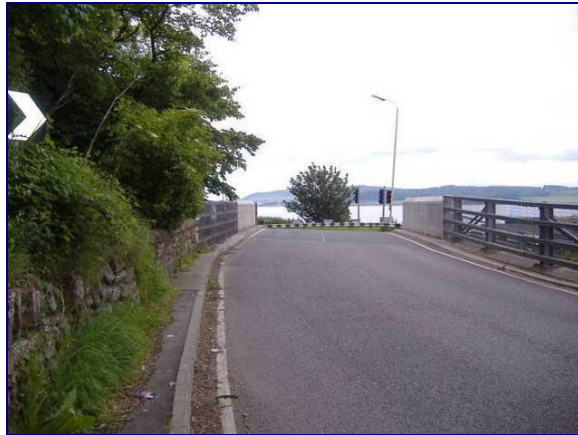
Section A: Railway/Bridge at Clachnaharry

- Three way signalised junction on bridge over railway
- Anti skid surfacing
- Recent bridge renovation
- No facilities for pedestrians
- Inter-green time seems adequate for cyclists

Width	Bridge is 6.6m from kerb to kerb. East side of traffic lights 7.3m from kerb to wall. West side of traffic lights 7.5m
Surface	Good condition, recently resurfaced
Gradient	Mostly flat, small incline on approach to bridge going towards Clachnaharry
Signage	No existing signage for cyclists
Lighting/ Visibility	Very poor visibility in all directions, lighting adequate
Problems/barriers for cyclists	No advanced stop lines Narrow road can lead to drivers overtaking cyclists too closely Identified in consultation as a particular hazard for vulnerable road users

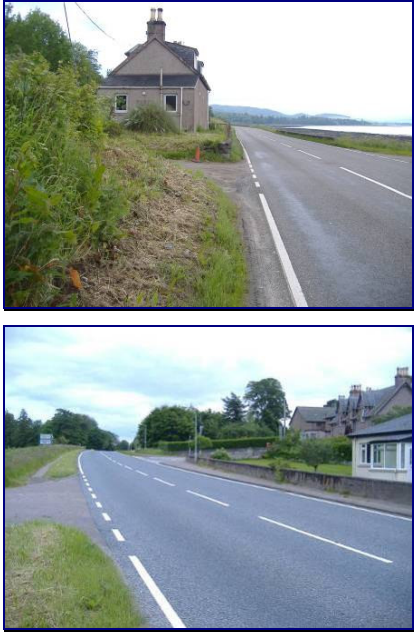
<p>Section B: Clachnaharry to Bunchrew</p> <p>Key points:</p> <ul style="list-style-type: none"> • Standard width carriageway • No footways • Carriageway bounded by seawall on northern side • Five properties on southern side of road very close to carriageway • Small residential community in Bunchrew with narrow footways in some sections on southern side of road • 60mph speed limit

Width	Approx 7.3m
Surface	Good
Gradient	Excellent - flat
Signage	No signage
Lighting/ Visibility	Mostly good visibility, but poor in some sections. No lighting
Problems/barriers for cyclists	<p>Narrow road can lead to drivers overtaking cyclists too closely</p> <p>Traffic travels at high speed</p> <p>Cyclists hemmed in by seawall and have no room to take evading action</p> <p>No lighting</p>

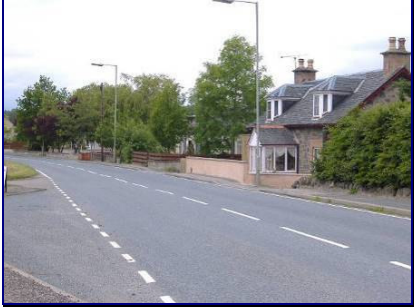
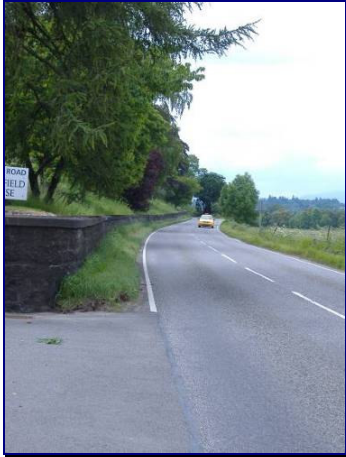
<p>Section C: Bunchrew to Inchmore</p> <p>Key points:</p> <ul style="list-style-type: none"> • Standard width carriageway • Footways on northern side of road through Inchmore • Carriageway bounded by railway and seawall on northern side for most of this section • Five properties on southern side of road very close to carriageway • 60mph speed limit but dropping to 40mph in Lentrane and Inchmore • Toucan crossing at Inchmore

Width	6.3m in Inchmore
Surface	Good
Gradient	Excellent – flat
Signage	Interpretation board at Old North Inn at Inchmore detailing local paths
Lighting/ Visibility	Mostly good, but poor in some sections. Lighting within Inchmore
Problems/barriers for cyclists	<p>Narrow road can lead to drivers overtaking cyclists too closely</p> <p>Traffic travels at high speed</p> <p>Cyclists hemmed in through some sections and have no room to take evading action</p> <p>No lighting</p>

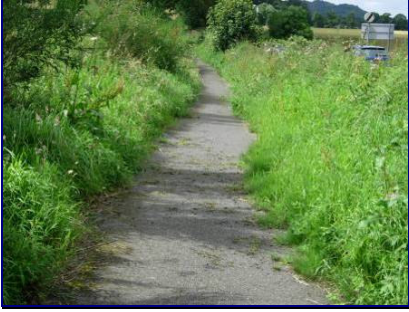
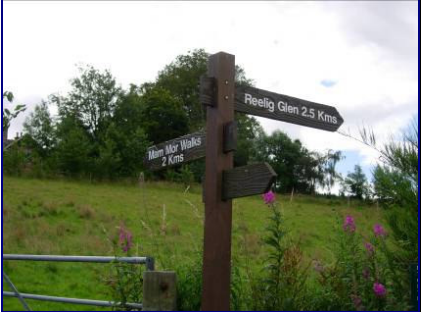
<p>Section D: Inchmore to Easter Moniak</p> <p>Key points:</p> <ul style="list-style-type: none"> • Standard width carriageway • Footway/cycle track on southern side of road, but in poor state of repair • 60mph speed limit

Width	Cycle track is reduced to 1.0m due to vegetation. True width approximately 2.0m.
Surface	Good
Gradient	Excellent – flat
Signage	Fingerposts and interpretation boards along this section
Lighting/ Visibility	Mostly good visibility, but poor in some sections. No lighting
Problems/barriers for cyclists	<p>Off road track can be hard to spot to cyclists who are new to the area</p> <p>Path is poorly maintained and not signed specifically as route for cyclists</p> <p>No lighting</p>

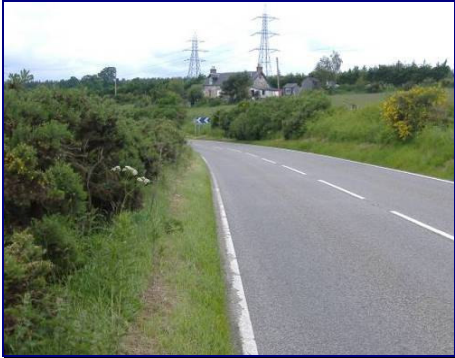
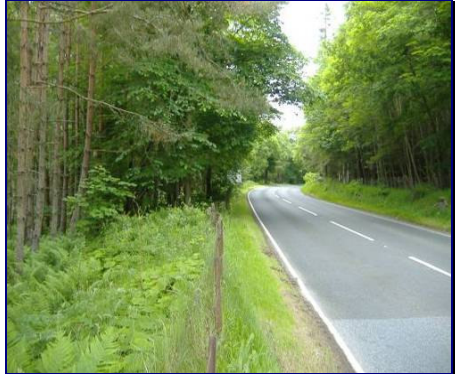
<p>Section E: Easter Moniack to Dunbolloch</p> <p>Key points:</p> <ul style="list-style-type: none"> • Standard width carriageway • No footways • 60mph speed • Very few properties along this section

Width	7.2m
Surface	Good
Gradient	Excellent - flat
Signage	None
Lighting/ Visibility	Poor at a number of locations. No lighting
Problems/barriers for cyclists	<p>Narrow road can lead to drivers overtaking cyclists too closely</p> <p>Traffic travels at high speed</p> <p>No lighting</p>

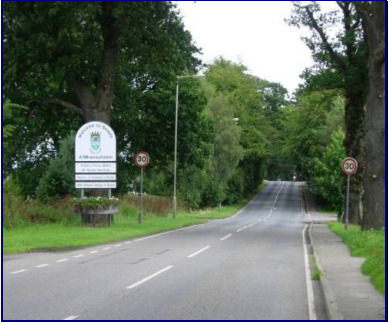
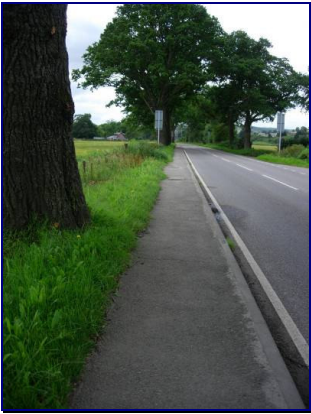
<p>Section F: Dunballoch to Beauly train station</p> <p>Key points:</p> <ul style="list-style-type: none"> • Standard width carriageway • No footways • 60mph speed and beginning of 30mph zone through Beauly • Pinch point at Lovat Bridge (listed) • Very few properties along this section • Sharp bend at junction with A831

Width	7.2m
Surface	Good
Gradient	Two hills – one on the approach to Beauly going over the railway line, the second from Dunballoch to Lovat Bridge which is quite a considerable incline
Signage	Fingerposts at Dunballoch
Lighting/ Visibility	Mostly good, but poor in some sections. No lighting until 30mph zone
Problems/barriers for cyclists	<p>Narrow road can lead to drivers overtaking cyclists too closely</p> <p>Traffic travels at high speed</p> <p>No lighting</p> <p>Steep inclines</p> <p>Pinch point at Lovat Bridge was identified in the consultation as a particular hazard for vulnerable road users</p>

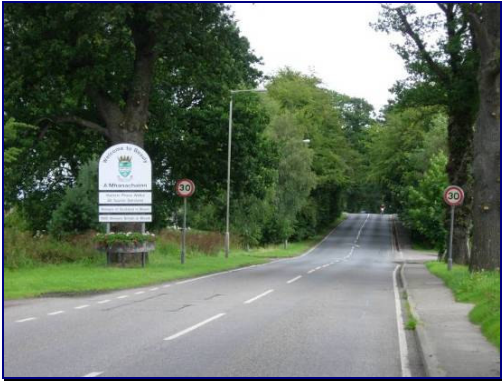
<p>Section G: Beauly train station to Beauly town centre</p> <p>Key points:</p> <ul style="list-style-type: none"> • Standard width carriageway • Footways on both sides of road • 30mph speed limit • Local as well as through traffic

Width	9.0m at pedestrian crossing
Surface	Good
Gradient	Excellent - flat
Signage	None
Lighting/ Visibility	Good visibility and adequate street lighting
Problems/barriers for cyclists	Cyclists face typical urban cycling problems: parked cars, traffic stopping and starting, pedestrians crossing unexpectedly, no cycle parking

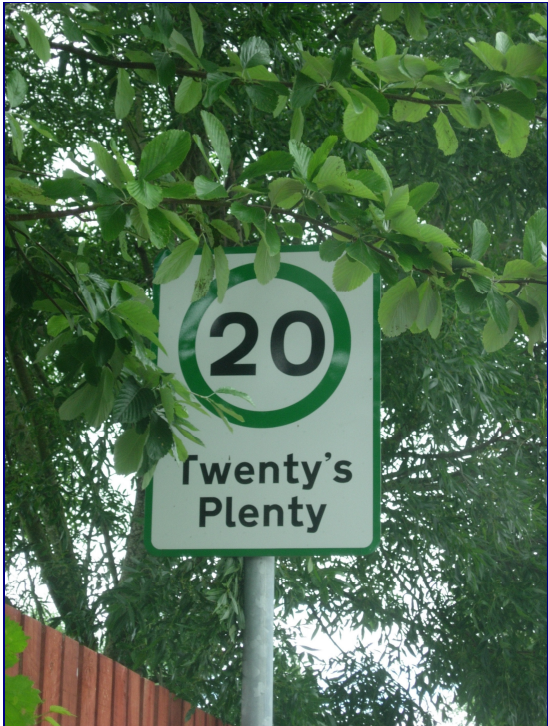
<p>Section H: Inchmore to Kirkhill</p> <p>Key points:</p> <ul style="list-style-type: none"> • Standard width carriageway on approach to village, but narrower within Kirkhill • Footway on east side of road into Kirkhill, footways within village • 30mph speed limit in village, 60mph on the approach • Traffic calming and 'Twenty's Plenty' advisory 20mph zone outside school • Zebra crossing in village

Width	6.0m on approach to Kirkhill
Surface	Good
Gradient	Excellent - flat
Signage	None
Lighting/ Visibility	Good visibility and adequate street lighting
Problems/barriers for cyclists	<p>Fast traffic speeds on the road to Kirkhill</p> <p>Am and pm peaks in traffic, especially around the school during term times</p>
