The Highland Council

Agenda Item	9.
Report No	SCC/04/17

Road maintenance on the A839 Mound to Rogart

Report by Director of Community Services

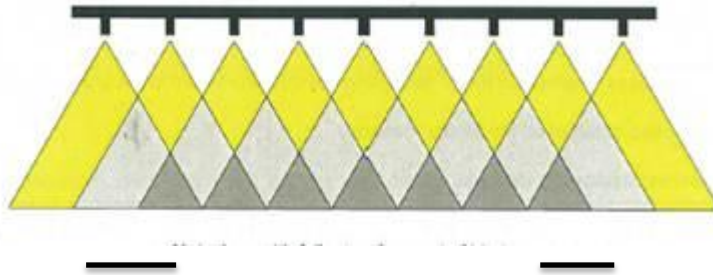
6.5 The carpet tile tests carried out throughout the operations were all within tolerance but did show less bitumen being applied to the offside wheeltrack

6.6 The carpet tile tests are carried out by laying carpet tiles across the lane and driving the sprayer over them. They are then weighed and bitumen spray rate is calculated. However the tiles cannot be laid in the wheel tracks so the jets above the wheel tracks cannot be checked using this test. We have to rely on the pyramid test carried out first thing in the morning for their calibration.

- 6.7 The diagram below shows the overlap of the jet sprays across the bar with the wheel tracks shown below

- 6.8 Failure of one of the jets above or either side of the wheel track would not be detected by the carpet tile test.
- 6.9 It has been concluded that failure of one of the jets above the offside wheel track is the mechanism of failure in this case.

- 7.1 In order to ensure consistent operation of the sprayer unit full service and calibration will be carried out prior to the season starting by a sprayer calibration company
- 7.2 The set up of a sprayer calibration site is being investigated within the Highland Council Area managed by the Council's accredited testing Laboratory to allow accurate spraybar output checks to be carried out throughout the Surface Dressing season.
