A890 Maman Hill

Annual Slope Inspection 2025

The Highland Council

Project number: 60685712
AECOM Report Ref.: GLRP0011

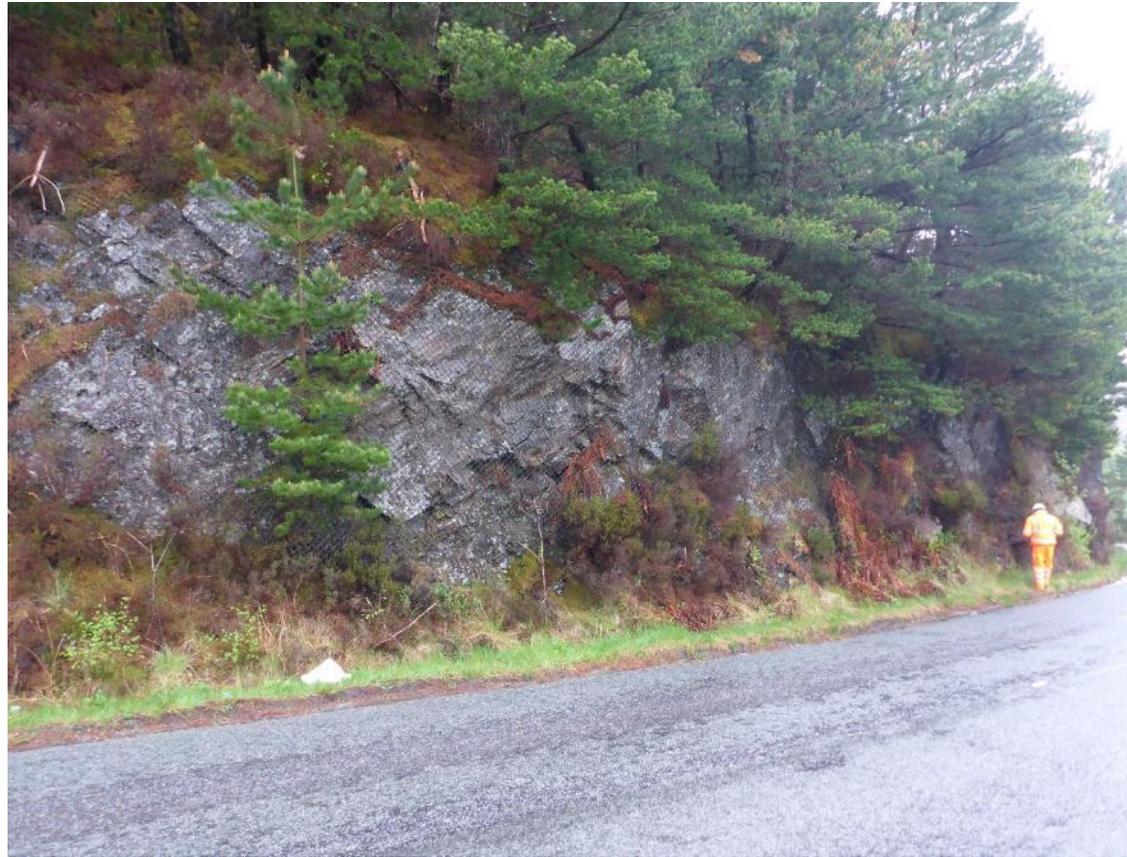
Existing netting or other remedial work details:				
Year of Works	Description of Works	Comments	2025 Inspection Observations	Photo Reference
Unknown. Pre-dates AECOM's first involvement in the A890 Stromeferry Bypass in 2012.	Localised chain-link drape netting between Ch 030 to 075.	Netting covers c.65% of slope (anchorages have not been inspected). The netting is highly corroded and locally damaged and should be considered ineffective.	No change noted during the 2025 inspection. Numerous visible tears to the netting, particularly across lower third. Significant proportion obscured by vegetation cover, including anchorages.	M1-1

<p>M1-1</p>	<p>Localised chain-link drape netting between Ch 030 to 075.</p> <p>Netting covers c. 65% of slope (anchorages have not been inspected). The netting is highly corroded and locally damaged and should be considered ineffective.</p> <p>Numerous visible tears to the netting, particularly across lower third. Significant proportion obscured by vegetation cover, including anchorages.</p>	<p>Year First Observed:</p>	<p>2019</p>
-------------	---	-----------------------------	-------------

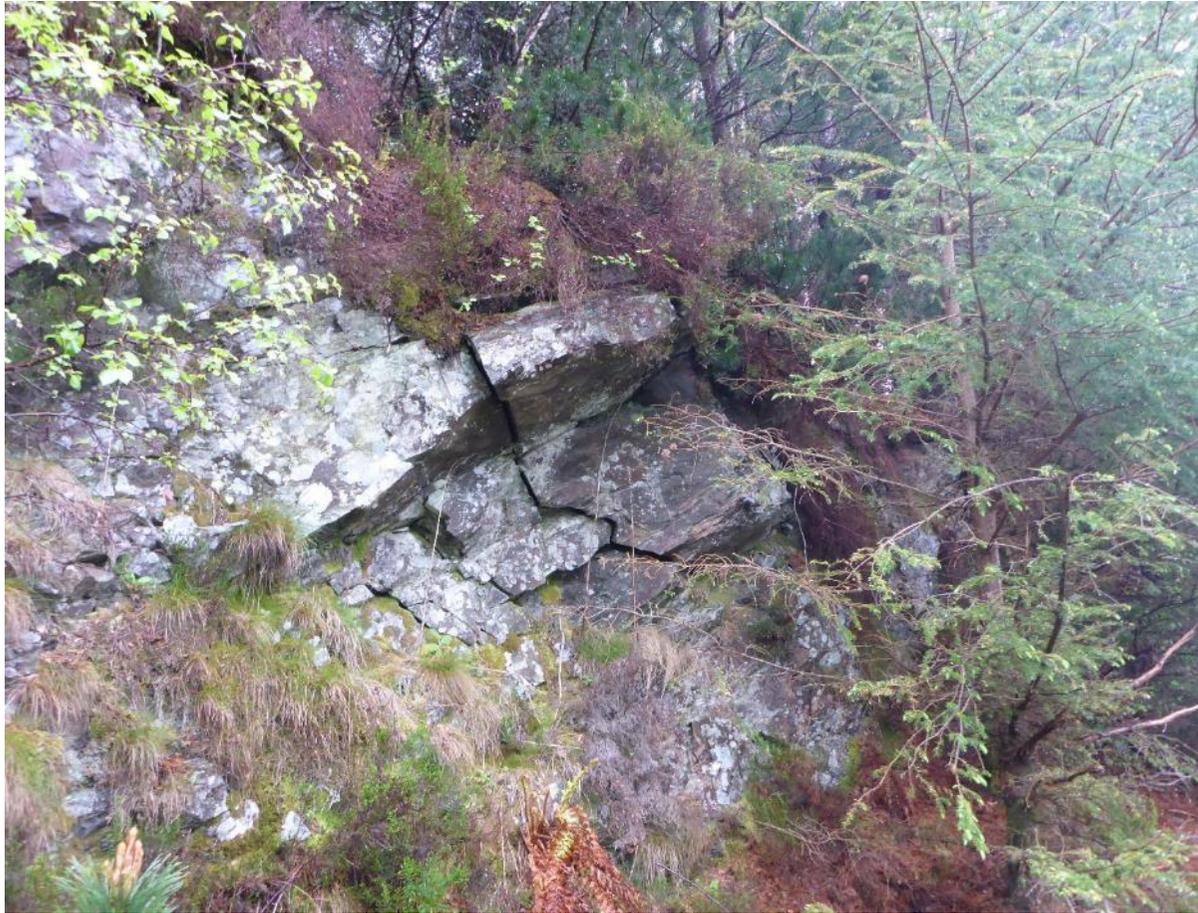
M1-2

Ch. 023: Block c. 2.0 x 1.0 x 1.5 m with dilated back fracture. Poses low risk to road due to presence of verge.

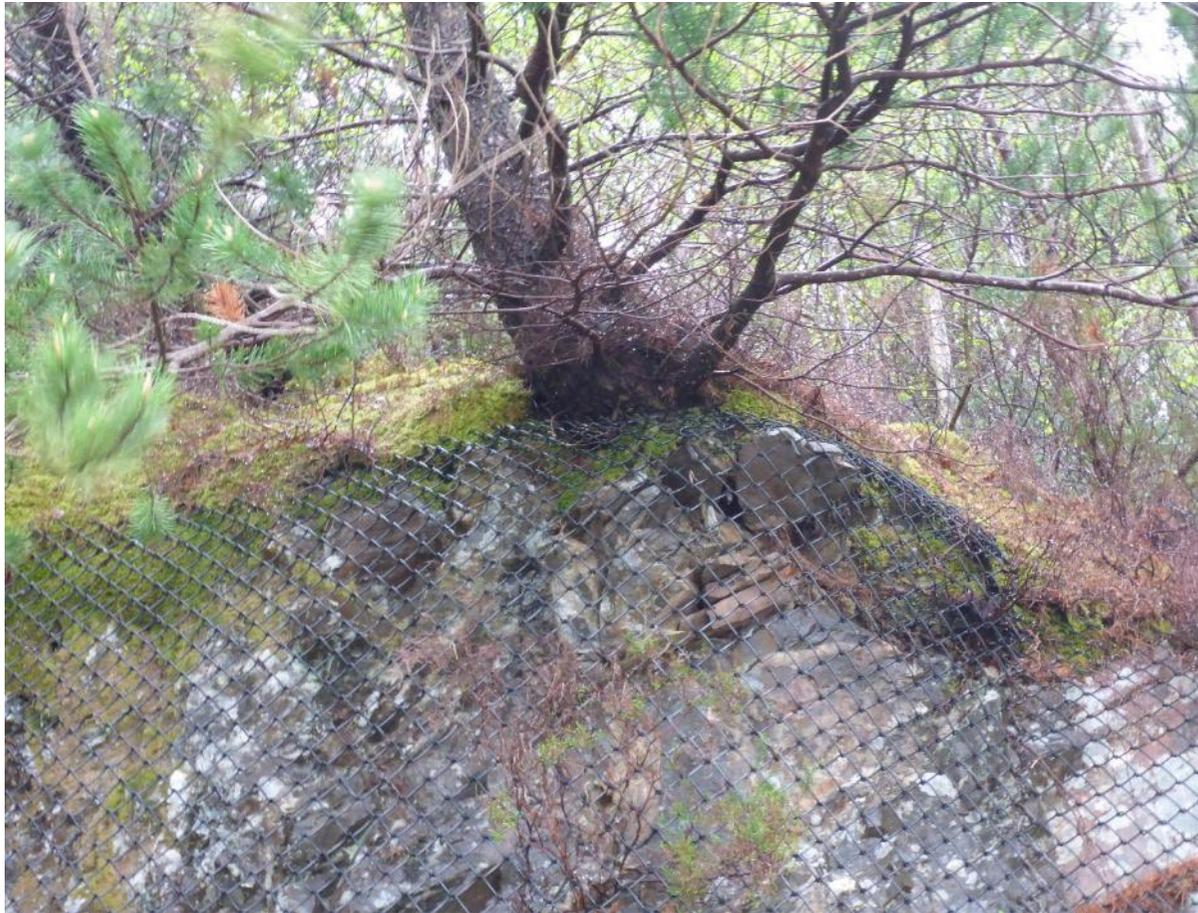
Hazards Observed:			
	2023 Inspection: There are a few dilated blocks behind the netting (between Ch. 030 to 070) which look keyed in – could benefit from scaling.		
Throughout M1	2019 Inspection: Semi-mature coniferous trees growing at crest have potential to cause root jacking (e.g. Ch. 018)	No change noted during the 2025 inspection.	N/A
Ch. 018	2022 Inspection: Trees at crest of slope presenting risk of root-jacking. Approx. 6 blocks c.2.0 x 0.1 x 0.1 m are in the verge.	No change noted during the 2025 inspection.	N/A
Ch. 023	2022 Inspection: Block (c.2.0 x 1.0 x 1.5 m) with dilated back fracture (low risk due to presence of verge)	No change noted during the 2025 inspection.	M1-2
Ch. 032	2024 Inspection: Tree root has rotated out from slope. Rock slope behind is clean and does not present a hazard.	No change noted during the 2025 inspection.	N/A
Ch. 053	2024 Inspection: Several small blocks present in the verge which have a source location 5 m high, at the crest of the slope. There is potential for more blocks to fall and land on the verge or edge of the road.	Source of rockfall is root jacking by a semi-mature tree at the crest of the slope. Several small blocks are loose and retained between the rockface and the netting c. 1 m below the tree.	M1-3

<p>M1-3</p>	<p>Ch. 053: Several small blocks present in the verge which have a source location 5 m high, at the crest of the slope. There is potential for more blocks to fall and land on the verge or edge of the road.</p> <p>Source of rockfall is root jacking by a semi-mature tree at the crest of the slope. Several small blocks are loose and retained between the rockface and the netting c. 1 m below the tree.</p>	<p>Year First Observed:</p>	<p>2024</p>
-------------	--	-----------------------------	-------------

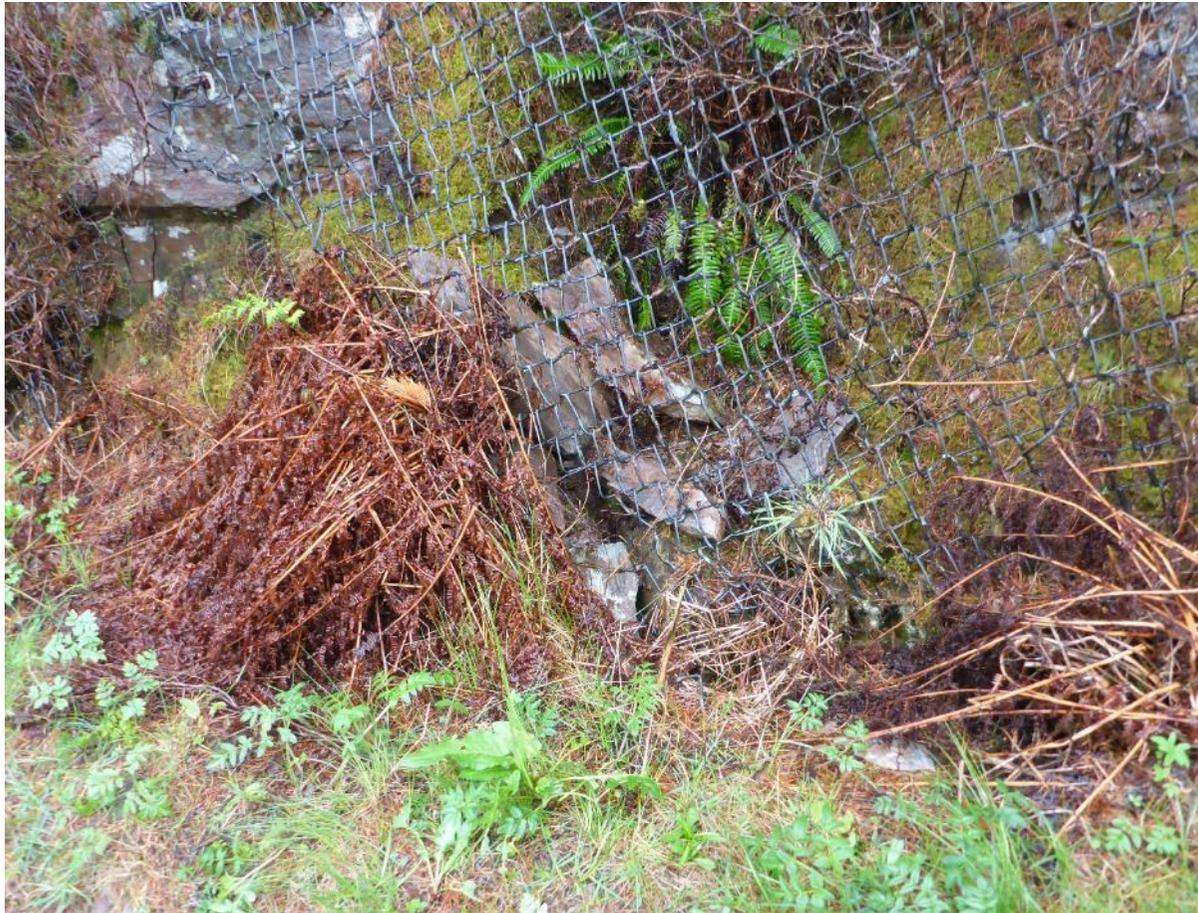
Ch. 072	N/A	Small accumulation of blocks up to 0.30 m (long axis) at the toe of the slope behind the netting. Source of rockfall 1.5 m above toe. Netting is considered to be ineffective due to excessive corrosion (numerous holes noted) and no ditch is present. The 0.9 m wide verge should prevent the majority of falling blocks from reaching the roadside; however, there is the potential for some small blocks to reach the road, particularly if debris build up creates the potential for random bounce trajectories.	M1-4

<p>M1-4</p>	<p>Ch. 072: Small accumulation of blocks up to 0.30 m (long axis) at the toe of the slope behind the netting. Source of rockfall 1.5 m above toe.</p> <p>Netting is considered to be ineffective due to excessive corrosion (numerous holes noted) and no ditch is present. The 0.9 m wide verge should prevent the majority of falling blocks from reaching the roadside; however, there is the potential for some blocks to reach the road, particularly if debris build up creates the potential for random bounce trajectories.</p>	<p>Year First Observed:</p>	<p>2025</p>
-------------	---	-----------------------------	-------------

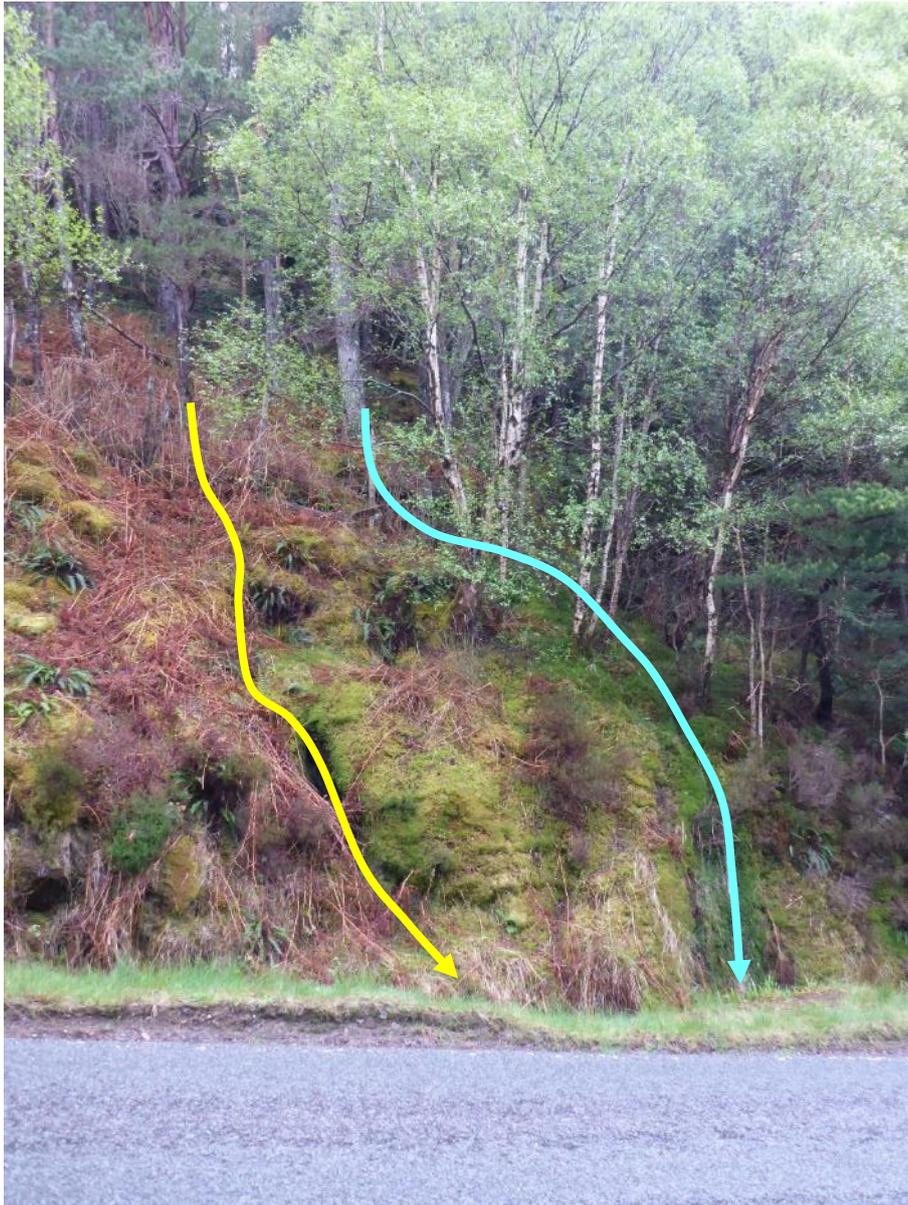
Diversion of existing surface watercourse / water flow observed at Ch. 217; the flow has been diverted upslope, which may signify a blocked channel upslope which may break through in high rainfall conditions. Large verge and ditch should reduce the potential for debris to reach the road.

<p>M2-1</p>	<p>Ch. 217: Surface water flow appears to have been diverted upslope, with the downslope length of the issue ~4.0 m up chainage from the location of the existing culvert.</p> <p>Yellow: Previous watercourse pathway. Blue: Current watercourse pathway.</p>	<p>Year First Observed:</p>	<p>2025</p>
-------------	--	-----------------------------	-------------

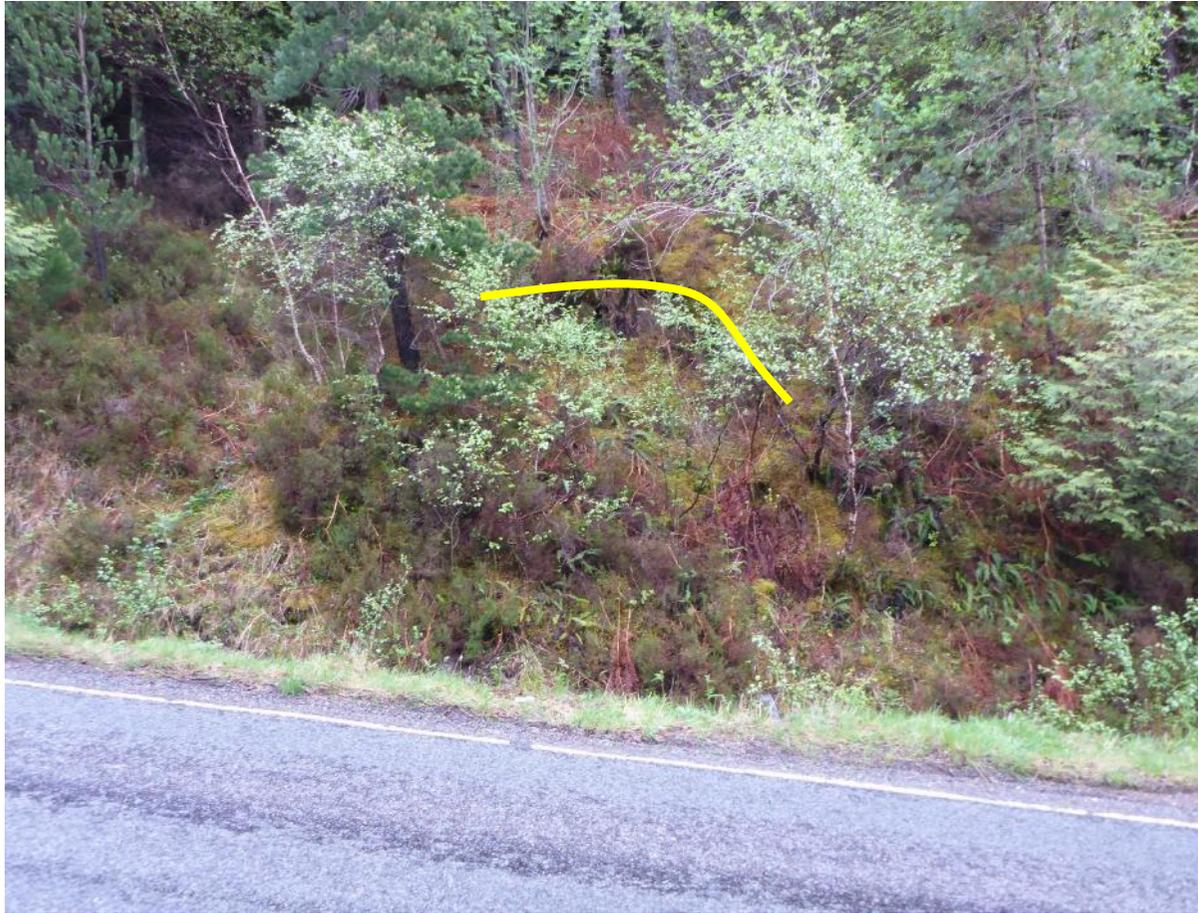
Hazards Observed:			
Location	Description of Hazard(s) from Previous Inspections	2025 Inspection Observations	Photo Reference
Throughout M2	2019 Inspection: Small scale (<0.02 m ³) ravelling / root jacking rock falls likely as rock mass continues to weather. However, ditch and verge at toe are considered effective and the associated likelihood of debris reaching the road is therefore low.	No change noted during the 2025 inspection.	N/A
Ch. 217	N/A	Surface water flow appears to have been diverted upslope in forestry area, with the water flowing down slope ~4.0 m up chainage from the location of the existing culvert.	M2-1
Ch. 226 to 235	2023 Inspection: Ditch has been locally damaged by vehicle going off road. Maintenance works not required as ditch is not below an area of significant rock fall hazard.	No change noted during the 2025 inspection.	N/A
Ch. 235	N/A	Minor soil slip/slump ~1.5 m high (4.0 to 5.0 m above road level) by 3.0 m wide. Slip/slump is set back from the road and the existing ditch would retain debris should it slip/slump further. Drainage capacity of ditch is impacted.	M2-2

<p>M2-2</p>	<p>Minor soil slip/slump ~1.5 m high (4.0 to 5.0 m above road level) by 3.0 m wide. Slip/slump is set back from the road and the existing ditch would retain debris should it slip/slump further. Drainage capacity of ditch is impacted.</p> <p>Yellow: Approximate position of slip back scar.</p>	<p>Year First Observed:</p>	<p>2025</p>
-------------	--	-----------------------------	-------------

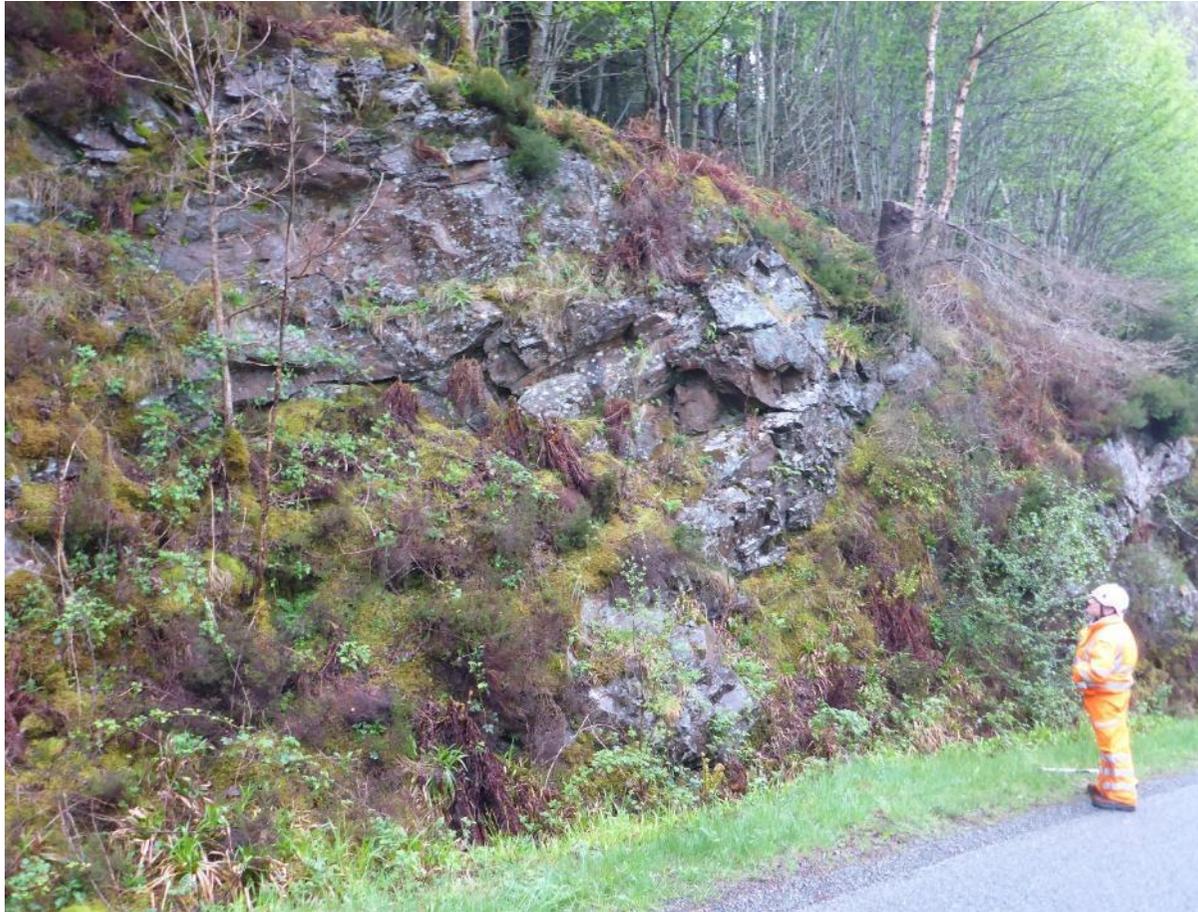
M3-1	Throughout M3: Localised overhangs with potential for rock fall of unsupported blocks. Individual block size typically <math><0.1 \text{ m}^3</math>.	Year First Observed:	2019
------	---	----------------------	------

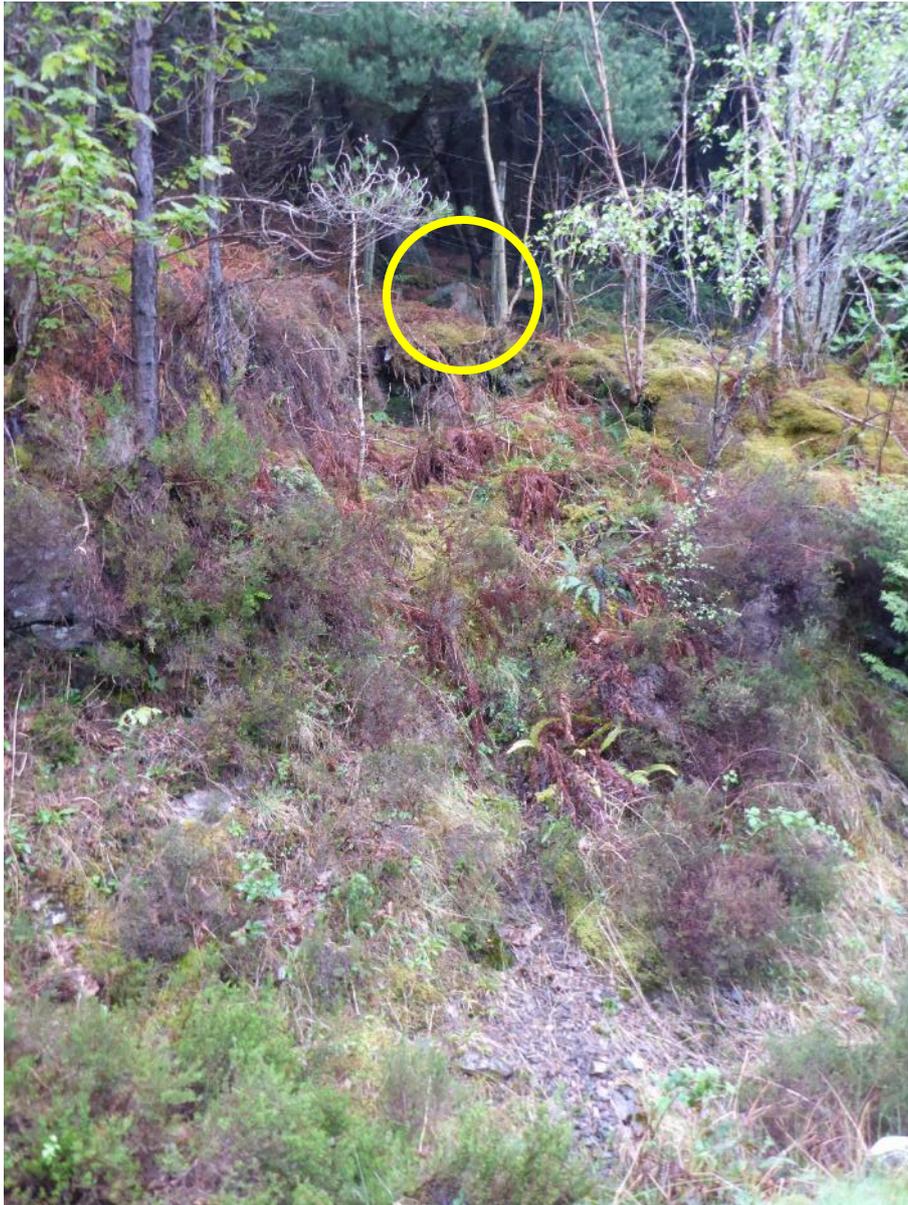
M3-2	Ch. 280: Boulder at fence above rock slope (side length 0.50 m) (circled in yellow). Source unknown.	Year First Observed:	2025
------	--	----------------------	------

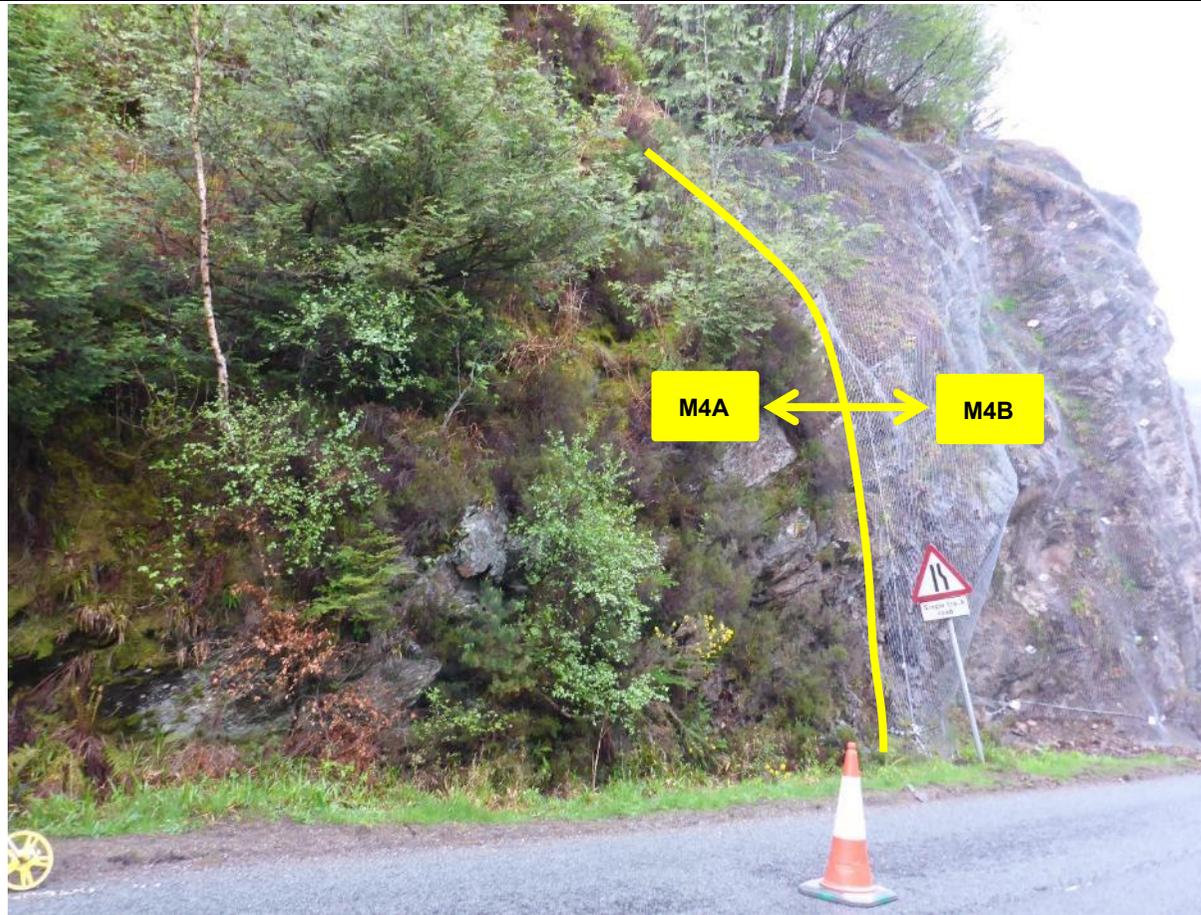
Hazards Observed:			
Location	Description of Hazard (s) from Previous Inspections	2025 Inspection Observations	Photo Reference
Throughout M4A	2019 Inspection: Numerous small scale (<0.02 m ³) ravelling type failures observed, some of which were deemed to be imminent (i.e. readily dislodged by hand).	No change noted during the 2025 inspection.	N/A
Throughout M4A	N/A	Significant vegetation cover present across the slope, including small trees and heather with root jacking potential. No specific hazards observed.	M4A-1

M4A-1	Significant vegetation cover present across the slope, including small trees and heather with root jacking potential	Year First Observed:	2025
-------	--	----------------------	------

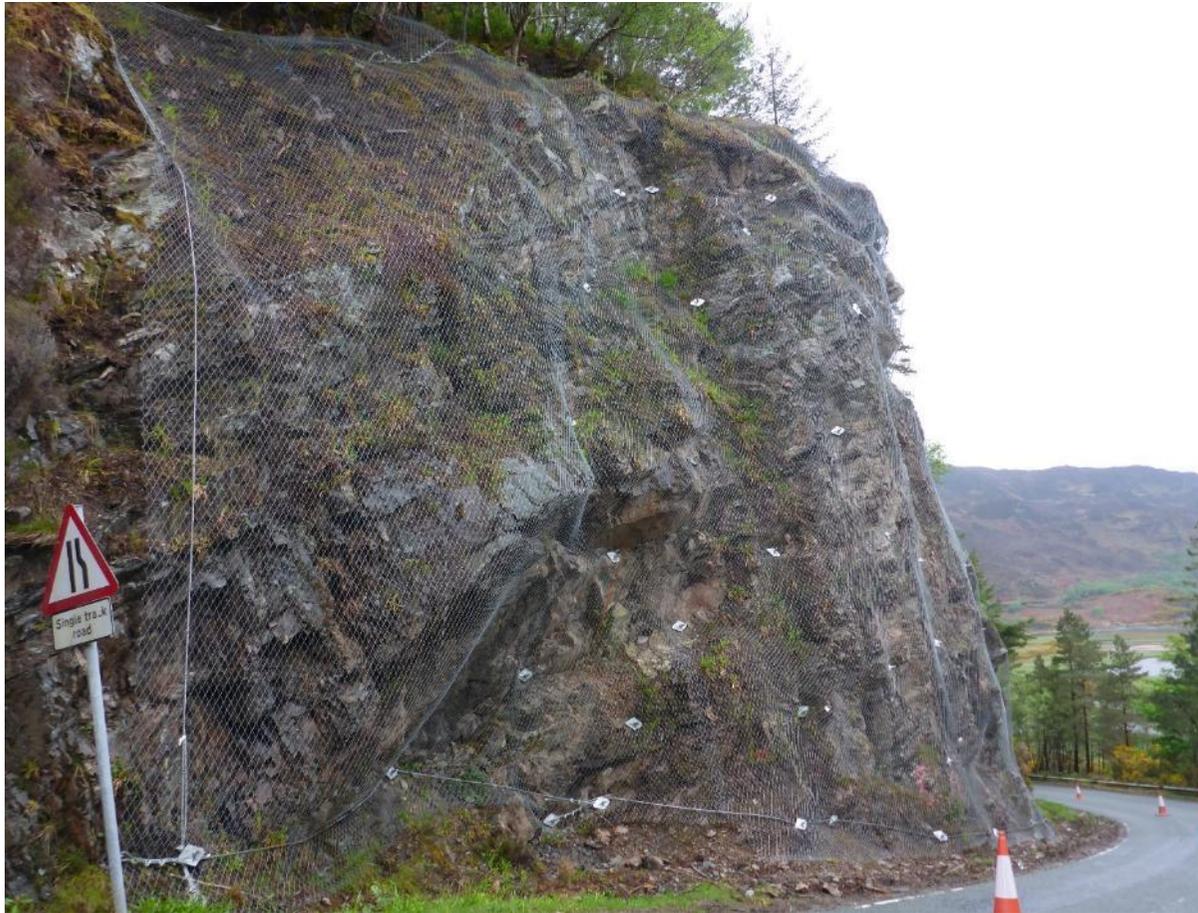
M4B-1	Tecco netting installed between Ch. 353 and 395; drape netting installed to Ch. 360; remainder of the face has been anchored and the netting profiled.	Year First Observed:	2025
-------	--	----------------------	------

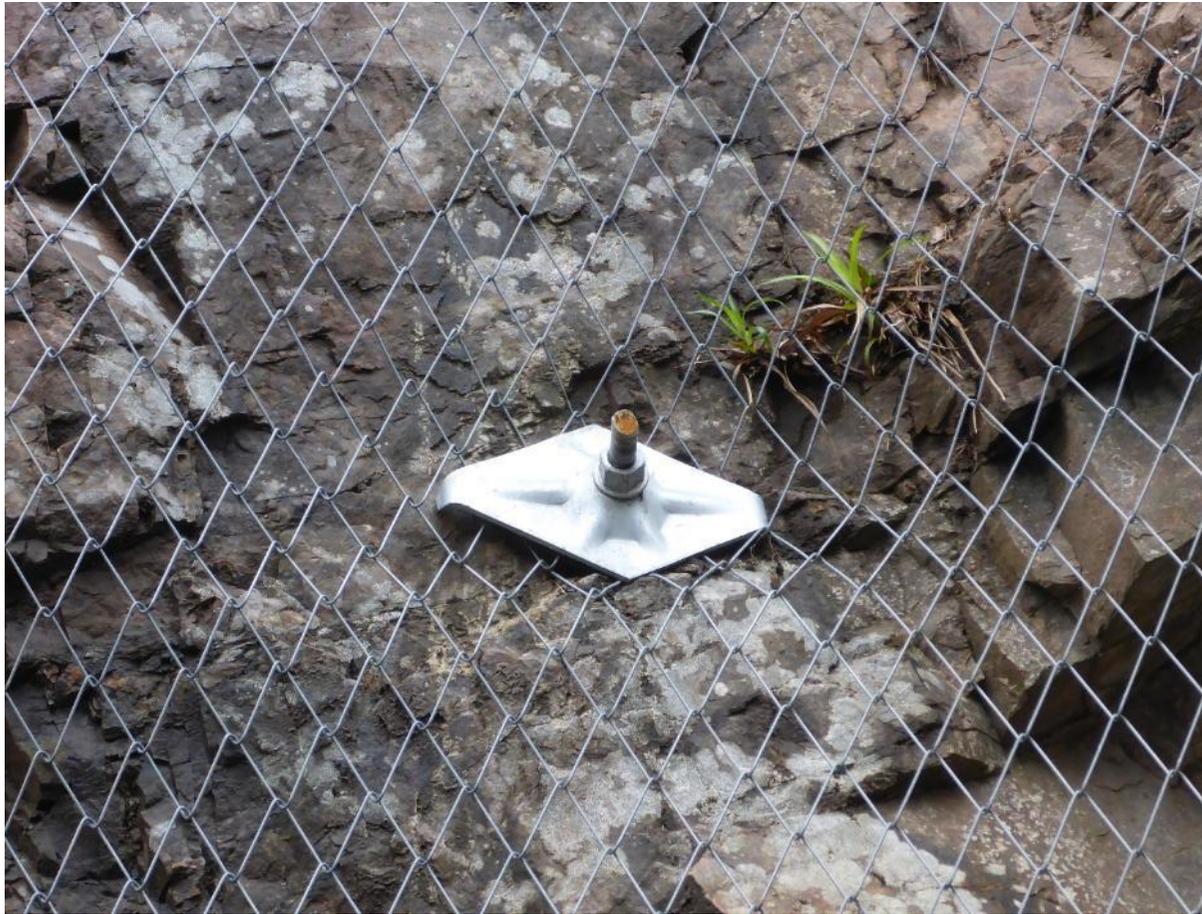
M4B-2

Ch. 370: Example of corroding cut bar end.

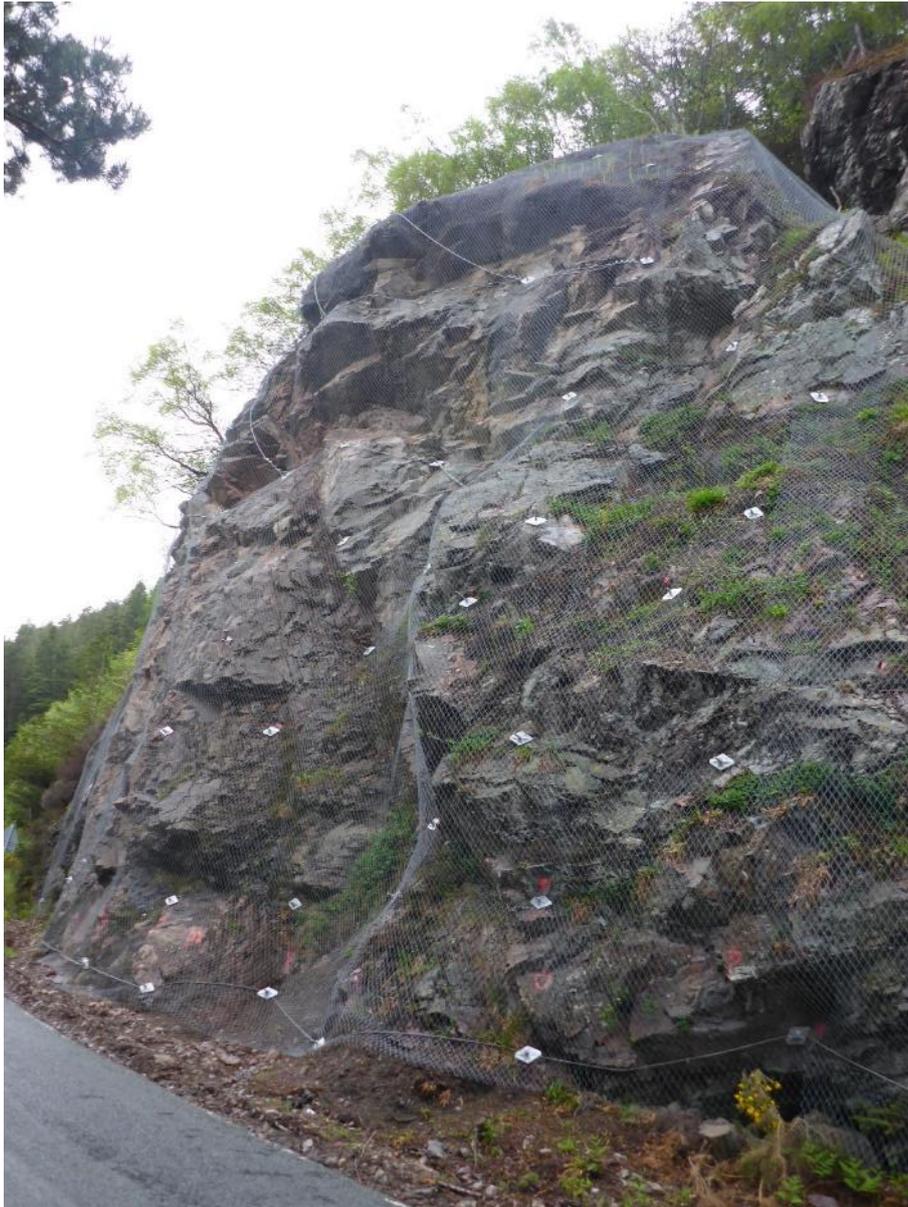
M4B-3	Tecco netting installed between Ch. 353 and 395; drape netting installed to Ch. 360; remainder of the face has been anchored and the netting profiled.	Year First Observed:	2025
-------	--	----------------------	------

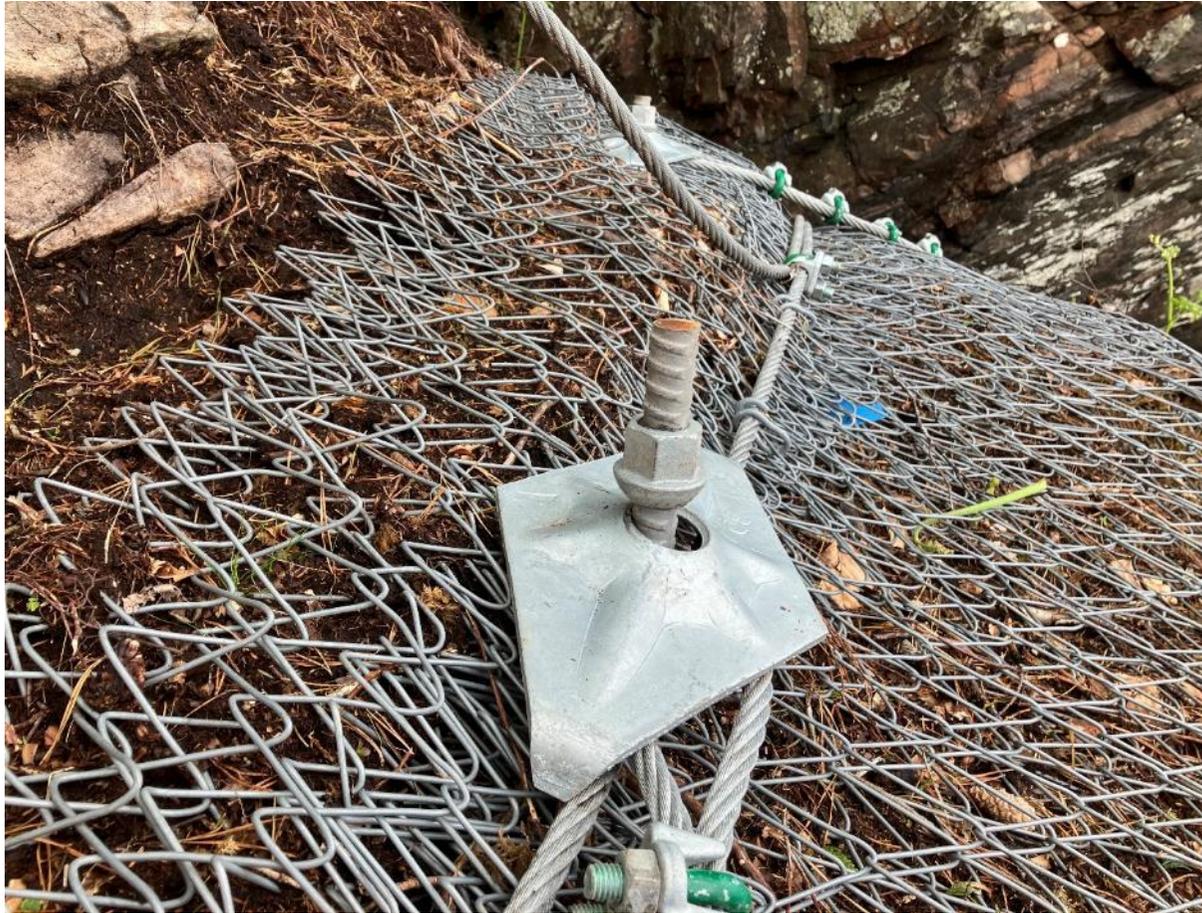
M4B-4	Example of corroded cut bar end and hemispherical nut not resting in corresponding spike plate hole. Lack of thimble for cable loop around dowel.	Year First Observed:	2025
-------	---	----------------------	------

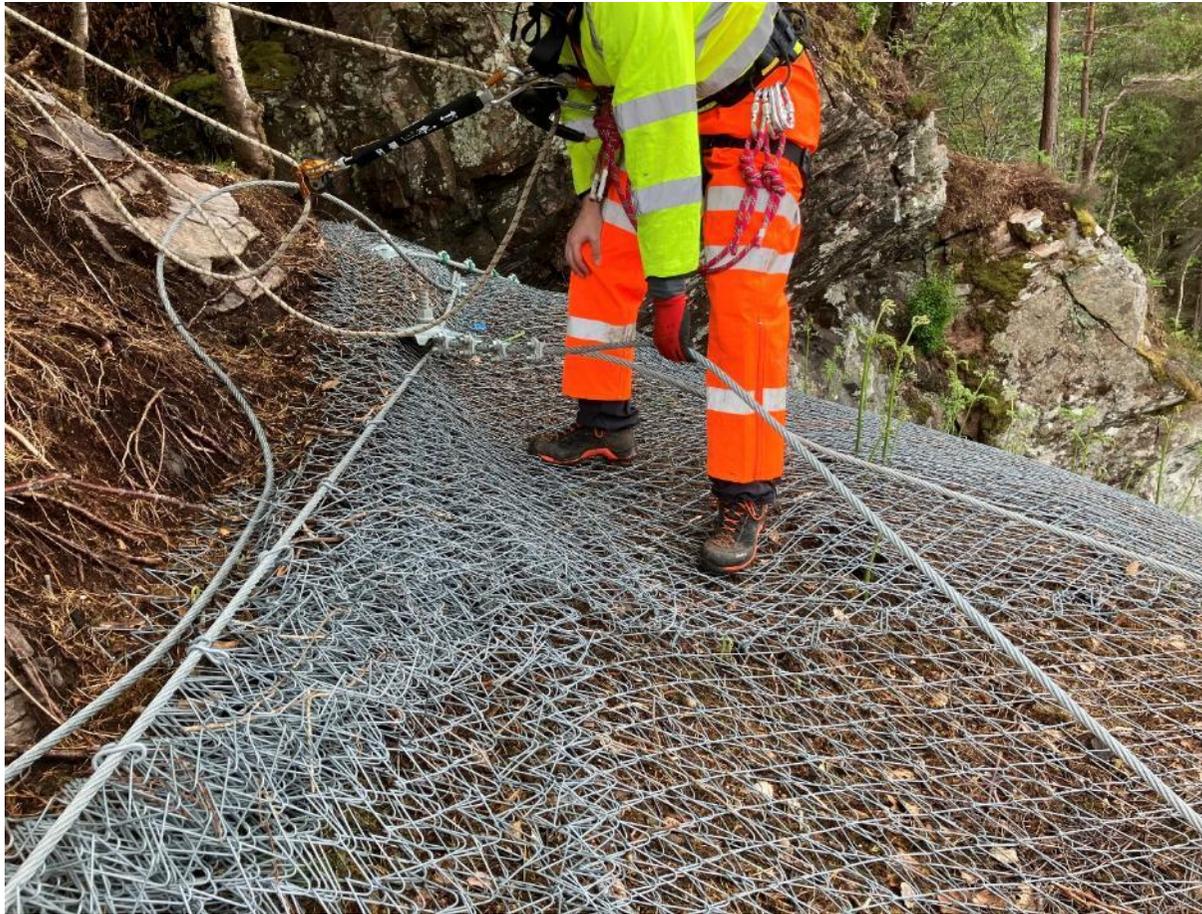
M4B-5

Example of slack profiling cable.

Hazards Observed:							
			- Tightening of cables where slack.				
Assessed in field by:	MT//PLM/CR		Date:	28/04/2025	Reviewed by:	MT	Date: 03/06/2025

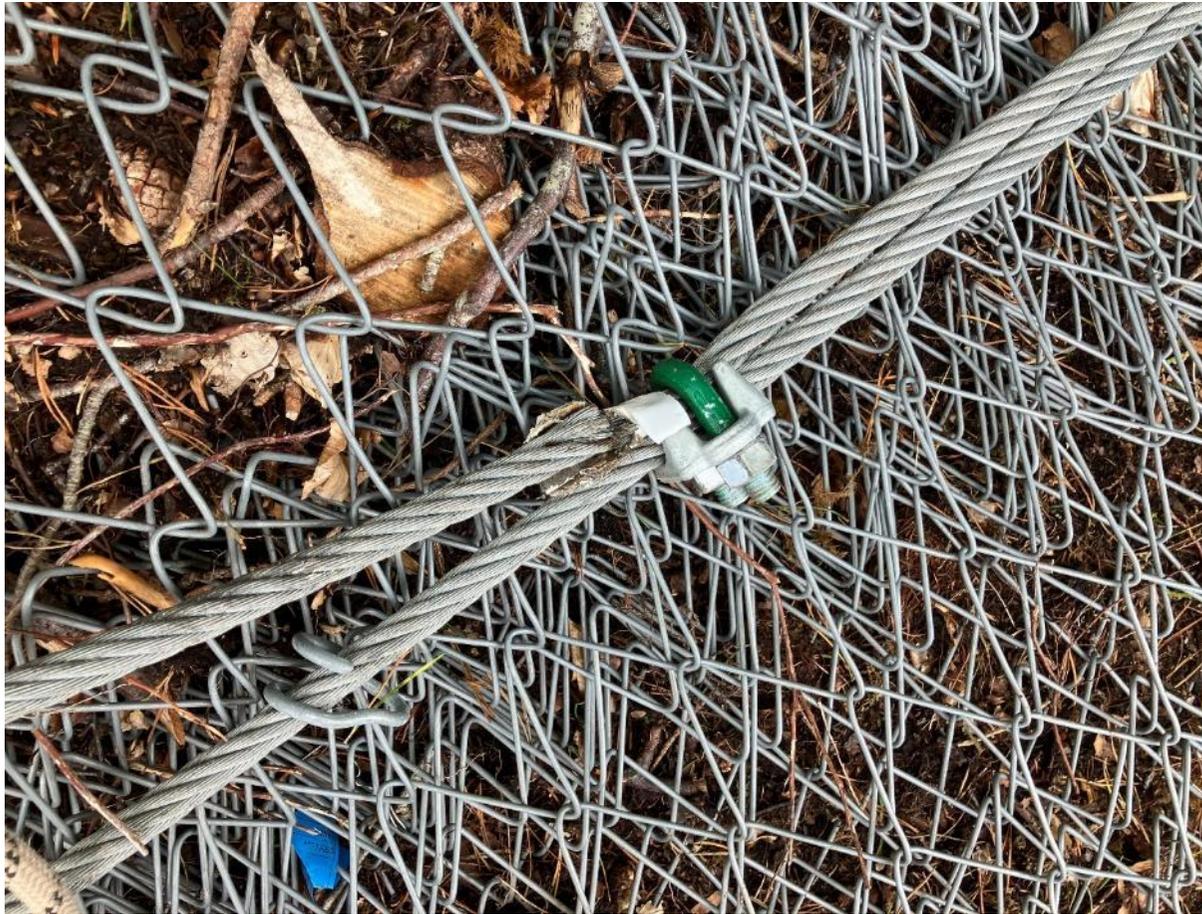
M4B-6

Example of missing cable grips.

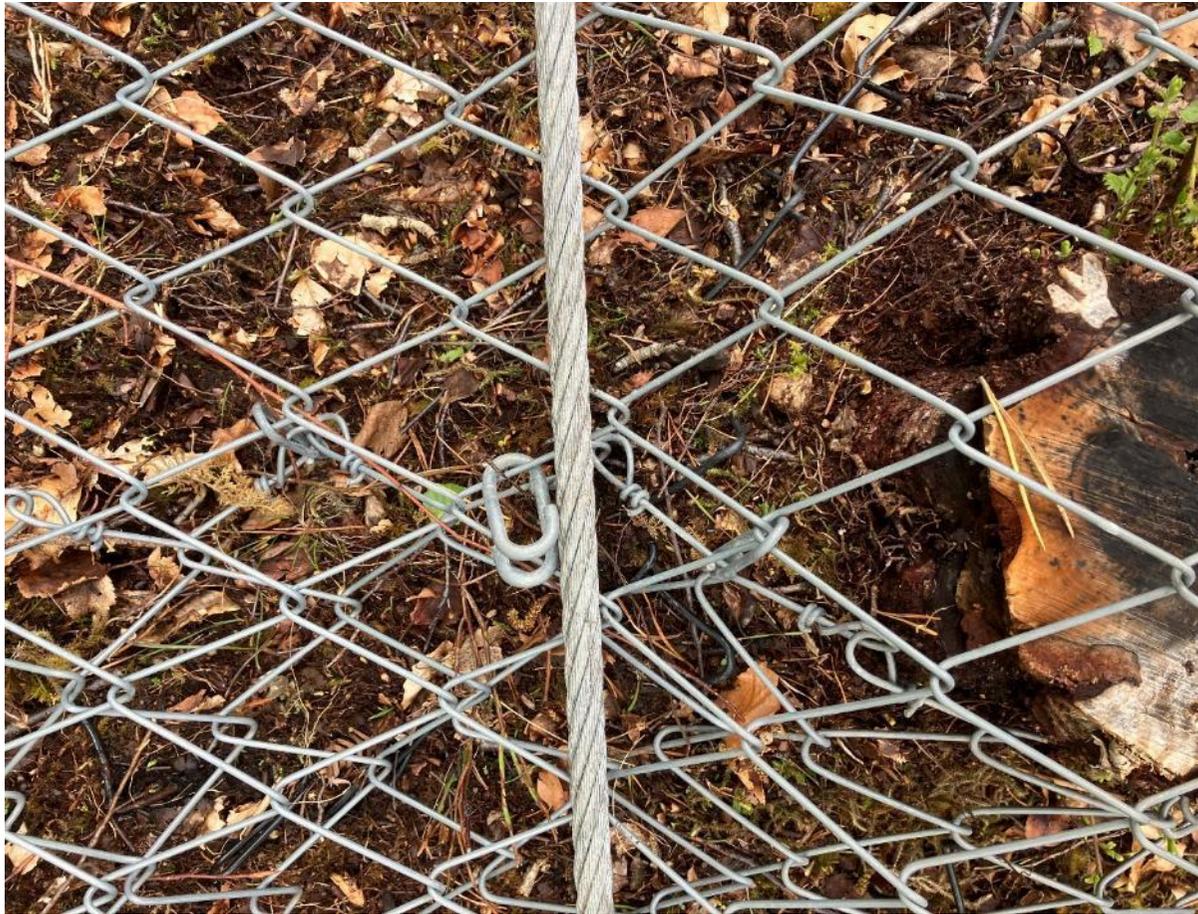
M4B-7

Example of cable not clipped to mesh.

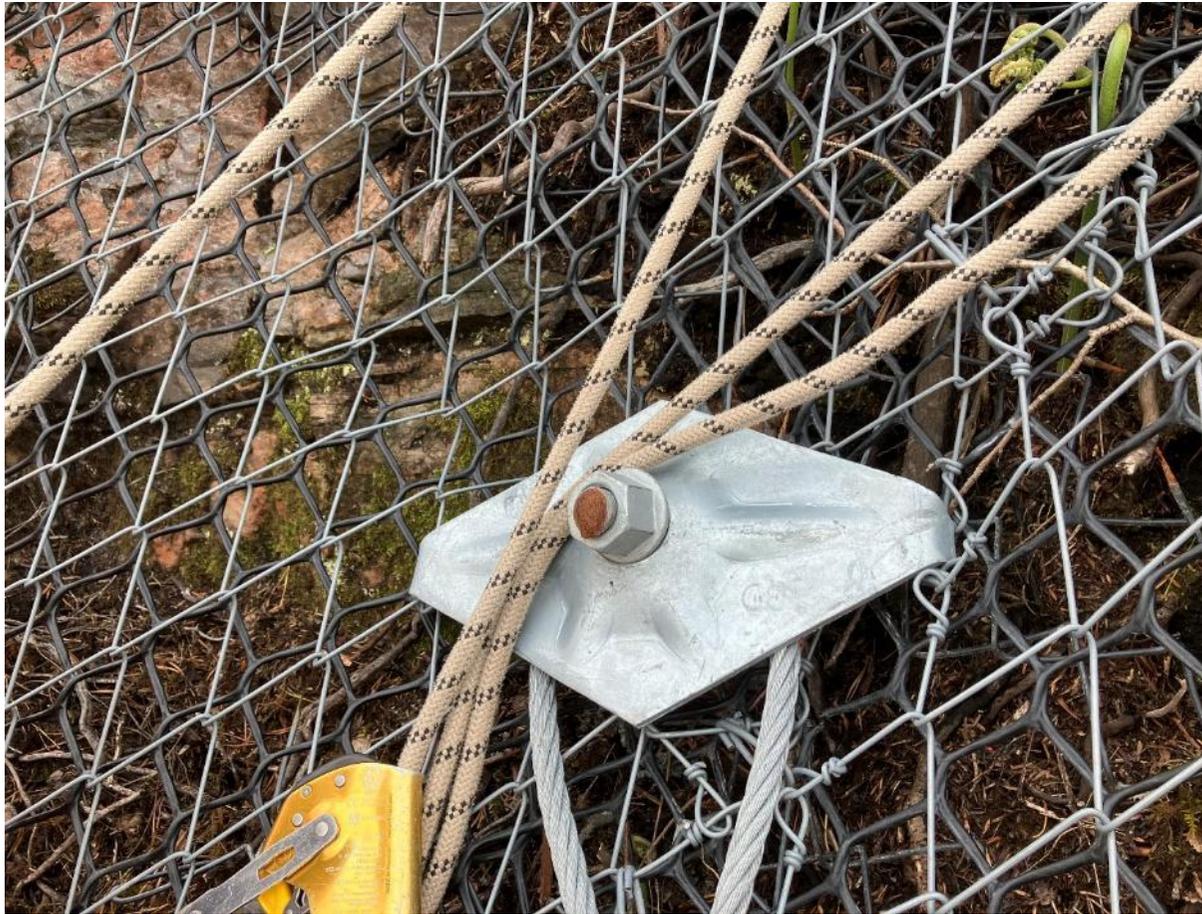
M4B-8

Example of corroding cut bar end and lack of thimble for cable loop around dowel.

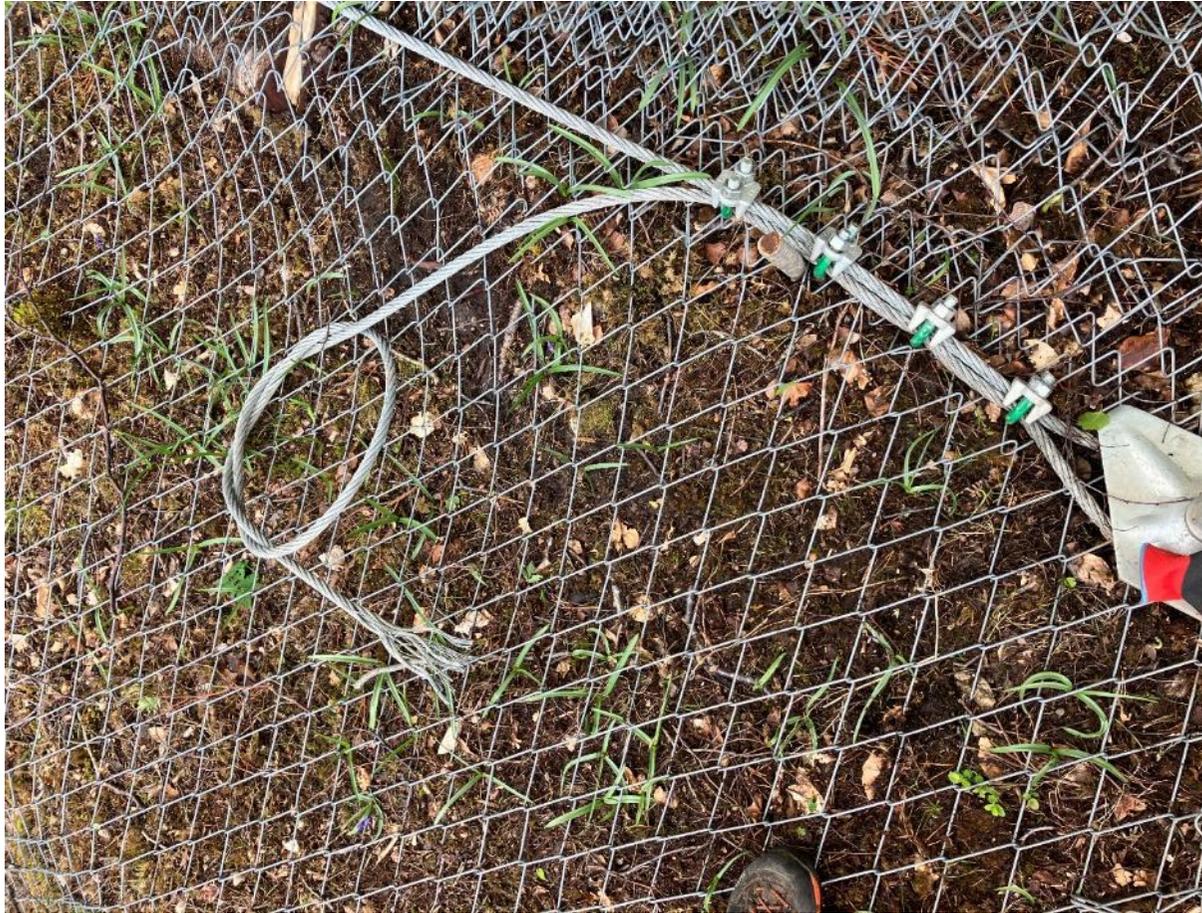
M4B-9

Example of excess wire rope with fraying end and lack of thimble for cable loop around dowel.

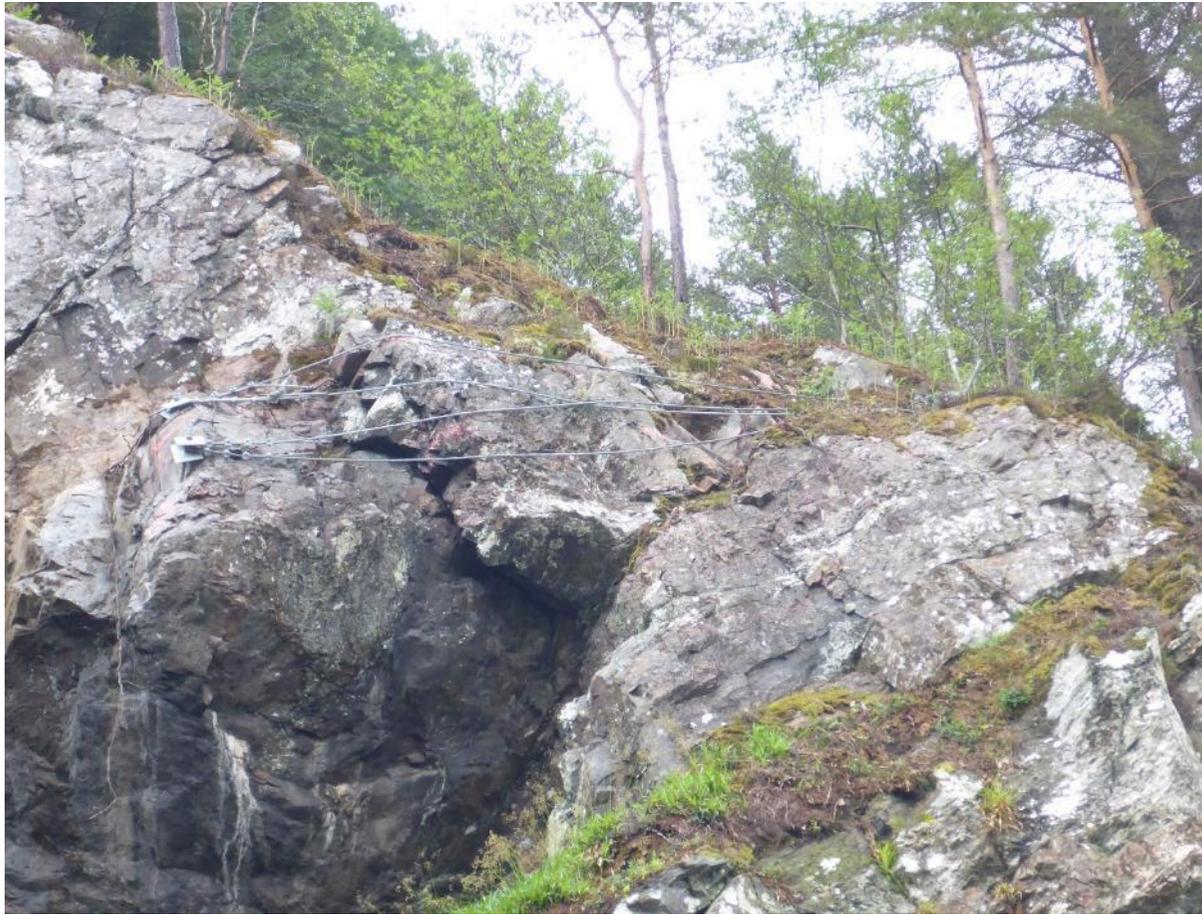
M5-1	Ch. 398 – Cable restraints with 4no. anchor points installed during Phase 13 works.	Year First Observed:	2025
------	---	----------------------	------
