A890 Maman Hill

Annual Slope Inspection 2025

The Highland Council

Project number: 60685712
AECOM Report Ref.: GLRP0011

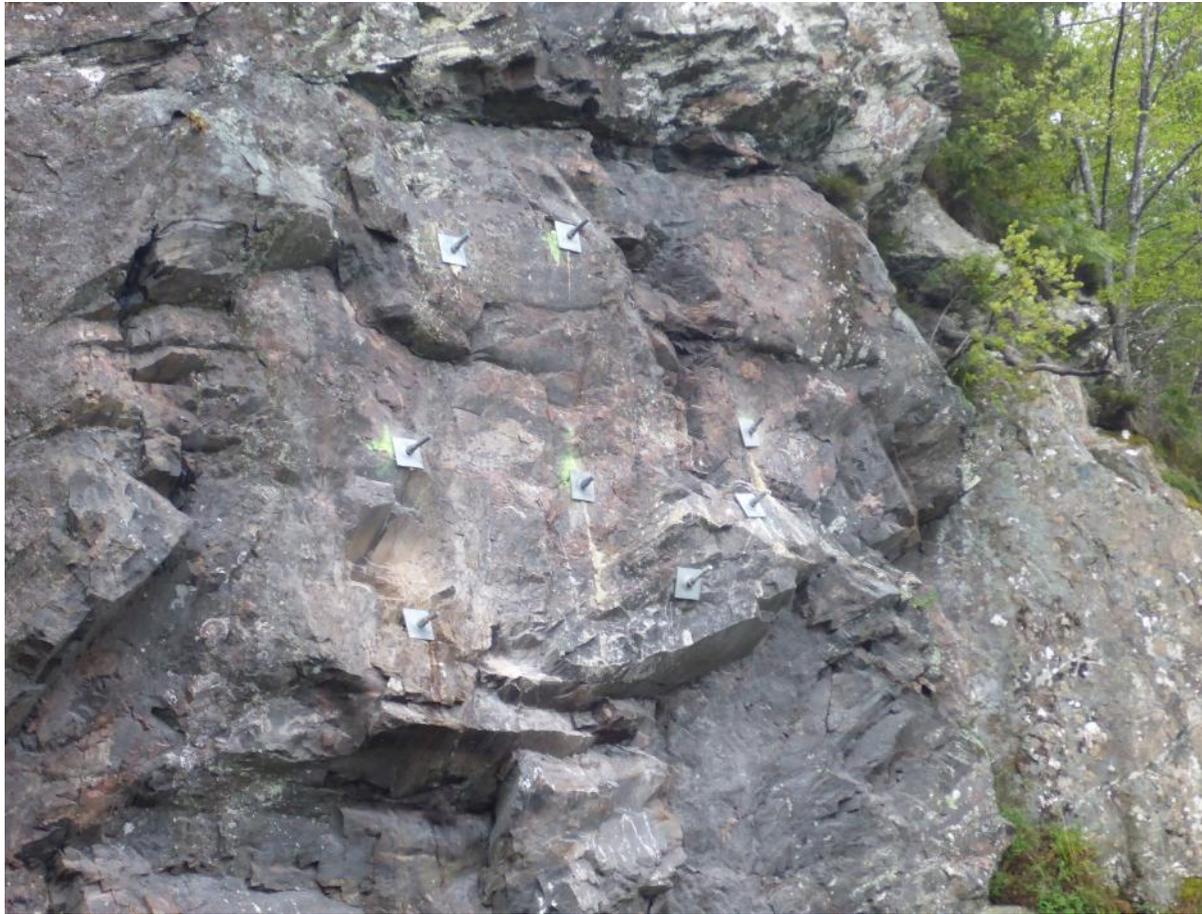
M5-2

Ch. 407 – 8no. rock dowels installed c. 8 to 11 m above slope toe during Phase 13 rock works.

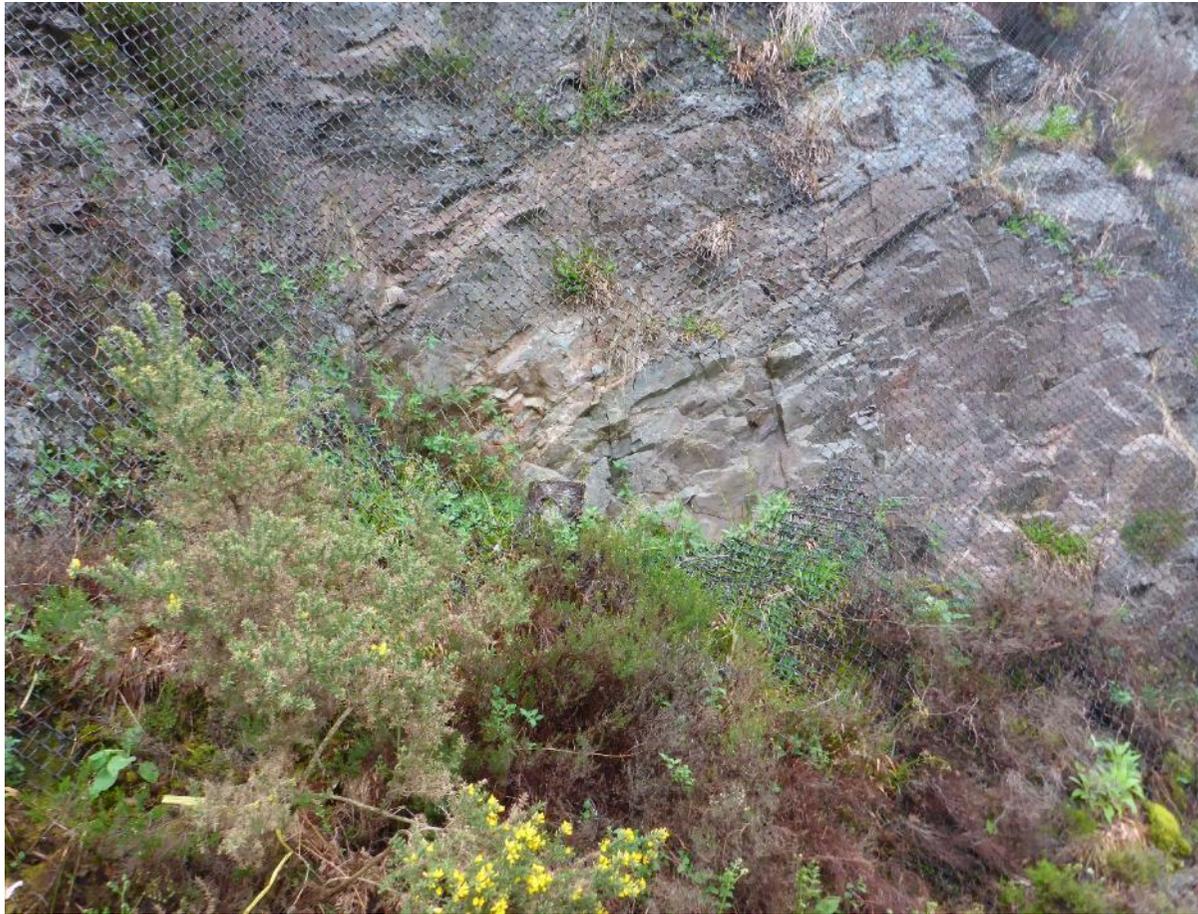
<p>M6-1</p>	<p>Chain-link drape netting installed between Ch 415 to 435. Completely corroded in places; drape netting considered to be ineffective due to the deteriorated condition of the netting. Holes present in the netting where blocks have fallen and burst through. Anchor points not known/inspected.</p>	<p>Year First Observed:</p>	<p>2025</p>
-------------	--	-----------------------------	-------------

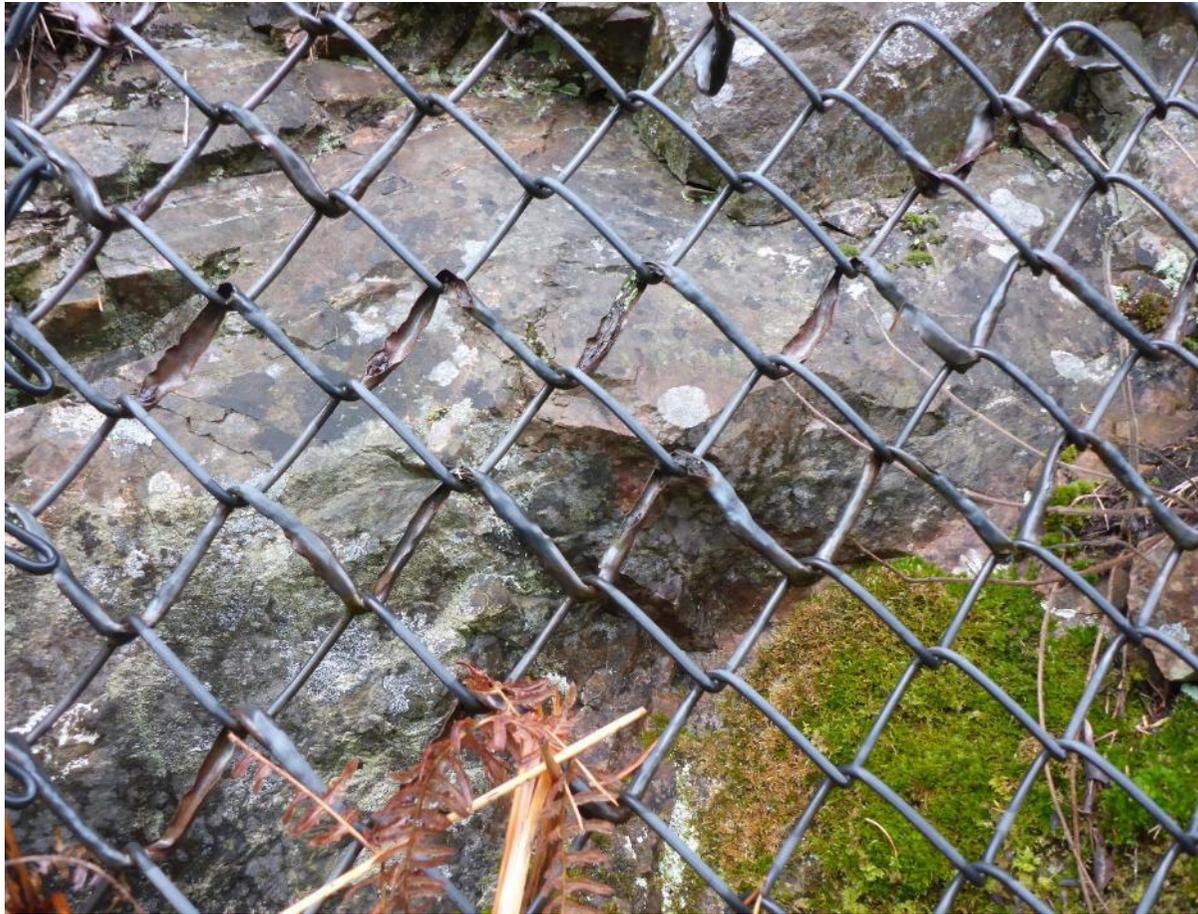
M6-2	Chain-link drape netting installed between Ch 415 to 435. Completely corroded in places; drape netting considered to be ineffective due to the deteriorated condition of the netting. Holes present in the netting where blocks have fallen and burst through. Anchor points not known/inspected.	Year First Observed:	2025
------	---	----------------------	------

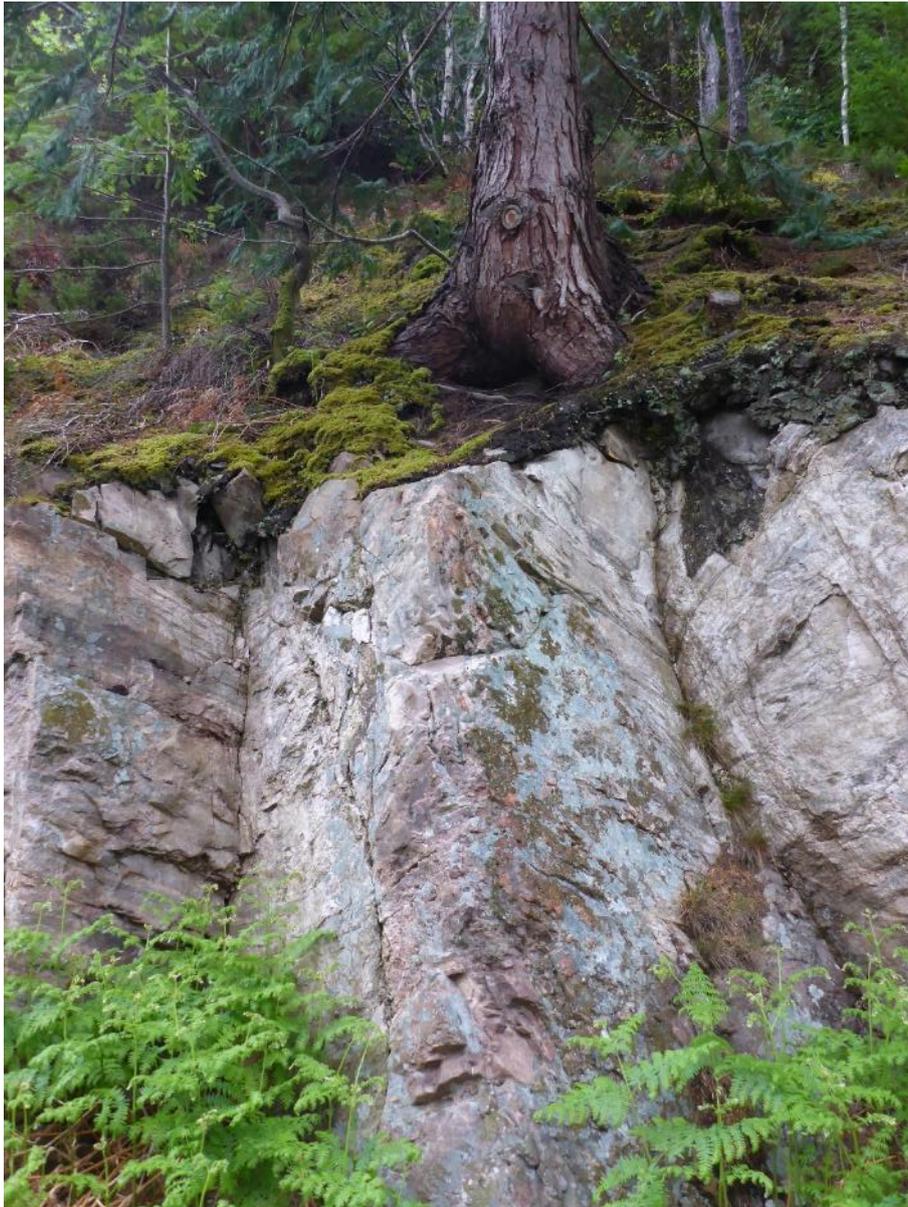
M6-3	Ongoing ravelling and root jacking potential, particularly along crest.	Year First Observed:	2019
------	---	----------------------	------

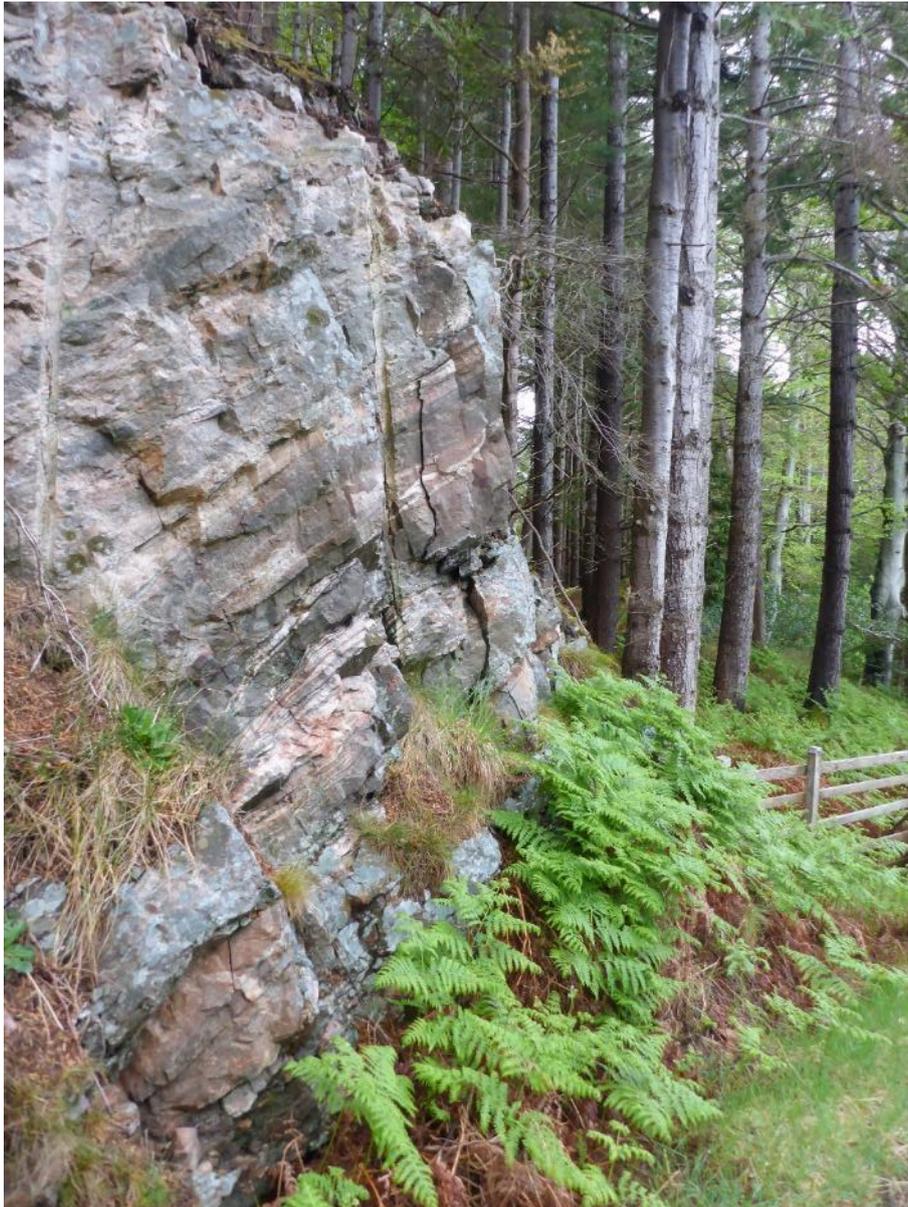
M6-4	Ongoing ravelling and root jacking potential, particularly along crest.	Year First Observed:	2019
------	---	----------------------	------

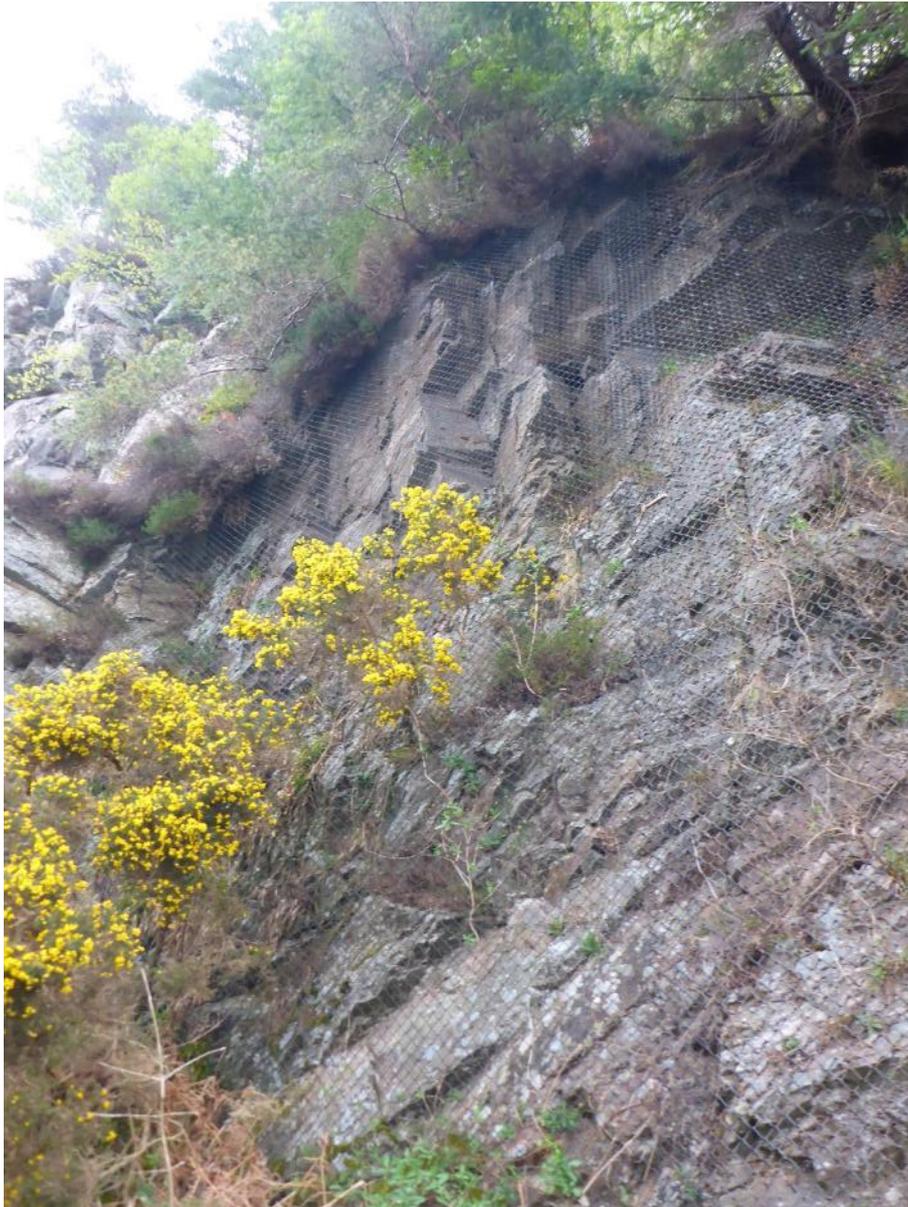
M6-5	Ch. 420: Potential toppling failure identified c. 6 m above road level. 0.5 to 1.0 m ³ . Dilated fractures.	Year First Observed:	2019
------	--	----------------------	------
