A890 Stromeferry Bypass

Annual Slope Inspection 2025

The Highland Council

Project number: 60685712
AECOM Report Ref.: GLRP0010

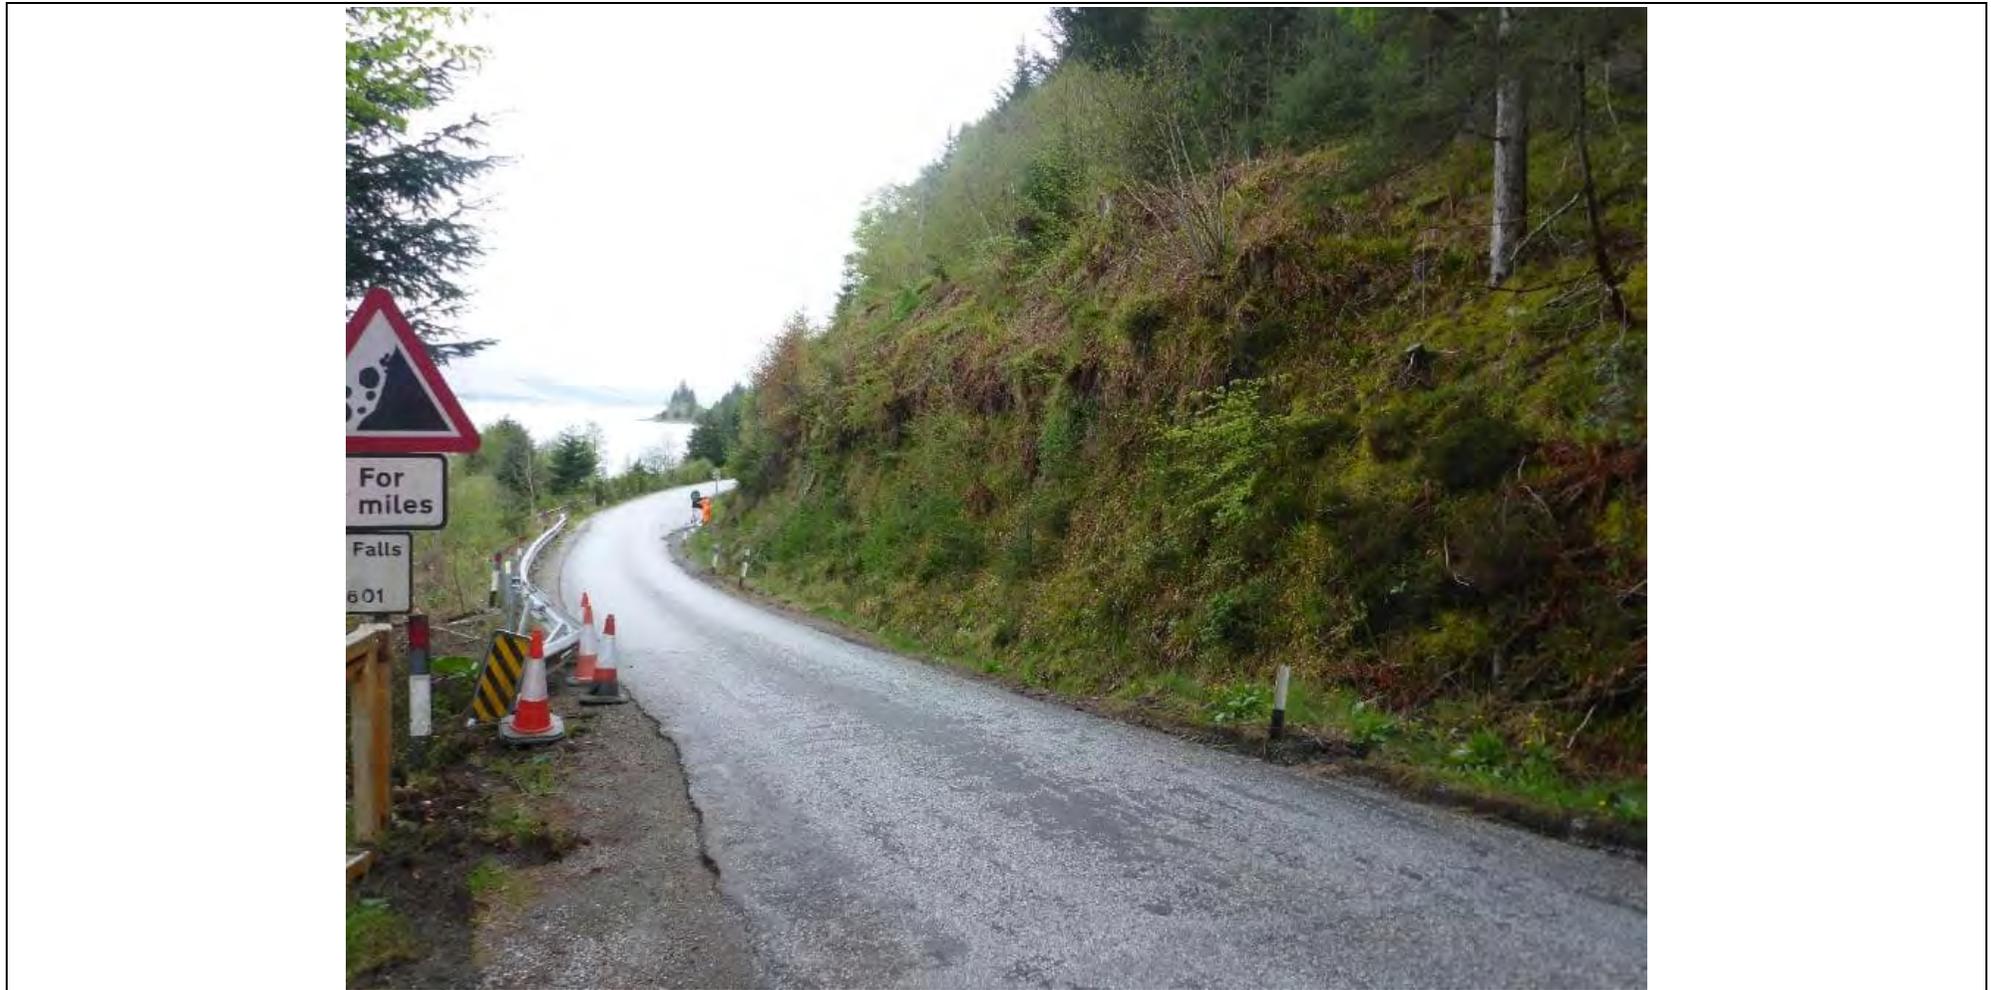
AA1-2	Ch. 0000: 2025 observation: Not related to rock fall risk, however it was observed that crash barrier has been struck; appears to have been a front-on collision. Supports sheared. Deformed barrier coned off.	Year First Observed:	2025
-------	--	----------------------	------

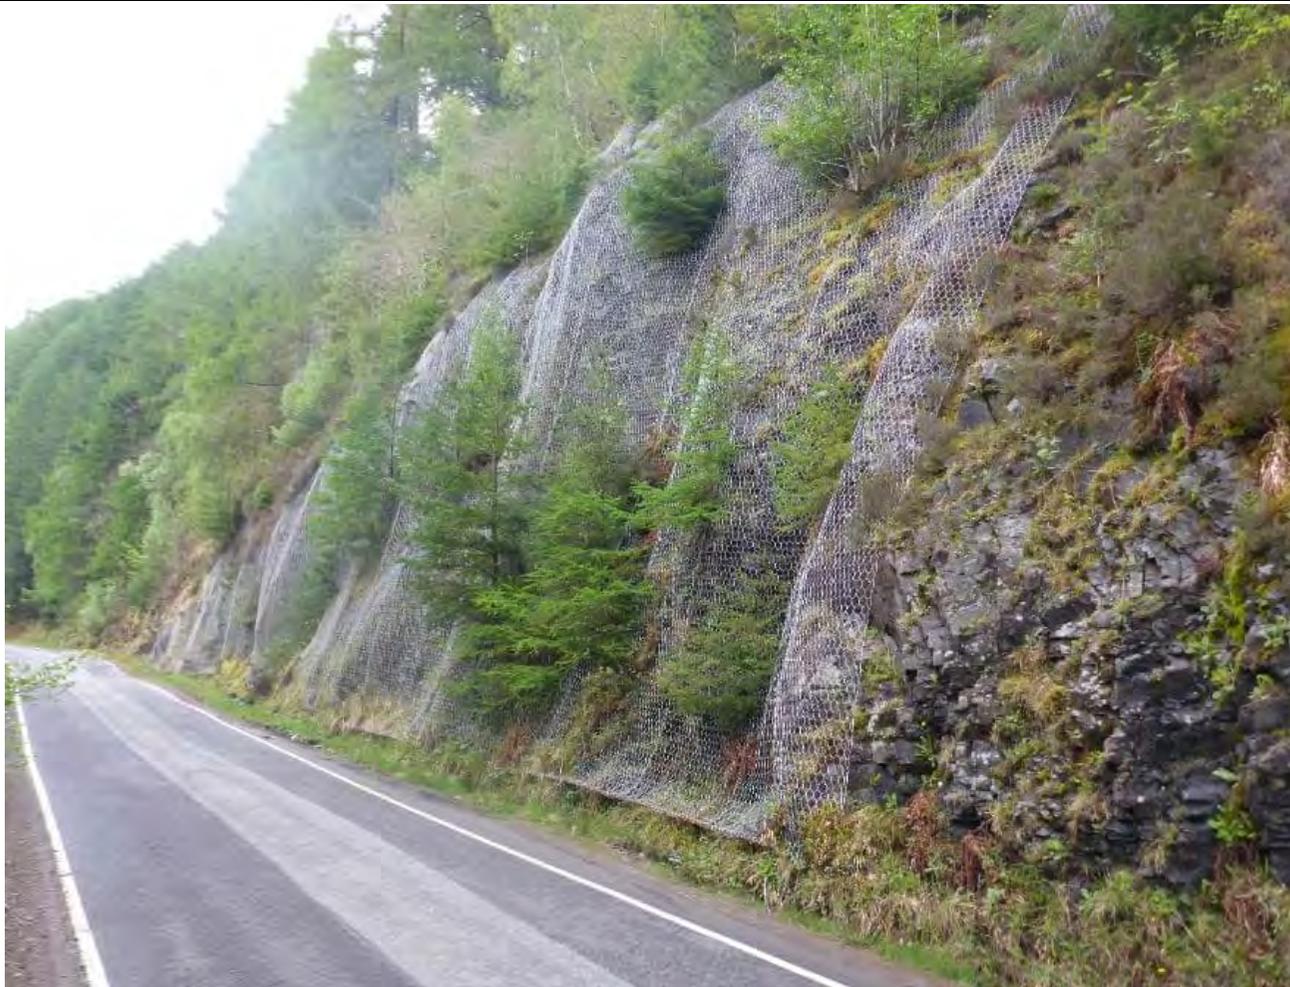
AA2-1	<p>Netting system from Ch. 0170 to 0202 and Ch. 0230 to 0292 installed before AECOM involvement (i.e., pre-2012). Generally, in good condition, although the bottom cable is corroded around Ch. 0273. Vegetation regrowth increases the potential for rock falls due to root jacking.</p>	Year First Observed:	2012
-------	--	----------------------	------

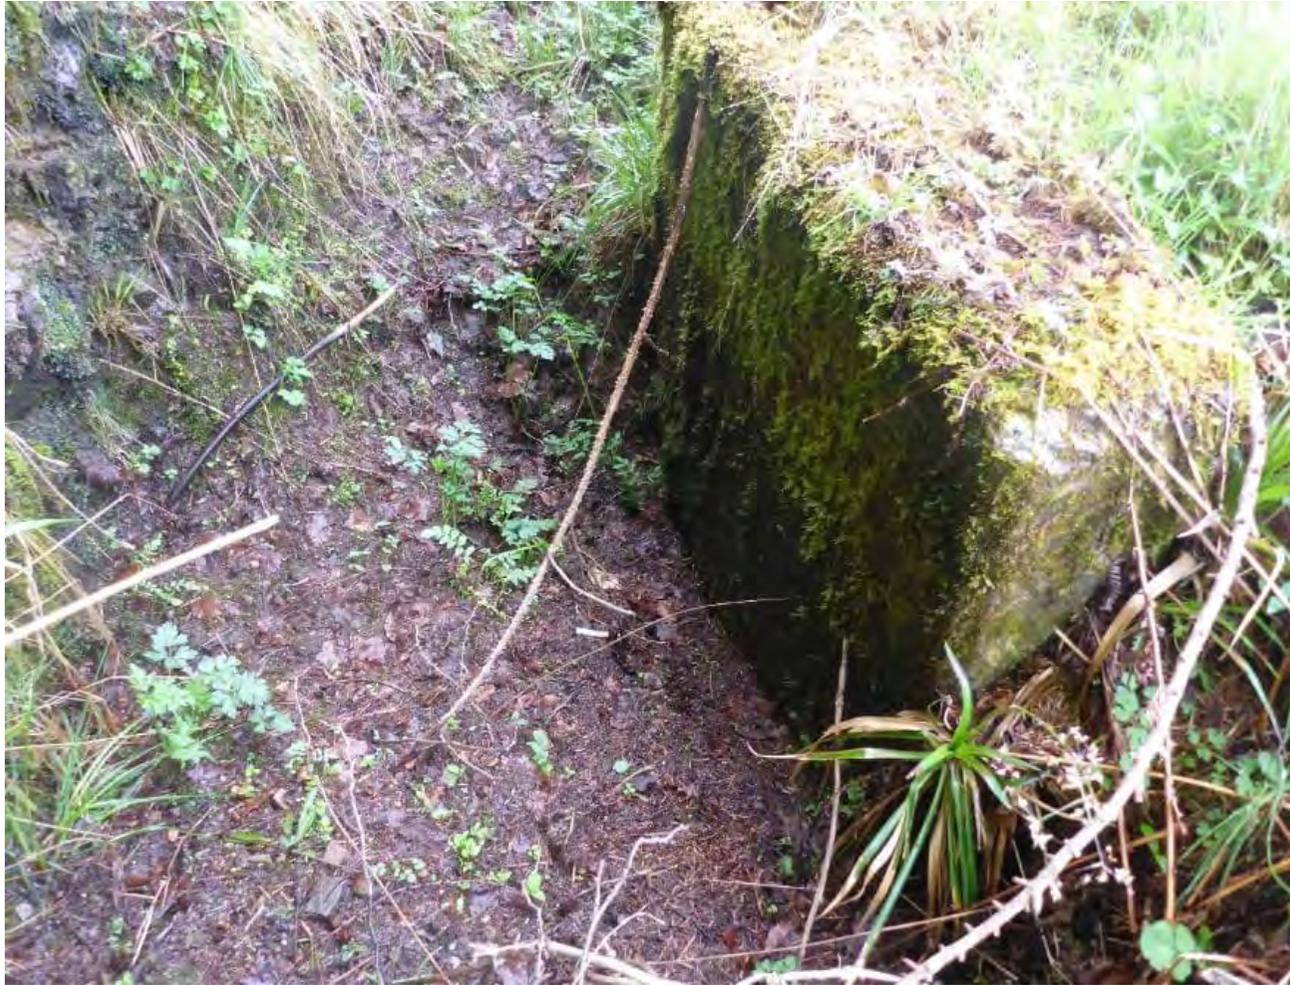
AA2-2	2021 – Phase 12 works: <ul style="list-style-type: none"> • Clearance of roadside ditch from Ch. 0200 to 0230, Ch. 0256. and Ch. 0310 to 0335 undertaken in 2021 (Phase 12 works). 50% blocked by 2023 and completely blocked by 2025 with build up of organic debris. Requires clearing out again. 	Year First Observed:	2022
-------	--	----------------------	------

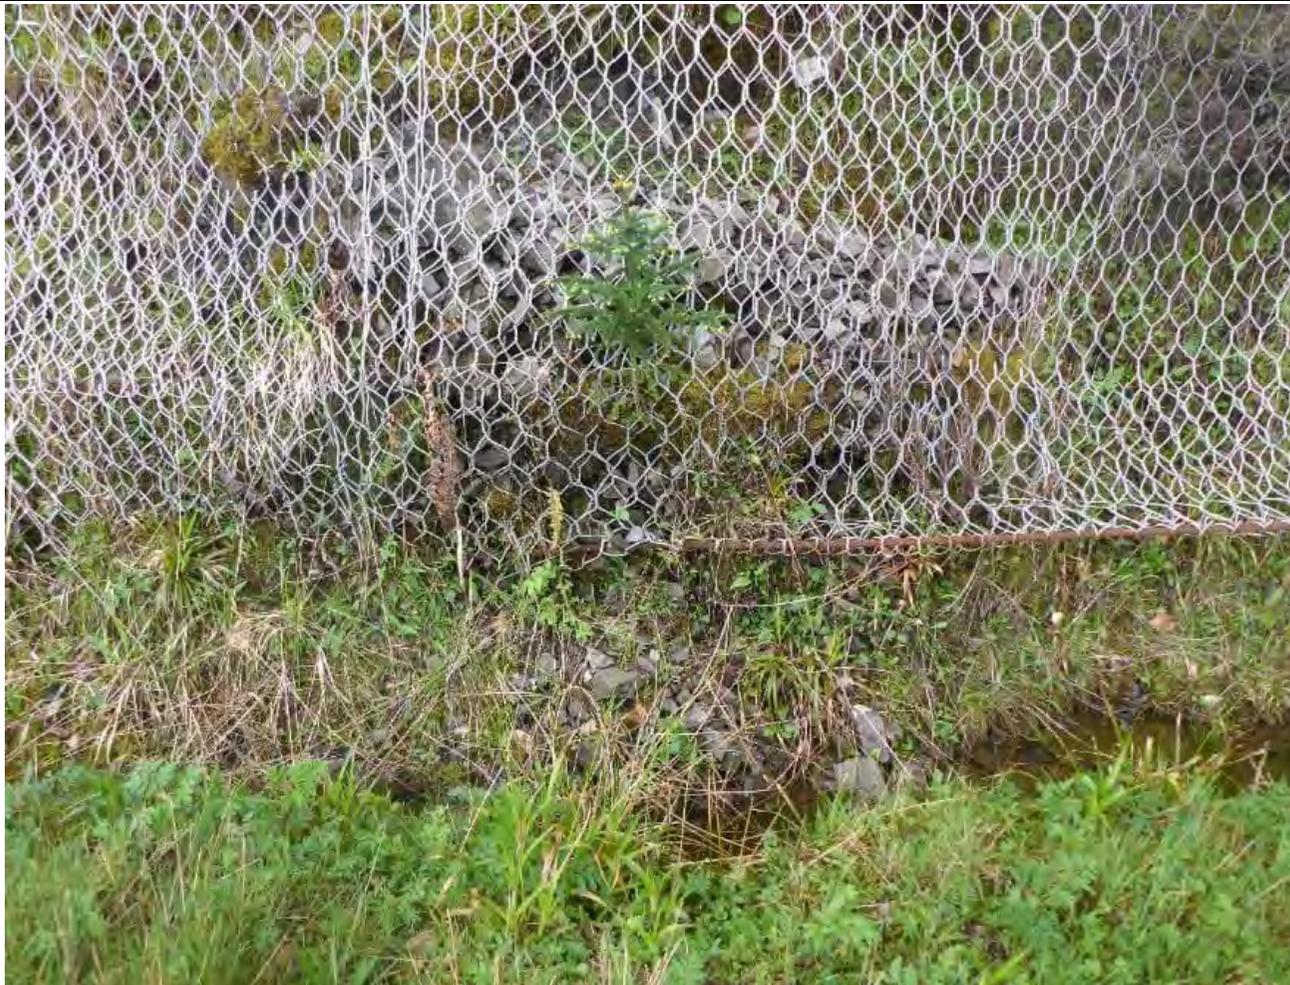
<p>AA2-5</p>	<p>Ch. 0278: 2017: Debris continues to build up behind netting. Not currently loading system significantly. In 2021, it was noted that some of the material had fallen out of base of netting and into ditch below. 2025: No changes observed during 2025 inspection.</p>	<p>Year First Observed:</p>	<p>2017</p>
--------------	---	-----------------------------	-------------

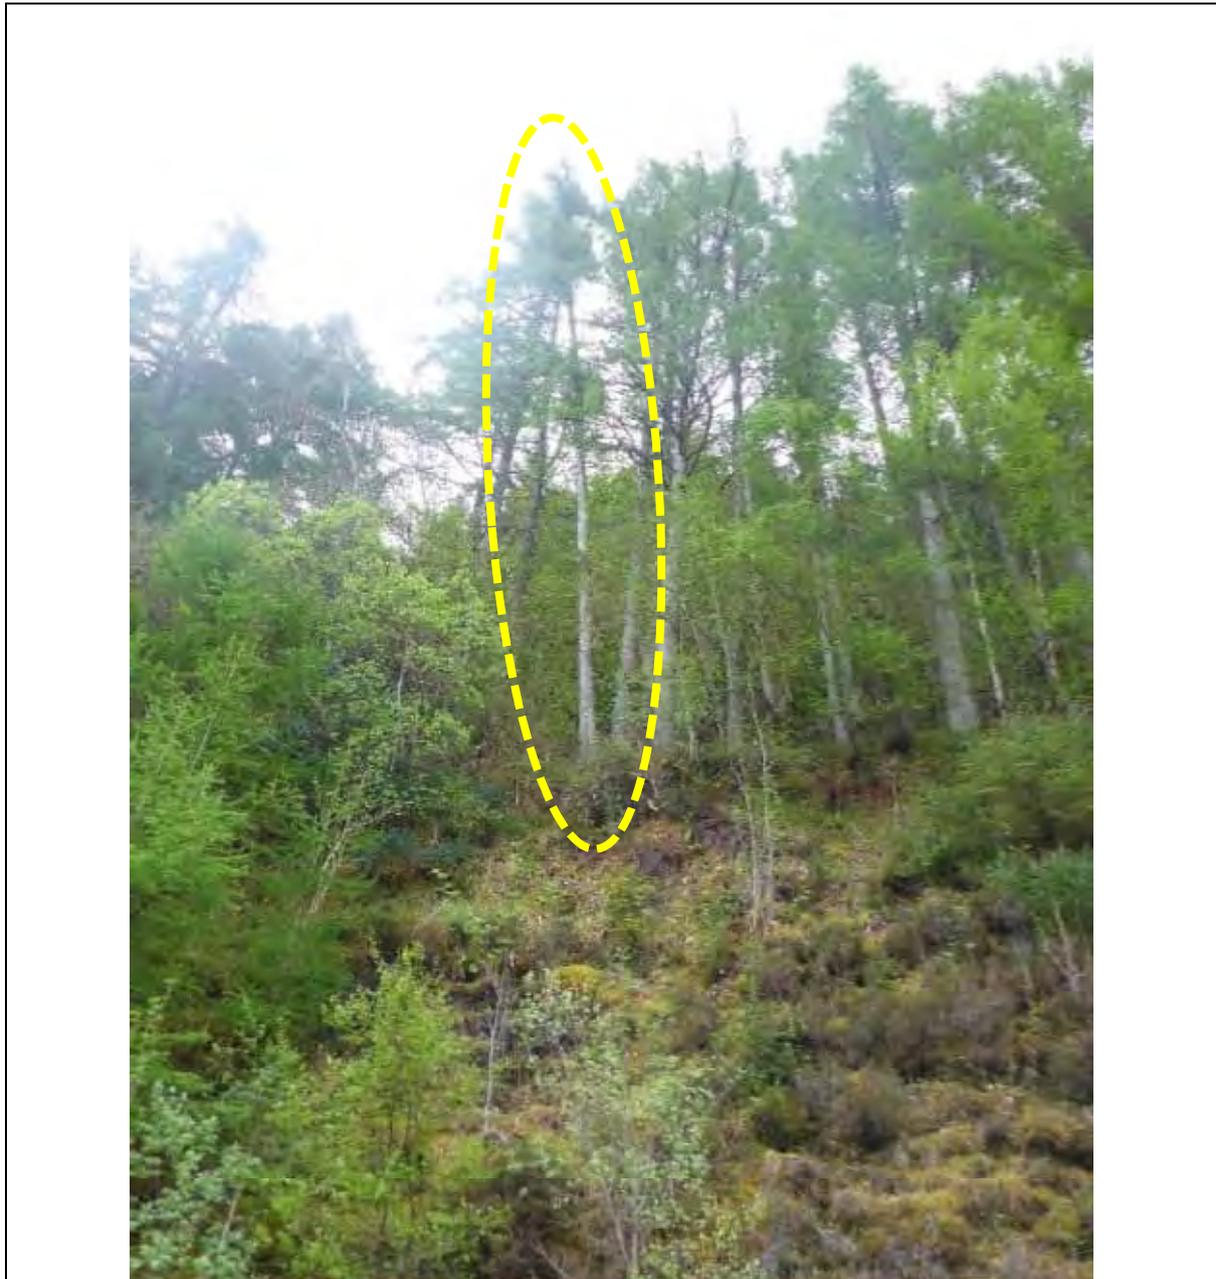
AA2-6	Ch. 0325: 2025: Tree at slope crest leaning by c. 5° from vertical.	Year First Observed:	2025
-------	--	-------------------------	------

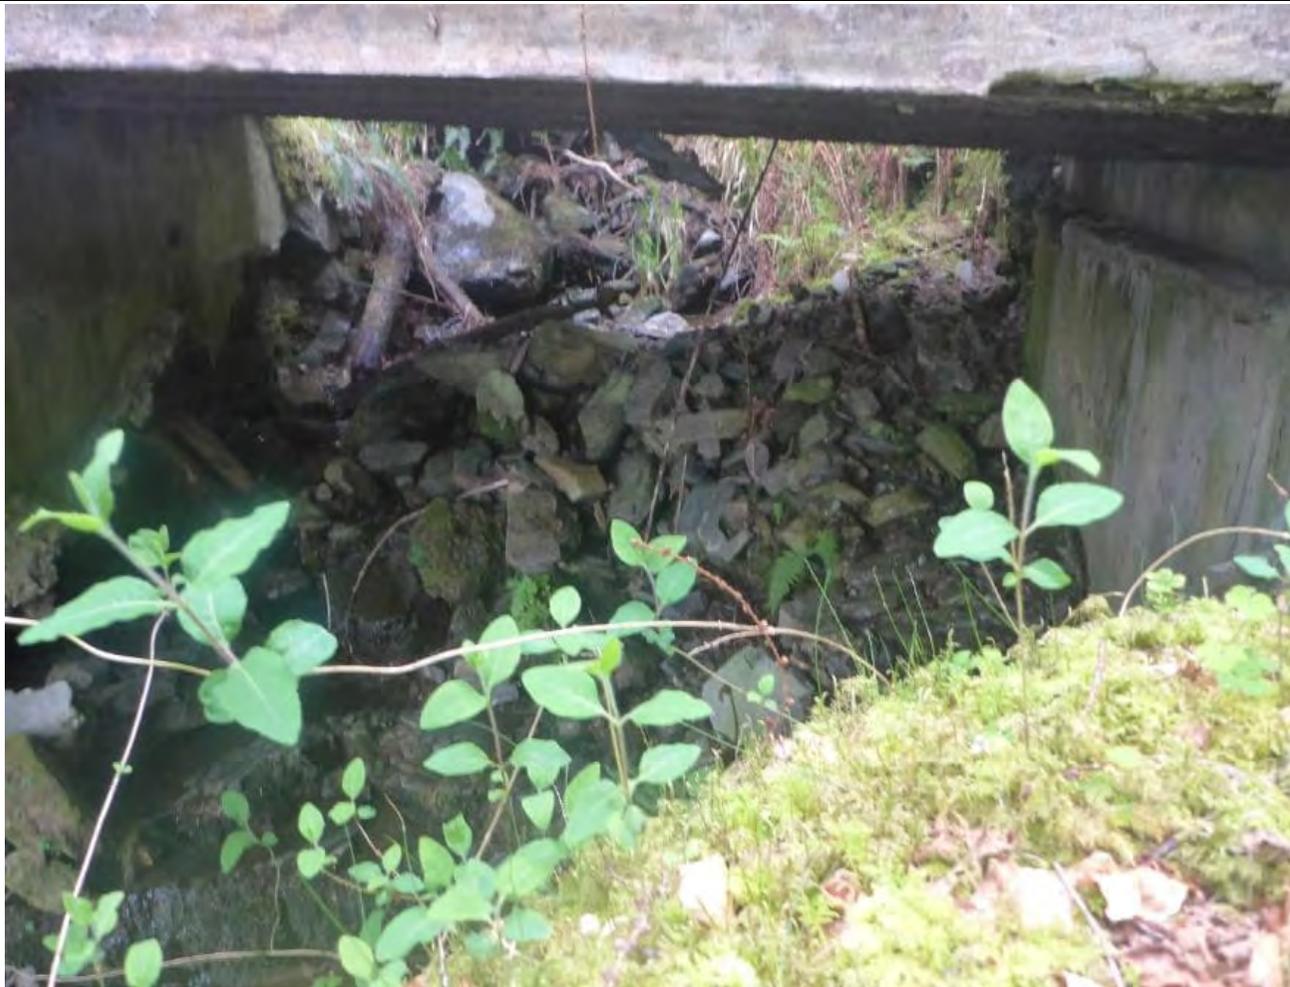
AA2-8	<ul style="list-style-type: none"> Above AA2 NG 89203 35827: Fallen tree blocking channel upstream of bridge. Granular material accumulating beneath the bridge. Channel down-slope towards the road is steep with localised branches and granular debris. 	Year First Observed:	2023
-------	---	----------------------	------

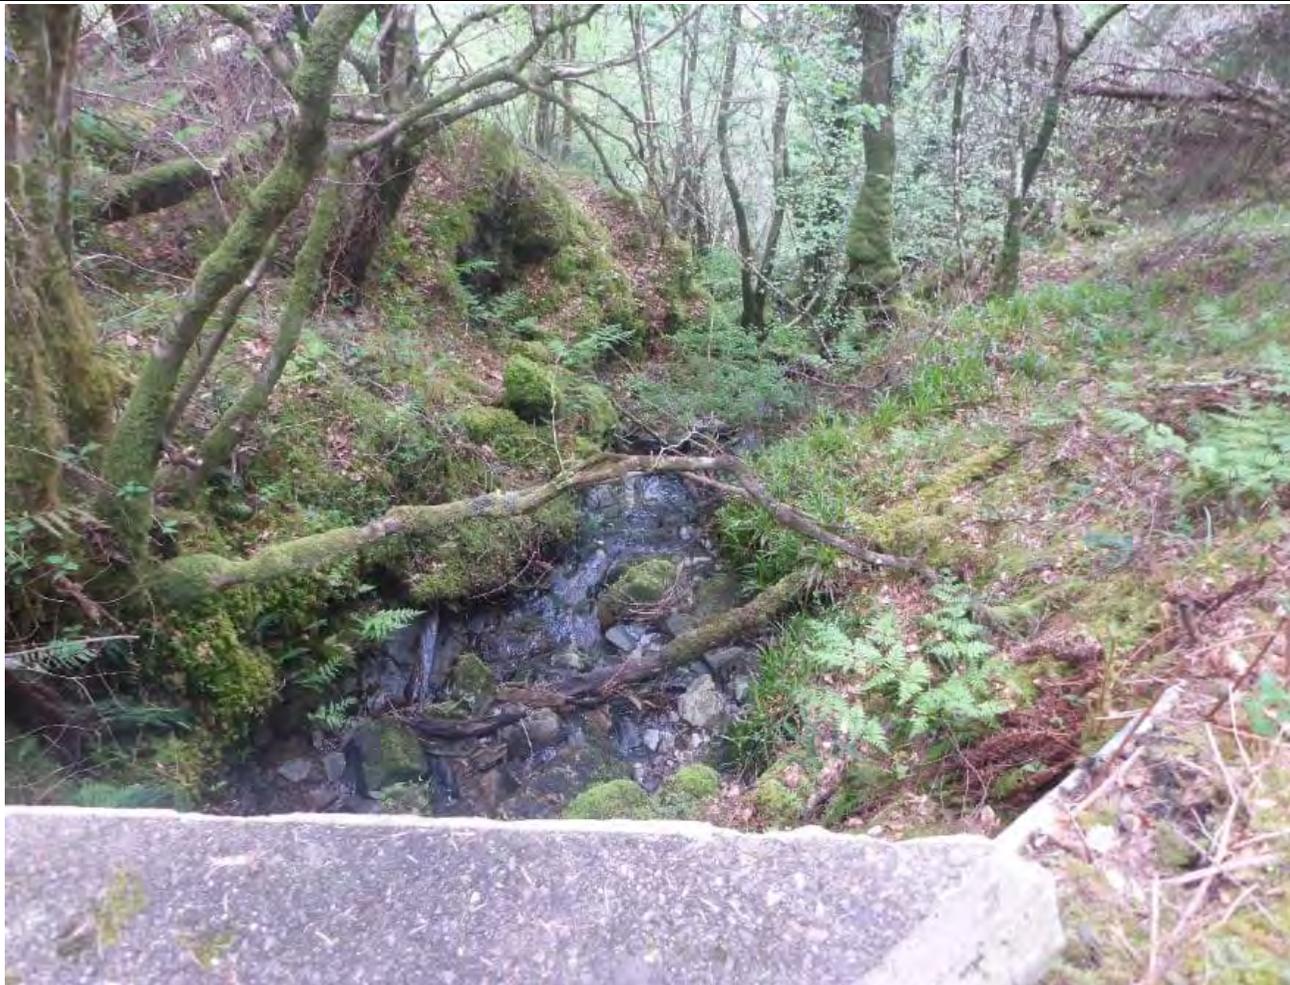
AA2-9	<ul style="list-style-type: none"> Above AA2 NG 89203 35827: Fallen tree blocking channel upstream of bridge. Granular material accumulating beneath the bridge. Channel down-slope towards the road is steep with localised branches and granular debris. 	Year First Observed:	2023
-------	---	----------------------	------

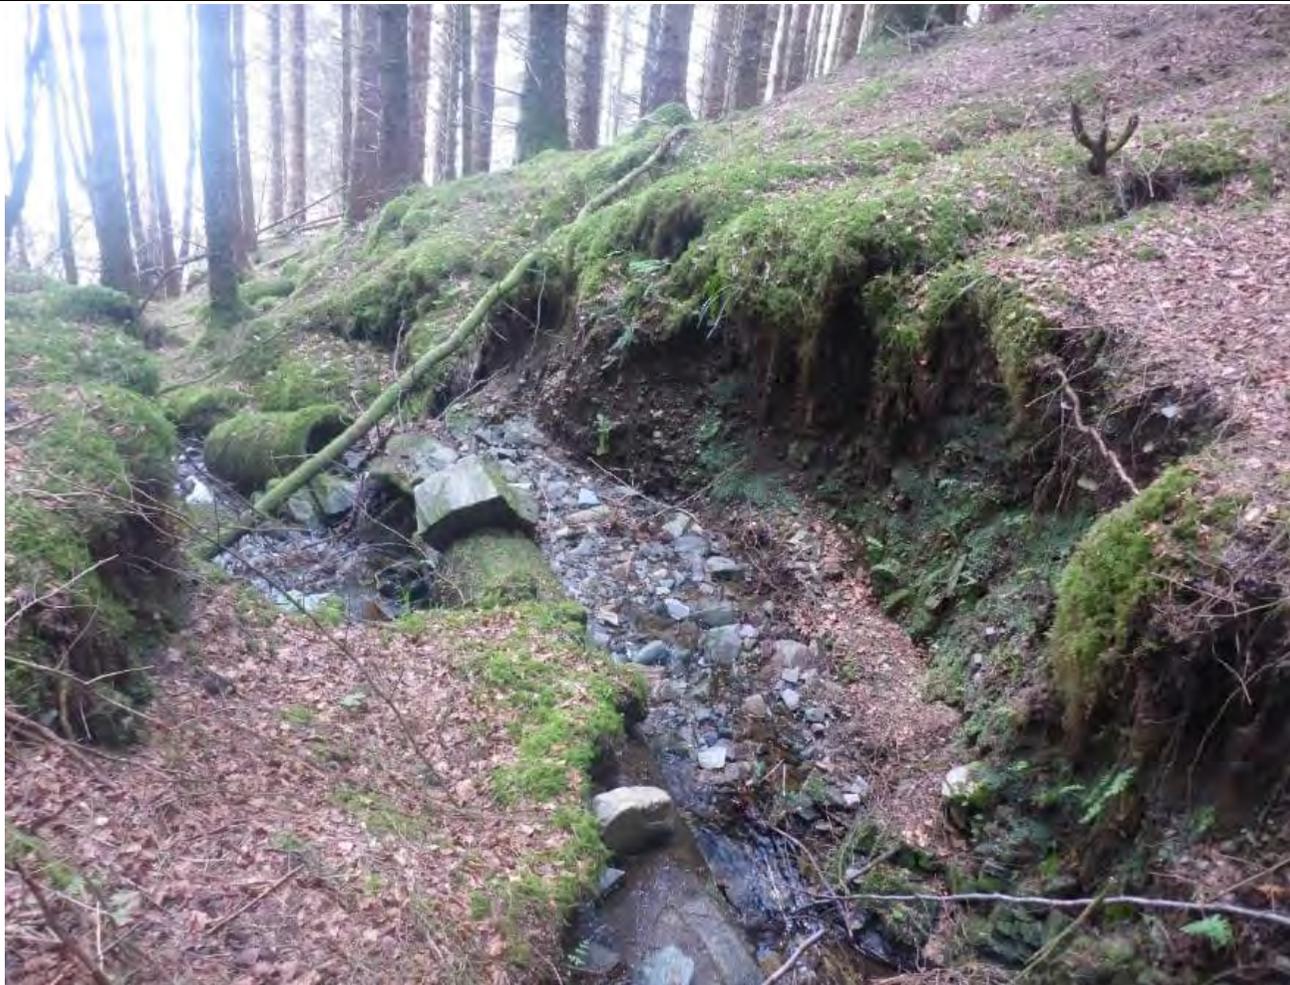
AA2-10	<ul style="list-style-type: none"> Above AA2 NG 89215 35799: Former culvert beneath unmaintained forestry track (upper track) washed away. Not recent but first time this area has been inspected. 	Year First Observed:	2025
--------	---	----------------------	------

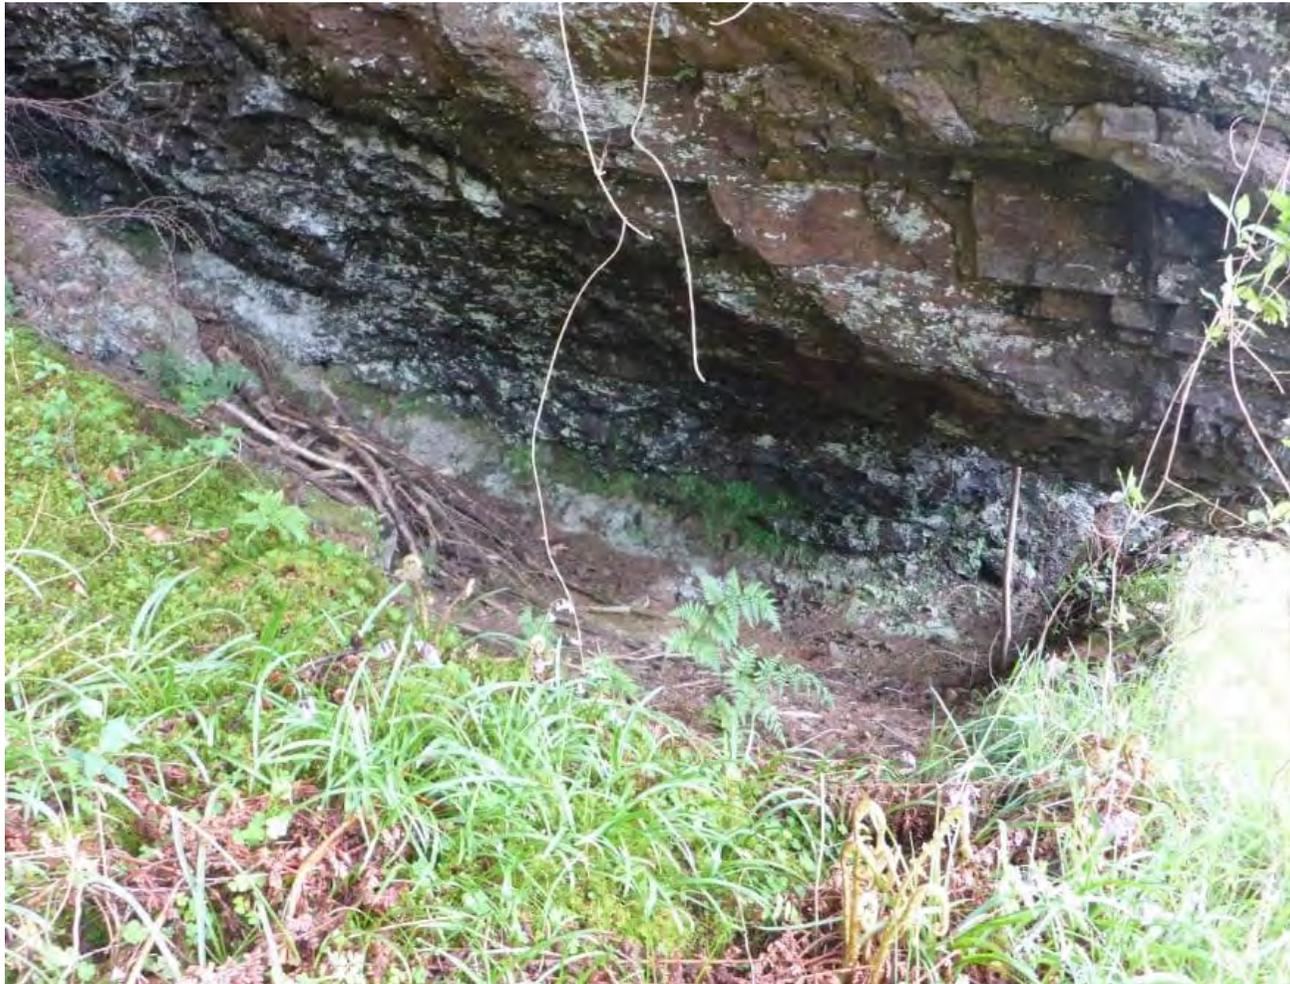
AA2A-2	<p>Ch. 0400: Weaker / more fractured material near the base of the overhanging boulder has preferentially weathered, leaving a 2.5 m overhang. Overhanging block approx. 1.5 x 1.5 x 2.0 m. If this block were to fail it would reach the road.</p>	Year First Observed:	2016
--------	---	----------------------	------

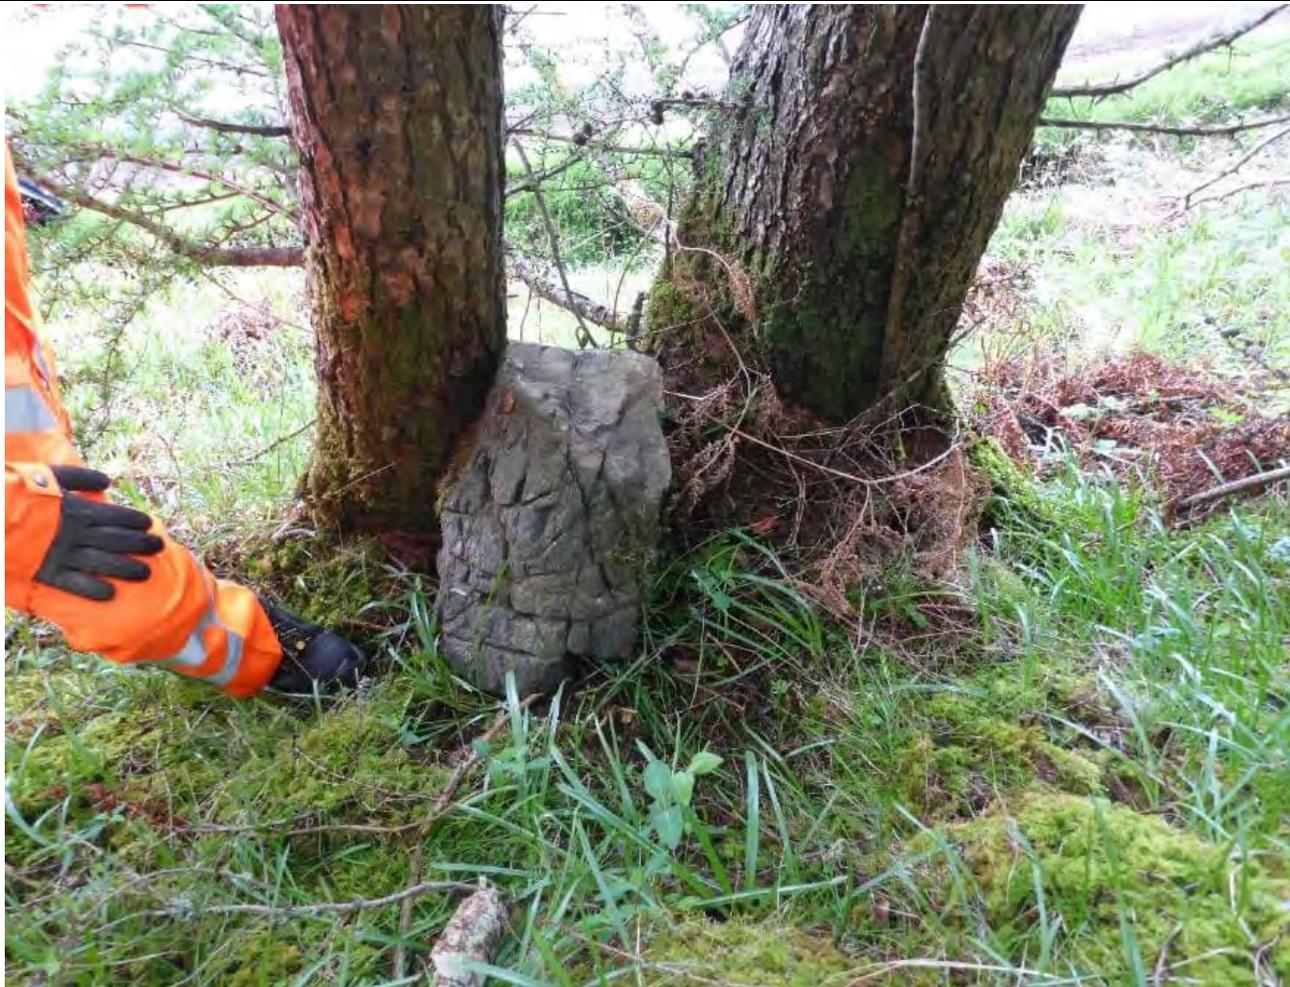
AA2A-3	<p>Ch. 0409: 2025: Boulder resting on / wedged behind a tree ~3 m upslope. Dimensions 0.3 x 0.5 x 0.2 m. Source of rock fall a fallen tree c. 25 m above road level with blocks weathering out of the root ball.</p>	Year First Observed:	2025
--------	---	----------------------	------

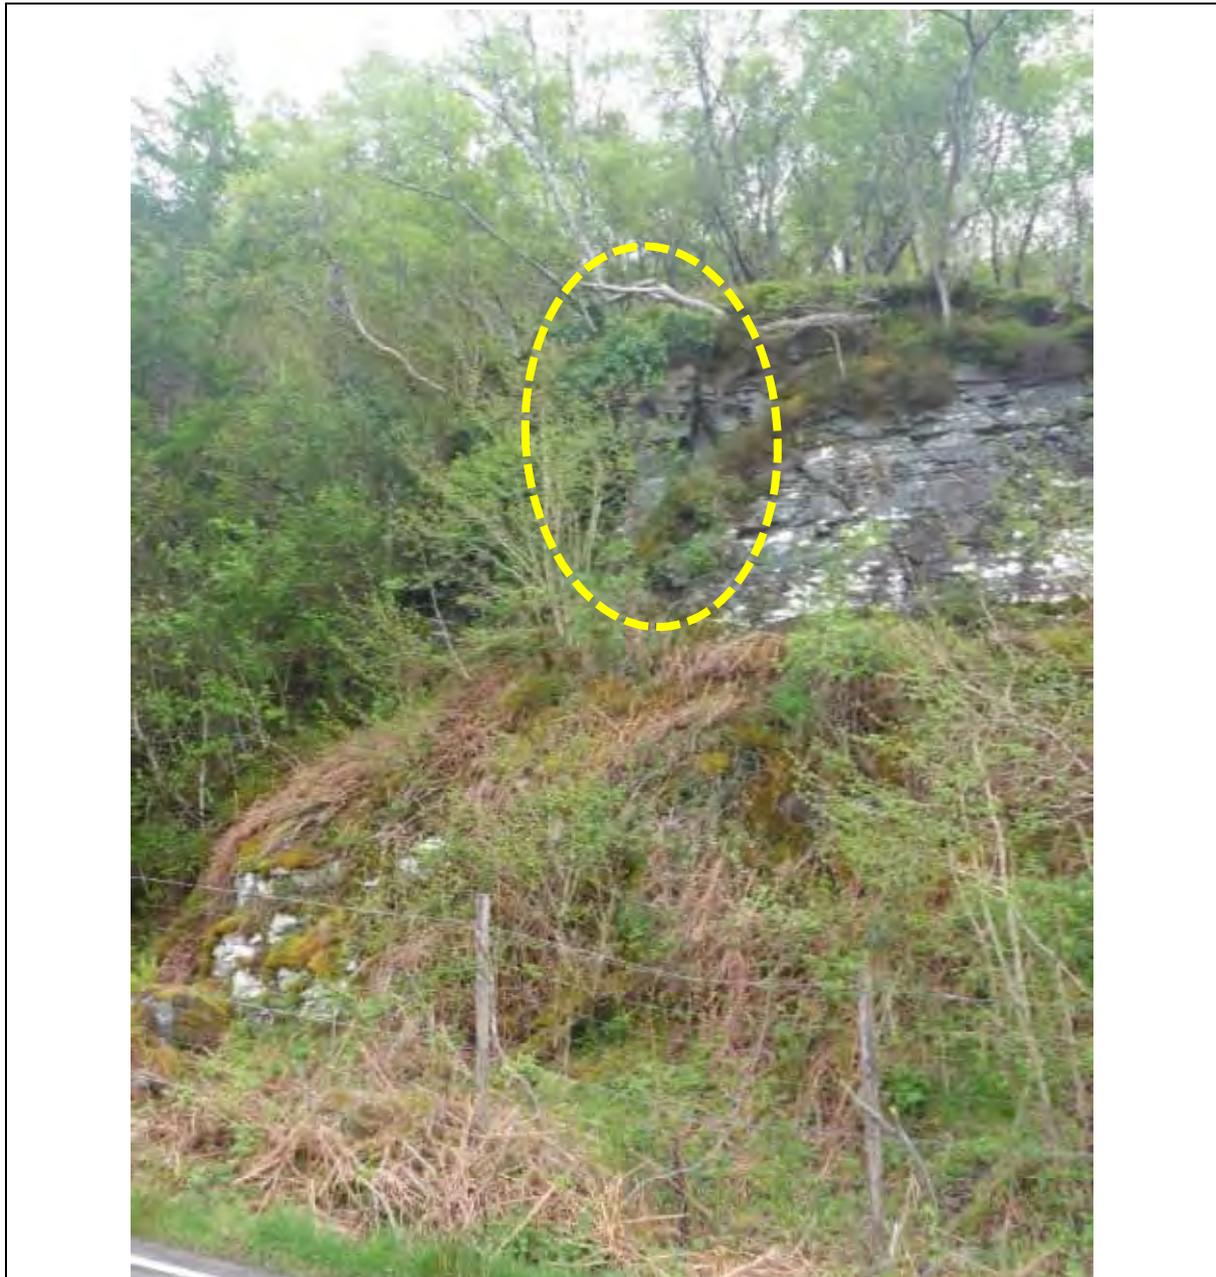
<p>AA3-1</p>	<p>Ch. 0573: Potential for toppling/block fall up to 2 m³ originating from 5 to 8 m above road level. There is a relatively flat 3.5 m wide verge and it is considered unlikely that blocks will reach road in event of a failure.</p>	<p>Year First Observed:</p>	<p>2016</p>
--------------	---	-----------------------------	-------------

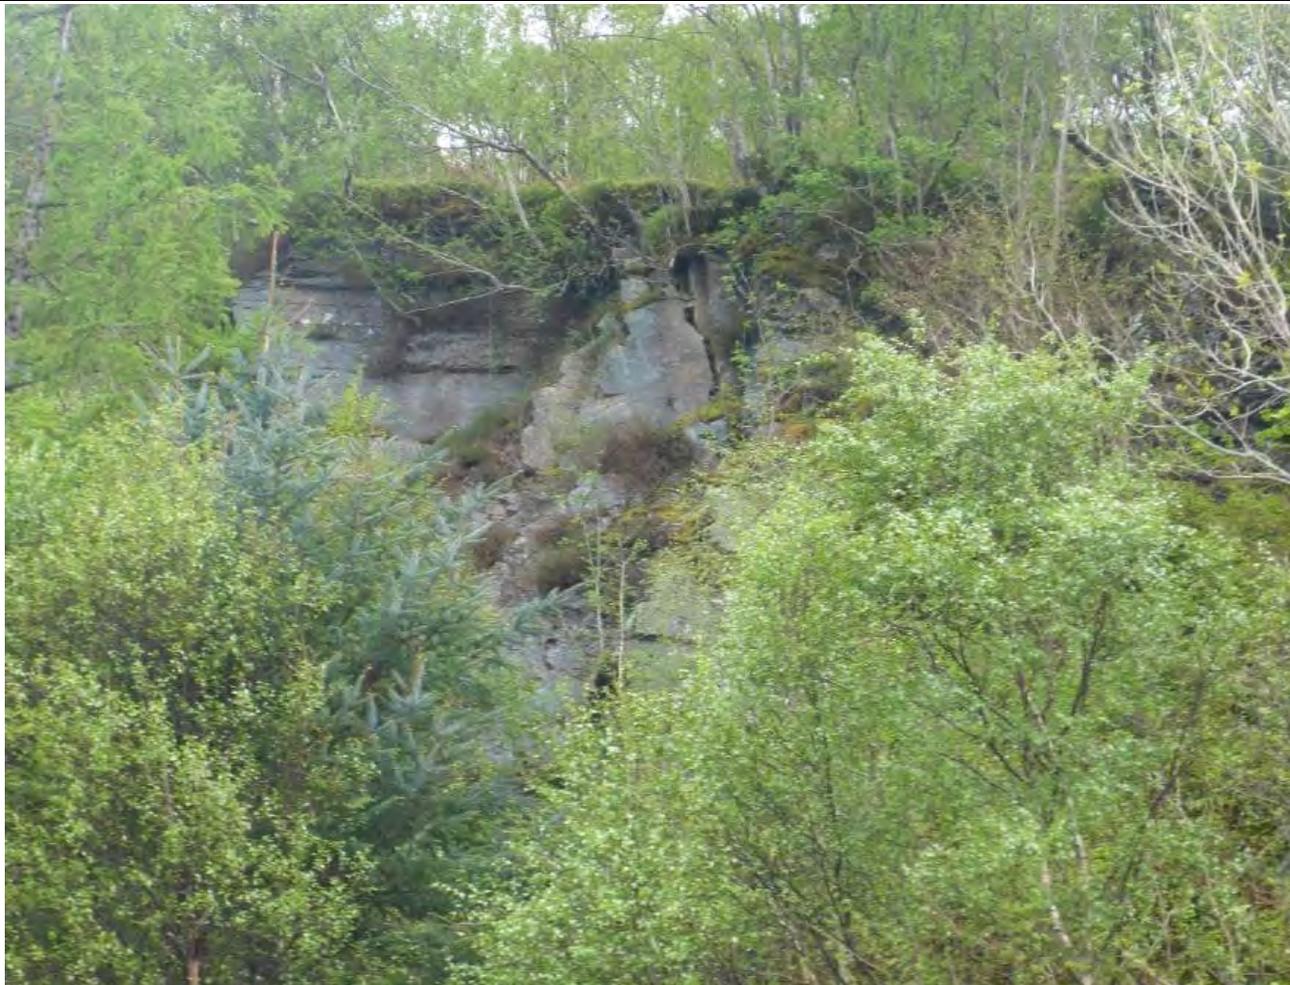
AA3-3	<p>Ch. 0600: Large block / slab of rock with dilated fractures and potential for root jacking at crest of rock slope. No significant change since last inspection. Set well back from road with adequate rock trap so low risk to road.</p>	Year First Observed:	2021
-------	---	----------------------	------

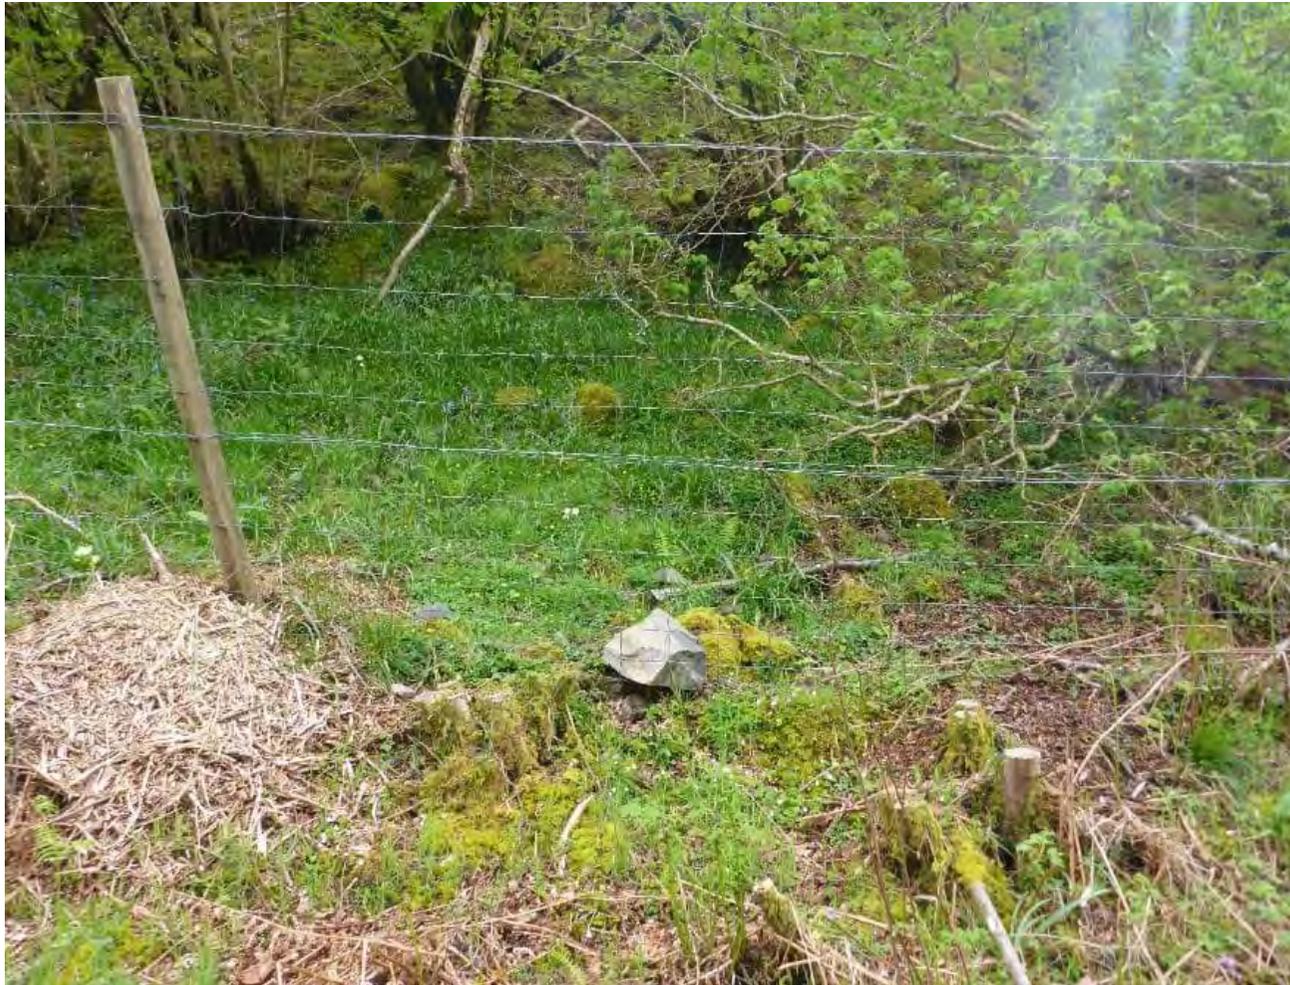
<p>AA3A-2</p>	<p>Ch. 0705 to 0715: 2024: Accumulation of small blocks behind deer fence. 2025: Four fresh rock fall blocks present amongst other blocks, distinguished by not having been overgrown with mass. Dimensions of largest block c. 0.3 x 0.2 x 0.1 m</p>	<p>Year First Observed:</p>	<p>2024</p>
---------------	---	-----------------------------	-------------

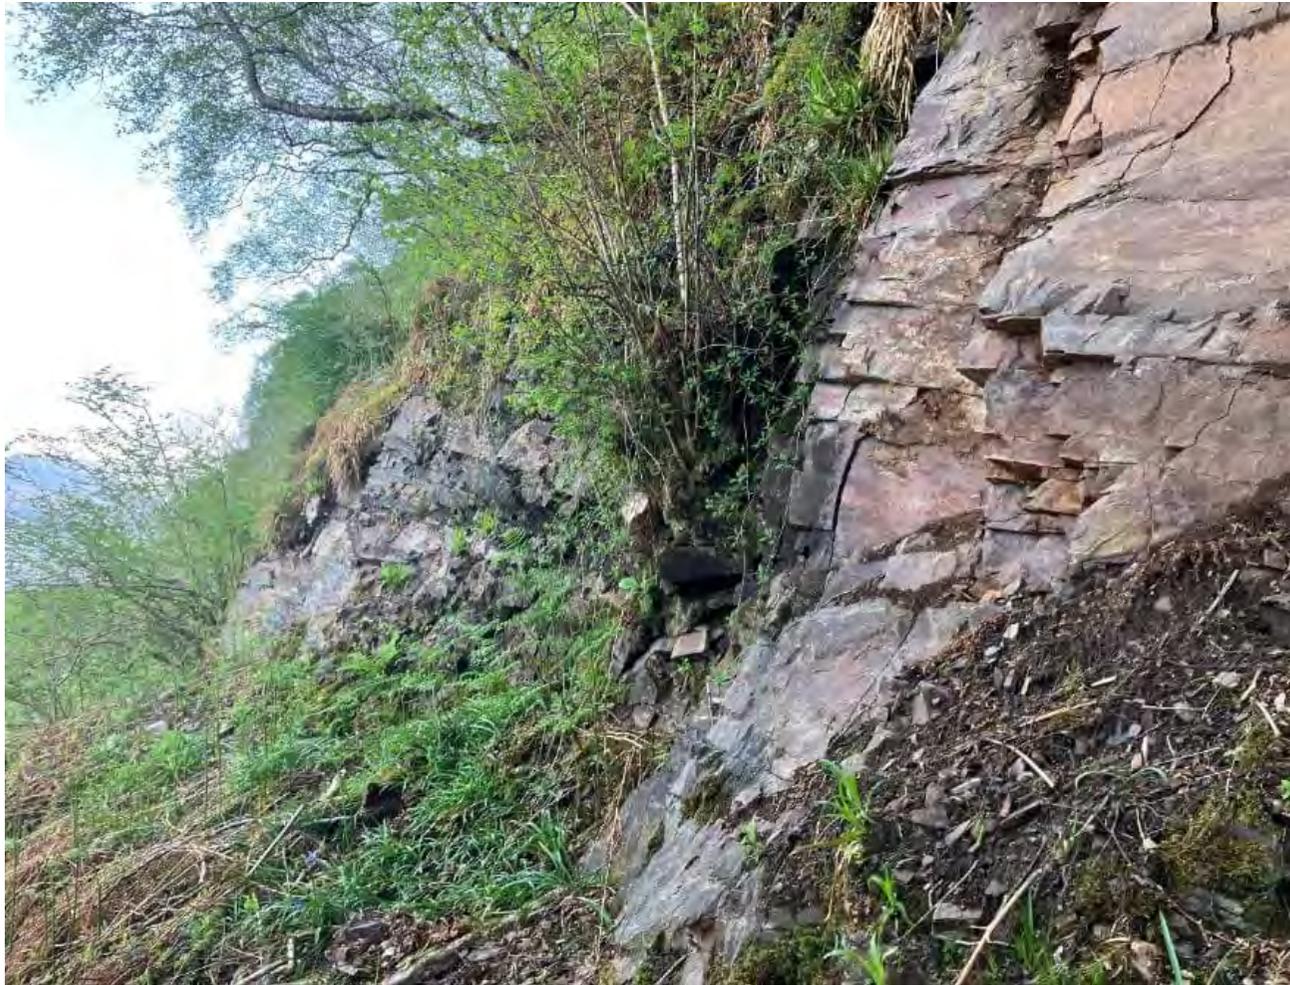
AA5-3	Scaling works from 2025 (Phase 13) has removed the majority of loose material from the crags upslope of Ch. 1360. Potential for future ravelling-type failure with root jacking of small blocks	Year First Observed:	2025
-------	---	----------------------	------

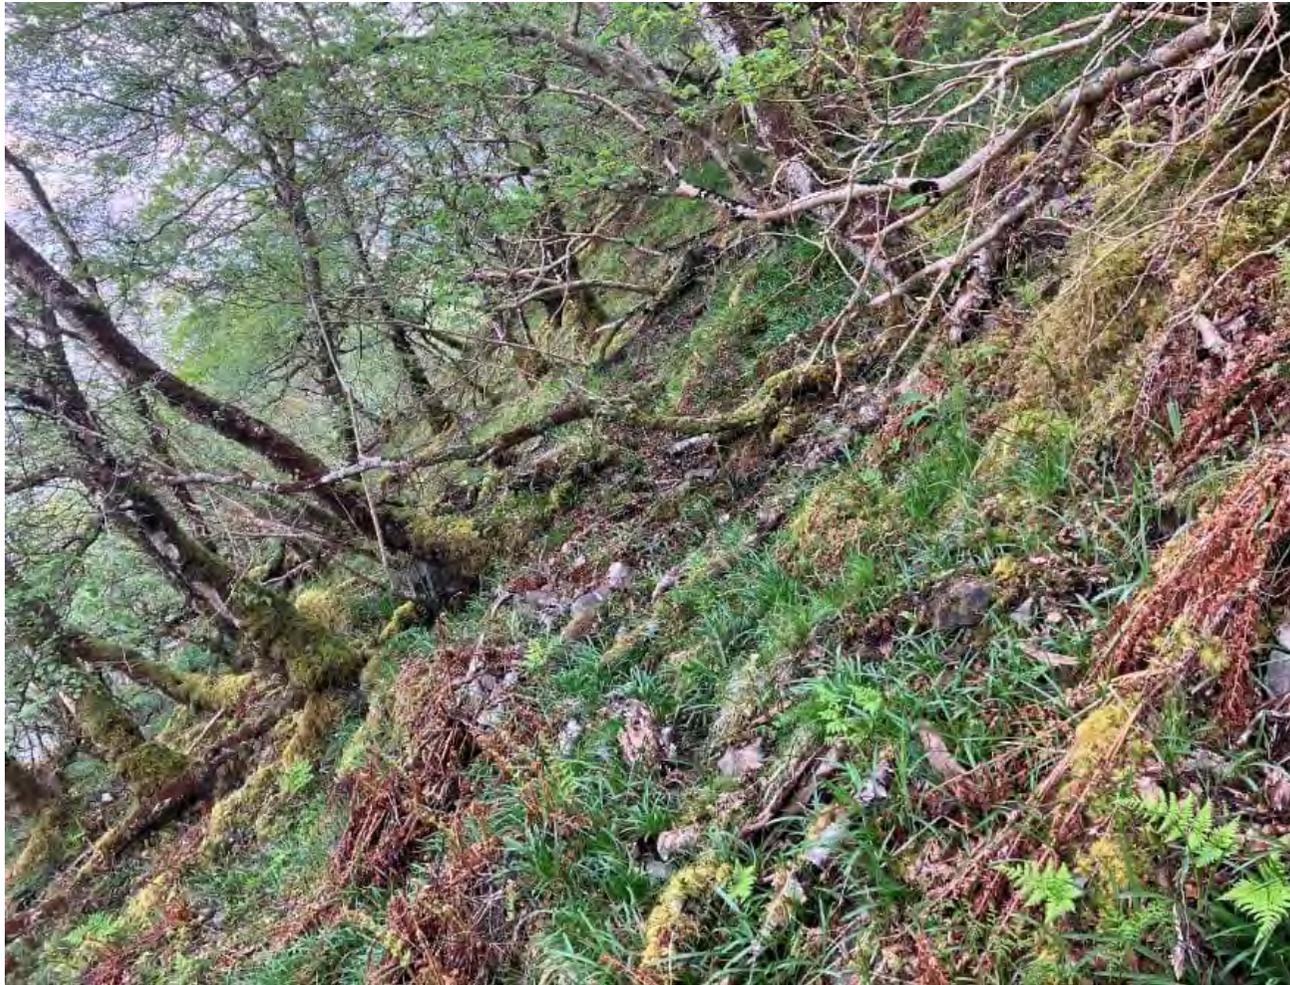
AA5-5	<ul style="list-style-type: none"> • Branches and loose rock debris remains at the toe of the upper slope (below the scaled area). This material could be disturbed and move downslope but is considered unlikely to impact road. 	Year First Observed:	2025
-------	--	----------------------	------

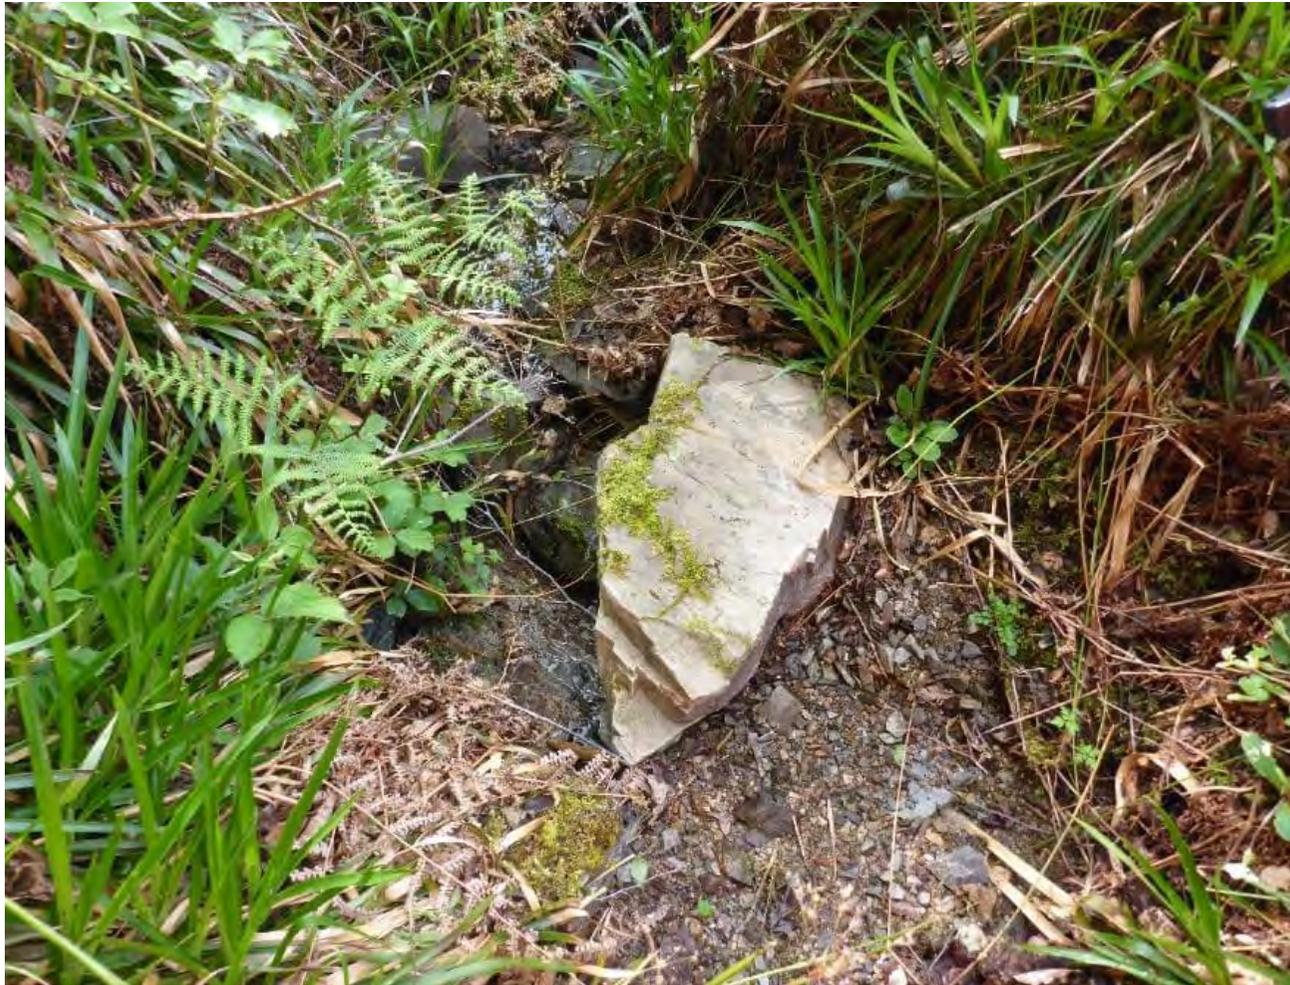
<p>AA5-8</p>	<p>Ch. 1380: Large block (0.7 x 0.3 x 0.2) present in ditch, appearing to have struck the roadside edge of the ditch before rolling/bouncing into the ditch. Deer fence broken by the impact and wiring has snapped. A small hollow with shattered rock and a groundwater flow is present slightly upslope of the block, but is likely unrelated. Source of the rock fall is unclear but the slope is steep and vegetated, i.e., potential for further blocks to be present on the slope but unobserved.</p>	<p>Year First Observed:</p>	<p>2025</p>
--------------	---	-----------------------------	-------------
