A890 Stromeferry Bypass

Annual Slope Inspection 2025

The Highland Council

Project number: 60685712
AECOM Report Ref.: GLRP0010

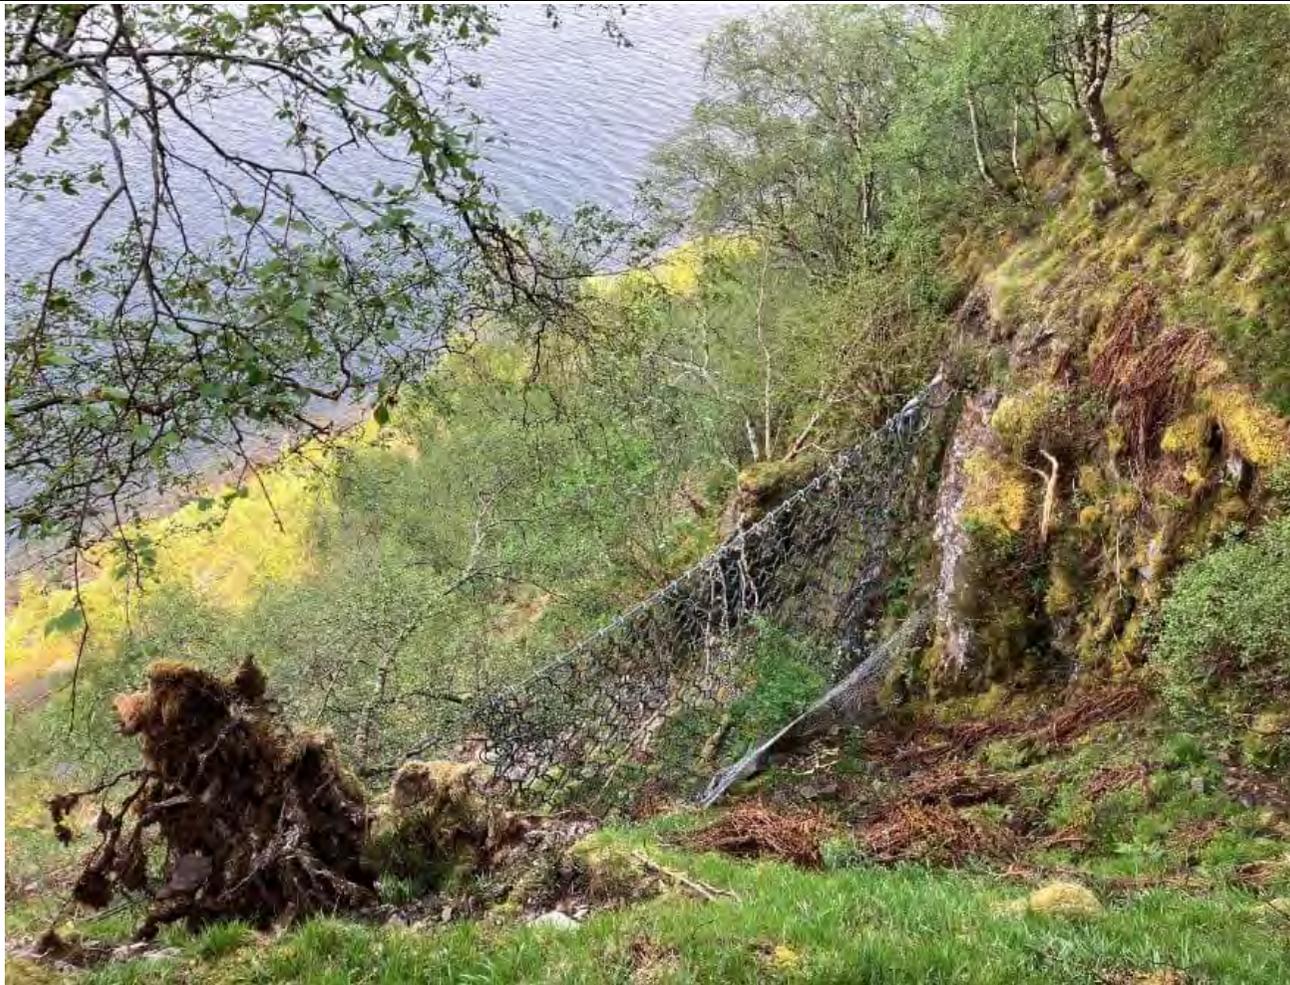
AA6A-1	Ch. 1511: Debris flow catch fence in good condition with no obvious signs of corrosion or blocks in fence; uprooted tree resting on top cable on west side, with root ball exposing broken rock mass	Year First Observed:	2025
--------	---	----------------------	------

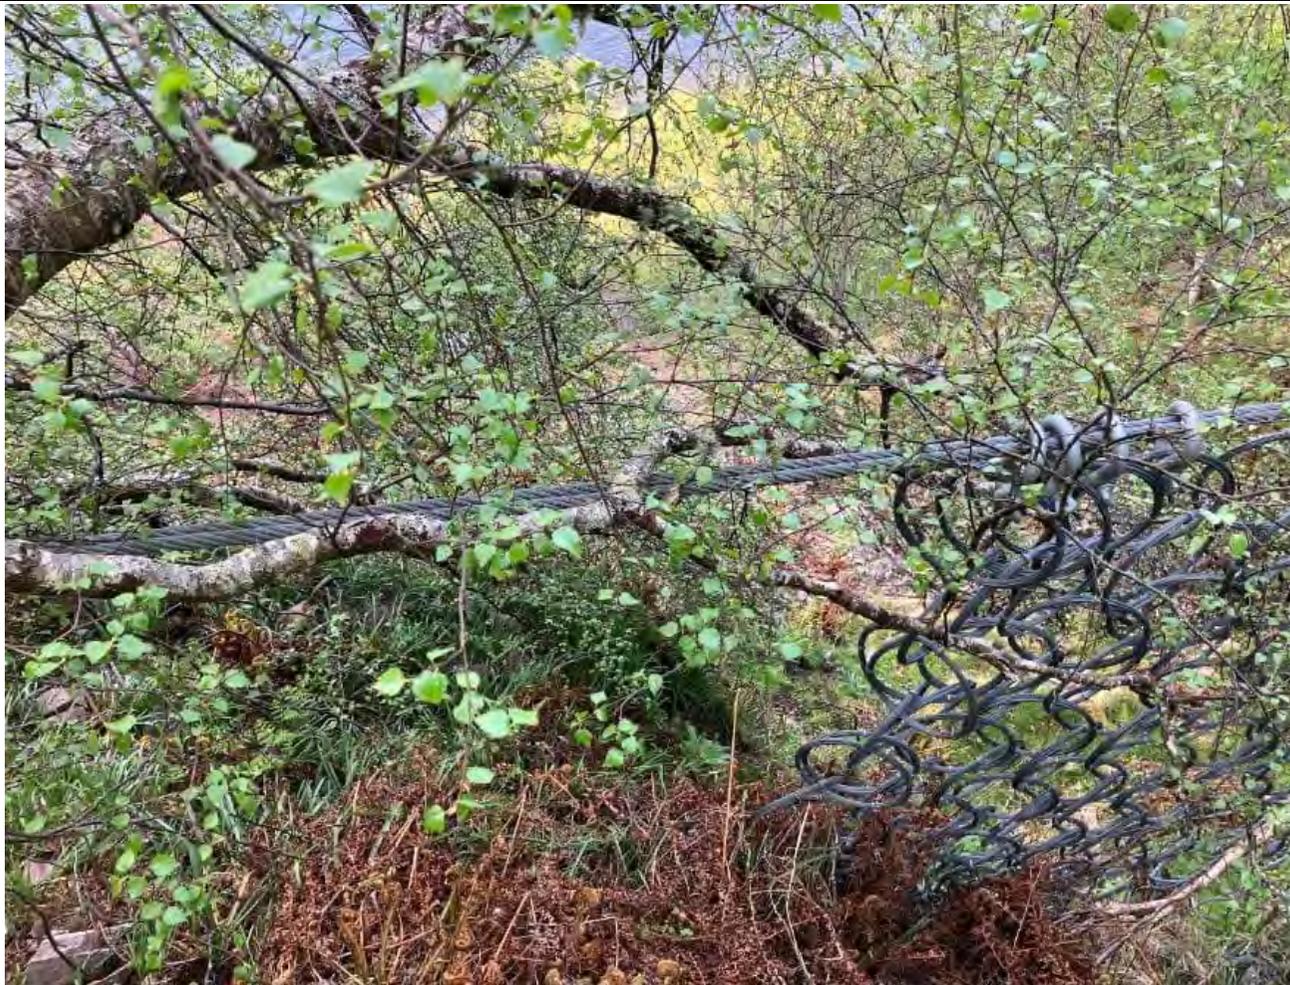
AA6A-2	Ch. 1511: Debris flow catch fence in good condition with no obvious signs of corrosion or blocks in fence; uprooted tree resting on top cable on west side, with root ball exposing broken rock mass	Year First Observed:	2025
--------	---	----------------------	------

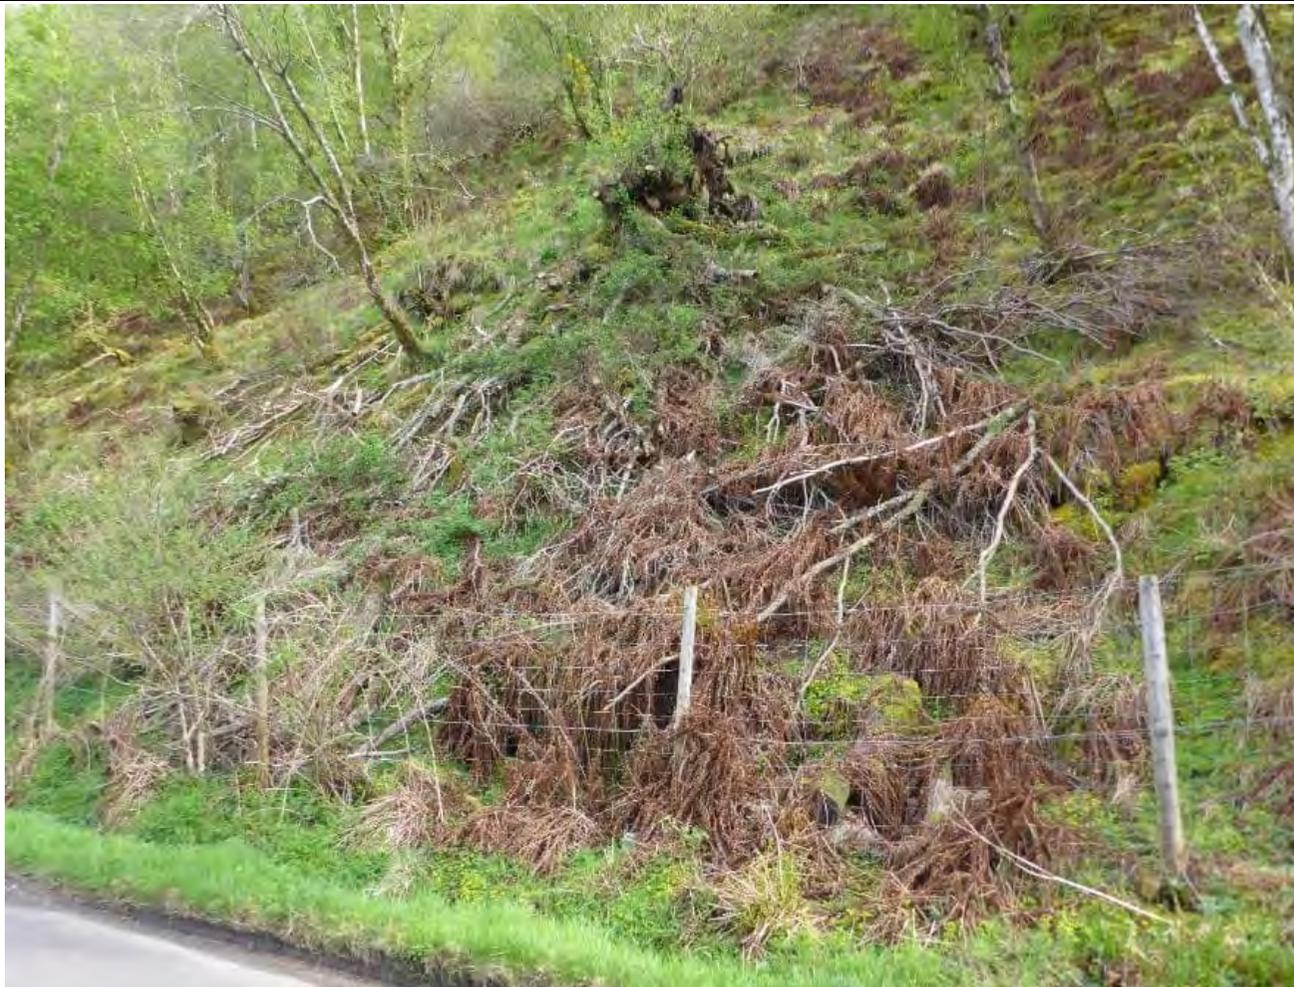
AA6B-2	Ch. 1708: Fallen trees first observed in 2020 and cut back in 2024 have been coppiced, with cut branches distributed across the slope.	Year First Observed:	2020
--------	---	----------------------	------

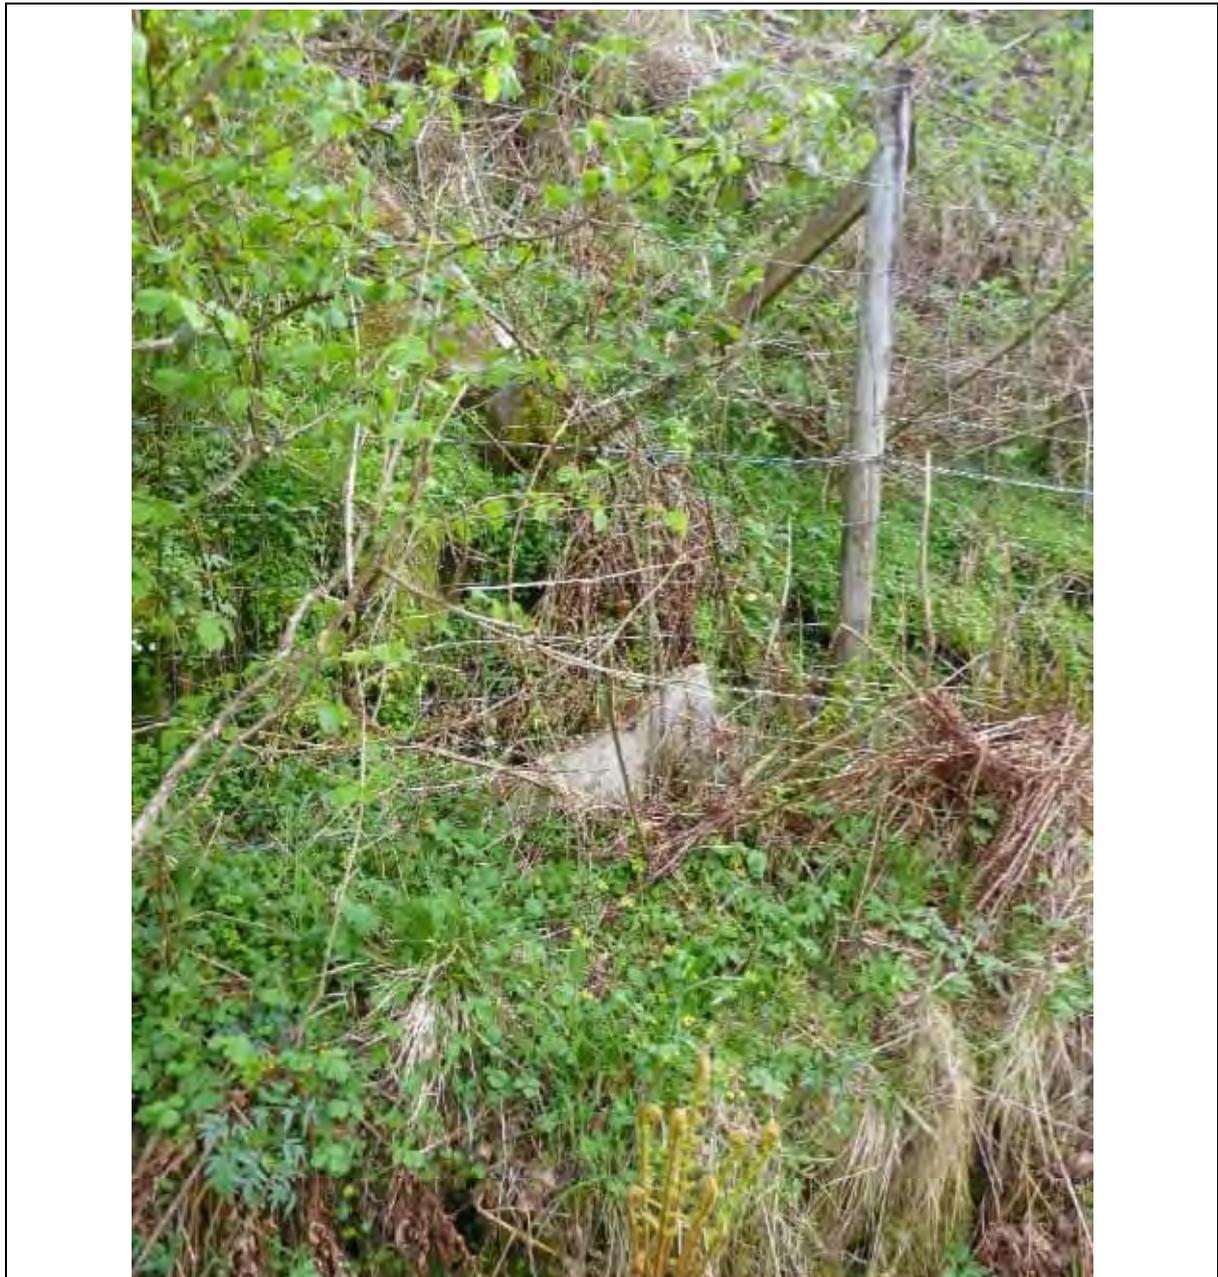
AA6B-3	Ch. 1714: 2025: 0.8 x 0.5 x 0.15 m block resting against deer fence; appears to be an older rock fall.	Year First Observed:	2025
--------	---	----------------------	------

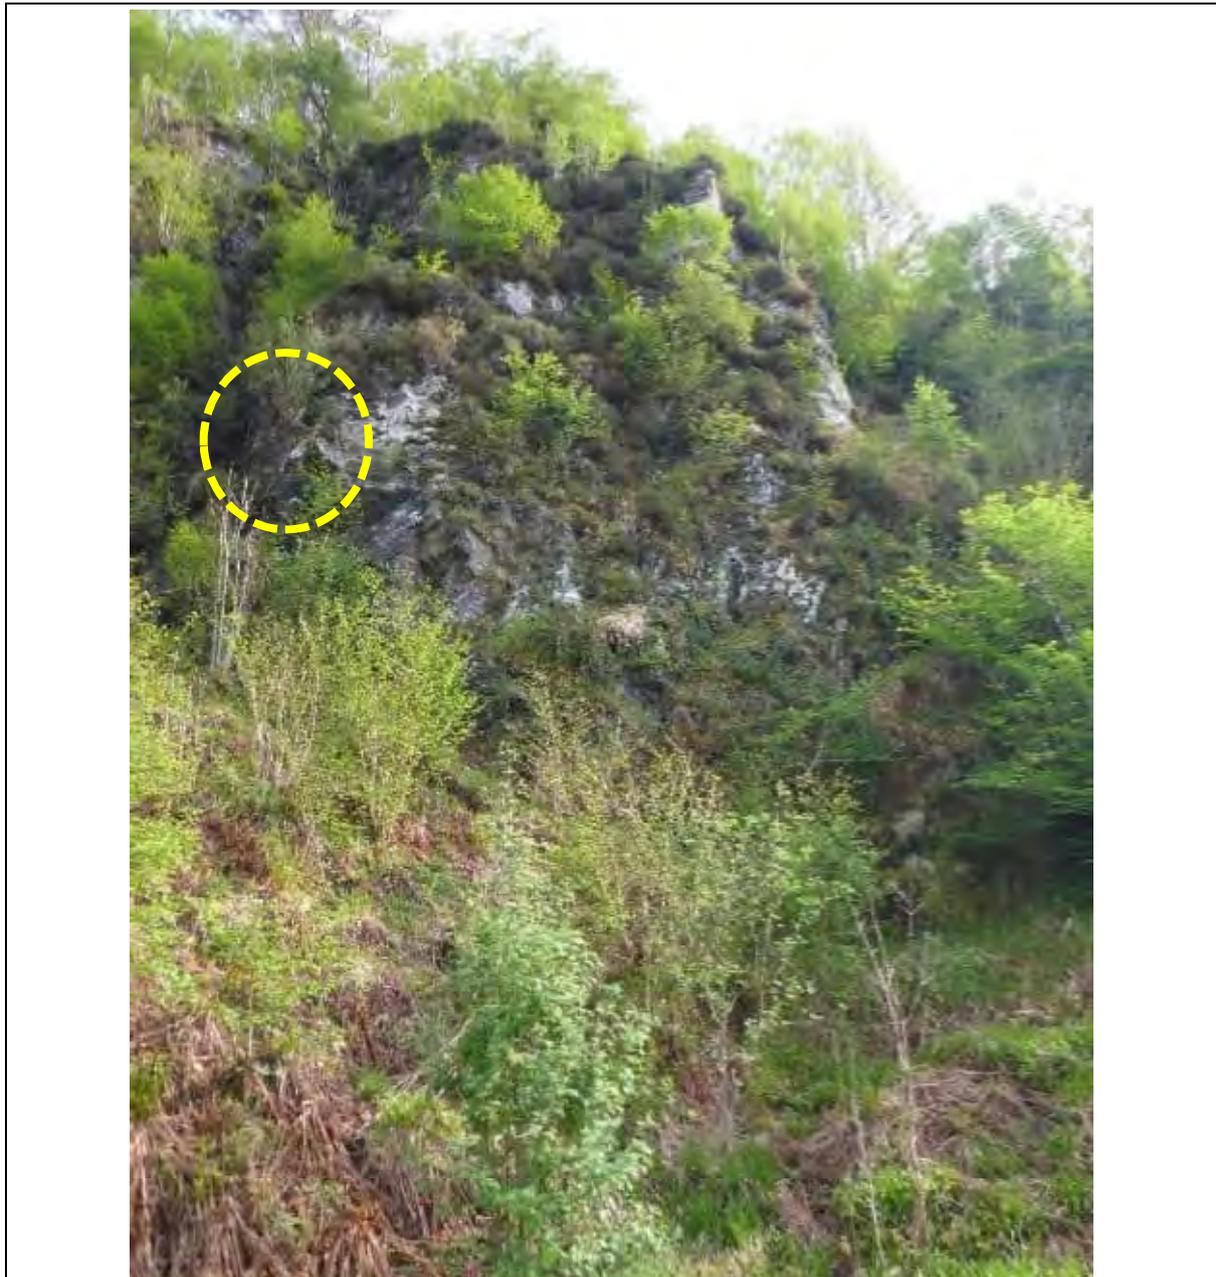
AA7-1	<p>Phase 13 Works – Ch. 1820 to 1826: Area proposed to be scaled during Phase 13 works which was de-scoped following review of risk and accessibility; likelihood of a natural rock fall to reach the road is relatively low.</p>	<p>Year First Observed:</p>	<p>2025</p>
-------	--	-----------------------------	-------------

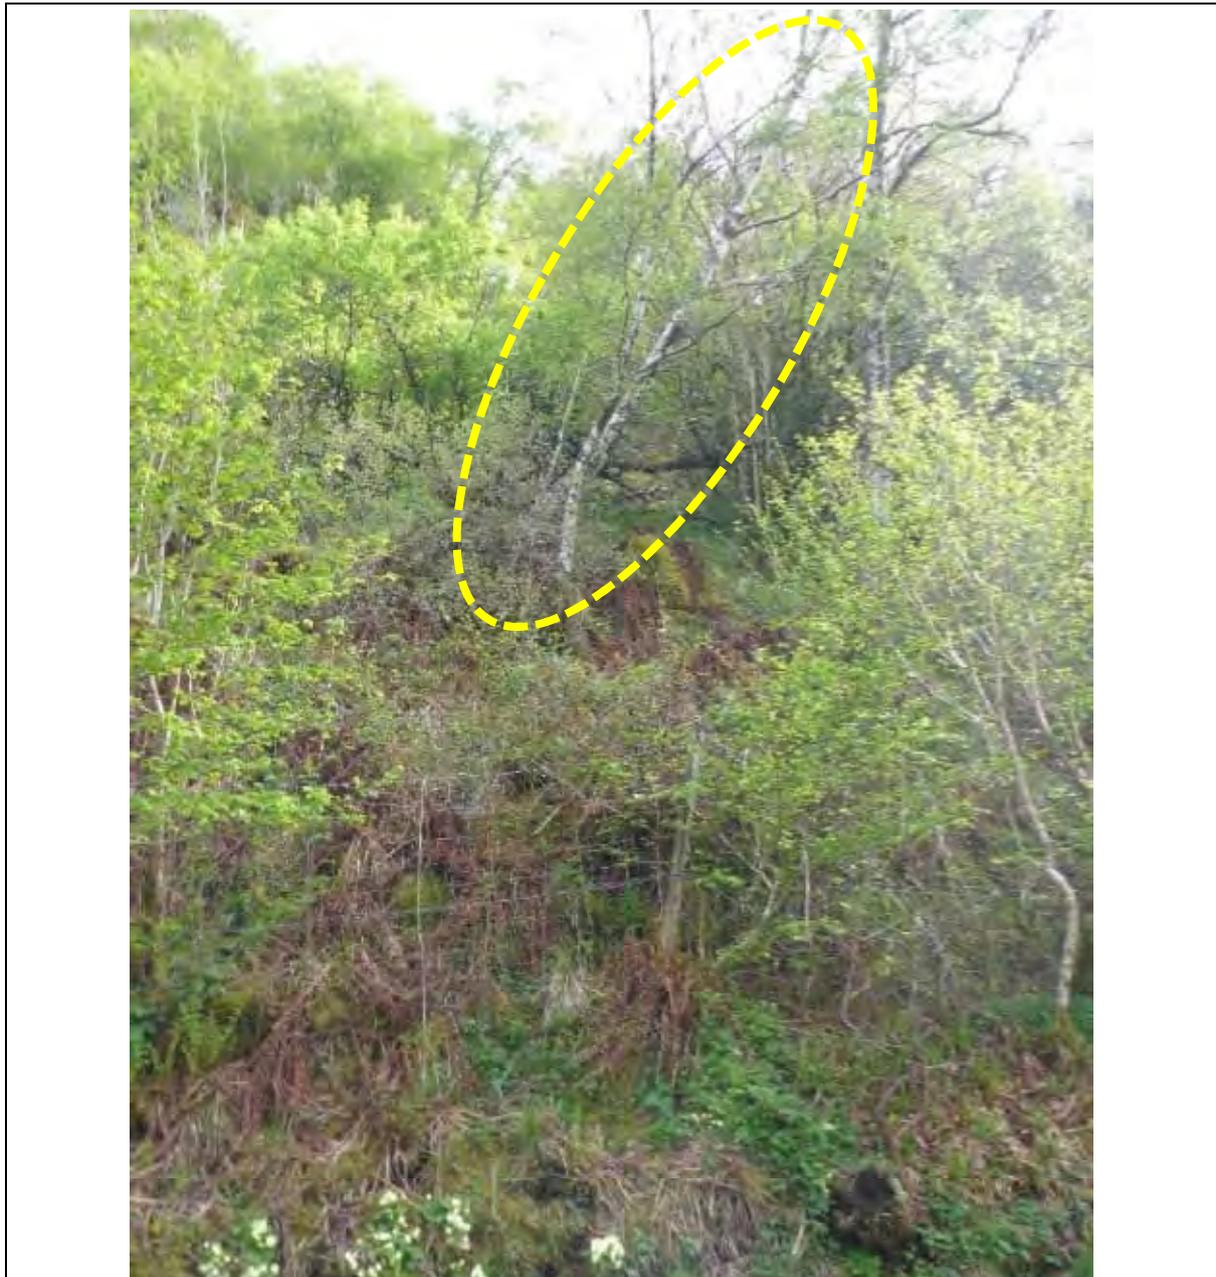
<p>AA7-2</p>	<p>Ch. 1760: 2025: Severely leaning tree c. 8 m above road level. May dislodge boulders if it were to fall but poses relatively low risk to road.</p>	<p>Year First Observed:</p>	<p>2025</p>
--------------	---	-----------------------------	-------------

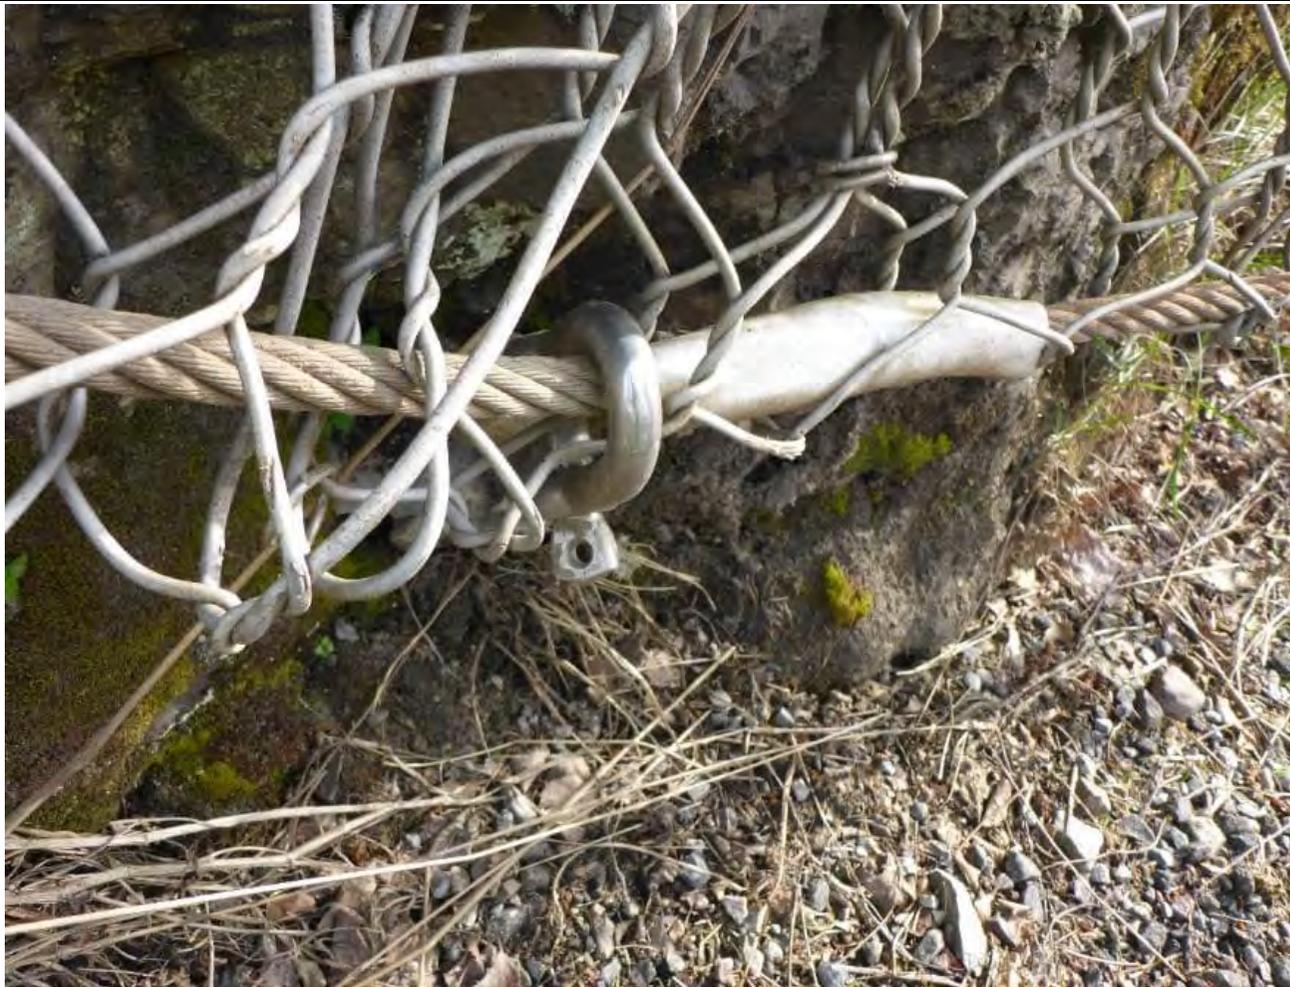
AA8-1	Netting between Ch. 1895 and 1932: Bottom anchors and shackles are stainless steel. There is a plastic sheathing, however, locally the shackles are in contact with the galvanised cable. PVC coating cracking locally; no corrosion of wire where visible.	Year First Observed:	2012
-------	---	----------------------	------

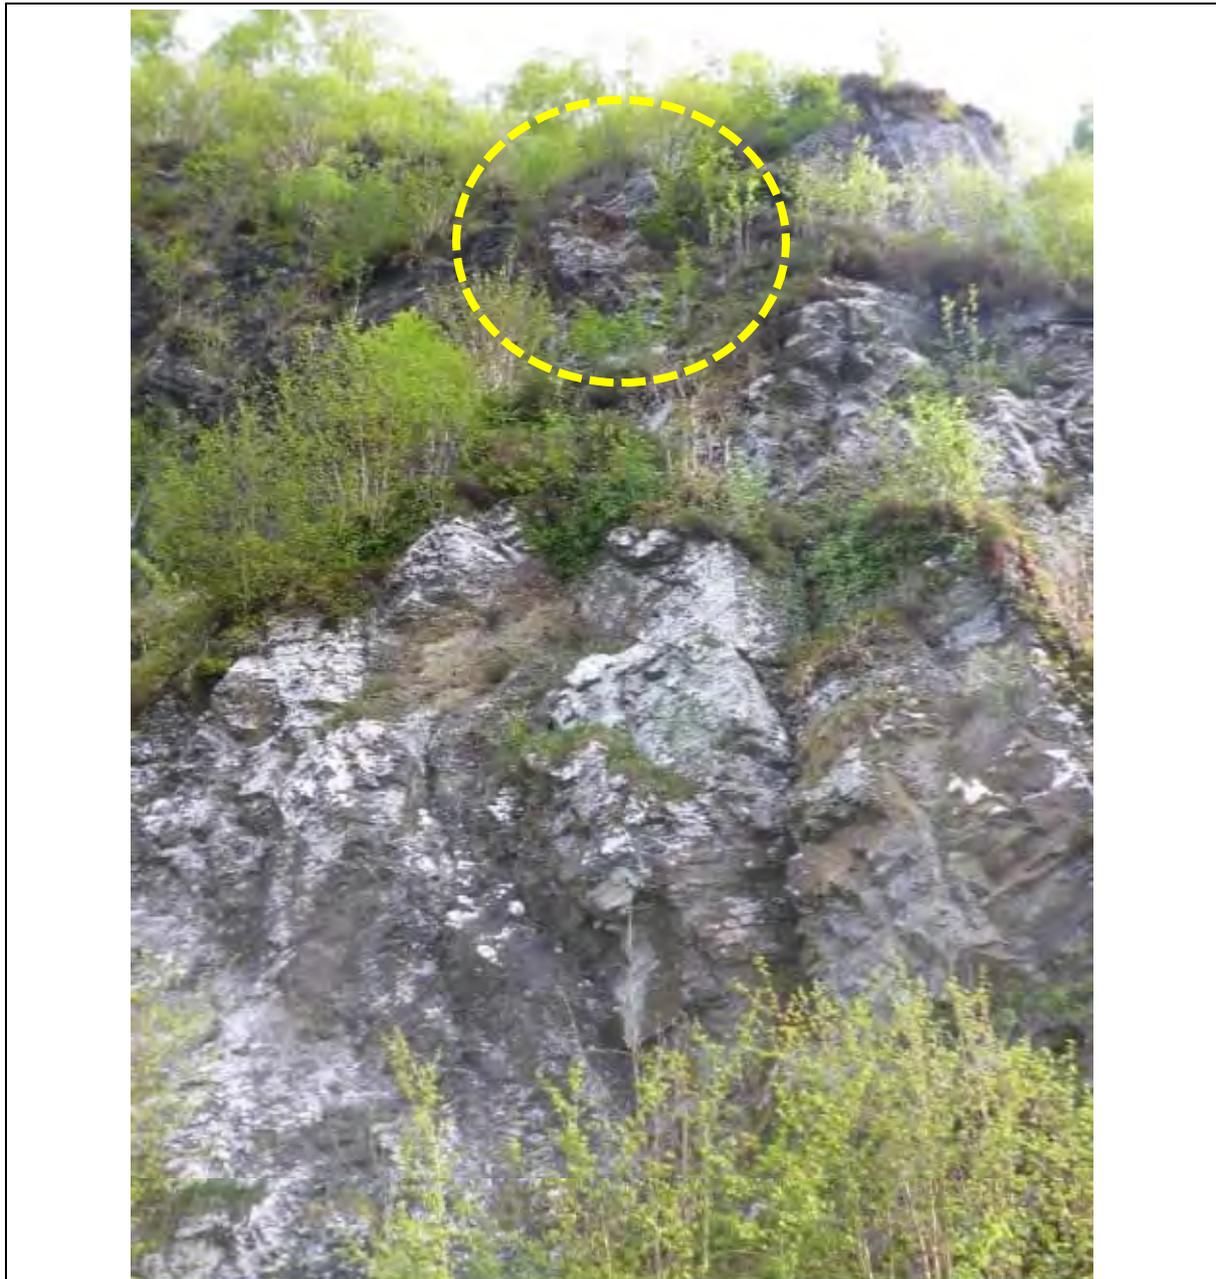
<p>AA9-1</p>	<p>Ch. 1978: 2020: Overhanging square blocks near crest with dilated joint at rear observed. Rope access inspection completed in 2021. 2025: No changes observed during 2025 inspection.</p>	<p>Year First Observed:</p>	<p>2020</p>
--------------	--	-----------------------------	-------------

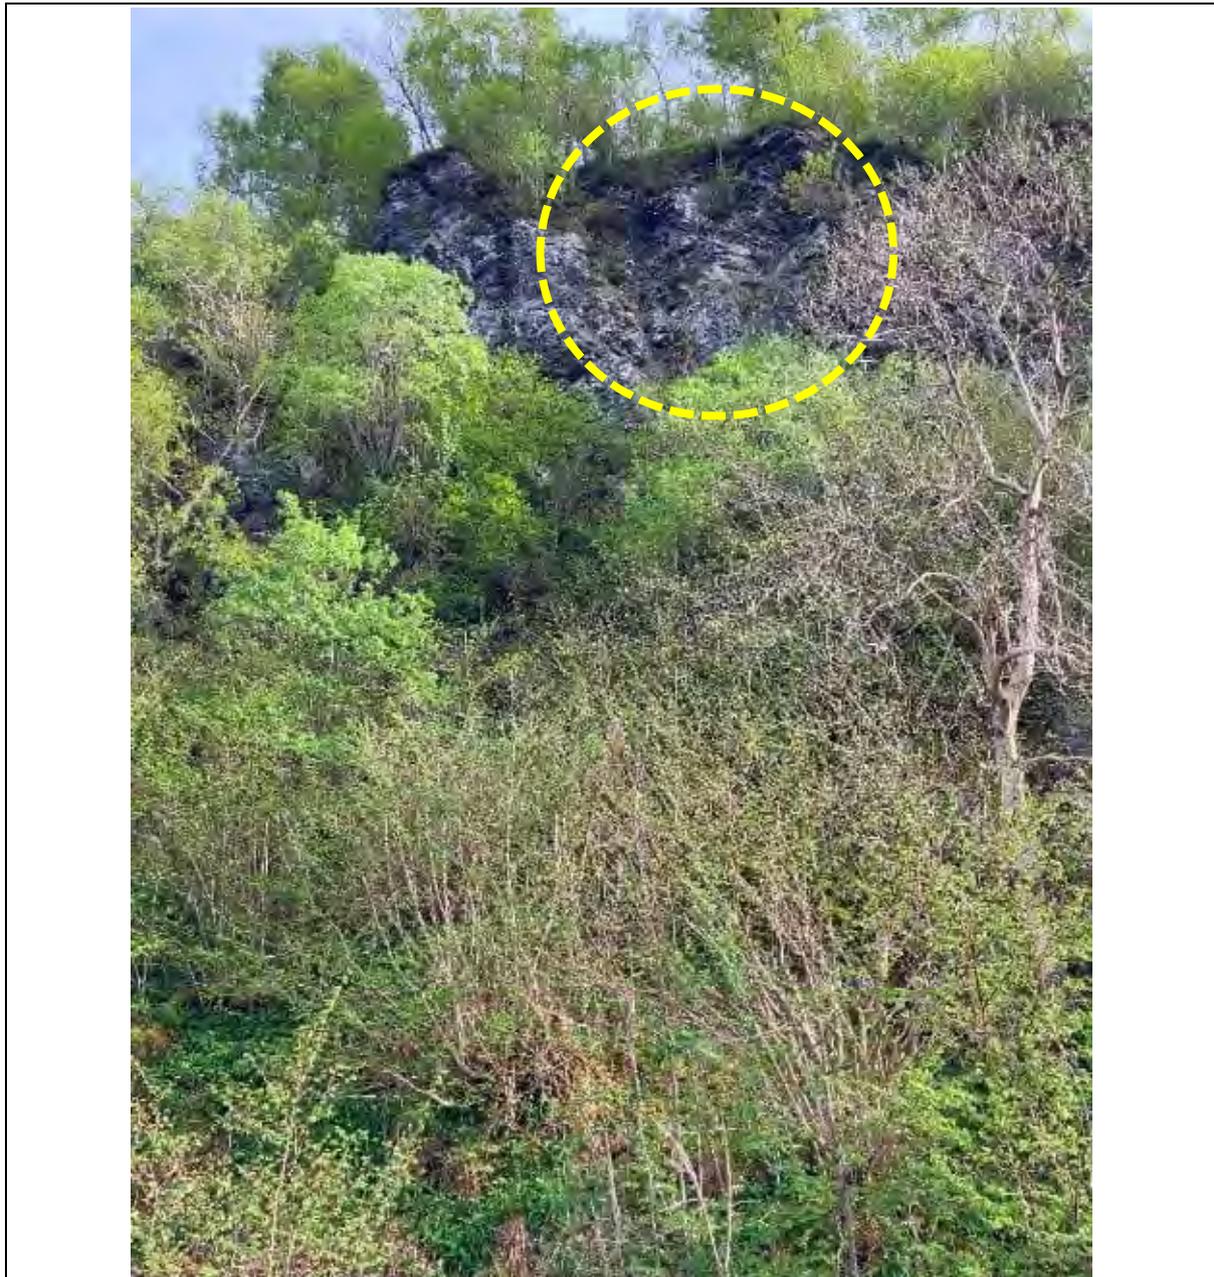
<p>AA10-7</p>	<p>Ch. 2000: 2012: Large scale potential wedge failure. c. 10 m wide x 10 m high feature at the crest of the rock slope. No evidence of dilated fractures here and mass failure considered unlikely. 2025: No changes observed during 2025 inspection.</p>	<p>Year First Observed:</p>	<p>2012</p>
---------------	--	-----------------------------	-------------

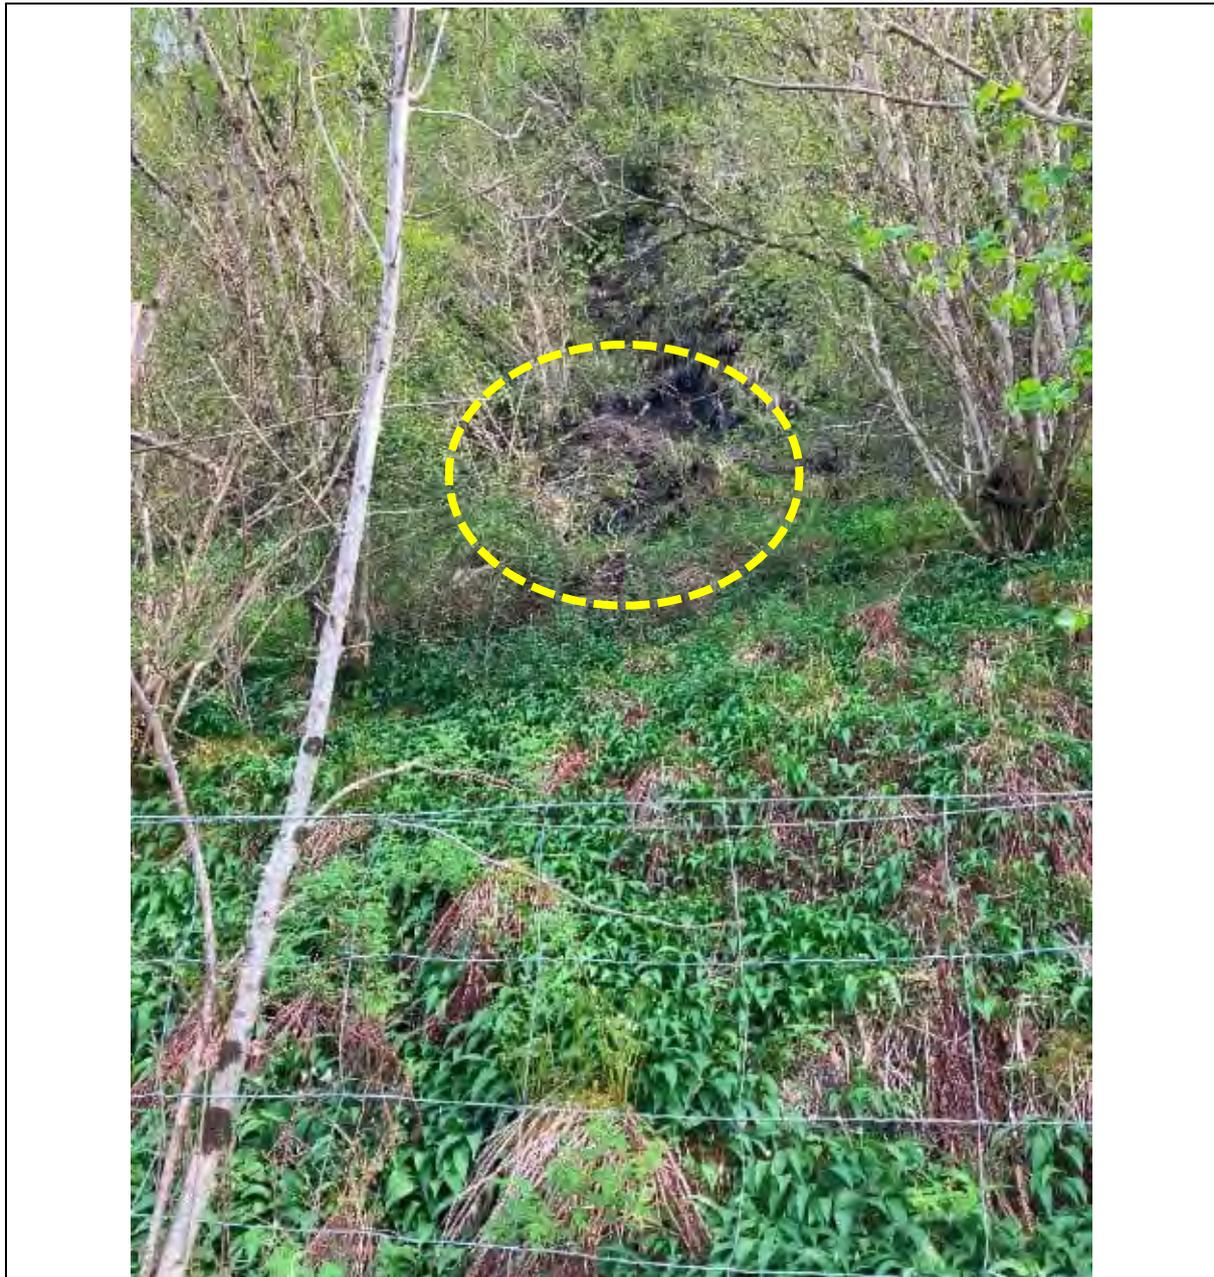
<p>AA10-8</p>	<p>Ch. 2030: 2024: Tree has fallen down c. 15 m above road level and washout present. Soil, vegetation, and tree are resting on slope c. 6 m above road. Source area does not pose an increased risk of rock fall. 2025: No changes observed during 2025 inspection.</p>	<p>Year First Observed:</p>	<p>2024</p>
---------------	--	-----------------------------	-------------

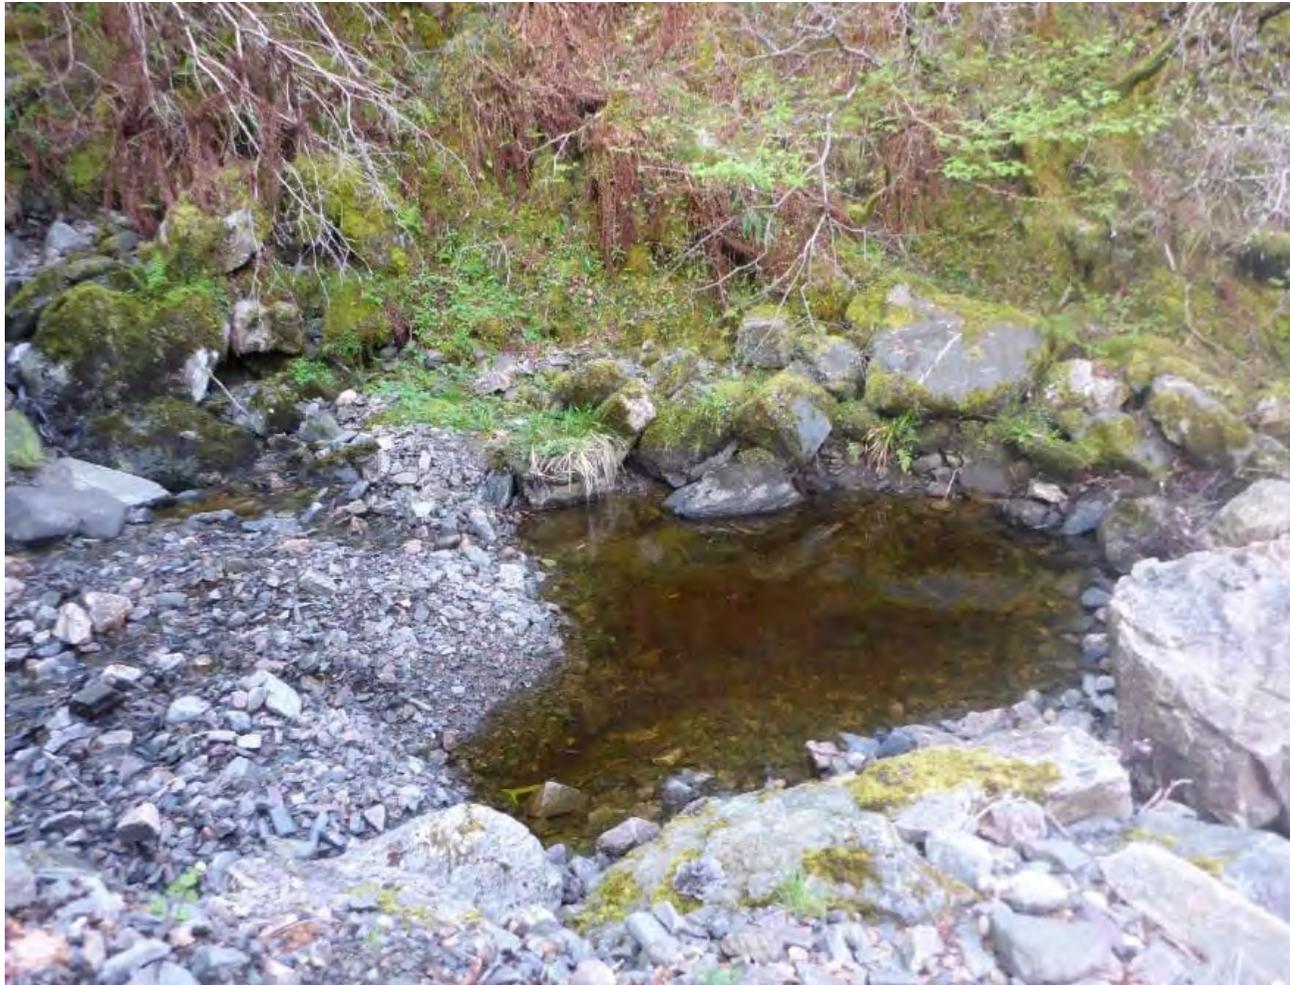
FB-1	Ch. 2315: Upper catch basin 60 to 70% full.	Year First Observed:	2021
------	--	----------------------	------

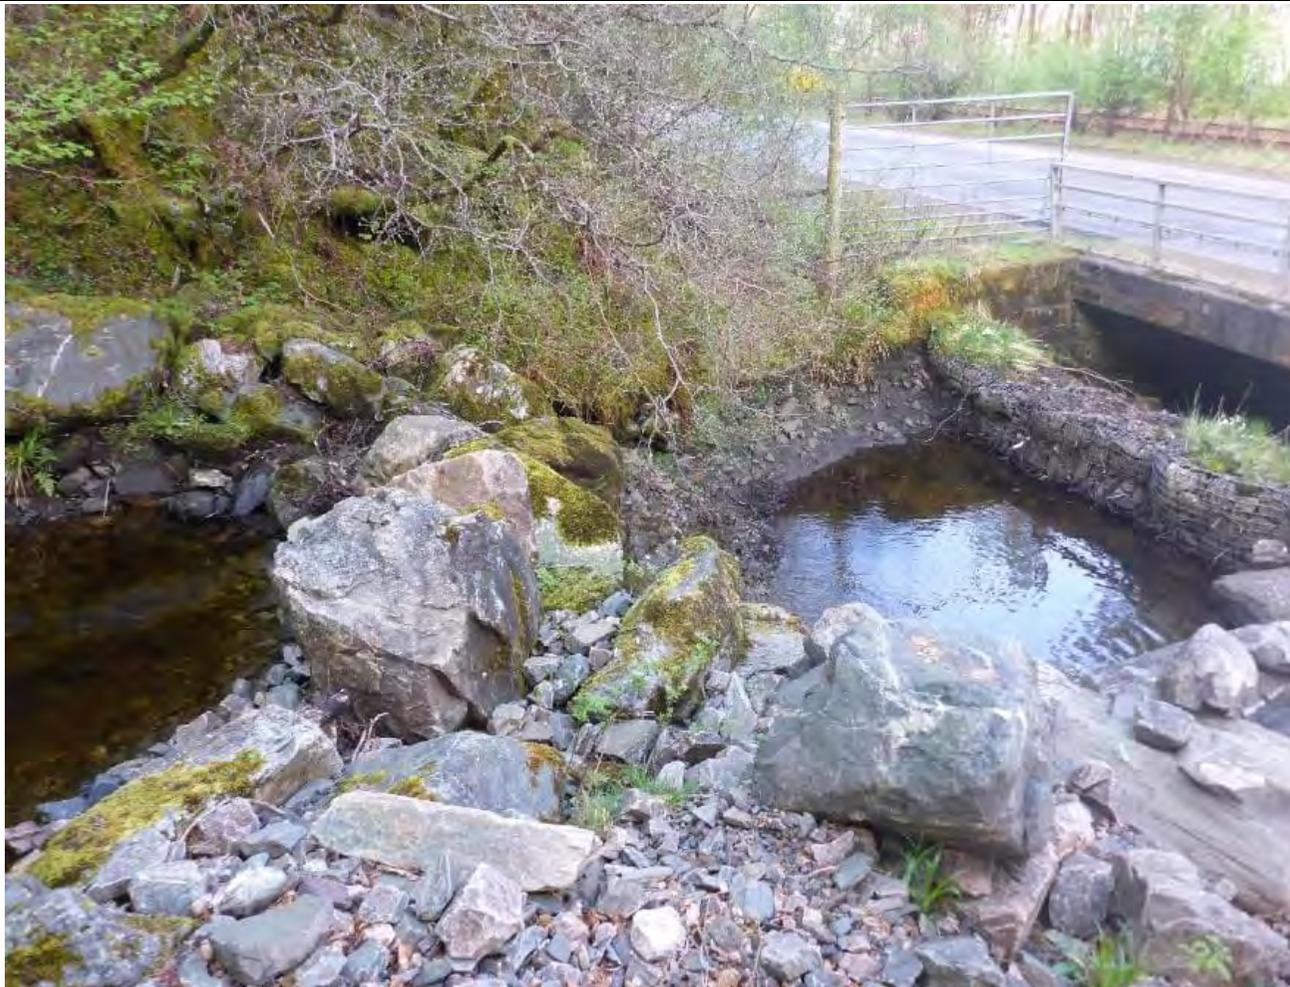
FB-2	Ch. 2315: Lower catch basin 25% full.	Year First Observed:	2021
------	--	----------------------	------

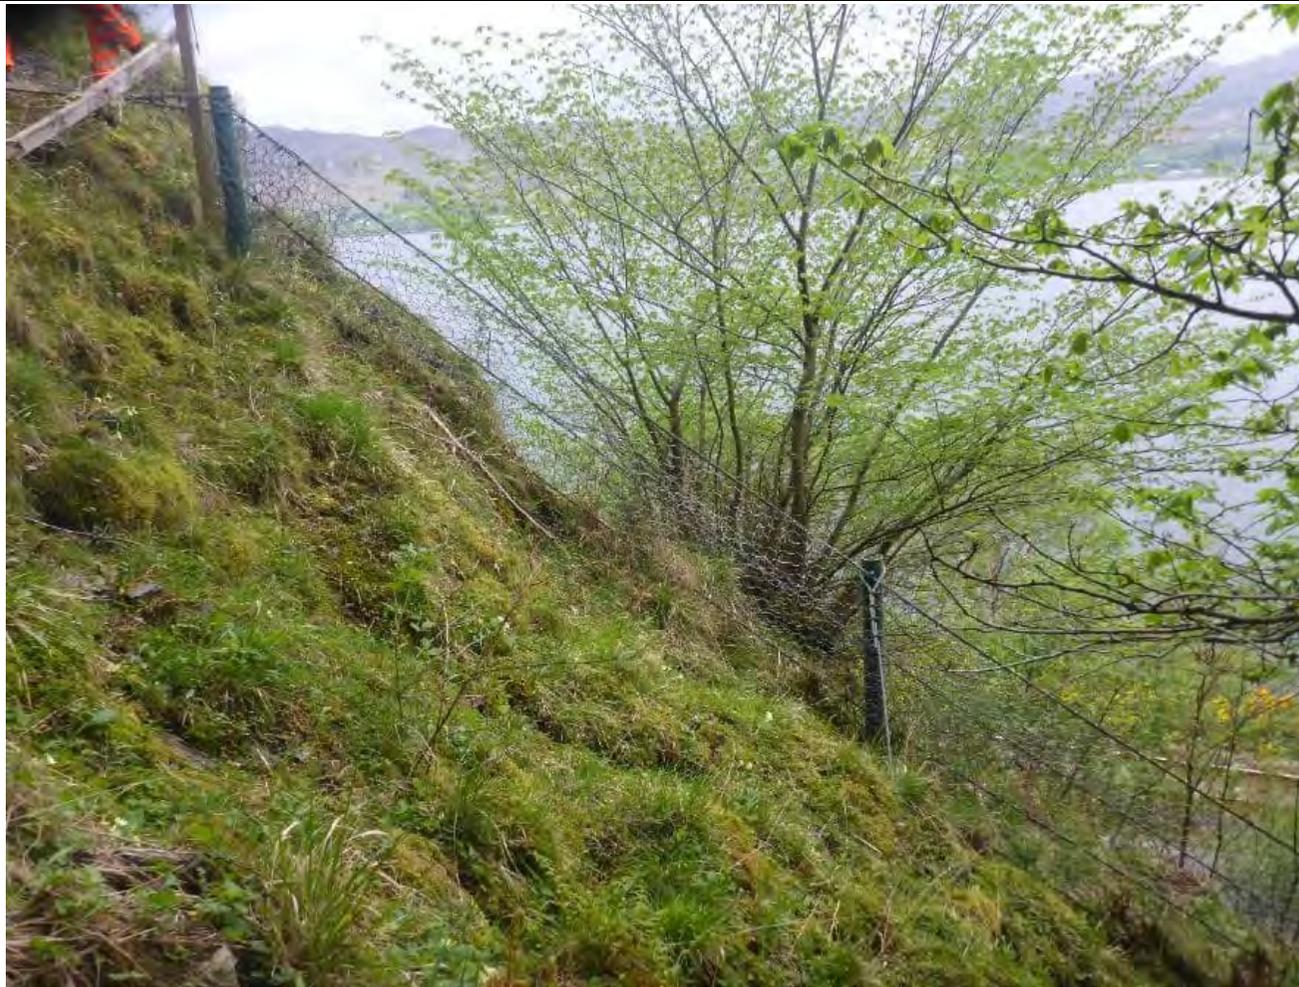
AA14E-1	Catch fence installed pre-2012 positioned mid-slope, c. 1.5 m high.	Year First Observed:	2012
---------	---	----------------------	------

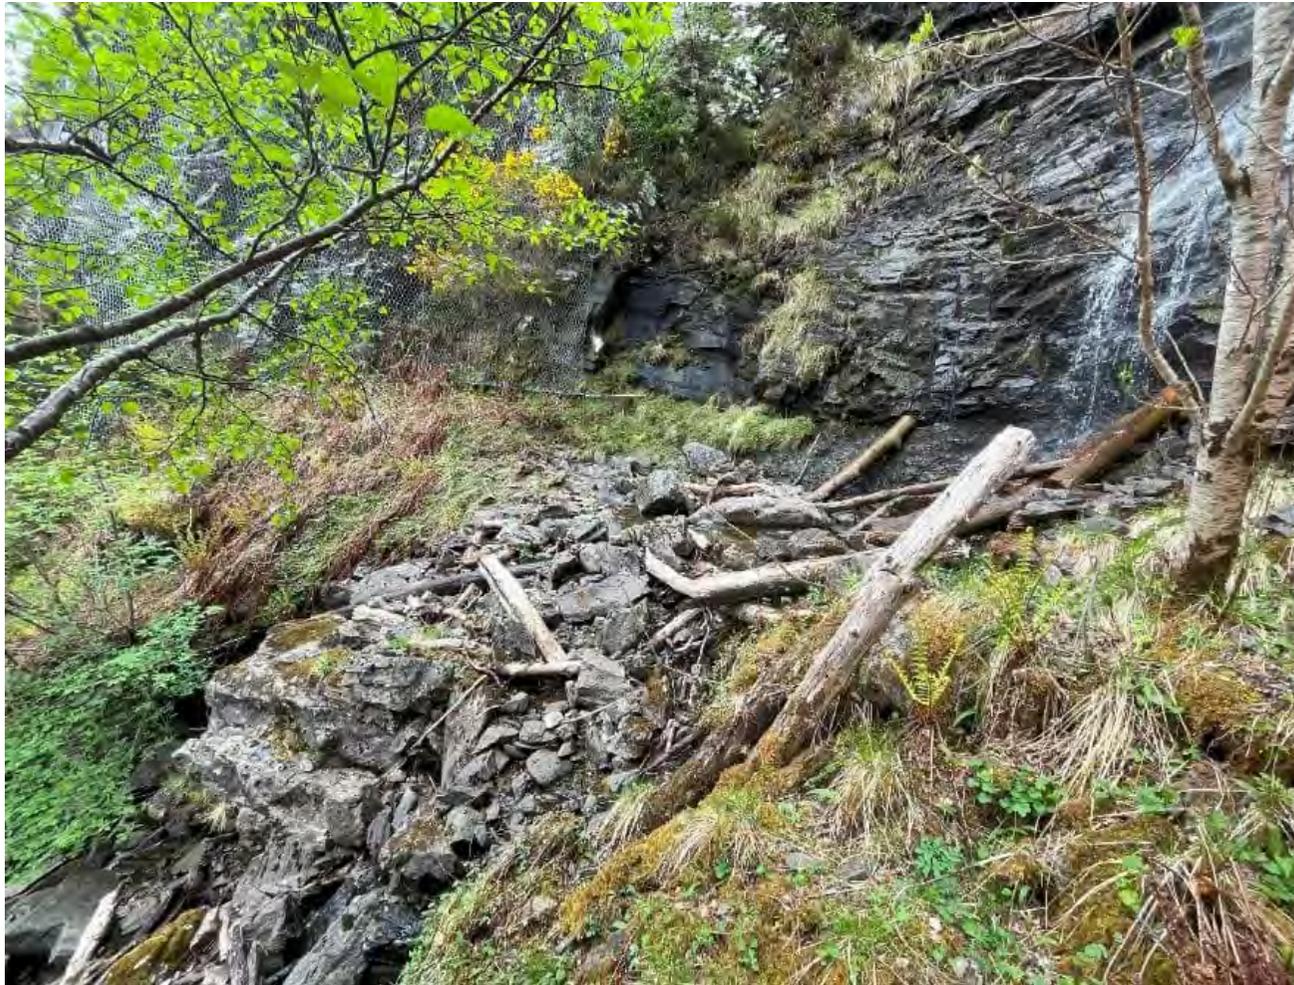
AA14E-2	Base of waterfall – view along possible line of in-channel debris barrier.	Year First Observed:	2012
---------	--	----------------------	------

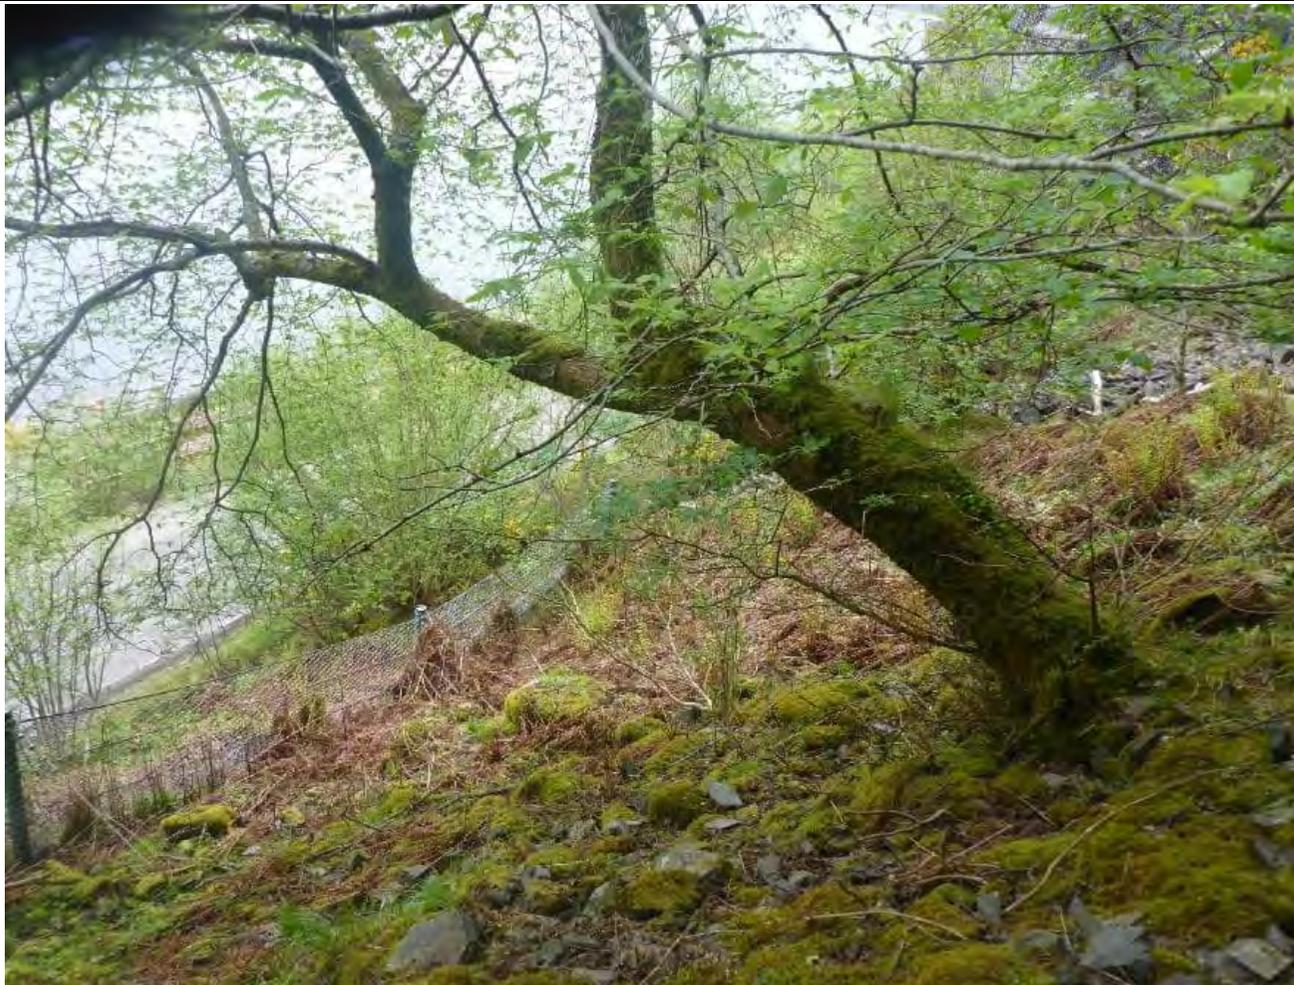
AA14E-5	Leaning tree growing within scree slope between rock face and catch fence. Potential for scree to be destabilised if tree falls.	Year First Observed:	2012
---------	--	----------------------	------

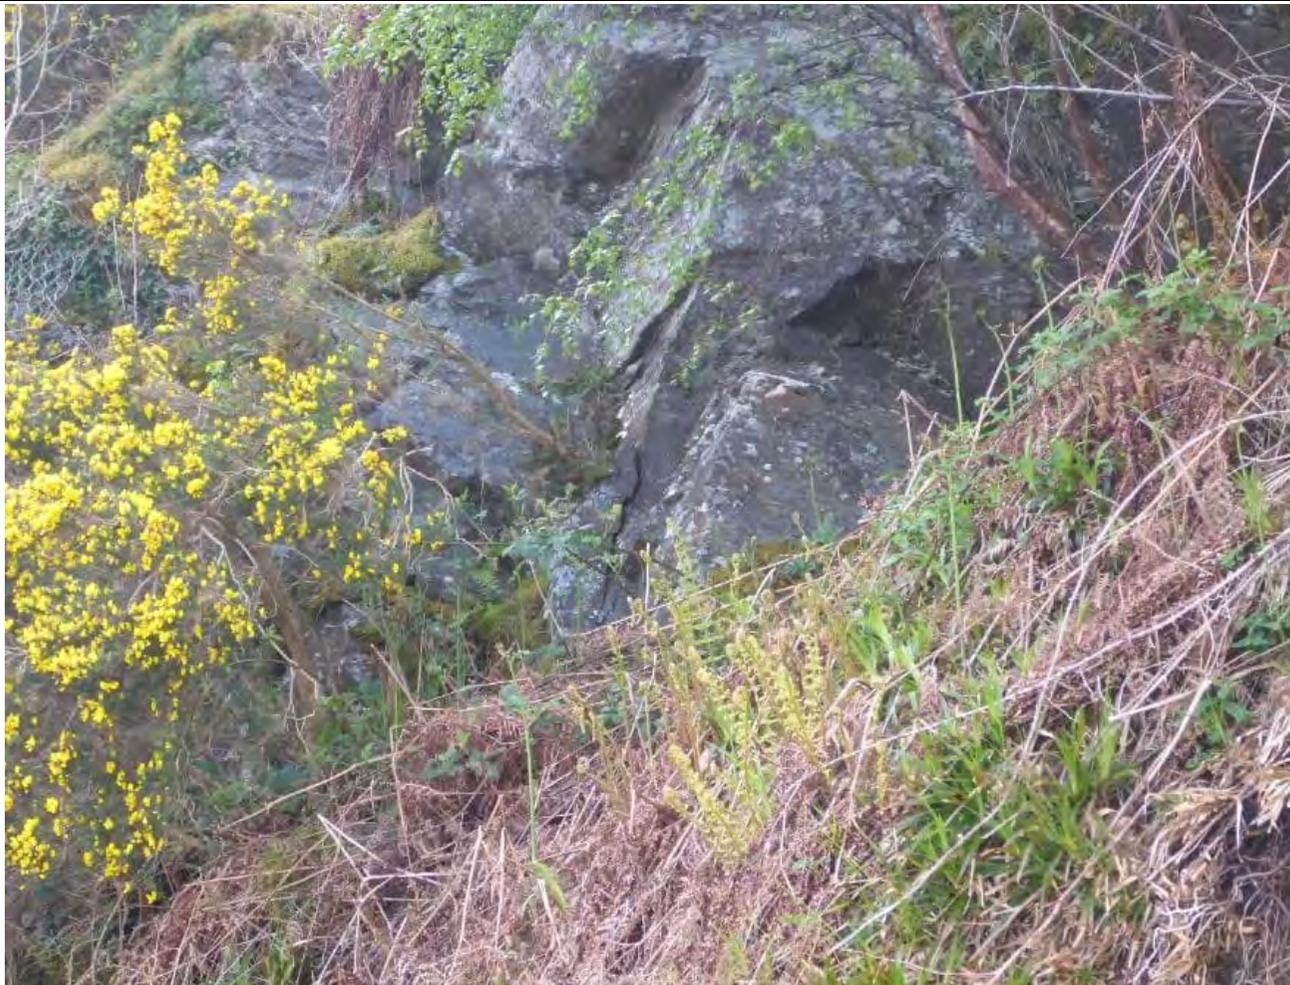
AA16-1	<p>Ch. 2865: Dilated fracture with root jacking c. 5 m above road level. Long axis of the slab is c. 0.7 m. Not considered to pose a significant hazard to the road.</p>	Year First Observed:	2025
--------	---	----------------------	------
