A890 Stromeferry Bypass

Annual Slope Inspection 2025

The Highland Council

Project number: 60685712
AECOM Report Ref.: GLRP0010

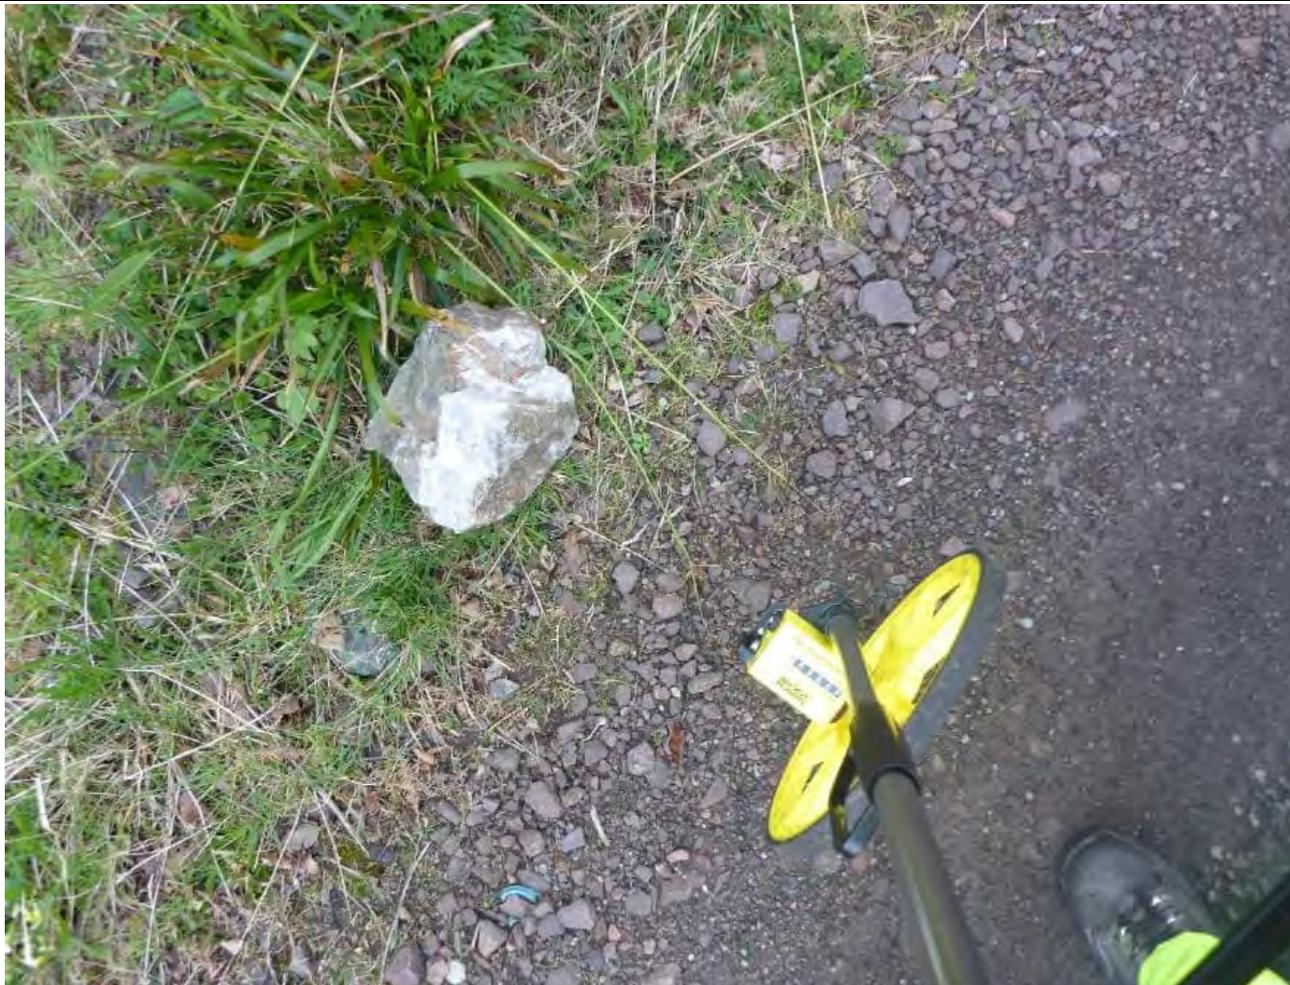
AA16-2	Ch. 2904: Boulder c. 0.2 x 0.2 x 0.1 m at base of gully on the verge. Block possibly not native and appears to be a gneiss with quartz veins; possibly fallen from upper slope.	Year First Observed:	2025
--------	--	----------------------	------

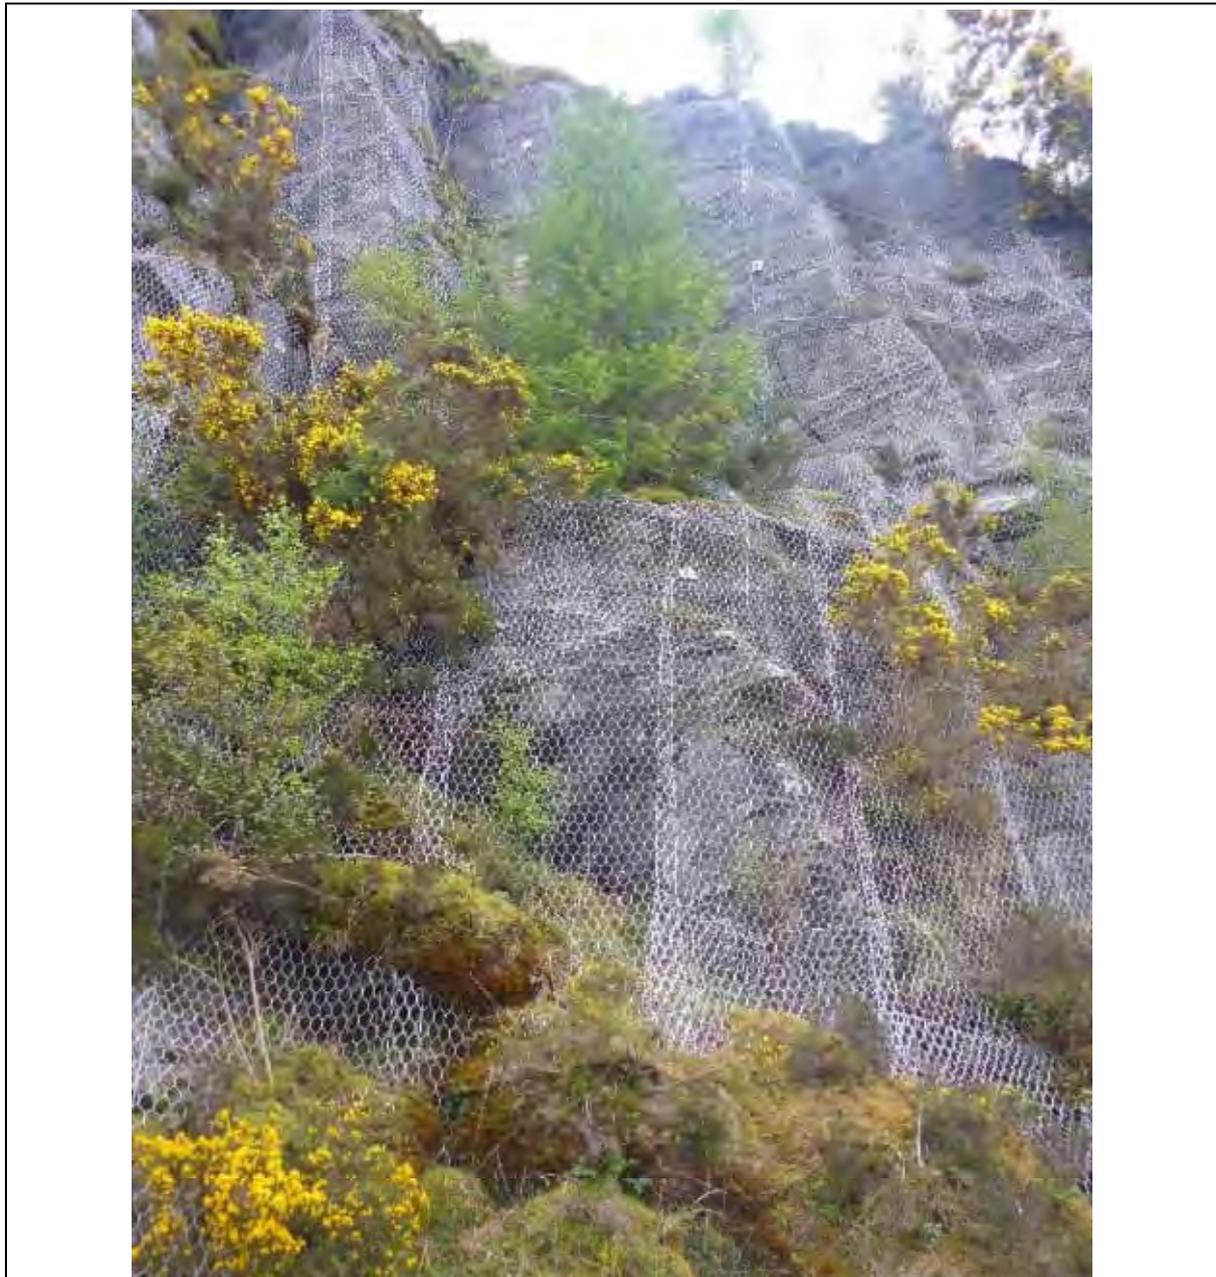
<p>AA17-3</p>	<p>Ch. 2957: Large tree on ledge in rock face, potential root jacking of the block below; block dowelled in place but the length and capacity of the dowel(s) is not known.</p>	<p>Year First Observed:</p>	<p>2025</p>
---------------	---	-----------------------------	-------------

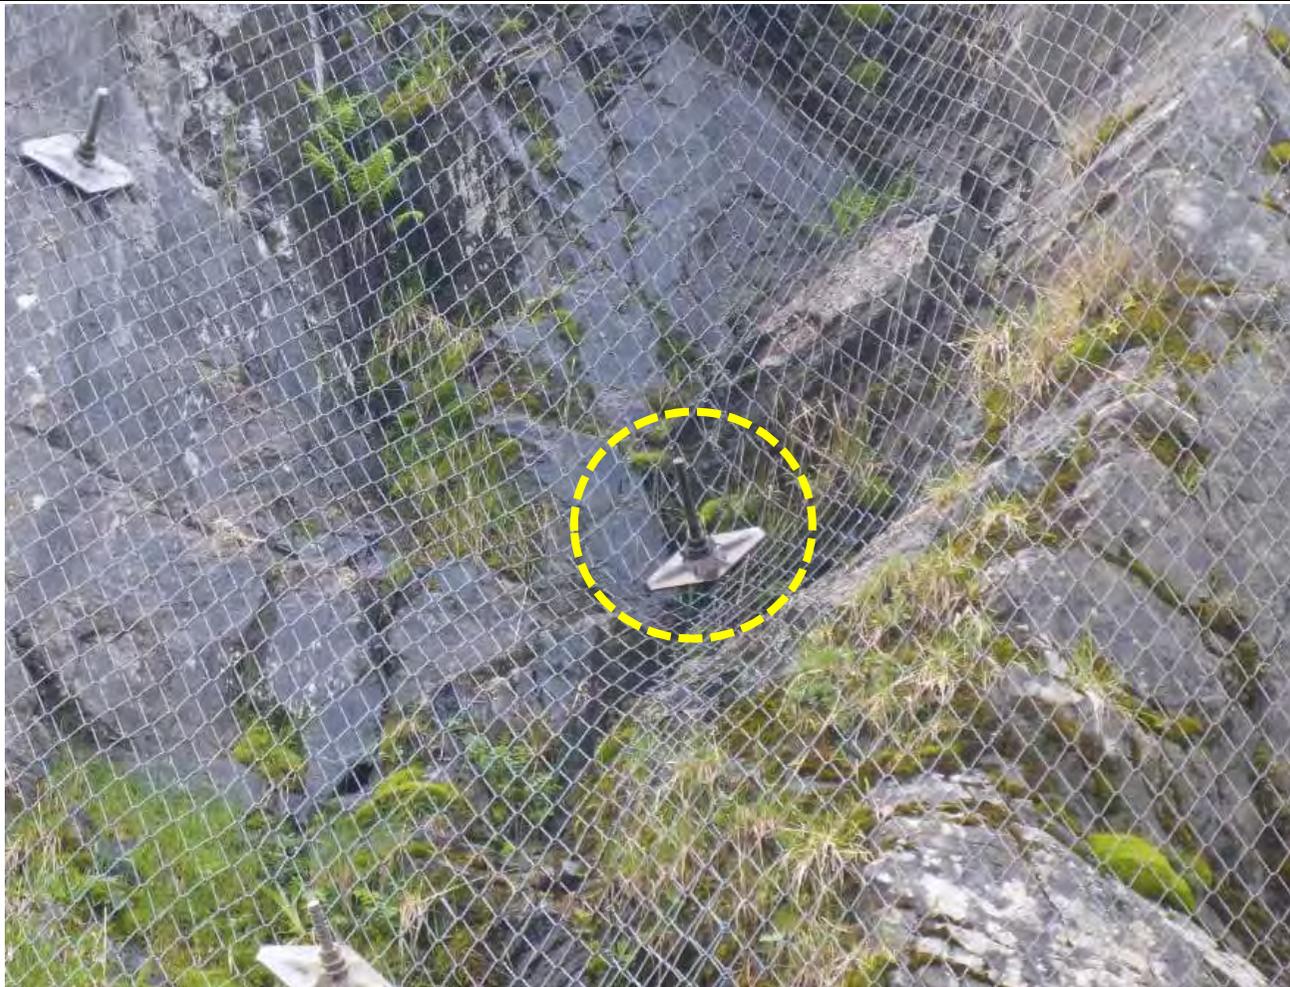
AA18-2	At Ch. 2990 (waterfall area), TECCO showing greenish discolouration. Spike plate discoloured.	Year First Observed:	2018
--------	---	----------------------	------

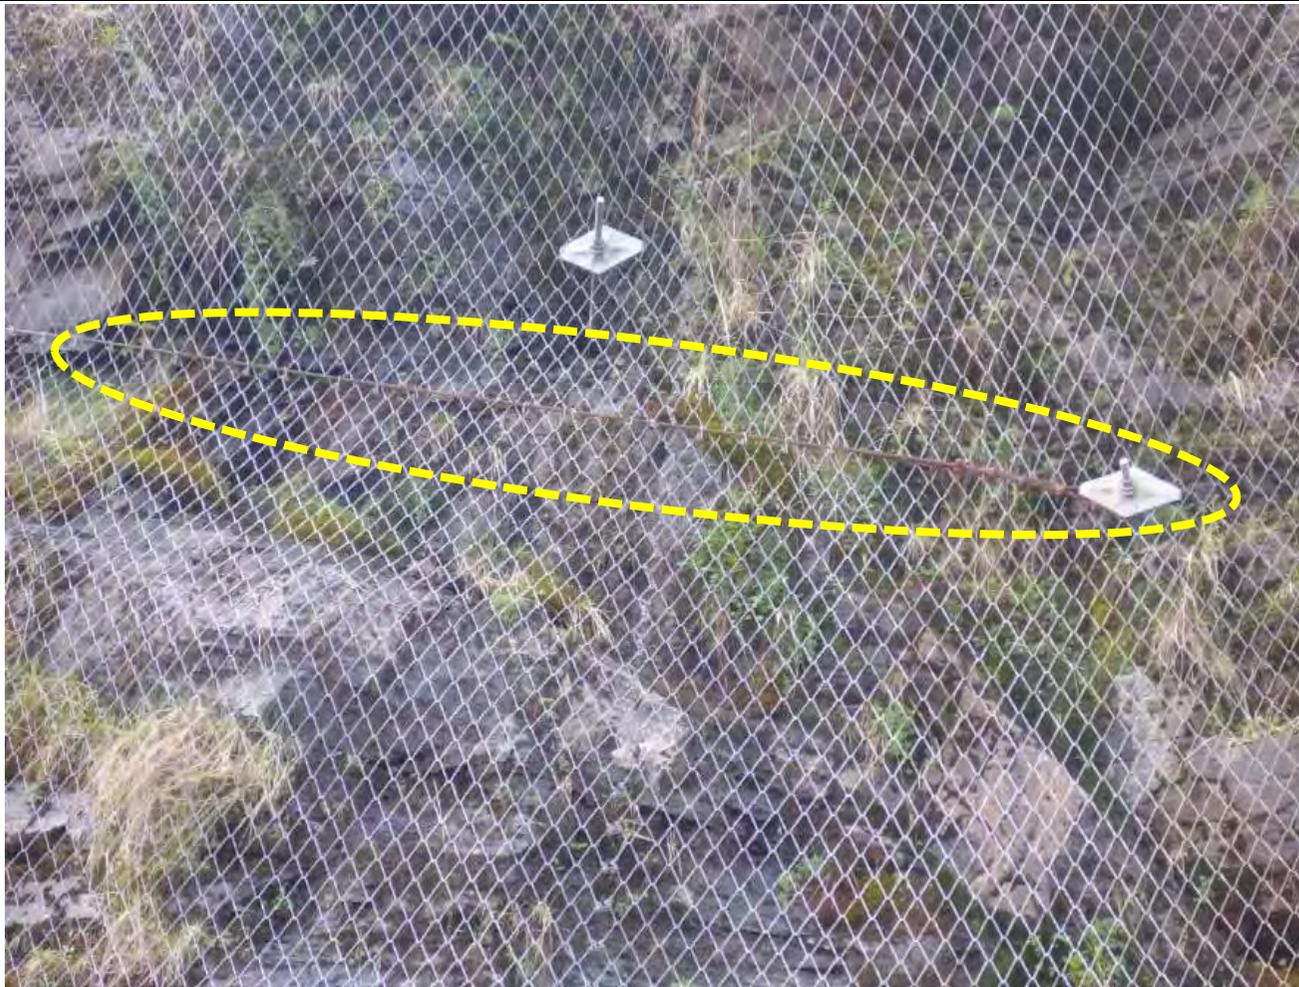
AA18-3	Mid-slope profiling cable at Ch. 3032 highly corroded.	Year First Observed:	2018
--------	--	----------------------	------

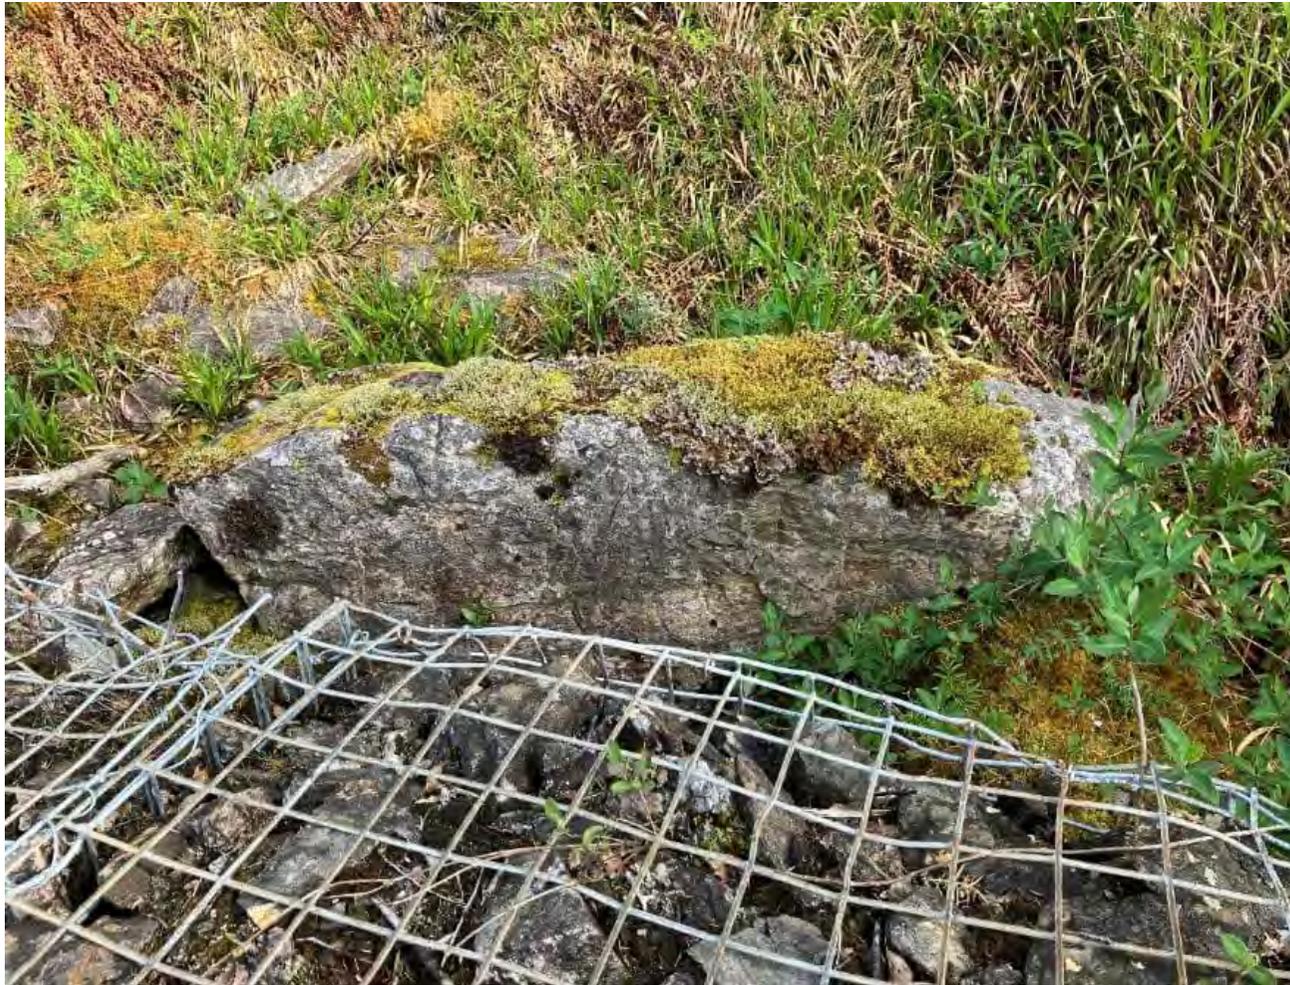
AA19-1	Rear and top of gabions are damaged. Has worsened since 2023 with additional debris present. Would be beneficial to clear out debris behind the gabions	Year First Observed:	2023
--------	---	----------------------	------

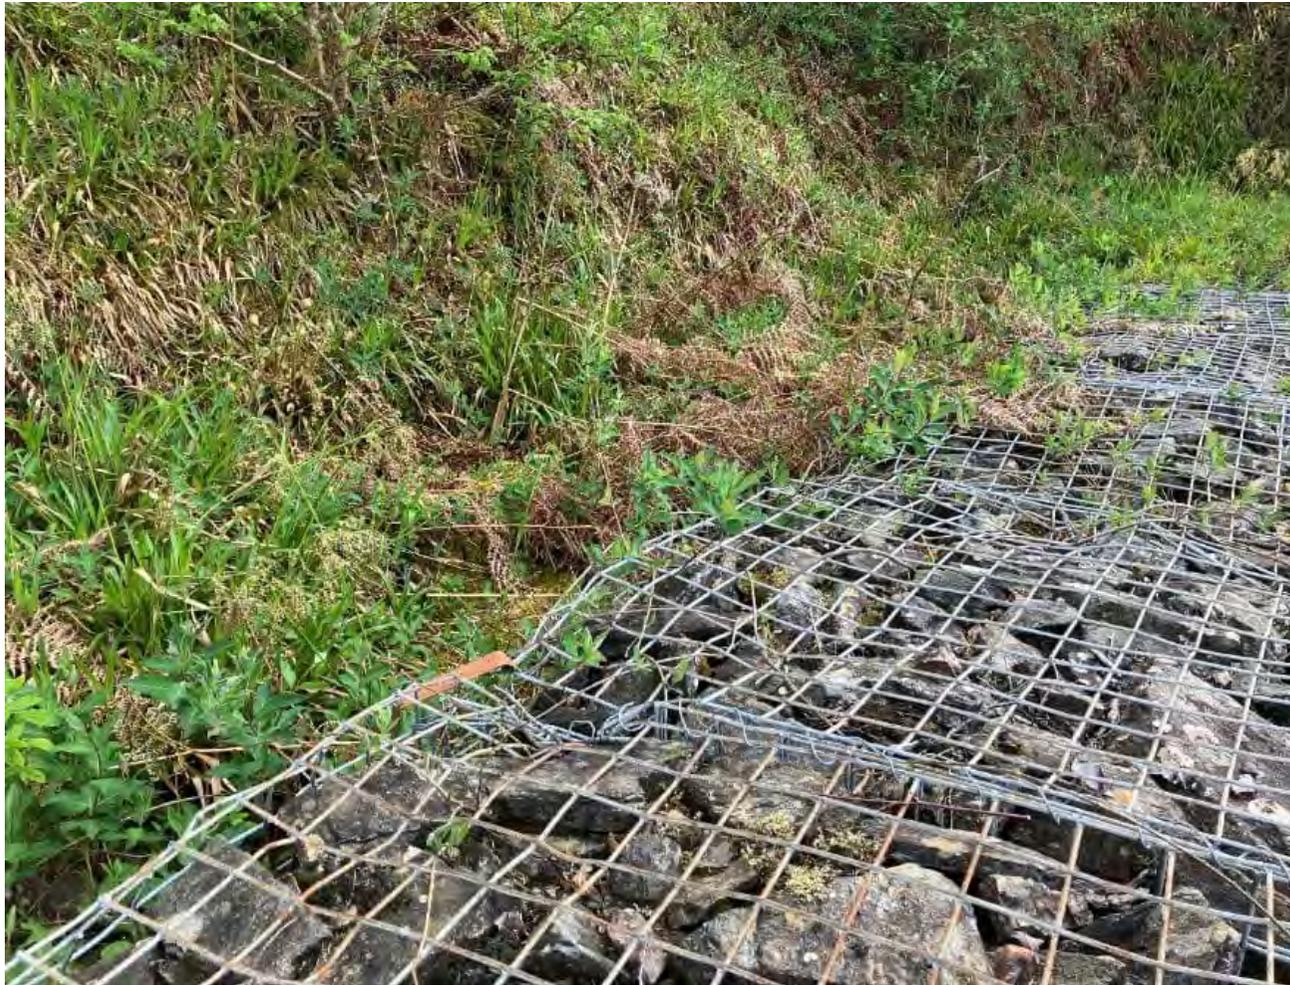
AA19-2	Rear and top of gabions are damaged. Has worsened since 2023 with additional debris present. Would be beneficial to clear out debris behind the gabions.	Year First Observed:	2032
--------	--	----------------------	------

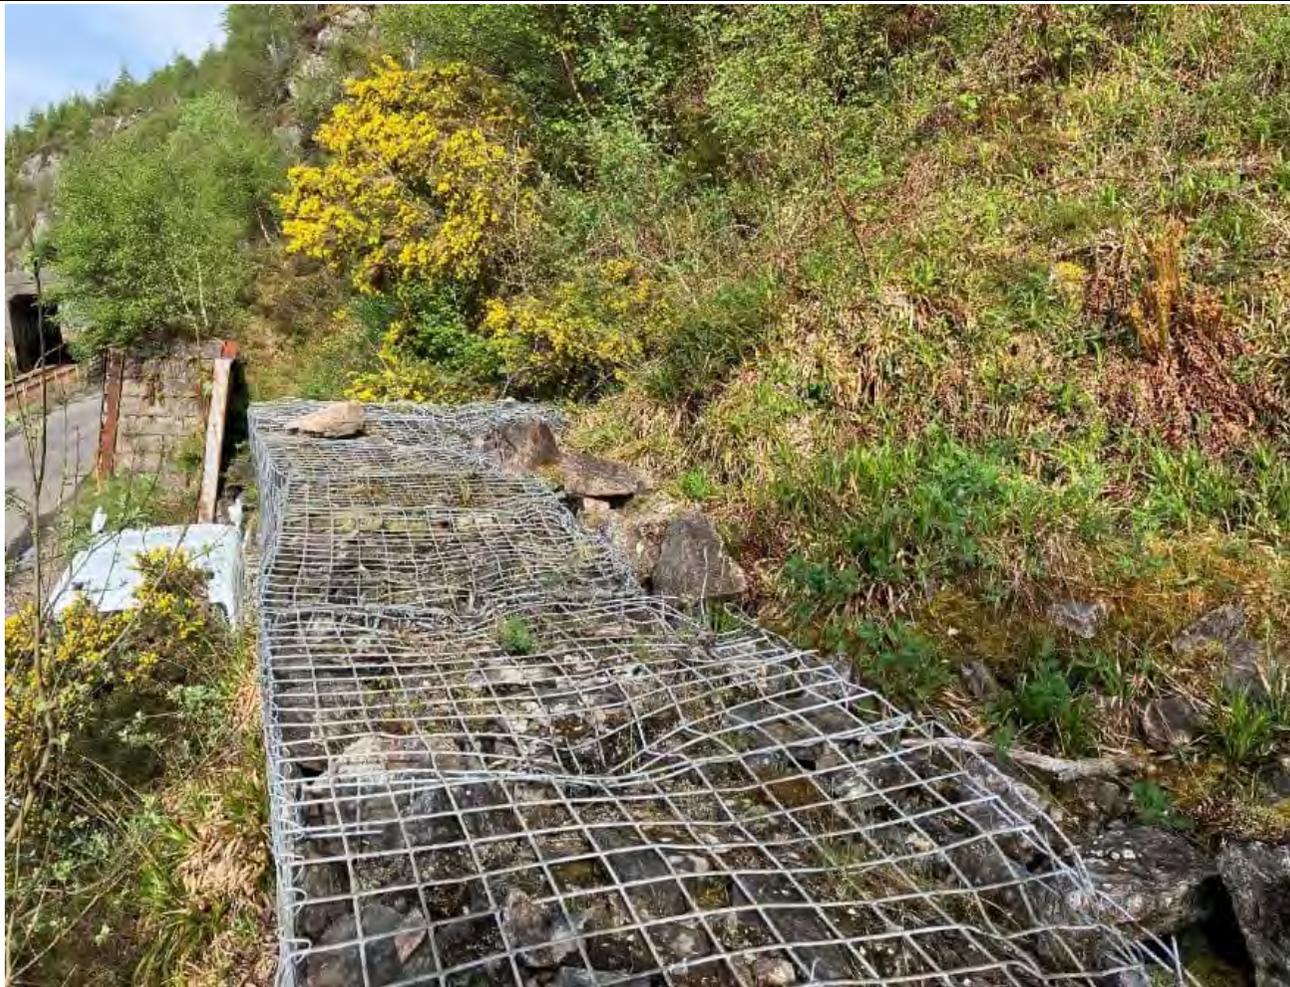
AA19-3	Rear and top of gabions are damaged. Has worsened since 2023 with additional debris present. Would be beneficial to clear out debris behind the gabions	Year First Observed:	2025
--------	---	----------------------	------

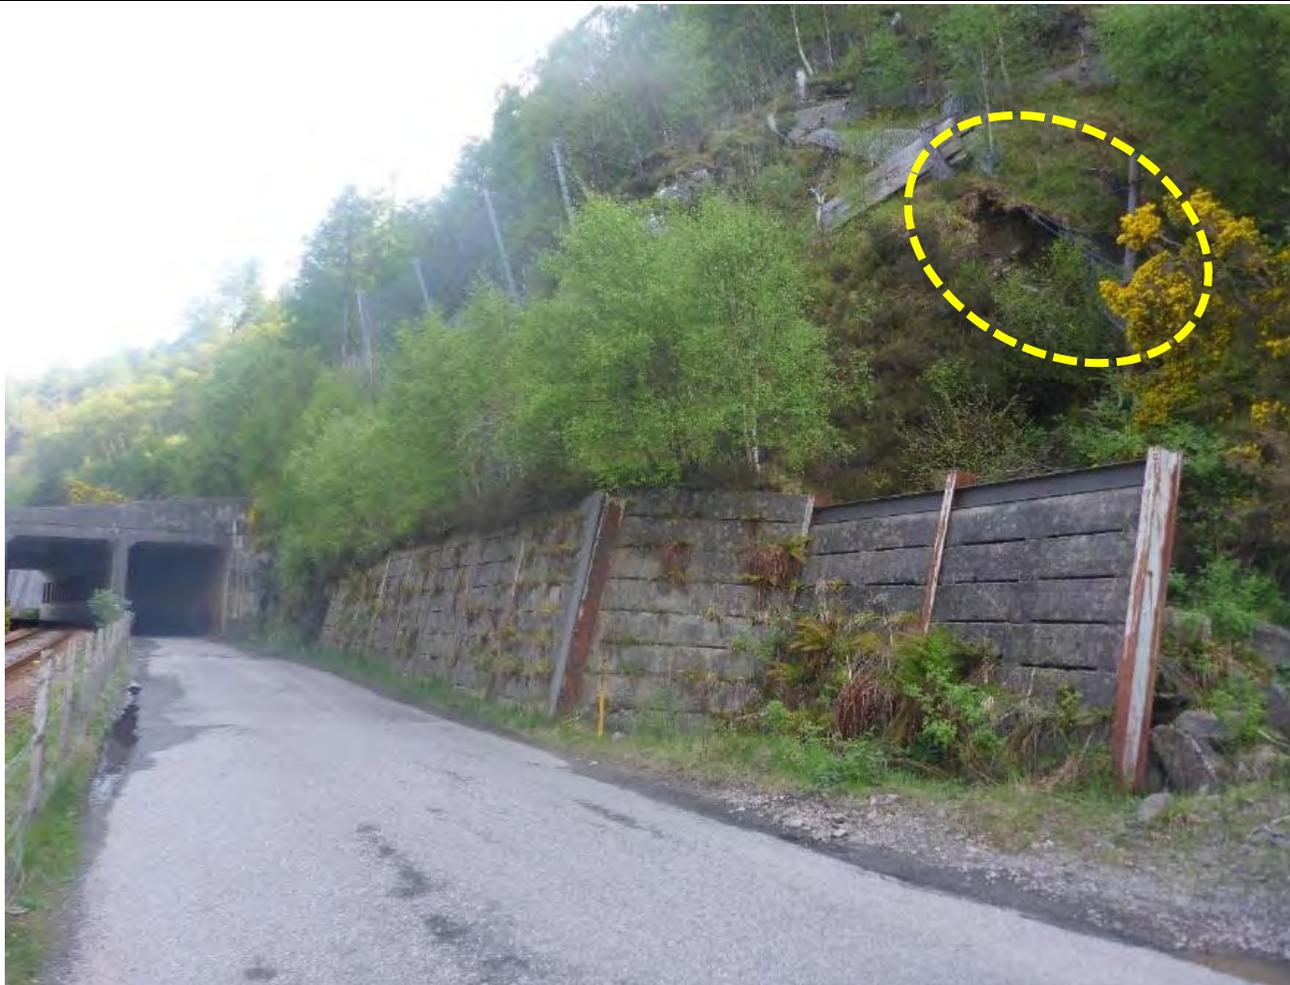
<p>AA20-1</p>	<p>Ch. 3155: Soil slip above the retaining wall c. 10 to 12 m above road level within the eastern sidewall of the gully. Debris retained in gully. Fall appears to have started with a tree fall; cables of the temporary catch fence (pre-2012) now slack. The temporary cable restraint is no longer effective, however, future soil slips / falling debris not considered to pose a significant risk to the road; due to downslope presence of retaining wall at base of gully.</p>	<p>Year First Observed:</p>	<p>2025</p>
---------------	--	-----------------------------	-------------

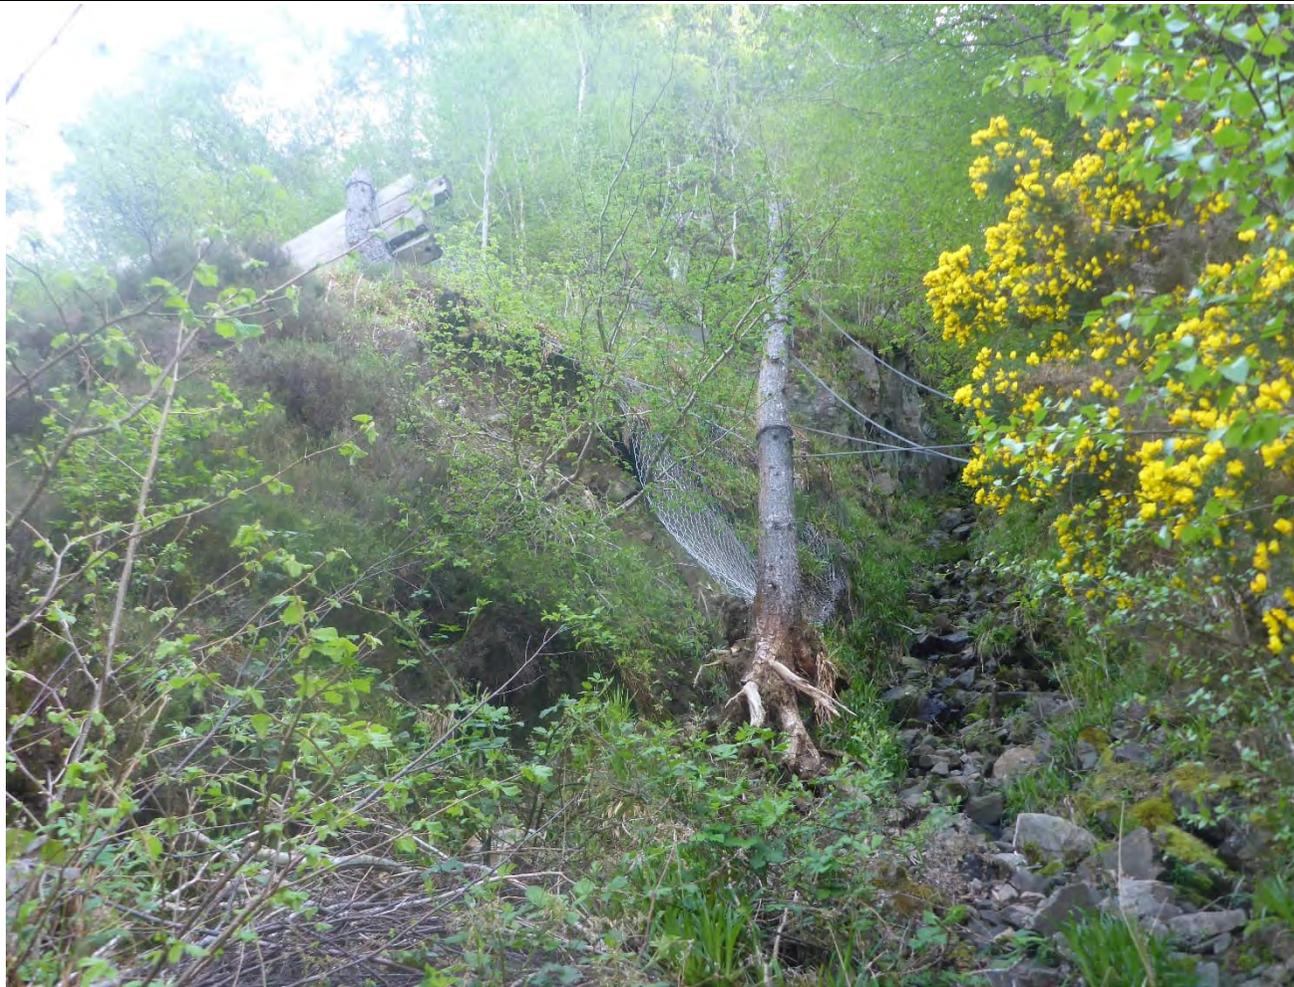
<p>AA20-2</p>	<p>Ch. 3155: Soil slip above the retaining wall c. 10 to 12 m above road level within the eastern sidewall of the gully. Debris retained in gully. Fall appears to have started with a tree fall; cables of the temporary catch fence (pre-2012) now slack. The temporary cable restraint is no longer effective, however, future soil slips / falling debris not considered to pose a significant risk to the road; due to downslope presence of retaining wall at base of gully.</p>	<p>Year First Observed:</p>	<p>2025</p>
---------------	--	-----------------------------	-------------

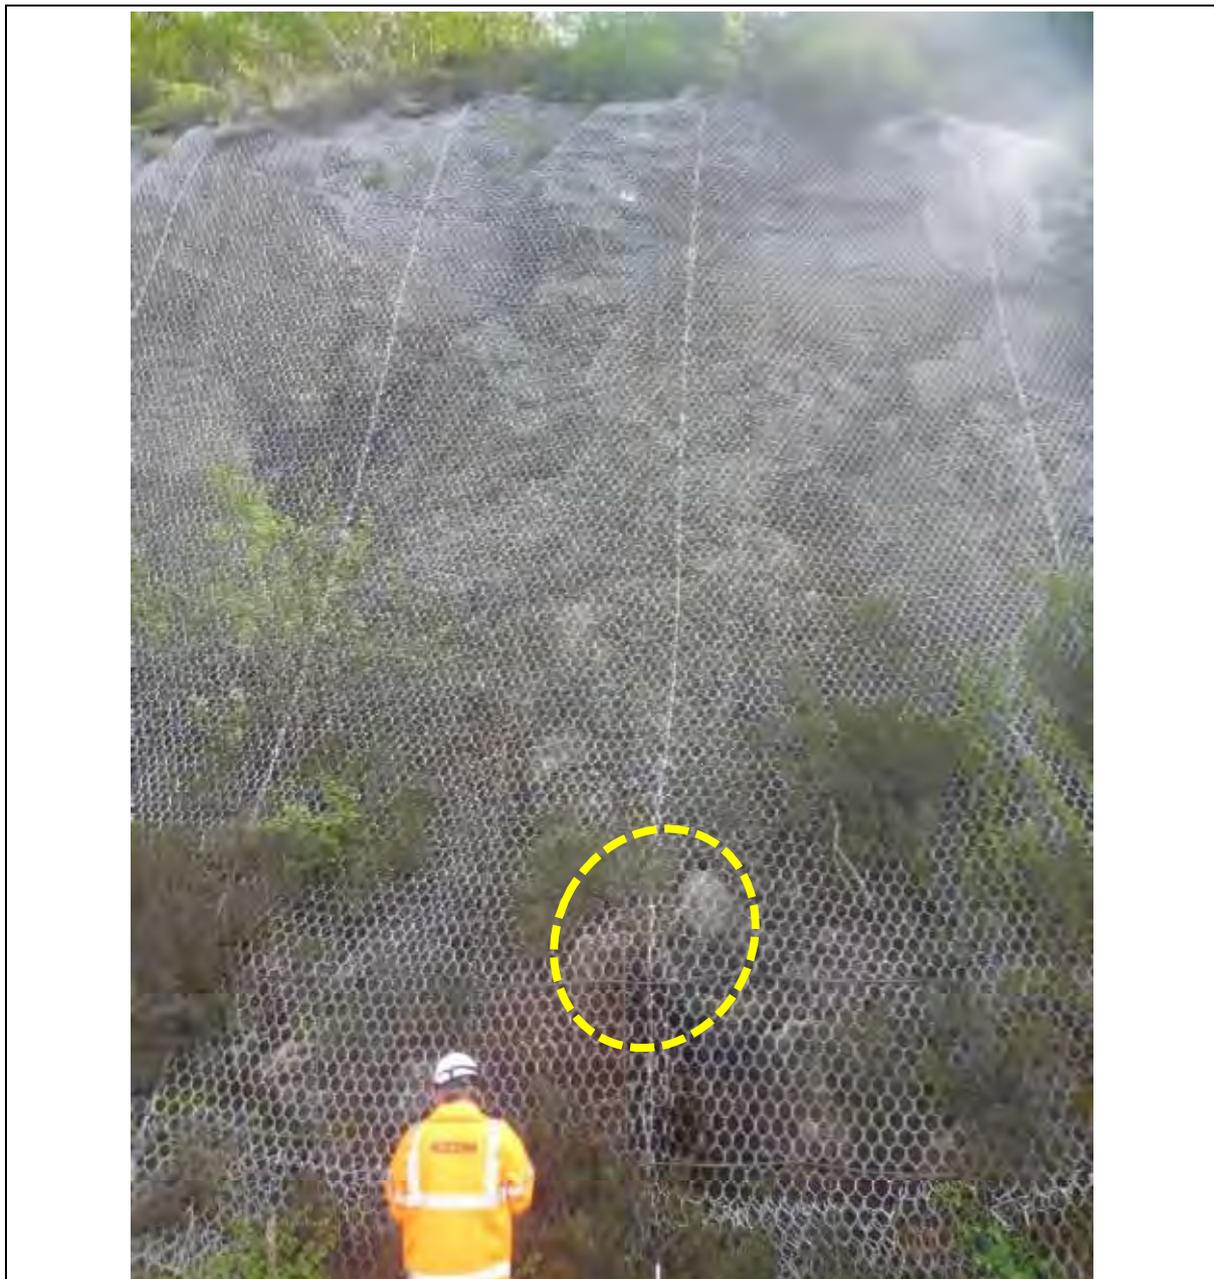
<p>AA21-1</p>	<p>Ch. 3300 to 3303: Few small blocks resting against the netting. No significant risk to the road; no requirement for clearance in the short-term. Blocks 0.4 x 0.2 x 0.1 m and 0.4 x 0.5 x 0.1 m.</p>	<p>Year First Observed:</p>	<p>2025</p>
---------------	--	-----------------------------	-------------

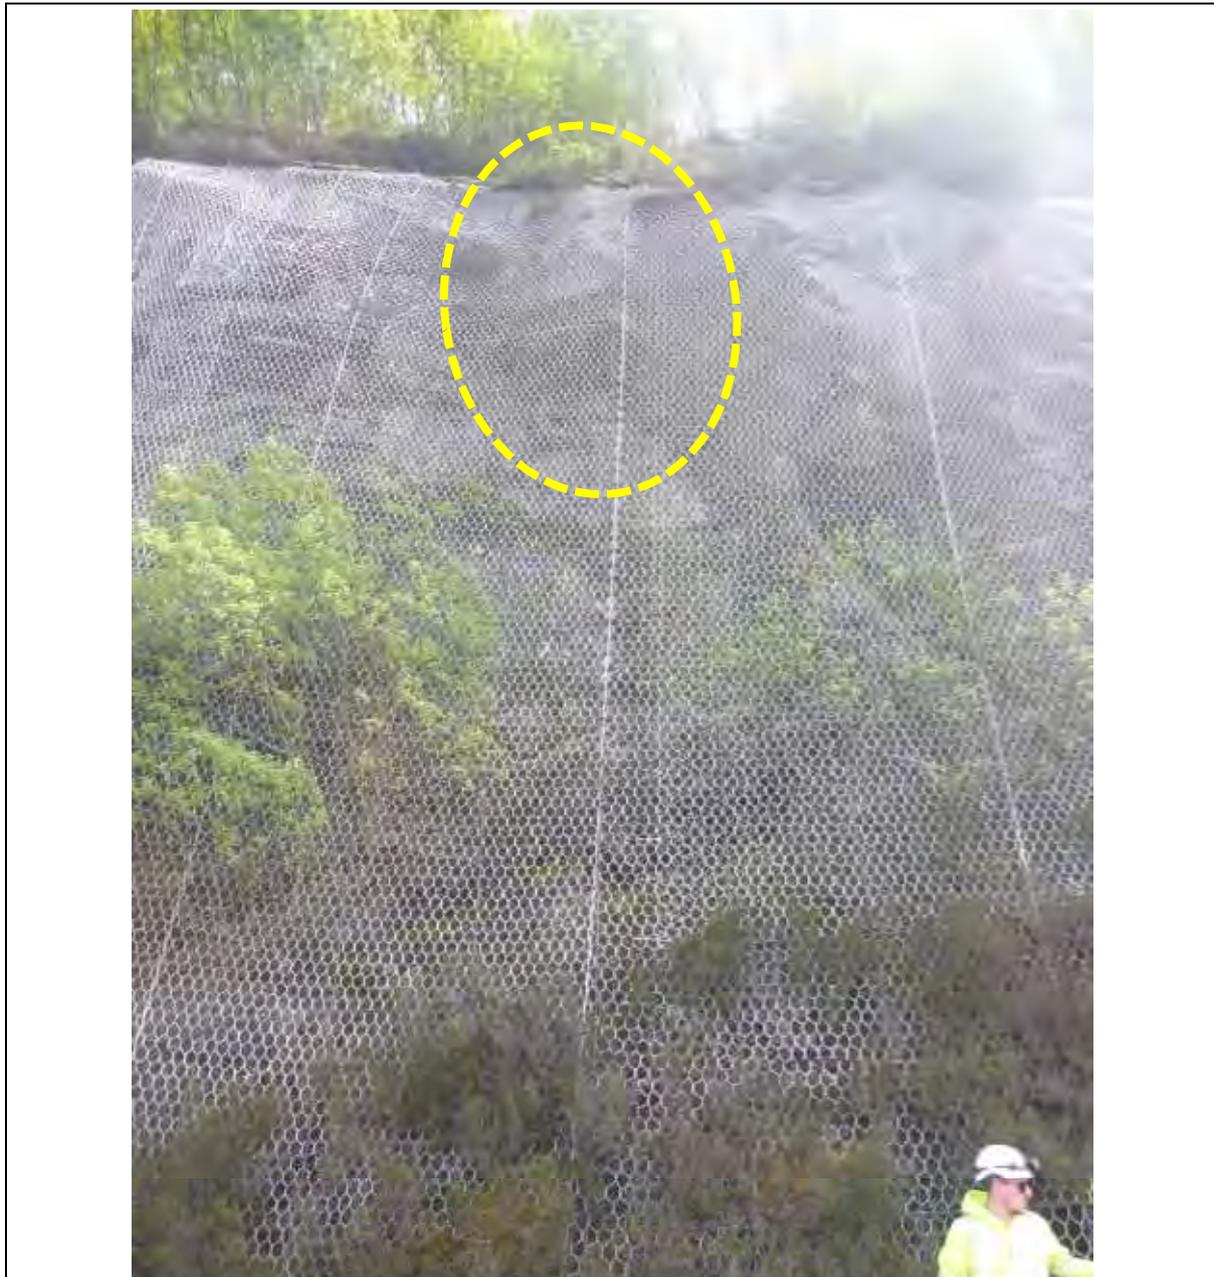
AA21-2	<p>Ch. 3305: Large wedge at crest of rock slope (2 x 5 x 5 to 6 m high). Rock mass blast damaged and dilated discontinuities present. Big gap between drape mesh and rockface would allow failure to gain energy and potentially exceed capacity of netting, impacting road below. No change in condition 2025.</p>	<p>Year First Observed:</p>	<p>2016</p>
--------	--	-----------------------------	-------------

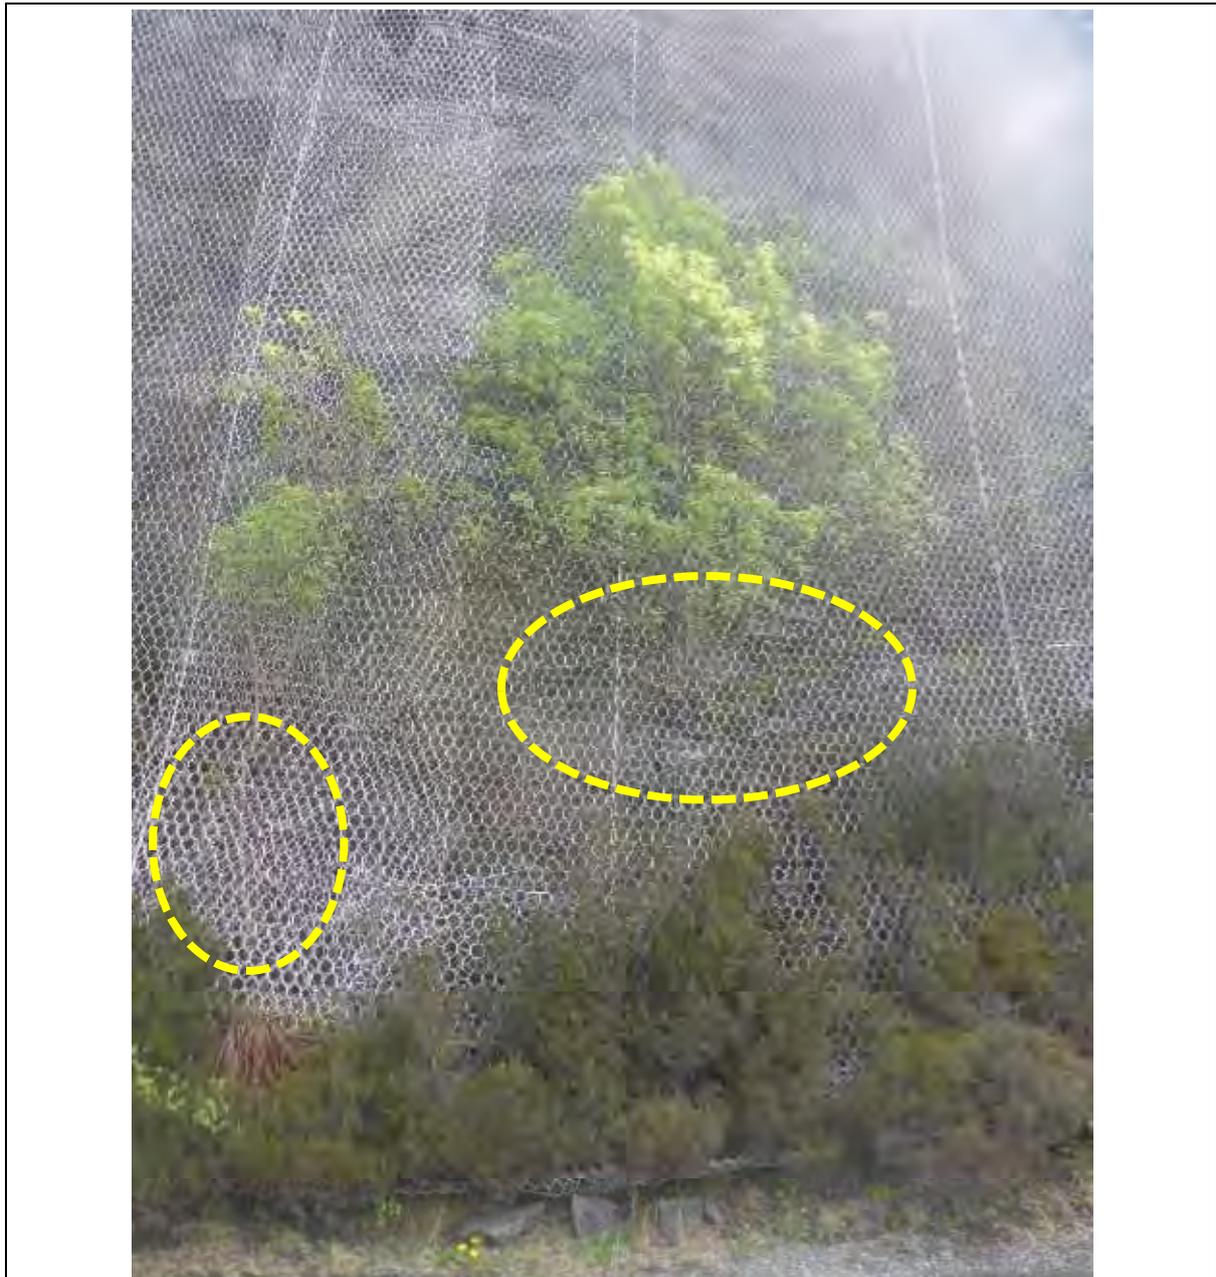
AA21-3	Ch. 3310: Root jacking evident approximately 3 m above road level. No immediate risk of failure but would be worth coppicing. No change to condition in 2025.	Year First Observed:	2016
--------	--	----------------------	------

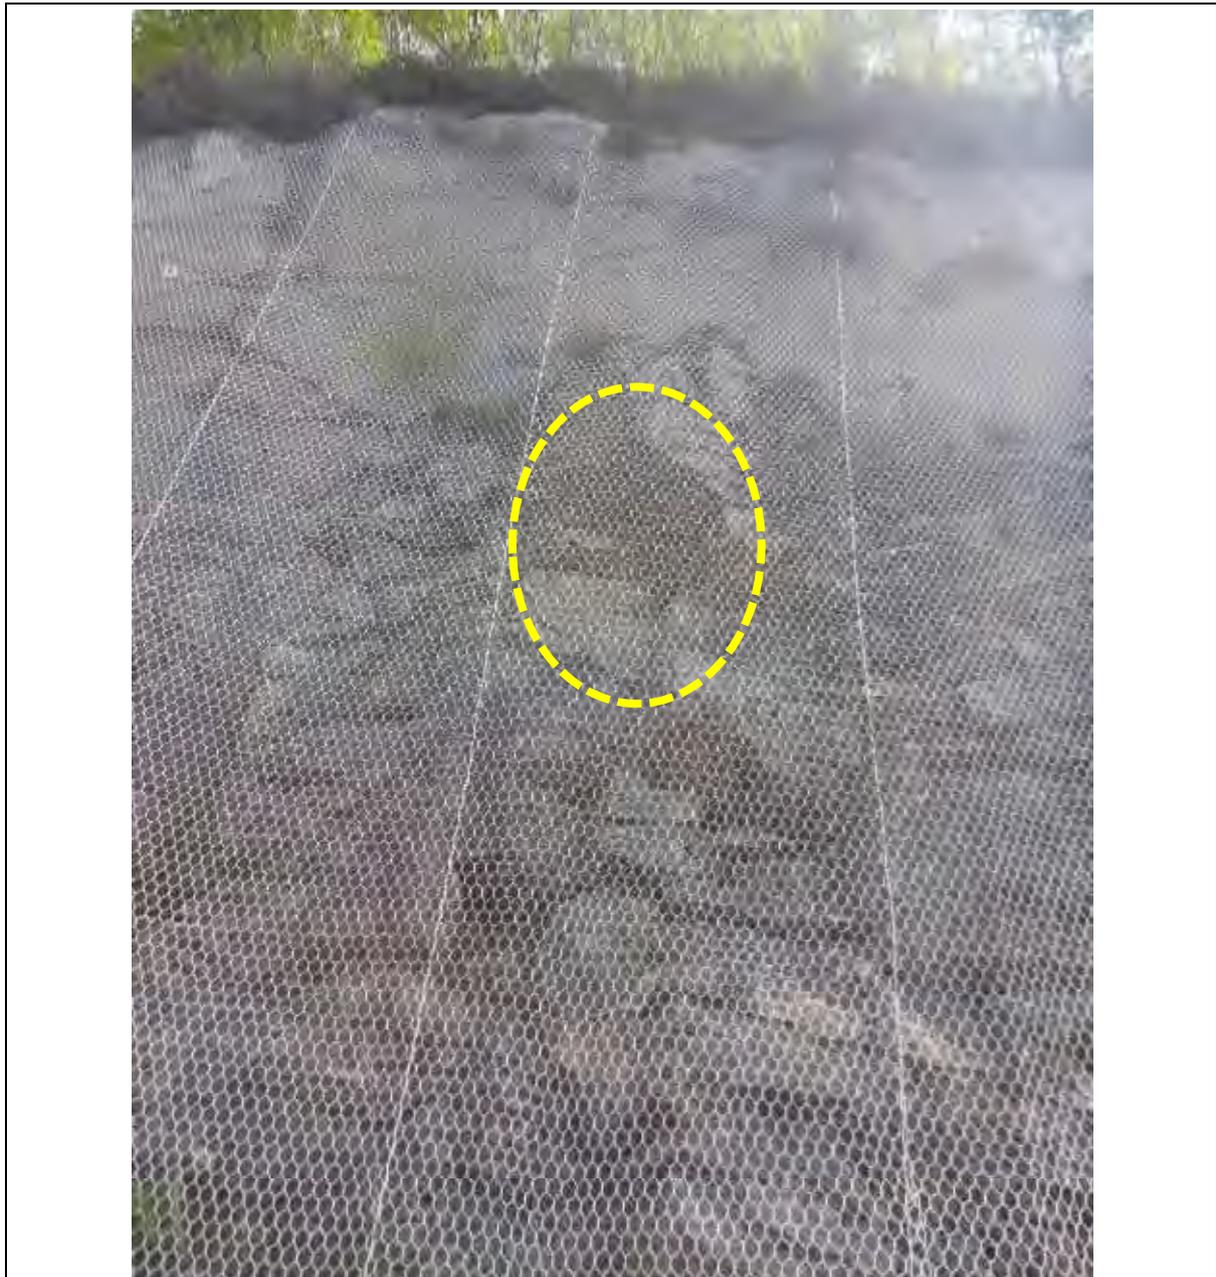
<p>AA21-4</p>	<p>Ch. 3322: Potential wedge failure approximately 5 m above road level. Multiple blocks, total volume 1.5 m³. No change in condition 2025.</p>	<p>Year First Observed:</p>	<p>2016</p>
---------------	--	-----------------------------	-------------

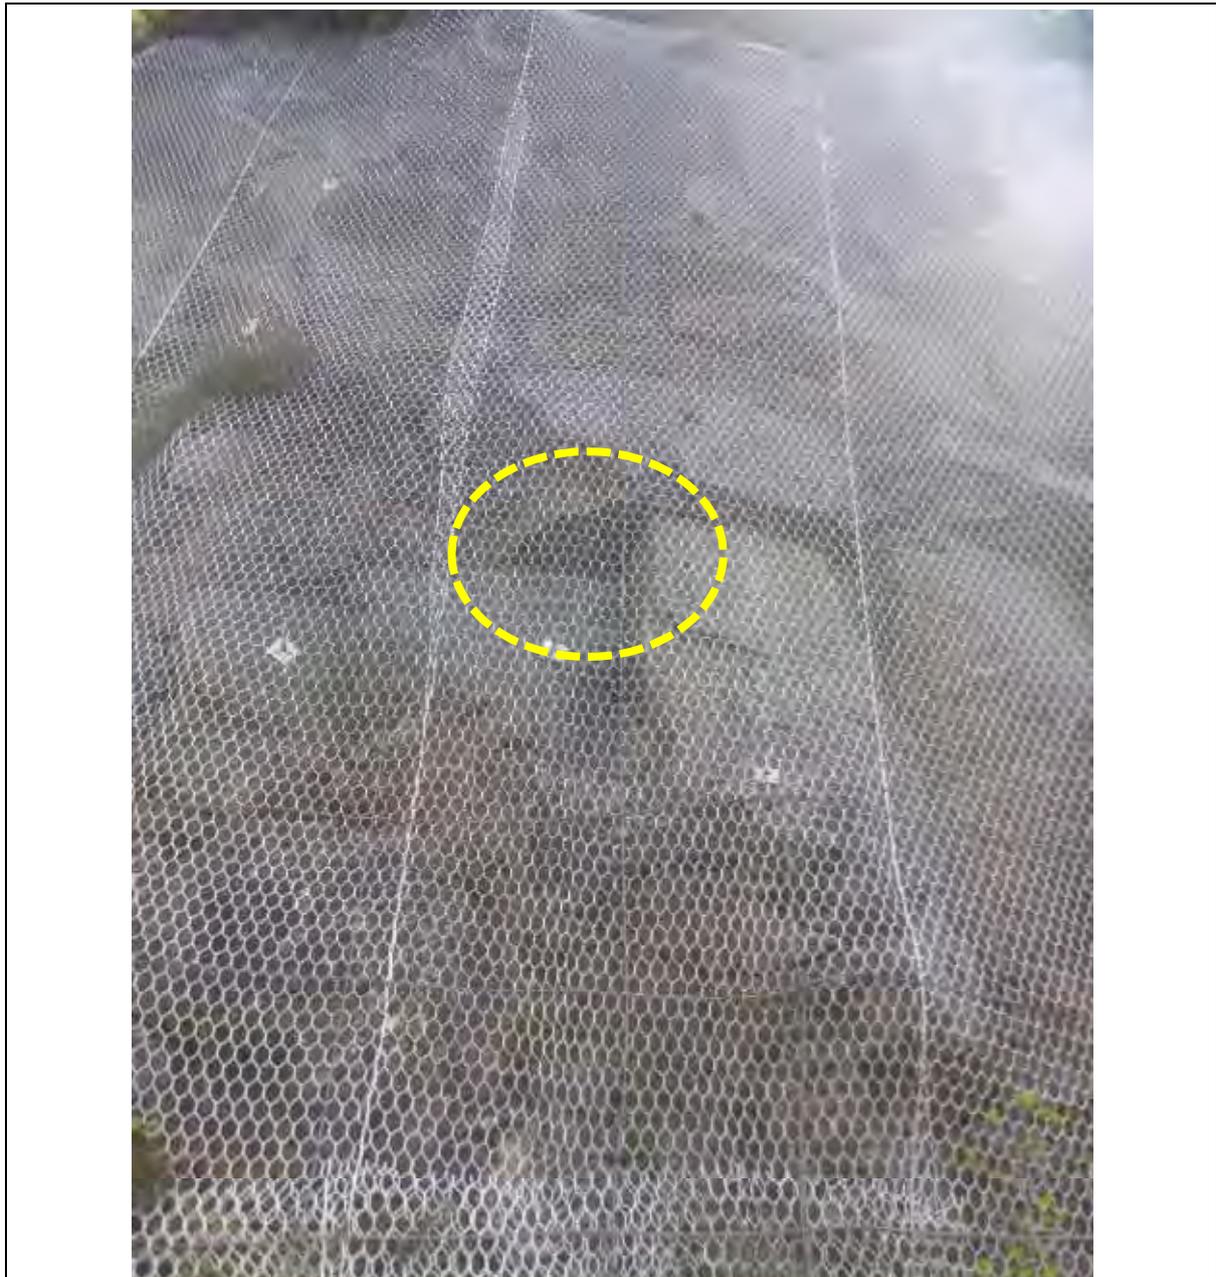
AA21-5	Ch. 3346: Blast damage crack observed with potential to form wedge failure at 3 to 4 m height. Block likely to be within design capacity of netting so no significant risk at present.	Year First Observed:	2025
--------	--	-------------------------	------

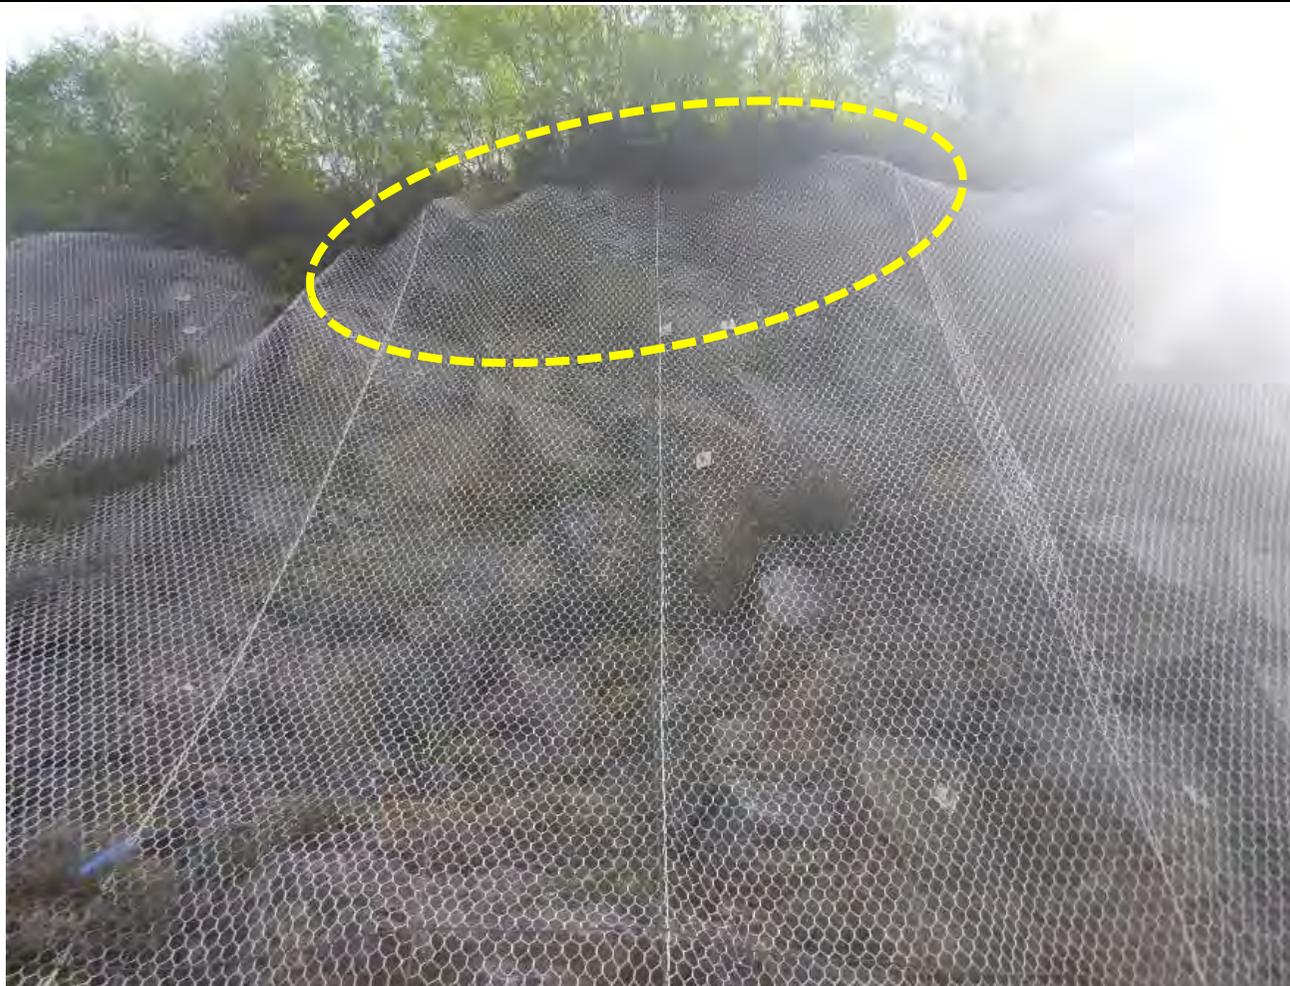
AA21-6	<p>Ch. 3350: Rock mass at crest with dilated release plane. Numerous dowels, but only in one block, and a cable present c. 15 m above road level. 3 x 2 x 1.5 m. No change in condition 2025.</p>	Year First Observed:	2019
--------	--	----------------------	------
