A890 Stromeferry Bypass

Annual Slope Inspection 2025

The Highland Council

Project number: 60685712
AECOM Report Ref.: GLRP0010

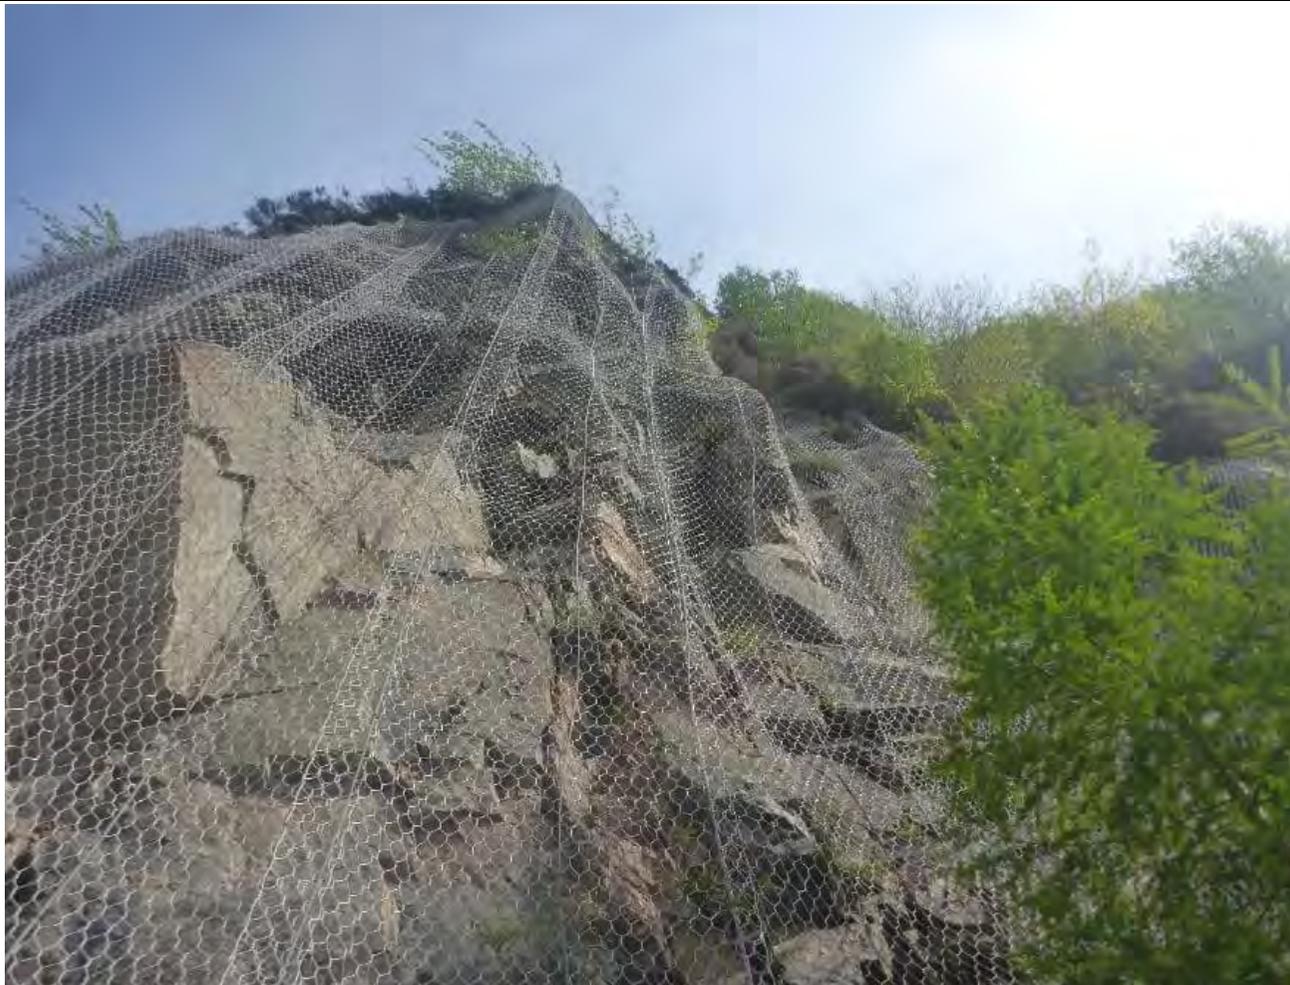
AA22B-3	Ch. 3434: Large overhangs at top of slopes; small rock falls to date but there remains the potential for larger failures in future.	Year First Observed:	2024
---------	--	----------------------	------
