Our Ref: DRM/401479.01

Date: 19 February 2026

401479: STRUCTURAL CONDITION INSPECTION AT INVERGORDON TOWN HALL

With reference to the above property and your instruction to Fairhurst to carry out a visual structural inspection, we can confirm that our Technical Director, Donald Macarthur, visited the above site on Tuesday 3rd February 2026 and can report as follows:

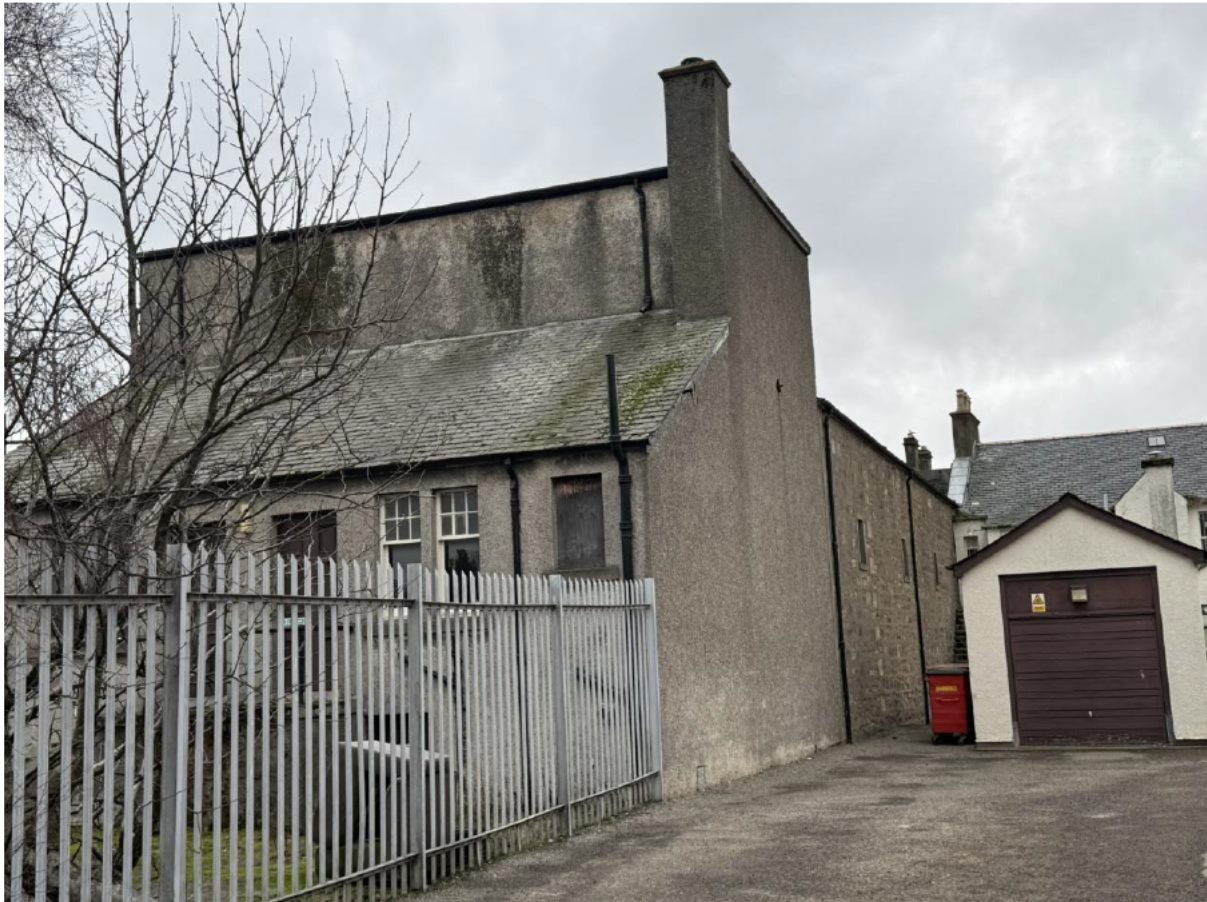
Photograph 03 – Rear Extension

A masonry brickwork extension has been constructed to the rear forming the main stage area and back of house accommodation including basement plant room and ground floor dressing area with toilet. The stage area is a clear three storeys with a flat roof, and the rear accommodation has a lean to mono-pitch slate roof on timber trusses.

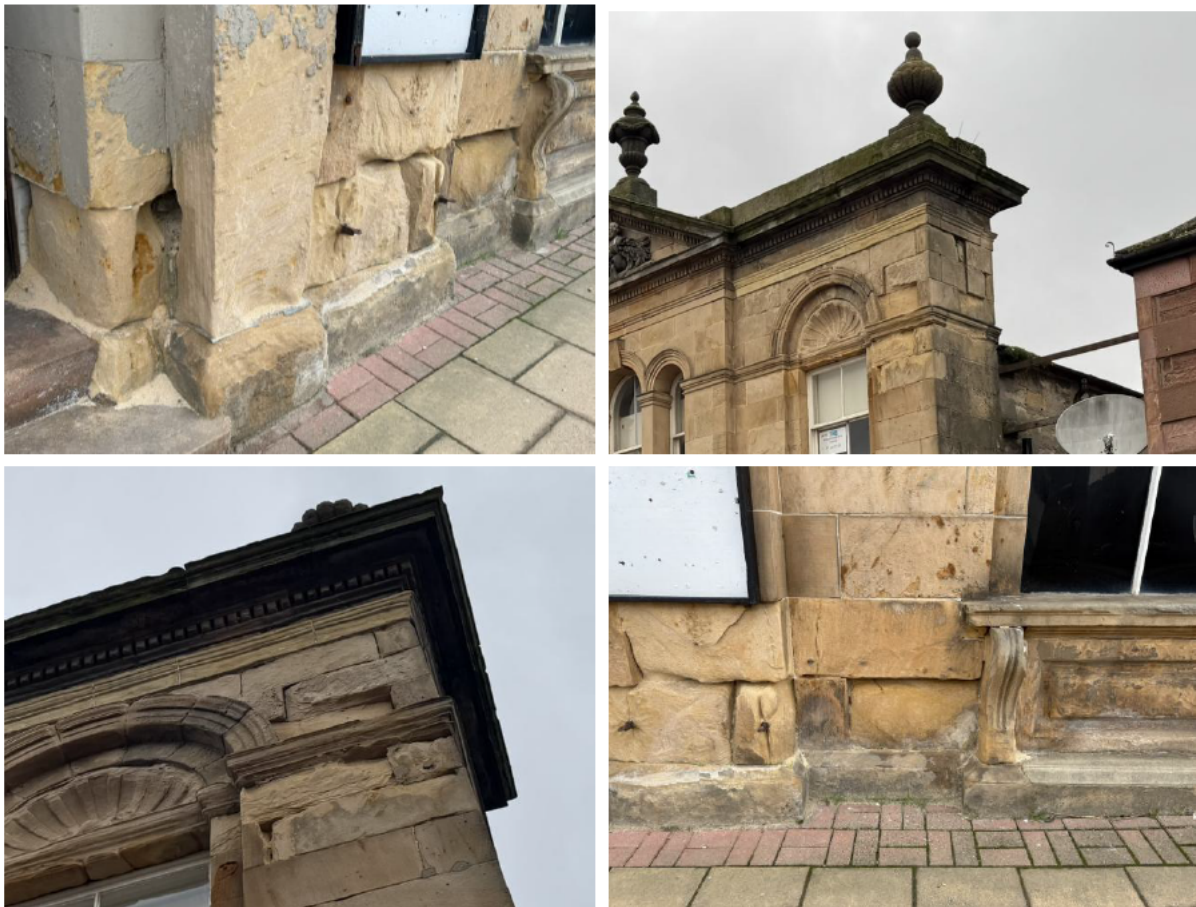
There is significant weathering of the sandstone to the front elevation particular around the lower courses at the front entrance and the corners of the parapet.

Photograph 04-07 – Stone Weathering to Front Elevation

We would recommend that an experienced stone mason provides options for repair or replacement of the weathered sandstone façade to the front elevation.

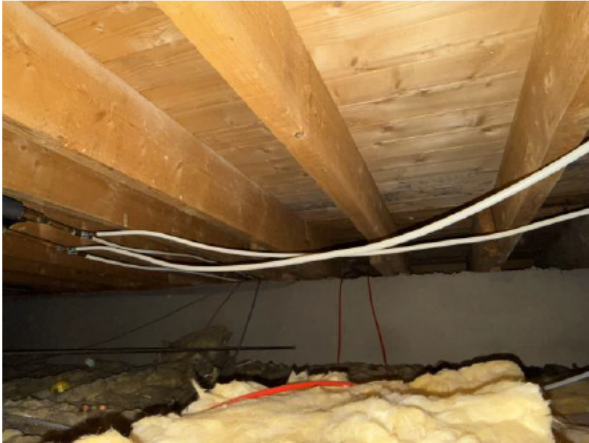
A small hatch in the ceiling of the main lobby allowed for the first floor joists to be inspected. All timber joists appeared to be in fair condition. The supporting floor beams were concealed and could not be inspected. These beams support the first floor joists and suspended ground floor ceiling joists.

Photograph 08 – First Floor Joists and Beam

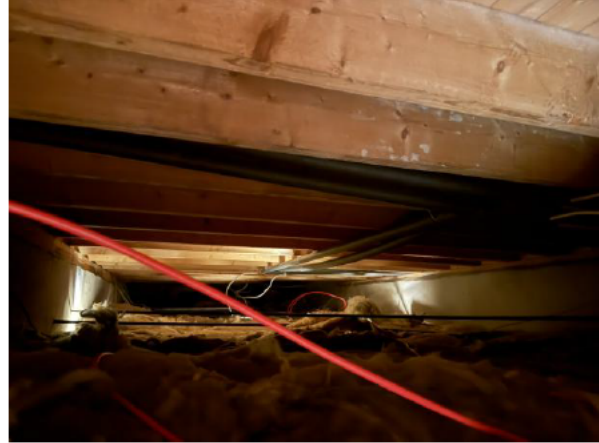
Photograph 09 – First Floor Joists and Ceiling

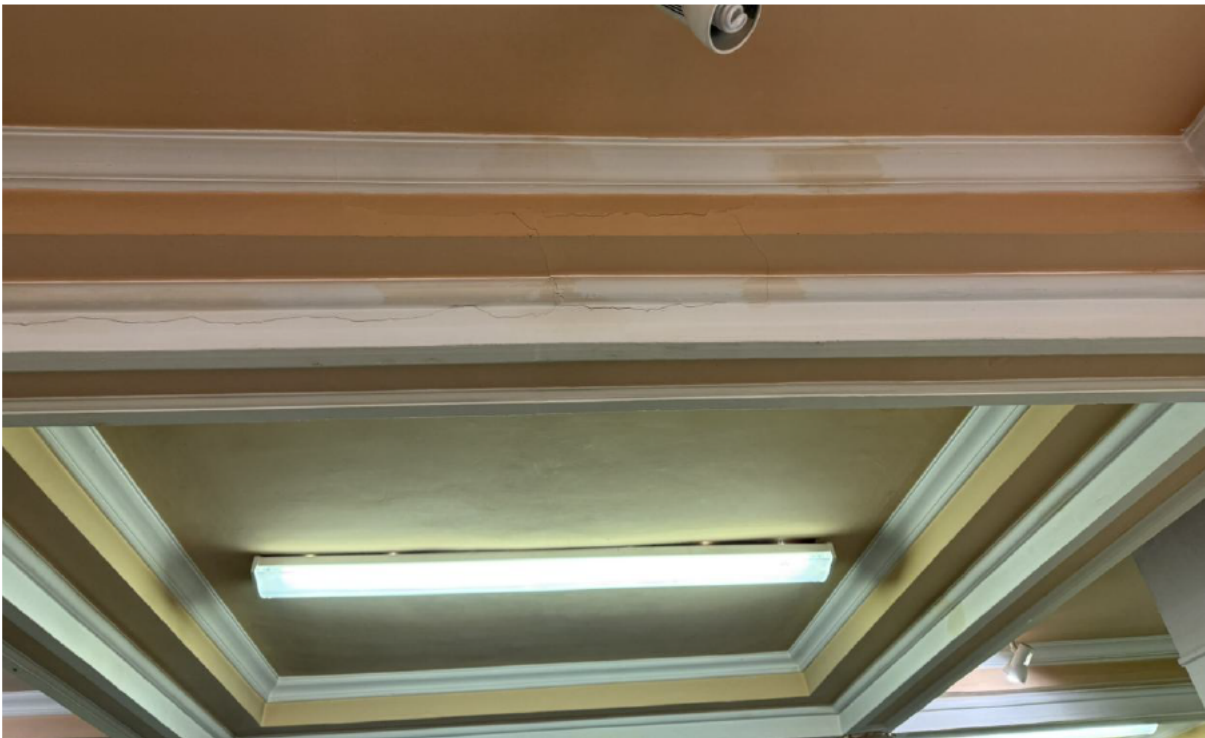
There are hairline to 1mm wide cracks to the plaster ceiling finishes throughout the first floor.

Photograph 10 – Hairline Cracking to First Floor Ceiling

The general cracking observed throughout the building is not considered to be indicative of any global structural instability and is assessed as being of no major structural concern, provided moisture ingress is addressed and no further movement is identified.

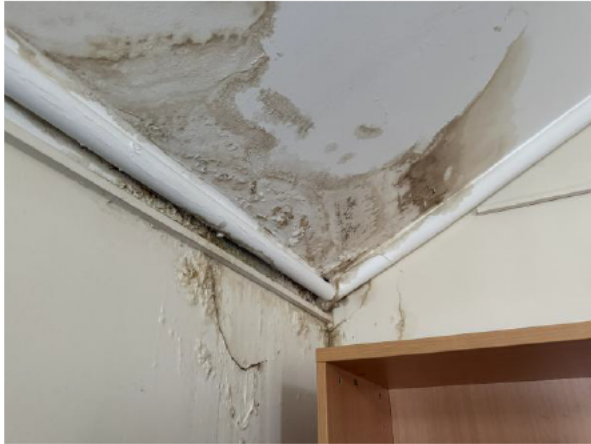
There is evidence of prolonged water ingress to the corner of the front first floor office. This has caused timber decay to the timber finishes and floorboards. There was no access to inspect the structural timbers in these areas and therefore we are unable to comment on their condition.

Photograph 11 – Water Ingress to First Floor

It is recommended that the rainwater goods are cleared of vegetation and flushed through as a matter of priority to reduce the risk of continued moisture ingress. In addition, a roofing contractor should inspect the roof coverings to identify and carry out any necessary repairs to ensure the roof is fully watertight, with particular attention given to slipped or damaged slates and the condition of lead flashings and detailing.

We would recommend that a timber specialist is employed to inspect all timber elements.

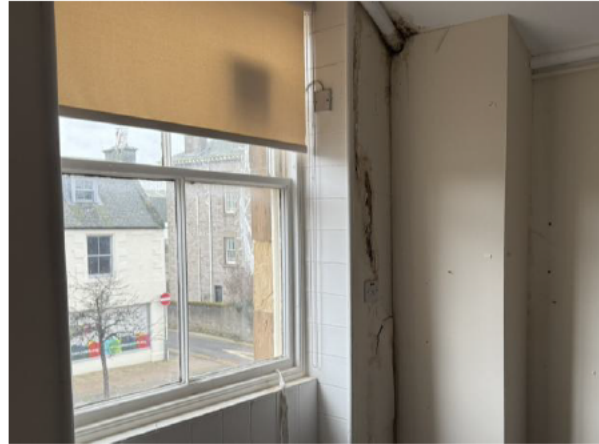
Photograph 12 – Water Ingress at Front Corner

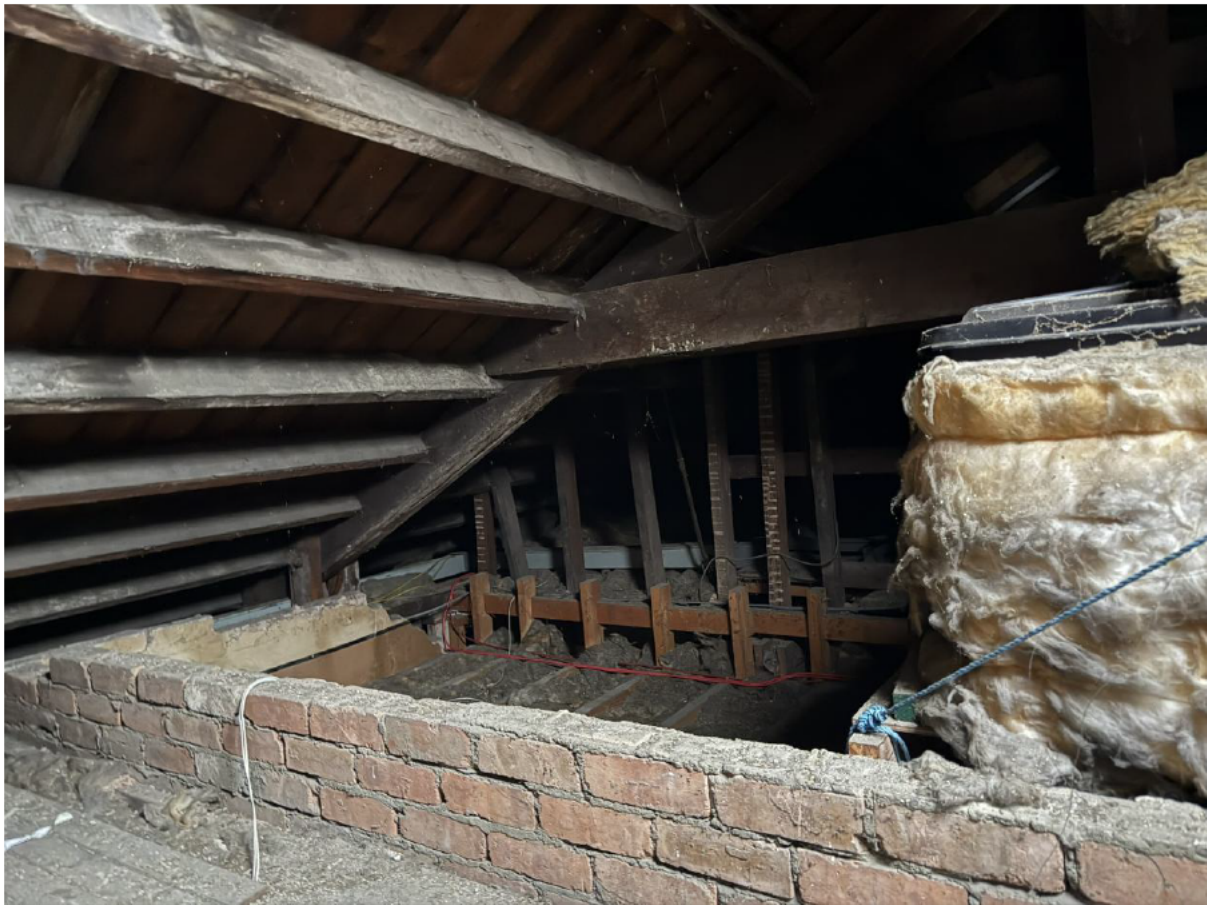
There is evidence of water staining to the structural roof members, however the timber appears in fair condition for its age.

Photograph 13 – Evidence of Water staining to King Post Truss and Purlins
