# A890 Strome ferry Bypass

Annual Slope Inspection 2026

The Highland Council

Project number: 60685712  
AECOM Report Ref.: GLRP0013

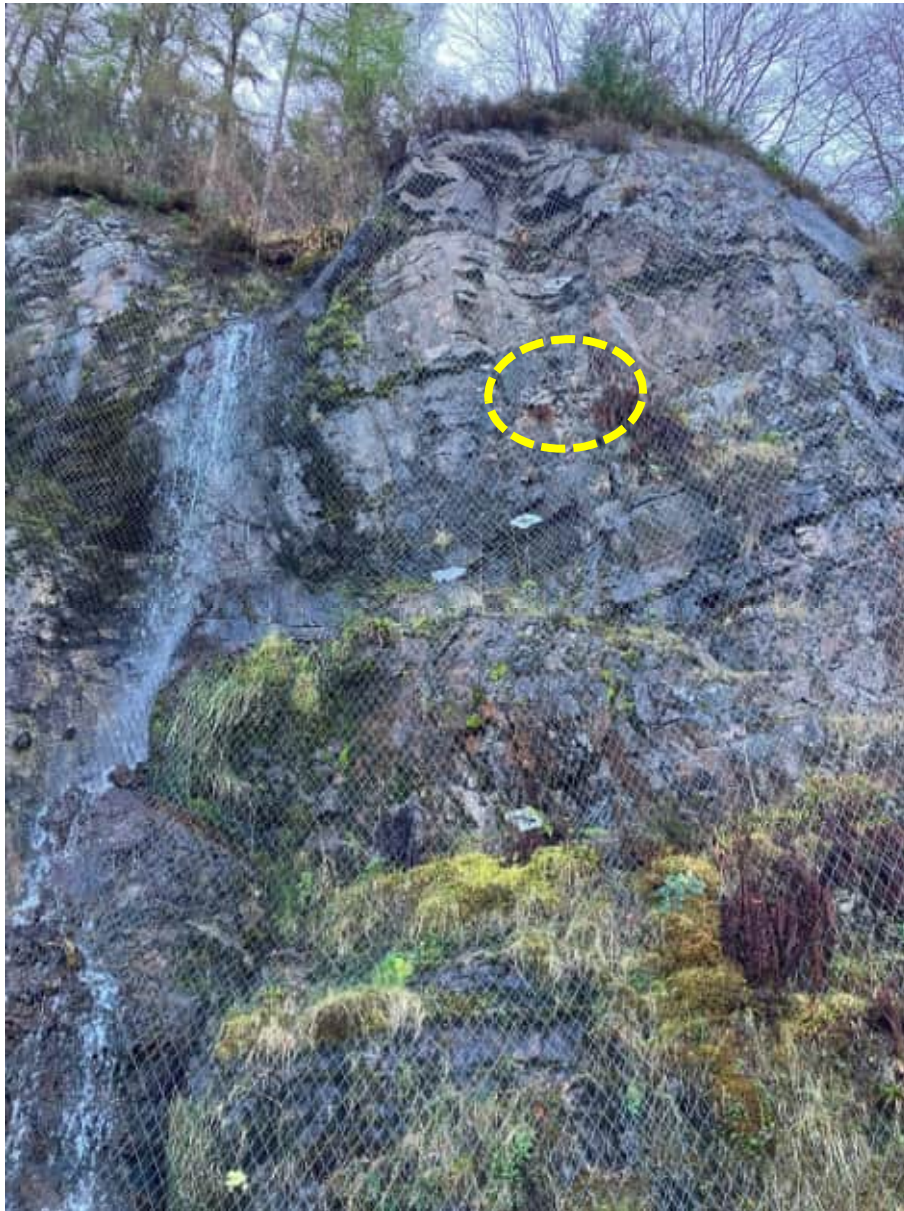
| AA1-1 | <p>Ch. 0150:</p> <p>2021: Small accumulation of blocks on ledge behind TECCO netting c. 8 m above toe of slope. &lt;0.1 m<sup>3</sup> total volume. Not straining or deforming netting so no maintenance requirements at this time.</p> <p>2026: No changes observed during 2026 inspection.</p> | Year First Observed: | 2021 |

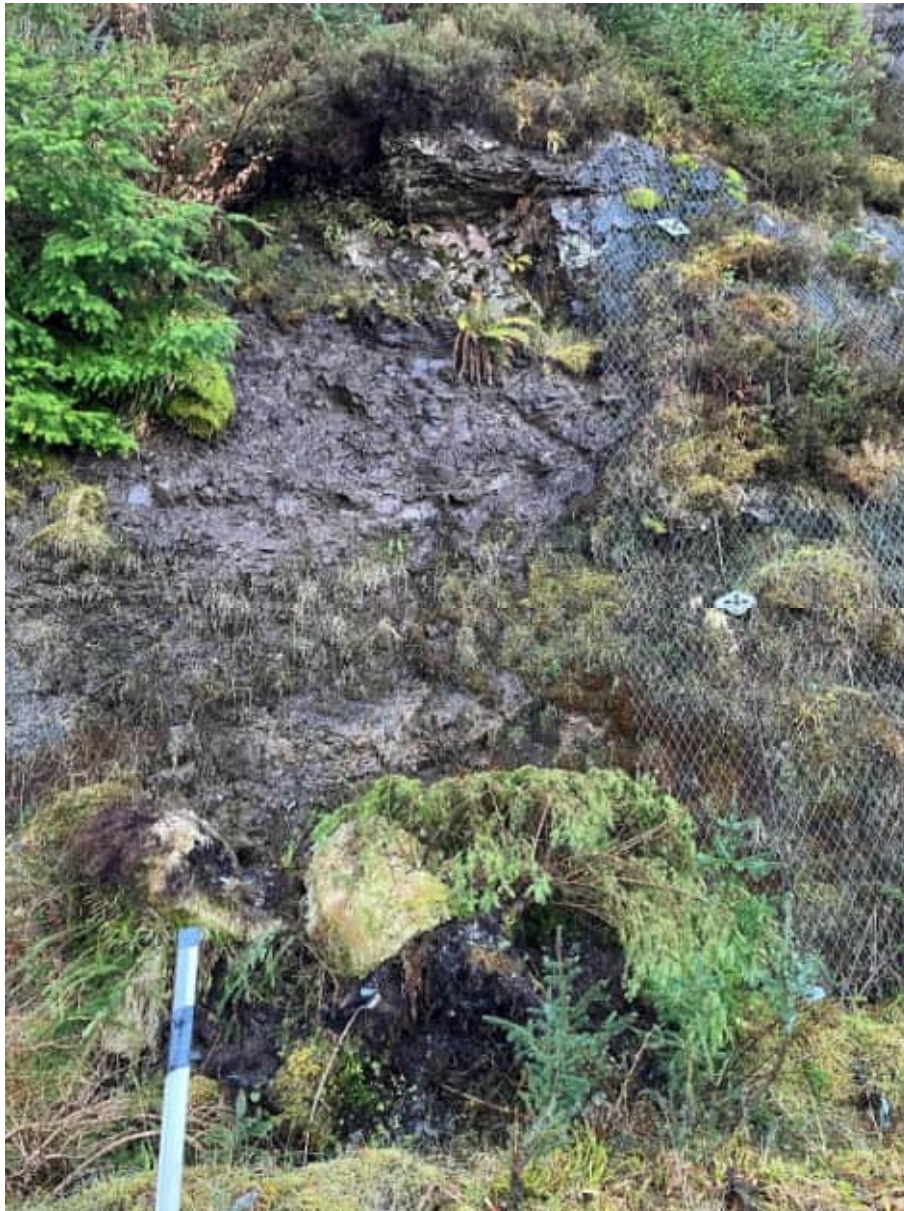
| AA1-2 | <p>Ch. 0166:</p> <p>2026: A small tree fall approx. 3 to 5 m above road level has resulted in a small soil slip / slump, creating an overhang on the exposed rock face. Overhang would most likely drop into the ditch and is not considered to pose a risk to the road. A second tree appears likely to fall in the short-term.</p> | <p>Year First Observed:</p> | 2026 |

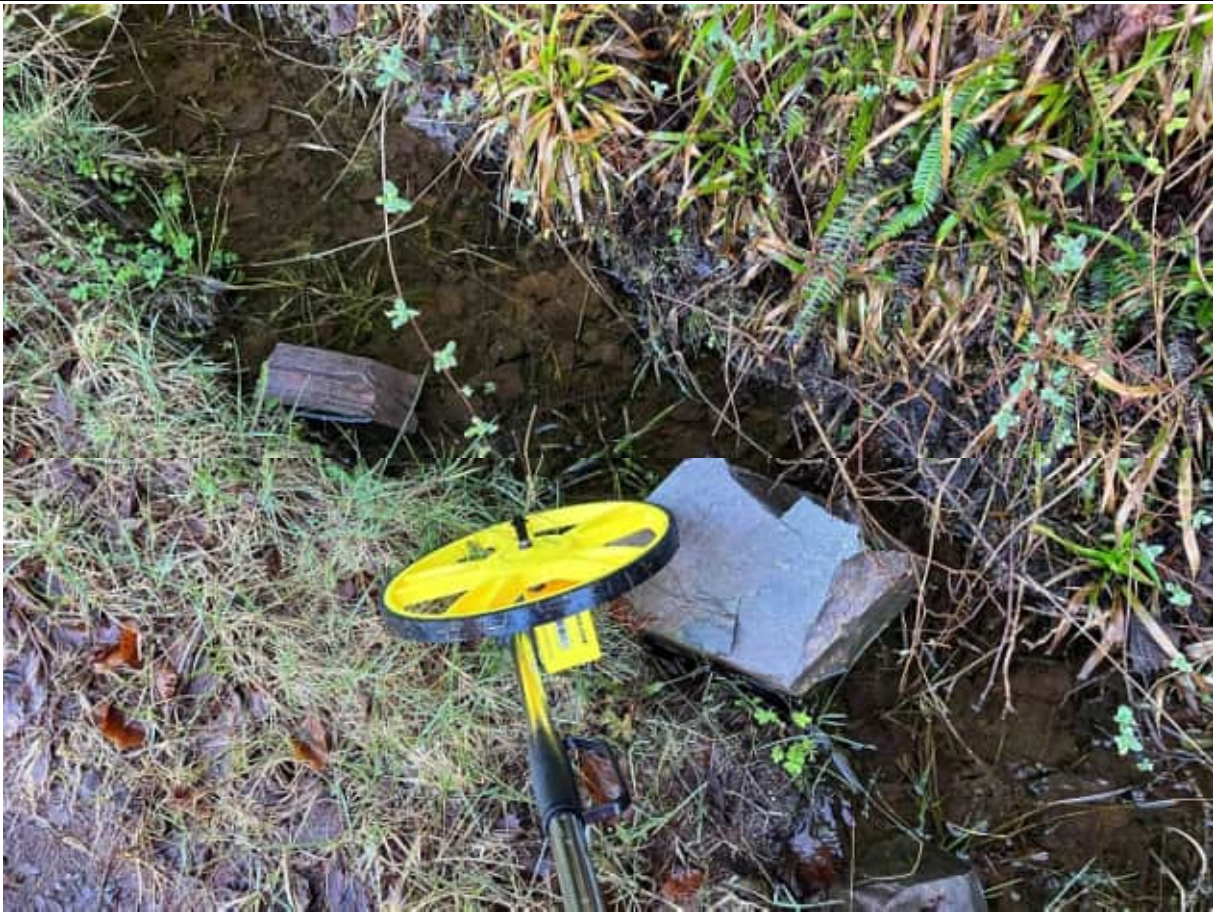
| AA2-5 | <p>Ch. 0328:</p> <p>2026: Two blocks present in the base of the ditch, the largest block is approx. 0.3 x 0.3 x 0.3 m. Origin of blocks is unclear as the slope is too heavily vegetated to fully assess the source, possibly ravelled out of a root ball approx. 8 m above road level.</p> | Year First Observed: | 2026 |

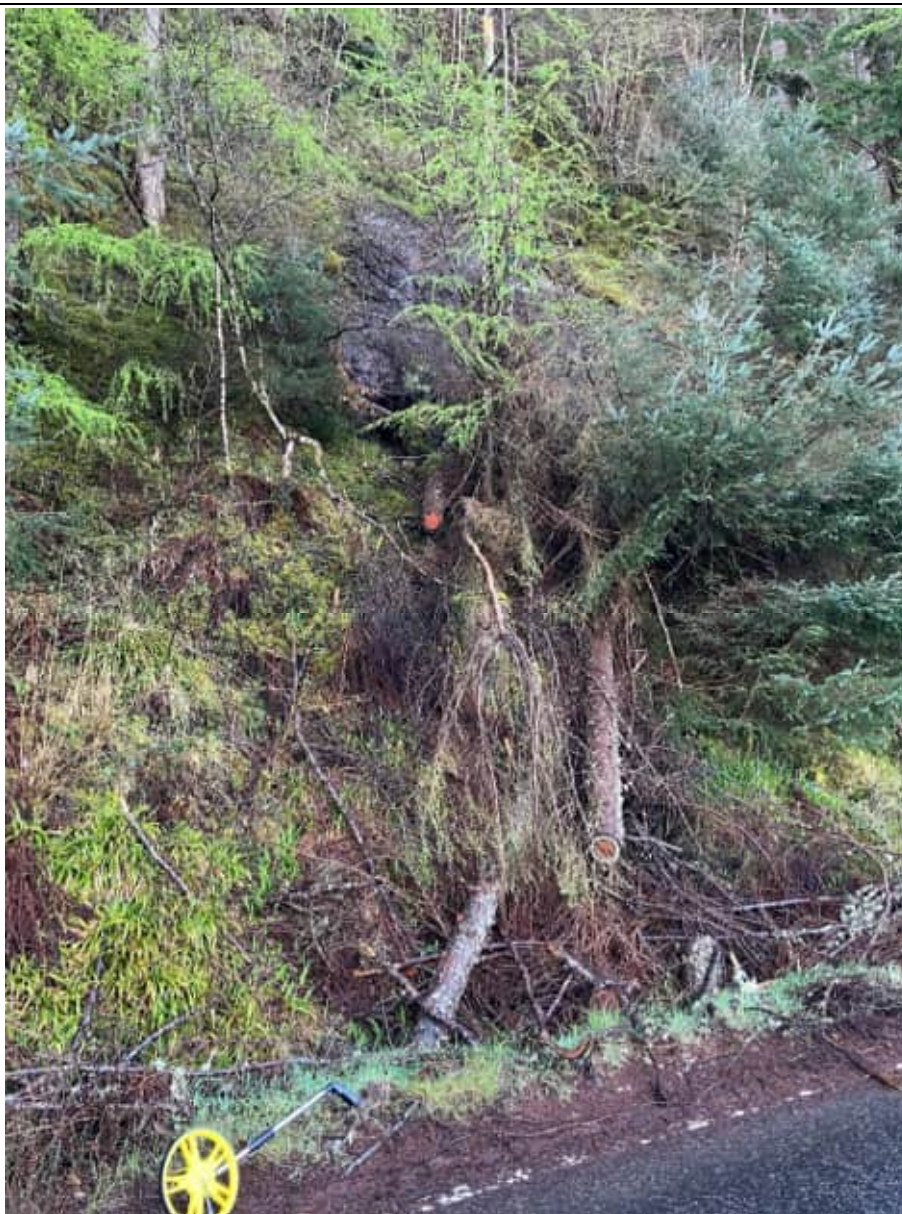
| AA2A-1 | <p>Ch. 0350 to 0356:</p> <p>2026: Three/four trees have fallen from the slope. Deadwood material has been trimmed back and waste left in the roadside ditch, which is completely blocked and requires clearance. Exposed rock scar, between 6 and 12 m above road level, appears reasonably competent and does not represent a significant ongoing risk of rockfall.</p> | Year First Observed: | 2026 |

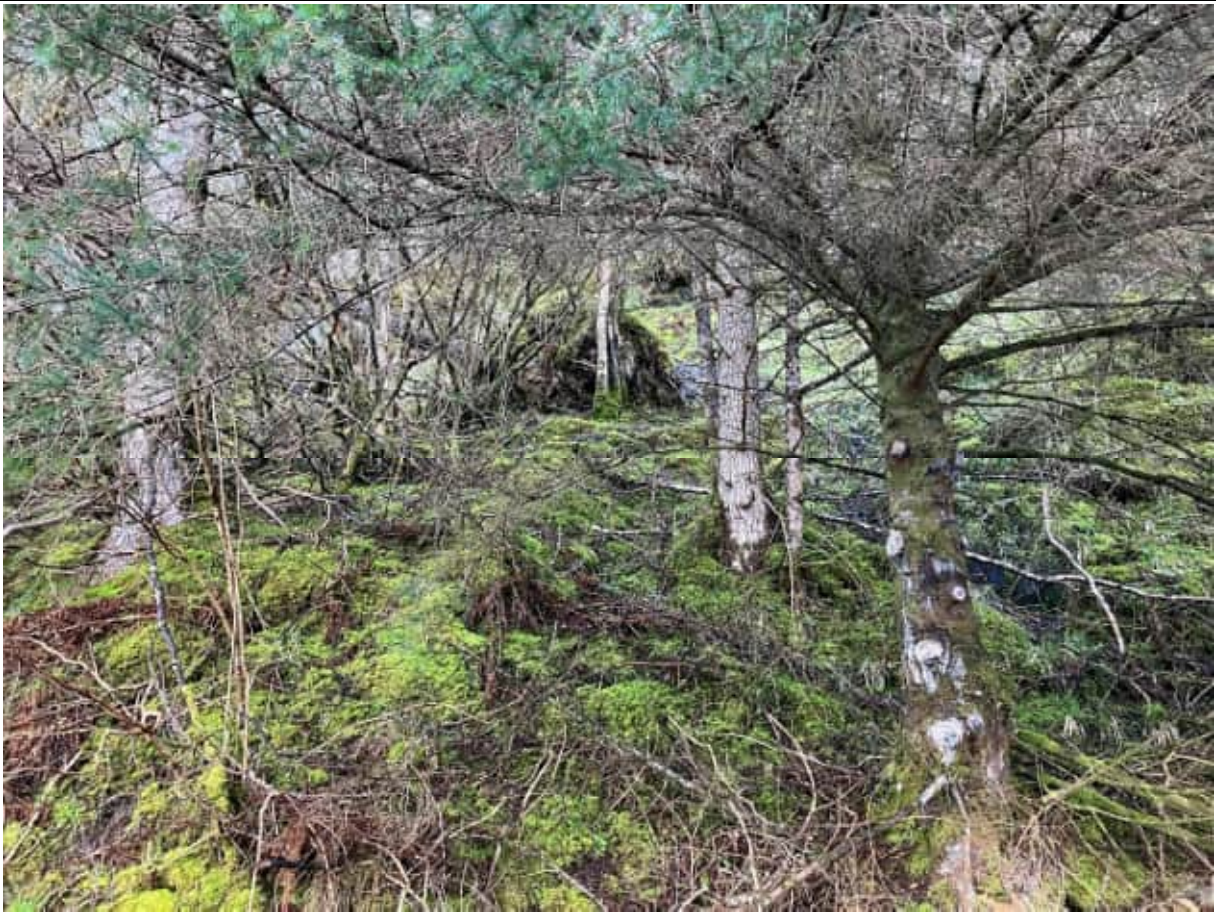
| AA2A-3 | Ch. 0400:<br>2026: Tree fallen on slope approx. 12 m above road level. Possible source of future ravelling-type rockfall from the root ball. | Year First Observed: | 2026 |

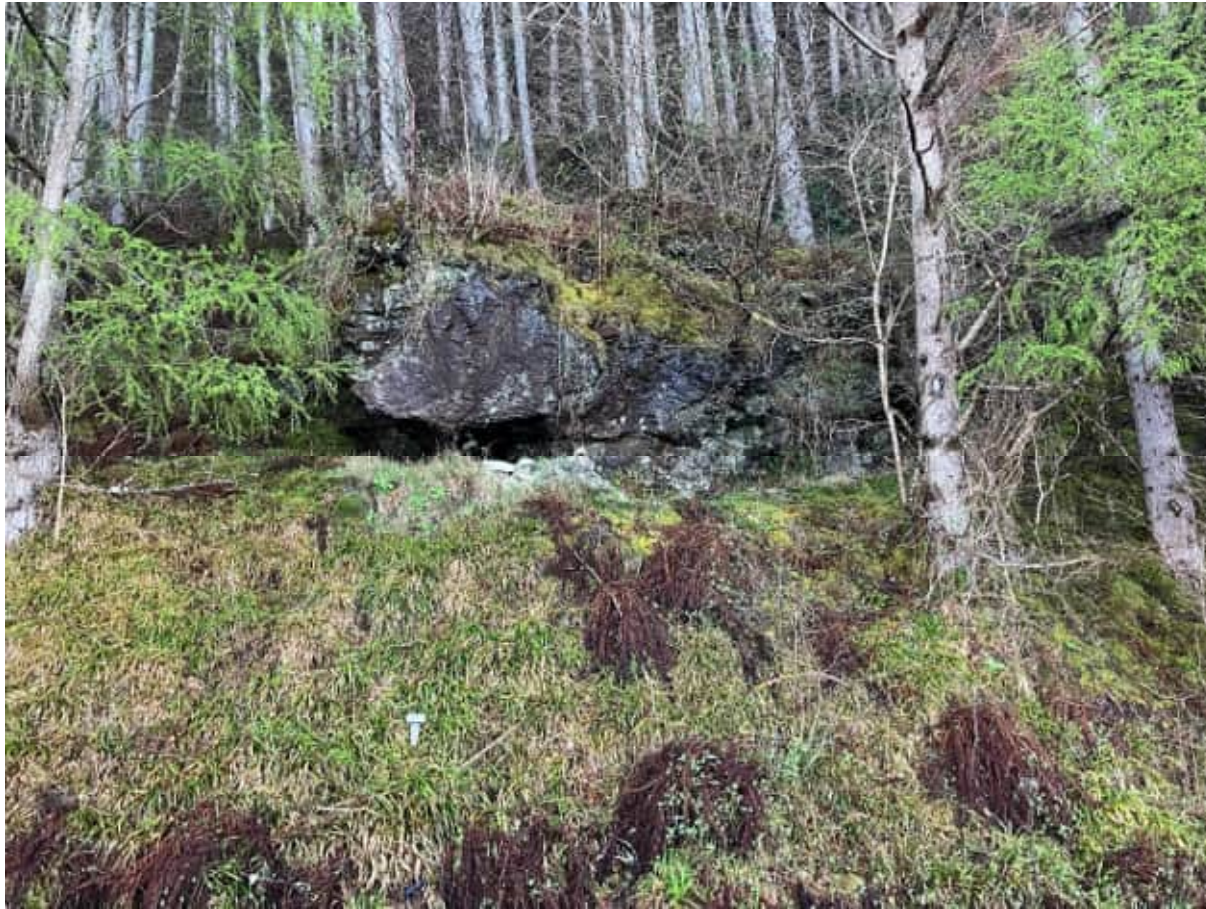
| AA2A-4 | <p>Ch. 0400:</p> <p>2016: Large overhanging boulder 5 m above road level. Weaker / more fractured material near the base of the boulder has preferentially weathered, leaving a 2.5 m overhang. Dilated discontinuities within upper part of boulder form a distinct block (approx. 1.5 x 1.5 x 2.0 m) above the overhang, which is at risk of failure due to loss of support and root jacking (trees growing on boulder have been coppiced in the past but were noted to be re-growing). Passing place beneath potential rock fall. If this block were to fail it would reach the road. In 2020 Inspection, it was noted that a few small blocks have spalled / ravelled from the southern side of the boulder.</p> | Year First Observed: | 2016 |

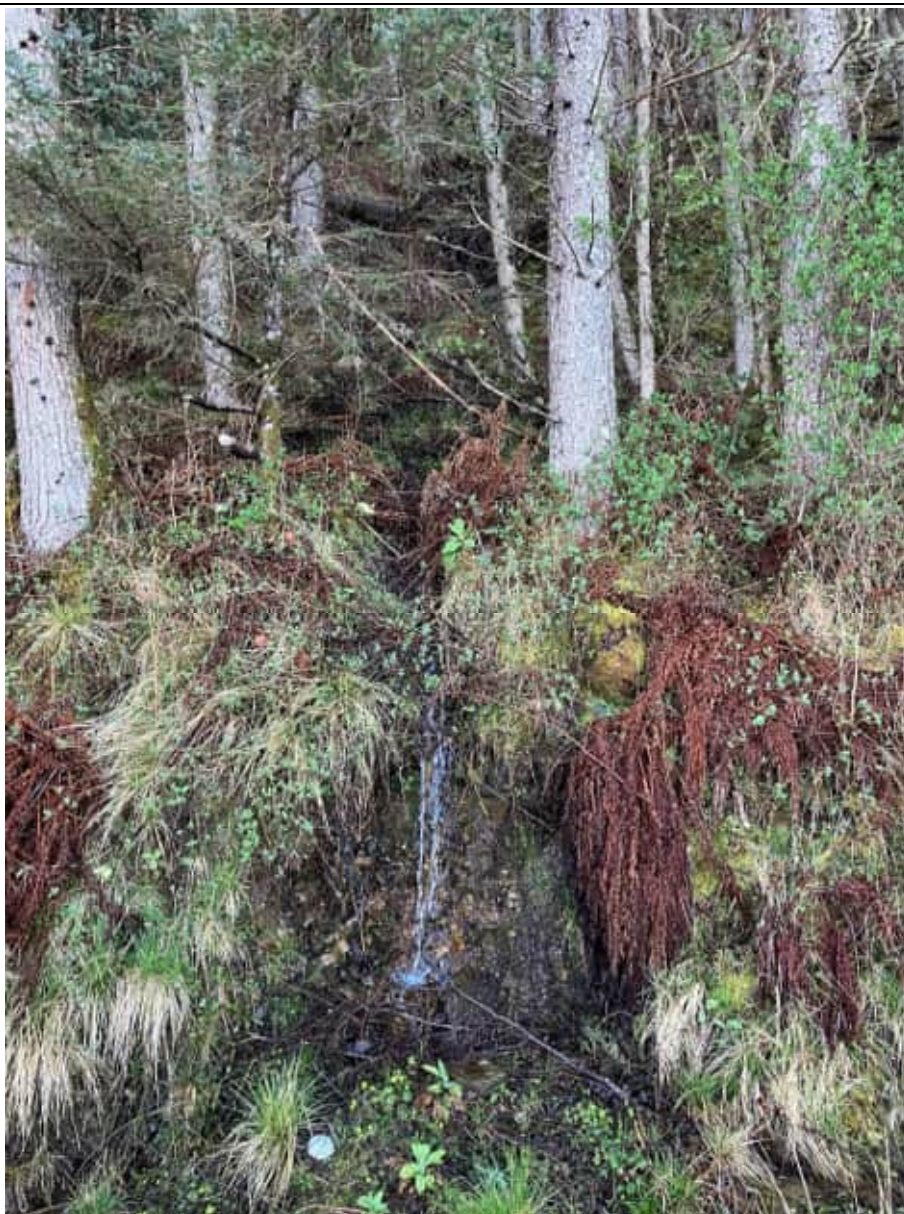
| AA2A-6 | <p>Ch. 0429:</p> <p>2026: A significant number of trees have fallen on the slope above the roadside, resulting in an ongoing risk of ravelling-type rockfalls due to the weathering out of blocks from exposed root balls. Evidence from this section of the route (see comments at Ch. 0419 and 0434) suggests the ditch is an effective rock trap and that the likelihood of rockfalls from affecting the road is considered to be low.</p> | <p>Year First Observed:</p> | 2026 |

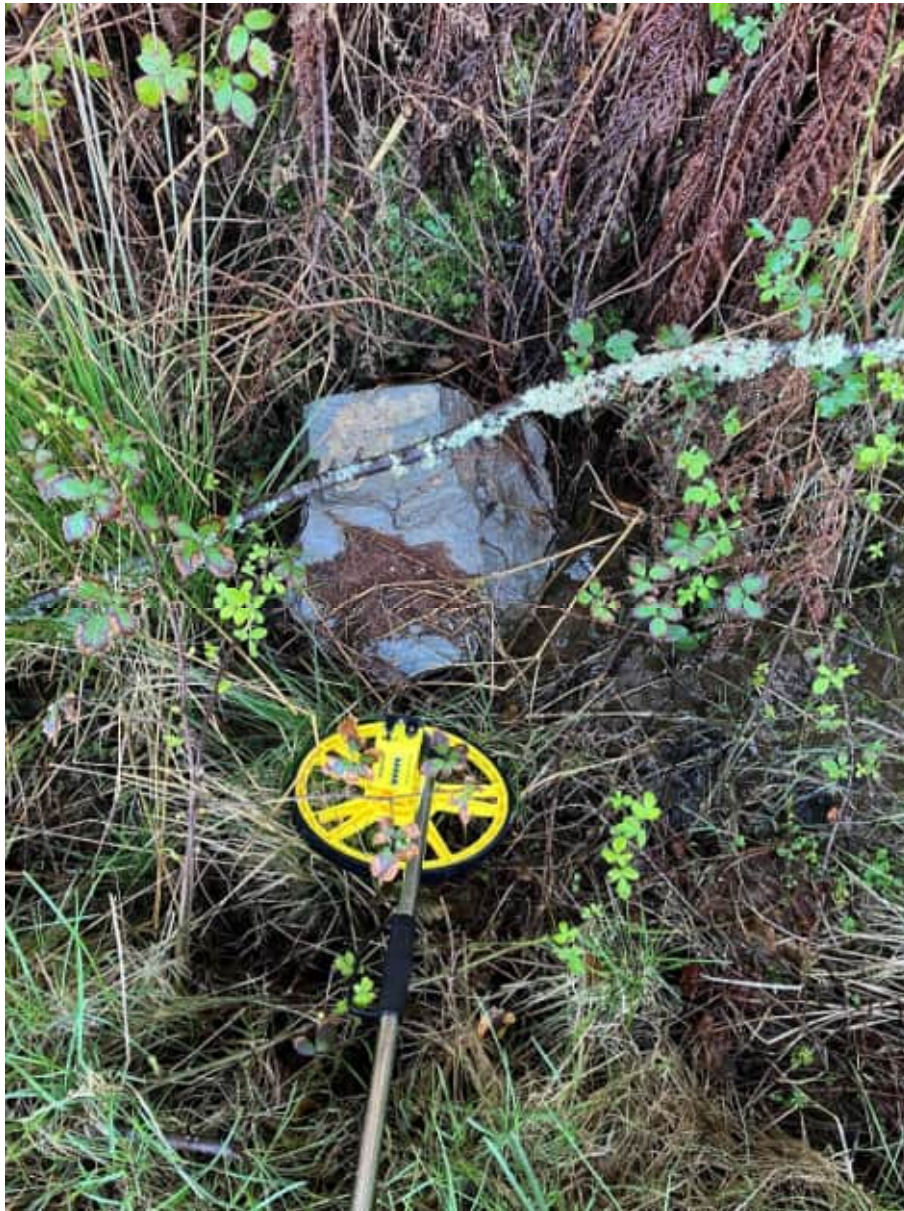
| AA2A-7 | <p>Ch. 0434:</p> <p>2026: One new block (approx. 0.5 x 0.4 x 0.3 m) present in the ditch. Likely dislodged from tree fall further upslope (see comments at Ch. 0429). Evidence that the ditch remains an effective rock trap.</p> | <p>Year First Observed:</p> | 2026 |

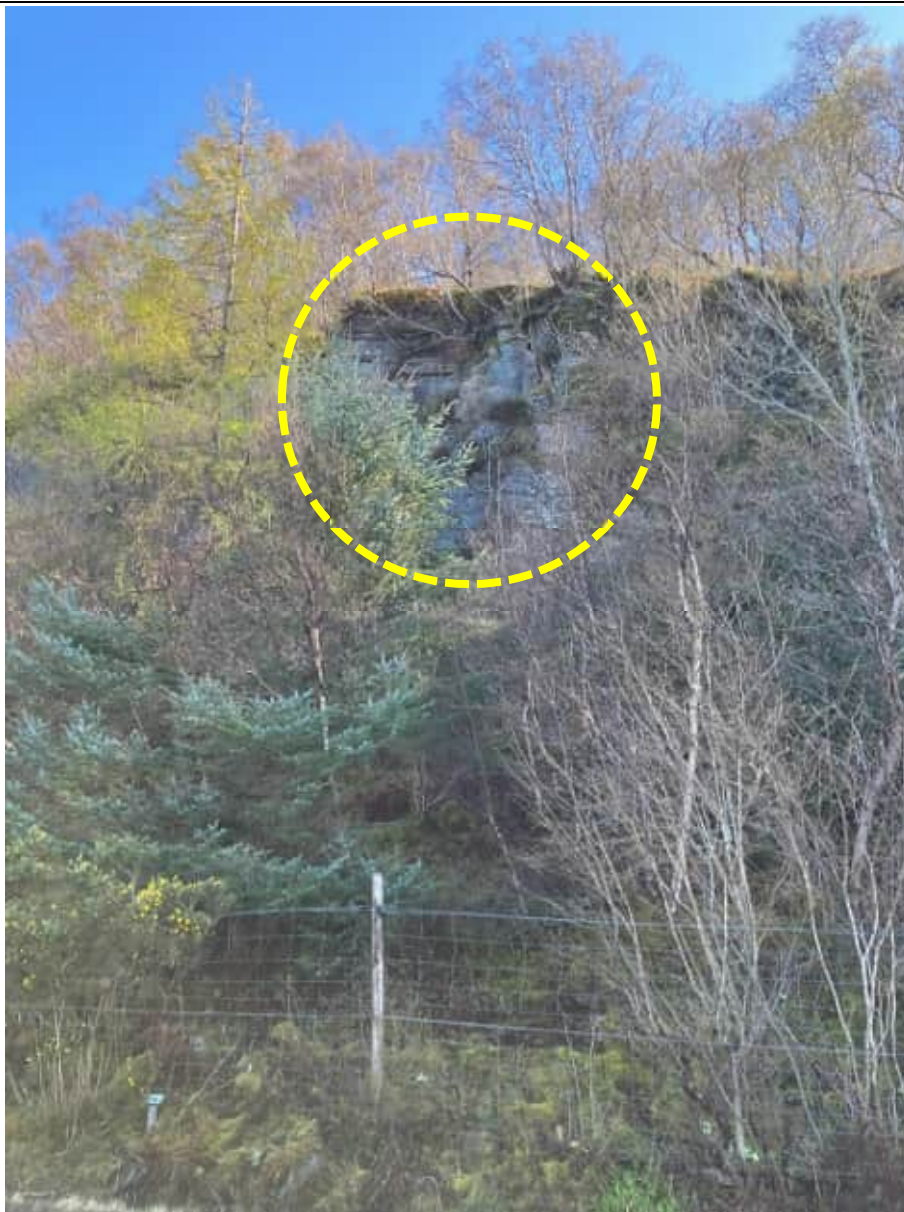
| AA3-2 | <p>Ch. 0600:</p> <p>2021: Block / slab of rock with dilated fractures and potential for root jacking at crest of rock slope. No significant change since last inspection. Set well back from road with adequate rock trap so low risk to road.</p> <p>2026: No changes observed during 2026 inspection.</p> | Year First<br>Observed: | 2021 |

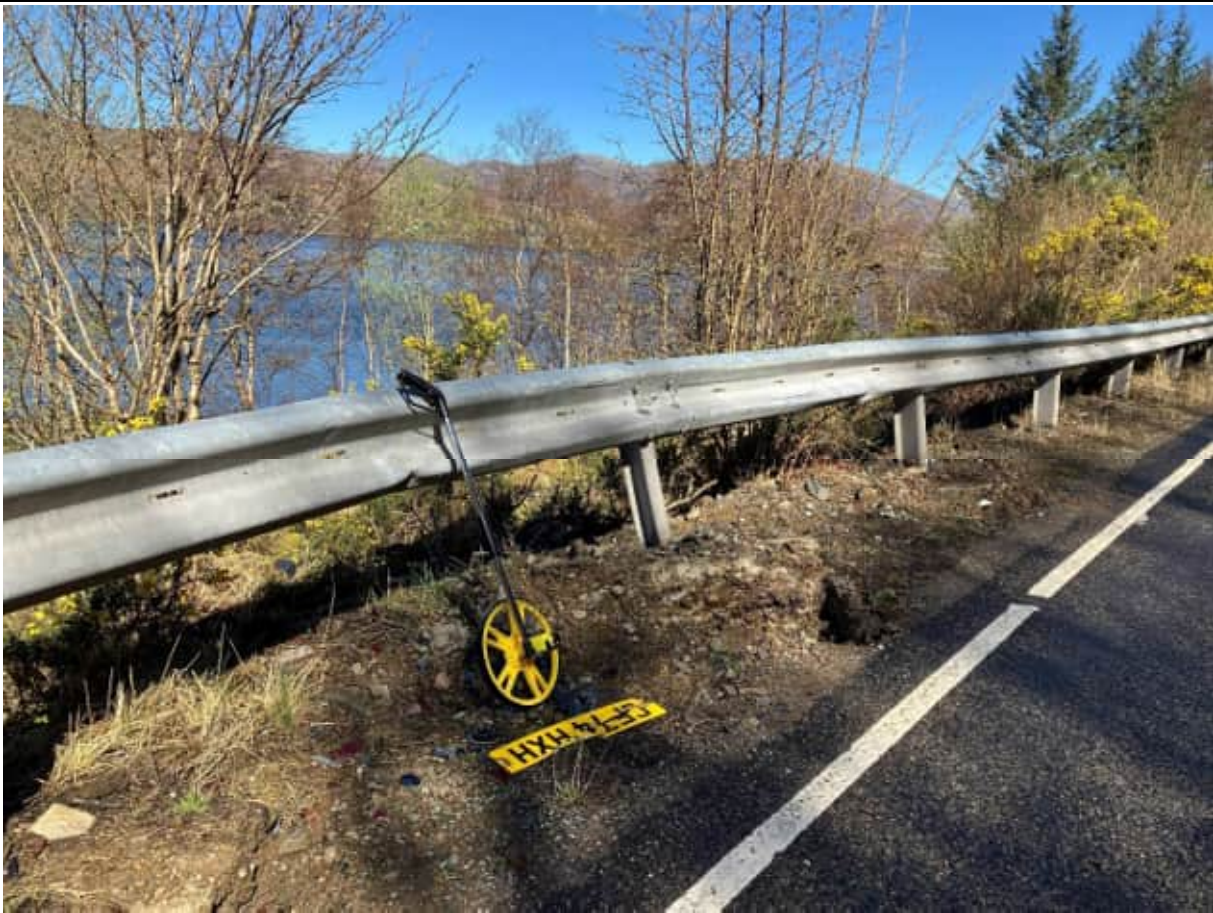
| AA3-3 | Ch. 0616:<br>2026: Crash barrier has been struck. Supports have been pulled from the ground and barrier deformed. Repair/replacement advised. | Year First Observed: | 2026 |

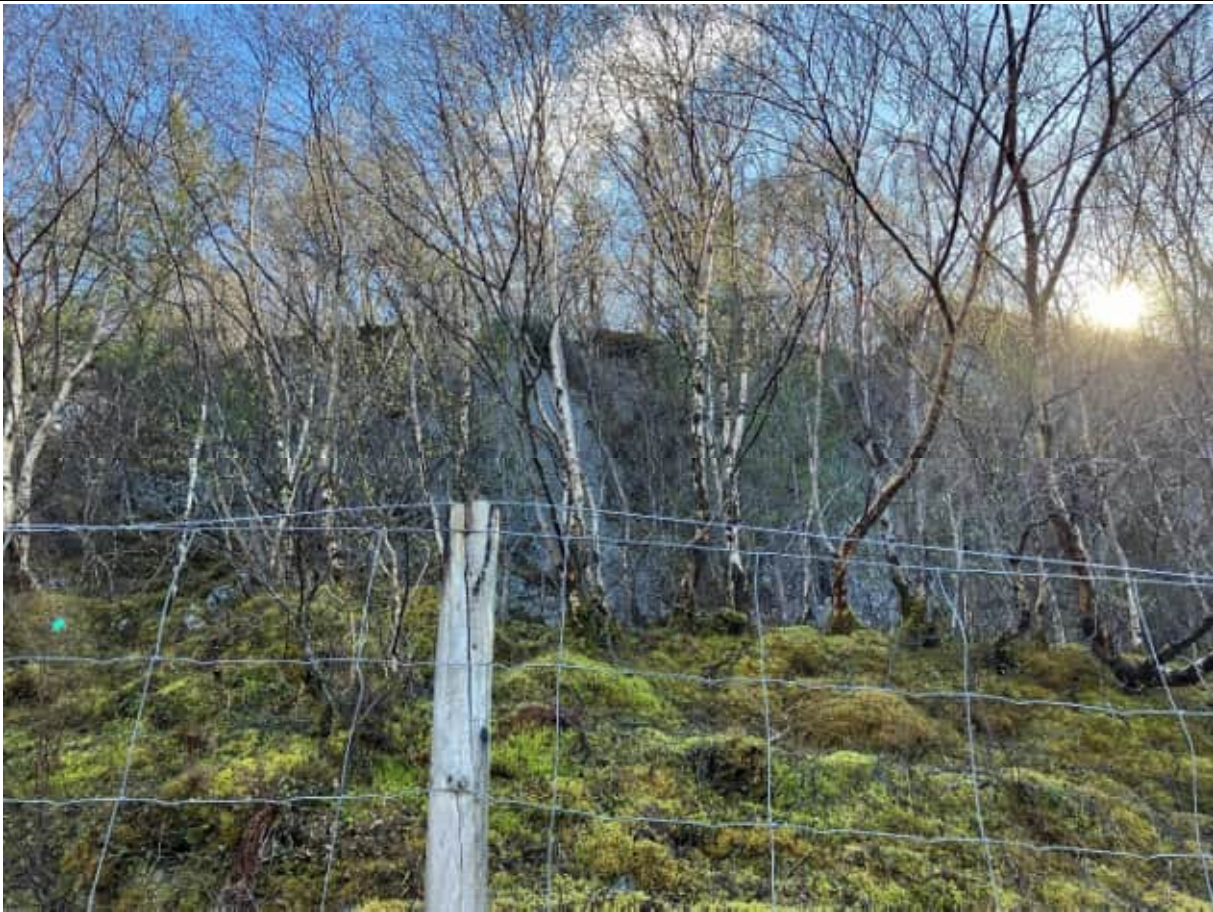
| AA3-4 | <p>Ch. 0622:</p> <p>2025: Potential toppling failure with dilated fracture at crest of slope. View of feature largely obscured by vegetation.</p> <p>2026: Possible further rockfall and presence of 'fresh' surfaces at height, although vegetation growth inhibits the assessment from road level.</p> | Year First Observed: | 2025 |

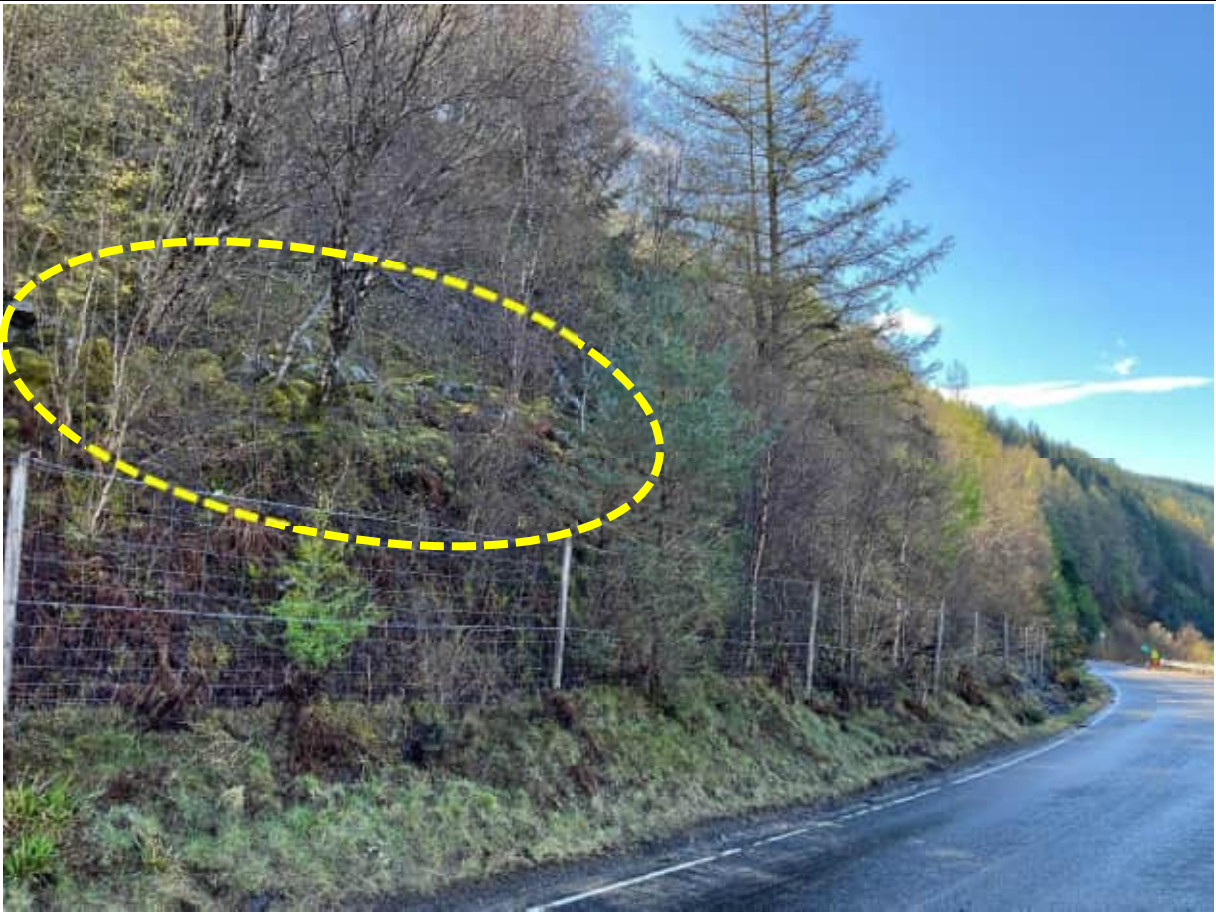
| AA3-6 | <p>Ch. 0662:</p> <p>2024: Loose granular material forming roadside slope. Blocks occasionally moving downslope and coming to rest in ditch.</p> <p>2026: No changes observed during 2026 inspection.</p> | Year First Observed: | 2024 |

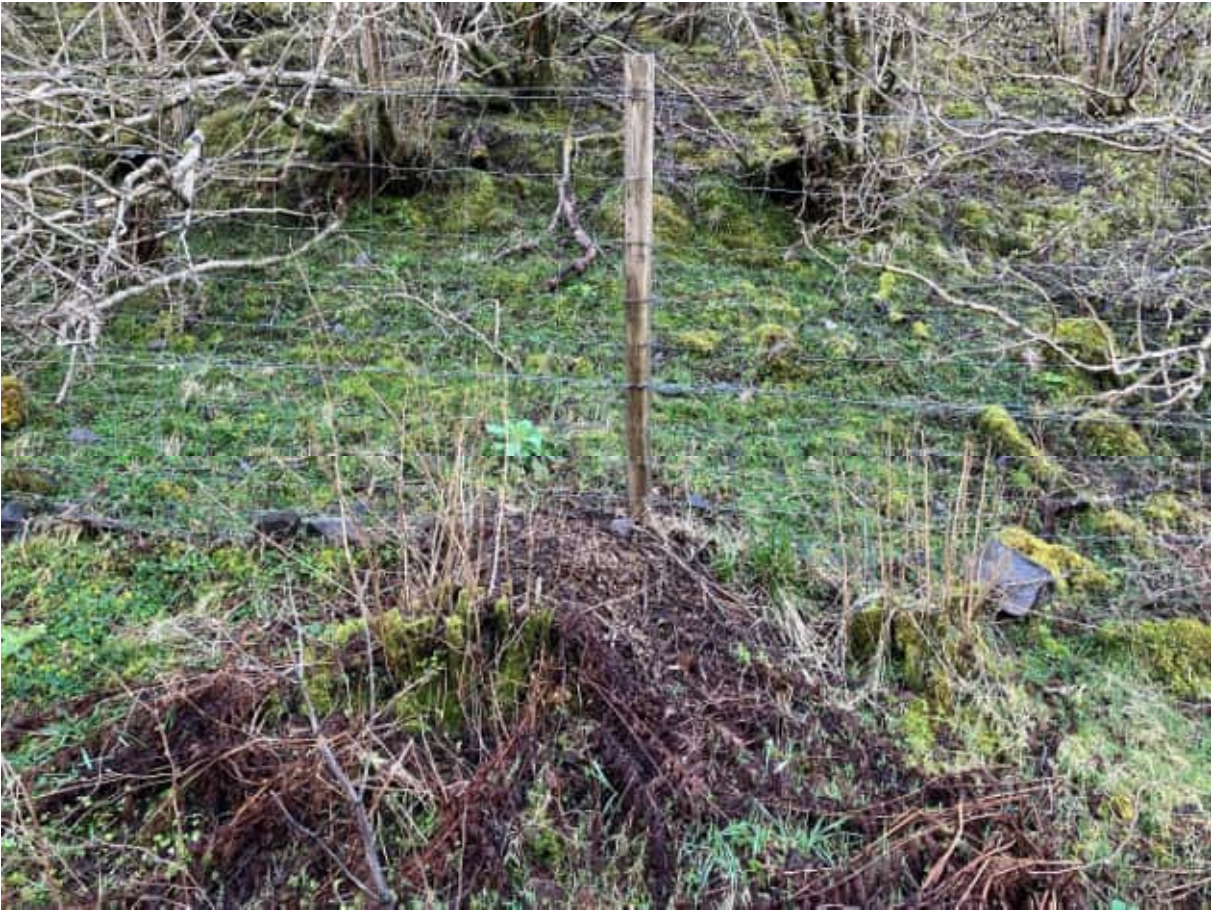
| AA3A-1 | <p>Ch. 0705 to 0715:</p> <p>2024: Accumulation of small blocks behind deer fence.</p> <p>2025: Four fresh rock fall blocks present amongst other blocks, distinguished by not having been overgrown with mass. Dimensions of largest block c. 0.3 x 0.2 x 0.1 m</p> <p>2026: No changes observed during 2026 inspection.</p> | Year First Observed: | 2024 |

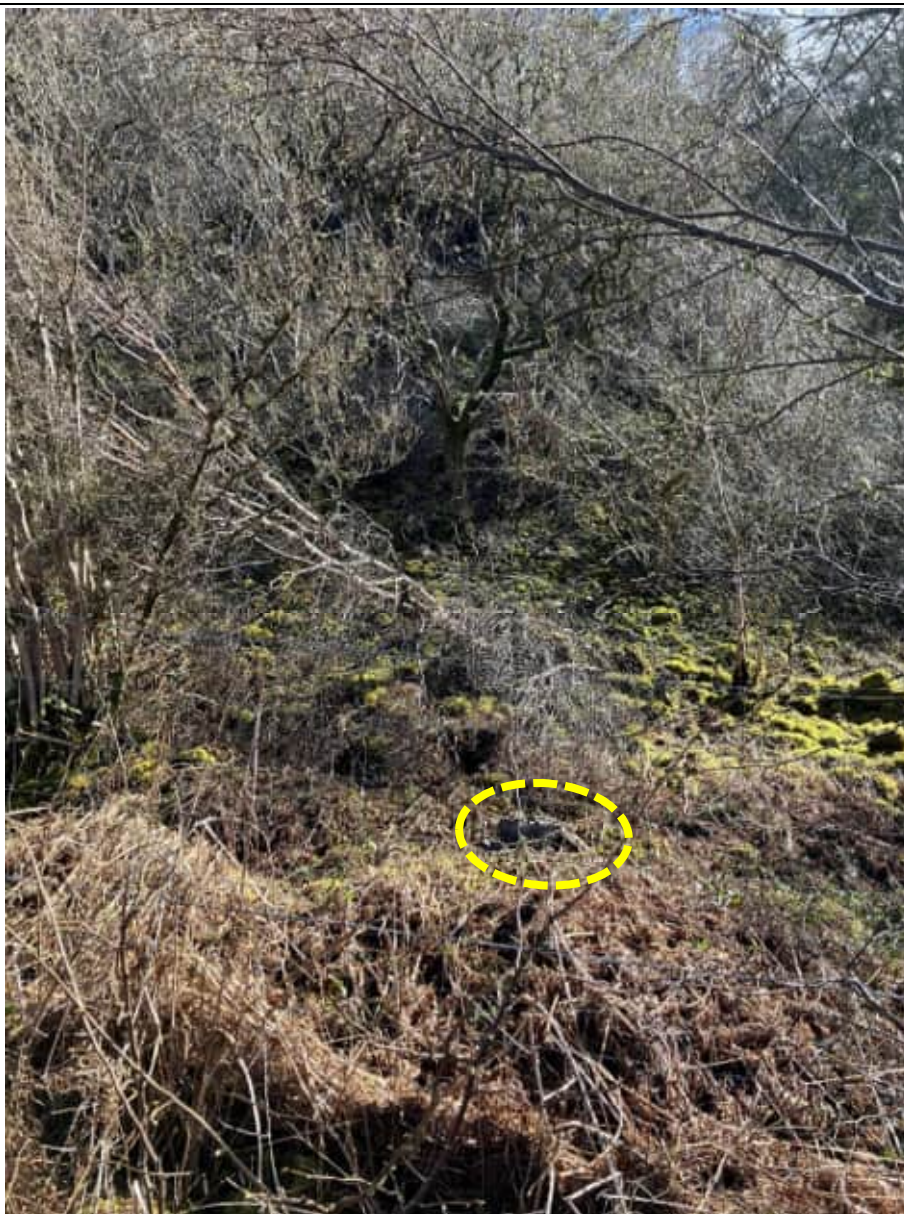
| AA5-1 | <p>Ch. 1253 (between section AA4 Upper and section AA5):</p> <p>2026: One large block present resting on the slope, upslope of the deer fence. Dimensions approx. 1.0 x 0.5 x 0.4 m. Likely fallen from upper crags approx. 25 m upslope. Unlikely to become mobilised in future and, therefore, represents a low risk to the road; however, there remains the potential for future rockfall from the upper crags.</p> | Year First Observed: | 2026 |

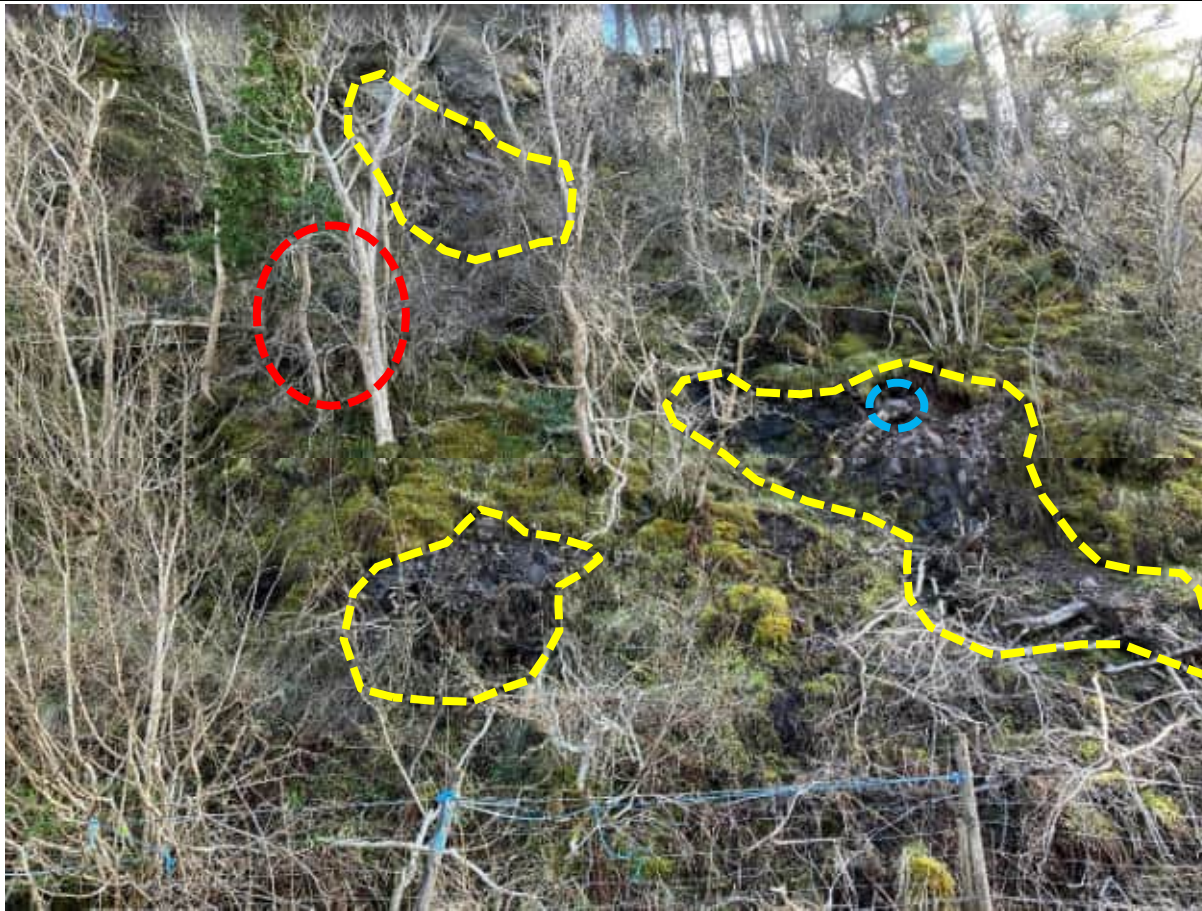
| AA5A-1 | <p>Ch. 1420 to 1431:</p> <p>2026: Three fallen trees at circa 6, 8, and 15 m above road level (yellow). All three trees appear to have 'peeled' off the slope face, leaving large areas of exposed rock at surface and dislodging a large amount of soil and rock, with debris completely filling the ditch. A fourth tree (red) has also fallen (immediately below tree fall at 15 m height) and is completely detached but is propped up by other trees. Further tree falls in future highly likely. Exposed rock is blocky, however, the metamorphic foliation/fabric dip into the slope and there does not appear to be a release joint. Tree fall at 6 m – Small number of blocks present downslope of the tree fall (Ch. 1432). Tree fall at 8 m – Tree fall has left a vegetated overhang over the slip scar. One boulder (0.35 x 0.25 x 0.15 m) (blue) is completely detached from the exposed rockface and is held at height resting against a rotten, large diameter tree root. Loose gravel to cobble sized fragments of rock held in vegetation of overhang.</p> | Year First Observed: | 2026 |

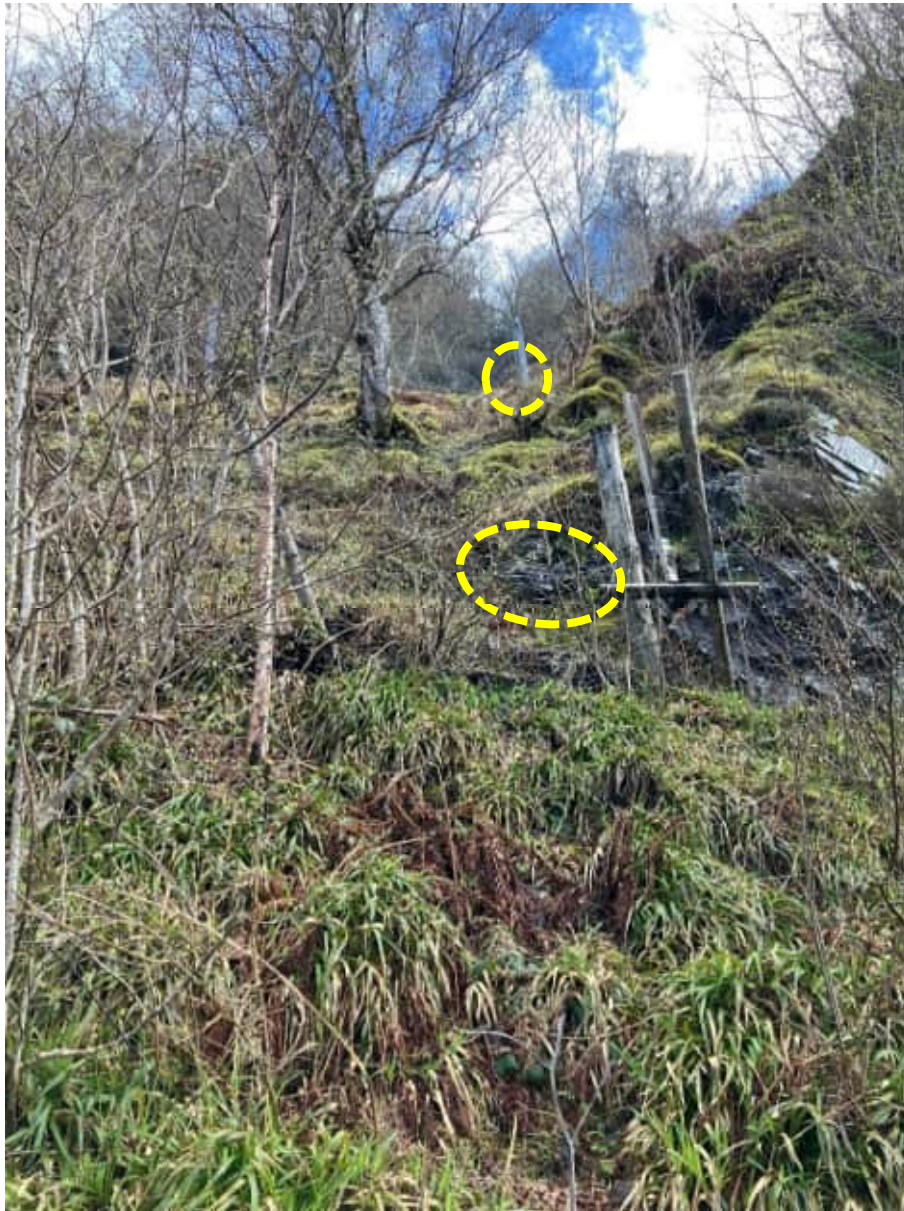
| AA6A-4 | <p>Ch. 1505:</p> <p>2023: Accumulation of blocks at roadside deer fence c. 3 m above road level, along 5 m length of slope. Debris height c. 0.4 m. Generally, 0.1 x 0.1 x 0.1 m blocks but maximum 0.3 x 0.3 x 0.3 m. Directly downslope of catch fence but there is a scree slope between catch fence and deer fence so scree has possibly washed down slope. Clearance recommended as the deer fence is not designed to retain material.</p> <p>2025: Accumulation of debris partially cleared.</p> <p>2026: Numerous small blocks retained at the eastern end of the lower catch fence. A small channel is also present by the deer fence with a small number of loose blocks present within. Maximum block size circa 0.1 x 0.1 x 0.1 m.</p> | Year First Observed: | 2023 |

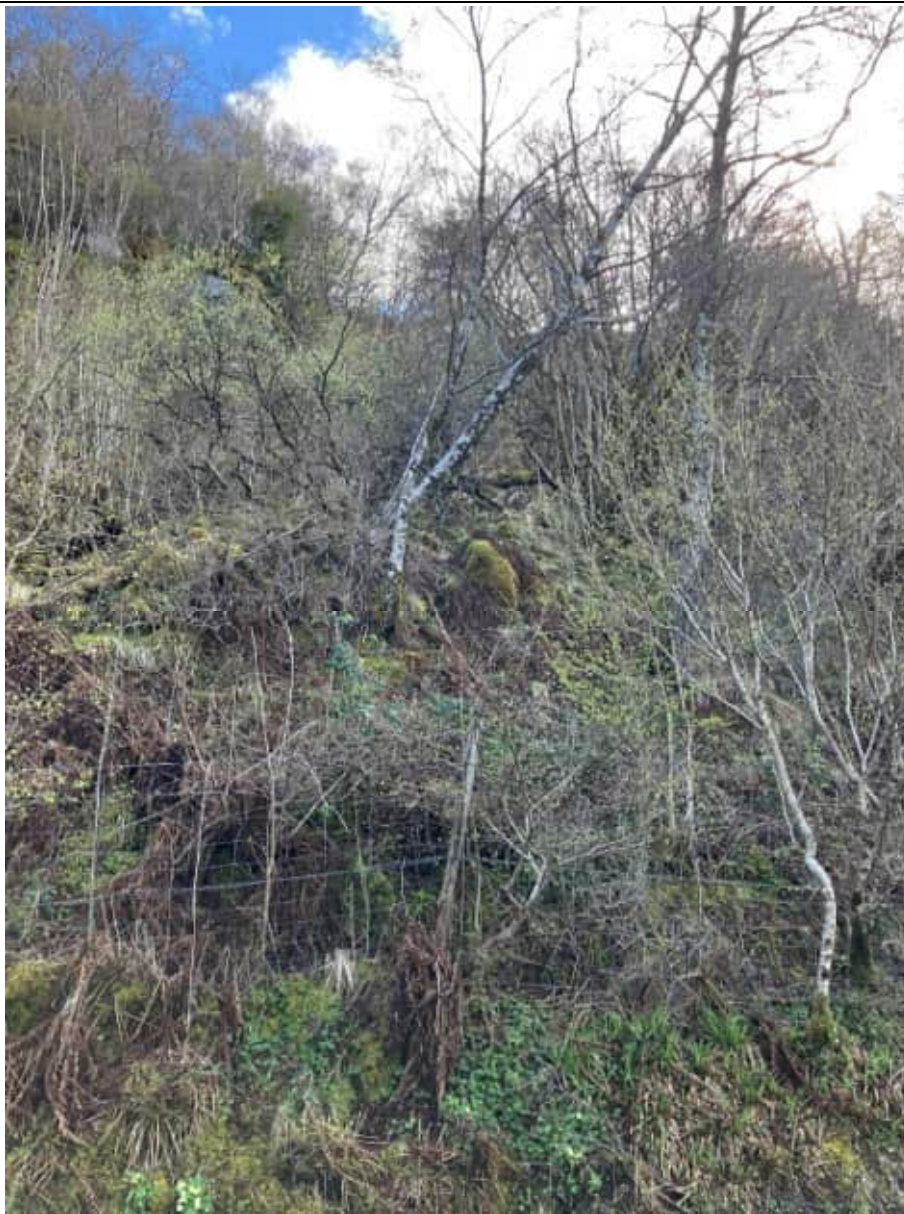
| AA7-2 | <p>Ch. 1760:</p> <p>2025: Severely leaning tree c. 8 m above road level. May dislodge boulders if it were to fall but poses relatively low risk to road.</p> <p>2026: Tree is not leaning – reduced vegetation cover versus 2025 inspection shows that it is a branch and not the trunk of the tree that is 'leaning'.</p> | Year First Observed: | 2025 |

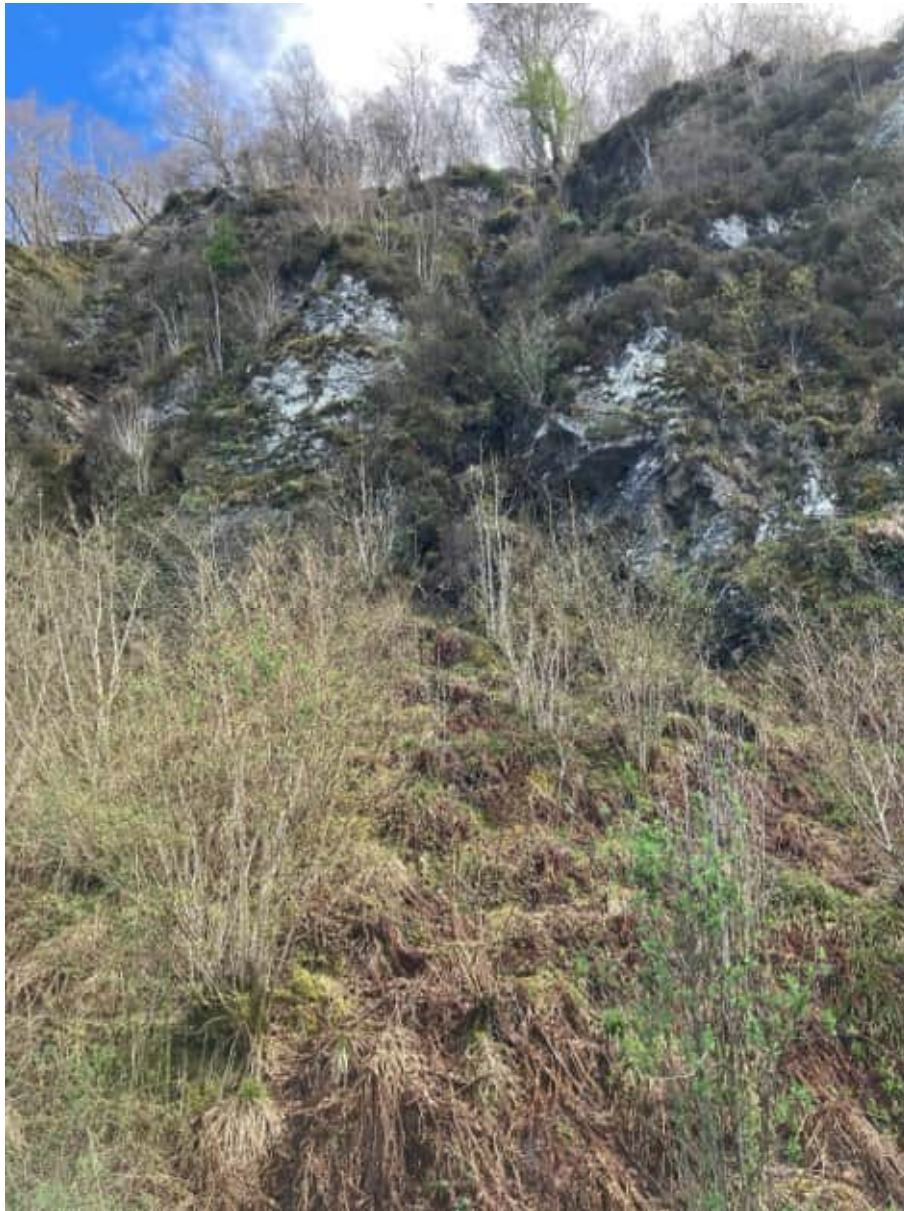
| AA7-3 | Ch. 1800:<br>2026: Gully appears to have partially washed out. No new rockfall hazards noted, however, the lower slope could slip if saturated/surcharged. | Year First<br>Observed: | 2026 |

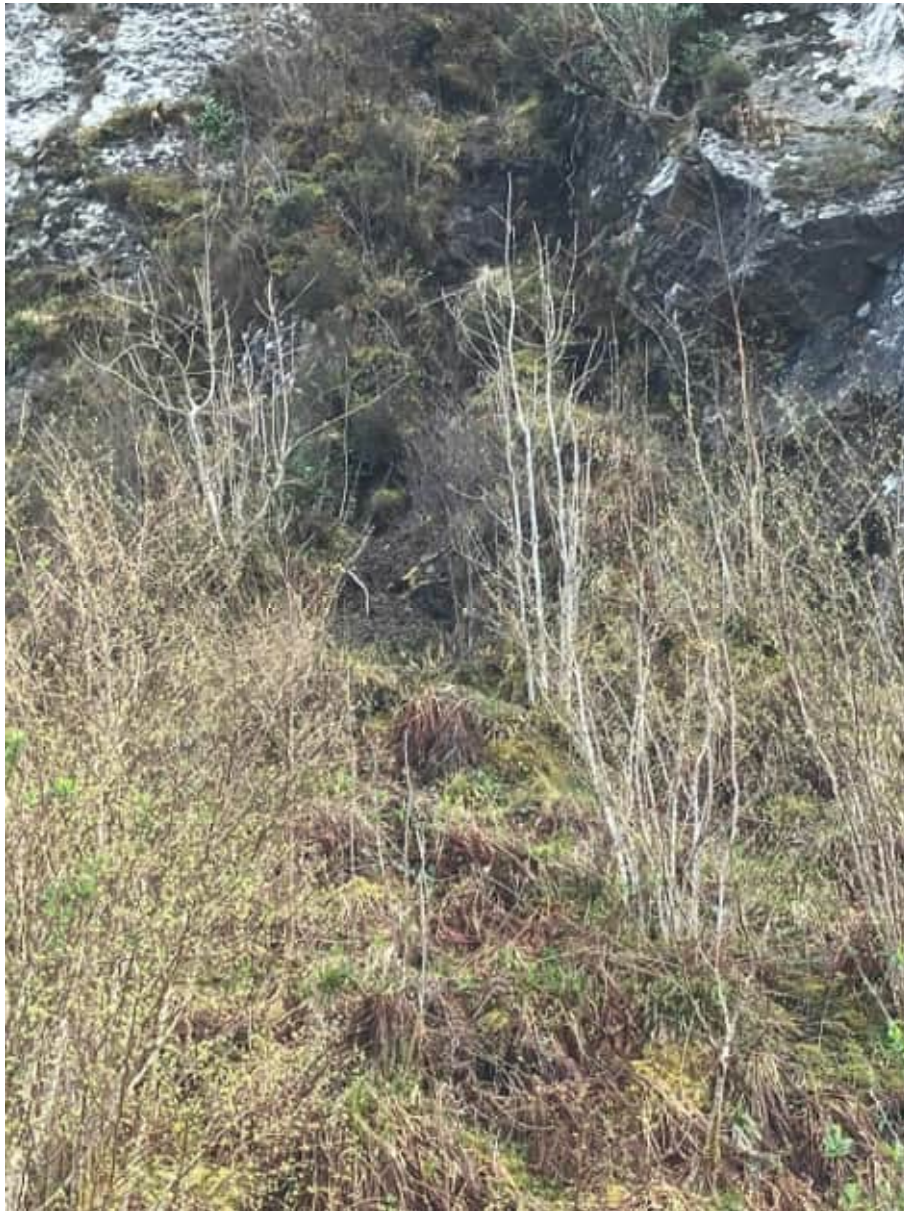
| AA7-4 | Ch. 1800:<br>2026: Gully appears to have partially washed out. No new rockfall hazards noted, however, the lower slope could slip if saturated/surcharged. | Year First<br>Observed: | 2026 |
