# A890 Strome ferry Bypass

Annual Slope Inspection 2026

The Highland Council

Project number: 60685712  
AECOM Report Ref.: GLRP0013

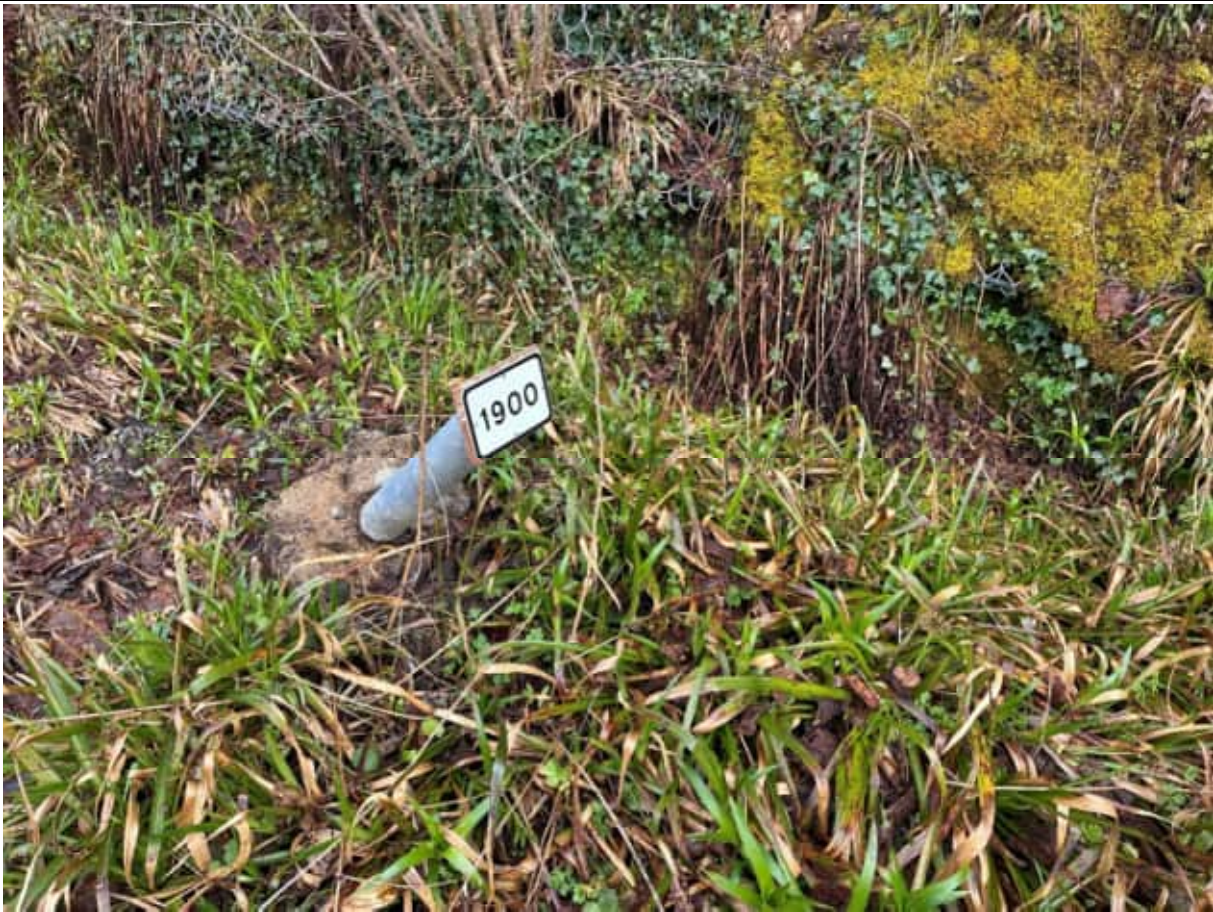
| AA8-2 | Ch. 1900:<br>2026: Ch. 1900 marker has been struck by a vehicle. | Year First Observed: | 2026 |

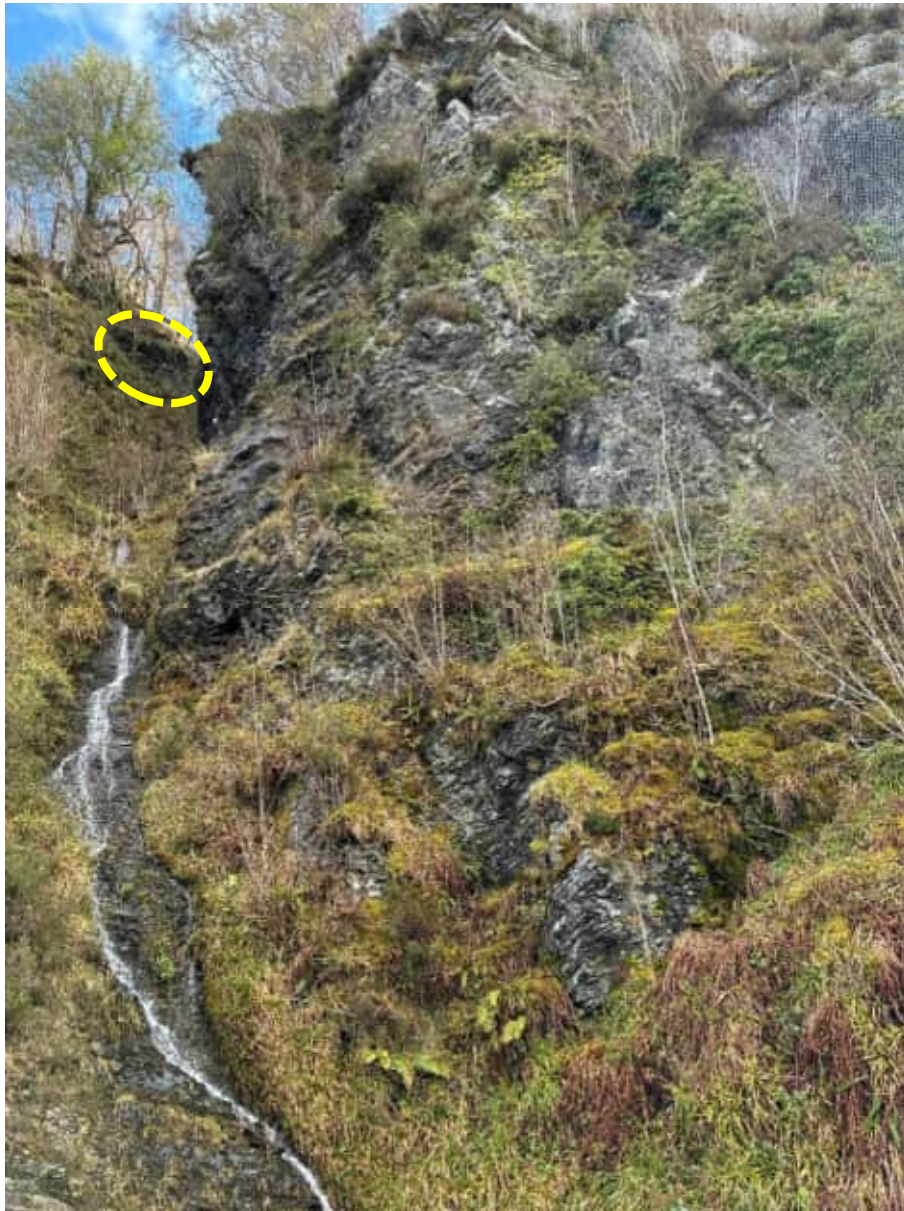
| AA8-2 | <p>Ch. 1944:</p> <p>2021: Overhangs towards crest. Vegetation cover c. 40 to 50% and dilated fractures evident. Some accumulation of gravel to cobble sized rock debris at base of watercourse within a 1 to 2 m wide x 1 m deep ditch with roadside bund. Still capacity and so does not require clearance.</p> <p>2025: Debris may collect in the upslope portion of the gully.</p> <p>2026: Ditch approx. one-third full. Exposed rock at the slope crest directly below a tree; appears to be in good condition.</p> | Year First Observed: | 2021 |

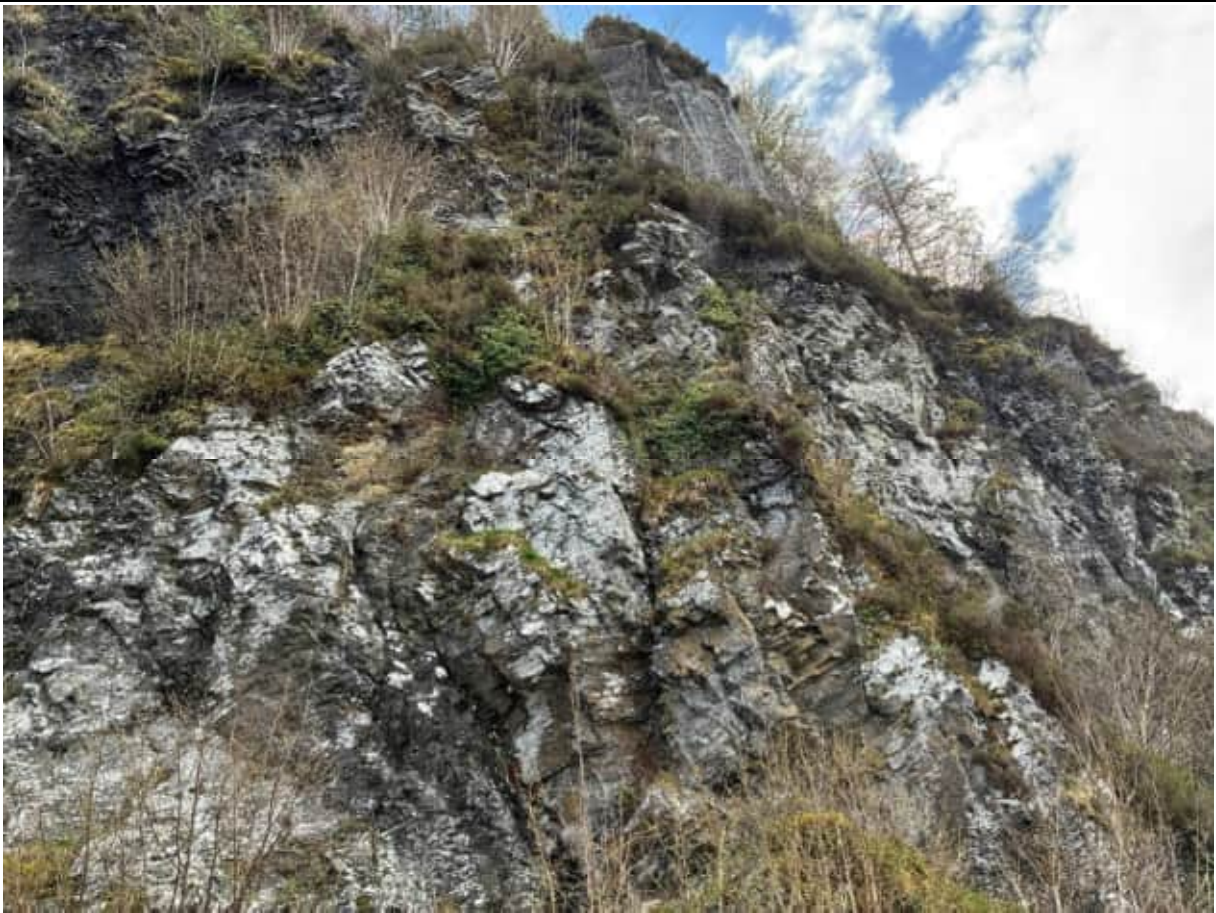
| AA9-1 | <p>Ch. 1978:</p> <p>2020: Overhanging square blocks near crest with dilated joint at rear observed. Rope access inspection completed in 2021.</p> <p>2026: No changes observed during 2026 inspection.</p> | Year First Observed: | 2020 |

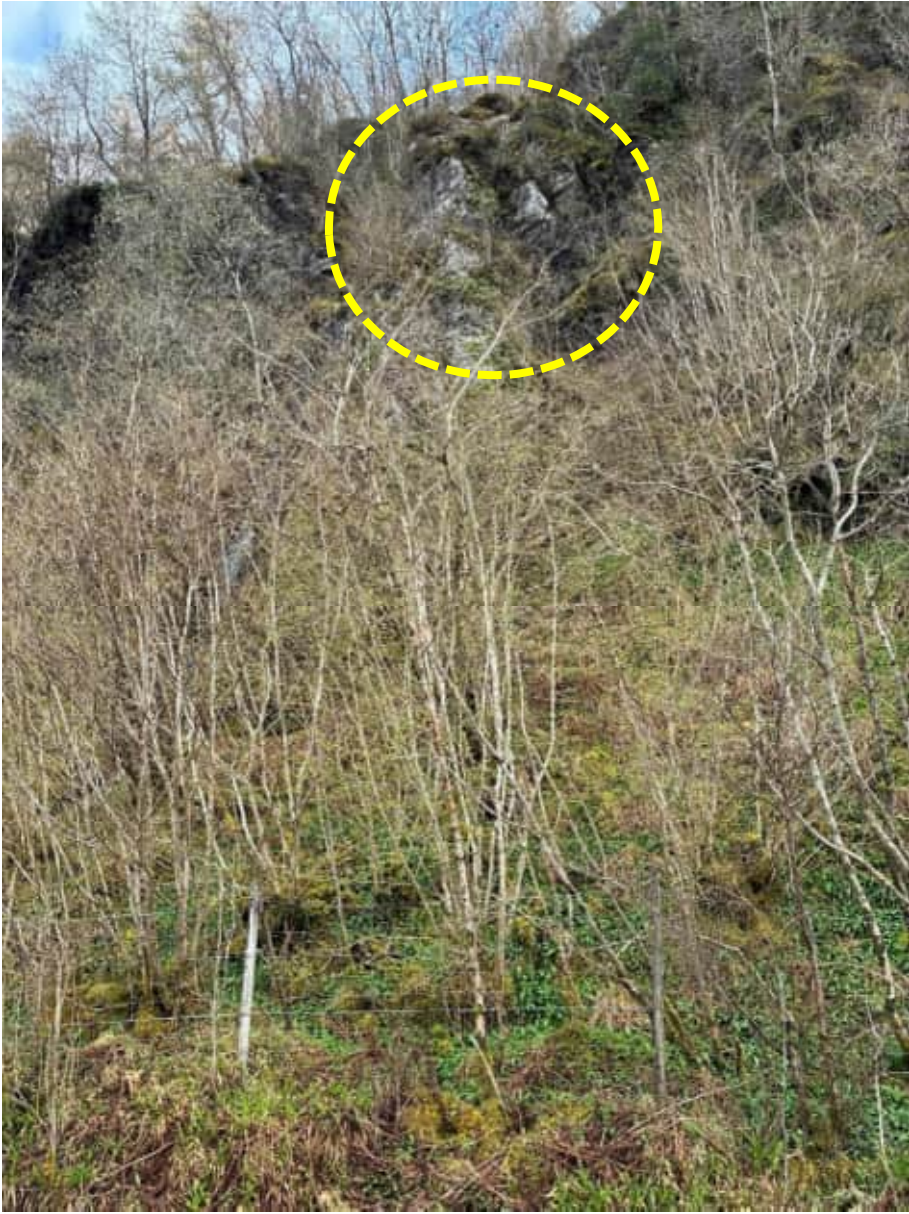
| AA10-1 | <p>Ch. 2000:</p> <p>2012: Large scale potential wedge failure. Is c. 10 m wide x 10 m high feature at the crest of the rock slope. No evidence of dilated fractures here and mass failure considered unlikely.</p> <p>2026: No changes observed during 2026 inspection.</p> | Year First Observed: | 2012 |

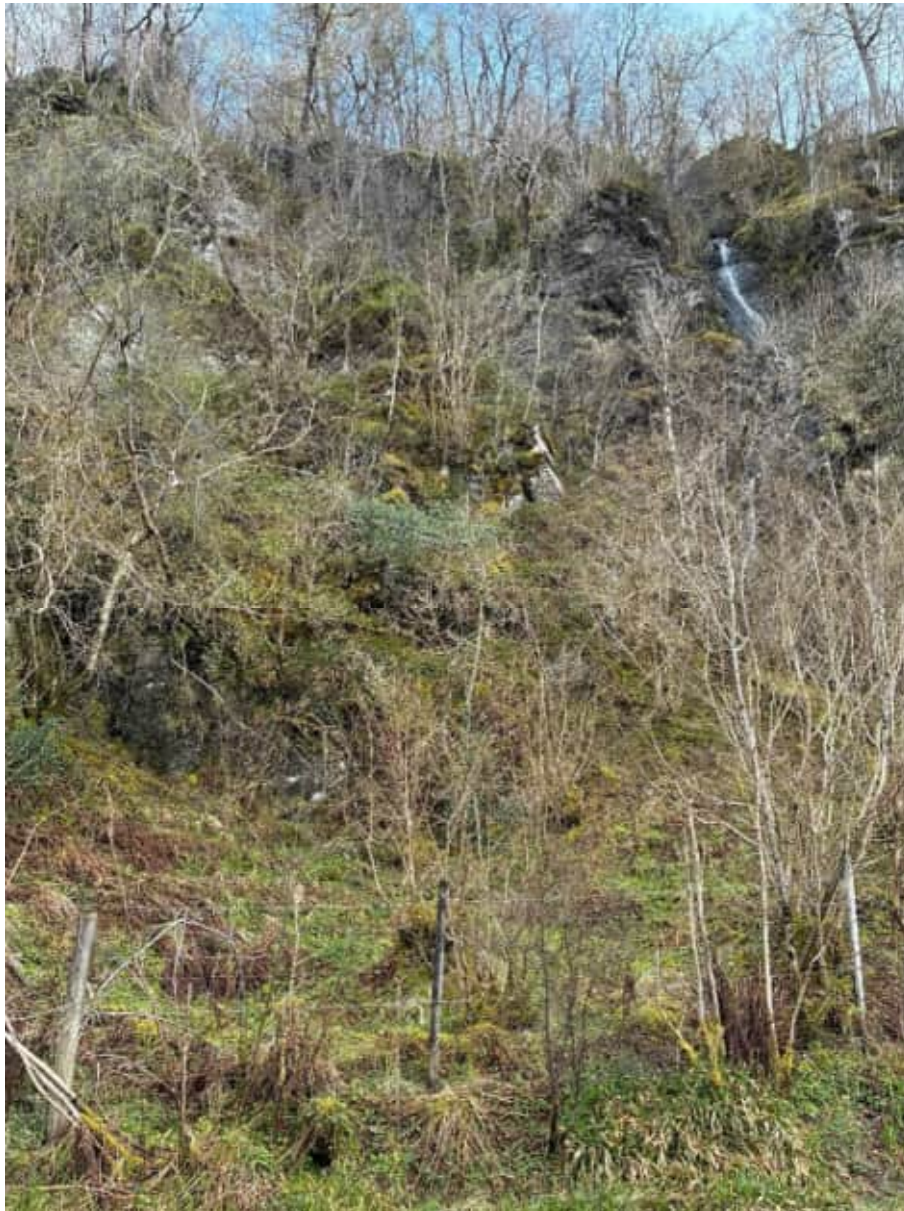
| AA10-2 | <p>Ch. 2033 to 2188:</p> <p>2016: Noted that slope is well vegetated in this area with uprooted trees. Root jacking evident, with potential to dislodge blocks. Recent failures evident. Specific hazards identified at Ch. 2060 and 2130.</p> <p>2026: No changes observed during 2026 inspection.</p> | <p>Year First Observed:</p> | 2016 |

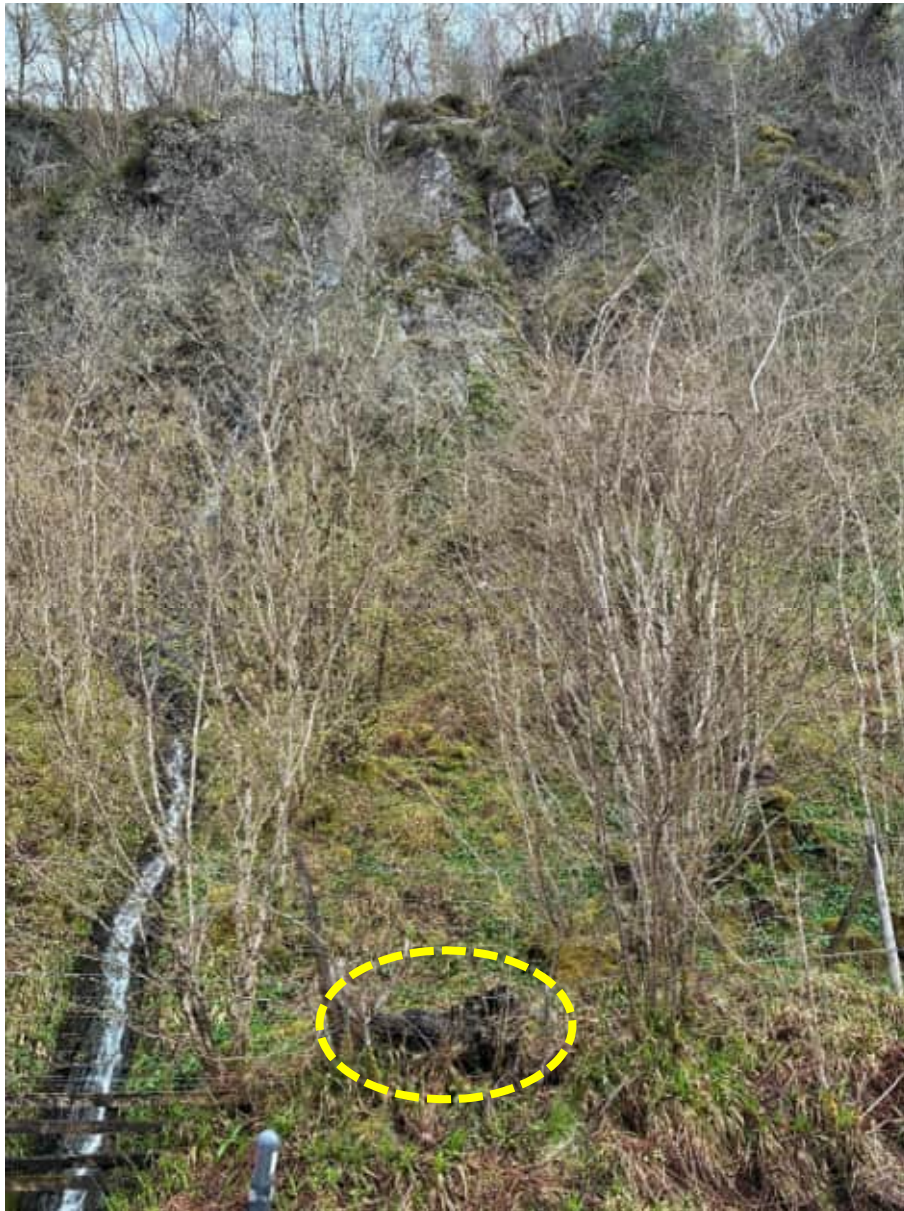
| AA10-3 | <p>Ch. 2024:</p> <p>2026: A partially rotten tree stump is present resting against the deer fence, suspected to having fallen from above the slope crest. Wood debris present on the slope; however, it is unlikely to become remobilised and is no considered to represent a risk to the road. The likelihood of further falls from above the crest is unclear but assumed to be negligible.</p> | <p>Year First Observed:</p> | 2026 |

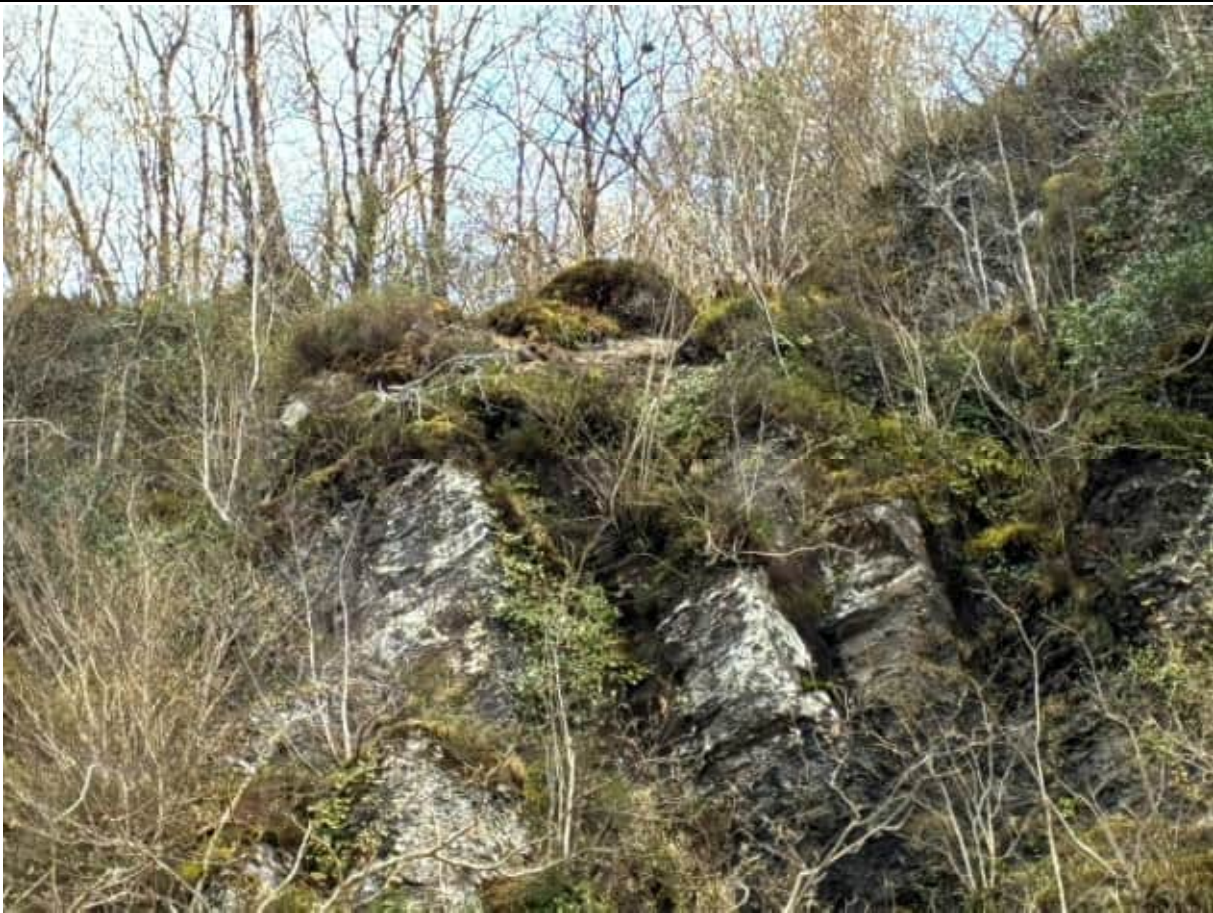
| AA10-4 | <p>Ch. 2085:</p> <p>2012: Potential wedge failure with root jacking identified.</p> <p>2024: Ivy starting to obscure view.</p> <p>2025: Completely obscured by vegetation cover.</p> <p>2026: No changes observed during 2026 inspection.</p> | Year First Observed: | 2012 |

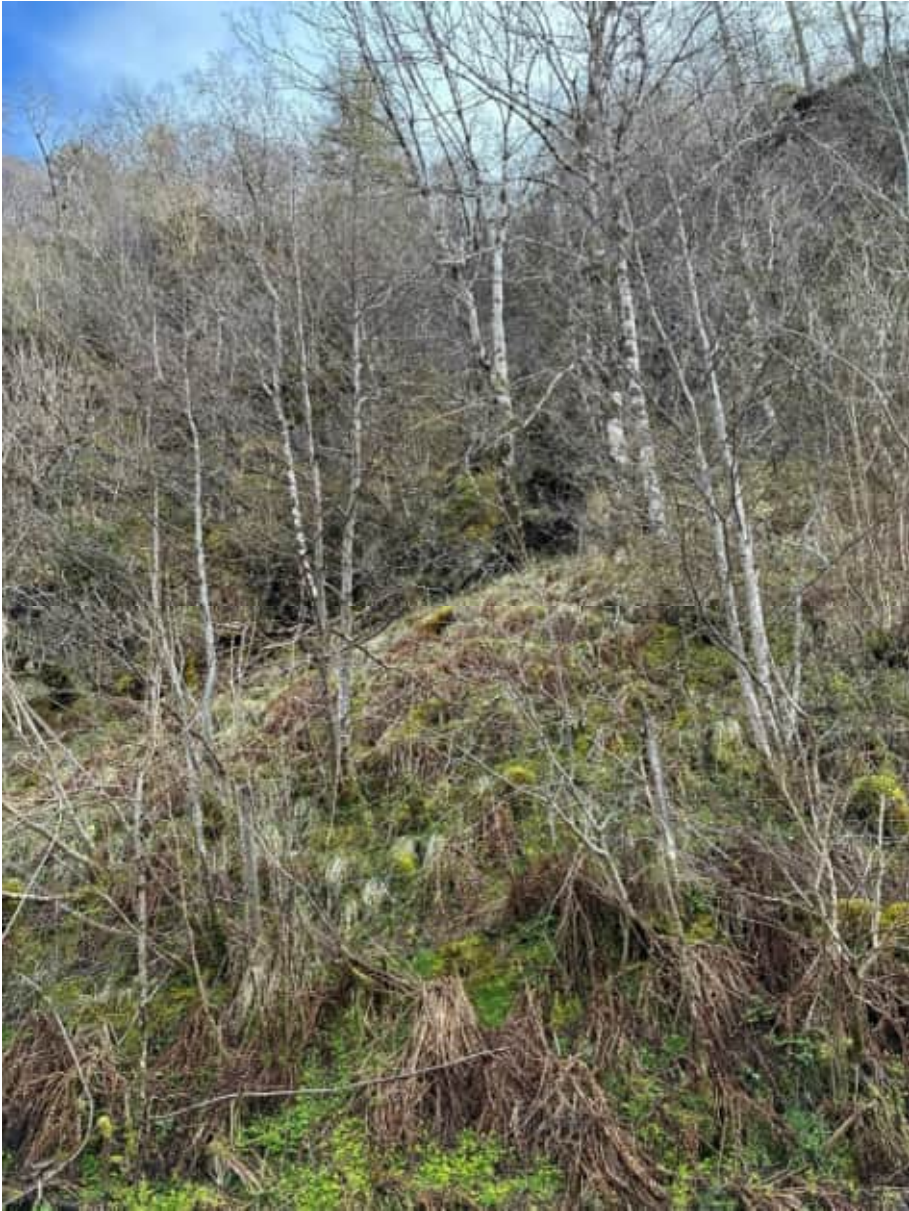
| AA10-8 | <p>Ch. 2140 to 2163:</p> <p>2025: Observation from road level: Small debris flow (in gully) c. 15 m above road level but set back by c. 40 m. Debris on slope, spray paint marker at road level. One block noted at the deer fence (c. 0.4 m) and a fallen tree is present on the slope. Correlates with location of THC observed landslide reported in January 2025. See additional notes under rope access inspection.</p> <p>2026: Further tree falls have occurred. No significant changes to risk assessment.</p> | <p>Year First Observed:</p> <p>2025</p> |

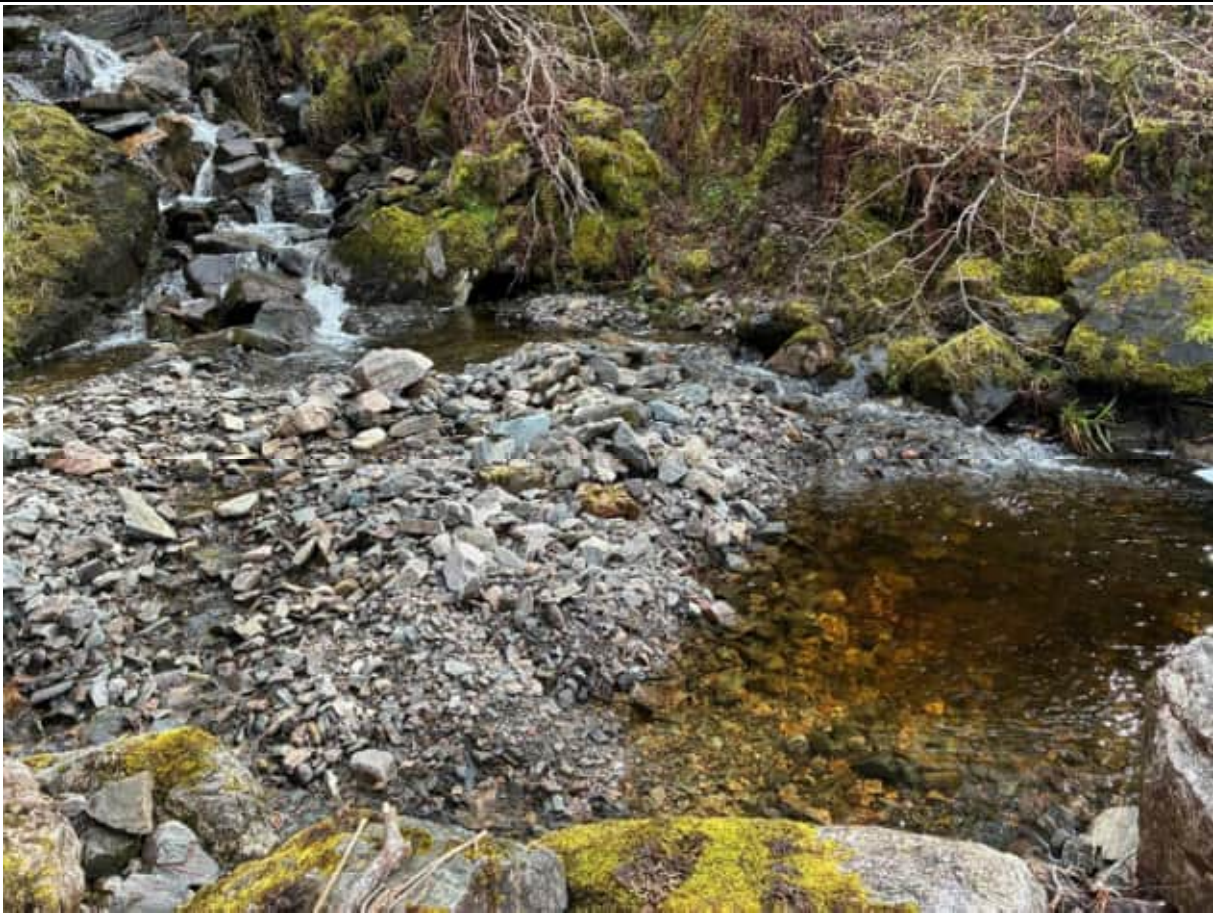
| FB-1 | <p>Ch. 2315:</p> <p>2021: Water levels are low. Both the lower and upper catchpits have good capacity.</p> <p>2020: Upper basin 50% full and lower basin 25% full but high-water level so harder to visually access. Appears that debris may have been recently cleared out.</p> <p>2025: Upper catch basin 60 to 70% full; requires clearance.</p> <p>2026: Upper catch basin approx. 80% full; requires clearance.</p> | Year First Observed: | 2021 |

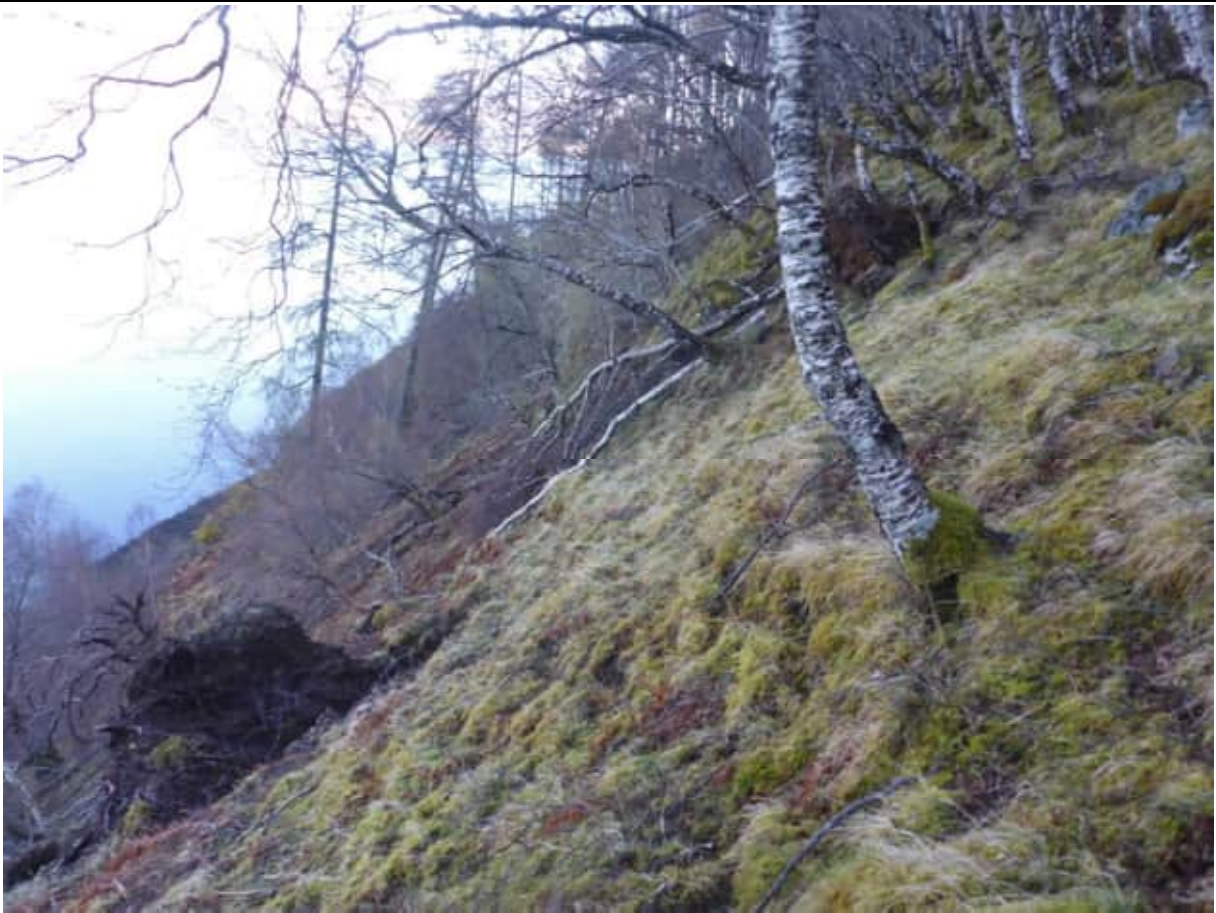
| AA11-2 | <p>Above AA11:</p> <p>2026: A small number of overblown trees are present lying on the hillside at c. 80 to 90 m AOD. Exposed root balls, loose rock, and bedrock. Ongoing release of weathered material is unlikely to reach the road.</p> | Year First Observed: | 2026 |

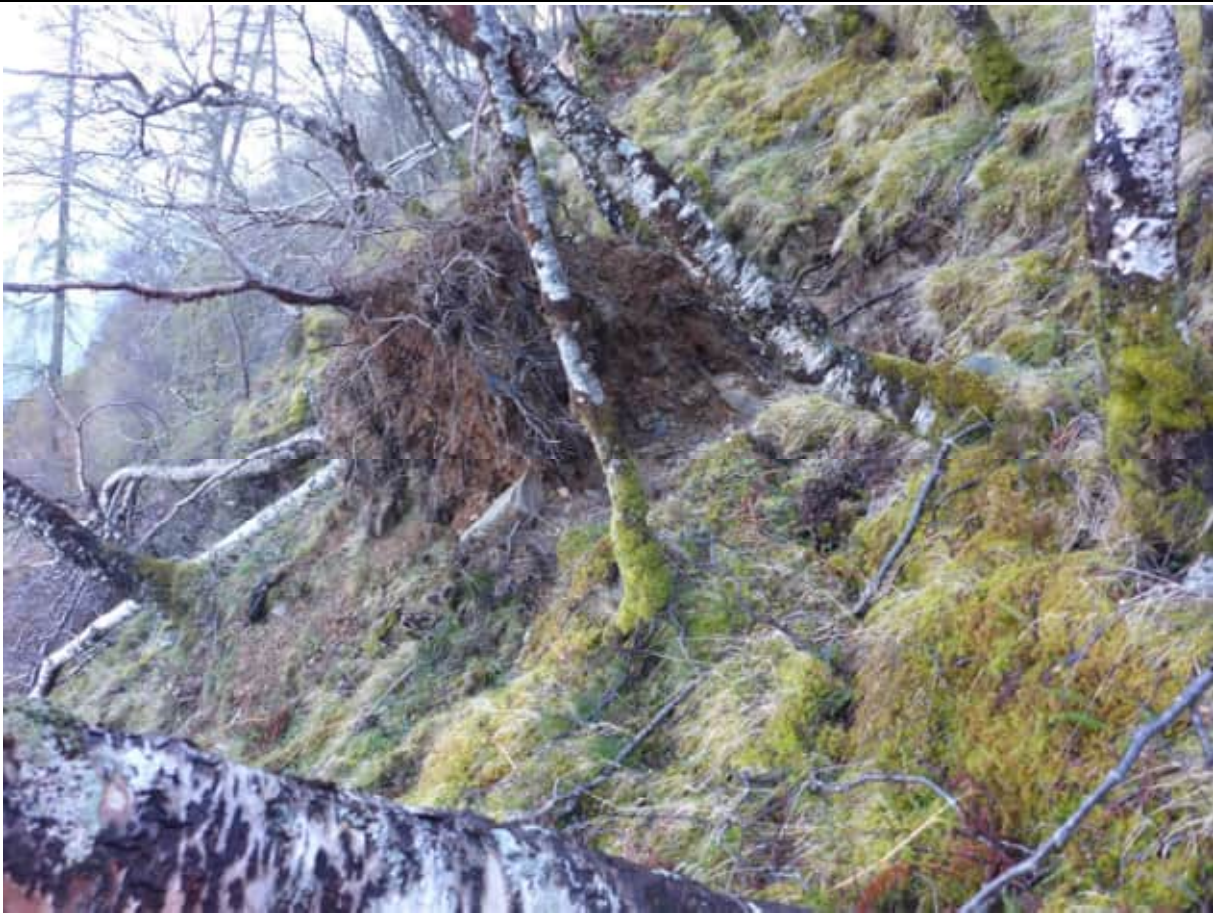
| AA11-3 | <p>Above AA11:</p> <p>2026: A small number of overblown trees are present lying on the hillside at c. 80 to 90 m AOD. Exposed root balls, loose rock, and bedrock. Ongoing release of weathered material is unlikely to reach the road.</p> | Year First Observed: | 2026 |

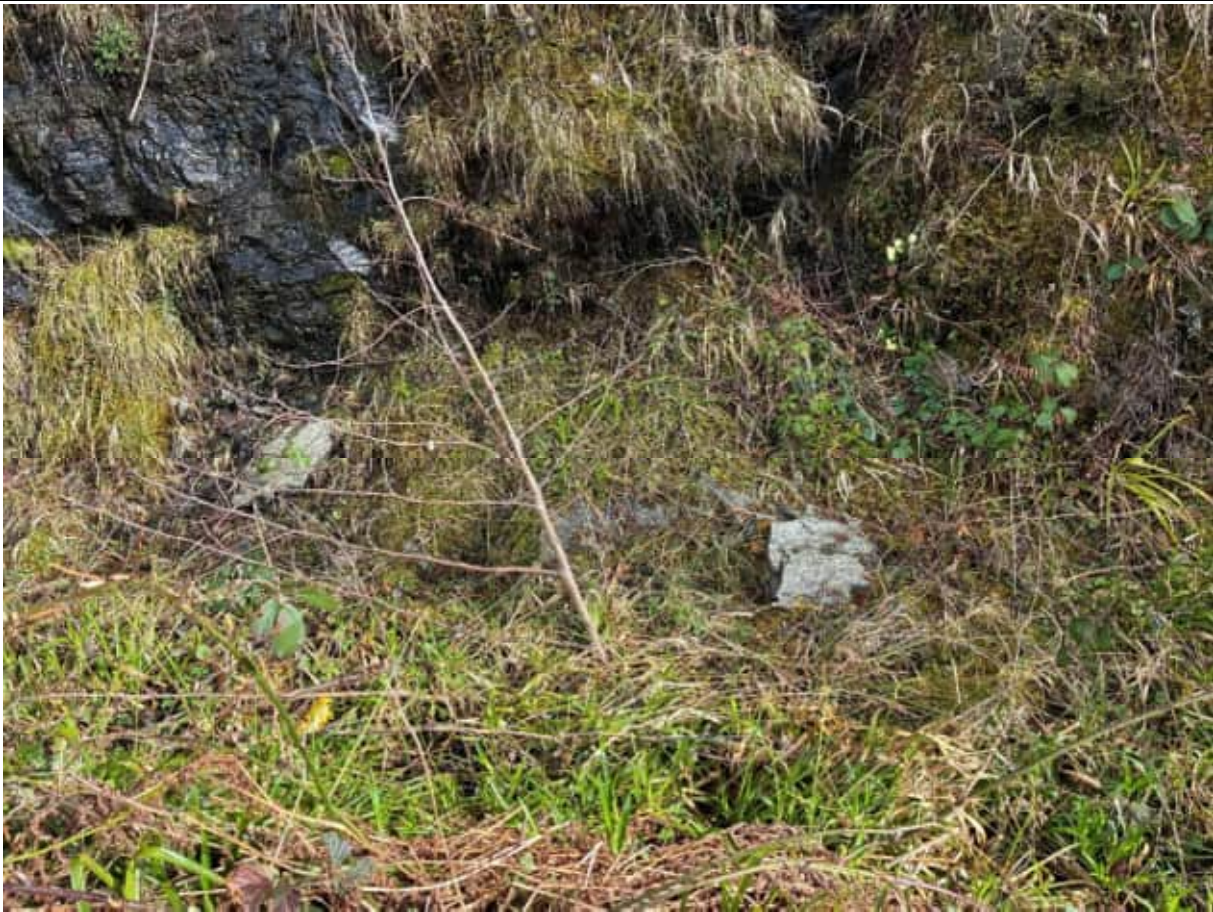
| AA12-1 | Ch. 2442:<br>2026: Four thin, elongate blocks present in the ditch; largest block long axis circa 0.7 m. Suspected to have delaminated and are possibly older rockfalls which were previously obscured by vegetation. | Year First Observed: | 2026 |

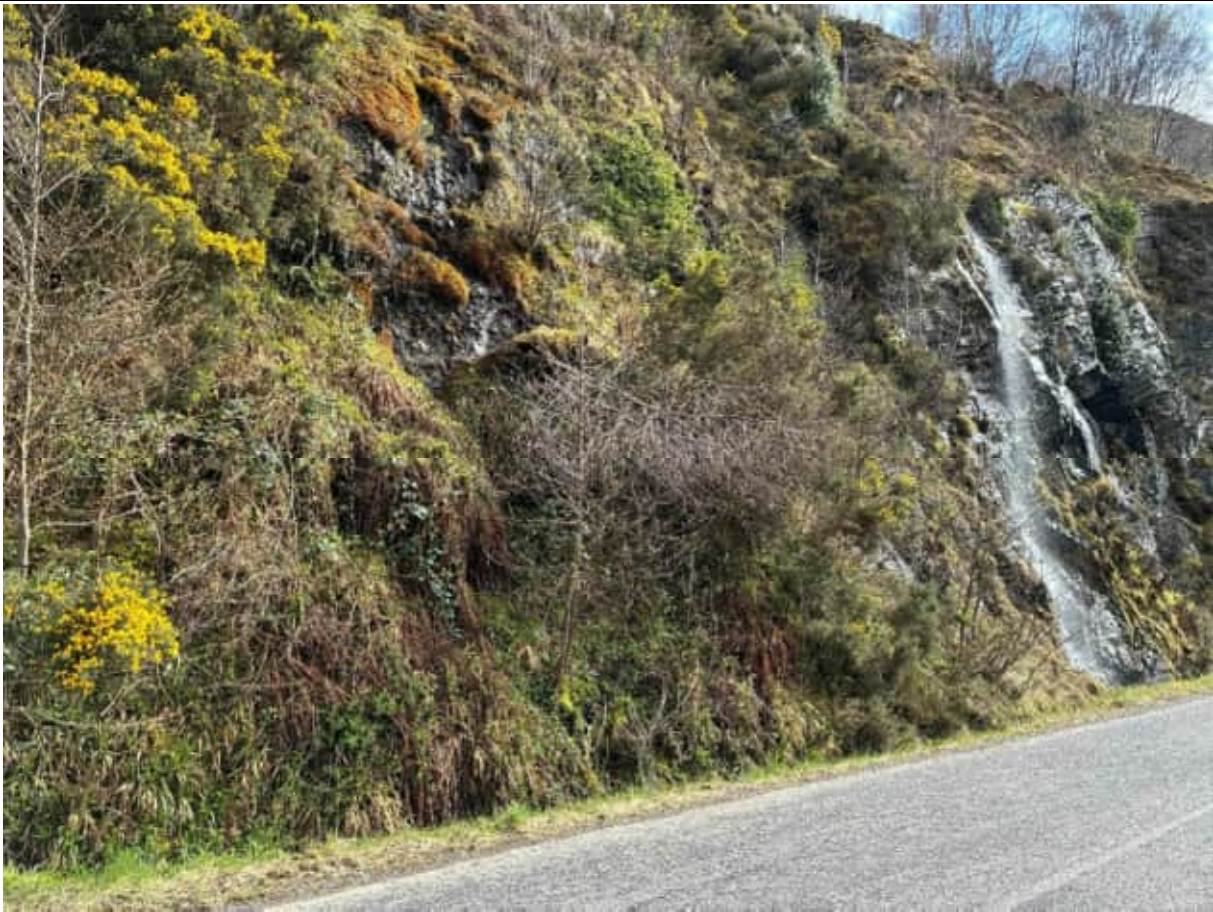
| AA12-2 | Ch. 2471:<br>2026: A tree has fallen (delaminated) from the rock face at approx. 4 to 5 m above road level. A small accumulation of gravel is present above the tree which the potential to impact the road. Removal of the tree and scaling of loose material is required. | Year First Observed: | 2026 |

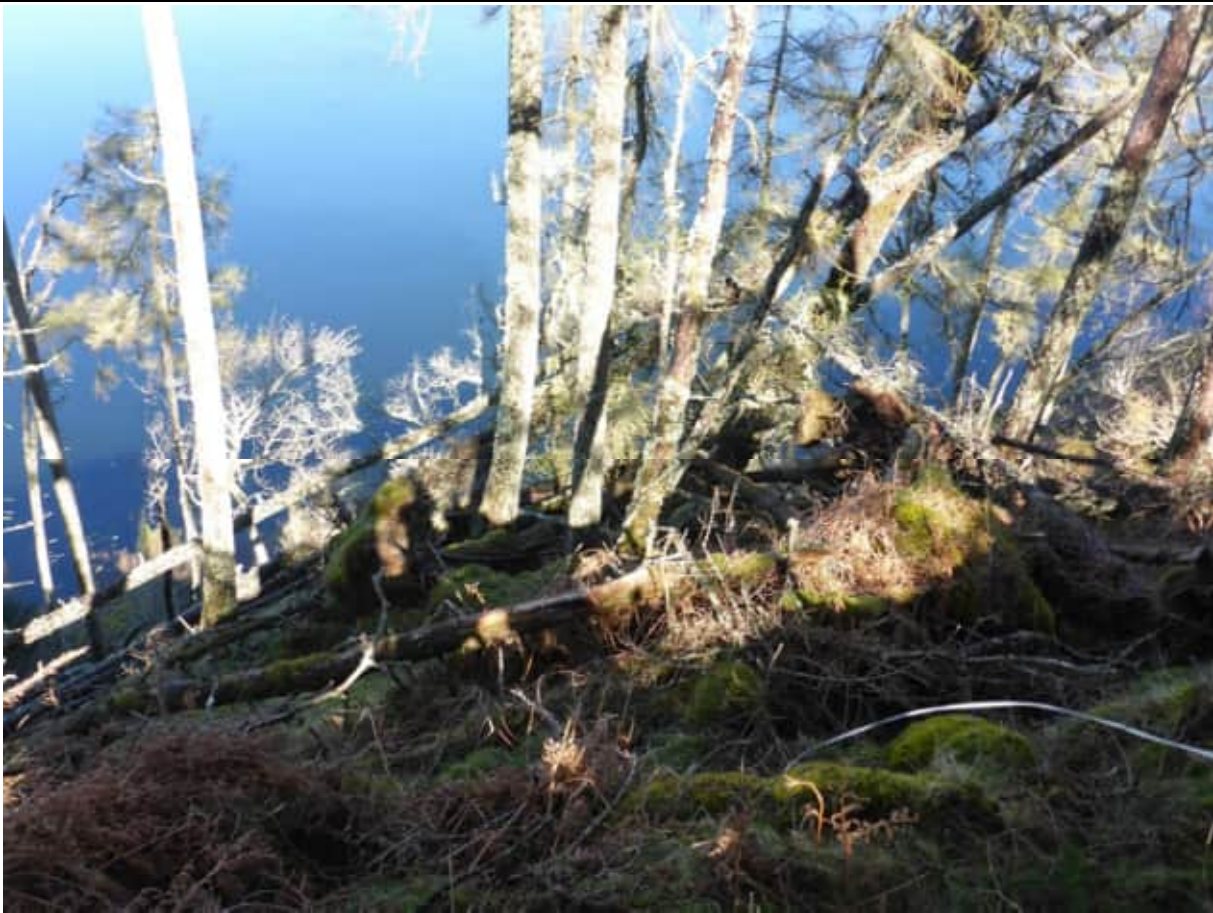
| AA13/14-U-2 | NG 90911 37375:<br>2026: A significant number of trees have fallen; half-fallen and intertwined trees are also present on the slope and will continue to rot and fall.<br>The underlying slope is very steep. | Year First Observed: | 2026 |

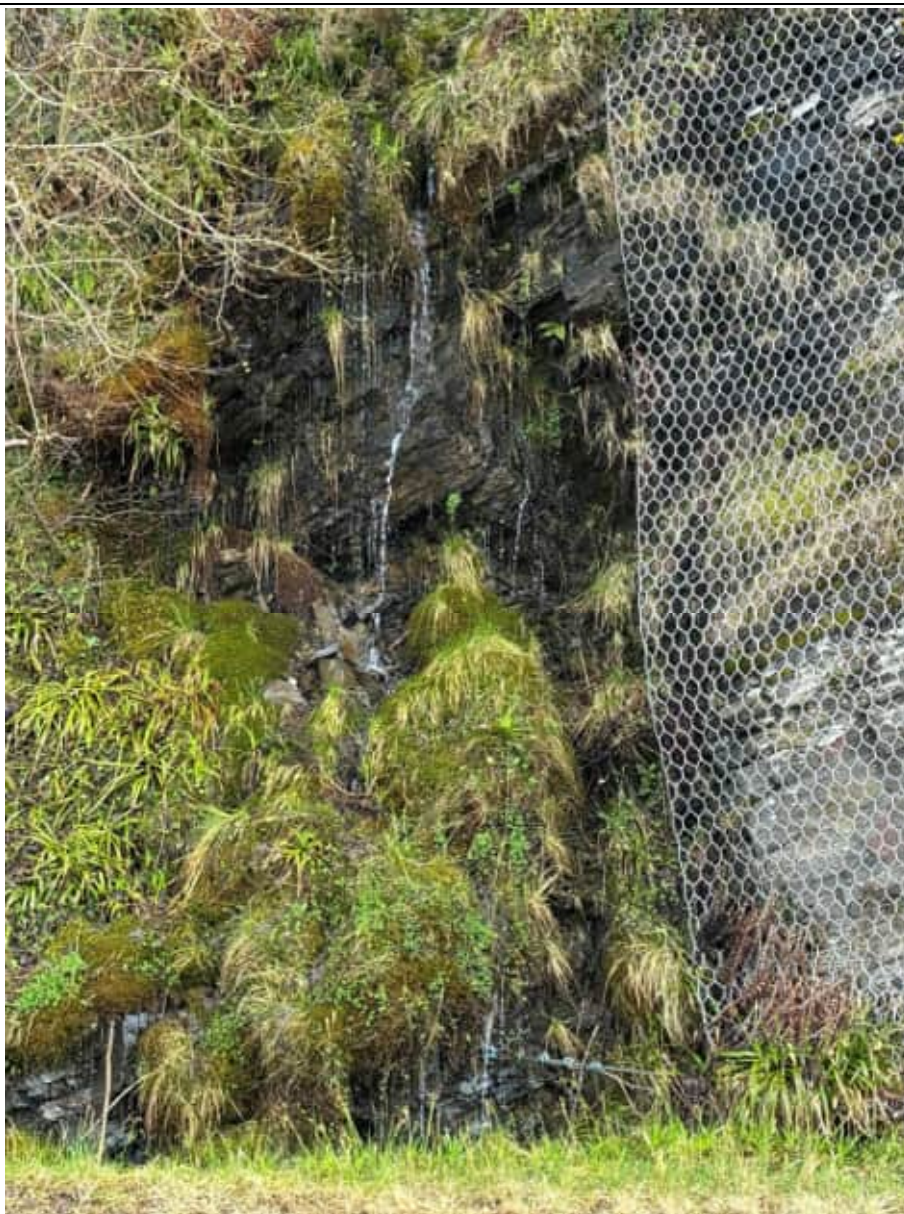
| AA14-W-2 | Ch. 2628:<br>2026: Small accumulation of blocks within a small waterfall; no risk to road. | Year First<br>Observed: | 2026 |

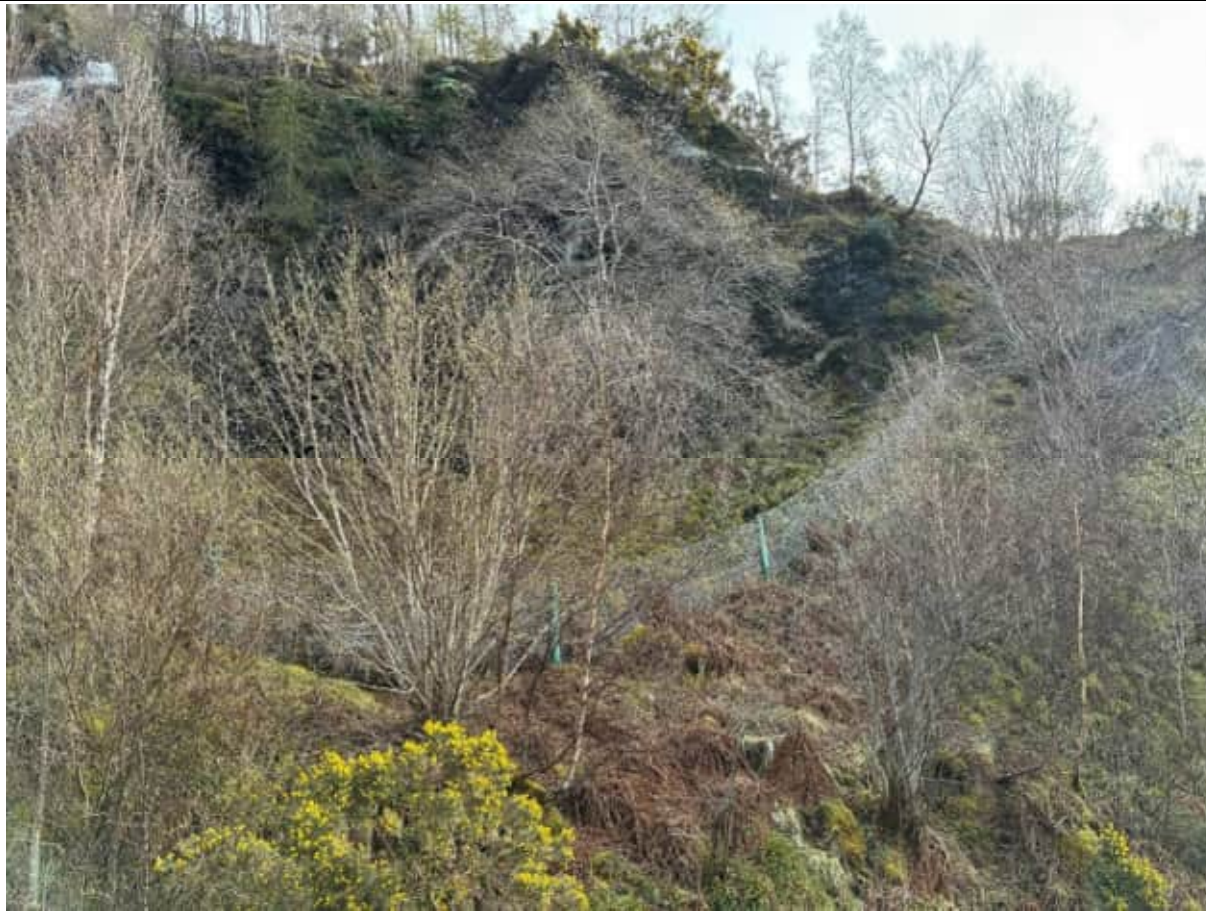
| AA14-E-1 | <p>Catch fence positioned mid-slope, c. 1.5 m high Fence constructed from double twist netting with 16 mm horizontal stainless steel reinforcing cables at 0.4 m vertical spacing. No brake rings.</p> <p>2024: Fence in good condition. Only surface corrosion on galvanised cable clamps. No blocks in fence. No obvious change in cliffs above. Scree area between fence and cliff is very moss covered suggesting been there a long time. However, area at base of cliff has an accumulation of scree blocks indicating more activity. No immediate action.</p> <p>2026: No significant changes noted during 2026 inspection.</p> | Year First Observed: | 2012 |

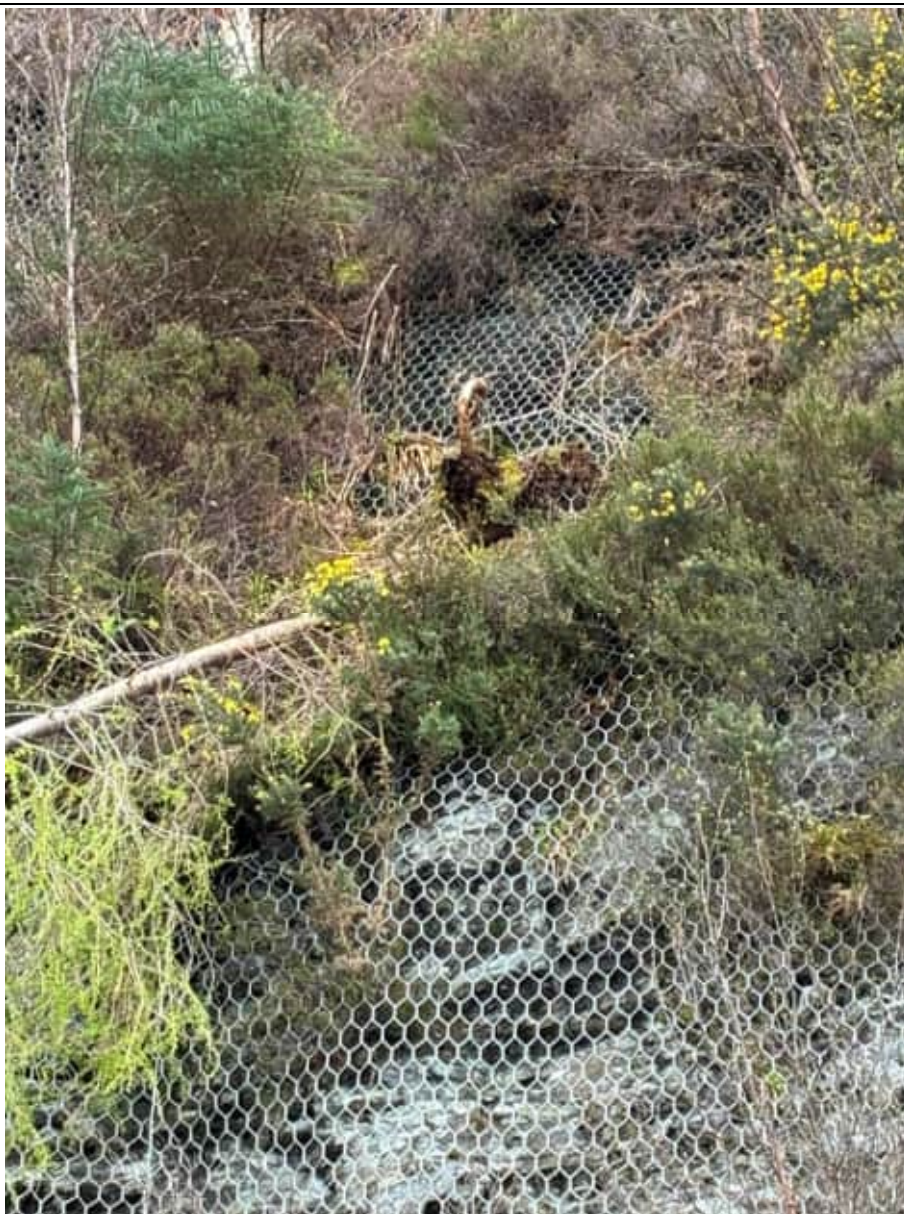
| AA15-2 | Ch. 2700:<br>2026: A fallen tree at approx. 6 m above road level has torn the netting. No evidence of fallen blocks. The tree should be removed and the netting patched. | Year First<br>Observed: | 2026 |

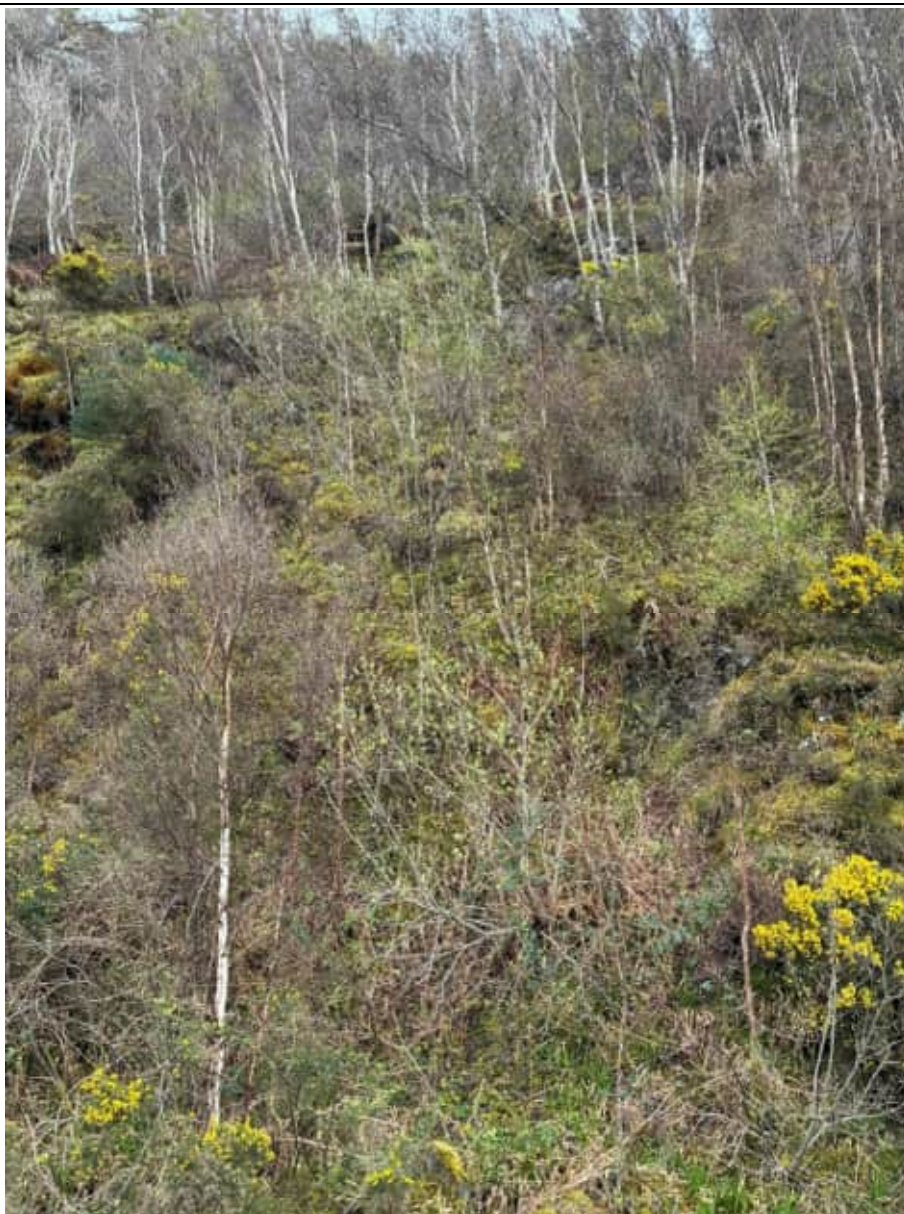
| AA15-3 | <p>Ch. 2817:</p> <p>2026: Two trees have fallen, having 'peeled' away from the slope face. One block is present resting on the slope face at approx. 10 m height (circa 0.3 m long axis), possibly having been dislodged by the tree fall(s). Presence of the wide ditch and verge in this area will most likely catch the block if mobilised. Not considered to represent a significant risk to the road.</p> | Year First Observed: | 2026 |

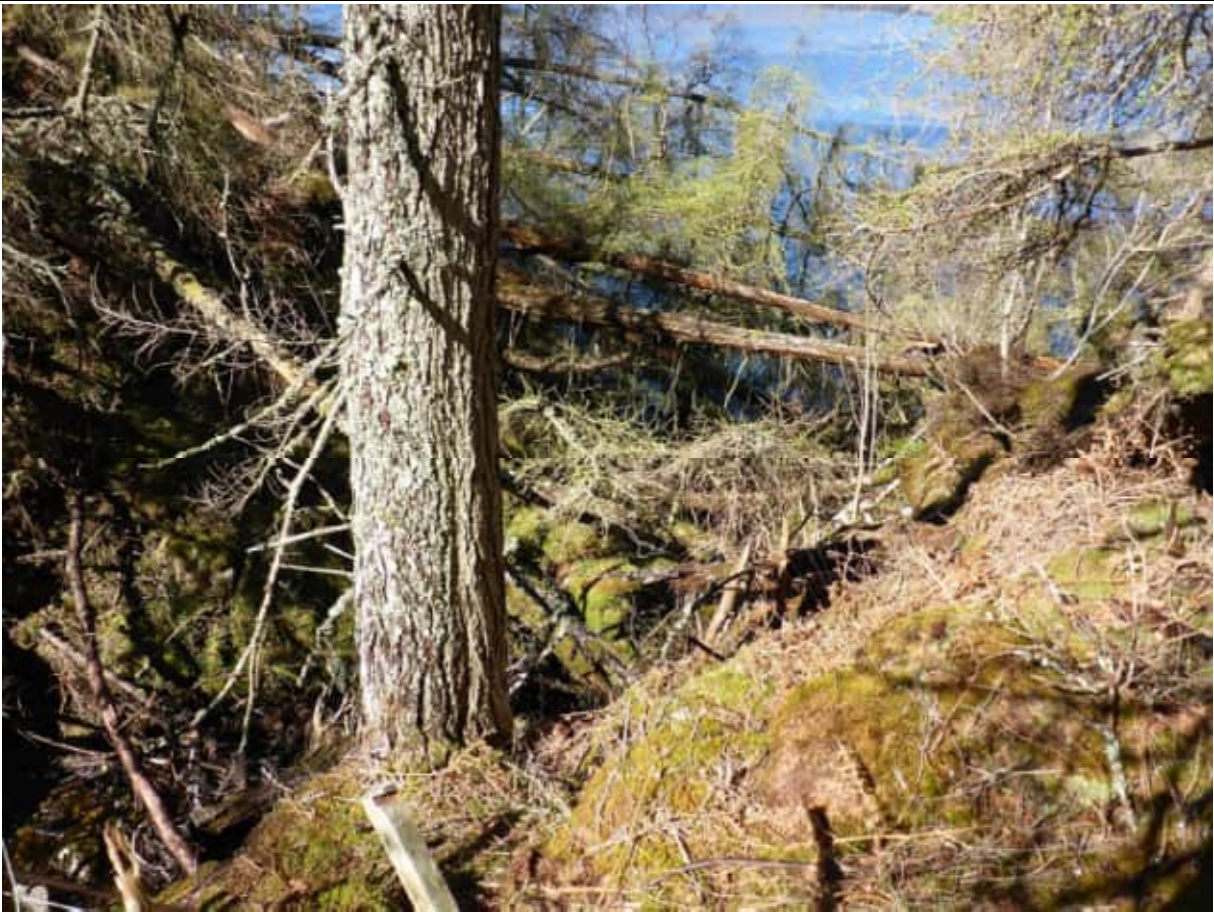
| AA15-U-1 | In-gully:<br>2026: Debris dam starting to form in gully below fence line at the top of the treeline. | Year First Observed: | 2026 |
