# A890 Strome ferry Bypass

Annual Slope Inspection 2026

The Highland Council

Project number: 60685712  
AECOM Report Ref.: GLRP0013

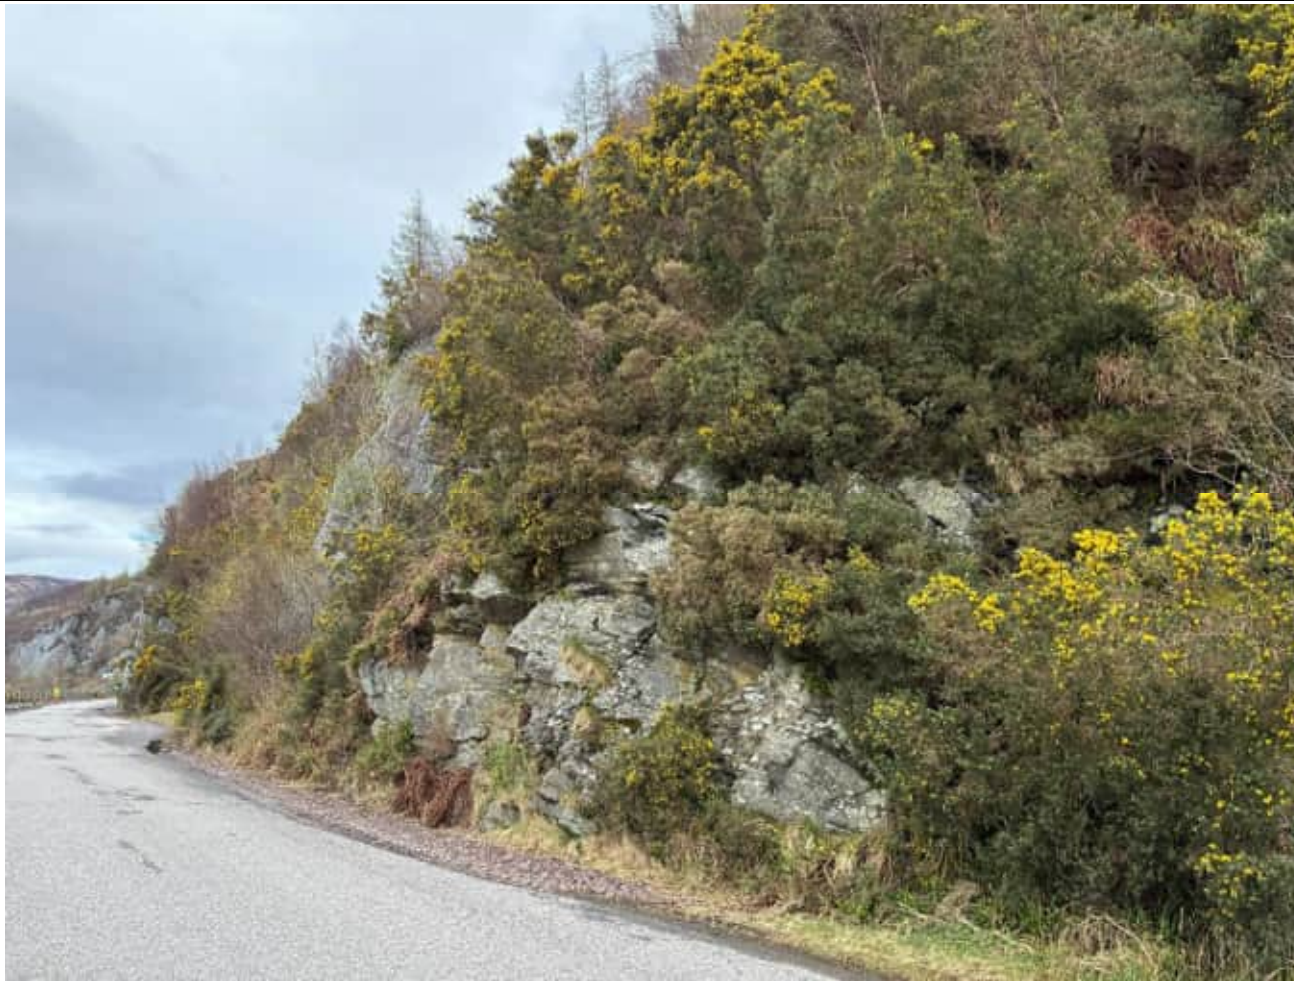
| AA16-1 | <p>Ch. 2865:</p> <p>2025: Dilated fracture with root jacking c. 5 m above road level. Long axis of the slab is c. 0.7 m. Not considered to pose a significant hazard to the road.</p> <p>2026: Obscured by vegetation.</p> | Year First Observed: | 2025 |

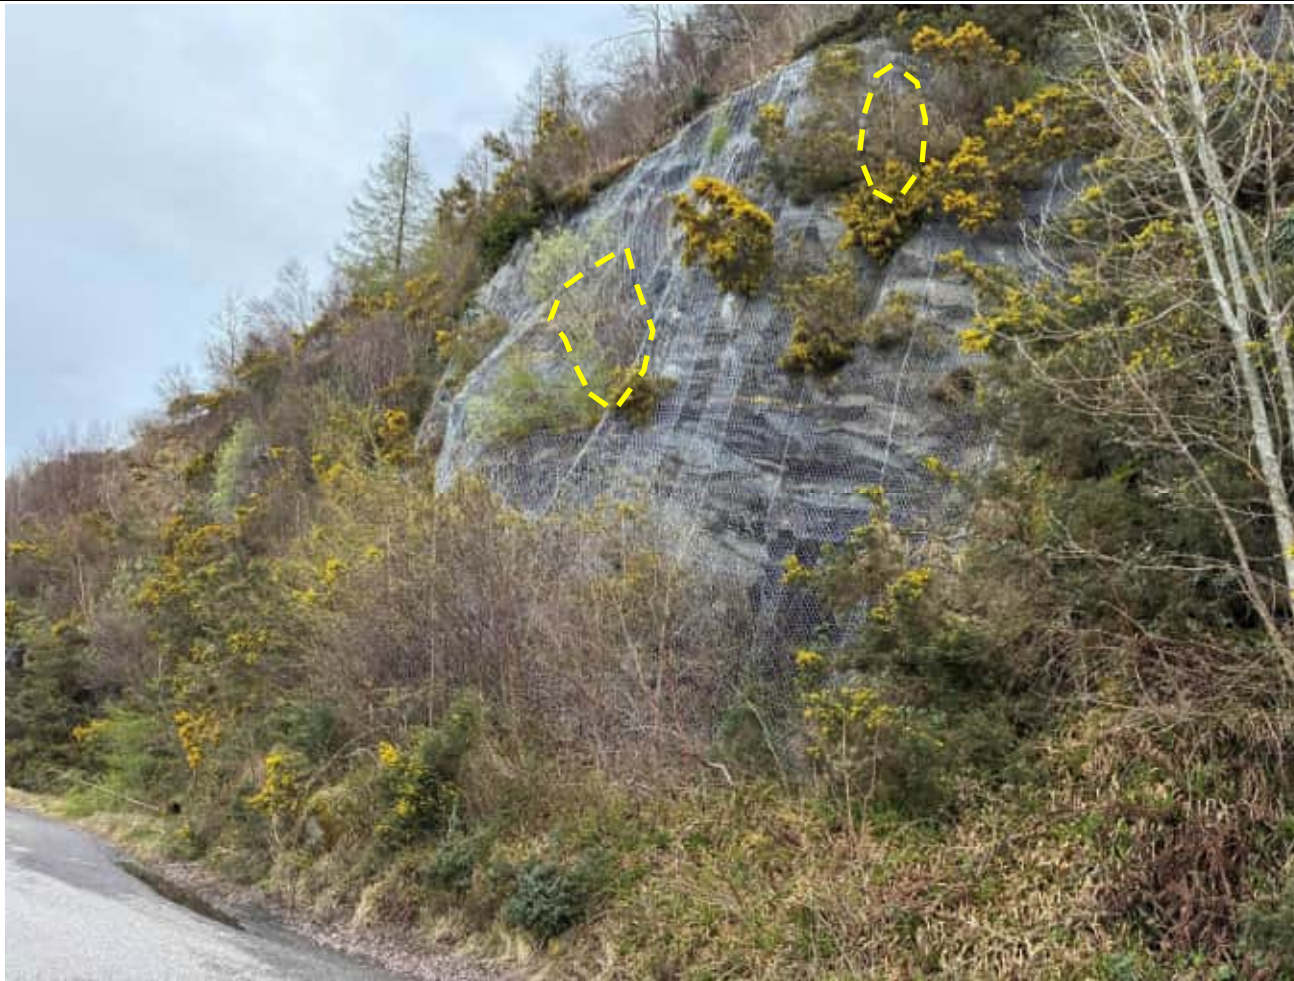
| AA16-2 | <p>Ch. 2888:</p> <p>2016: Broken section of rock mass 5 to 10 m above road level with potential to fail if root jacking continues. Block size typically ~0.1 m<sup>3</sup> but total failure volume could be 2 to 3 m<sup>3</sup>. May exceed capacity of mesh if all fails at same time. Verge quite narrow so could reach road.</p> <p>2026: No changes observed during 2026 inspection.</p> | Year First Observed: | 2016 |

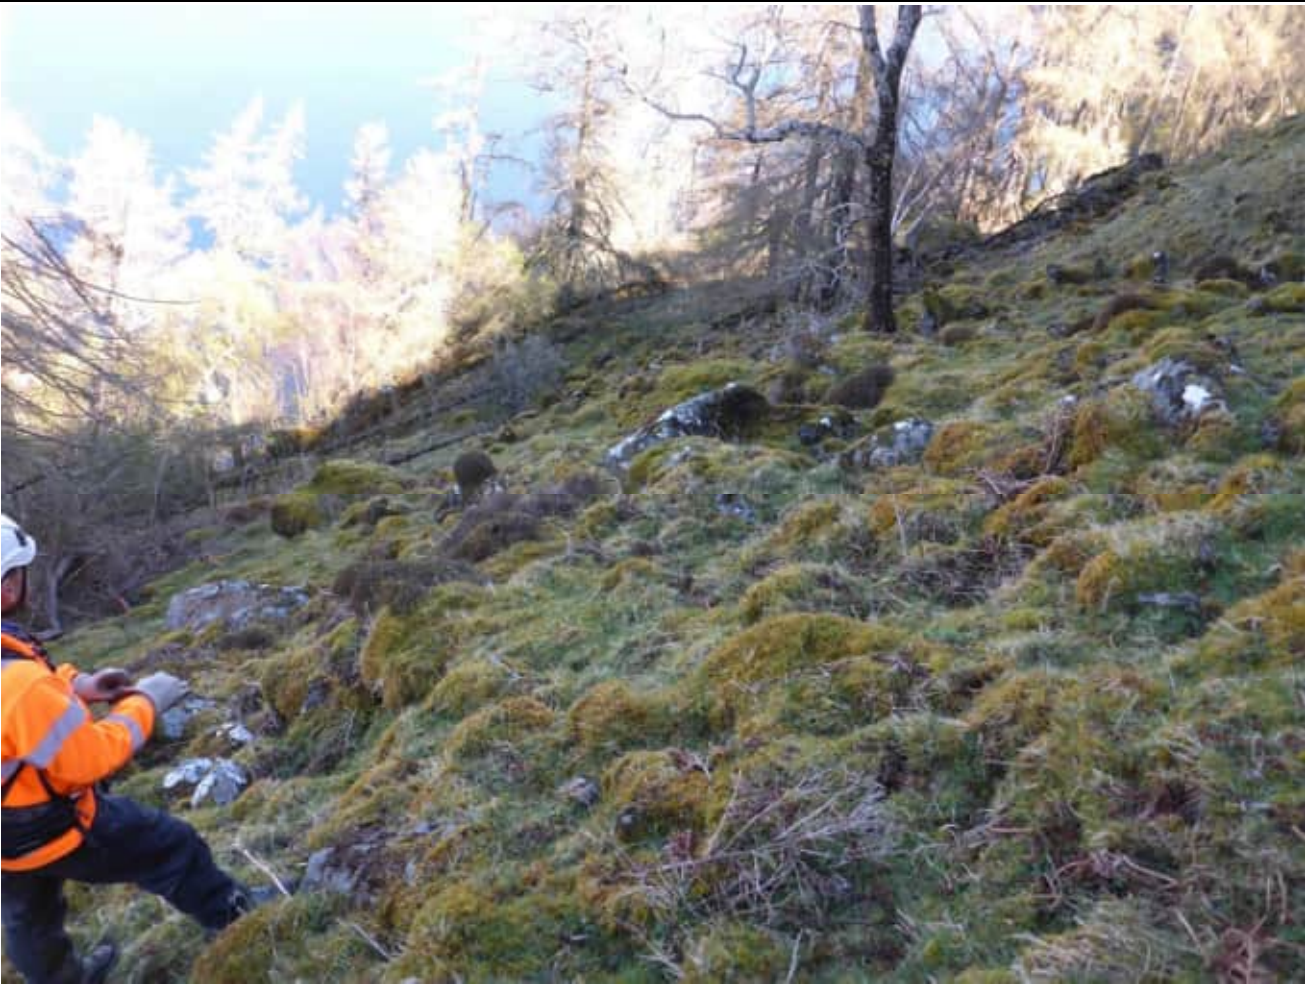
| AA16/17/18-U-1 | Above AA16 at NG 91079 37474:<br>2026: Remnant boulder field present above the treeline and beneath the upper natural crags. Thick moss covering across the field. | Year First Observed: | 2026 |

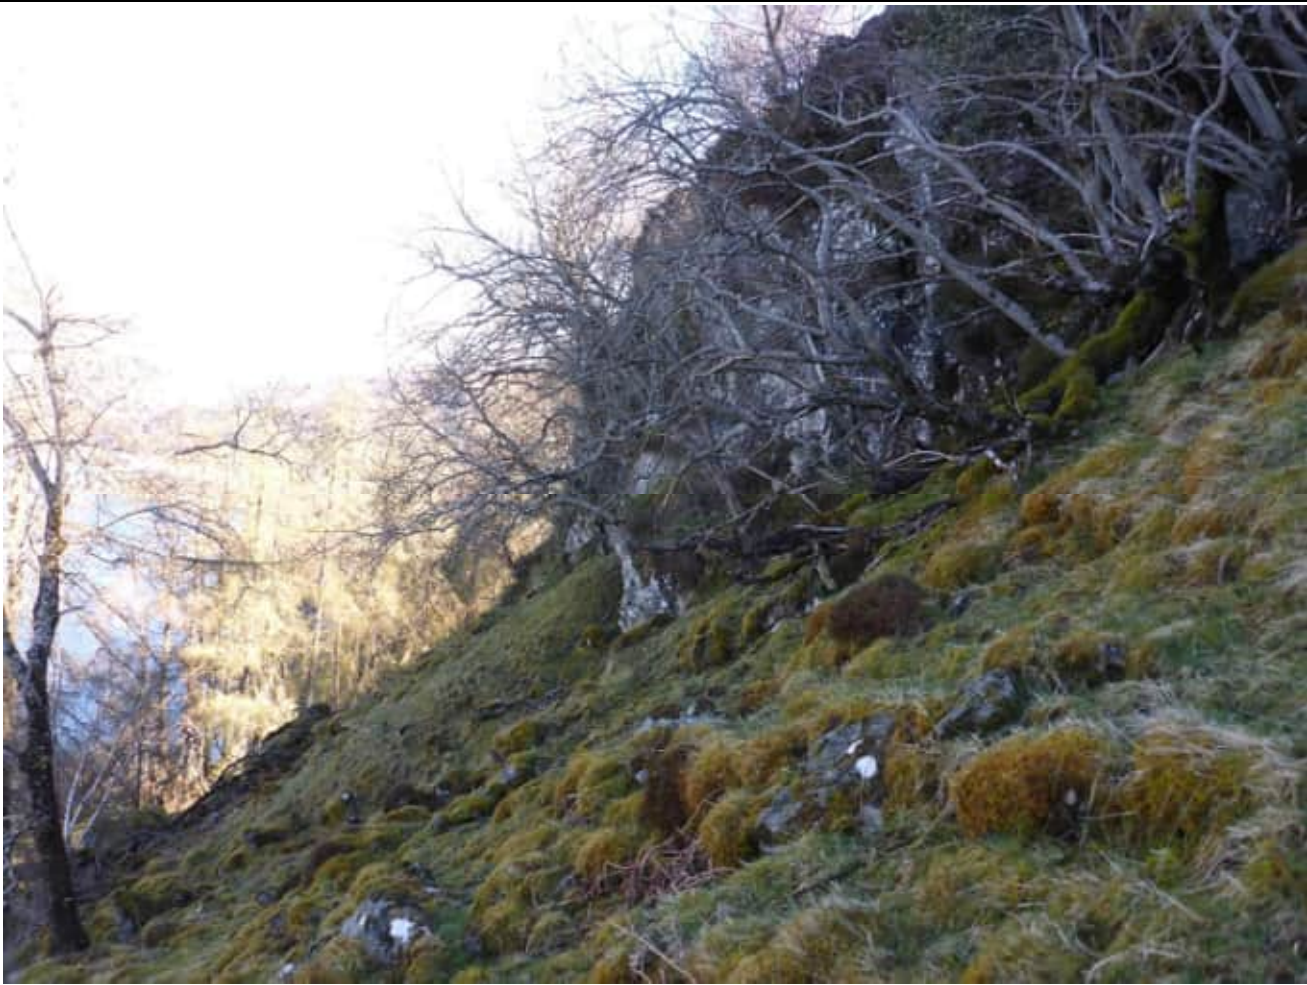
| AA16/17/18-U-1 | Above AA16 at NG 91079 37474:<br>2026: Remnant boulder field present above the treeline and beneath the upper natural crags. Thick moss covering across the field. | Year First Observed: | 2026 |

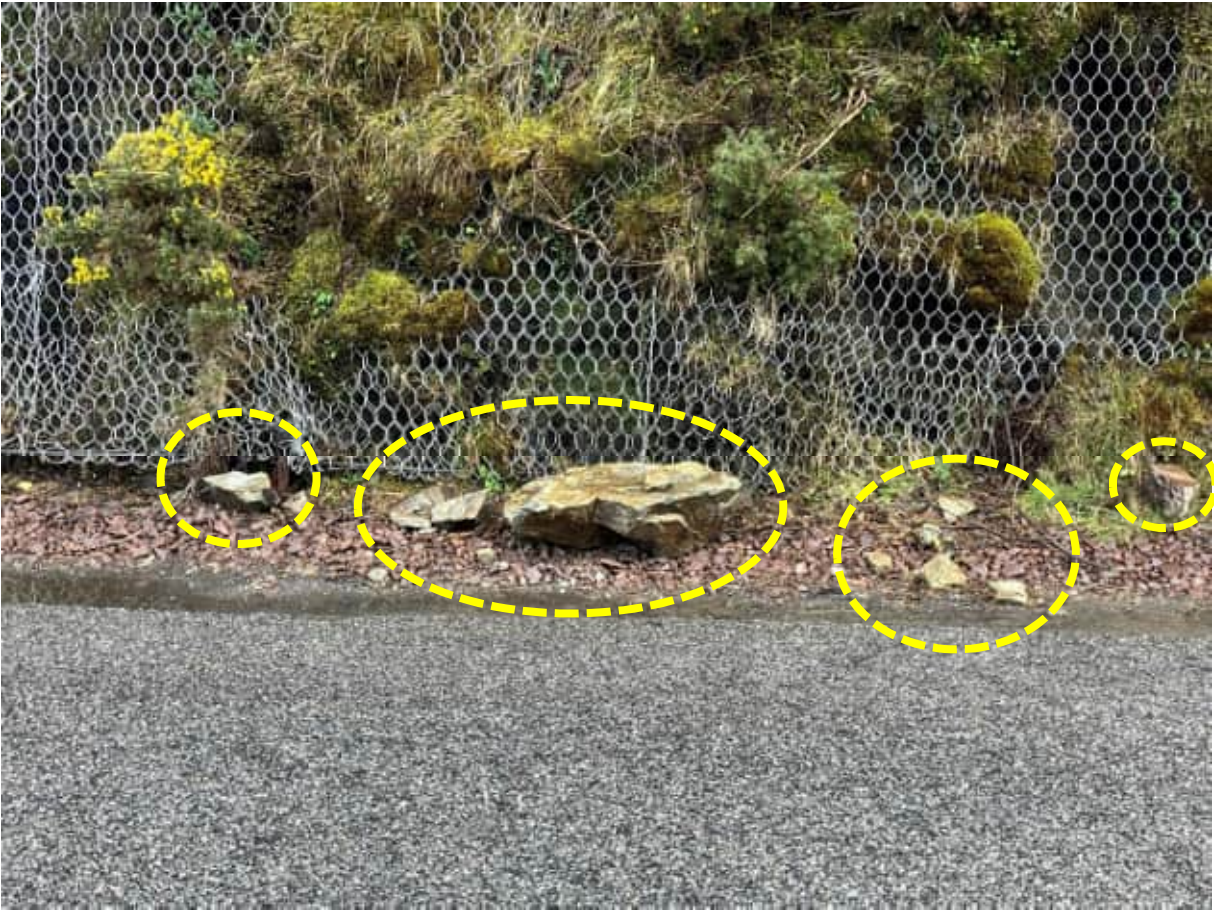
| AA17-1 | <p>Ch. 2929:</p> <p>2026: A large block is present on the verge at the toe of the slope of approx. dimensions 1.0 x 0.4 x 0.4 m. Approx 10no. smaller blocks are also present, and there is a significant indentation on the road hardstanding. In person conversations with THC on-site indicates the rockfall occurred in autumn 2025. Given the netting is intact in this area, the blocks are inferred to have fallen from be above the slope crest. The potential for further rockfalls from above the slope crest cannot be ruled out; a rope access inspection above the slope crest should be considered as part of the 2027 inspection works to assess the presence of further blocks with the potential to fall and impact the road.</p> | Year First Observed: | 2026 |

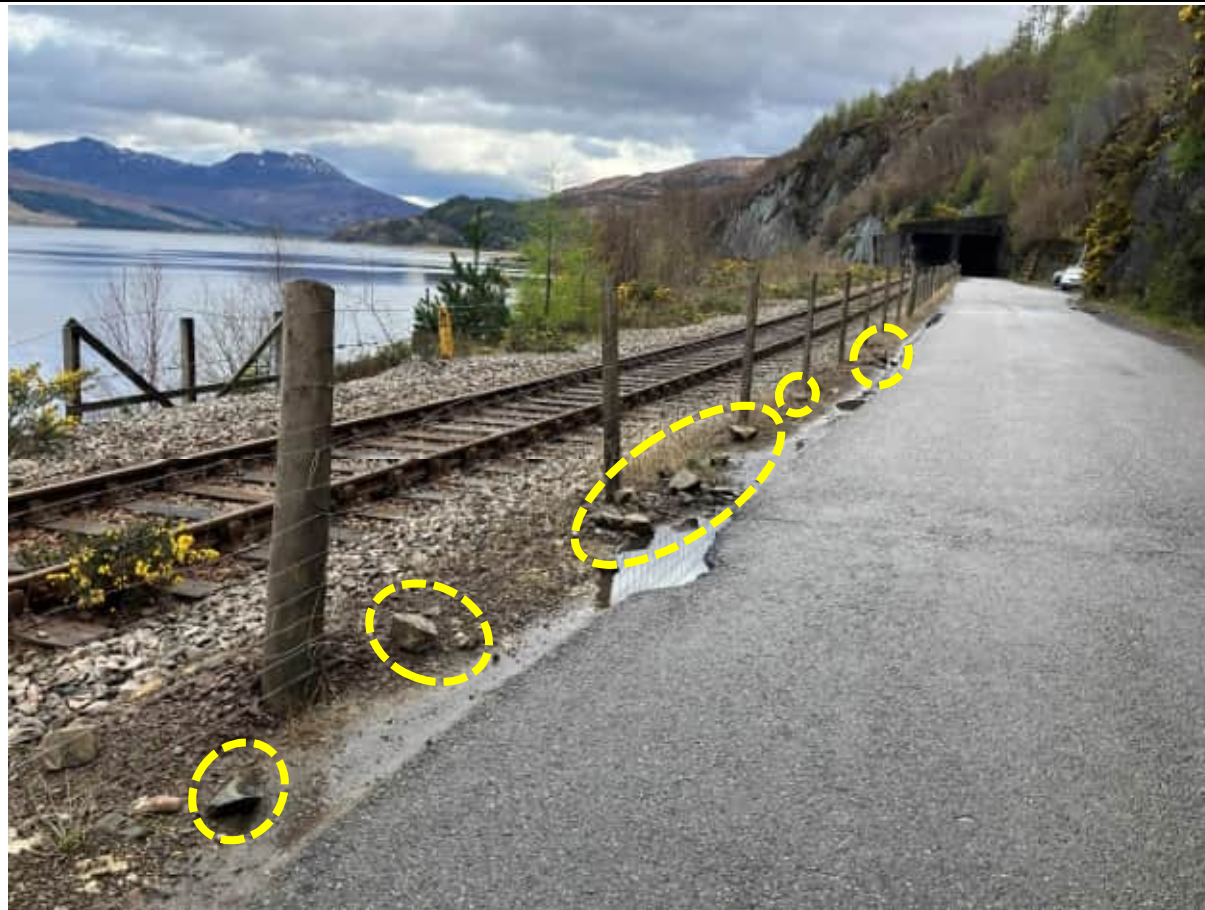
| AA18/19-1 | <p>Ch. 3051 to 3068 (concentrated at approx. Ch. 3056):</p> <p>2026: A recent rockfall has occurred and the fallen blocks have been moved to the roadside. Numerous blocks are present within the catchpit, on the rim of the catchpit, and on both sides of the road; material is not present on the road itself and is suspected to have been pushed to the roadsides (debris seen on drone survey completed 07/04/2026, suspected to have fallen during Storm Dave between 04/04/2026 and 05/04/2026). The largest block is approx. 0.5 x 0.3 x 0.2 m. The total volume of the rockfall material is estimated to be 0.5 m<sup>3</sup>. The source of the rockfall material is inferred to be the upper crags.</p> | Year First Observed: | 2026 |

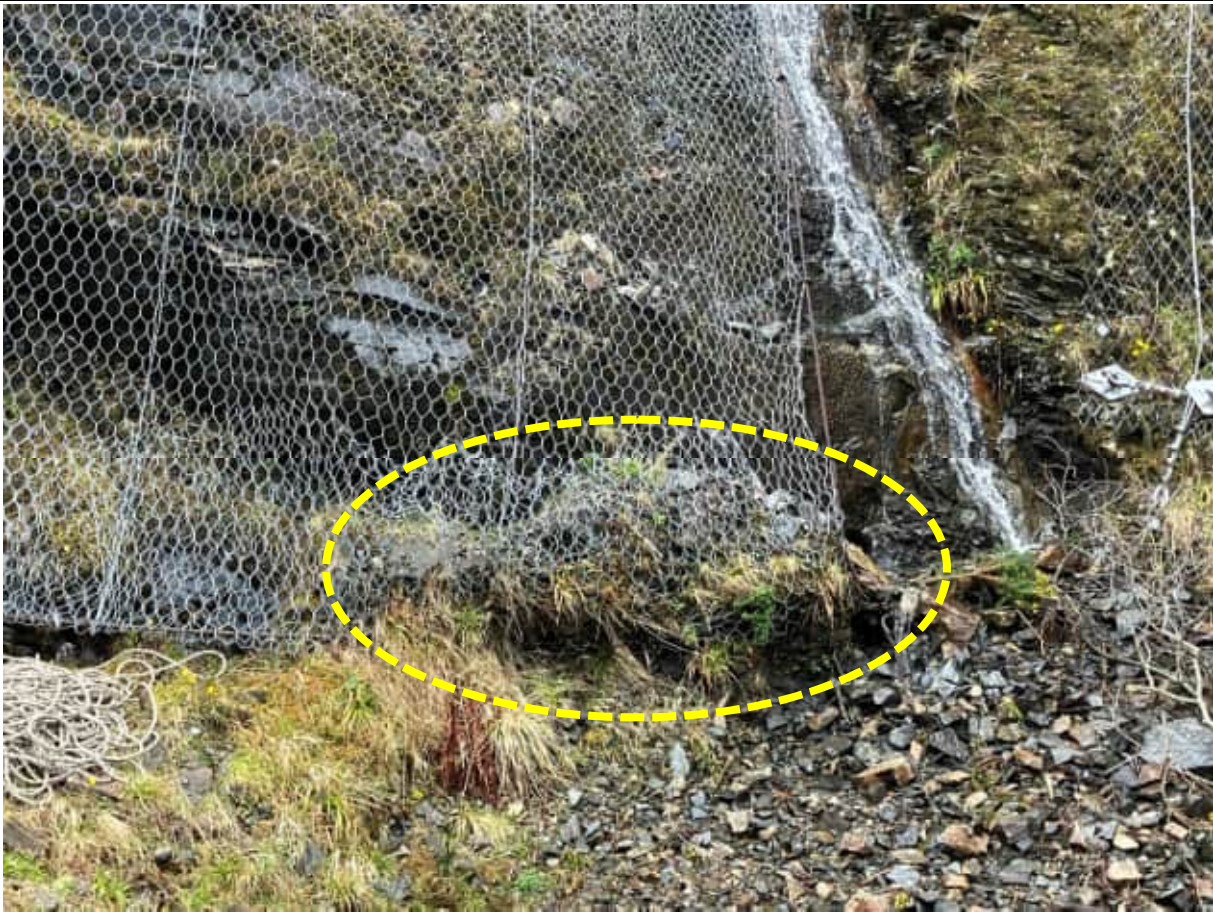
| AA18/19-4 | <p>Ch. 3052:</p> <p>2018: Minor debris accumulation at bottom right of mesh but not loading system.</p> <p>2025: Debris accumulation is beginning to load the mesh. Requires clearance.</p> <p>2026: No changes observed during 2026 inspection. Clearance required.</p> | Year First Observed: | 2018 |

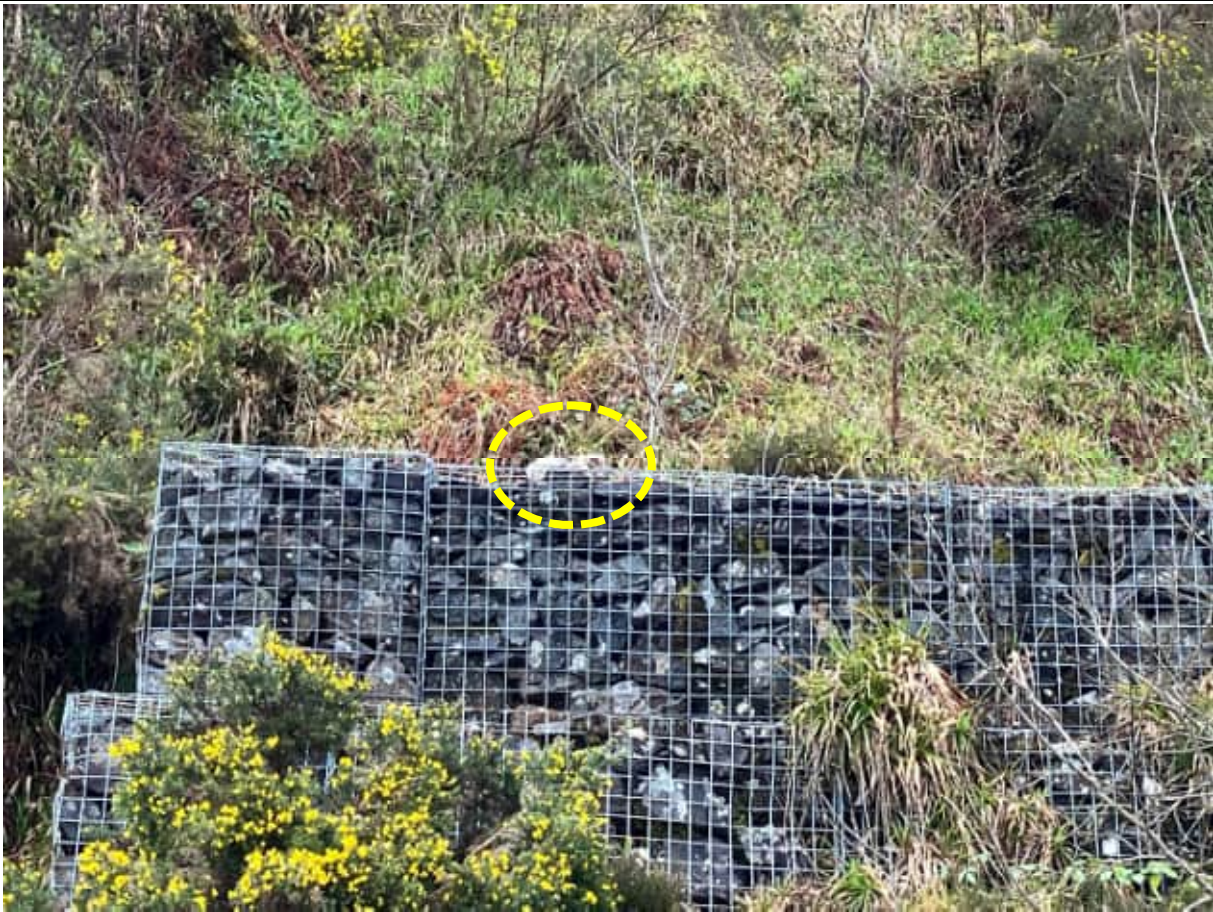
| AA19-2 | <p>Ch. 3130:</p> <p>2025: Small block resting on top of the Gabion having fallen from the upper slopes.</p> <p>2026: No changes observed during 2026 inspection.</p> | Year First Observed: | 2025 |

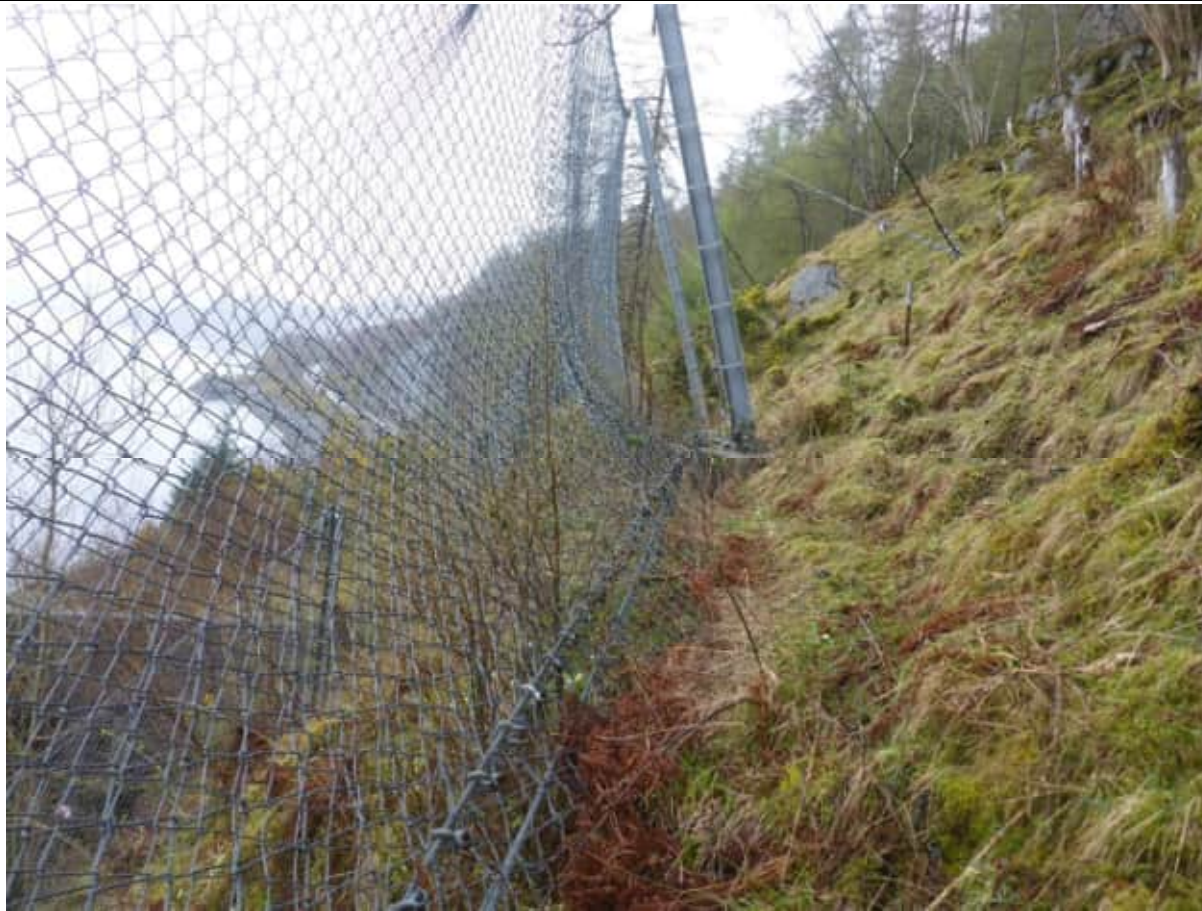
| AA20-U-1 | <p>2021 – Phase 12 works: 3000kJ, 30 m wide x 6 m high rock fall catch fence installed c. 15 m above road level between Ch. 3170 to 3215:</p> <p>2023: New catch fence assessed and noted to be in good condition. There is some surface corrosion evident on shackle bolts. Additionally, there are a few small blocks which have been retained behind the fence.</p> <p>2024: Catch fence pins in large shackles along bottom rope of catch fence exhibiting surface corrosion.</p> <p>2025: Surface corrosion of bottom rope shackle bolts; otherwise fence and all attachments in good condition. A small number of small blocks have been caught in the base of the fence.</p> <p>2026: No significant changes observed during 2026 inspection. Slight corrosion of shackles along the lower rope.</p> | Year First Observed | 2021 |

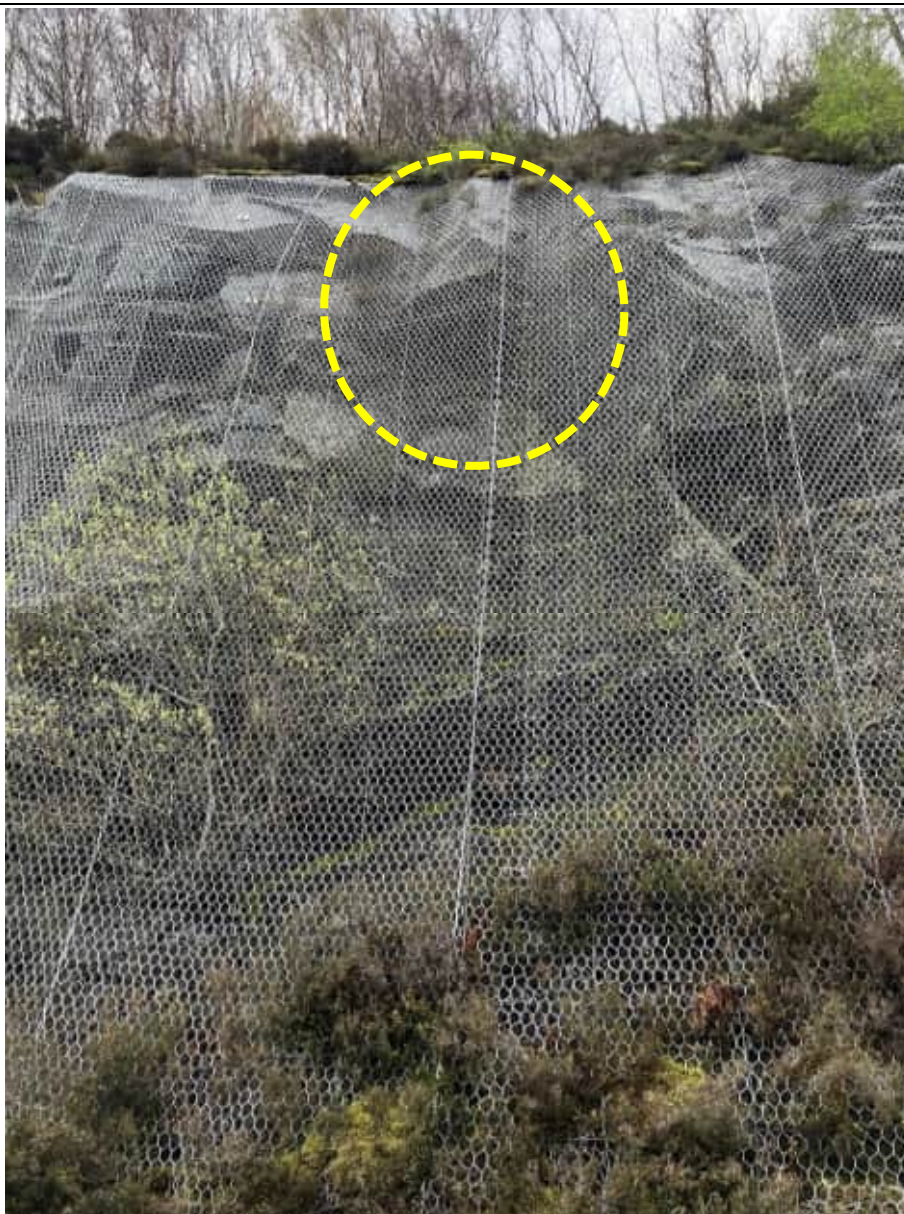
| AA21-1 | <p>Ch. 3305:</p> <p>2016: Large wedge at crest of rock slope (2 x 5 x 5 to 6 m high). Rock mass blast damaged and dilated discontinuities present. Big gap between drape mesh and rockface would allow failure to gain energy and potentially exceed capacity of netting, impacting road below.</p> <p>2026: No changes observed during 2026 inspection.</p> | <p>Year First Observed:</p> | 2016 |

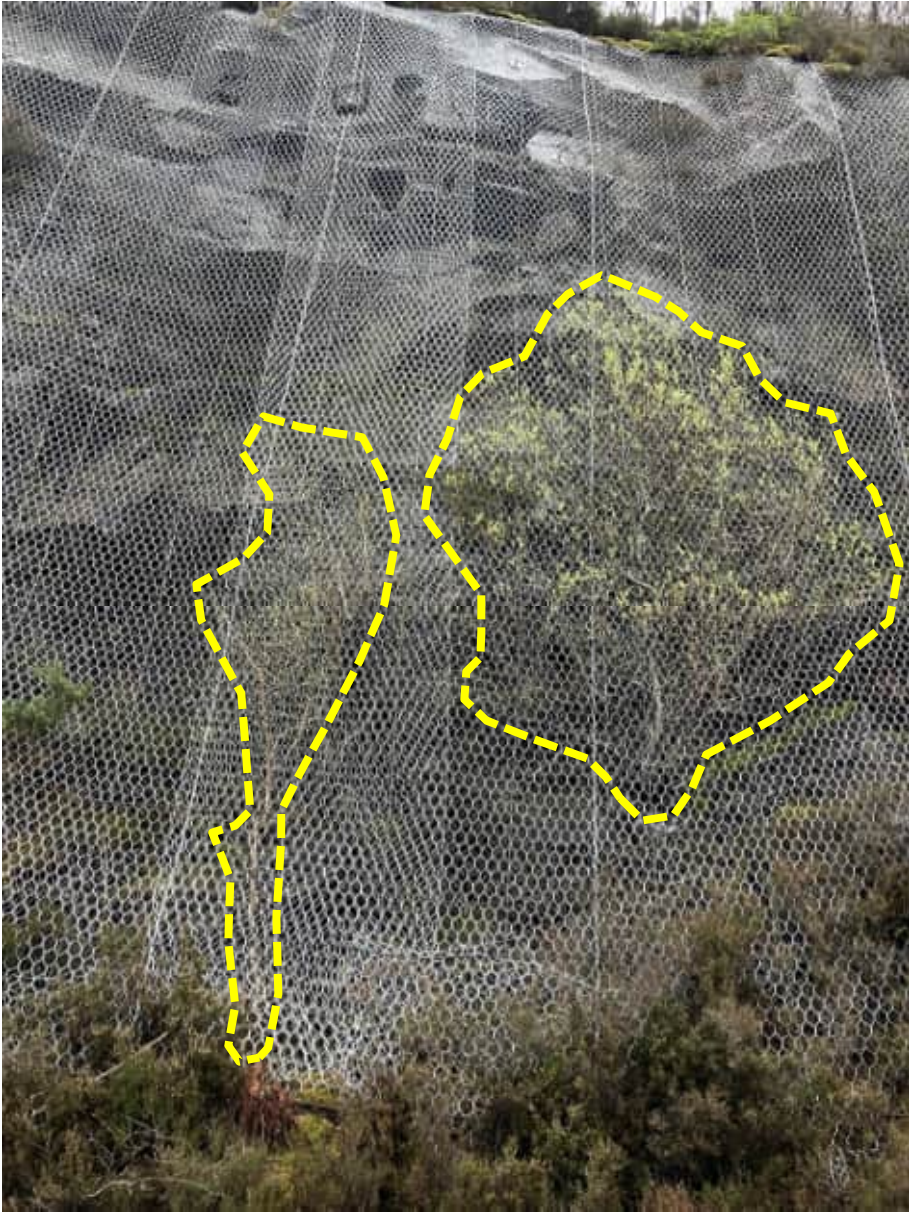
| AA21-2 | <p>Ch. 3310:</p> <p>2016: Root jacking evident approximately 3 m above road level. No immediate risk of failure but would be worth coppicing.</p> <p>2026: No changes observed during 2026 inspection.</p> | Year First Observed: | 2016 |

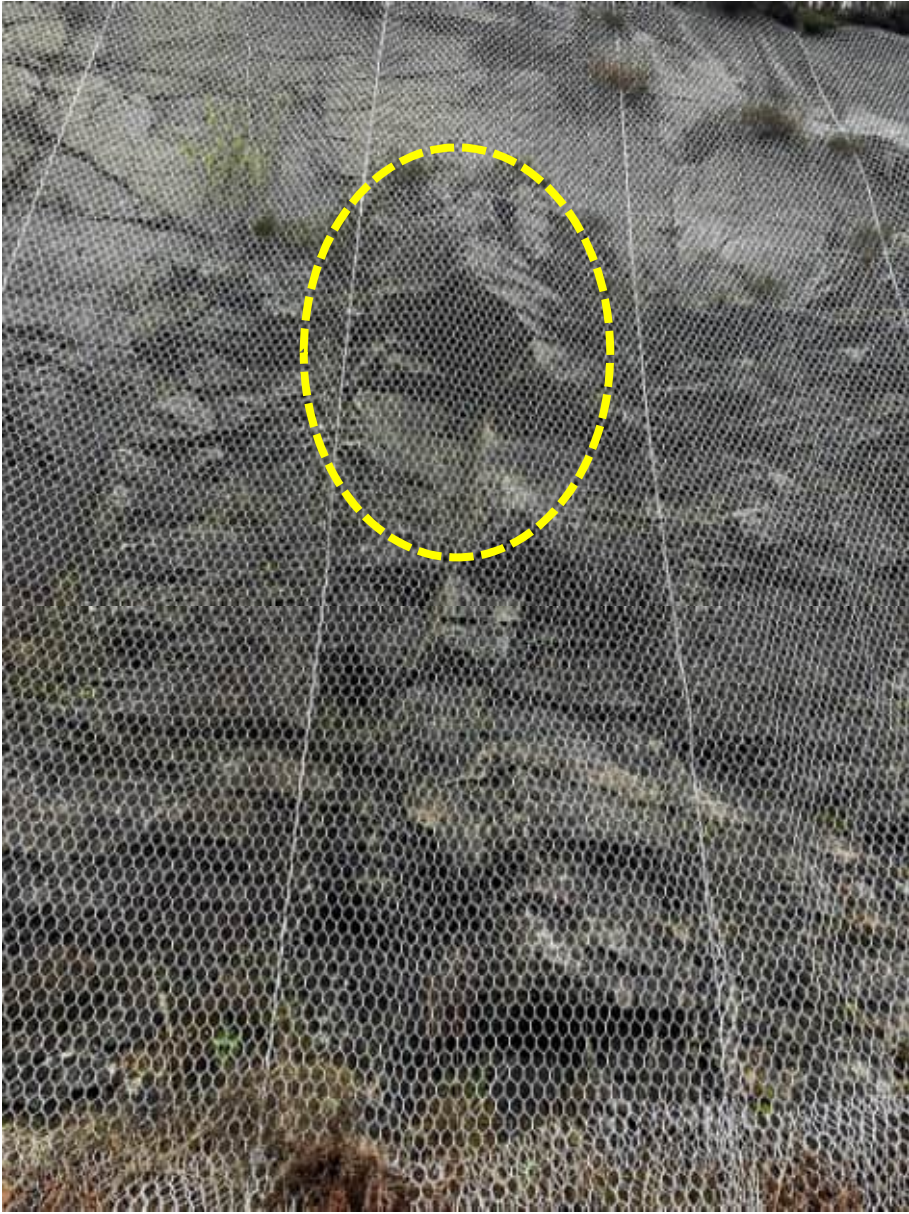
| AA21-3 | <p>Ch. 3322:</p> <p>2016: Potential wedge failure approximately 5 m above road level. Multiple blocks, total volume 1.5 m<sup>3</sup>.</p> <p>2026: No changes observed during 2026 inspection.</p> | Year First Observed: | 2016 |

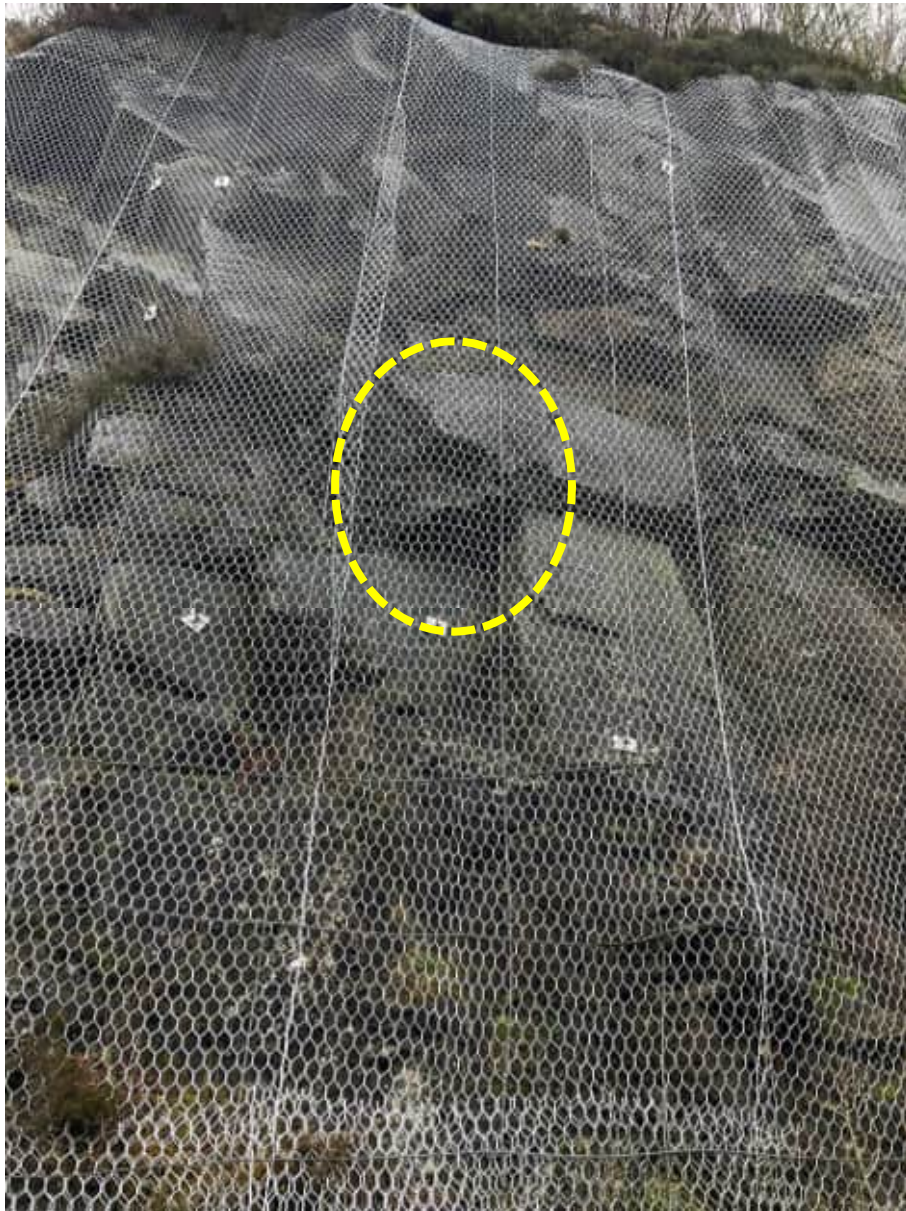
| AA21-4 | <p>Ch. 3346:</p> <p>2025: Blast damage crack observed with potential to form wedge failure at 3 to 4 m height. Block likely to be within design capacity of netting so no significant risk at present.</p> <p>2026: No changes observed during 2026 inspection.</p> | Year First Observed: | 2025 |

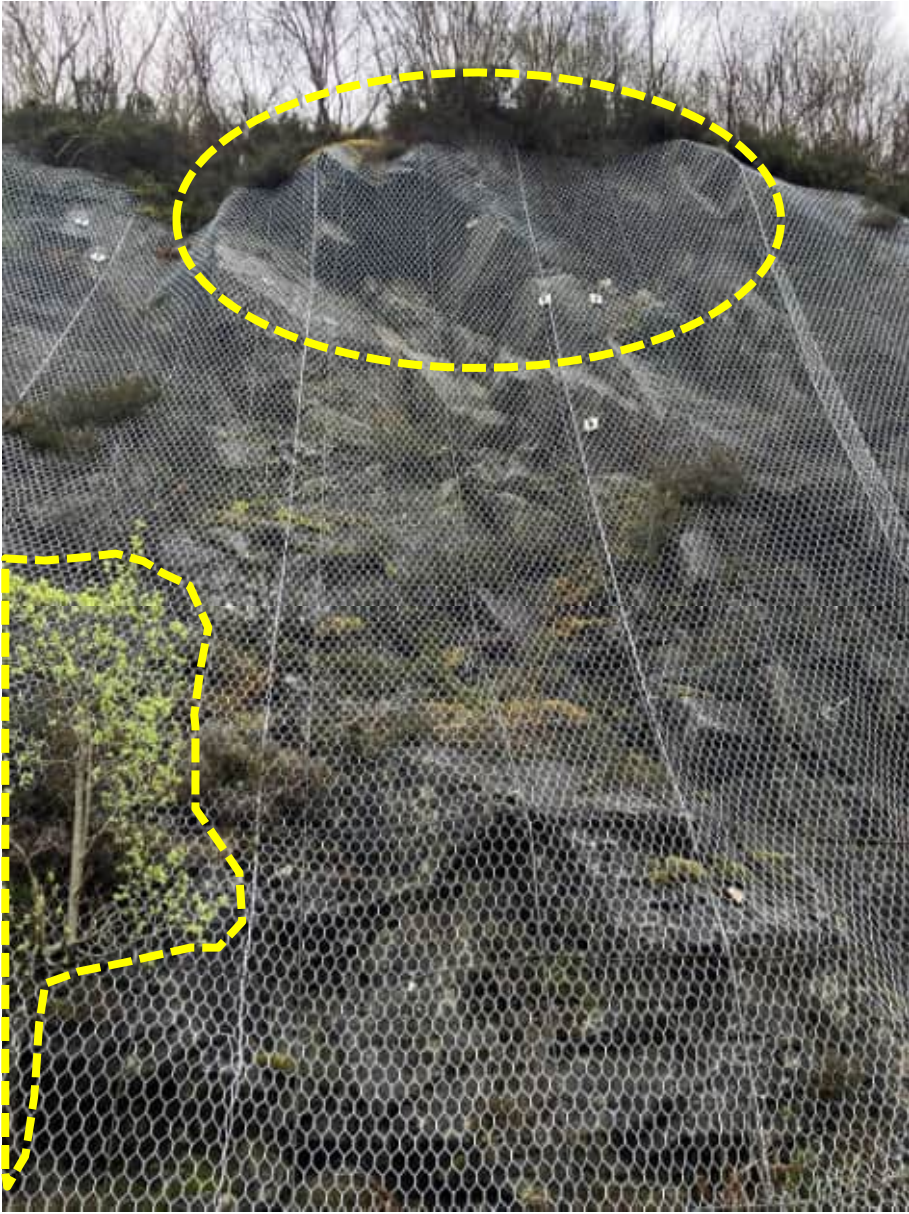
| AA21-5 | <p>Ch. 3350:</p> <p>2019: Rock mass at crest with dilated release plane. Numerous dowels, but only in one block, and a cable present c. 15 m above road level. 3 x 2 x 1.5 m.</p> <p>2026: No changes observed during 2026 inspection. Root jacking an issue lower down the slope.</p> | Year First Observed: | 2019 |
