# A890 Maman Hill

Annual Slope Inspection 2026

The Highland Council

Project number: 60685712  
AECOM Report Ref.: GLRP0012

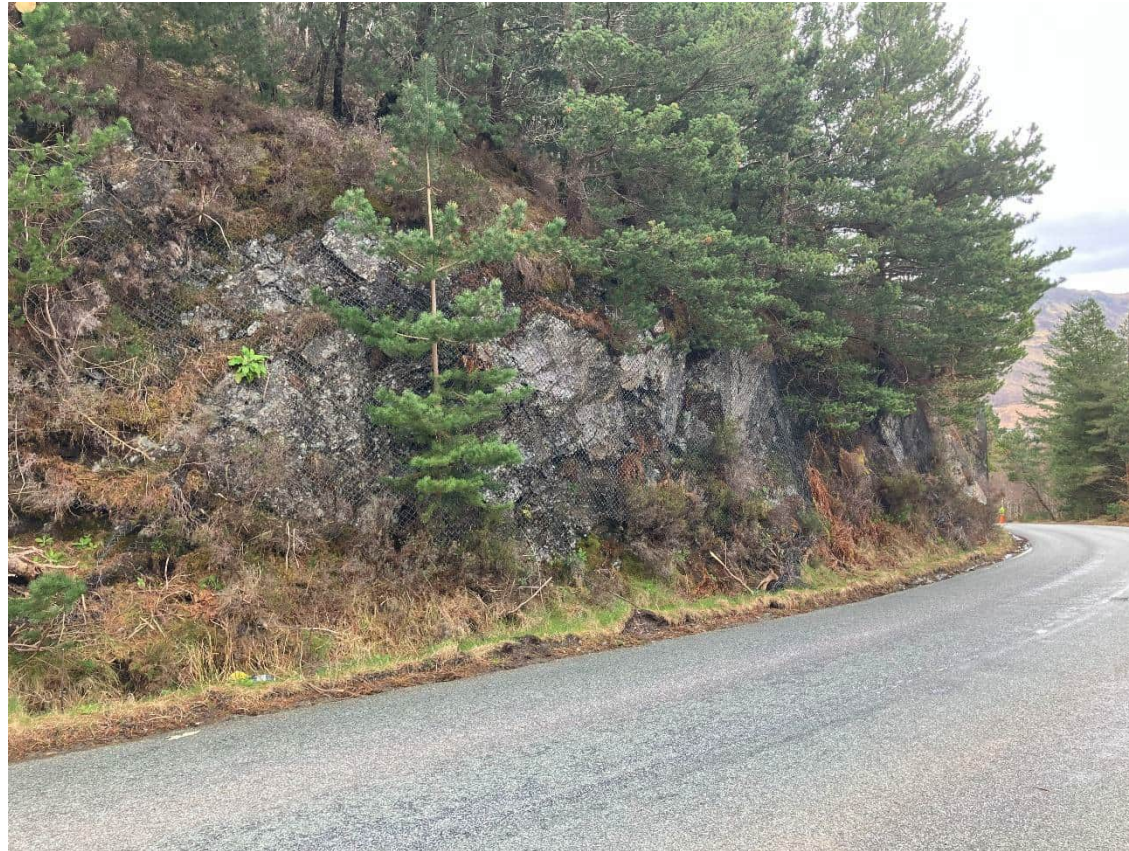
| Year of Works | Description of Works | Comments | 2026 Inspection Observations | Photo Reference |
|---|---|---|---|---|
| Unknown.<br><br>Pre-dates AECOM's first involvement in the A890 Stromeferry Bypass in 2012. | Localised chain-link drape netting between Ch 030 to 075. | Netting covers c.65% of slope (anchorages have not been inspected).<br><br>The netting is highly corroded and locally damaged and should be considered ineffective.<br><br>Numerous visible tears to the netting, particularly across lower third. A significant proportion is obscured by vegetation cover, including anchorages. | No change noted during the 2026 inspection. | M1-1 |

Localised chain-link drape netting between Ch 030 to 075. Netting covers c. 65% of slope (anchorages have not been inspected). The netting is highly corroded and locally damaged and should be considered ineffective.

2026: No change noted during the 2026 inspection.

| Recommended Remedial Works / Actions | | | | | | | |
|---|---|--|---|---|---|---|---|
| N/A | | | <ul style="list-style-type: none"> <li>Consider replacement of existing ineffective drape netting between Ch. 030 and Ch. 075.</li> </ul> | | | <ul style="list-style-type: none"> <li>Re-inspection by end of April 2027</li> <li>Felling of trees along crest and de-vegetation of the slope</li> <li>Scaling of loose rock behind netting (between Ch. 030 to 075)</li> </ul> | |

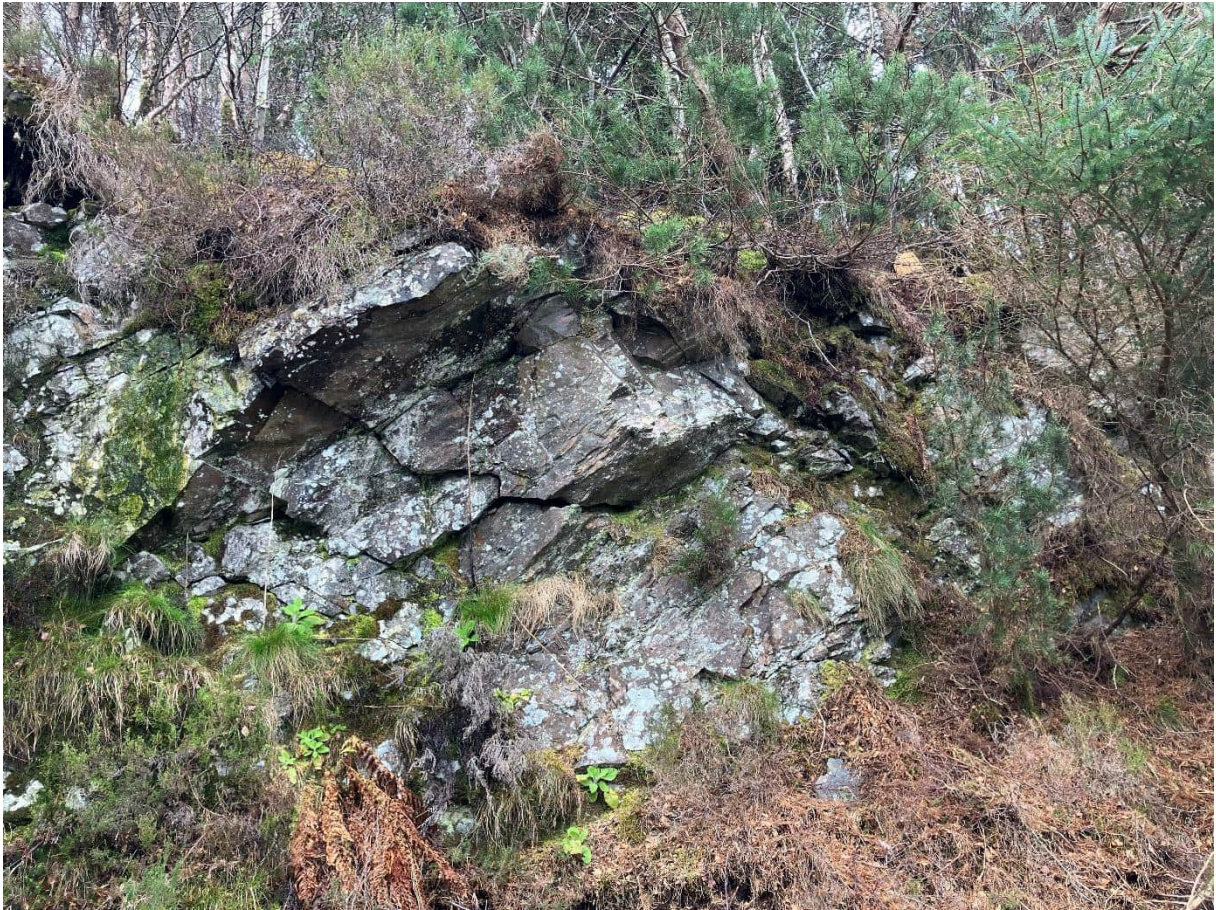
| Hazards Observed: | | | |
|---|---|---|---|
| Ch. 023 | <b>2022 Inspection:</b> Block (c.2.0 x 1.0 x 1.5 m) with dilated back fracture (low risk due to presence of verge beneath) | No change noted during the 2026 inspection. | M1-2 |

| M1-2 | Ch. 023:<br>2022: Block c. 2.0 x 1.0 x 1.5 m with dilated back fracture. Poses low risk to road due to presence of verge beneath.<br>2026: No change noted during the 2026 inspection. | Year First Observed: | 2022 |

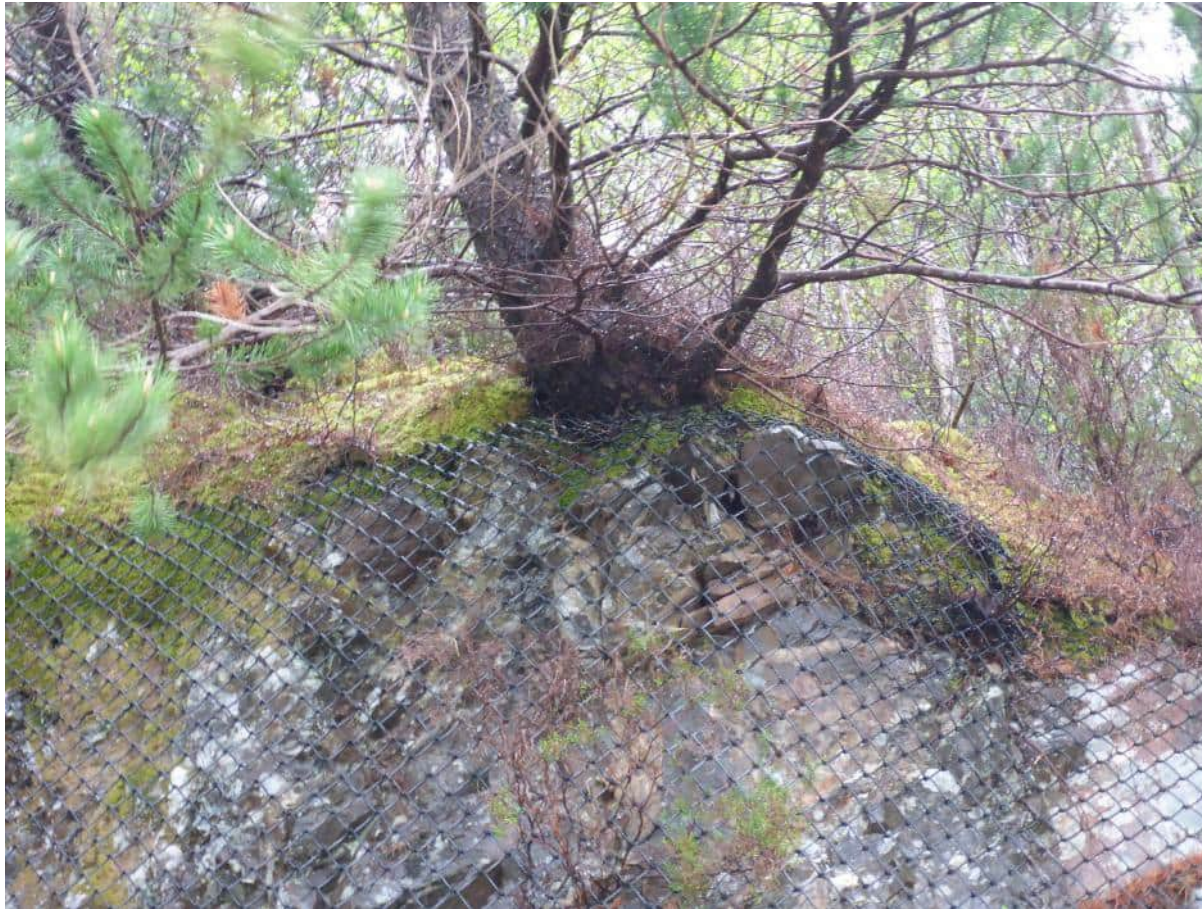
| Hazards Observed: | | | |
|---|---|---|---|
| Ch. 053 | <b>2024 Inspection:</b> Several small blocks present in the verge which have a source location 5 m high, at the crest of the slope. There is potential for more blocks to fall and land on the verge or edge of the road.<br><br><b>2025 Inspection:</b> Source of rockfall is root jacking by a semi-mature tree at the crest of the slope. Several small blocks are loose and retained between the rockface and the netting c. 1 m below the tree. | No change noted during the 2026 inspection. | M1-3 |

Ch. 053:

2025: Source of rockfall is root jacking by a semi-mature tree at the crest of the slope. Several small blocks are loose and retained between the rockface and the netting c. 1 m below the tree.

2026: No change noted during the 2026 inspection.

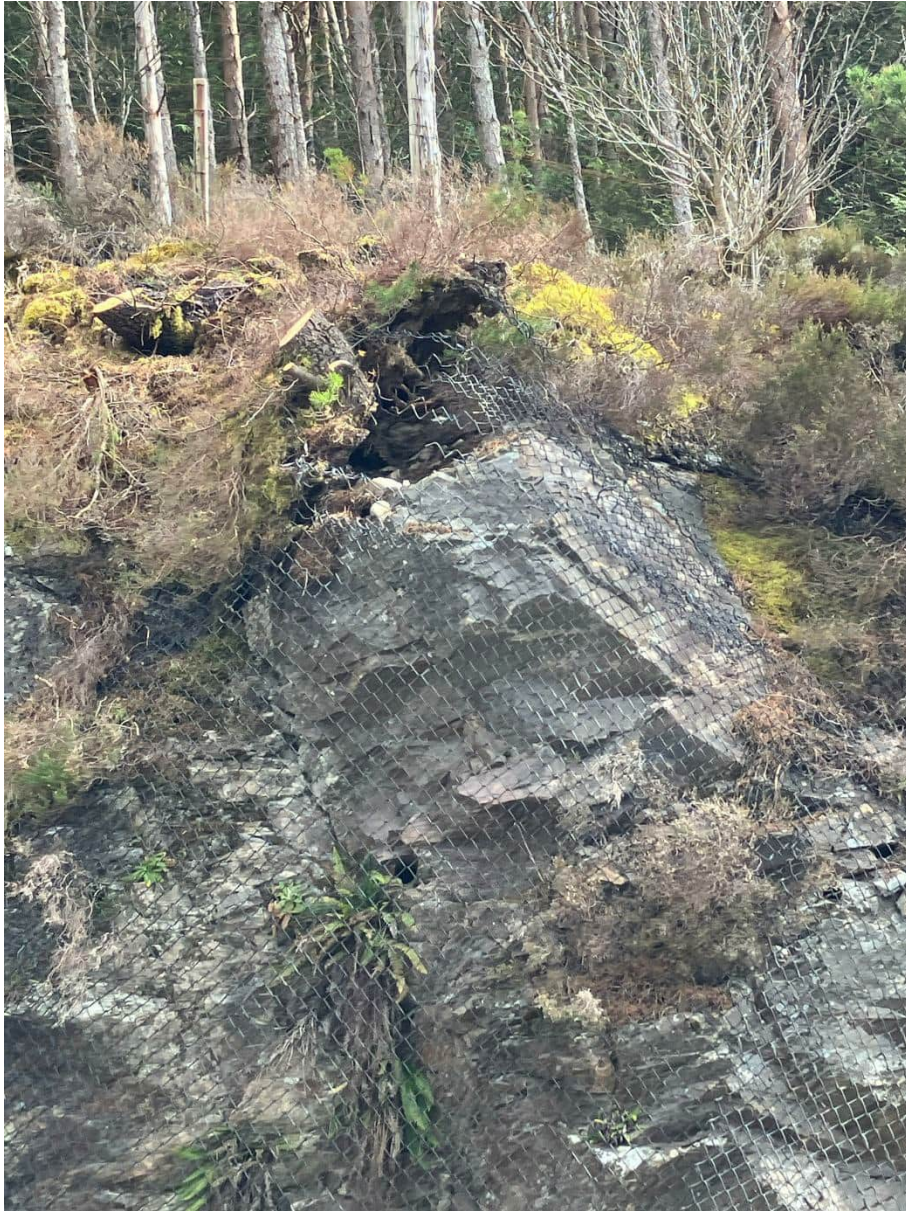
| M1-4 | Ch. 067:<br>2026: A tree has fallen from the crest, rotating away from the slope and ripping the netting. The tree has since been cut back. No increased risk of rockfall. | Year First<br>Observed: | 2026 |

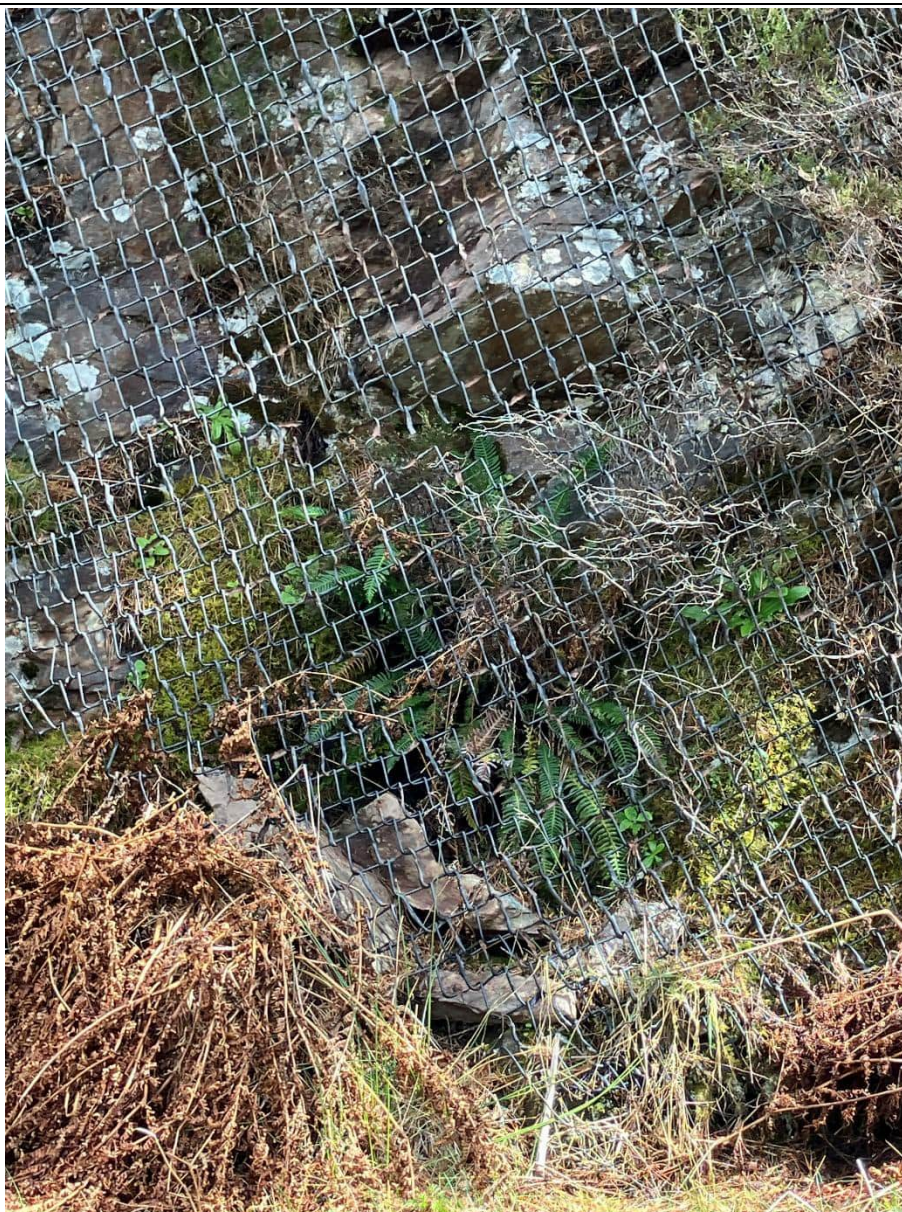
| Hazards Observed: | | | |
|---|---|---|---|
| Ch. 072 | <b>2025 Inspection:</b> Small accumulation of blocks up to 0.30 m (long axis) at the toe of the slope behind the netting. Source of rockfall 1.5 m above toe.<br><br>Netting is considered to be ineffective due to excessive corrosion (numerous holes noted) and no ditch is present. The 0.9 m wide verge should prevent the majority of falling blocks from reaching the roadside; however, there is the potential for some small blocks to reach the road, particularly if debris build up creates the potential for random bounce trajectories. | No change noted during the 2026 inspection. | M1-5 |

| M1-5 | <p>Ch. 072:</p> <p>2025: Small accumulation of blocks up to 0.30 m (long axis) at the toe of the slope behind the netting. Source of rockfall 1.5 m above toe. Netting is considered to be ineffective due to excessive corrosion (numerous holes noted) and no ditch is present. The 0.9 m wide verge should prevent the majority of falling blocks from reaching the roadside; however, there is the potential for some blocks to reach the road, particularly if debris build up creates the potential for random bounce trajectories.</p> <p>2026: No change noted during the 2026 inspection.</p> | <p>Year First Observed:</p> | 2025 |

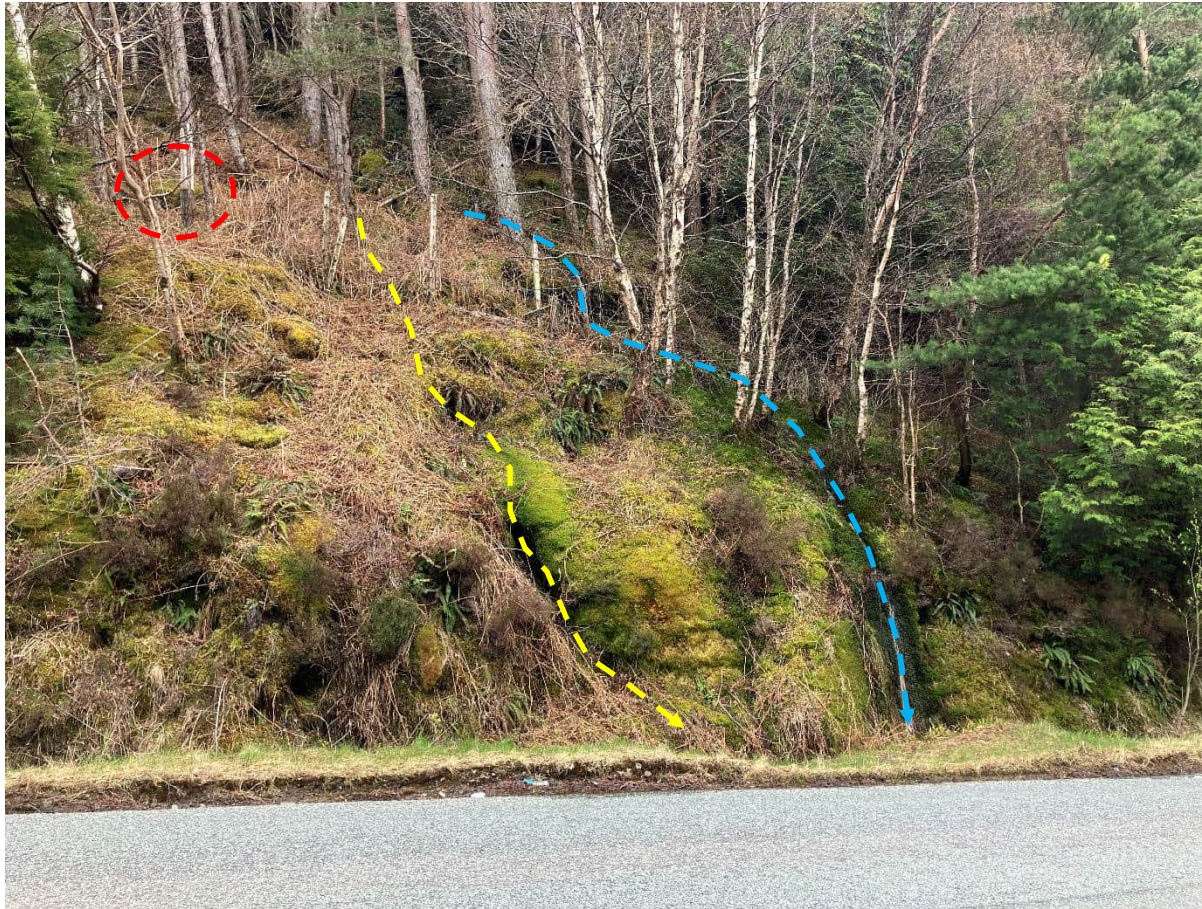
| Location | Description of Hazard(s) from Previous Inspections | 2026 Inspection Observations | Photo Reference |
|---|---|---|---|
| Ch. 217 | <b>2025 Inspection:</b> Surface water flow appears to have been diverted upslope in forestry area, with the water flowing down slope ~4.0 m up chainage from the location of the existing culvert. | Surface water no longer flows towards and into the culvert. Craggs are noted circa 20 m above the road level. One block noted on the slope circa 25 m back from the road, although there does not appear to be any evidence of movement. | M2-1 |

| Other Comments |
|---|
| <p>Diversion of existing surface watercourse / water flow observed at Ch. 217; the flow has been diverted upslope, which may signify a blocked channel upslope which may break through in high rainfall conditions. A block on the slope has been noted above the diverted watercourse, although there does not appear to be any evidence of movement. Large verge and ditch should reduce the potential for debris to reach the road.</p> <p>No groundwater flows.</p> <p>Isolated low height (2 m max) rock exposures. Rock mass generally in good condition, although dilated fractures noted locally. Potential for kinematic failure is low.</p> <p>No debris at toe or other evidence of previous rock falls at this location. Presence of effective ditch and verge.</p> |

| M2-1 | <p>Ch. 217:</p> <p>2025: Surface water flow appears to have been diverted upslope, with the downslope length of the issue ~4.0 m up chainage from the location of the existing culvert.</p> <p>2026: Surface water no longer flows towards and into the culvert. Crags are noted circa 20 m above the road level. One block noted on the slope circa 25 m back from the road, although there does not appear to be any evidence of movement.</p> <p>Yellow: Previous watercourse pathway; Blue: Current watercourse pathway; Red: Block present on slope</p> | Year First Observed: | 2025 |

| Recommended Remedial Works / Actions | | | | | | | |
|---|---|--|---|---|---|---|---|
| N/A | | | N/A | | | <ul style="list-style-type: none"> <li>Re-inspection by end of April 2027</li> <li>De-vegetation of the slope</li> <li>Reinstatement of upslope drainage to original channel</li> </ul> | |

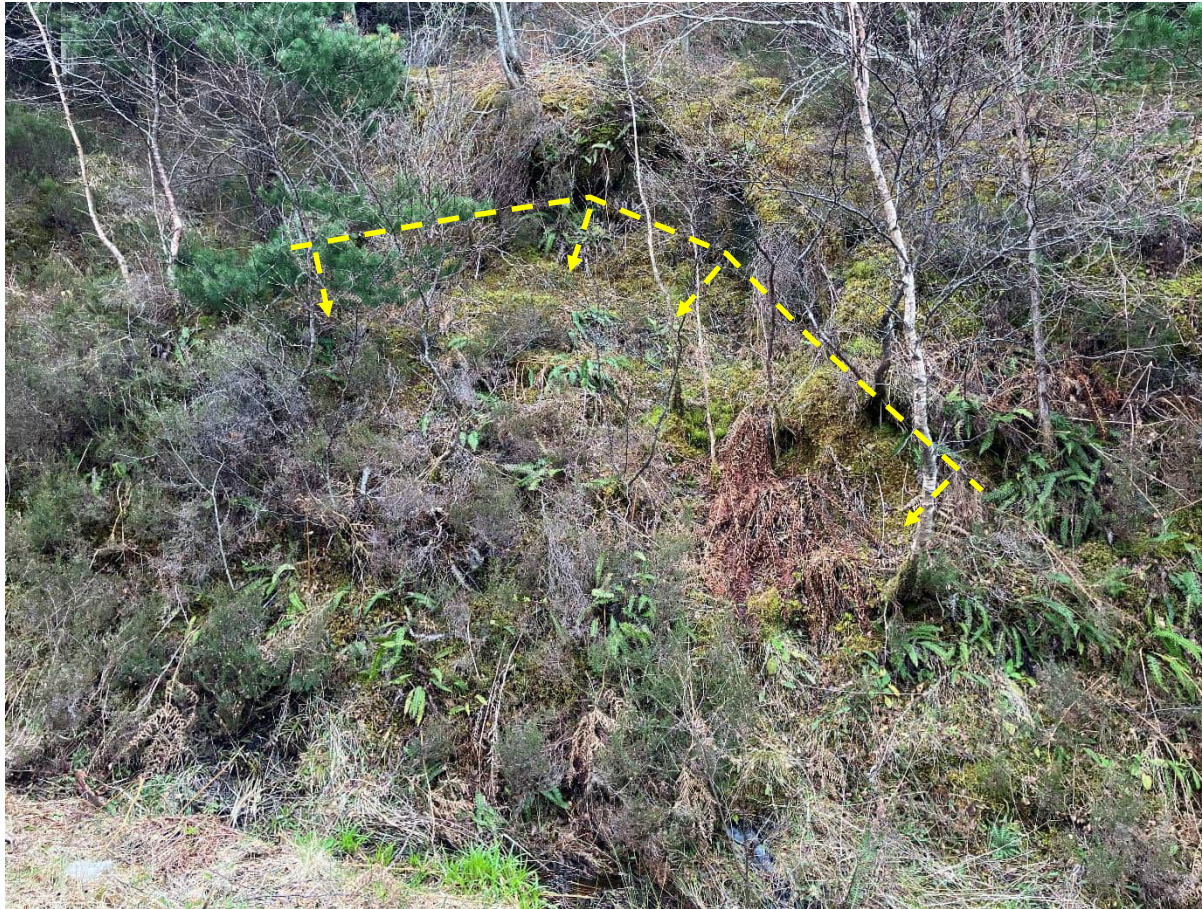
| Hazards Observed: | | | |
|---|---|---|---|
| Ch. 235 | <b>2025 Inspection:</b> Minor soil slip/slump ~1.5 m high (4.0 to 5.0 m above road level) by 3.0 m wide. Slip/slump is set back from the road, and the existing ditch would retain debris should it slip/slump further. Drainage capacity of ditch is impacted. | No change noted during the 2026 inspection. | M2-2 |

Ch. 235:

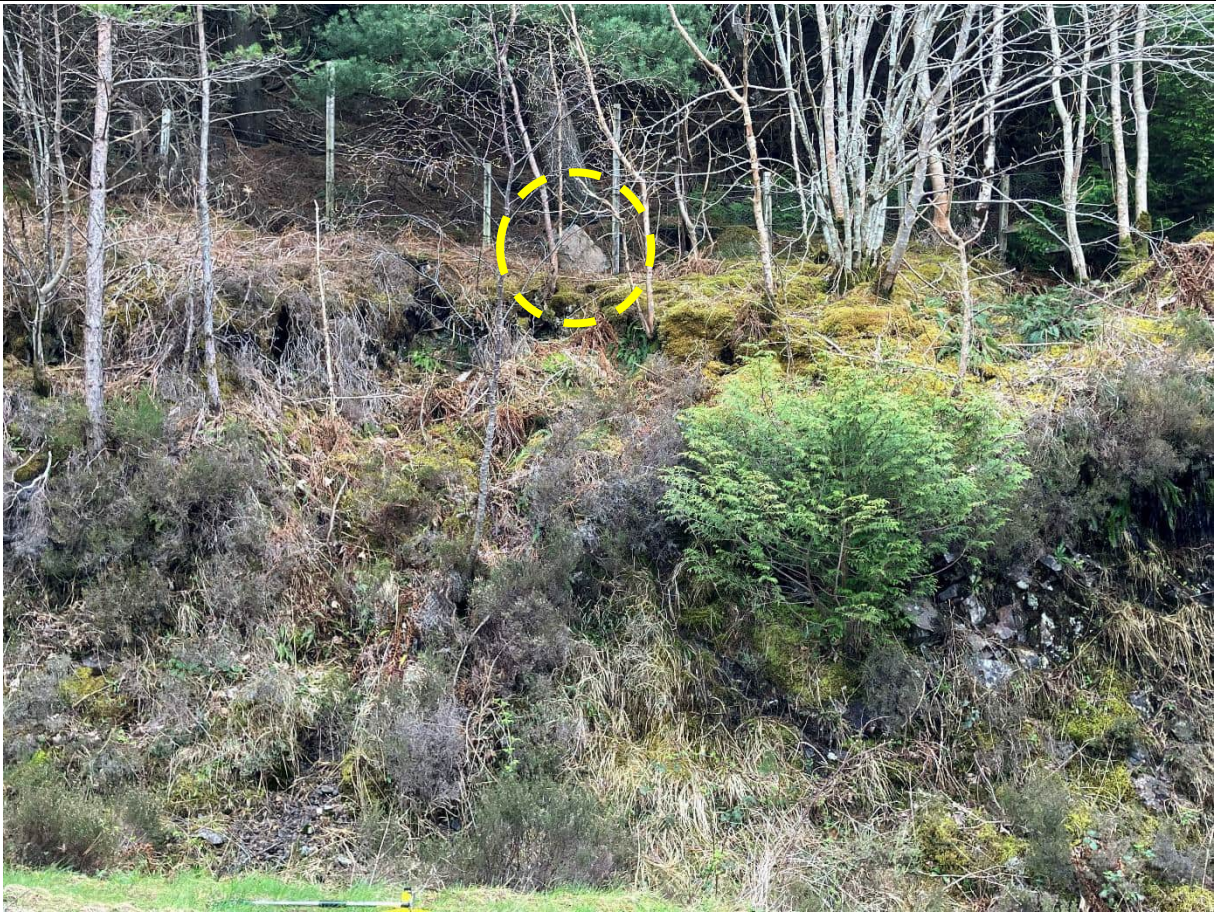
| M3-1 | Ch. 280:<br>2025: Boulder at fence above rock slope (side length 0.50 m) (circled in yellow). Source unknown.<br>2026: No change noted during the 2026 inspection. | Year First Observed: | 2025 |

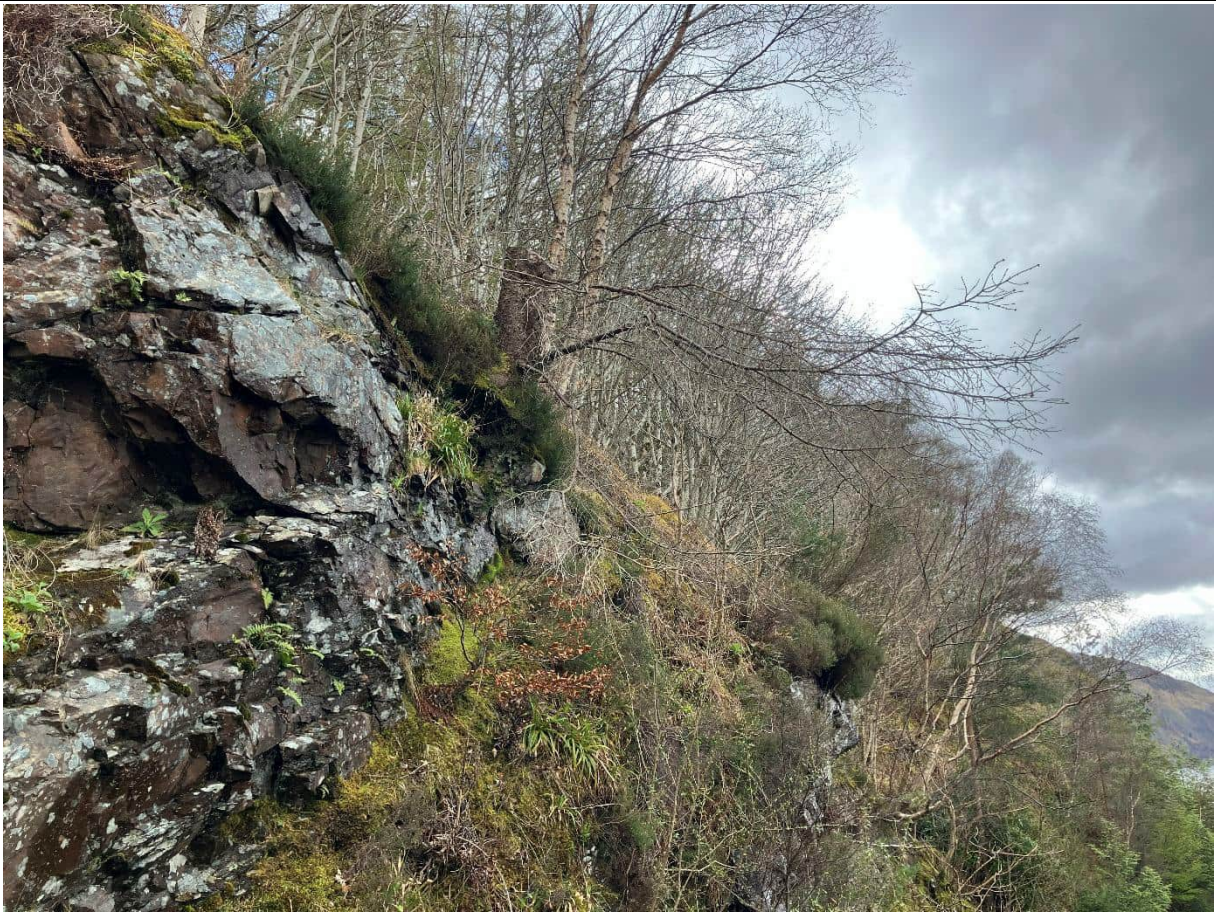
| M3-2 | Ch. 304:<br>2023: Rock mass beneath tree exhibiting root-jacking potential.<br>2026: No change noted during the 2026 inspection. | Year First Observed: | 2023 |

| Recommended Remedial Works / Actions | | | | | | | |
|---|---|--|---|---|---|---|---|
| N/A | | | N/A | | | <ul style="list-style-type: none"> <li>Re-inspection by end of April 2027</li> <li>Felling of trees along crest and de-vegetation of the slope</li> </ul> | |

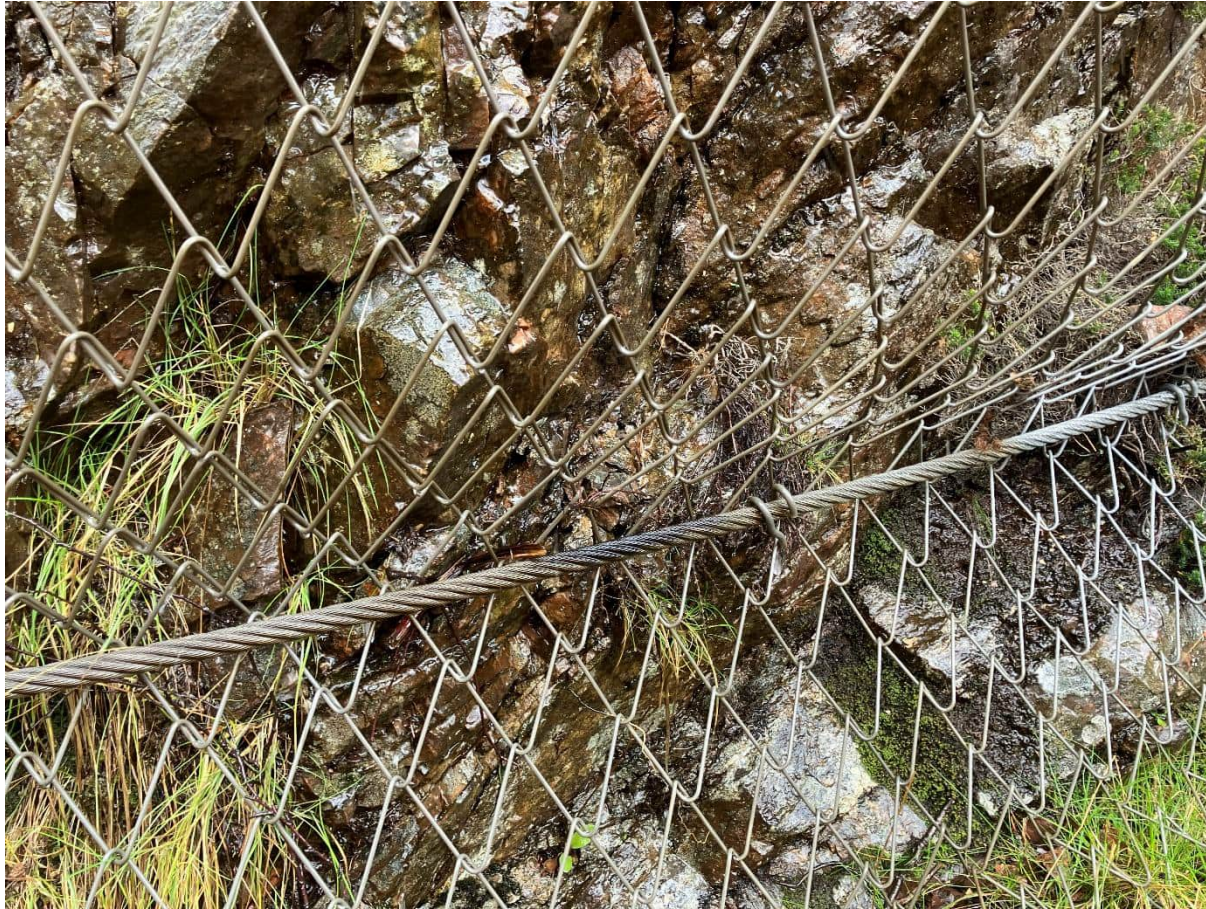
M4B-1

Ch. 355:

| Recommended Remedial Works / Actions | | | | | | |
|---|---|---|---|---|---|---|
| N/A | | <ul style="list-style-type: none"> <li>Correction of issues noted during the 2026 rope access inspection, including: <ul style="list-style-type: none"> <li>Removal of two trees above the crestline (one small tree, one large tree);</li> <li>Clearing and light (hand) scaling of loose material within the channel area;</li> <li>Extend netting beyond the current top rope to cover the area of exposed soil and rock; and</li> <li>Patch damaged netting.</li> </ul> </li> </ul> | | | <ul style="list-style-type: none"> <li>Re-inspection by end of April 2027</li> </ul> | |

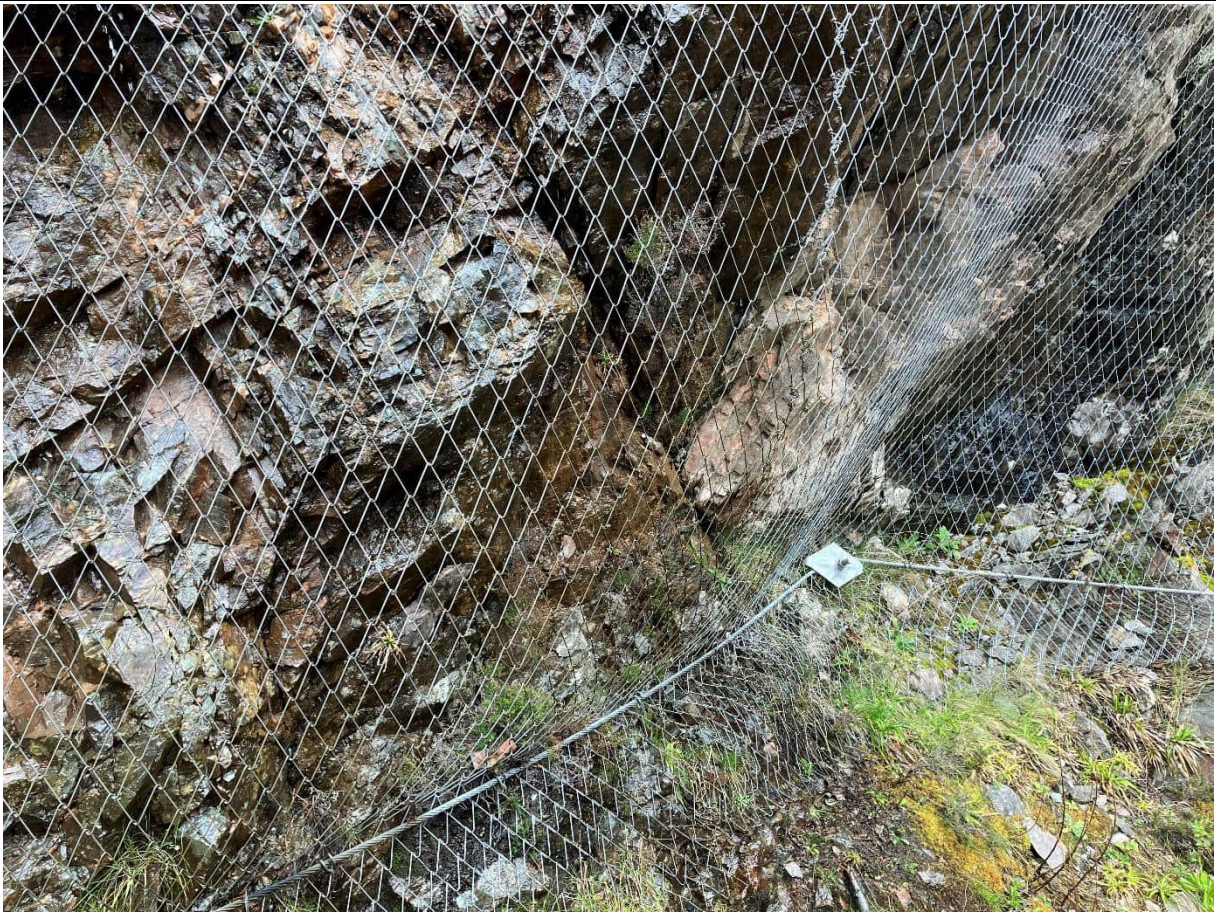
| M4B-2 | Ch. 355:<br>2026: 10 to 15 cm length of the bottom cable has discoloured to black in an area of water flow alongside localised discolouration of the netting.<br>The rock face in this area was dry during previous inspections (see comments for Ch. 357) | Year First Observed: | 2026 |

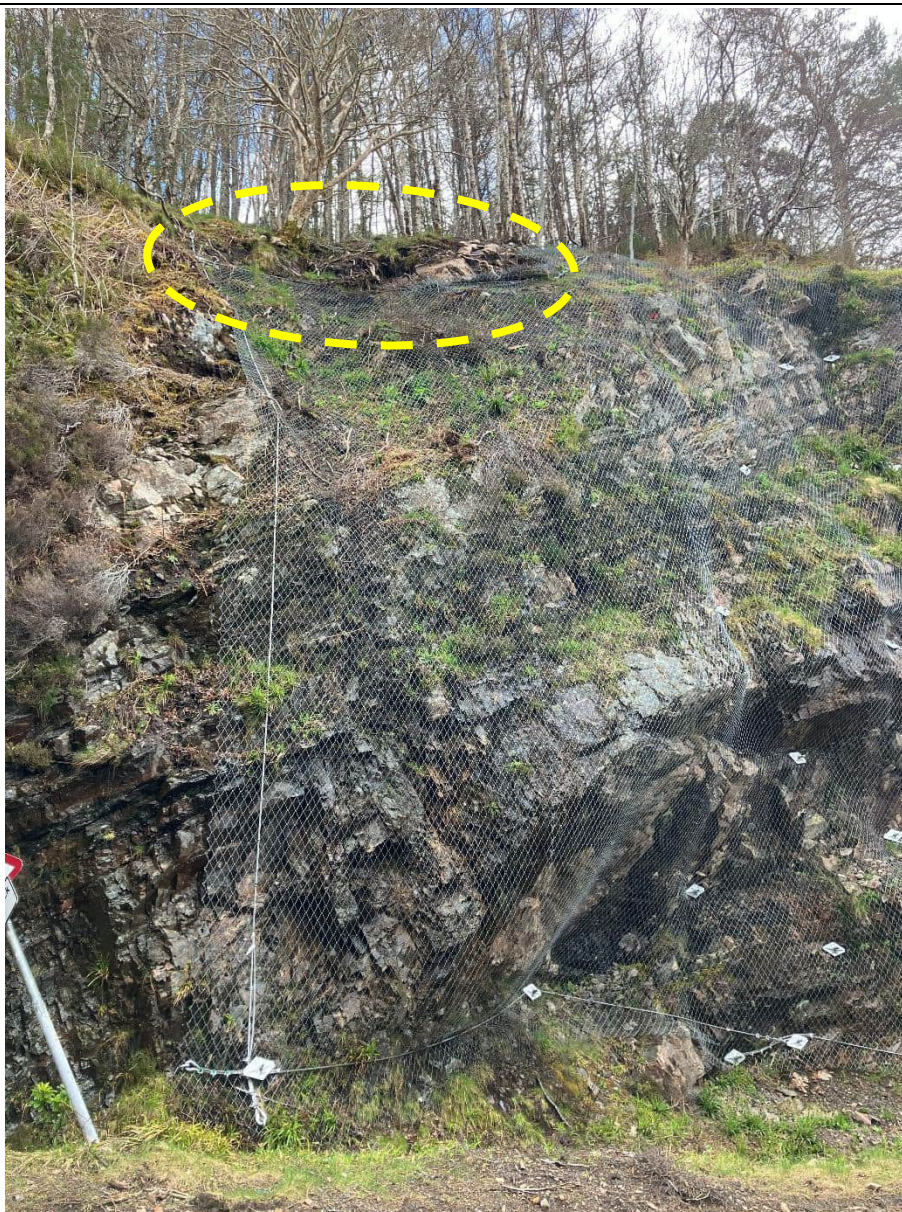
| M4B-3 | <p>Ch. 357:</p> <p>2026: Drape netting at the crest has slipped due to tree fall immediately above the top rope, creating a 6 m wide by 4 m high channel area at the top of the rock face. Tree fall has been cut back, and the material is on the western side of the road, including two tree stumps. A groundwater seepage has emerged at the location of the tree fall, with the seepage flowing down the rockface and discolouring the netting at Ch. 355 (see comments for Ch. 355).</p> | <p>Year First Observed:</p> | 2026 |

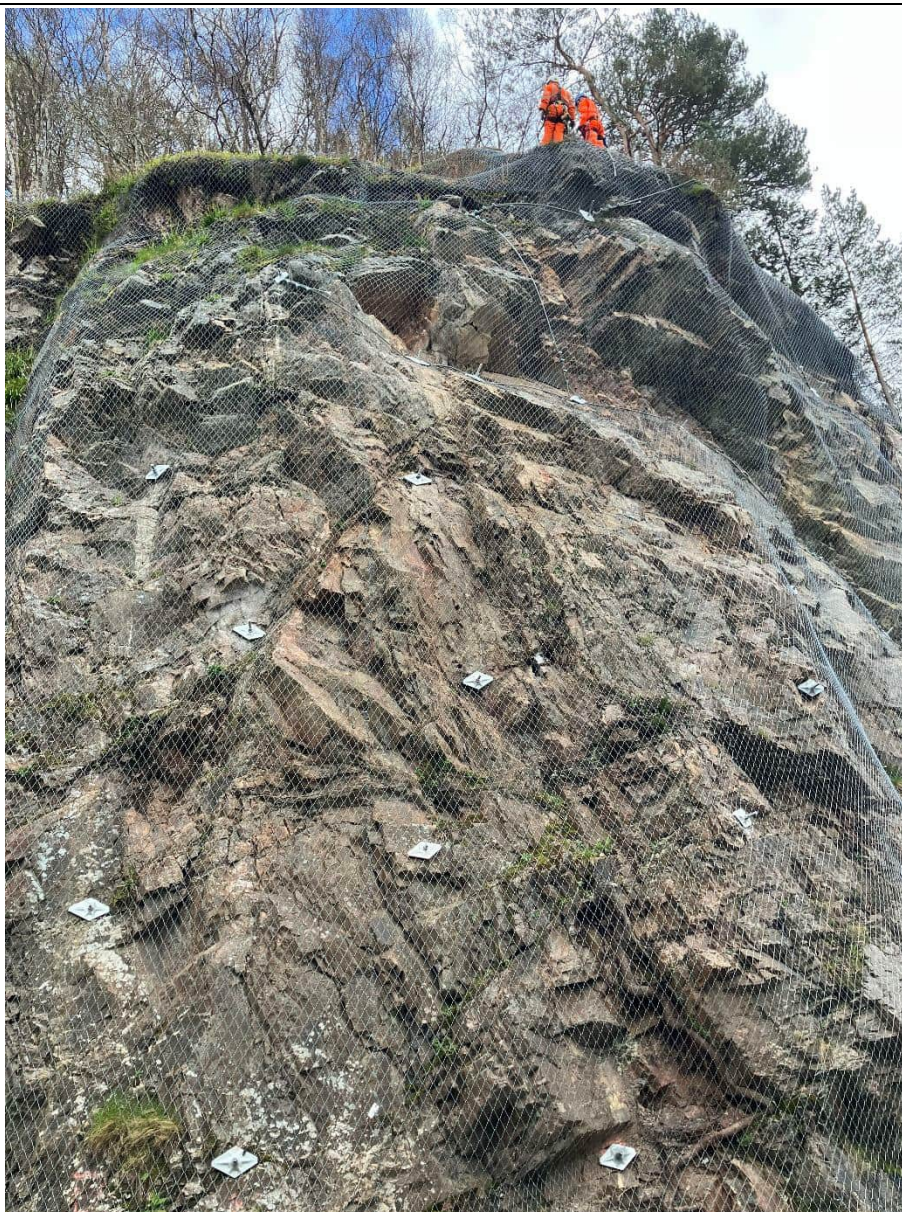
| M4B-6 | <p>Ch. 370:</p> <p>2019: A dilated sliding plane at 50° and with a 1.5 m high x 2.5 m wide x 1.5 m deep block above was observed c. 10 m above road level. Loose rock noted along sliding plane. Risk of c. 5 m<sup>3</sup> plane failure. No ditch and narrow verge so rock fall debris likely to reach road. (Repeat rope access inspection completed in 2021 – no change)</p> <p>2025: Partially scaled during 2024/2025 Phase 13 works; hazard area now located within anchored / profiled (Tecco) netting system.</p> <p>2026: No change noted during the 2026 inspection.</p> | Year First Observed: | 2019 |

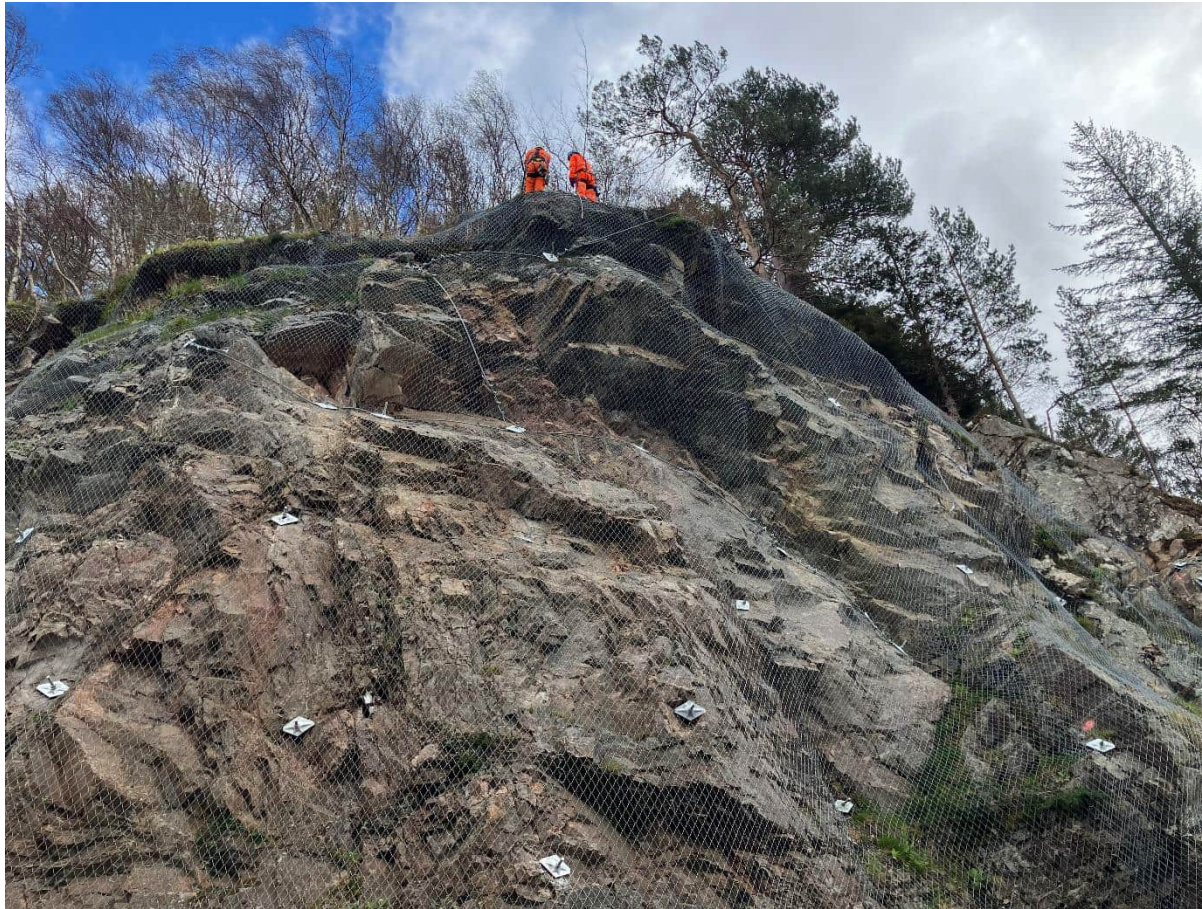
| M4B-7 | <p>Ch. 370 to 380:</p> <p>2019: A large overhang was observed c. 3 to 5 m below the crest of the rock face; however, joints were observed to be tight and no significant risk of rock fall identified.</p> <p>2025: Hazard area now located within anchored / profiled (Tecco) netting system.</p> <p>2026: No change noted during the 2026 inspection.</p> | Year First Observed: | 2019 |

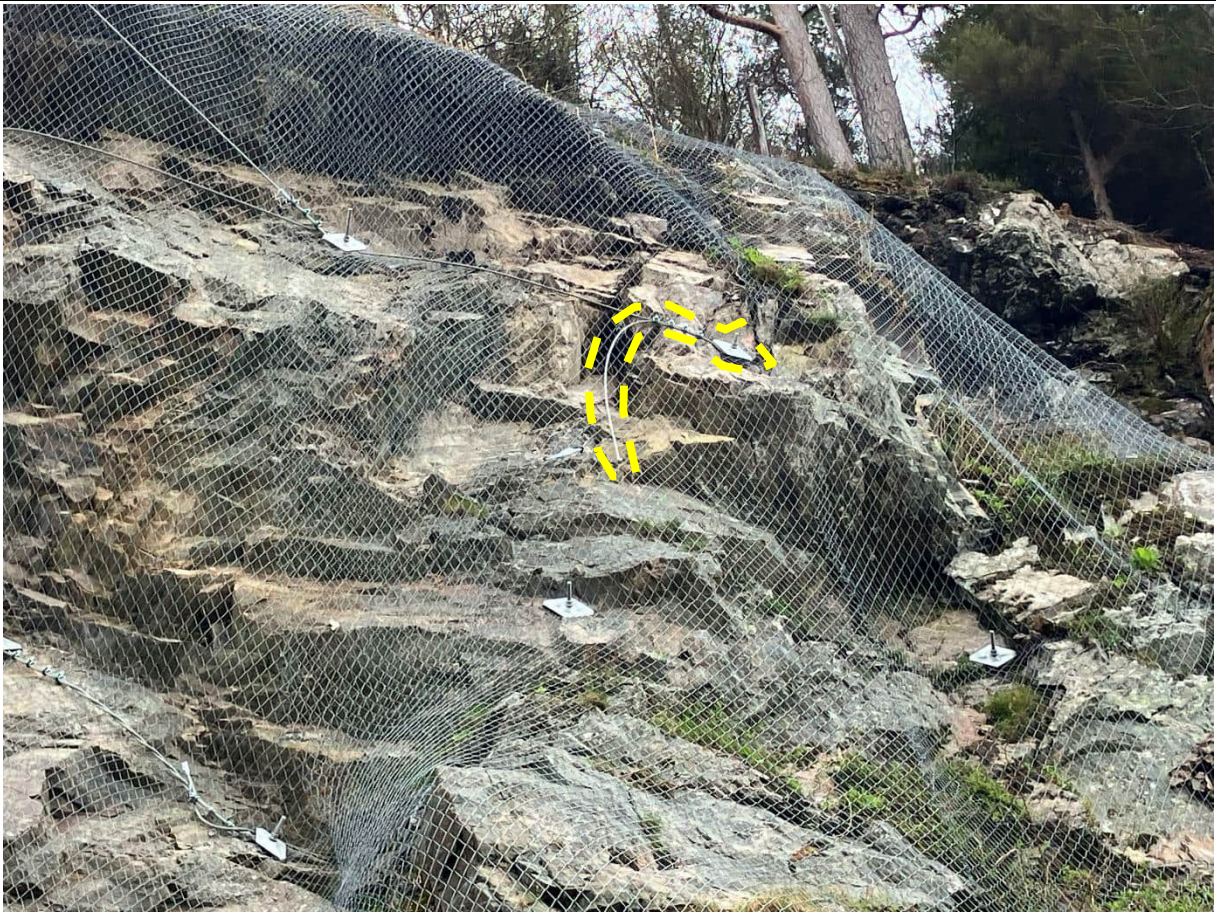
| M4B-8 | Ch. 385:<br>2026: Cable free end left long and loose | Year First Observed: | 2026 |

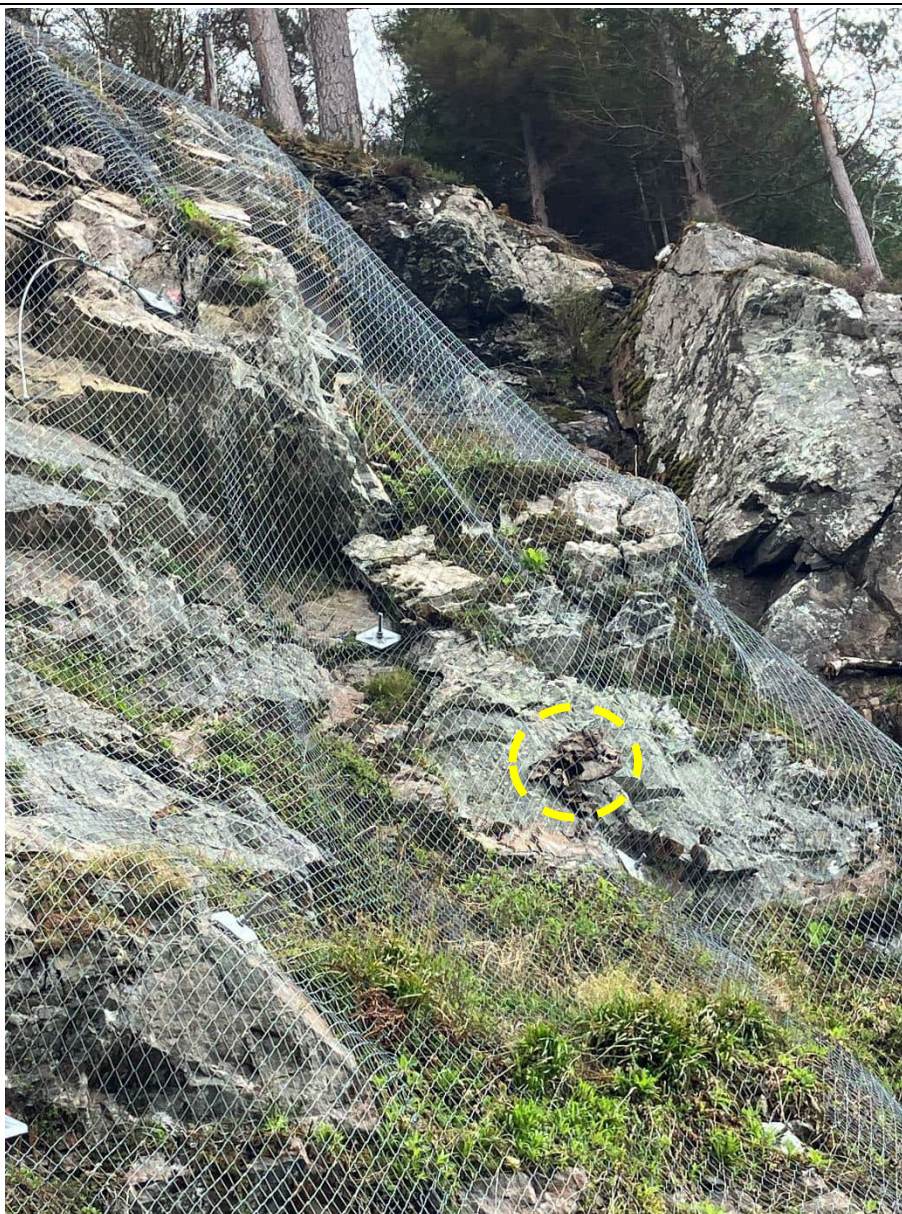
| M4B-9 | <p>Ch. 388:</p> <p>2023: 3no. new blocks in ditch up to 0.3 m side length.</p> <p>2025: Blocks no longer evident (ditch re-profiled during Phase 13 works).</p> <p>2026: Collection of small ravelling-type blocks retained within the netting circa 8 m above road level. Source of rock fall located circa 4 to 5 m above the debris. Netting does not appear to be damaged or adversely loaded by the rock fall. Rock fall does not represent a concern in the short term and debris build up to be monitored in future inspections.</p> | <p>Year First Observed:</p> | 2023 |

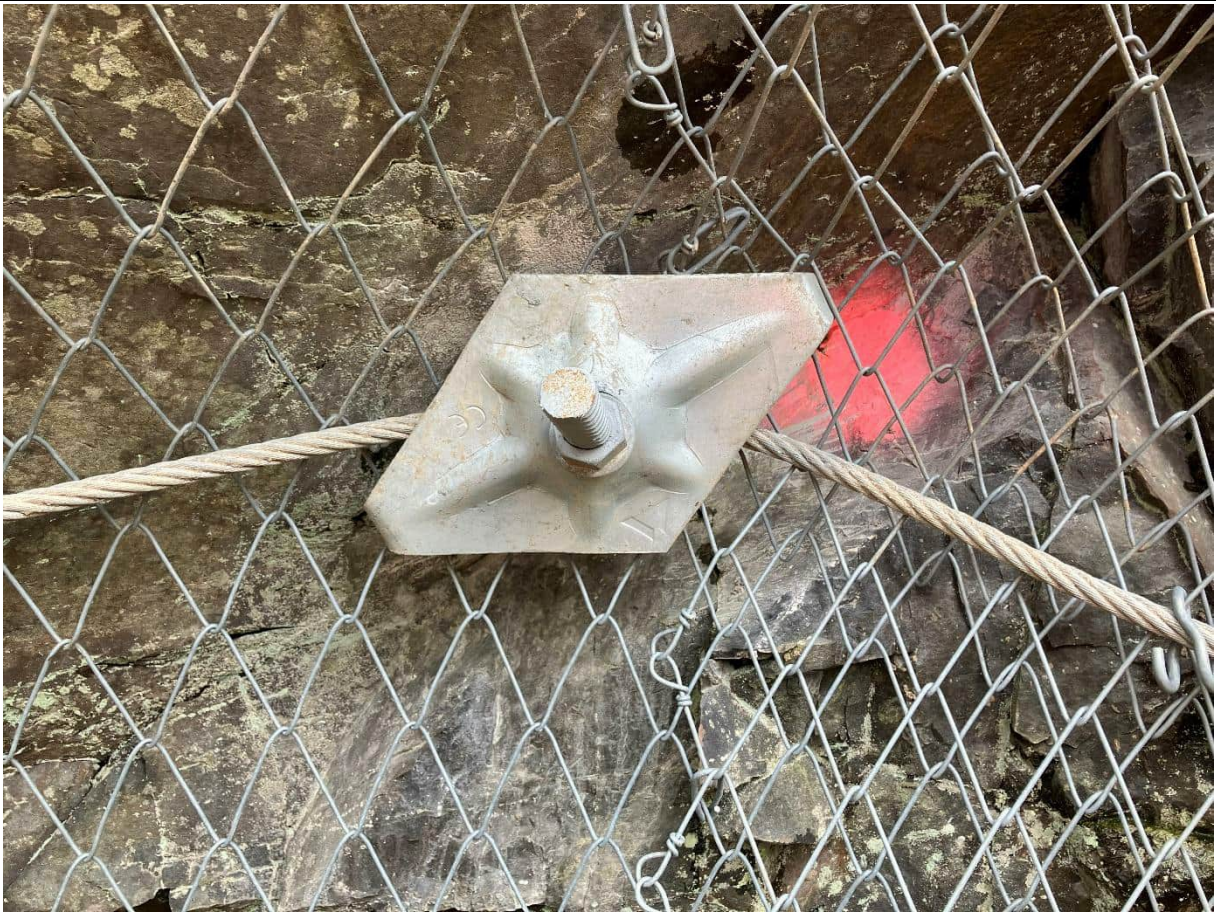
| M4B-10 | Ch. 395:<br>2026: Slight discolouration of a cut bar end | Year First Observed: | 2026 |

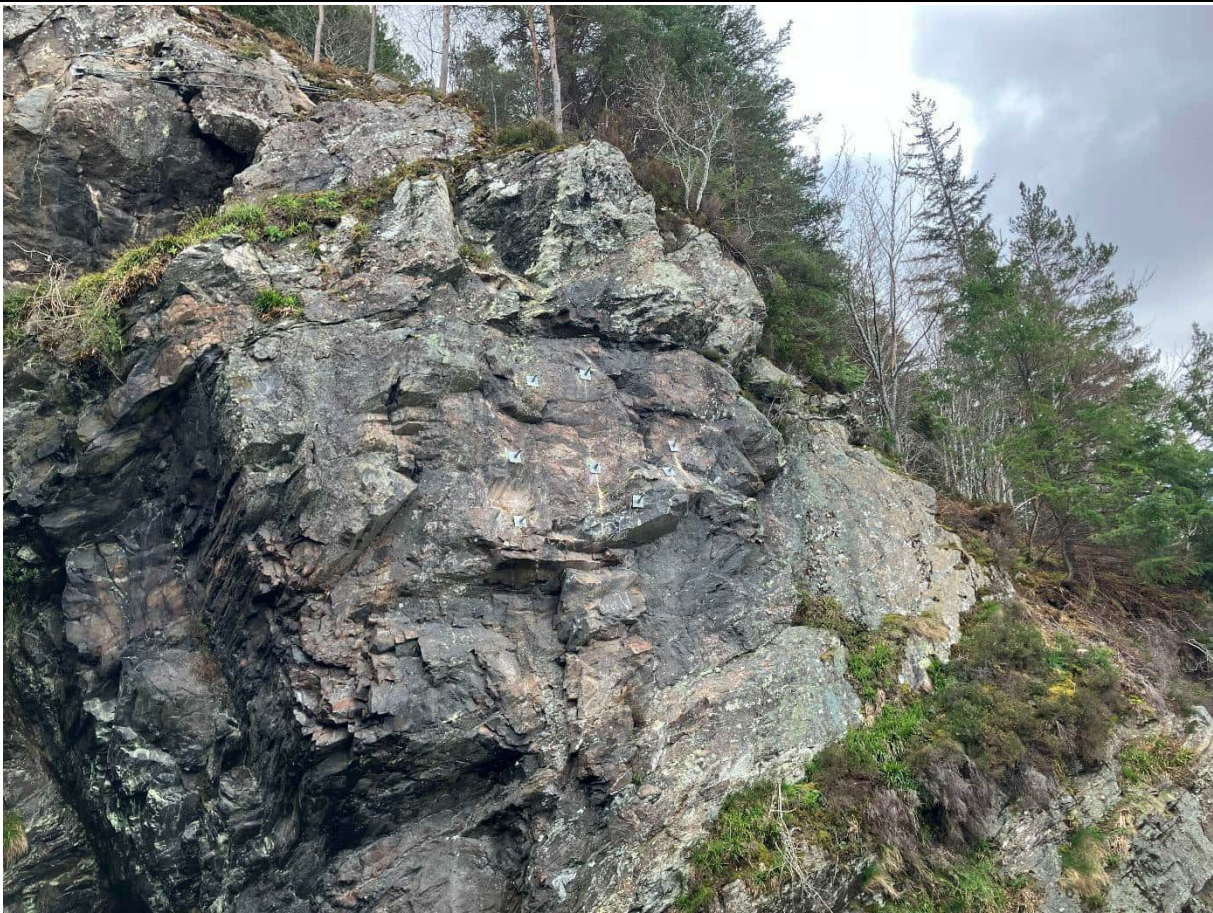
| M5-1 | Ch. 407:<br>2025: 8no. rock dowels installed c. 8 to 11 m above slope toe during Phase 13 rock works.<br>2026: No change noted during the 2026 inspection. | Year First Observed: | 2019 |
