# A890 Maman Hill

Annual Slope Inspection 2026

The Highland Council

Project number: 60685712  
AECOM Report Ref.: GLRP0012

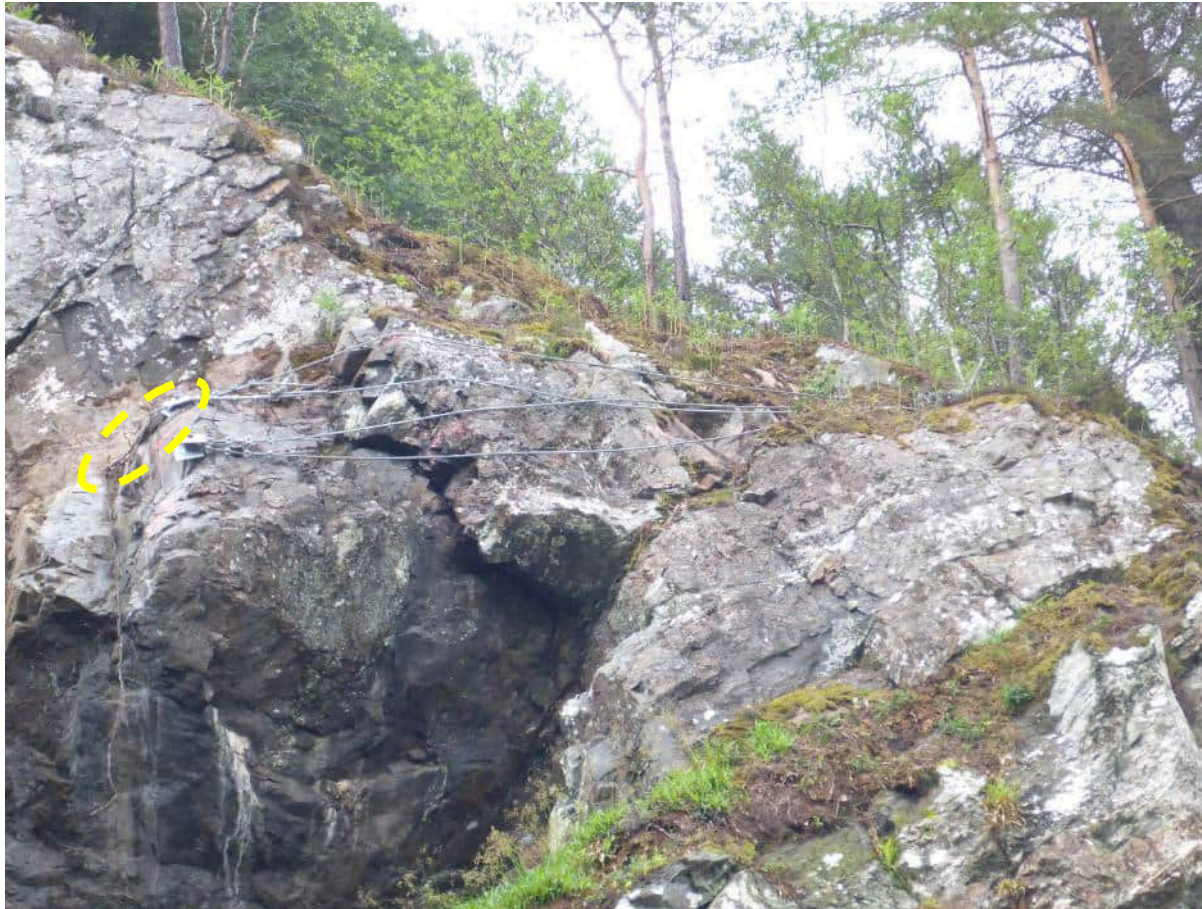
| M5-2 | <p>Ch. 398:</p> <p>2019: Detached block c. 2 x 2 x 0.7 m. Open on left hand side and with a dilated back release joint. Keyed in on right hand side but difficult to see how well. Upper part of right-hand side has 70 mm dilated joint. Trajectory of block fall hard to predict so doweling may be required to protect road.</p> <p>2025: Detached block secured in place using cable restraints anchored to adjacent rock mass (Phase 13 remedial works).</p> <p>2026: Deadwood resting on a ledge above the cable restraints. Source of deadwood is unknown. Presence of the verge and bund means it is unlikely that the deadwood would affect the road if it were to fall from the ledge.</p> | Year First Observed: | 2026 |

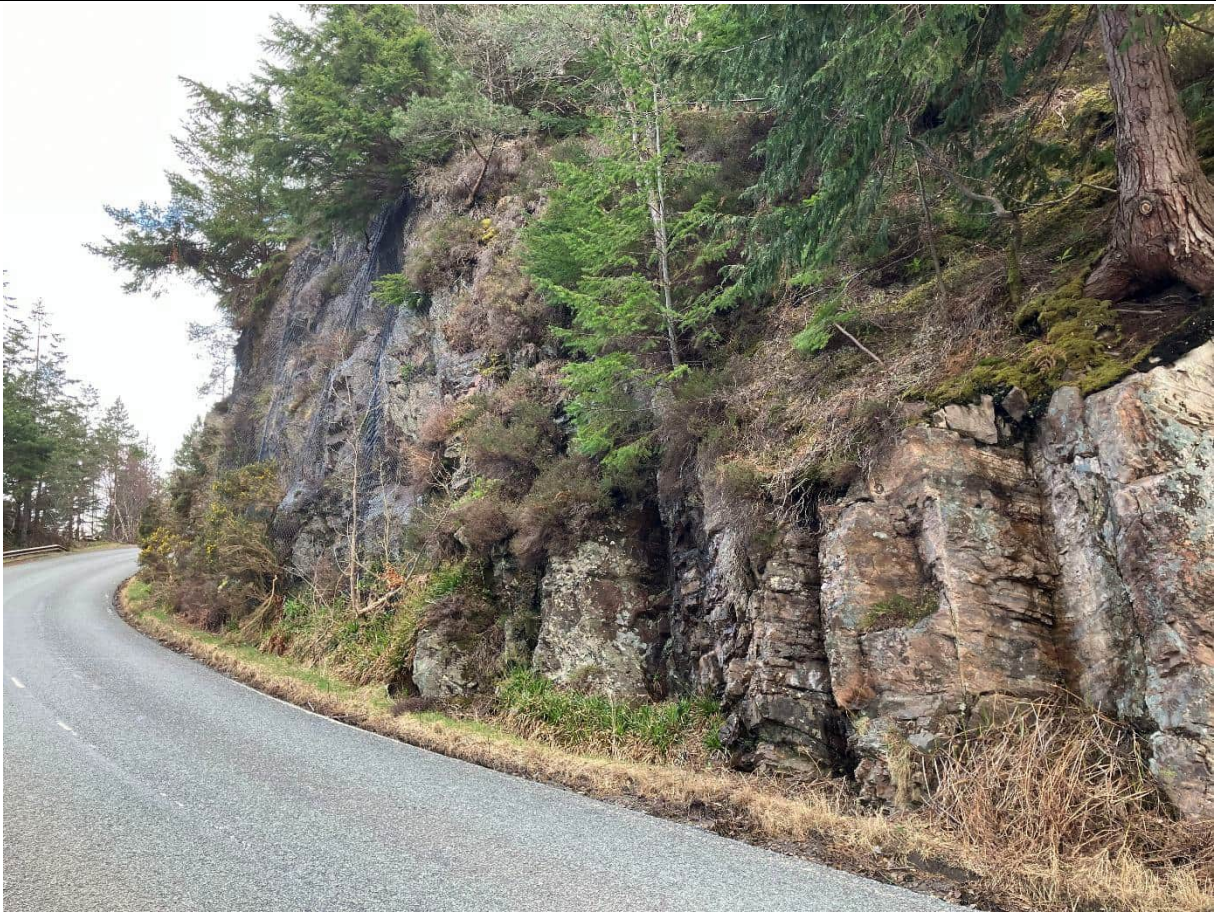
| M6-1 | Throughout M6:<br>2019: Ongoing ravelling and root jacking, particularly along crest.<br>2026: No change noted during the 2026 inspection. | Year First Observed: | 2019 |

| Recommended Remedial Works / Actions | | | | | | | |
|---|---|--|---|---|---|---|---|
| <ul style="list-style-type: none"> <li>Consider replacement of existing ineffective drape netting.</li> </ul> | | | N/A | | | <ul style="list-style-type: none"> <li>Re-inspection by end of April 2027</li> <li>Fell trees at crest of rock</li> <li>Scaling of loose rock</li> </ul> | |

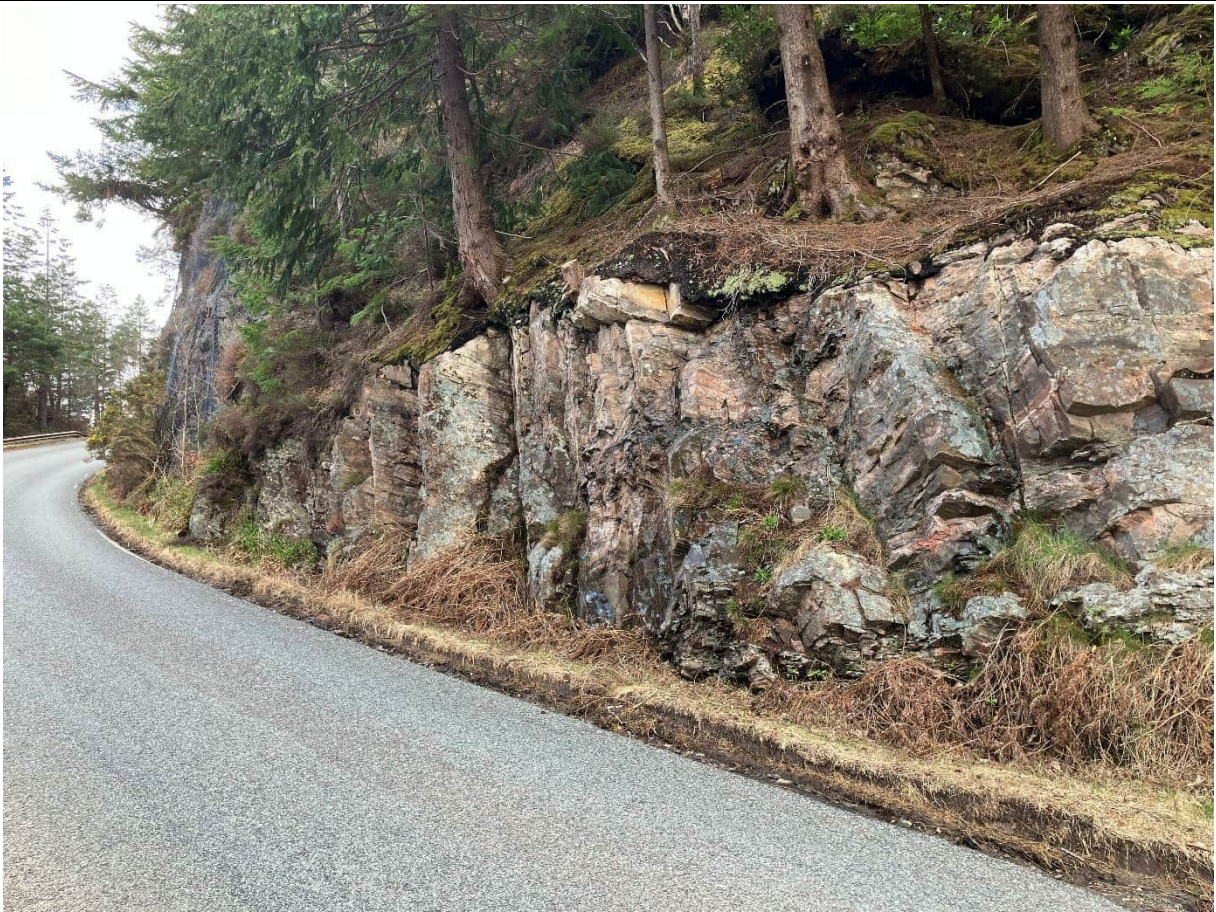
| M6-2 | Throughout M6:<br>2019: Ongoing ravelling and root jacking, particularly along crest.<br>2026: No change noted during the 2026 inspection. | Year First Observed: | 2019 |

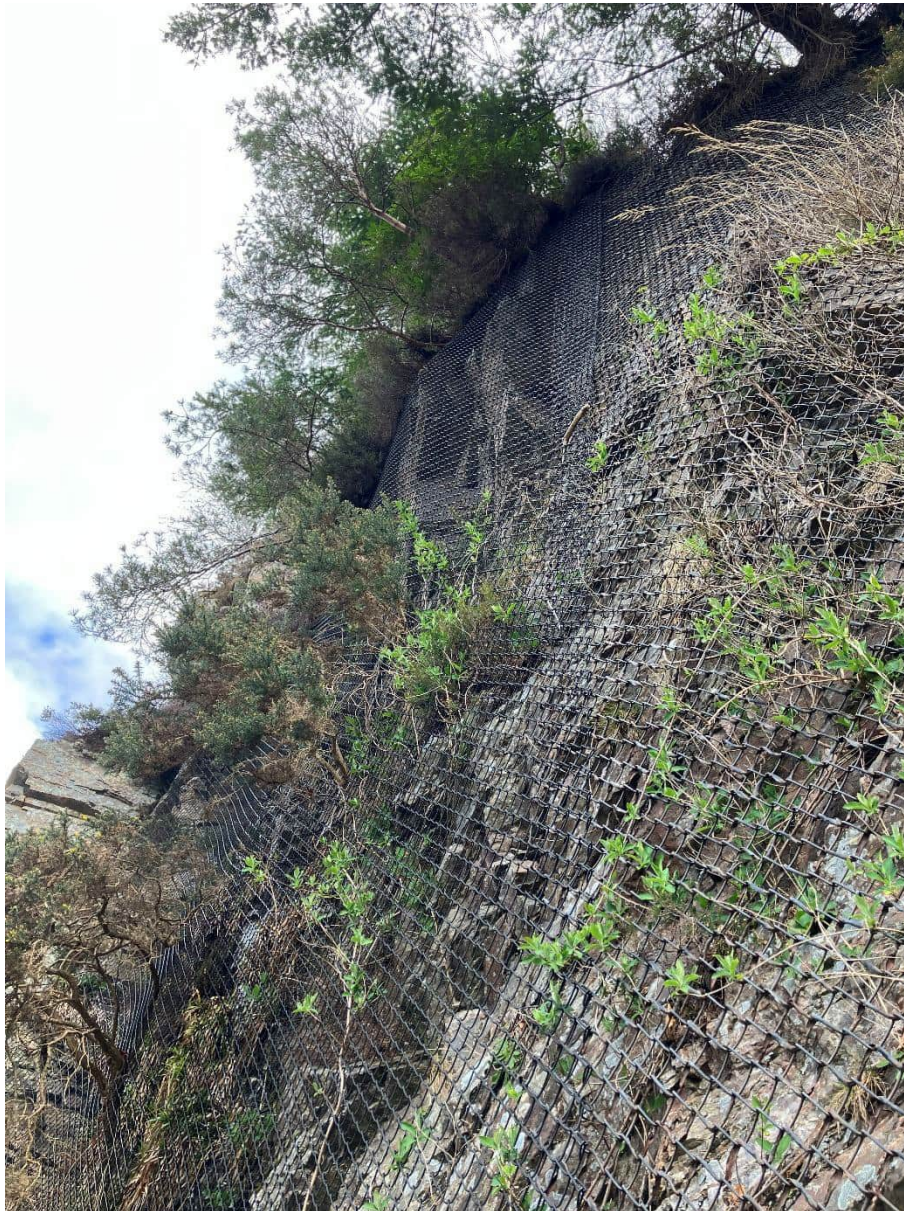
| M6-3 | <p>Ch. 420:</p> <p>2019: Potential toppling failure identified c. 6 m above road level. 0.5 to 1.0 m<sup>3</sup>. Dilated fractures.</p> <p>2026: No change noted during the 2026 inspection.</p> | Year First Observed: | 2019 |
