HIGHLAND REGIONAL COUNCIL

A890 STROME FERRY BYPASS

ALTERNATIVE ROUTES: INCEPTION REPORT

Report No. 4453/10605/001

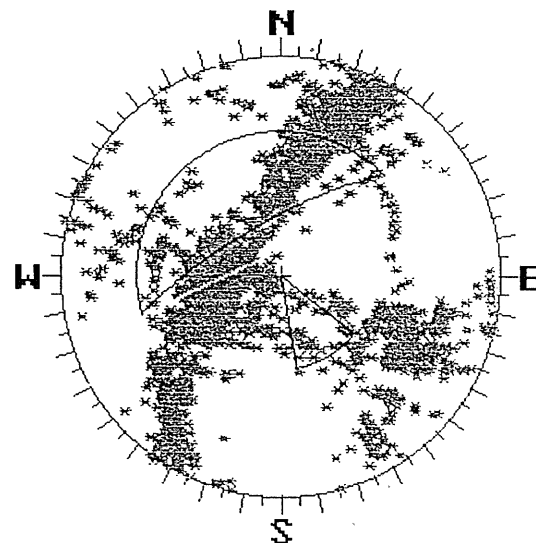
TRL - Rock Stability AssessmentA890 Gully East of Avalanche
Shelter All Data

Poles (76)

Intersections (2848)

The limited amount of discontinuity data recorded from this area and field observations indicate that rock excavations are likely to be prone to large scale wedge failure. A large wedge failure scar was observed in a natural rock face high on the hillside behind the shelter. The joints forming the wedge were both minor fault planes.
