Uig Harbour Redevelopment

Sediment Disposal Site Seabed Survey Report

The Highland Council

Project number: 60536743
UHRD-ACM-XX-DG-RP-EG-00001

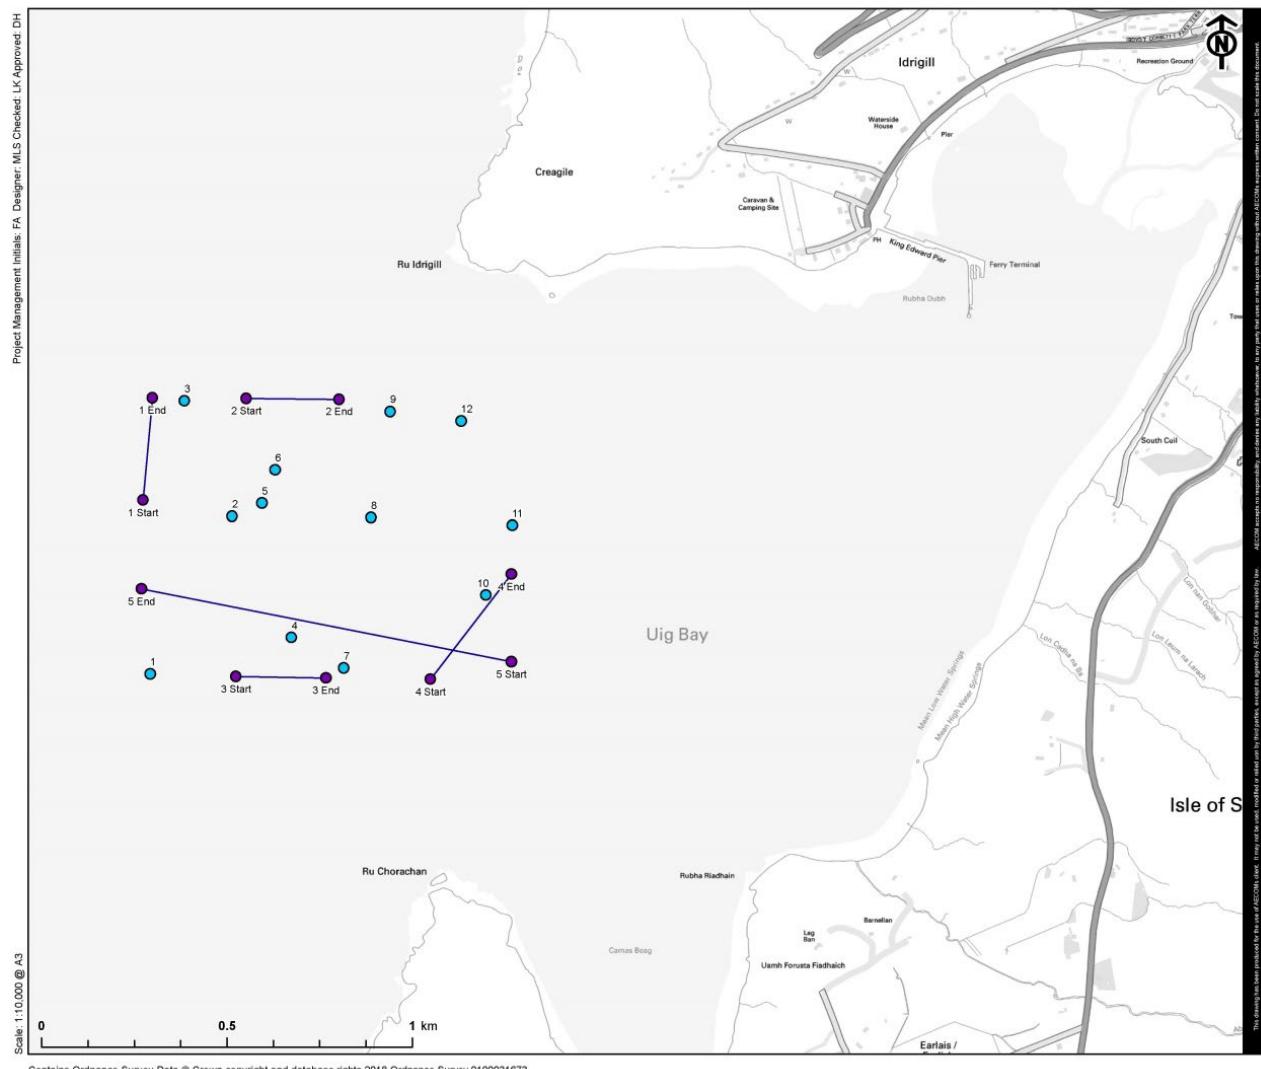
Figure 1.1 Uig Bay proposed sediment disposal site search area survey stations (DDV and grab sampling)

infaunal benthic habitats, and in particular to establish the presence of any priority marine features in the proposed site. The sampling locations are shown in **Figure 1.1** below.

The grab survey involved the collection of 12 surface sediment samples within the disposal site search area (**Figure 1-1**). The location of these samples along with coordinates is provided in **Appendix A**. The sample locations were based on a 3 x 4 grid (250 m x 250 m boxes), with a randomly selected sampling location within each box².

The only other chemical variable determined that exceeded limits was the PAH Dibenzo(a,h)anthracene, which was observed at concentrations greater than AL1 at stations 1, 3 and 12 (see **Figure 1-1** for station locations).

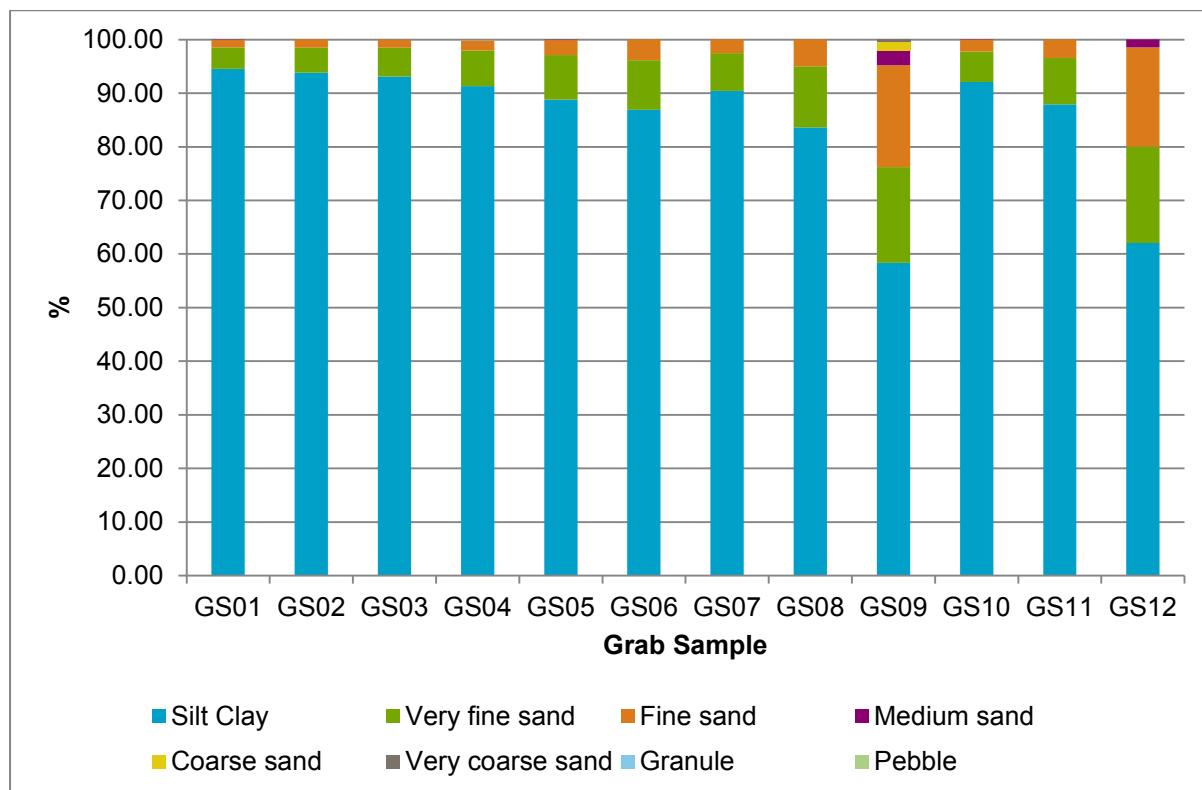
Figure 3-1: Particle size distribution of sediments at 12 grab stations in the proposed sediment disposal site search area in Uig Bay

Particle size analysis (PSA) described according to Wentworth sediment class⁵ are presented below in **Figure 3-1**. With the exception of GS9 (41.7% sand) and GS12 (38.0% sand), all samples indicated more than 80% of the sediment was silt/clay. None of the samples included gravel fractions (>2 mm). The difference in the physical nature of the sediments in GS9 and GS12 were also evident in a lower percentage of total organic carbon (1.0 and 1.6% respectively, compared to around 2.0% across all other stations), as would be predicted from the greater average particle size.

The dominant sediment type across the dredge disposal search area was found to be silt/clay. A few stations in the north of the area had more sandy sediment but mud was still the dominant particle size. The sediment chemistry analysis indicates that the sediments in the search area had elevated concentrations, compared to the Cefas Action Levels for dredge disposal, of chromium and nickel. At all stations concentrations were above AL 1 and above AL2 at 2 stations. Concentrations of these metals were similarly high at the dredge location. For example, at the proposed disposal site search area chromium was between 100 and 490 mg/kg and nickel between 140 and 260 mg/kg. At the dredge site the concentration of chromium were between 117 and 528 mg/kg and nickel was between 53 and 189 mg/kg. This indicates that sediment contaminants are widespread in Uig Bay.

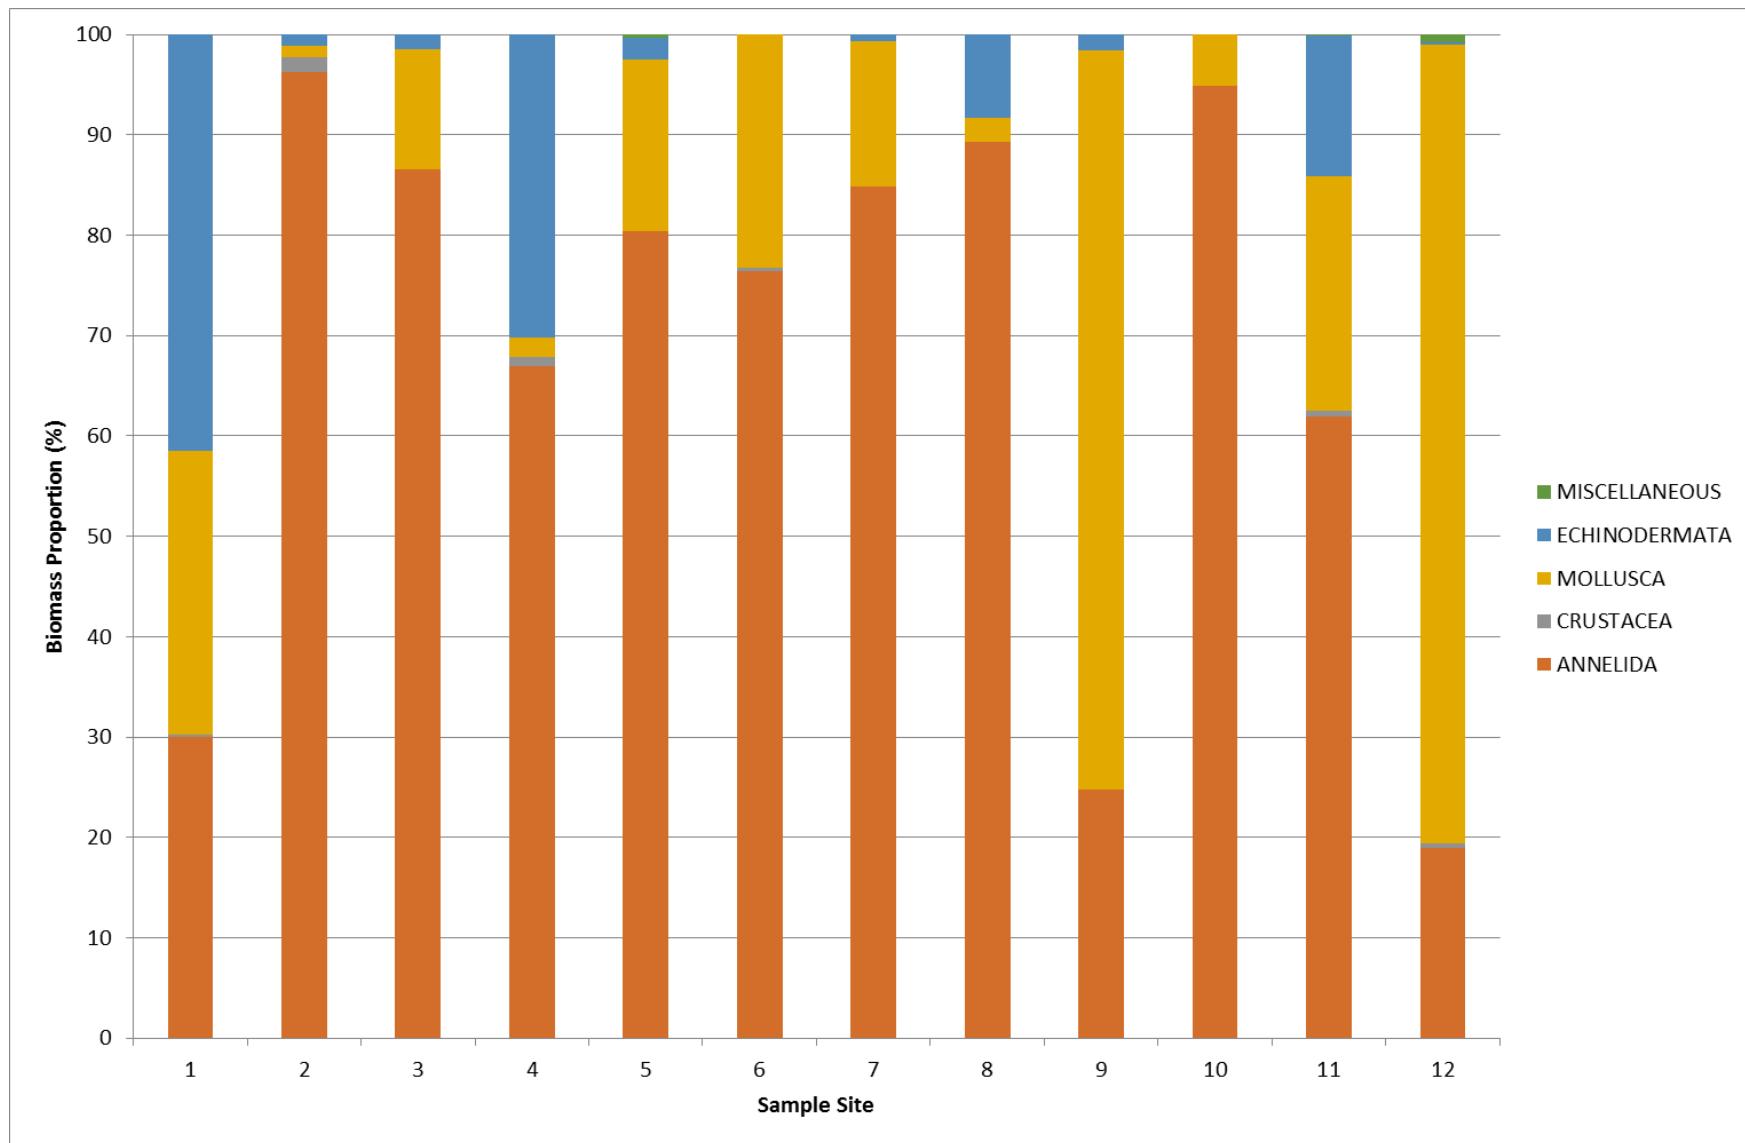
Figure 3-2: Benthic biomass by major faunal group at each of the 12 grab stations in the proposed disposal site search area

With the exception of stations 1, 9 and 12, polychaetes accounted for the highest proportion of faunal biomass (**Figure 3-2**). For station 1, biomass was dominated by echinoderms (a relatively low number of large bodied individuals) and at stations 9 and 12 molluscs accounted for most of the biomass in the samples.

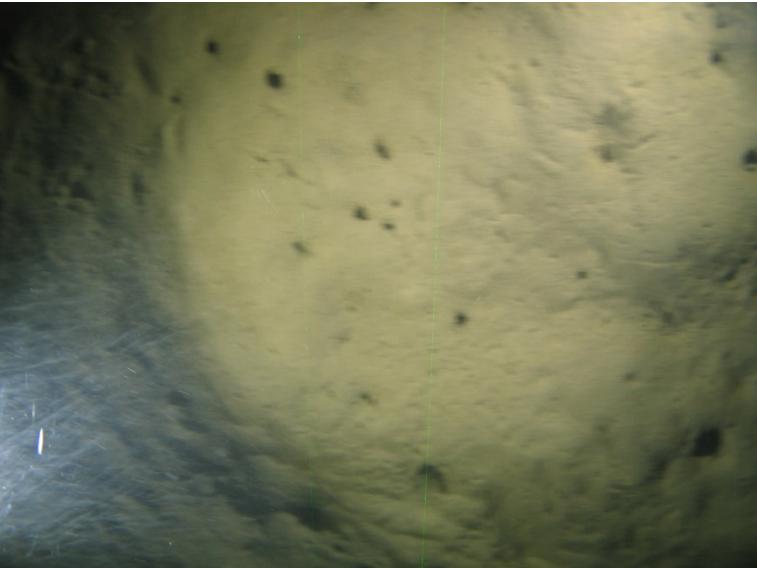
Figure 3-3: Transect 1_IMG_1143

Transect ID: TR01	Survey Date: 20 th February 2018
SOL Easting: 654928.709	SOL Northing: 6384517.830
EOL Easting: 655255.16	EOL Northing: 6384308.324
No. of still images taken: 31	Video File name: Dive 07 18-02-20 23.25.59
Still Image IDs: IMG_1143 – IMG_1173	Dominant UK Marine Habitat Classification/EUNIS: A5.361 - Seapens and burrowing megafauna in circalittoral fine mud
Representative still image of transect features:

Video Limitations: The ROV appears to move rapidly across the seabed, benthic features are rarely in frame for a sufficient time period in order to clearly identify. The ROV appears to collide with the seabed, suspending soft sediments and obscuring view. Biological Summary: Unidentified benthic fish were recorded and burrows present within the seabed sediment were clearly visible intermittently throughout the video transect.

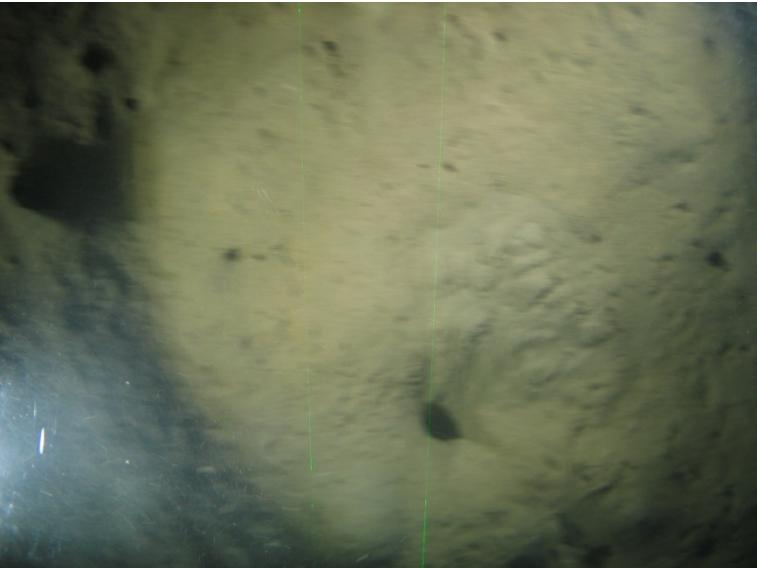
Figure 3-4: Transect 2_IMG_1108

Transect ID: TR02	Survey Date: 20 th February 2018
SOL Easting: 654925.982	SOL Northing: 6384775.709
EOL Easting: 655501.345	EOL Northing: 6384320.875
No. of still images taken: 49	Video File name: Dive 06 18-02-20 22.40.25
Still Image IDs: IMG_1092 to IMG_1140;	Dominant UK Marine Habitat Classification/EUNIS: A5.361 - Seapens and burrowing megafauna in circalittoral fine mud
Representative still image of transect features:

Video Limitations: As with other transects, the ROV moves rapidly across the seabed, regularly colliding and suspending soft sediments, which obscures the view. Biological Summary: Burrows were frequently observed within the soft sediment, with the occasional <i>Nephrops norvegicus</i> spotted within the burrows (Figure 3-5). The only other signs of biological presence were the sporadic possible seepen sightings and large patches of bryozoan (<i>Flustra</i> spp.), indicating some occasional hard substrata (Figure 3-6).

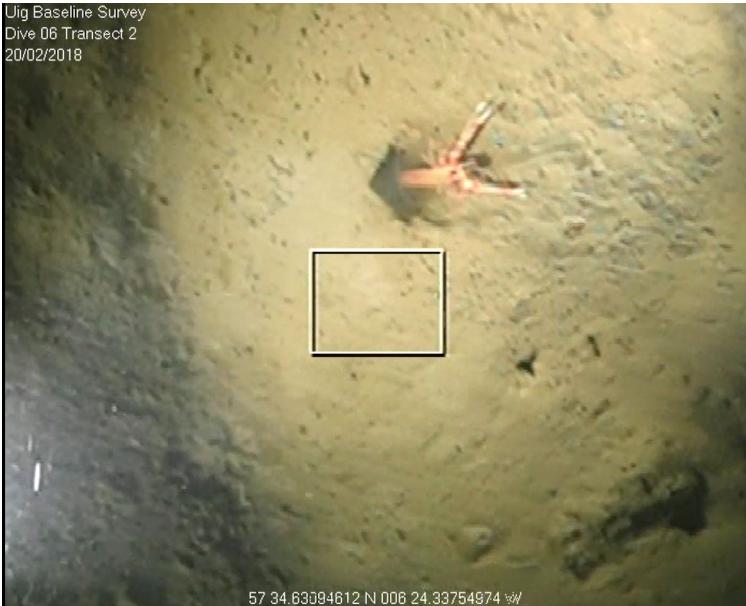
<p>57 34.63094812 N 006 24.33754874 W</p>	
<p>Figure 3-5: <i>Nephrops norvegicus</i> (langoustine)</p> <p>Uig Baseline Survey Dive 06 Transect 2 20/02/2018</p>

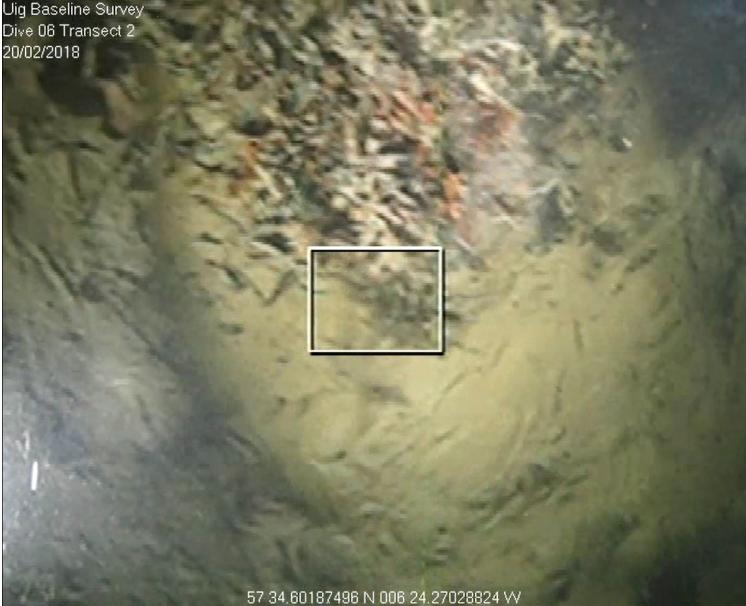
<p>57 34.60187496 N 006 24.27028824 W</p>	<p>Figure 3-6: Bryozoan, <i>Flustra</i> spp.</p>

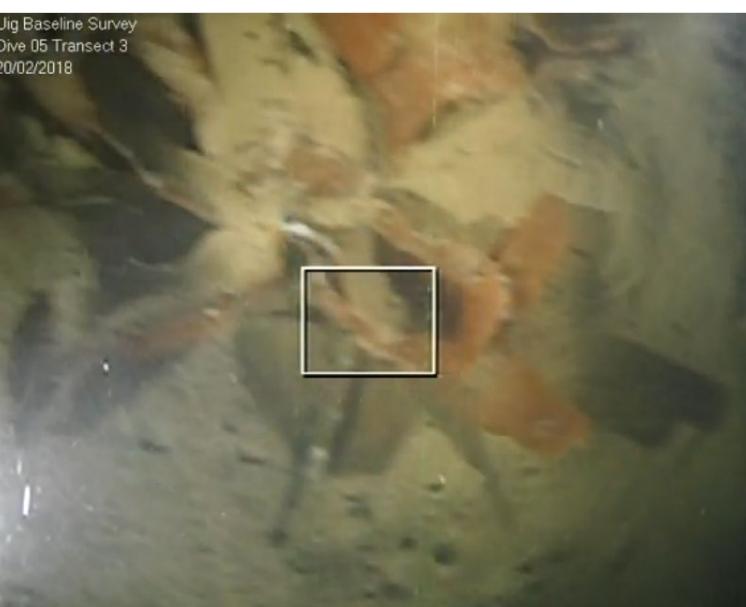
Figure 3-7: Kelp debris

Transect ID: TR03	Survey Date: 20 th February 2018
SOL Easting: 654921.688	SOL Northing: 6385036.982
EOL Easting: 655769.619	EOL Northing: 6384350.670
No. of still images taken: 81	Video File name: Dive 05 18-02-20 21.39.20 and Dive 05 18-02-20 22.09.22
Still Image IDs: IMG_1009 to IMG_1089	Dominant UK Marine Habitat Classification/EUNIS: A5.361 - Seapens and burrowing megafauna in circalittoral fine mud
Representative still image of transect features:

<p>Uig Baseline Survey Dive 05 Transect 3 20/02/2018</p>	Video Limitations: The rapidly moving ROV collides intermittently with the seabed, suspending sediment. Biological Summary: When the light is sufficient, it is possible to see burrows within the soft sediment on the seabed. Some debris was also recorded along the transect including detached fronds and holdfasts of kelp (Figure 3-7 and Figure 3-8). Some benthic fishes were also seen within the footage, however they flee too quickly to be able to identify. A starfish was recorded in the first video (Dive 05 18-02-20 21.39.20, Figure 3-9). The second video (Dive 05 18-02-20 22.09.22) despite the same difficulties, confirmed the presence of <i>Nephrops norvegicus</i> along the transect route.

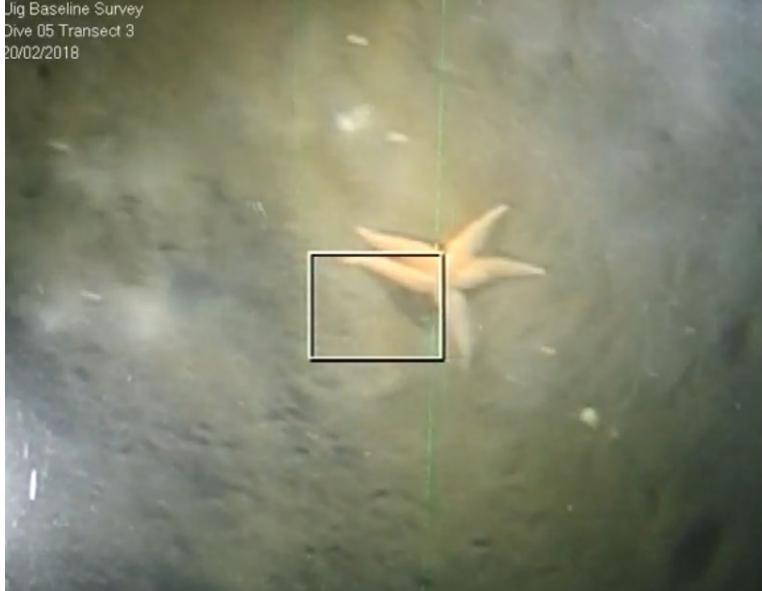
<p>Uig Baseline Survey Dive 05 Transect 3 20/02/2018</p>	
Figure 3-8: Kelp debris

Transect ID: TR03	Survey Date: 20 th February 2018

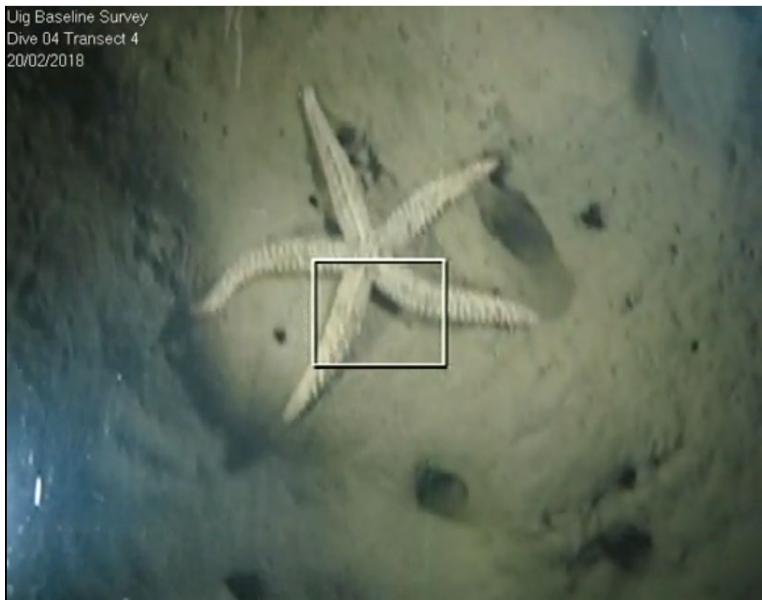
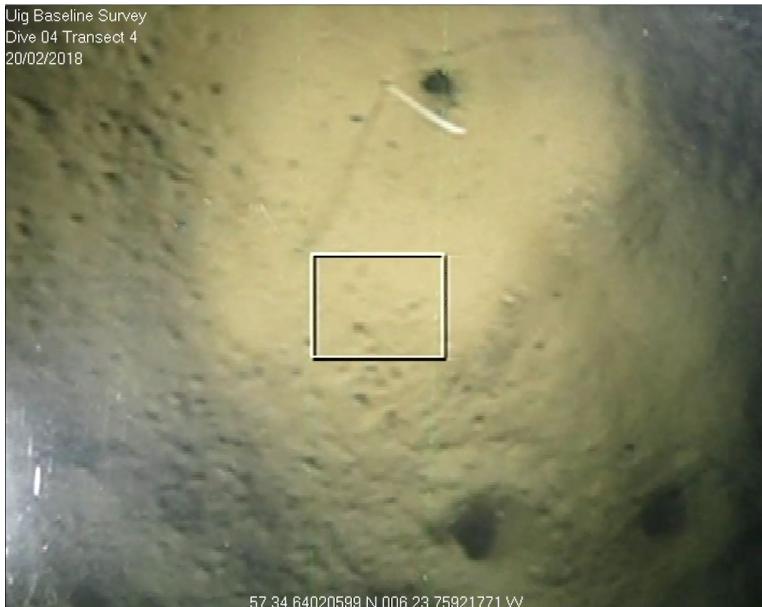
Uig Baseline Survey Dive 04 Transect 4 20/02/2018	Video Limitations: The first video, recorded from dive 04 18-02-20 20.41.04 was the least limited by the speed of the ROV and suspended sediment issues. The second video (Dive 04 18-02-20 21.11.05) was dark and had little clear content of the seabed. Biological Summary: The first video (Dive 04 18-02-20 20.41.04) documented the most biological evidence for the transect, capturing footage of starfish (Figure 3-11), seapens (Figure 3-12) and <i>Nephrops norvegicus</i> (Figure 3-13). Dive 04 18-02-20 21.11.05 recorded seapens amongst the burrow holes within the fine soft sediments.

Uig Baseline Survey Dive 04 Transect 4 20/02/2018 57 34.64020599 N 006 23 75921771 W	
Figure 3-11: Starfish - <i>Marthasterias glacialis</i>	
Figure 3-12: Seapen - <i>Virgularia mirabilis</i> and <i>Nephrops</i> burrow holes

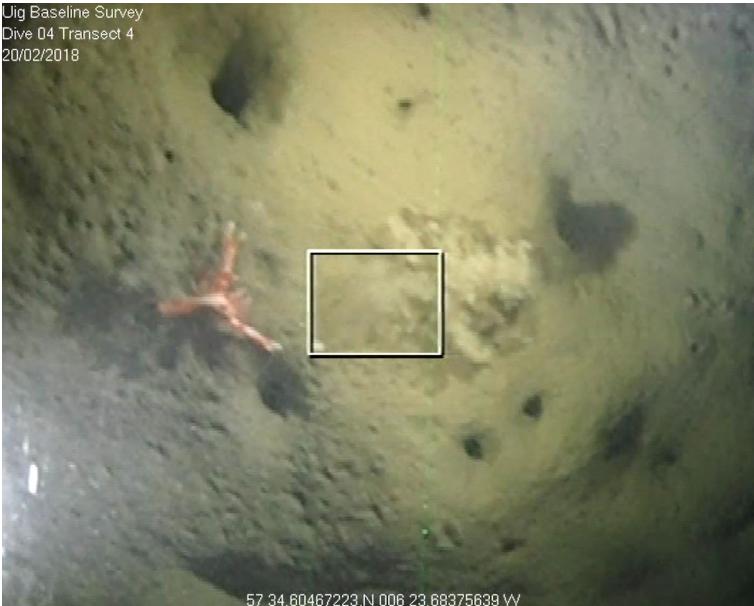
<p>57 34.60467223.N 006 23.68375639.W</p> <p>Figure 3-13: <i>Nephrops norvegicus</i> and burrow holes</p>

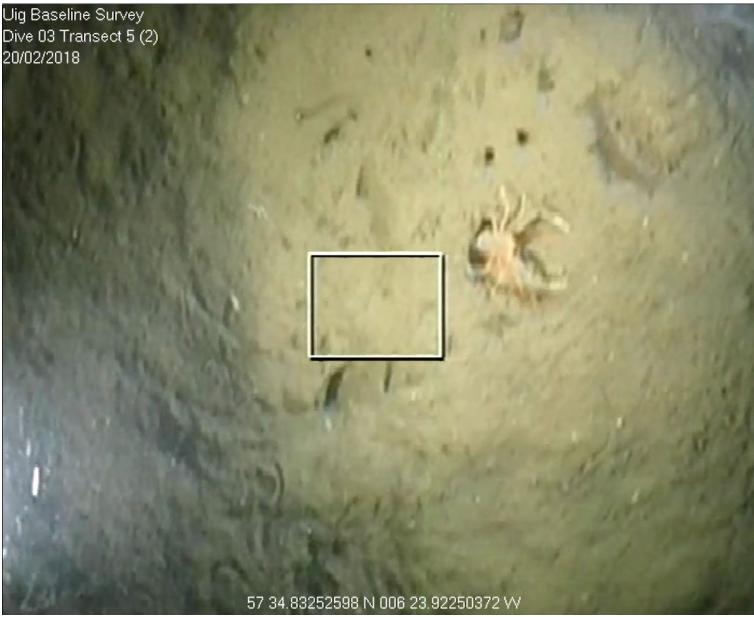
Transect ID: TR05(3)	Survey Date: 20 th February 2018
SOL Easting: 655419.076	SOL Northing: 6385080.308
EOL Easting: 655961.526	EOL Northing: 6384656.818
No. of still images taken: 32	Video File name: Dive 03 18-02-20 19.50.25
Still Image IDs: IMG_0909 to IMG_0940	Dominant UK Marine Habitat Classification/EUNIS: A5.361 - Seapens and burrowing megafauna in circalittoral fine mud
Representative still image of transect features:	<p>Video Limitations: As with all other transects, the ROV collided with the seabed frequently, suspending soft sediments.</p> <p>Biological Summary: Some rocks and boulders were seen to be present on the soft sediment seabed. Burrows within the soft sediment were visible when the footage was clear. Species present included <i>Nephrops</i>, benthic fishes (which dispersed rapidly with the presence of the ROV) and squat lobster (Figure 3-14).</p>

<p>57 34.83252598 N 006 23.92250372 W</p> <p>Figure 3-14: Squat lobster - <i>Galathea Squamifera</i></p>
