**ANNUAL ROCK SLOPE INSPECTION -
JUNE 2009**

The Highland Council
A890 Stromeferry Bypass

454.1-090519-R1.2-Annual09
August 2009

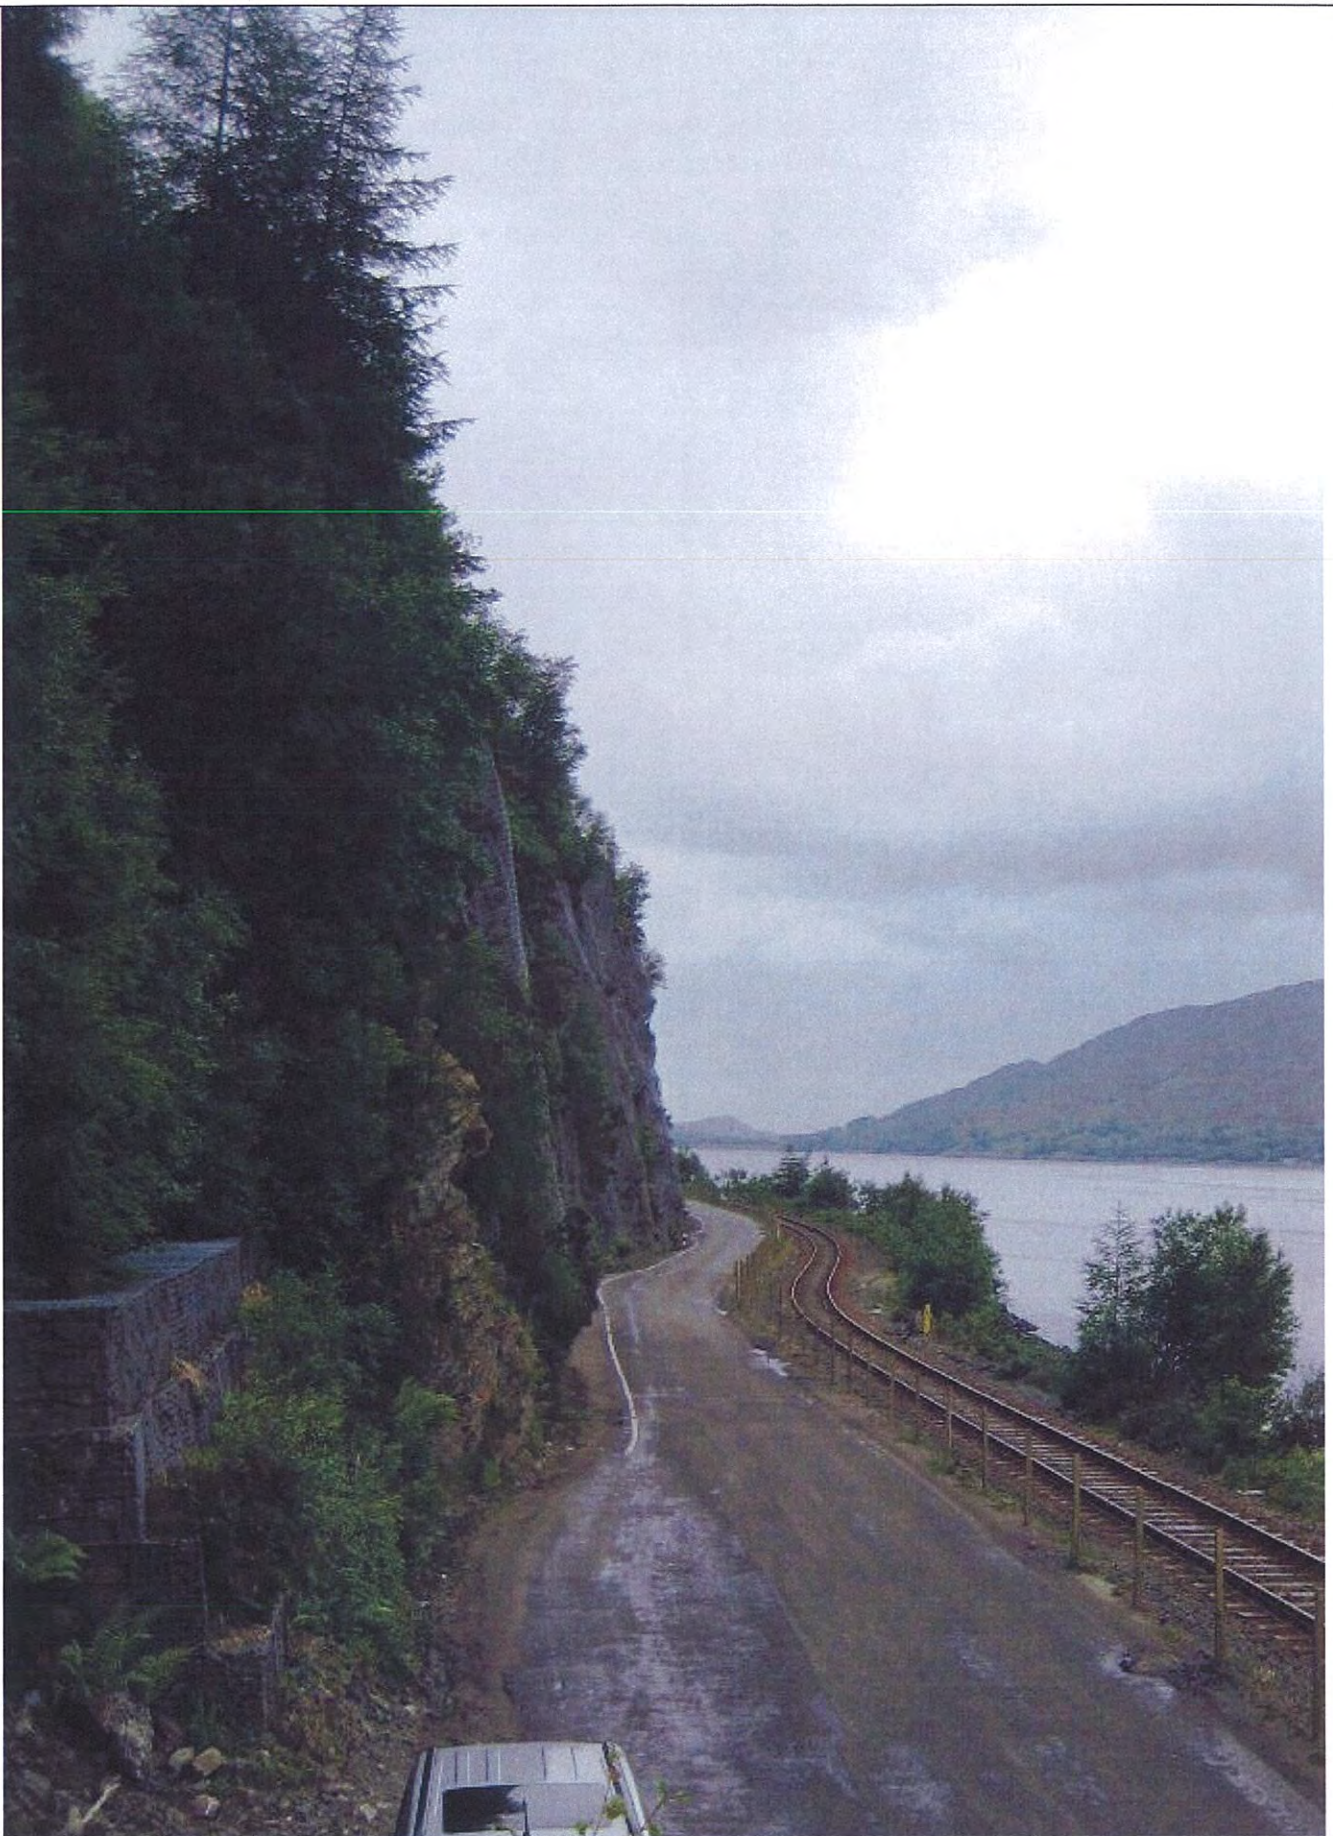
<p>coffey geotechnics SPECIALISTS MANAGING THE EARTH</p>	client:	The Highland Council		
approved	N/A		project:	A890 Strome ferry Bypass Annual Inspection June 2009		
date	10th & 11 th June 2009		title:	Slope AA18		
scale	NTS		project no:	454.1	photograph no:	21
original size	A4

Inspection Findings: # 2911 Hole between sections of netting from the toe to 2m up. Not significant, old netting underneath and low down on face. # 2916 Culvert clear. # 2927 Recently installed dowels require packing washers, ends of bar cutting down and nuts tightening. # 2935 Unstable blocks at crest, will be controlled by the netting. # 2949 Gully catch fence (incorporated part of netting system) has caught a boulder (Appendix B - photograph 21) # 2950 Small nose of rock has dilated along several joints 5m above road level – Keep under observation. # 2955 Blocks failed from approx. 8m height. No fresh falls - Keep area under observation.				
Current Hazard Index Value: 11				
Remedial / Maintenance Works Required: Clear out ditch (Annual Maintenance).

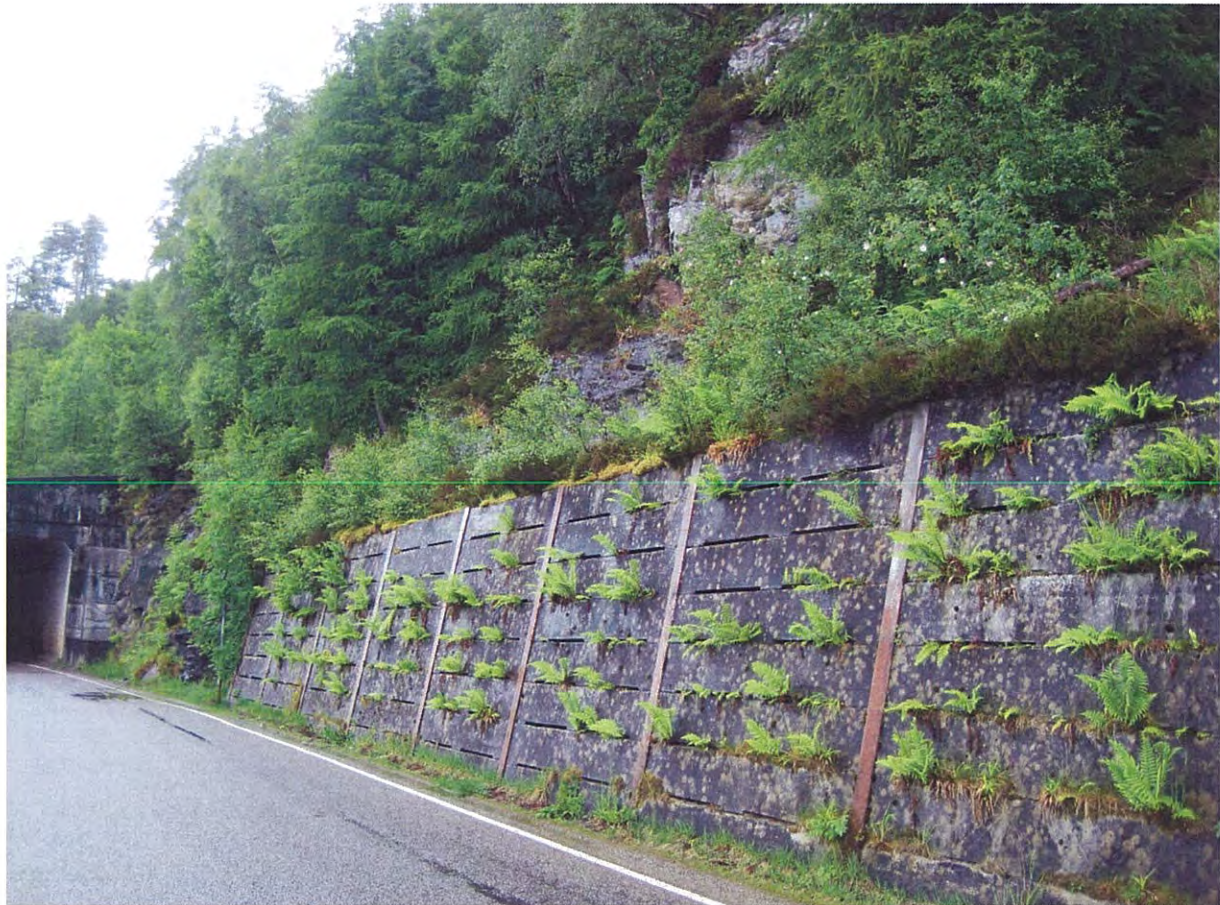
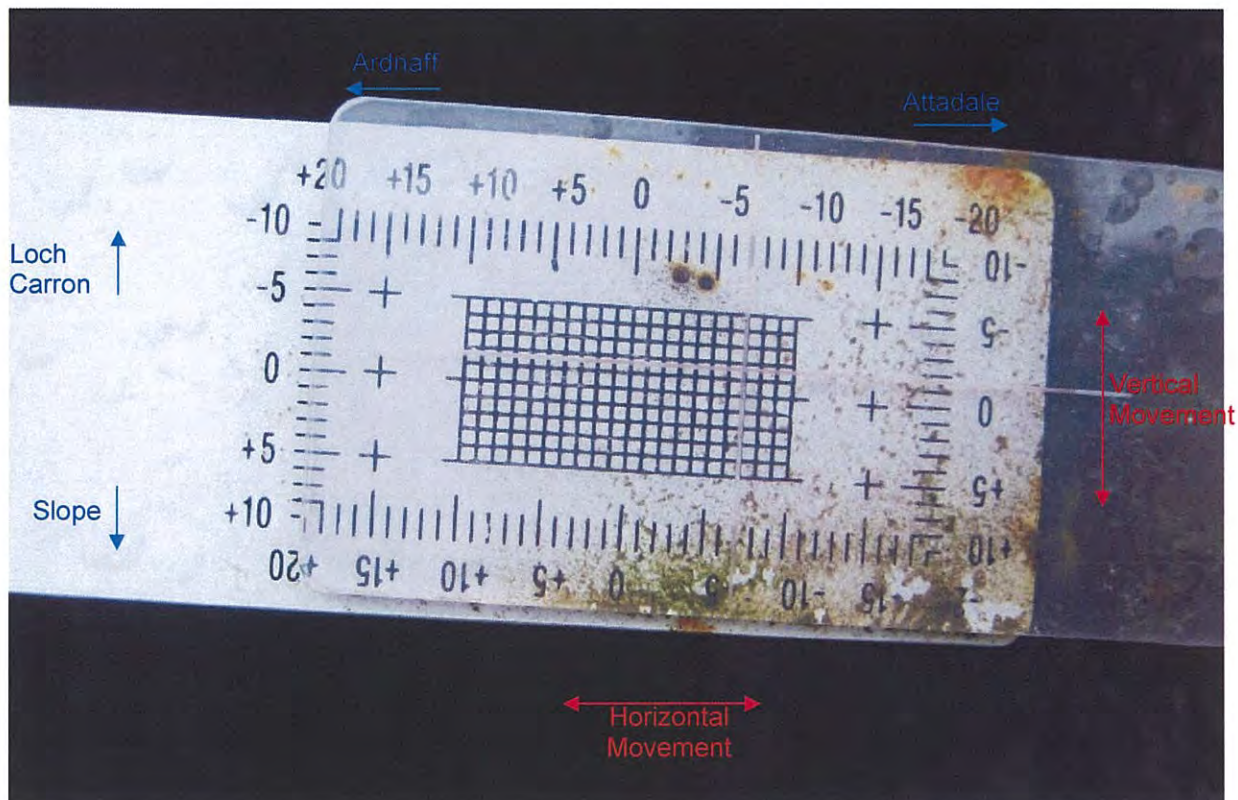
coffey geotechnics SPECIALISTS MANAGING THE EARTH	client:	The Highland Council	
approved	N/A		project:	A890 Stromeferry Bypass Annual Inspection June 2009	
date	10th June 2009		title:	Slope AA19	
scale	NTS		project no: 454.1	photograph no: 22	
original size	A4

# 3017 Column beginning to dilate 1m above road level – keep under observation.			
# 3032 Minor ravelling around the dowels installed in 2008.			
Current Hazard Index Value: <1			
Remedial / Maintenance Works Required:

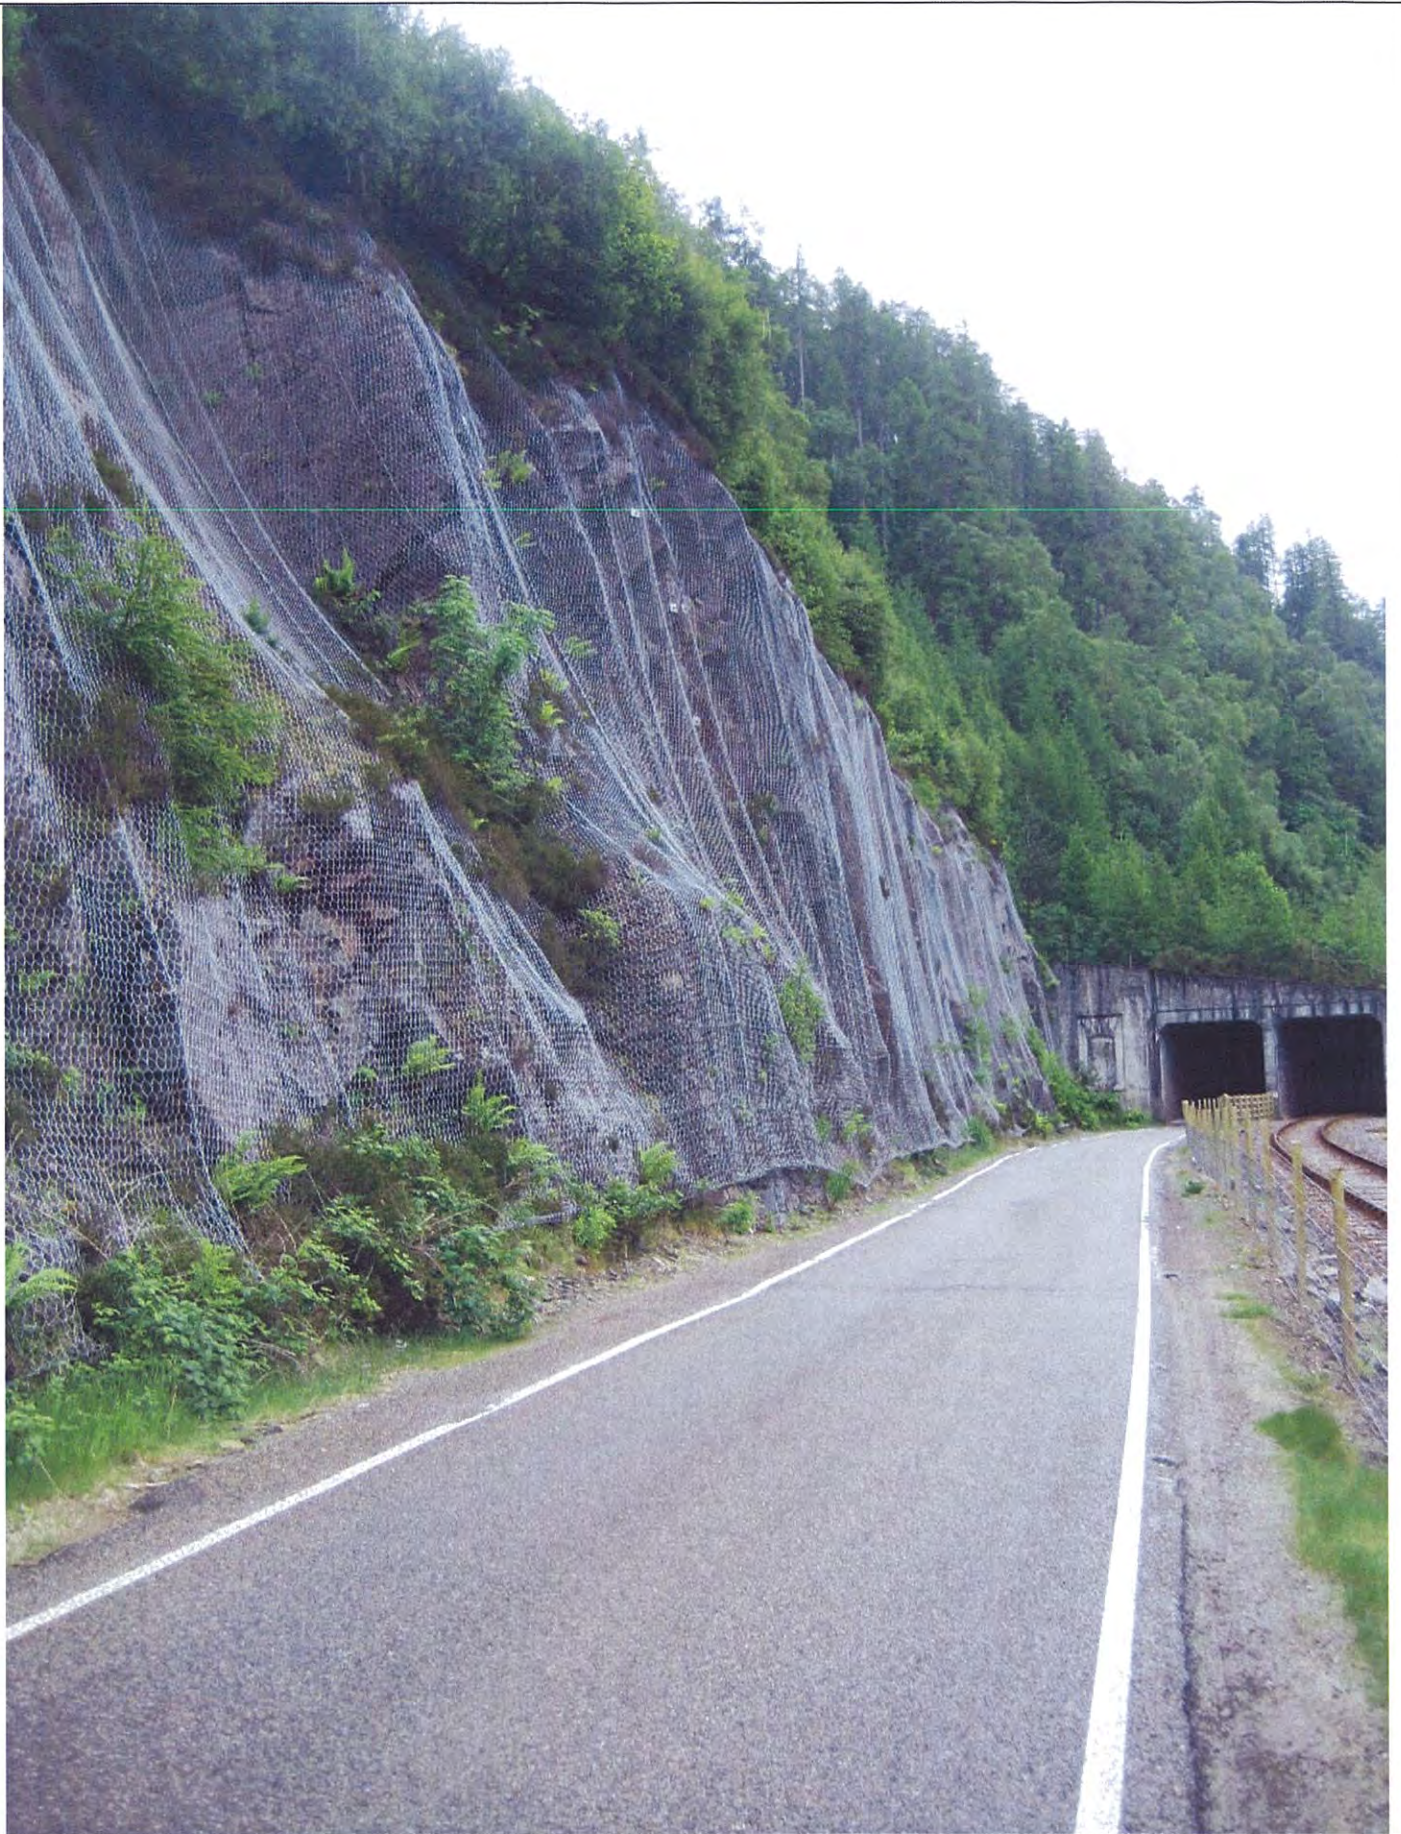
<p>coffey geotechnics SPECIALISTS MANAGING THE EARTH</p>	client:	The Highland Council		
approved	N/A		project:	A890 Stroneferry Bypass Annual Inspection June 2009		
date	10th June 2009		title:	Slope AA20 & Tell Tale		
scale	NTS		project no:	454.1	photograph no:	23 & 24
original size	A4

<p>Inspection Findings: Vegetation is continuing to establish on the coir matt, in the area of the September 2001 Emergency remedial works. Top tell tale: hor = +6.5mm, vert = +2.5mm (Appendix B - photograph 24). Bottom tell tale has been removed during installation of flange. No significant change to "I" beam wall since June 2006 Annual Inspection. Trees immediately above "I" beam wall have been cut down. # 3079 Culvert clear. # 3130 Culvert partially blocked by material behind wall next to avalanche shelter.</p>			
<p>Current Hazard Index Value: 5</p>

The "I" beams require maintenance to treat existing corrosion and to protect the steel work from further corrosion (Annual Maintenance) **Outstanding**.

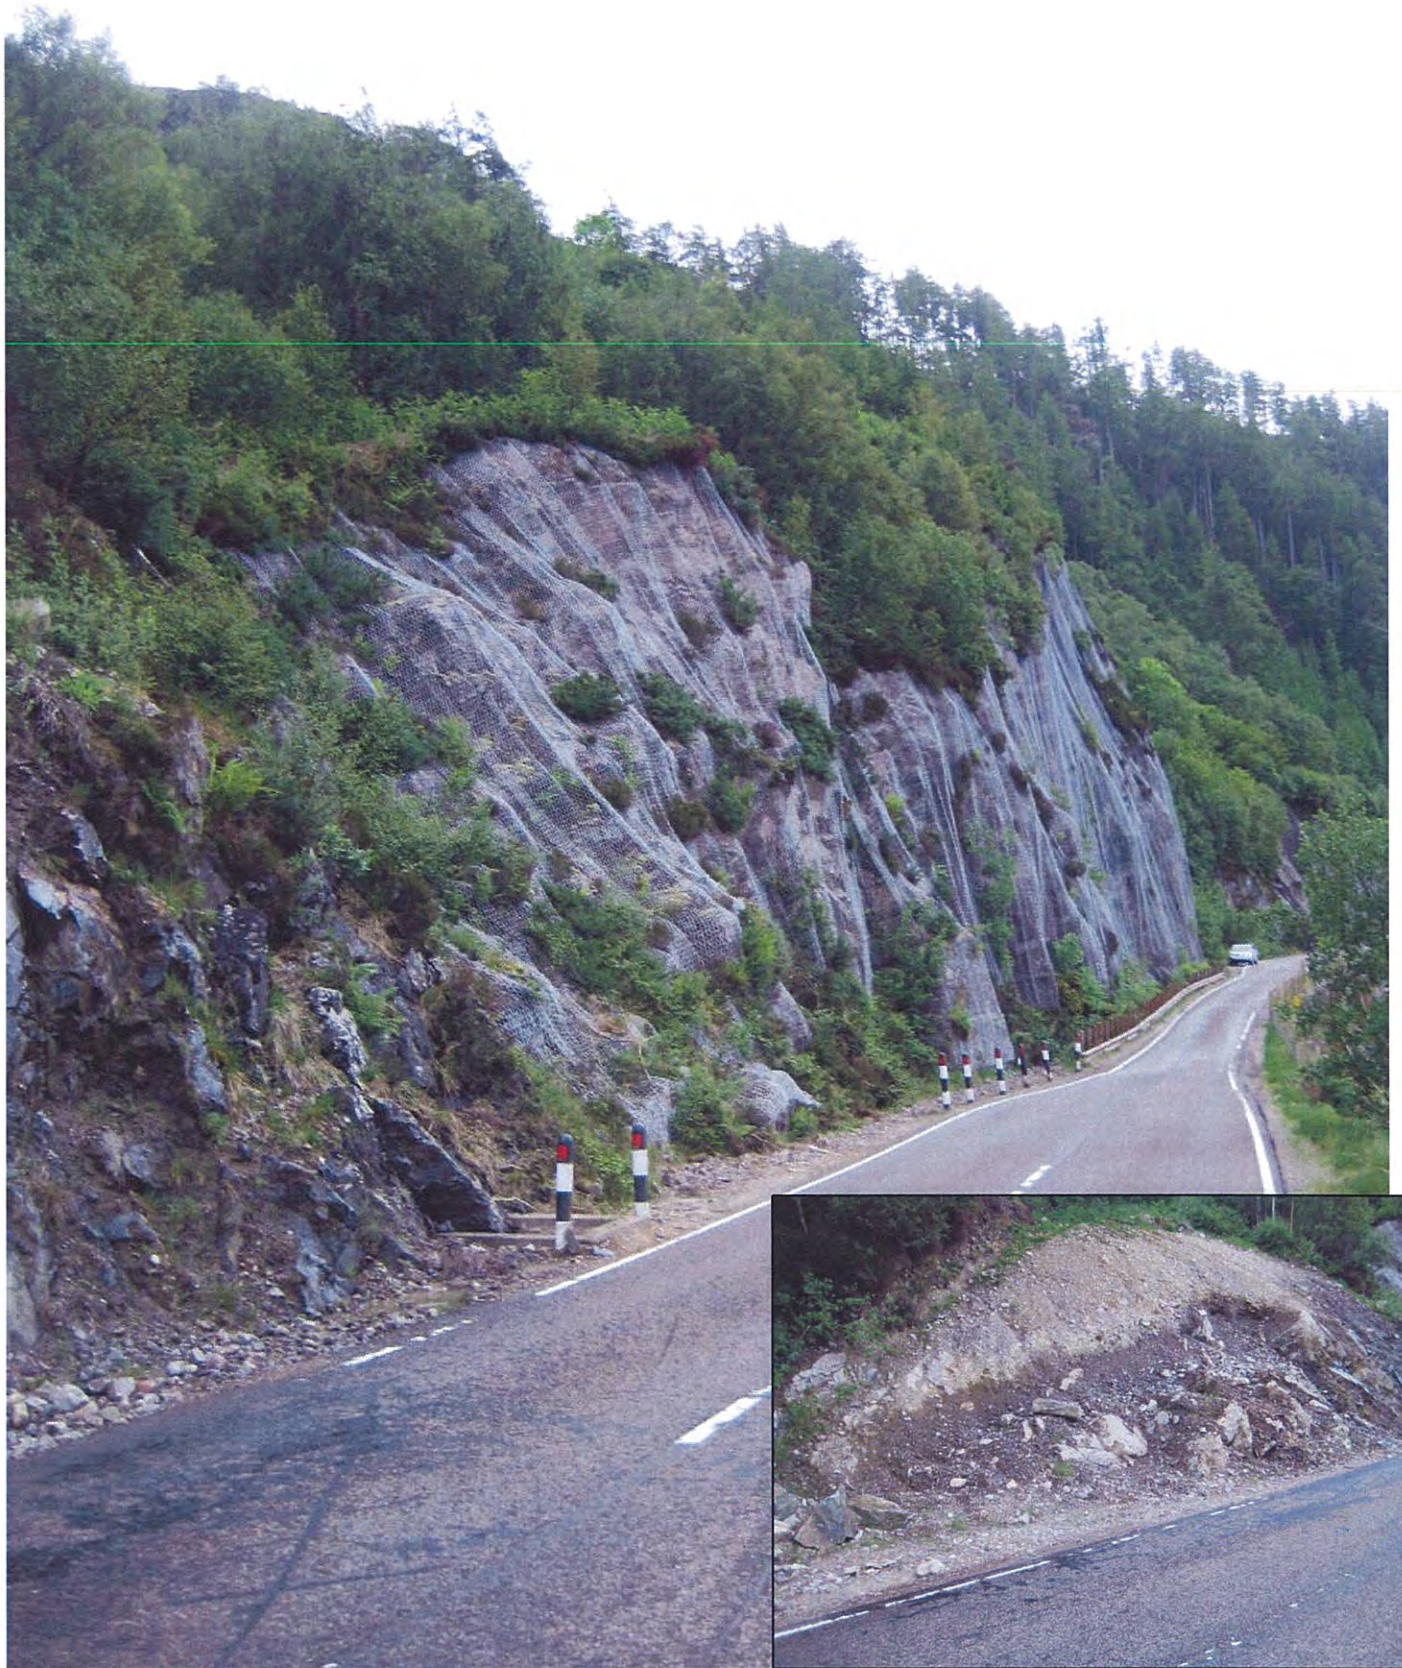
client:	The Highland Council		
approved	N/A		project:	A890 Stromeferry Bypass Annual Inspection June 2009		
date	10th June 2009		title:	Slope AA21		
scale	NTS		project no:	454.1	photograph no:	25
original size	A4

3216 6m high column of material – no change since last year– keep under observation for deterioration.

3272-3277 Masonry toe buttress in satisfactory condition, plants are still growing on the buttress.

3282 Block (300 X 300 X 150mm) 3m up on slope likely to fail but will be retained by the verge / ditch / netting.

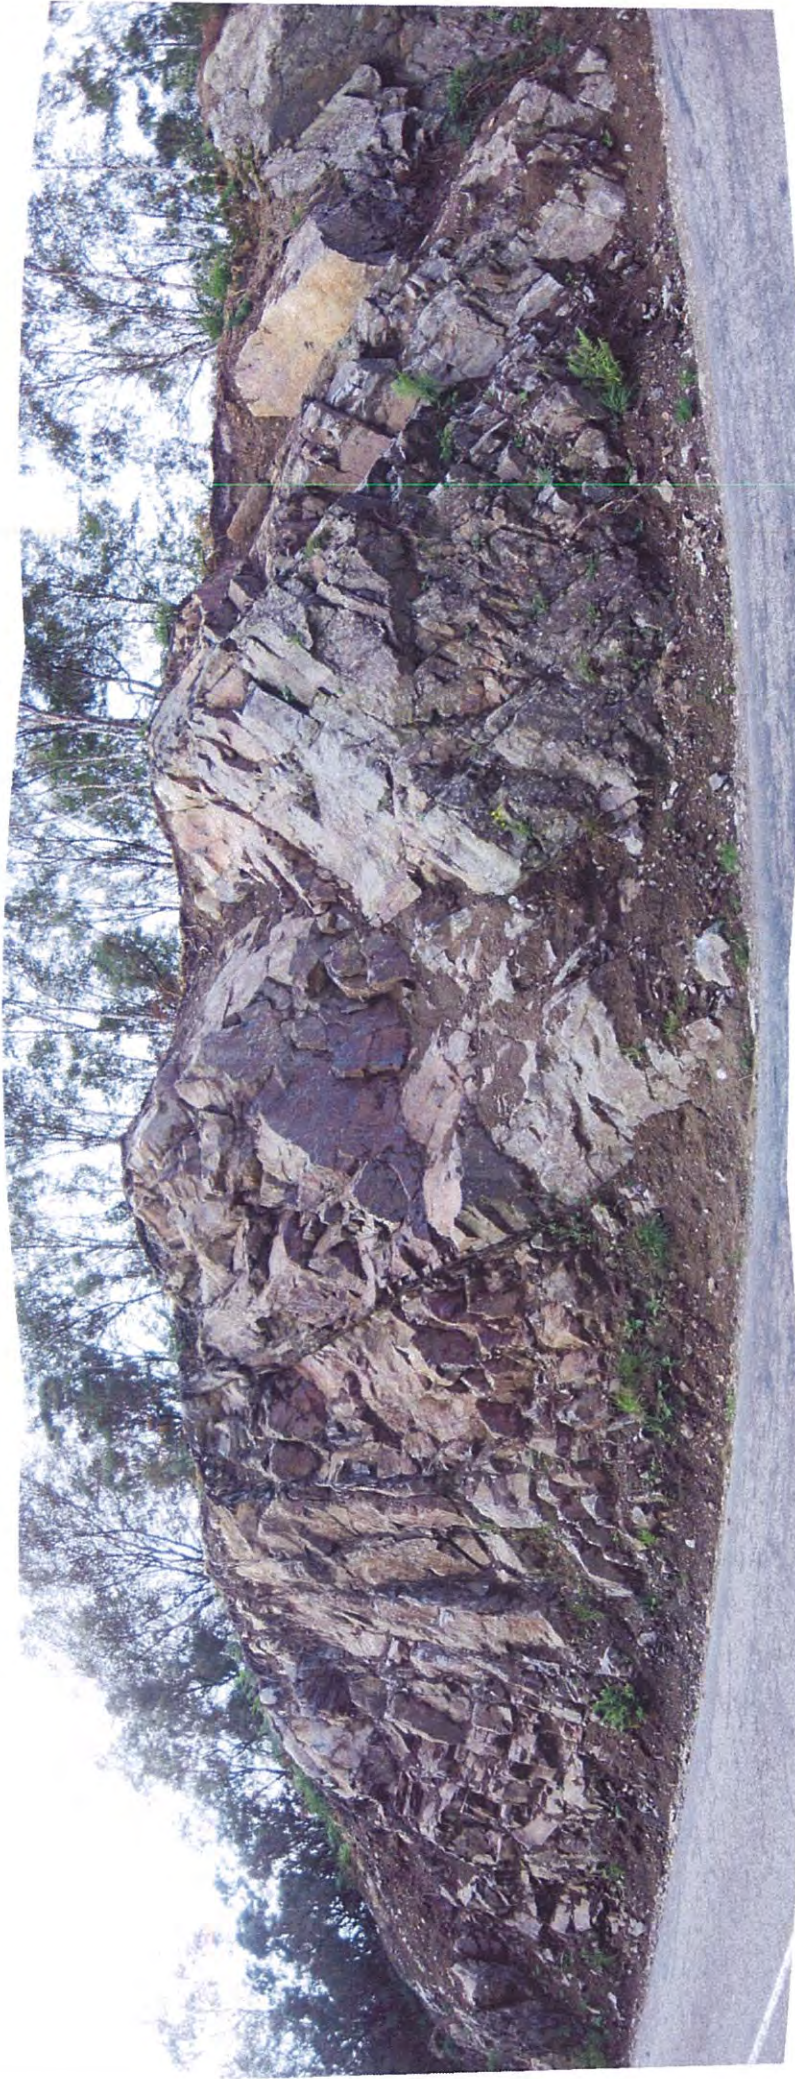
client:	The Highland Council	
project:	A890 Stromeferry Bypass Annual Inspection June 2009	
title:	Slopes 22a & 22b	
project no: 454.1	photograph no: 26

3352 to 3356 Area on face undercut rock 25m up. Material is likely to fail at this location, but should be controlled by the reinforced rockfall netting. Keep under observation.

3362 Block (2m high x 1.5m wide x 1m deep) will continue to break up and fail with time. The debris should be contained and controlled by the rockfall netting. No signs of further deterioration.

3372 Nose of material approx. 10m up. Failures may occur at this location, but should be controlled by the reinforced rockfall netting. Keep under observation.

3382 Failure scar from 20t rockfall in December 2001. More material is likely to fail at this location, but should be controlled by the reinforced rockfall netting. Keep under observation.

3356, 3372 and 3382 – Potential failures keep under particular observation during periodic and annual inspections.

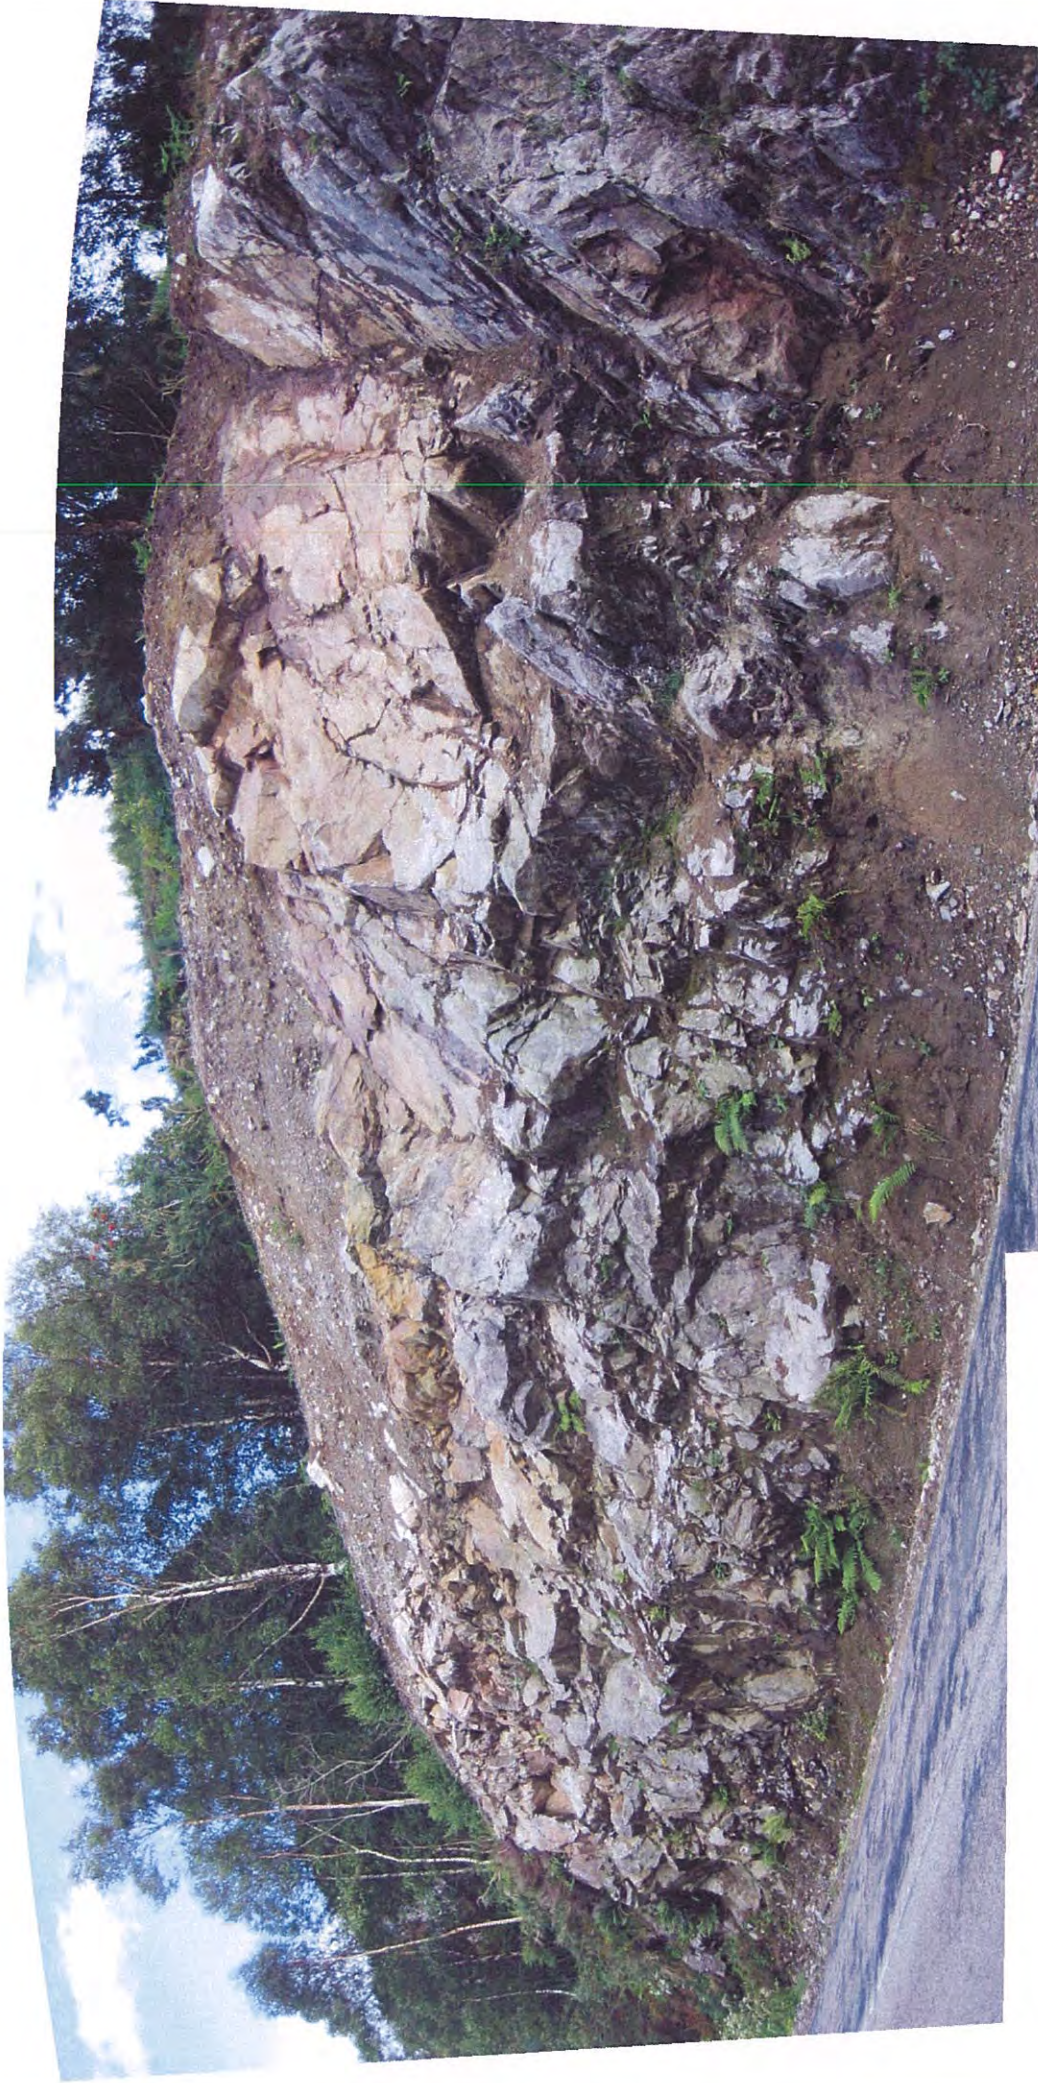
SPECIALISTS MANAGING THE EARTH		client:	The Highland Council
approved	N/A			project:	A890 Stromeferry Bypass Annual Inspection June 2009
date	12th August 2009			title:	Slope 23N
scale	NTS			project no:	454.1
original size	A4				photograph no: 27

AA23N	Chainage: 3553 - 3607	Length: 54m	Height: 2 - 5m
	Grid Ref	Start: NG 91551 37982	Finish: NG 91577 38011
Description of Slope: Excavated rock slope forming Northbound side of a "box cutting". Grass and shrub covered hillside above slope. Verge (2m wide).			
Failure Characteristics: General ravelling.			
Existing Remedial Works: 1995: Verge built up and ditch deepened. February 2008: # 3579 Blast damaged area heavy scaled by Skye Rope Access. October 2008: #3565 – 3585 Slope reprofiled and dense gorse removed by RJ McLeod and Geo-Rope. July 2009: # 3570 – 3580 Slope scaled by CAN.			
Inspection Findings: Slope has been partially reprofiled and the dense gorse removed. Ditch has been infilled during recent reprofiling and is no longer acting as an effective rock trap.			
Current Hazard Index Value: 1			
Remedial / Maintenance Works Required: # 3570 – 3580 Light scale. Clear out and reform ditch (Annual Maintenance).

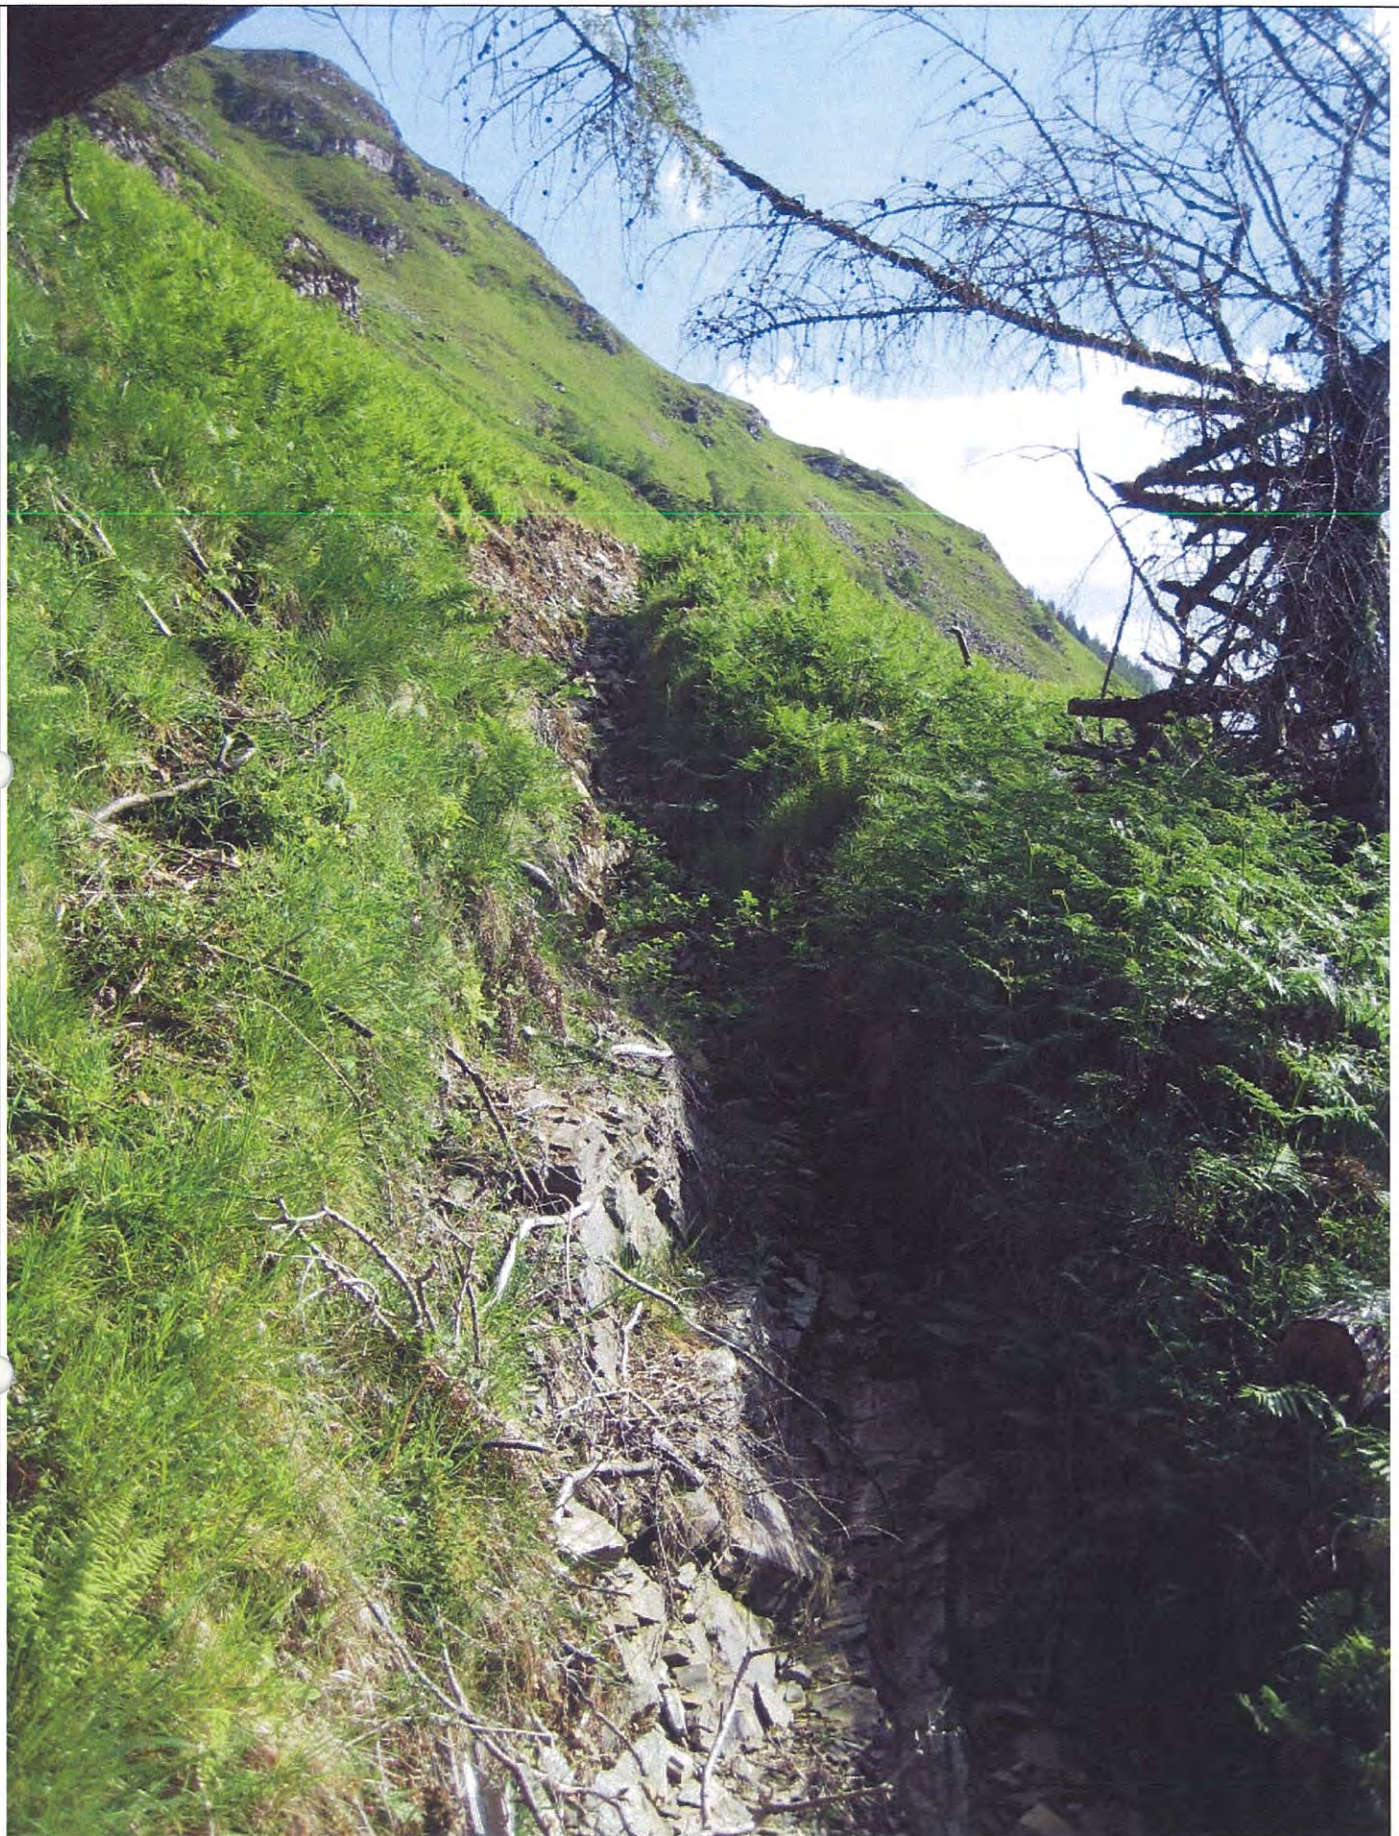
coffey geotechnics SPECIALISTS MANAGING THE EARTH	client:	The Highland Council		
approved	N/A		project:	A890 Strome ferry Bypass Annual Inspection June 2009		
date	11th June 2009		title:	Stream Gully Between Slopes AA19 & AA20		
scale	NTS		project no:	454.1	photograph no:	31
original size	A4

Stream Gully Between Slope AA19 and AA20	Chainage: 3072
	Grid Ref: NG 91270 37696
Description: Large deeply incised gully with a small stream. The stream flows in wet weather conditions and flows in spate during / following heavy rainfall / snowmelt. The stream carries significant quantities of rock debris during spate events.	
Existing Remedial Works: # 3072 to 3104 "I" Beam and segmental Concrete retaining wall at base of gully installed pre-1972. In November 1994 a significant rockfall damaged the retaining wall.	
Inspection Findings: Following a landslide with block fall, approximately 40m above road, observed in October 2000, remedial works were completed in September 2001. Vegetation is well established on the coir mat. The concrete beam and associated works show no observable signs of deterioration. Up the gully from the coir matting an area was noticed in 2005 to have been eroded away (3m high by 2m wide) – this has not deteriorated further.
