**ANNUAL ROCK SLOPE INSPECTION -
JUNE ~~2009~~ 2010**

The Highland Council
A890 Stroneferry Bypass

454.1_R_001A_RMD-Annual10
July 2010

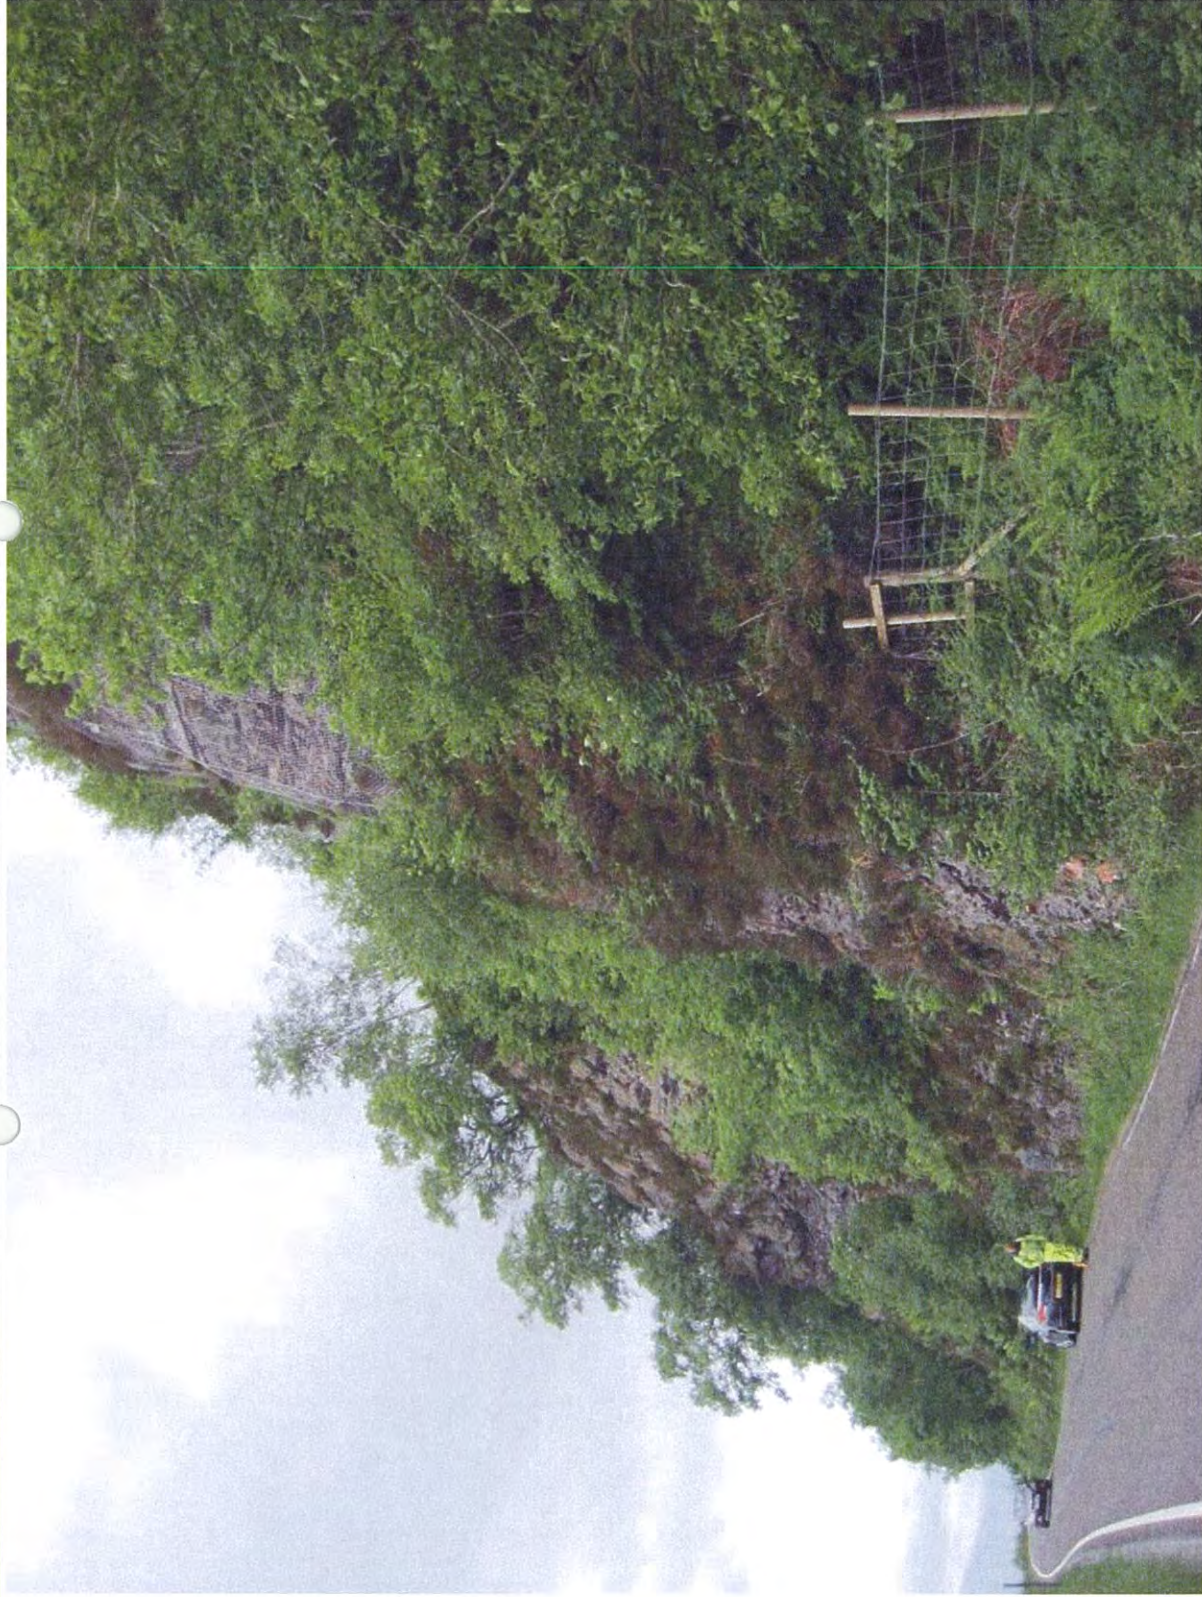
SPECIALISTS MANAGING THE EARTH	client:	The Highland Council
date	09/06/2010		project:	A890 Stromeferry Bypass Annual Rock Slope Inspection - June 2010
scale	NTS		title:	Slope AA4
original size	A4		project no:	454.1
				figure no: FIGURE 4

AA4	Chainage: 0705 -0800	Length: 95m	Height: 10 - 20m
	Grid Ref	Start: NG 89511 36265	Finish: NG 89567 36340
Description of Slope: Natural and excavated rock slope. Shrubs and mixed forest above slope. Ditch (0.5m to 1m wide x 0.5m to 1m deep).			
Failure Characteristics: General ravelling. Potential plane, wedge and toppling failures.			
Existing Remedial Works: 2002: # 0728 Heavy scaling of a plane failure block, some material in ditch, small overhang of remaining material solid, keep under observation. January 2008: # 0725 Vegetation removed and light scaling of small overhanging block by Skye Rope Access.			
Inspection Findings: # 0705 to 0751 Vegetation almost entirely obscuring the slope. # 0712 undercut column. Base of column is fractured and deteriorating. # 0728 2No. overhangs have deteriorated (rockfall reported). # 0740 Overhanging superficial (2m long by 0.5m high by 0.5m deep) 5m above the road level (Appendix B - photograph 6). # 0774 Culvert is clear. # 0795 Superficials washed away during debris flow on 4/10/2004. Ditch is partially blocked in places.

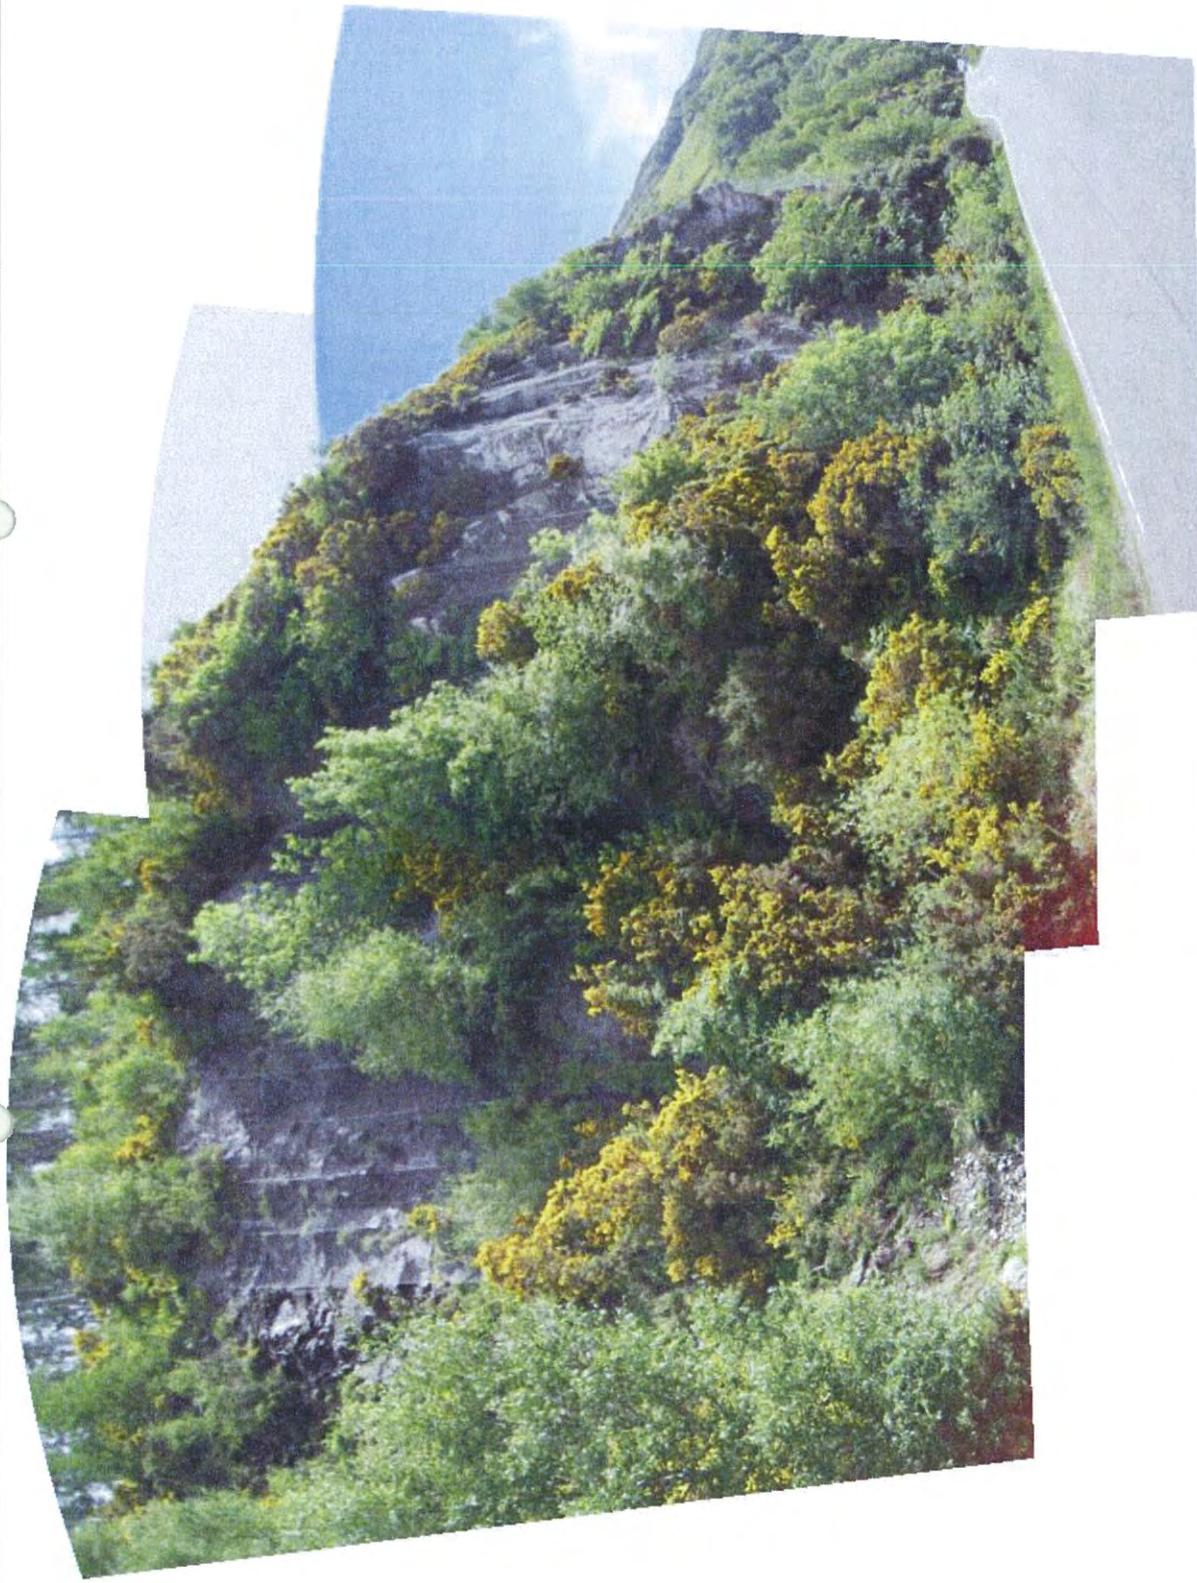
coffey geotechnics <small>SPECIALISTS MANAGING THE EARTH</small>	client:	The Highland Council	
date	08/06/2010		project:	A890 Stromeferry Bypass Annual Rock Slope Inspection - June 2010	
scale	NTS		title:	Slope AA12	
original size	A4		project no: 454.1	figure no: FIGURE 12

AA12	Chainage: 2329 - 2404	Length: 75m	Height: 20 - 40m
	Grid Ref	Start: NG 90688 37272	Finish: NG 90739 37331
Description of Slope: Natural and excavated rock slope. Grass and shrub covered hillside with woodland above slope. Ditch: # 2329 to 2375 ditch has been infilled with a French drain. # 2375 – 2383 (1.0 – 2.0m wide, 0.5 - 1.0m deep) # 2383 – 2404 (<0.5m wide, <0.5m deep).			
Failure Characteristics: General ravelling.			
Existing Remedial Works: January 2006: # 2350 Potential small plane / ravelling area scaled and vegetation removal by TRAC (Photograph 16). # 2367 Removal of holly bush, undertaken by TRAC. February 2008: # 2350 Heavy scaling of block by Skye Rope Access. # 2367 Holy bush re-poisoned by Skye Rope Access.			
Inspection Findings: # 2378 Culvert beneath waterfall clear. # 2395 Tree (300 to 500mm girth) has died on the talus slope between the rock slope and the road. The ditch is no longer present due to the widening of the road. Replaced with a French drain.

Current Hazard Index Value: 8			
Remedial / Maintenance Works Required: None

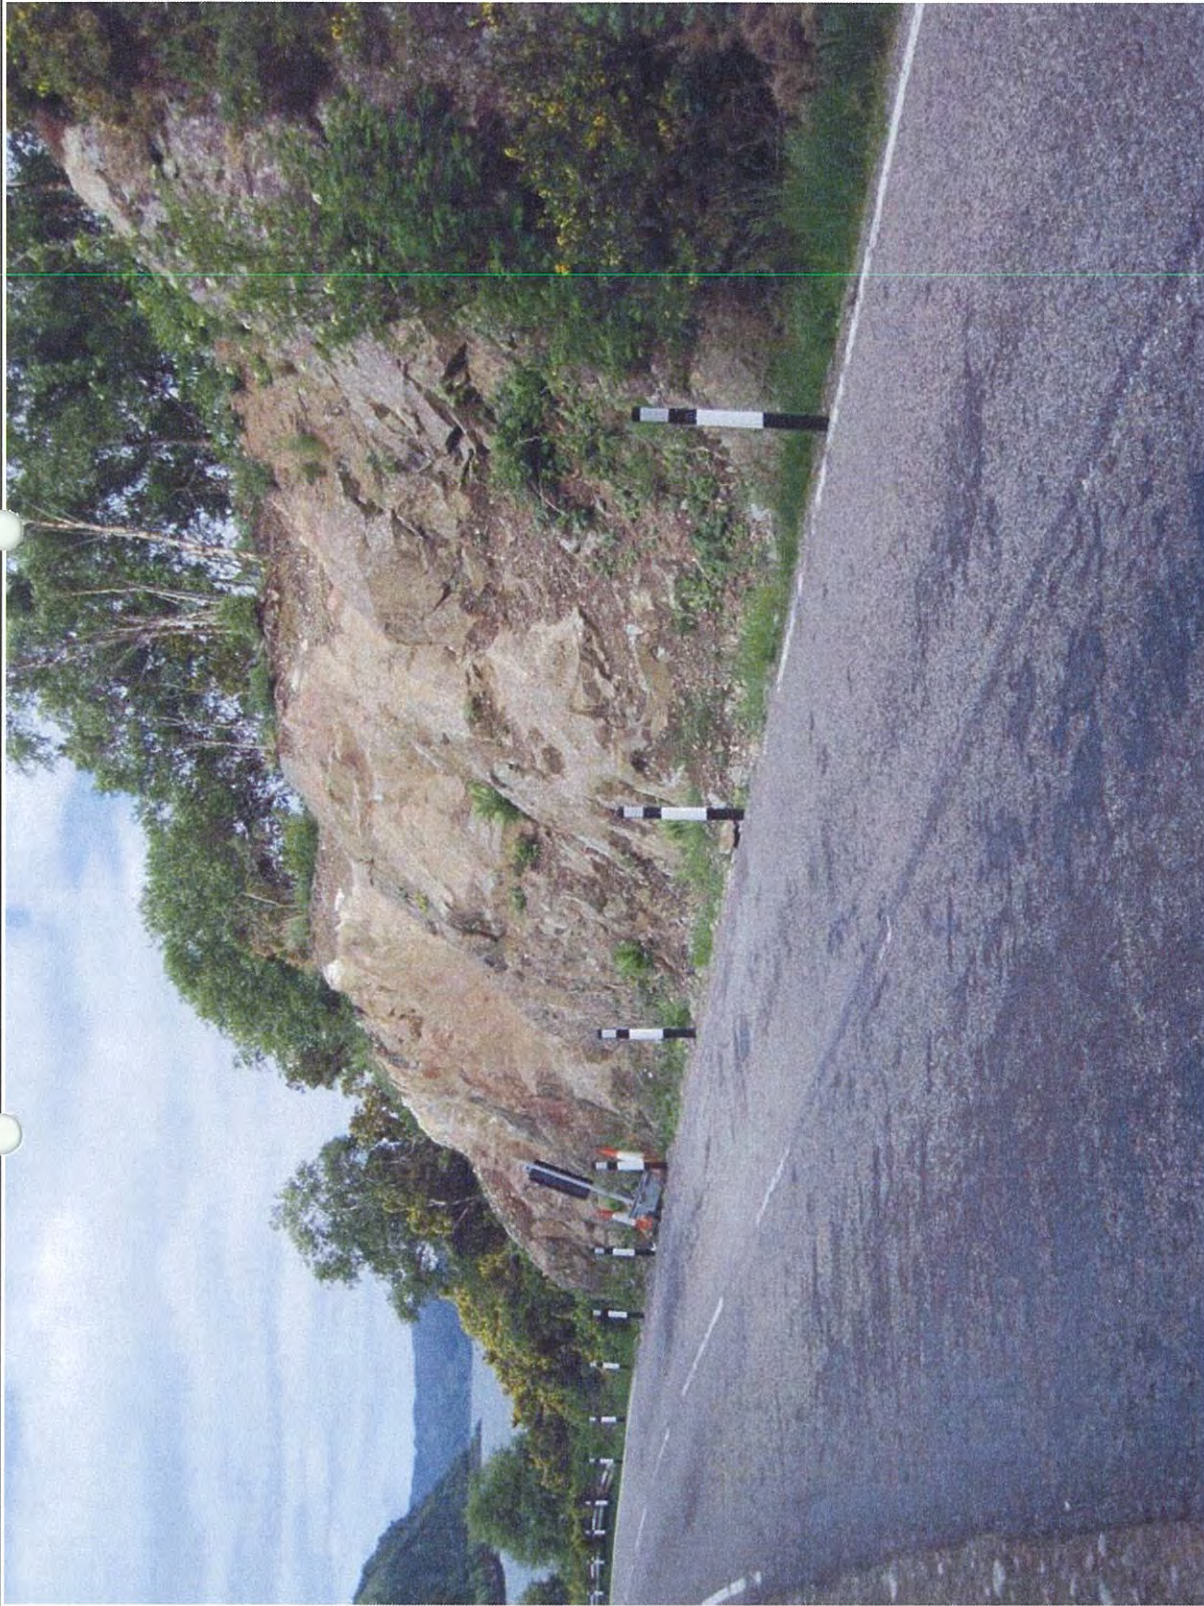
coffey geotechnics <small>SPECIALISTS MANAGING THE EARTH</small>	client:	The Highland Council	
date	10/06/2010		project:	A890 Stromeferry Bypass Annual Rock Slope Inspection - June 2010	
scale	NTS		title:	Slope AA22a	
original size	A4		project no: 454.1	figure no: FIGURE 23

AA22a	Chainage: 3294 - 3346	Length: 52m	Height: >40m
	Grid Ref	Start: NG 91427 37820	Finish: NG 91461 37863
Description of Slope: Excavated rock slope. Grass and shrub covered hillside with mixed woodland above slope. Verge at the toe of the slope: # 3294 – 3312 (1.0 – 2.0m wide) # 3312 – 3338 (2.0 – 4.0m wide)			
Failure Characteristics: General ravelling. Potential plane, wedge and toppling failures.			
Existing Remedial Works: 1998: 500m ² Light scaling. 50m ³ Heavy scaling. 150m ³ Controlled removal (# 3316, 3338). 2860m ² Draped Double twist rockfall netting (# 3304-3346), reinforced with 10mm diameter vertical cables (# 3315-3346). January 2006: # 3294 Tree trunk and root ball removed from crest netting cable by TRAC. #3296 Block heavy scaled by TRAC.			
Inspection Findings: # 3298 Minor ravelling from waterfall, material present at the toe. # 3303 Culvert clear # 3338 Observe area 20m above the road on the rock slope for deterioration. No significant change since previous annual inspection.

Current Hazard Index Value: 11			
Remedial / Maintenance Works Required: None.

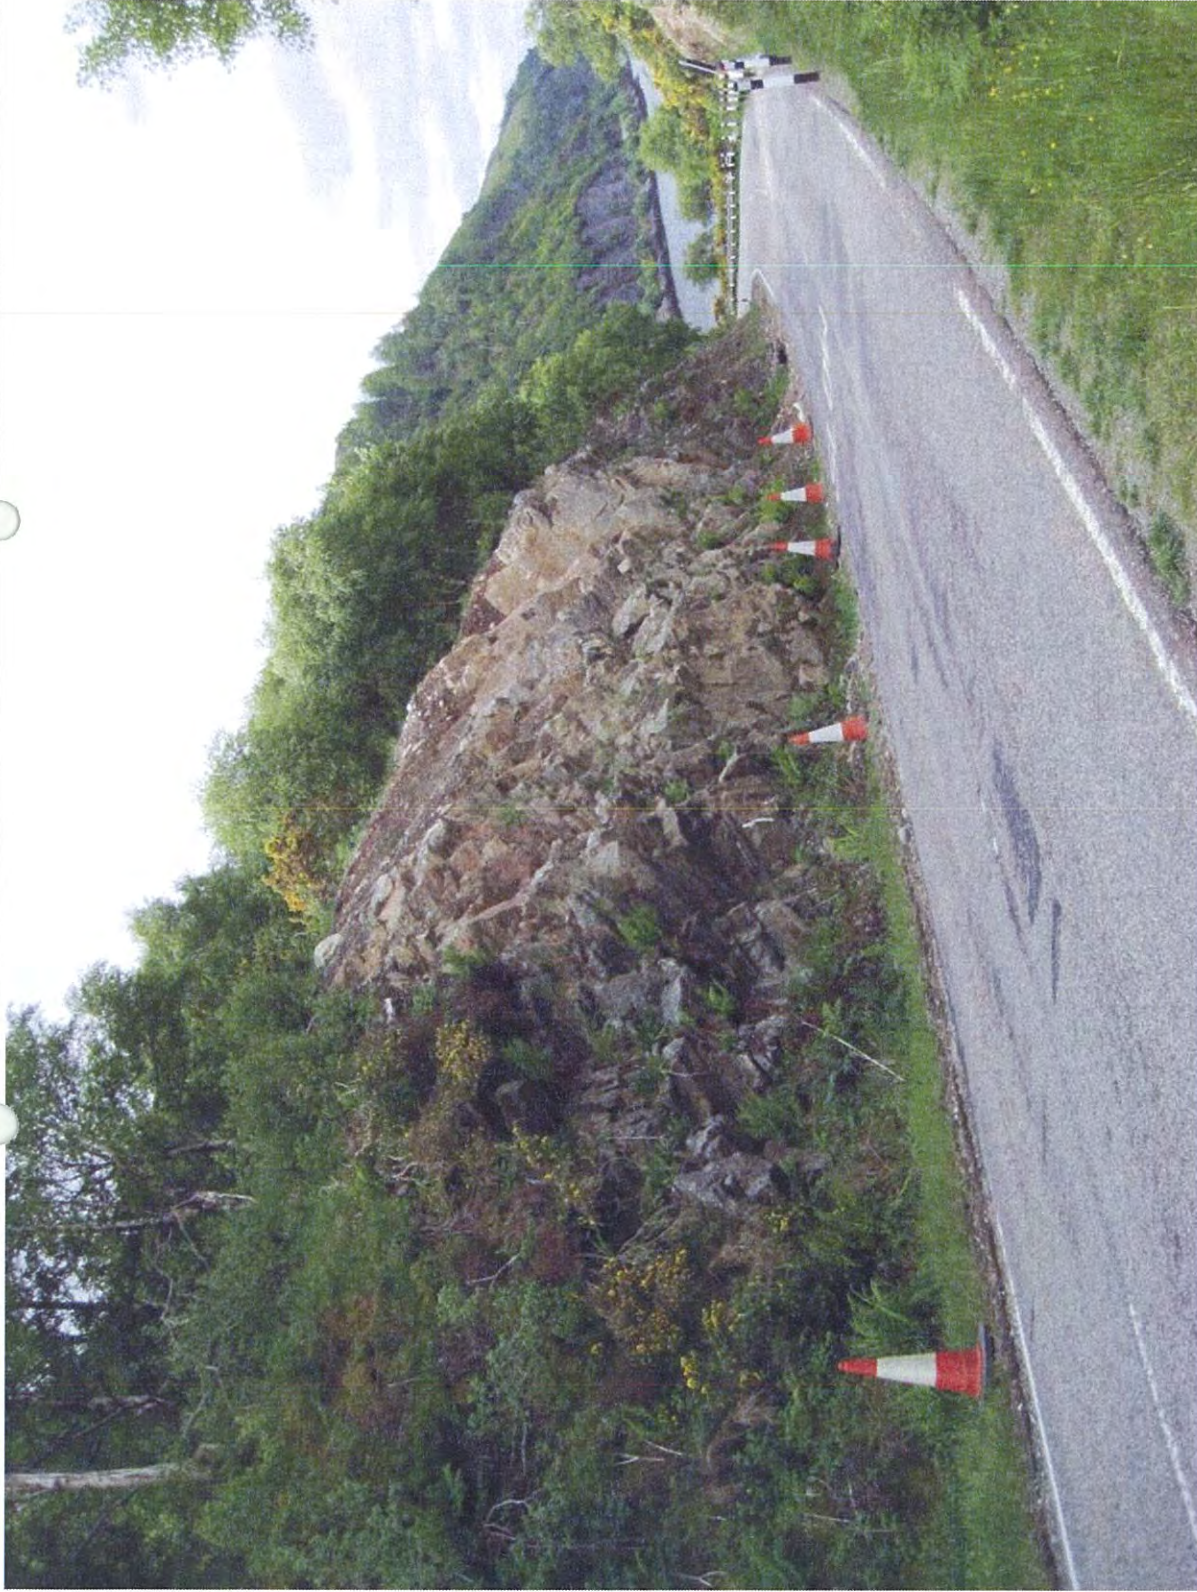
AA23N	Chainage: 3553 - 3607	Length: 54m	Height: 2 - 5m
	Grid Ref	Start: NG 91551 37982	Finish: NG 91577 38011
Description of Slope: Excavated rock slope forming Northbound side of a "box cutting". Grass and shrub covered hillside above slope. Verge (2m wide).			
Failure Characteristics: General ravelling.			
Existing Remedial Works: 1995: Verge built up and ditch deepened. February 2008: # 3579 Blast damaged area heavy scaled by Skye Rope Access. October 2008: #3565 – 3585 Slope reprofiled and dense gorse removed by RJ McLeod and Geo-Rope. July 2009: # 3570 – 3580 Slope scaled by CAN.			
Inspection Findings: Ditch has been partially infilled during previous reprofiling and is no longer acting as an effective rock trap.			
Current Hazard Index Value: 1			
Remedial / Maintenance Works Required: Clear out and reform ditch (Annual Maintenance).

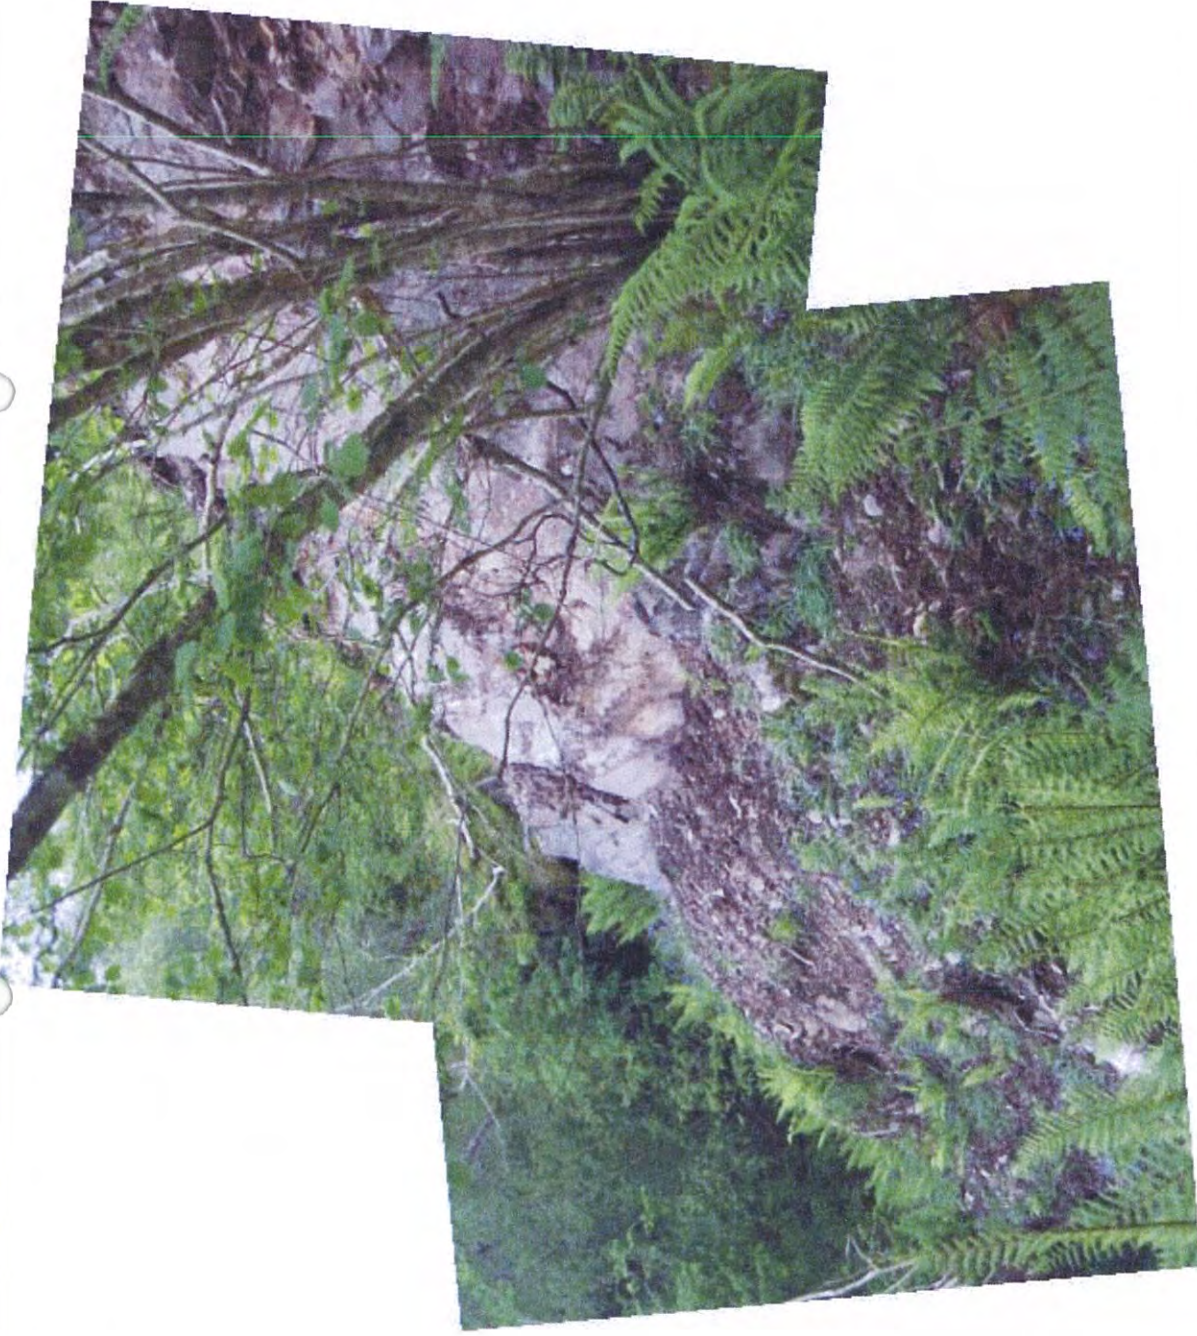
client:	The Highland Council
project:	A890 Stromeferry Bypass Annual Rock Slope Inspection - June 2010
title:	AA19/AA20 Gully
project no:	454.1
figure no:	FIGURE 30

Further erosion of the east gully wall between slopes AA19 and AA20 has occurred up and down stream of the erosion protection measures. Erosion has also occurred immediately below these measures. If this is allowed to continue, it could eventually lead to the undermining of the concrete beam and associated works above. We would recommend that additional erosion protection measures / training of stream within gully are undertaken during the next Phase (VI) of rock slope remedial works.

Stream Gully Between Slope AA19 and AA20	Chainage: 3072
	Grid Ref: NG 91270 37696
Description: Large deeply incised gully with a small stream. The stream flows in wet weather conditions and flows in spate during / following heavy rainfall / snowmelt. The stream carries significant quantities of rock debris during spate events.	
Existing Remedial Works: # 3072 to 3104 "I" Beam and segmental Concrete retaining wall at base of gully installed pre-1972. In November 1994 a significant rockfall damaged the retaining wall. September 2001: Beam installed approximately 40m above road level following landslide with blockfall in October 2000. Coir matting and rockfall netting installed in gully as erosion protection measures.	
Inspection Findings: The concrete beam and associated works show no observable signs of deterioration. Vegetation is well established on the coir mat. Erosion of the gully wall (observed in 2005) has increased, now occurring up and down stream of the erosion protection measures and immediately below them. If allowed to continue will eventually undermine the concrete beam and associated works.
