Stromeferry Bypass, The Scottish Highlands

A890 Slope Inspection
Report

September 2012

Prepared for:
The Highland Council

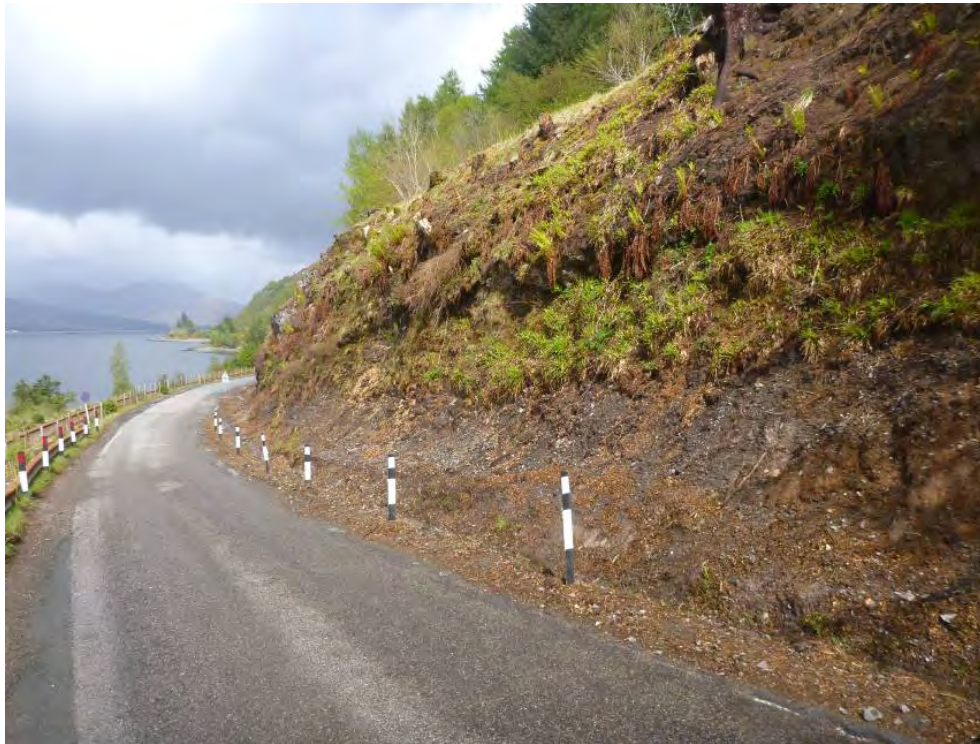
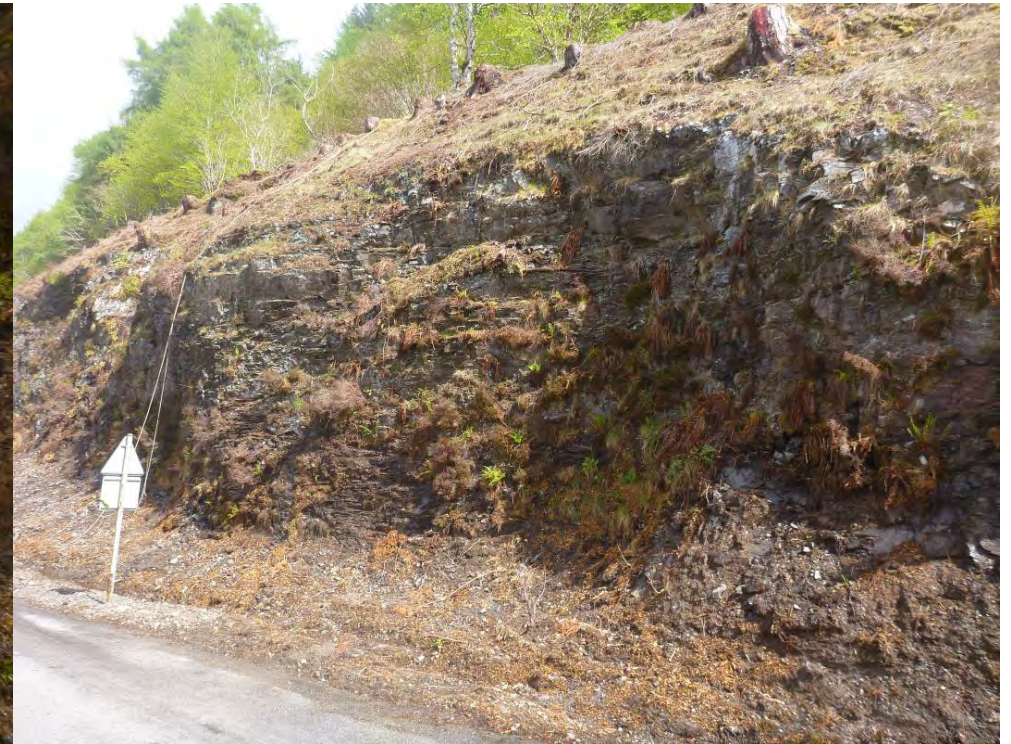
Dip: 85	Azimuth: 302	Height (m): 7	Length (m): 146	Vegetation Cover: 50-60% cover comprising moss, grass and ferns. Occasional saplings and cut tree stumps.	Ditch Details: 0.4m deep, 1.0m wide	Roughness (Profile): Rough	Verge Width: 1.5m
---------	--------------	---------------	-----------------	---	-------------------------------------	----------------------------	-------------------

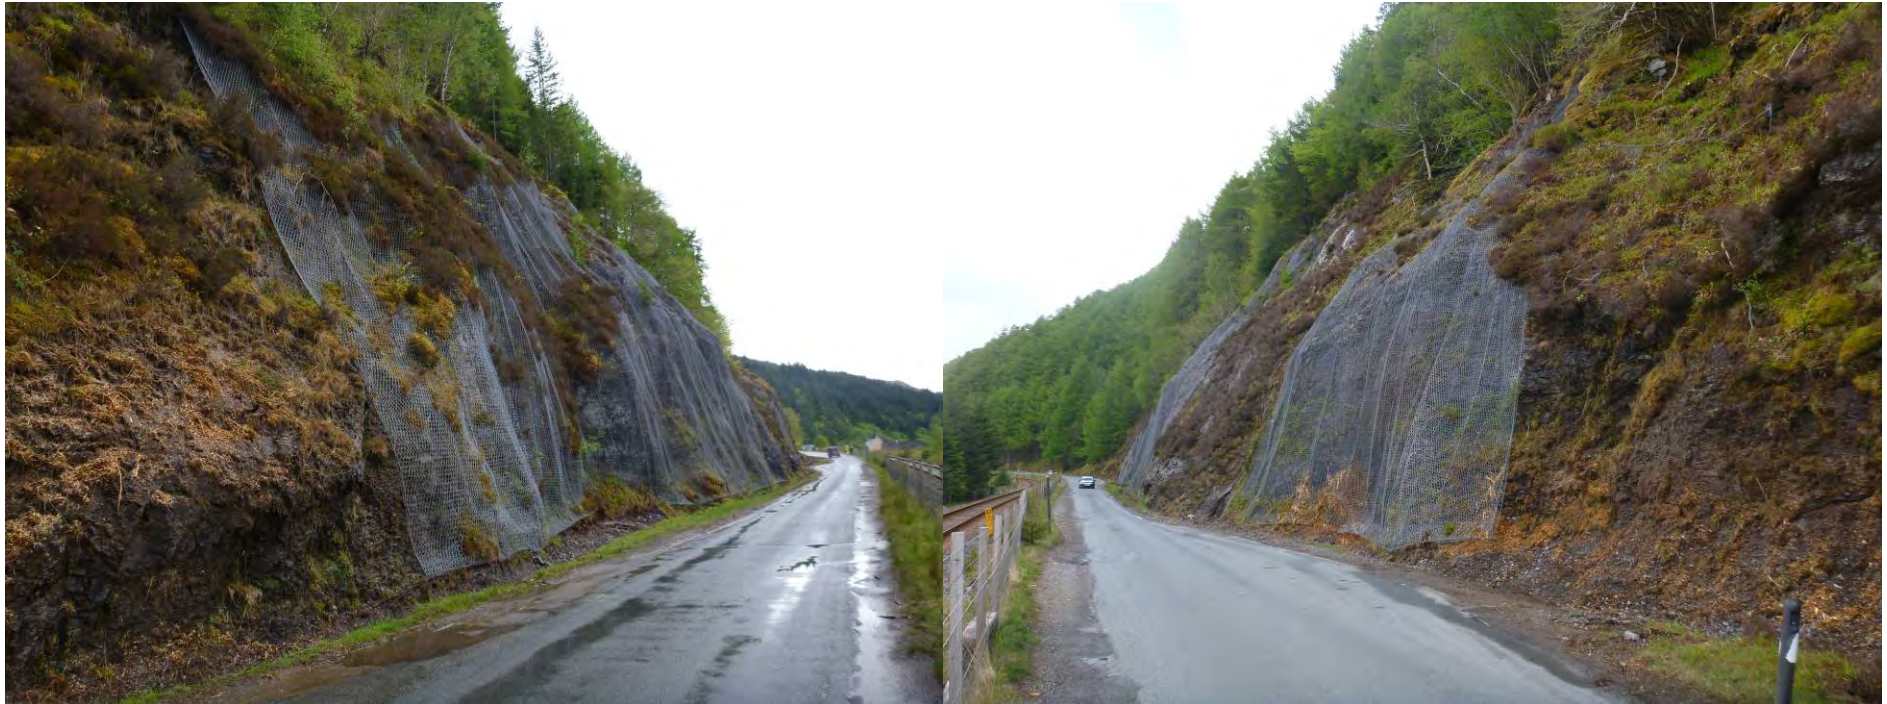
Dip:	74	Azimuth:	319	Height (m):	20	Length (m):	150	Vegetation Cover:	60 – 65% cover. Generally comprises moss and heather with occasional fern. Trees along crest.	Ditch Details:	0.5m wide, 0.4m deep	Roughness (Profile):	Rough	Verge width:	0.8m
------	----	----------	-----	-------------	----	-------------	-----	-------------------	---	----------------	----------------------	----------------------	-------	--------------	------

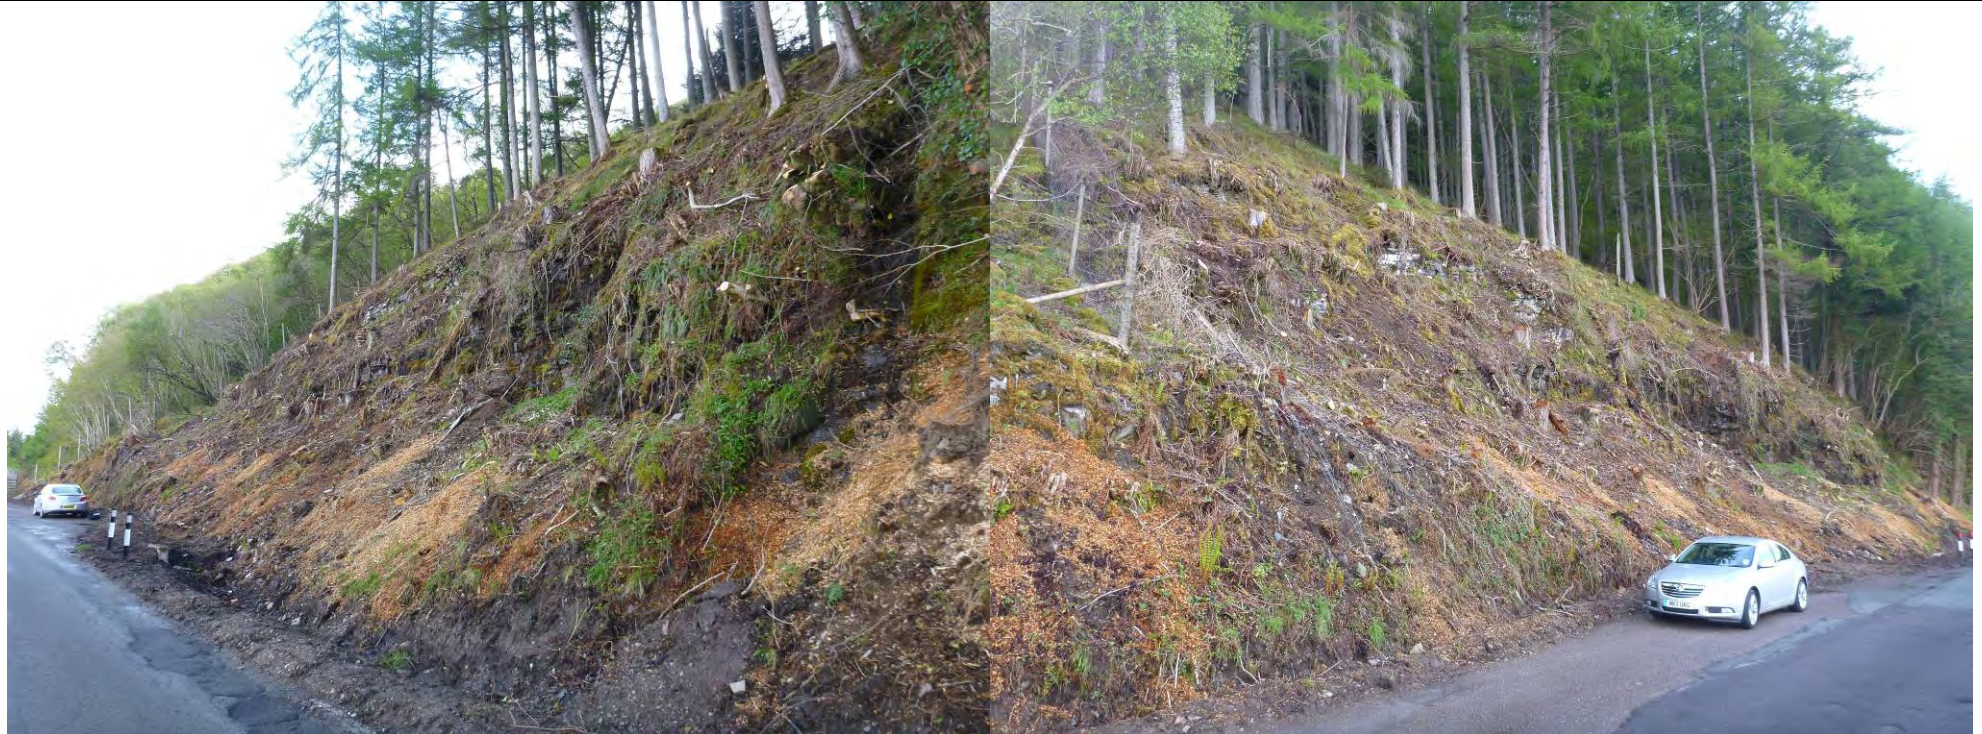
Dip:	84	Azimuth:	300	Height (m):	12	Length (m):	80	Vegetation Cover:	70 – 80% cover. Generally comprises moss and grass. Many tree stumps, branches, wood chip and root systems.	Ditch Details:	1.0m wide, 0.2 m deep	Roughness (Profile):	Rough	Verge Details:	3.4m
------	----	----------	-----	-------------	----	-------------	----	-------------------	---	----------------	-----------------------	----------------------	-------	----------------	------

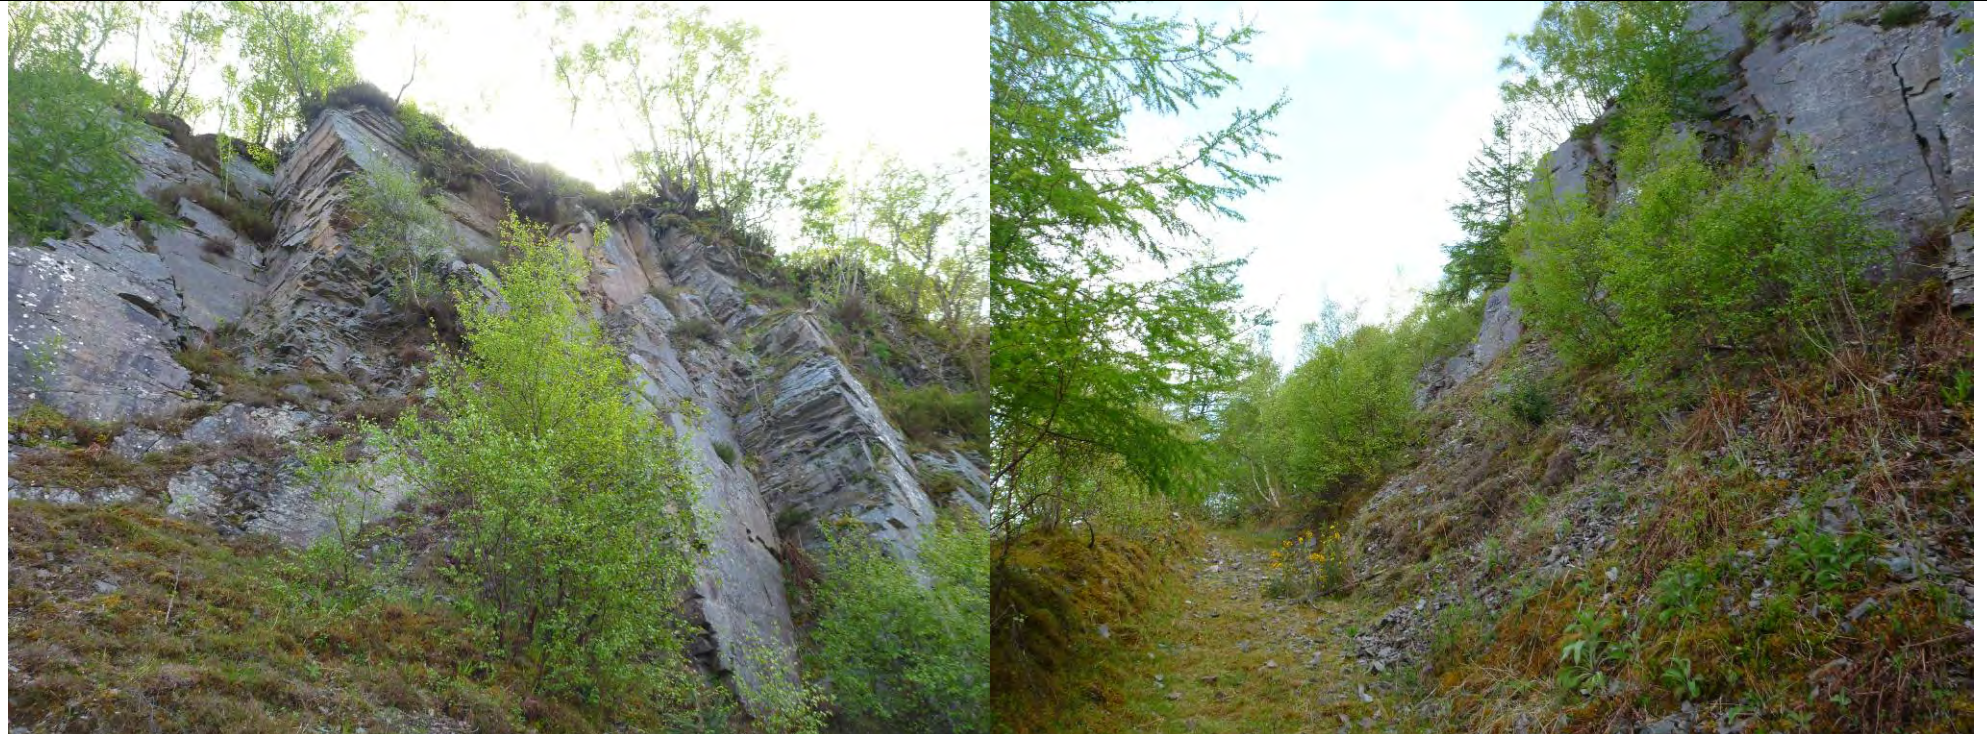
Dip:	80	Azimuth:	317	Height (m):	16	Length (m):	70	Vegetation Cover:	5 - 10% cover. Moss and ground cover with occasional trees. Trees on ditch edge forming barrier. Some trees overhanging at crest.	Ditch Details:	2.2m wide, 1.2m deep	Roughness (Profile):	Smooth	Verge Details:	13.0m
------	----	----------	-----	-------------	----	-------------	----	-------------------	---	----------------	----------------------	----------------------	--------	----------------	-------

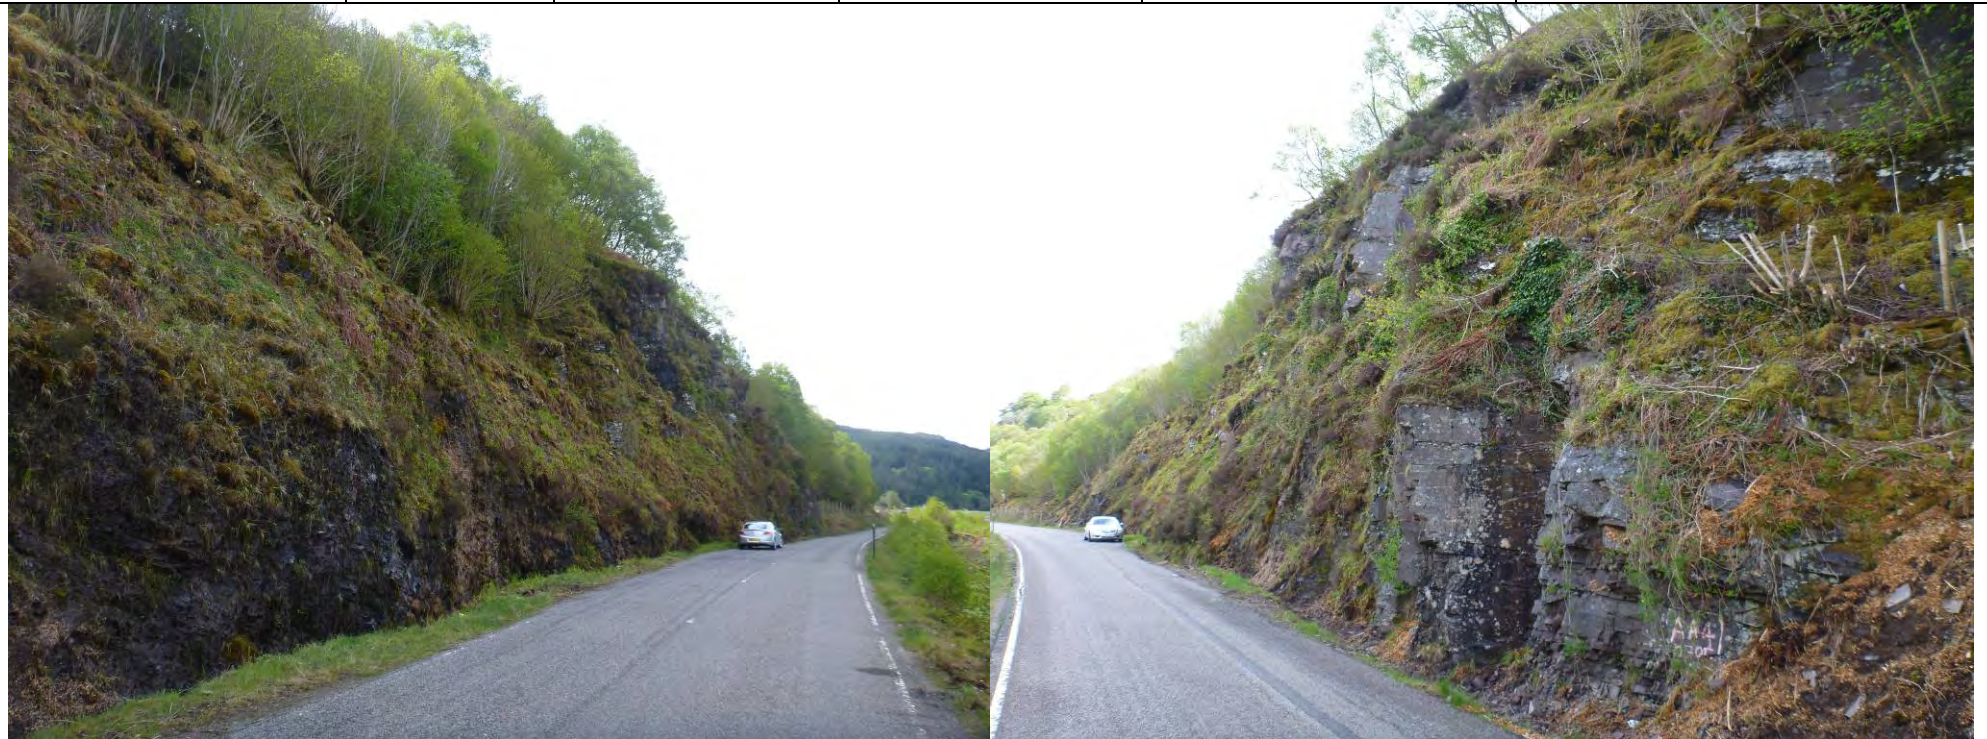
Dip:	80	Azimuth:	310	Height (m):	20	Length (m):	115	Vegetation Cover:	60 – 70% cover. Generally comprised ground cover.	Ditch Details:	1.0m wide, 0.6m deep	Roughness (Profile):	Rough	Verge Details:	1.0m
------	----	----------	-----	-------------	----	-------------	-----	-------------------	---	----------------	----------------------	----------------------	-------	----------------	------

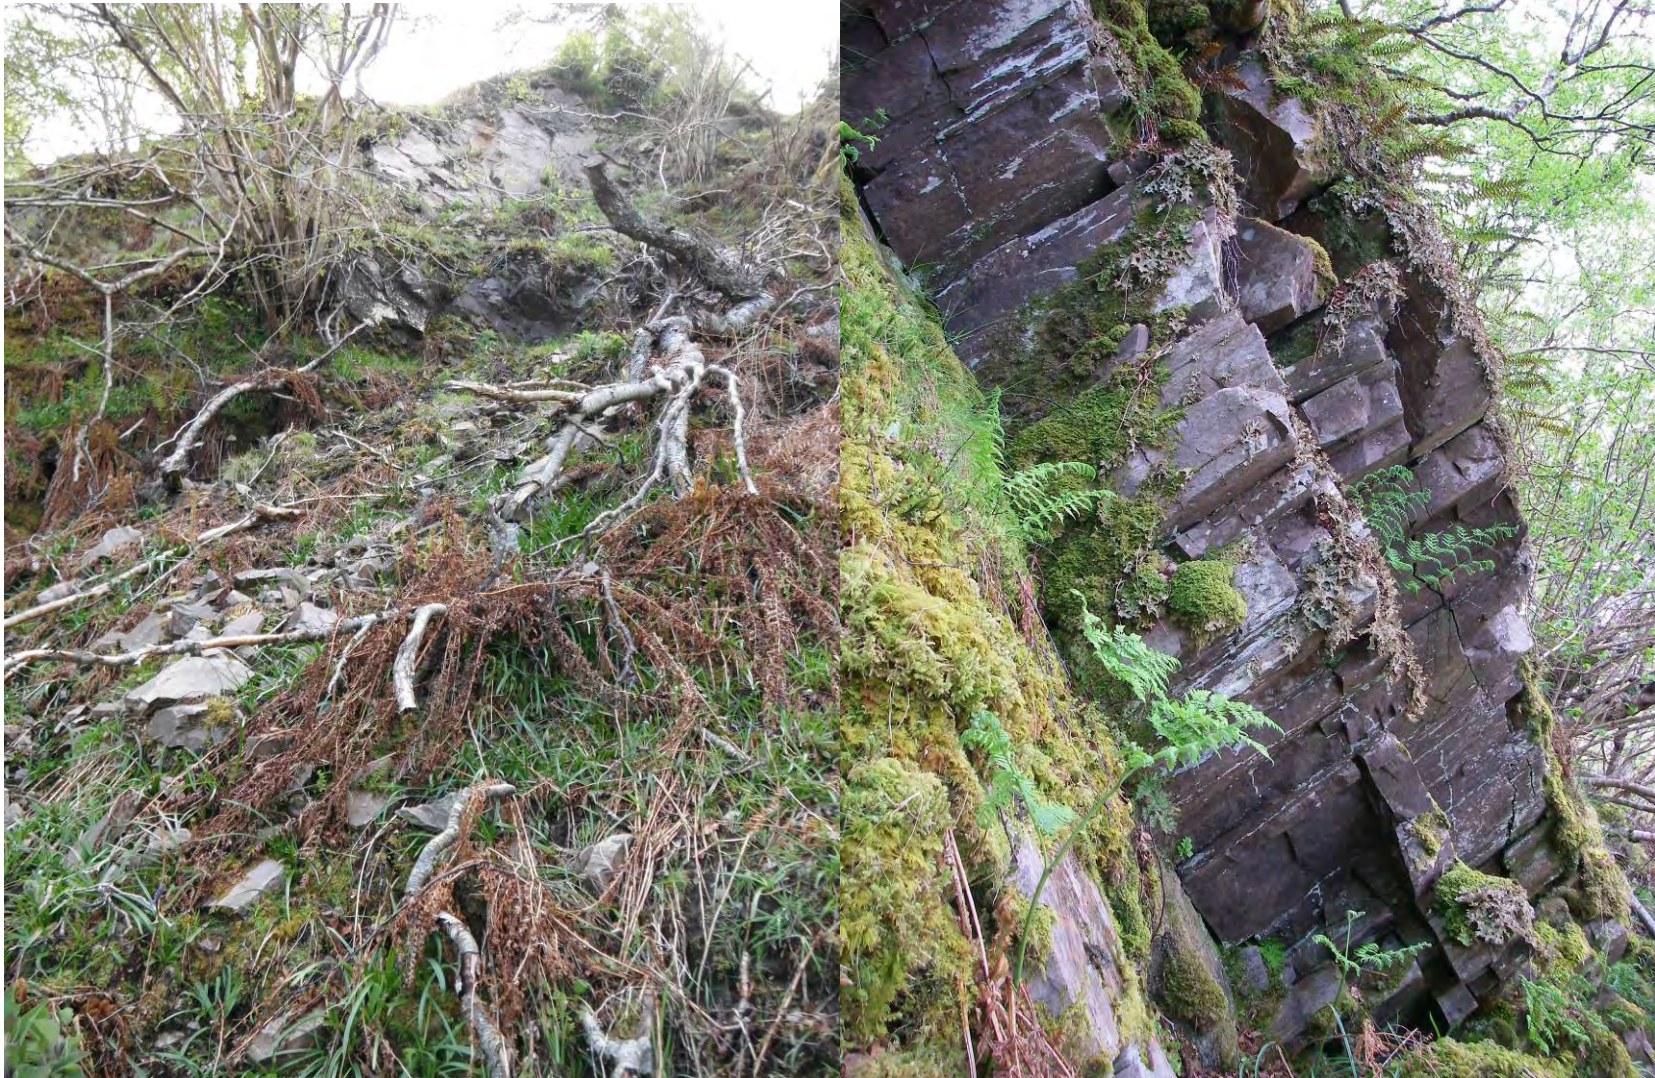
Rock Slope Characteristics:											
Dip: 70	Azimuth: 320	Height (m): 70	Length (m): 79	Vegetation Cover:	90% cover lower lope, 60% cover upper slope. Moss and bracken. Moss is up to 0.15 to 2.0m thick.	Ditch Details:	0.3m wide, 0.5m deep	Roughness (Profile):	Rough	Verge Details:	2.0m
Engineering Description of Rock:											
Strong to very strong thinly foliated pinkish grey medium grained schist (PSAMMITE).											
Principal Discontinuities:											
Set	Type	Dip	Azi.	Spacing	Persistence	Roughness	Aperture	Infill	Seepage	Comments	
1	Foliation	32	100	0.5m	1.2m	Straight, Planar, Smooth	1 – 5mm	None	None		
2	Joint	60	275	0.9m	>3.5	Straight, Planar, Smooth	30mm	None	None		
3	Joint	55	170	0.1 – 0.4m	0.6	Wavy, Stepped, Rough	0.5mm	None	None		
4	Joint	70	190	0.6 - 1.0m	0.3m	Straight, Planar, Smooth	10mm	None	None		
Existing Netting Details or other remedial work details:											
None

Previous Rock Slope Hazard Index Value and Recommended Remedial Works (2010):						Current NGI 'Q' Value					
RSHV = 5						1.9 – 5.8					
Potential Failure Types (From Stereographic Analysis):											
Ref	Type									Comments	
1	Toppling									Joint set 3	
2	Plane									Joint set 3	
Hazards Observed:											
Ref	Type	Height above toe (m)	Size of individual failure(s) (m ³)	Comments							
1	Blockfall	50 (above road level)	0.027 – 0.125								
2	Plane	50 (above road level)	0.027 – 0.125	Large existing failure. Most of the debris came to rest on the slope. 2 No. blocks in ditch.							
SUMMARY				Comments							
Overall Hazard Rating =		3									
Pathway Rating =		1		25m long lower slope at ~40°. Moss and bracken covered. Low pathway.							
Receptor Rating =		1									
Risk Value =		3									
Risk Level =		Low

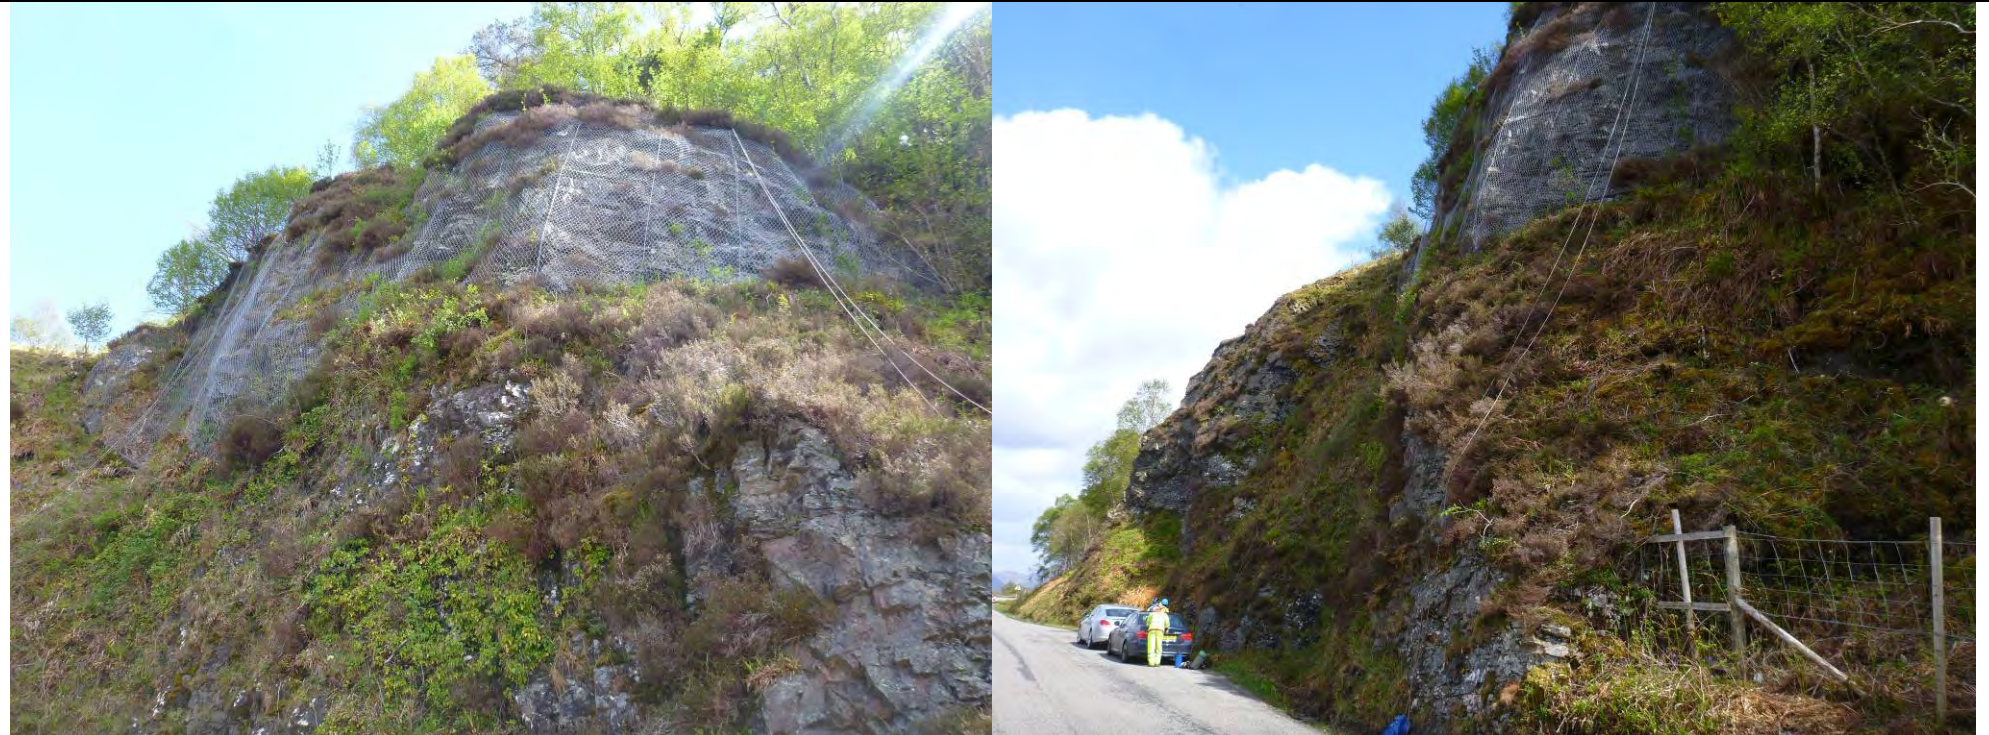
Dip:	71	Azimuth:	310	Height (m):	35	Length (m):	62	Vegetation Cover:	50% cover. Generally comprises ground cover.	Ditch Details:	Widest section 0.8m deep, 2.3m wide (no ditch where rock slope close to road).	Roughness (Profile):	Rough	Verge Details:	0.8 - 3.0m
------	----	----------	-----	-------------	----	-------------	----	-------------------	--	----------------	--	----------------------	-------	----------------	------------

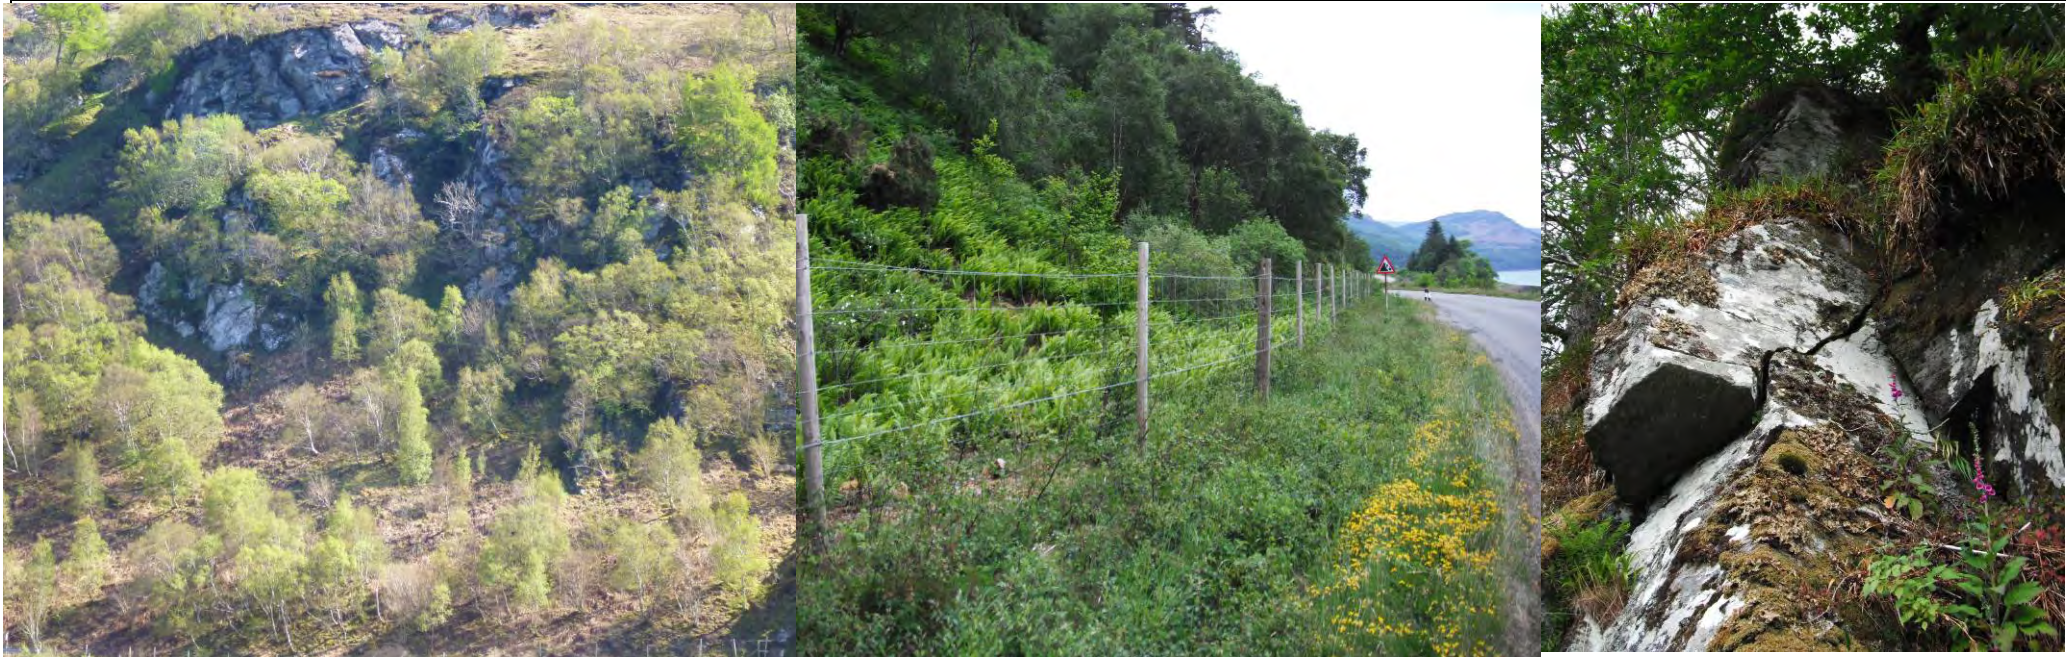
Dip:	70	Azimuth:	300	Height (m):	35	Length (m):	111	Vegetation Cover:	Ferns and trees.	Ditch Details:	CH 1495 - 1525: 0.7m wide, 0.3m deep CH 1525 - 1606: 0.5m wide, 0.3m deep	Roughness (Profile):	Rough	Verge Details:	CH 1495 - 1525: 1.0m CH 1525 - 1606: 8.0m
------	----	----------	-----	-------------	----	-------------	-----	-------------------	------------------	----------------	--	----------------------	-------	----------------	--

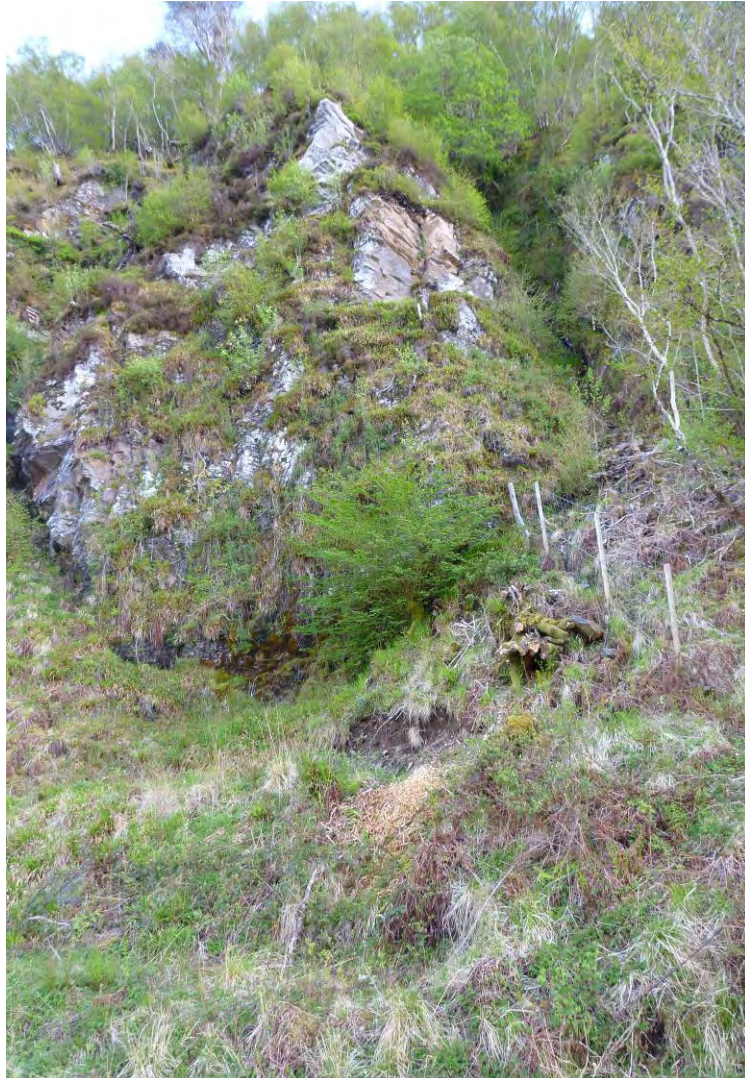
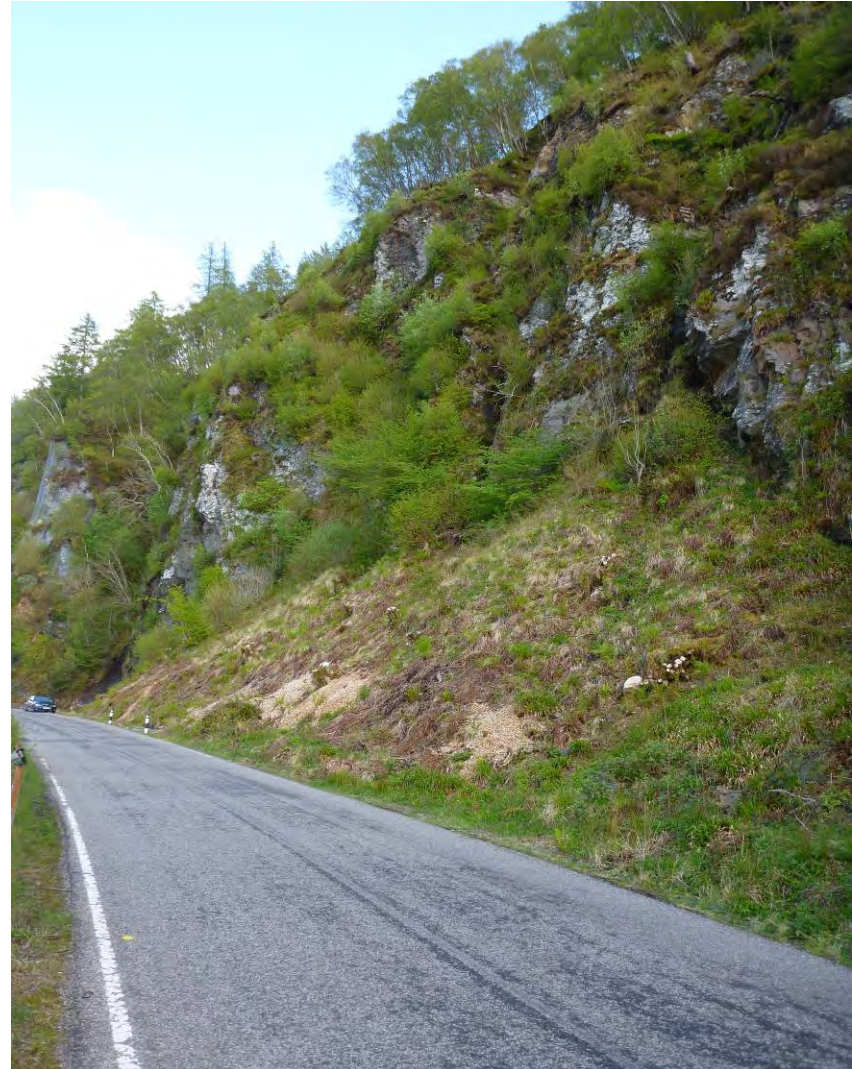
Rock Slope Characteristics:															
Dip:	75 - 80	Azimuth:	336	Height (m):	30	Length (m):	110	Vegetation Cover:	50% cover. Generally comprises small trees.	Ditch Details:	None. Large ditch by slope AA8.	Roughness (Profile):	Rough	Verge Details:	1.0m
Engineering Description of Rock:															
Very strong thinly foliated dark grey schist (PSAMMITE).															
Principal Discontinuities:															
Set	Type	Dip	Azi.	Spacing	Persistence	Roughness	Aperture	Infill	Seepage	Comments					
1	Foliation	16	143	0.1 -1.0m	>20m	Curved, Planar, Smooth	<0.1	None.	None.						
2	Joint	75	041	0.3 – 2m	0.5 – 1m	Curved, Planar, Rough	Unable to measure	None.	None.						
3	Joint	79	293	0.5 – 3m	0.3 – 3m	Curved, Planar, Smooth	Unable to measure	None.	None.						
Existing Netting Details or other remedial work details:															
None															
Previous Rock Slope Hazard Index Value and Recommended Remedial Works (2010):						Current NGI 'Q' Value

RSHV = 12 Clear culverts.						2.5 – 3.8									
Potential Failure Types (From Stereographic Analysis):															
Ref	Type									Comments					
1	Wedge									Joint sets 2 and 3					
Developing Hazards Observed (Considered likely to fail with the next 5 years):															
Ref	Type	Height above toe (m)	Size of individual failure(s) (m ³)	Comments											
1	Plane	20	4 - 5	1 block observed											
2	Ravelling	All over slope	0.001												
SUMMARY				Comments											
Overall Hazard Rating =		3													
Pathway Rating =		3													
Receptor Rating =		1.2													
Risk Value =		10.8													
Risk Level =		High

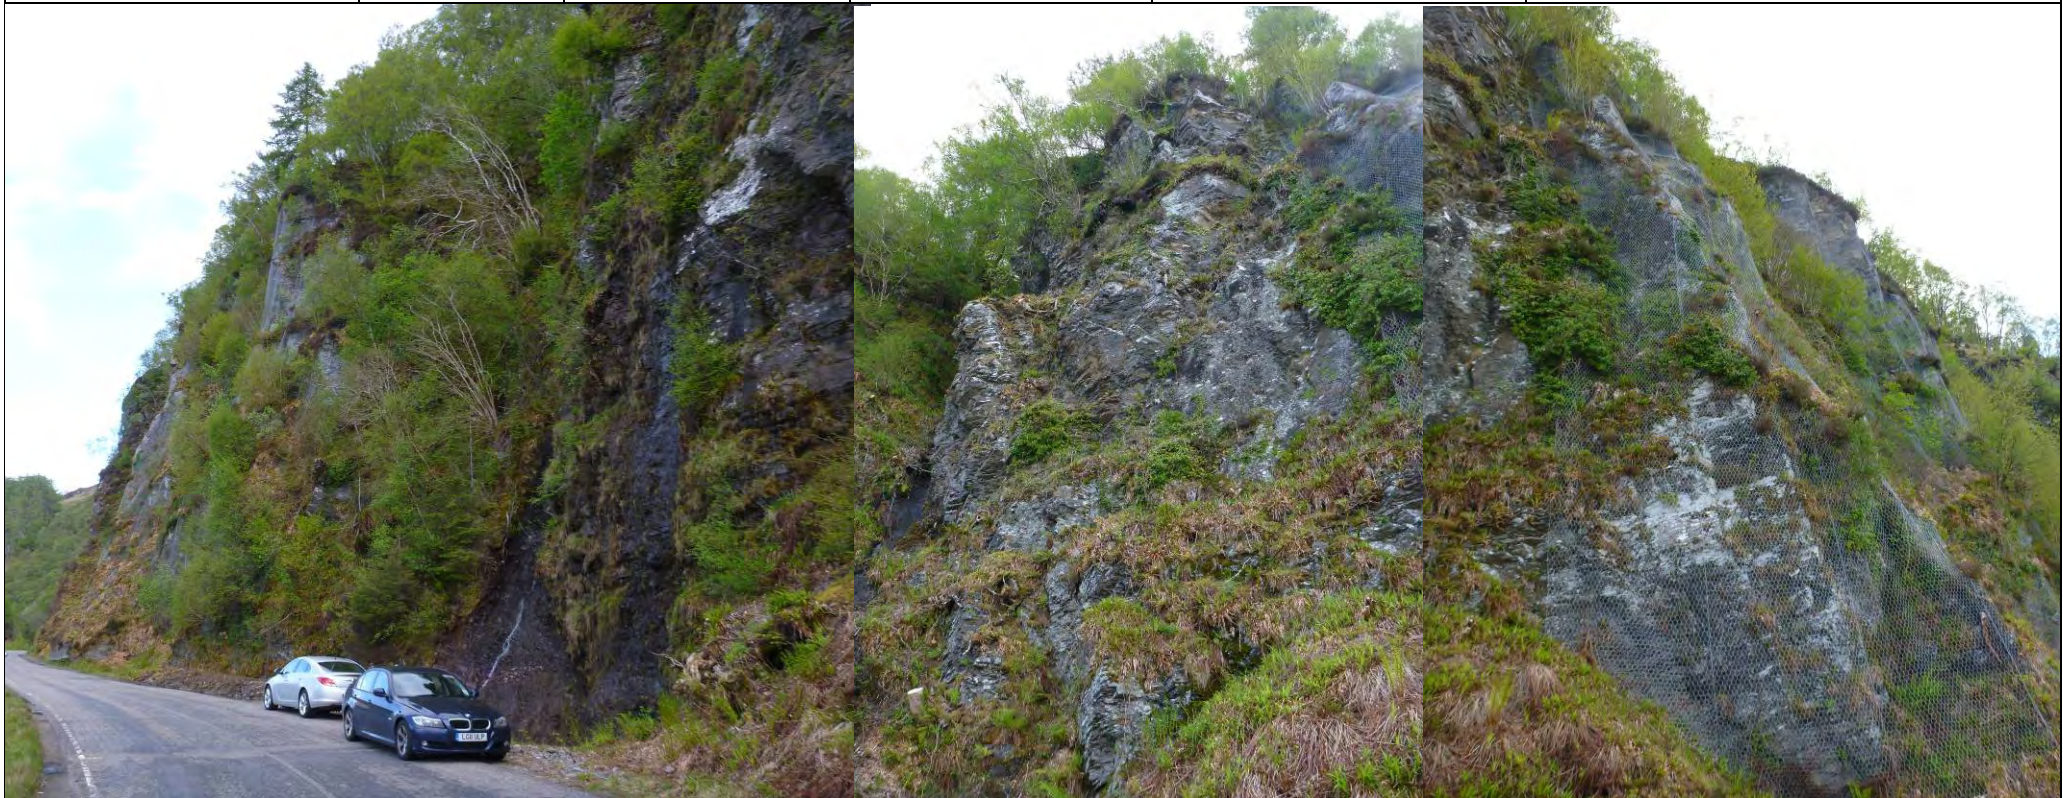
Dip:	75 – 80	Azimuth:	326	Height (m):	25 – 30	Length (m):	63	Vegetation Cover:	50 – 60% cover. Generally comprises ground cover and trees.	Ditch Details:	None	Roughness (Profile):	Rough	Verge Details:	1 -5m
------	---------	----------	-----	-------------	---------	-------------	----	-------------------	---	----------------	------	----------------------	-------	----------------	-------

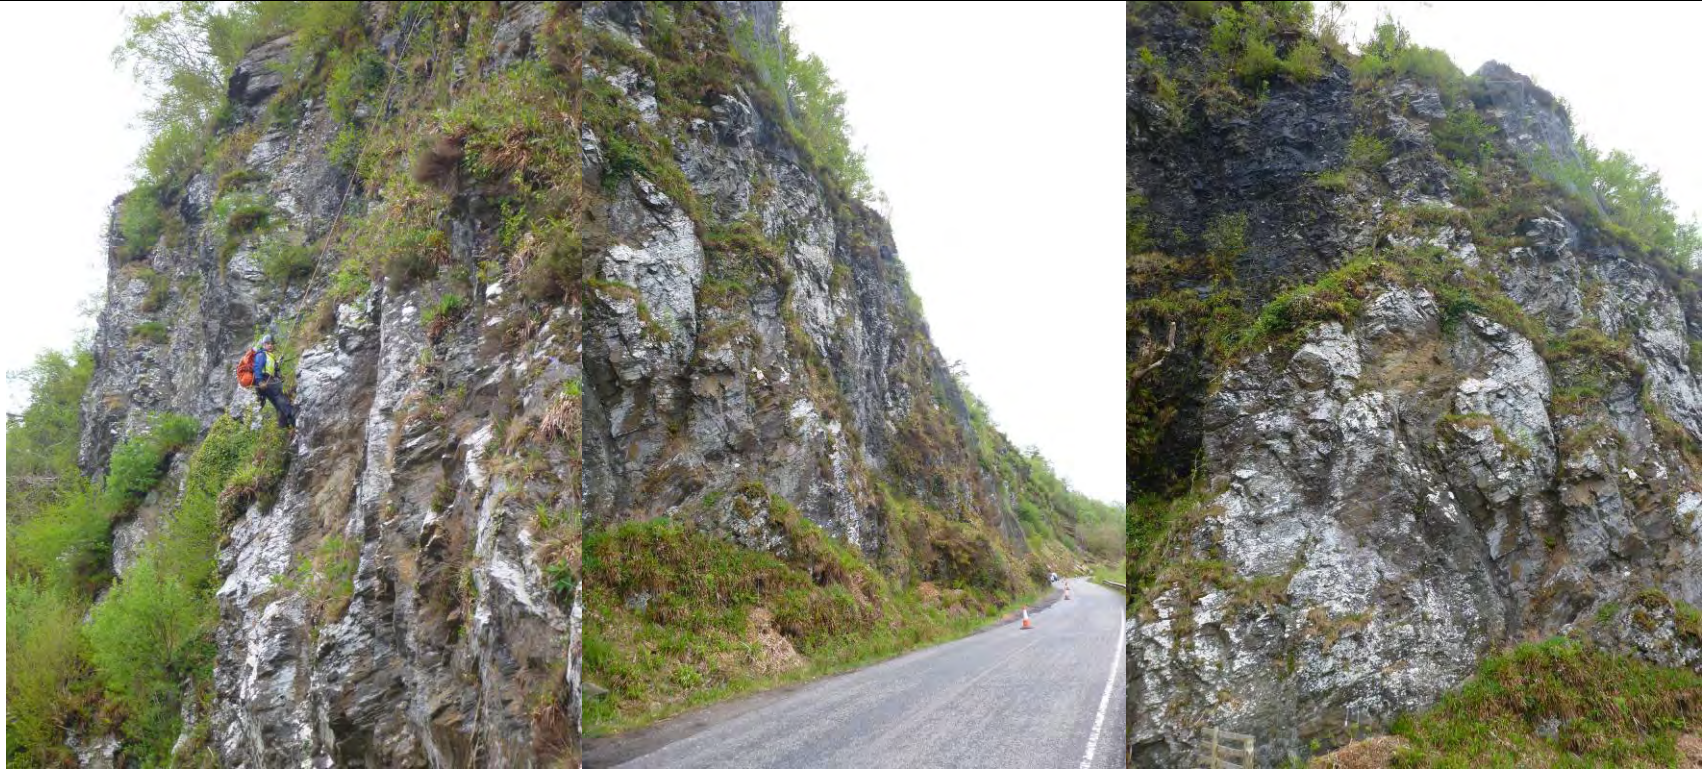
Dip:	82	Azimuth:	350	Height (m):	30	Length (m):	42	Vegetation Cover:	20% cover. Generally comprises grass and small to medium trees.	Ditch Details:	None	Roughness (Profile):	Rough	Verge Details:	1.4m
------	----	----------	-----	-------------	----	-------------	----	-------------------	---	----------------	------	----------------------	-------	----------------	------

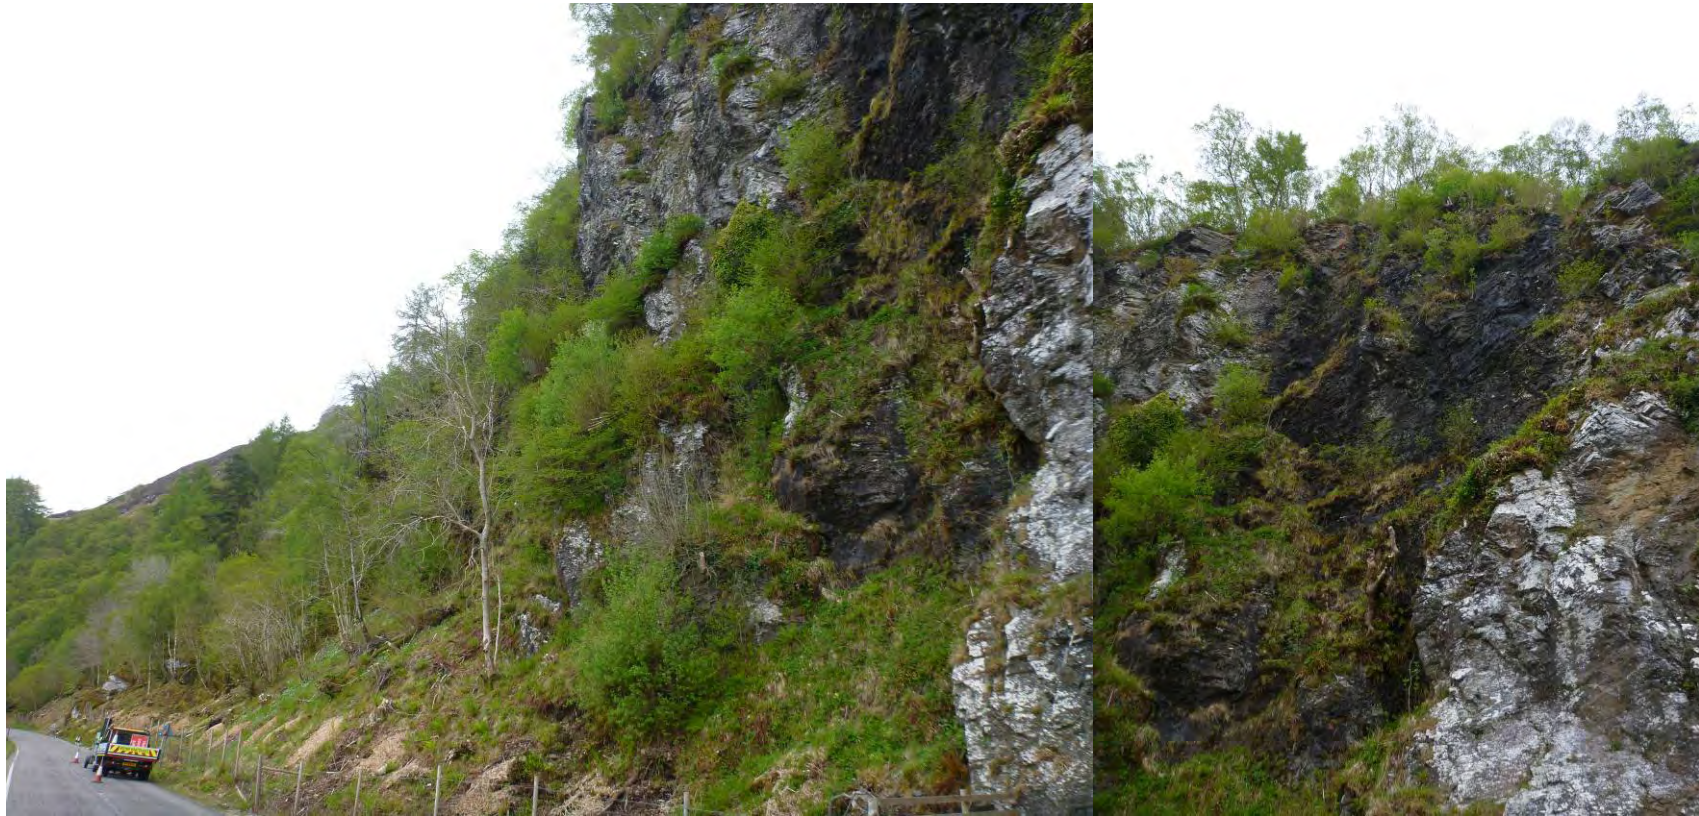
Dip: 85	Azimuth: 332	Height (m): 40	Length (m): 173	Vegetation Cover: 40% cover. Generally comprises grass and small to medium sized trees, with occasional large trees.	Ditch Details: Slight ditch at start of AA10 - Width 1.7, Depth 0.4	Roughness (Profile): Rough	Verge Details: Generally 10m, but 1m minimum.
----------------	---------------------	-----------------------	------------------------	---	--	-----------------------------------	--

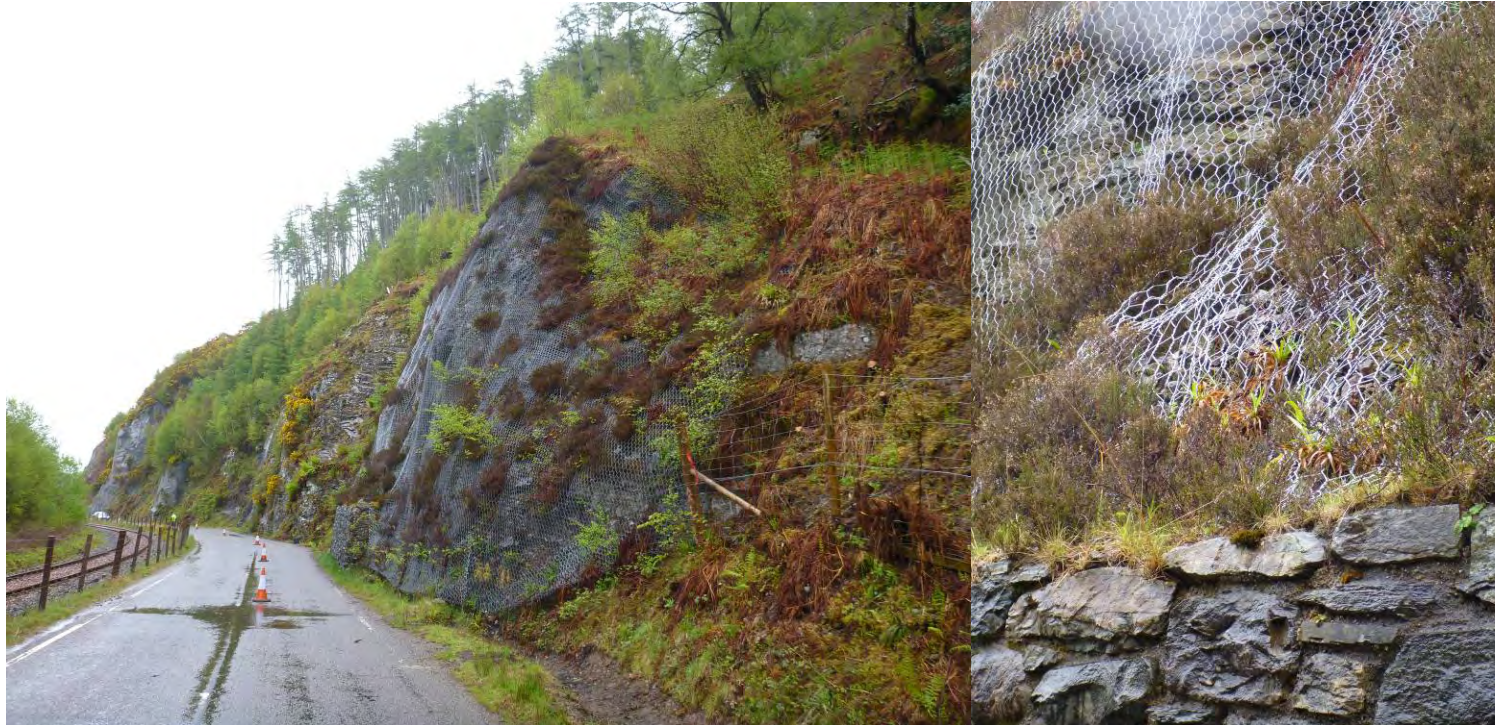
Dip: 80	Azimuth: 322	Height (m): 20	Length (m): 44	Vegetation Cover: 60% cover comprising heather, grass and some sapling trees.	Ditch Details: 0.4m deep, 0.6m wide	Roughness (Profile): Rough	Verge Width: 0.3m min.
---------	--------------	----------------	----------------	---	-------------------------------------	----------------------------	------------------------

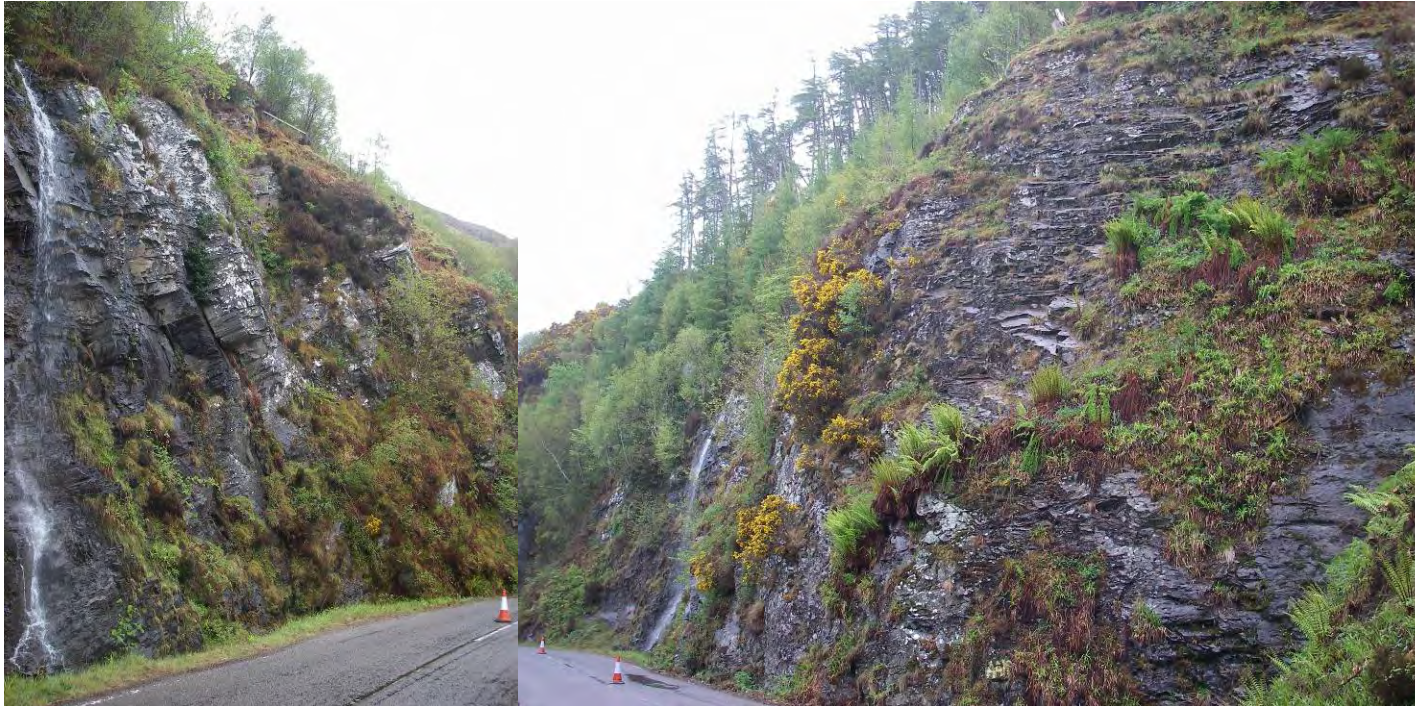
Dip: 80	Azimuth: 306	Height (m): 20	Length (m): 63	Vegetation Cover: 40% ground cover b (gorse, heather, ferns) and small to medium trees.	Ditch Details: None in part, otherwise: 1.1m deep, 2.8m wide	Roughness (Profile): Rough	Verge Width: 0m
---------	--------------	----------------	----------------	---	--	----------------------------	-----------------
