Stromeferry Bypass, The Scottish Highlands

A890 Slope Inspection
Report

September 2012

Prepared for:
The Highland Council

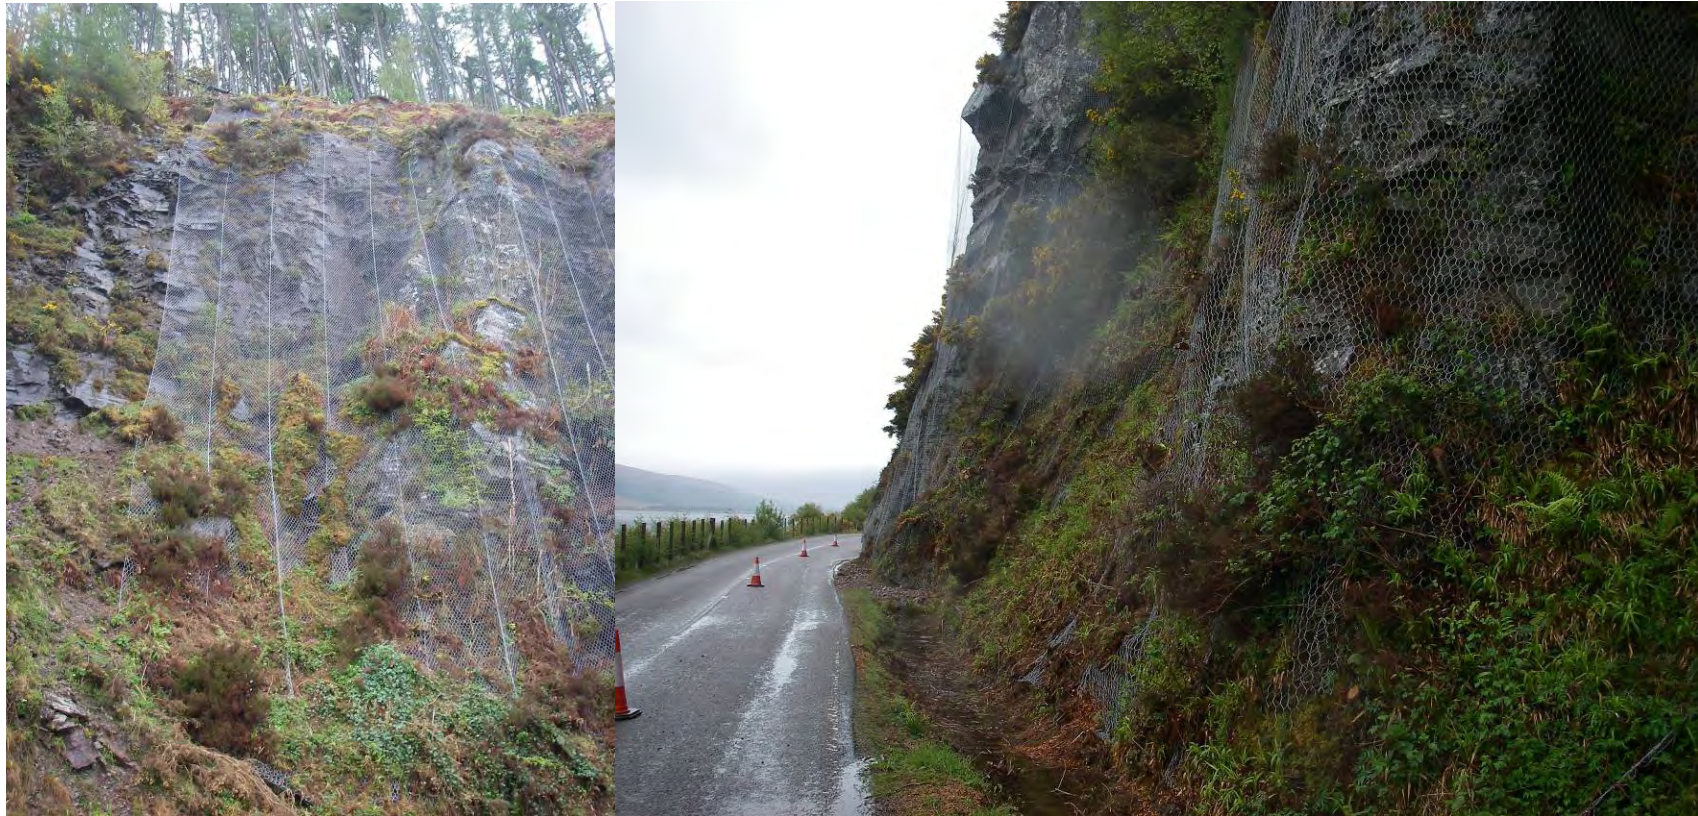
Dip: 70 to 80	Azimuth: 301	Height (m): 25 to 30	Length (m): 100	Vegetation Cover: 50-60% cover. Generally comprises ground cover and trees.	Ditch Details: 0.5m deep, 1.0m wide. Bund half way along	Roughness (Profile): Rough	Verge Width: 1-4m
---------------	--------------	----------------------	-----------------	---	--	----------------------------	-------------------

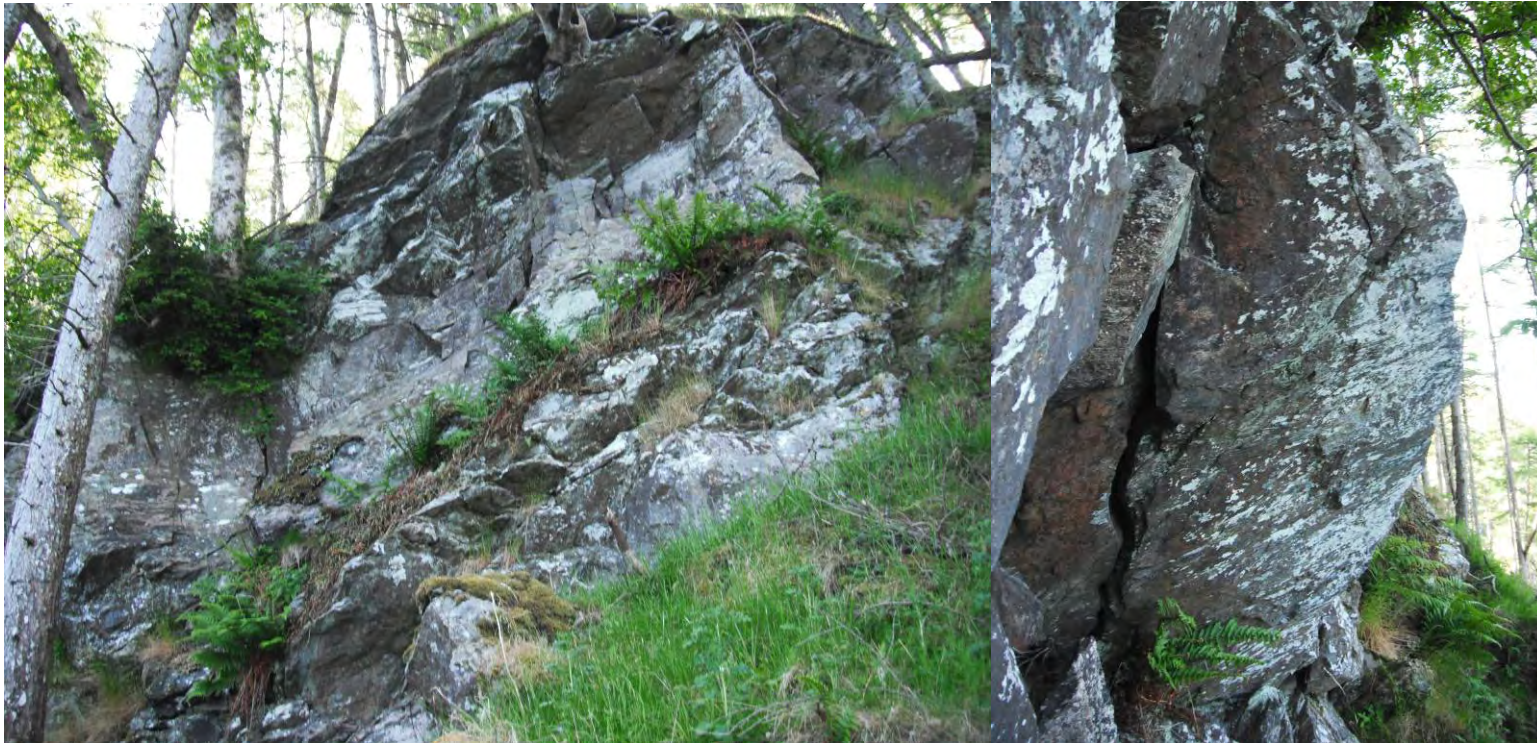
Site: A890 Stromeferry Bypass	Slope Ref: AA13/14 Upper	Chainage: 2505 – 2650	Start Grid Ref: NG 90830, 37319	End Grid Ref: NG 90904, 37388	Elevation: 90 mAOD
--	------------------------------------	---------------------------------	---	---	------------------------------

Principal Discontinuities:											
Set	Type	Dip	Azi.	Spacing	Persistence	Roughness	Aperture	Infill	Seepage	Comments	
1	Foliation	28	120	0.06 – 1.5m	5m	Wavy, Undulating, Rough	1 – 10mm	None	None		
2	Joint	88	205	0.2 – 1.7m	2m	Straight, Undulating, Rough	2 – 10mm	None	None		
3	Joint	70	300	0.5 – 1m	3m	Straight, Planar, Rough	15 – 50mm	None	None		
Existing Netting Details or other remedial work details:											
None											
Previous Rock Slope Hazard Index Value and Recommended Remedial Works (2010):						Current NGI 'Q' Value					
Not previously inspected.						4.1 – 8.2					
Potential Failure Types (From Stereographic Analysis):											
Ref	Type					Comments					
Hazards Observed:											
Ref	Type	Height above toe (m)	Size of individual failure(s) (m ³)	Comments							
1	Toppling	90m above road	6.6								
2	Blockfall	90m above road	0.5	Gouging of blocks in root balls of fallen trees.

SUMMARY				Comments							
Overall Hazard Rating =		3									
Pathway Rating =		2									
Receptor Rating =		1.2									
Risk Value =		7.2									
Risk Level =		Moderate									
Recommended Remedial Works / Actions				Residual Risk Value After Remedial Works / Actions			Timescales for Remedial works / Management Actions				
-Controlled removal of blocks -Include in future inspections				2.4			Within 3 yrs				
Assessed in field by:		RP		Date:		17/5/12		Reviewed by:		LN	
								Date:		5/7/12

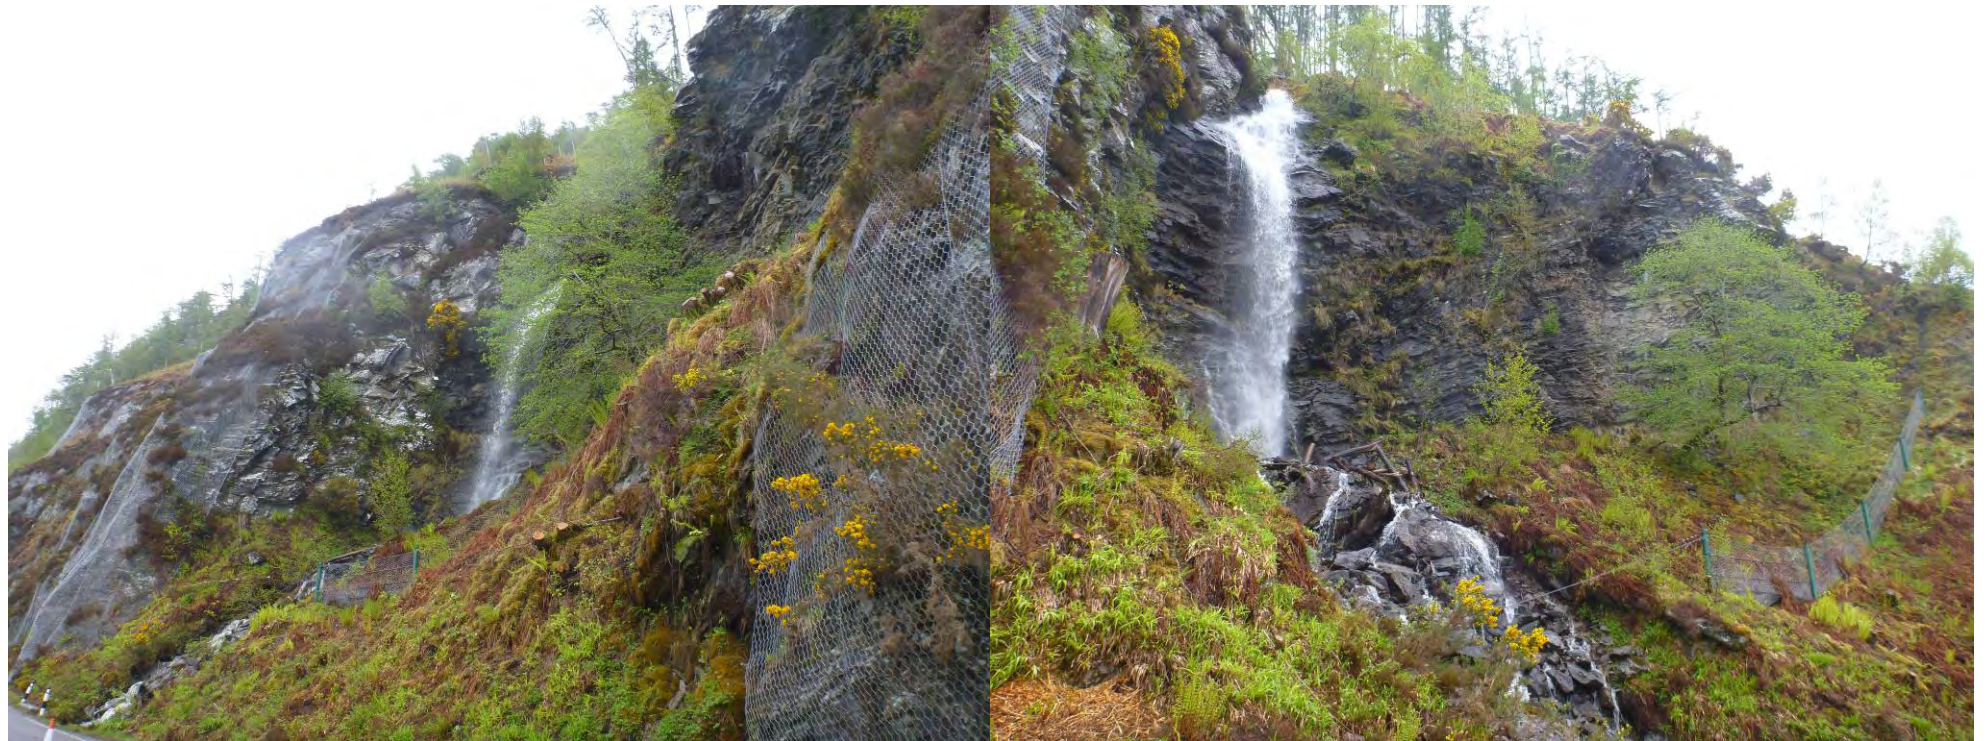
Site: A890 Stromeferry Bypass	Slope Ref: AA14E	Chainage: 2614 – 2650	Start Grid Ref: NG 90883, 37435	End Grid Ref: NG 90868, 37444	Elevation: 11 mAOD
--	-------------------------	------------------------------	--	--------------------------------------	---------------------------

Potential Failure Types (From Stereographic Analysis):										
Ref	Type	Comments								
1	Planar	Joint sets 2, 3 and 4								
2	Wedge	Joint sets 2 and 4, 2 and 3, 3 and 4								
Hazards Observed:										
Ref	Type	Height above toe (m)	Size of individual failure(s) (m ³)	Comments						
1	Wedge	15	0.25							
2	Planar	17	3							
3	Blockfall	25	0.015							
4	Ravelling	20	0.002							
SUMMARY				Comments						
Overall Hazard Rating =		3								
Pathway Rating =		1								
Receptor Rating =		1.4								
Risk Value =		4.2								
Risk Level =		Low								
Recommended Remedial Works / Actions				Residual Risk Value After Remedial Works / Actions			Timescales for Remedial works / Management Actions			
Observation, remove any failed material if failure occurs				4.2			NA			
Assessed in field by: RA		Date: 17/5/12		Reviewed by: LN			Date: 5/7/12

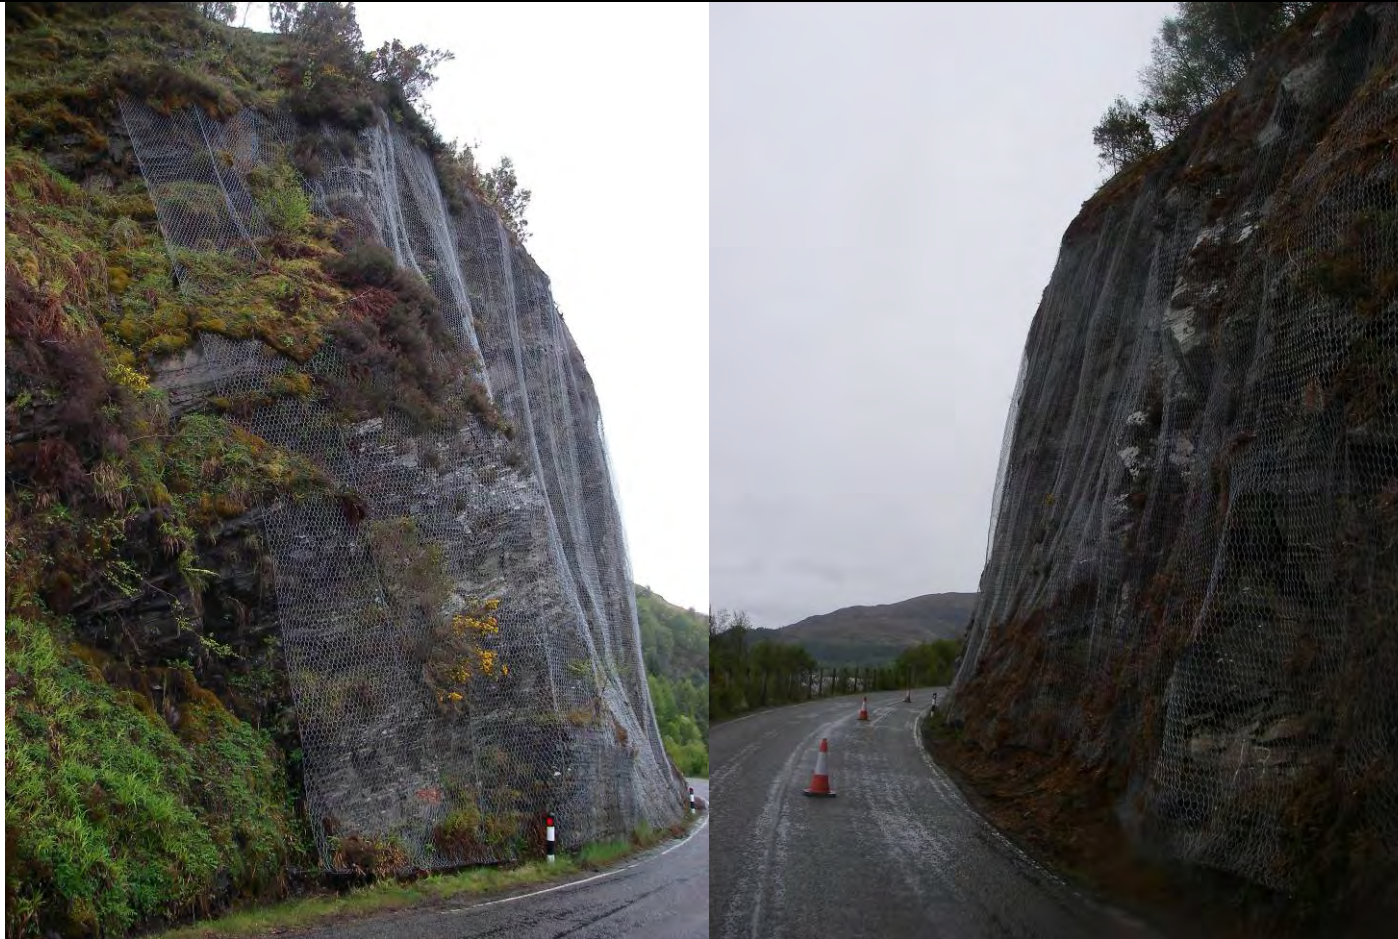
Site: A890 Stromeferry Bypass	Slope Ref:	AA14W	Chainage: 2250 – 2614	Start Grid Ref: NG 90795, 37399	End Grid Ref: NG 90833, 37435	Elevation: 12 mAOD
--	-------------------	-------	------------------------------	--	--------------------------------------	---------------------------

Previous Rock Slope Hazard Index Value and Recommended Remedial Works (2010):						Current NGI 'Q' Value				
RSHV = 8 Ch 2500 – 2539: Remove vegetation from rock slope at crest area. Ch 2543: Rock fall (<0.125m ³) material lying on top of buttress. Keep under particular observation during periodic inspections. Rope access inspection of area above buttress.						1.5 – 4.4				
Potential Failure Types (From Stereographic Analysis):										
Ref	Type								Comments	
1	Toppling								Joint set 2	
2	Planar								Joint set 4	
Hazards Observed:										
Ref	Type	Height above toe (m)	Size of individual failure(s) (m ³)	Comments						
1	Wedge	10	3							
2	Planar	5	2							
3	Blockfall	10	1							
SUMMARY				Comments						
Overall Hazard Rating =		3								
Pathway Rating =		4		Only 2 No. top anchors (both rotting tree stumps) over 40m length of cable. Terminal anchors in poor condition

Receptor Rating =	1.2			
Risk Value =	14.4			
Risk Level =	High			
Recommended Remedial Works / Actions		Residual Risk Value After Remedial Works / Actions	Timescales for Remedial works / Management Actions	
- Install top anchors and top cable		3.6	Within 1yr	
Assessed in field by:	RA	Date: 17/6/12	Reviewed by:	LN
			Date:	5/7/12

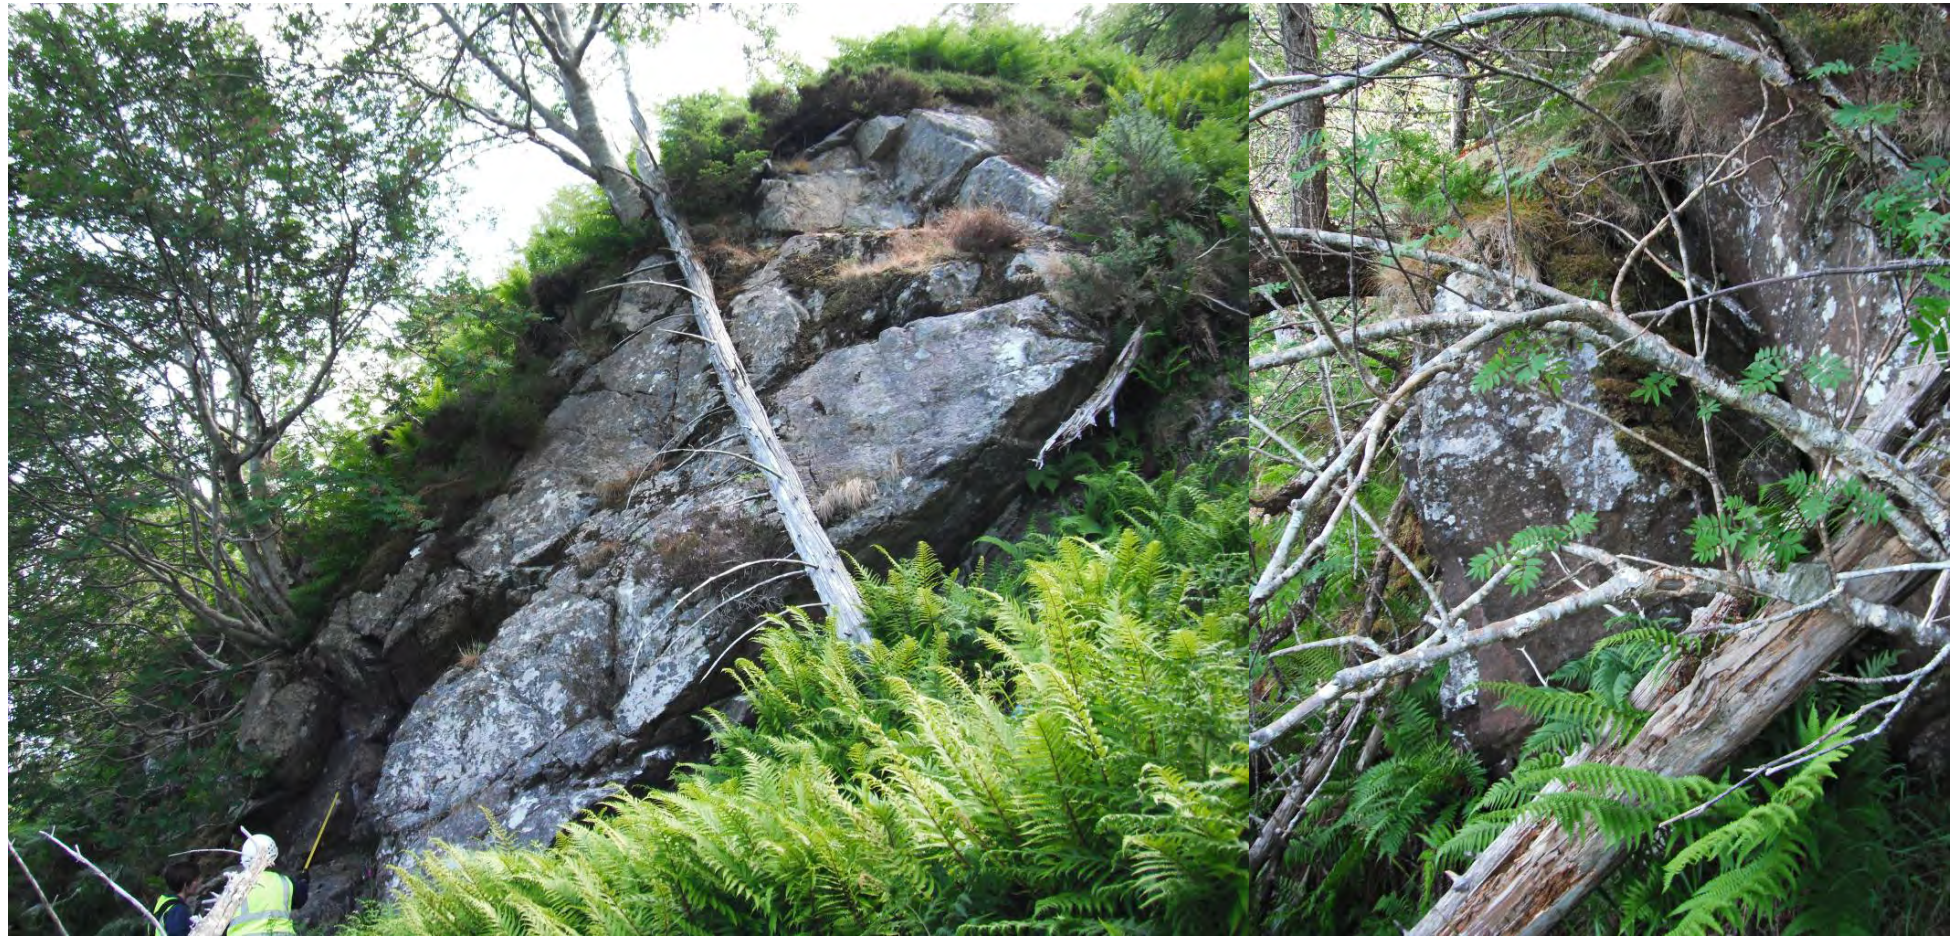
Site: A890 Stromeferry Bypass	Slope Ref: AA15 Upper	Chainage: 2710 – 2733	Start Grid Ref: NG 90955, 37420	End Grid Ref: NG 90971, 37437	Elevation: 100 mAOD
--	---------------------------------	---------------------------------	---	---	-------------------------------

2	Wedge									Joint set 1 and 3, 1 and 2, 2 and 4, 4 and 3.
Developing Hazards Observed (Considered likely to fail with the next 5 years):										
Ref	Type	Height above toe (m)	Size of individual failure(s) (m ³)	Comments						
1	Blockfall	100 (above road level)	4	Block is undercut and wedged in behind a flake that shows signs of dilation						
2	Ravelling	100 (above road level)	0.025							
3										
SUMMARY				Comments						
Overall Hazard Rating =		3								
Pathway Rating =		5								
Receptor Rating =		1.2								
Risk Value =		18								
Risk Level =		Very high

Recommended Remedial Works / Actions	Residual Risk Value After Remedial Works / Actions	Timescales for Remedial works / Management Actions
Controlled removal of block using pyrotechnic breaking capsules	4.8	Within 1 yr
Assessed in field by: RP	Date: 17/5/12	Reviewed by: LN
Date: 5/7/12

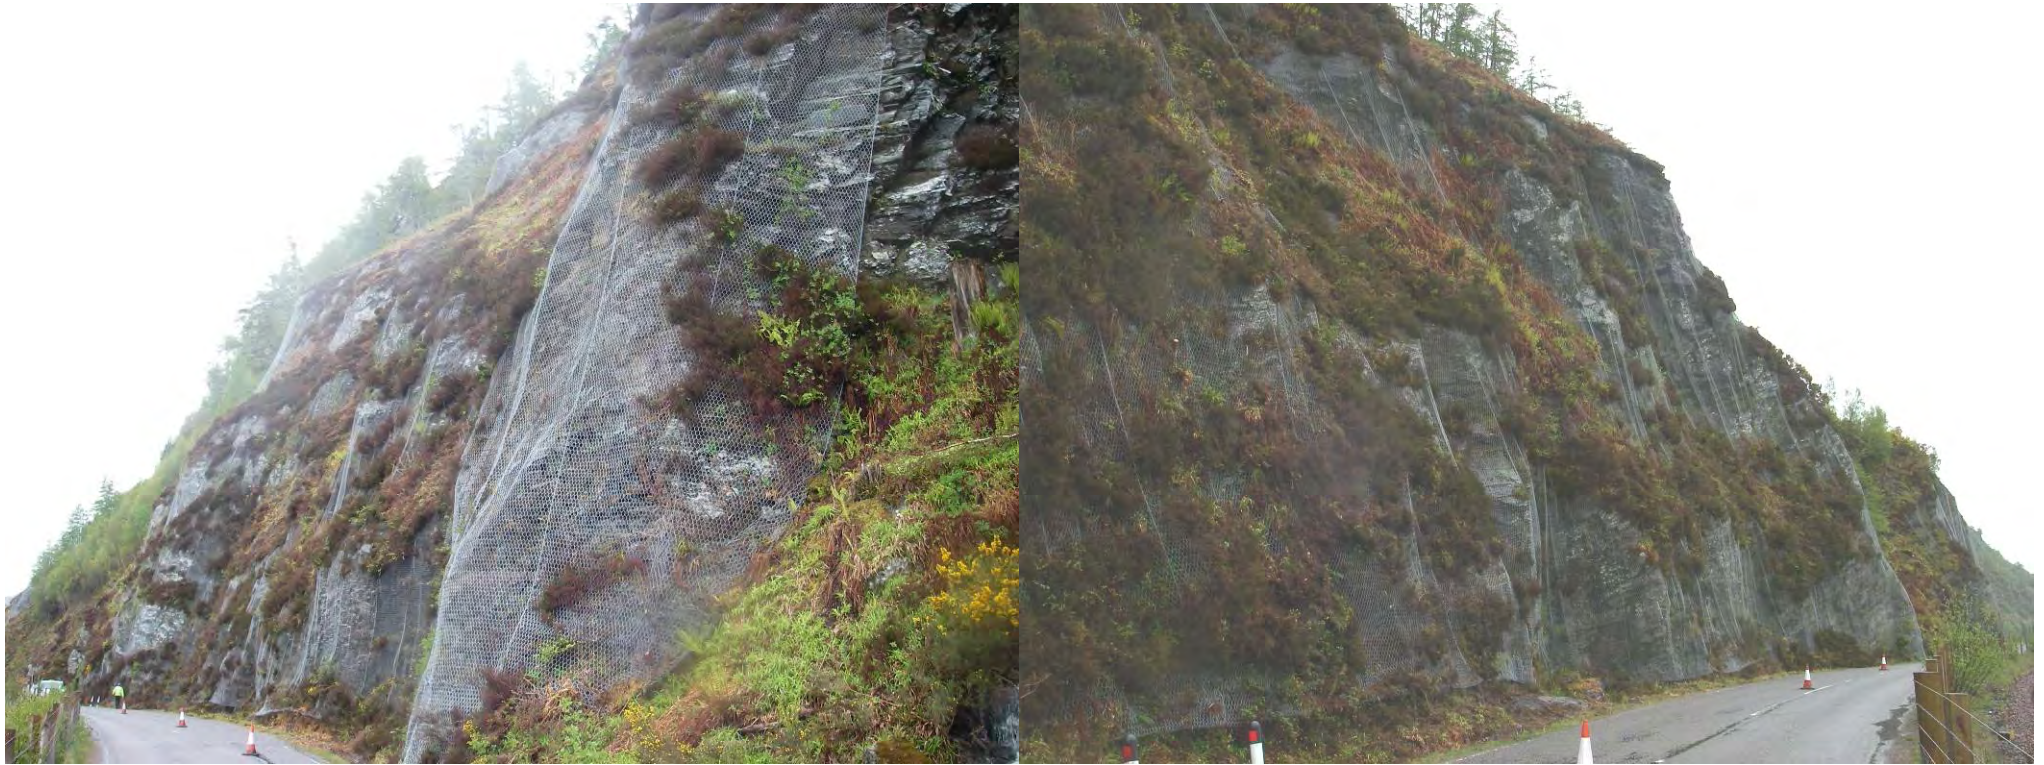
Site: A890 Stromeferry Bypass	Slope Ref: AA15	Chainage: 2650 – 2800	Start Grid Ref: NG 90868, 37444	End Grid Ref: NG 91005, 37551	Elevation: 18 mAOD
--	------------------------	------------------------------	--	--------------------------------------	---------------------------

Previous Rock Slope Hazard Index Value and Recommended Remedial Works (2010):						Current NGI 'Q' Value				
RSHV = 9 Ch 2592 – 2760: Remove vegetation from rock slope and crest area						2.6 – 5.2				
Potential Failure Types (From Stereographic Analysis):										
Ref	Type					Comments				
1	Planar					Joint set 3				
2	Toppling					Joint set 4				
3	Wedge					Joint set 2 and 3				
Developing Hazards Observed (Considered likely to fail with the next 5 years):										
Ref	Type	Height above toe (m)	Size of individual failure(s) (m ³)	Comments						
1	Planar	10 - 20	6	Ch 2700						
2										
3										
SUMMARY				Comments						
Overall Hazard Rating =		3								
Pathway Rating =		2								
Receptor Rating =		1.2								
Risk Value =		7.2								
Risk Level =		Moderate

Recommended Remedial Works / Actions		Residual Risk Value After Remedial Works / Actions	Timescales for Remedial works / Management Actions	
- Add reinforcing cable across at potential failure Ch 2700 - Ch 2788 create bund		3.6	3 -5yrs	
Assessed in field by: RA	Date: 17/6/12	Reviewed by: LN	Date: 5/7/12

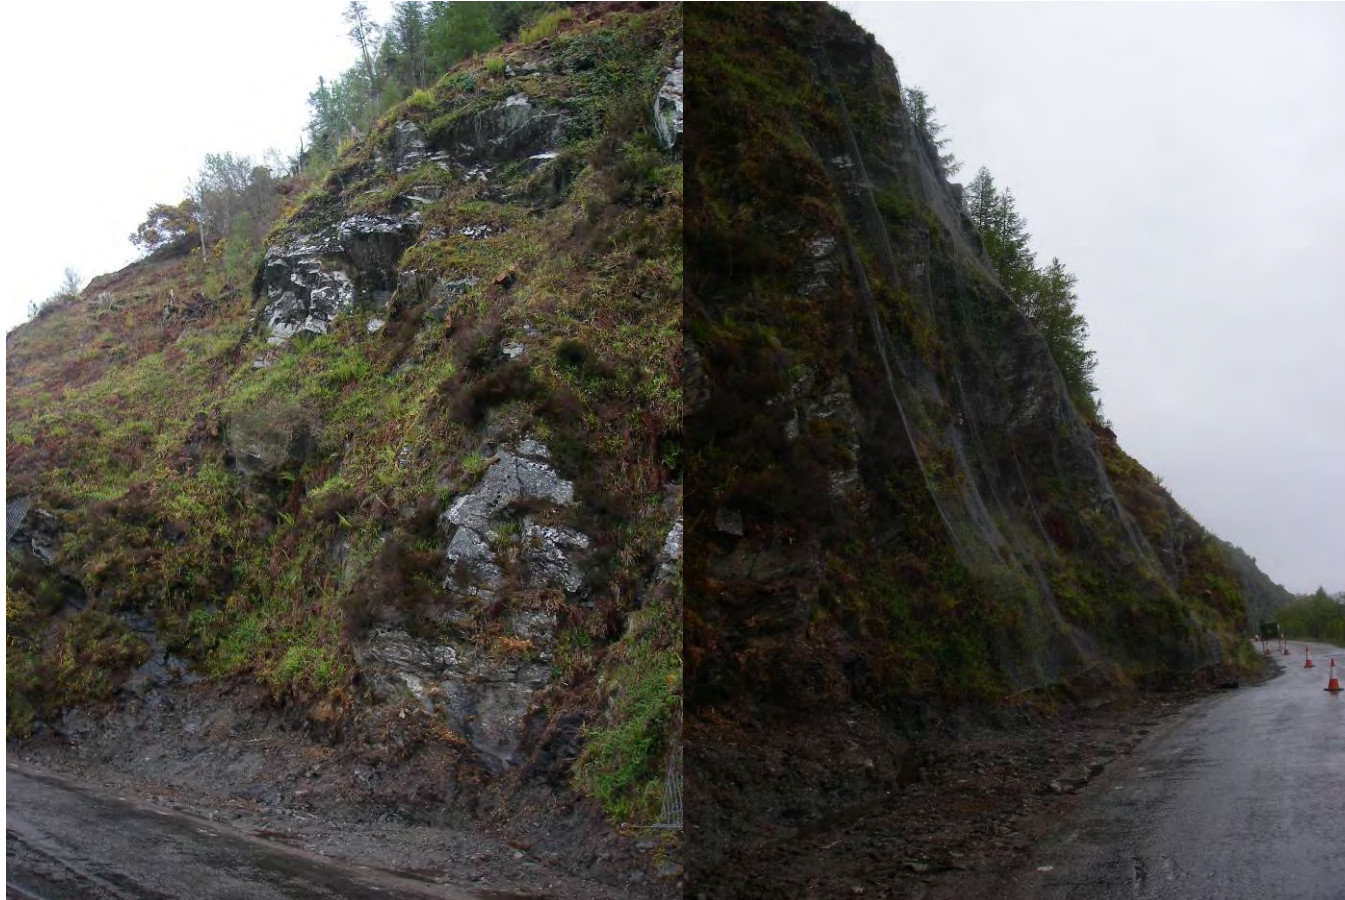
Site: A890 Stromeferry Bypass	Slope Ref: AA16	Chainage: 2800 - 2894	Start Grid Ref: NG 91005, 37551	End Grid Ref: NG 91069, 37600	Elevation: 18 mAOD
--	------------------------	---------------------------------	---	---	---------------------------

Previous Rock Slope Hazard Index Value and Recommended Remedial Works (2010):						Current NGI 'Q' Value				
RSHV = 9						3.7 – 7.4				
Potential Failure Types (From Stereographic Analysis):										
Ref	Type								Comments	
1	Planar								Joint set 2 and 3	
2	Wedge								Joint sets 2 and 3, 3 and 4, 2 and 4	
Hazards Observed:										
None observed										
SUMMARY				Comments						
Overall Hazard Rating =		1								
Pathway Rating =		1								
Receptor Rating =		1								
Risk Value =		1								
Risk Level =		Low

Recommended Remedial Works / Actions		Residual Risk Value After Remedial Works / Actions	Timescales for Remedial works / Management Actions	
Maintain netting		1	NA	
Assessed in field by: RA	Date: 17/5/12	Reviewed by: LN	Date: 5/7/12

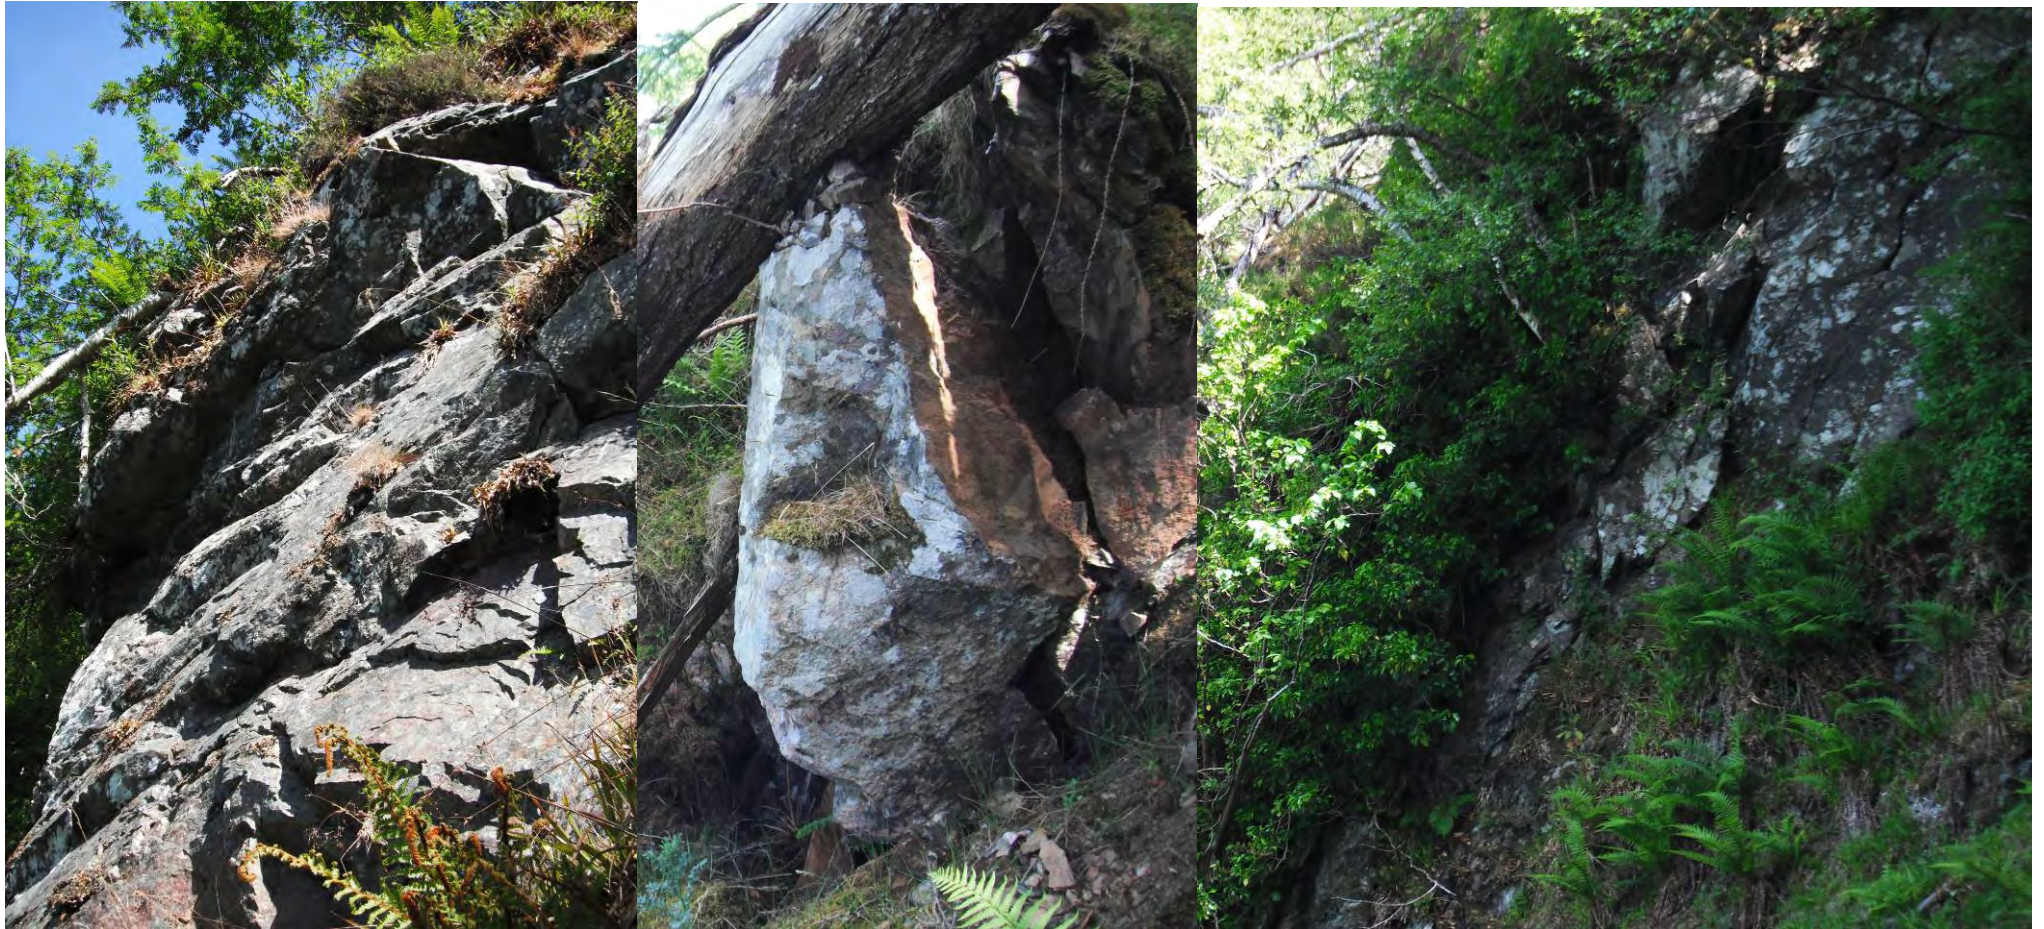
Site: A890 Stromeferry Bypass	Slope Ref: AA16-AA17 Upper	Chainage: 2766 – 2901	Start Grid Ref: NG 91016, 37460	End Grid Ref: NG 91089, 37577	Elevation: 50 mAOD
--	--------------------------------------	---------------------------------	---	---	------------------------------

Not previously inspected						3.3 – 6.6					
Potential Failure Types (From Stereographic Analysis):											
Ref	Type					Comments					
1	Planar					Foliation					
2	Wedge					Joint set 3 and 4					
Developing Hazards Observed (Considered likely to fail with the next 5 years):											
Ref	Type	Height above toe (m)	Size of individual failure(s) (m ³)	Comments							
1	Blockfall	100m above road	0.5								
2	Toppling	85m above road	0.6	5 No. at one location (NG 91054, 37487)							
3	Planar	60m above road	1.875								
SUMMARY			Comments								
Overall Hazard Rating =	3		Only ~1/4 of rock inspected due to vegetation cover								
Pathway Rating =	3										
Receptor Rating =	1.2										
Risk Value =	10.8										
Risk Level =	High

Recommended Remedial Works / Actions		Residual Risk Value After Remedial Works / Actions	Timescales for Remedial works / Management Actions	
Controlled removal of large blocks Light scaling		3.6	1 yr	
Assessed in field by: RP	Date: 17/5/12	Reviewed by: LN	Date: 5/7/12

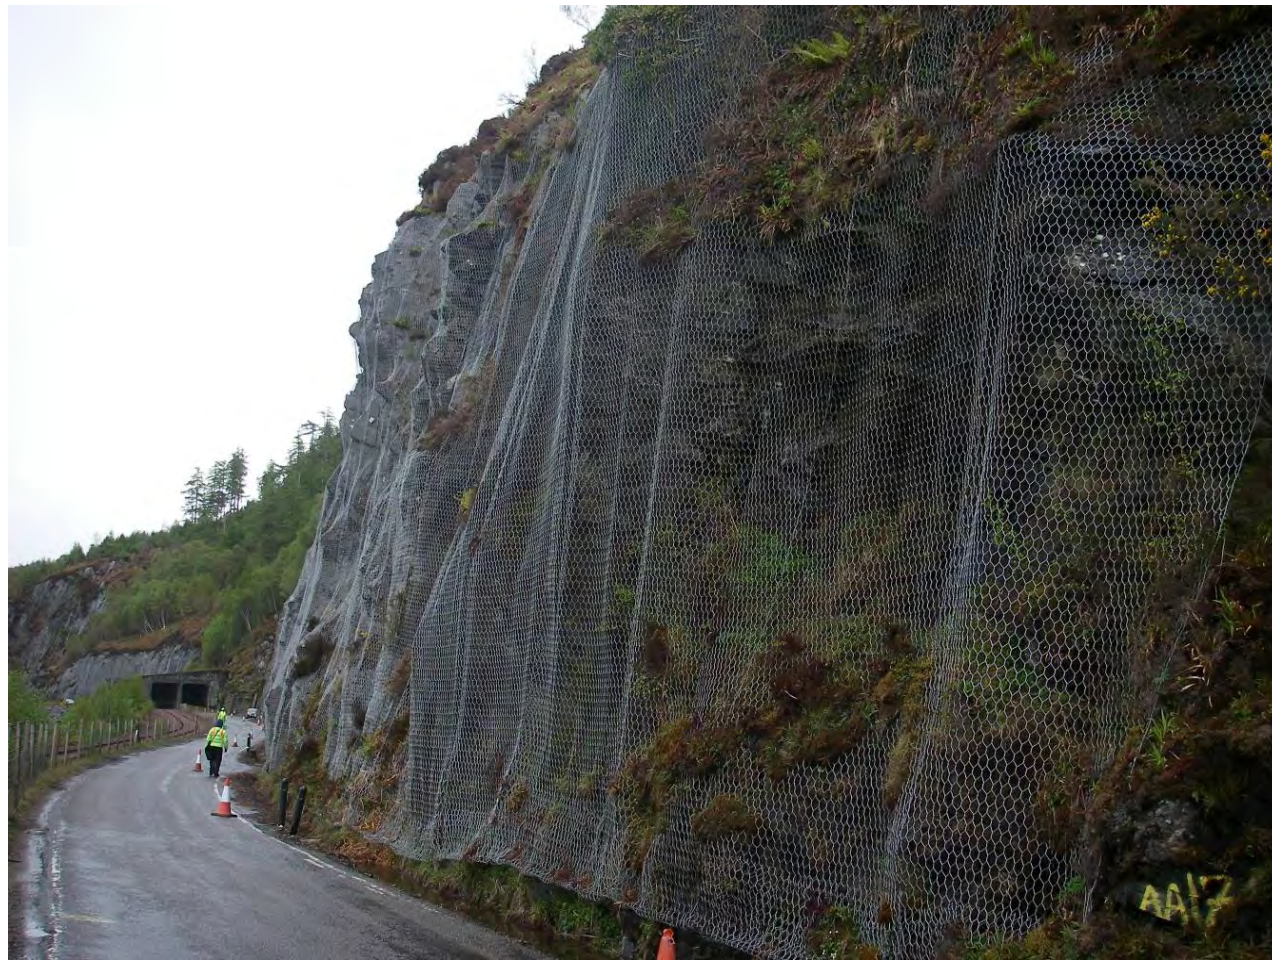
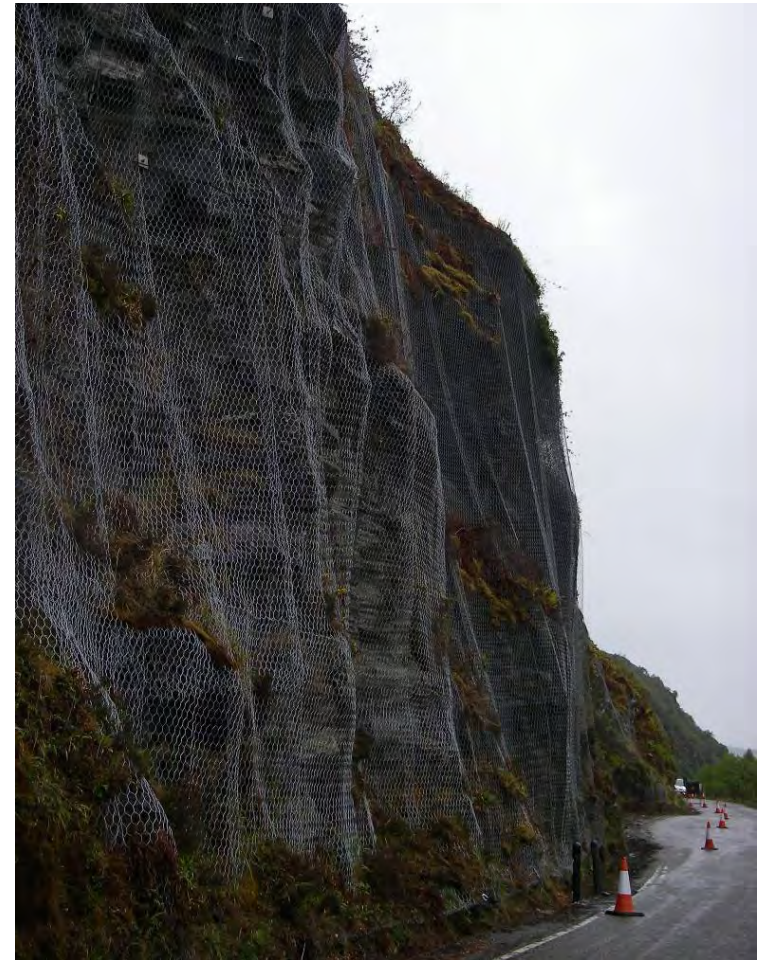
Site: A890 Stromeferry Bypass	Slope Ref: AA17	Chainage: 2894 - 2958	Start Grid Ref: NG 91069, 37600	End Grid Ref: NG 91127, 37628	Elevation: 11 mAOD
--	------------------------	---------------------------------	---	---	------------------------------

Previous Rock Slope Hazard Index Value and Recommended Remedial Works (2010):						Current NGI 'Q' Value				
RSHV = 13 Ch 2860: column of fractured rock under the netting by "Hughie MacKenzy" graffiti – keep under observation during periodic and annual inspections.						2.5 – 7.5				
Potential Failure Types (From Stereographic Analysis):										
Ref	Type						Comments			
Hazards Observed:										
Ref	Type	Height above toe (m)	Size of individual failure(s) (m ³)	Comments						
1	Planar	2.5	3	Failed and resting on netting

SUMMARY		Comments	
Overall Hazard Rating =	3		
Pathway Rating =	4		
Receptor Rating =	1.2		
Risk Value =	14.4		
Risk Level =	High		
Recommended Remedial Works / Actions		Residual Risk Value After Remedial Works / Actions	Timescales for Remedial works / Management Actions
Ch 2918 – 2958: new top anchors and cable. Addition of spenax jointing to old netting. Also remove failed mass from behind netting.		3.6	3 yrs
Assessed in field by: RA	Date: 17/5/12	Reviewed by: LN	Date: 5/7/12

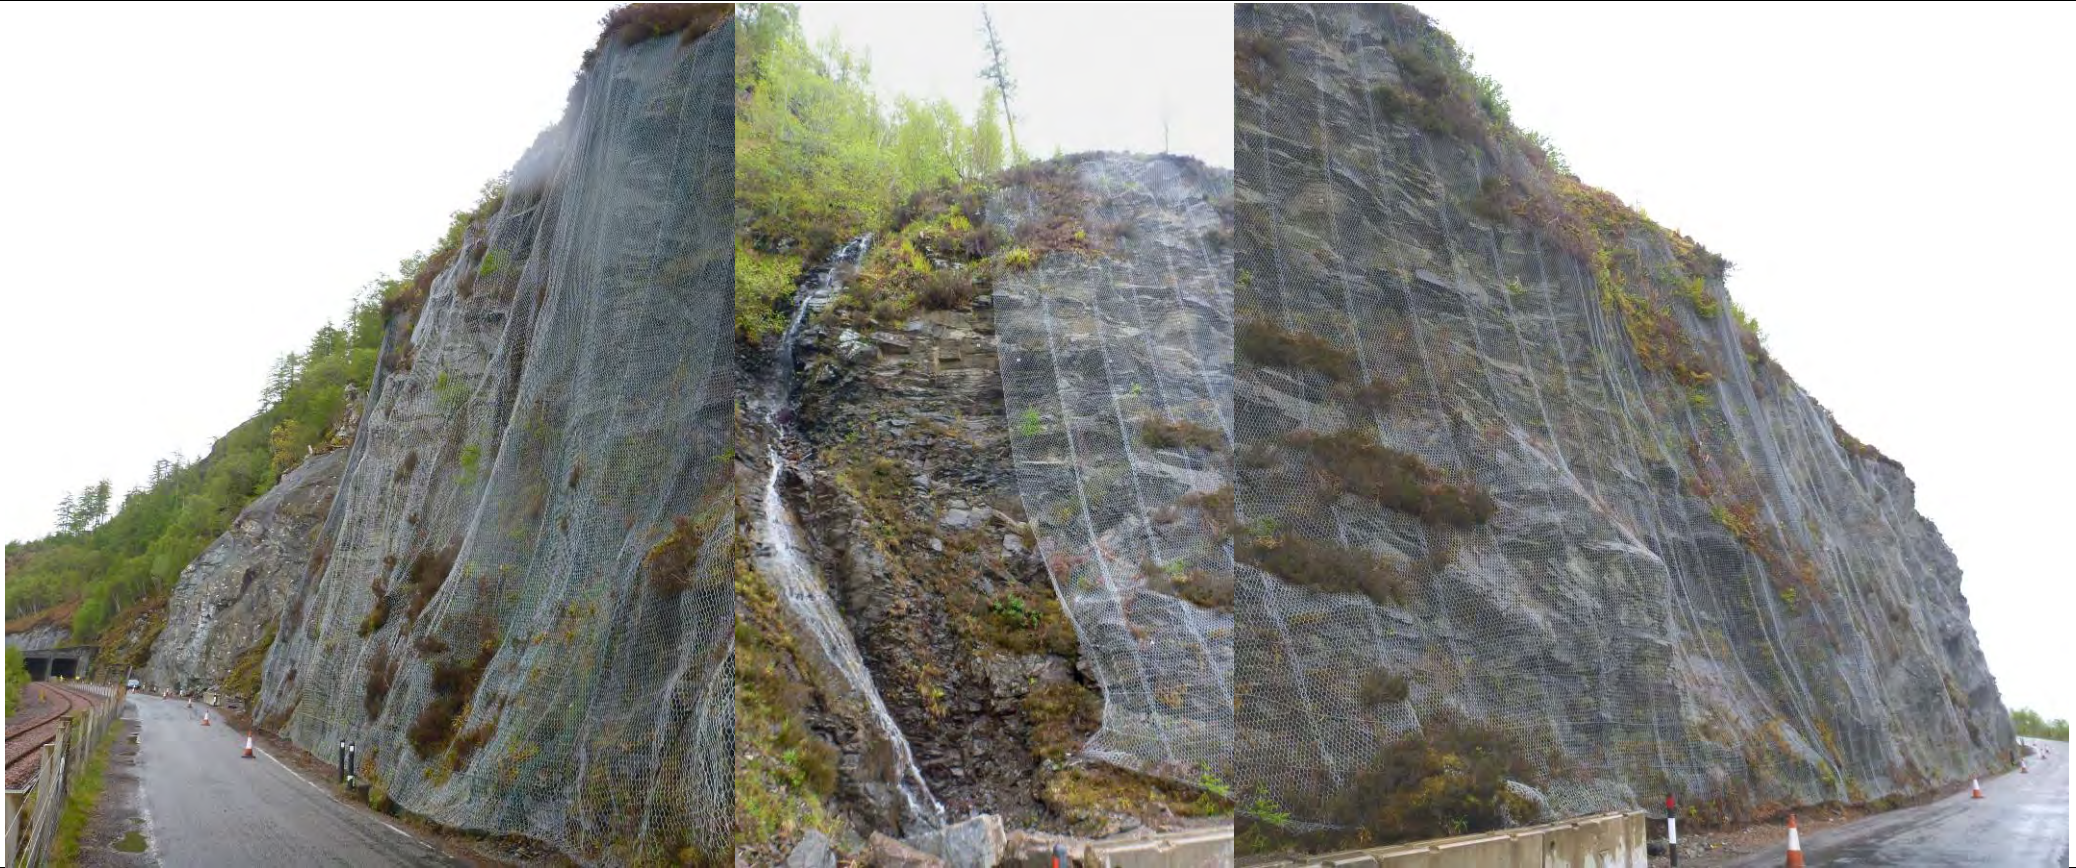
Site: A890 Stromeferry Bypass	Slope Ref: AA18	Chainage: 2958 – 3050	Start Grid Ref: NG 91127, 37628	End Grid Ref: NG 91198, 37638	Elevation: 10 mAOD
--	------------------------	---------------------------------	---	---	------------------------------

3	Wedge	Joint sets 4 and 5, 5 and 3, 5 and 2, 2 and 3									
Hazards Observed:											
Ref	Type	Height above toe (m)	Size of individual failure(s) (m ³)	Comments							
1	Planar	10	0.3								
2	Wedge	10	0.4								
SUMMARY			Comments								
Overall Hazard Rating =		2									
Pathway Rating =		1									
Receptor Rating =		1.2									
Risk Value =		2.4									
Risk Level =		Low

Recommended Remedial Works / Actions		Residual Risk Value After Remedial Works / Actions	Timescales for Remedial works / Management Actions	
None		N/A	N/A	
Assessed in field by: RA	Date: 17/5/12	Reviewed by: LN	Date: 5/7/12

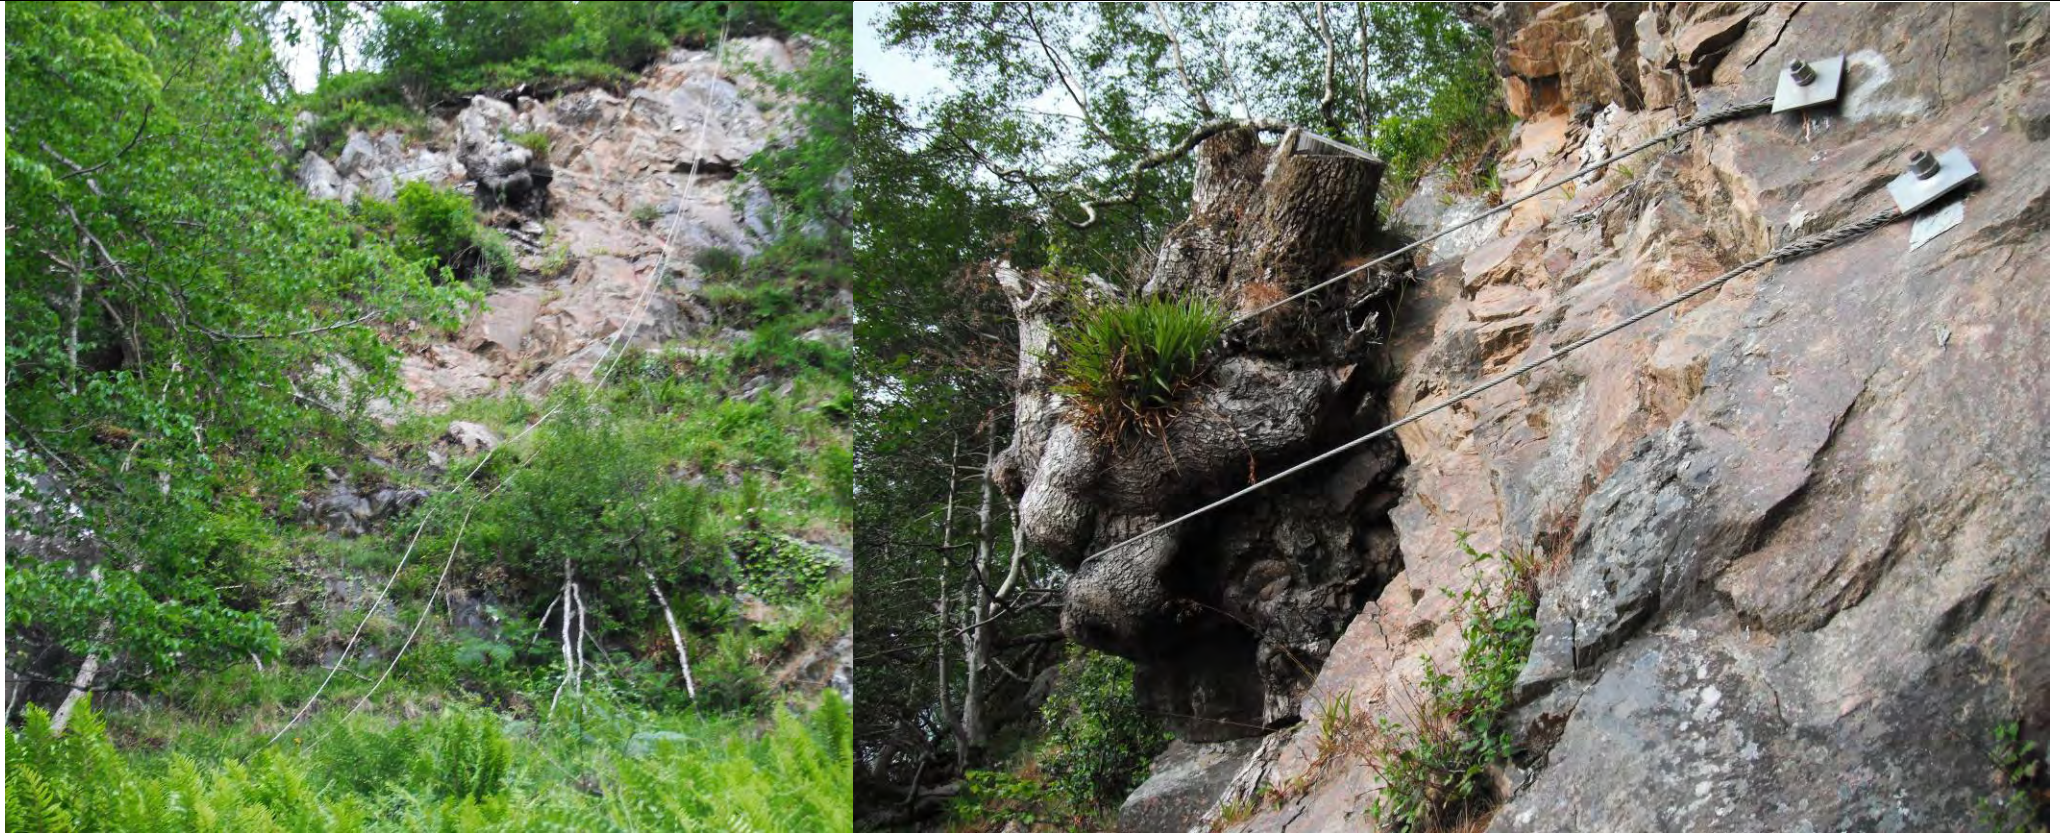
Site: A890 Stromeferry Bypass	Slope Ref: AA19 Upper	Chainage: 3050 - 3123	Start Grid Ref: NG 91198, 37638	End Grid Ref: NG 91278, 37685	Elevation: 60 mAOD
--	------------------------------	---------------------------------	---	---	------------------------------

Previous Rock Slope Hazard Index Value and Recommended Remedial Works (2010):					Current NGI 'Q' Value						
NA					2.2 – 6.6						
Potential Failure Types (From Stereographic Analysis):											
Ref	Type				Comments						
1	Planar				Foliation, Joint set 3						
2	Wedge				Joint set 3 and 4						
Developing Hazards Observed (Considered likely to fail with the next 5 years):											
Ref	Type	Height above toe (m)	Size of individual failure(s) (m ³)		Comments						
1	Blockfall	60	0.5 – 1.0								
2	Planar	60	0.5 – 1.0								
3	Ravelling	60	0.125								
4	Root jacking	60	0.125

SUMMARY		Comments	
Overall Hazard Rating =	2		
Pathway Rating =	3		
Receptor Rating =	1		
Risk Value =	6		
Risk Level =	Moderate		
Recommended Remedial Works / Actions		Residual Risk Value After Remedial Works / Actions	Timescales for Remedial works / Management Actions
-Scale face -Remove 2m ³ tree stump currently retained by cable straps and add nut to existing rock dowel to secure face plate -Remove fallen/cut logs from above AA19		3	1 yr
Assessed in field by:	RP	Date: 17/5/12	Reviewed by: LN Date: 5/7/12

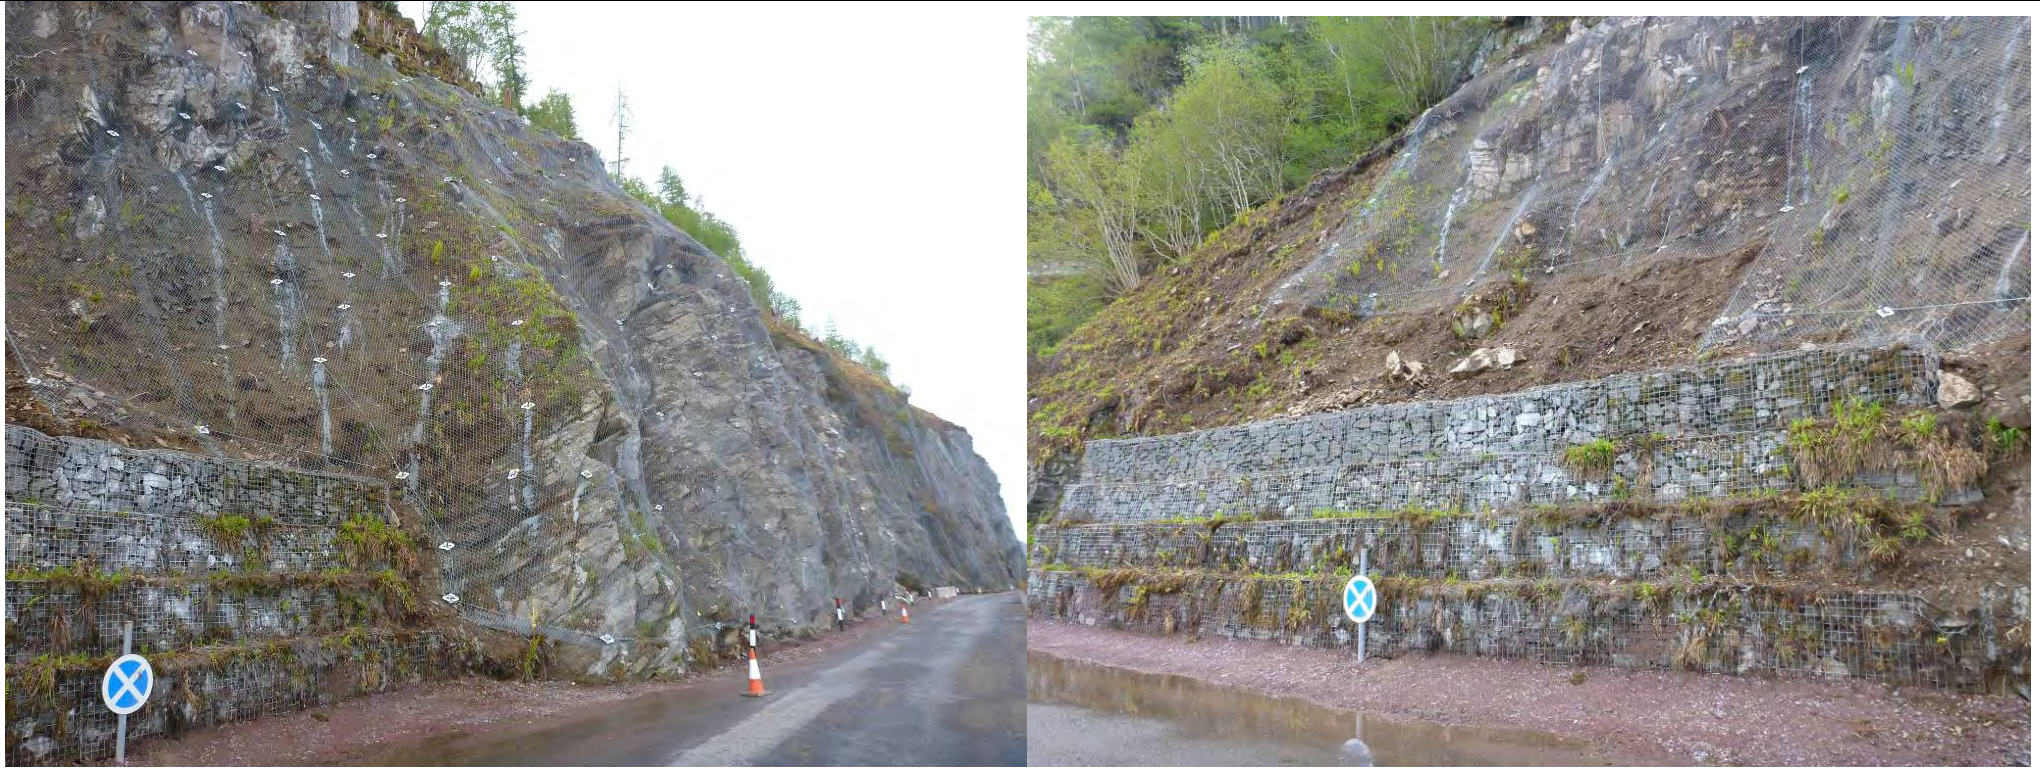
Site: A890 Stromeferry Bypass	Slope Ref: AA19	Chainage: 3050 – 3123	Start Grid Ref: NG 91198, 37638	End Grid Ref: NG 91278, 37685	Elevation: 10 mAOD
--	------------------------	---------------------------------	---	---	------------------------------

Previous Rock Slope Hazard Index Value and Recommended Remedial Works (2010):						Current NGI 'Q' Value				
RSHV = <1						2.1 – 4.2				
Potential Failure Types (From Stereographic Analysis):										
Ref	Type									Comments
1	Planar									Joint set 4
2	Wedge									Joint set 2 and 4
Hazards Observed:										
Ref	Type	Height above toe (m)	Size of individual failure(s) (m ³)	Comments						
SUMMARY				Comments						
Overall Hazard Rating =		1								
Pathway Rating =		1								
Receptor Rating =		1								
Risk Value =		1								
Risk Level =		Low								
Recommended Remedial Works / Actions				Residual Risk Value After Remedial Works / Actions			Timescales for Remedial works / Management Actions			
None				N/A			N/A			
Assessed in field by: RA		Date: 17/5/12		Reviewed by: LN			Date: 5/7/12
