Stromeferry Bypass, The Scottish Highlands

A890 Slope Inspection
Report

September 2012

Prepared for:
The Highland Council

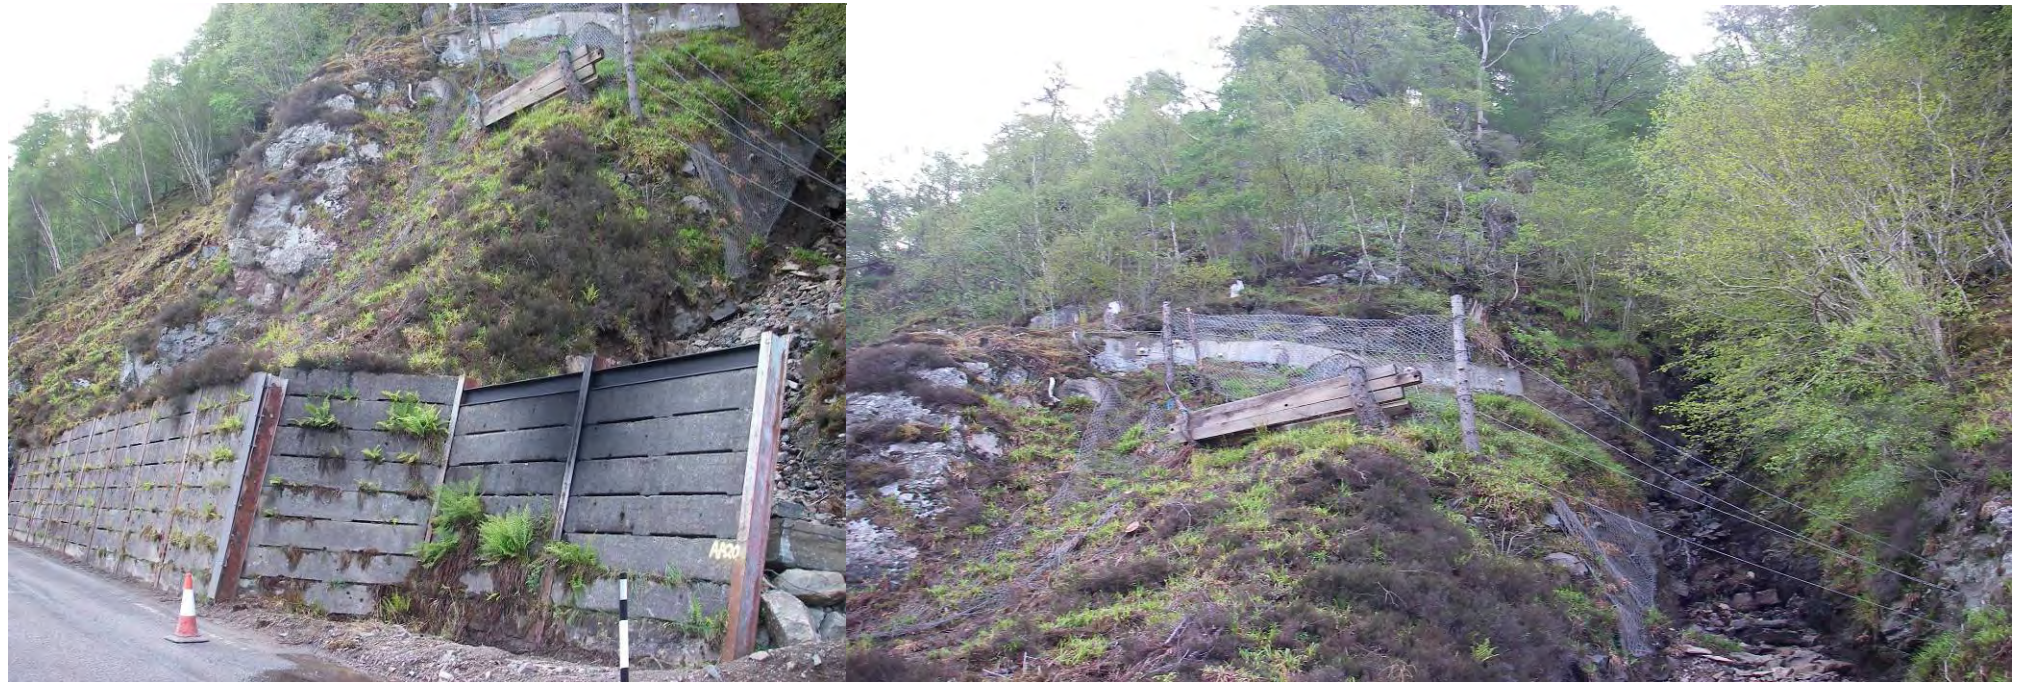
RSHV = 5
 Ch 3080: 'I' beam post – the measurements do not enable monitoring of the whole wall. Hence, additional telltales and an inclinometer should be installed.
 The 'I' beams require maintenance to treat existing corrosion and to protect the steel work from further corrosion.
 Clear culverts.

Ref	Type	Height above toe (m)	Size of individual failure(s) (m ³)	Comments
1	Toppling	2	0.75	Tight (2 – 3mm) joints not going to fail imminently
2				
3				
4

Comments
Overall Hazard Rating =	2
Pathway Rating =	3
Receptor Rating =	1.2
Risk Value =	7.2
Risk Level =	Moderate

Recommended Remedial Works / Actions		Residual Risk Value After Remedial Works / Actions	Timescales for Remedial works / Management Actions	
1 No. rock dowel Clear out base of gully behind fence		1.2	3 – 5 yrs	
Assessed in field by: RA	Date: 18/5/12	Reviewed by: LN	Date: 5/7/12

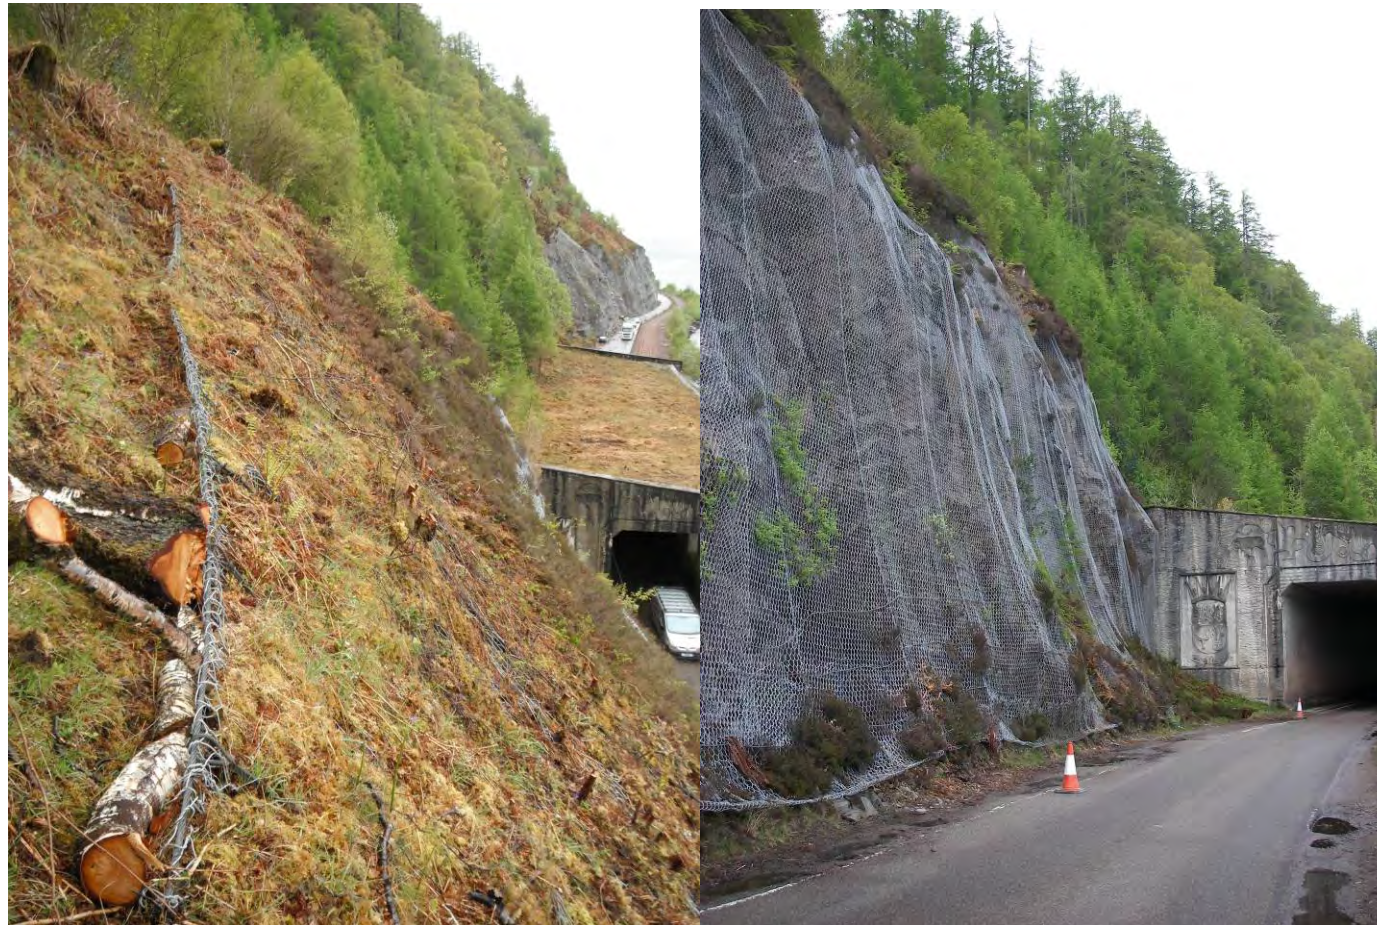
Engineering Description of Rock:										
Very strong thinly foliated dark grey GNEISS with white quartz banding.										
Principal Discontinuities:										
Set	Type	Dip	Azi.	Spacing	Persistence	Roughness	Aperture	Infill	Seepage	Comments
1	Foliation	45	140	0.5 – 2m	>20m	Straight, Undulating, Rough	<0.1 – 2mm	None	None	
2	Joint	90	317	Not observed	>20m	Straight, Planar	Not observed	None	None	
3	Joint	30	043	2m	3m	Straight, Planar	Not observed	None	None	
4	Joint	60	320	0.5 – 2m	6m	Straight, Planar	Not observed	None	None	
Existing Netting Details or other remedial work details:										
Netting Type	Top cable	Typical anchor spacing (m)	Anchor Type	Cable-Anchor connection	No. of cable clamps	Netting lap connections	Laps on anchors	Vertical Reinforcing	Notes	
PVC coated double twist	16mm galvanised	5 – 5.5m	25mm? galvanized bars	Stainless steel eye nuts (bar machined to M20 thread)	4	2 rows of staggered spenax rings	Yes, every fourth anchor. 2 cable clamps on each side	8mm cable at 1m spacing (2 cable clamps)	Logs resting on top cable to be removed. Unused resin capsules noted at slope crest

Previous Rock Slope Hazard Index Value and Recommended Remedial Works (2010):						Current NGI 'Q' Value				
RSHV = 8 Ch 3271: removal block next to buttress						2.0 – 6.0				
Potential Failure Types (From Stereographic Analysis):										
Ref	Type								Comments	
1	Toppling								Foliation	
2	Planar								Joint set 4	
Hazards Observed:										
Ref	Type	Height above toe (m)	Size of individual failure(s) (m ³)	Comments						
1	Toppling	5	5	Failure at end of netting where water flows over face						
SUMMARY				Comments						
Overall Hazard Rating =		3								
Pathway Rating =		2								
Receptor Rating =		1								
Risk Value =		6								
Risk Level =		Moderate

Recommended Remedial Works / Actions	Residual Risk Value After Remedial Works / Actions	Timescales for Remedial works / Management Actions
3 – 4 No. logs trapped under top cable to be removed Bolt and light scale unnetted area	2	3 – 5 yrs
Assessed in RA field by:	Date: 18/5/12	Reviewed by: LN
		Date: 5/7/12
