# A890 Stromeferry Bypass

Annual Slope Inspection Report 2022

The Highland Council

07 September 2022

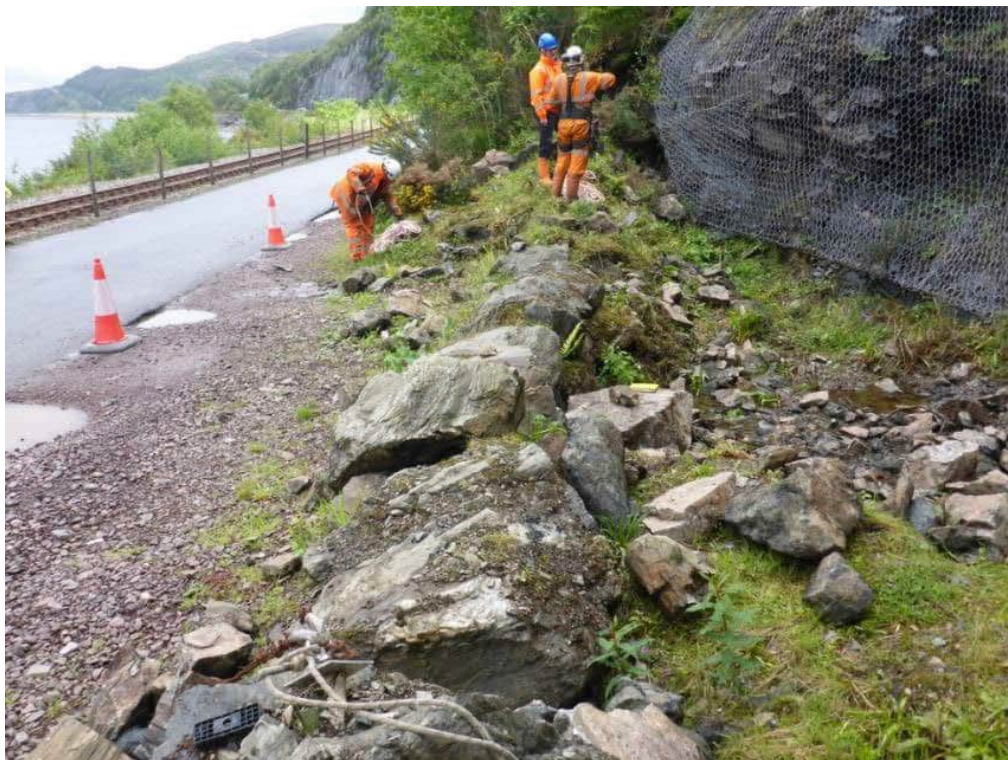
Between the toe of the slope and edge of the road there is a lower area associated with the watercourse which acts as a rock-trap feature (photos 2 and 3). This lower area measures approximately 2 to 5m wide, 10m long and 0.5 to 1.0m deep. This catch pit was partially constructed using scaled boulders generated from adjacent rock slope remedial works in 2012.

**Photo 3: Edge of debris catch pit between toe of slope and road. Recent debris visible on both side of 'bund' formed of boulders sourced from previous scaling works from adjacent rock cuttings.**

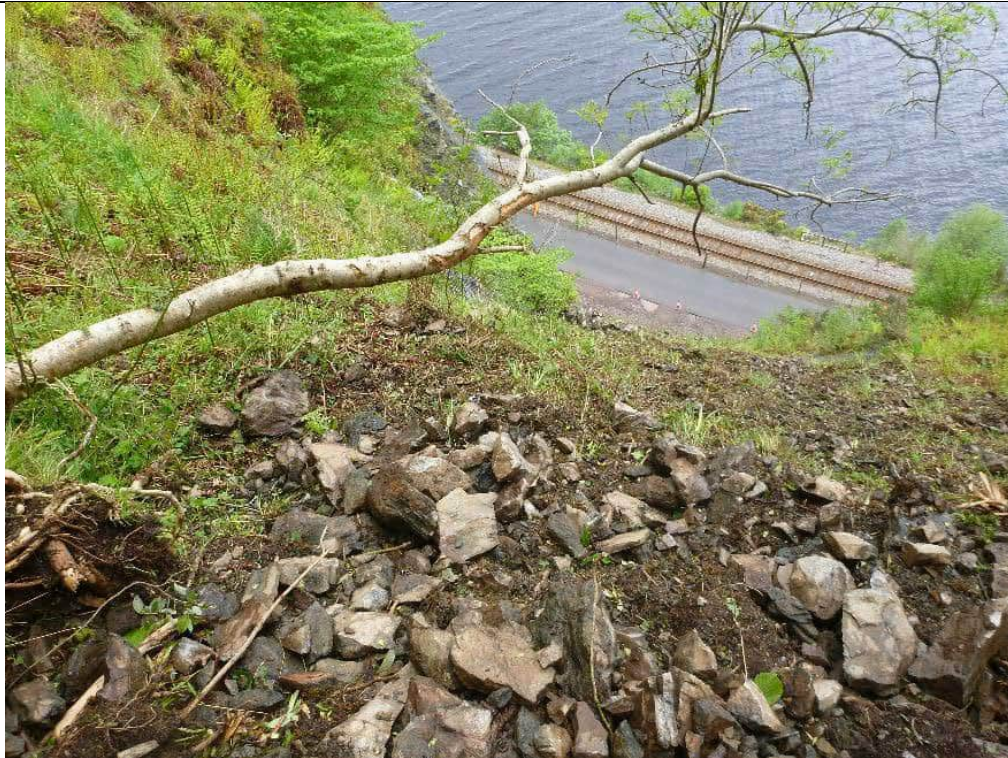
**Photo 8: Scree accumulation on break of slope below upper crags.**

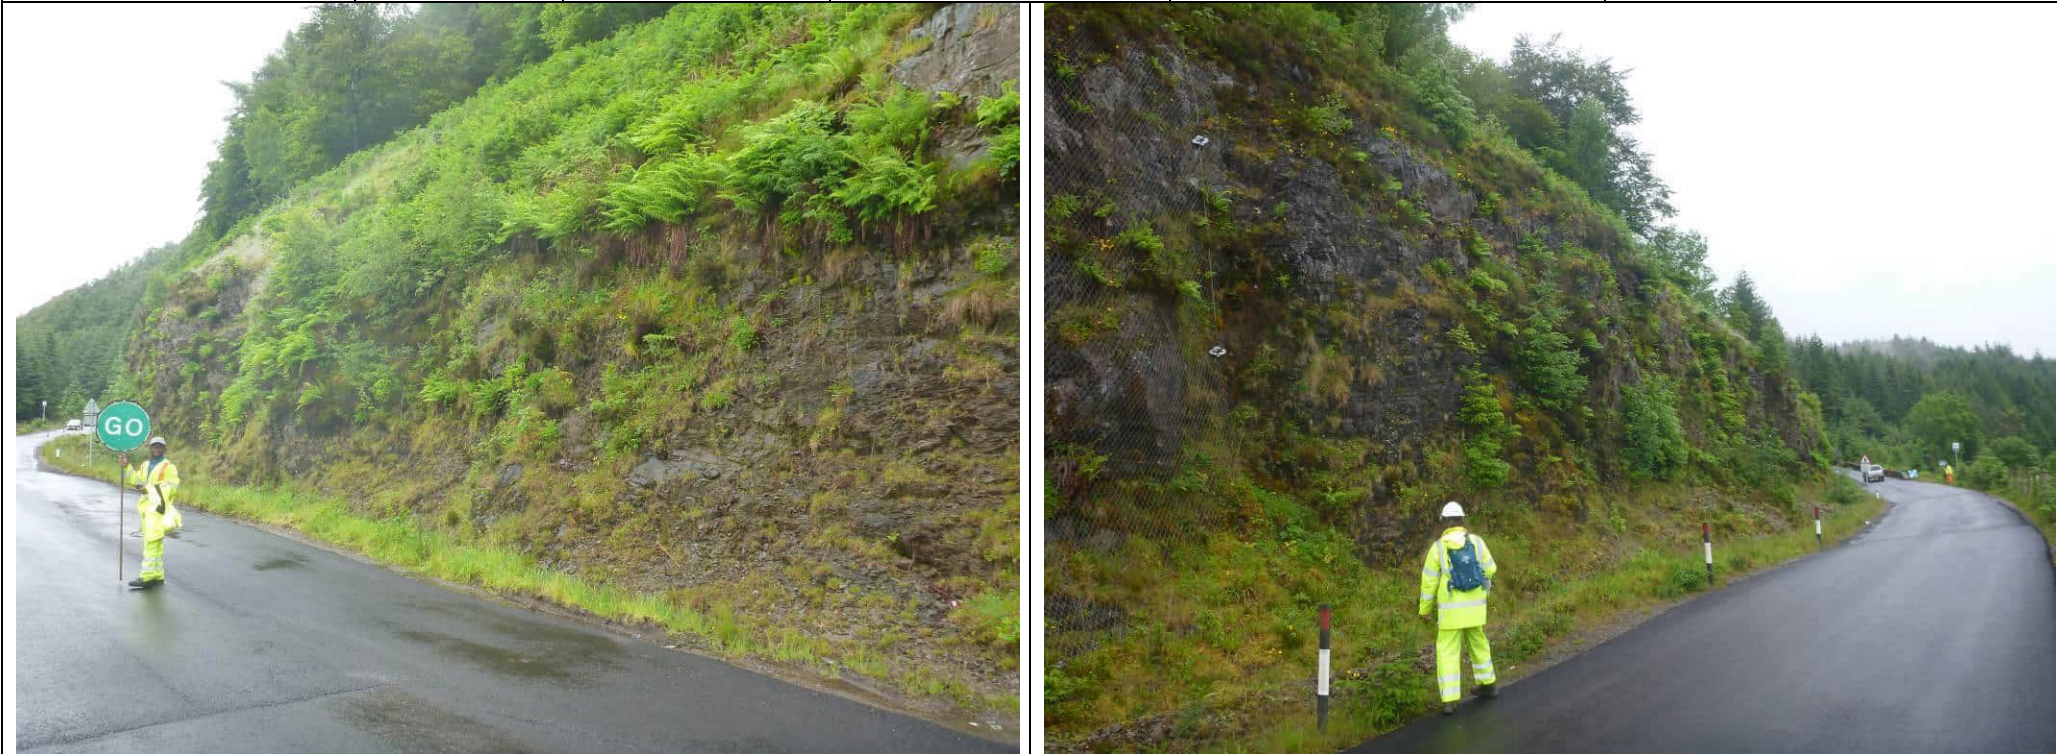
Slope	AA1
Chainage	0000 - 0170
National Grid Reference	NG 89063 35689 to NG 89166 35810
2022 Risk rating	2.4 / Low
Recommended maintenance / remedial works	None required.

Dip: 85	Azimuth: 302	Height (m): 7	Length (m): 170	Vegetation Cover: Ch. 0 to Ch. 100: 50-90% Ch. 100 to Ch. 146: 30-50% Ch. 146 to Ch. 163: 10% Ch. 163 to Ch. 170: 90%  Grass, moss, saplings and ferns.	Ditch Details:  Typically 0.5-1m deep, 1m wide. Reduces to 0.15m deep, 0.3m wide from Ch. 60 to 65	Roughness (Profile): Rough	Verge Width: 1.5
---------	--------------	---------------	-----------------	---	---	----------------------------	------------------

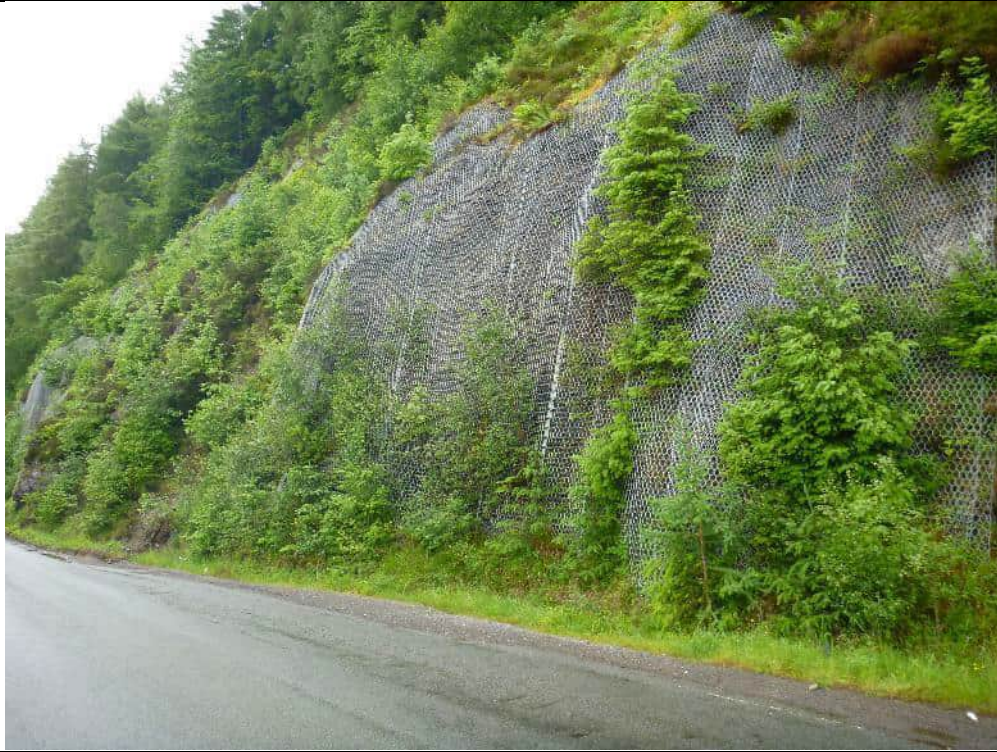
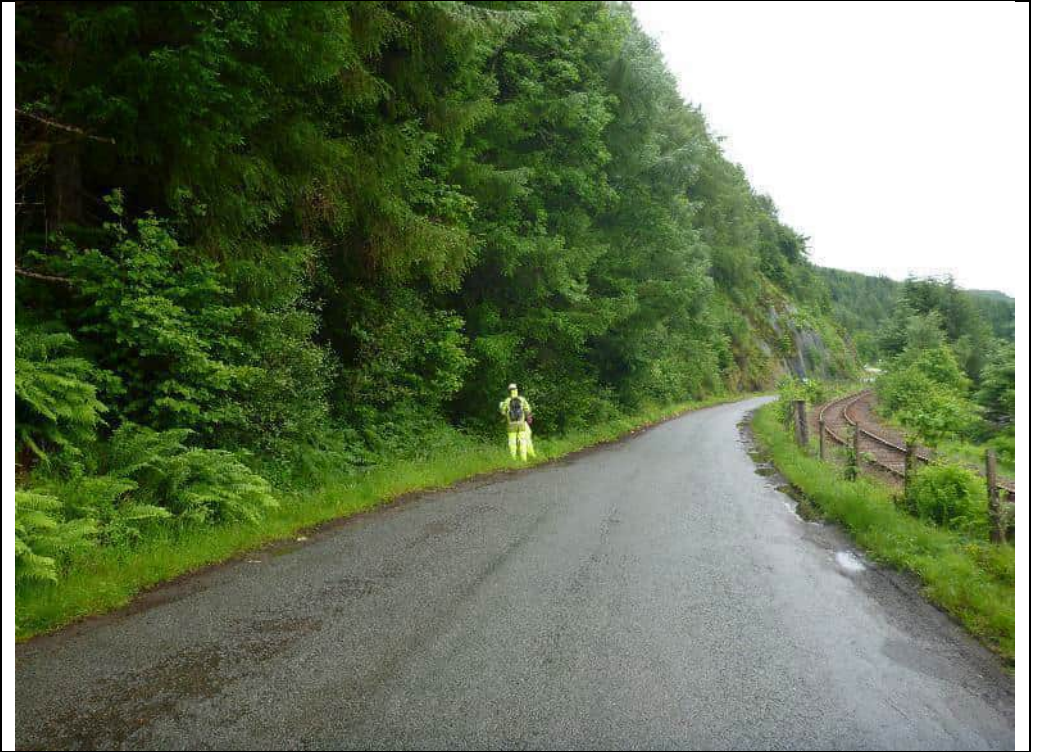
Slope	AA2
Chainage	0170 - 0477 (at small stream)
National Grid Reference	NG 89166 35810 to NG 89366 36040
2022 Risk rating	14.4 / High
Recommended maintenance / remedial works	Coppice trees at crest of slope at Ch.205 and within 10m of road from Ch.340 to 447; Clear out debris from base of netting at Ch.273; Heavy scaling / controlled removal of overhang on boulder at Ch. 400.

Dip: 74	Azimuth: 319	Height (m): 20	Length (m): 307	Vegetation Cover: Ranges between 10-100% across the slope comprising of moss, heather and occasional fern. Small saplings becoming established. Trees along crest.	Ditch Details: 0.5m to 1.0m wide, 0.4m deep	Roughness (Profile): Rough	Verge width: 0.8m
---------	--------------	----------------	-----------------	--	---	----------------------------	-------------------

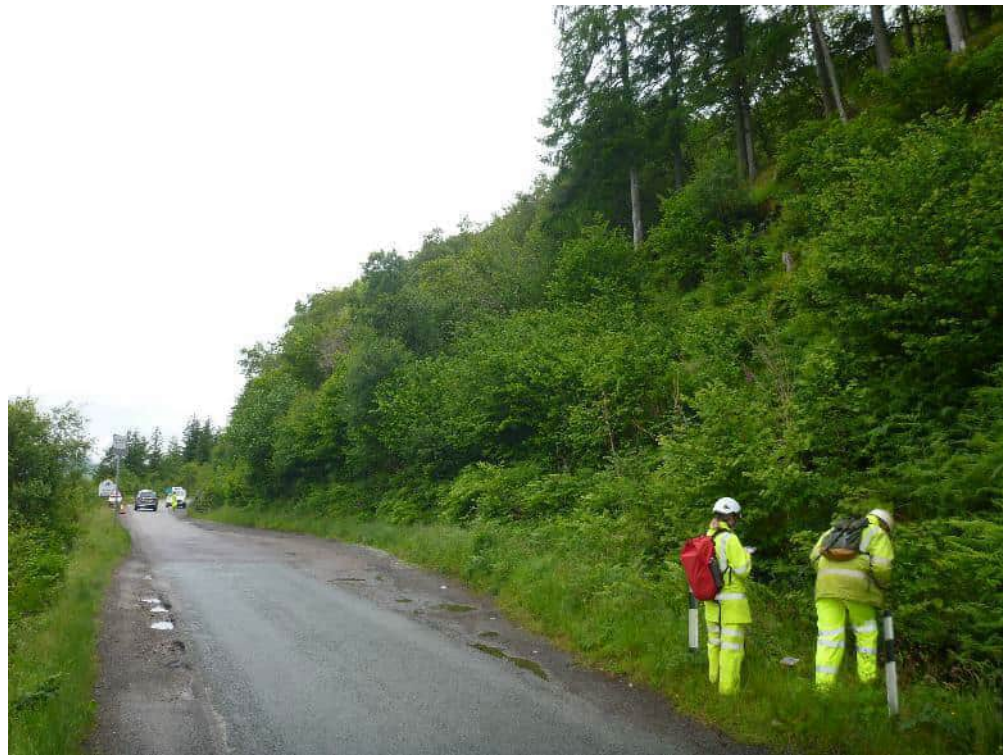
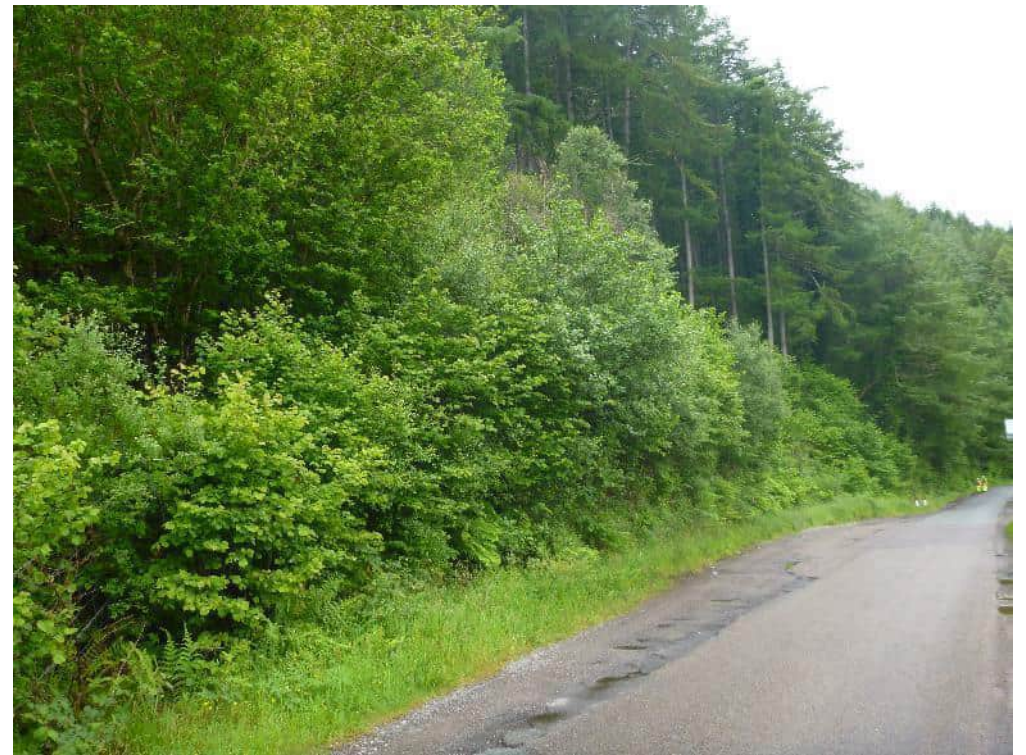
Slope	AA2A
Chainage	0477 - 0555
National Grid Reference	NG 89366 36040 to NG 89393 36104
2022 Risk rating	2.0 / Low
Recommended maintenance / remedial works	None required.

Dip: 84	Azimuth: 300	Height (m): 12	Length (m): 78	Vegetation Cover: c.95% cover. Generally comprises moss, grass, saplings and bushes. Many tree stumps.	Ditch Details: 1.5m wide, 0.5 - 1 m deep	Roughness (Profile): Rough	Verge Details: 3.5m
---------	--------------	----------------	----------------	--	--	----------------------------	---------------------

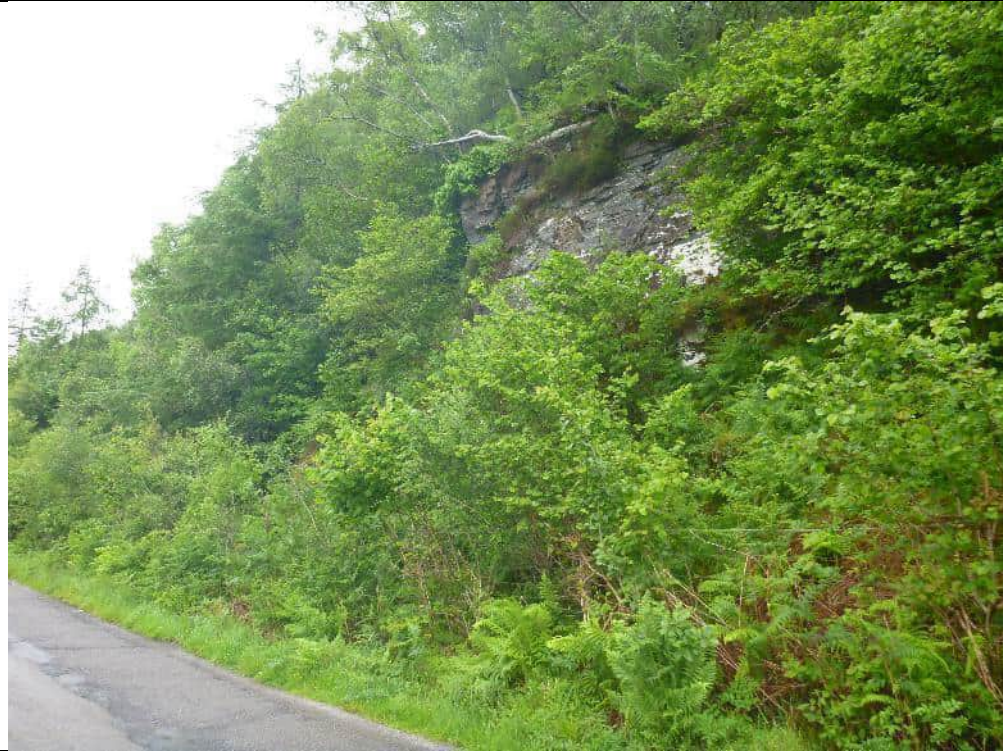
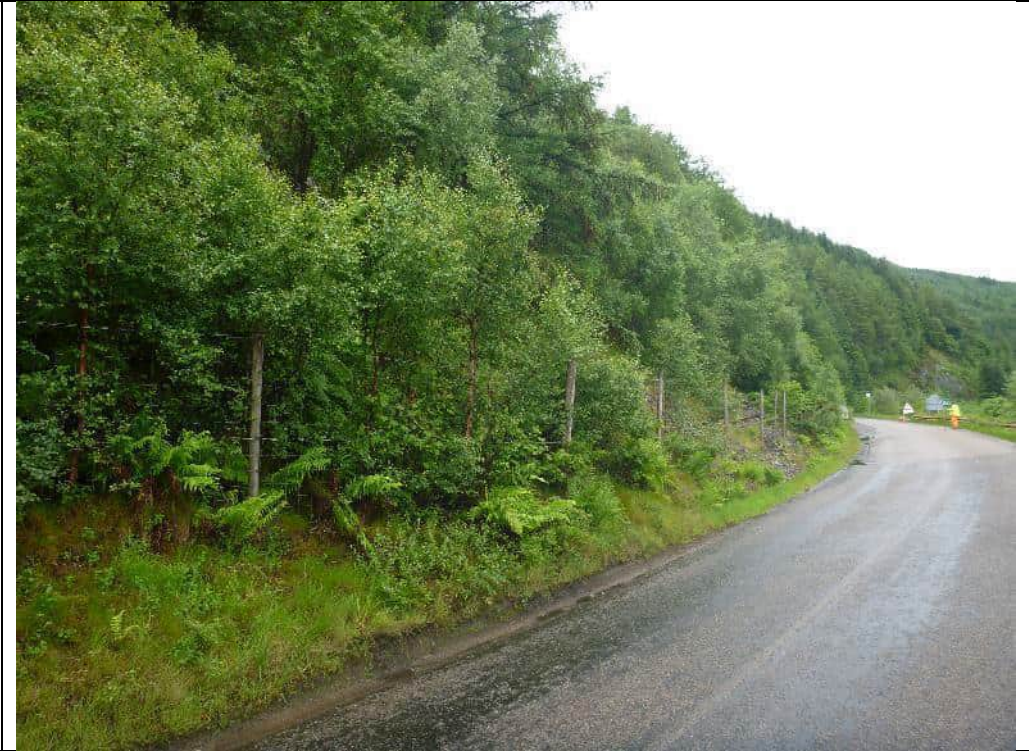
Slope	AA3
Chainage	0560 - 0670
National Grid Reference	NG 89397 36107 to NG 89454 36200
2022 Risk rating	4.0 / Low
Recommended maintenance / remedial works	None required.

Dip: 80	Azimuth: 317	Height (m): 16	Length (m): 110	Vegetation Cover: 20-30% cover. Moss and ground cover with occasional trees. Trees on ditch edge forming barrier. Some trees overhanging at crest.	Ditch Details: Ch. 605 to Ch. 670: 2.2m wide, 1.2m deep	Roughness (Profile): Smooth	Verge Details: Ch. 560 to Ch. 605 = 3.5m Ch. 605 to Ch. 670 = 13m
---------	--------------	----------------	-----------------	--	---	-----------------------------	--

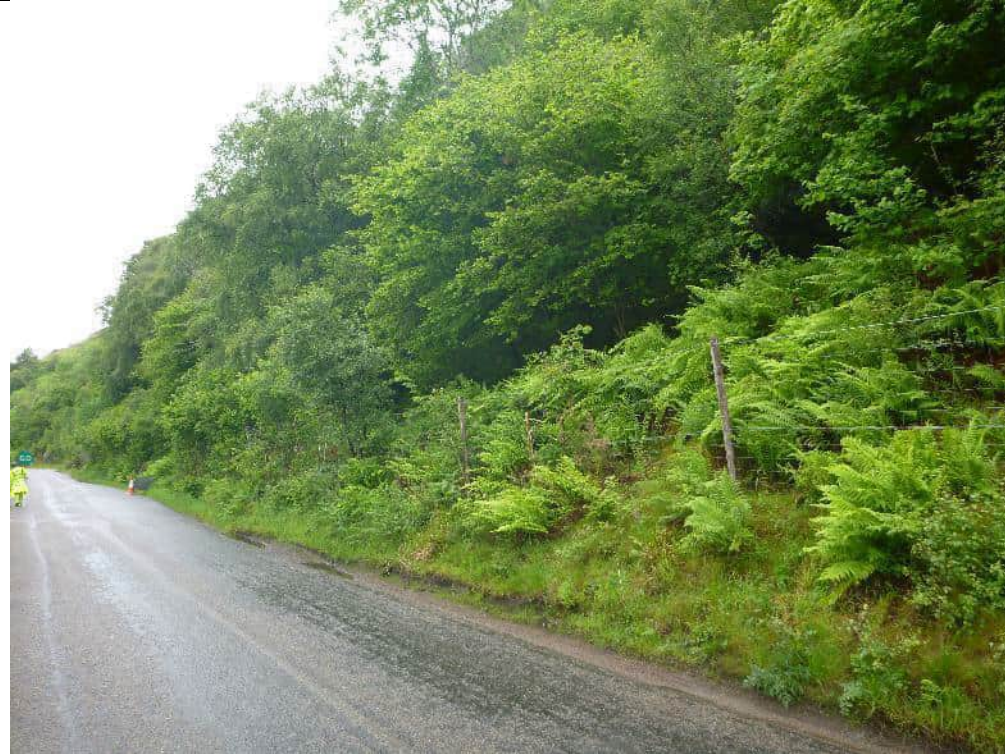
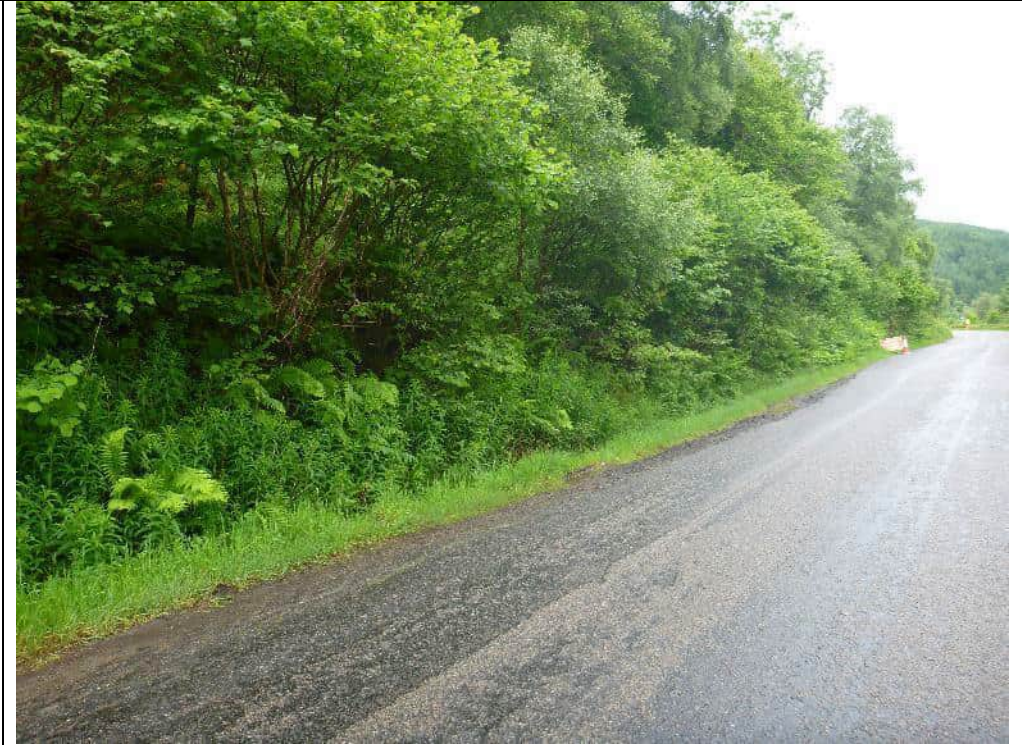
Slope	AA3A
Chainage	0670 - 0745
National Grid Reference	NG 89454 36200 to NG 89508 36254
2022 Risk rating	2 / Low
Recommended maintenance / remedial works	None required.

Dip: 35 to 45	Azimuth: 315	Height (m): N/A (vegetated slope with isolated rock outcrops)	Length (m): 75	Vegetation Cover: 100%. Fully vegetated slopes (trees, grass and moss ground cover).	Ditch Details: 0.5m wide, 0.3m deep.	Roughness (Profile): Smooth	Verge Details: 0m
---------------	--------------	---	----------------	--	--------------------------------------	-----------------------------	-------------------

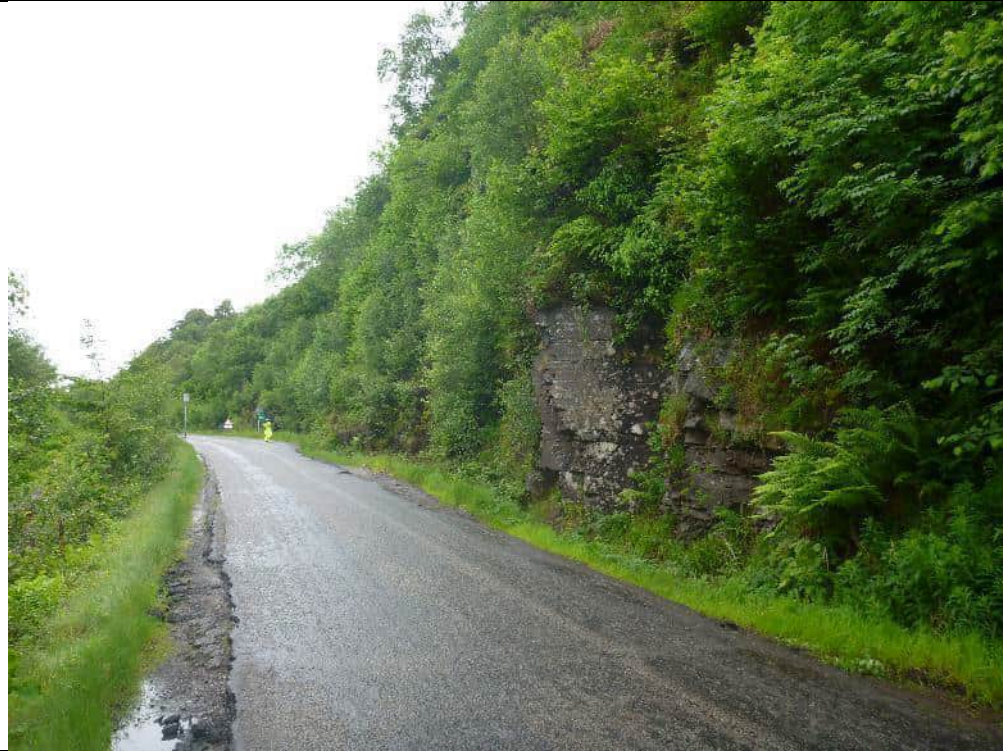
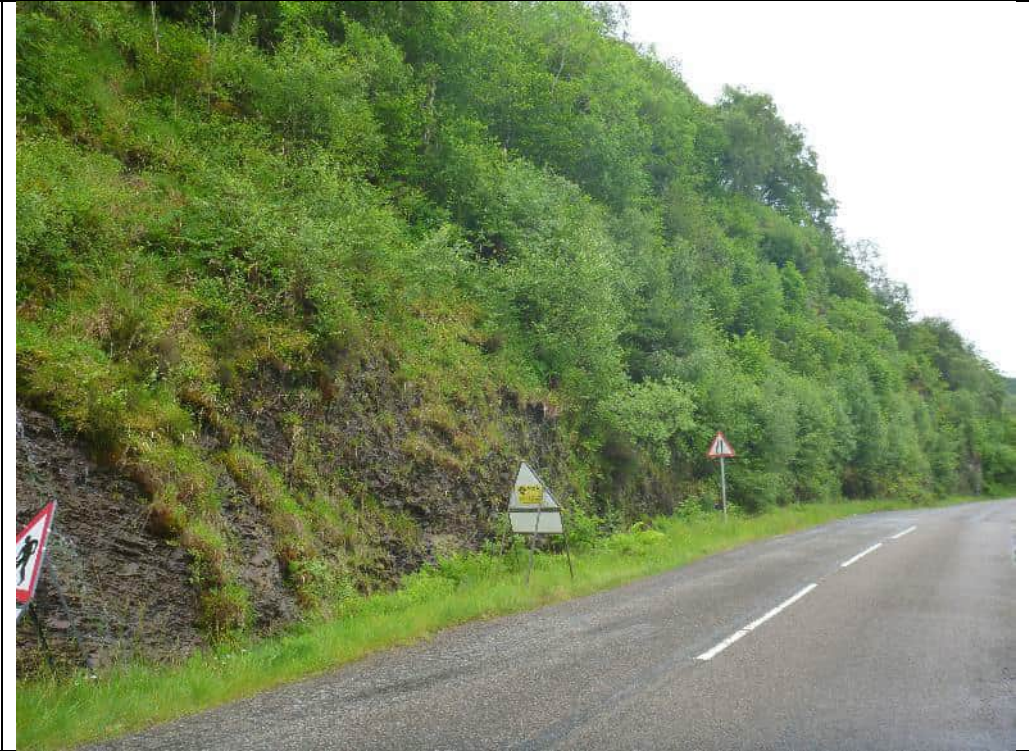
Slope	AA4
Chainage	0745 - 0855
National Grid Reference	NG 89508 36254 to NG 89572 36332
2022 Risk rating	9 / Moderate
Recommended maintenance / remedial works	Scale fractured rock mass at Ch. 745; Scale / dowel overhanging block at Ch.788, coppice adjacent holly tree and inspect rock mass behind.

Dip: 80	Azimuth: 310	Height (m): 20	Length (m): 110	Vegetation Cover: 75-80% cover. Lots of ivy, grass/small shrubs and small saplings.	Ditch Details: 1.0m wide, 0.6m deep	Roughness (Profile): Rough	Verge Details: 1.0m
---------	--------------	----------------	-----------------	---	-------------------------------------	----------------------------	---------------------

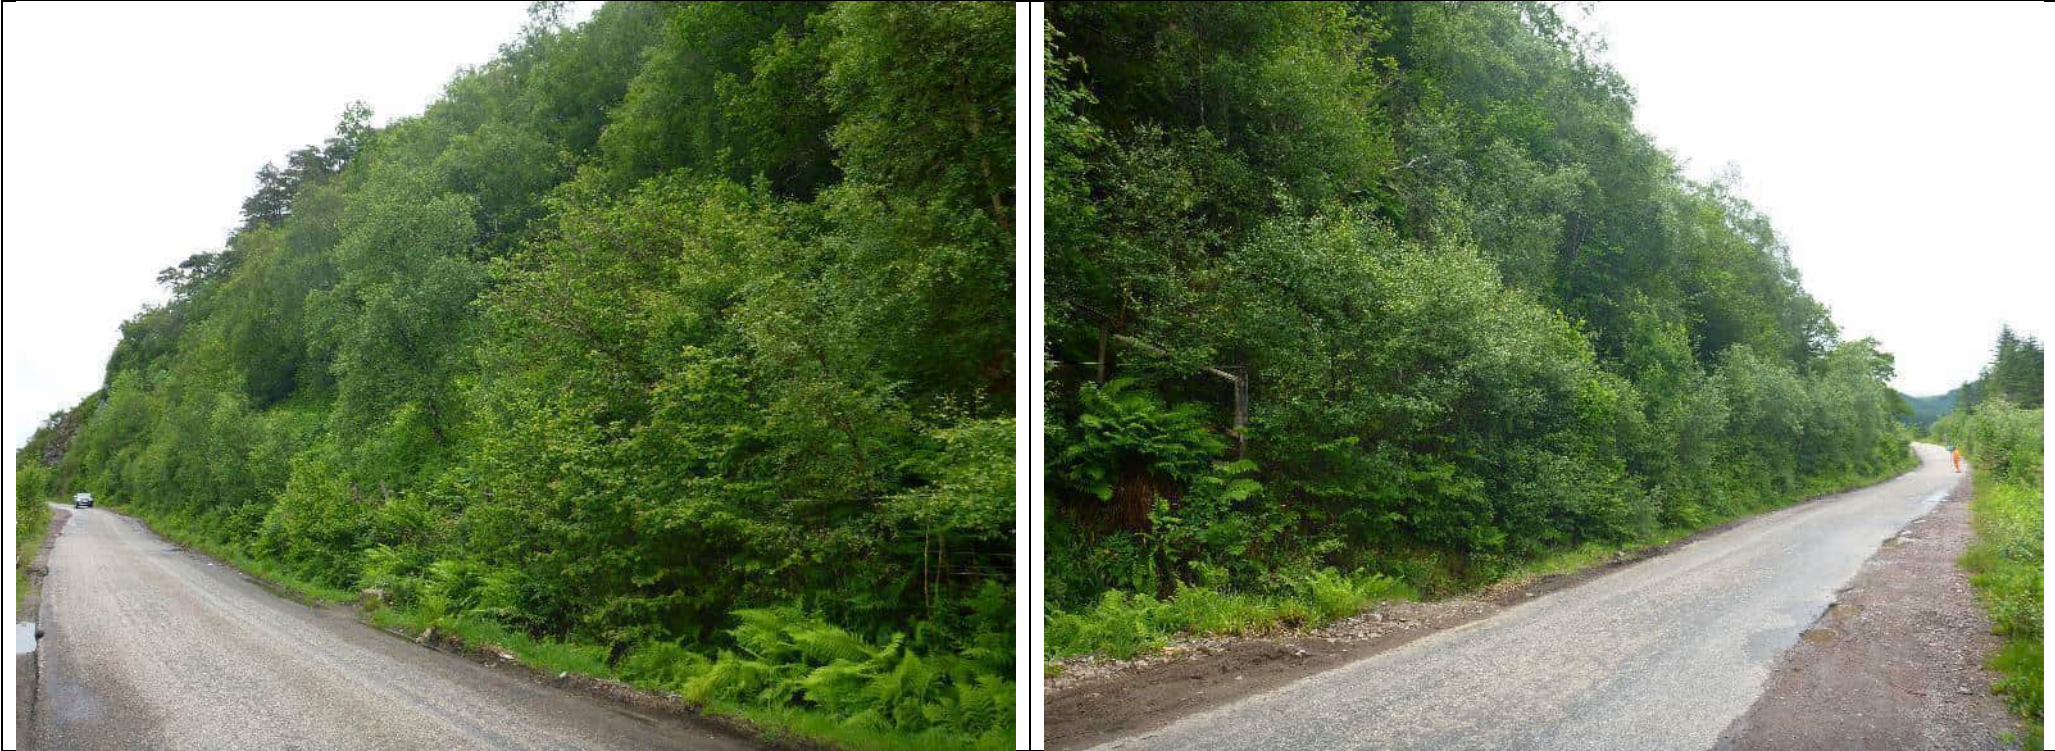
Slope	AA5
Chainage	1285 - 1383
National Grid Reference	NG 89799 36709 to NG 89864 36775
2022 Risk rating	12 / High
Recommended maintenance / remedial works	Install rockfall catch fence along toe of slope; Light scale outcrops at NG 89808 36661 and NG 89828 36663.

Dip: 70	Azimuth: 320	Height (m): 70	Length (m): 98	Vegetation Cover: 90% cover lower slope, 60% cover upper slope. Moss and bracken. Moss is up to 0.15 to 2.0m thick. Numerous deciduous trees upslope with large saplings down slope.	Ditch Details: 1m wide, 0.5m deep	Roughness (Profile): Rough	Verge Details: 2.0m
---------	--------------	----------------	----------------	--	-----------------------------------	----------------------------	---------------------

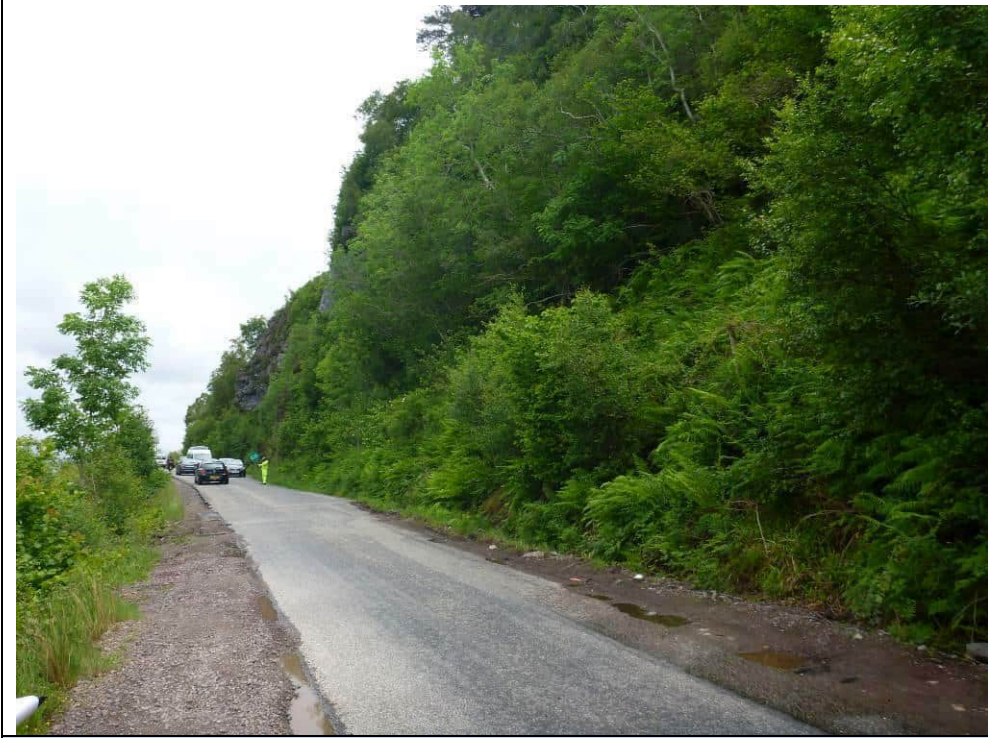
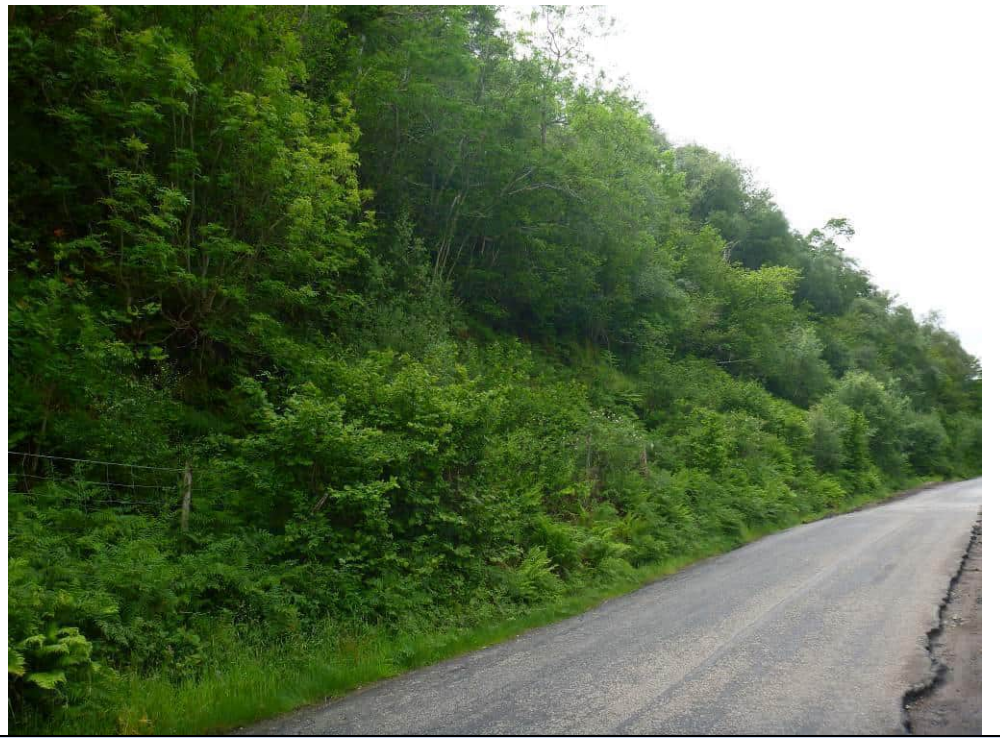
Slope	AA5A
Chainage	1383 - 1446
National Grid Reference	NG 89864 36775 to NG 89902 36818
2022 Risk rating	6 / Moderate
Recommended maintenance / remedial works	Install roadside rock fall catch fence.

Dip: 70	Azimuth: 320	Height (m): 70 – almost completely vegetated slope with isolated outcrops.	Length (m): 83	Vegetation Cover: 90% cover lower slope, 70% cover upper slope. Moss and bracken. Numerous deciduous trees upslope with large saplings down slope.	Ditch Details: 0.5m wide, 0.3 deep	Roughness (Profile): Rough	Verge Details: 0.8m
---------	--------------	--	----------------	--	------------------------------------	----------------------------	---------------------

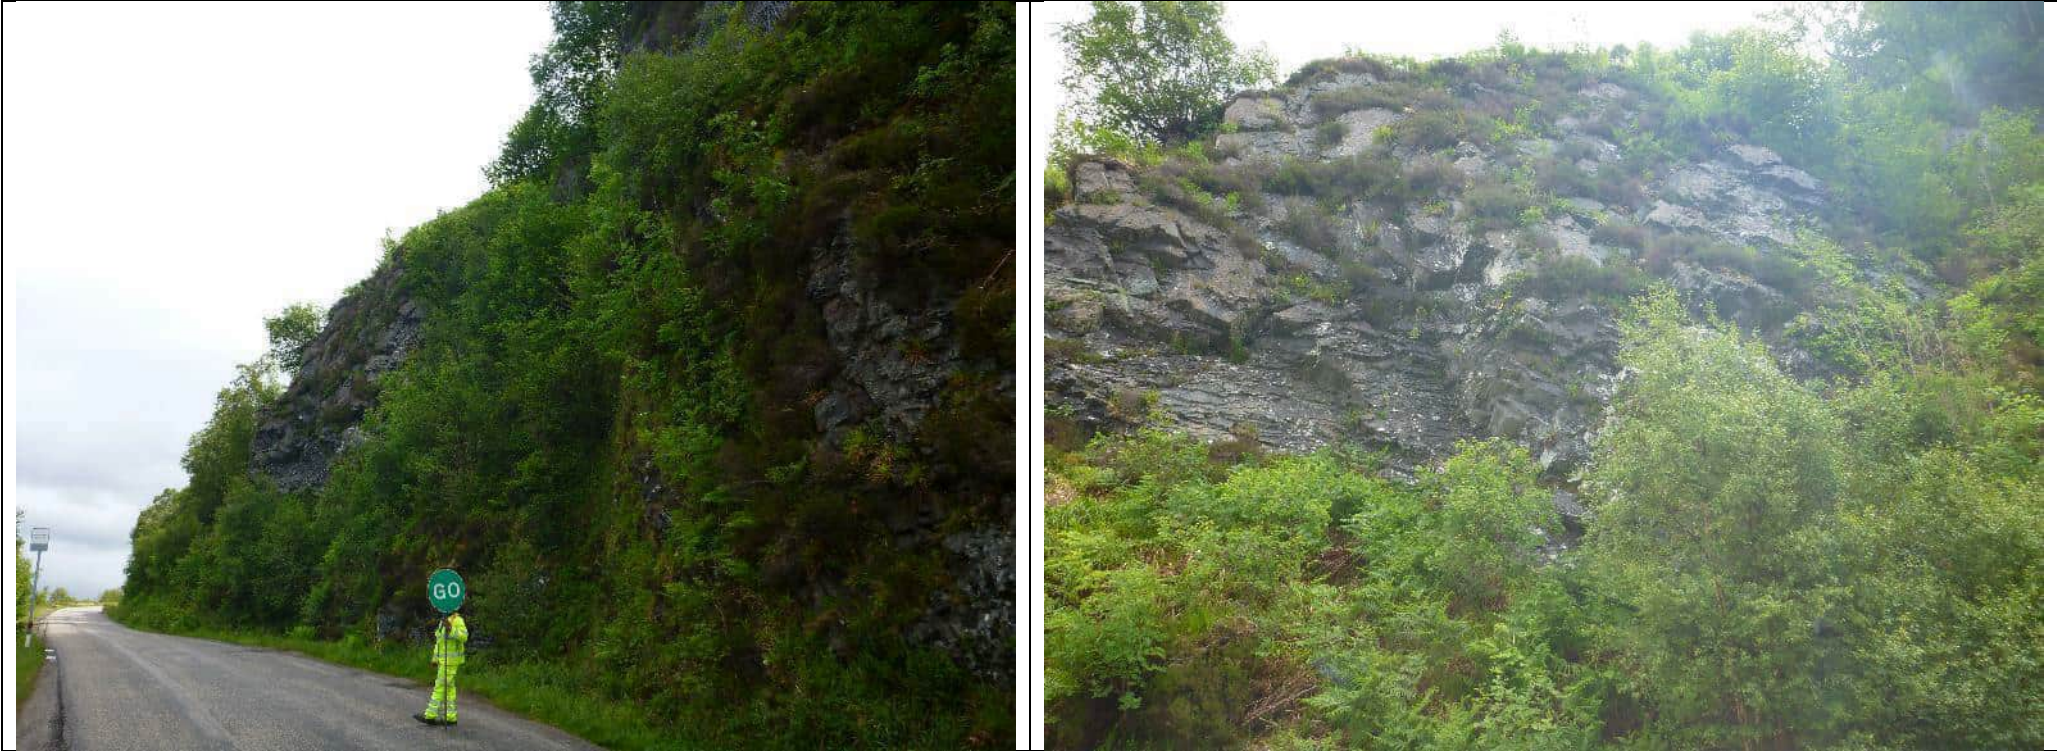
Slope	AA6
Chainage	1446 - 1503
National Grid Reference	NG 89902 36818 to NG 89936 36862
2022 Risk rating	2 / Low
Recommended maintenance / remedial works	None required.

Dip: 71	Azimuth: 310	Height (m): 35	Length (m): 57	Vegetation Cover: Ranges between 40-100%. Generally comprises ground cover and saplings.	Ditch Details: Widest section 0.8m deep, 2.3m wide (no ditch where rock slope close to road).	Roughness (Profile): Rough	Verge Details: 0.8 – 1.5m
---------	--------------	----------------	----------------	--	---	----------------------------	---------------------------

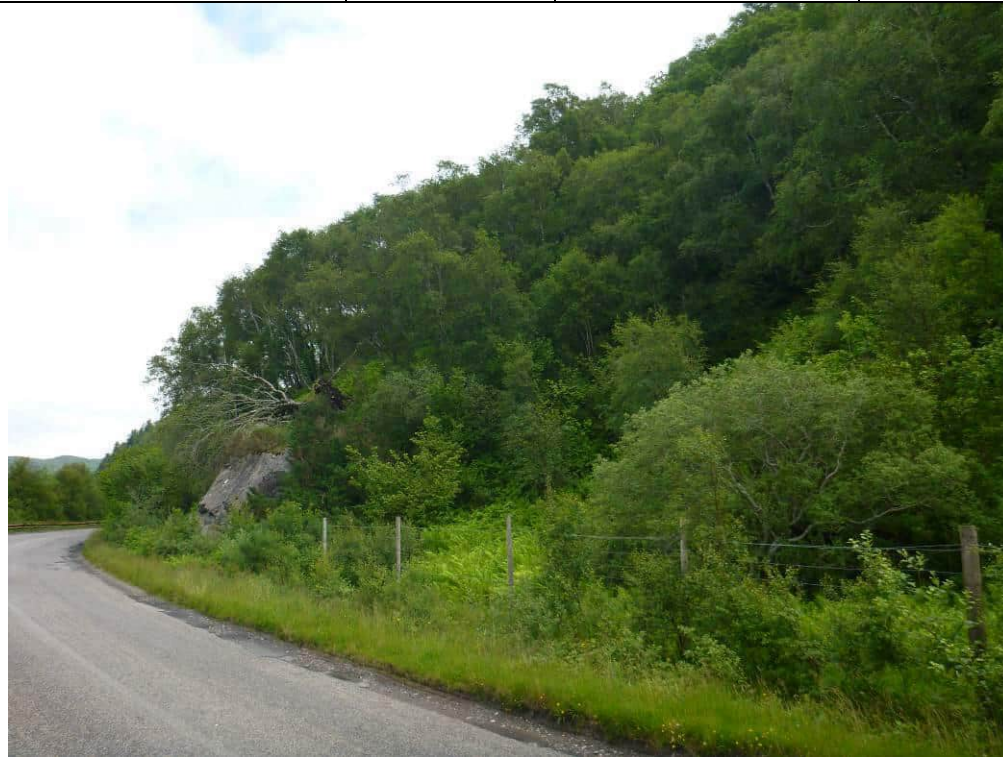
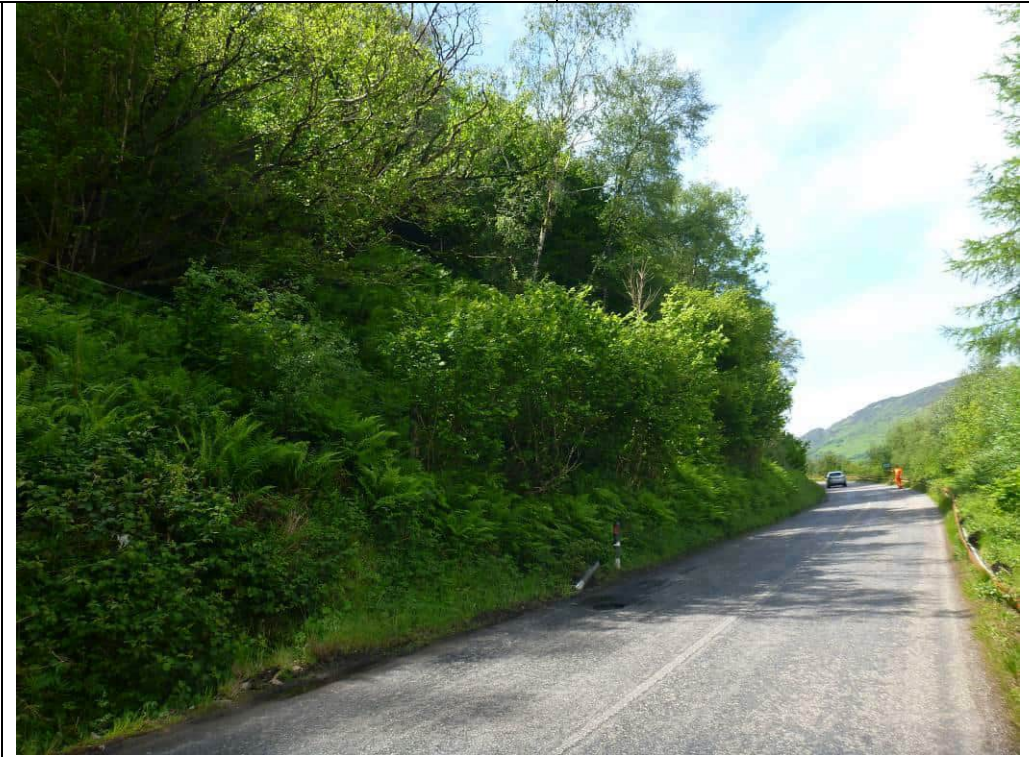
Slope	AA6B
Chainage	1606 to 1752
National Grid Reference	NG 89995 36943 to NG 90124 36990
2022 Risk rating	4.8 / Low
Recommended maintenance / remedial works	None required.

Dip: 70	Azimuth: 300	Height (m): 35	Length (m): 146	Vegetation Cover: 100% - No rock outcrops noted and slope is covered in vegetation	Ditch Details: N/A	Roughness (Profile): N/A	Verge Width: N/A
---------	--------------	----------------	-----------------	--	--------------------	--------------------------	------------------

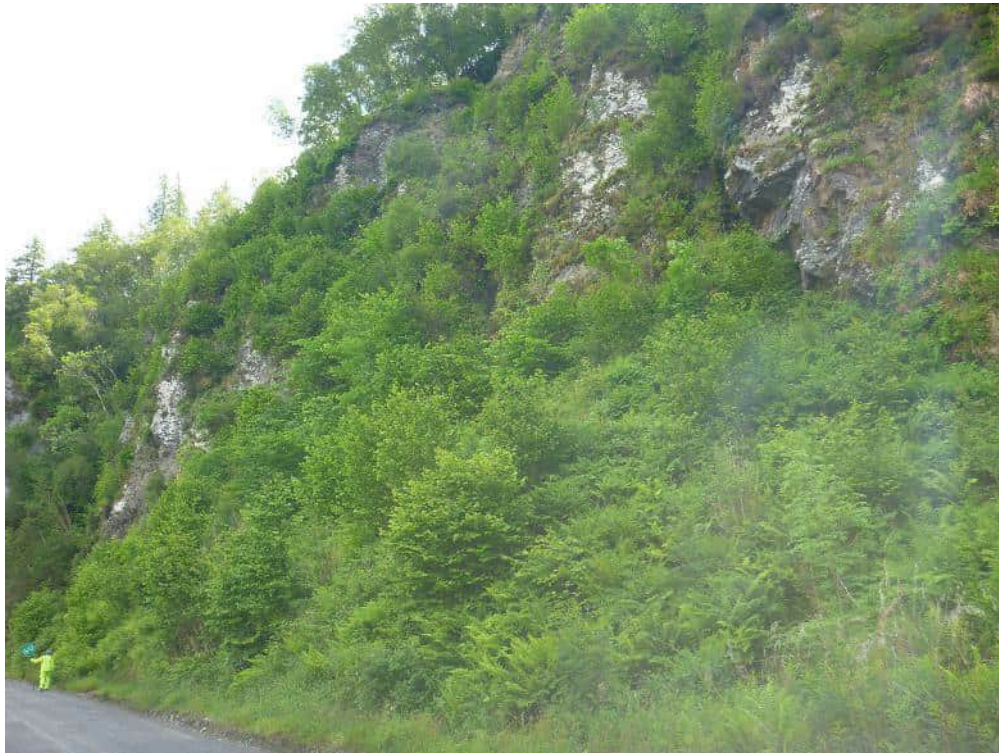
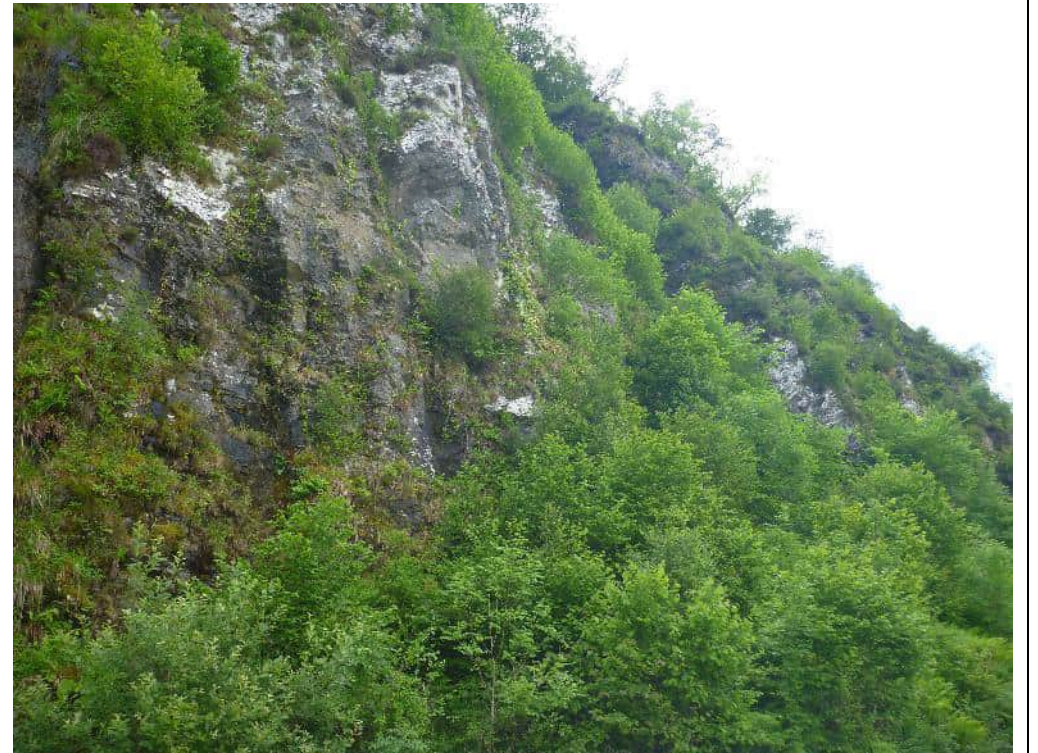
Slope	AA7
Chainage	1752 - 1880
National Grid Reference	NG 90124 36990 to NG 90213 37019
2022 Risk rating	4.8 / Low
Recommended maintenance / remedial works	None required.

Dip: 75 - 80	Azimuth: 336	Height (m): 30	Length (m): 128	Vegetation Cover: 60-70% cover. Lots of saplings established on slope.	Ditch Details: 1m wide, 0.75 deep. Bund 0.6m wide, 0.3m high	Roughness (Profile): Rough	Verge Details: None
--------------	--------------	----------------	-----------------	--	--	----------------------------	---------------------

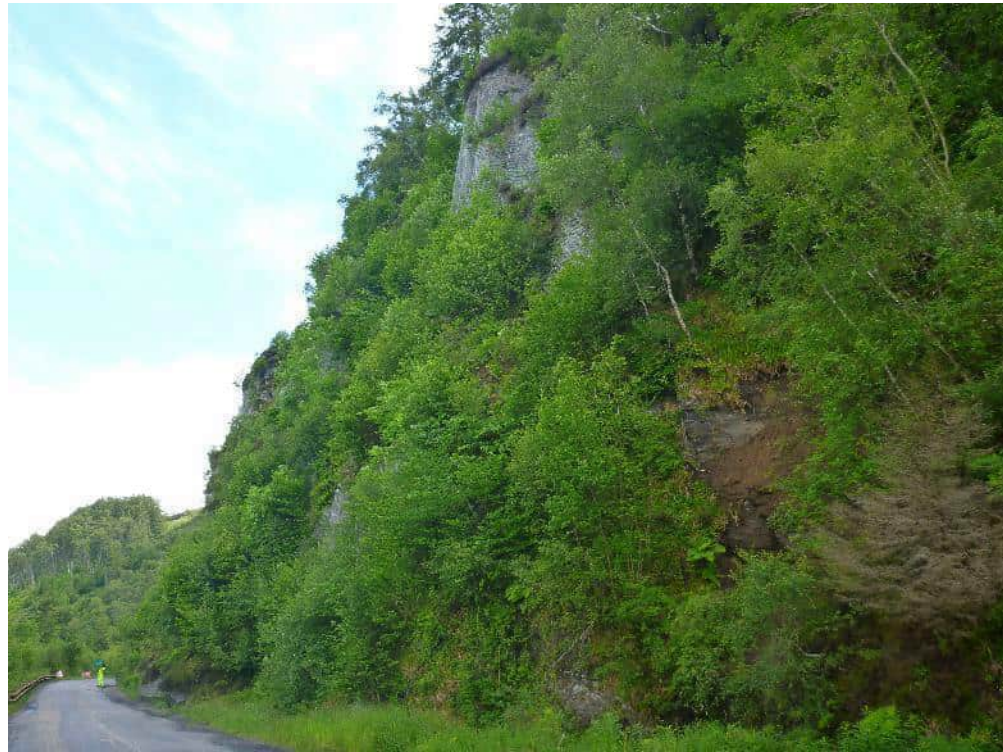
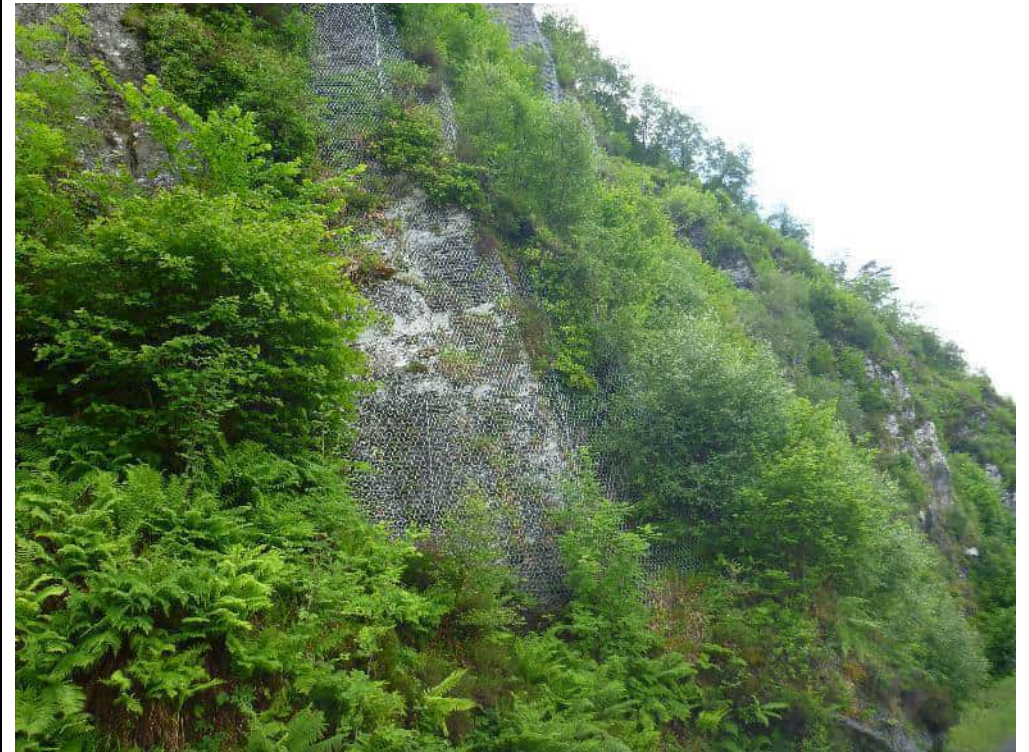
Slope	AA8
Chainage	1880 - 1940
National Grid Reference	NG 90243 37019 to NG 90299 37045
2022 Risk rating	4 / Low
Recommended maintenance / remedial works	De-vegetation / coppicing (approx. 60% cover).

Dip: 75 – 80	Azimuth: 326	Height (m): 25 – 30	Length (m): 63	Vegetation Cover: Up to 60% cover comprising lots of ivy, grass and small saplings.	Ditch Details: 0.5-1m deep; 2-5m wide Bund: 0.5m high, 0-4m wide	Roughness (Profile): Rough	Verge Details: 0-1m
--------------	--------------	---------------------	----------------	---	--	----------------------------	---------------------
