# A890 Stromeferry Bypass

Annual Slope Inspection Report 2022

The Highland Council

07 September 2022

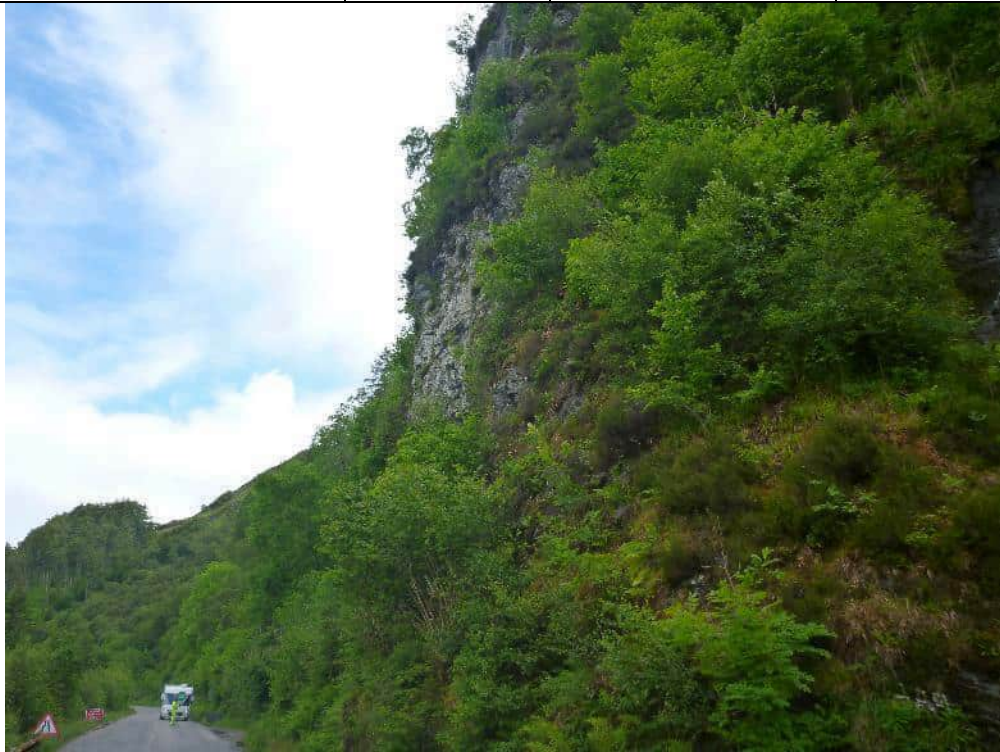
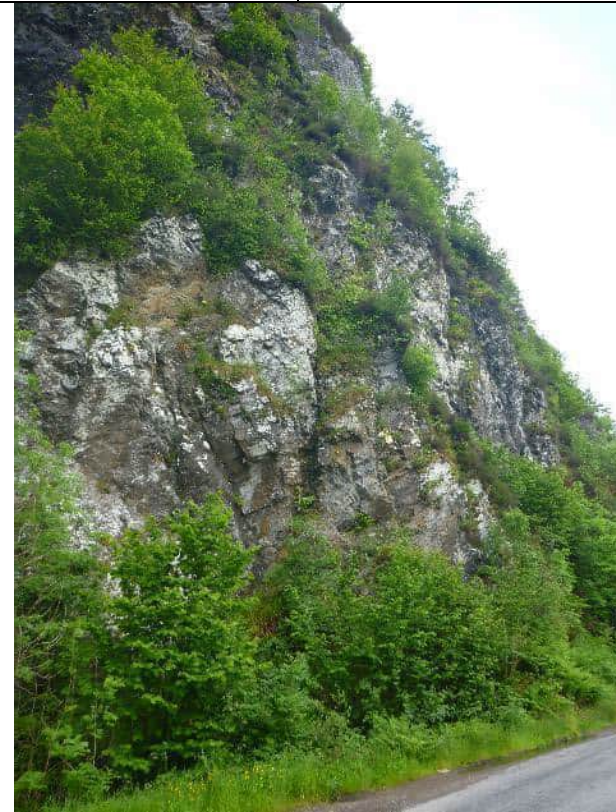
Ch.1978	Overhanging block at crest with buff coloured, fresher surfaces at base (possibly representative of past scaling). Block c.2m x 1m x 0.5m and appears to have dilated fracture at right hand side. Overall appears keyed in but vegetation growth around block could lead to root jacking.								
SUMMARY		Comments							
Overall Hazard Rating =	2								
Pathway Rating =	3								
Receptor Rating =	1								
Risk Value =	6								
Risk Level =	Moderate								
Recommended Remedial Works / Actions									
<ul style="list-style-type: none"> <li>- Improve netting system at Ch. 1965-1975: installation of vertical cables and side anchors down either side of netting and additional bottom anchors to secure netting at base. Installation of lateral cables to profile netting also recommended.</li> <li>- Future rope access inspection recommended to inspect the overhanging block at Ch.1978.</li> </ul>

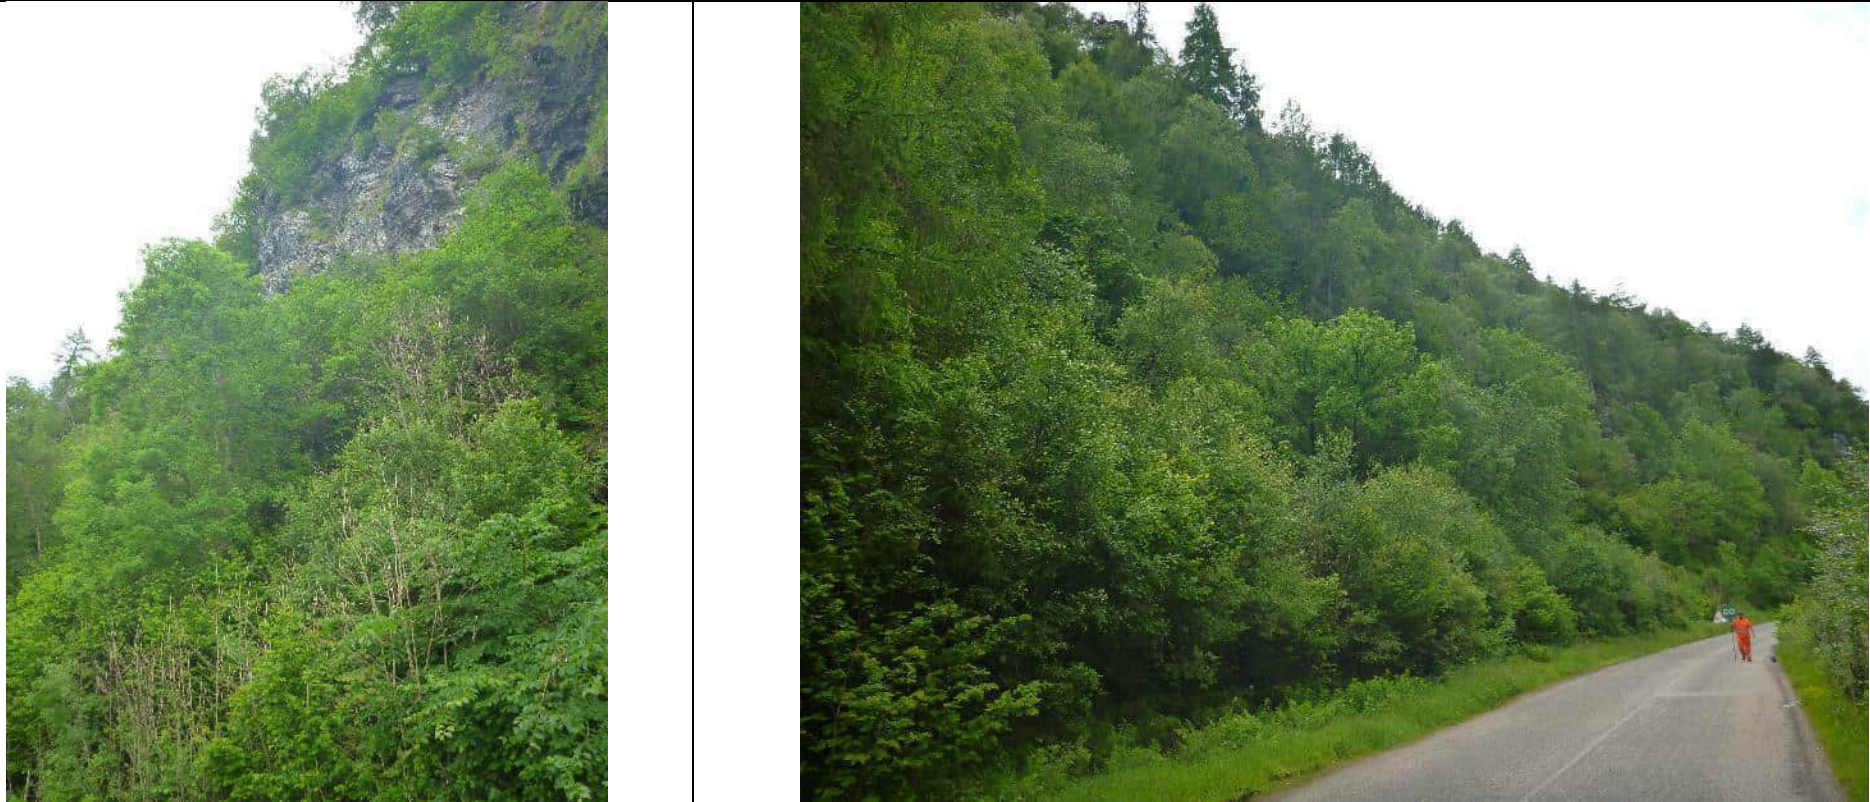
Location	Comments
Ch. 2033-2188	Noted that slope is well vegetated in this area with uprooted trees. Root jacking evident, with potential to dislodge blocks. Recent failures evident.
Ch. 2075	Potential wedge failure with root jacking identified.
Ch.2110	Tree down c.8m above road level. Root ball has soil and rock weathering out but unlikely to be a risk to the road.
Ch. 2130	Wedge failure observed ~15m above road level. Potential for root jacking and release joints observed. The trajectory of a potential failure is difficult to predict, with the probable pathway to the left of the roadside outcrop. Potential failure volume is large enough to burst through the deer fence and may either come to rest in the ditch or at the edge of the road.
Ch. 2240	At crest of slope there are a number of trees leaning towards the road. If these fall there is potential for root balls to dislodge blocks, however, these are unlikely to impact the road as slope is set-back from road.

SUMMARY		Comments
Overall Hazard Rating =	3	Reduced from 4 in 2018 due to detailed rope access inspection of wedge failure and accurate determination of potential failure volume.
Pathway Rating =	3	Increased from 2 in 2018 due to inspection of failure trajectory.
Receptor Rating =	1	
Risk Value =	<b>9</b>	
Risk Level =	<b>Moderate</b>

- Installation of catch fence at toe of slope and targeted rockfall netting.
- Coppice trees growing on rock exposure (if catch fence/netting not installed).
- Scale potential wedge failure at Ch. 2130.

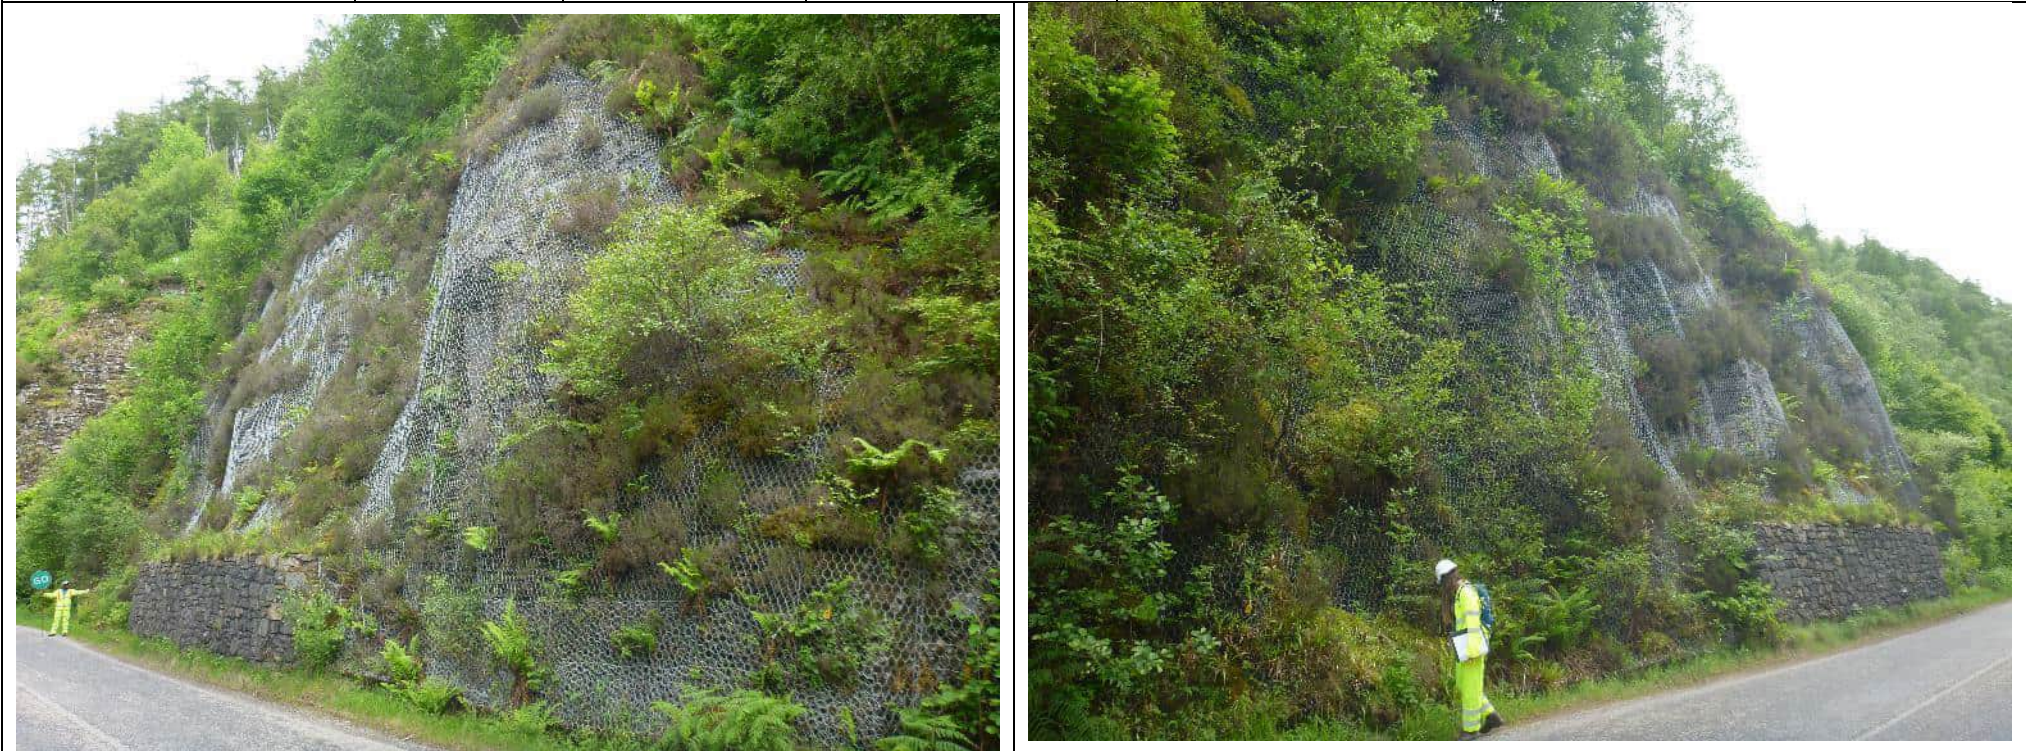
Ch. 2377		Overhang noted ca. 8m above road level at up chainage end of buttress. Overhang ca. 1m. Dilated fractures and potential for small blocks to free fall ca. 2-3m before impacting mesh. Maximum block size ca. 0.4m x 0.4m x 0.4m so likely to be retained by existing netting.							
Ch. 2386		Damaged intermediate bottom anchor (mesh caught and torn by grass cutter, pulling <1m long corroded anchor from face).							
<b>SUMMARY</b>				<b>Comments</b>					
Overall Hazard Rating =		2							
Pathway Rating =		2							
Receptor Rating =		1.4							
Risk Value =		4.8							
Risk Level =		Low							
<b>Recommended Remedial Works / Actions</b>									
<ul style="list-style-type: none"> <li>- Install bimetallic corrosion between galvanised cables and stainless steel eye nuts.</li> <li>- Replace bottom cable and install additional bottom anchors</li> <li>- Replace dropper cables and install additional anchors.</li> </ul>

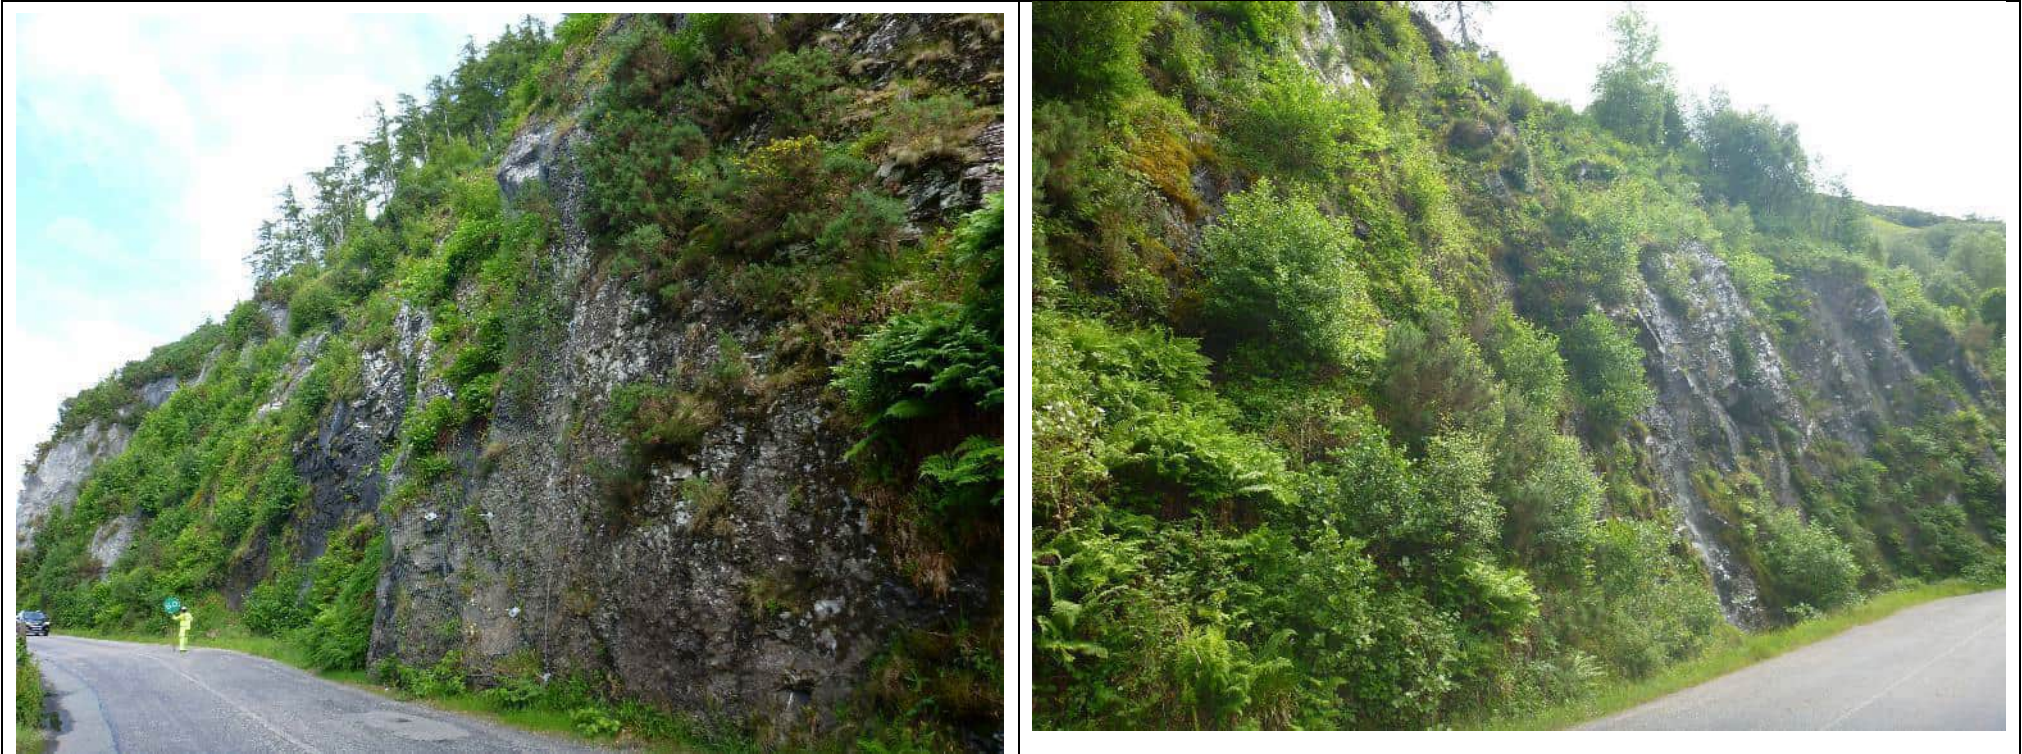
Existing Netting Details or other remedial work details:							
7 No. dowels installed during Phase 8 (2015) works.							
Tecco netting system installed during Phase 9 (2017) works between Ch. 2411 and 2427. In good condition, no defects.							
Spider netting system installed during Phase 9 (2017) works at Ch. 2462. In good condition, no defects.							
Hazards Observed:							
Location		Comments					
NG 90790 37253		Large gully ca. 15m wide and 4m deep with watercourse above boundary between AA12/AA13. There is watercourse at risk of being washed out below.					
SUMMARY			Comments				
Overall Hazard Rating =	1						
Pathway Rating =	2		Pathway rating increased from 1 in 2019 following re-assessment.				
Receptor Rating =	1						
Risk Value =	2						
Risk Level =	Low						
Recommended Remedial Works / Actions

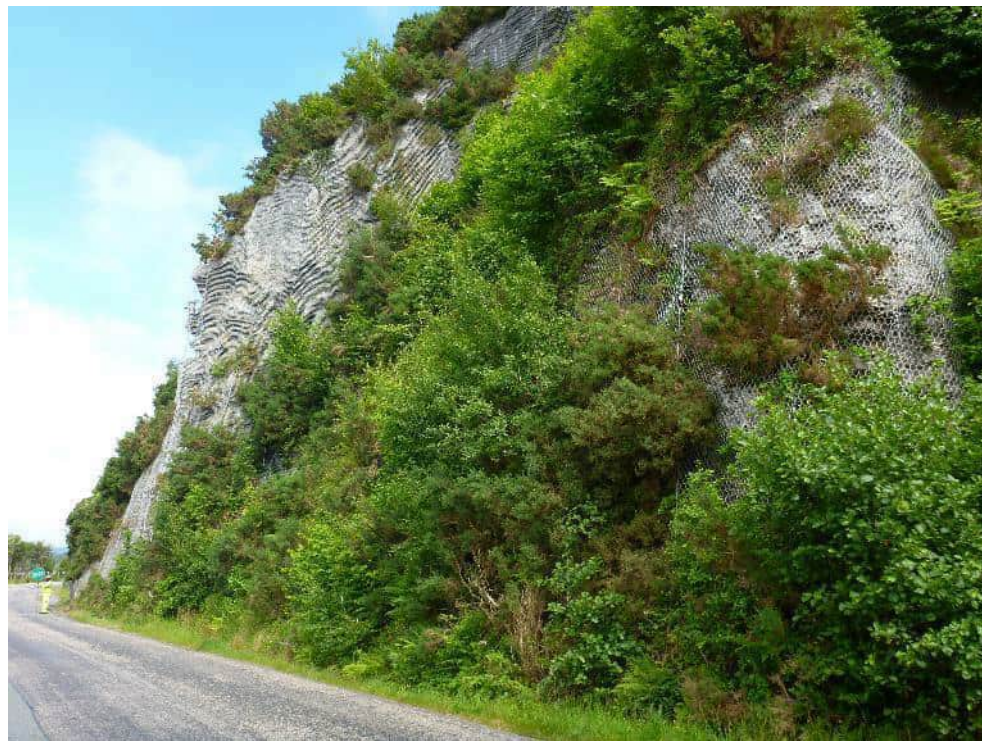
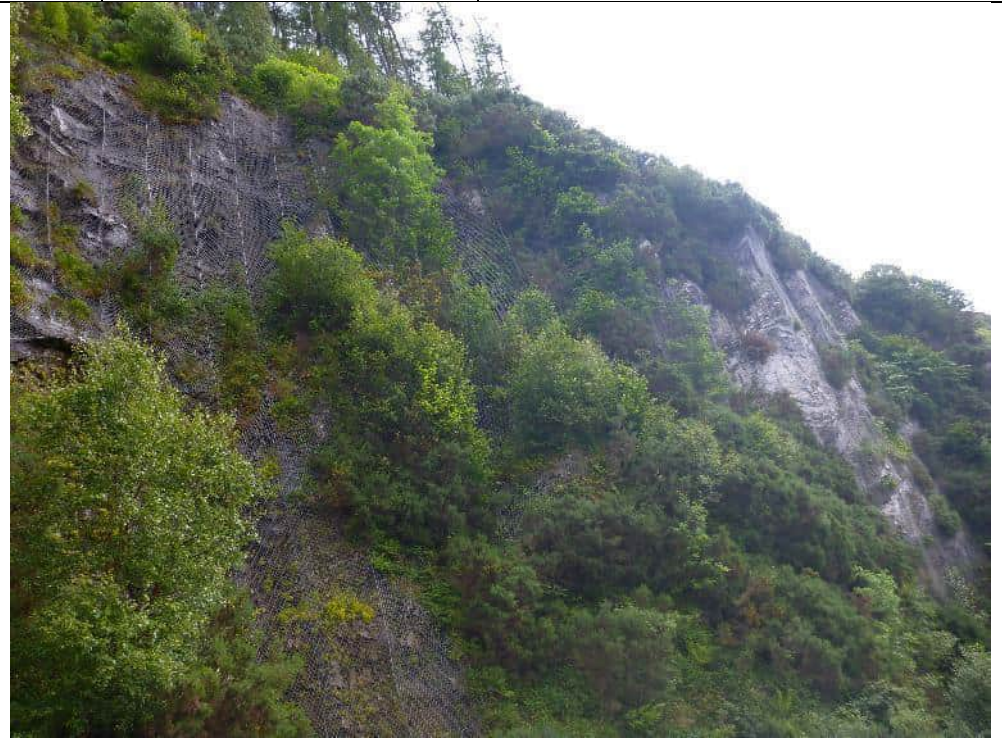
Hazards Observed:									
Location		Comments							
		No significant hazards observed.							
Ch. 2535		Overhanging area c.12 to 15m above toe with gaping mesh below. Potentially some dilated fractures around base of overhang. Large verge and ditch at toe mean low risk to road.							
Ch. 2560		Ongoing washing out of debris from gully.							
SUMMARY			Comments						
Overall Hazard Rating =		1							
Pathway Rating =		2	Pathway rating increased in 2019 following re-assessment.						
Receptor Rating =		1.2							
Risk Value =		2.4							
Risk Level =		Low							
Recommended Remedial Works / Actions									
<ul style="list-style-type: none"> <li>- Replace corroded cable clamps, re-tension and install additional spenax rings on vertical reinforcing cables between Ch. 2513 and 2528.</li> </ul>									
Assessed in field by:	PLM/JG	Date:	21/06/2022	Reviewed by:	Martha Taylor	Date:	06/09/2022

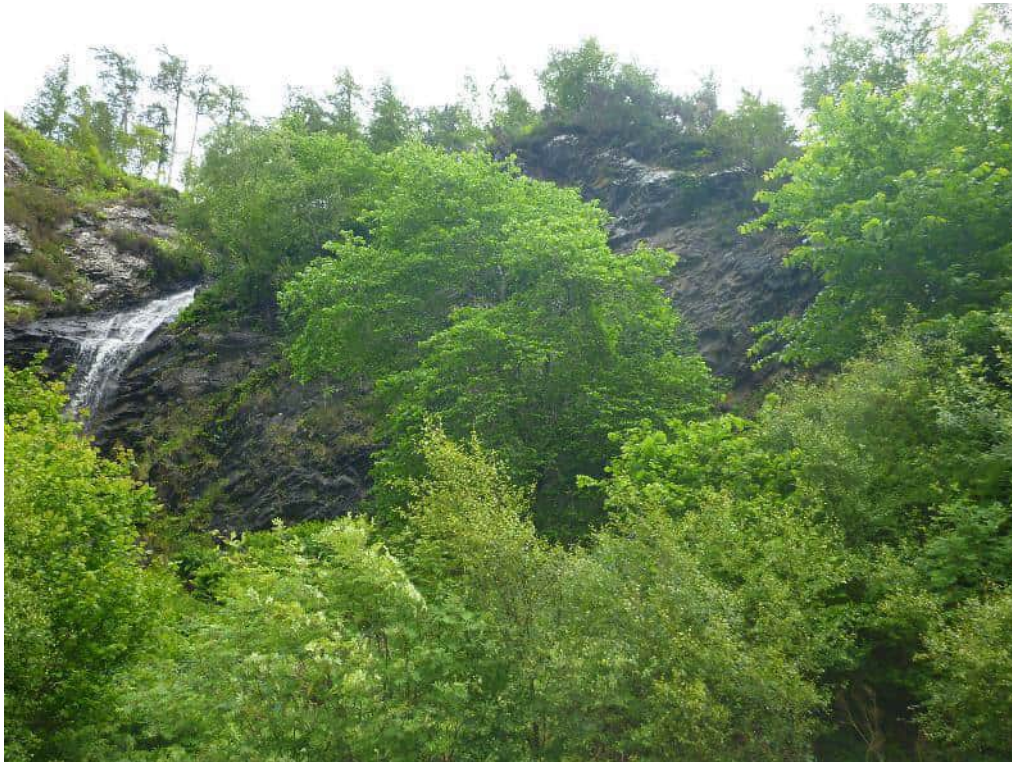
<b>Site:</b> A890 Stromeferry Bypass	<b>Slope Ref:</b> AA14E	<b>Chainage:</b> 2630 - 2664	<b>Start Grid Ref:</b> NG 90846 37438	<b>End Grid Ref:</b> NG 90871 37455	<b>Elevation:</b> 11 mAOD
--	-------------------------	---------------------------------	--	--	---------------------------

Location	Comments
Crest of slope	Large overhang with dilated joints and potential for failures to exceed catch fence capacity/height.

Overall Hazard Rating =	3	Comments
Pathway Rating =	3	
Receptor Rating =	1.4	
Risk Value =	<b>12.6</b>	
Risk Level =	<b>High</b>

- Install TECCO netting with face pattern bolts on upper half of slope with TECCO drape over lower half. Alternatively an appropriately designed catch fence could be considered;
- Accumulation of debris behind existing catch fence to be monitored during monthly and annual inspections and clearance works undertaken in the event of a failure.

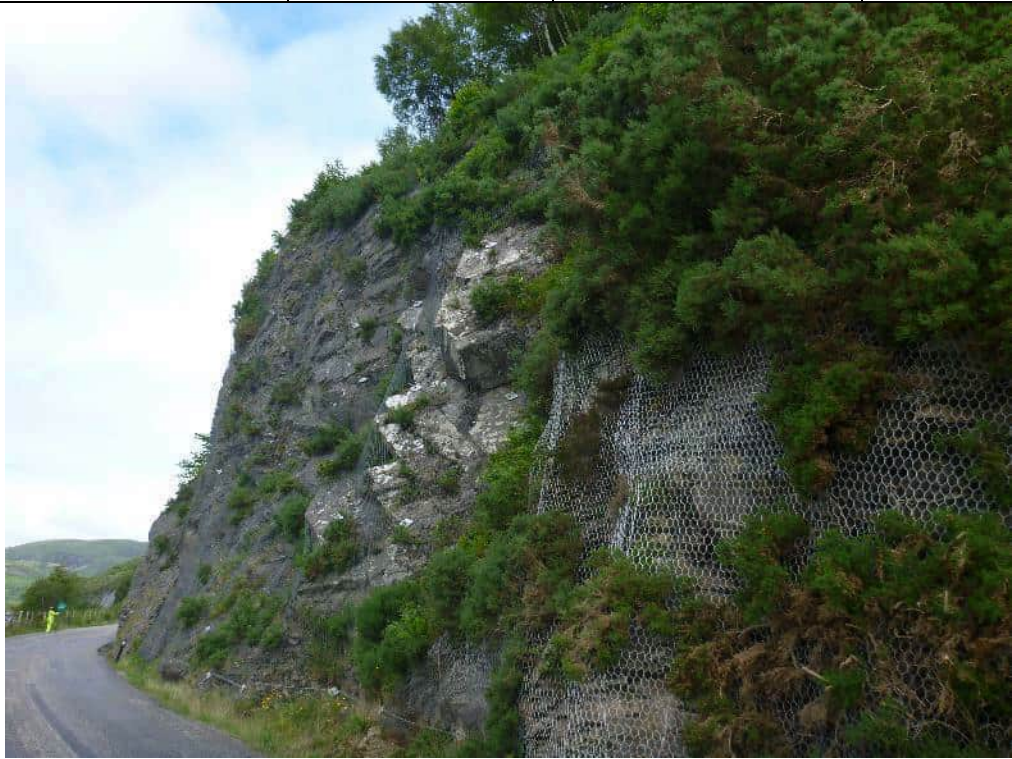
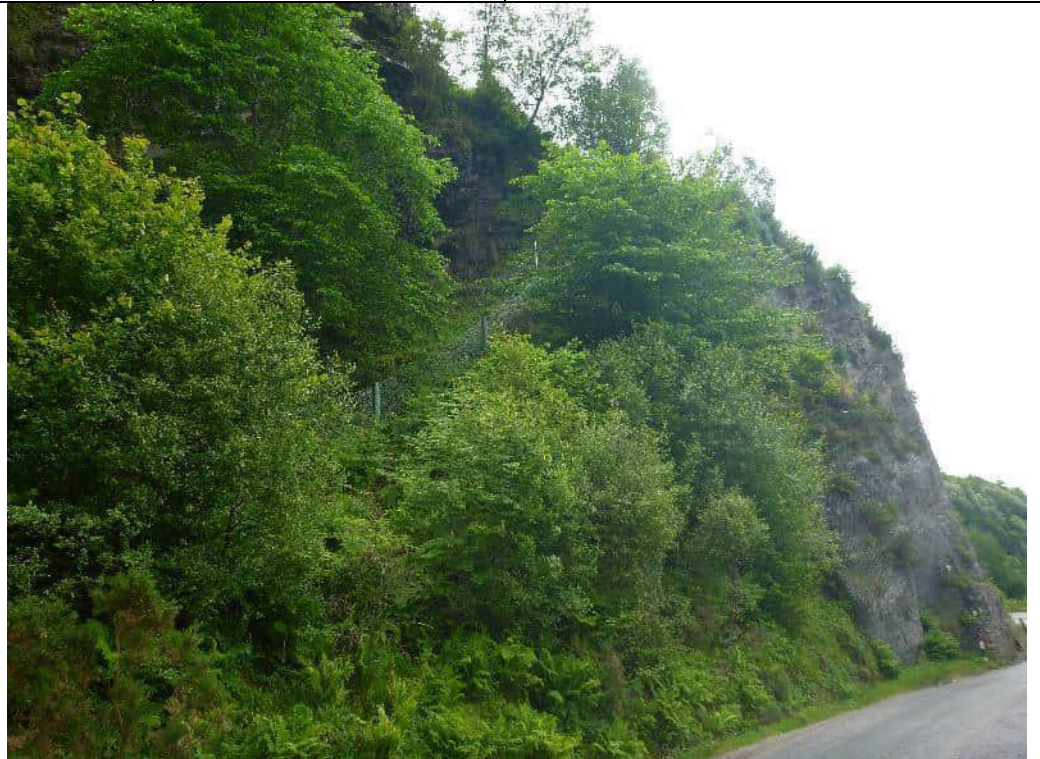
<b>Site:</b> A890 Stromeferry Bypass	<b>Slope Ref:</b> AA14W	<b>Chainage:</b> 2562- 2630	<b>Start Grid Ref:</b> NG 90796 37399	<b>End Grid Ref:</b> NG 90846 37438	<b>Elevation:</b> 12 mAOD
--	-------------------------	--------------------------------	--	--	---------------------------

Pathway Rating =	1								
Receptor Rating =	N/A		Receptor rating only applicable when pathway rating is $\geq 2$ .						
Risk Value =	2		- Formerly very high risk. Re-assessed following Phase 11 works and hazard and pathway ratings reduced. - Re-assessed during the 2022 inspection following changes to receptor rating. Risk value reduced from 2.4.						
Risk Level =	Low								
Recommended Remedial Works / Actions									
None.									
Assessed in field by:	PLM/JG	Date:	21/06/2022	Reviewed by:	Martha Taylor	Date:	06/09/2022

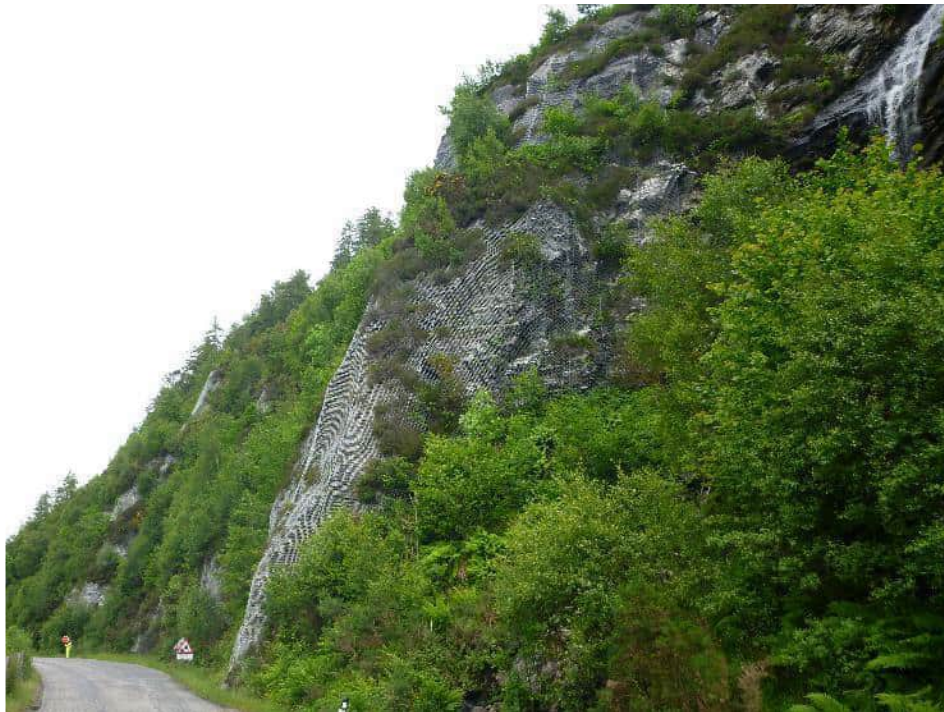
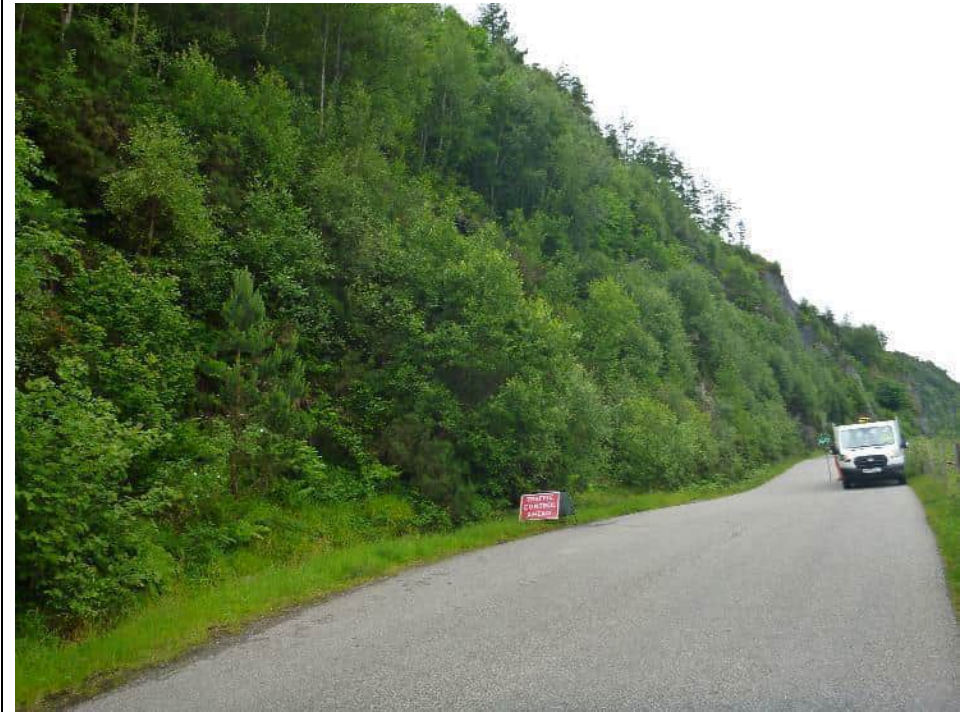
<b>Site:</b> A890 Stromeferry Bypass	<b>Slope Ref:</b> AA15	<b>Chainage:</b> 2664- 2851	<b>Start Grid Ref:</b> NG 90871 37455	<b>End Grid Ref:</b> NG 91005 37551	<b>Elevation:</b> 18 mAOD
--	------------------------	--------------------------------	--	--	---------------------------

- Active high strength netting (SPIDER mesh) installed over potential failure at Ch.2680 during Phase 8 works (2015).									
Hazards Observed									
Location		Comments							
Ch. 2790		Root jacking recorded beyond end of netting approximately 10m above road level and may have associated hazards.							
Ch. 2807-2810		Numerous blocks in roadside ditch originating from failure ca. 4-5m above road level, the largest is 0.5 x 0.4 x 0.2m. Total failure volume of ca. 0.5-0.75m <sup>3</sup> . Root jacking is evident as the cause. Dilated fracture observed to left hand side of failure scar with the potential for similar size failures to occur in the future but the 2m wide x 0.3m deep ditch/verge should contain these failures. No remedial measures determined to be required.							
Netted Section		Vegetation (particularly gorse) becoming well established on rock slope obscuring rock mass and introducing potential for root jacking.

SUMMARY			Comments						
Overall Hazard Rating =		3	Increased from 2 in 2021 to reflect increased root jacking risk,						
Pathway Rating =		2	Reduced from 3 in 2018 following re-assessment of potential for failures to reach road.						
Receptor Rating =		1.2							
Risk Value =		<b>7.2</b>							
Risk Level =		<b>Moderate</b>							
Recommended Remedial Works / Actions									
<ul style="list-style-type: none"> <li>- Coppice trees towards crest of slope outwith netting system and de-vegetate rock face within netting system;</li> <li>- Install additional top and bottom anchors (max. 5m spacing) and replace top cable.</li> </ul>									
Assessed in field by:		PLM/JG	Date:	21/06/2022	Reviewed by:	Martha Taylor	Date:	06/09/2022

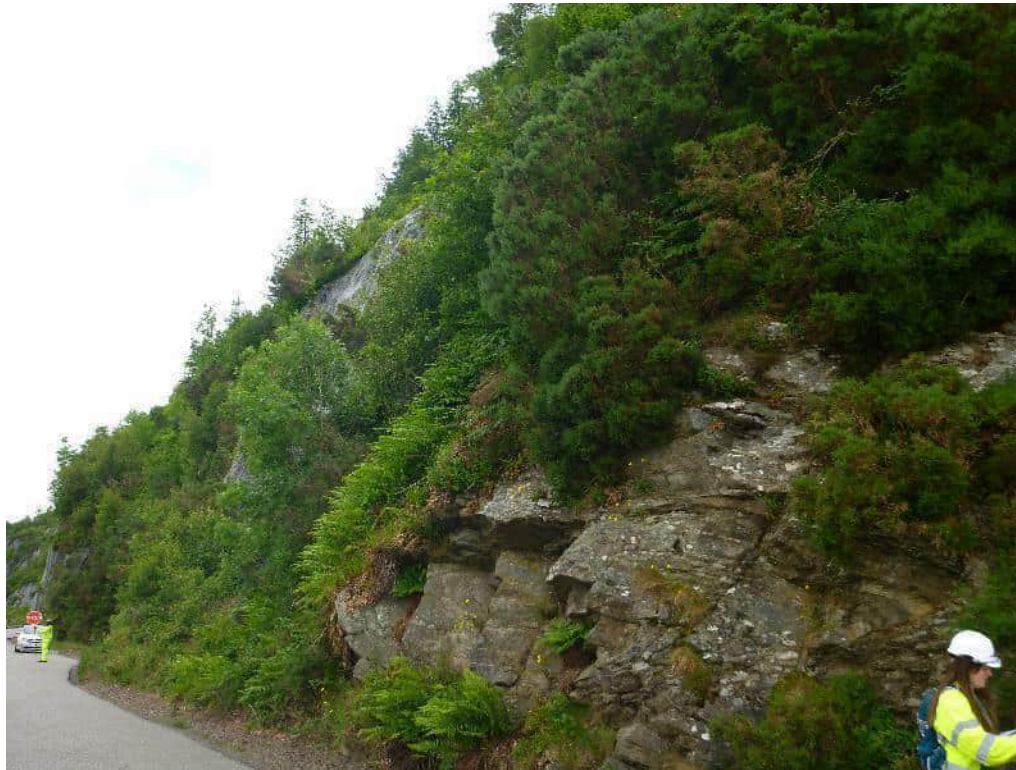
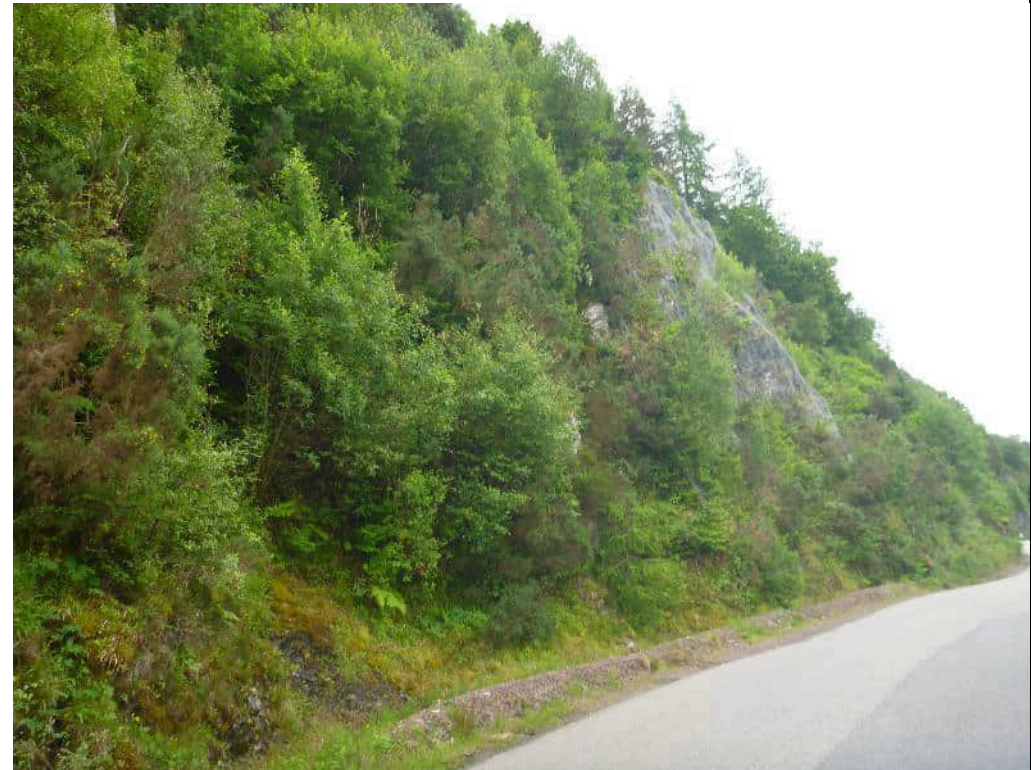
<b>Site:</b> A890 Stromeferry Bypass	<b>Slope Ref:</b> AA16	<b>Chainage:</b> 2851- 2923	<b>Start Grid Ref:</b> NG 91005 37551	<b>End Grid Ref:</b> NG 91069 37601	<b>Elevation:</b> 18 mAOD
--	------------------------	--------------------------------	--	--	---------------------------

Existing Netting Details or other remedial work details:									
Netting Type	Top cable	Typical anchor spacing (m)	Anchor Type	Cable-Anchor connection	No. of cable clamps	Netting lap connections	Laps on anchors	Vertical Reinforcing	Notes
PVC coated double twist	16mm galvanised	4 - 5	25mm galvanized bars	Galvanised eye nuts	3	3 rows of galvanised spenax rings	No	None?	Netting present between Ch. 2872 and 2899. At each top anchor on the top cable an additional dowel is located approximately 2m above and connected to the main cable with a 16mm dropper cable.
<b>Hazards Observed:</b>									
<b>Location</b>		<b>Comments</b>							
Ch. 2888		Broken rock mass 5-10m above road level. Block size ~0.1m <sup>3</sup> but total potential volume (2-3m <sup>3</sup> ) may exceed netting capacity. Tree causing root jacking.							
Ch. 2910		Overhang noted at the crest of the slope, however, rope access inspection indicated generally keyed in with no obvious dilation of joints. Area to be kept under observation in future inspections for signs of deterioration.

General		Vegetation well established.							
<b>SUMMARY</b>					<b>Comments</b>				
Overall Hazard Rating =		3		Increased form 2 in 2021 to reflect increased root jacking risk.					
Pathway Rating =		2							
Receptor Rating =		1							
Risk Value =		6							
Risk Level =		Moderate							
<b>Recommended Remedial Works / Actions</b>									
<ul style="list-style-type: none"> <li>- Coppice tree at Ch.2888</li> <li>- Vegetation clearance / tree coppicing across slope</li> <li>- Build-up of debris in ditch should be monitored during monthly and annual inspections and clearance works undertaken as required to maintain its capacity.</li> </ul>									
<b>Assessed in field by:</b>		PLM/JG		<b>Date:</b> 21/06/2022		<b>Reviewed by:</b> Martha Taylor		<b>Date:</b> 06/09/2022

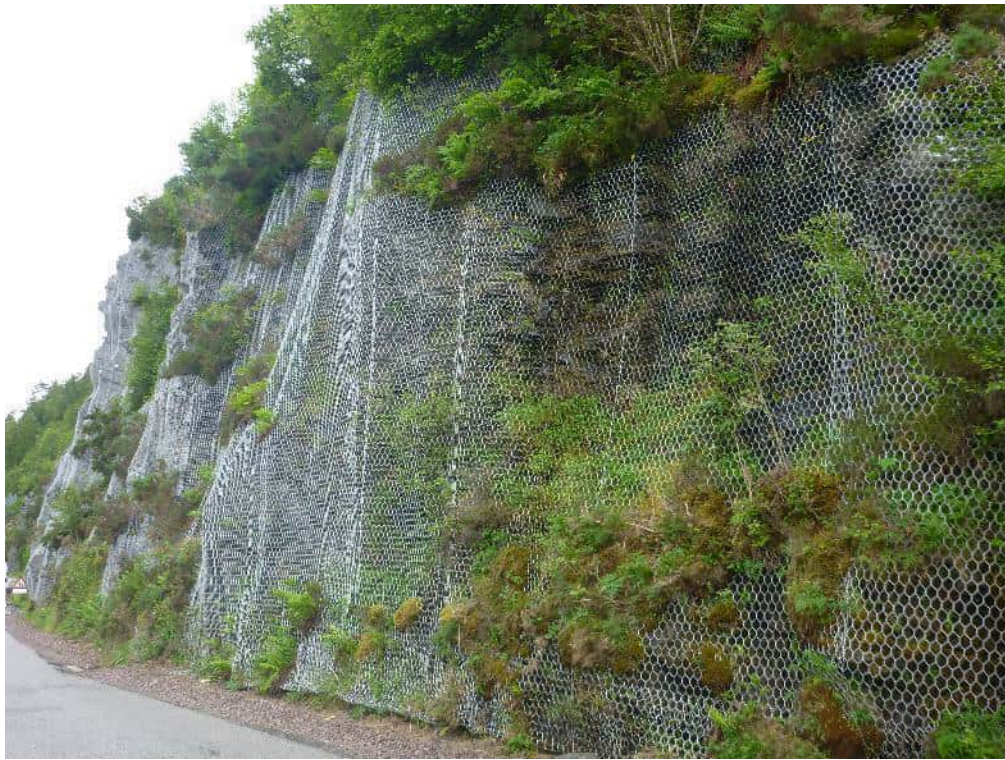
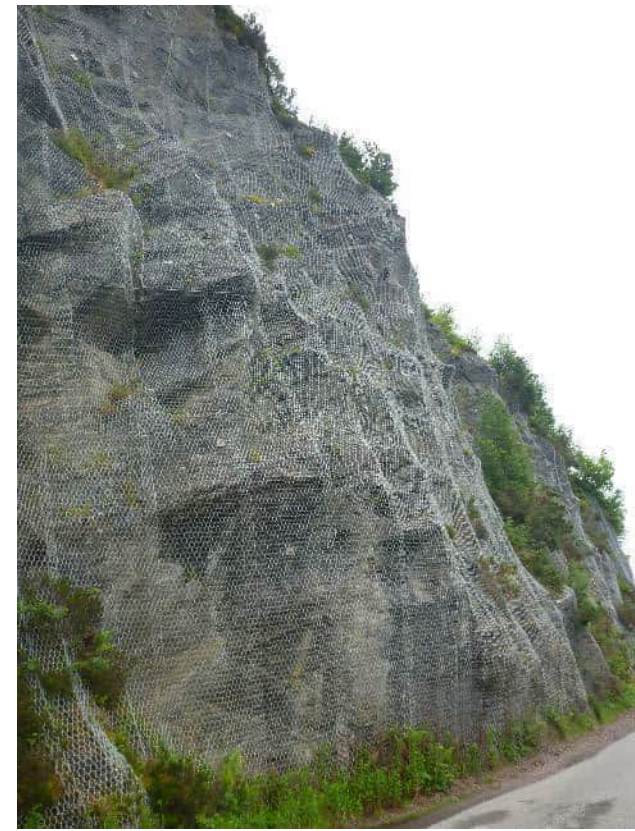
<b>Site:</b> A890 Stromeferry Bypass	<b>Slope Ref:</b> AA17	<b>Chainage:</b> 2923- 2987	<b>Start Grid Ref:</b> NG 91069 37601	<b>End Grid Ref:</b> NG 91123 37630	<b>Elevation:</b> 11 mAOD
--	------------------------	--------------------------------	--	--	---------------------------

Existing Netting Details or other remedial work details:										
Netting Type	Top cable	Typical anchor spacing (m)	Anchor Type	Cable-Anchor connection	No. of cable clamps	Netting lap connections	Laps on anchors	Vertical Reinforcing	Notes	
PVC coated double twist	16-20mm galvanised	2.5m at crest but up to 12m at toe	25mm galvanized bars	None	2	Netting joined with cable twists and lacing wire, with additional Spenax rings installed in 2015	No	None but numerous lateral/diagonal reinforcing cables (note that many of the anchors for these appear corroded).	New top cable and anchors and additional spenax jointing installed during Phase 8 works (2015).  Bottom cable has some localised corrosion (first observed during the 2022 annual inspection)	
<b>Hazards Observed:</b>										
<b>Ref</b>		<b>Comments</b>								
Ch. 2933-2946		Large area of blast damaged rock mass with potential to exceed capacity of mesh in event of failure.

Ch. 2965		Large wedge approximately 10m above road level, with smaller wedge above. Rope access inspection confirmed blocks are currently keyed in but condition should be monitored during future inspections.								
Ch. 2923-2935		Wide spacing of bottom anchors (up to 12m) with partially buried mesh and corroded eyelets observed.								
<b>SUMMARY</b>				<b>Comments</b>						
Overall Hazard Rating =		3								
Pathway Rating =		3								
Receptor Rating =		1.2								
Risk Value =		<b>10.8</b>								
Risk Level =		<b>High</b>								
<b>Recommended Remedial Works / Actions</b>										
<ul style="list-style-type: none"> <li>- Ch. 2933-2946: Open up Macafferri netting and carry out scaling before re-assessing. Netting to be reinstated on completion.</li> <li>- Replace corroded anchor points on reinforcing cables.</li> </ul>										
<b>Assessed in field by:</b>		PLM/JG		<b>Date:</b>		21/06/2022		<b>Reviewed by:</b>		<b>Date:</b>

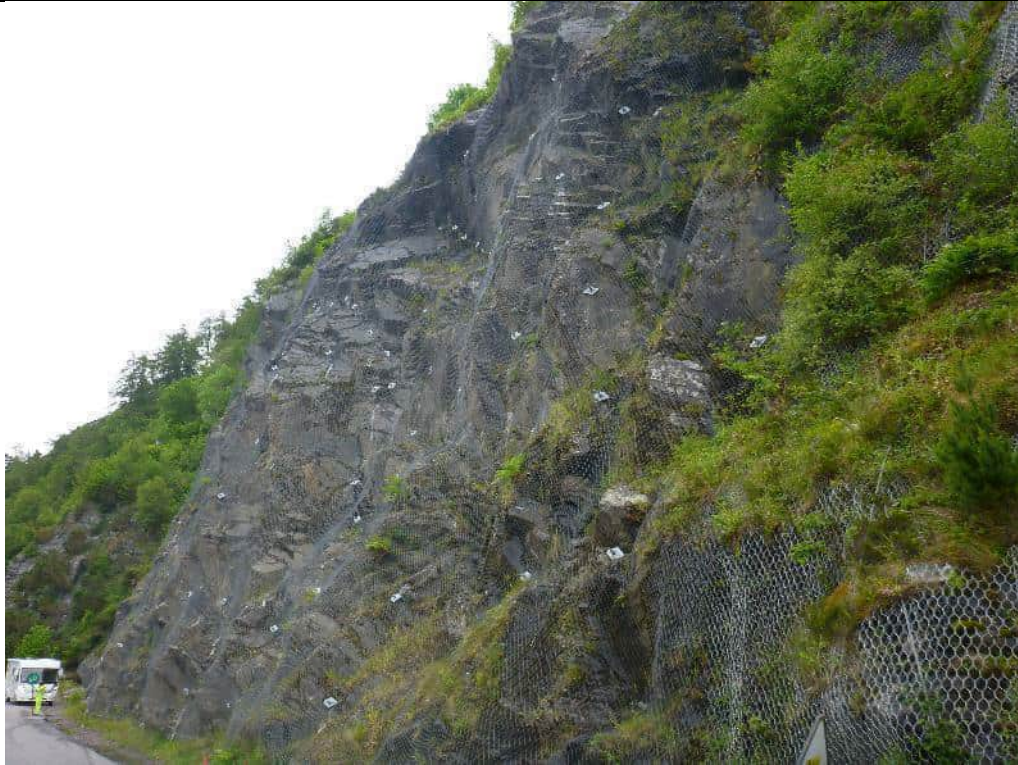
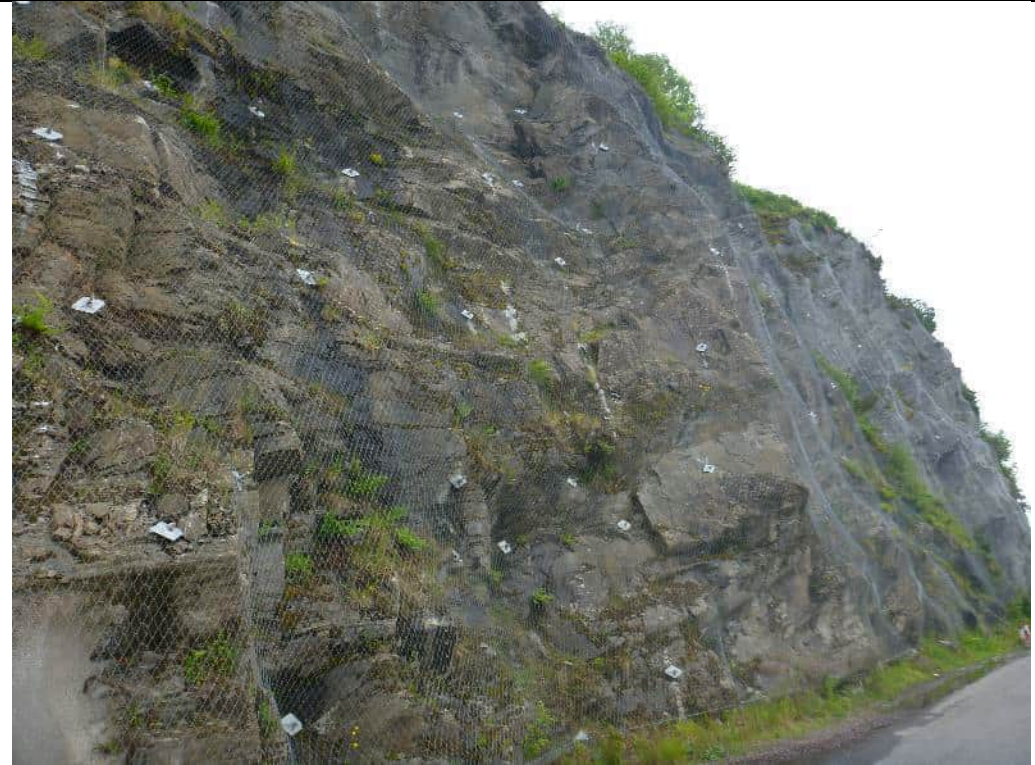
<b>Site:</b> A890 Stromeferry Bypass	<b>Slope Ref:</b> AA18	<b>Chainage:</b> 2987- 3059	<b>Start Grid Ref:</b> NG 91123 37630	<b>End Grid Ref:</b> NG 91186 37649	<b>Elevation:</b> 10 mAOD
--	------------------------	--------------------------------	--	--	---------------------------

Maccaferri drape netting removed and replaced by active Tecco netting system in 2018 (Phase 10 works). De-vegetation and scaling also carried out at this time and a sprayed concrete buttress installed. Netting system in good condition but installation of incorrect spike plate / nut combination has not been resolved.

Ch.3032: Potential corrosion of netting mid-slope and bottom cable observed during the 2022 annual inspection. To be inspected at height in 2023.

Location	Comments
	No significant hazards.
Ch.2995	Some loose blocks behind netting near crest. One block c.0.15m x 0.15m x 0.15m caught behind netting and pulling netting out slightly from slope.
Ch.3012	A few small blocks sitting on ledge of rock face c.7m from toe. Not straining or deforming mesh so removal not required.

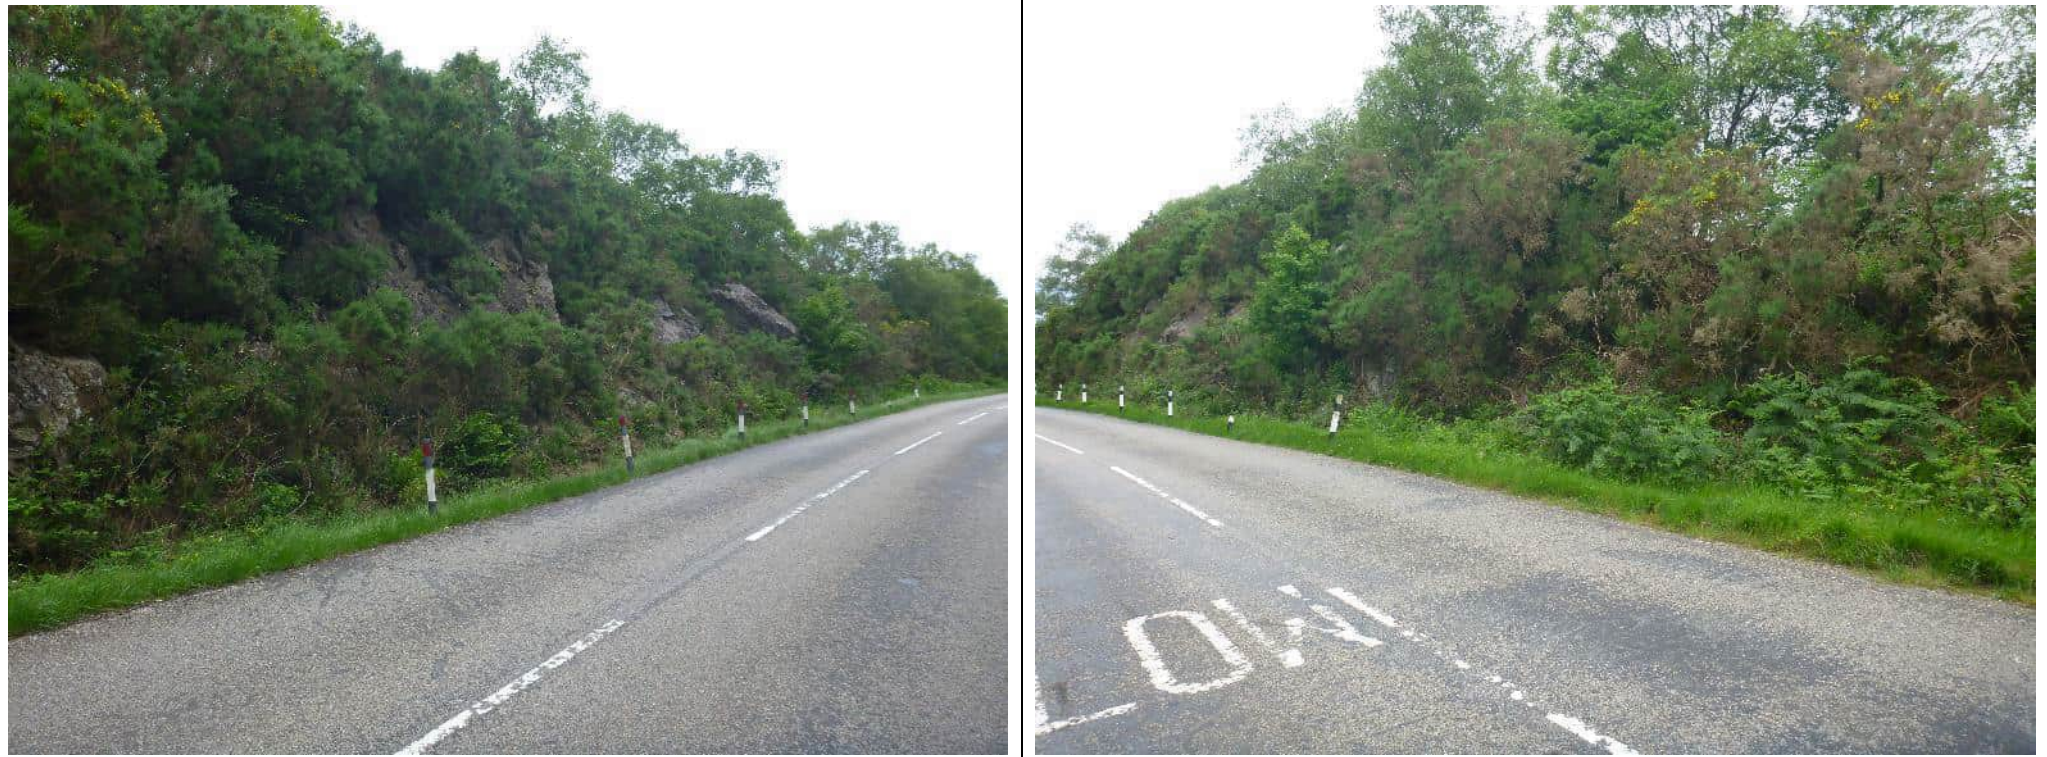
Rock Slope Characteristics:															
Dip:	60	Azimuth:	230	Height (m):	6	Length (m):	50	Vegetation Cover:	c.50% cover: predominantly gorse	Ditch Details:	1m wide, 0.2m deep	Roughness (Profile):	Rough	Verge Details:	0.5m

**Engineering Description of Rock:**  
 Very strong very thinly banded grey and white GNEISS.

Hazards Observed:			
Location		Comments	
Northern end of slope		Localised root jacking (see photos above), however, small blocks will be retained by ditch.	
Ch. 3669		Block fall c.0.4m x 0.4m x 0.3m has landed in the ditch. Block originated c.2m up rock slope. (Observed during the 2022 annual inspection)	
SUMMARY		Comments	
Overall Hazard Rating =	1		
Pathway Rating =	2		
Receptor Rating =	1.2		
Risk Value =	<b>2.4</b>		
Risk Level =	<b>Low</b>		
Recommended Remedial Works / Actions			
<ul style="list-style-type: none"> <li>- Build-up of debris within ditch should be monitored and clearance works undertaken as required to maintain its capacity.</li> </ul>			
Assessed in field by:	PLM/JG	Date:	22/06/2022
		Reviewed by:	Martha Taylor
		Date:	06/09/2022
